NC DEPARTMENT OF TRANSPORTATION  
 DIVISION OF HIGHWAYS  
 STRUCTURE MANAGEMENT UNIT

ATTENTION: PARS SUBMITTED

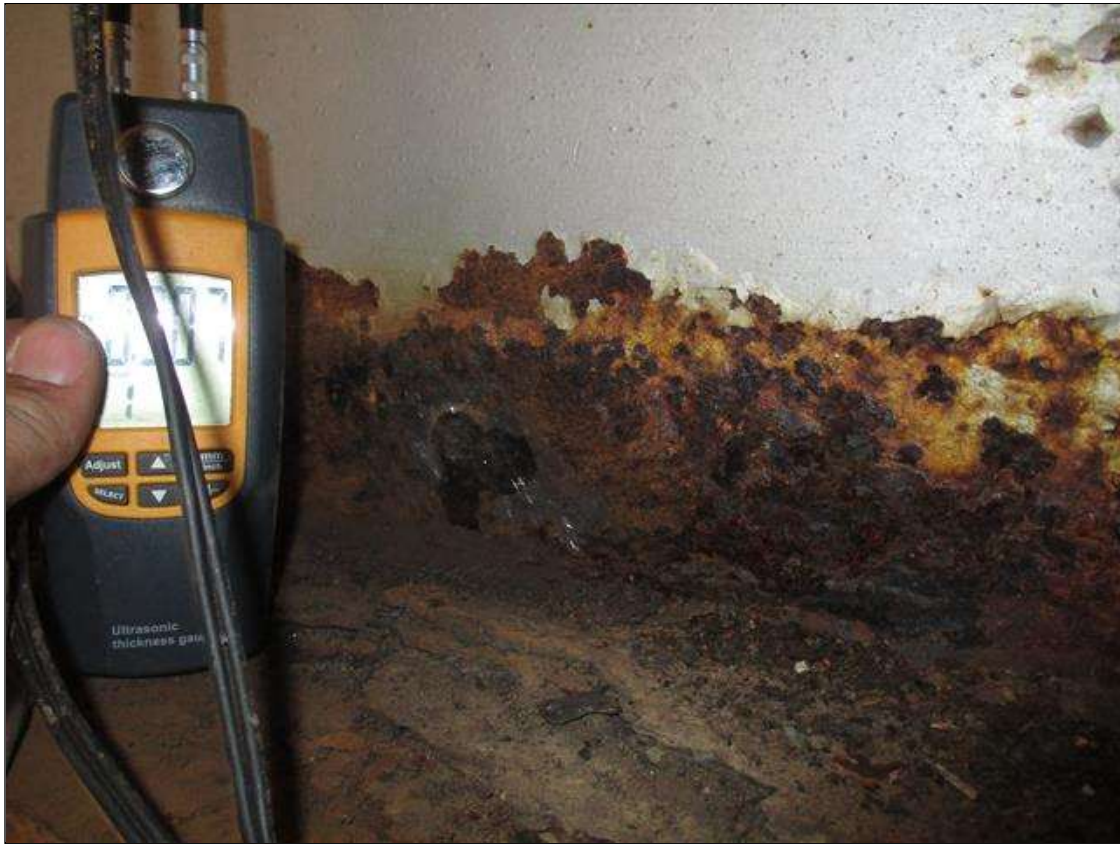
Span 1 Beam 2: (PAR) CORROSION ALONG RIGHT FACE OF WEB AND BOTTOM FLANGE UP TO 39" LONG X 10" HIGH DOWN TO 0.3" RESIDUAL WEB, AND 35" LONG X 5" WIDE DOWN TO 0.48" RESIDUAL FLANGE AT BENT 1 BEARING

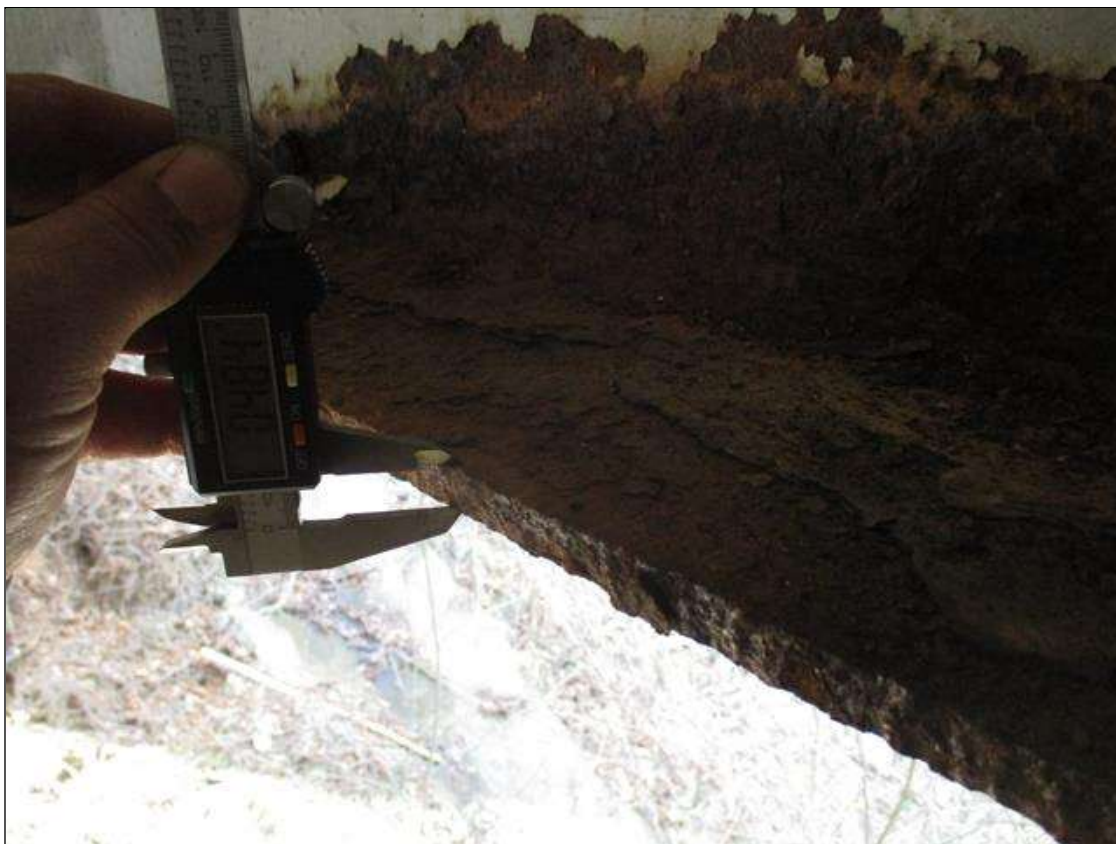
Span 1 Beam 2: (PAR) CORROSION ALONG RIGHT FACE OF WEB AND BOTTOM FLANGE UP TO 39" LONG X 10" HIGH DOWN TO 0.3" RESIDUAL WEB, AND 35" LONG X 5" WIDE DOWN TO 0.48" RESIDUAL FLANGE AT BENT 1 BEARING

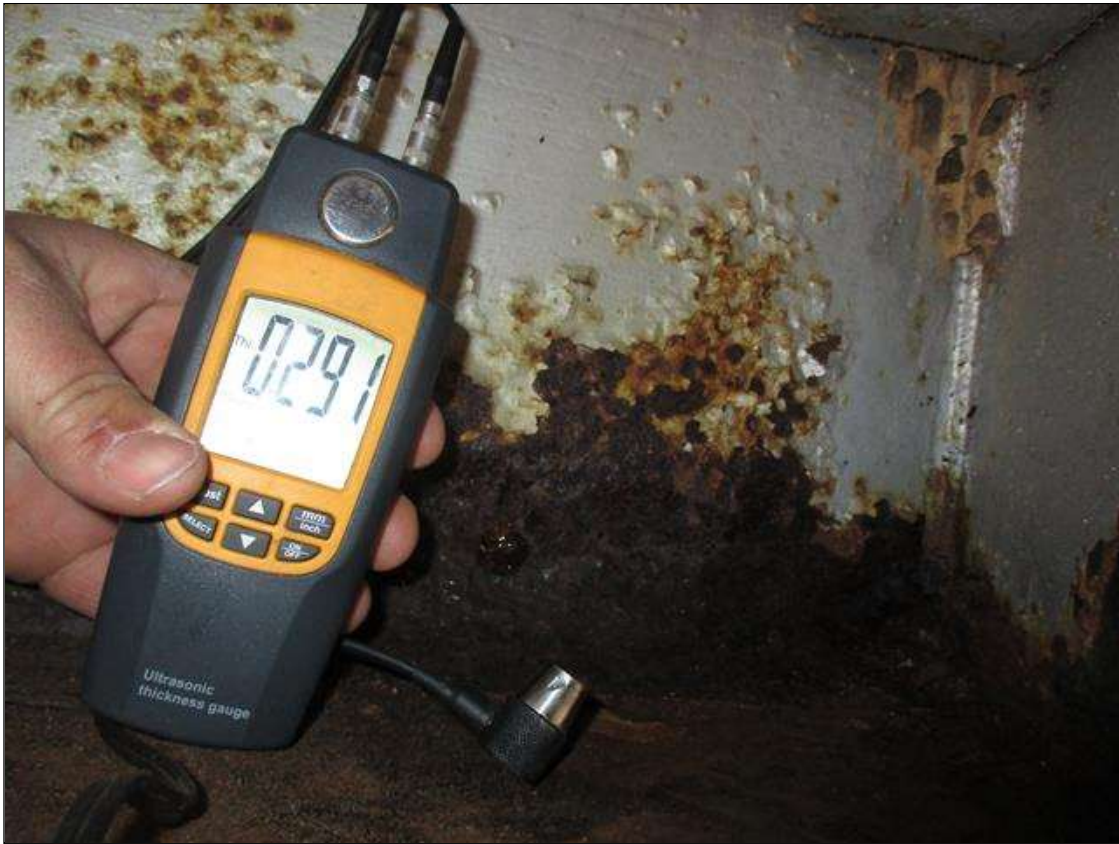
Span 1 Beam 3: (PAR) CORROSION ALONG BOTH FACES OF WEB AND BOTTOM FLANGE UP TO 34" LONG X 24" HIGH DOWN TO 0.291" RESIDUAL WEB, AND 36" LONG X 5" WIDE DOWN TO 0.289" RESIDUAL FLANGE AT BENT 1 BEARING

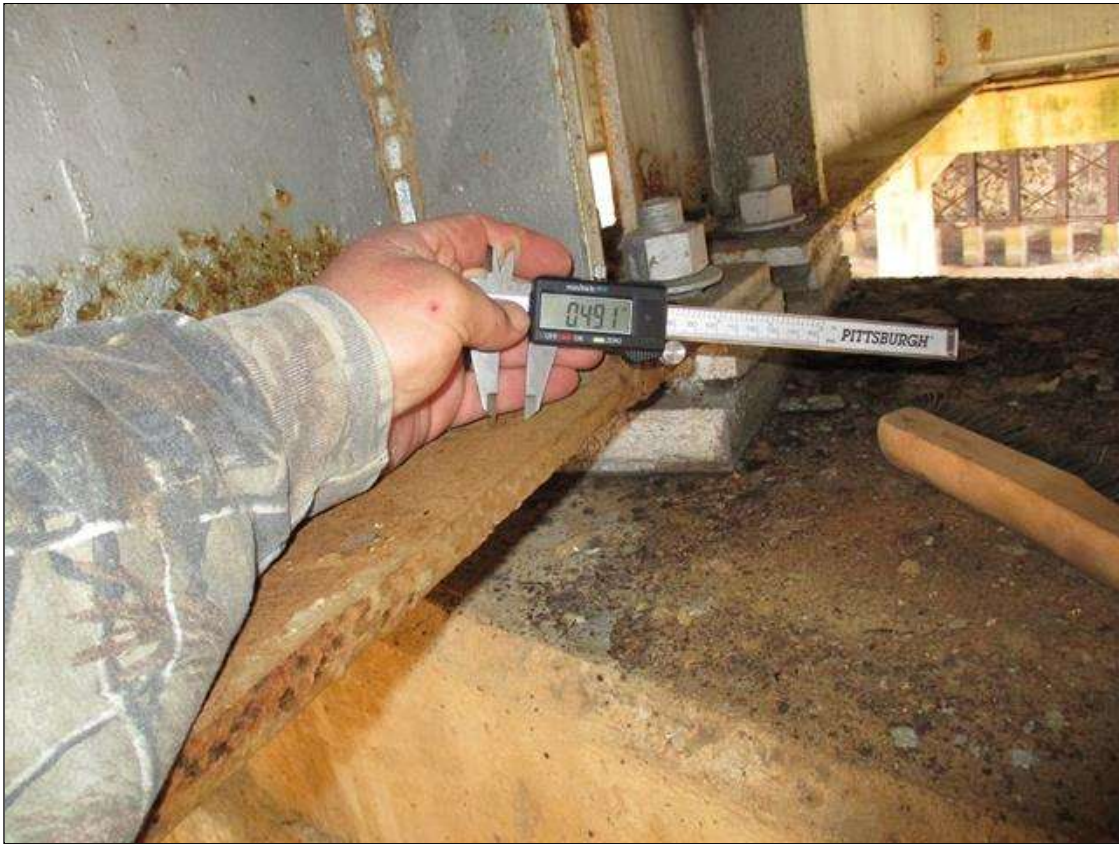
Span 1 Beam 4: (PAR) CORROSION ALONG RIGHT FACE OF WEB AND BOTTOM FLANGE UP TO 36" LONG X 4" HIGH WITH NO MEASURABLE LOSS OF SECTION BENEATH PAINT REPAIR IN WEB, AND 20" LONG X 5" WIDE DOWN TO .49" RESIDUAL FLANGE, APPROXIMATELY 4" FROM FACE OF BENT 1 BEARING

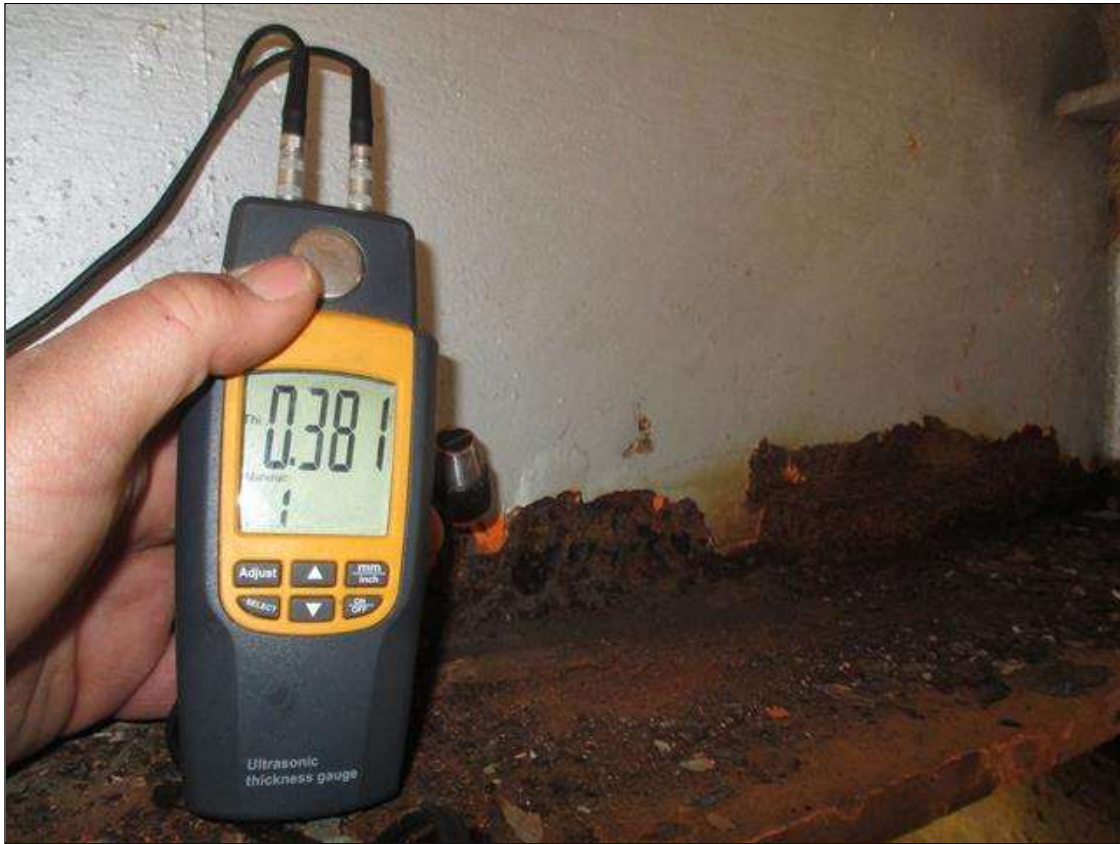
Span 1 Beam 5: (PAR) CORROSION AT BEAM END DOWN TO .38" IN LOWER WEB

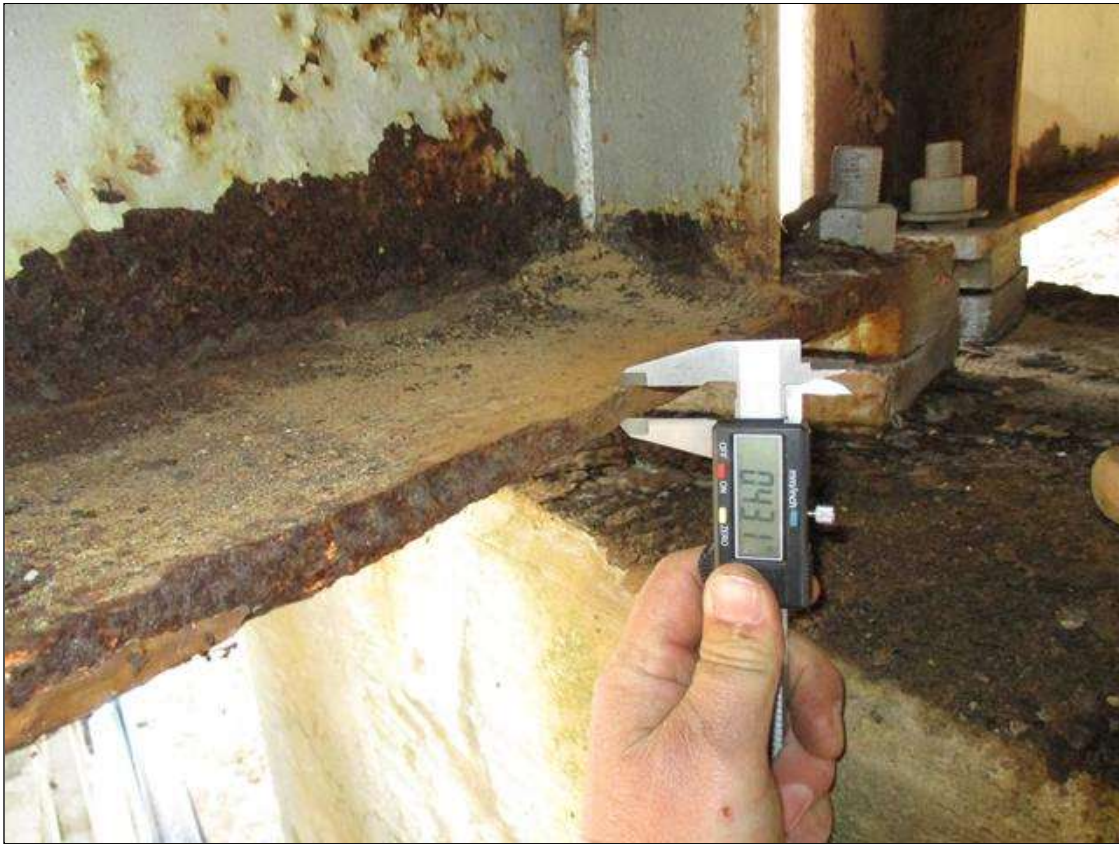
Span 2 Beam 1: (PAR) CORROSION ALONG BOTH FACES OF WEB AND BOTTOM FLANGE UP TO 36" LONG X 24" HIGH SURFACE CORROSION ON WEB, AND 36" LONG X 11 3/4" WIDE DOWN TO .431" RESIDUAL FLANGE AT BENT 2 BEARING

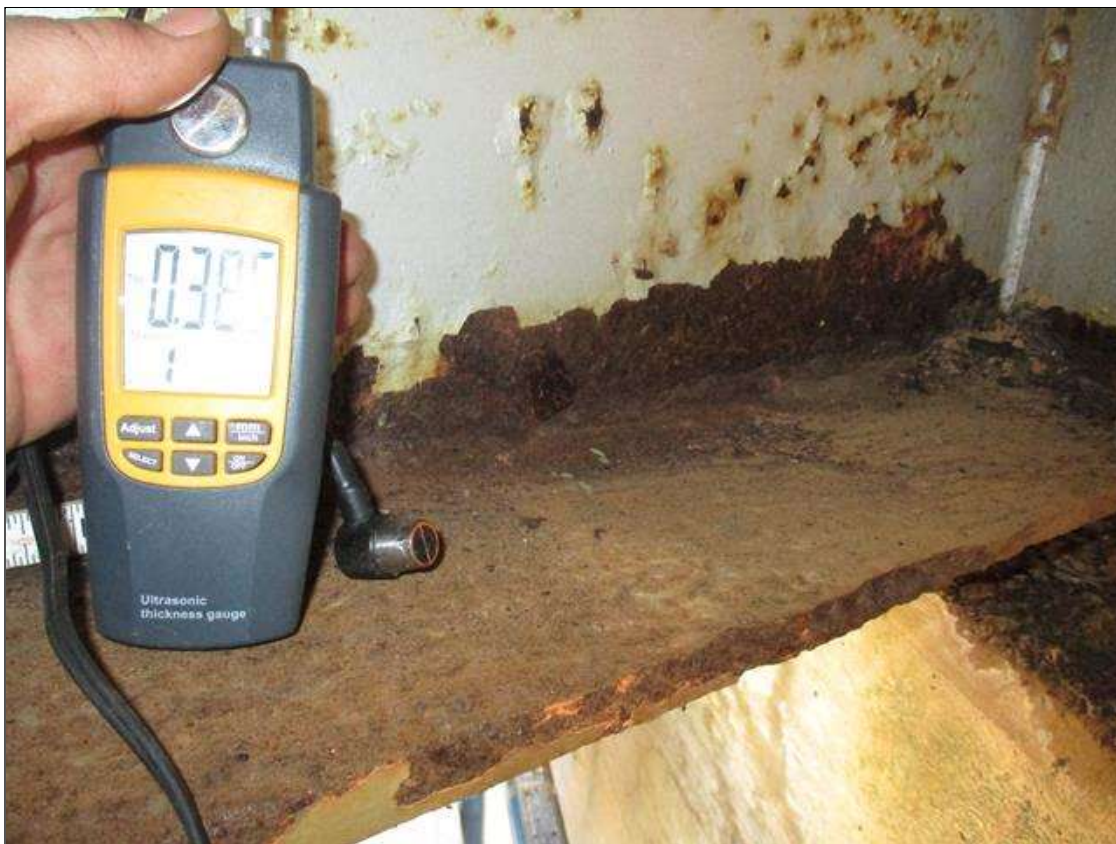
Span 2 Beam 1: (PAR) CORROSION ALONG BOTH FACES OF WEB AND BOTTOM FLANGE UP TO 68" LONG X 10" HIGH DOWN TO 0.431" RESIDUAL WEB, AND 61" LONG X 11 3/4" WIDE DOWN TO 5/8" RESIDUAL FLANGE AT BENT 1 BEARING

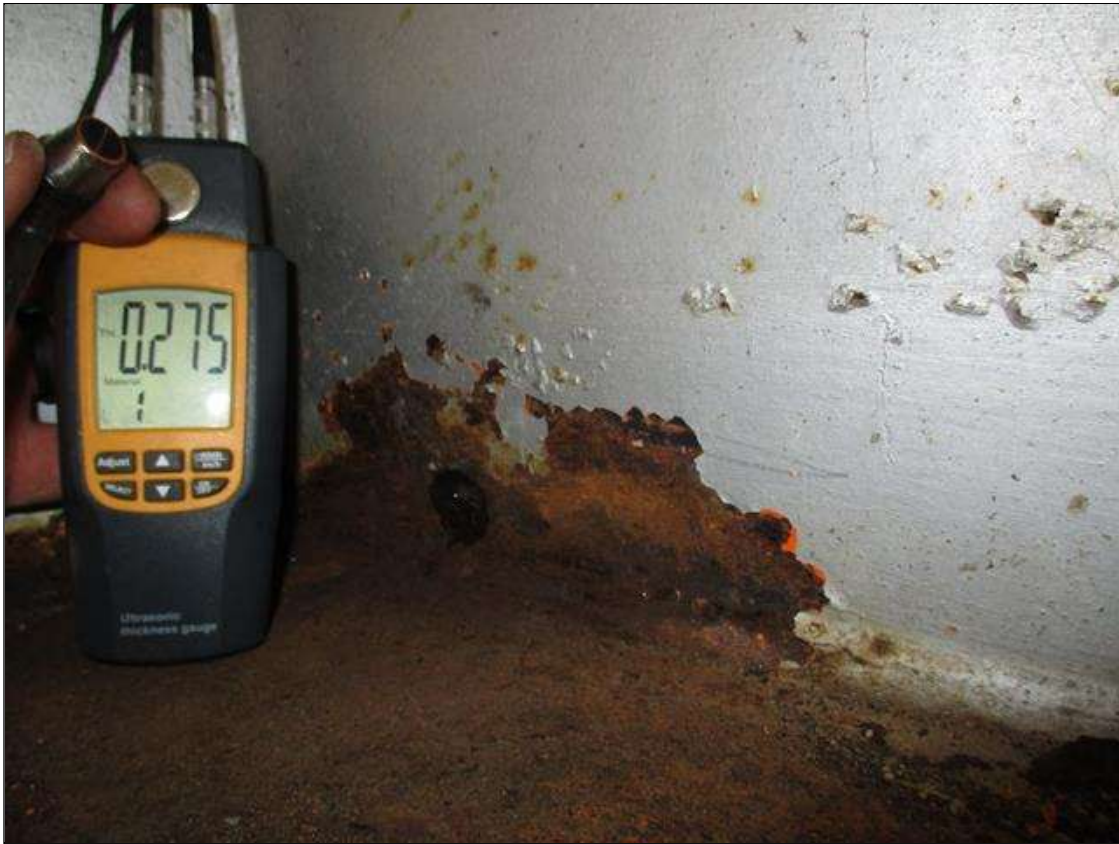
Span 2 Beam 2: (PAR) CORROSION ALONG BOTH FACES OF WEB AND BOTTOM FLANGE UP TO 33" LONG X 6" HIGH DOWN TO 0.275" RESIDUAL WEB, AND 34" LONG X 5" WIDE DOWN TO .328" RESIDUAL FLANGE AT BENT 2 BEARING

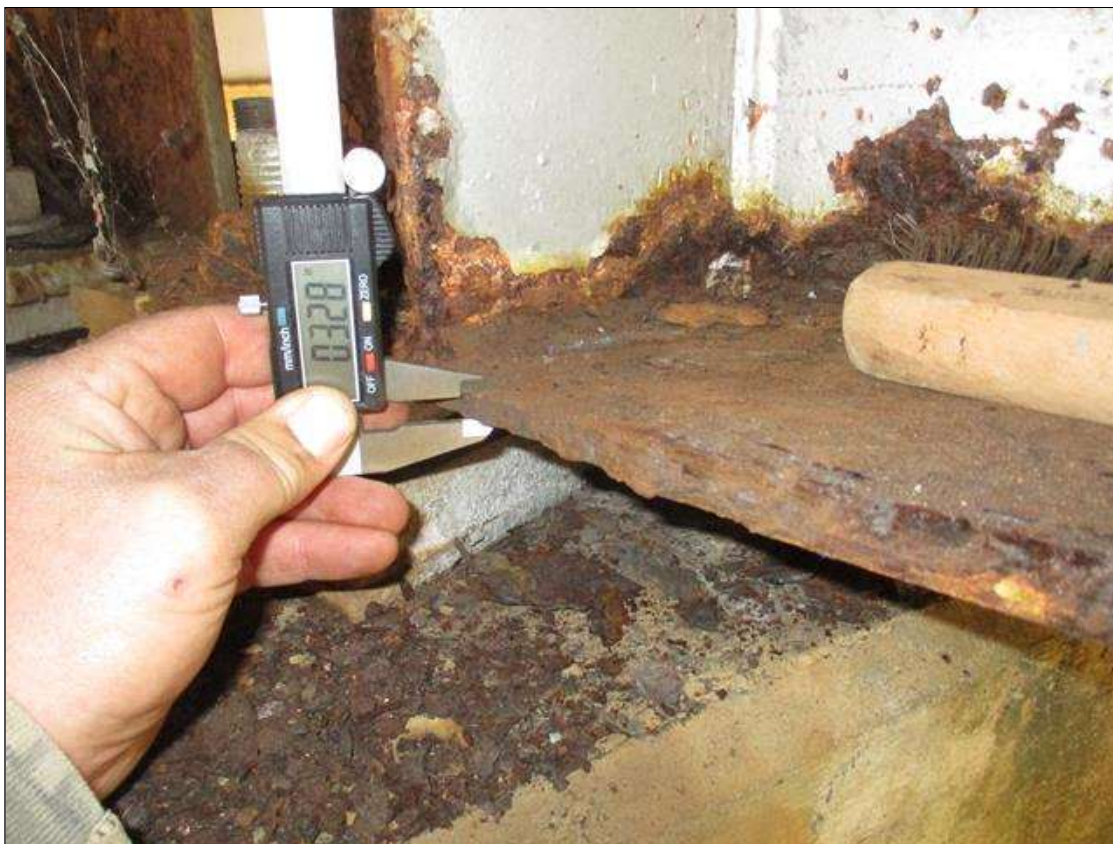
Span 2 Beam 2: (PAR) CORROSION ALONG BOTH FACES OF WEB AND BOTTOM FLANGE UP TO 33" LONG X 6" HIGH DOWN TO 0.275" RESIDUAL WEB, AND 34" LONG X 5" WIDE DOWN TO .328" RESIDUAL FLANGE AT BENT 2 BEARING

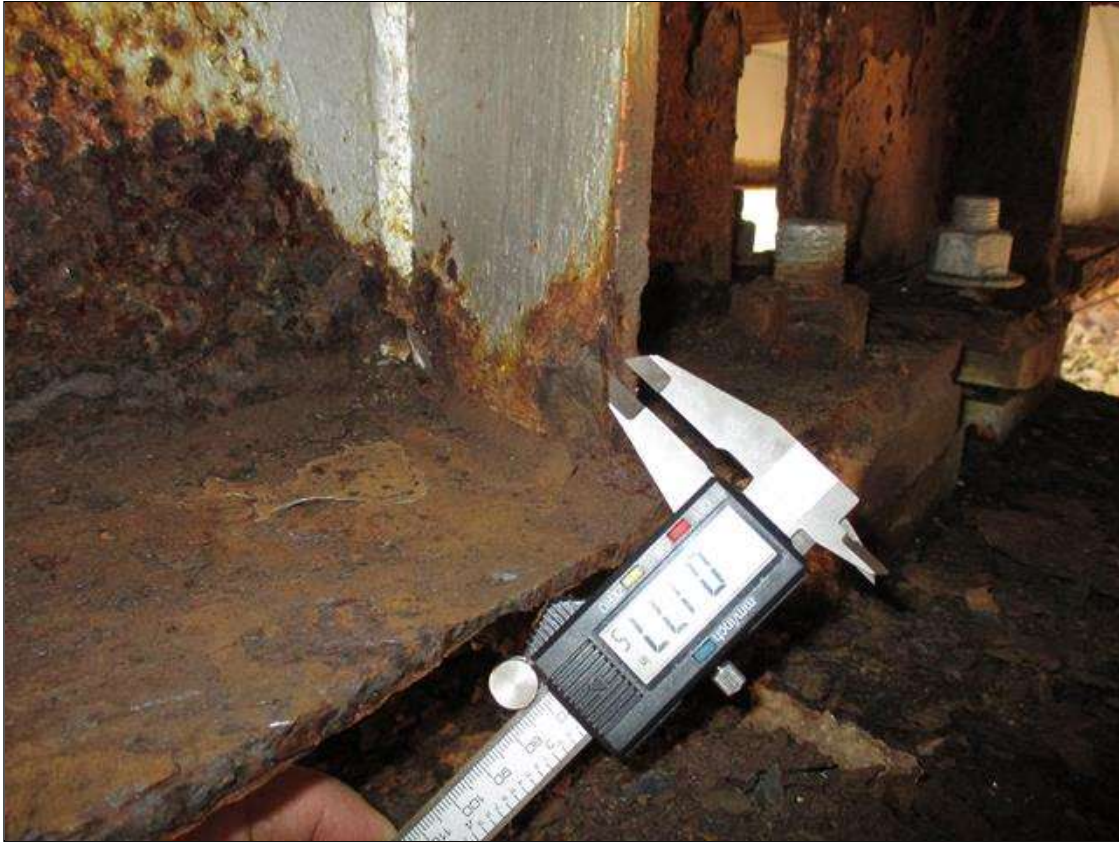
Span 2 Beam 3: (PAR) CORROSION ALONG BOTH FACES OF WEB AND BOTTOM FLANGE UP TO 25" LONG X 24" HIGH DOWN TO RESIDUAL WEB WITH 3" X 3" LOSS OF SECTION, AND 24" LONG X 11 3/4" WIDE DOWN TO .177" RESIDUAL FLANGE AT BENT 2 BEARING

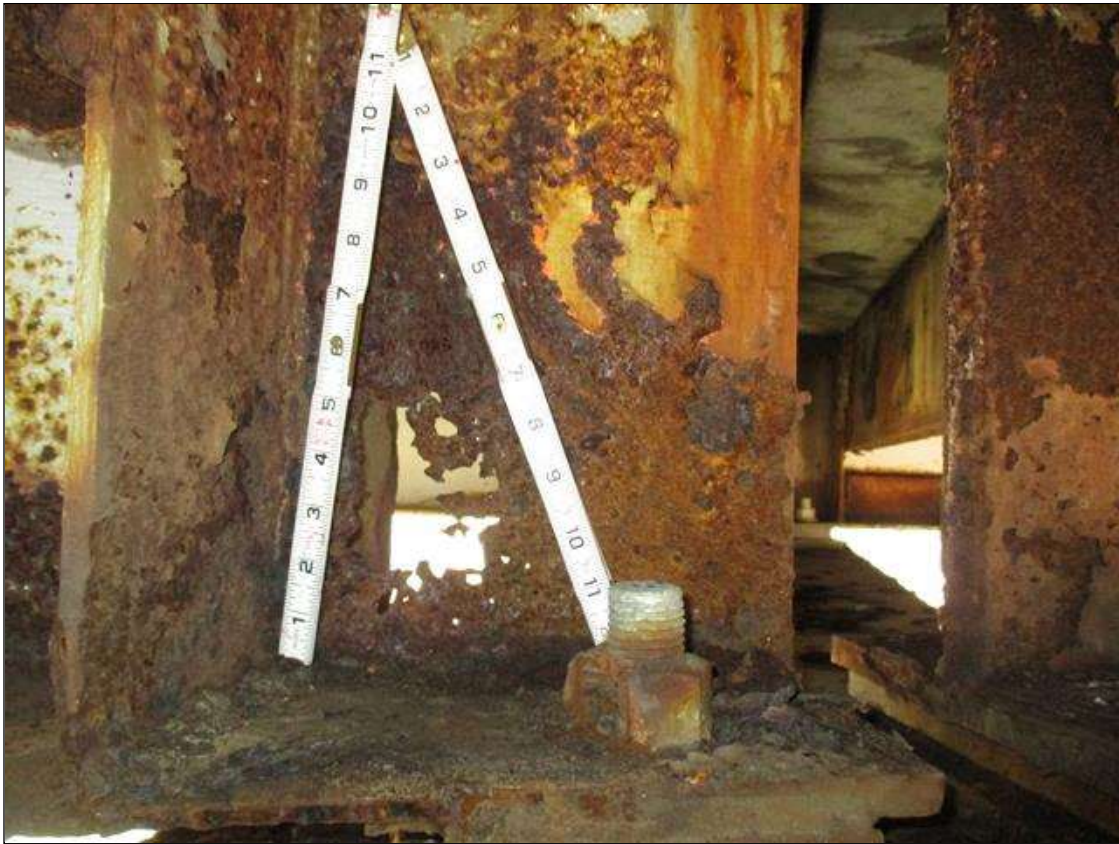
Span 2 Beam 3: (PAR) 100% SECTION LOSS FOR 7" LONG x 7" HIGH x 4" WIDE OVER BENT 2 BEARING

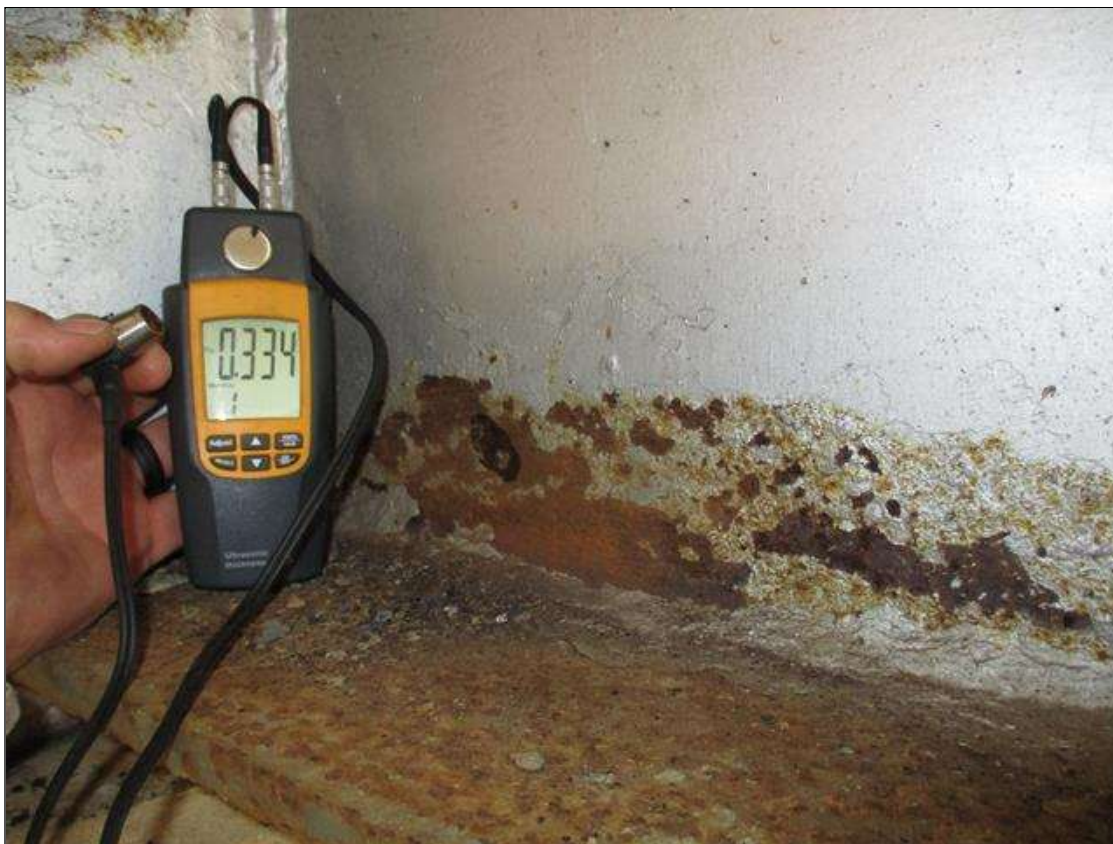
Span 2 Beam 4: (PAR) CORROSION ALONG LEFT FACE OF WEB AND BOTTOM FLANGE UP TO 60" LONG X 5" HIGH WITH DOWN TO 0.334" RESIDUAL WEB, AND 60" LONG X 11 3/4" WIDE DOWN TO 9/16" RESIDUAL FLANGE AT BENT 1 BEARING

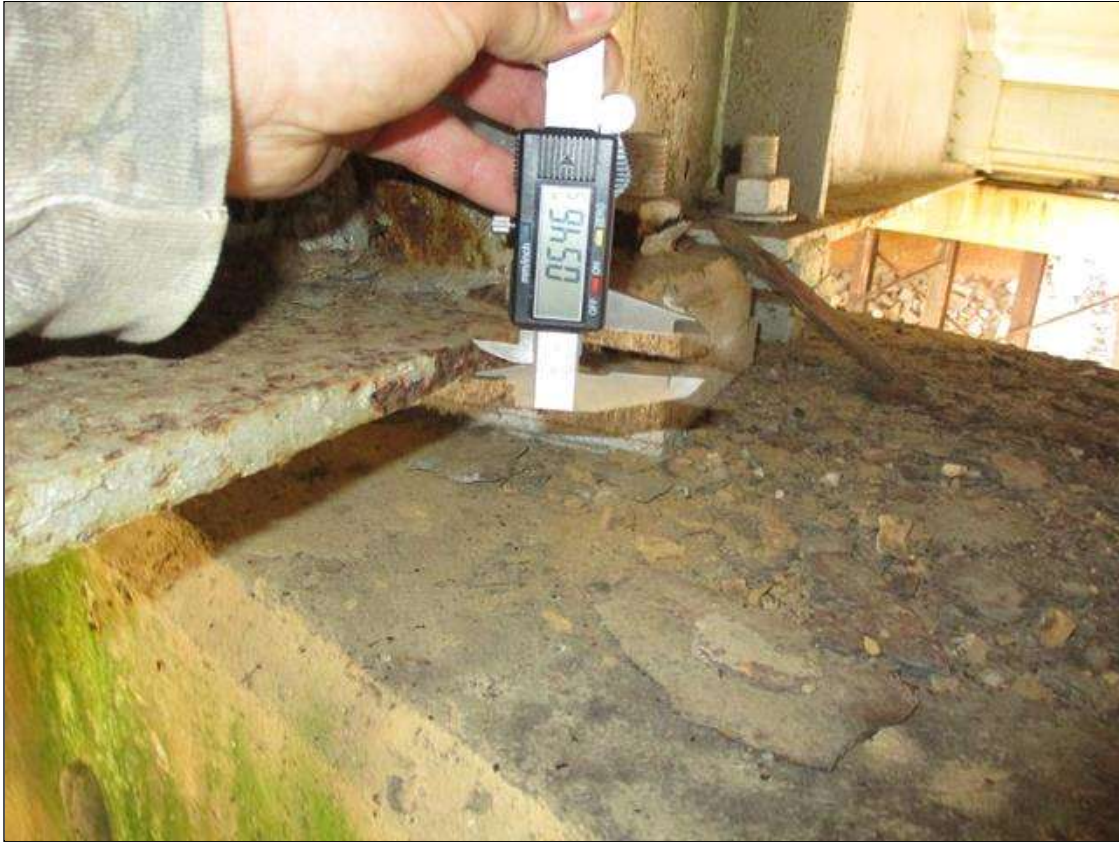
Span 2 Beam 5: (PAR) CORROSION ALONG BOTH FACES OF WEB AND BOTTOM FLANGE UP TO 17" LONG X 3" HIGH WITH NO MEASURABLE LOSS OF SECTION IN WEB, AND 14" LONG X 6" WIDE DOWN TO .546" RESIDUAL FLANGE AT BENT 2 BEARING

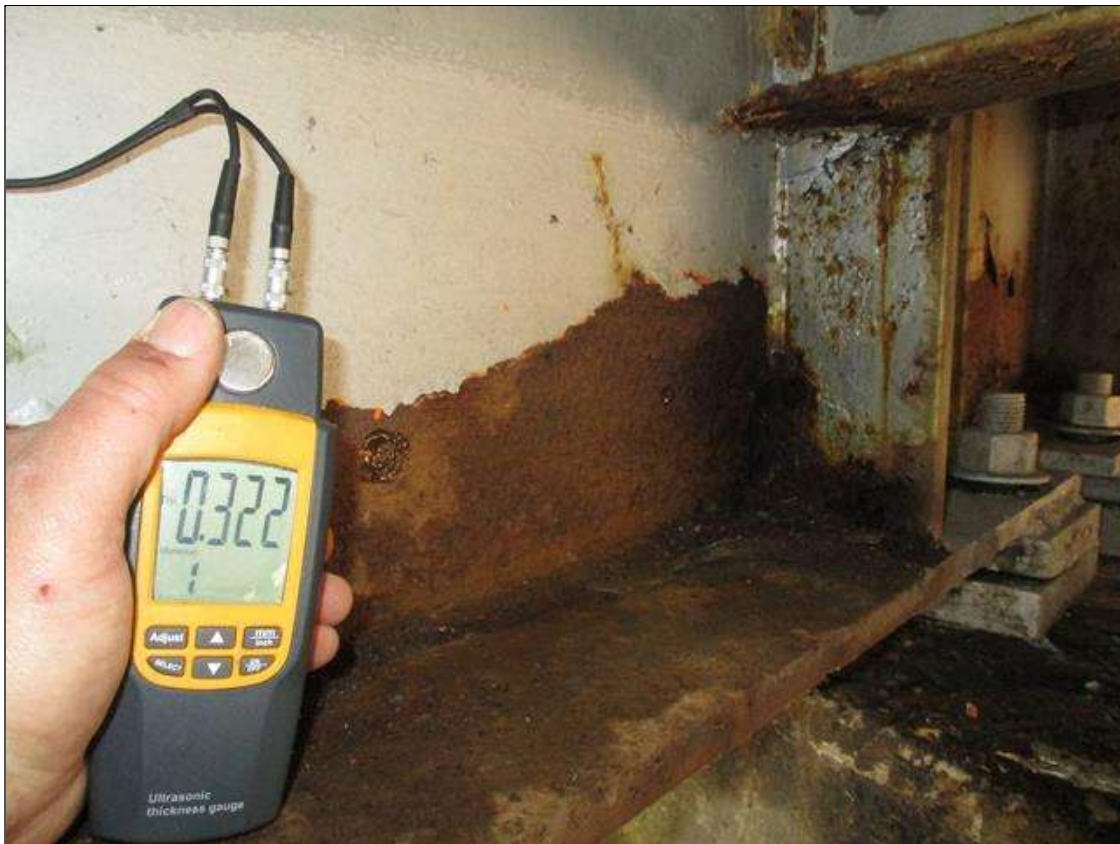
Span 2 Beam 5: (PAR) CORROSION ALONG BOTH FACES OF WEB UP TO 55" LONG X 10" HIGH WITH DOWN TO 0.322" REMAINING RESIDUAL WEB AT BENT 1 BEARING

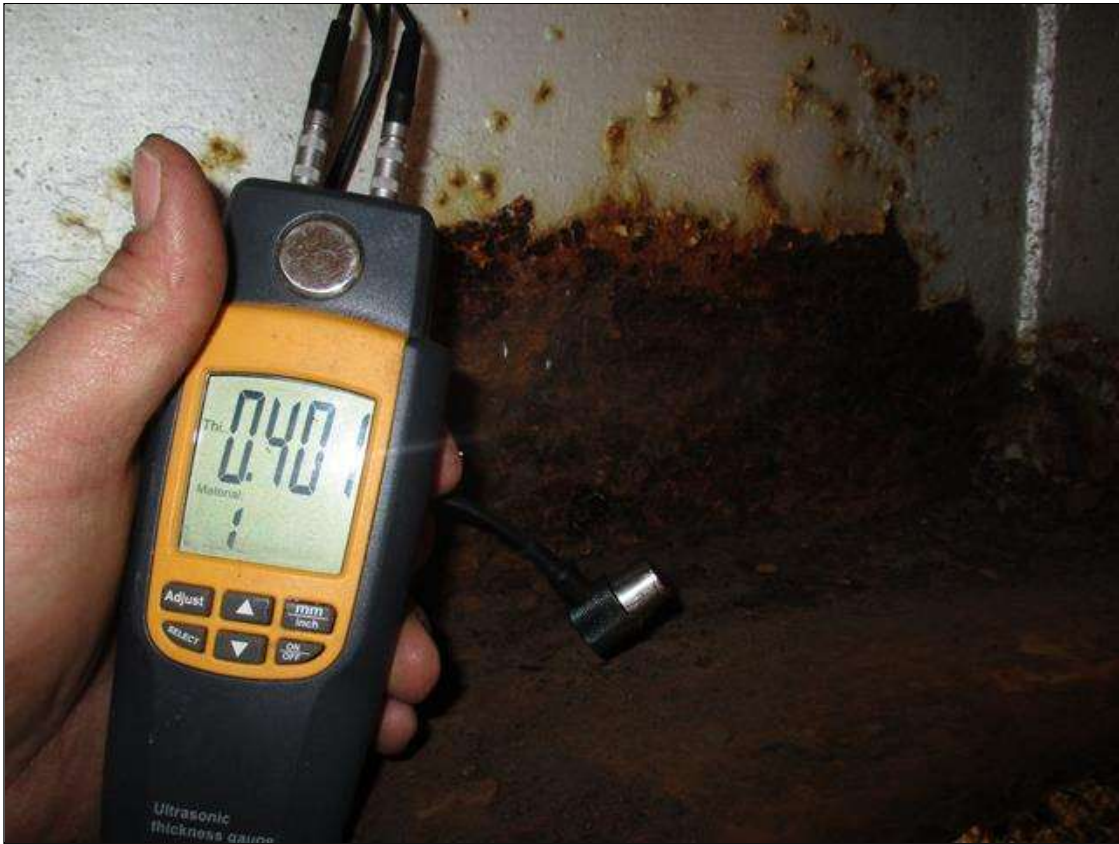
Span 3 Beam 1: (PAR) CORROSION ALONG RIGHT FACE OF WEB AND BOTTOM FLANGE UP TO 34" LONG X 5" HIGH DOWN TO 0.470" RESIDUAL WEB, AND 36" LONG X 5" WIDE DOWN TO 0.401" RESIDUAL FLANGE AT BENT 3 BEARING

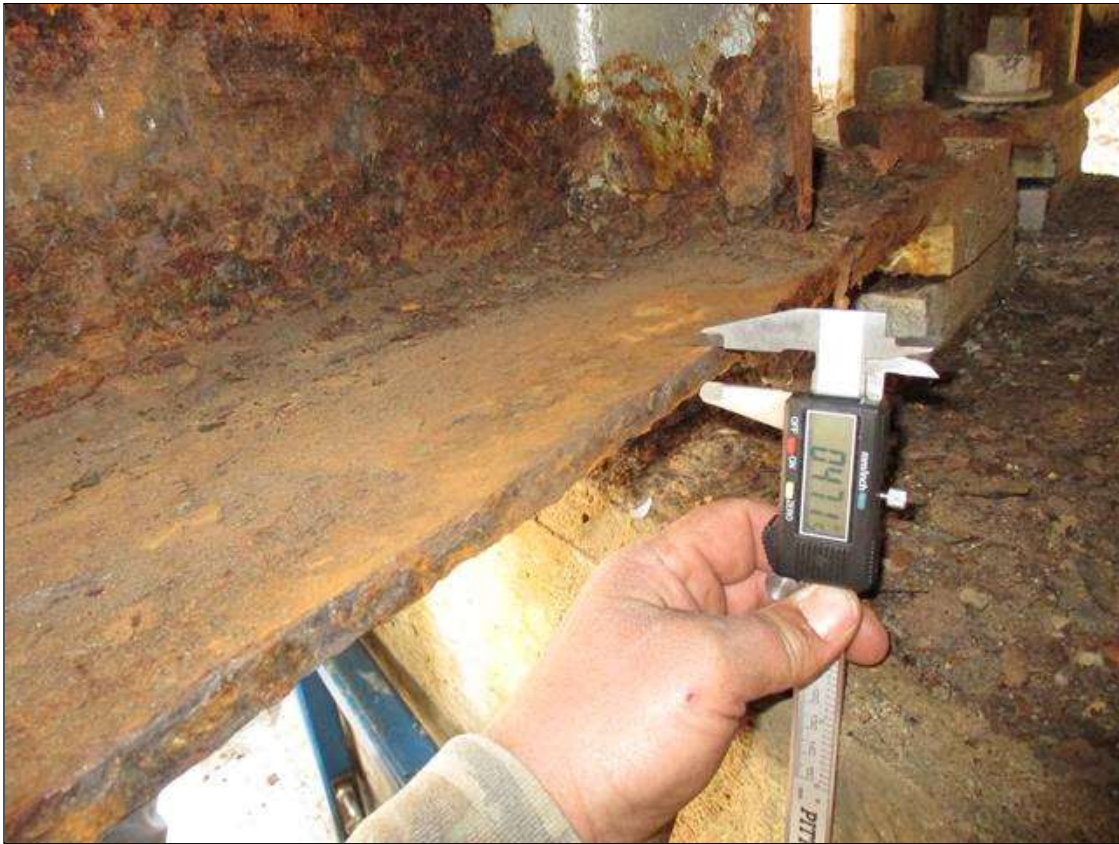
Span 3 Beam 1: (PAR) CORROSION ALONG RIGHT FACE OF WEB AND BOTTOM FLANGE UP TO 34" LONG X 5" HIGH DOWN TO 0.470" RESIDUAL WEB, AND 36" LONG X 5" WIDE DOWN TO 0.401" RESIDUAL FLANGE AT BENT 3 BEARING

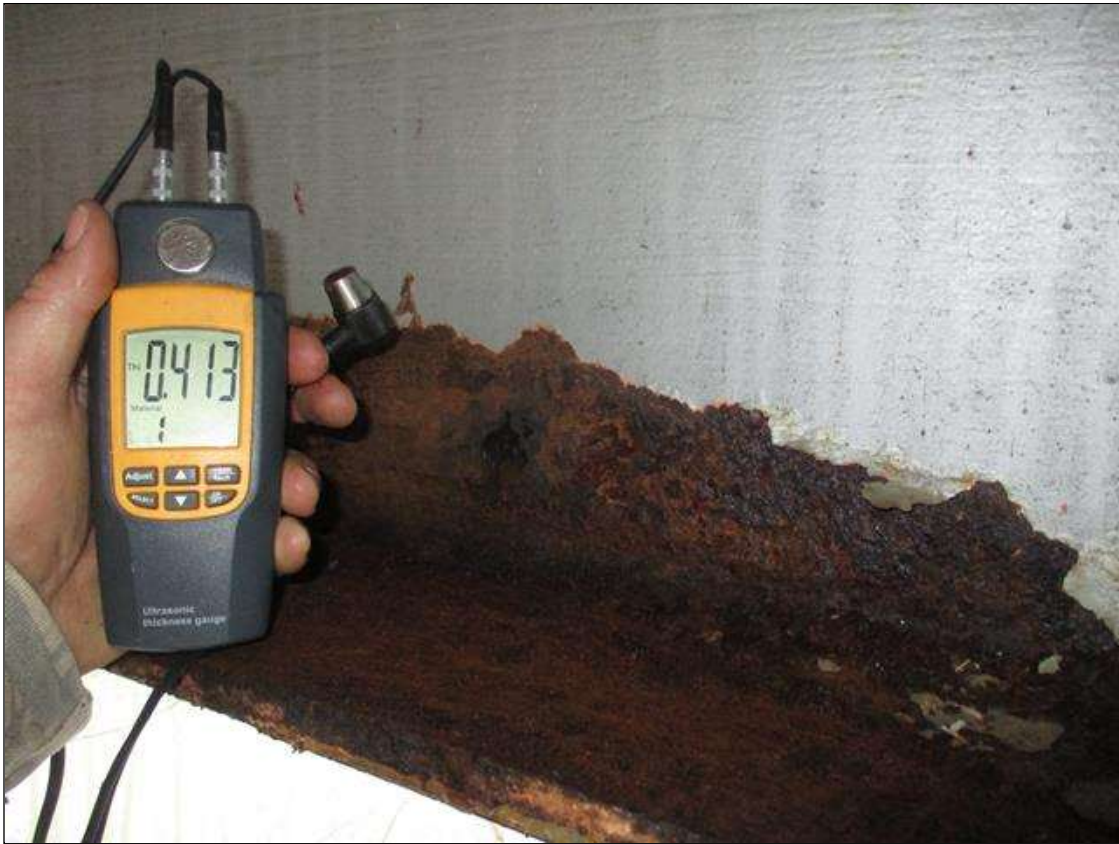
Span 3 Beam 1: (PAR) INTERMITTENT FULL LENGTH, CORROSION ALONG BOTH FACES OF WEB AND BOTTOM FLANGE UP TO 5" HIGH DOWN TO 0.413" RESIDUAL WEB, AND 5" WIDE IN BOTTOM OF MIDSPAN FLANGE WITH NO MEASURABLE SECTION LOSS

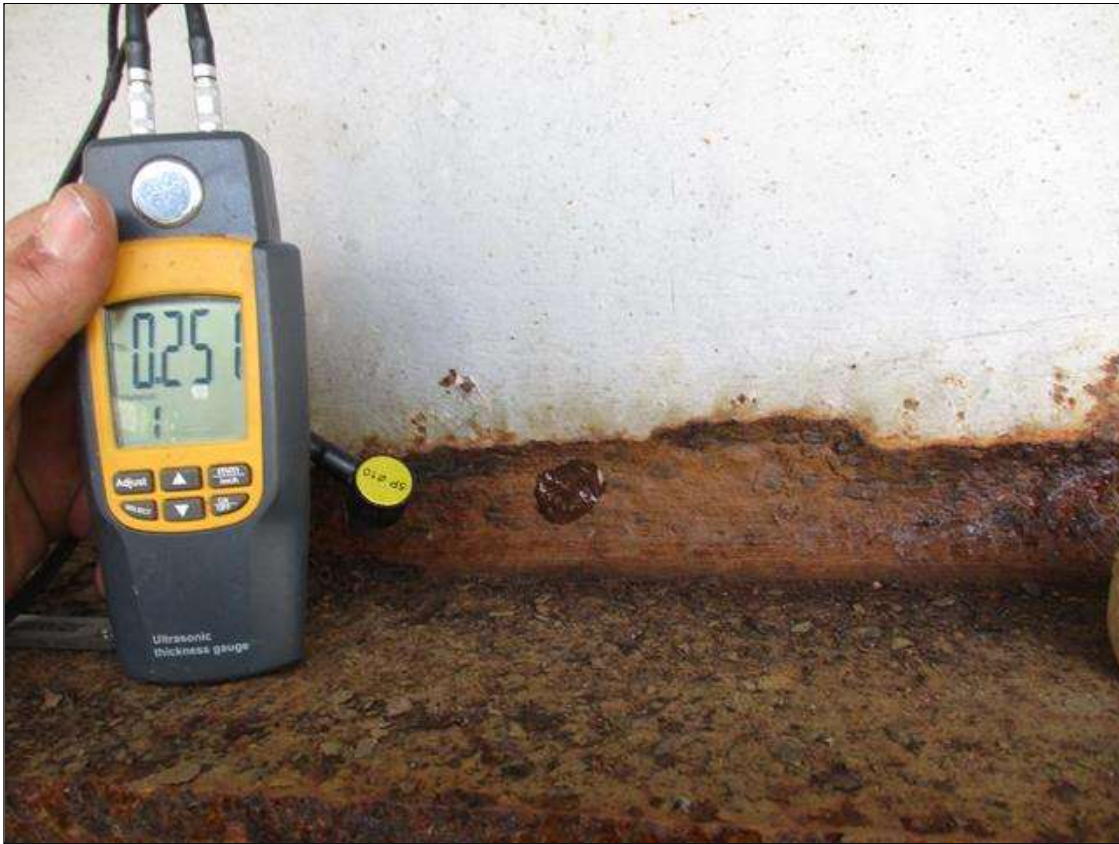
Span 3 Beam 1: (PAR) CORROSION EXTENDING 5' FROM BENT 2 WEB, 0.251" REMAINING UP 3" FROM FLANGE

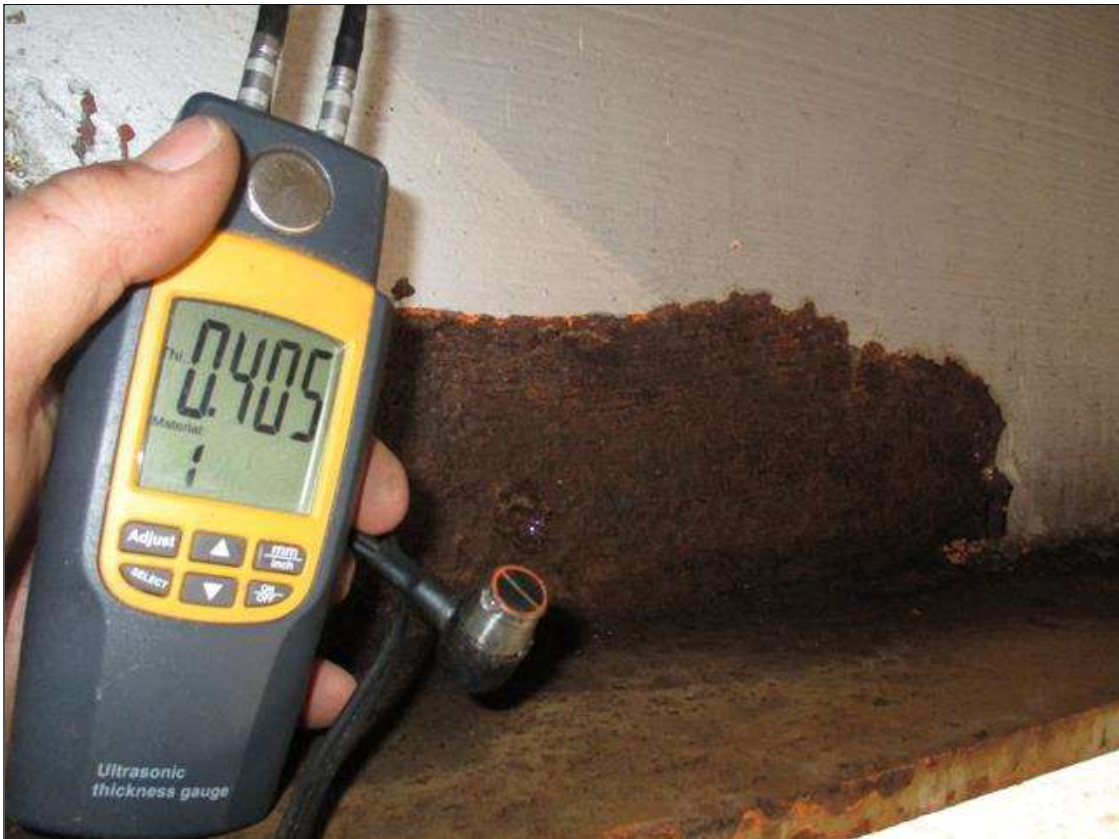
Span 3 Beam 2: (PAR) CORROSION ALONG BOTH FACES OF WEB UP TO 12" LONG X 24" HIGH DOWN TO 0.405" RESIDUAL WEB AT END OF BEAM AT BENT 2

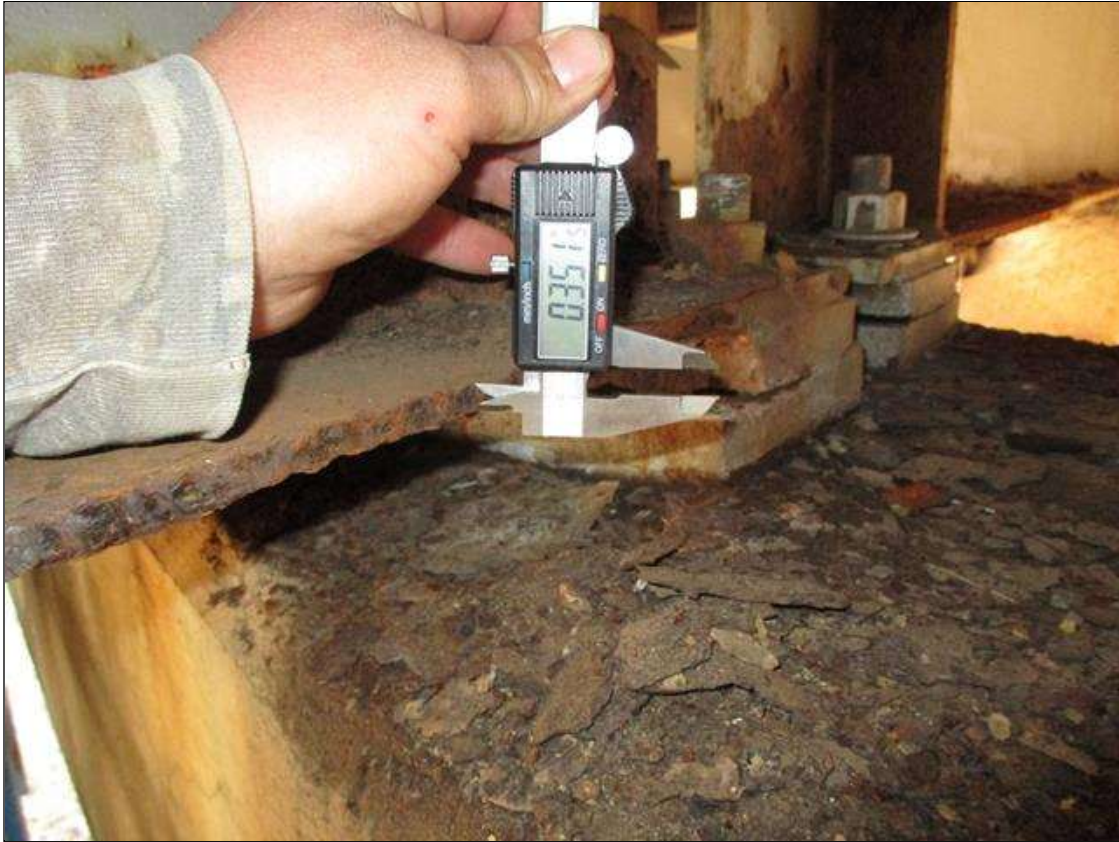
Span 3 Beam 2: (PAR) CORROSION ALONG BOTH FACES OF WEB AND BOTTOM FLANGE UP TO 32" LONG X 5" HIGH DOWN TO 0.212" RESIDUAL WEB, AND 34" LONG X 11 3/4" WIDE DOWN TO 0.350" RESIDUAL FLANGE AT BENT 3 BEARING

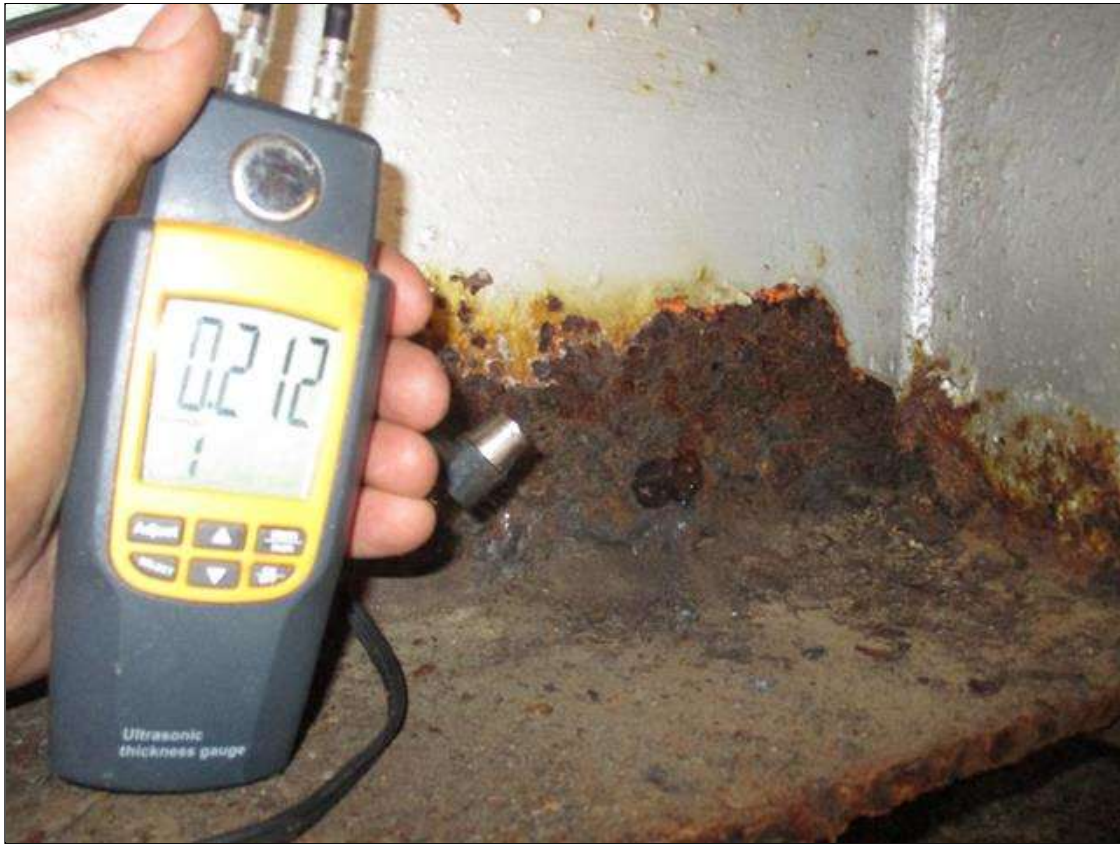
Span 3 Beam 2: (PAR) CORROSION ALONG BOTH FACES OF WEB AND BOTTOM FLANGE UP TO 32" LONG X 5" HIGH DOWN TO 0.212" RESIDUAL WEB, AND 34" LONG X 11 3/4" WIDE DOWN TO 0.350" RESIDUAL FLANGE AT BENT 3 BEARING

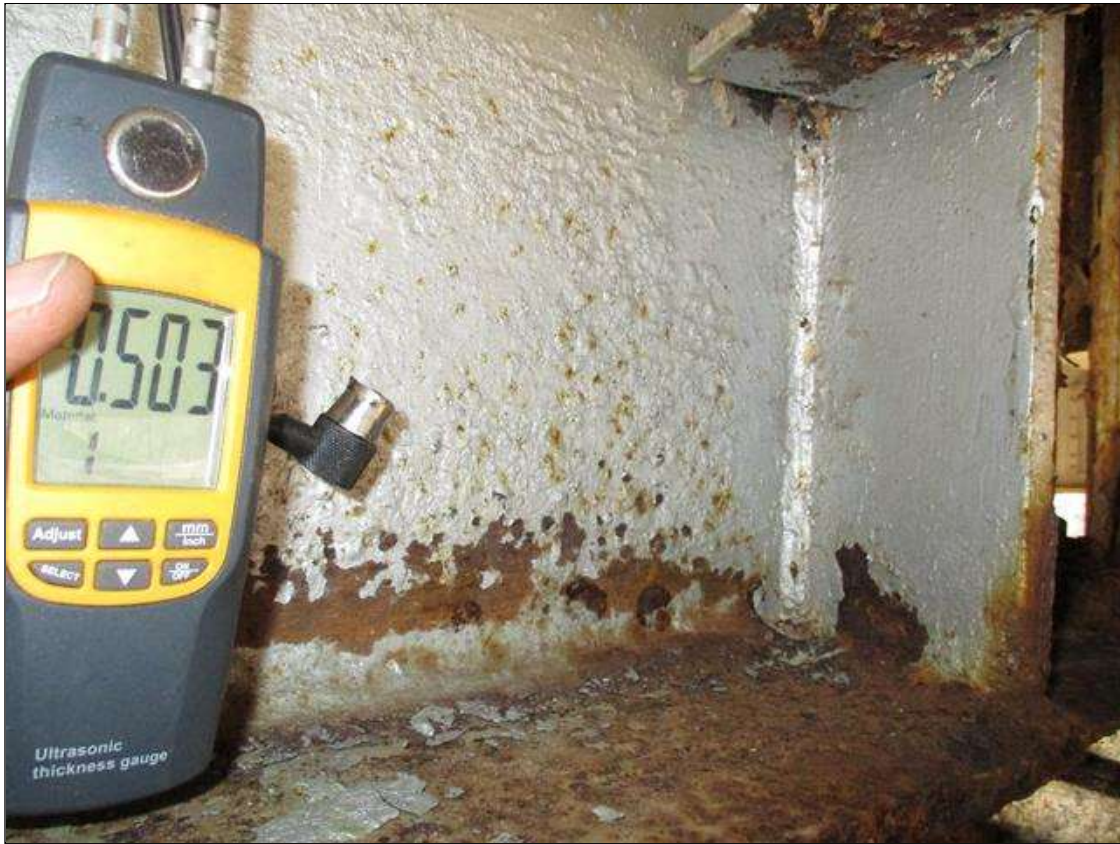
Span 3 Beam 3: (PAR) CORROSION ALONG BOTH FACES OF WEB AND BOTTOM FLANGE UP TO 15" LONG X 5" HIGH DOWN TO 0.503" RESIDUAL WEB, AND 18" LONG X 11 3/4" WIDE DOWN TO 0.199" RESIDUAL FLANGE AT BENT 3 BEARING

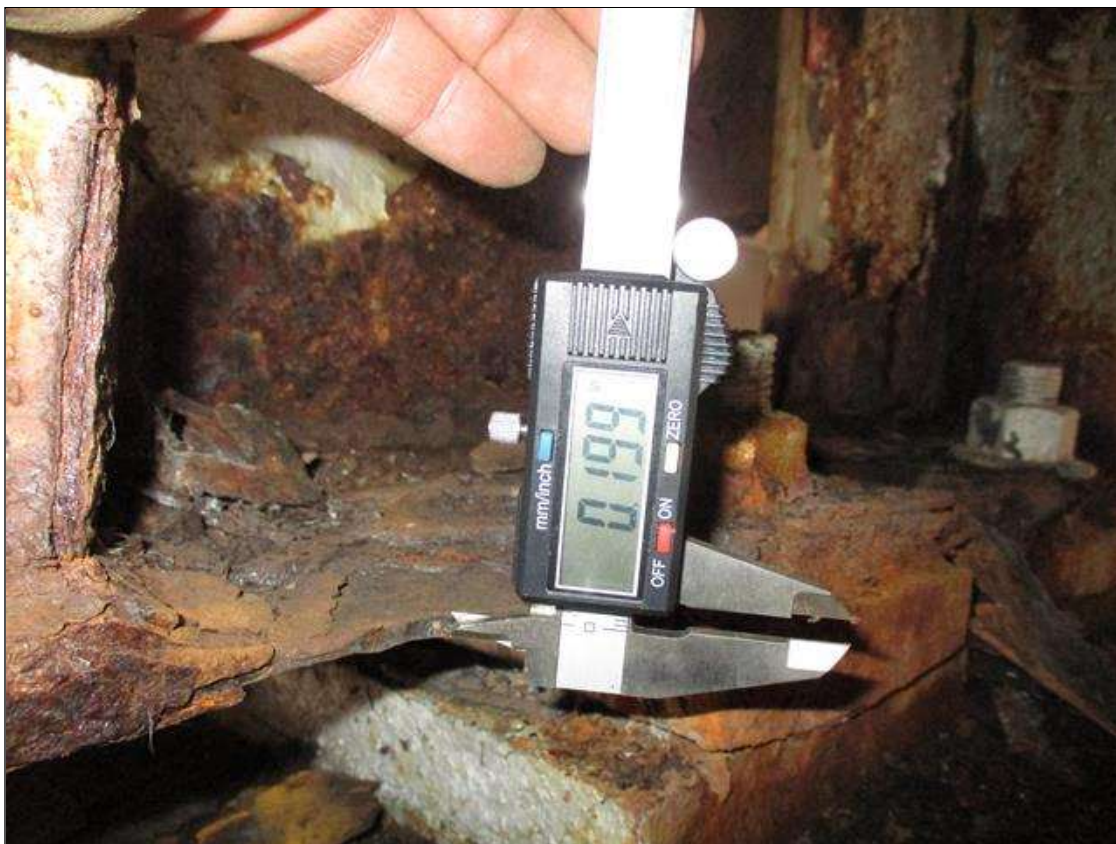
Span 3 Beam 3: (PAR) CORROSION ALONG BOTH FACES OF WEB AND BOTTOM FLANGE UP TO 15" LONG X 5" HIGH DOWN TO 0.503" RESIDUAL WEB, AND 18" LONG X 11 3/4" WIDE DOWN TO 0.199" RESIDUAL FLANGE AT BENT 3 BEARING
