NC DEPARTMENT OF TRANSPORTATION  
 DIVISION OF HIGHWAYS  
 STRUCTURE MANAGEMENT UNIT

ATTENTION: PARS SUBMITTED

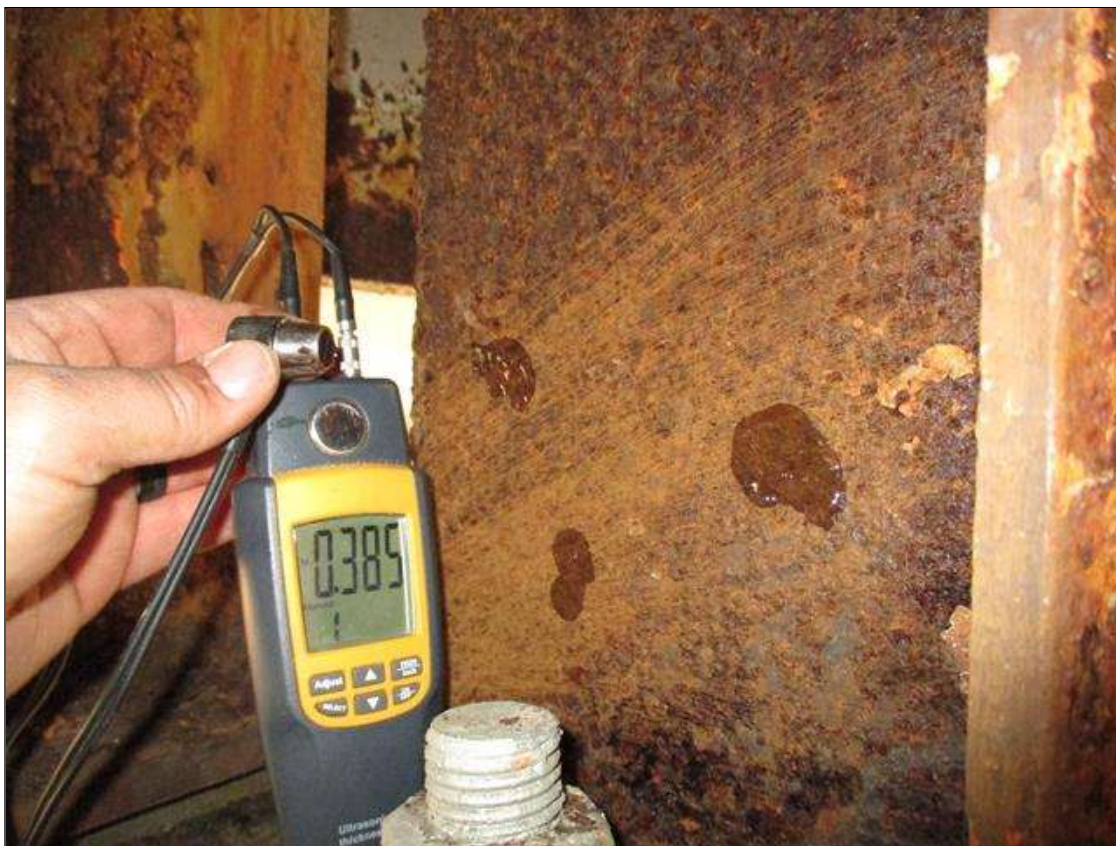
Span 3 Beam 3: (PAR) CORROSION ALONG LEFT FACE OF WEB AND BOTTOM FLANGE UP TO 72" LONG X 24" HIGH DOWN TO 0.385" RESIDUAL WEB, AND 72" LONG X 11 1/2" WIDE DOWN TO 0.360" RESIDUAL FLANGE AT BENT 2 BEARING (SEE PHOTOS)

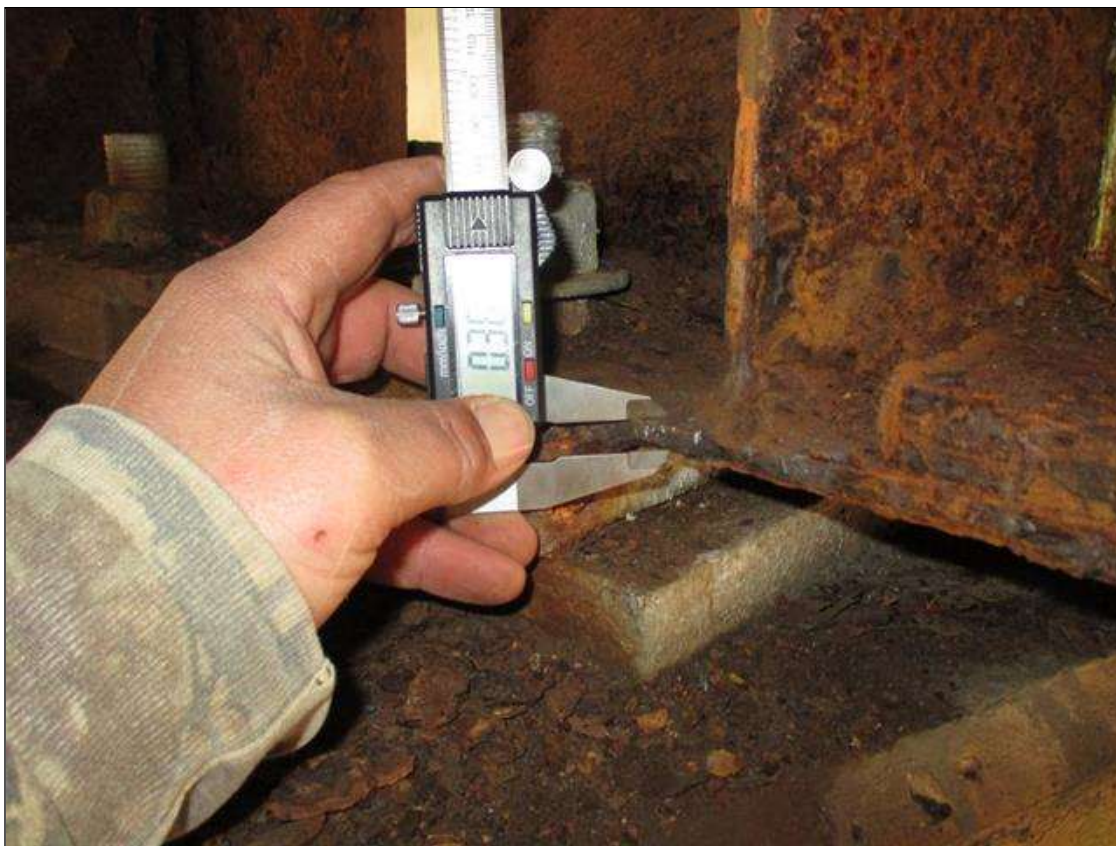
Span 3 Beam 3: (PAR) CORROSION ALONG LEFT FACE OF WEB AND BOTTOM FLANGE UP TO 72" LONG X 24" HIGH DOWN TO 0.385" RESIDUAL WEB, AND 72" LONG X 11 1/2" WIDE DOWN TO 0.360" RESIDUAL FLANGE AT BENT 2 BEARING (SEE PHOTOS)

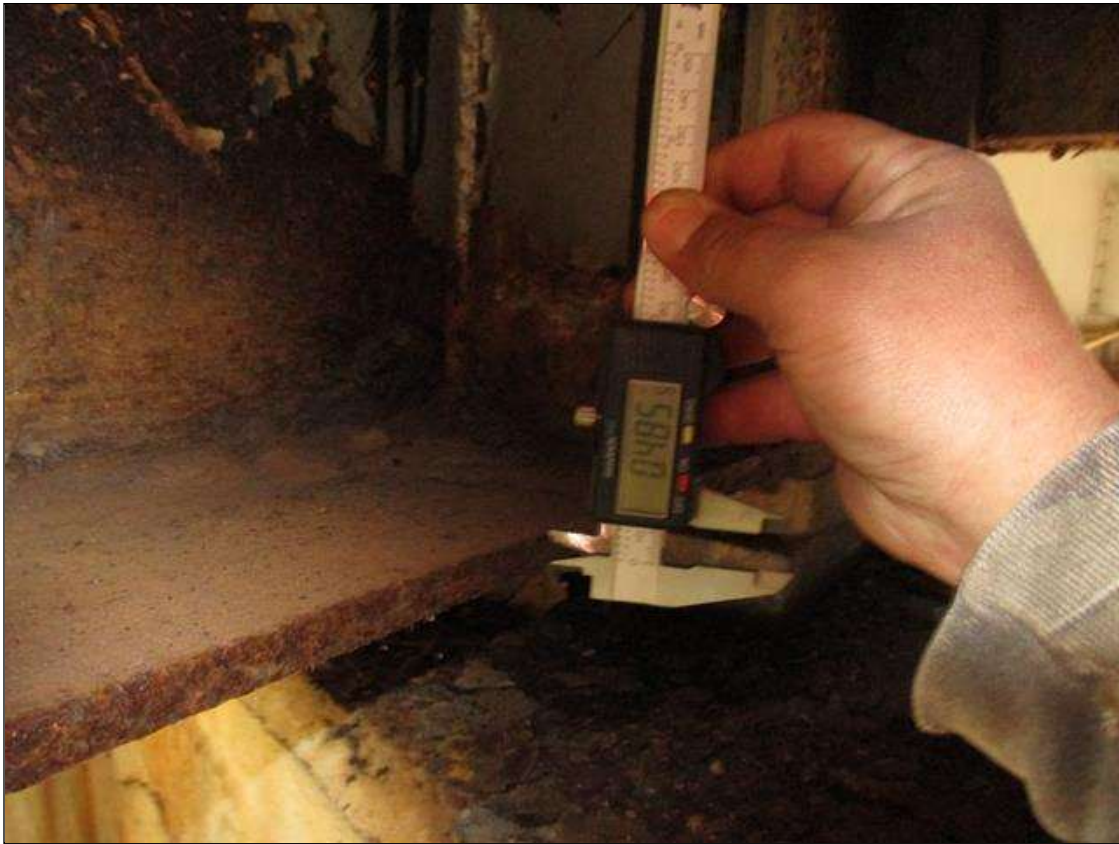
Span 3 Beam 4: (PAR) CORROSION ALONG BOTH FACES OF WEB AND BOTTOM FLANGE UP TO 38" LONG X 7" HIGH DOWN TO 0.413" RESIDUAL WEB, AND 41" LONG X 11 3/4" WIDE DOWN TO 0.485" RESIDUAL FLANGE AT BENT 3 BEARING

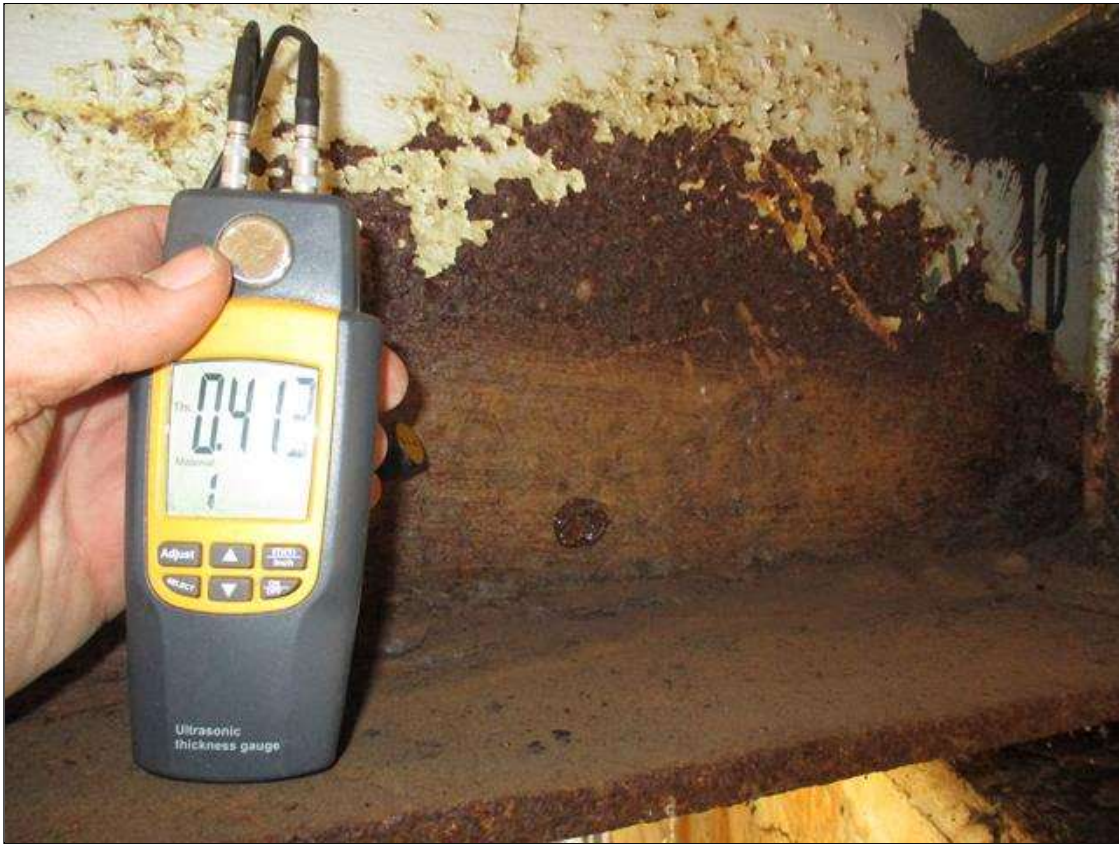
Span 3 Beam 4: (PAR) CORROSION ALONG BOTH FACES OF WEB AND BOTTOM FLANGE UP TO 38" LONG X 7" HIGH DOWN TO 0.413" RESIDUAL WEB, AND 41" LONG X 11 3/4" WIDE DOWN TO 0.485" RESIDUAL FLANGE AT BENT 3 BEARING

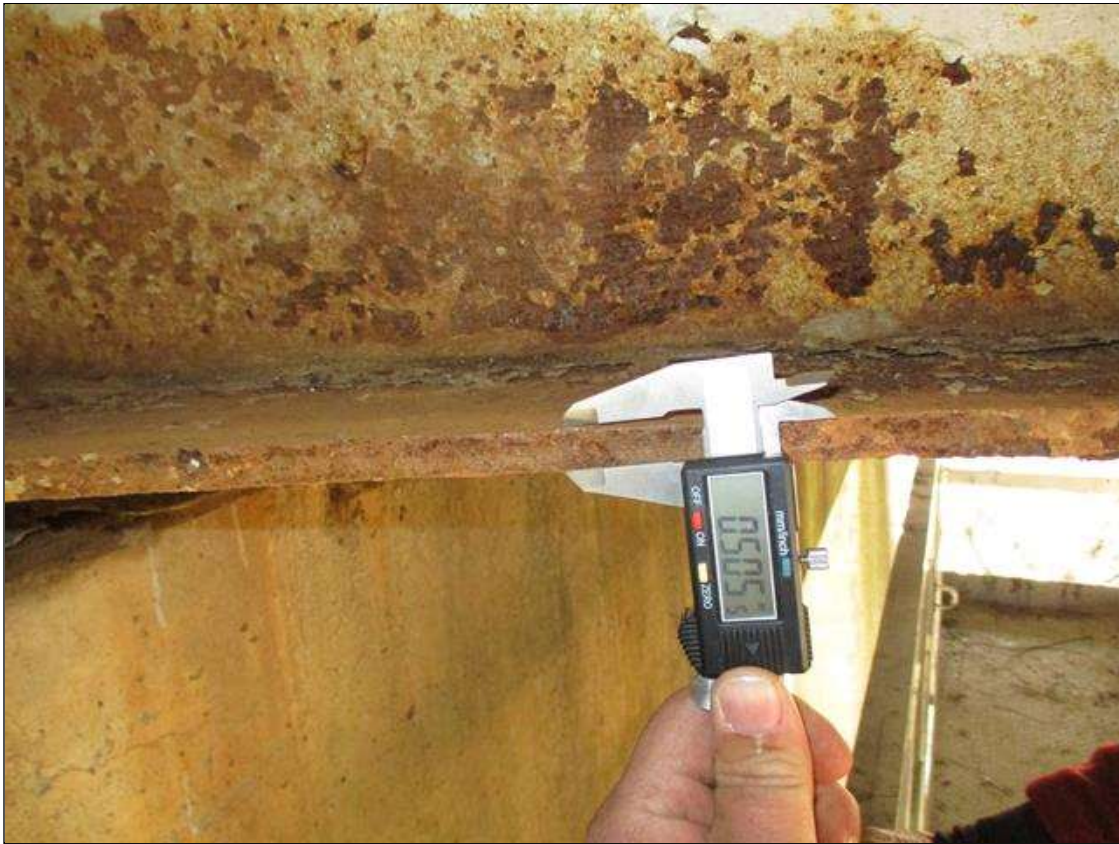
Span 3 Beam 4: (PAR) CORROSION ALONG BOTH FACES OF WEB AND BOTTOM FLANGE UP TO 58" LONG X 6" HIGH DOWN TO 0.342" RESIDUAL WEB, AND 39" LONG X 11 3/4" WIDE DOWN TO 0.505" RESIDUAL FLANGE AT BENT 2 BEARING

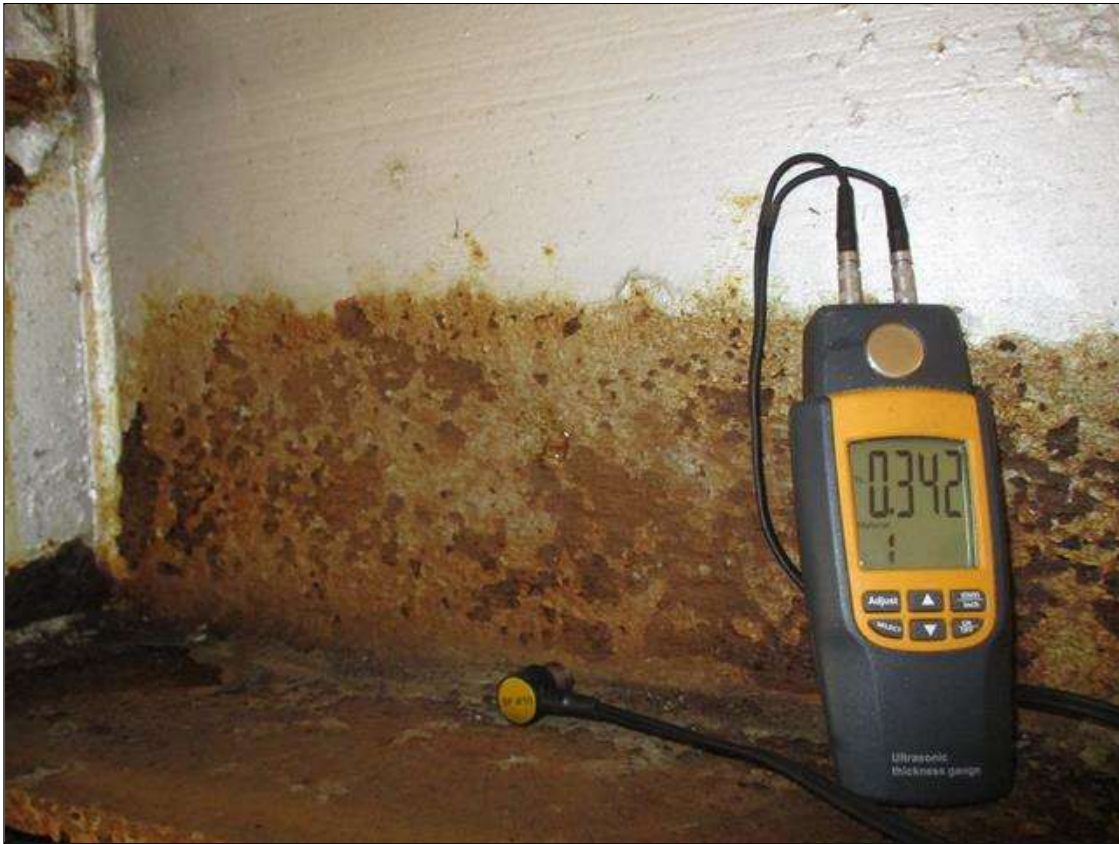
Span 3 Beam 4: (PAR) CORROSION ALONG BOTH FACES OF WEB AND BOTTOM FLANGE UP TO 58" LONG X 6" HIGH DOWN TO 0.342" RESIDUAL WEB, AND 39" LONG X 11 3/4" WIDE DOWN TO 0.505" RESIDUAL FLANGE AT BENT 2 BEARING

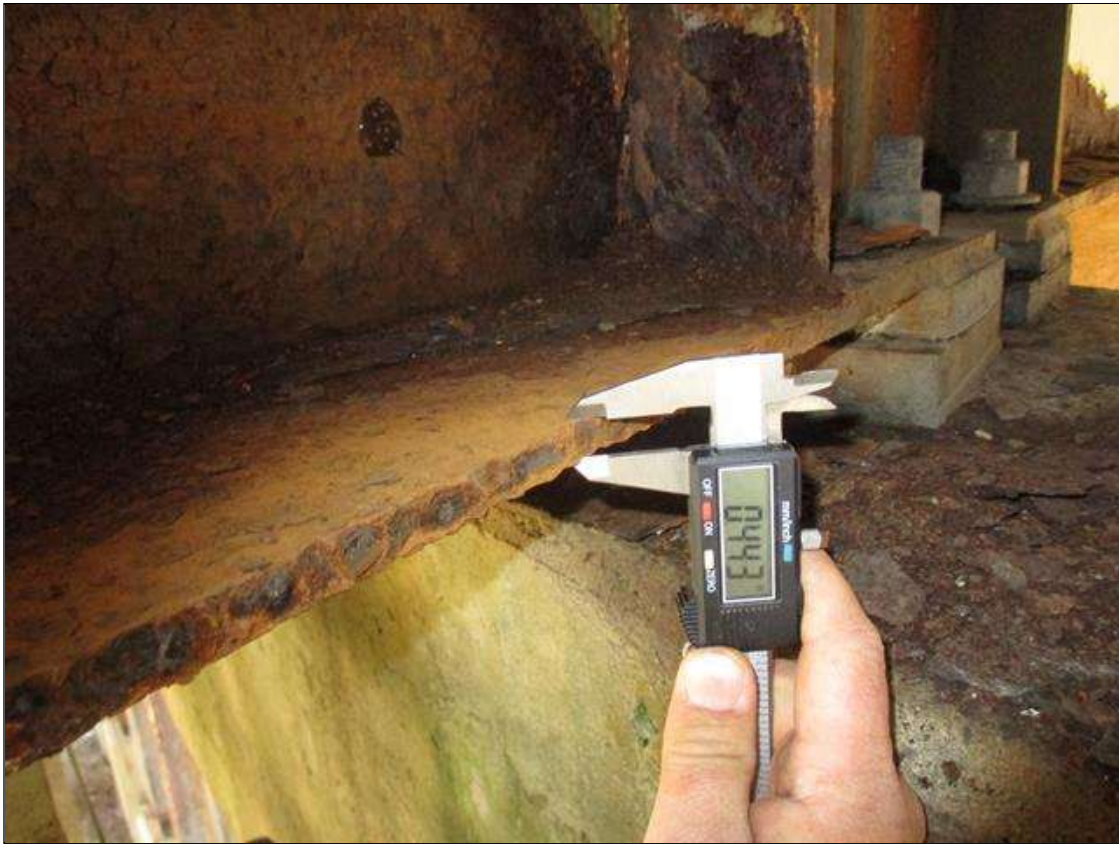
Span 3 Beam 5: (PAR) CORROSION ALONG BOTH FACES OF WEB AND BOTTOM FLANGE UP TO 24" LONG X 13" HIGH DOWN TO 0.301" RESIDUAL WEB, AND 29" LONG X 11 3/4" WIDE DOWN TO .443" RESIDUAL FLANGE AT BENT 3 BEARING

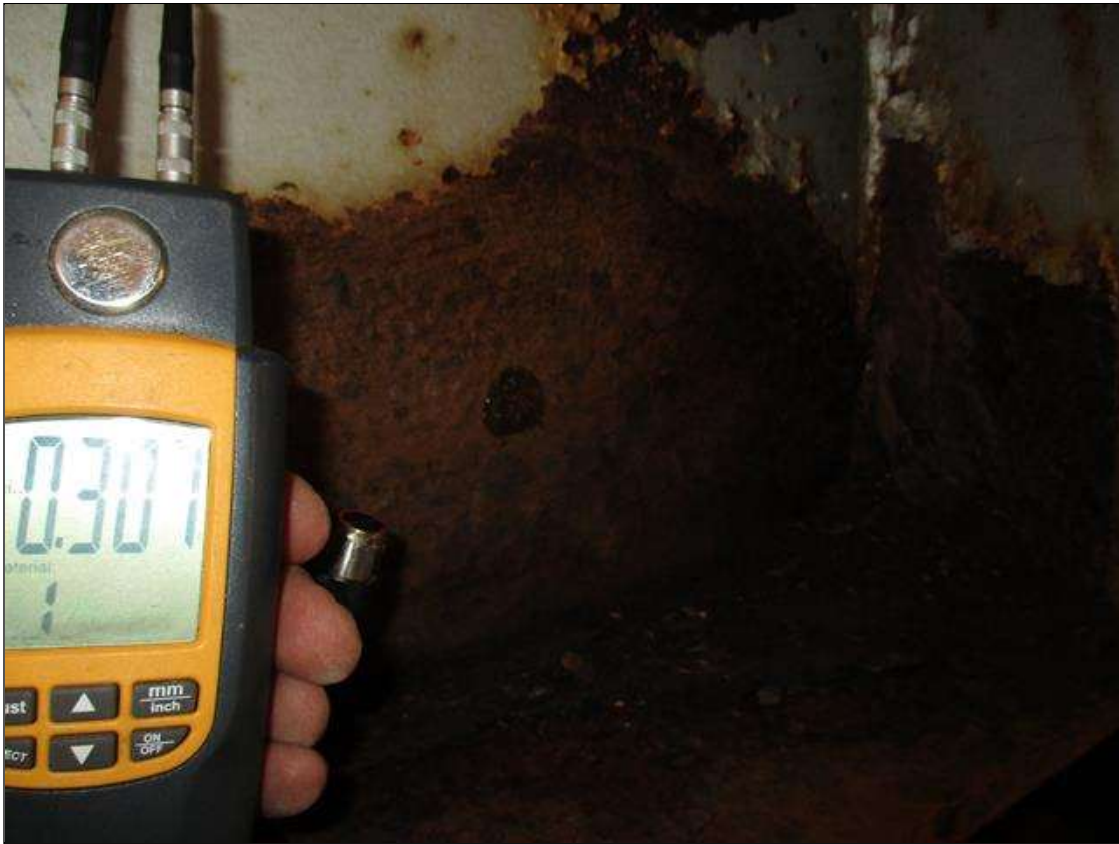
Span 3 Beam 5: (PAR) CORROSION ALONG BOTH FACES OF WEB AND BOTTOM FLANGE UP TO 24" LONG X 13" HIGH DOWN TO 0.301" RESIDUAL WEB, AND 29" LONG X 11 3/4" WIDE DOWN TO .443" RESIDUAL FLANGE AT BENT 3 BEARING

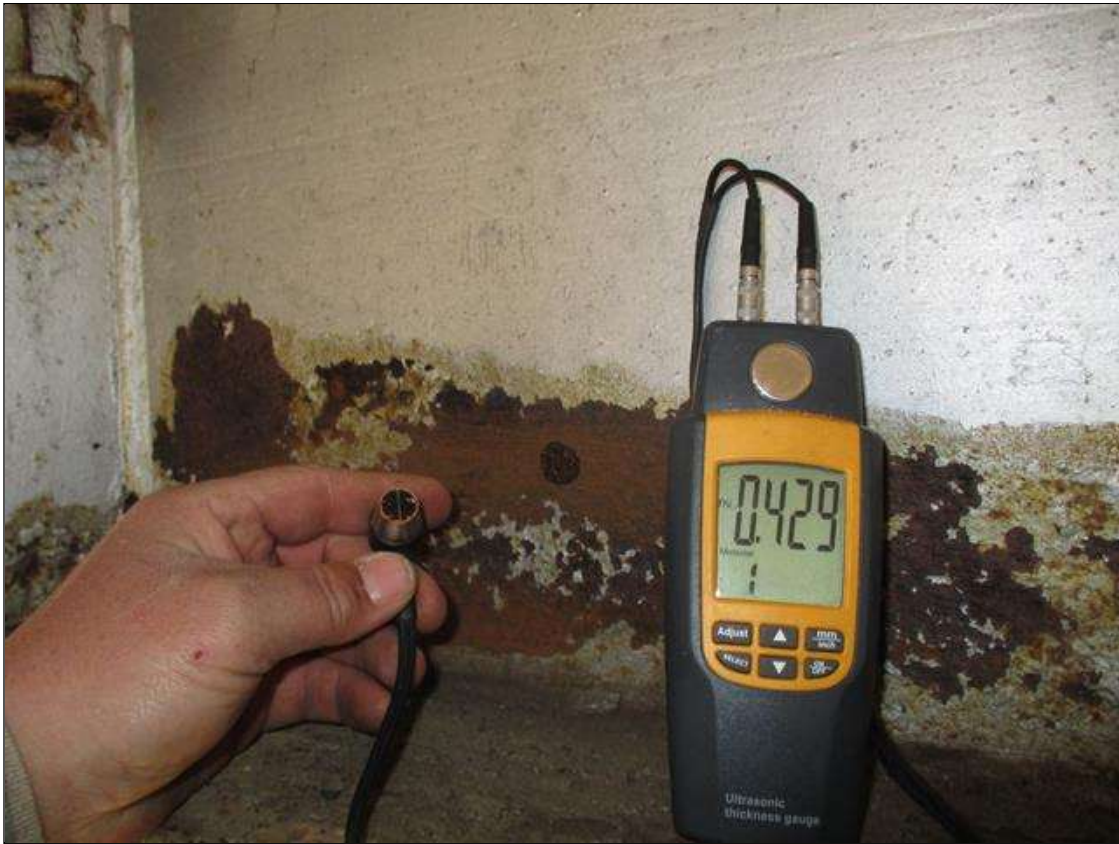
Span 3 Beam 5: (PAR) CORROSION AND EVIDENCE OF CORROSION BENEATH PAINT REPAIR ALONG BOTH FACES OF WEB AND BOTTOM FLANGE UP TO 105" LONG X 6" HIGH DOWN TO 0.429" RESIDUAL WEB, AND 90" LONG X 11 3/4" WIDE DOWN TO 9/16" RESIDUAL FLANGE AT BENT 2 BEARING

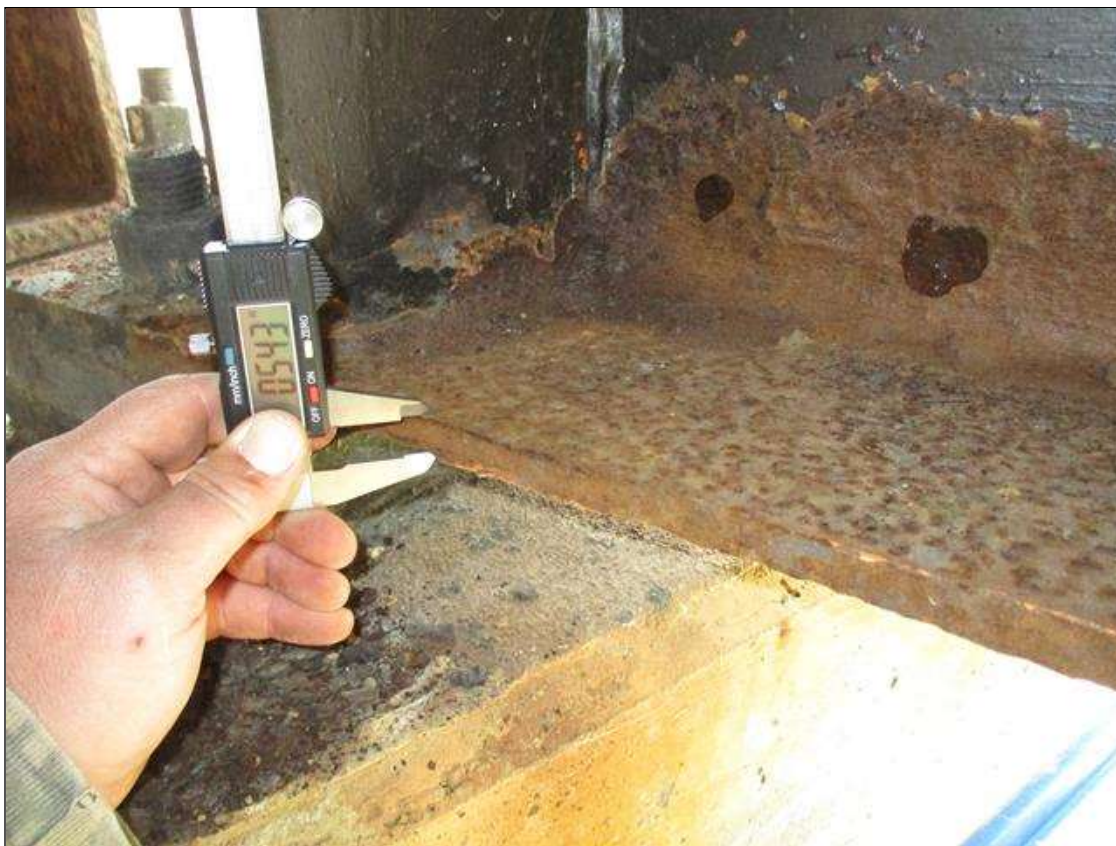
Span 3 Beam 6: (PAR) CORROSION ALONG BOTH FACES OF WEB AND BOTTOM FLANGE UP TO 20" LONG X 3" HIGH DOWN TO 0.362" RESIDUAL WEB, AND 11" LONG X 11 3/4" WIDE DOWN TO 0.543" RESIDUAL FLANGE AT BENT 3 BEARING

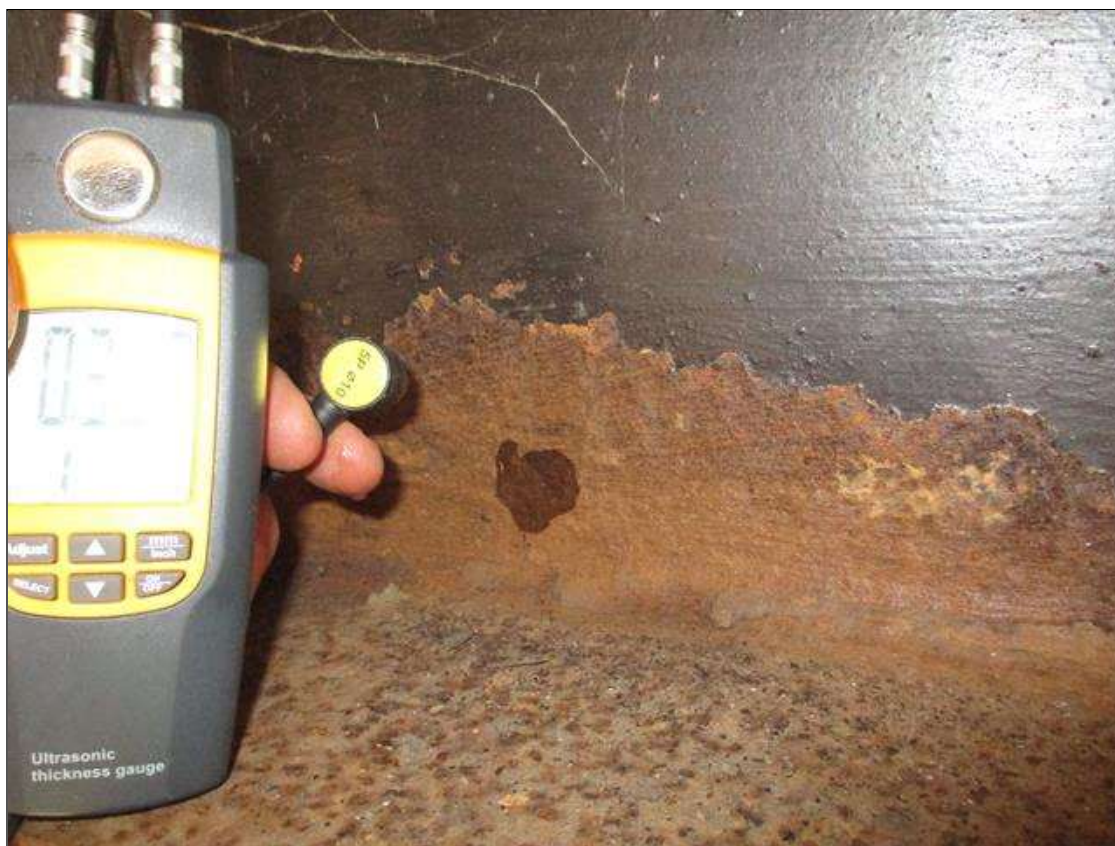
Span 3 Beam 6: (PAR) CORROSION ALONG BOTH FACES OF WEB AND BOTTOM FLANGE UP TO 20" LONG X 3" HIGH DOWN TO 0.362" RESIDUAL WEB, AND 11" LONG X 11 3/4" WIDE DOWN TO 0.543" RESIDUAL FLANGE AT BENT 3 BEARING

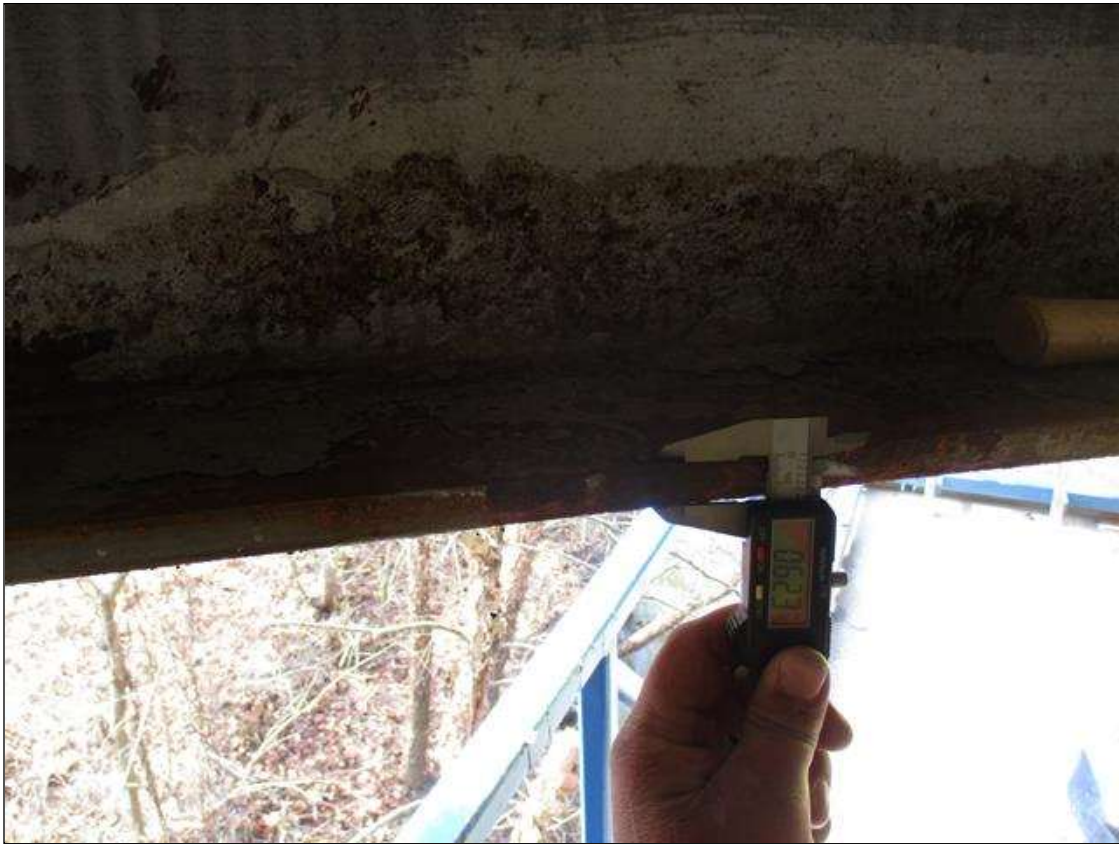
Span 3 Beam 6: 12' SECTION OF CORROSION ALONG LEFT FACE OF WEB AND BOTTOM FLANGE UP TO 4" HIGH WITH NO MEASURABLE LOSS OF SECTION IN WEB, AND 5" WIDE DOWN TO 0.623" RESIDUAL FLANGE, BEGINNING 7' FROM BENT 2 CAP

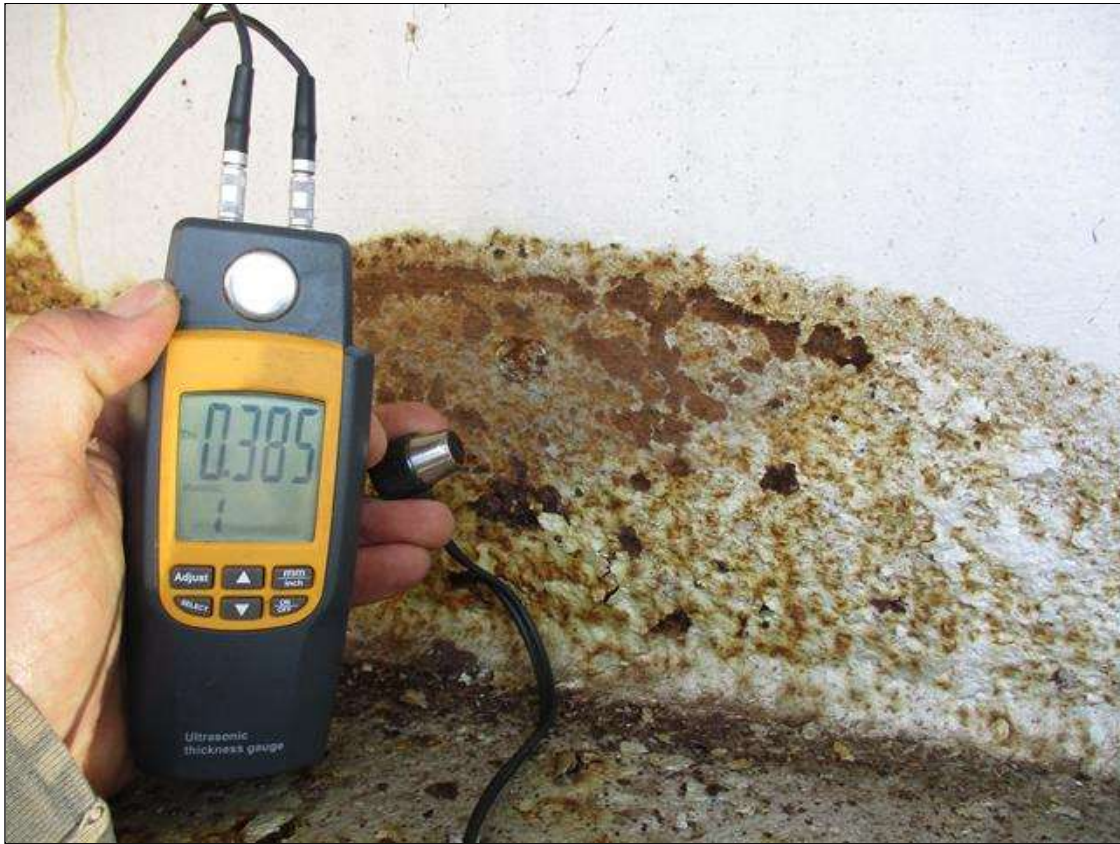
Span 2 Beam 6: (PAR) CORROSION ALONG BOTH FACES OF WEB AND BOTTOM FLANGE UP TO 58" LONG X 7" HIGH DOWN TO 0.385" RESIDUAL WEB, AND 67" LONG X 11 1/2" WIDE DOWN TO 9/16" RESIDUAL FLANGE AT BENT 1 BEARING

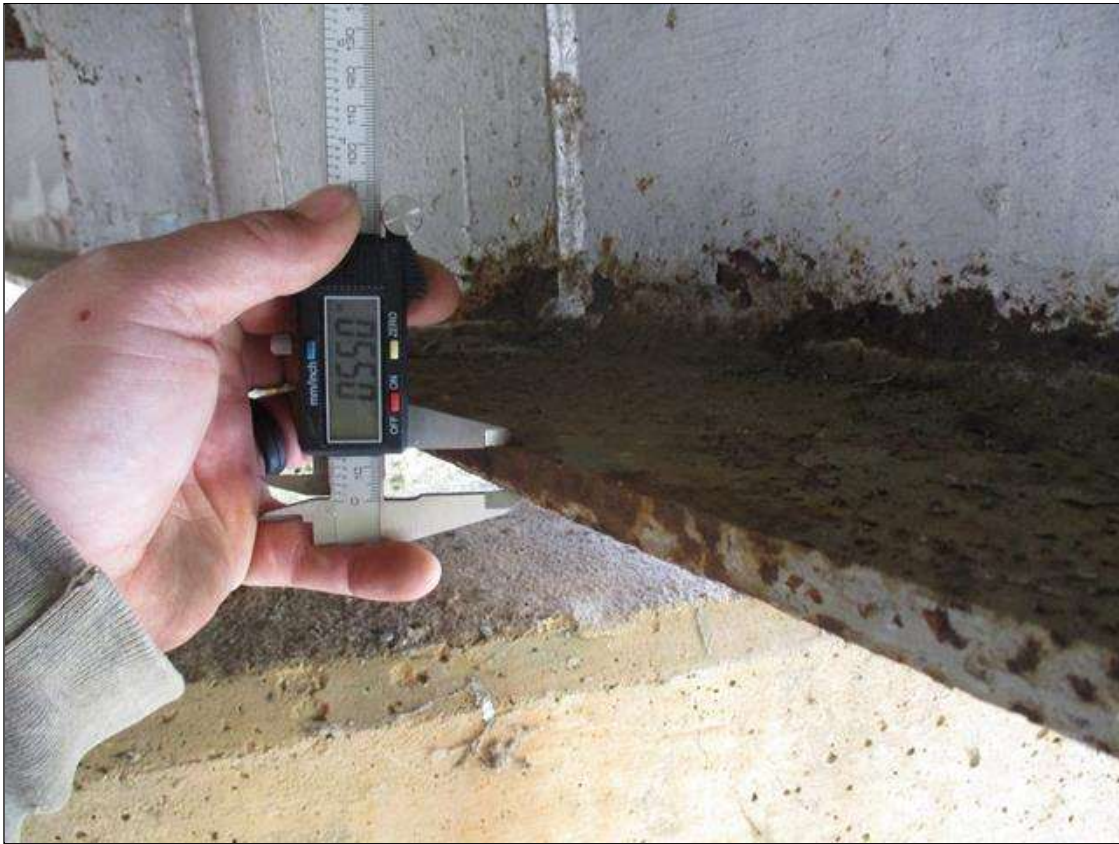
Span 2 Beam 6: CORROSION ALONG LEFT FACE OF WEB AND BOTTOM FLANGE UP TO 22" LONG X 4" HIGH WITH NO MEASURABLE LOSS OF SECTION IN WEB, AND 14" LONG X 5" WIDE DOWN TO 0.550" RESIDUAL FLANGE AT BENT 2 BEARING

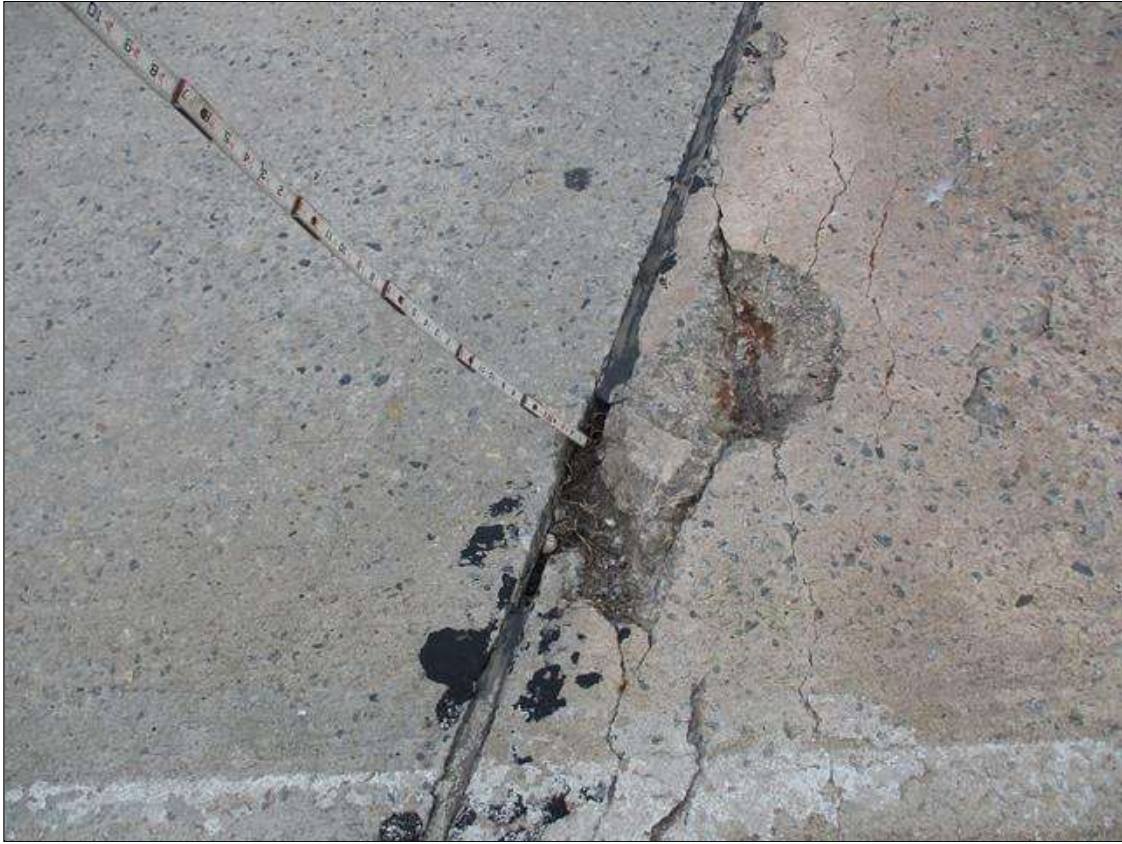
Span 4 Deck: (PAR) 15' X 11" X 3 1/2" DEEP SPALL WITH EXPOSED REBAR IN TOP OF DECK IN WHEEL LINE OF EASTBOUND LANE AT BENT 3 JOINT

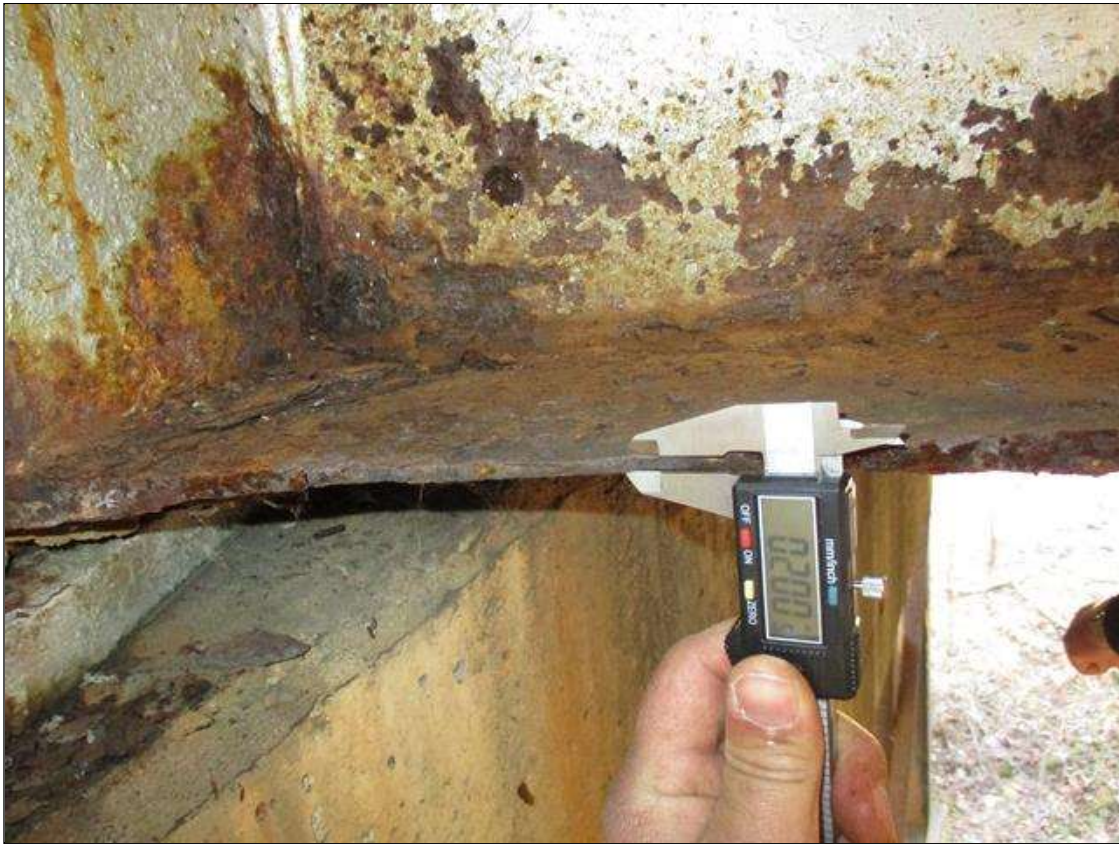
Span 4 Beam 3: (PAR) CORROSION ALONG BOTH FACES OF WEB AND BOTTOM FLANGE UP TO 14" LONG X 8" HIGH DOWN TO 0.236" RESIDUAL WEB, AND 24" LONG X 11 3/4" WIDE DOWN TO 0.200" RESIDUAL FLANGE AT BENT 3 BEARING

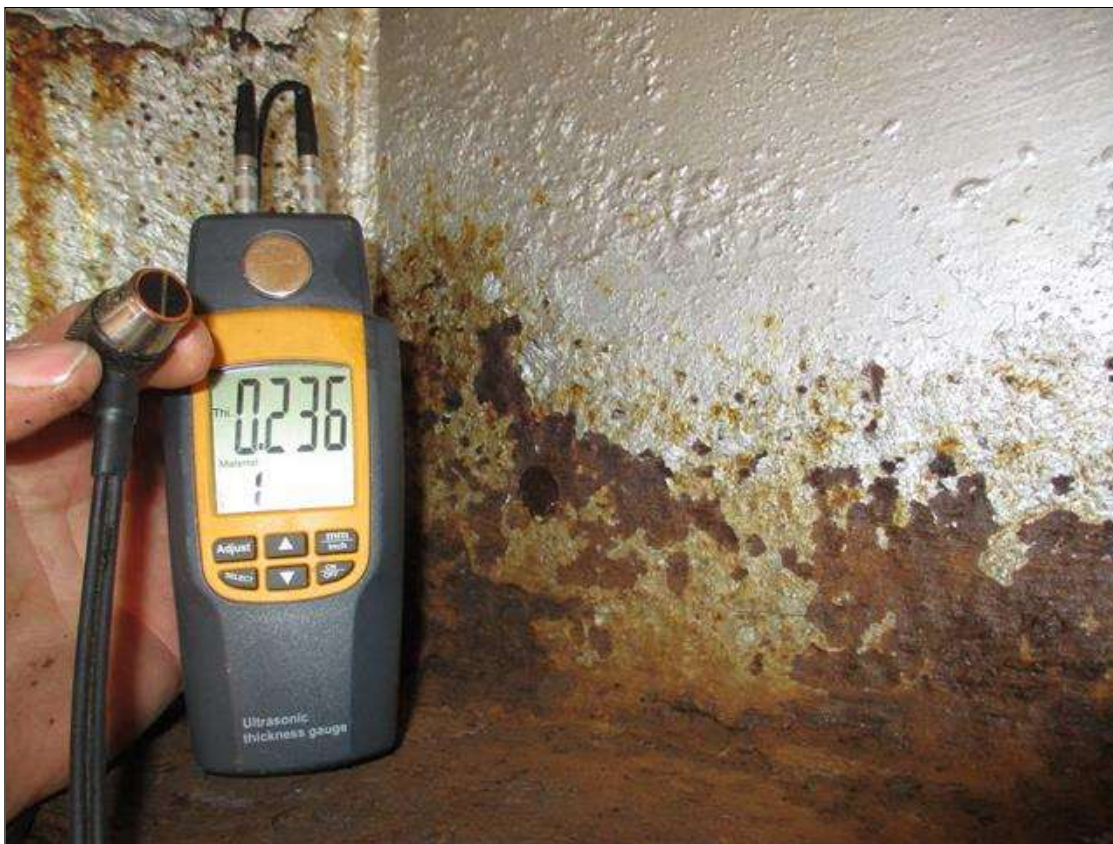
Span 4 Beam 3: (PAR) CORROSION ALONG BOTH FACES OF WEB AND BOTTOM FLANGE UP TO 14" LONG X 8" HIGH DOWN TO 0.236" RESIDUAL WEB, AND 24" LONG X 11 3/4" WIDE DOWN TO 0.200" RESIDUAL FLANGE AT BENT 3 BEARING

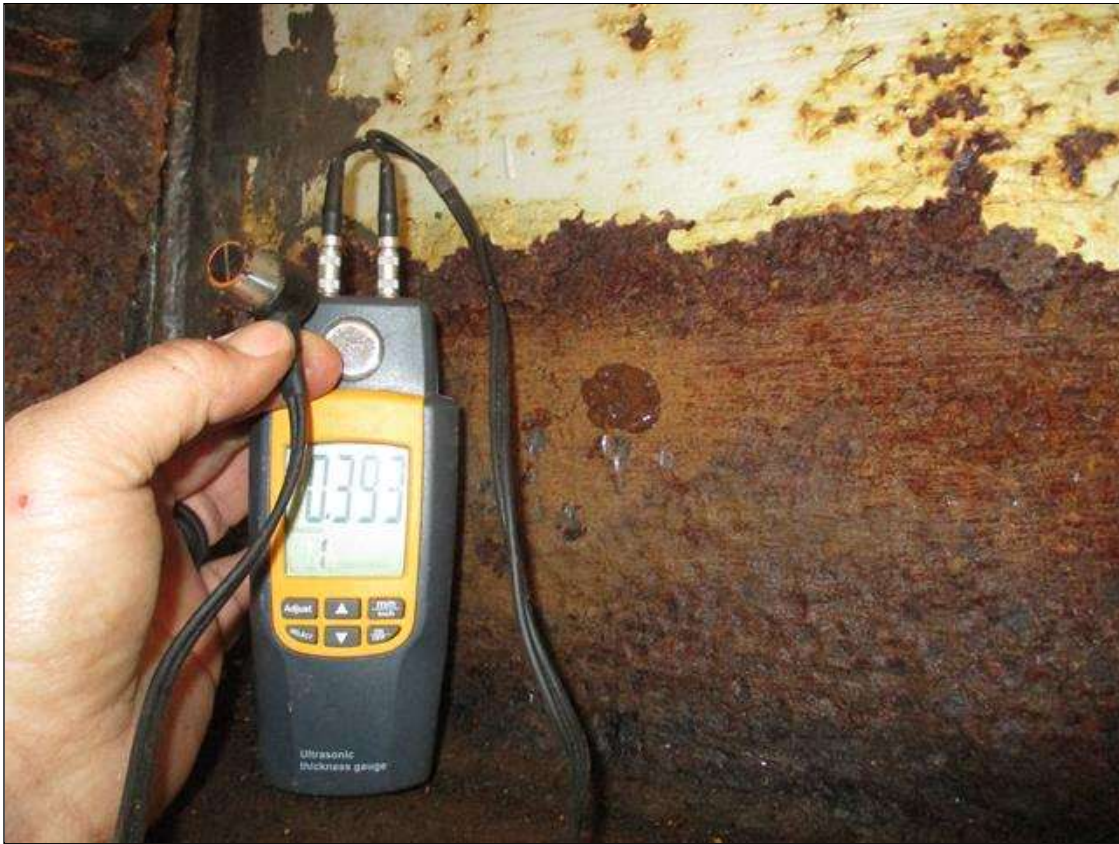
Span 4 Beam 4: (PAR) CORROSION ALONG BOTH FACES OF WEB AND BOTTOM FLANGE UP TO 108" LONG X 20" HIGH DOWN TO 0.393" RESIDUAL WEB, AND 103" LONG X 11 3/4" WIDE DOWN TO 0.500" RESIDUAL FLANGE AT BENT 3 BEARING

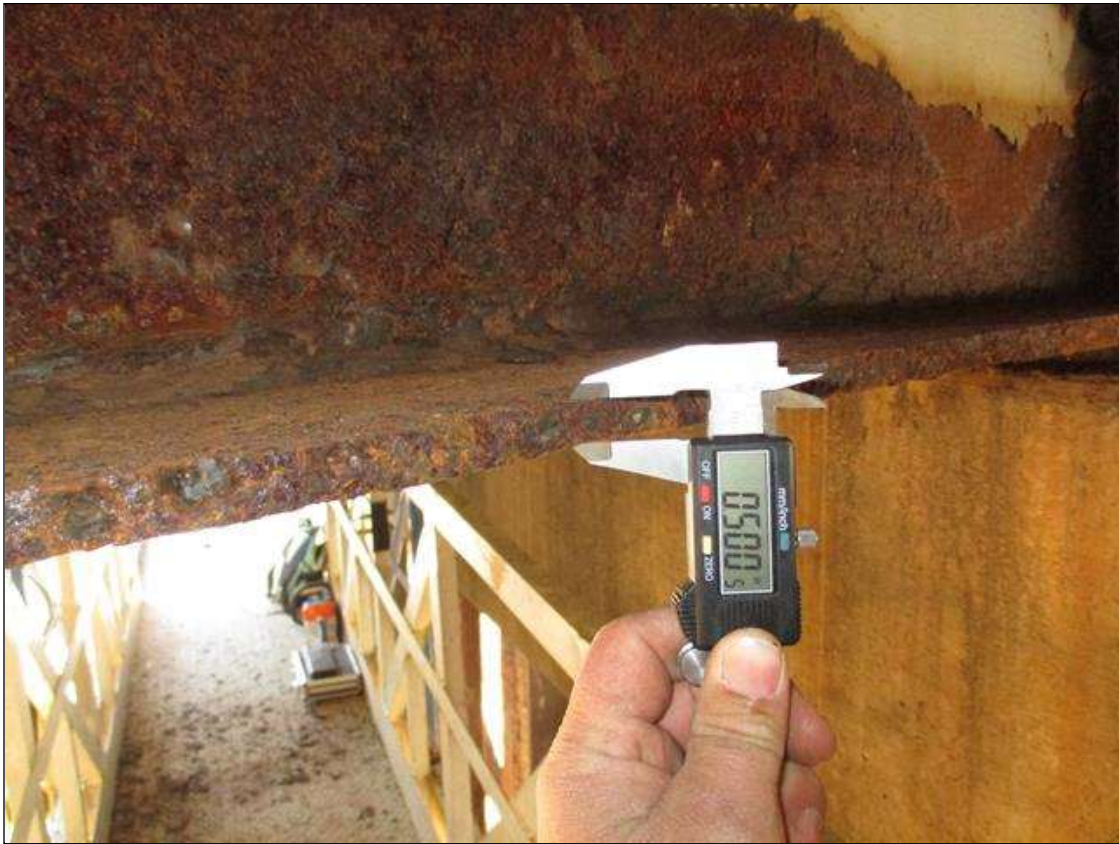
Span 4 Beam 4: (PAR) CORROSION ALONG BOTH FACES OF WEB AND BOTTOM FLANGE UP TO 108" LONG X 20" HIGH DOWN TO 0.393" RESIDUAL WEB, AND 103" LONG X 11 3/4" WIDE DOWN TO 0.500" RESIDUAL FLANGE AT BENT 3 BEARING

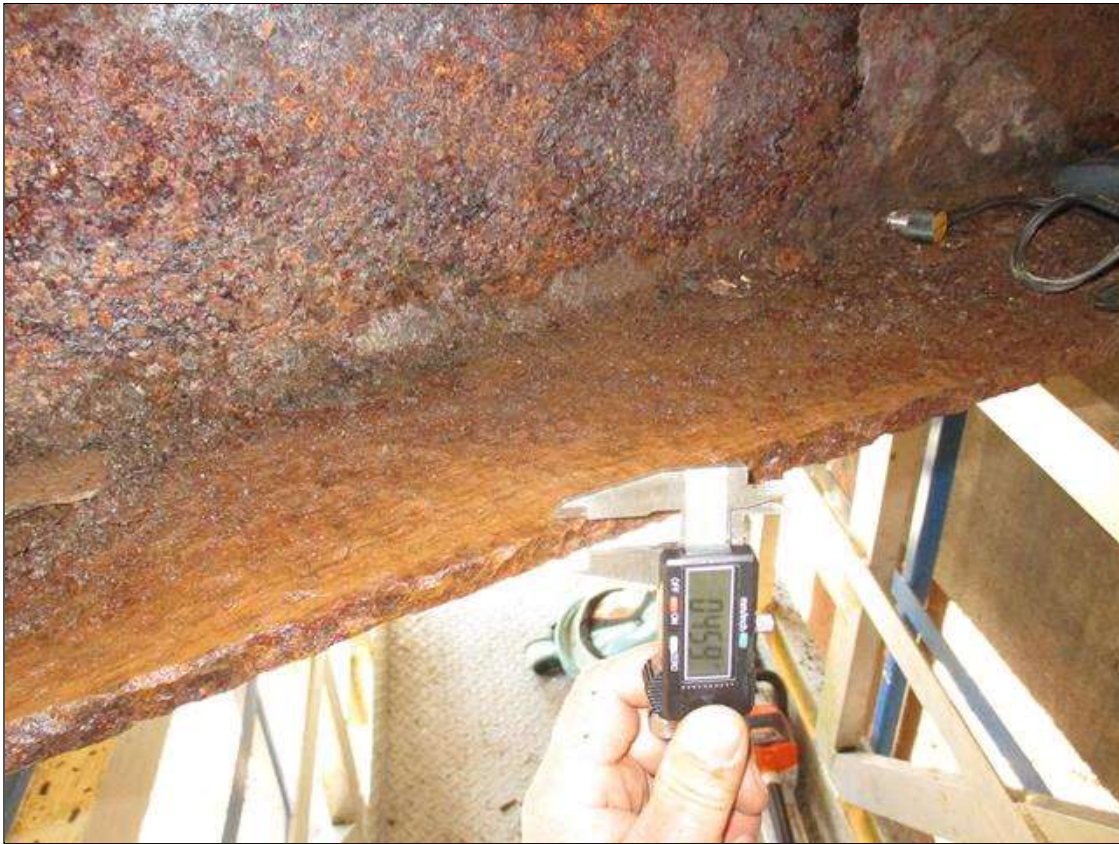
Span 4 Beam 5: (PAR) CORROSION ALONG BOTH FACES OF WEB AND BOTTOM FLANGE UP TO 105" LONG X 19" HIGH DOWN TO 0.358" RESIDUAL WEB, AND 72" LONG X 11 3/4" WIDE DOWN TO 0.459" RESIDUAL FLANGE AT BENT 3 BEARING

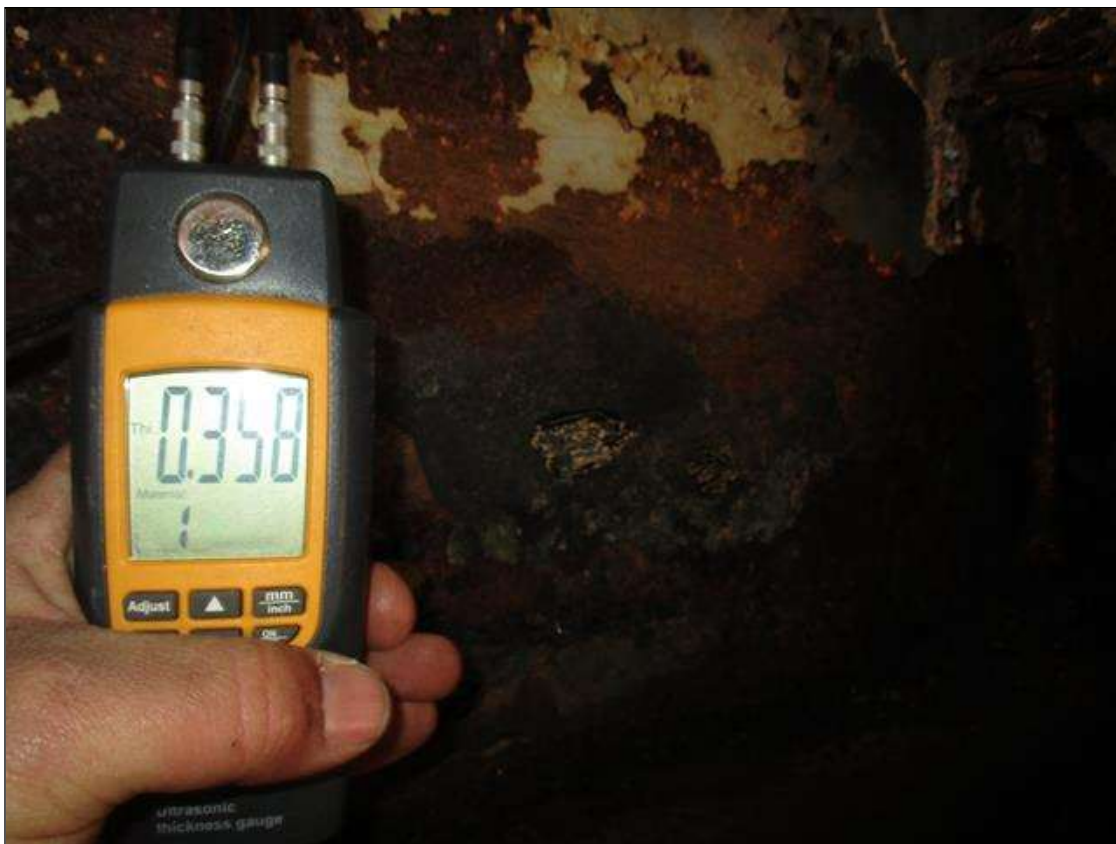
Span 4 Beam 5: (PAR) CORROSION ALONG BOTH FACES OF WEB AND BOTTOM FLANGE UP TO 105" LONG X 19" HIGH DOWN TO 0.358" RESIDUAL WEB, AND 72" LONG X 11 3/4" WIDE DOWN TO 0.459" RESIDUAL FLANGE AT BENT 3 BEARING

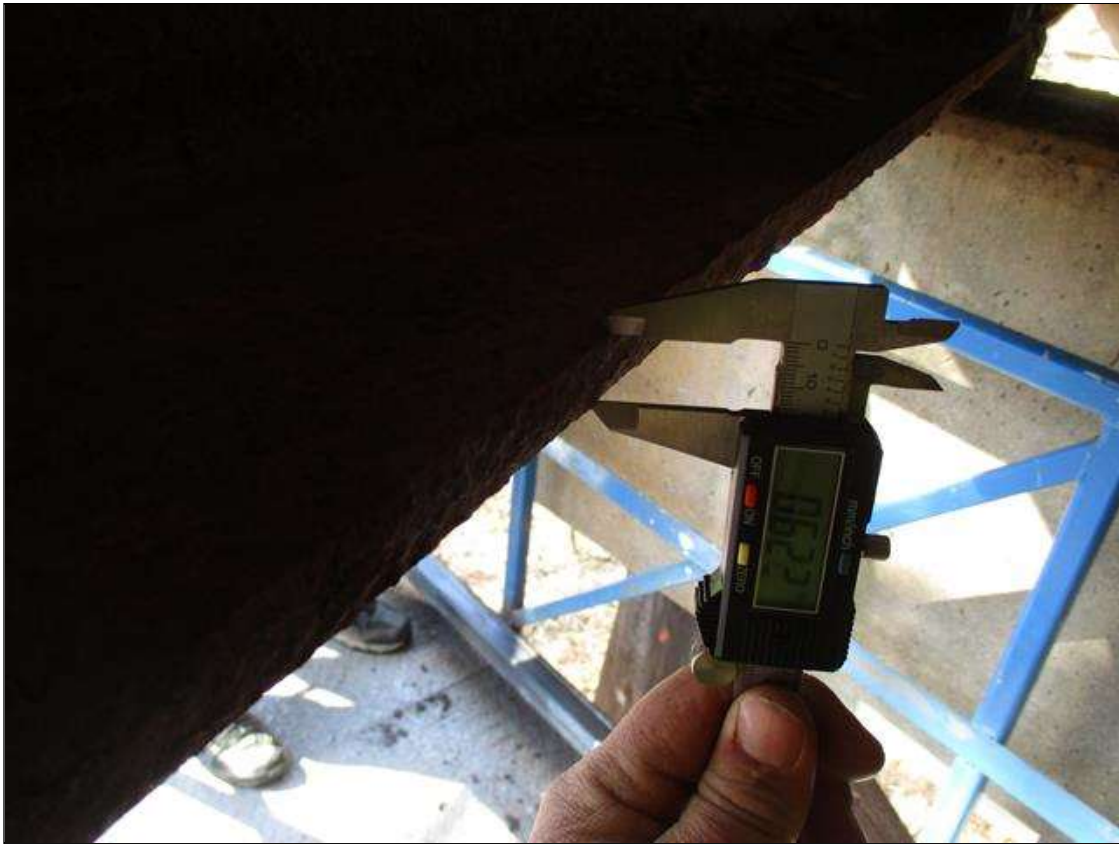
Span 4 Beam 6: CORROSION ON BOTTOM FLANGE, FULL WIDTH EXTENDING 5' FROM BENT 3, DOWN TO 0622" REMAINING FLANGE DEPTH

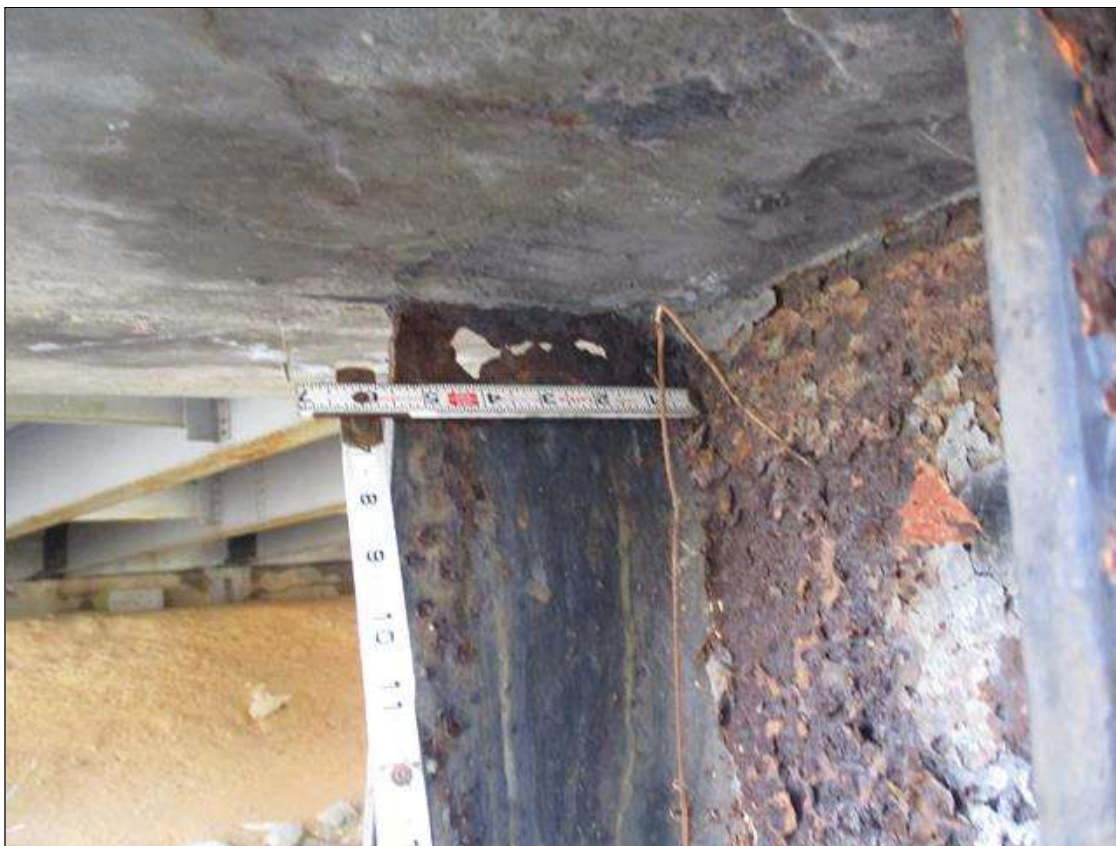
Bent 3 Pile 1: (PAR) CORROSION ALONG BOTH FLANGES UP TO 6" HIGH X 12" WIDE DOWN TO 3/8" RESIDUAL FLANGE AT BOTTOM OF CAP WITH UP TO 100% SECTION LOSS ON FAR FLANGE 4" WIDE X 1" HIGH ADJACENT TO CAP AND NEAR FLANGE
