NC DEPARTMENT OF TRANSPORTATION  
 DIVISION OF HIGHWAYS  
 STRUCTURE MANAGEMENT UNIT

ATTENTION: PARS SUBMITTED

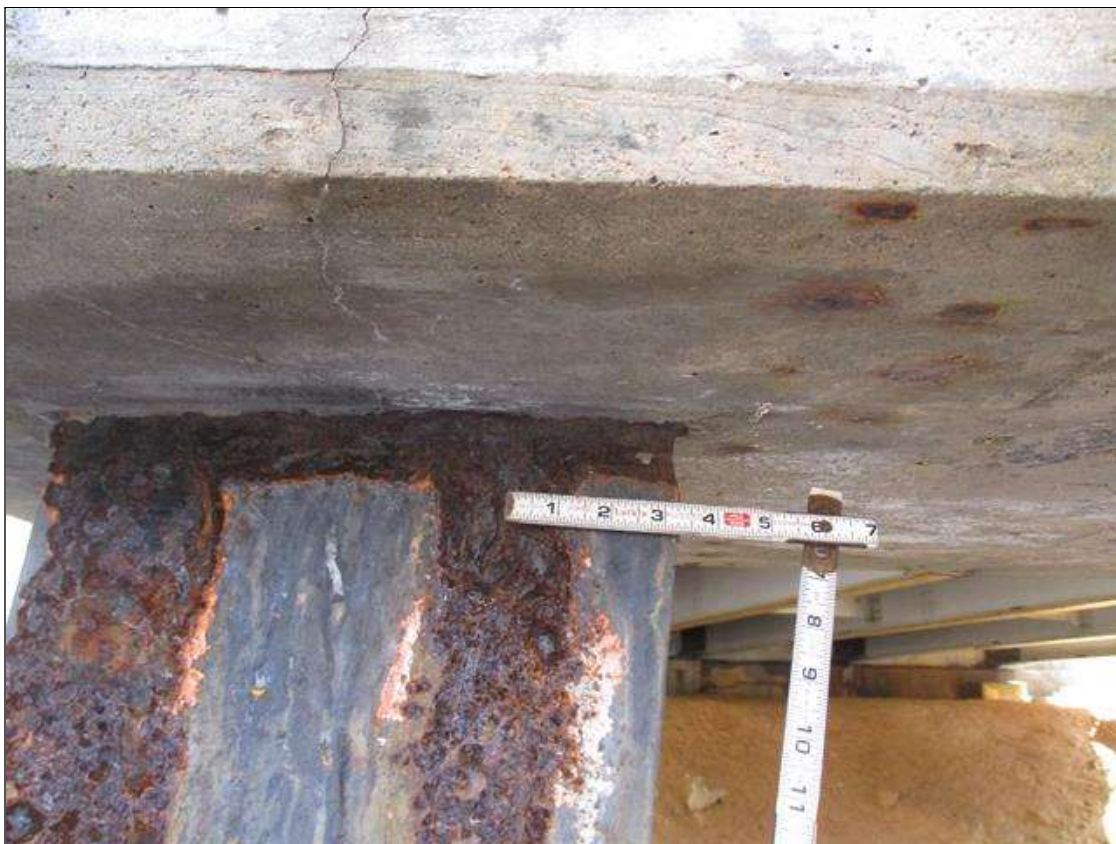
Bent 3 Pile 1: (PAR) CORROSION ALONG BOTH FLANGES UP TO 6" HIGH X 12" WIDE DOWN TO 3/8" RESIDUAL FLANGE AT BOTTOM OF CAP WITH UP TO 100% SECTION LOSS ON FAR FLANGE 4" WIDE X 1" HIGH ADJACENT TO CAP AND NEAR FLANGE

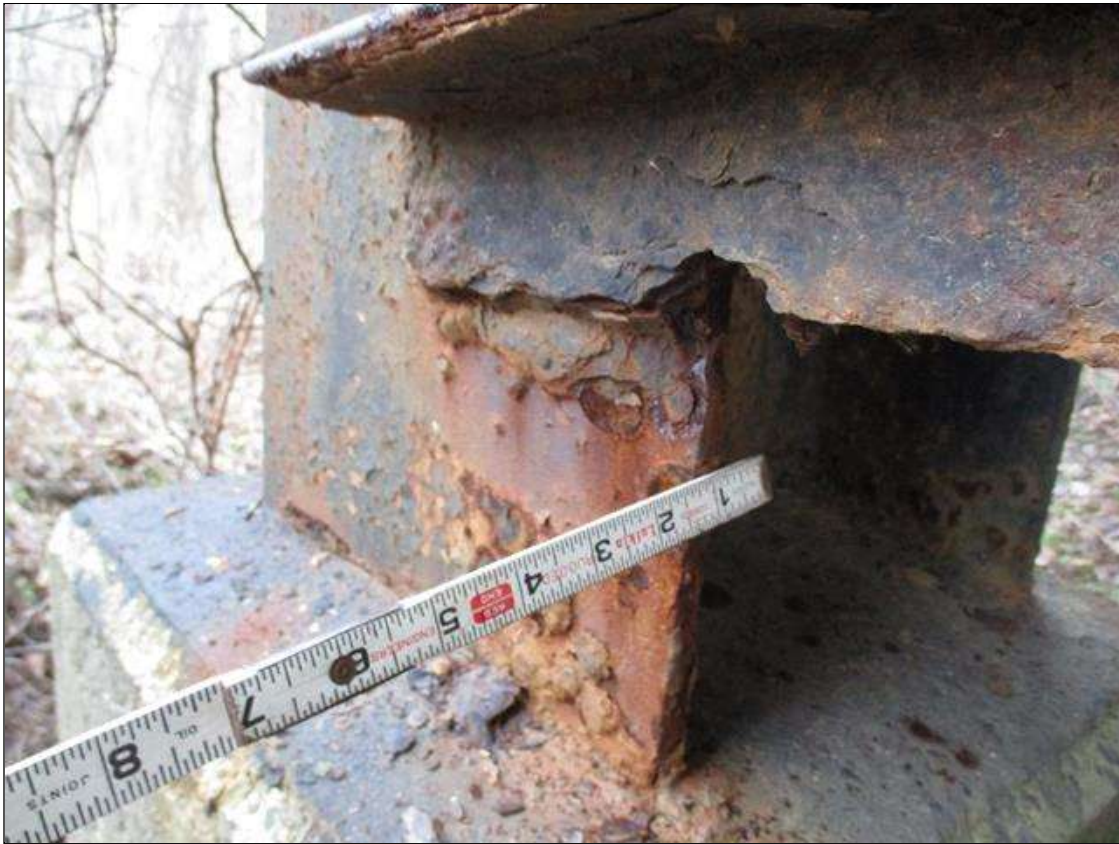
Bent 3 Pile 1: (PAR) CORROSION ALONG RIGHT EDGE OF NEAR FLANGE UP TO 23" HIGH X 6" WIDE DOWN TO 3/8" RESIDUAL FLANGE ABOVE CONCRETE ENCASEMENT

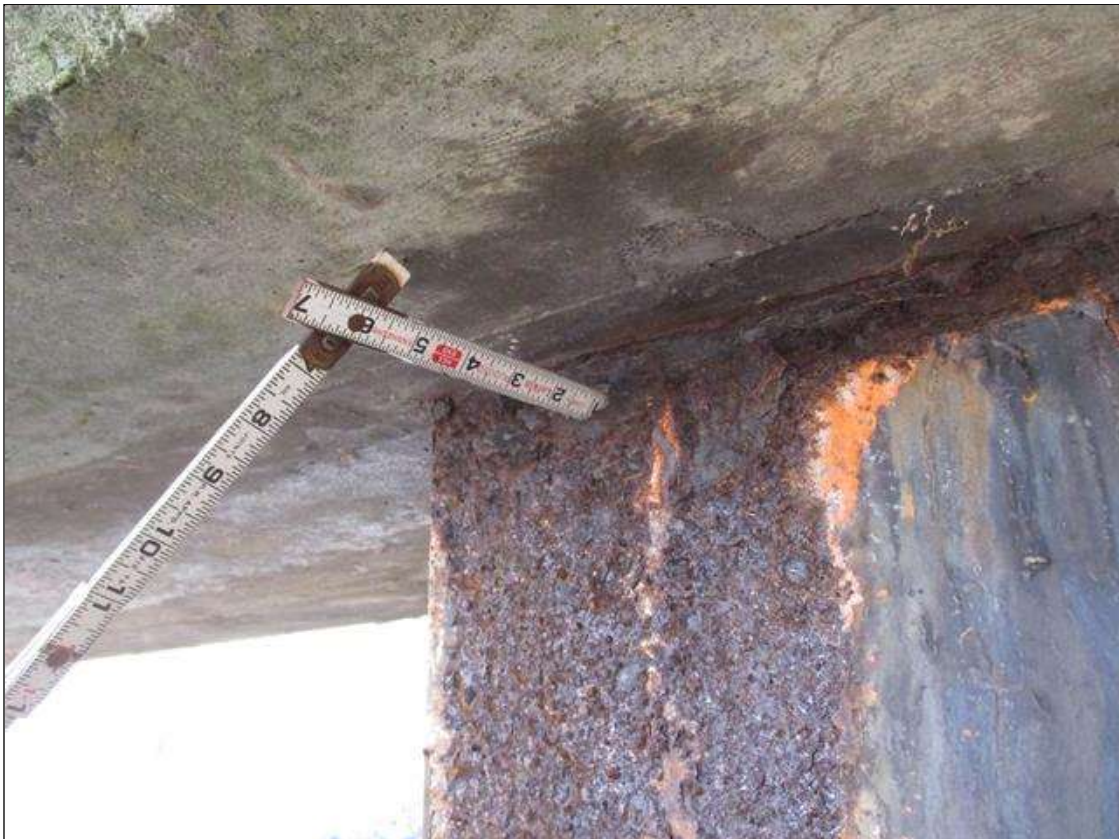
Bent 3 Pile 2: (PAR) CORROSION ALONG NEAR FLANGE UP TO 3" HIGH X 12" WIDE DOWN TO 1/4" RESIDUAL FLANGE WITH 3/16" DIAMETER HOLE AT BOTTOM OF CAP UP TO 3" LONG

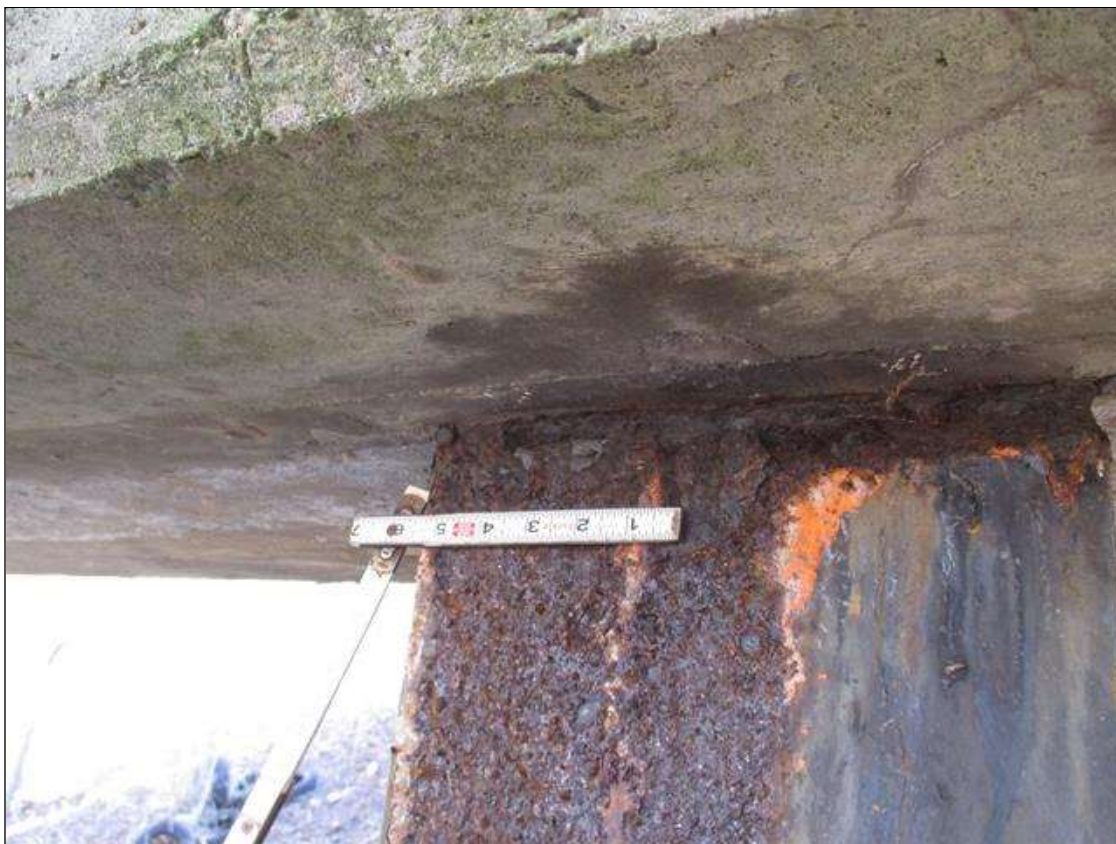
Bent 3 Pile 2: (PAR) CORROSION ALONG NEAR FLANGE UP TO 3" HIGH X 12" WIDE DOWN TO 1/4" RESIDUAL FLANGE WITH 3/16" DIAMETER HOLE AT BOTTOM OF CAP UP TO 3" LONG

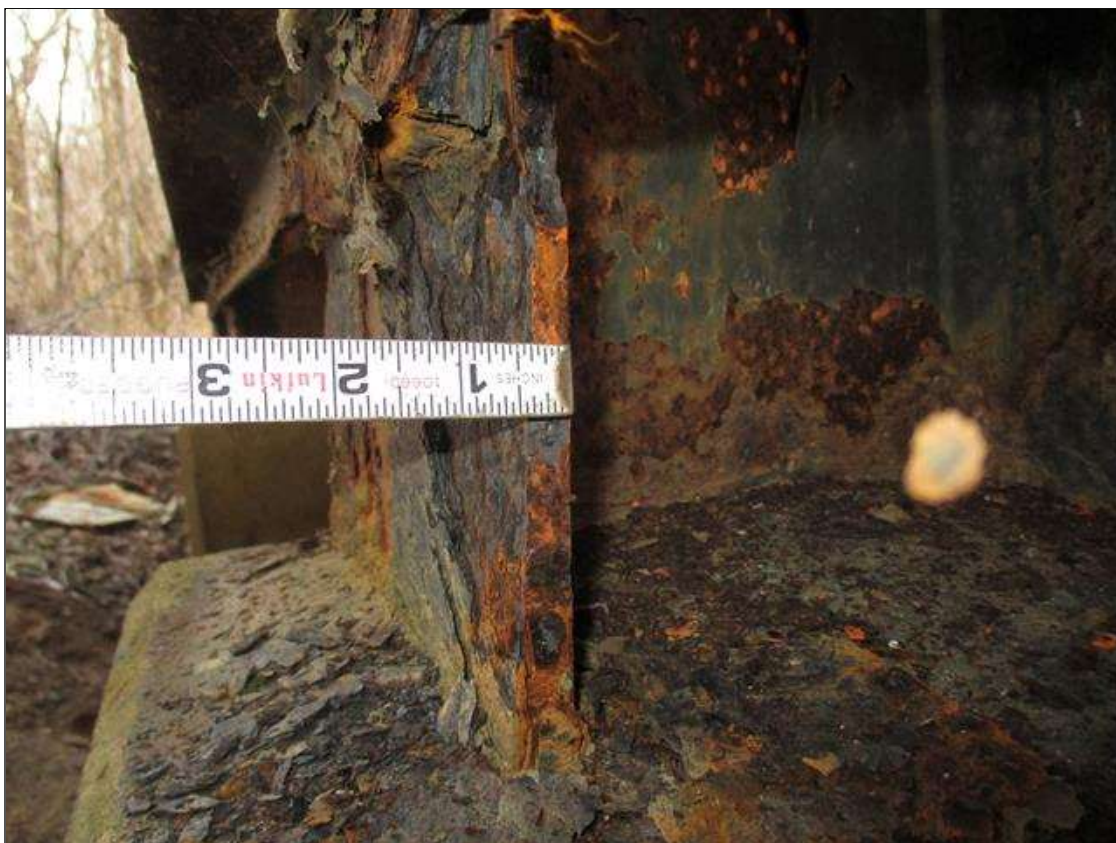
Bent 3 Pile 3: (PAR) CORROSION ALONG BOTH FLANGES UP TO 17" HIGH X 12" WIDE DOWN TO 3/8" RESIDUAL FLANGE ABOVE CONCRETE ENCASEMENT

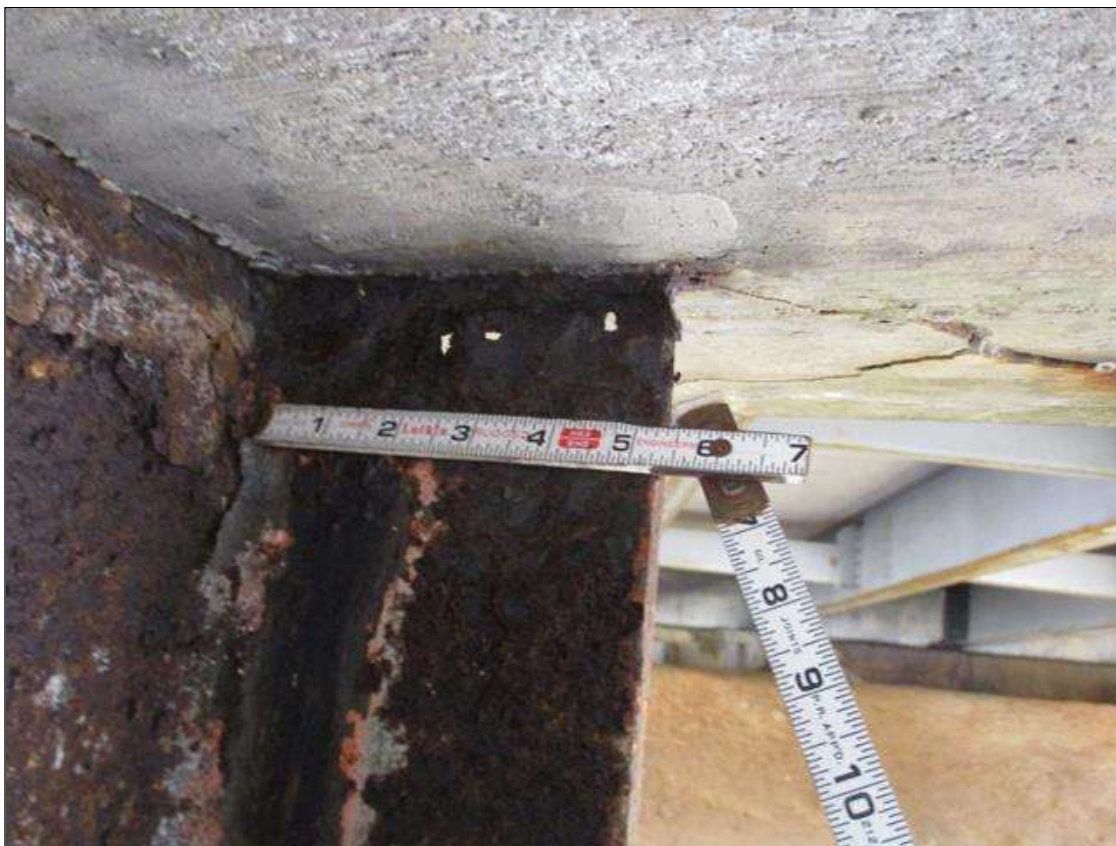
Bent 3 Pile 4: (PAR) CORROSION ALONG BOTH FLANGES UP TO 5" HIGH X 12" WIDE, 100% SECTION LOSS ON FLANGE AT BOTTOM OF CAP

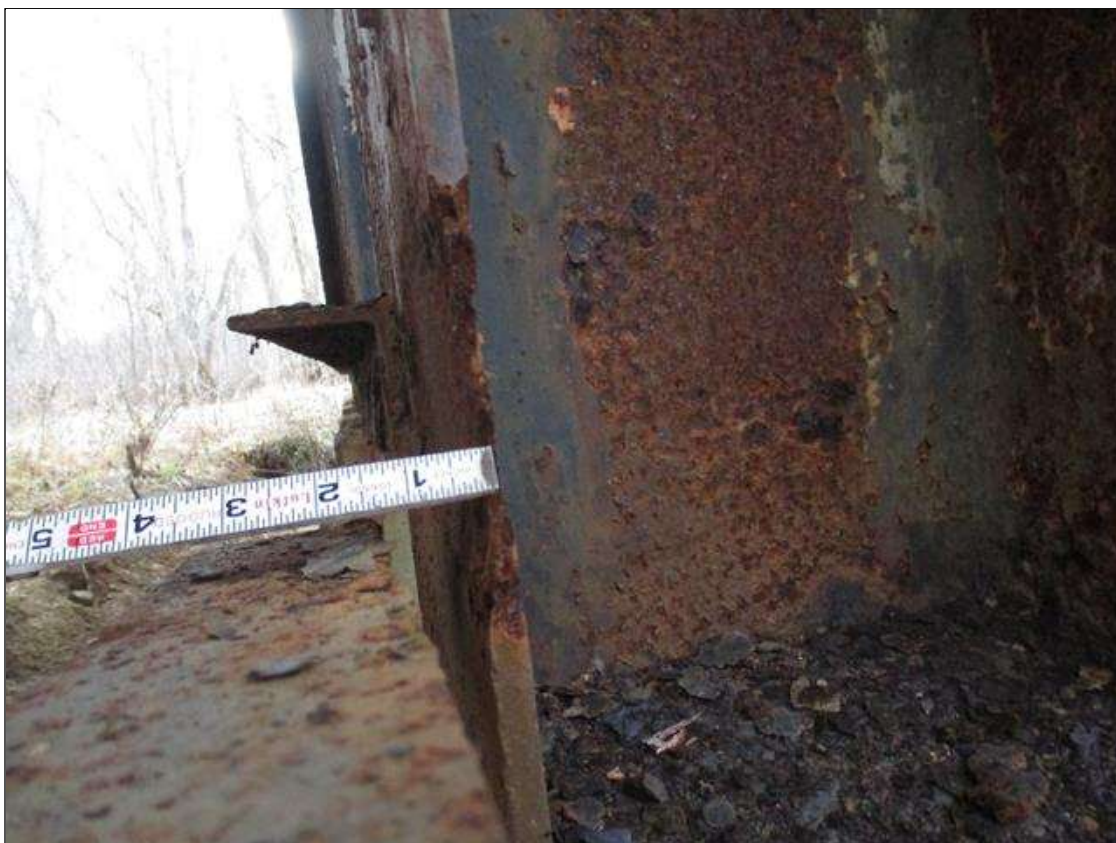
Bent 3 Pile 4: (PAR) FAR FLANGE DOWN TO KNIFE EDGE

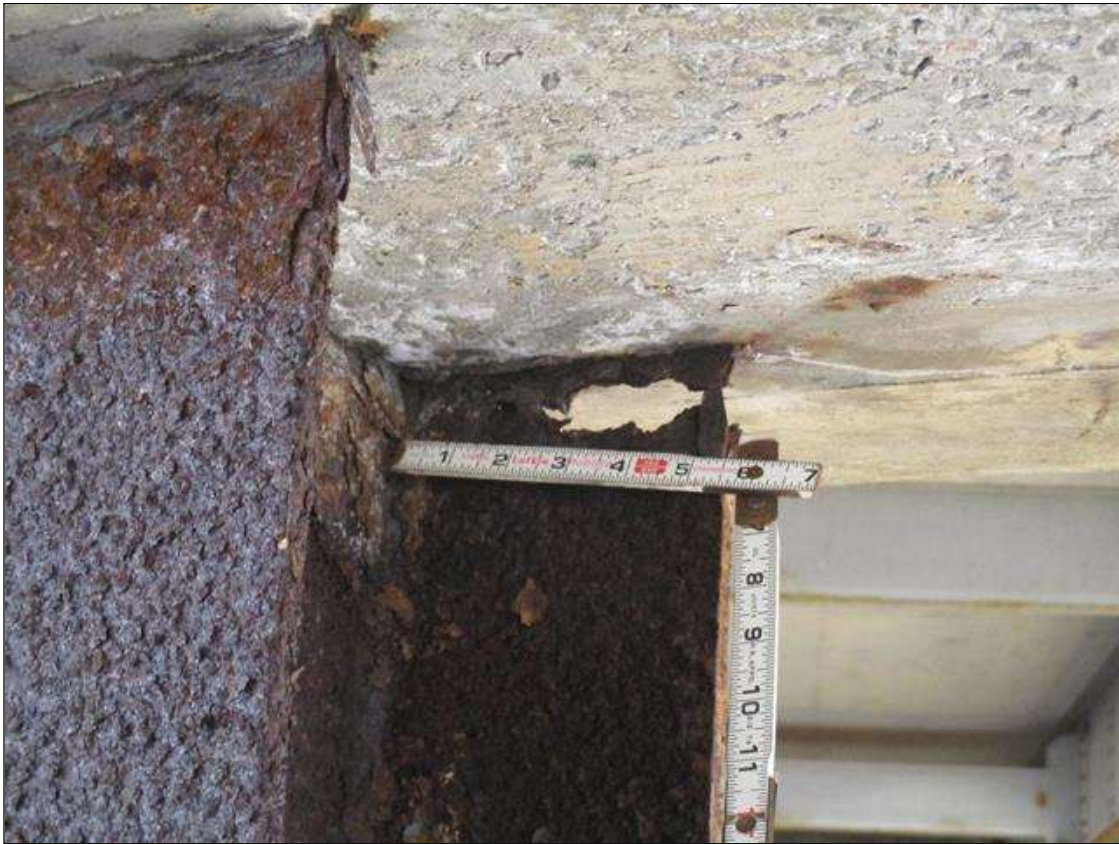
Bent 3 Pile 5: (PAR) CORROSION ALONG BOTH FLANGES UP TO 24" HIGH X 12" WIDE, 100% SECTION LOSS ON FLANGE WITH UP TO 2 1/2" WIDE X 1" HIGH HOLES AT BOTTOM OF CAP

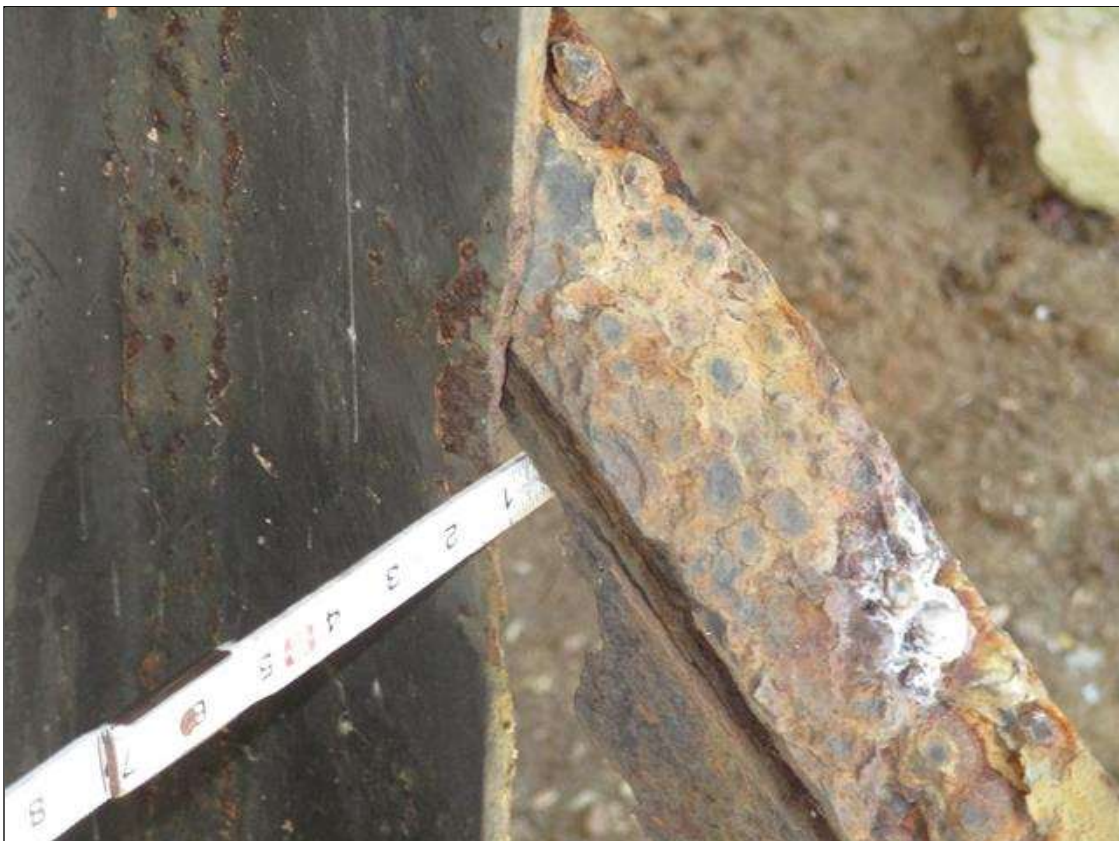
Bent 3 Pile 6: (PAR) CORROSION ALONG FAR FLANGE UP TO 5" HIGH X 12" WIDE DOWN TO 3/16" RESIDUAL FLANGE, APPROXIMATELY 4' FROM BOTTOM OF CAP

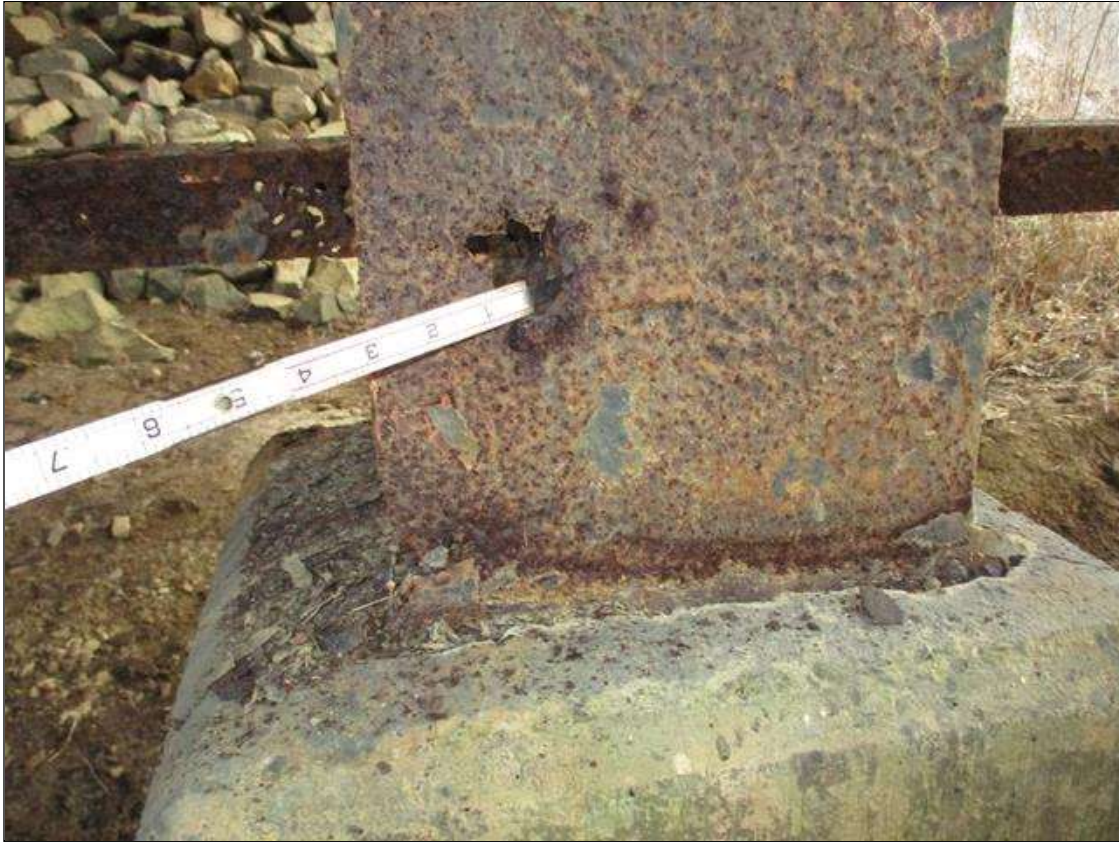
Bent 3 Pile 6: (PAR) CORROSION ALONG WEB AND BOTH FLANGES UP TO 19" HIGH X 11" WIDE WITH NO MEASURABLE LOSS OF SECTION IN WEB, AND 19" HIGH X 12" WIDE DOWN TO KNIFE'S EDGE RESIDUAL FLANGE WITH 2 LOCATIONS OF UP TO 6" HIGH X 3" WIDE 100% LOSS OF SECTION ABOVE CONCRETE ENCASEMENT

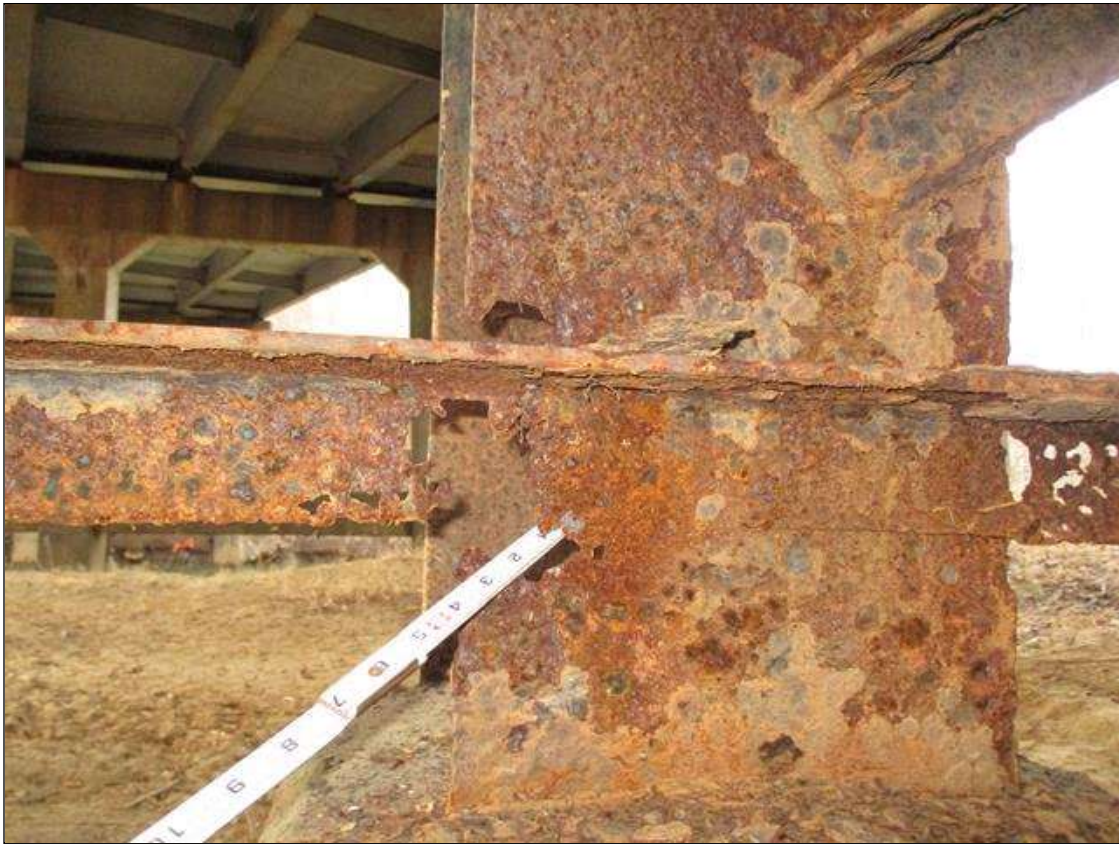
Bent 3 Pile 6: (PAR) CORROSION ALONG WEB AND BOTH FLANGES UP TO 19" HIGH X 11" WIDE WITH NO MEASURABLE LOSS OF SECTION IN WEB, AND 19" HIGH X 12" WIDE DOWN TO KNIFE'S EDGE RESIDUAL FLANGE WITH 2 LOCATIONS OF UP TO 6" HIGH X 3" WIDE 100% LOSS OF SECTION ABOVE CONCRETE ENCASEMENT

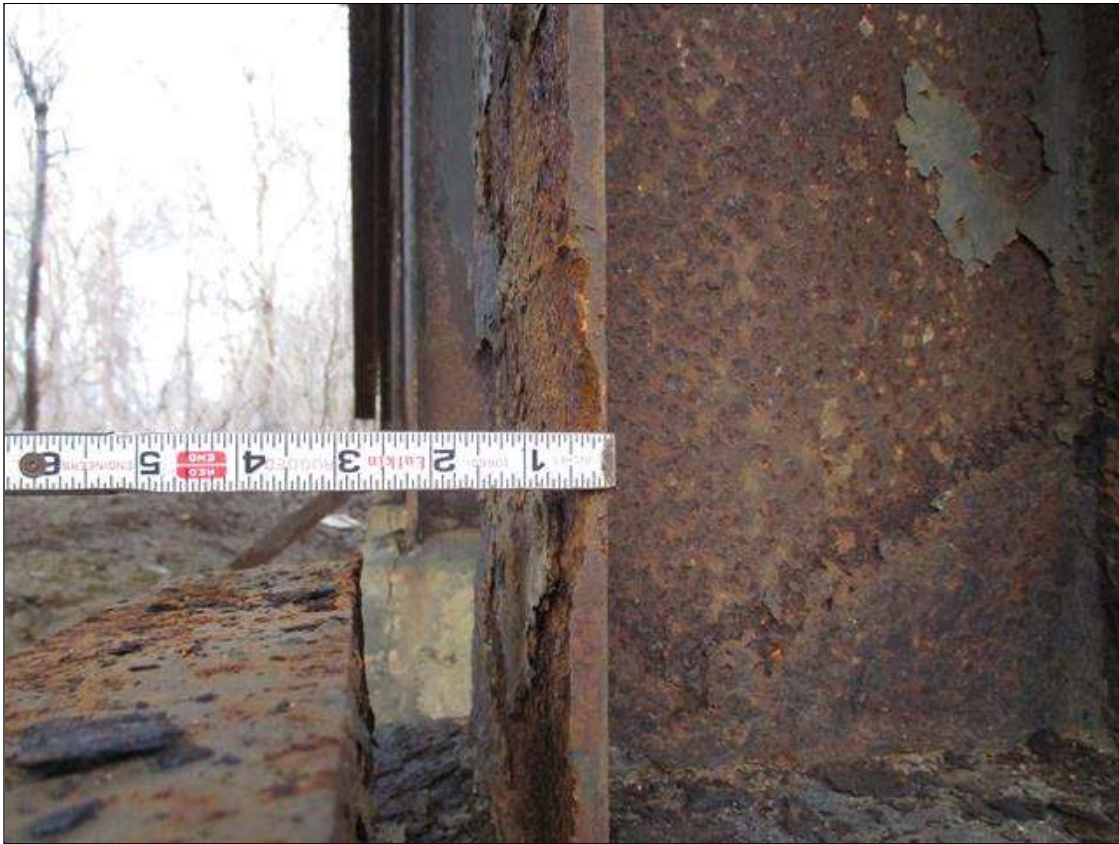
Bent 3 Pile 7: (PAR) CORROSION ALONG BOTH FLANGES UP TO 17" HIGH X 12" WIDE DOWN TO 1/4" RESIDUAL FLANGE ABOVE CONCRETE ENCASEMENT

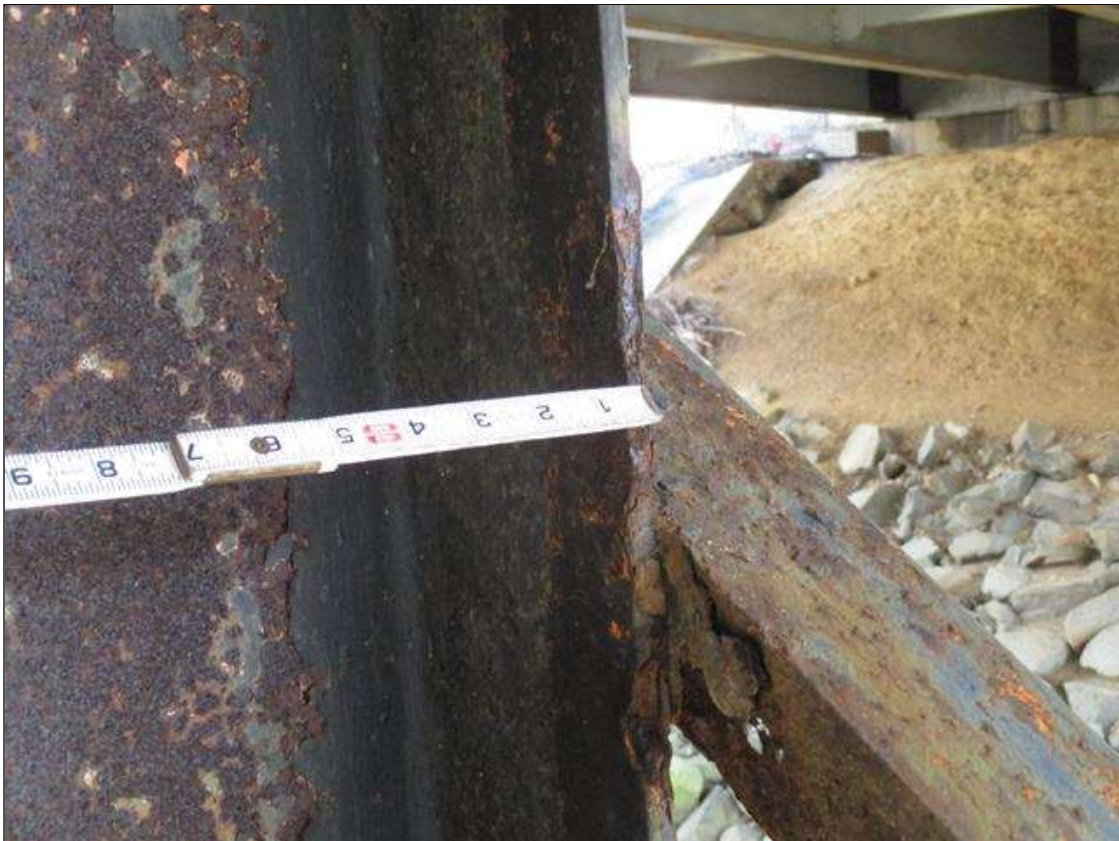
Bent 3 Pile 7: (PAR) CORROSION ALONG RIGHT EDGE OF FAR FLANGE UP TO 10" HIGH X 9" WIDE DOWN TO 1/4" RESIDUAL FLANGE, APPROXIMATELY 2' FROM BOTTOM OF CAP

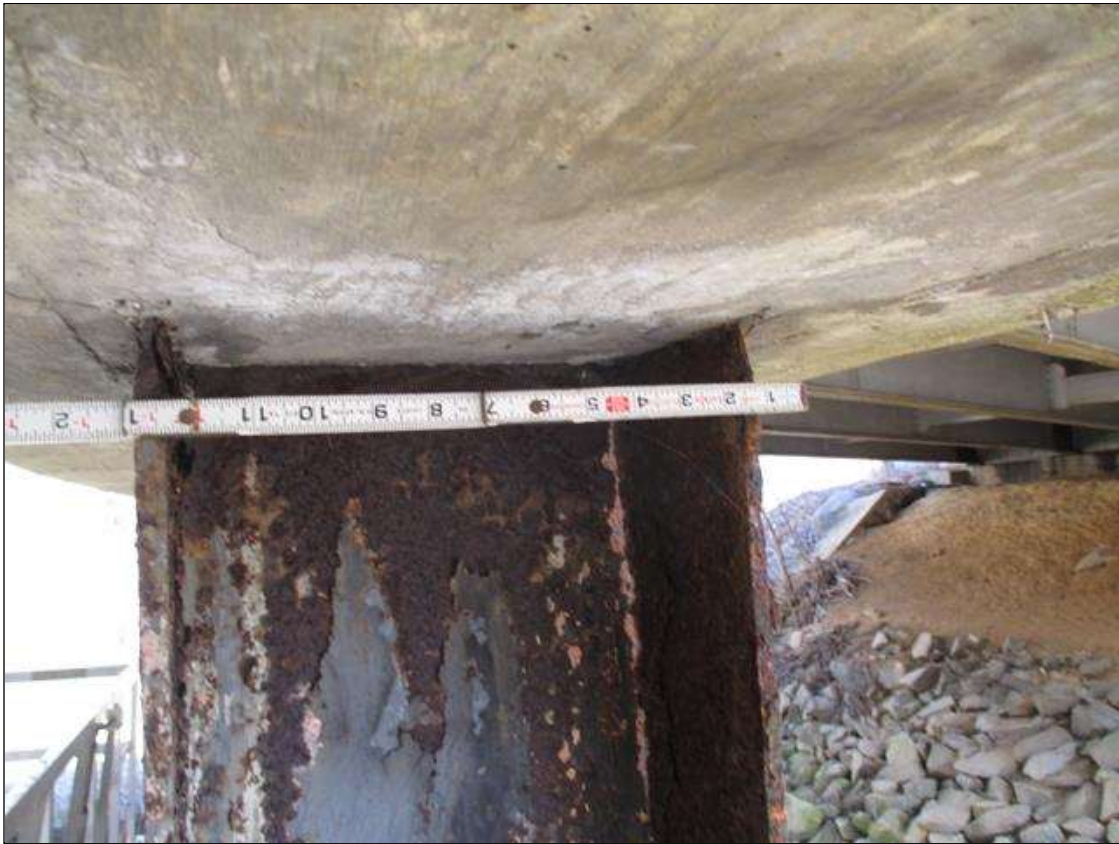
Bent 3 Pile 8: (PAR) CORROSION ALONG BOTH FLANGES UP TO 8" HIGH X 12" WIDE DOWN TO 1/8" RESIDUAL FLANGE AT BOTTOM OF CAP

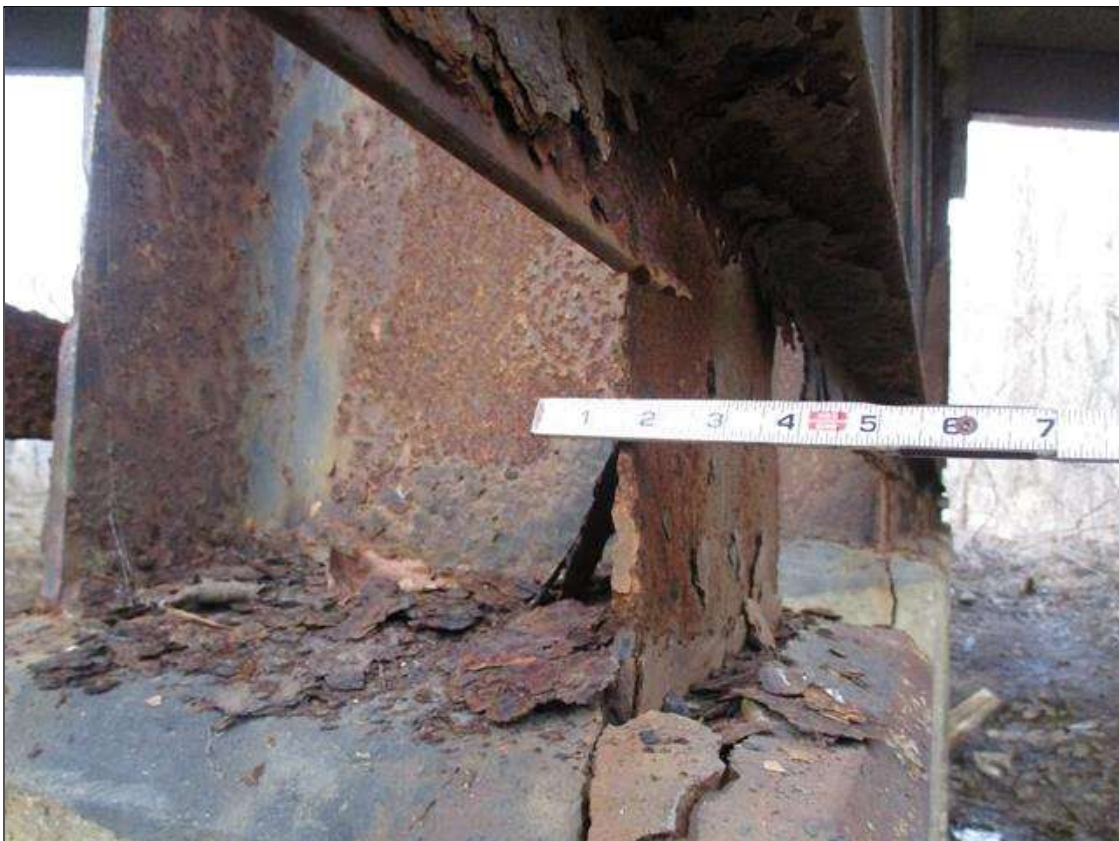
Bent 3 Pile 8: (PAR) CORROSION ALONG BOTH FLANGES UP TO 20" HIGH X 12" WIDE DOWN TO KNIFE'S EDGE RESIDUAL FLANGE ABOVE CONCRETE ENCASEMENT

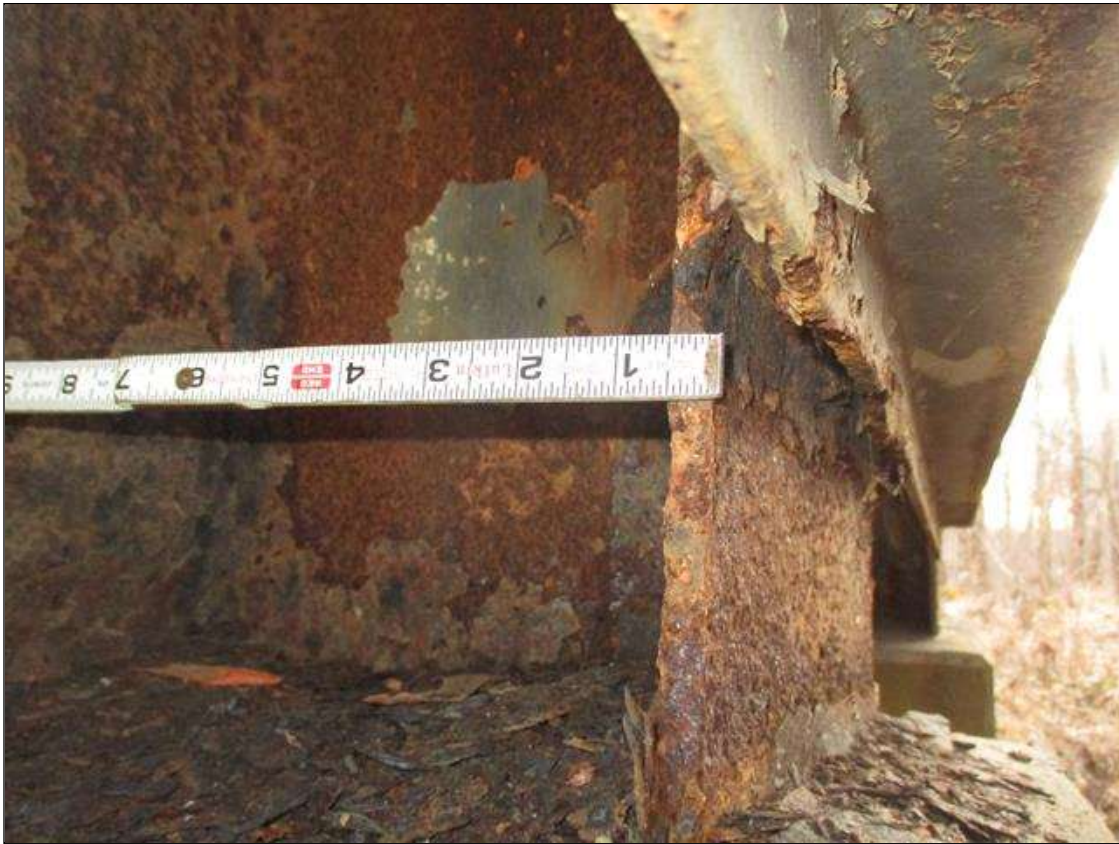
Bent 3 Pile 9: (PAR) CORROSION ALONG BOTH FLANGES UP TO 12" HIGH X 12" WIDE DOWN TO 5/16" RESIDUAL FLANGE ABOVE CONCRETE ENCASEMENT

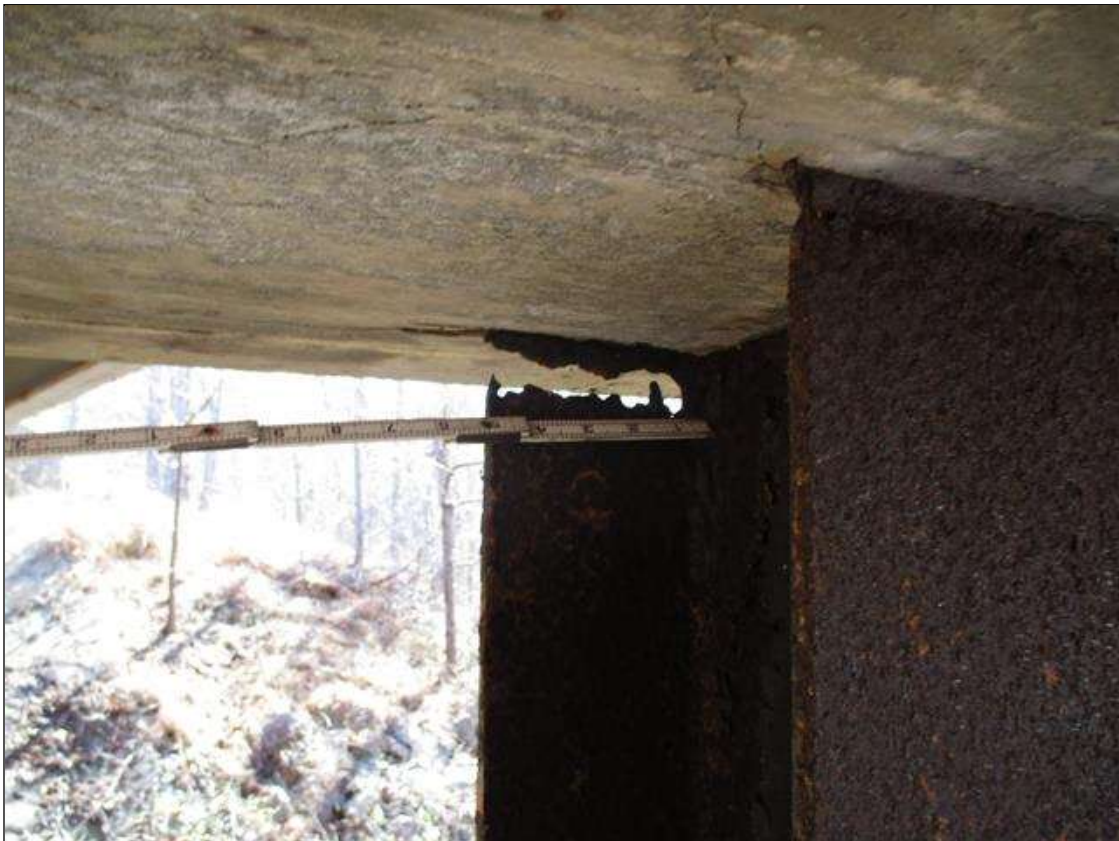
Bent 3 Pile 9: (PAR) CORROSION ALONG BOTH FLANGES UP TO 20" HIGH X 12" WIDE, 100% SECTION LOSS ON FLANGE WITH UP TO 4" WIDE X 1 1/2" HIGH LOSS OF SECTIONS AT BOTTOM OF CAP

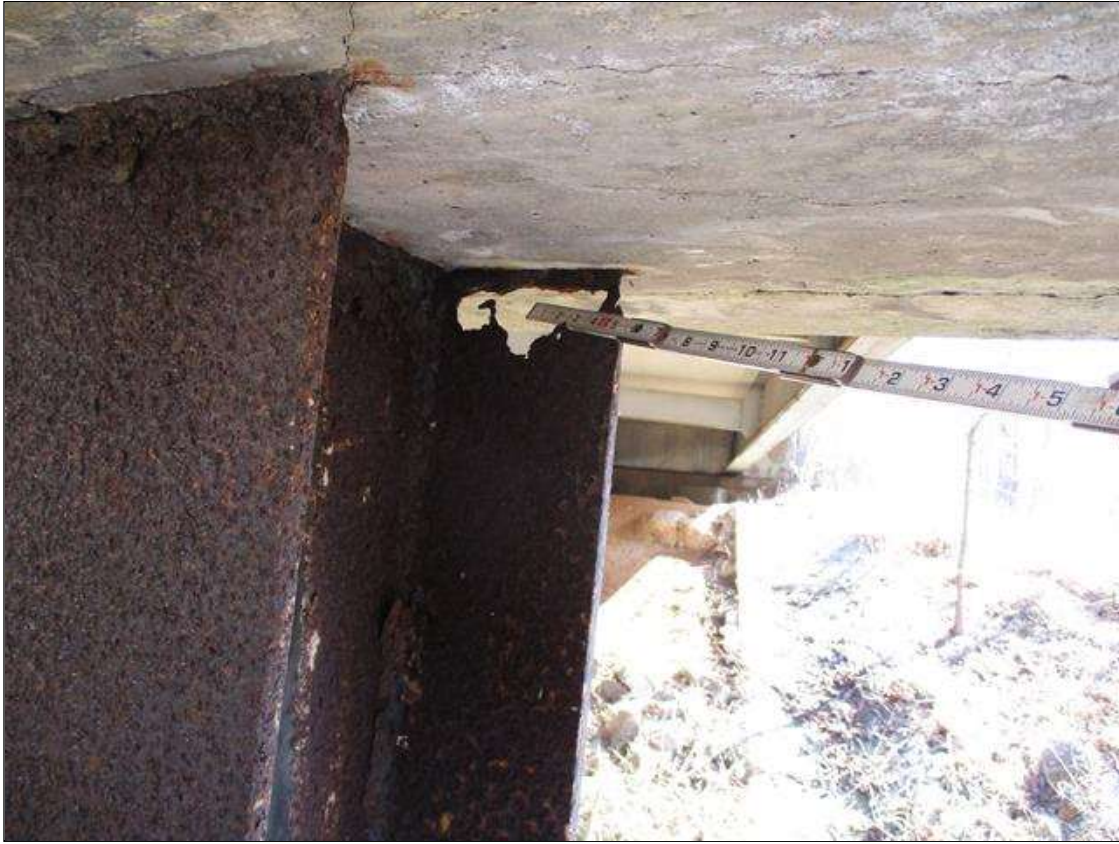
Bent 3 Pile 9: (PAR) CORROSION ALONG BOTH FLANGES UP TO 20" HIGH X 12" WIDE, 100% SECTION LOSS ON FLANGE WITH UP TO 4" WIDE X 1 1/2" HIGH LOSS OF SECTIONS AT BOTTOM OF CAP

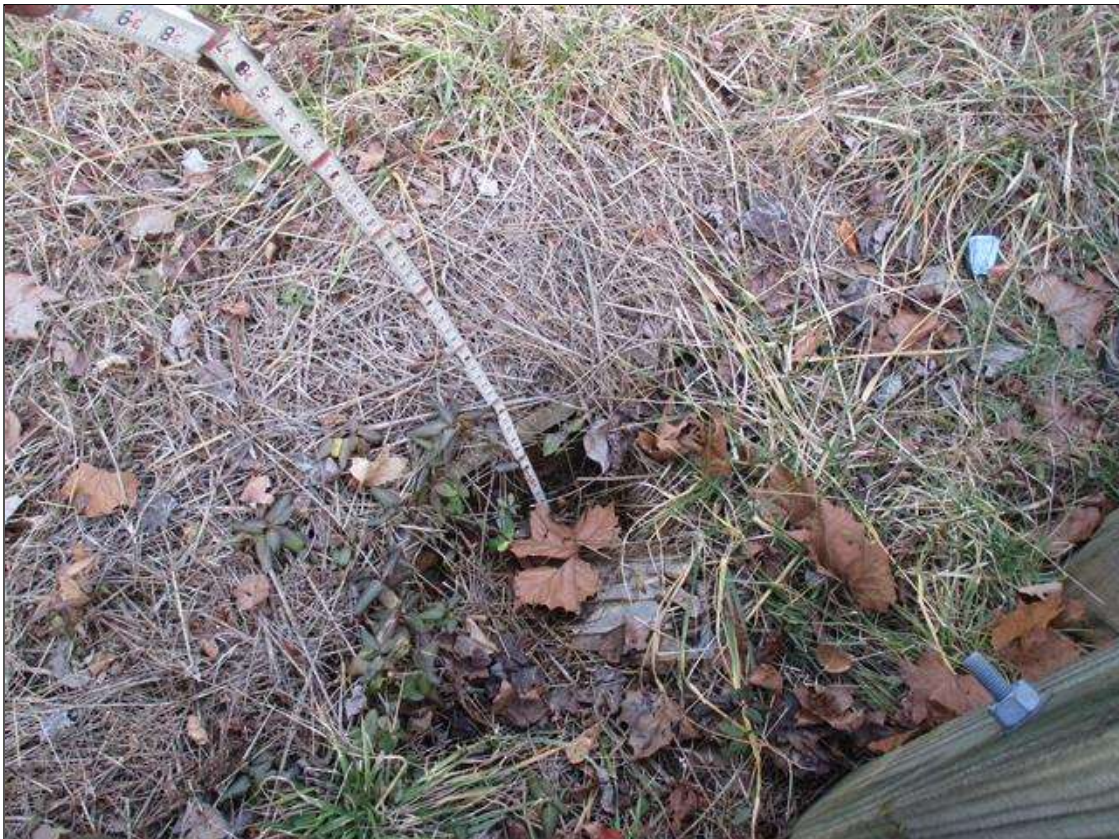
(PAR) BRIDGE DRAINAGE, CLOGGED EITHER PARTIALLY OF FULLY WITH VEGETATION GROWTH. (16) ALONG RIGHT CURB & (5) ALONG LEFT CURB

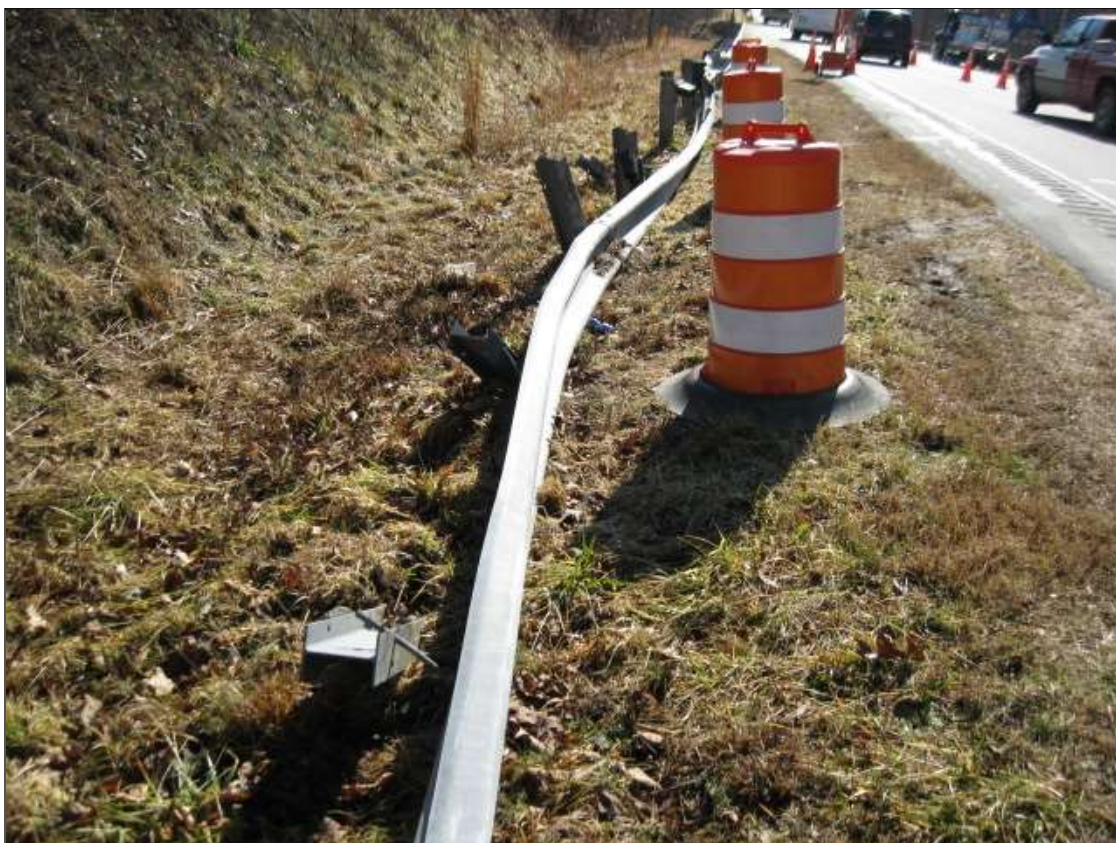
(PAR) GUARDRAIL DAMAGE AT NEAR LEFT APPROACH ADJACENT TO END TERMINATION, 50' SECTION IMPACTED

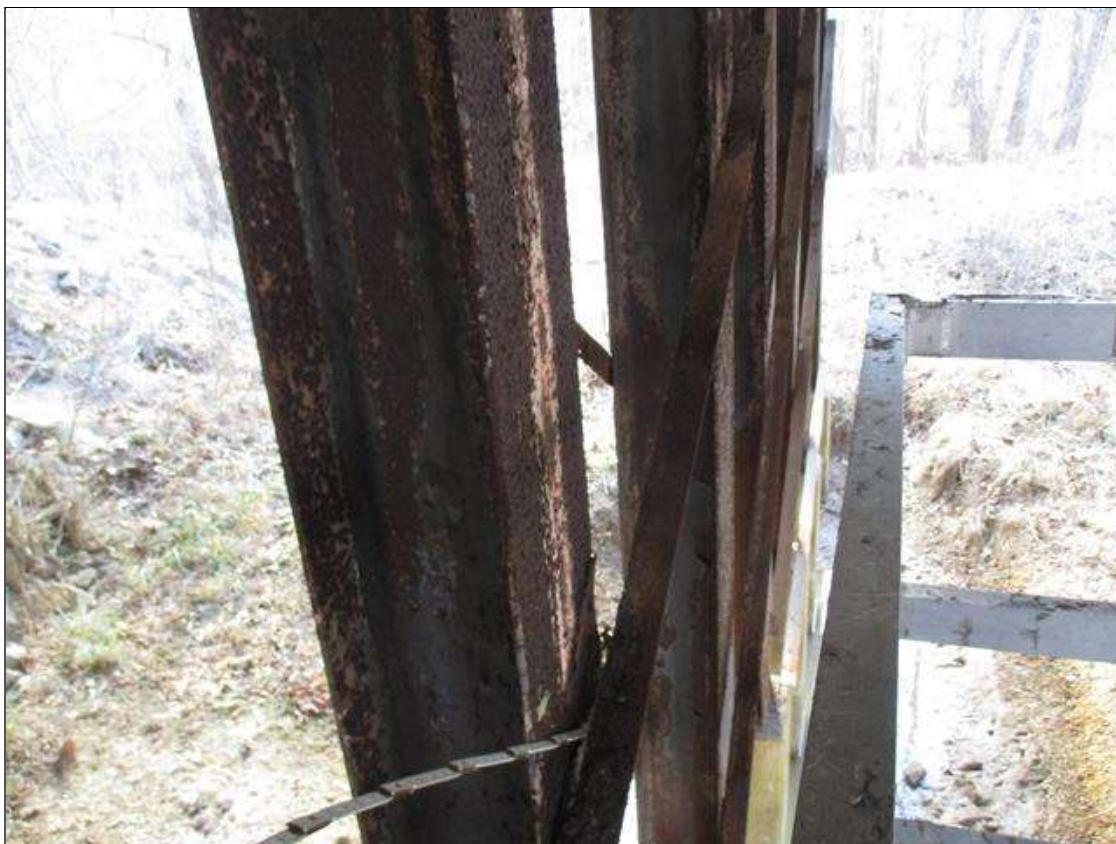
(PAR) AREAS OF 100% SECTION LOSS UP 17" X 3" AND BROKEN AND DETACHED CROSS BRACING INTERMITTENT THROUGHOUT BENT 3

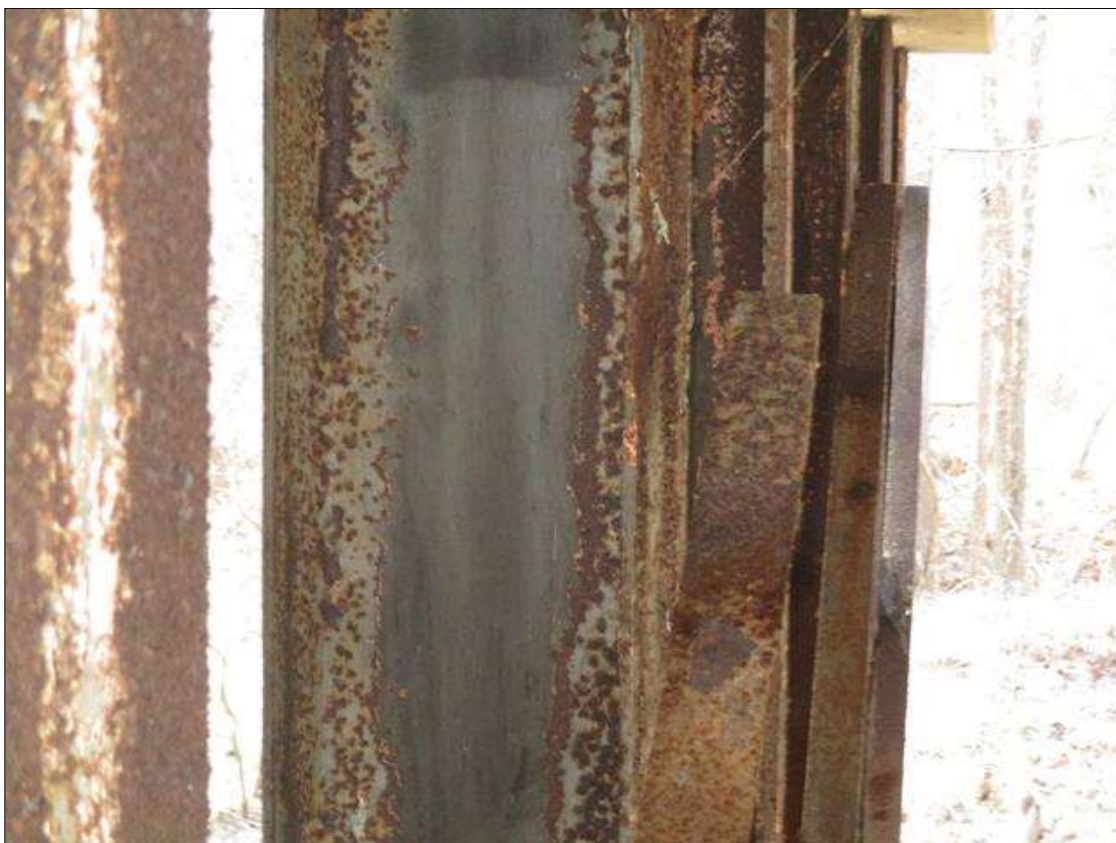
(PAR) AREAS OF 100% SECTION LOSS UP 17" X 3" AND BROKEN AND DETACHED CROSS BRACING INTERMITTENT THROUGHOUT BENT 3

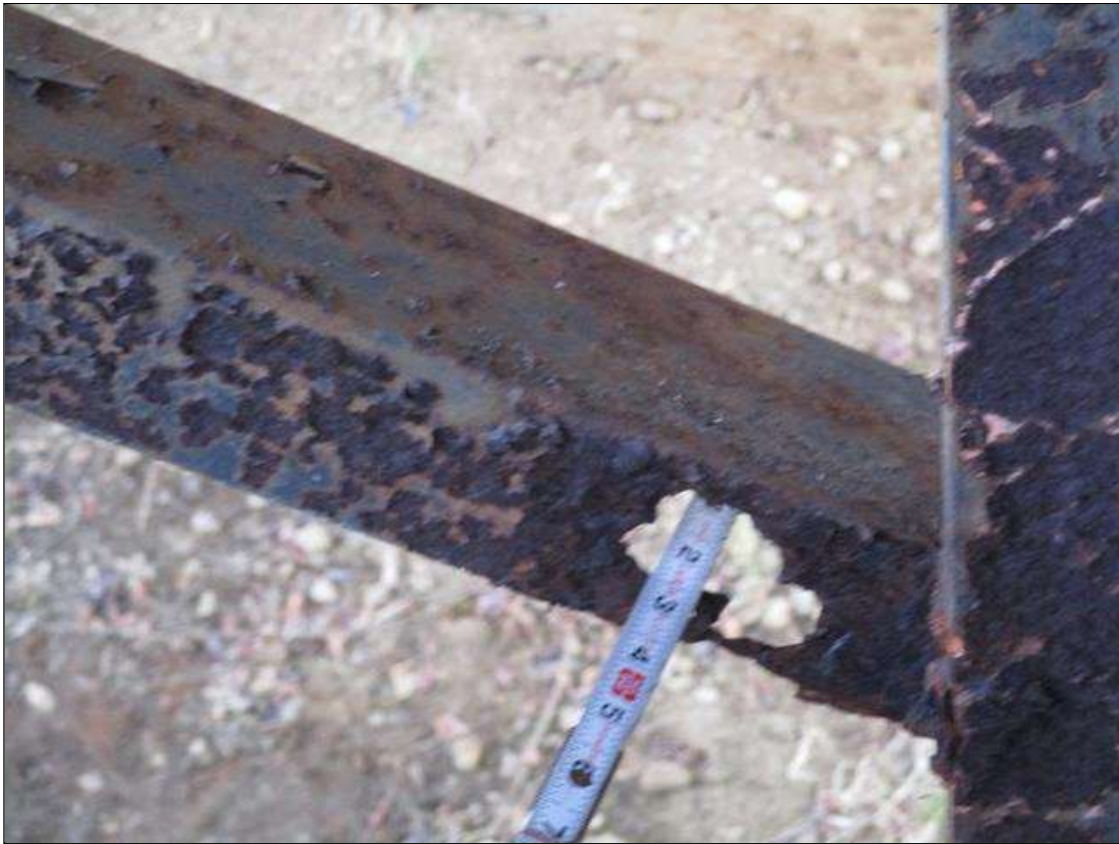
(PAR) AREAS OF 100% SECTION LOSS UP 17" X 3" AND BROKEN AND DETACHED CROSS BRACING INTERMITTENT THROUGHOUT BENT 3
