NC DEPARTMENT OF TRANSPORTATION  
 DIVISION OF HIGHWAYS  
 STRUCTURE MANAGEMENT UNIT

ATTENTION: PARS SUBMITTED

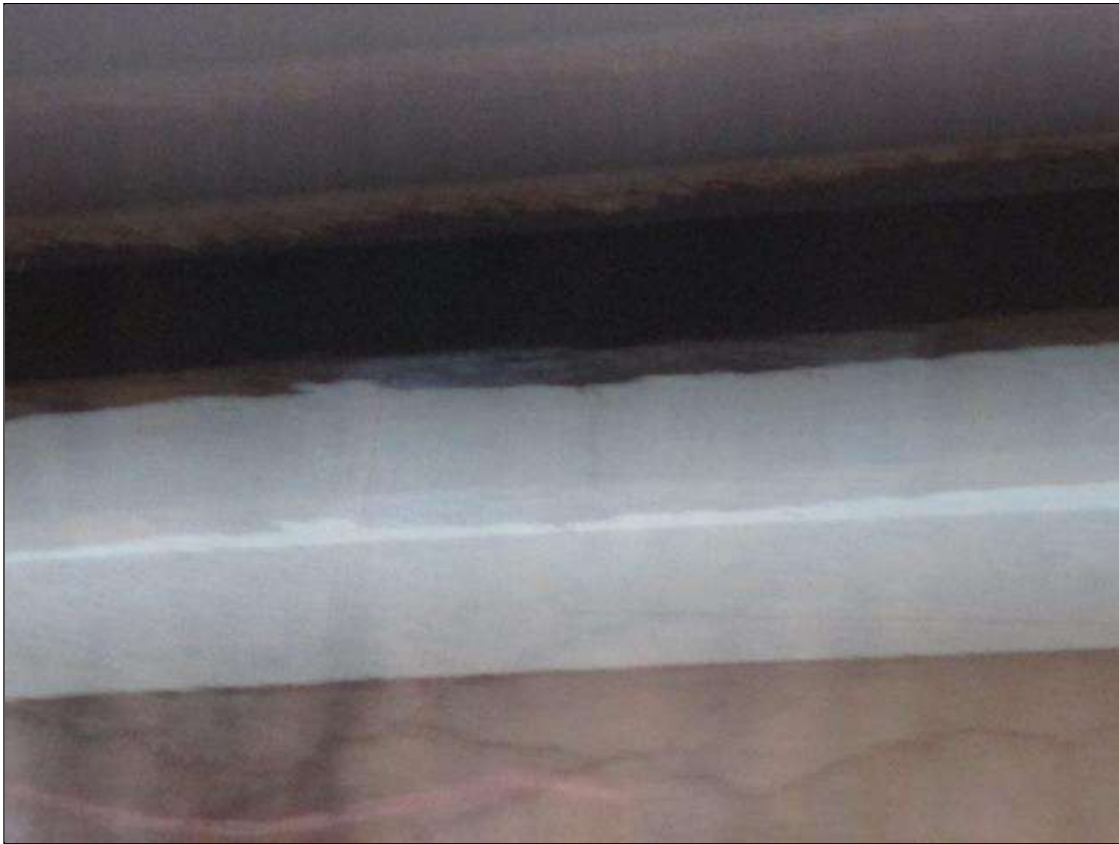
(PAR) STEEL DIAPHRAGM: SPAN 2 AT BENT 1 IN BAY 3, CORROSION ALONG TOP FLANGE UP TO 36" LONG X 1" WIDE WITH NO MEASURABLE LOSS OF SECTION, AND CORROSION ALONG BOTTOM FLANGE UP TO 22" X 3" DOWN TO KNIFE'S EDGE RESIDUAL FLANGE WITH 4" LONG X 1" WIDE LOSS OF SECTION NEAR MIDLNGTH

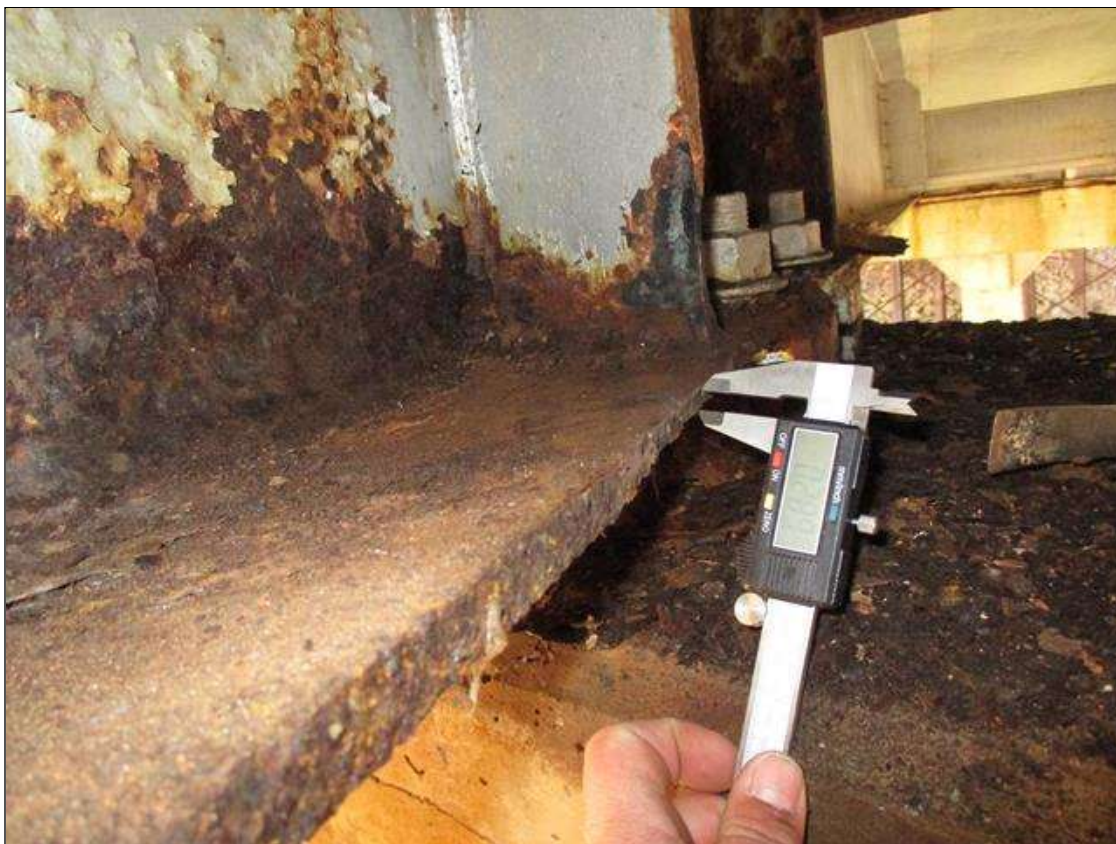
Span 1 Beam 3: (PAR) CORROSION ALONG BOTH FACES OF WEB AND BOTTOM FLANGE UP TO 34" LONG X 24" HIGH DOWN TO 0.291" RESIDUAL WEB, AND 36" LONG X 5" WIDE DOWN TO 0.289" RESIDUAL FLANGE AT BENT 1 BEARING

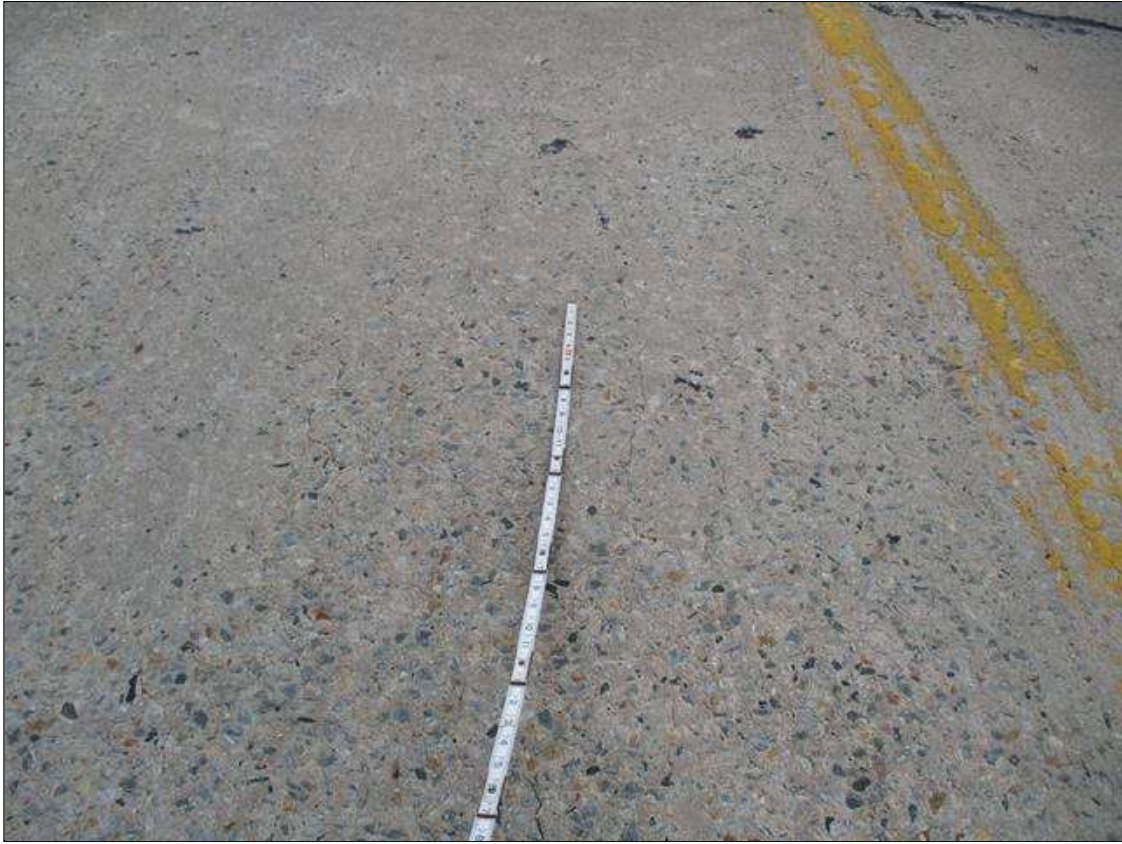
Span 1 Deck: UP TO 0.02" MAP CRACKS THROUGHOUT TOP OF DECK

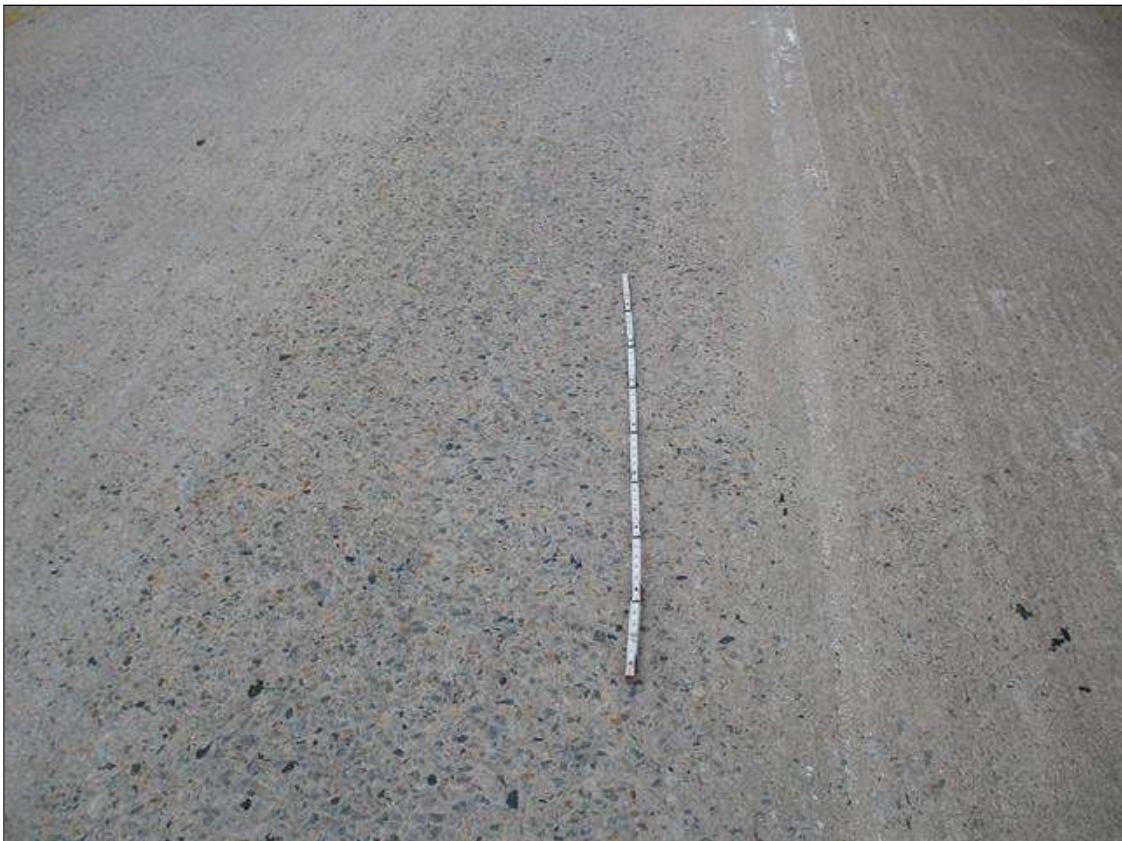
Span 1 Deck: 1320 SQUARE FEET OF SCALING WITH EXPOSED AGGREGATE IN TOP OF DECK THROUGHOUT TRAVEL LANES

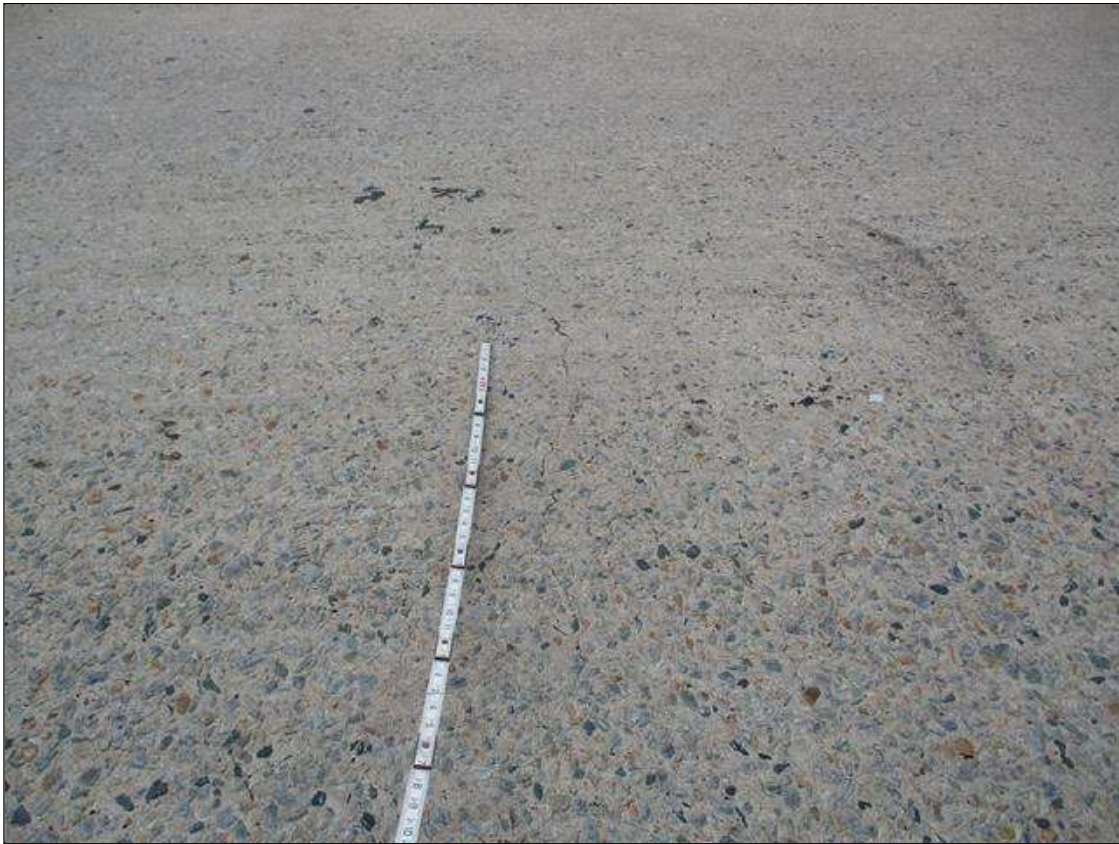
Span 1 Deck: UP TO 0.035" TRANSVERSE CRACKS IN TOP OF DECK IN TRAVEL LANES WITHIN 3' OF END BENT 1 FILL FACE

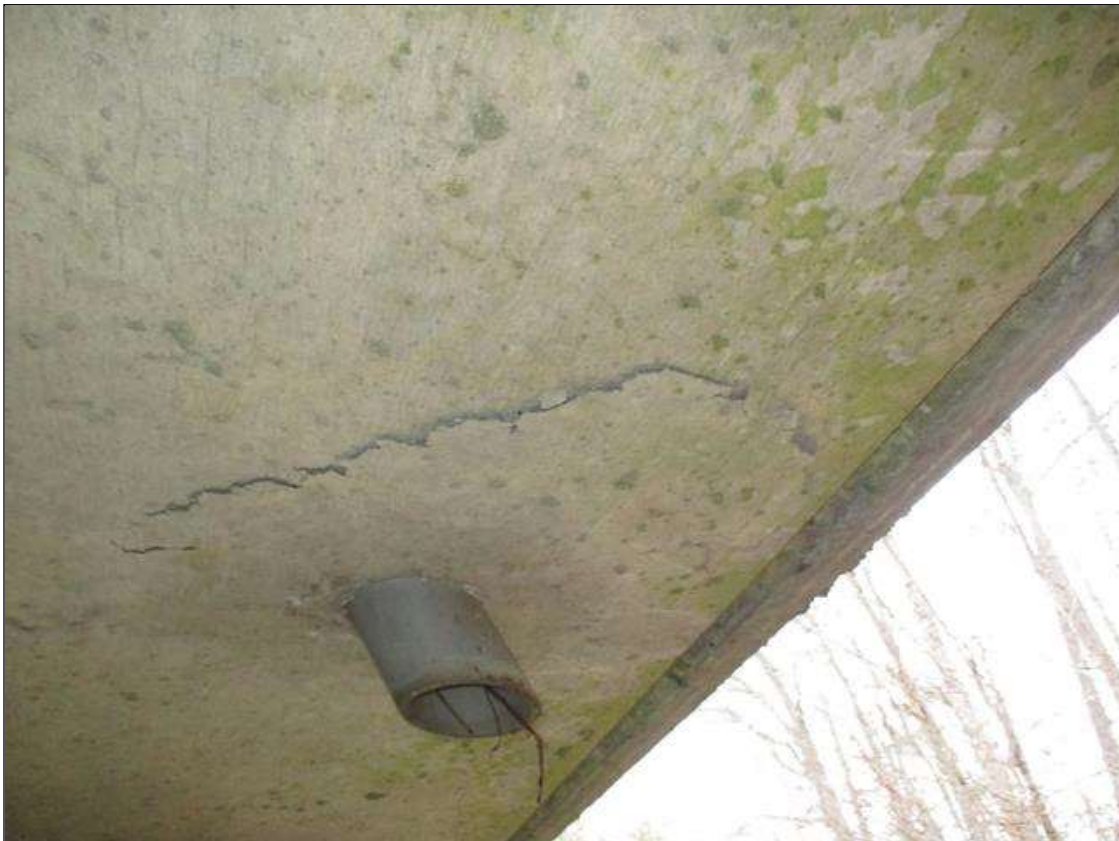
Span 1 Deck: UNDERSIDE, 17" X 12" AREA OF DELAMINATION IN BOTTOM OF LEFT OVERHANG AROUND DECK DRAIN AT BENT 1

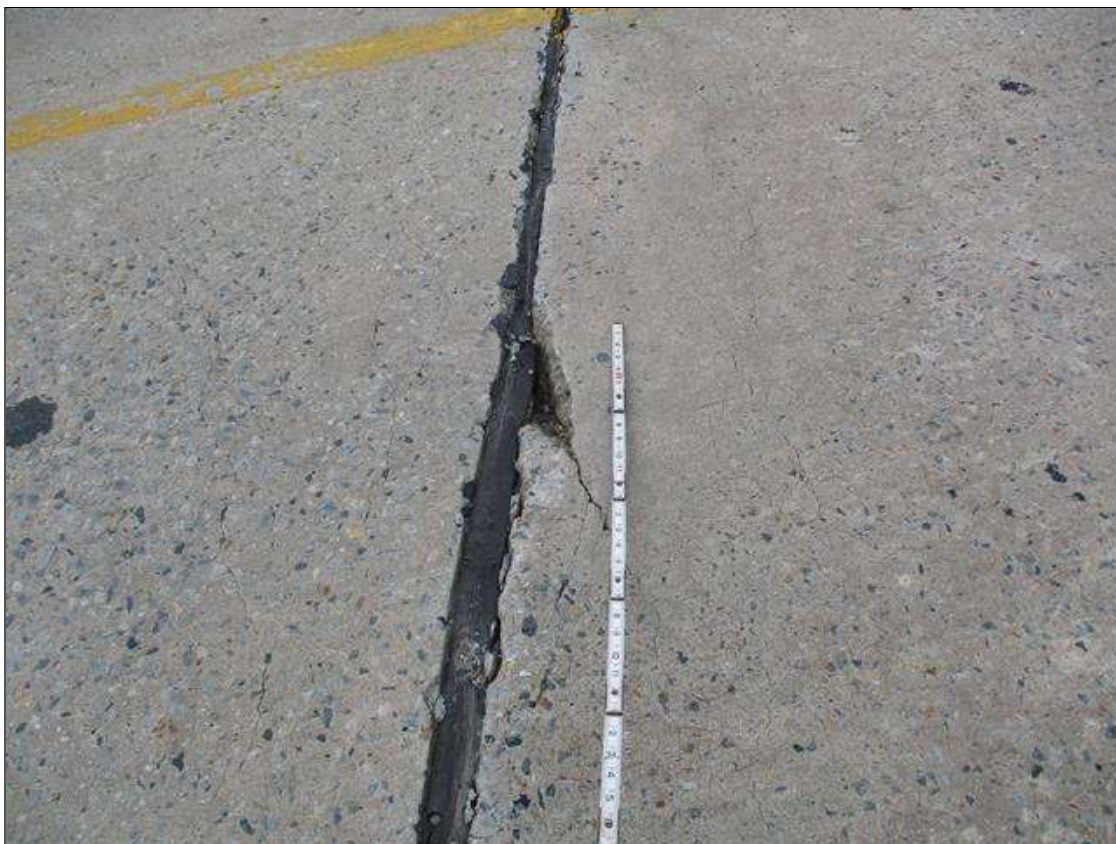
Span 1 Deck: AT BENT 1 JOINT, 10" X 3" X 3" DEEP SPALL IN TOP OF DECK IN WHEEL LINE OF WESTBOUND LANE

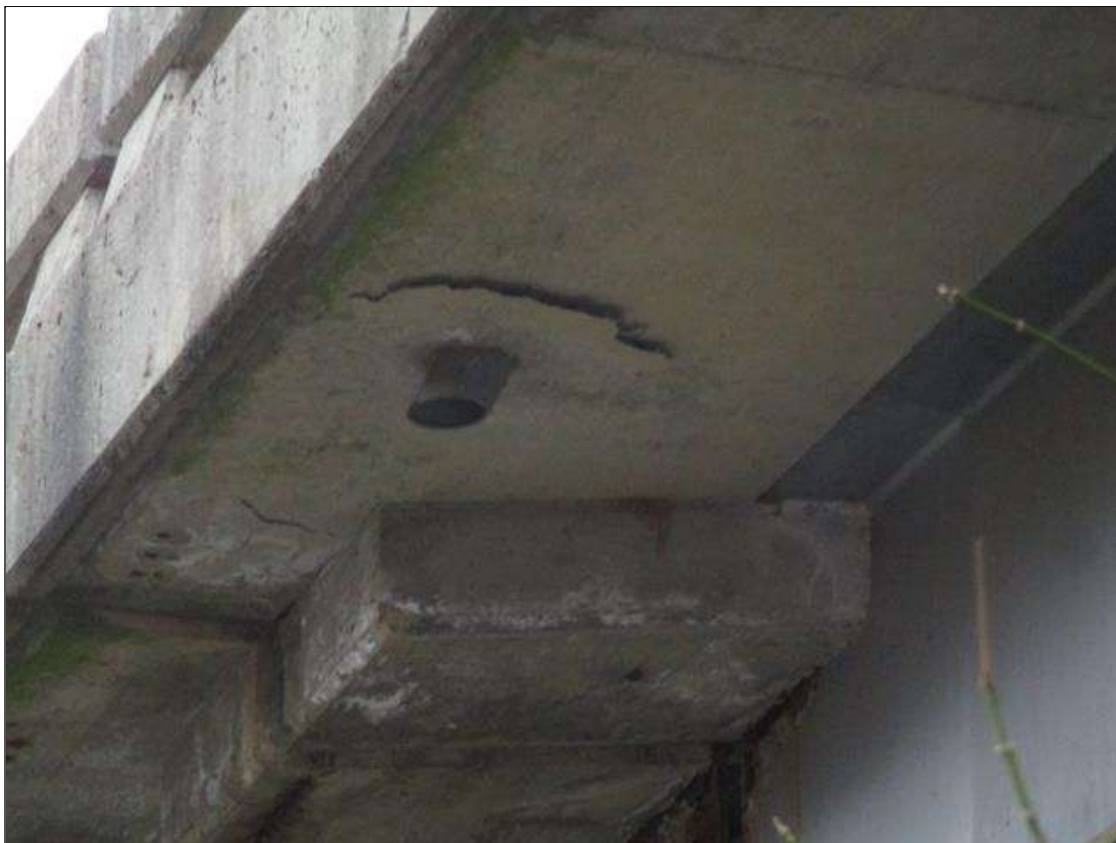
Span 1 Deck: UNDERSIDE, 12" X 11" AREA OF DELAMINATION IN BOTTOM OF LEFT OVERHANG ABOVE BENT 1

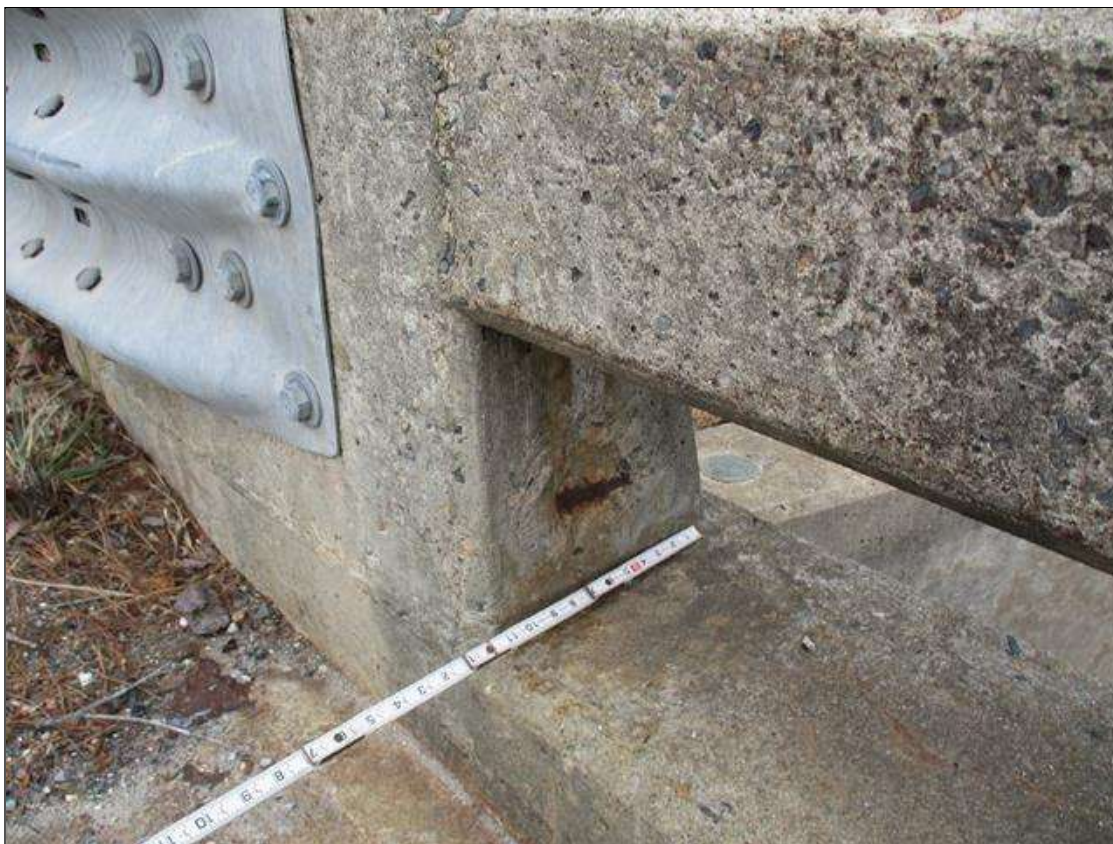
Span 1 Left Bridge Rail: 5" X 3" X 1/2" DEEP SPALL WITH EXPOSED REBAR IN EAST FACE OF END POST, APPROXIMATELY 3' FROM END BENT 1 FILL FACE

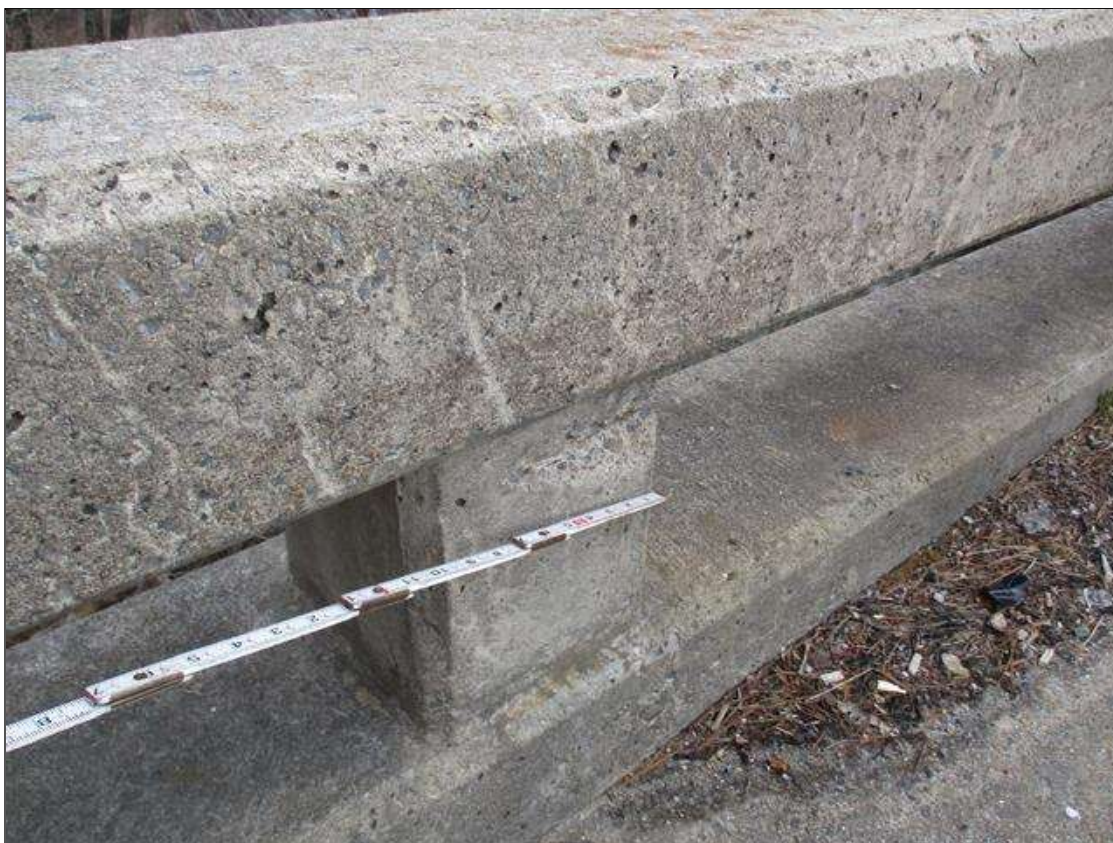
Span 1 Left Bridge Rail: THREE (3) SPALLS UP TO 6" X 3" X 1/2" DEEP IN FACE OF RAIL POSTS IN VARIOUS LOCATIONS

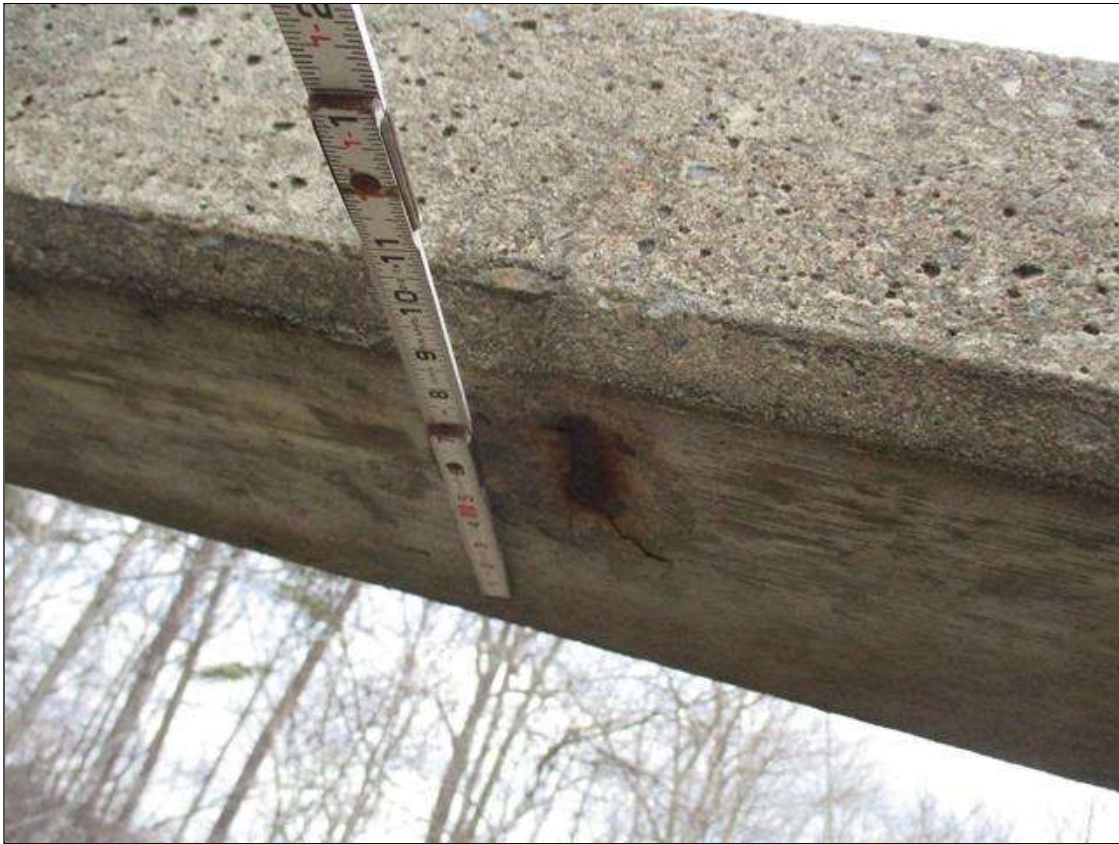
Span 1 Left Bridge Rail: 14 SPALLS WITH EXPOSED REBAR UP TO 6" X 4" X 3/4" DEEP IN BOTTOM OF RAIL IN VARIOUS LOCATIONS

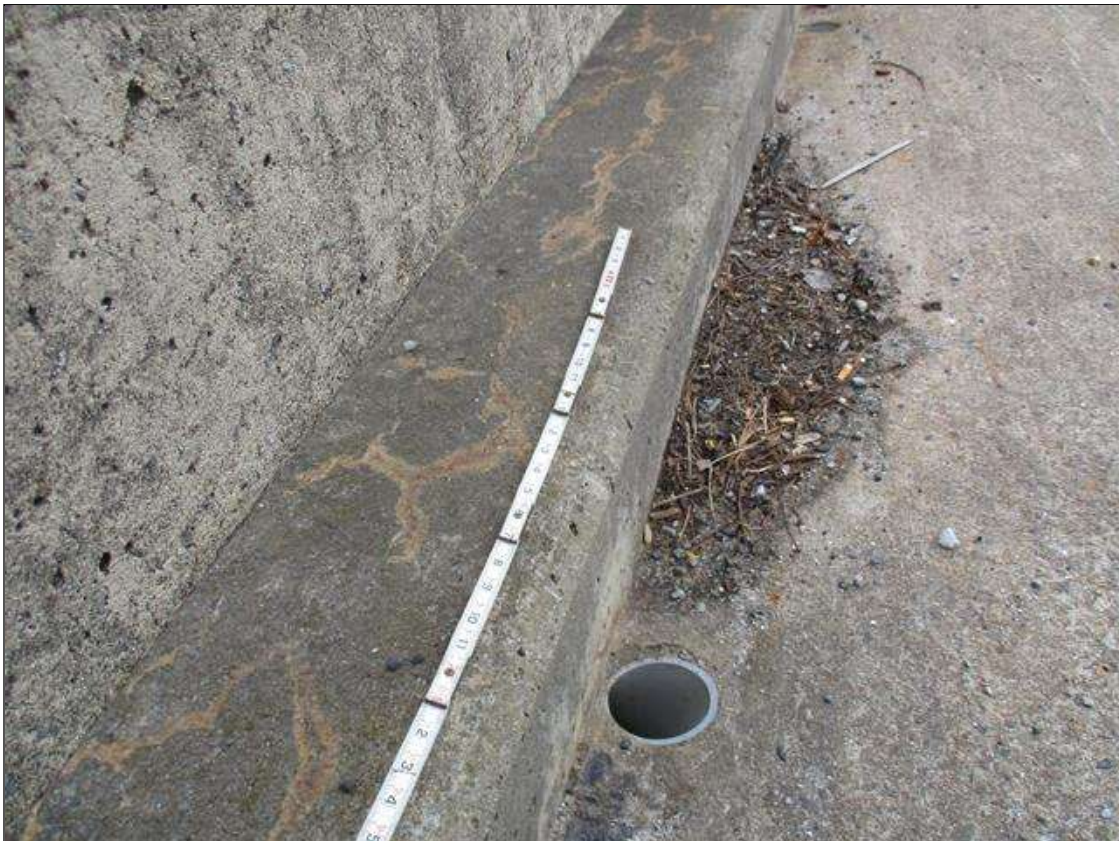
Span 1 Left Bridge Rail: ON TOP OF CURB THROUGHOUT, LESS THAN 0.01" WIDE CRACKING WITH EFFLORESCENCE

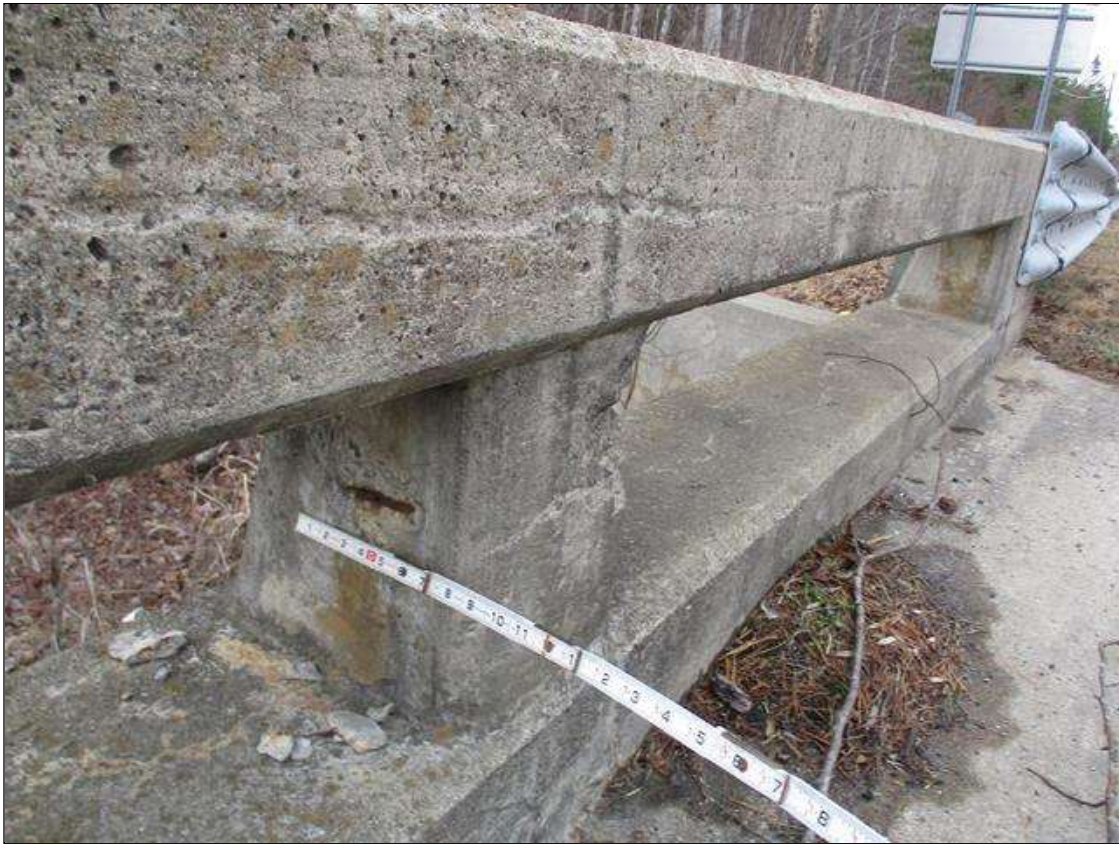
Span 1 Right Bridge Rail: 11" X 5" X 1/2" DEEP SPALL IN FACE OF RAIL, APPROXIMATELY 19' FROM END BENT 1 FILL FACE

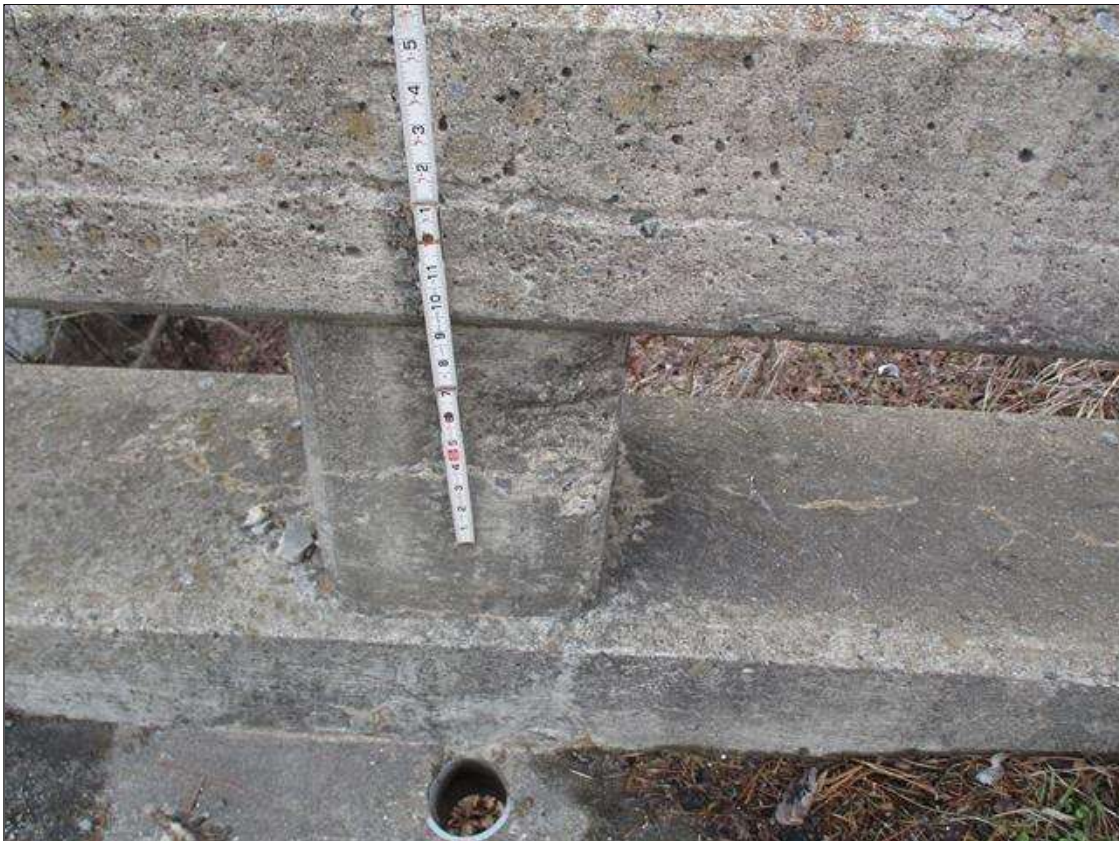
Span 1 Right Bridge Rail: 4" X 2" X 1/2" DEEP SPALL WITH EXPOSED REBAR IN EAST OF RAIL POST, APPROXIMATELY 9' FROM END BENT 1 FILL FACE

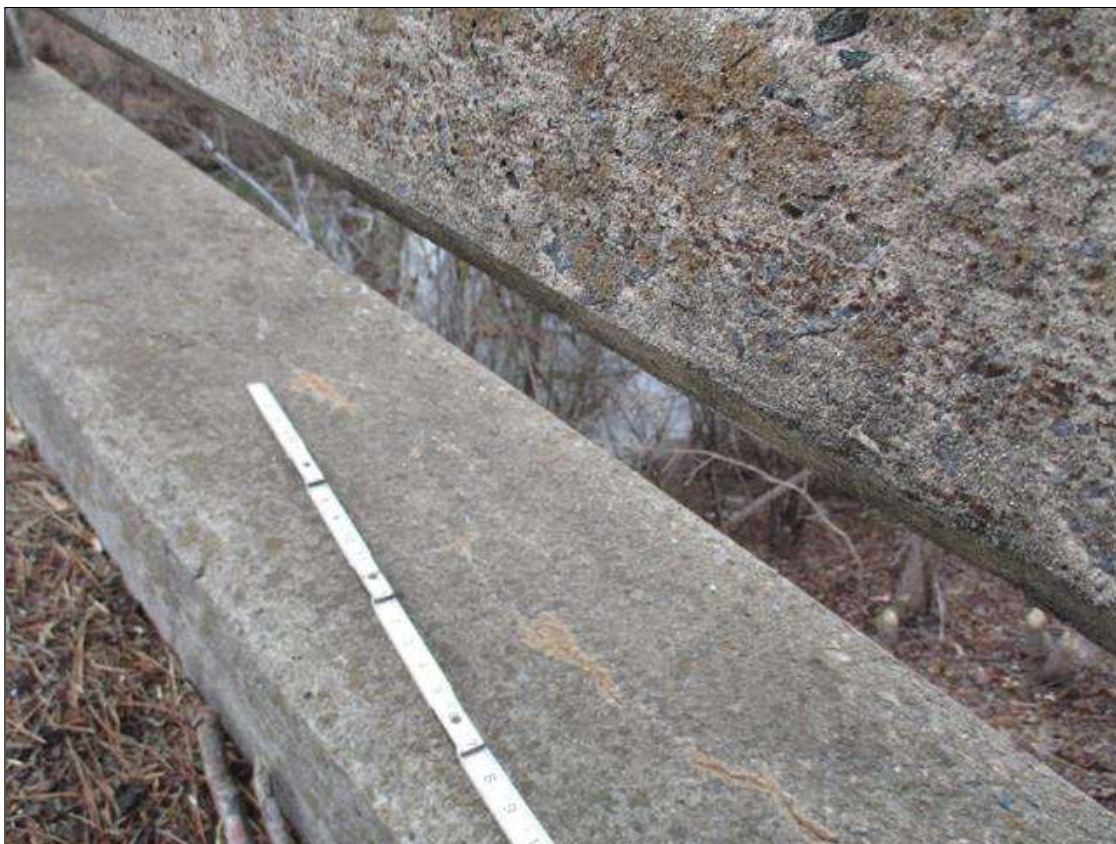
Span 1 Right Bridge Rail: UP TO 0.05" LONGITUDINAL, TRANSVERSE, VERTICAL AND MAP CRACKS IN TOP AND FACES OF RAIL IN VARIOUS LOCATIONS

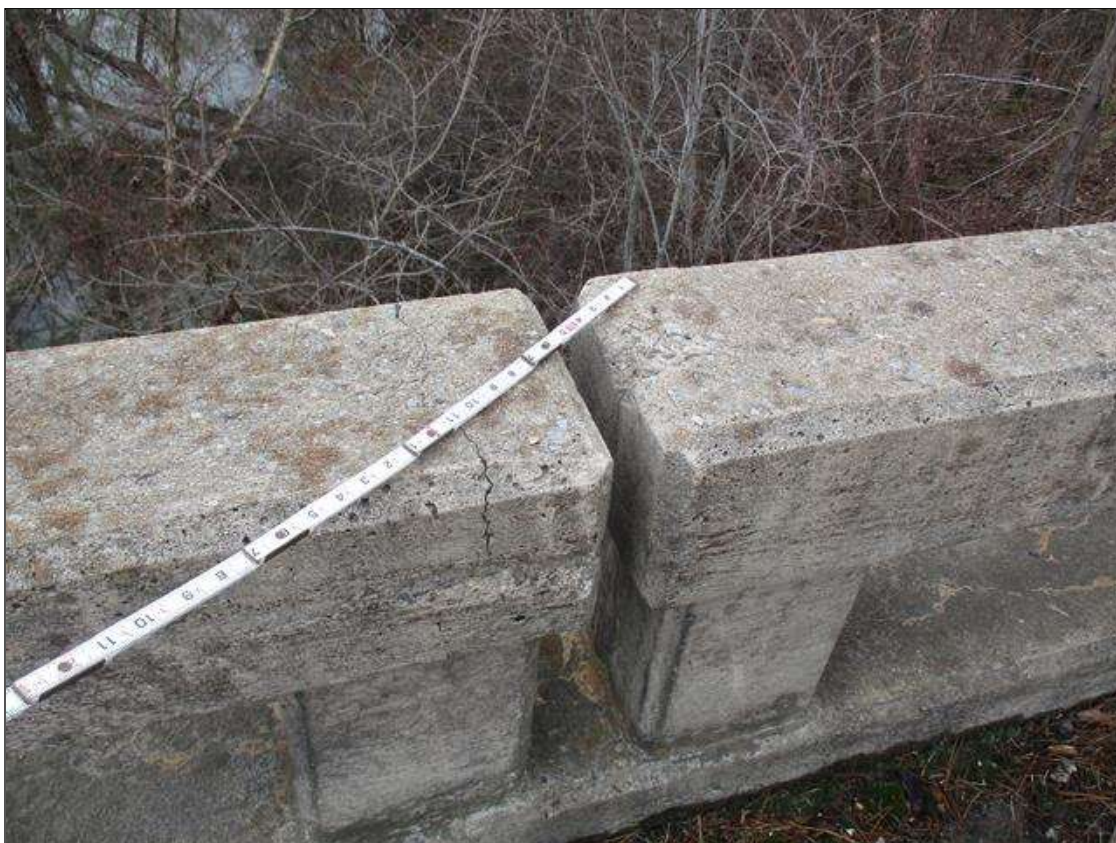
Span 1 Right Bridge Rail: 3 1/2" X 3" X 1" DEEP SPALL IN TOP OF RAIL, APPROXIMATELY 18' FROM BENT 1 JOINT

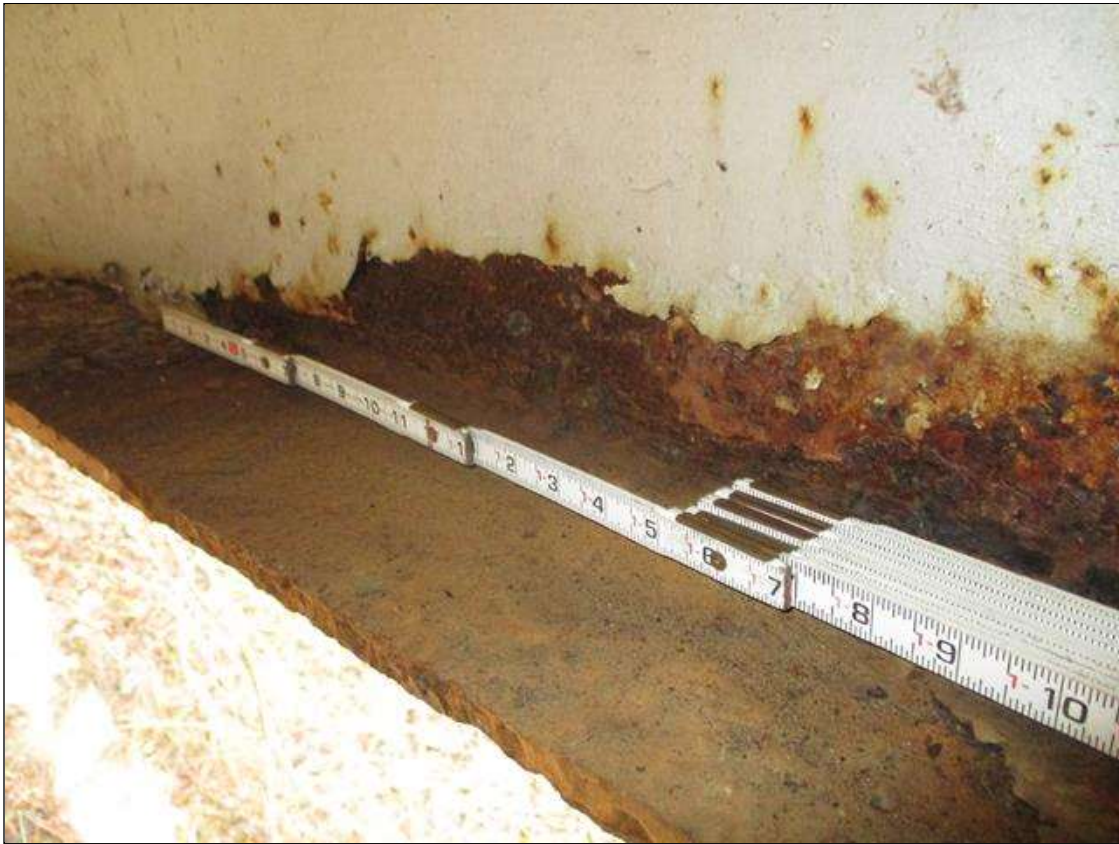
TYPICAL CORROSION IN SPAN 1, BEAM 1 @ BENT 1

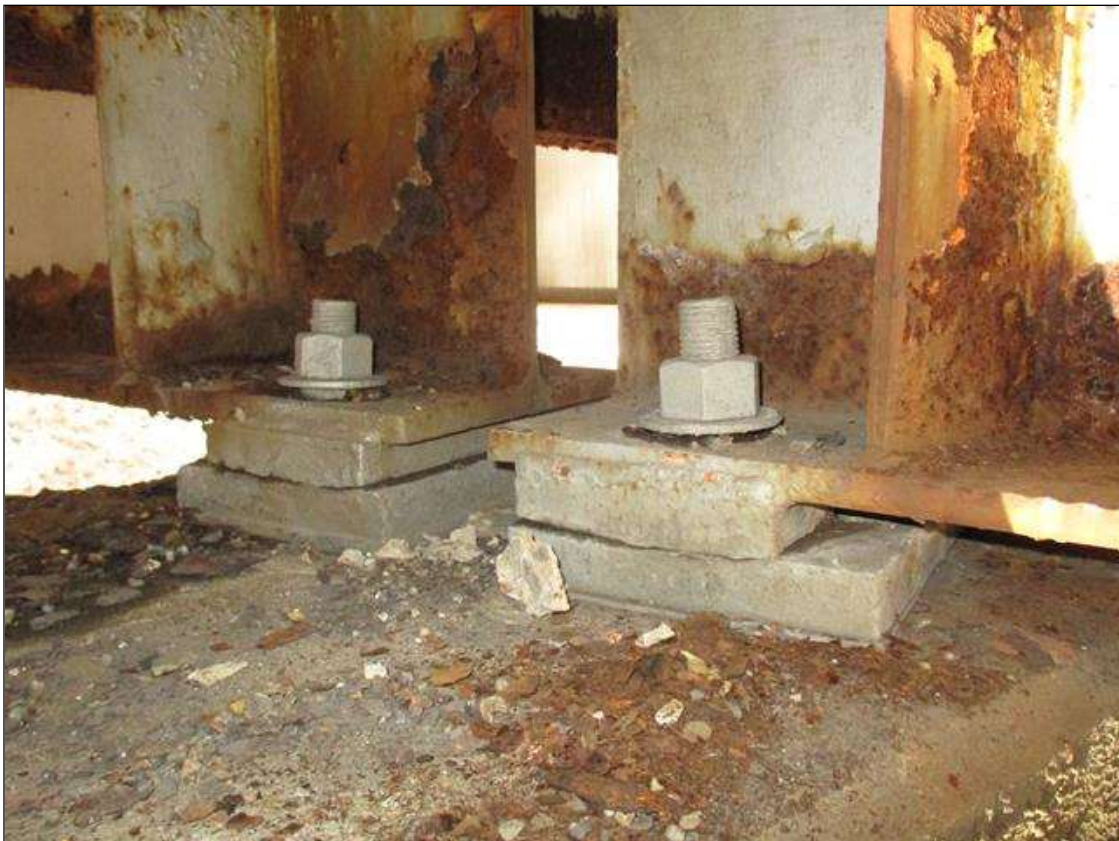
Span 1 Near Bearing: SURFACE CORROSION THROUGHOUT BEAM 1 BEARING

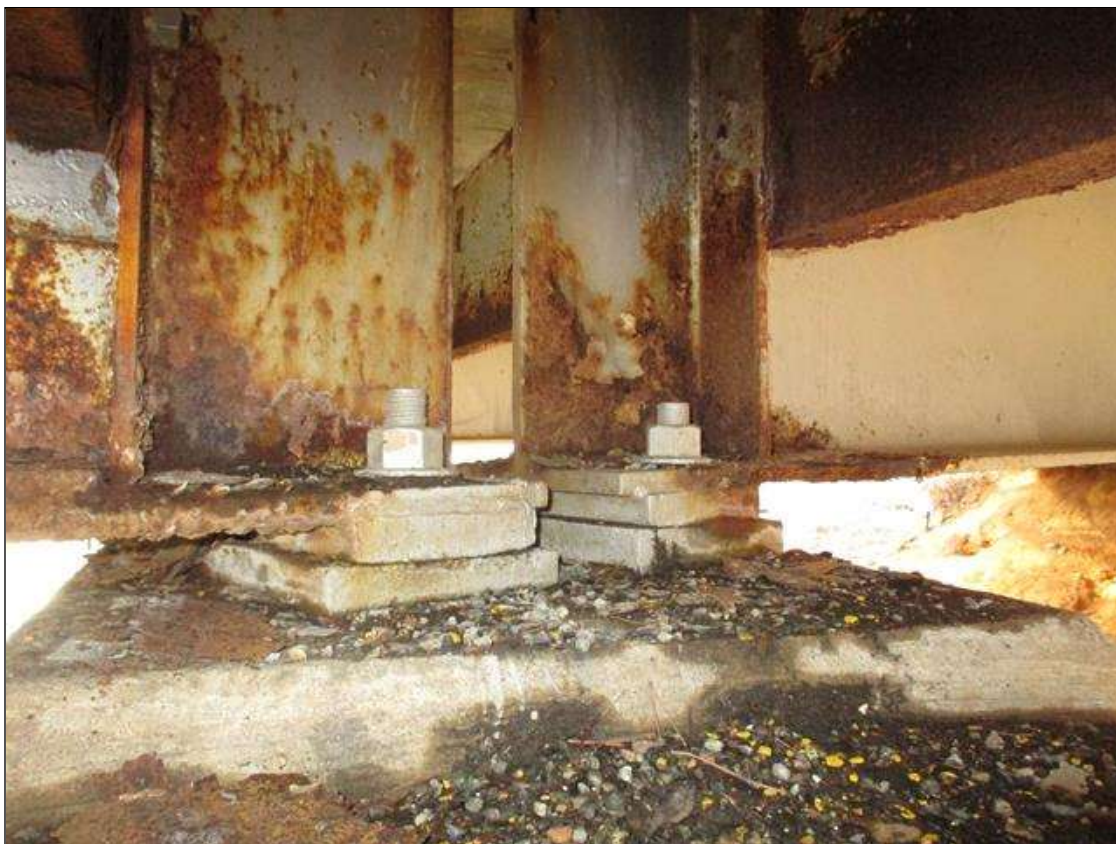
Span 1 Far Bearing: AREAS OF SURFACE CORROSION THROUGHOUT BEAM 1 BEARING

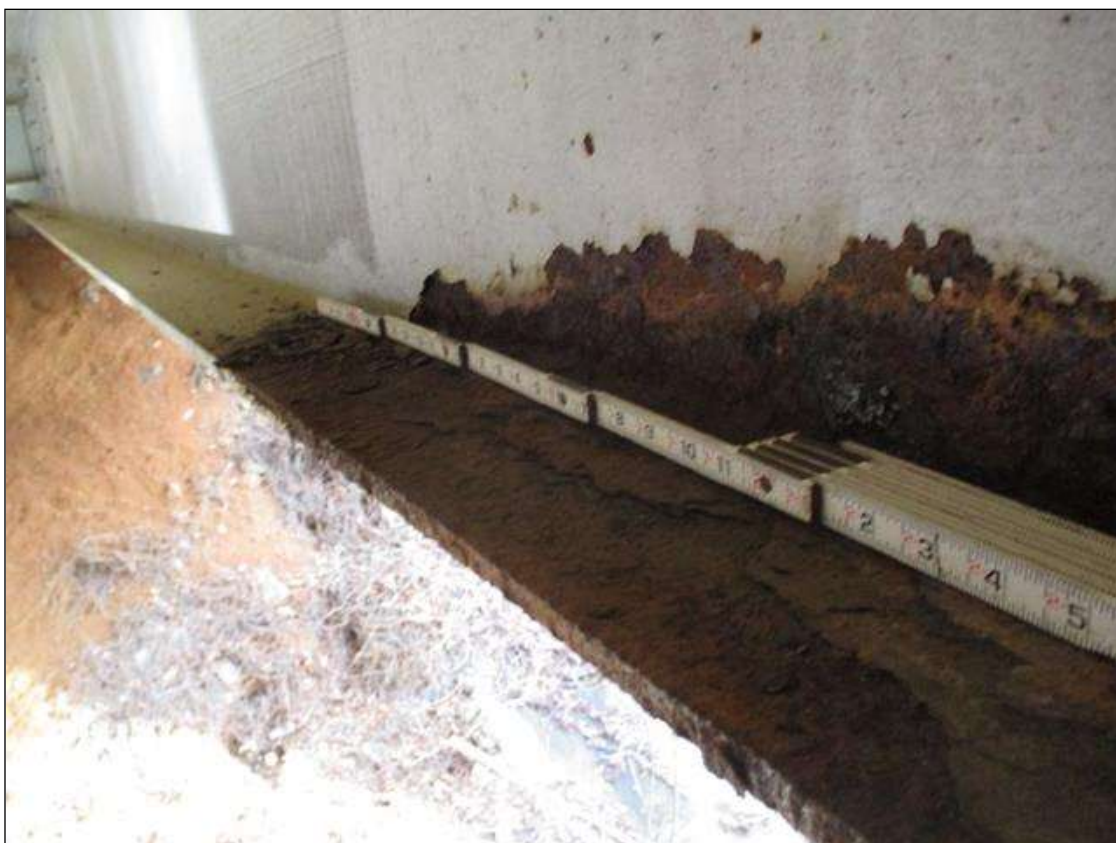
TYPICAL DETERIORATED PAINT SYSTEM SPAN 1, BEAM 2

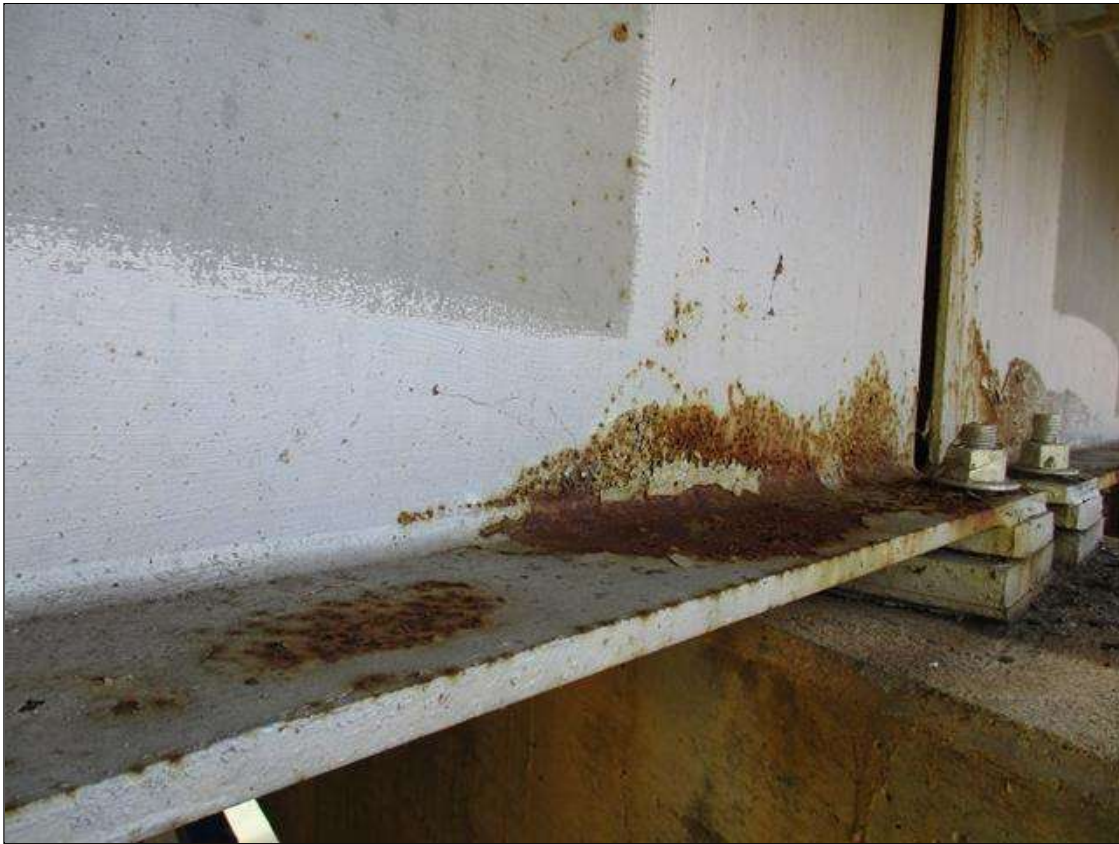
Span 1 Beam 6: AREAS OF SURFACE CORROSION THROUGHOUT WEB AND BOTH FLANGES IN VARIOUS LOCATIONS

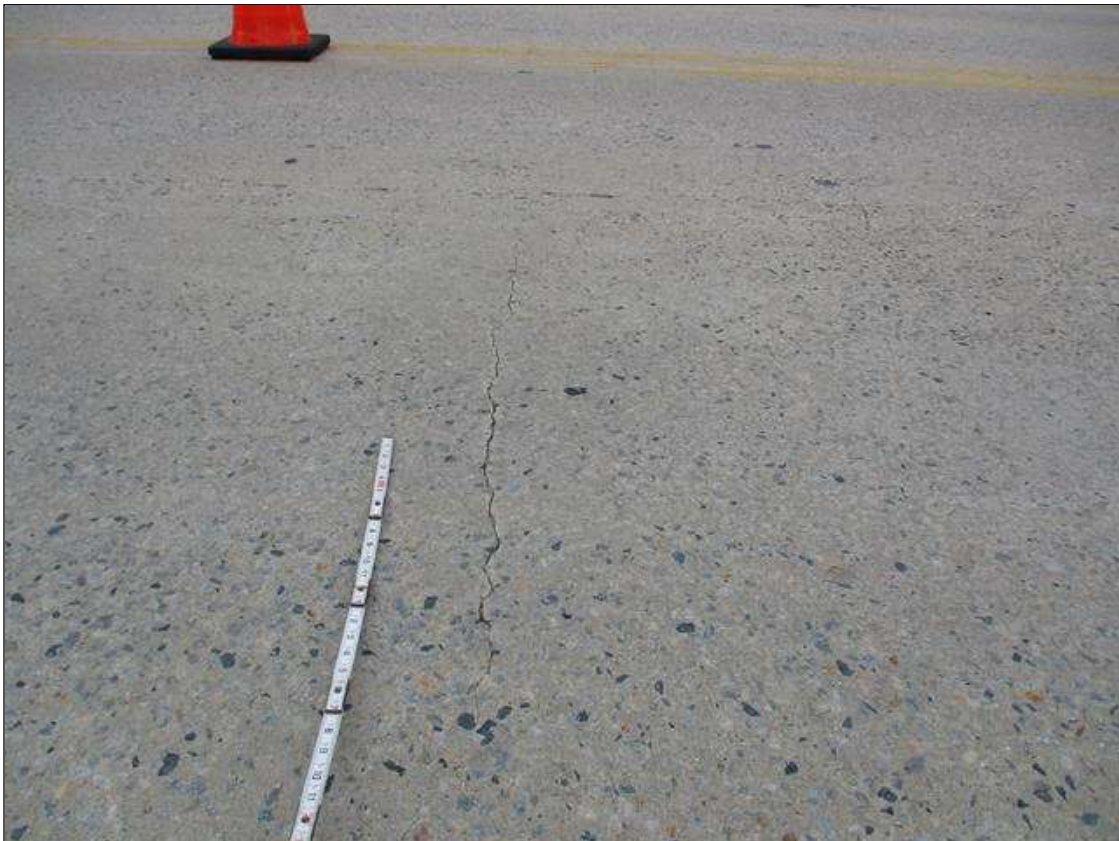
Span 2 Deck: UP TO 50" X 1/8" TRANSVERSE CRACKS IN TOP OF DECK IN EASTBOUND LANE AND RIGHT SHOULDER IN VARIOUS LOCATIONS

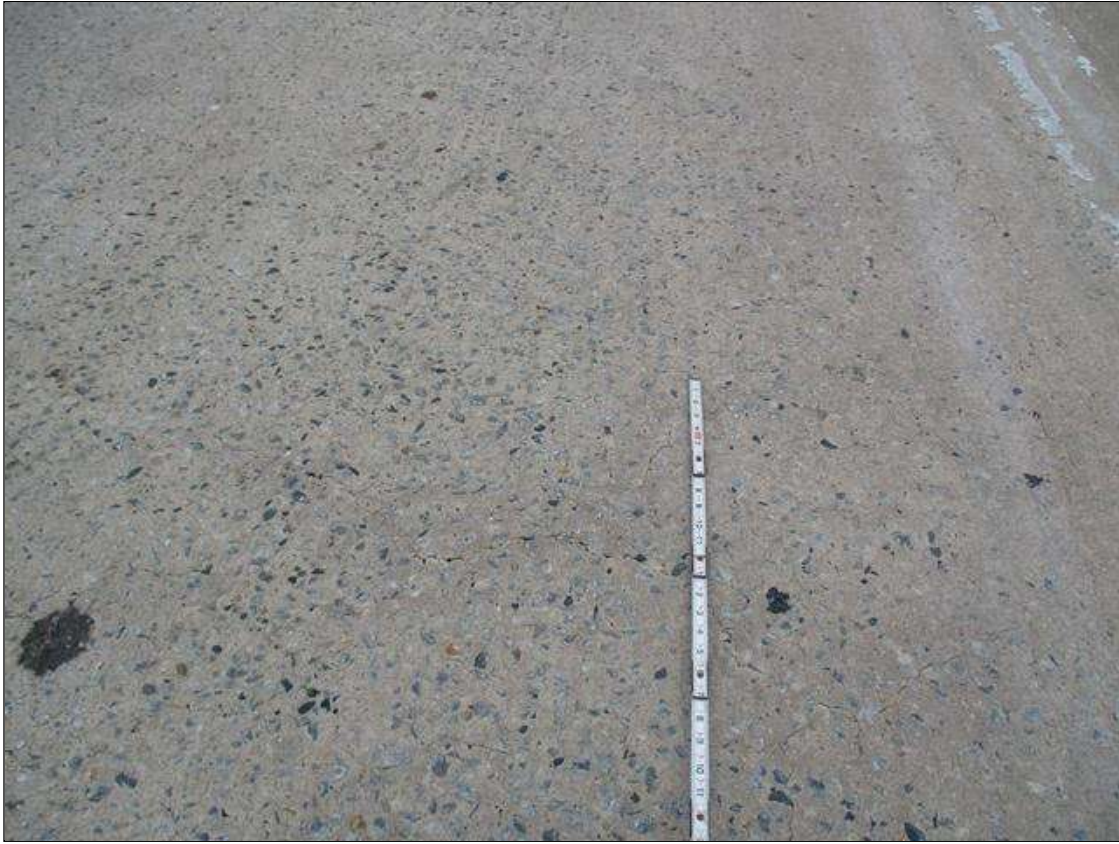
Span 2 Deck: UP TO 0.02" MAP CRACKS IN TOP OF DECK IN VARIOUS LOCATIONS

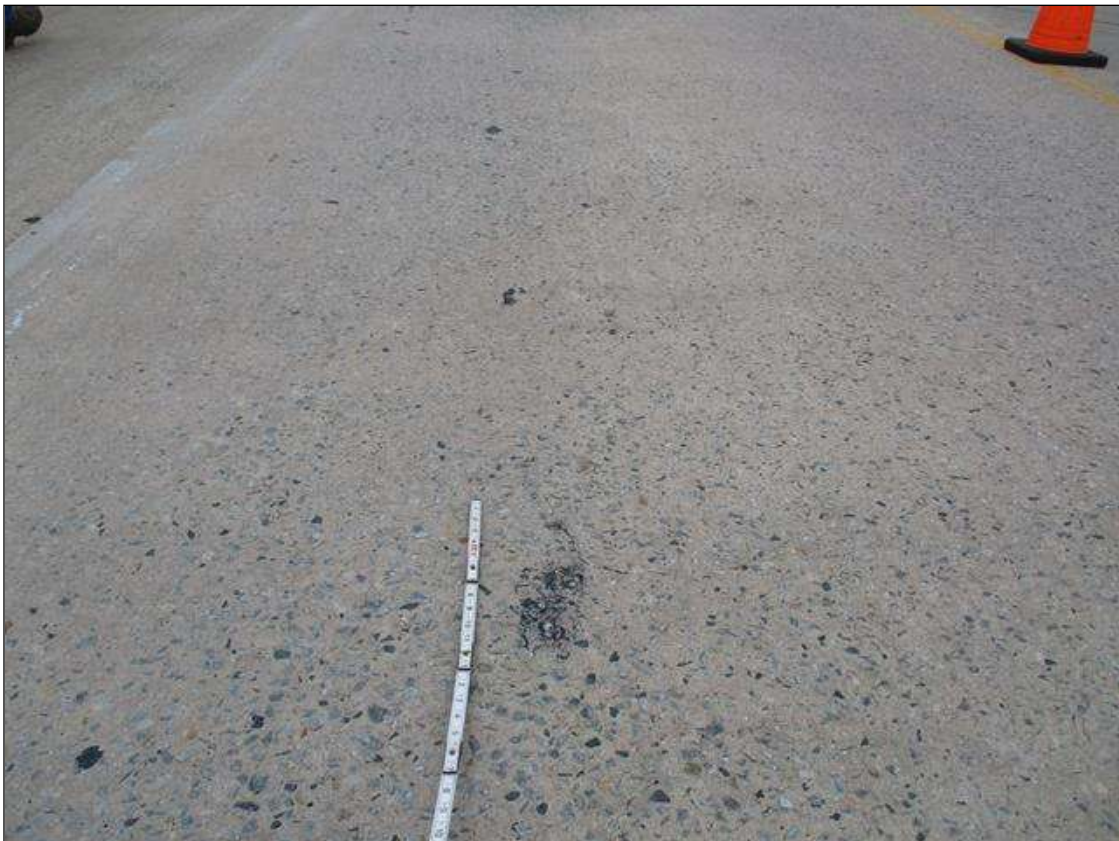
Span 2 Deck: 1320 SF OF SCALING WITH EXPOSED AGGREGATE IN TOP OF DECK THROUGHOUT TRAVEL LANES
