NC DEPARTMENT OF TRANSPORTATION  
 DIVISION OF HIGHWAYS  
 STRUCTURE MANAGEMENT UNIT

ATTENTION: PARS SUBMITTED

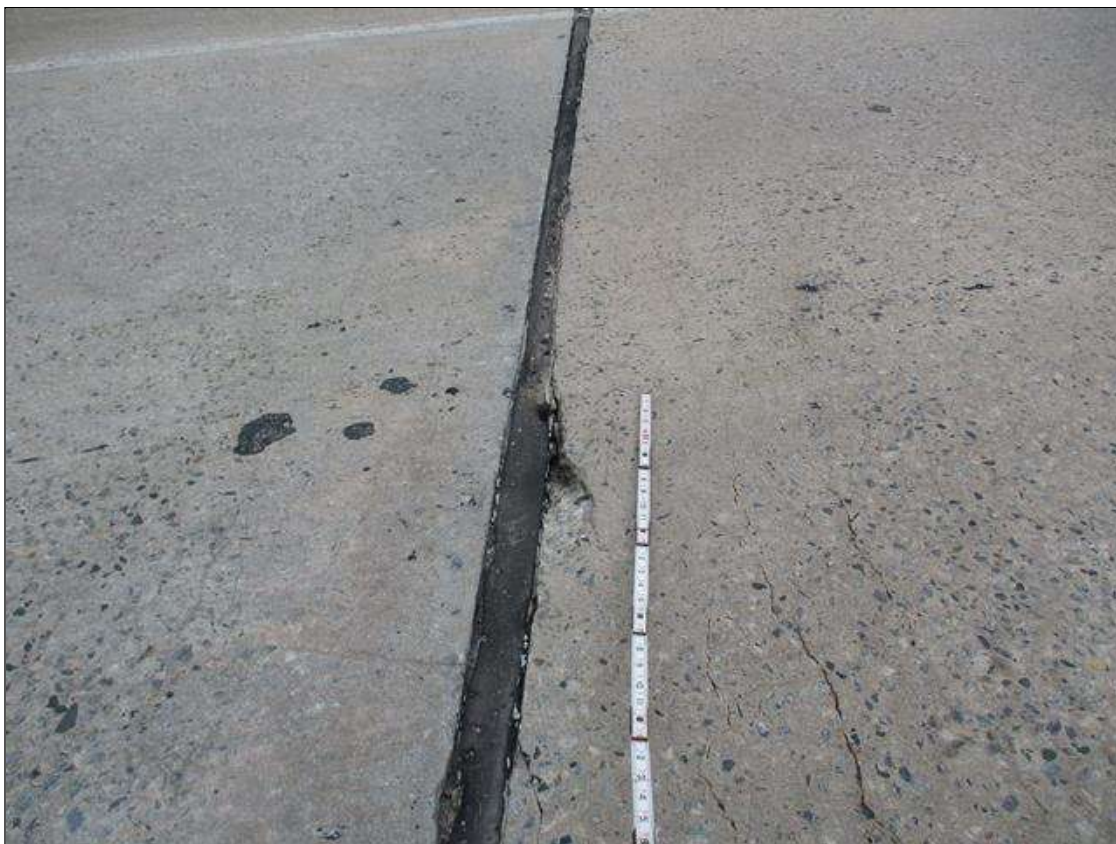
Span 2 Deck: UP TO 0.04" TRANSVERSE CRACKS IN TOP OF DECK IN TRAVEL LANES AT BENT 2 JOINT

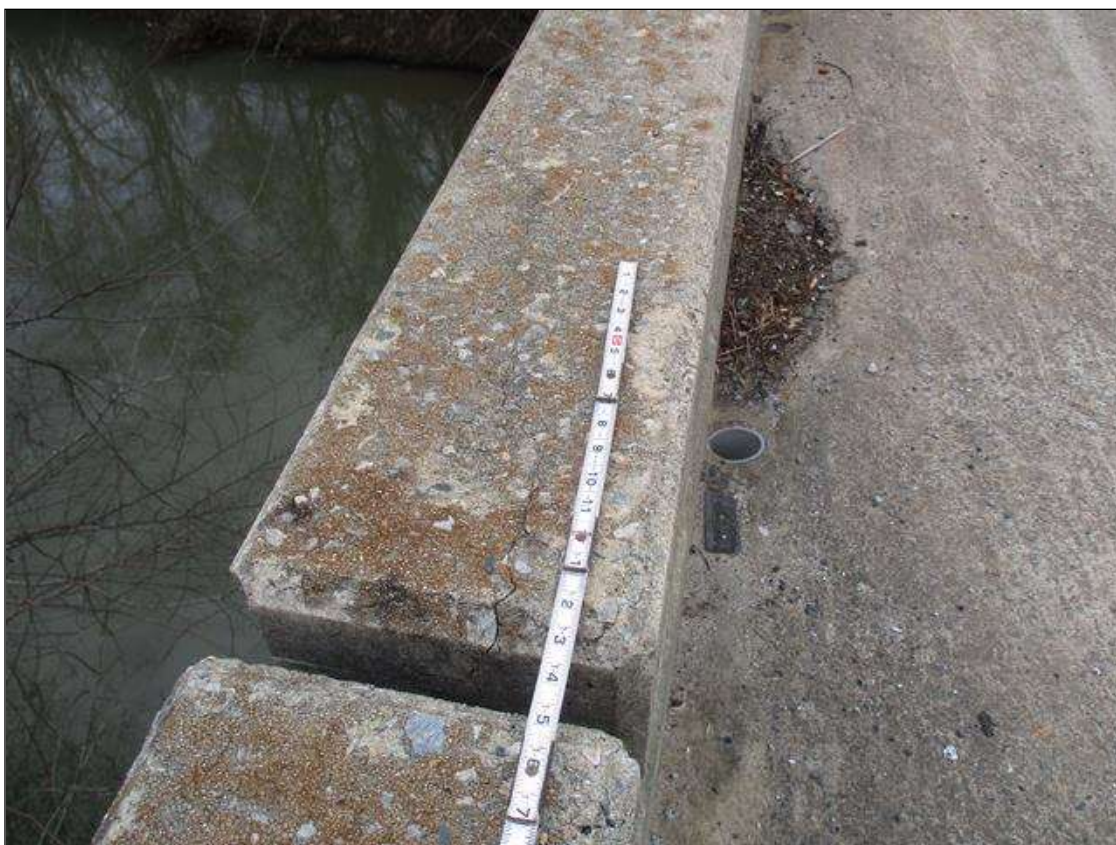
Span 2 Left Bridge Rail: UP TO 0.035" LONGITUDINAL AND VERTICAL CRACKS IN TOP AND ENDS OF RAIL IN VARIOUS LOCATIONS

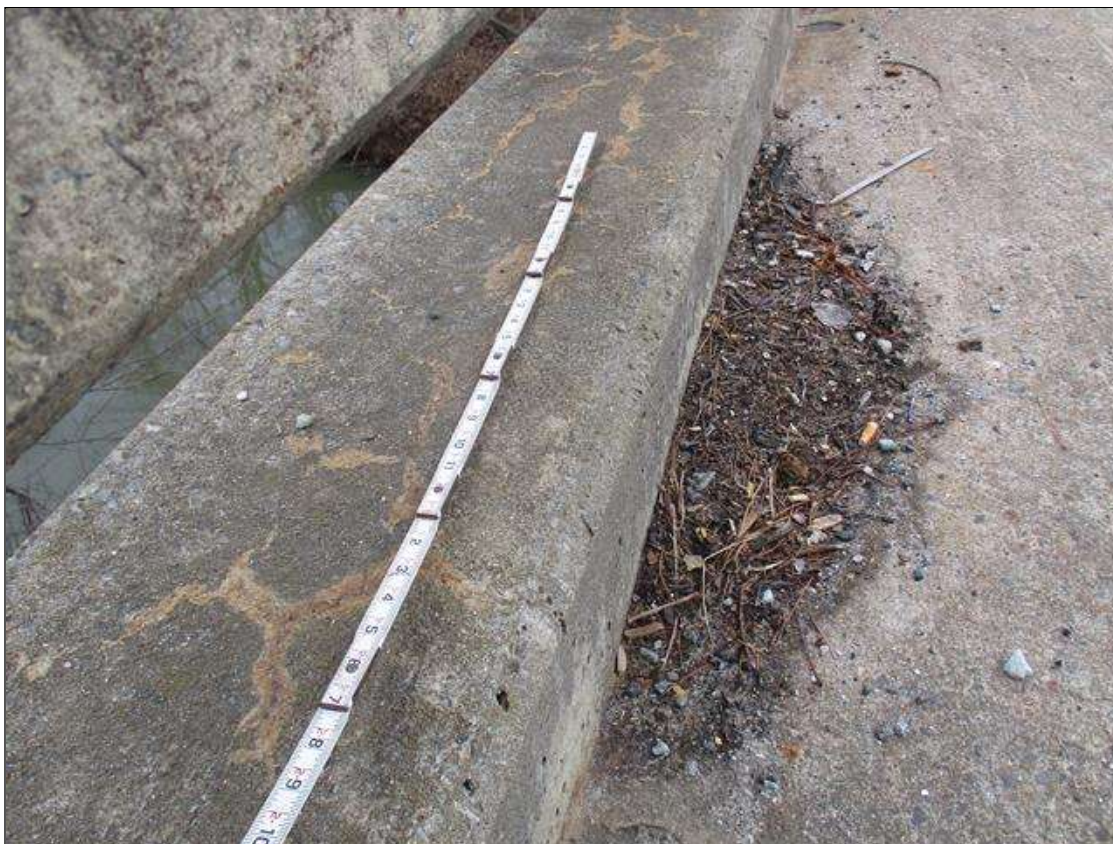
Span 2 Left Bridge Rail: ON TOP OF CURB THROUGHOUT, LESS THAN 0.01" WIDE CRACKING WITH EFFLORESCENCE

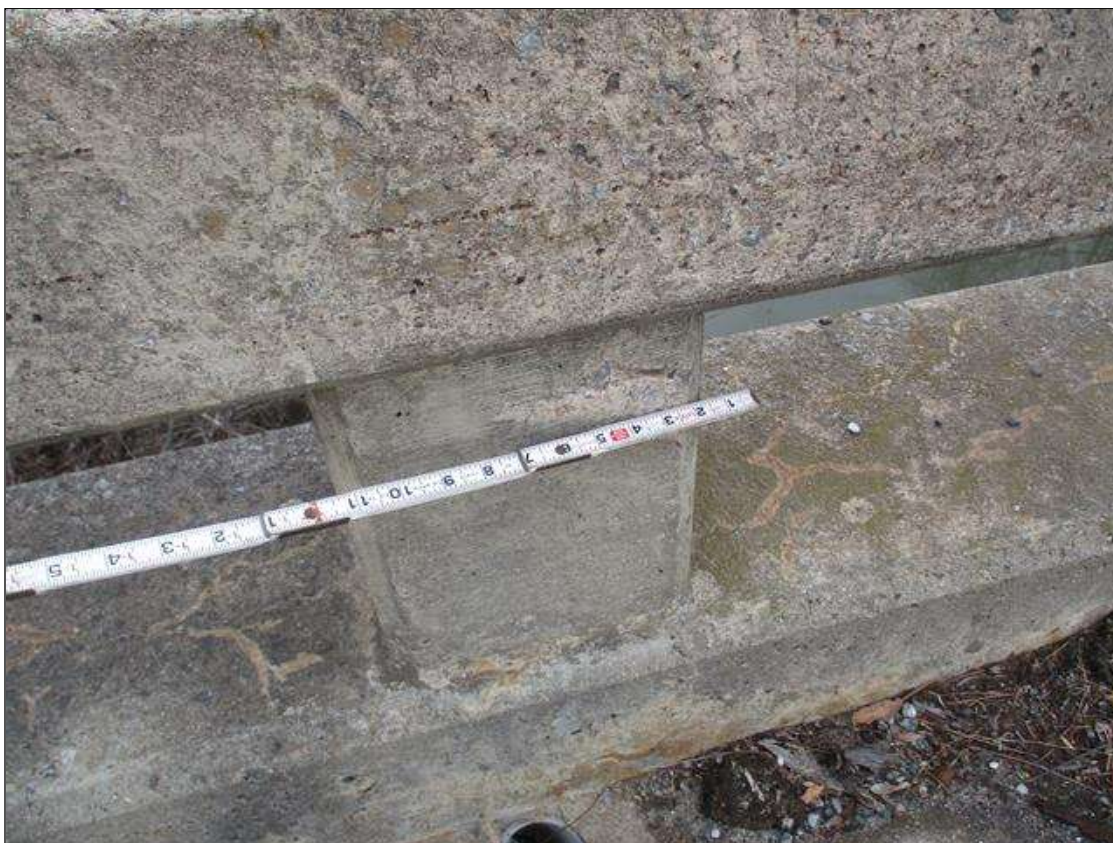
Span 2 Left Bridge Rail: FIVE (5) SPALLS UP TO 5" X 3 1/2" X 1/4" DEEP IN FACE OF RAIL POSTS IN VARIOUS LOCATIONS

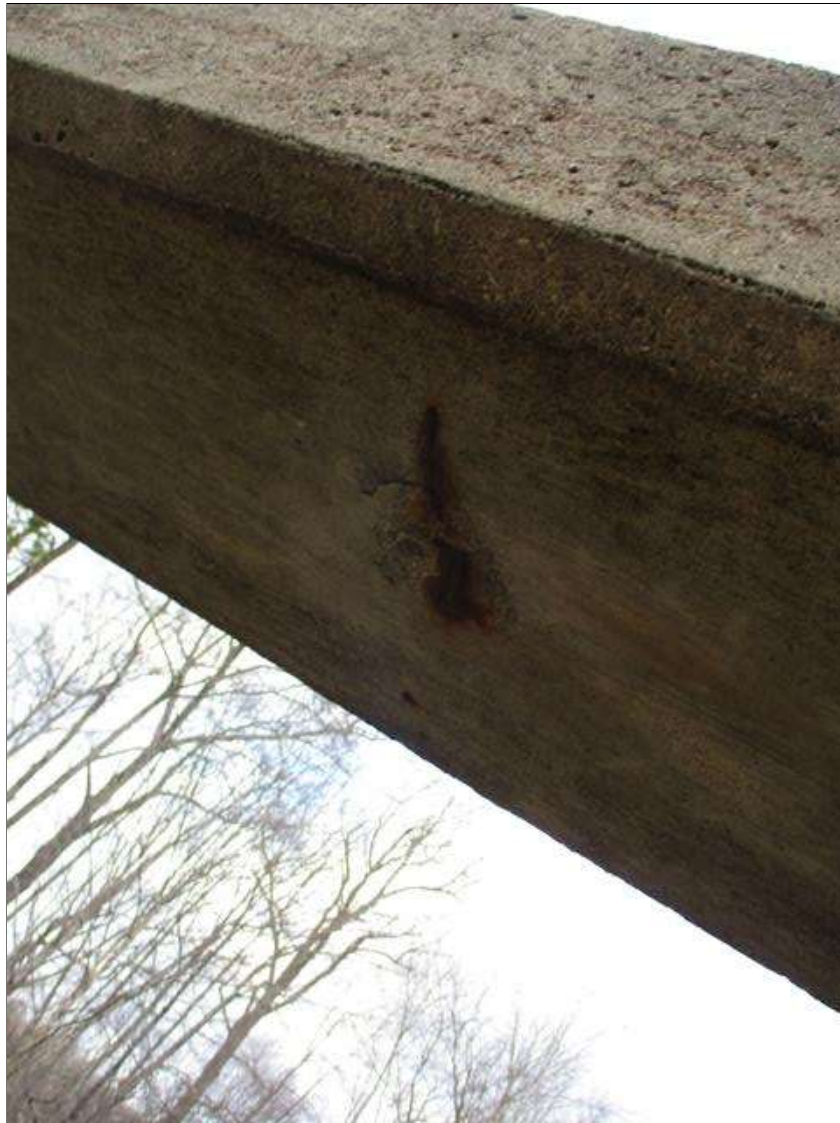
Span 2 Left Bridge Rail: THREE (3) SPALLS WITH EXPOSED REBAR UP TO 5" X 3" X 3/4" DEEP IN BOTTOM OF RAIL IN VARIOUS LOCATIONS

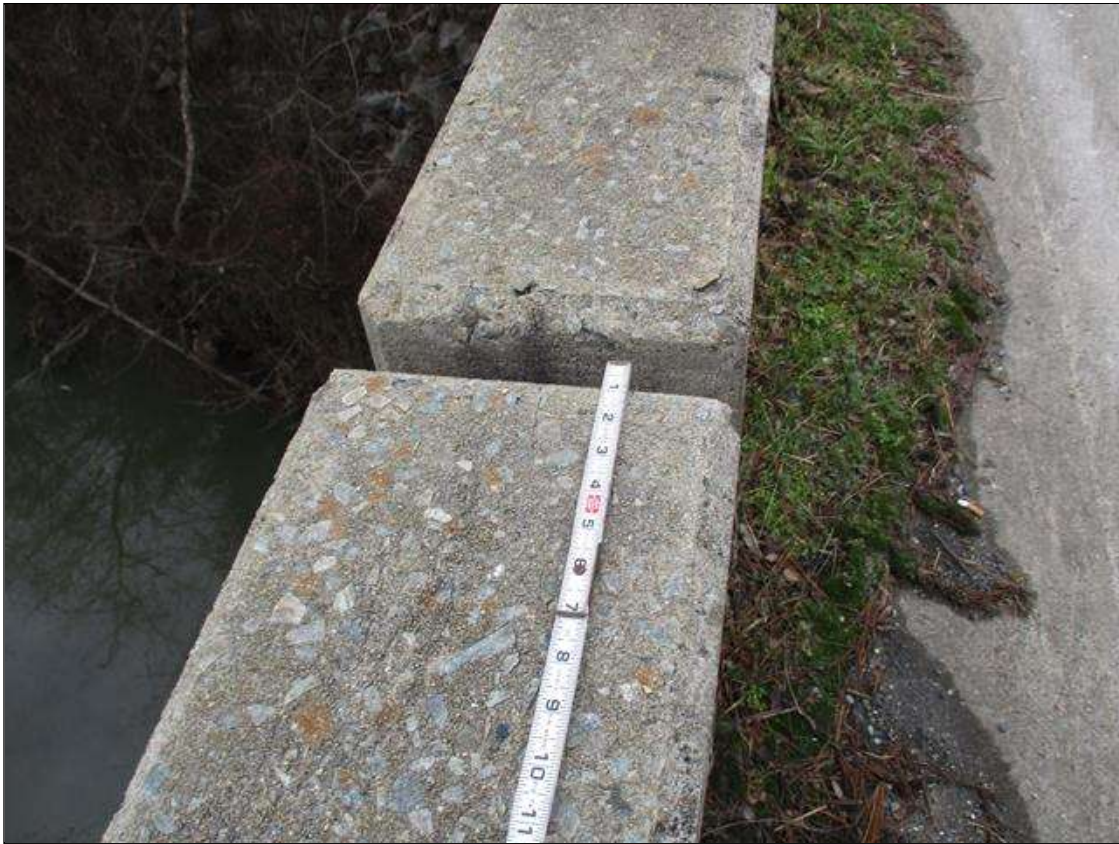
Span 2 Right Bridge Rail: UP TO 0.02" LONGITUDINAL CRACKS IN TOP OF RAIL IN VARIOUS LOCATIONS

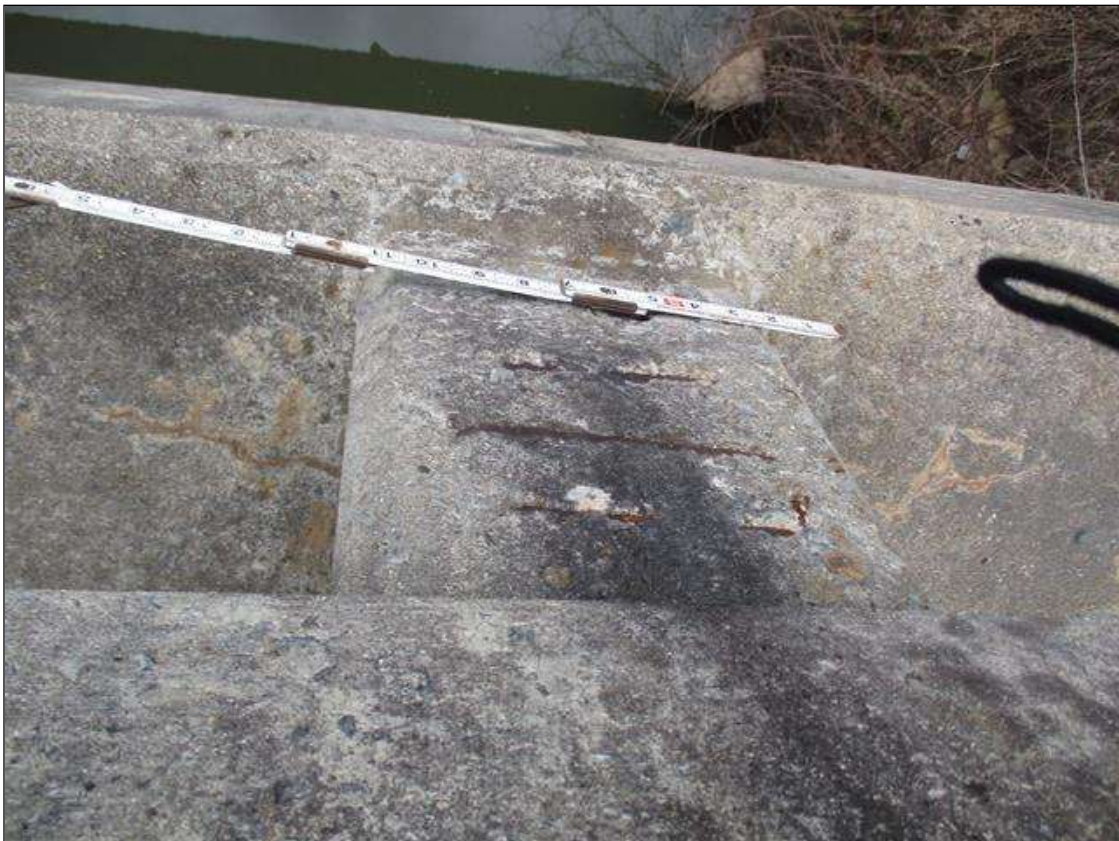
Span 2 Right Bridge Rail: SPALLS WITH EXPOSED REBAR UP TO 5" X 3" X 1/2" DEEP IN BOTTOM OF RAIL AND OUTSIDE FACES OF POSTS INTERMITTENT THROUGHOUT

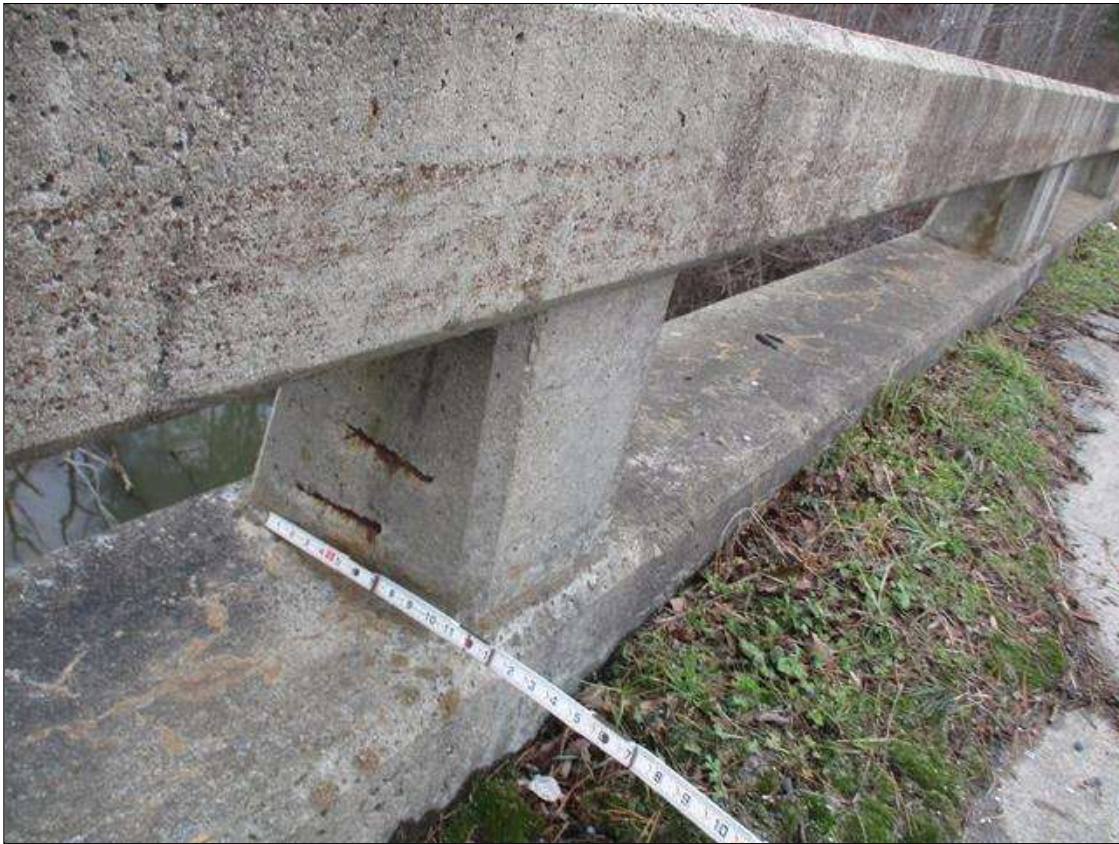
Span 2 Right Bridge Rail: TWO (2) SPALLS WITH EXPOSED REBAR UP TO 5" X 1 1/2" X 1/4" DEEP IN EAST FACE OF RAIL POST NEAR MIDSPAN

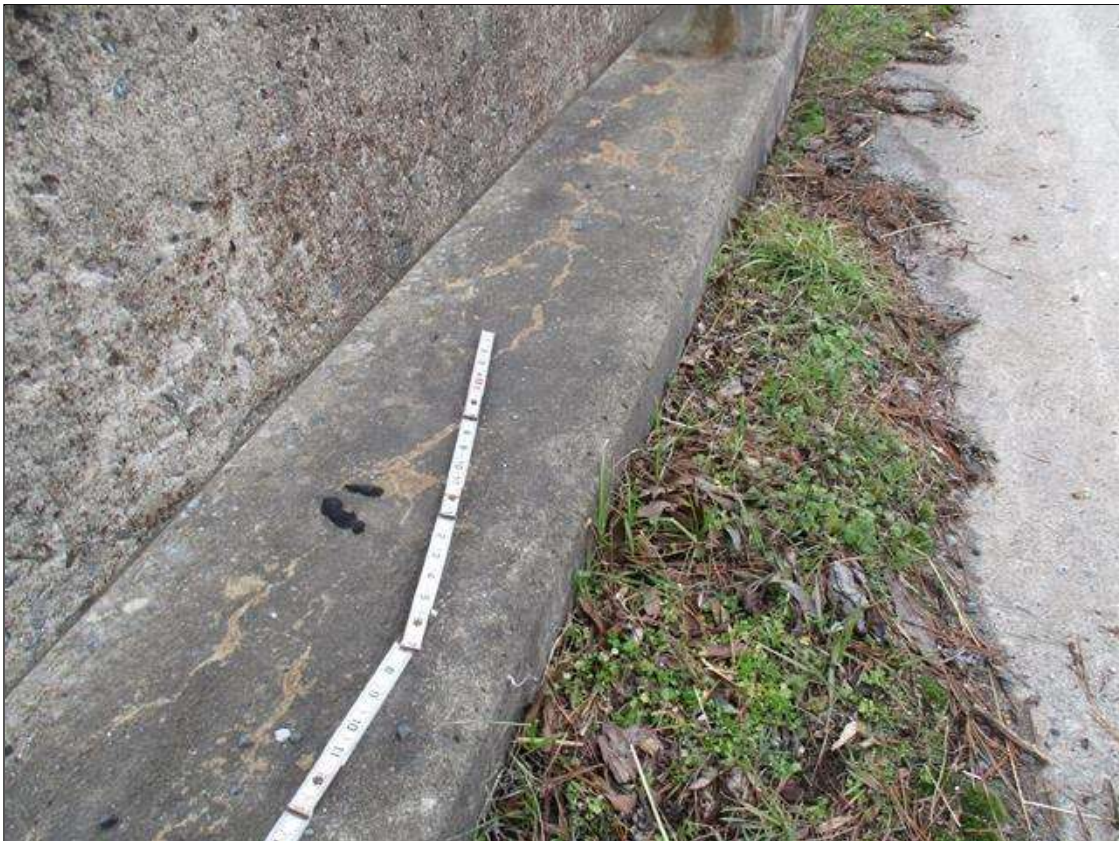
Span 2 Right Bridge Rail: ON TOP OF CURB THROUGHOUT, LESS THAN 0.01" WIDE CRACKING WITH EFFLORESCENCE

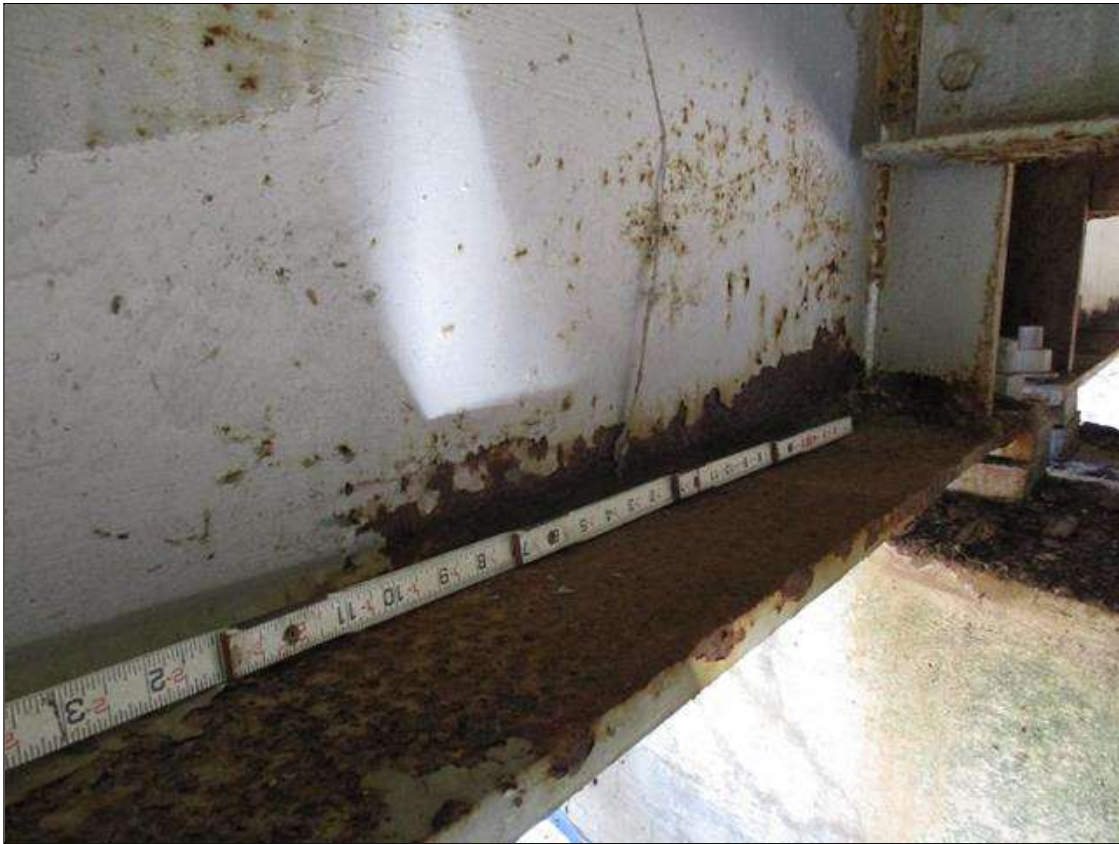
TYPICAL CORROSION (SPAN 2, BEAM 1)

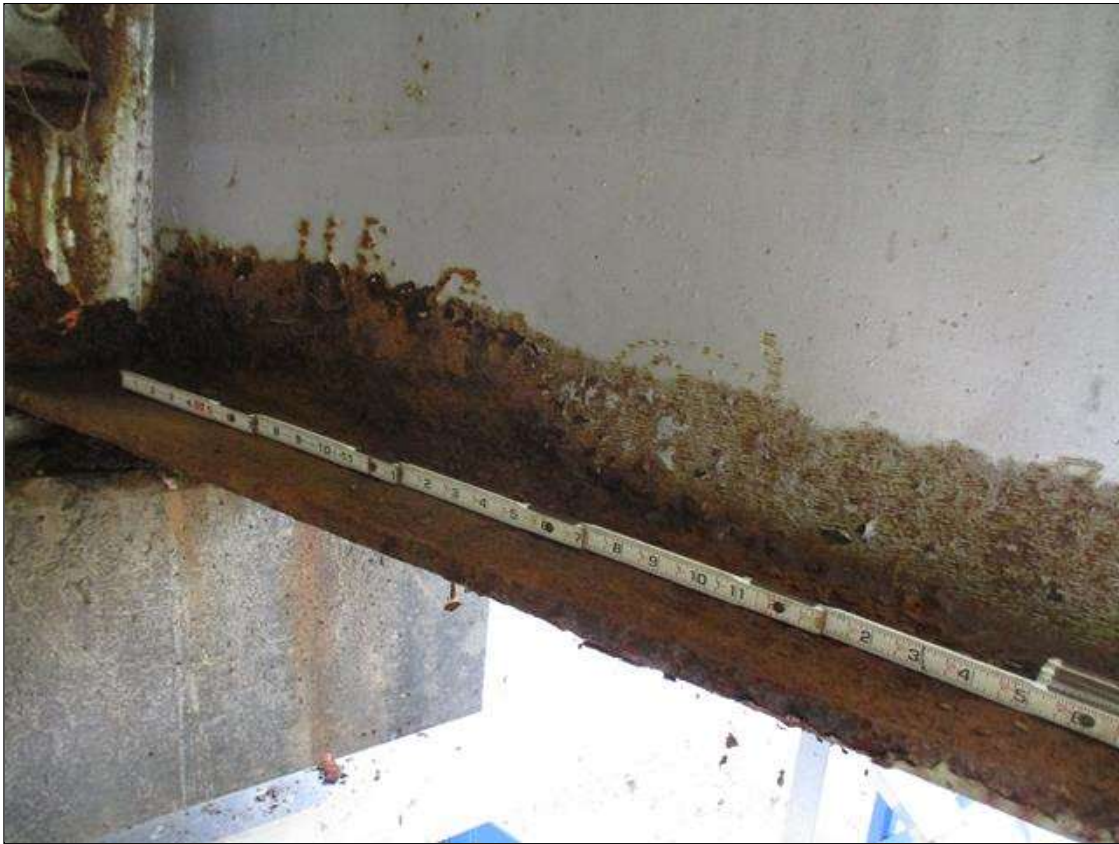
Span 2 Beam 1 - Protective System: DETERIORATED PAINT SYSTEM ALONG BOTH FACES OF WEB AND BOTTOM FLANGE UP TO 68" LONG X 10" HIGH IN WEB, AND 61" LONG X 11 3/4" WIDE IN FLANGE AT BENT 1 BEARING

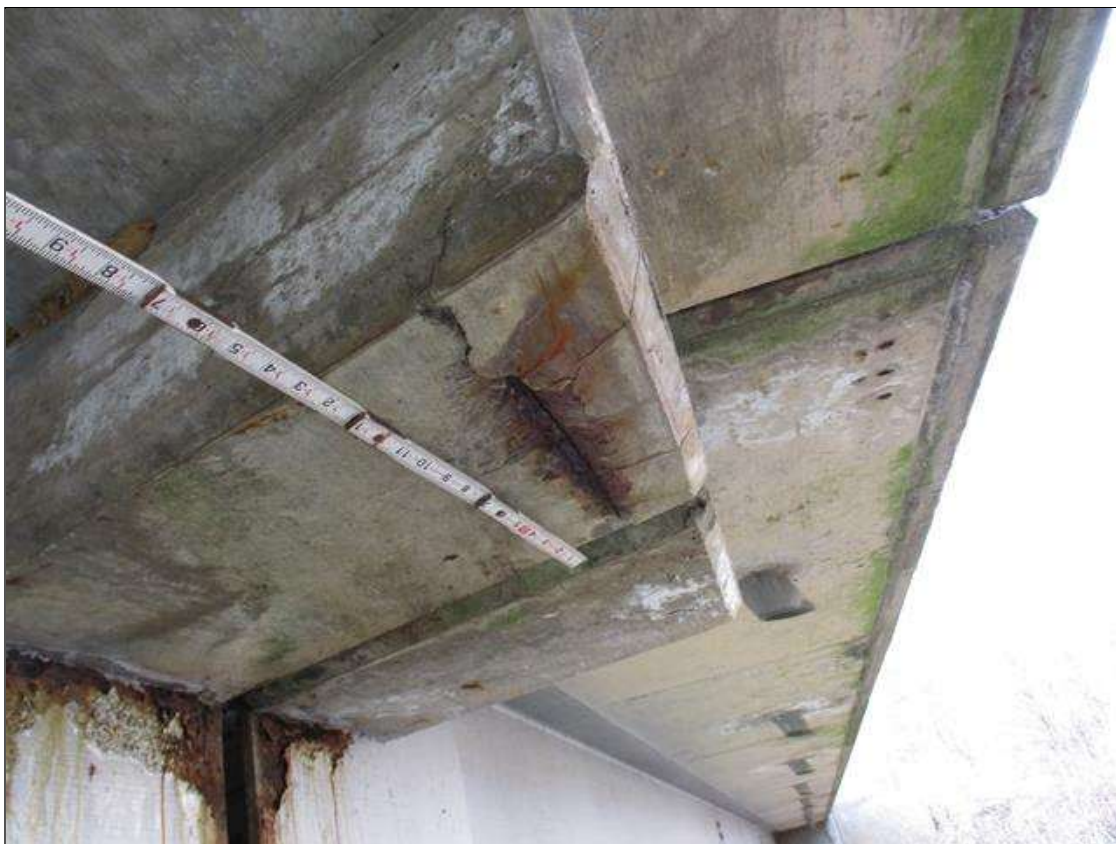
CONCRETE DIAPHRAGM, LEFT SIDE OF SPAN 2 BEAM 1 AT BENT 1, 12" LONG X 0.75" DEEP SPALL WITH EXPOSED REBAR WITH ACTIVE SECTION LOSS

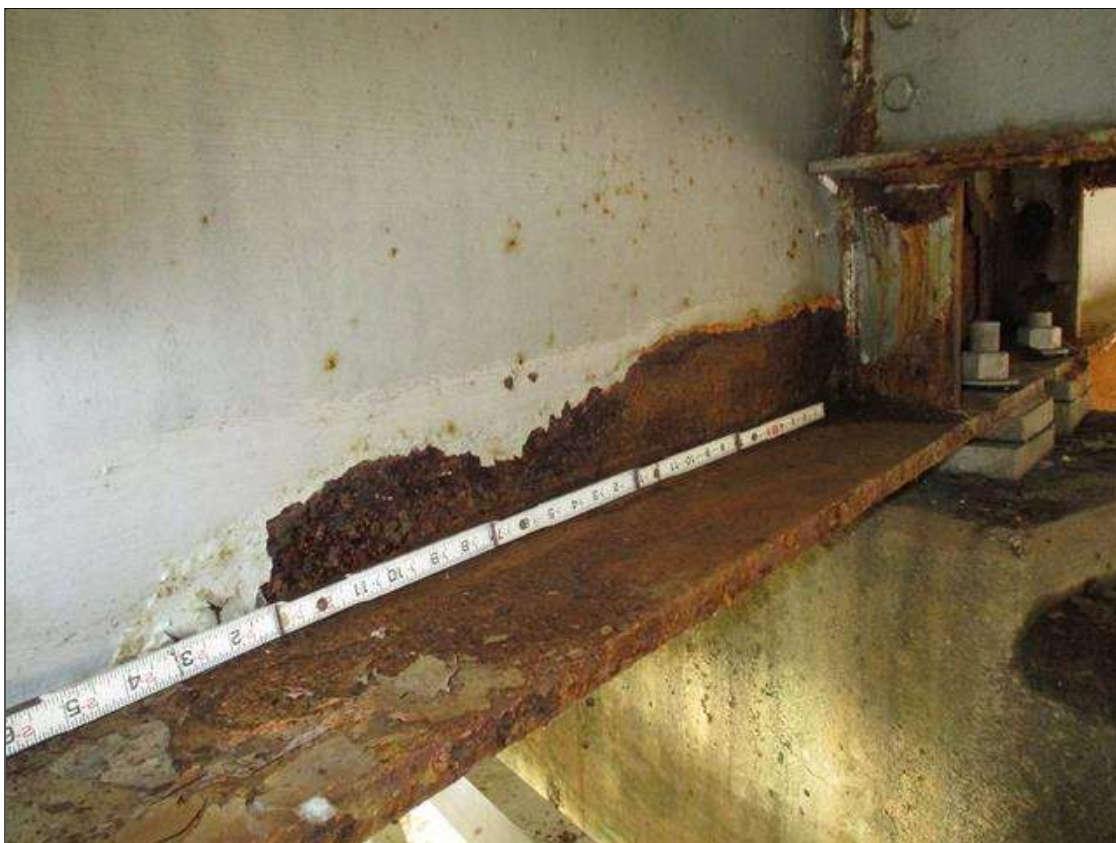
TYPICAL DETERIORATED PAINT SYSTEM (SPAN 2, BEAM 2)

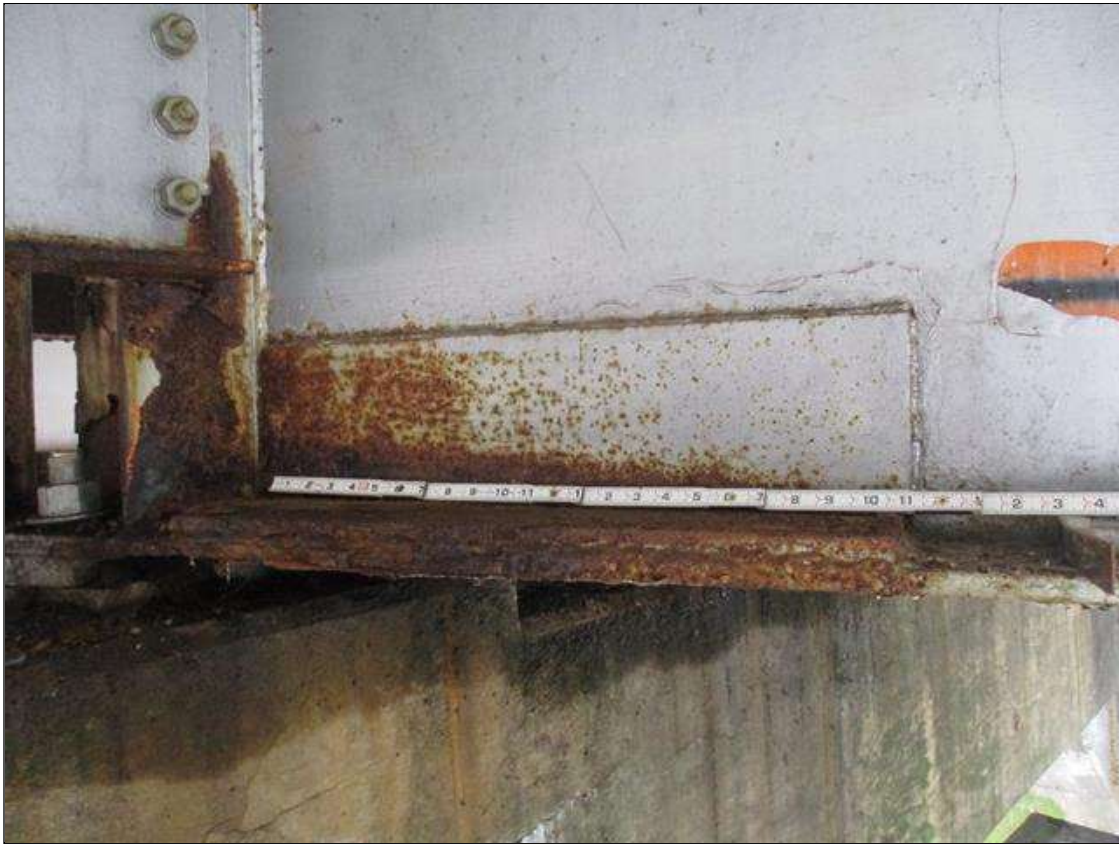
Span 2 Beam 3: SURFACE CORROSION THROUGHOUT 24" LONG X 5" WIDE X 6" HIGH PLATE REPAIR WELDED TO RIGHT FACE OF WEB AND BOTTOM FLANGE AT BENT 1 ON BOTH SIDES

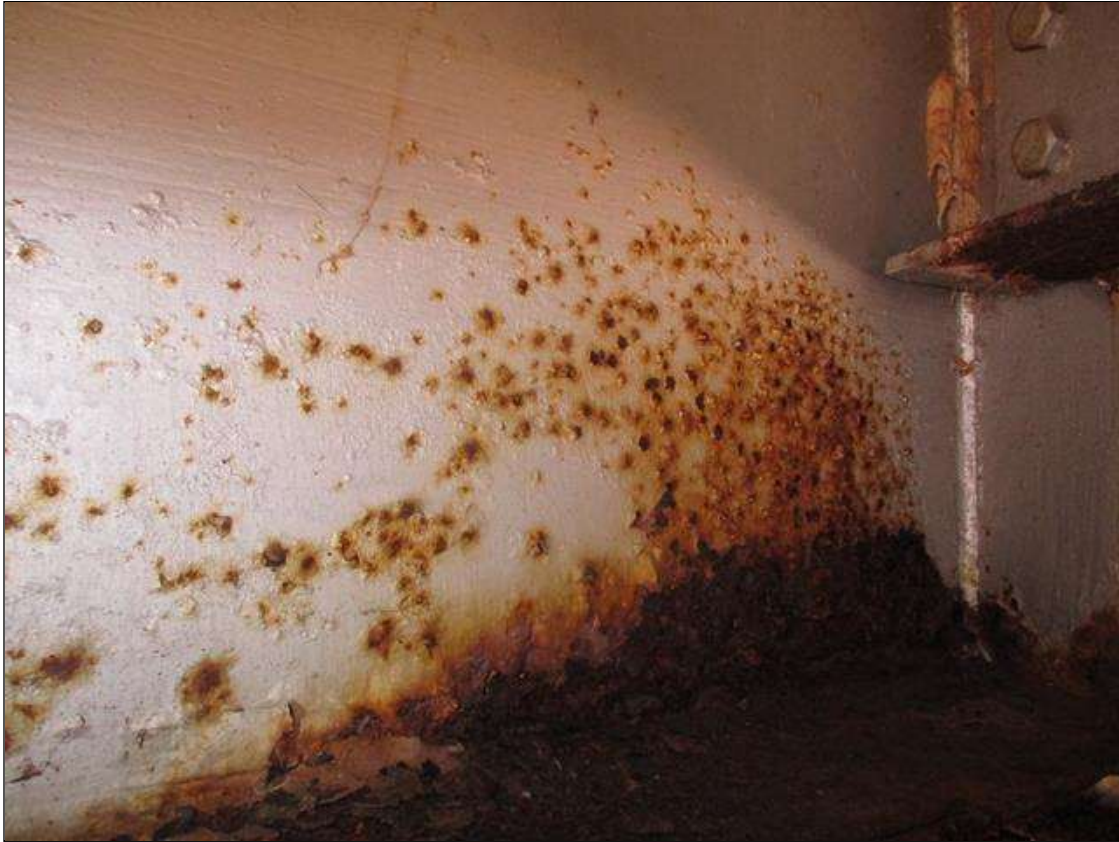
Span 2 Beam 3 - Protective System: DETERIORATED PAINT SYSTEM ALONG BOTH FACES OF WEB AND BOTTOM FLANGE UP TO 25" LONG X 24" HIGH IN WEB, AND 24" LONG X 11 3/4" WIDE IN FLANGE AT BENT 2 BEARING

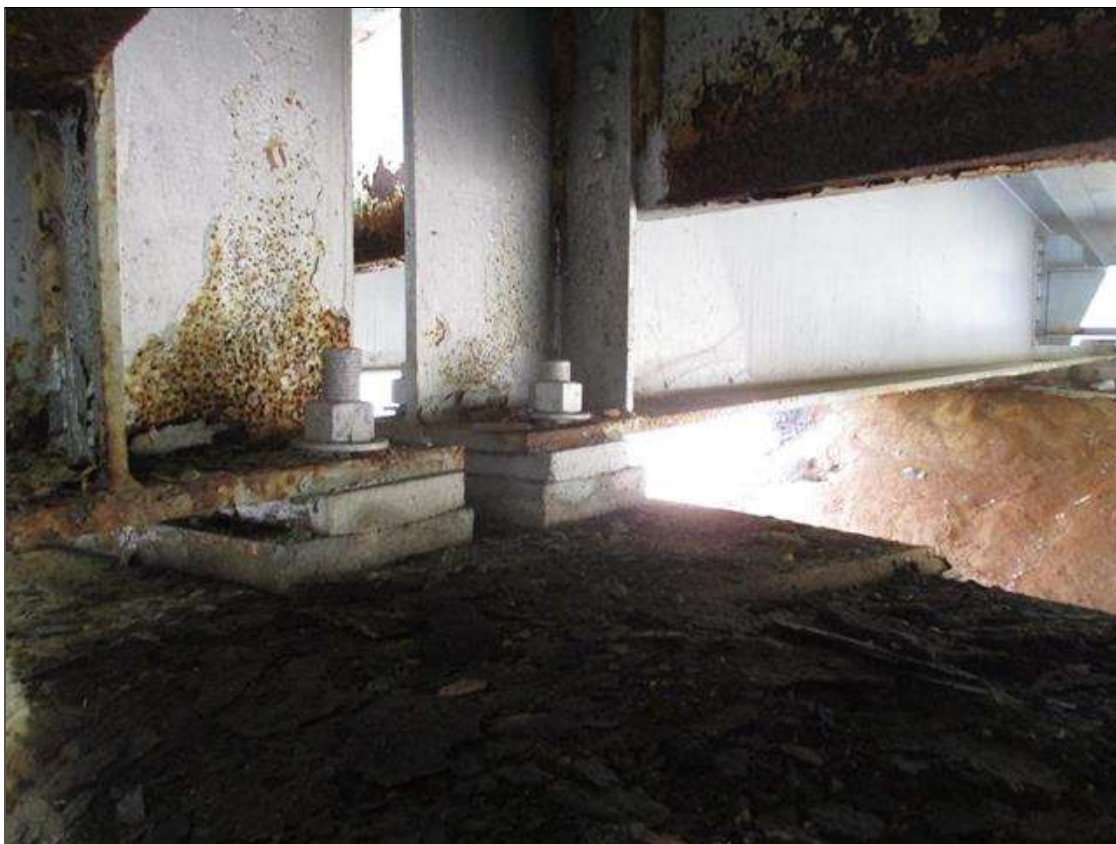
Span 2 Beam 3 - Near Bearing - Protective System: AREAS OF DETERIORATED PAINT SYSTEM THROUGHOUT BEAM 3 BEARING

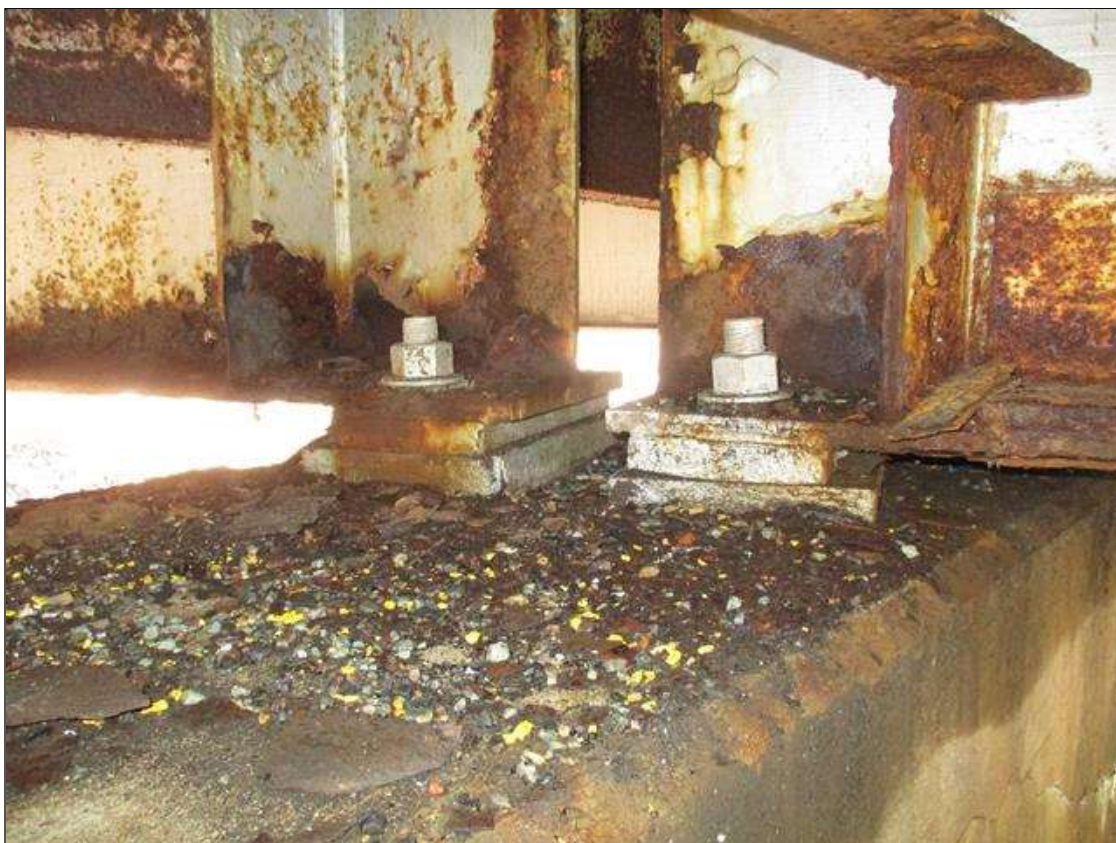
Span 2 Beam 3 - Far Bearing - Protective System: AREAS OF DETERIORATED PAINT SYSTEM THROUGHOUT BEAM 3 BEARING

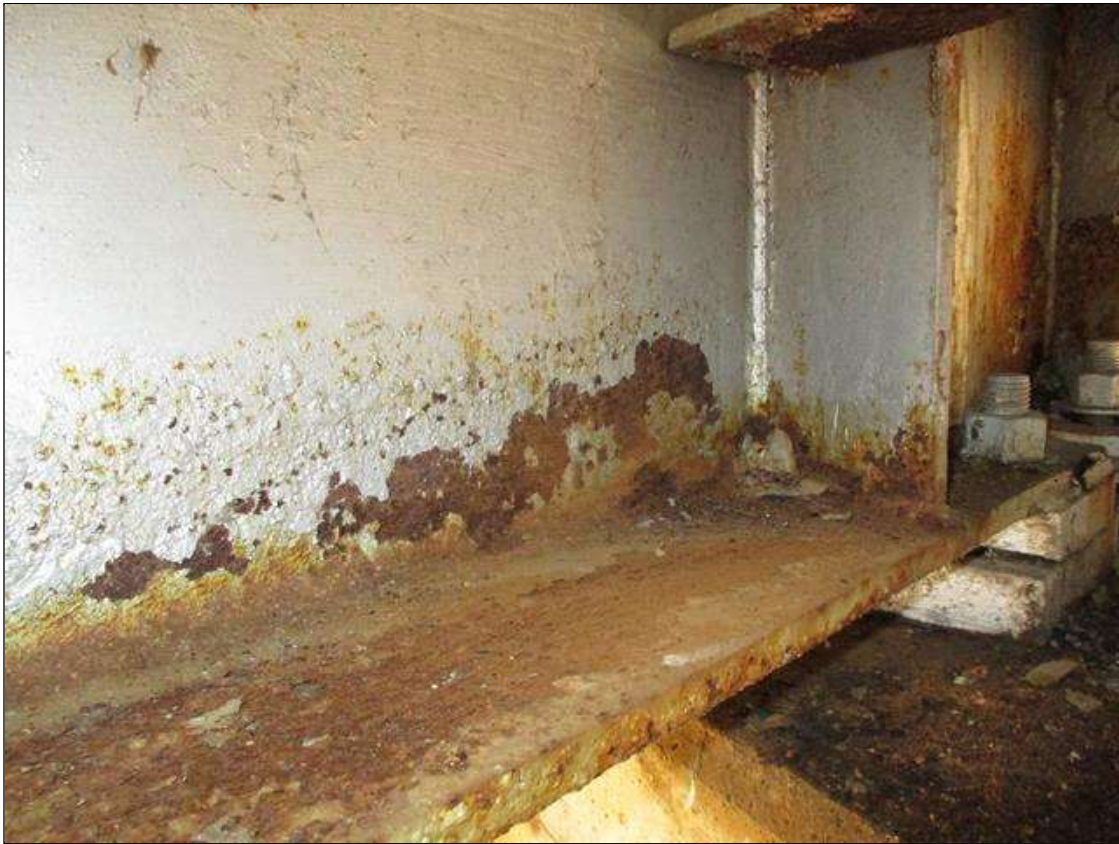
TYPICAL SURFACE CORROSION (SPAN 2, BEAM 4)

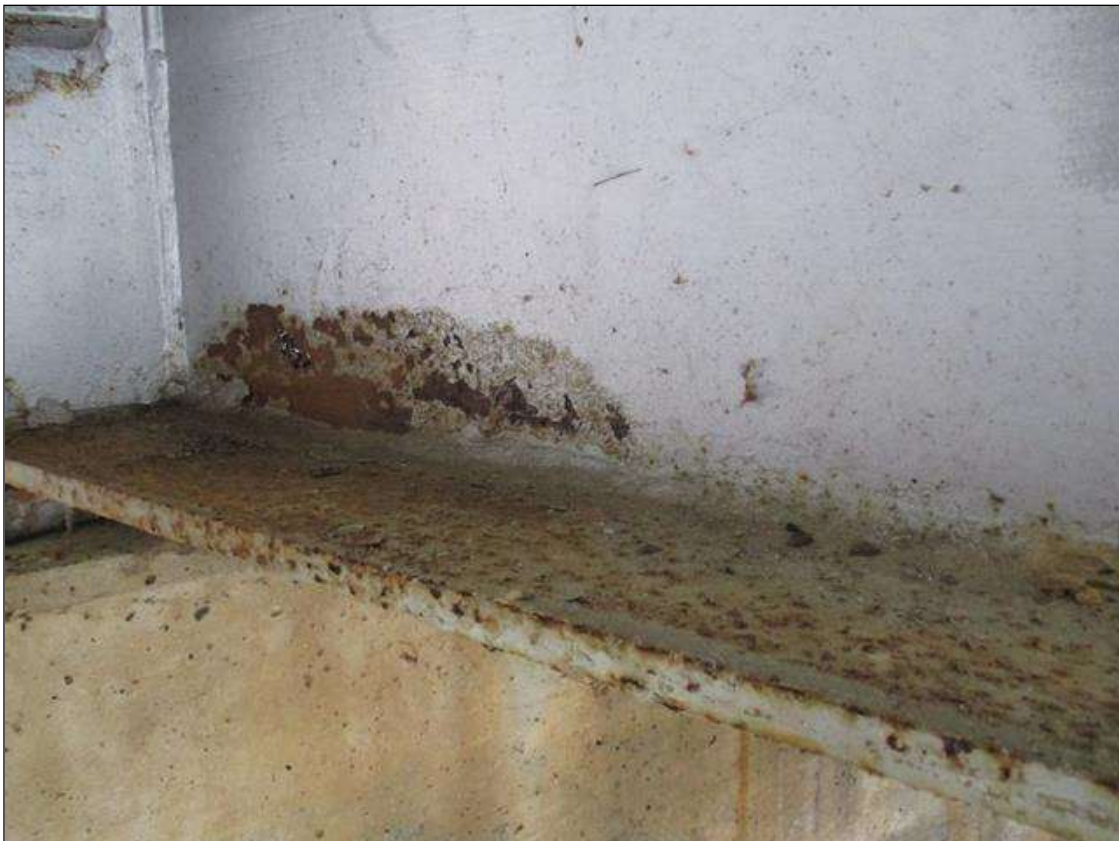
Span 2 Beam 4 - Protective System: DETERIORATED PAINT SYSTEM ALONG LEFT FACE OF WEB AND BOTTOM FLANGE UP TO 60" LONG X 5" HIGH IN WEB, AND 60" LONG X 11 3/4" WIDE IN FLANGE AT BENT 1 BEARING

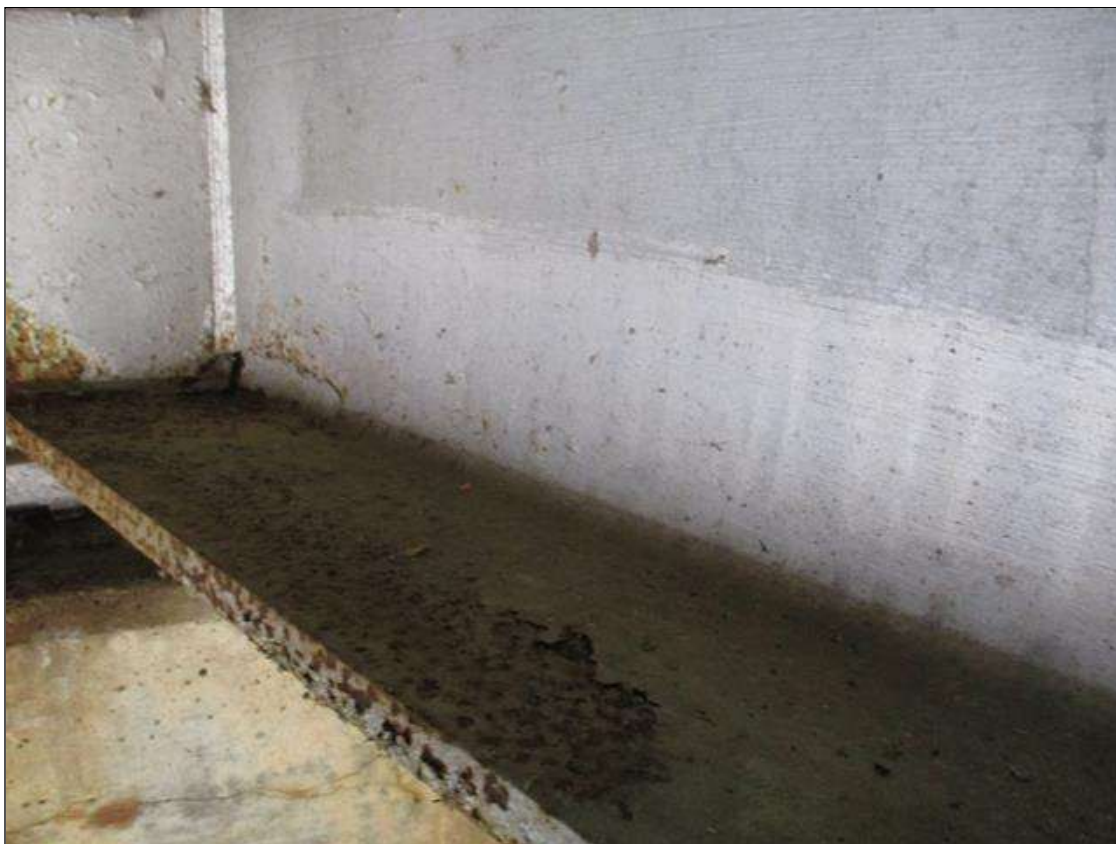
Span 2 Beam 4 - Protective System: AREAS OF DETERIORATED PAINT SYSTEM THROUGHOUT WEB AND BOTH FLANGES IN VARIOUS LOCATIONS

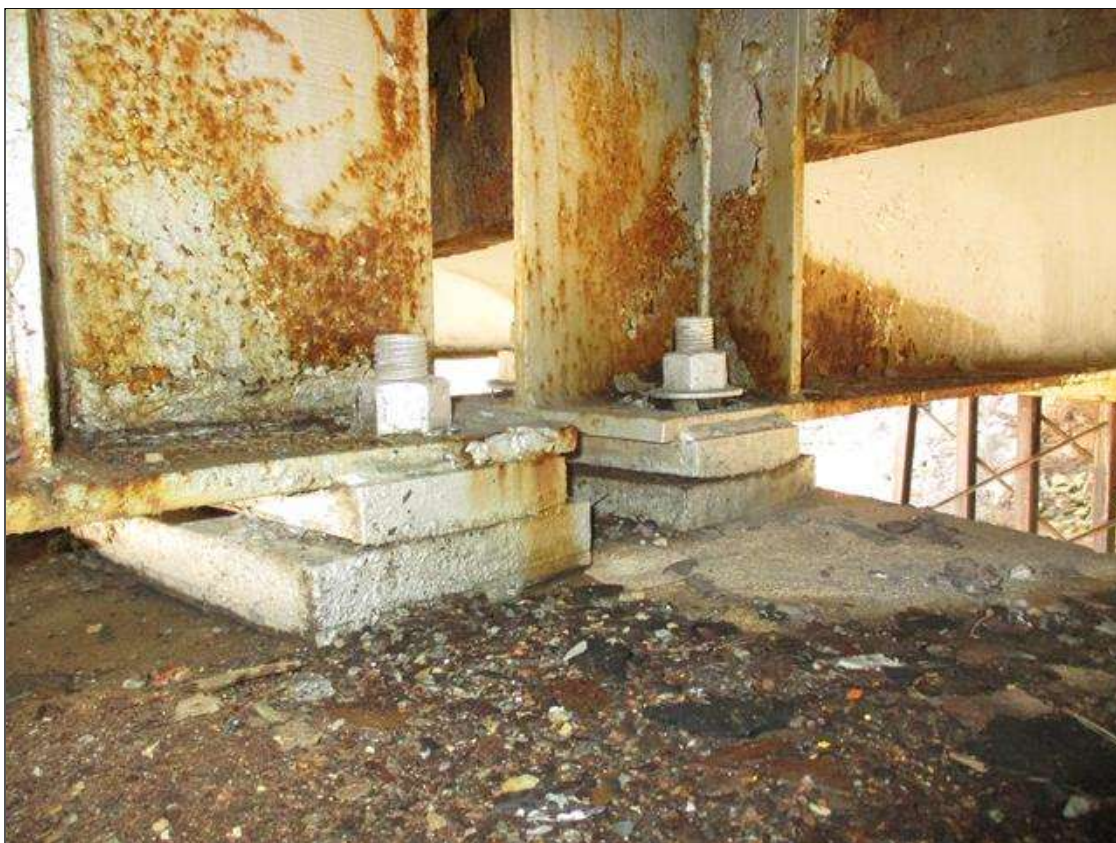
Span 2 Beam 4 - Near Bearing - Protective System: AREAS OF DETERIORATED PAINT SYSTEM THROUGHOUT BEAM 4 BEARING

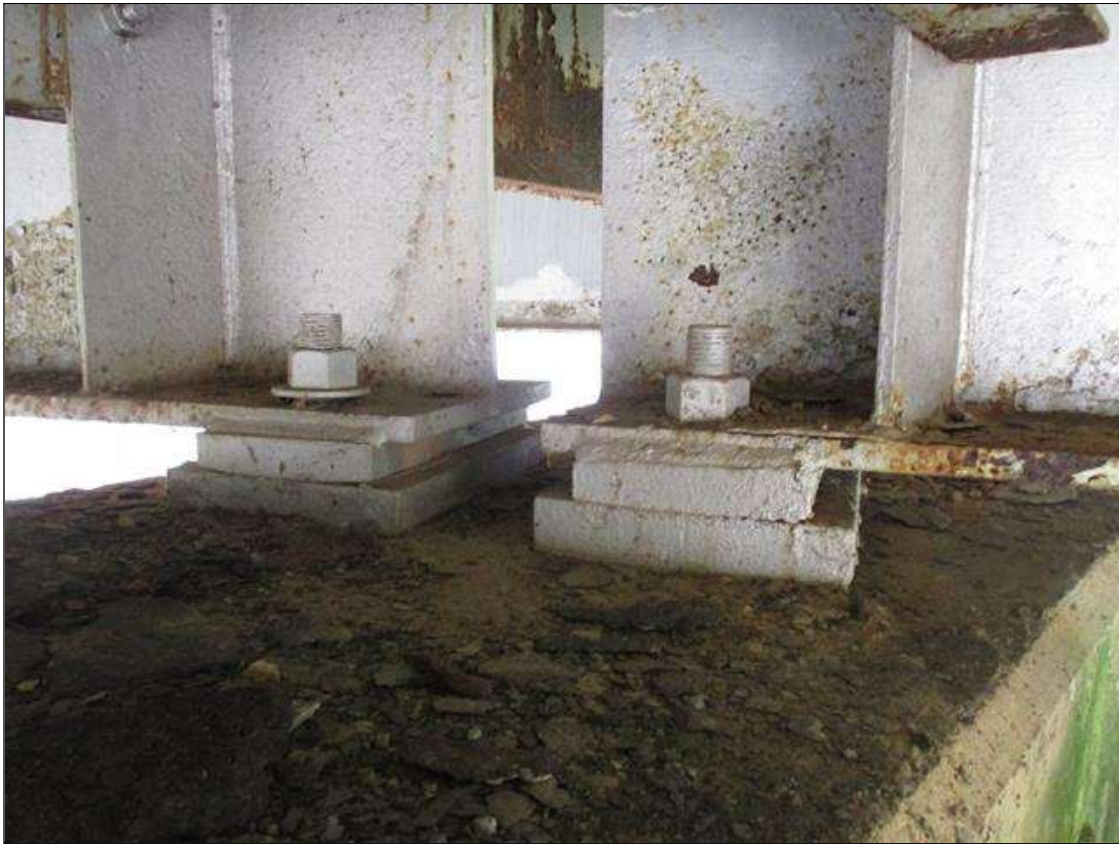
Span 2 Beam 4 - Far Bearing - Protective System: AREAS OF DETERIORATED PAINT SYSTEM THROUGHOUT BEAM 4 BEARING

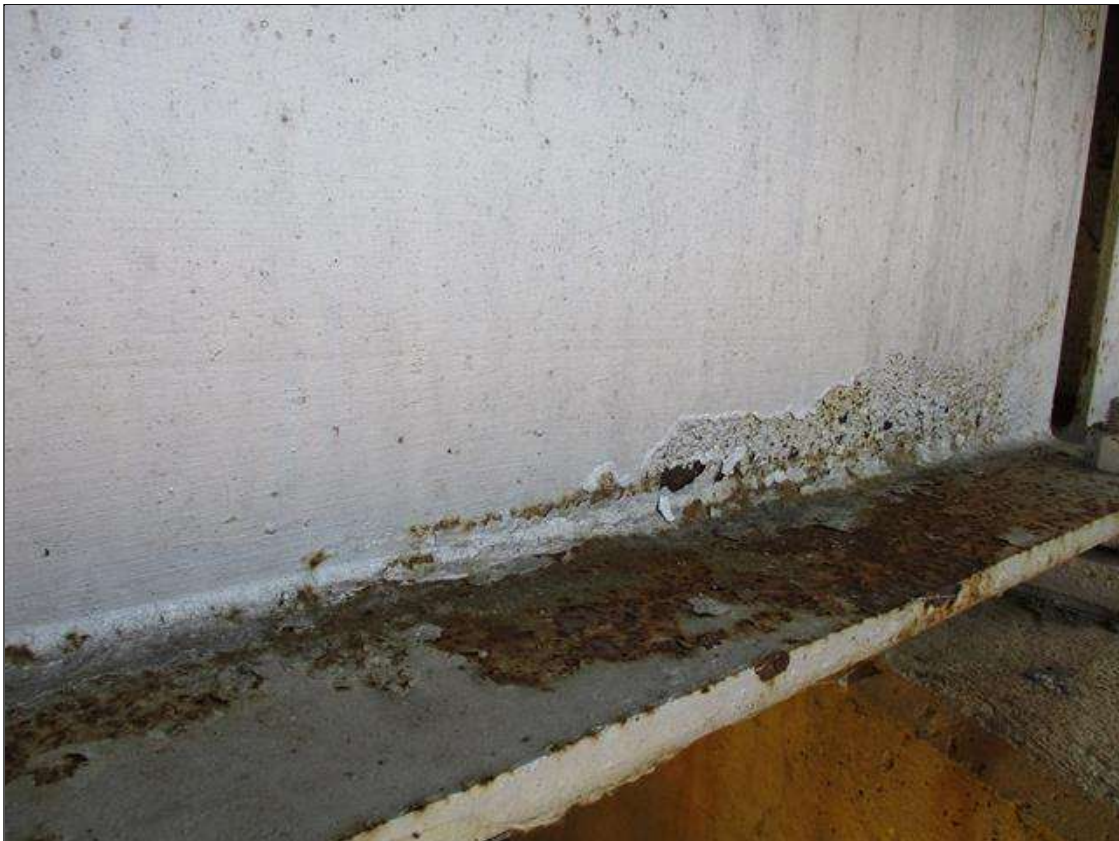
TYPICAL SURFACE CORROSION & DETERIORATED PAINT SYSTEM (SPAN 2, BEAM 5)

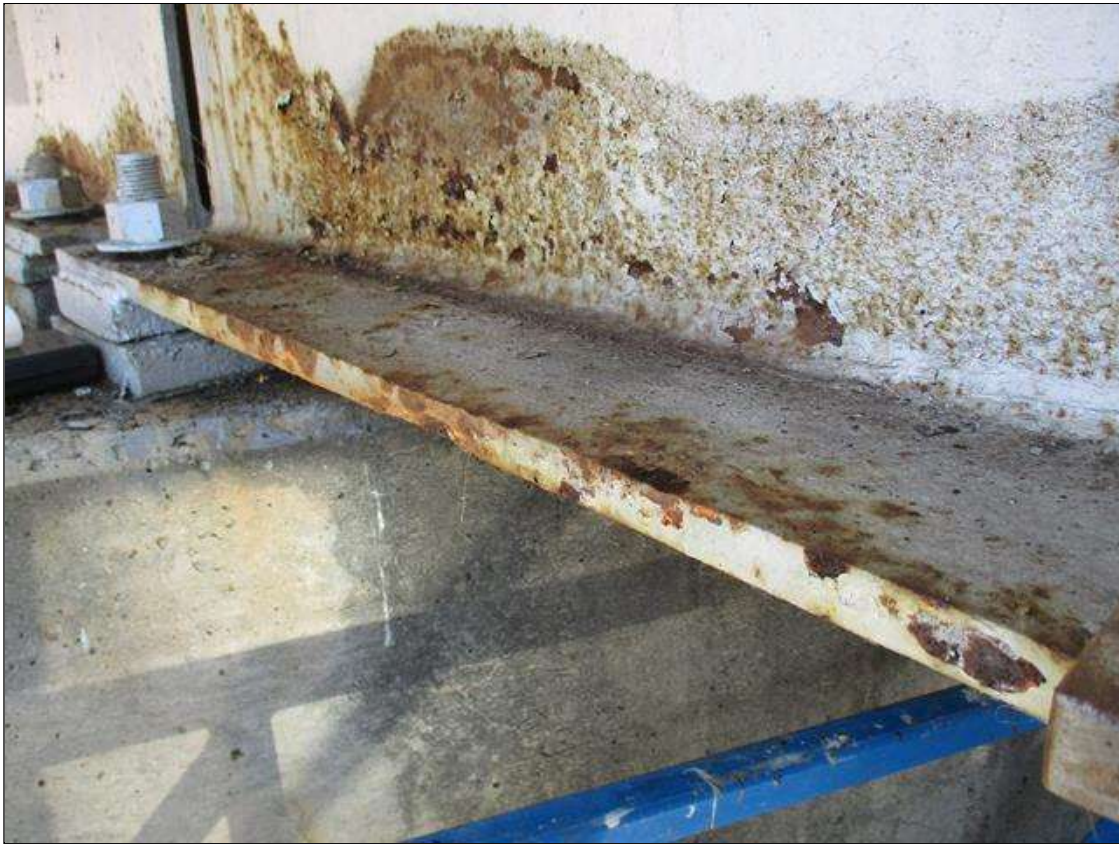
TYPICAL SURFACE OF CORROSION & DETERIORATED PAINT SYSTEM (SPAN 2, BEAM 6)
