NC DEPARTMENT OF TRANSPORTATION  
 DIVISION OF HIGHWAYS  
 STRUCTURE MANAGEMENT UNIT

ATTENTION: PARS SUBMITTED

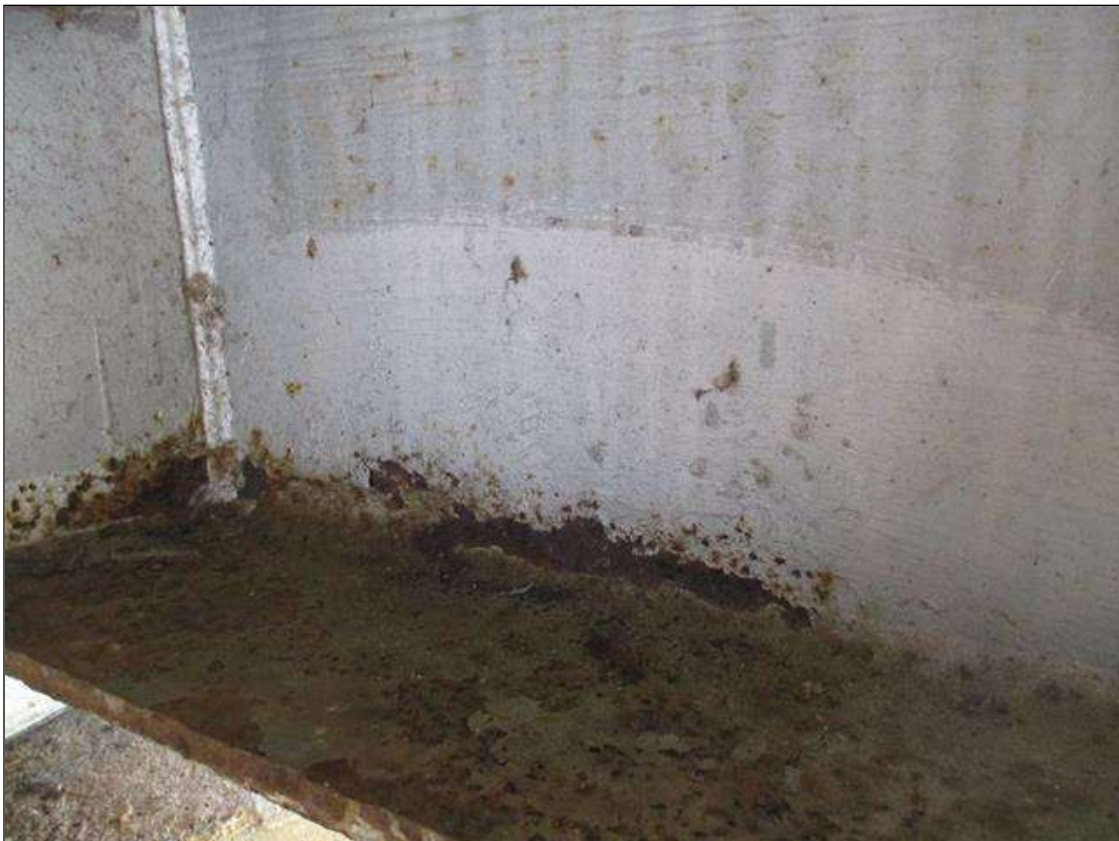
TYPICAL DETERIORATED PAINT SYSTEM (SPAN 2, BEAM 6)

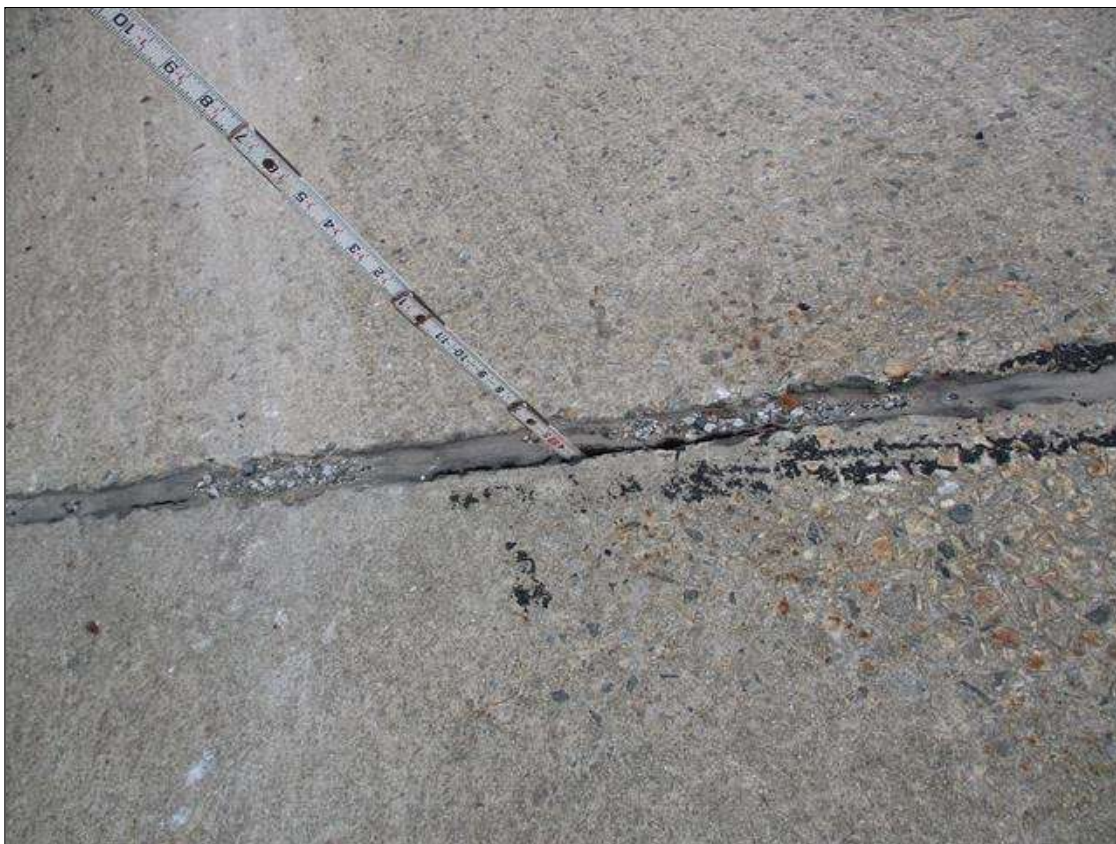
FULL DEPTH SEPARATION OF JOINT MATERIAL IN VARIOUS LOCATIONS (TYPICAL OF ALL JOINTS)

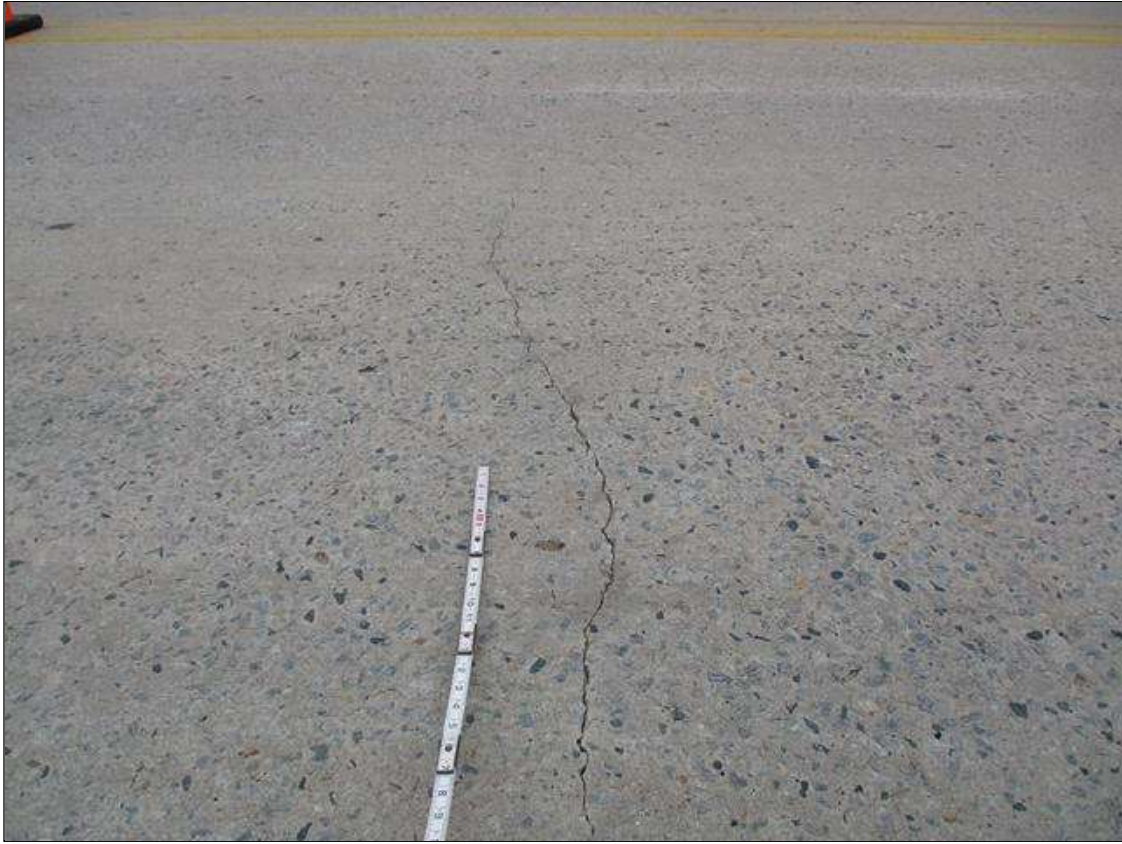
Span 3 Deck: UP TO 0.02" MAP CRACKS IN TOP OF DECK IN VARIOUS LOCATIONS

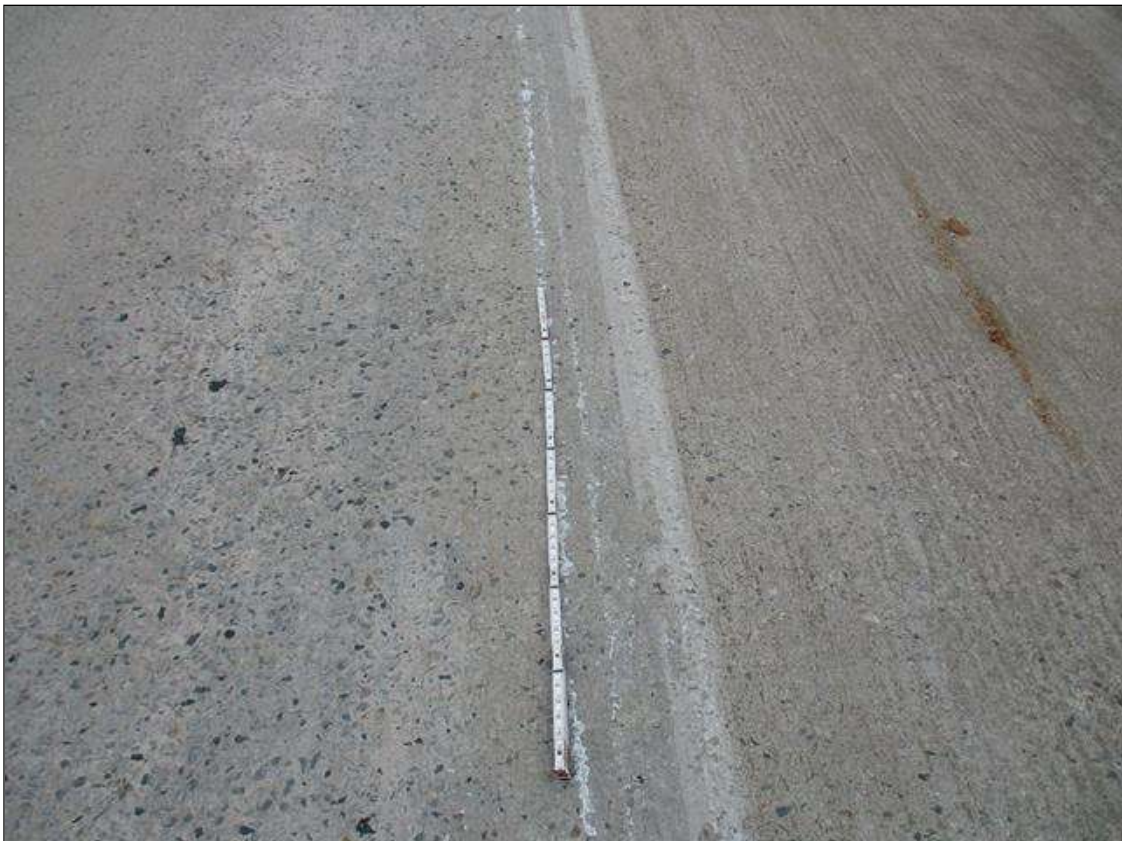
Span 3 Deck: 31" X 1/8" TRANSVERSE CRACK IN TOP OF DECK IN WESTBOUND LANE, APPROXIMATELY 14' FROM BENT 3 JOINT

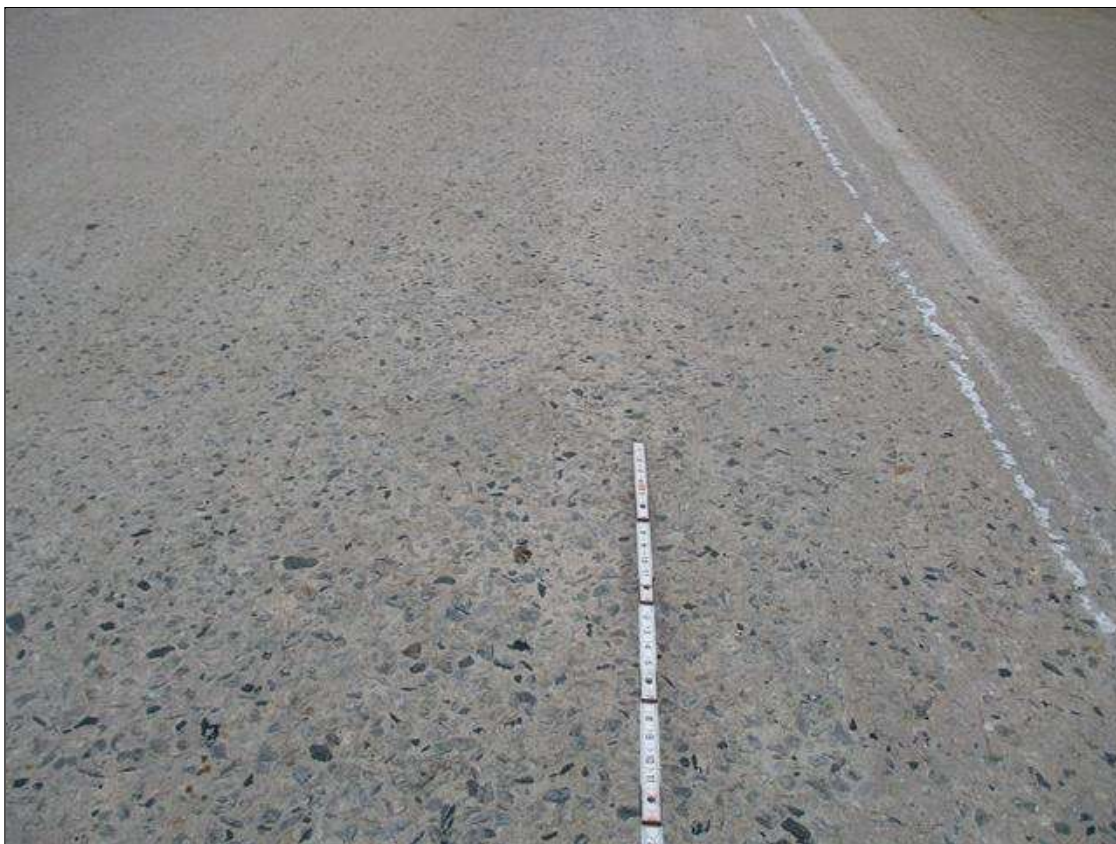
Span 3 Deck: SCALING WITH EXPOSED AGGREGATE IN TOP OF DECK THROUGHOUT TRAVEL LANES

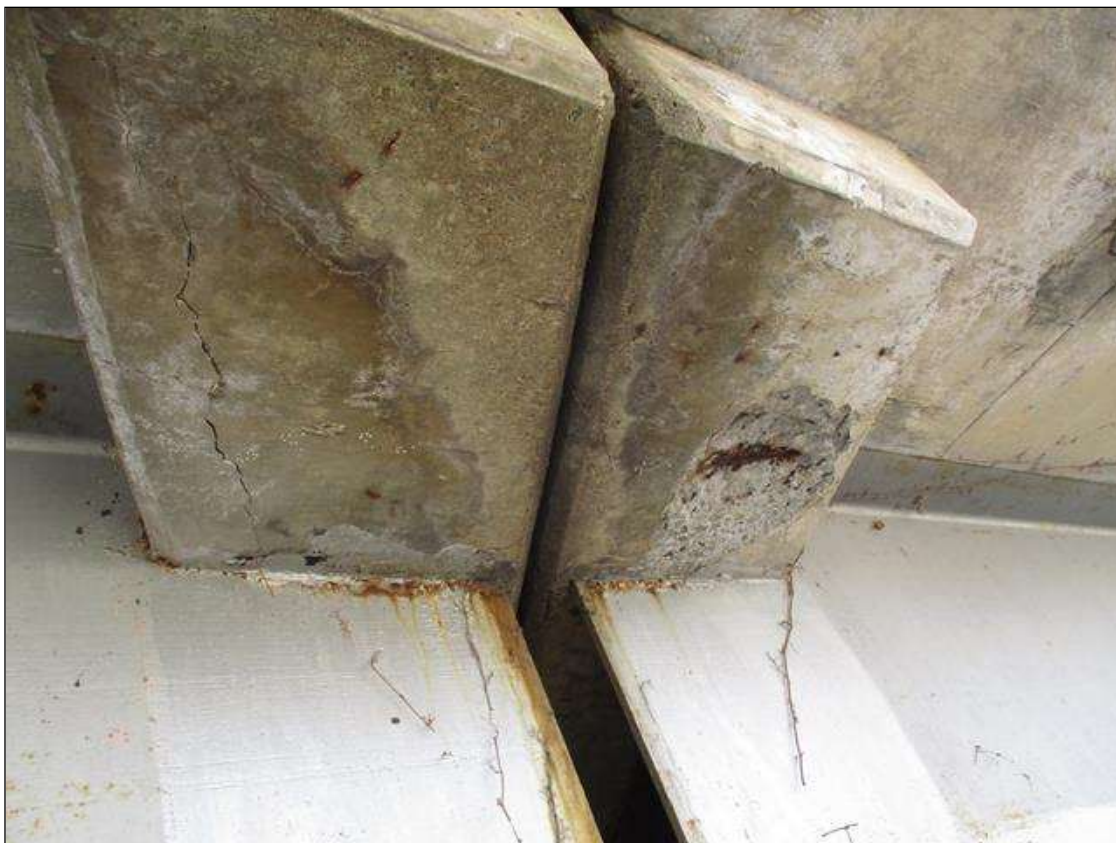
Span 3 Deck: 12"x 12"x 1" SPALL WITH EXPOSED REBAR BENT 3, LEFT SIDE, UNDERSIDE OF DECK

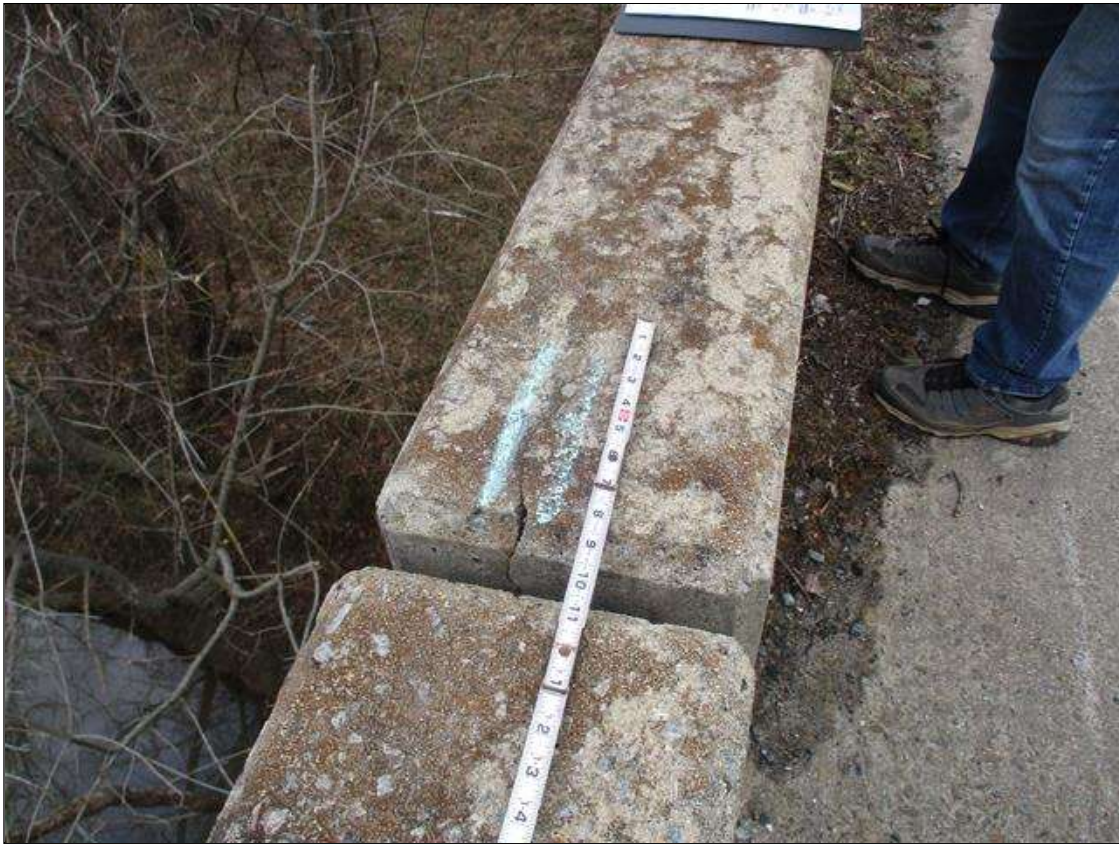
Span 3 Left Bridge Rail: UP TO 0.035" LONGITUDINAL AND VERTICAL CRACKS IN TOP AND ENDS OF RAIL IN VARIOUS LOCATIONS

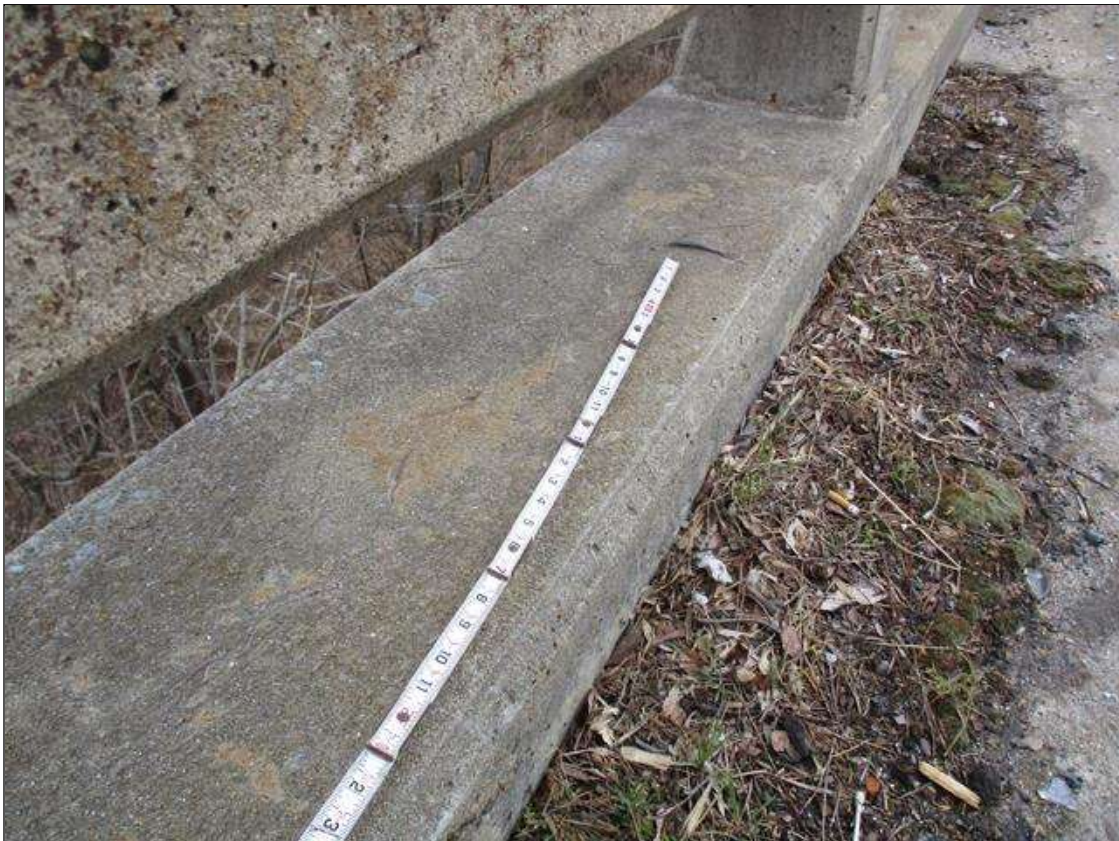
Span 3 Left Bridge Rail: ON TOP OF CURB THROUGHOUT, LESS THAN 0.01" WIDE CRACKING WITH EFFLORESCENCE

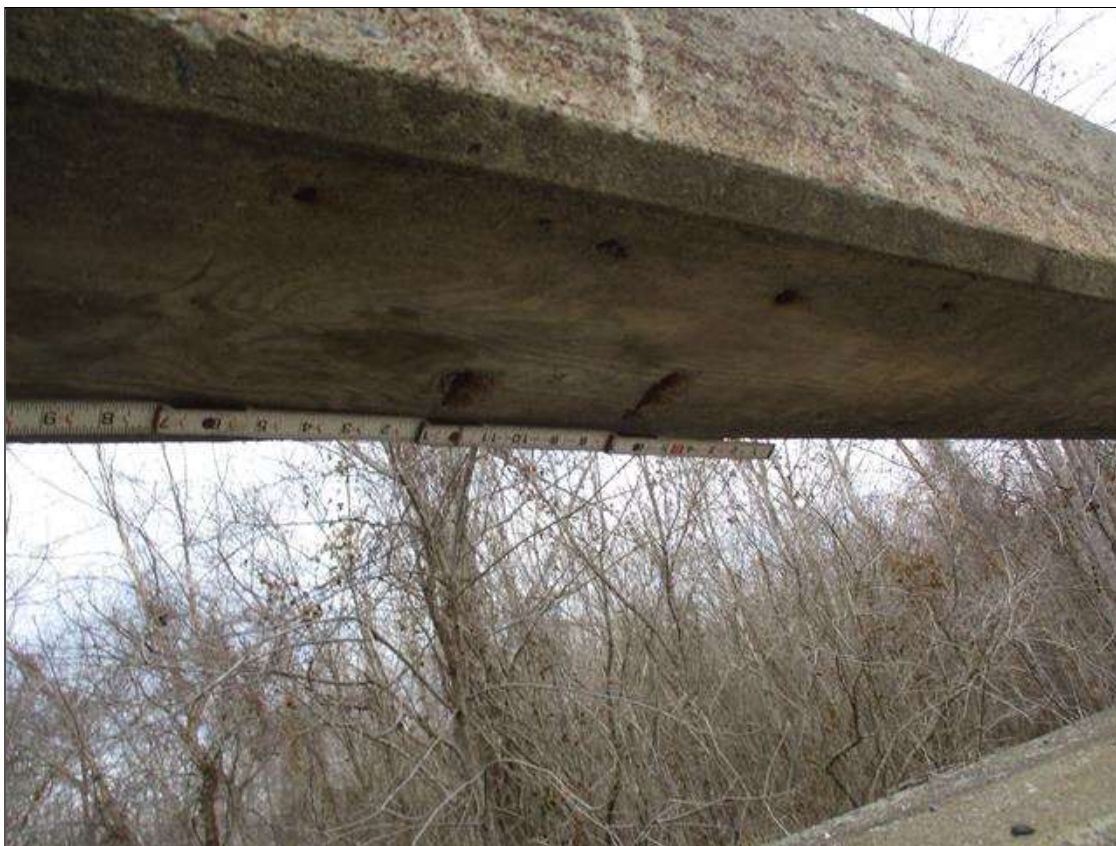
Span 3 Left Bridge Rail: WITHIN 8' OF BENT 3 JOINT, (3) 3" DIAMETER X 0.25" DEEP SPALLS WITH EXPOSED REBAR UNDER RAILING

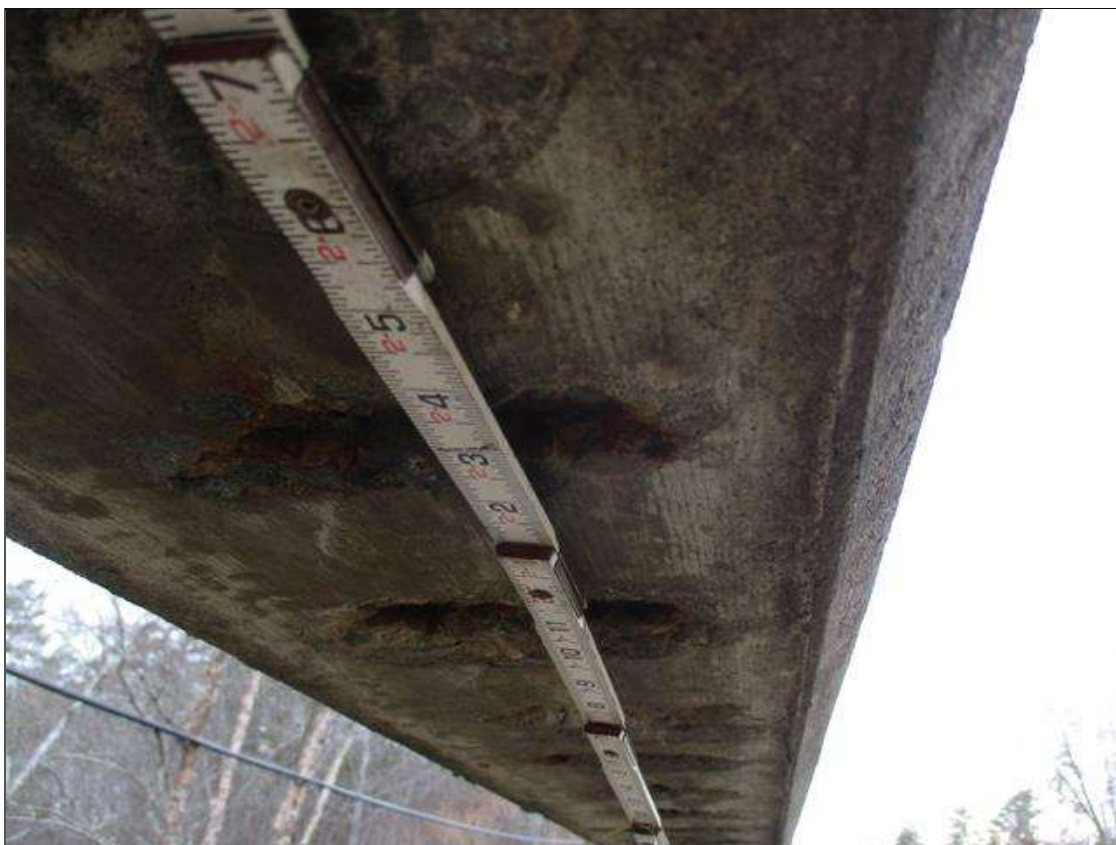
Span 3 Right Bridge Rail: SPALLS WITH EXPOSED REBAR UP TO 6" X 4" X 1/4" DEEP IN BOTTOM OF RAIL IN VARIOUS LOCATIONS

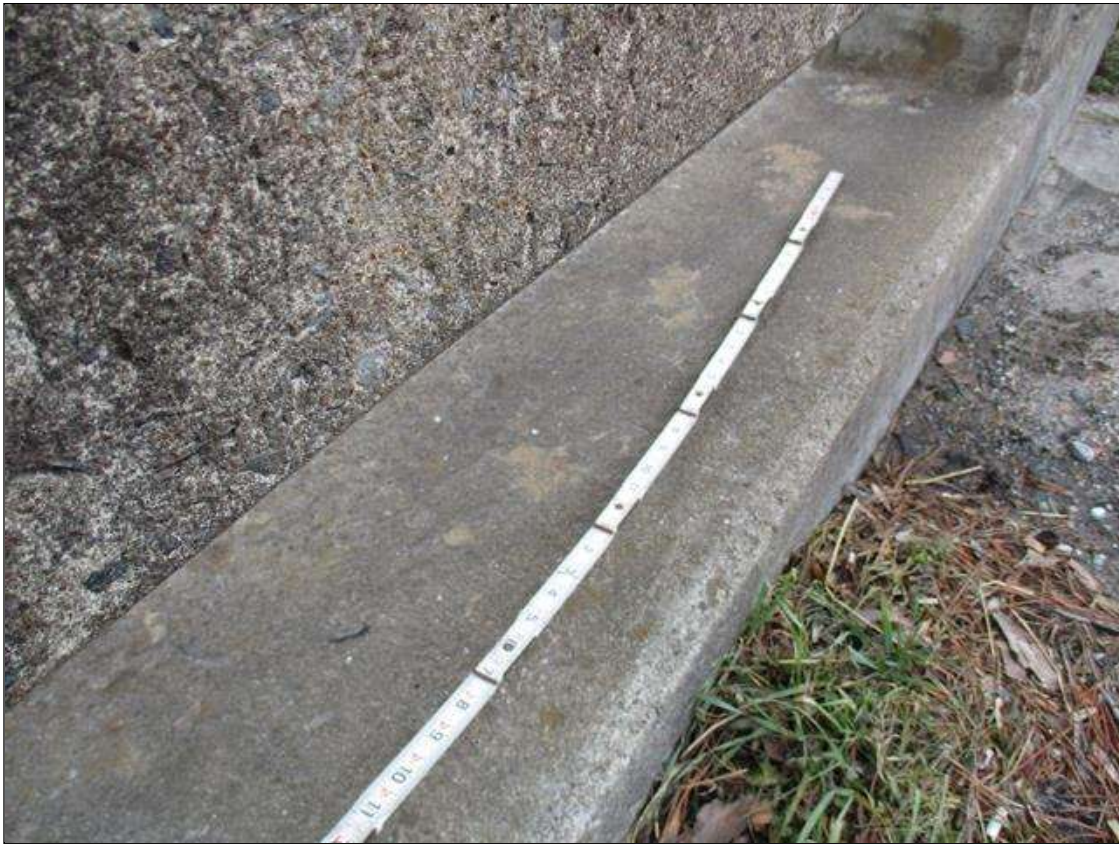
Span 3 Right Bridge Rail: ON TOP OF CURB THROUGHOUT, LESS THAN 0.01" WIDE CRACKING WITH EFFLORESCENCE

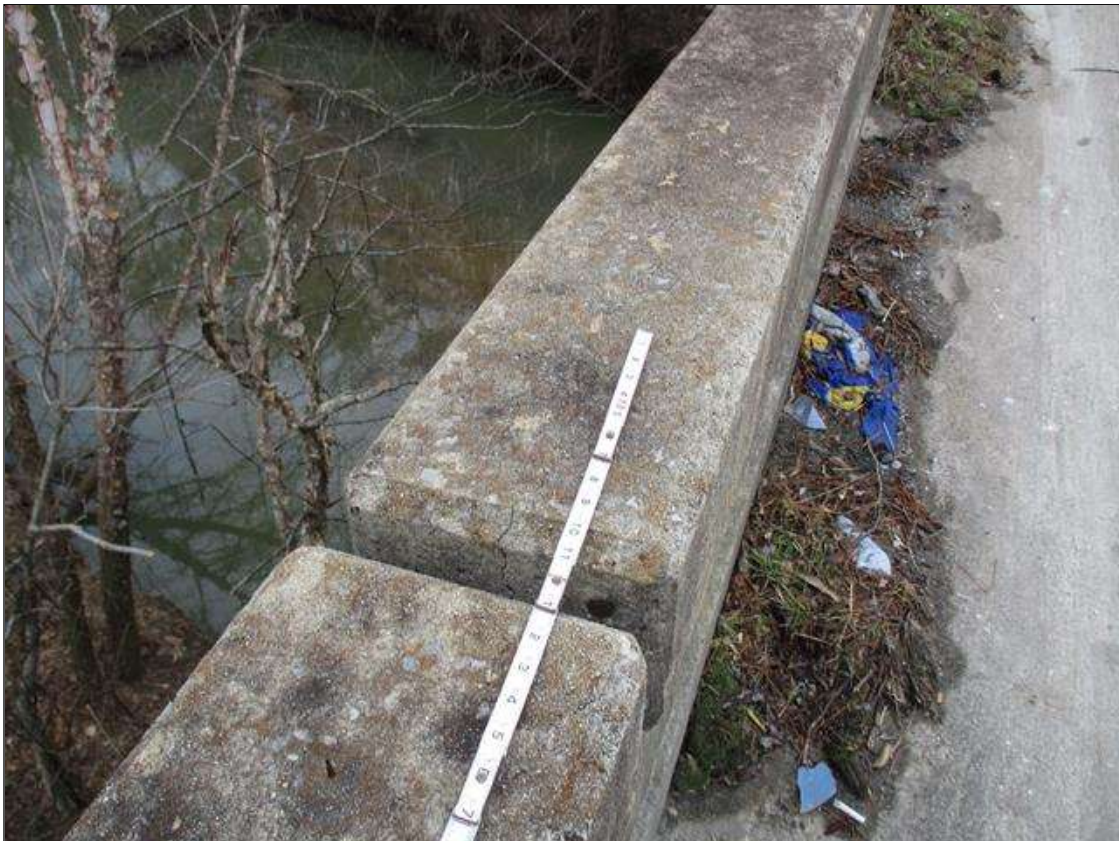
Span 3 Right Bridge Rail: UP TO 0.03" LONGITUDINAL AND VERTICAL CRACKS IN TOP AND ENDS OF RAIL IN VARIOUS LOCATIONS

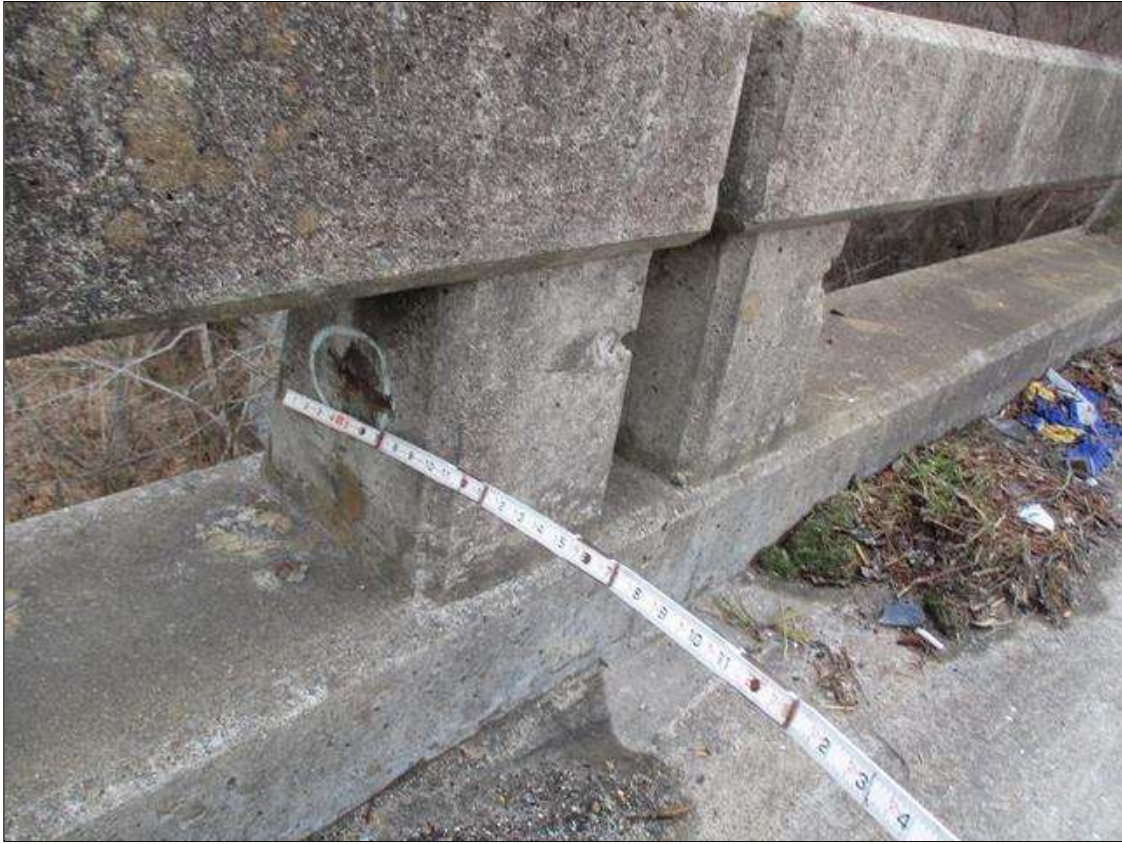
Span 3 Right Bridge Rail: THREE (3) SPALLS UP TO 4" X 3 1/2" X 1/4" DEEP IN FACE OF RAIL AND RAIL POSTS IN VARIOUS LOCATIONS

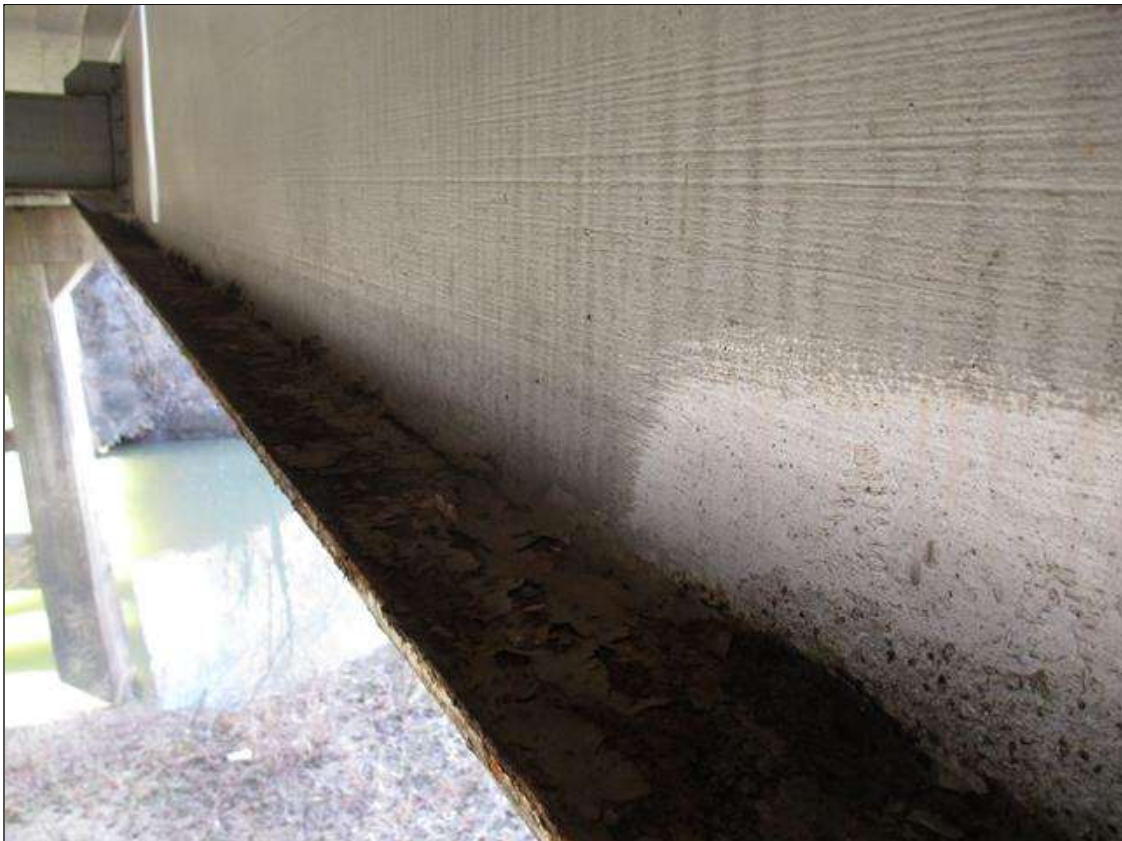
TYPICAL DETERIORATED PAINT SYSTEM (SPAN 3, BEAM 1)

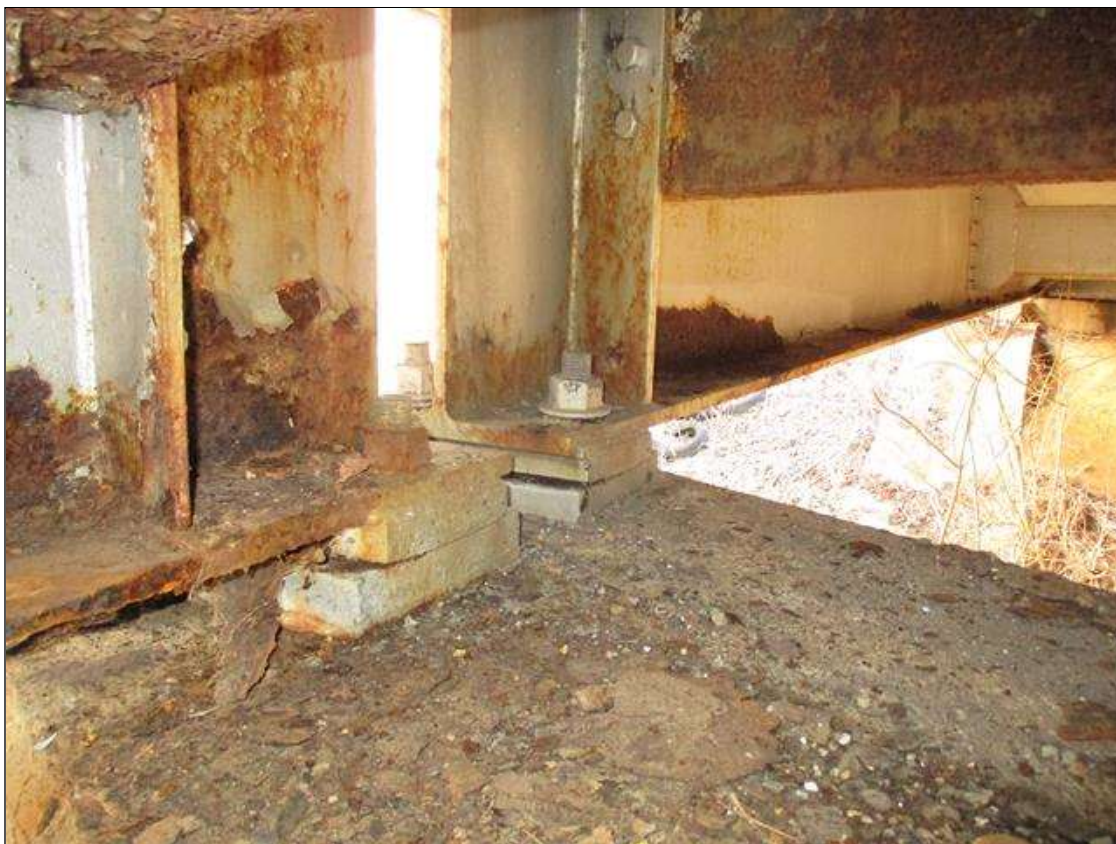
Span 3 Beam 1 - Near Bearing - Protective System: AREAS OF DETERIORATED PAINT SYSTEM THROUGHOUT BENT 1 BEARING

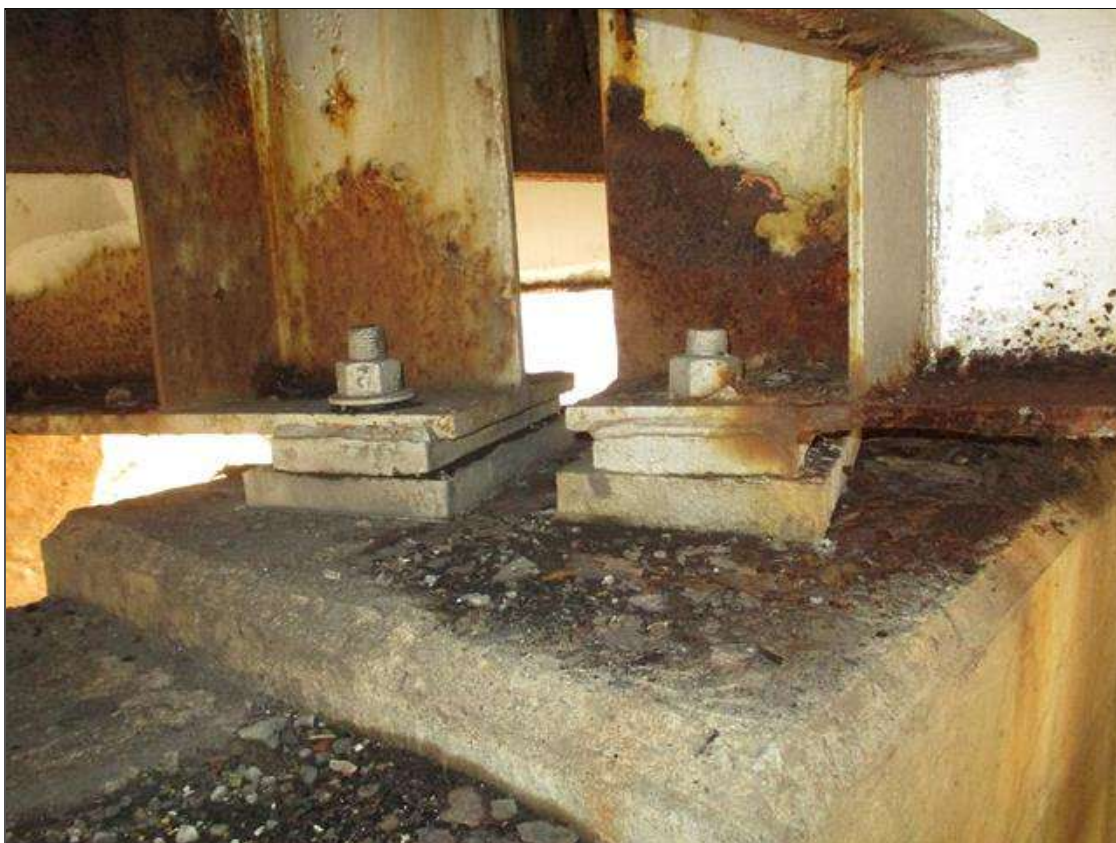
Span 3 Beam 1 - Far Bearing - Protective System: AREAS OF DETERIORATED PAINT SYSTEM THROUGHOUT BEAM 1 BEARING

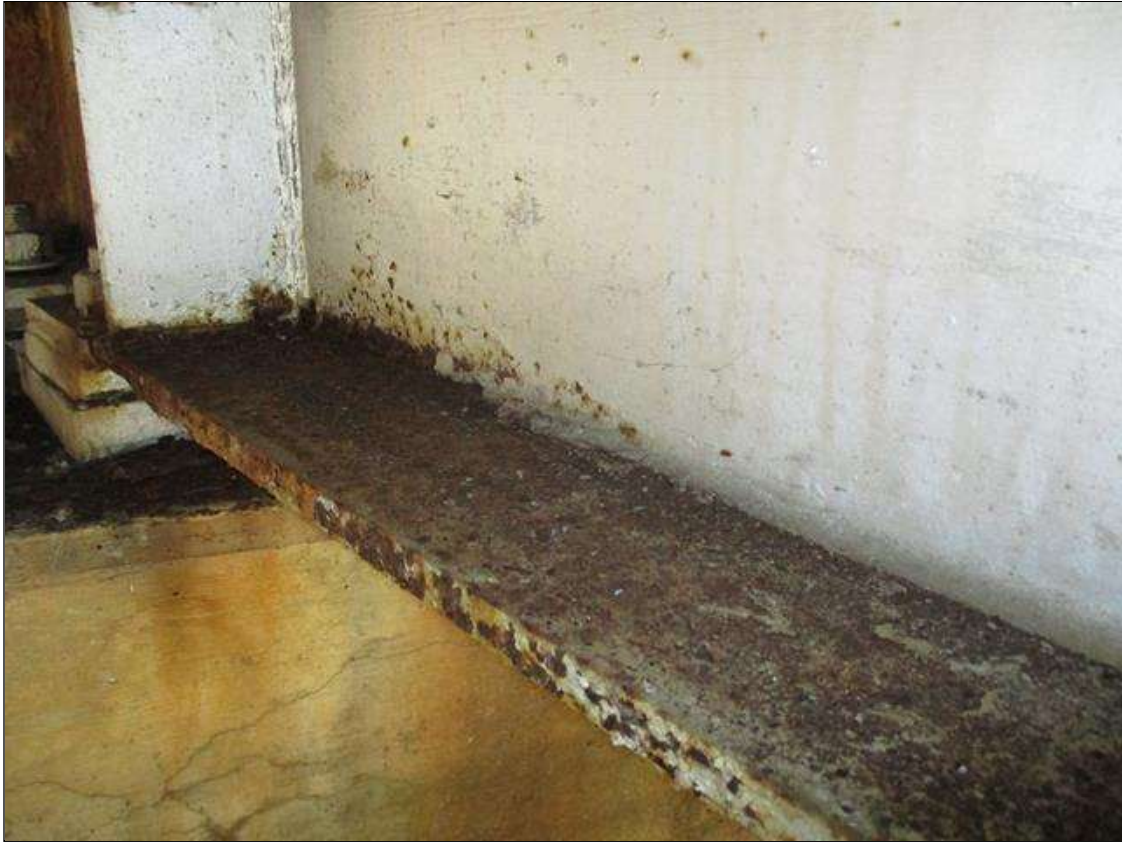
TYPICAL SURFACE CORROSION & DETERIORATED PAINT SYSTEM (SPAN 3, BEAM 2)

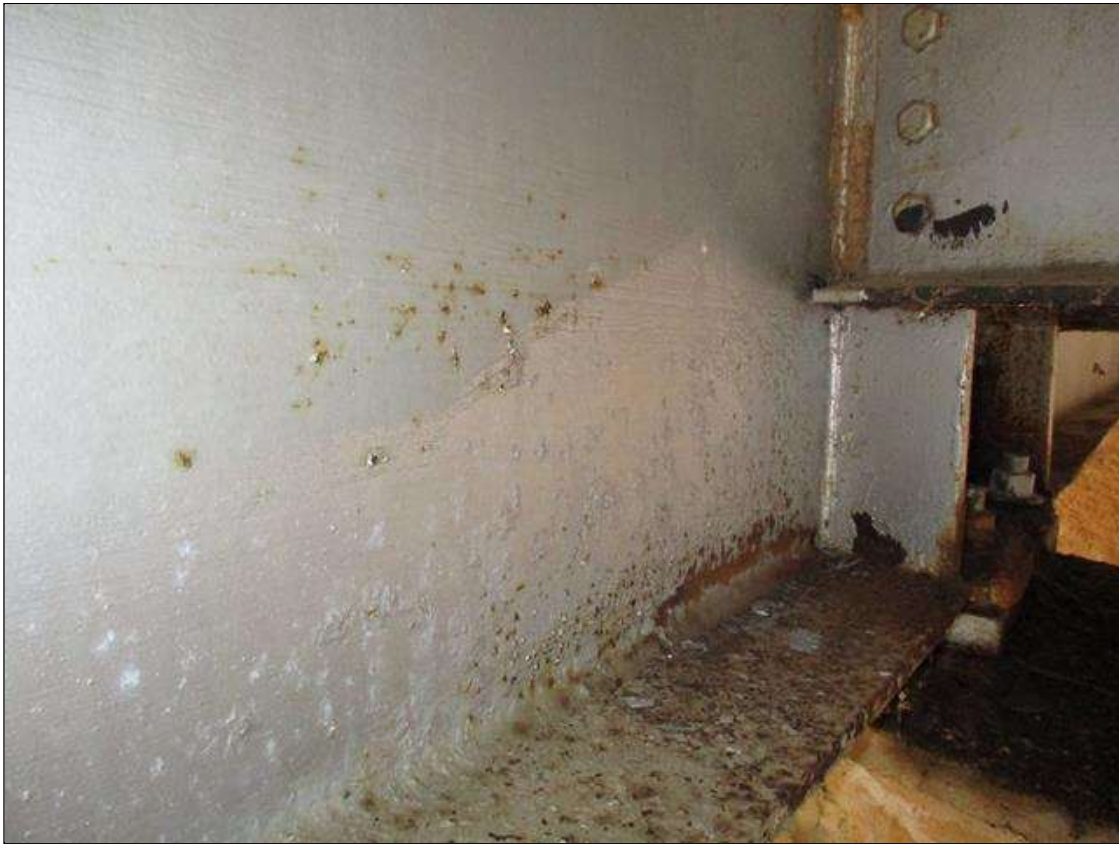
Span 3 Beam 3 - Protective System: DETERIORATED PAINT SYSTEM ALONG BOTH FACES OF WEB AND BOTTOM FLANGE UP TO 15" LONG X 5" HIGH IN WEB, AND 18" LONG X 11 3/4" WIDE IN FLANGE AT BENT 3 BEARING

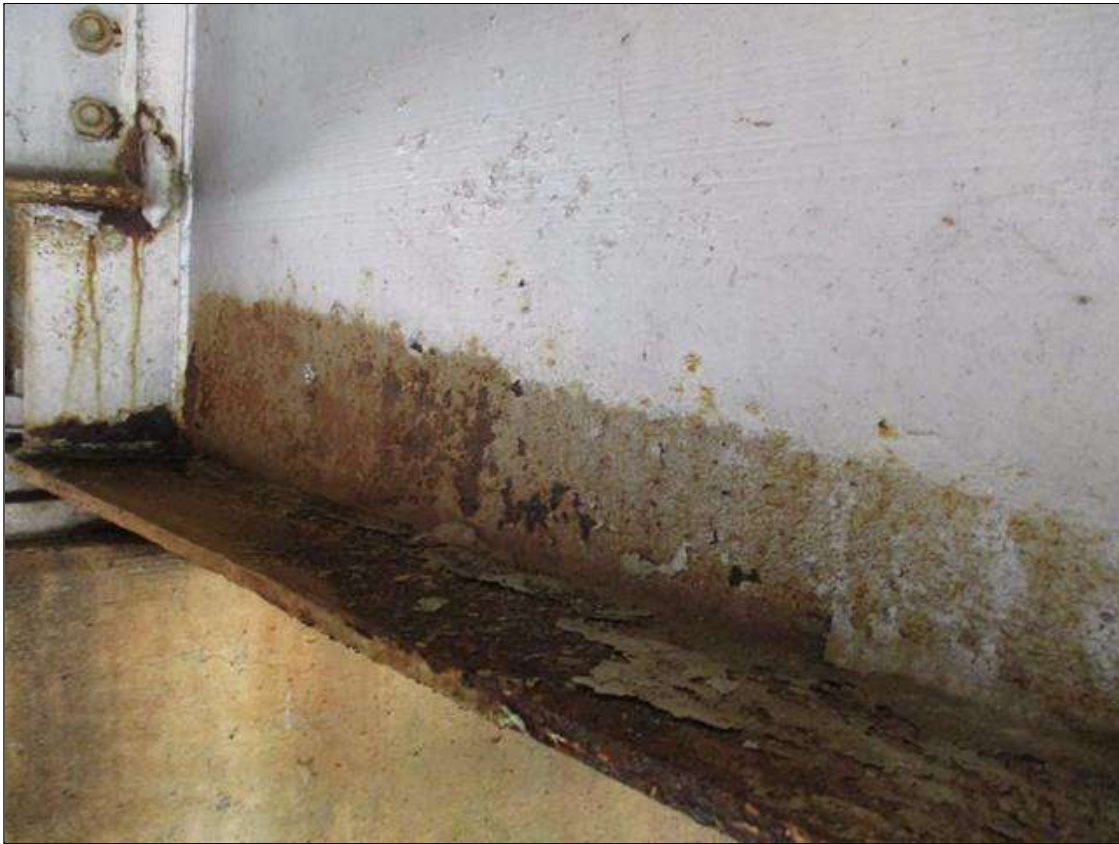
TYPICAL DETERIORATED PAINT SYSTEM (SPAN 3, BEAM 4)

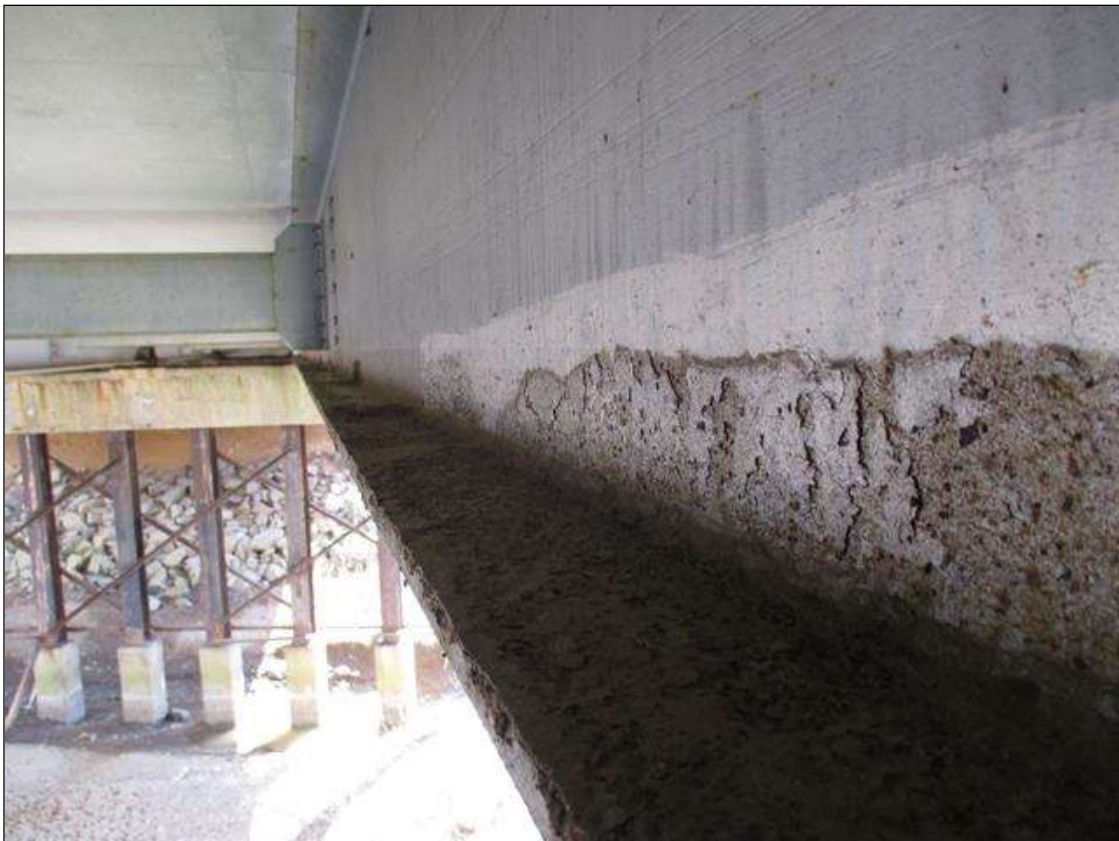
TYPICAL SURFACE CORROSION & DETERIORATED PAINT SYSTEM (SPAN 3, BEAM 5)

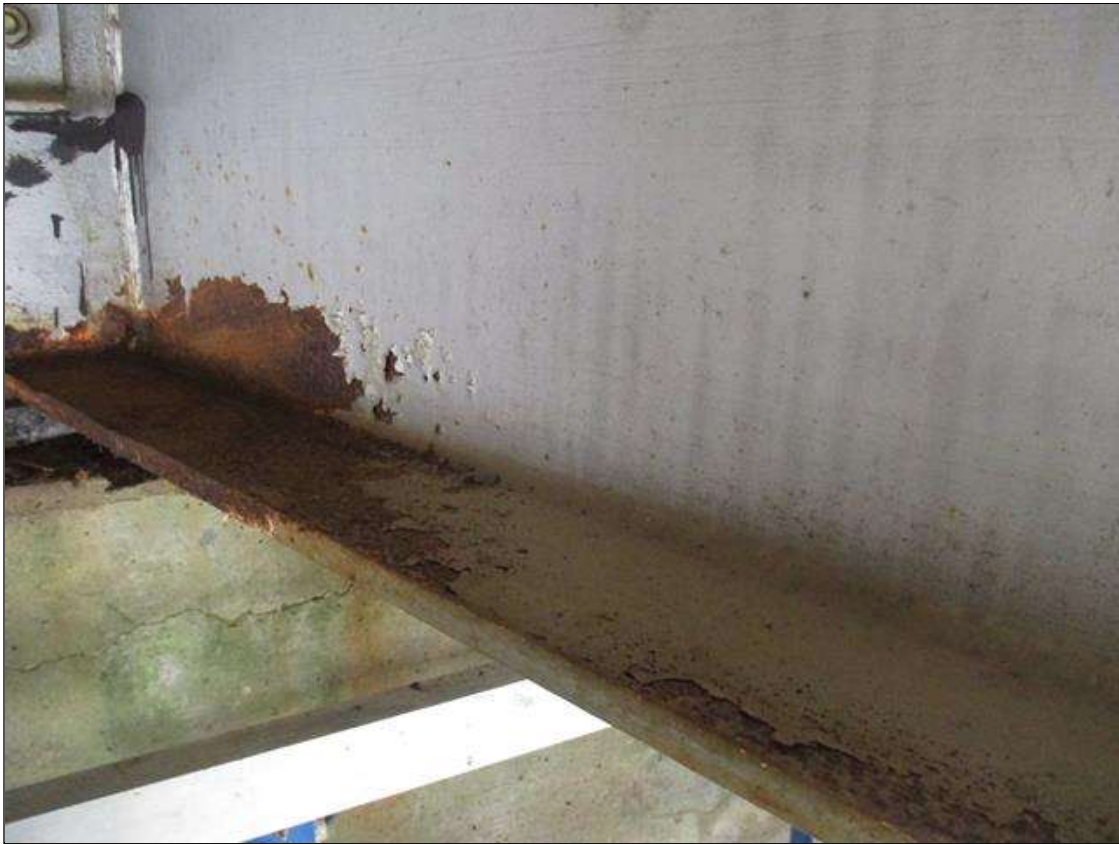
TYPICAL DETERIORATED PAINT SYSTEM (SPAN 3, BEAM 5)

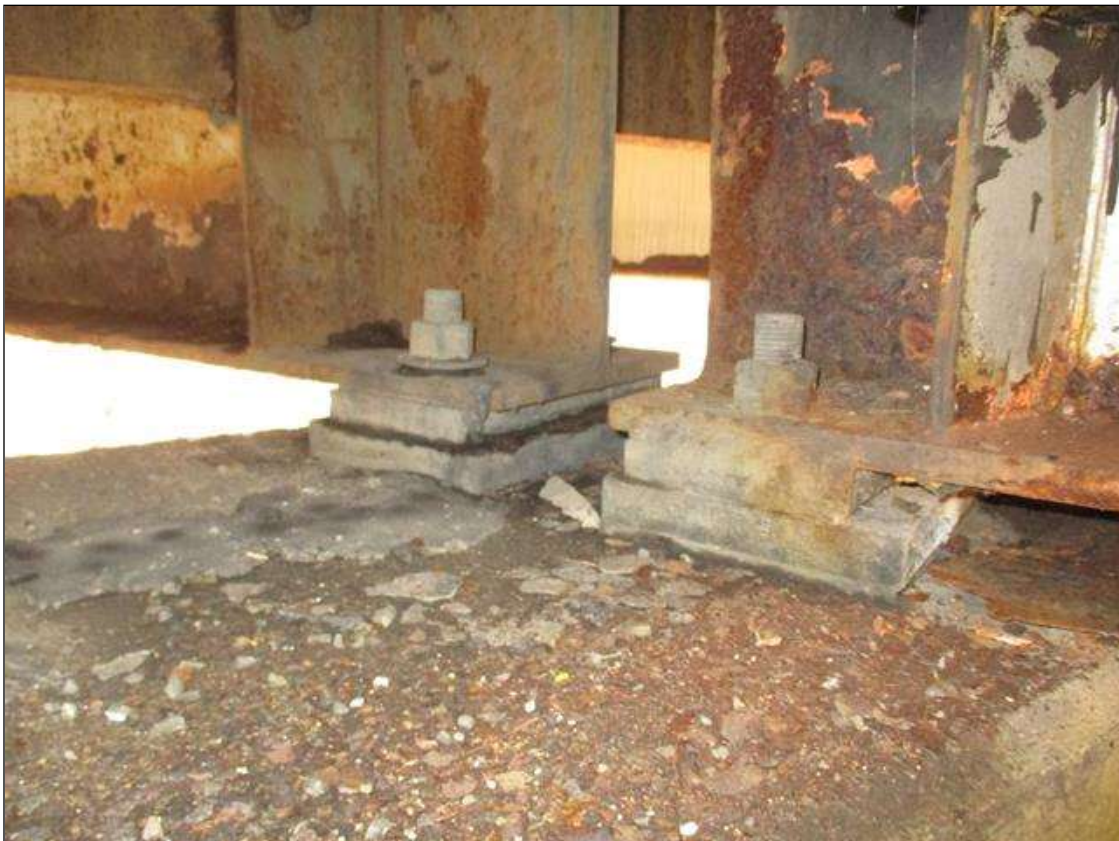
TYPICAL SURFACE CORROSION & DETERIORATED PAINT SYSTEM IN BEARINGS & BEAMS (SPAN 3, BEAMS 5 & 6)

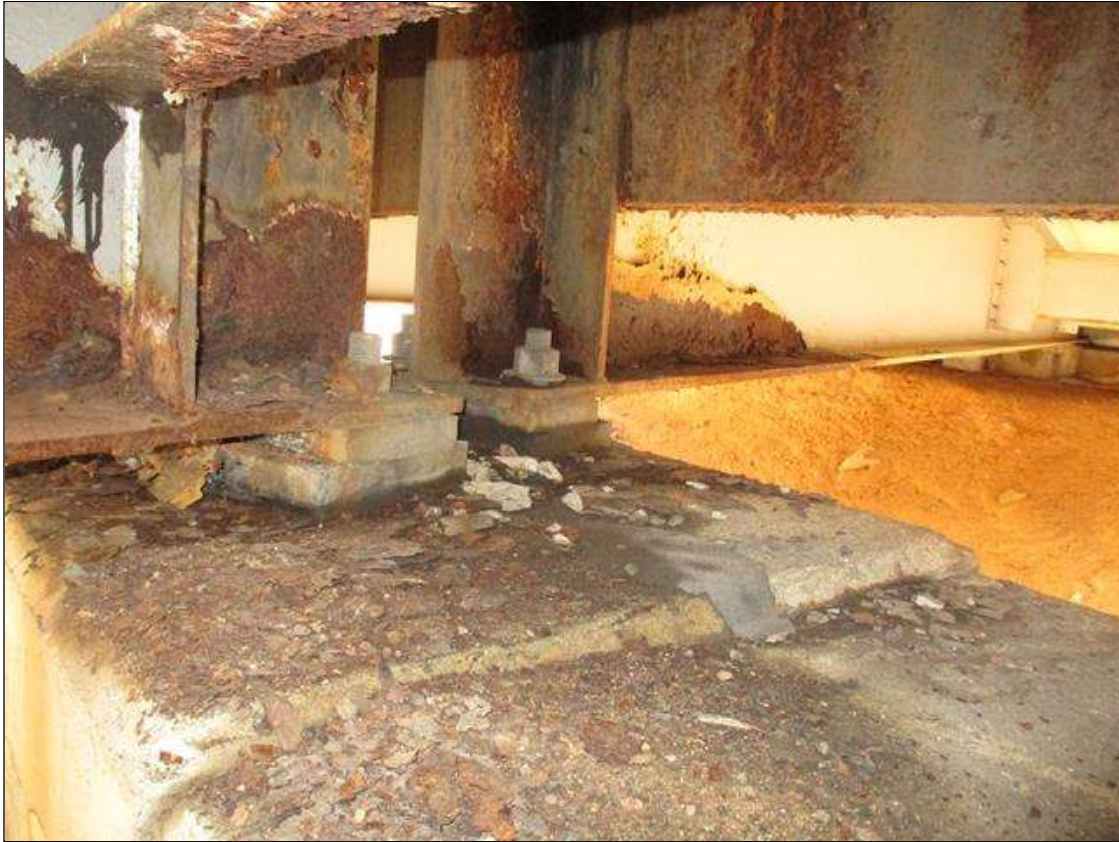
Span 3 Beam 5 - Far Bearing - Protective System: AREAS OF DETERIORATED PAINT SYSTEM THROUGHOUT BEAM 5 BEARING

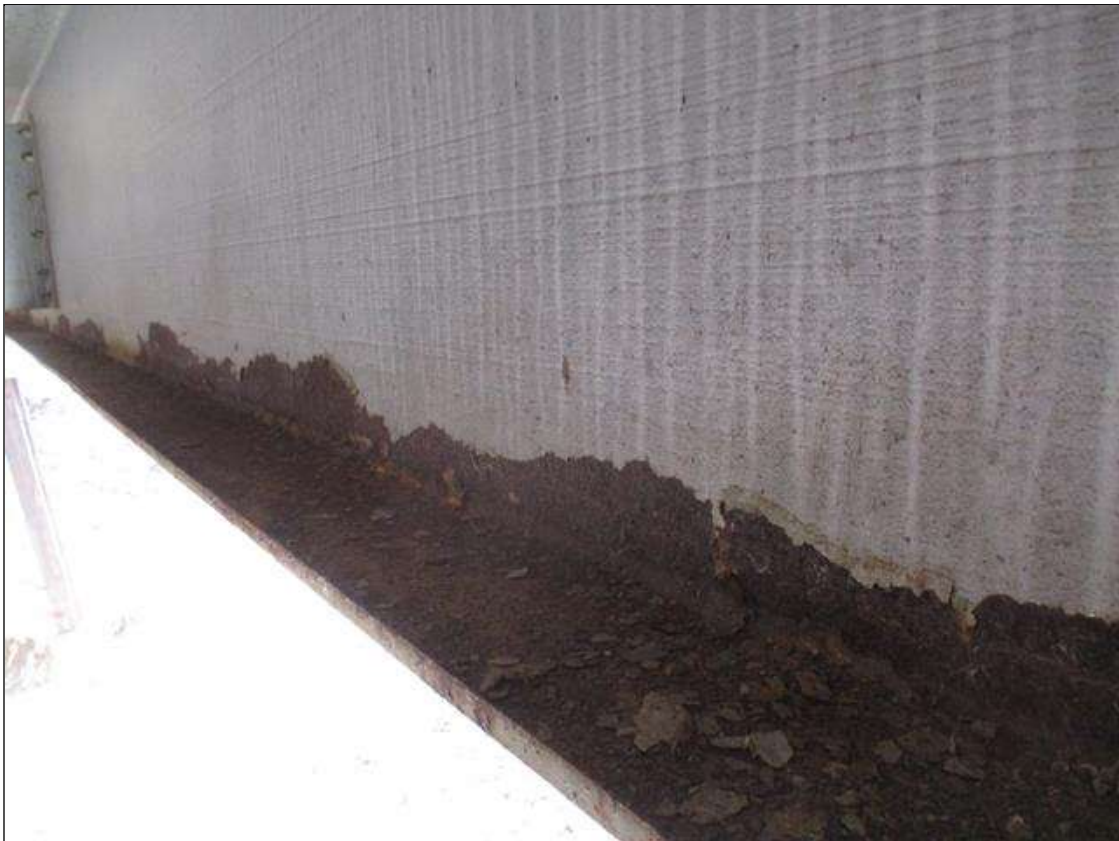
TYPICAL DETERIORATED PAINT SYSTEM (SPAN 3, BEAM 6)
