NC DEPARTMENT OF TRANSPORTATION  
 DIVISION OF HIGHWAYS  
 STRUCTURE MANAGEMENT UNIT

ATTENTION: PARS SUBMITTED

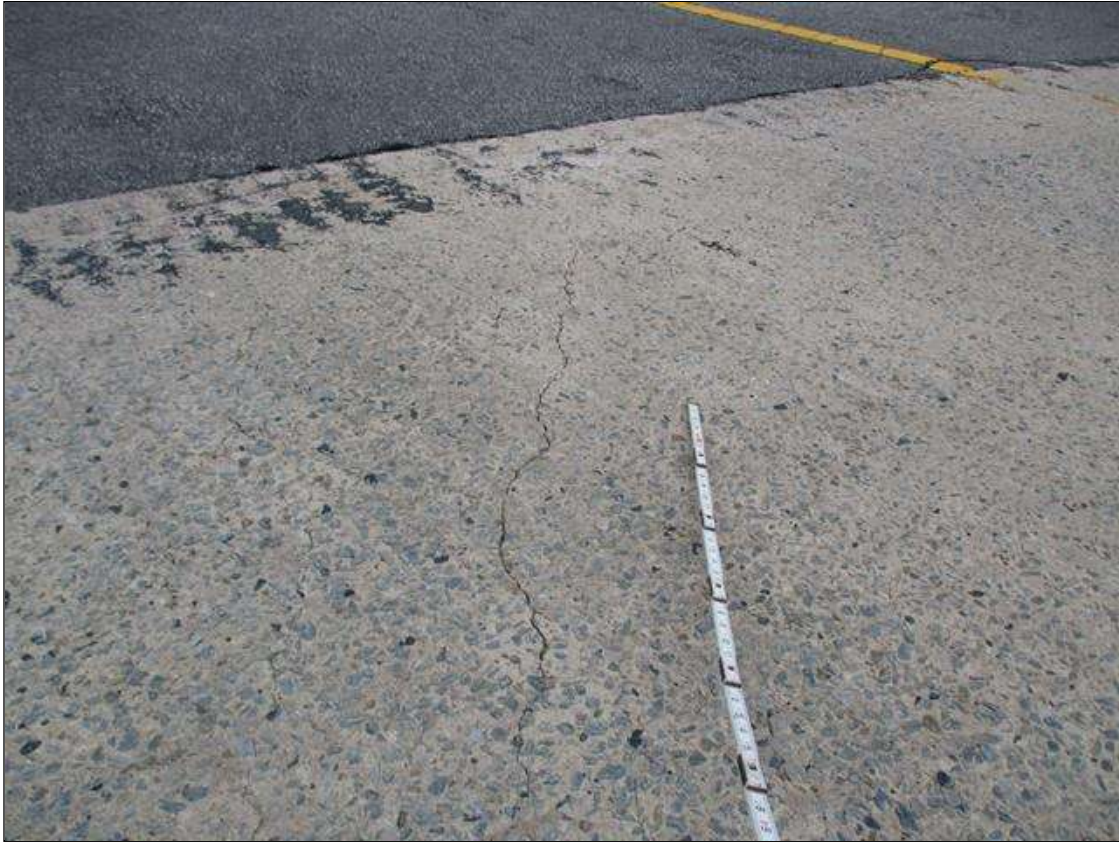
Span 4 Deck: 58" X UP TO 1/8" DIAGONAL CRACK IN TOP OF DECK IN WESTBOUND LANE NEAR END BENT 2 FILL FACE

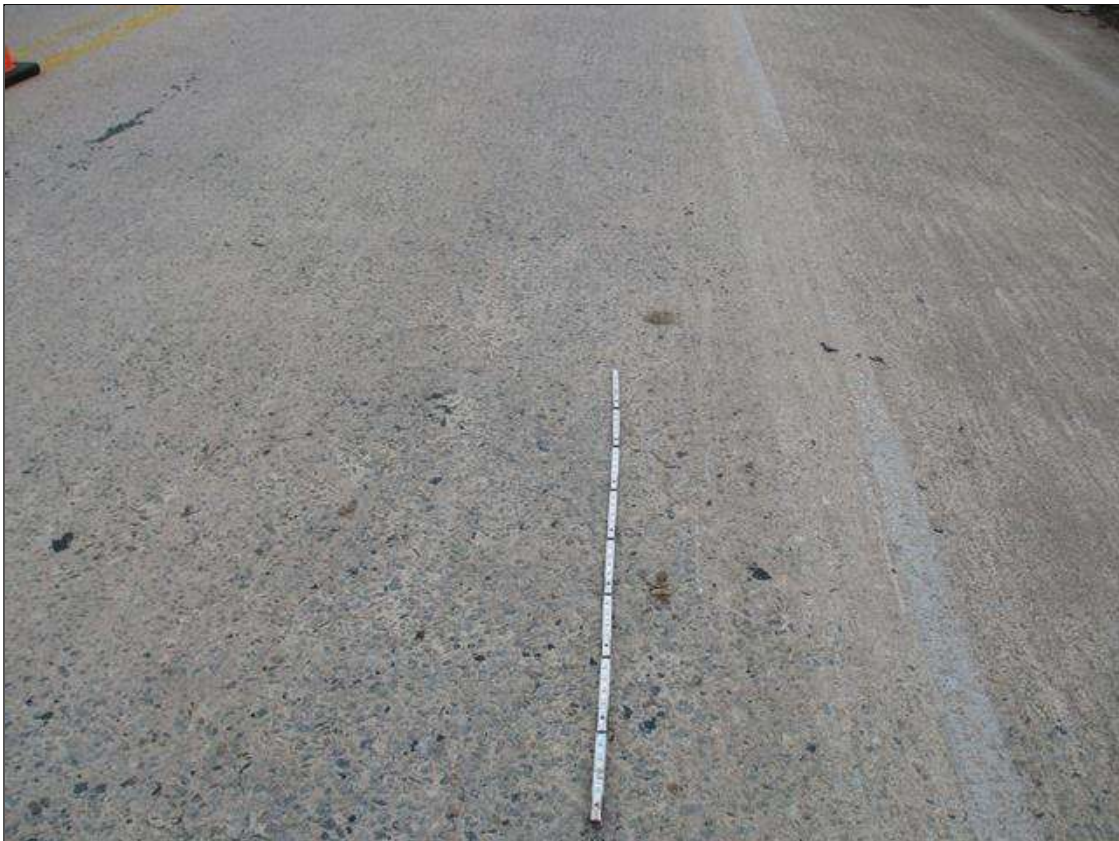
Span 4 Deck: SCALING WITH EXPOSED AGGREGATE IN TOP OF DECK THROUGHOUT TRAVEL LANES

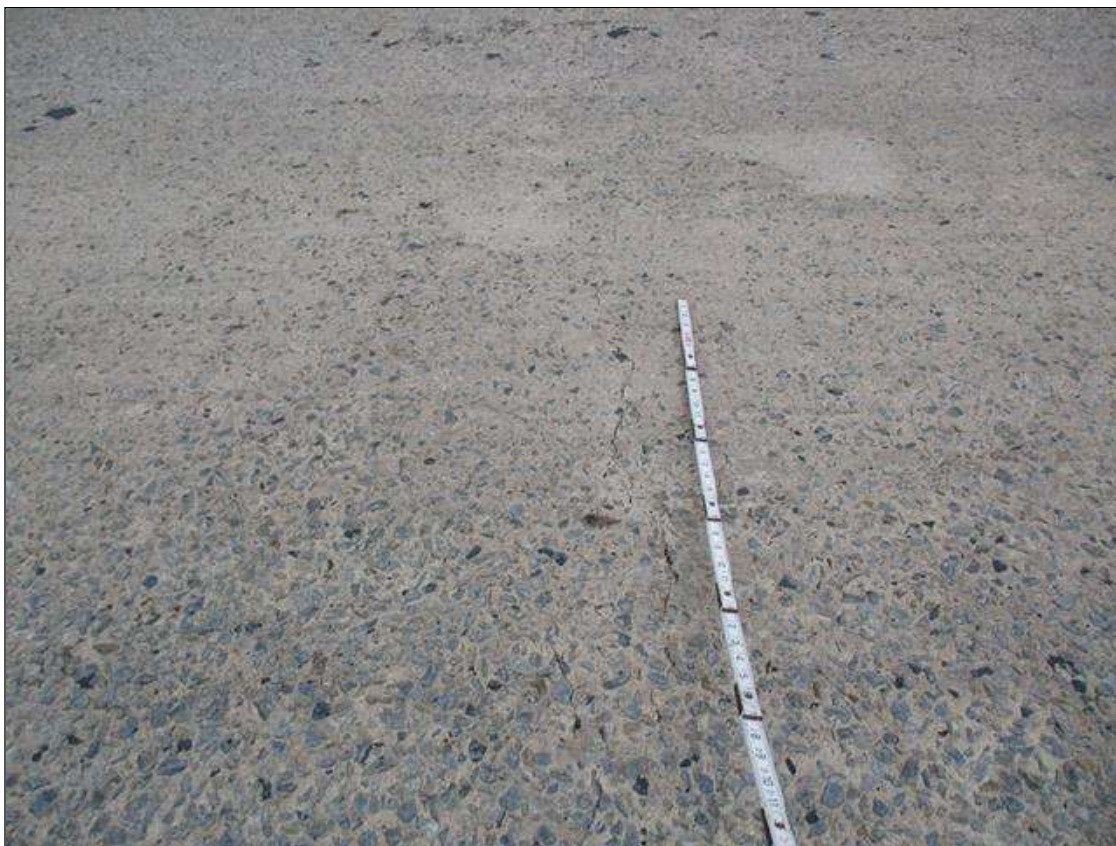
Span 4 Deck: UP TO 0.035" TRANSVERSE CRACKS IN TOP OF DECK IN TRAVEL LANES AT BENT 3 JOINT

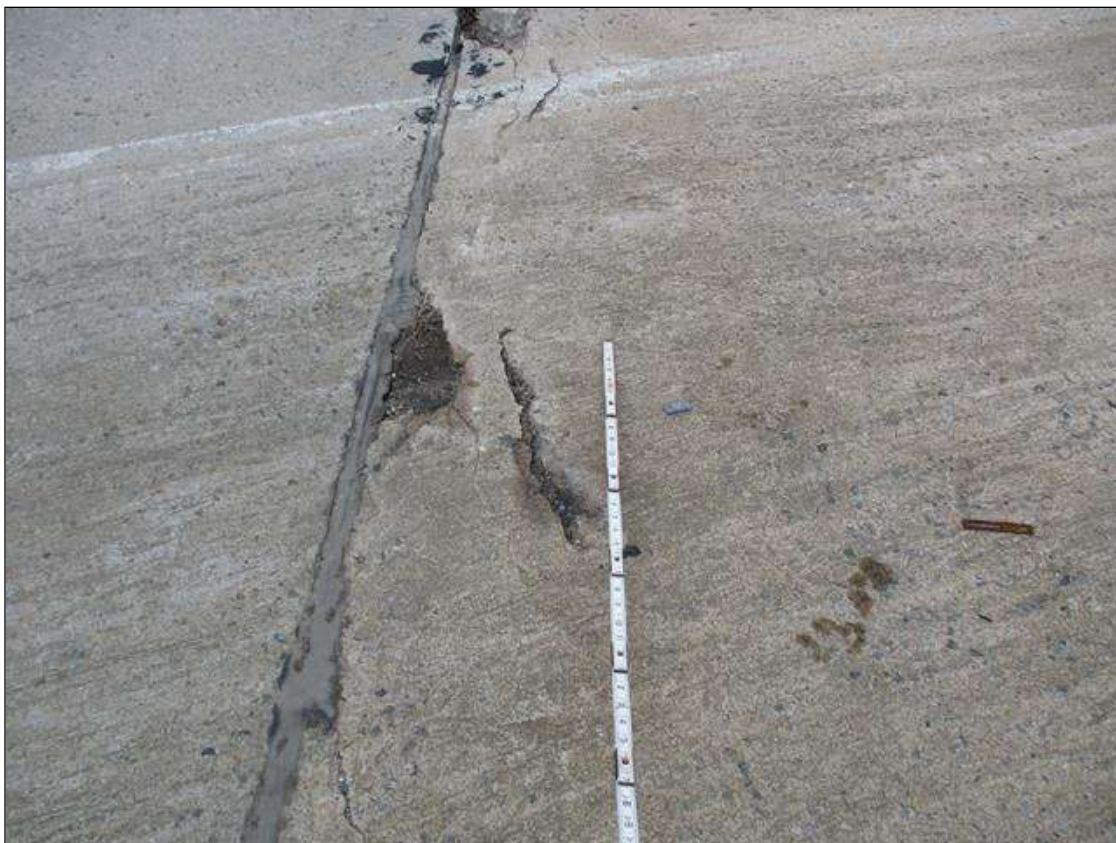
Span 4 Deck: 11" X 4" X 2" DEEP SPALL IN TOP OF DECK IN RIGHT SHOULDER AT BENT 3 JOINT

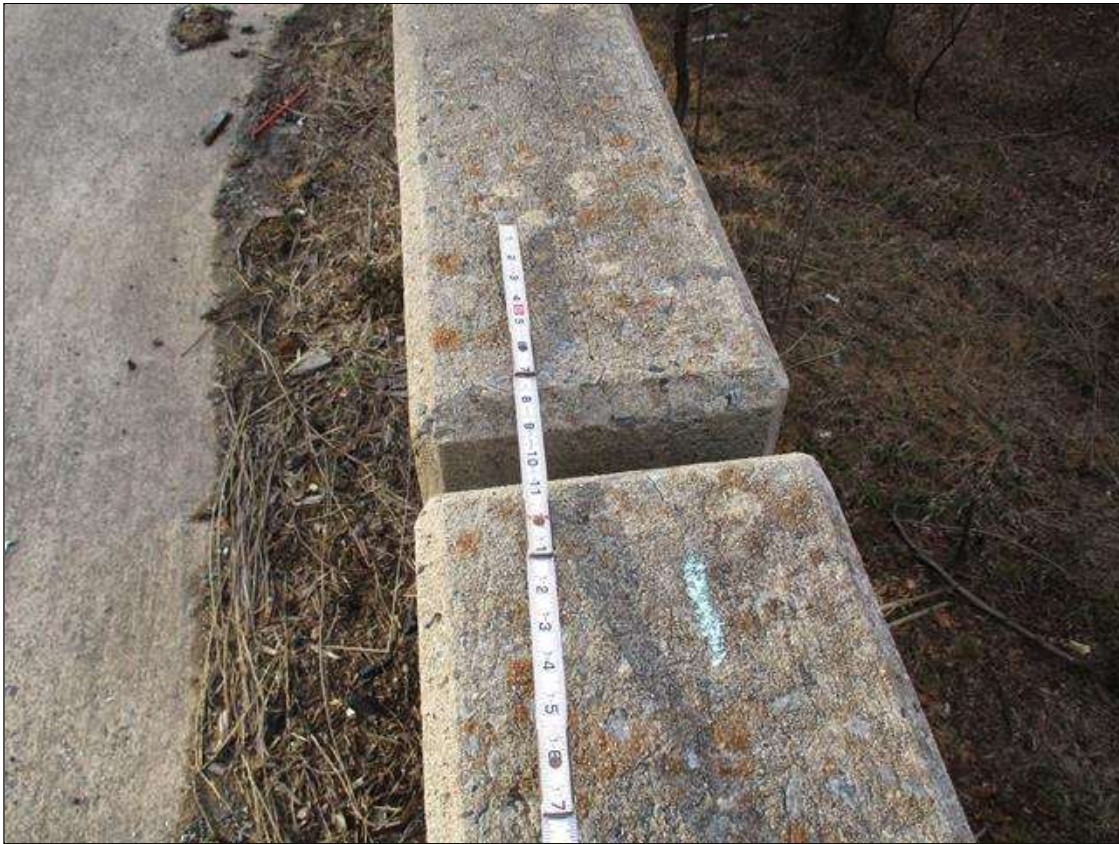
Span 4 Left Bridge Rail: UP TO 0.03" LONGITUDINAL AND VERTICAL CRACKS IN TOP AND ENDS OF RAIL IN VARIOUS LOCATIONS

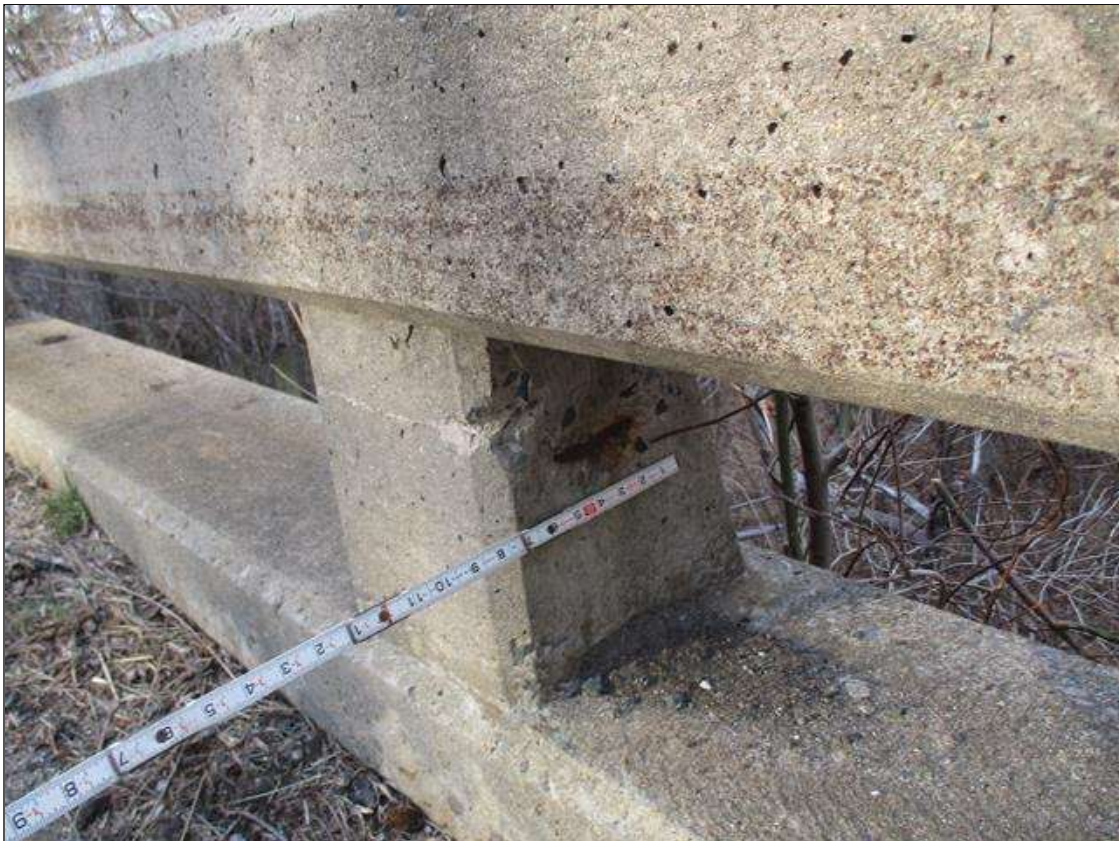
Span 4 Left Bridge Rail: 4 1/2" X 2 1/2" X 1/4" DEEP SPALL WITH EXPOSED REBAR IN EAST FACE OF RAIL POST NEAR MIDSPAN

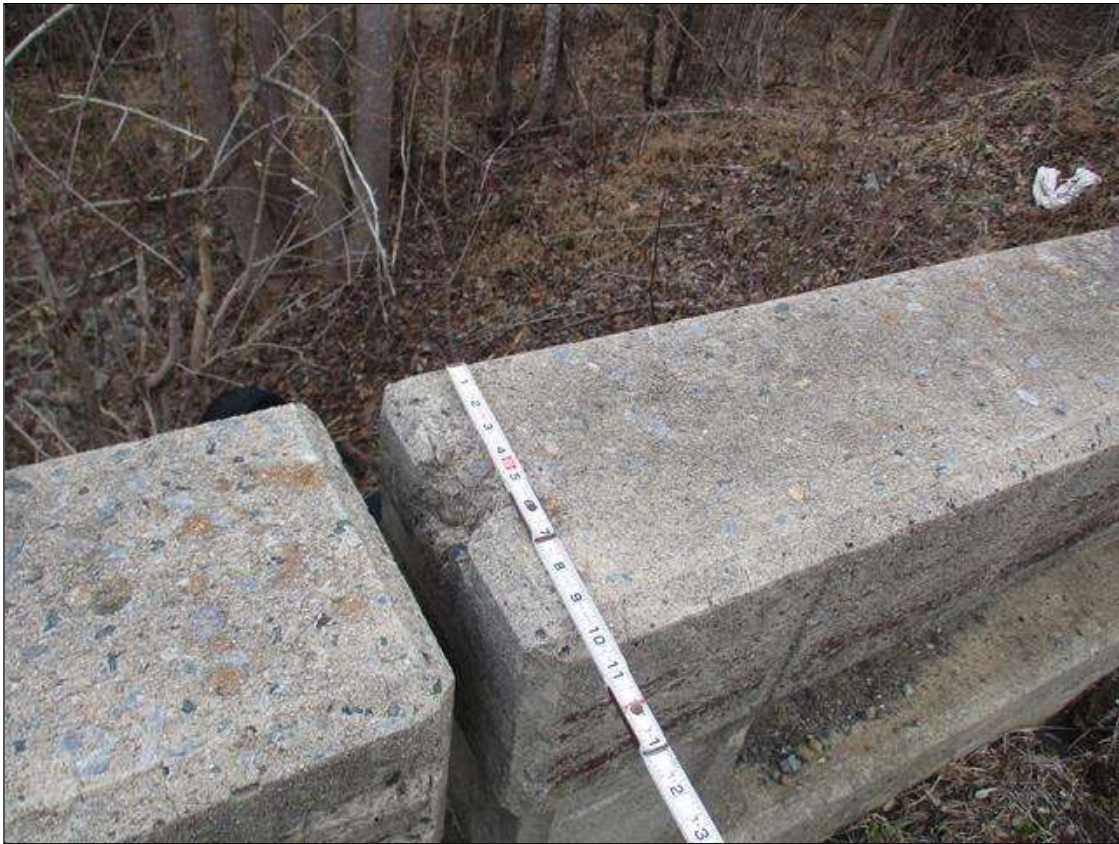
Span 4 Left Bridge Rail: 4" X 1 1/2" X 2" SPALL IN TOP AND WEST END OF RAIL, APPROXIMATELY 17' FROM END BENT 2 FILL FACE

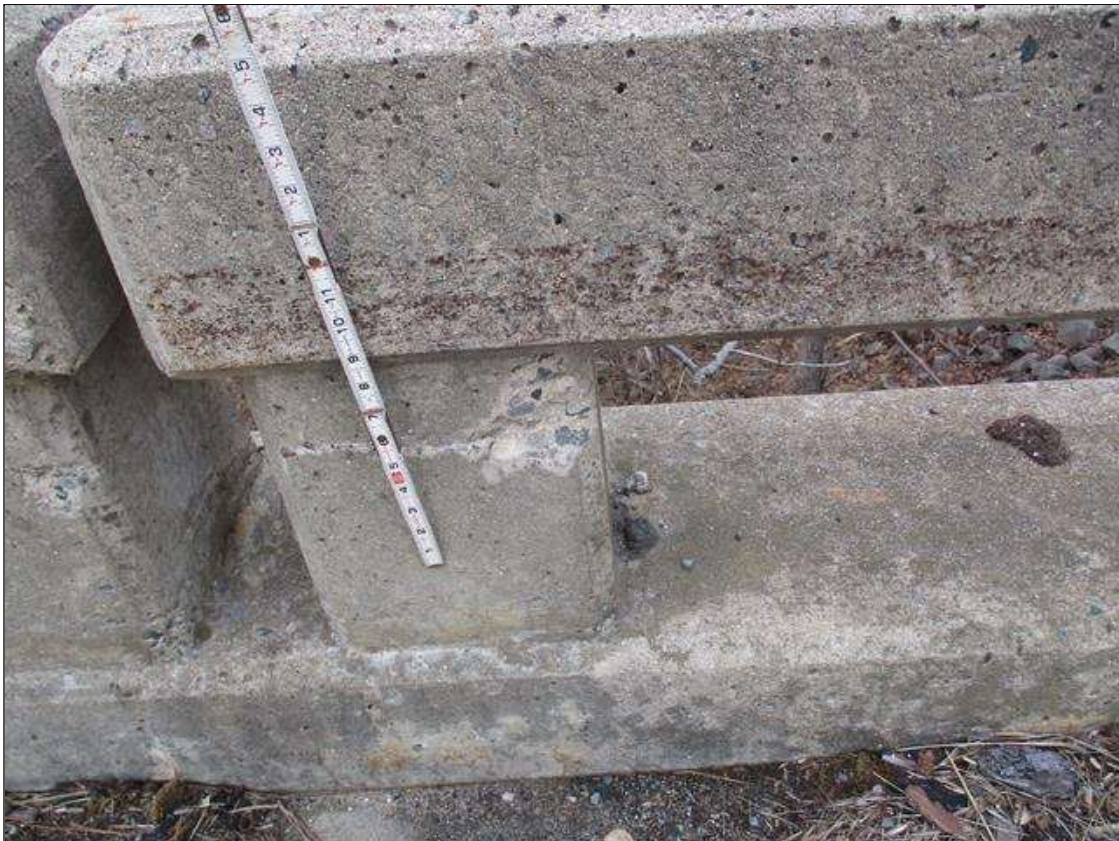
Span 4 Left Bridge Rail: FIVE (5) SPALLS UP TO 4" X 4" X 1/4" DEEP IN FACE OF RAIL POSTS IN VARIOUS LOCATIONS

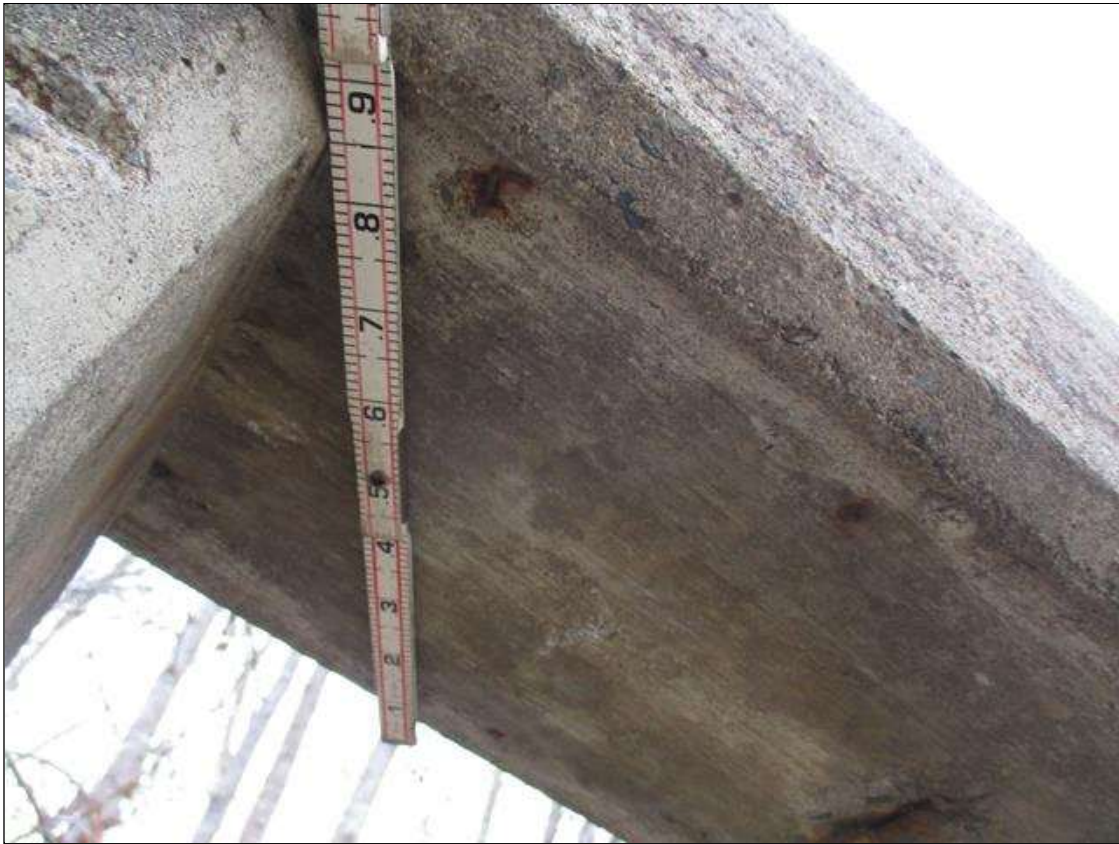
Span 4 Left Bridge Rail: FIVE (5) SPALLS WITH EXPOSED REBAR UP TO 5" X 4" X 1/2" DEEP IN BOTTOM OF RAIL IN VARIOUS LOCATIONS

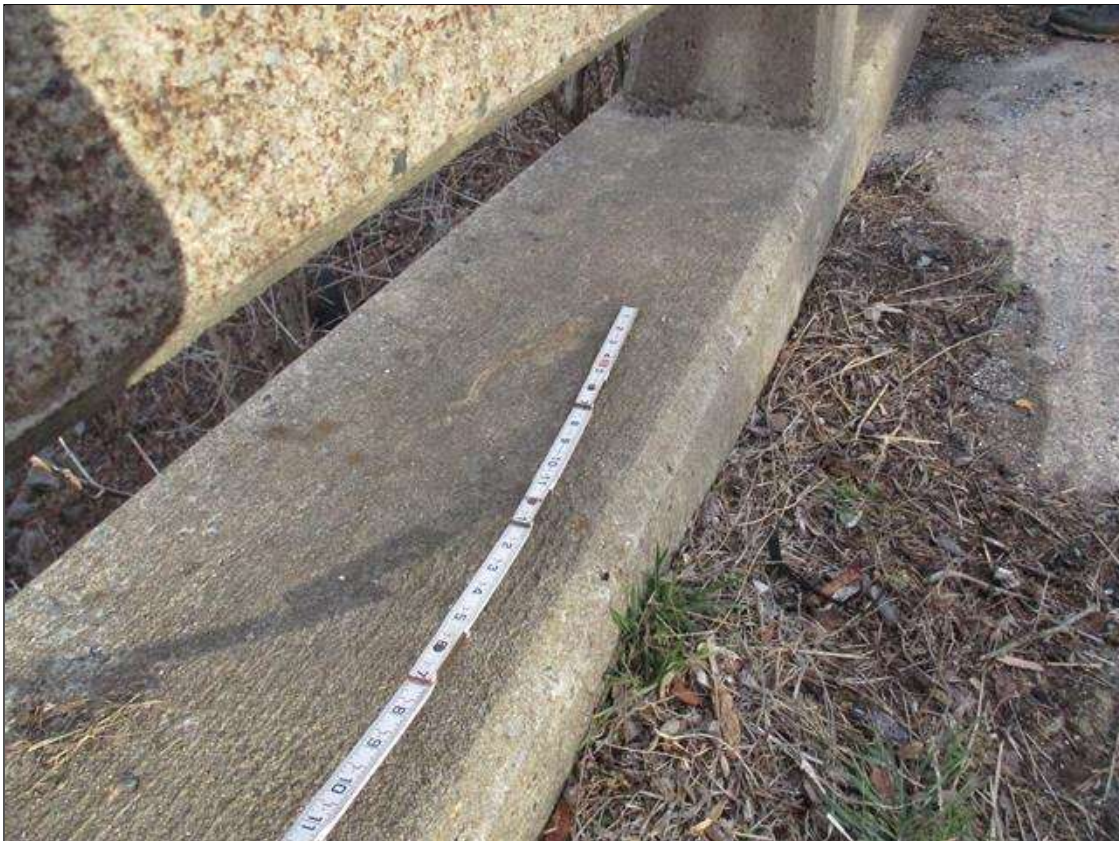
Span 4 Left Bridge Rail: ON TOP OF CURB THROUGHOUT, LESS THAN 0.01" WIDE CRACKING WITH EFFLORESCENCE

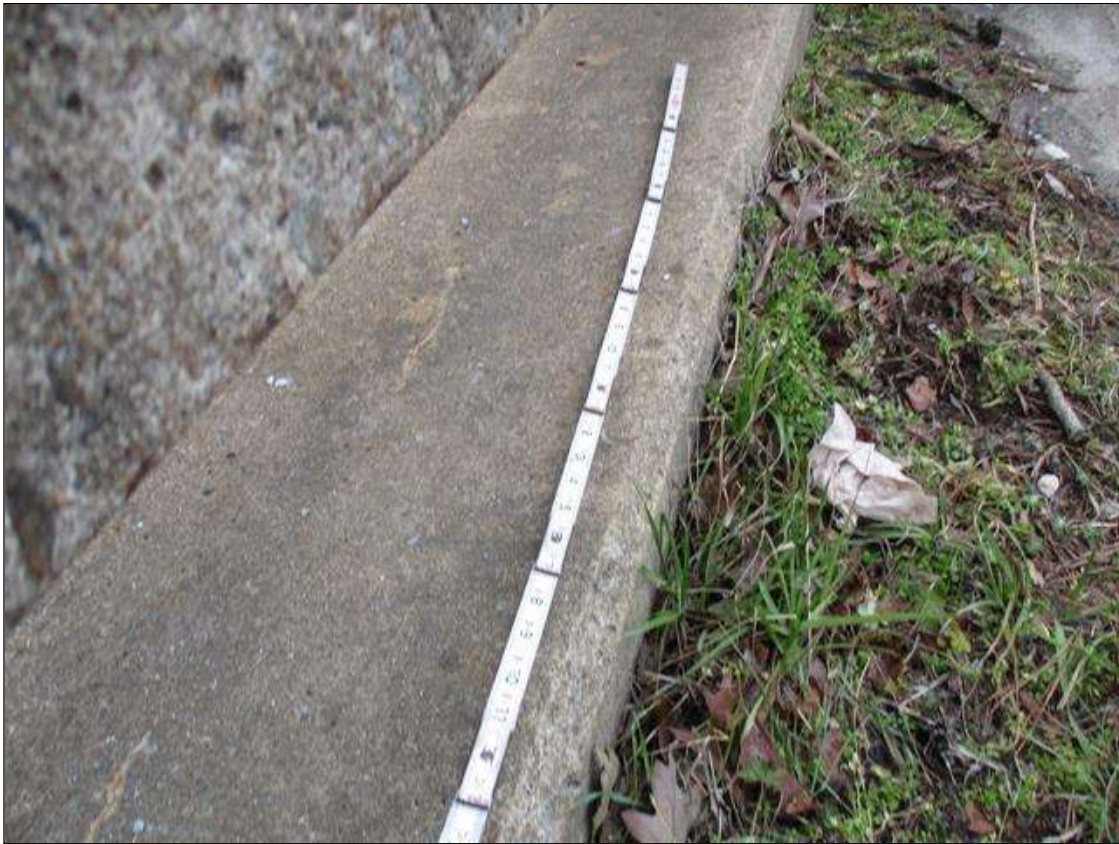
Span 4 Right Bridge Rail: ON TOP OF CURB THROUGHOUT, LESS THAN 0.01" WIDE CRACKING WITH EFFLORESCENCE

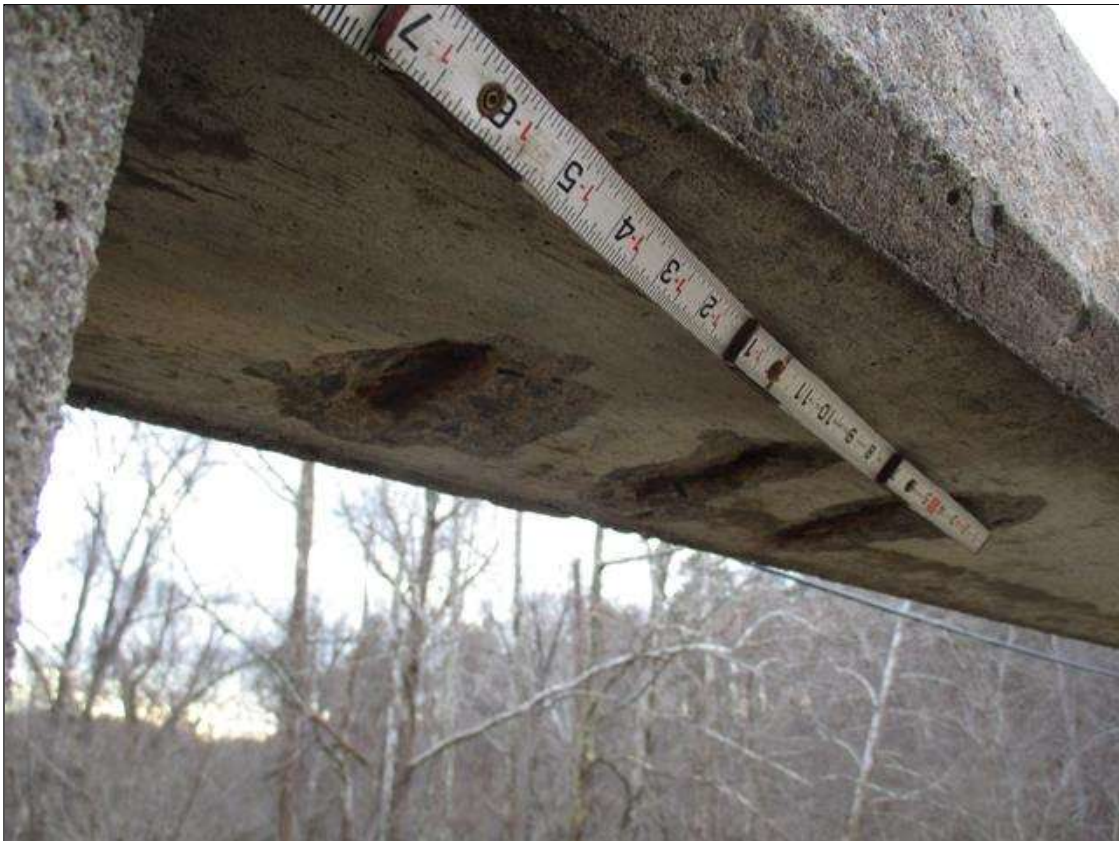
Span 4 Right Bridge Rail: THREE (3) SPALLS WITH EXPOSED REBAR UP TO 5" X 3 1/2" X 1/2" DEEP IN BOTTOM OF RAIL, APPROXIMATELY 14' FROM BENT 3 JOINT

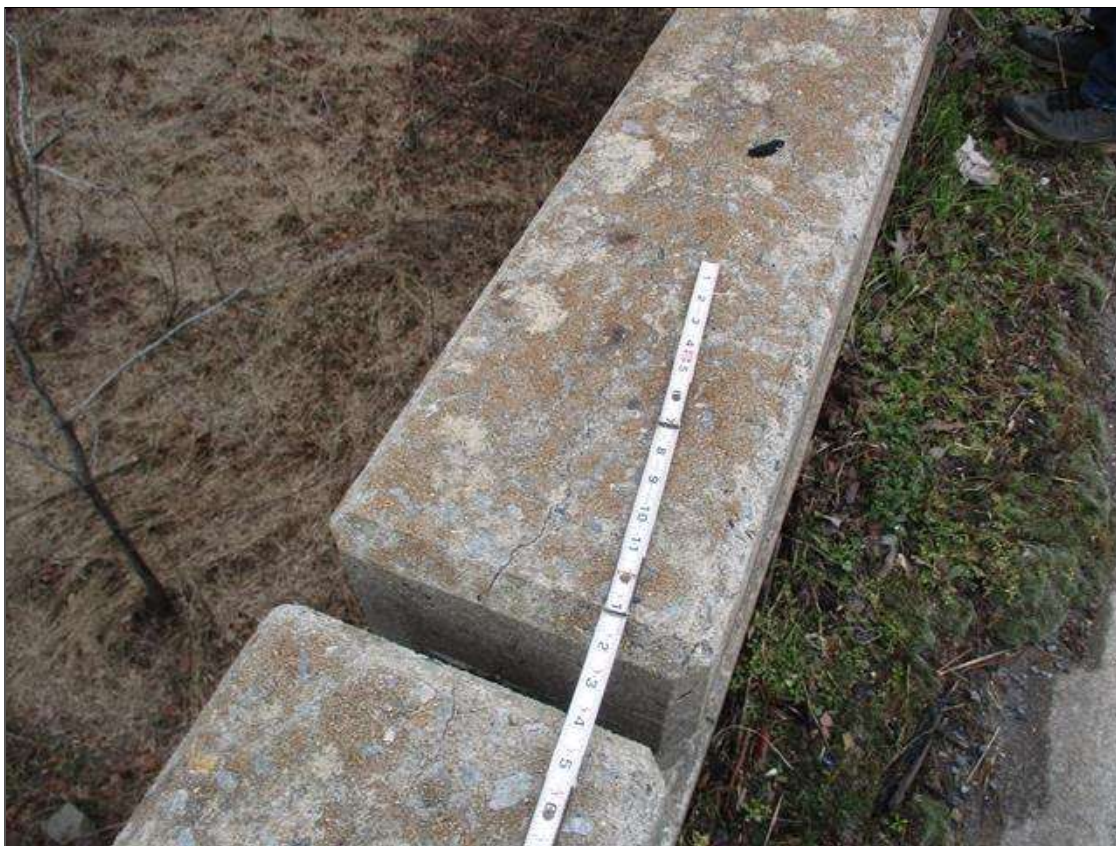
Span 4 Right Bridge Rail: UP TO 0.05" LONGITUDINAL AND VERTICAL CRACKS IN TOP AND ENDS OF RAIL IN VARIOUS LOCATIONS

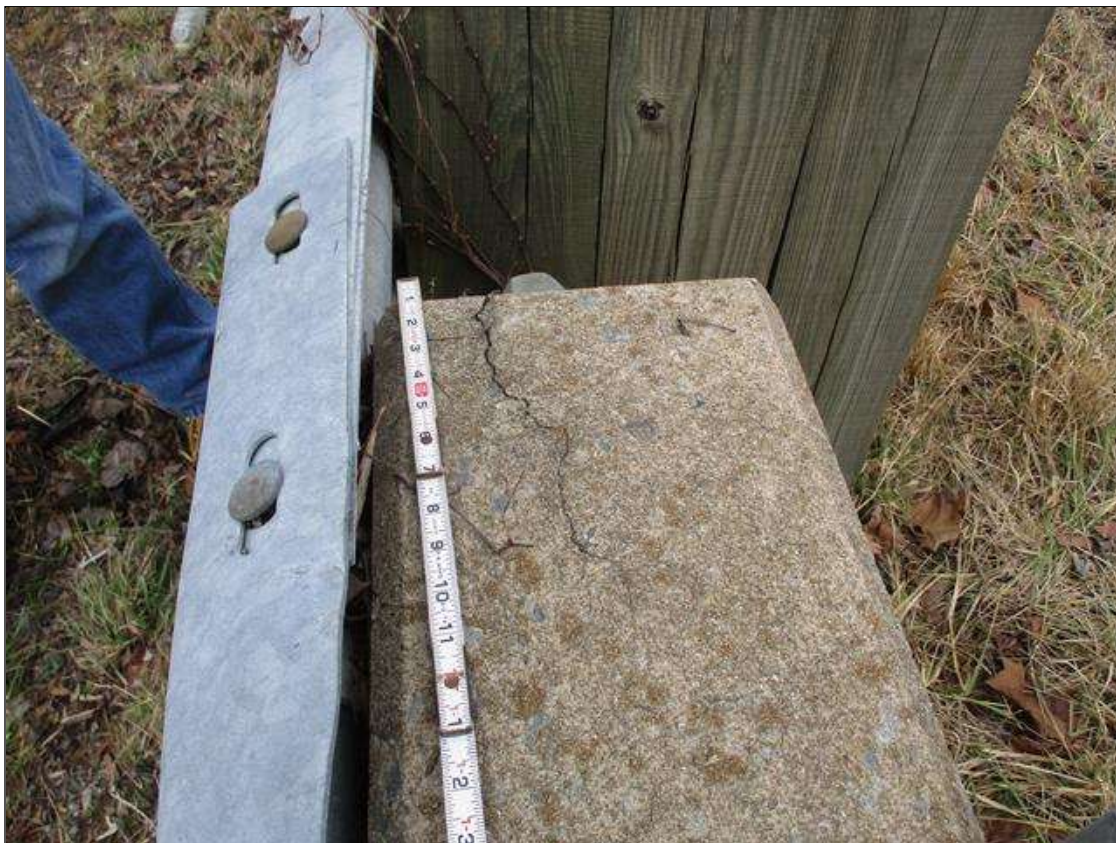
Span 4 Right Bridge Rail: AT END BENT 2 END RAIL, 1' LONG X UP TO 0.0625" WIDE ALONG TOP OF RAIL

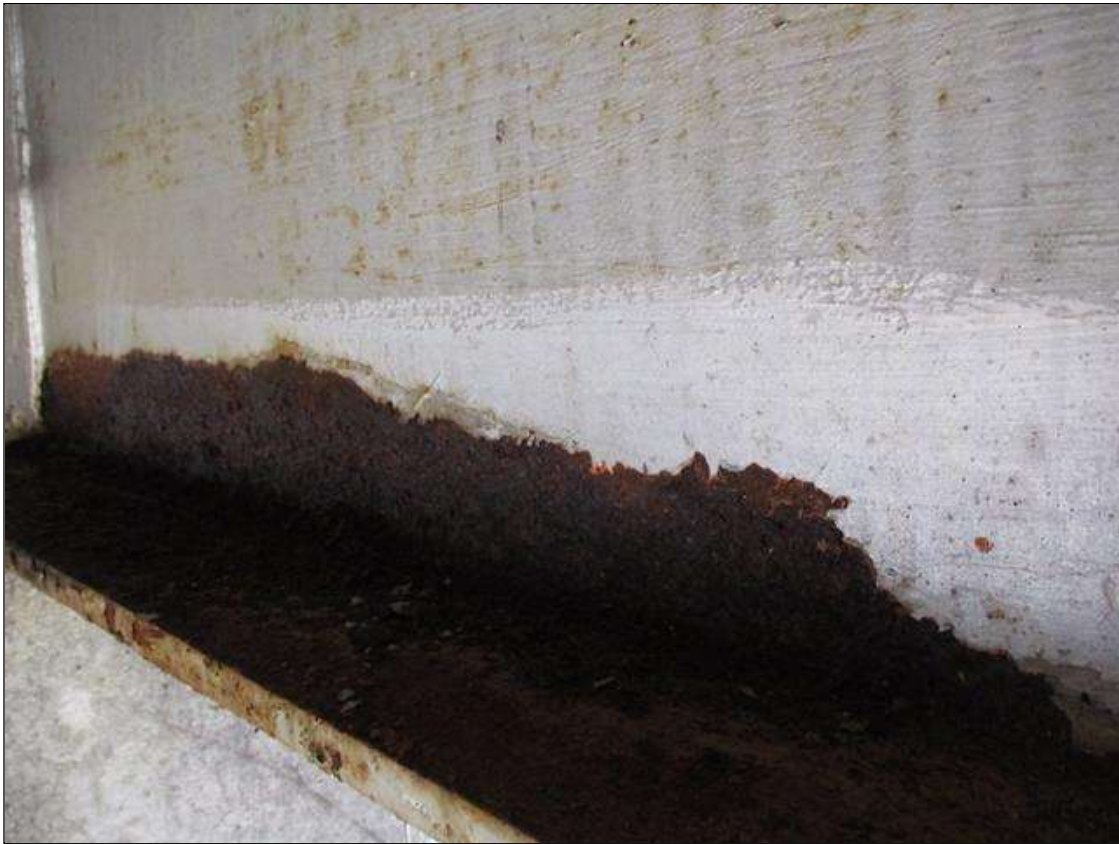
TYPICAL SURFACE CORROSION & DETERIORATED PAINT SYSTEM (SPAN 4, BEAM 1)

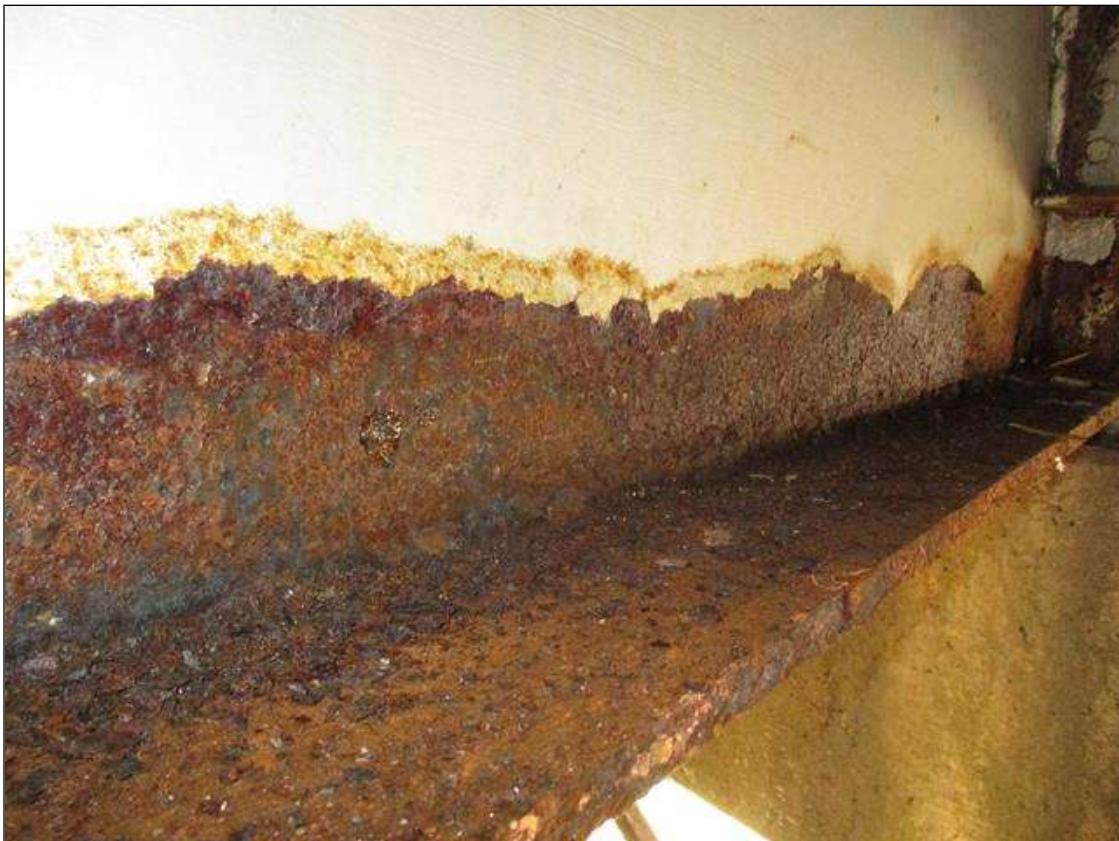
TYPICAL SURFACE CORROSION & DETERIORATED PAINT SYSTEM (SPAN 4, BEAM 2)

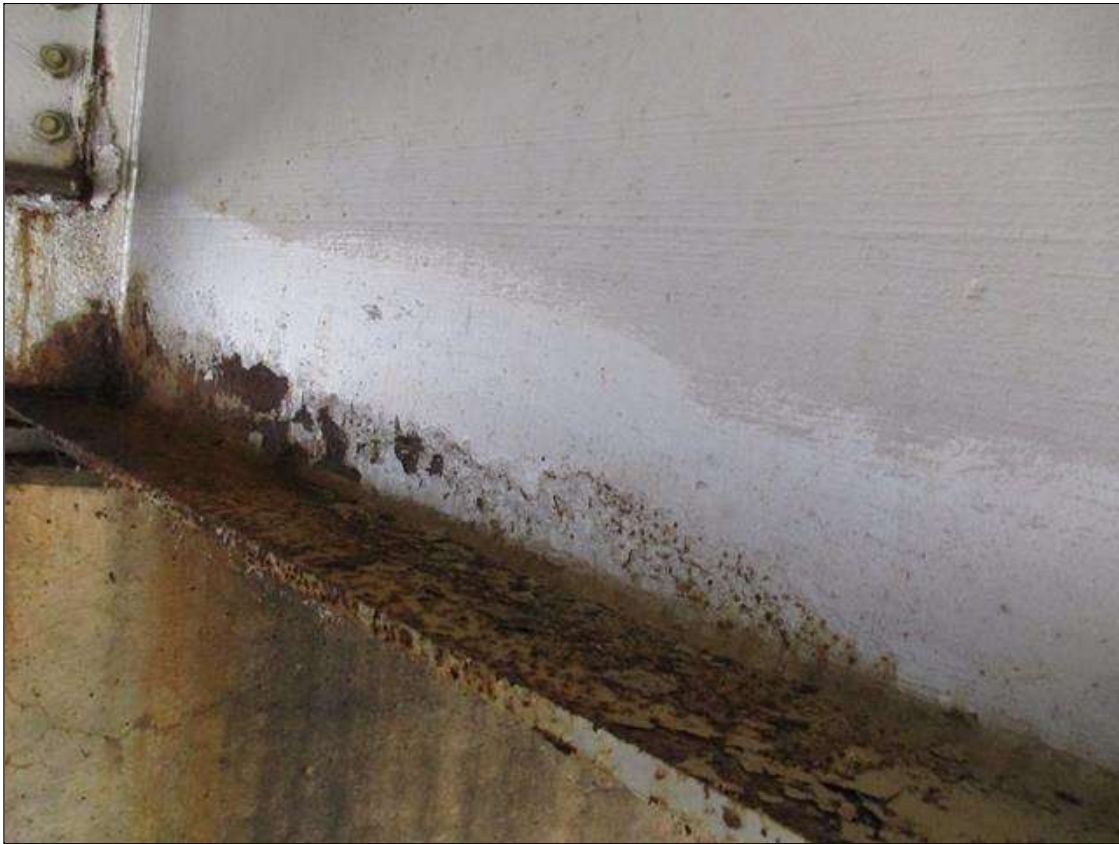
TYPICAL SURFACE CORROSION & DETERIORATED PAINT SYSTEM (SPAN 4, BEAM 3)

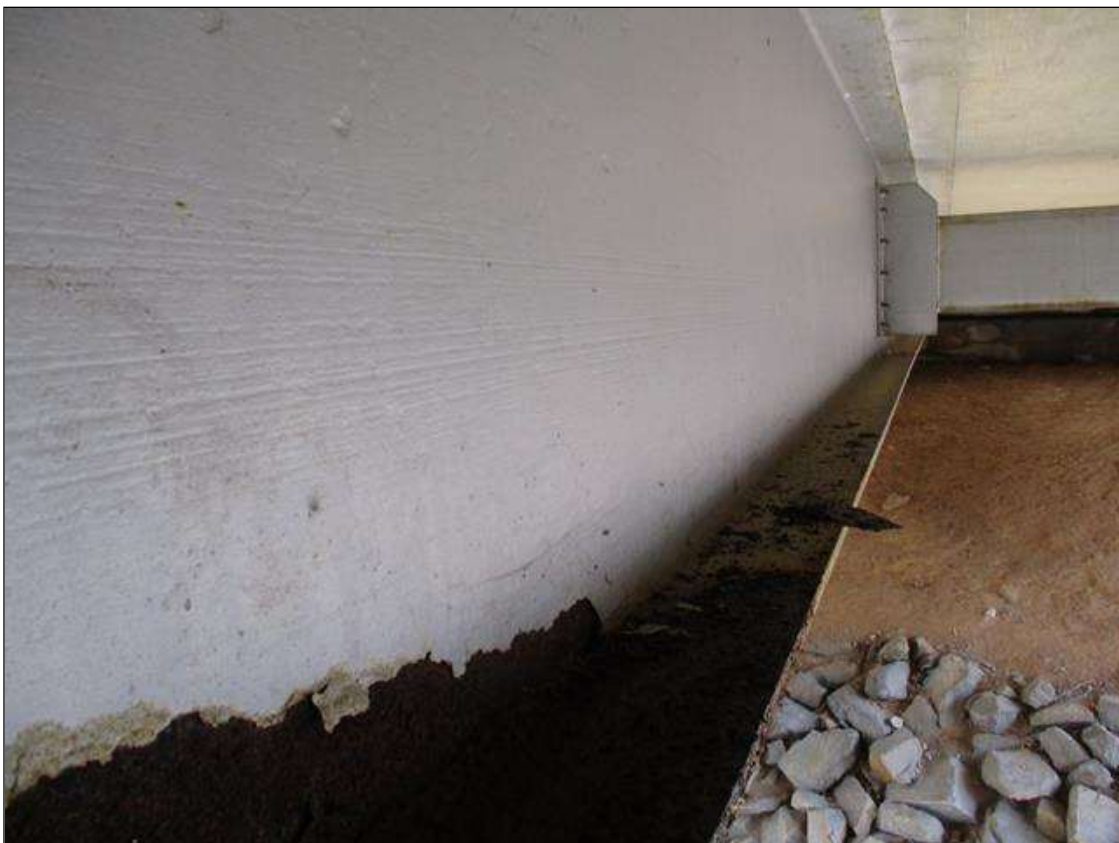
TYPICAL DETERIORATED PAINT SYSTEM (SPAN 4, BEAM 4)

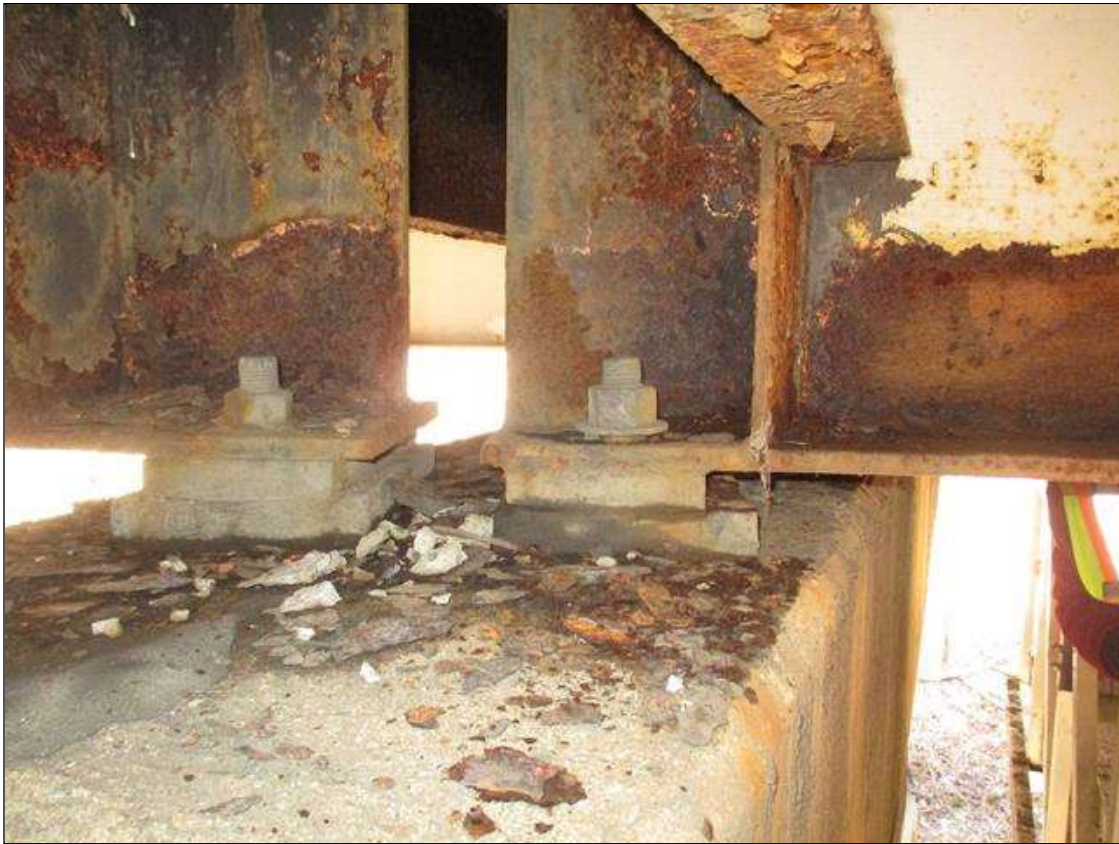
Span 4 Beam 4 - Near Bearing - Protective System: AREAS OF DETERIORATED PAINT SYSTEM THROUGHOUT BEAM 4 BEARING

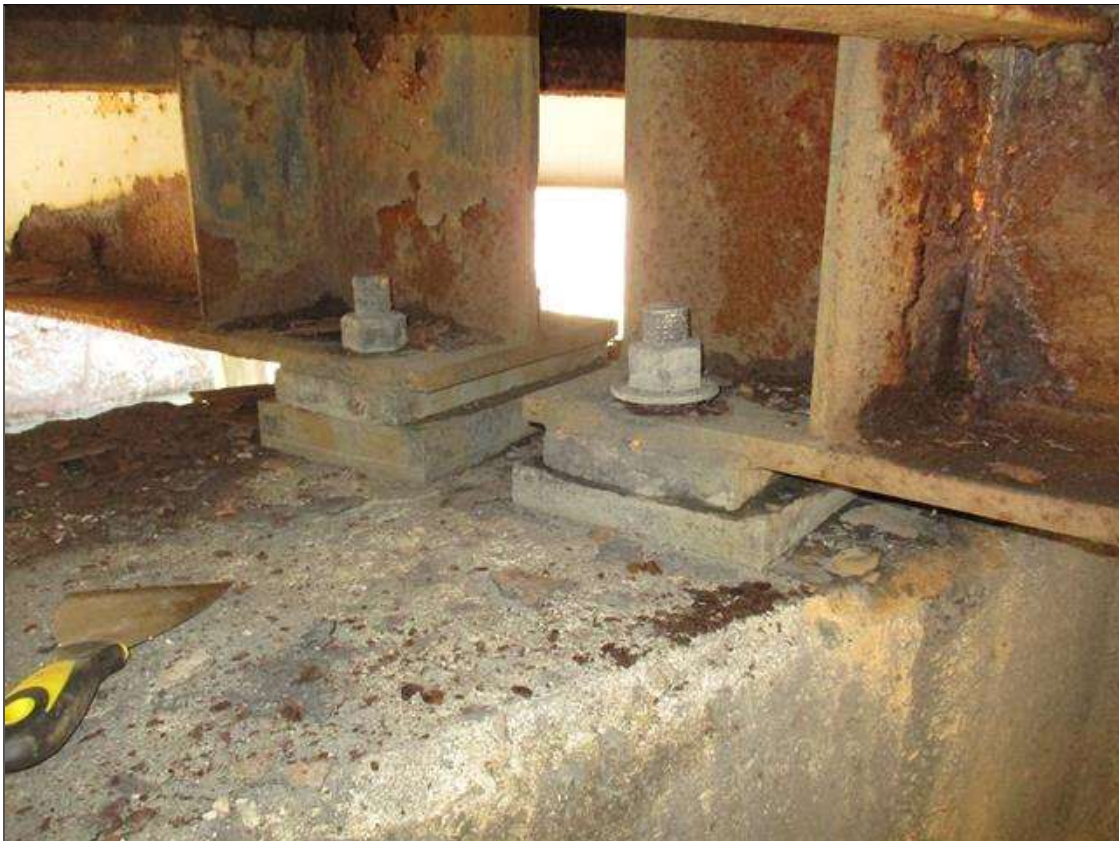
Span 4 Beam 4 - Far Bearing - Protective System: DETERIORATED PAINT SYSTEM THROUGHOUT BEAM 4 BEARING

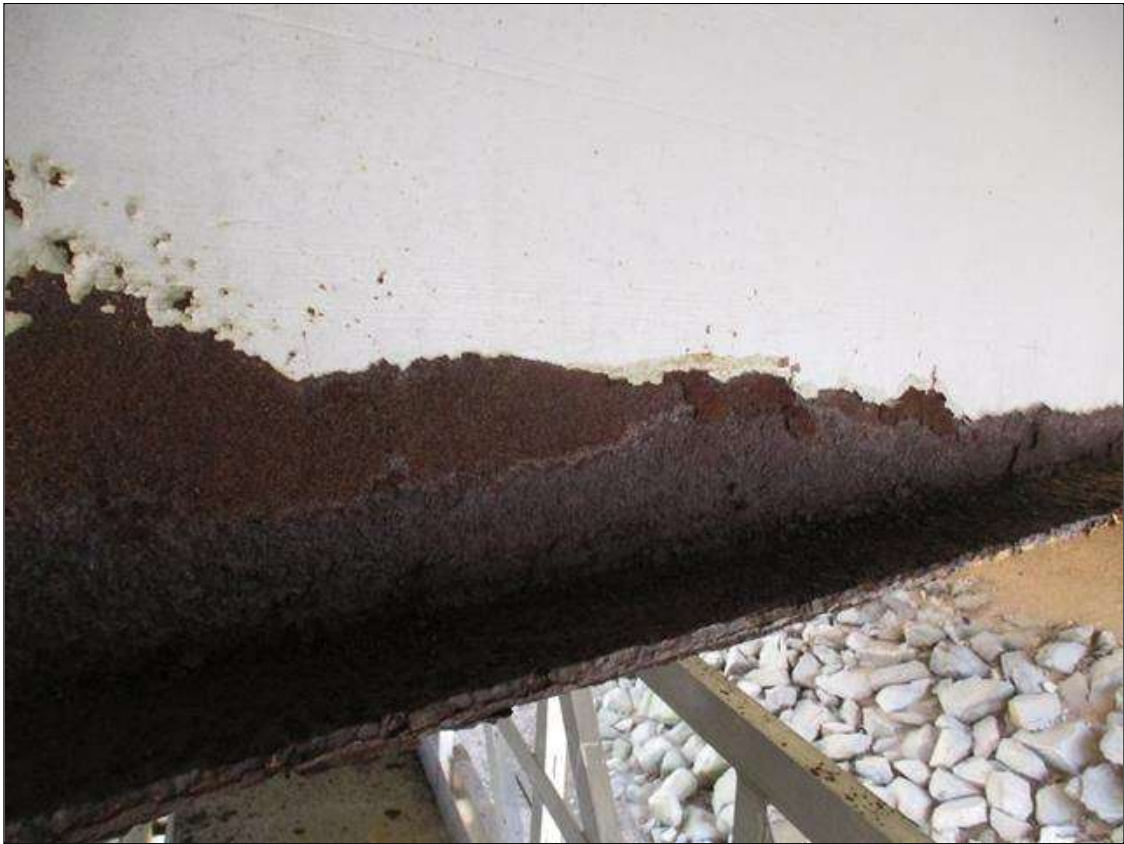
TYPICAL SURFACE CORROSION & DETERIORATED PAINT SYSTEM (SPAN 4, BEAM 5)

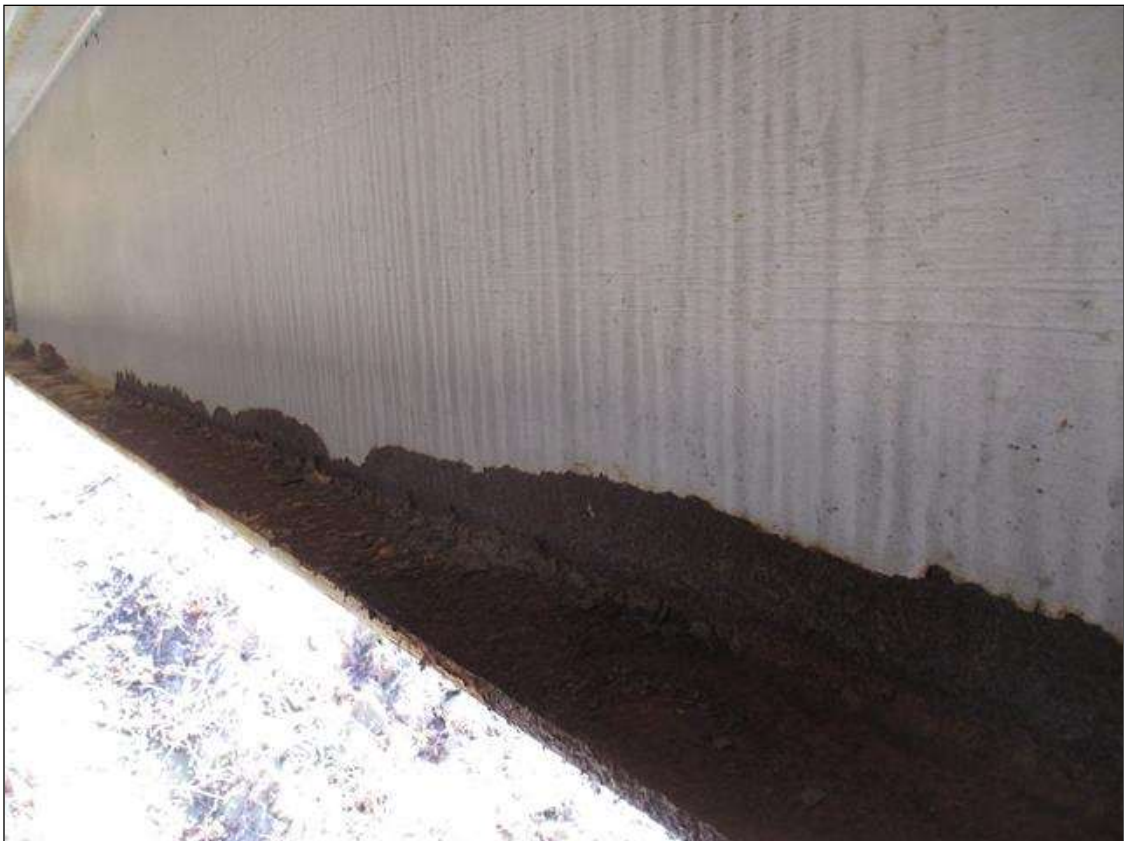
TYPICAL SURFACE CORROSION & DETERIORATED PAINT SYSTEM (SPAN 4, BEAM 6)

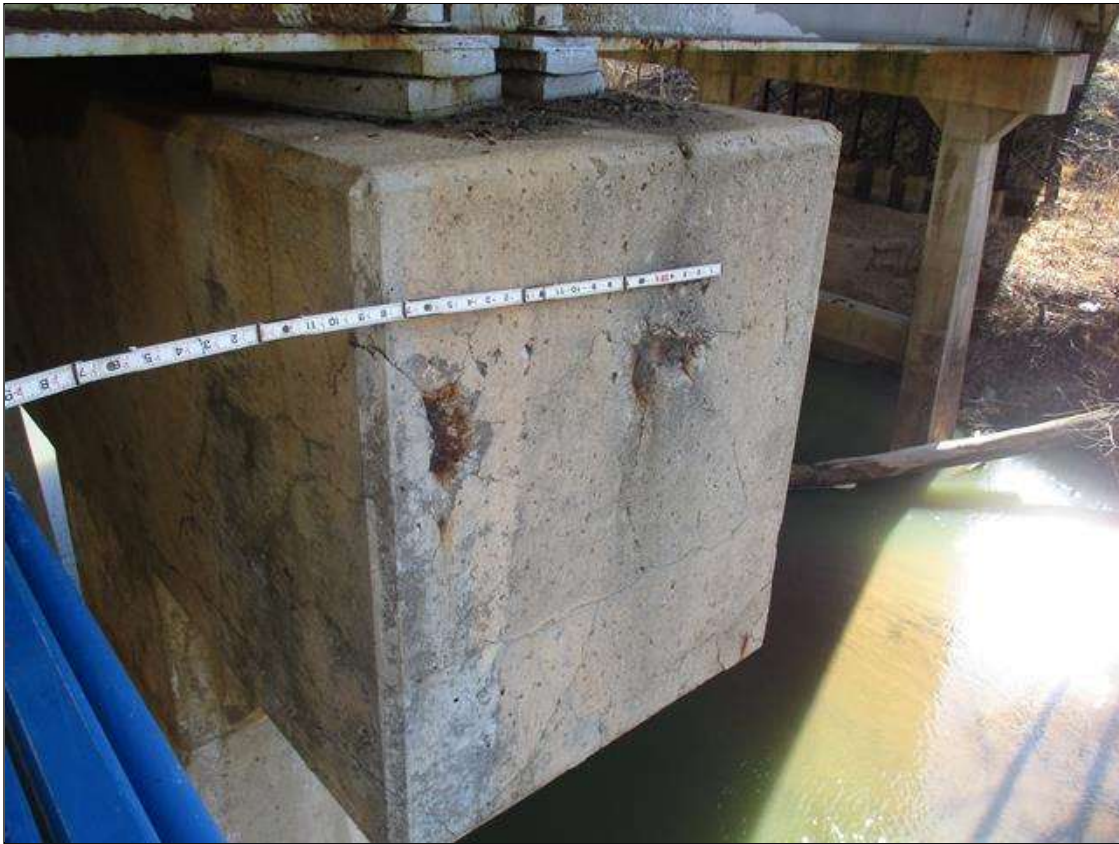
TYPICAL LONGITUDINAL, HORIZONTAL, MAP CRACKING & EXPOSED REBAR (BENT 1, CAP 1)

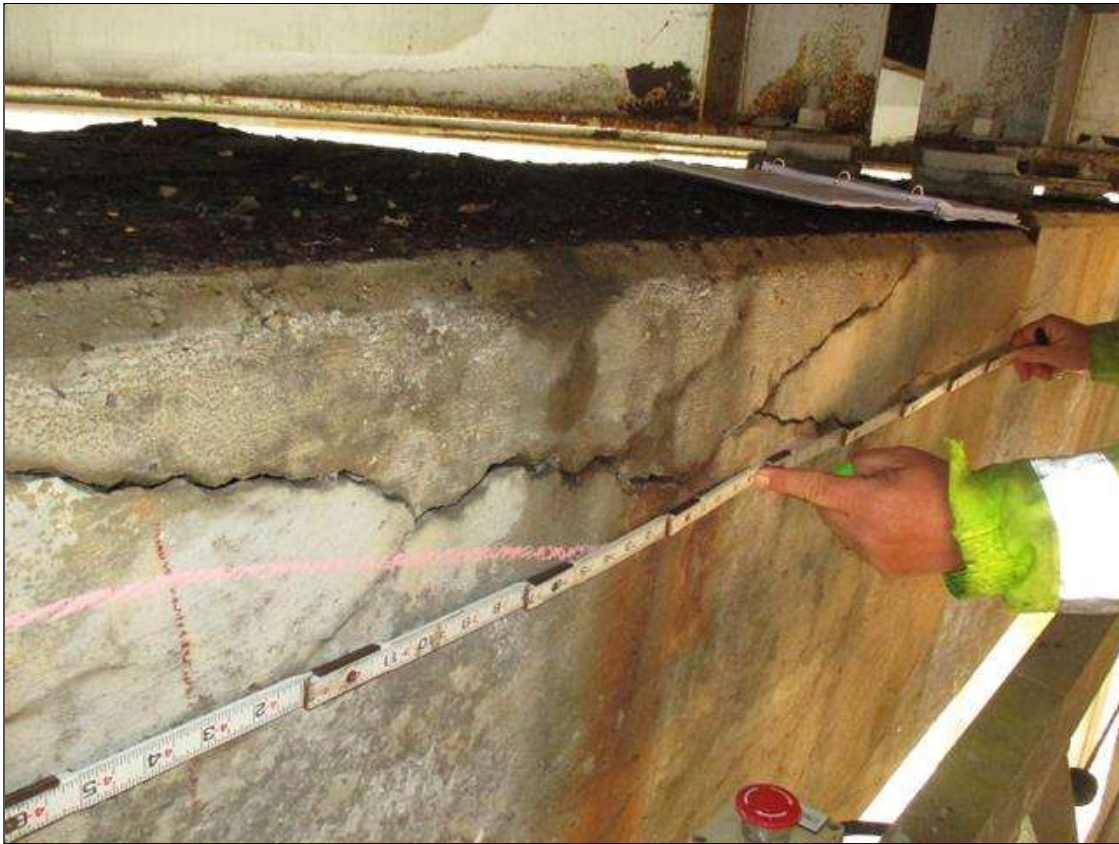
Bent 1 Cap 1: BOTH FACES, UP TO 1/4" LONGITUDINAL AND HORIZONTAL CRACKS AND HAIRLINE MAP CRACKS WITH AND WITHOUT EFFLORESCENCE AND RUST STAINING WITH UP TO 8' X 31" AREAS OF DELAMINATION THROUGHOUT CAP BENEATH BAYS 2 THRU 4
