NC DEPARTMENT OF TRANSPORTATION  
 DIVISION OF HIGHWAYS  
 STRUCTURE MANAGEMENT UNIT

ATTENTION: PARS SUBMITTED

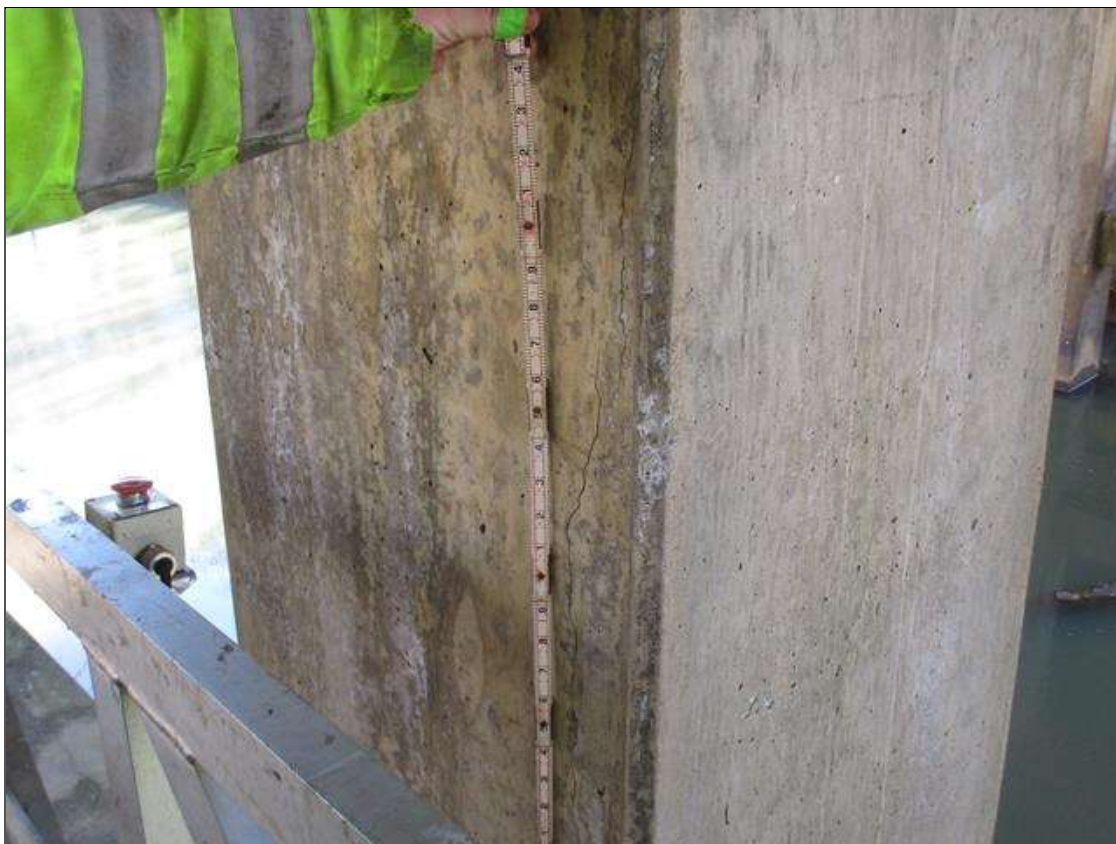
Bent 1 Pile 1: UP TO 14' X 1/8" VERTICAL CRACKS THROUGHOUT COLUMN AT WATER SURFACE & UP TO CAP

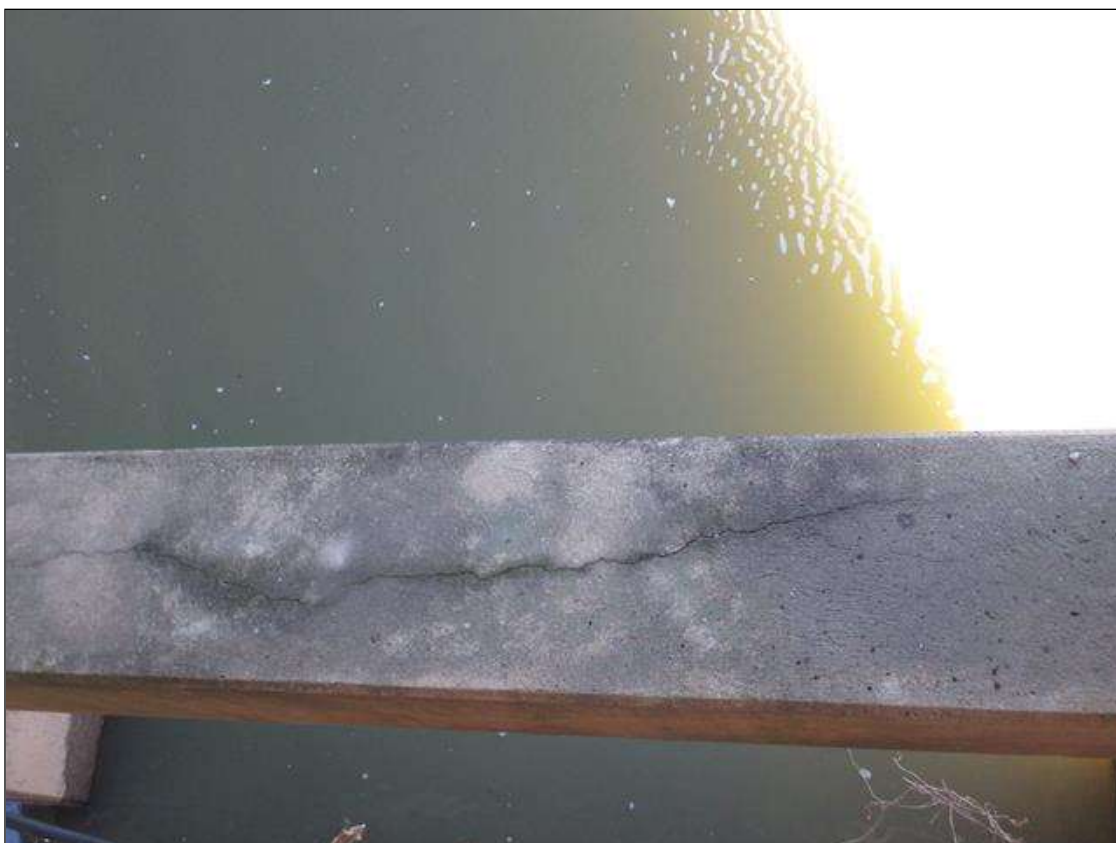
CRACKING IN TOP OF PILE BETWEEN 2 & 3 UP TO 1/4"

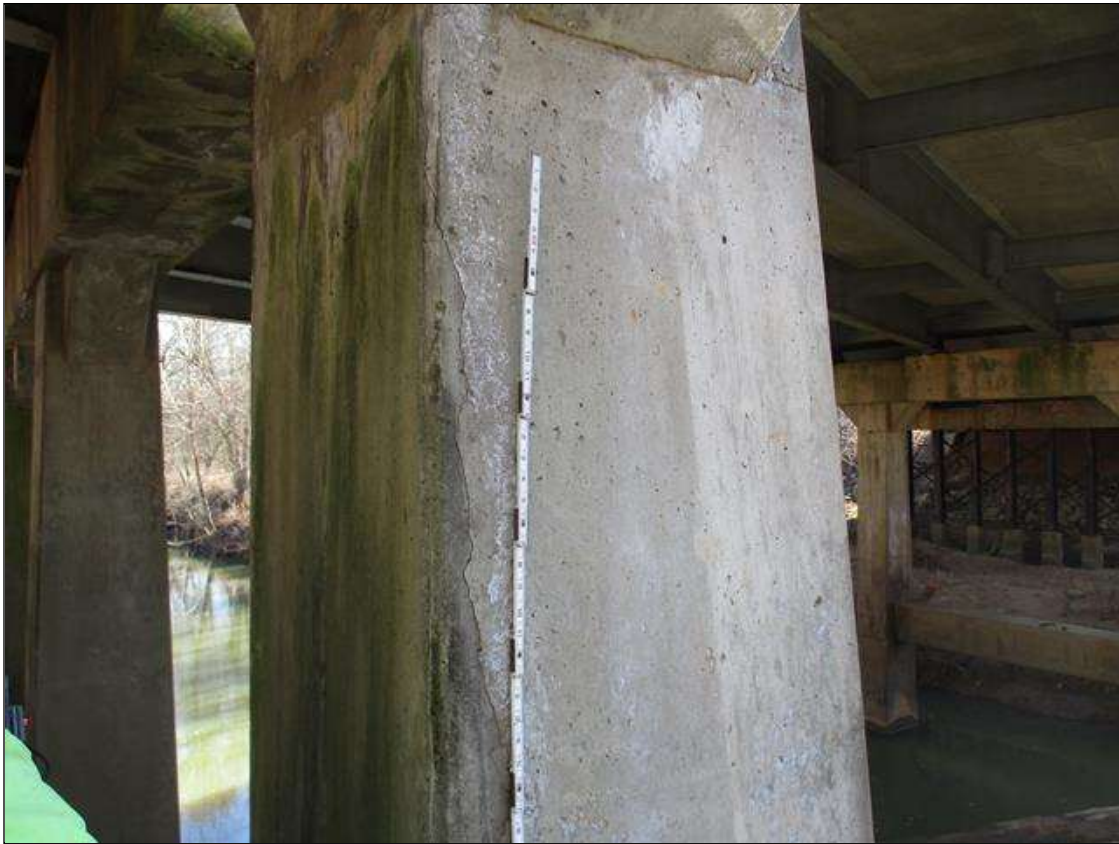
Bent 1 Pile 2: UP TO 48" X 1/8" VERTICAL CRACKS THROUGHOUT COLUMN AT WATER SURFACE

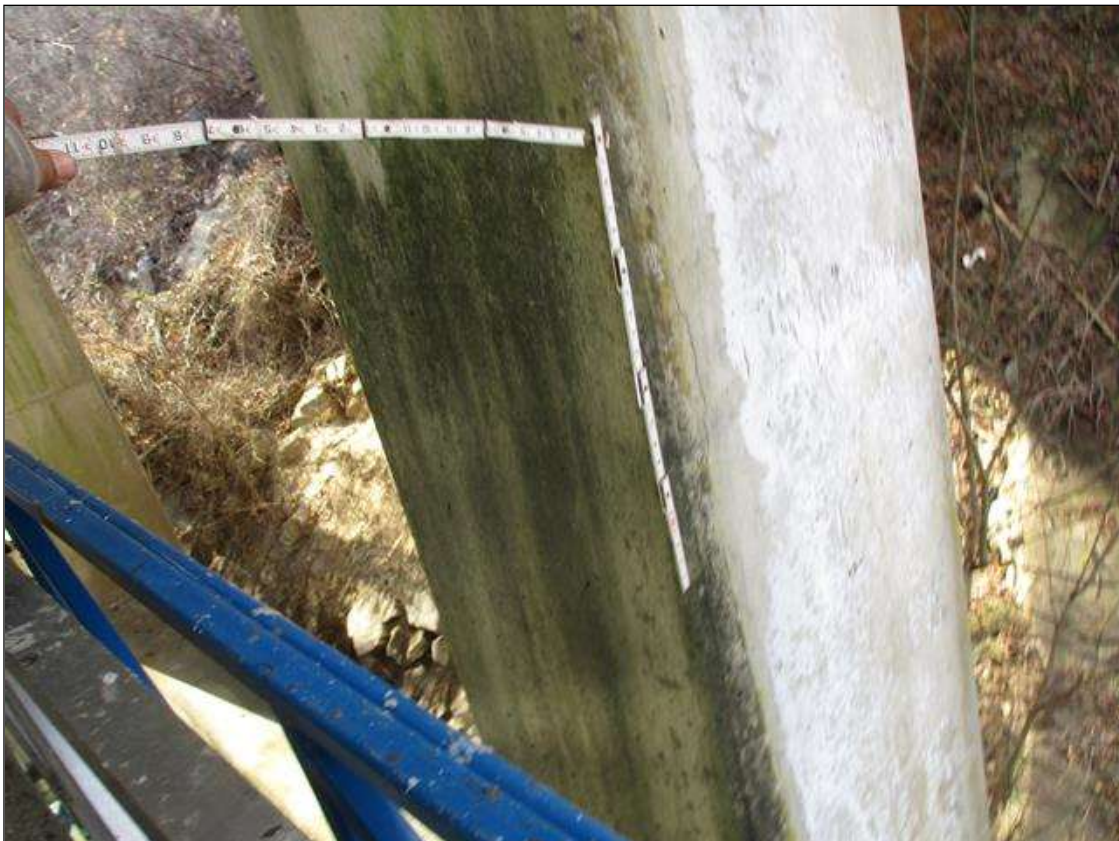
Bent 1 Pile 3: UP TO 8' X 0.03" VERTICAL CRACKS THROUGHOUT COLUMN

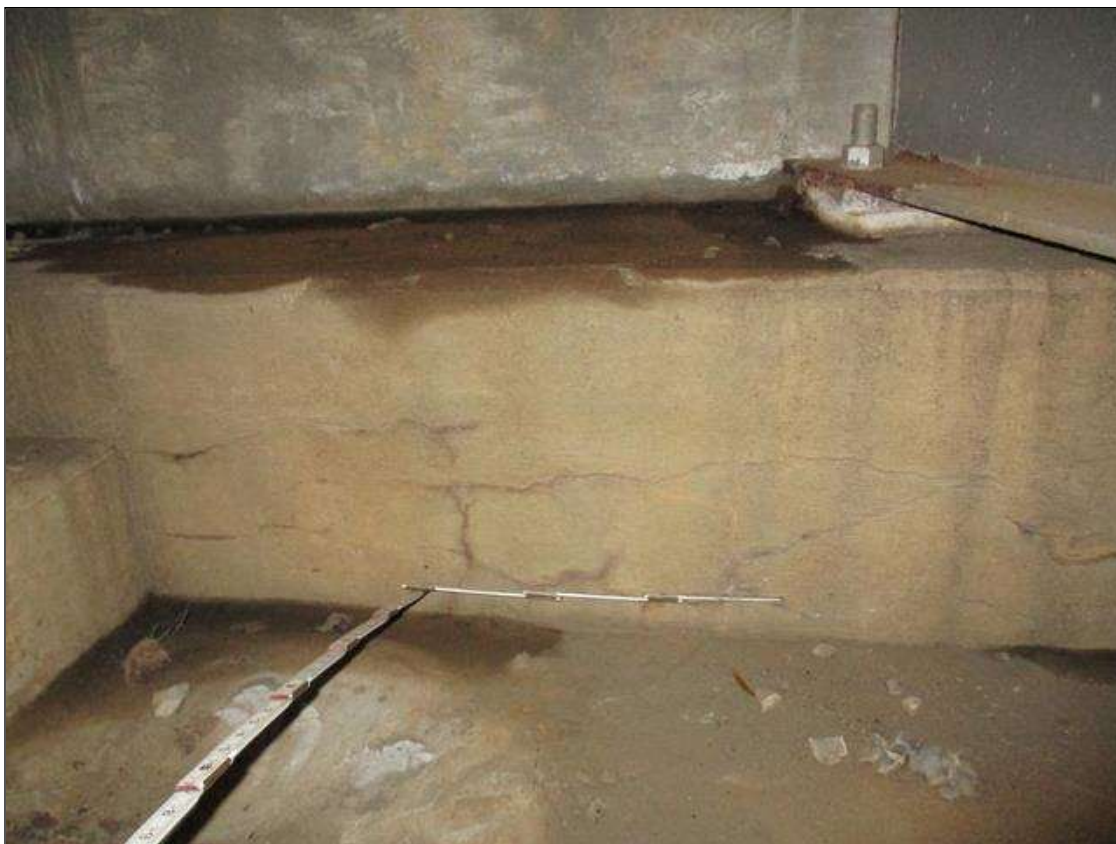
End Bent 1 Abutment: UP TO 0.03" LONGITUDINAL AND MAP CRACKS THROUGHOUT FACE OF CURTAIN WALL IN BAYS 1 THRU 5

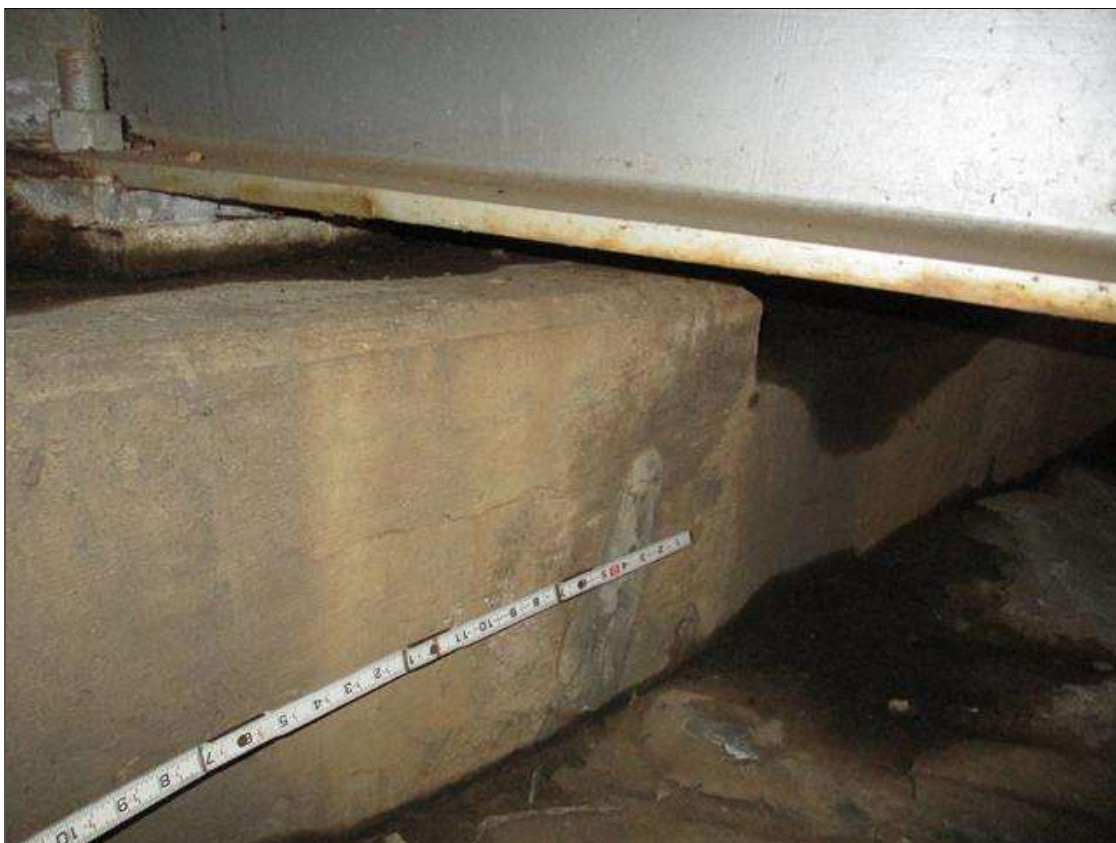
End Bent 1 Abutment: UP TO 0.03" LONGITUDINAL AND MAP CRACKS THROUGHOUT FACE OF CURTAIN WALL IN BAYS 1 THRU 5

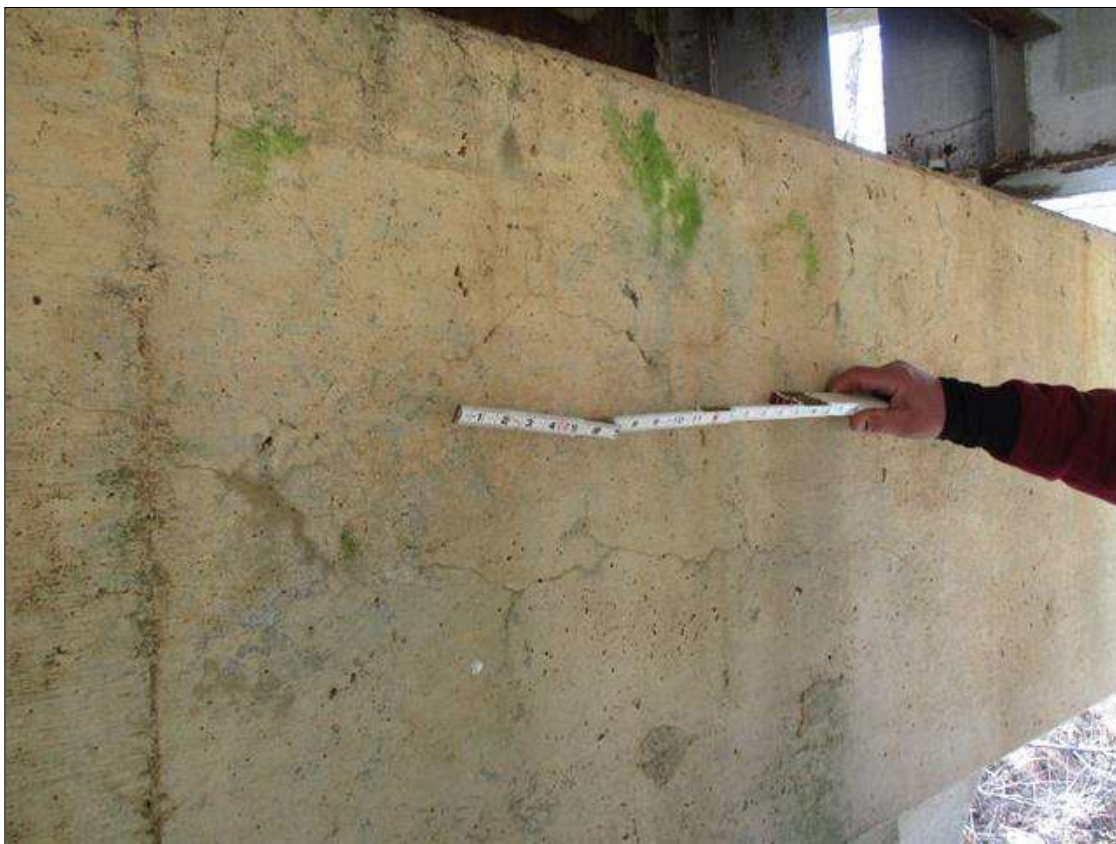
Bent 2 Cap 1: 48" SECTION OF UP TO 1/16" HORIZONTAL AND MAP CRACKS IN SPAN 2 FACE AND BOTTOM OF CAP, APPROXIMATELY 6' TO LEFT OF COLUMN 2

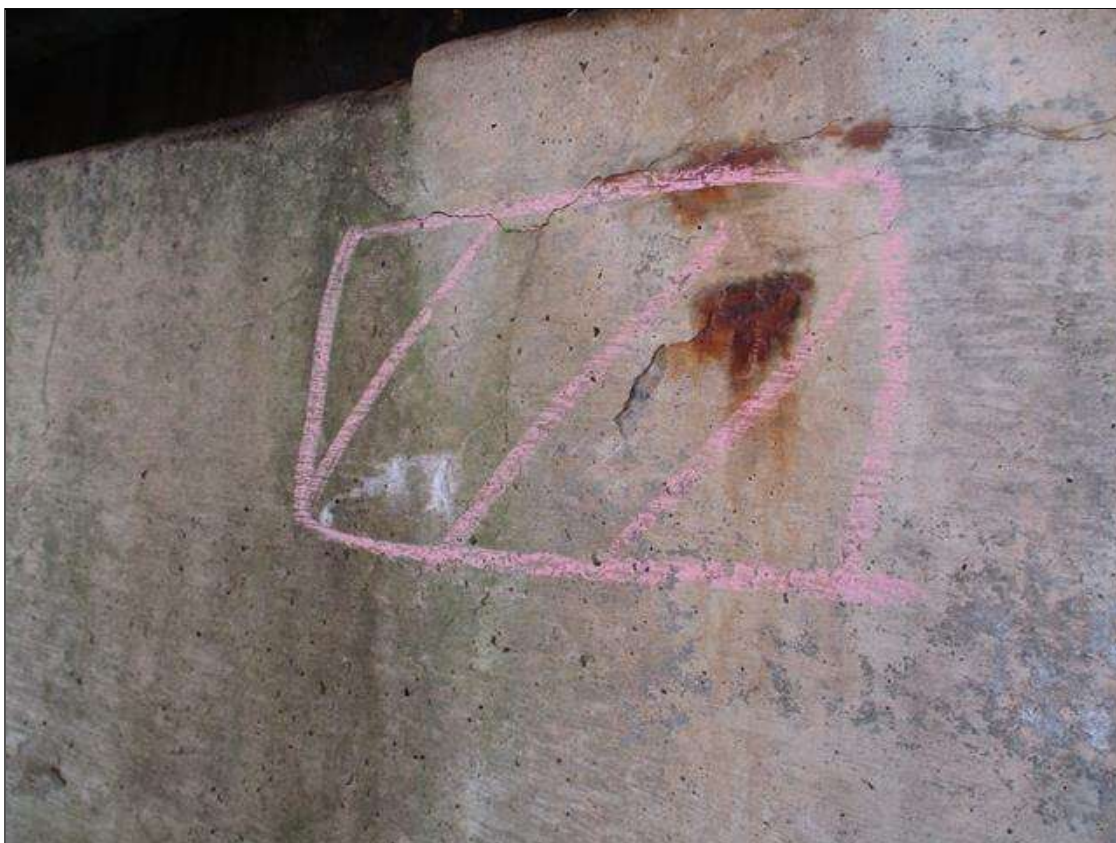
Bent 2 Cap 1: NEAR FACE, ABOVE COLUMN 2, DELAMINATED AREA 2' HIGH X 8" WIDE

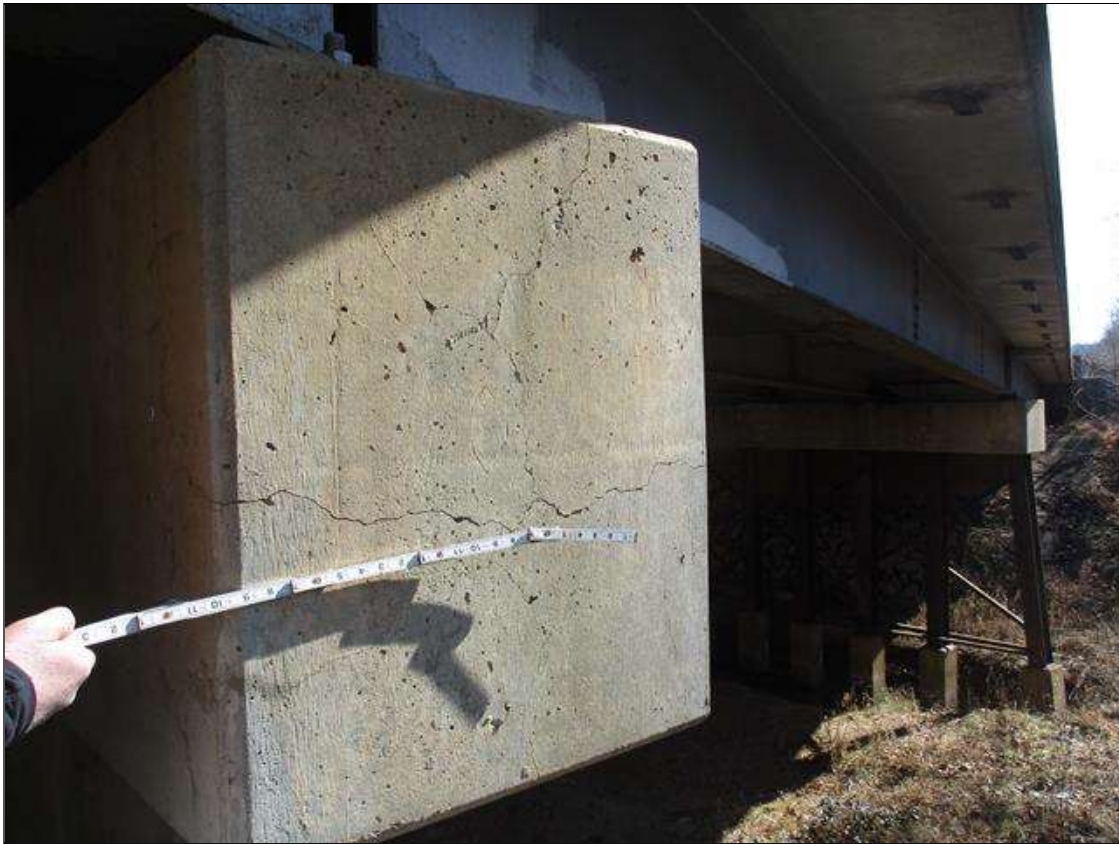
Bent 2 Cap 1: LONGITUDINAL CRACKING IN RIGHT END UP TO 1/16"

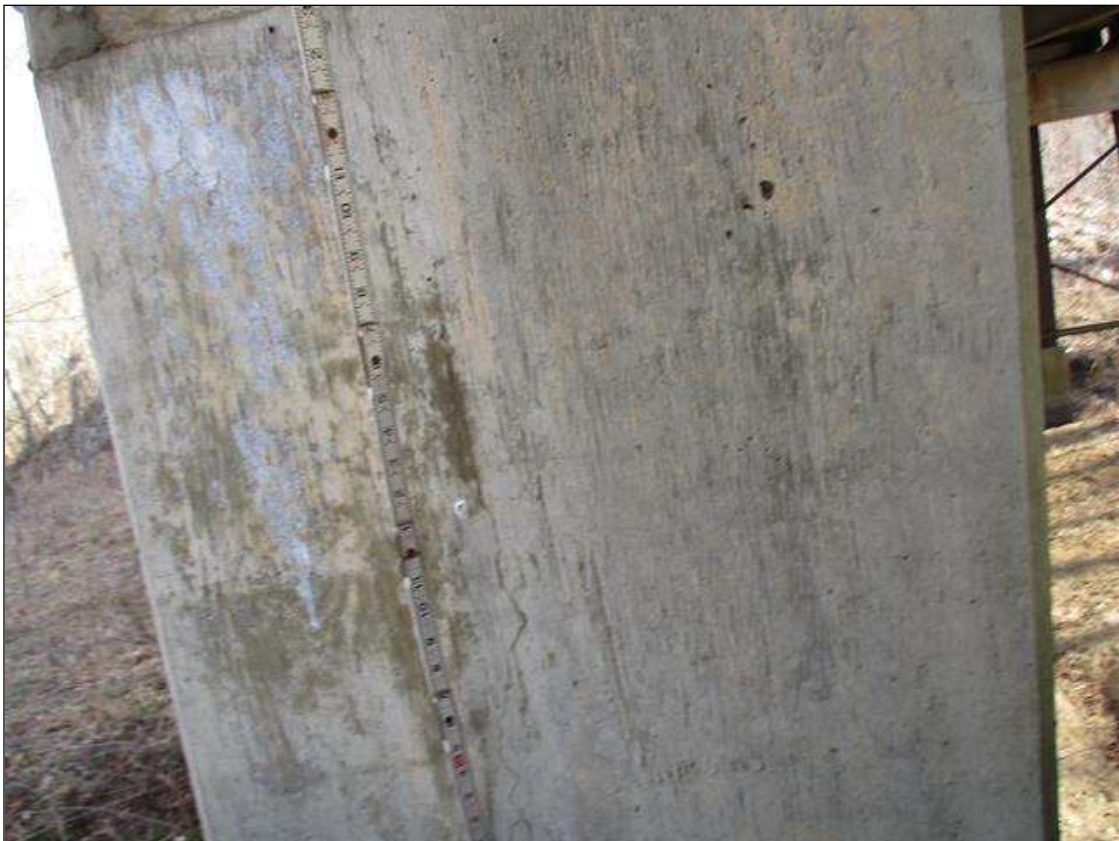
Bent 2 Pile 1: UP TO 0.02" VERTICAL CRACKS AND HAIRLINE MAP CRACKS WITH AND WITHOUT EFFLORESCENCE THROUGHOUT COLUMN

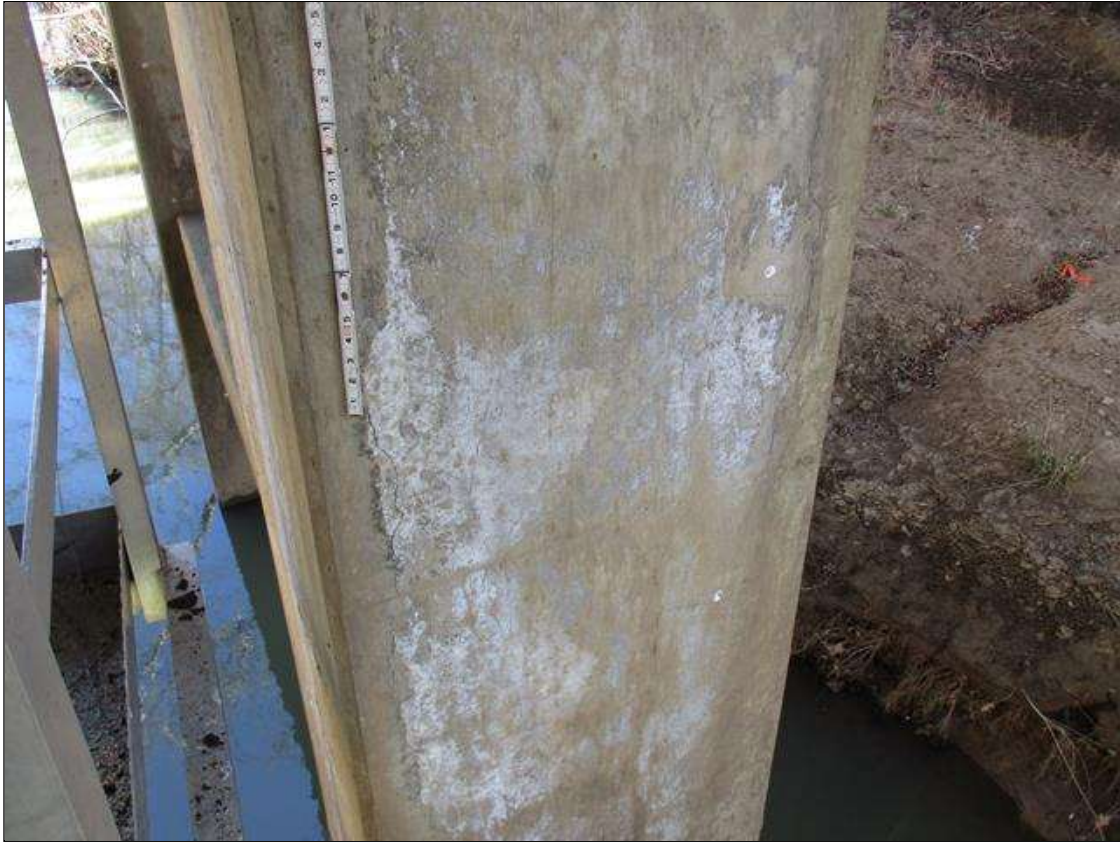
Bent 2 Pile 2: UP TO 18' X 1/16" VERTICAL CRACKS THROUGHOUT COLUMN, CRACK IN SPAN 2 FACE SHOWN IN PHOTO

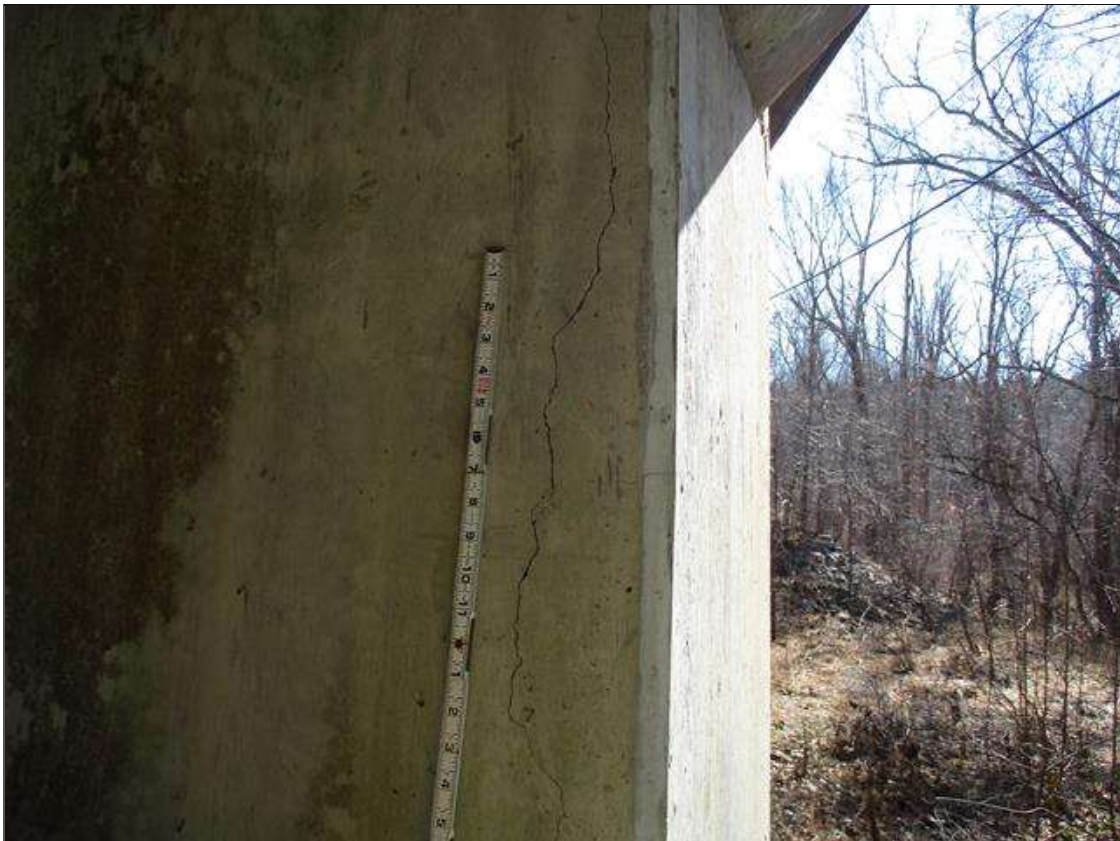
Bent 2 Pile 3: UP TO 8' X 1/16" VERTICAL CRACKS THROUGHOUT COLUMN AT WATER SURFACE & UP TO CAP

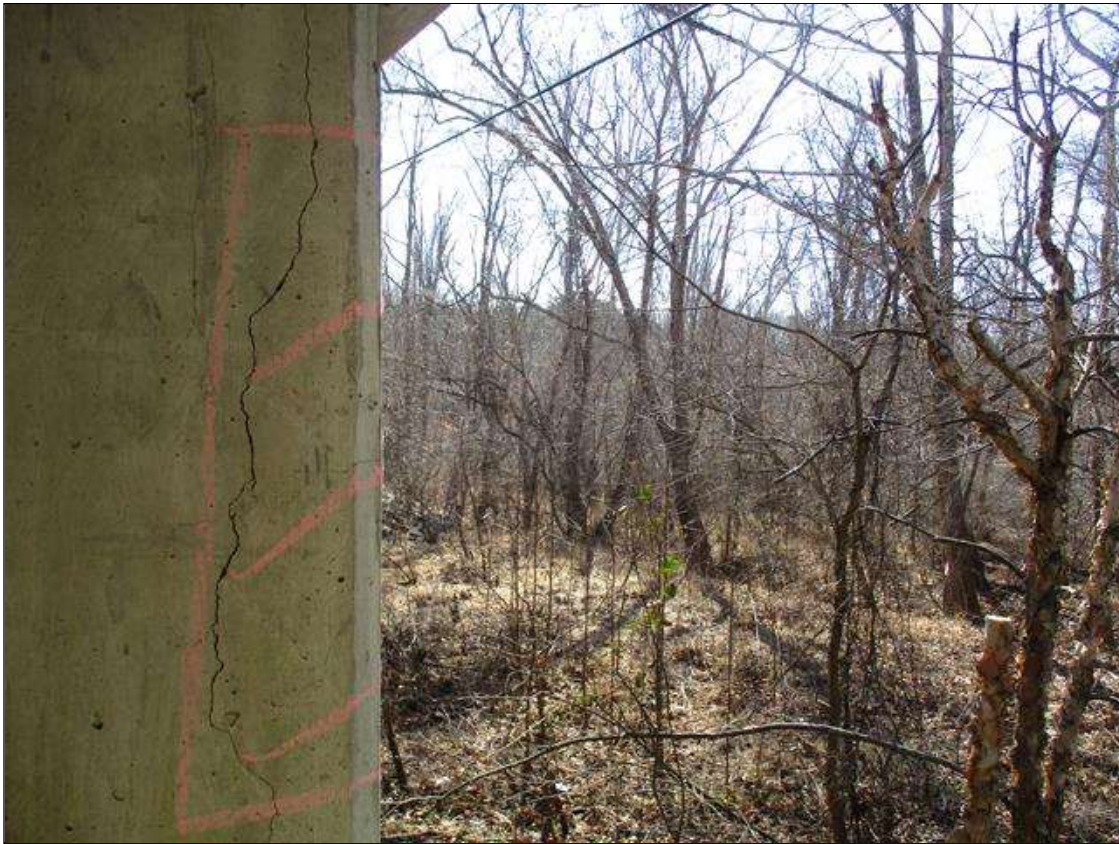
Bent 2 Pile 3: 22" X 5" X 5" AREA OF DELAMINATION WITH UP TO 0.05" VERTICAL CRACKS IN SOUTHWEST CORNER OF COLUMN, APPROXIMATELY 3' FROM BOTTOM OF CAP

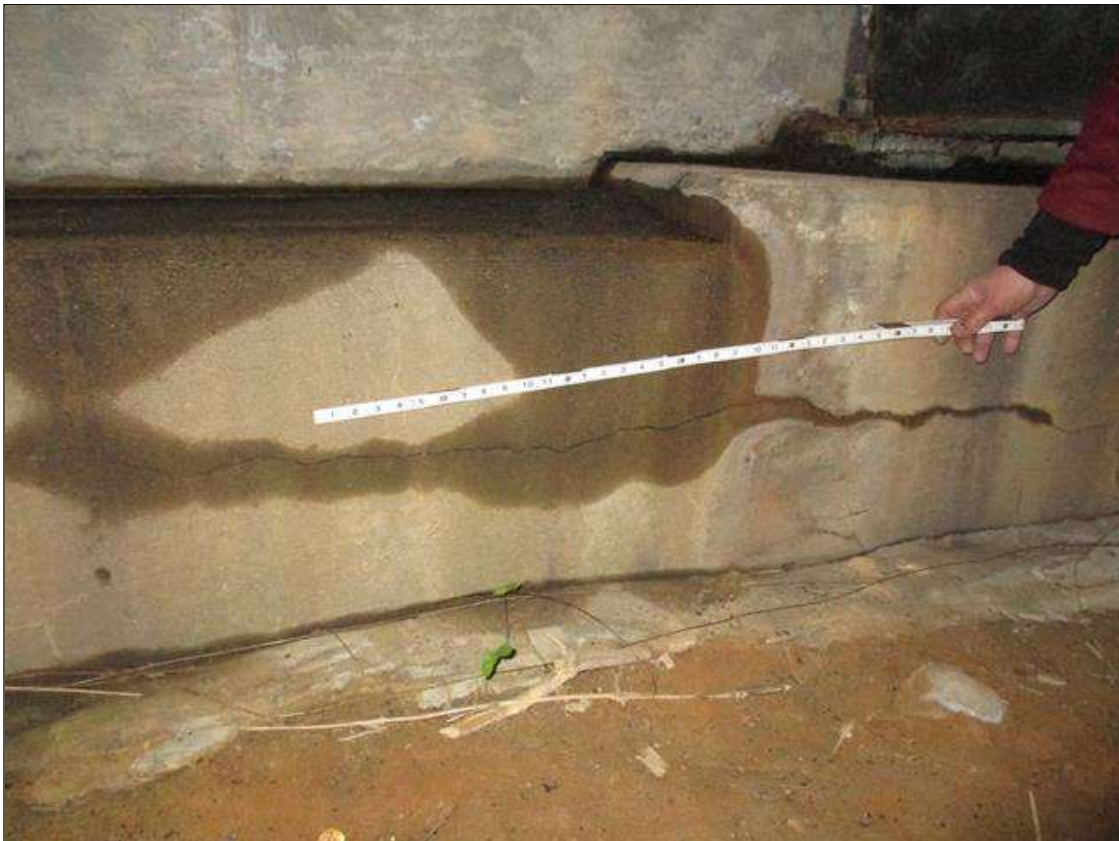
End Bent 2 Cap 1: UP TO 5/16" LONGITUDINAL AND HORIZONTAL CRACKS IN FACE OF CAP BENEATH BAYS 4 AND 5

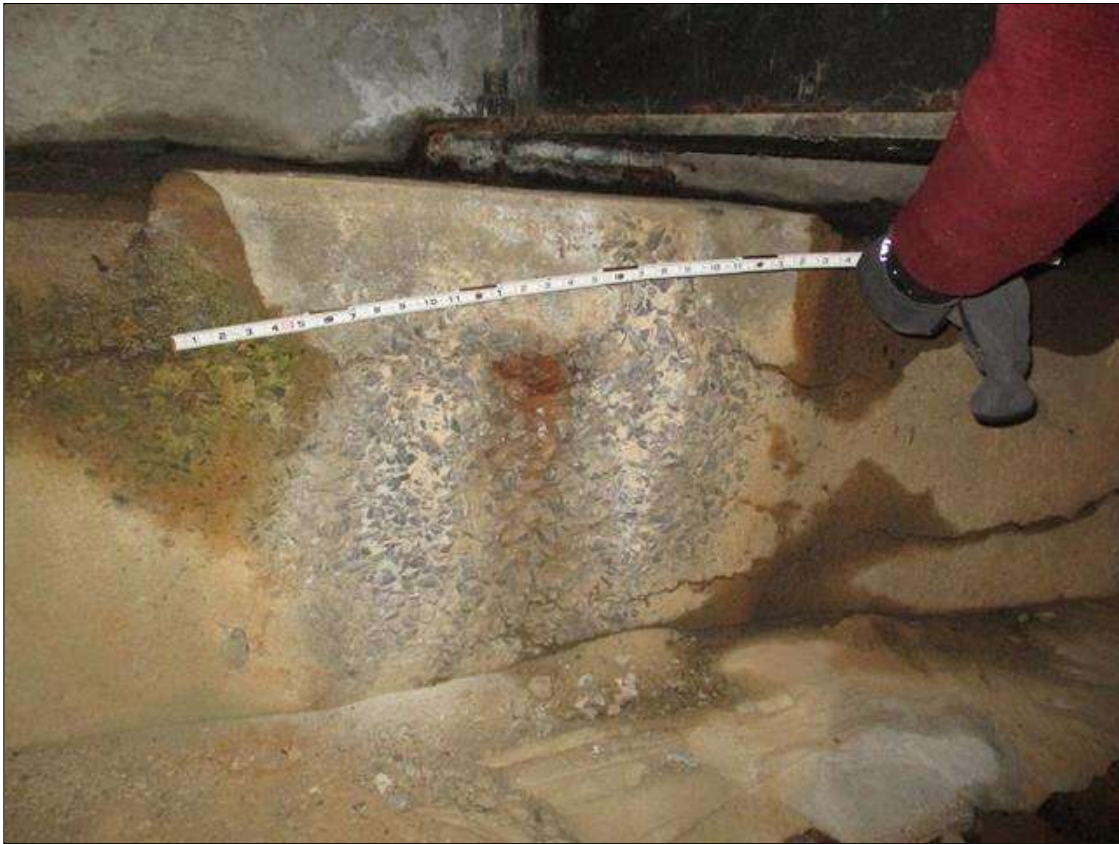
End Bent 2 Cap 1: 105" X 23" SECTION OF UP TO 22" X 20" AREAS OF SCALING WITH EXPOSED AGGREGATE IN FACE OF CAP AND BRACE PILE CAP BENEATH BAY 3

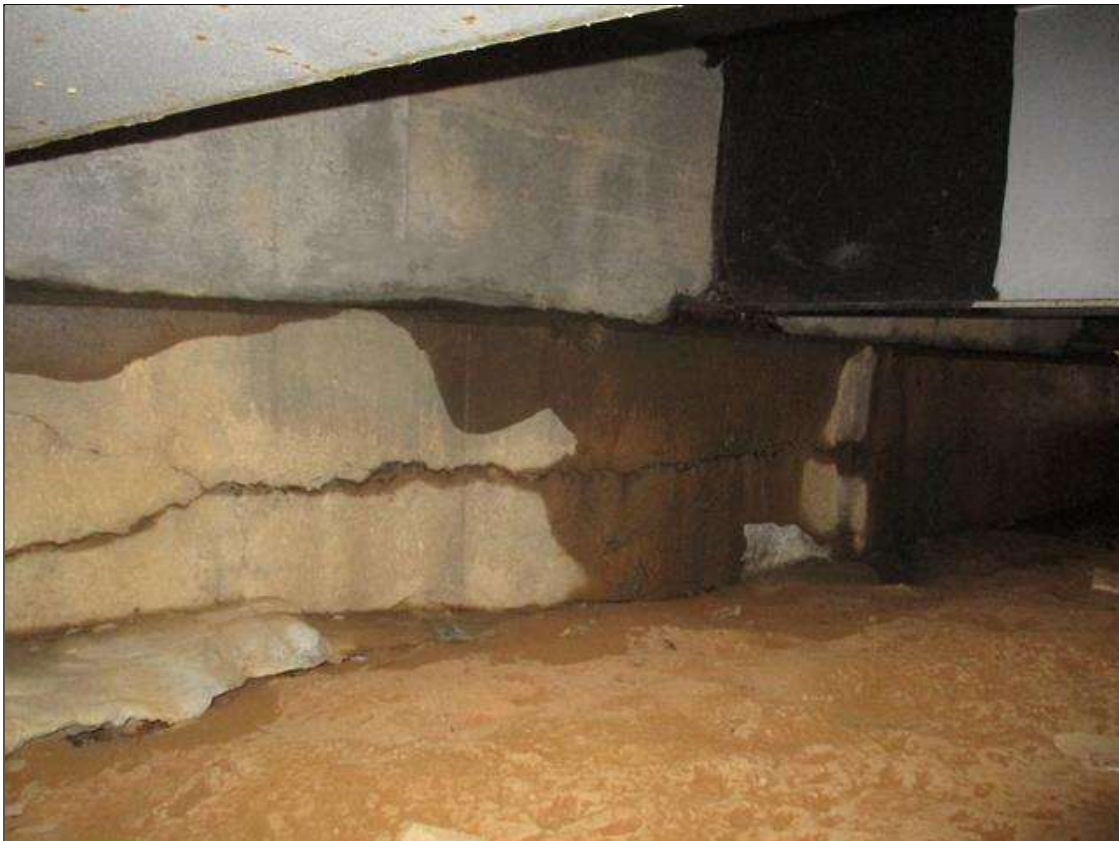
End Bent 2 Cap 1: UP TO 0.016" LONGITUDINAL AND HORIZONTAL CRACKS AND HAIRLINE MAP CRACKS WITH EFFLORESCENCE IN TOP AND FACE OF CAP AND BRACE PILE CAP AT LEFT END

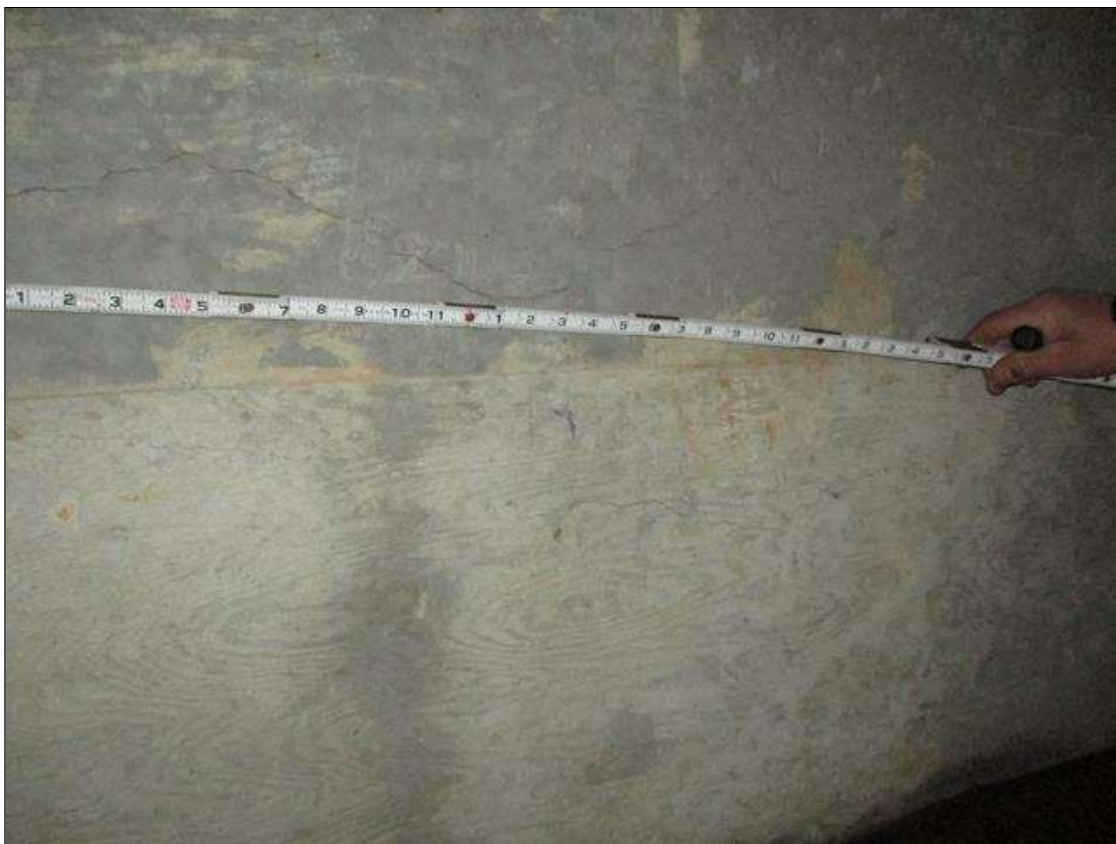
End Bent 2 Abutment: UP TO 0.02" HORIZONTAL AND MAP CRACKS THROUGHOUT FACE OF CURTAIN WALL IN BAYS 1 THRU 5

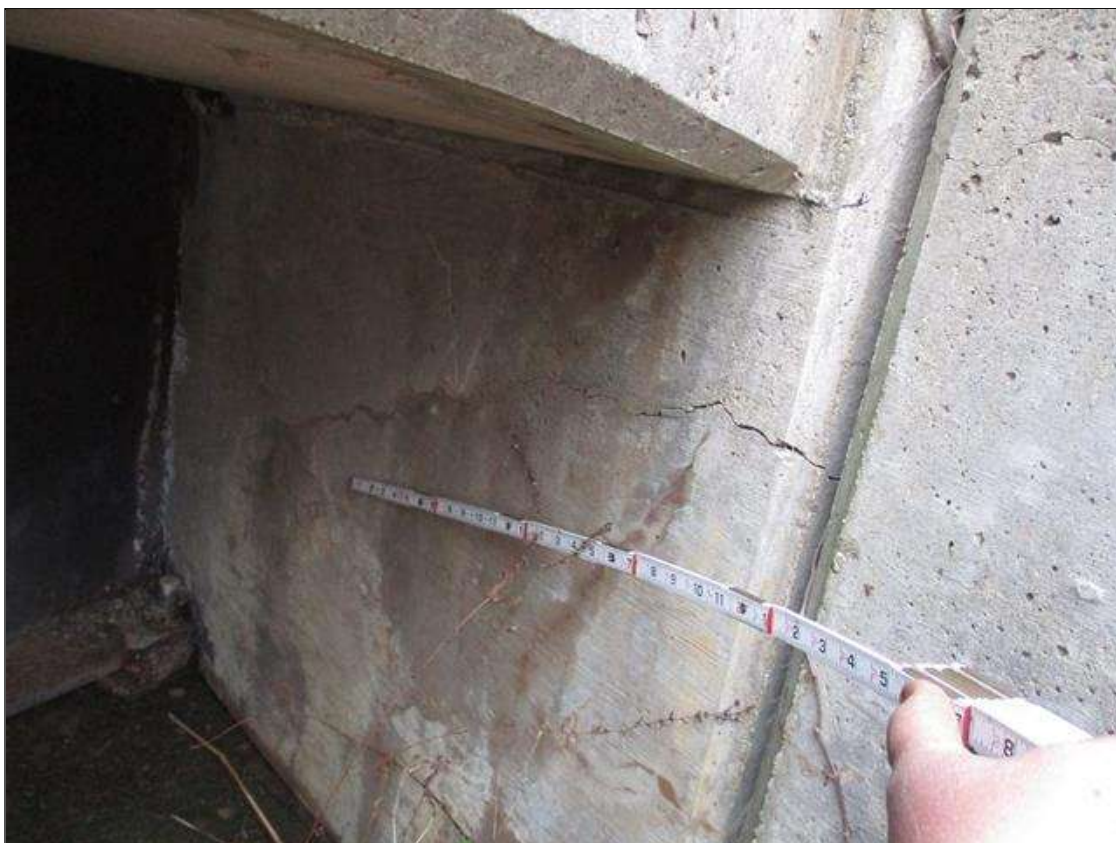
HORIZONTAL CRACKS AND HAIRLINE MAP CRACKS WITH EFFLORESCENCE IN FACE OF CURTAIN WALL (TYPICAL END BENT 2 ABUTMENT)

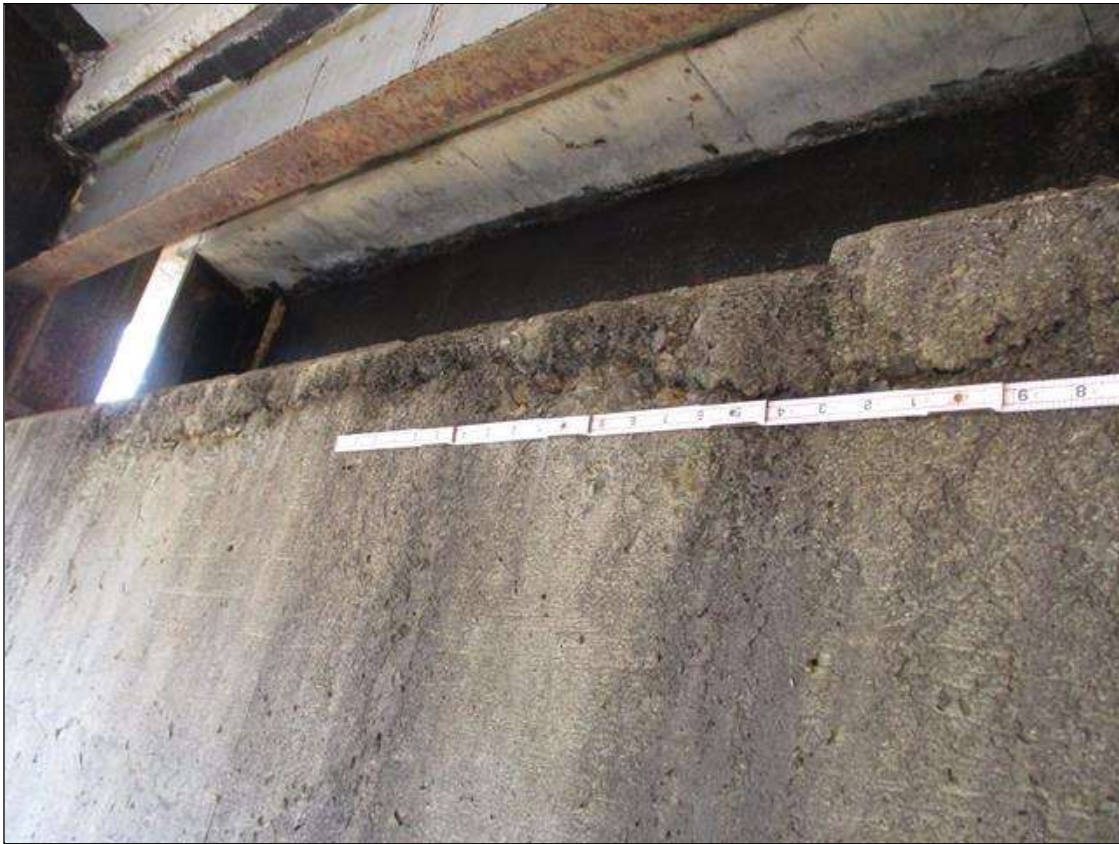
Bent 3 Cap 1: UP TO 1/4" LONGITUDINAL AND HORIZONTAL CRACKS AND HAIRLINE MAP CRACKING WITH AND WITHOUT EFFLORESCENCE IN BOTTOM AND BOTH FACES OF CAP

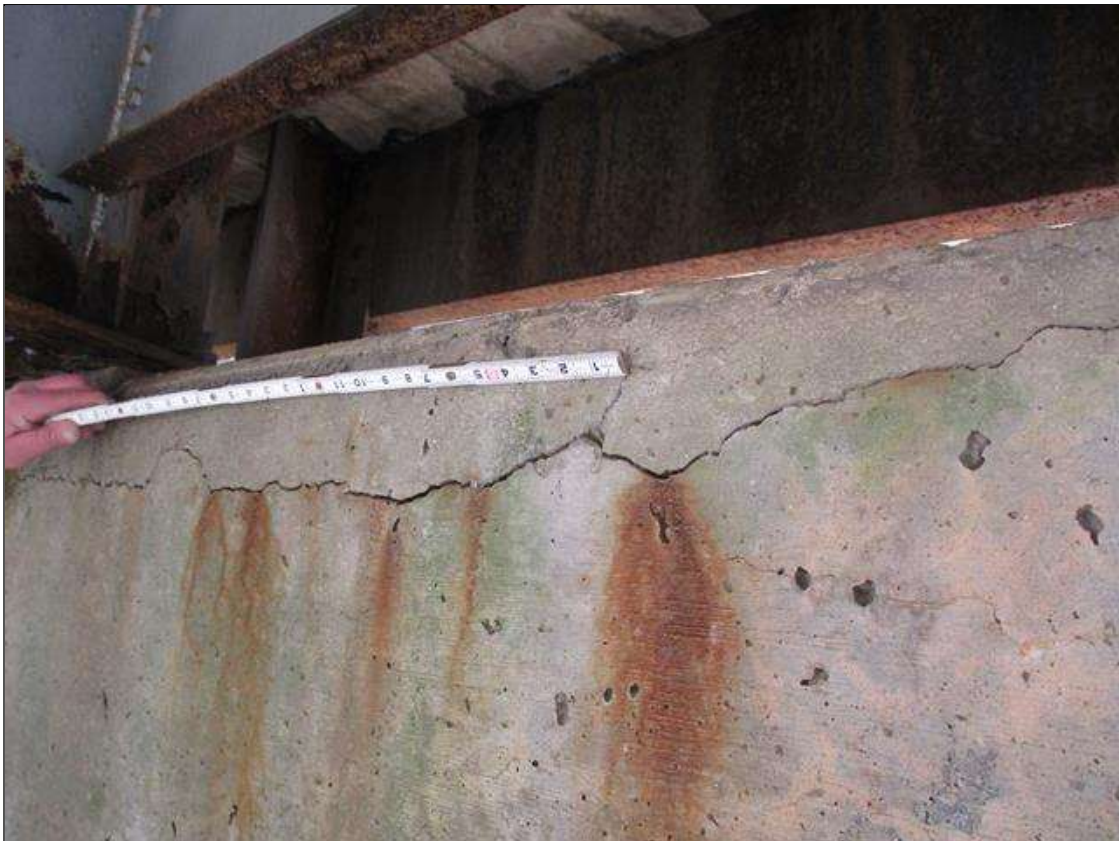
Bent 3 Cap 1: UP TO 1/4" LONGITUDINAL AND HORIZONTAL CRACKS AND HAIRLINE MAP CRACKING WITH AND WITHOUT EFFLORESCENCE IN BOTTOM AND BOTH FACES OF CAP

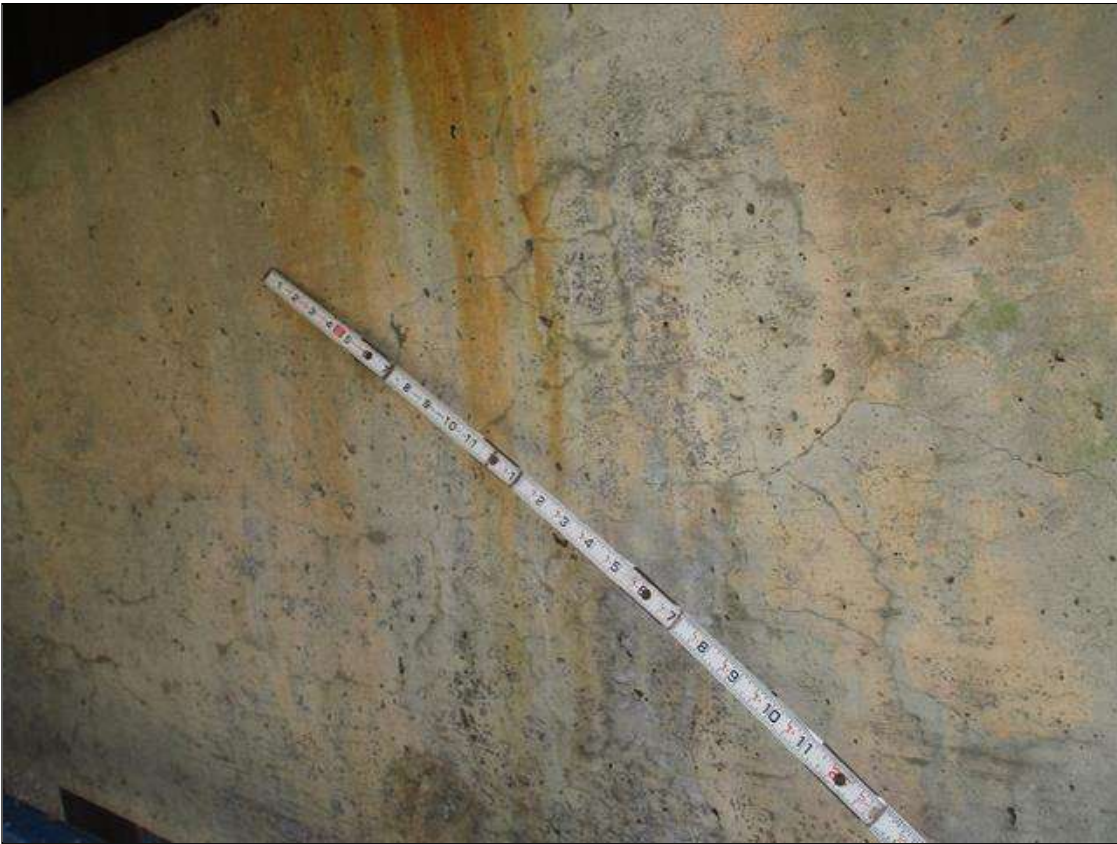
Bent 3 Cap 1: UP TO 1/4" LONGITUDINAL AND HORIZONTAL CRACKS AND HAIRLINE MAP CRACKING WITH AND WITHOUT EFFLORESCENCE IN BOTTOM AND BOTH FACES OF CAP

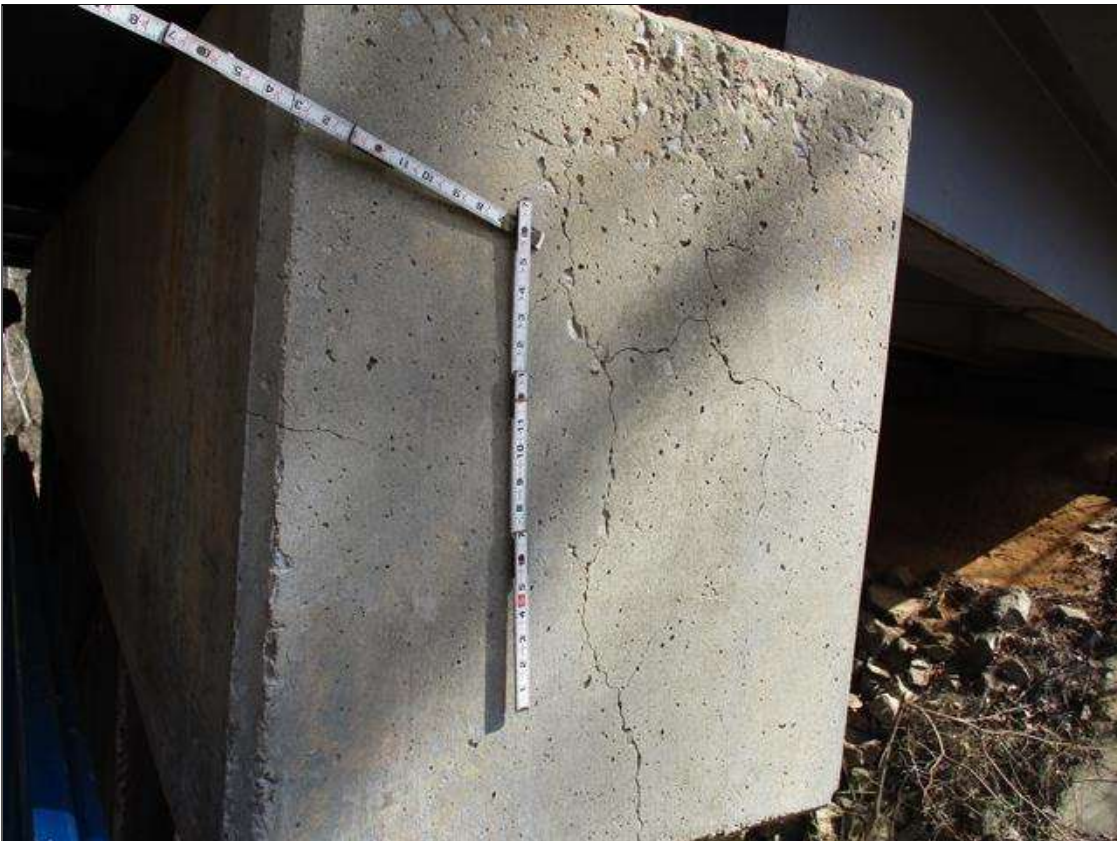
Bent 3 Cap 1: UP TO 1/4" LONGITUDINAL AND HORIZONTAL CRACKS AND HAIRLINE MAP CRACKING WITH AND WITHOUT EFFLORESCENCE IN BOTTOM AND BOTH FACES OF CAP

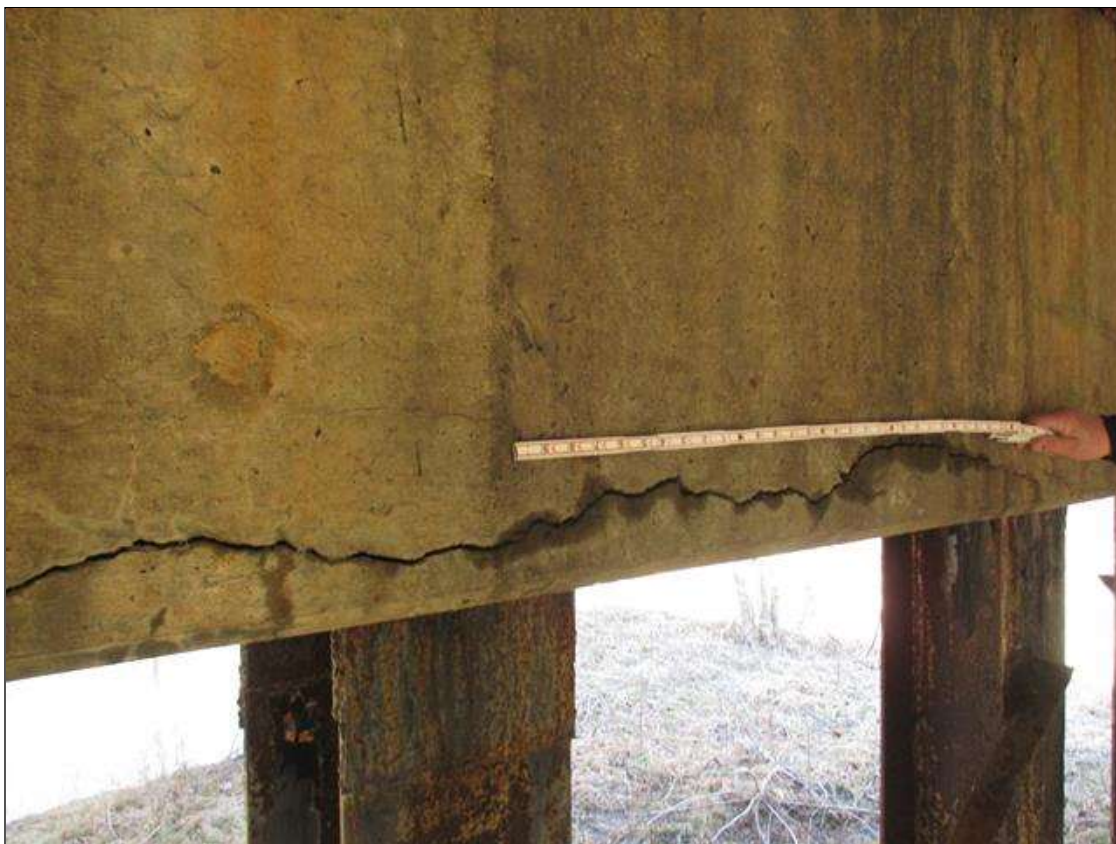
Bent 3 Cap 1: UP TO 1/4" LONGITUDINAL AND HORIZONTAL CRACKS AND HAIRLINE MAP CRACKING WITH AND WITHOUT EFFLORESCENCE IN BOTTOM AND BOTH FACES OF CAP

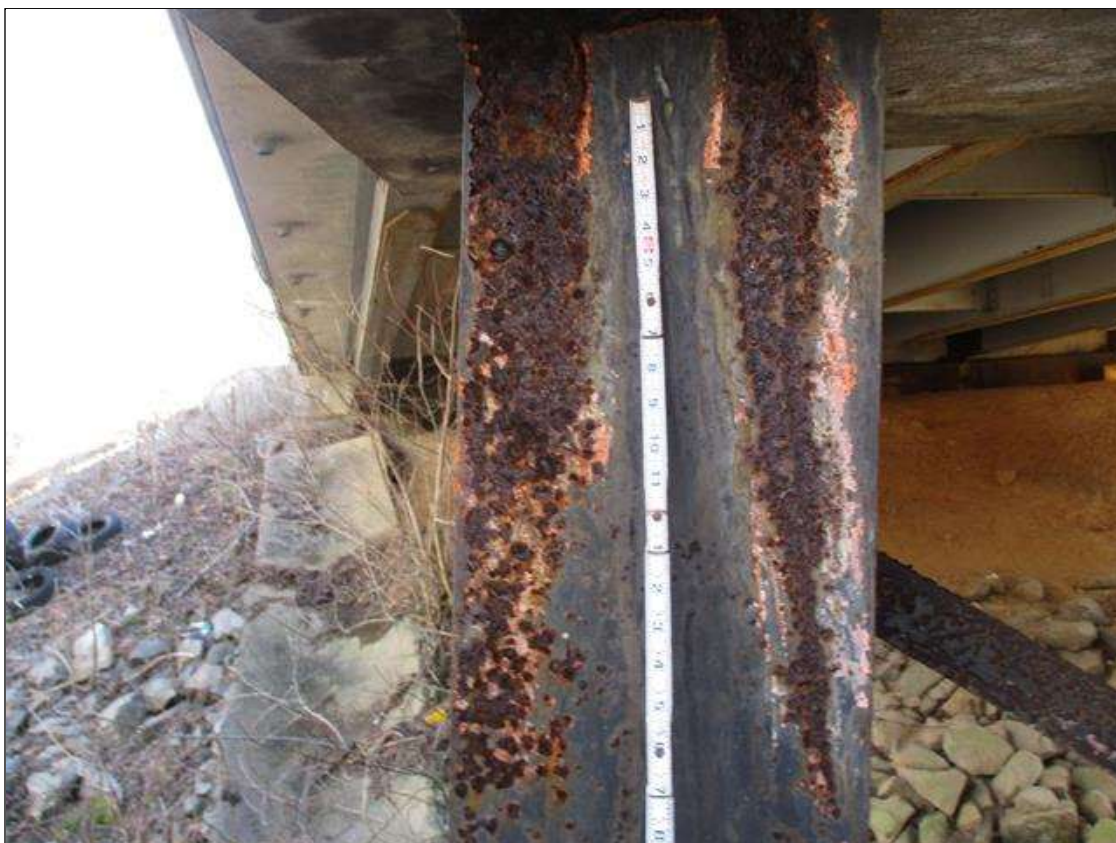
TYPICAL DETERIORATED PAINT SYSTEM (BENT 3, PILE 1)
