NC DEPARTMENT OF TRANSPORTATION  
 DIVISION OF HIGHWAYS  
 STRUCTURE MANAGEMENT UNIT

ATTENTION: PARS SUBMITTED

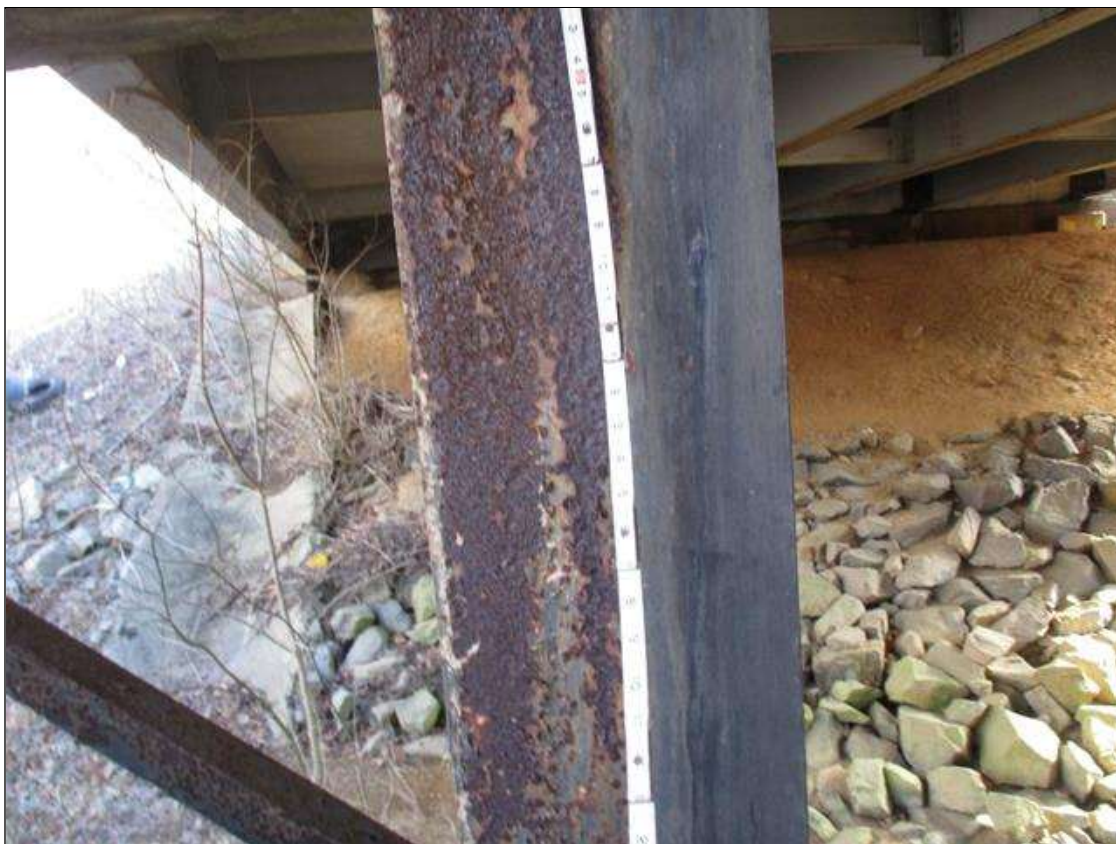
TYPICAL SURFACE CORROSION & DETERIORATED PAINT SYSTEM (BENT 3, PILE 2)

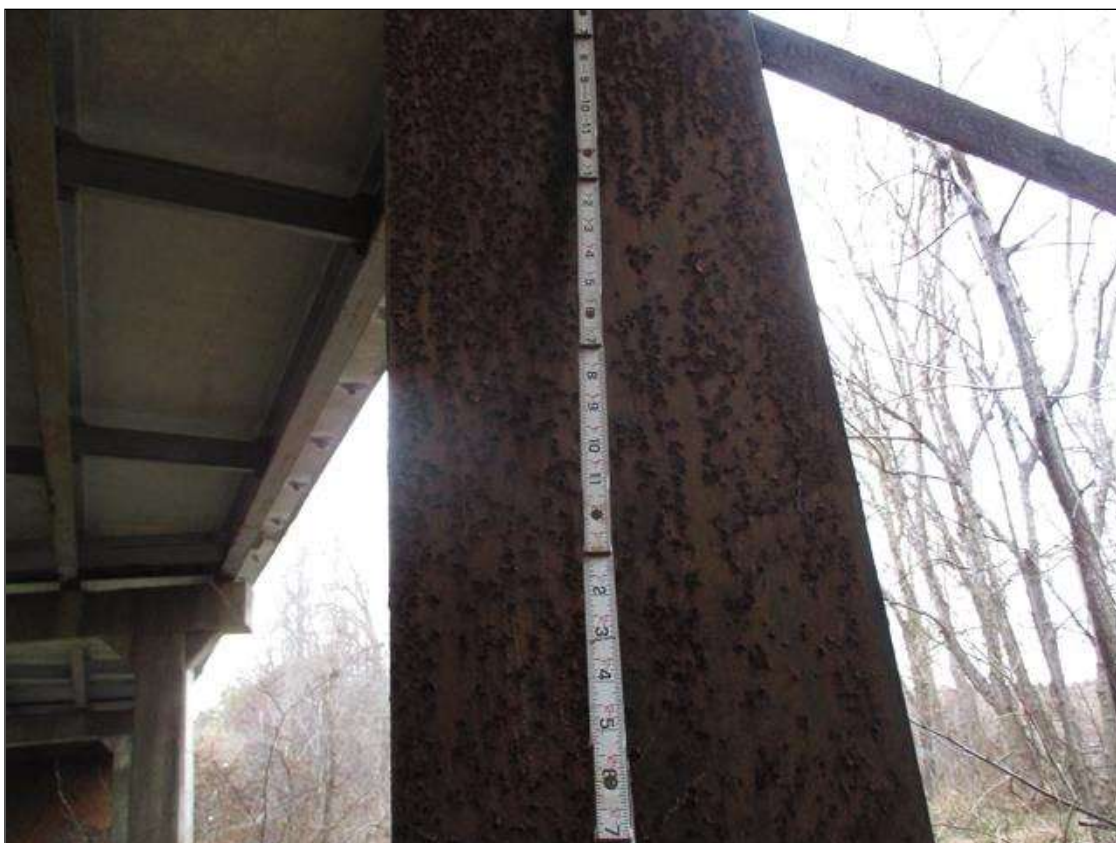
TYPICAL SURFACE CORROSION & DETERIORATED PAINT SYSTEM (BENT 3, PILE 2)

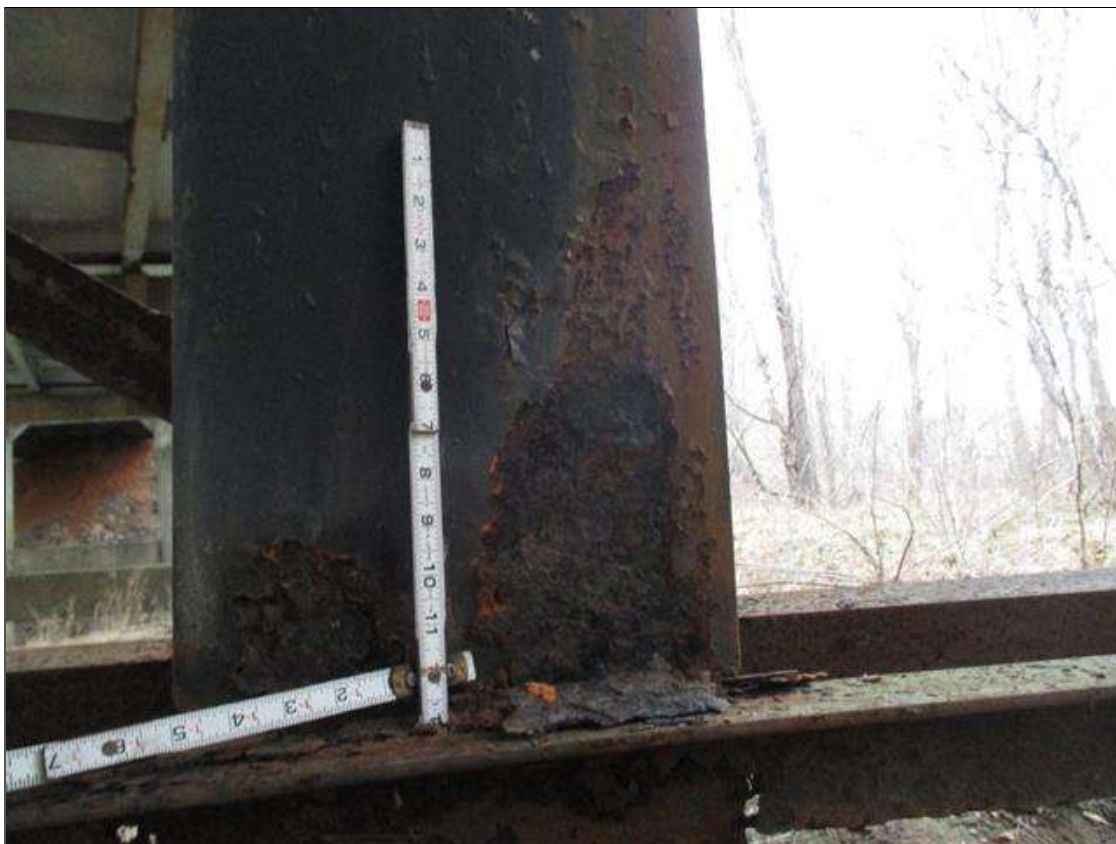
TYPICAL SURFACE CORROSION & DETERIORATED PAINT SYSTEM (BENT 3, PILE 3)

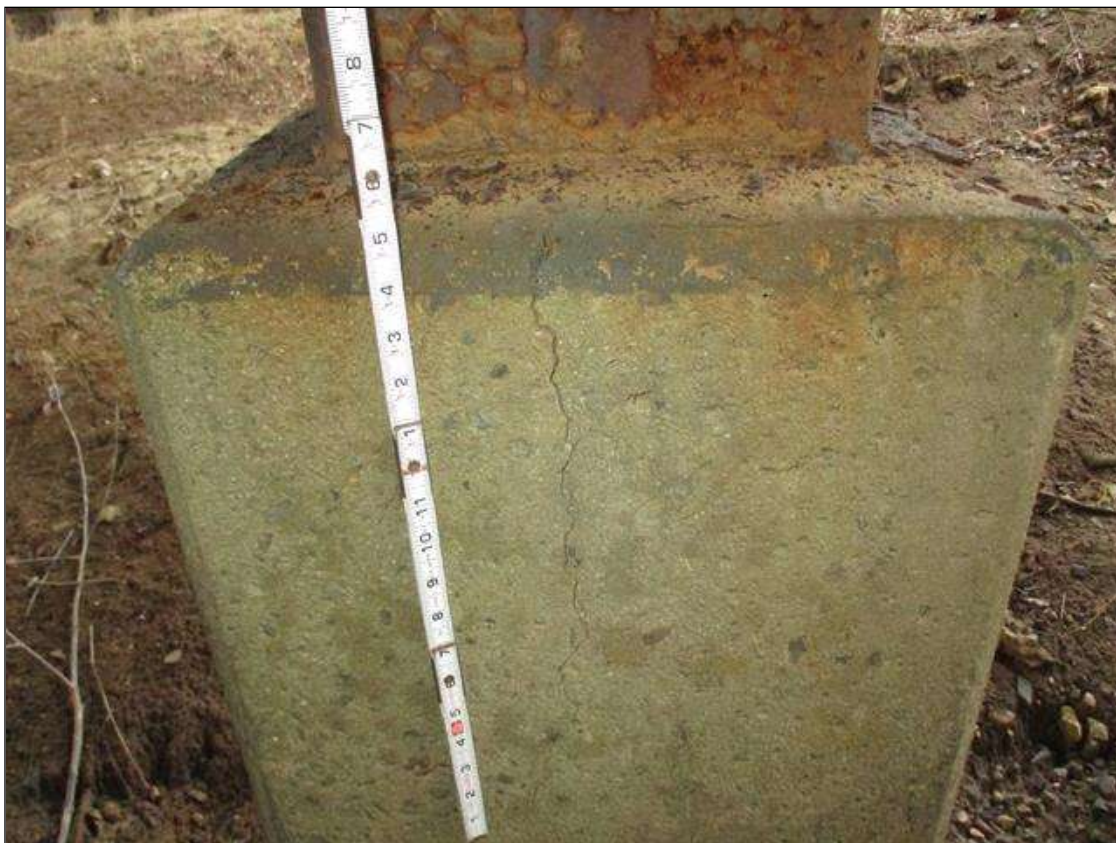
UP TO 1/16" TRANSVERSE & VERTICAL CRACKS IN ENCASEMEN (BENT 3, PILE 3)

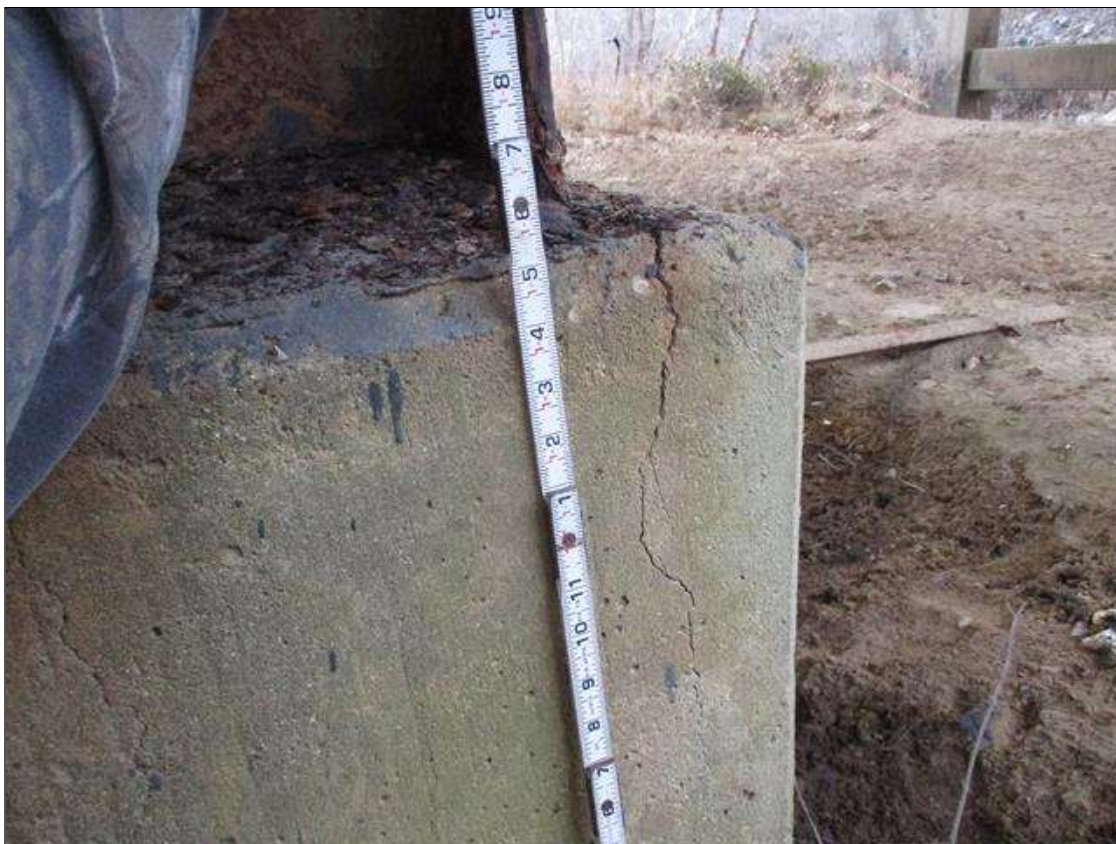
UP TO 1/16" TRANSVERSE & VERTICAL CRACKS IN ENCASEMEN (BENT 3, PILE 4)

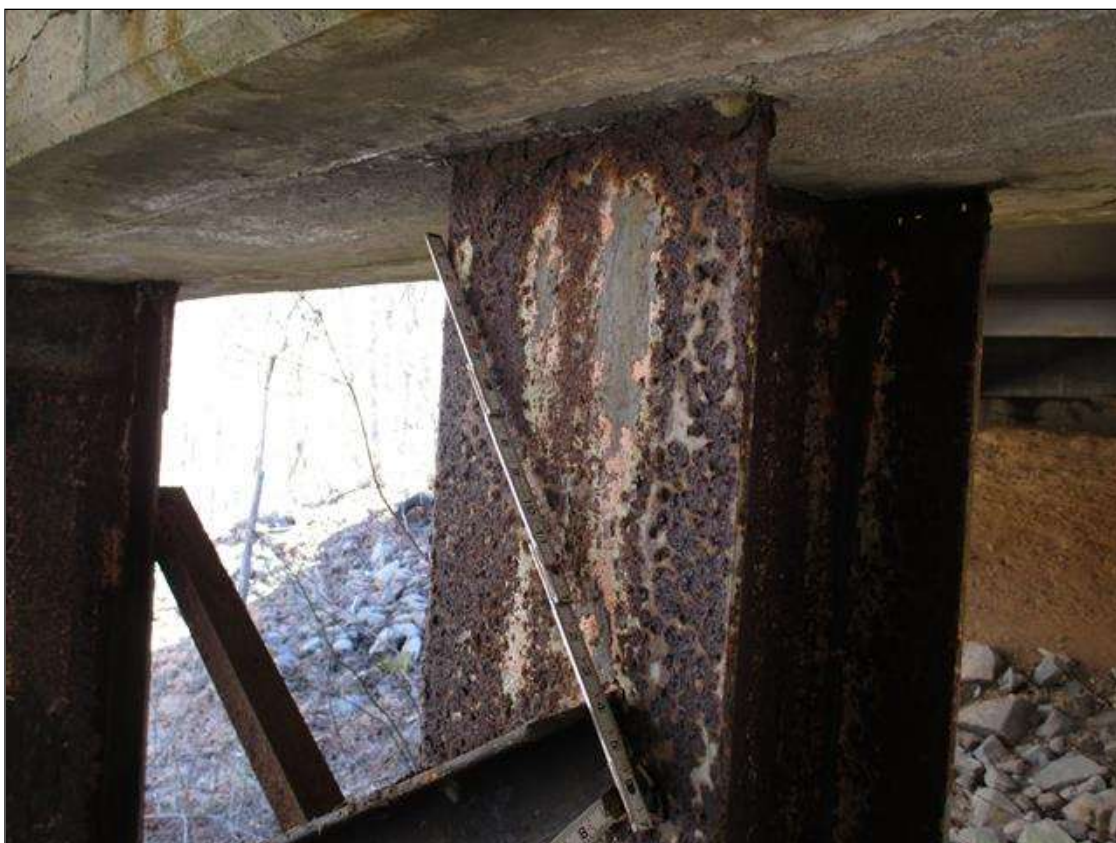
TYPICAL SURFACE CORROSION & DETERIORATED PAINT SYSTEM (BENT 3, PILE 4)

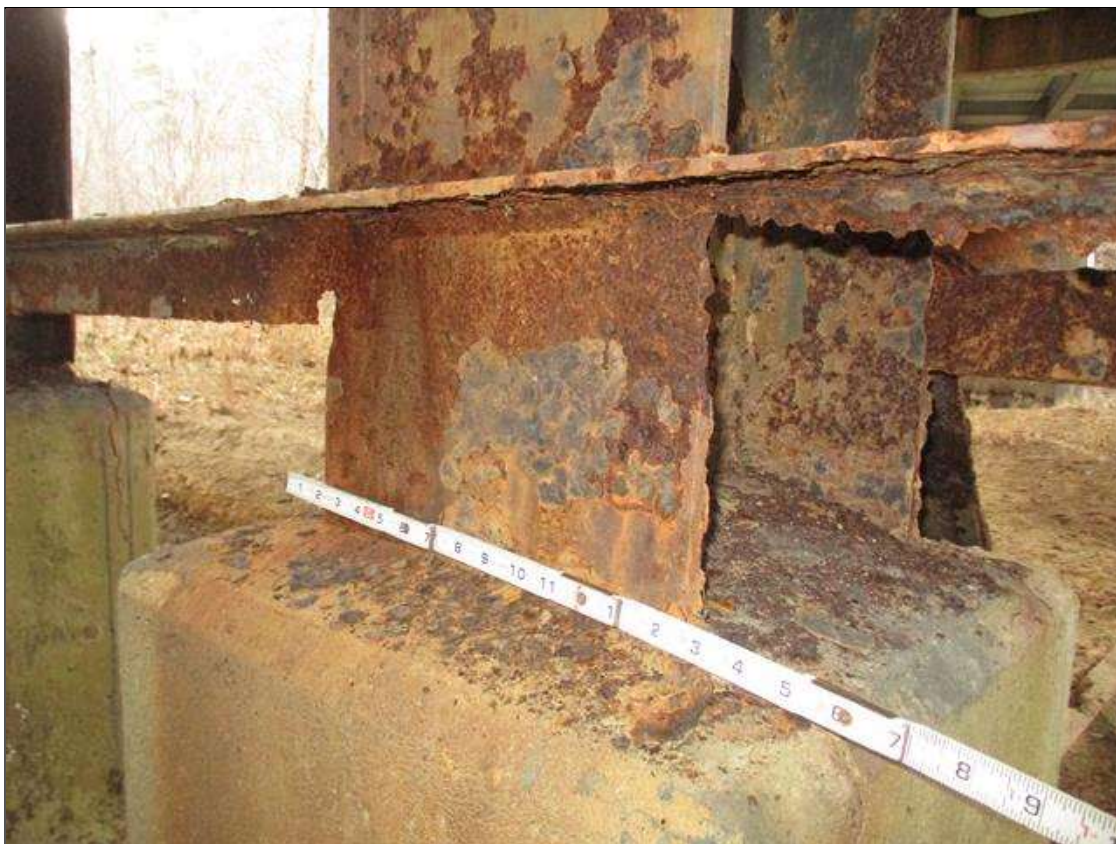
TYPICAL SURFACE CORROSION & DETERIORATED PAINT SYSTEM (BENT 3, PILE 5)

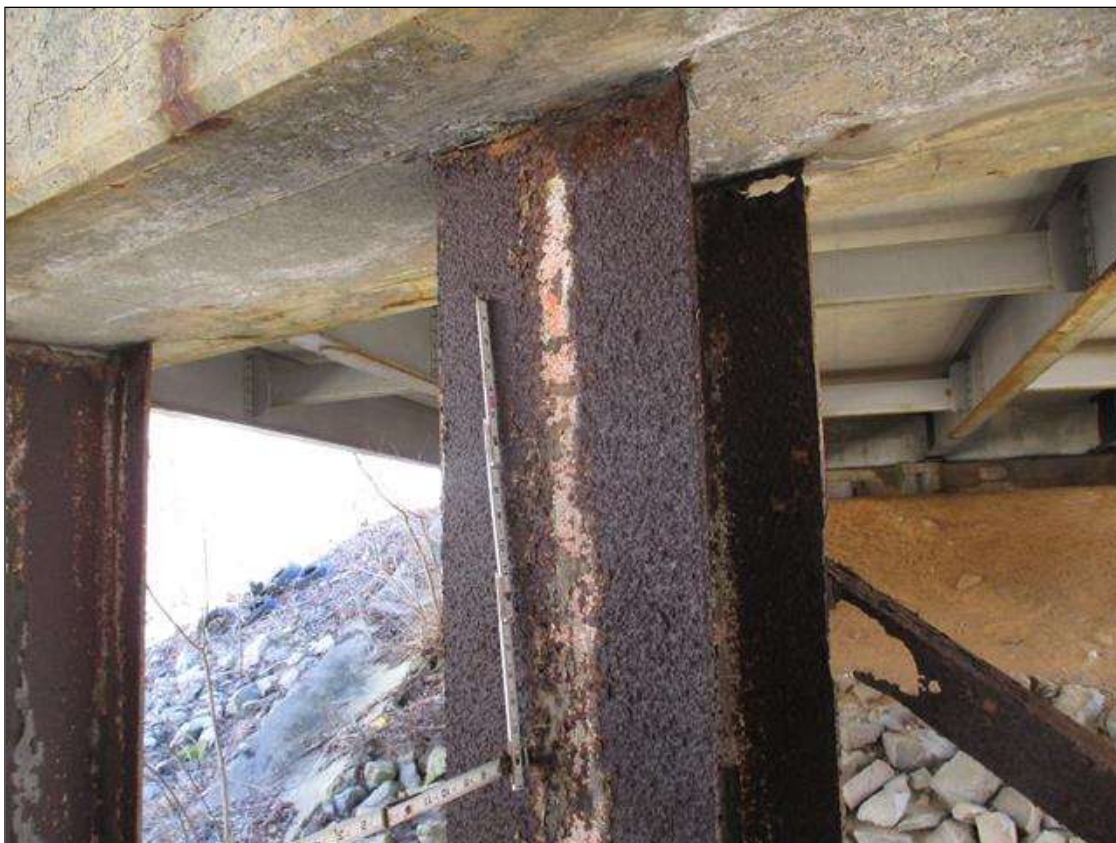
TYPICAL SURFACE CORROSION & DETERIORATED PAINT SYSTEM (BENT 3, PILE 5)

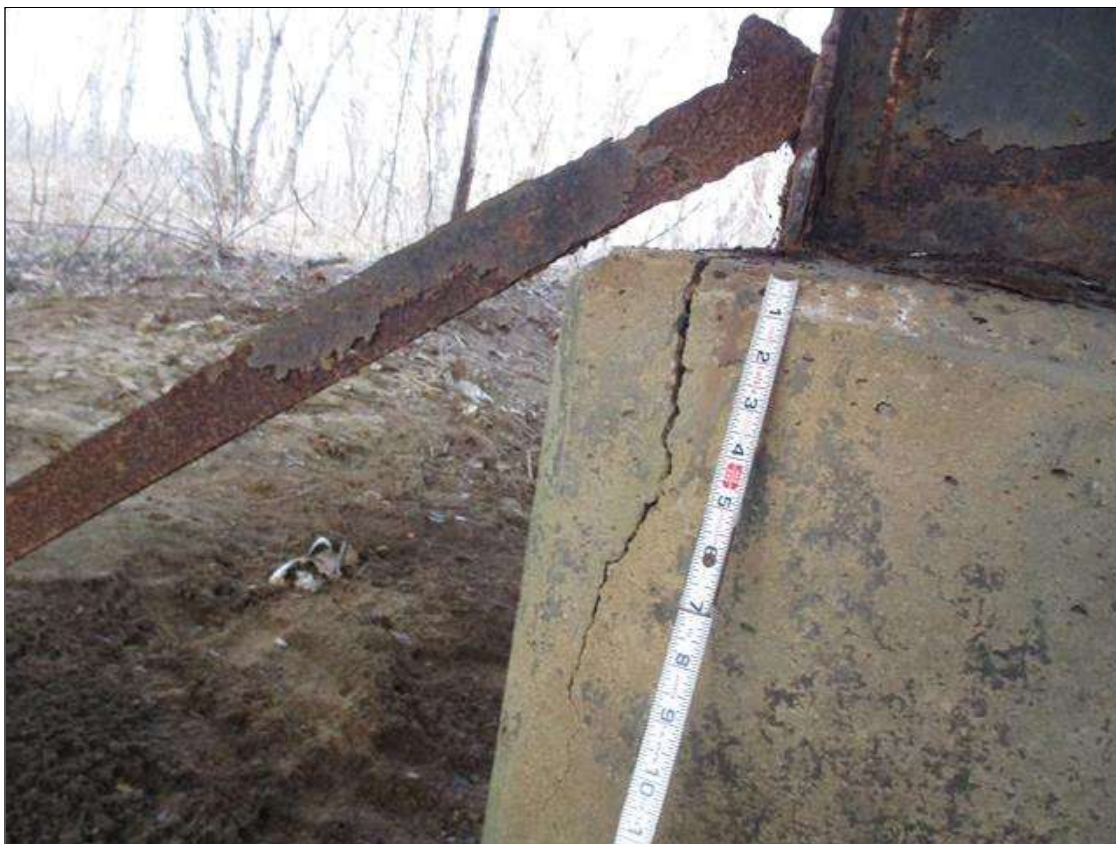
UP TO 1/8" TRANSVERSE & VERTICAL CRACKS IN ENCASEMENT (BENT 3, PILE 5)

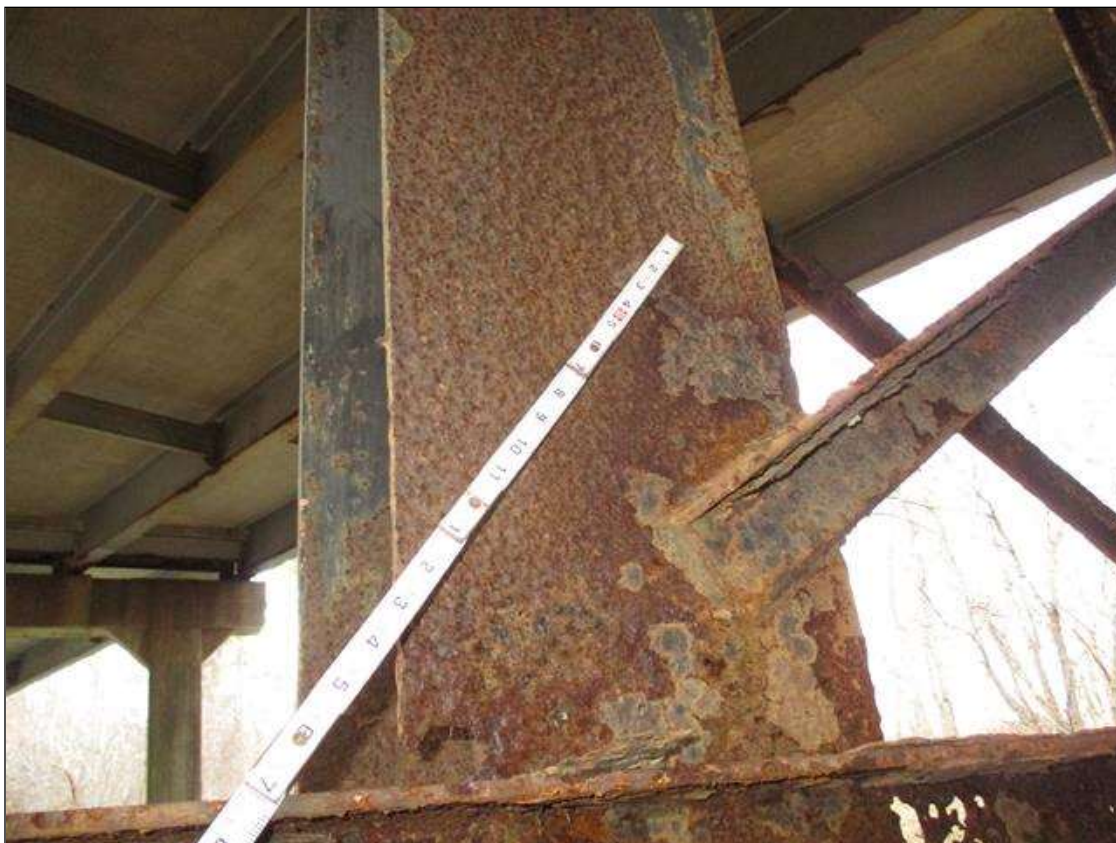
TYPICAL SURFACE CORROSION & DETERIORATED PAINT SYSTEM (BENT 3, PILE 6)

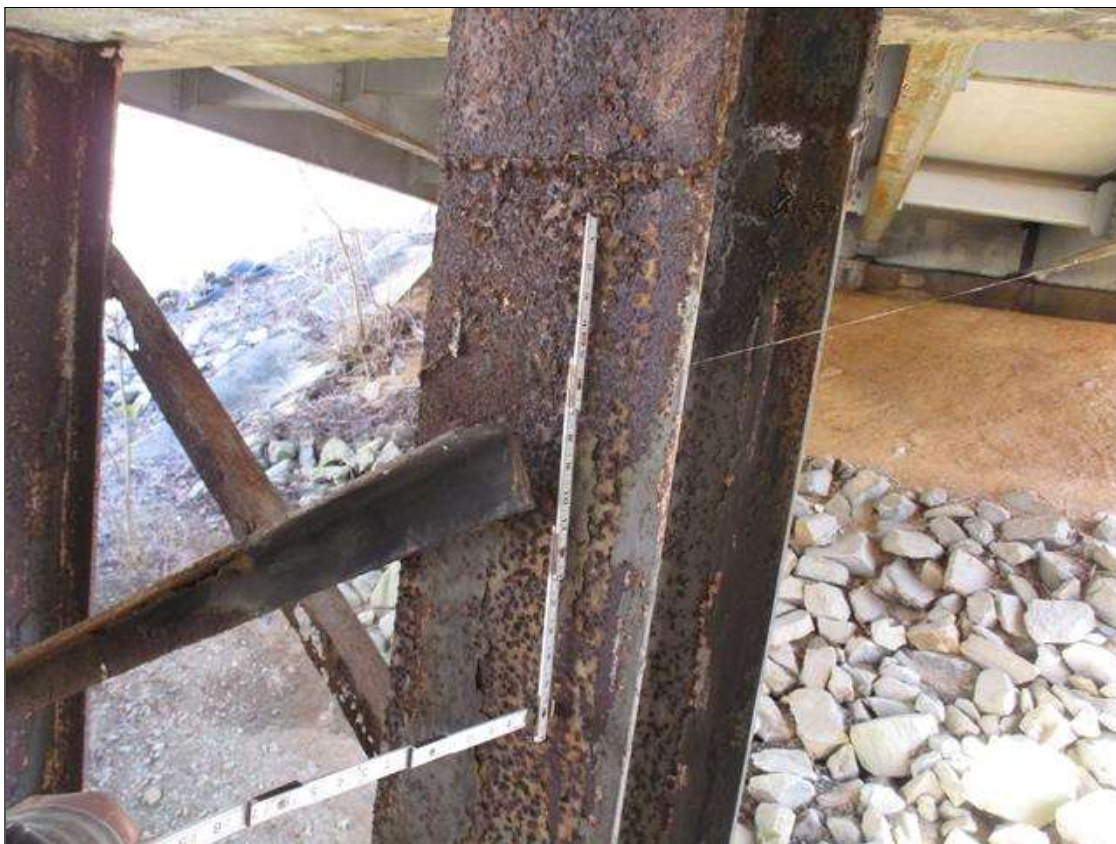
TYPICAL SURFACE CORROSION & DETERIORATED PAINT SYSTEM (BENT 3, PILE 6)

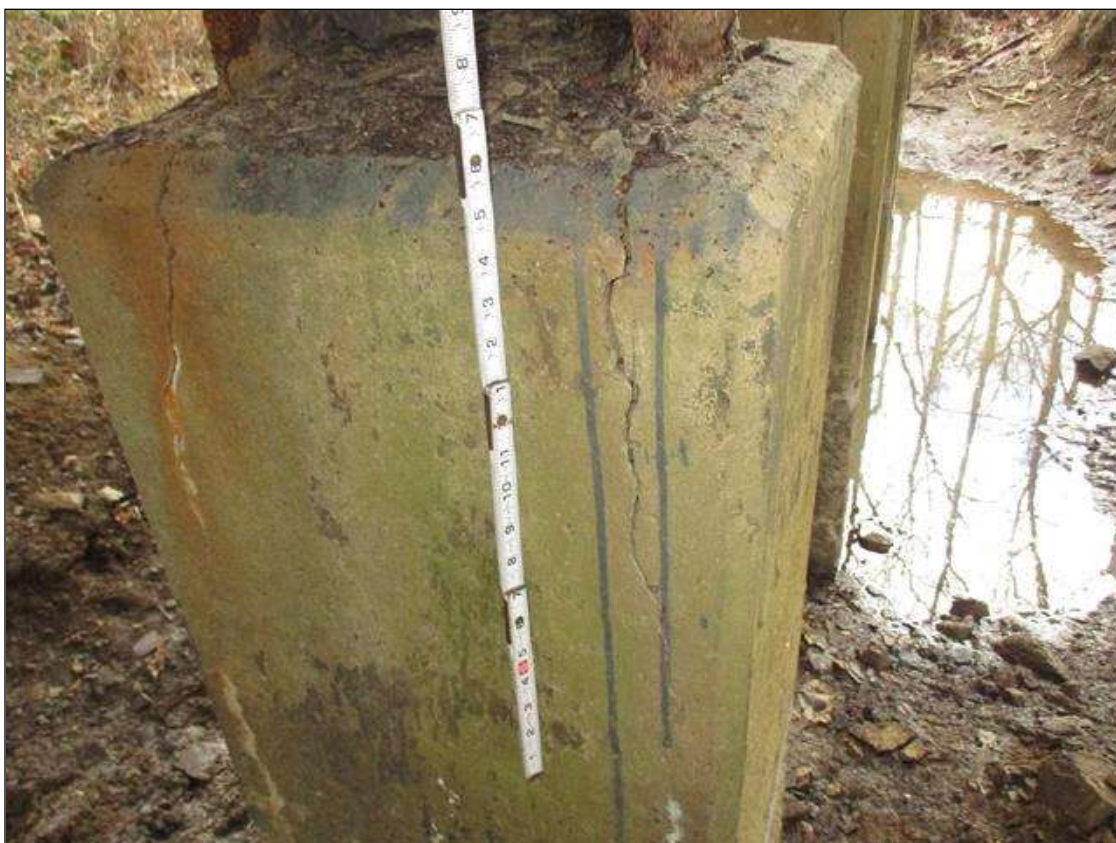
UP TO 1/4" TRANSVERSE AND VERTICAL CRACKS WITH AND WITHOUT EFFLORESCENCE IN ENCASEMENT

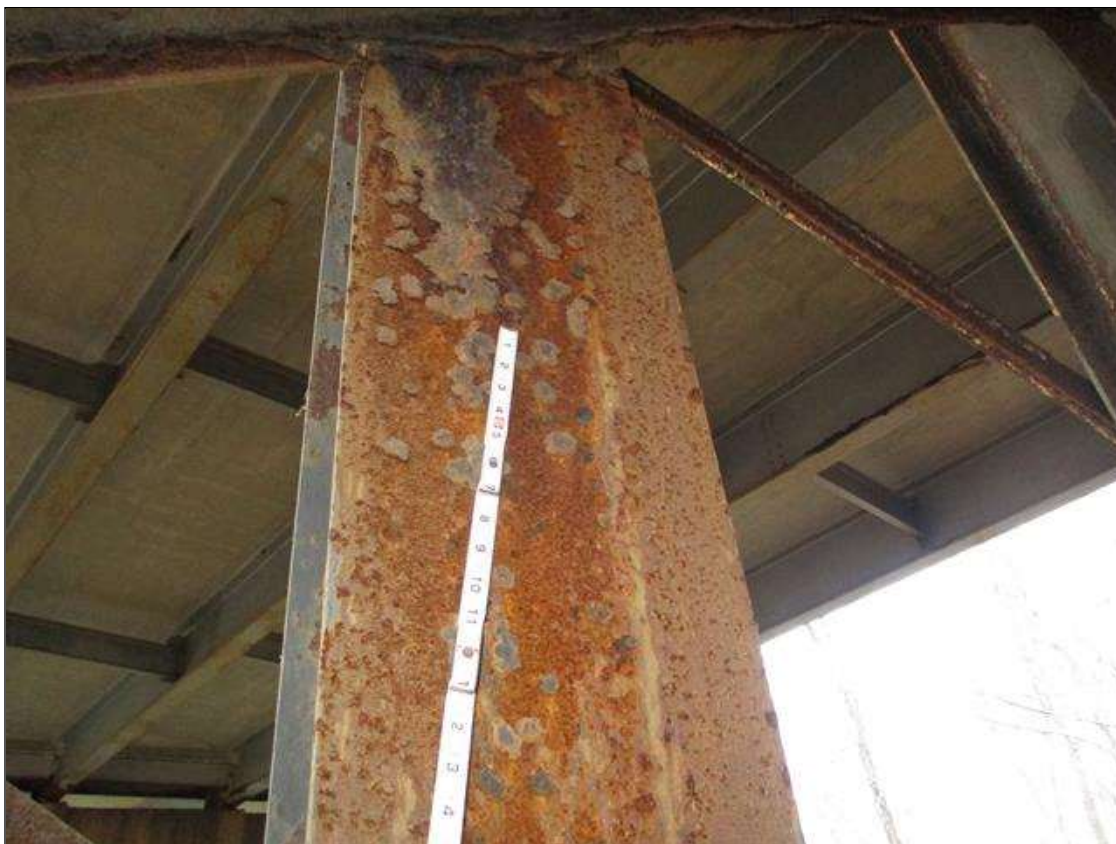
TYPICAL SURFACE CORROSION & DETERIORATED PAINT SYSTEM (BENT 3, PILE 7)

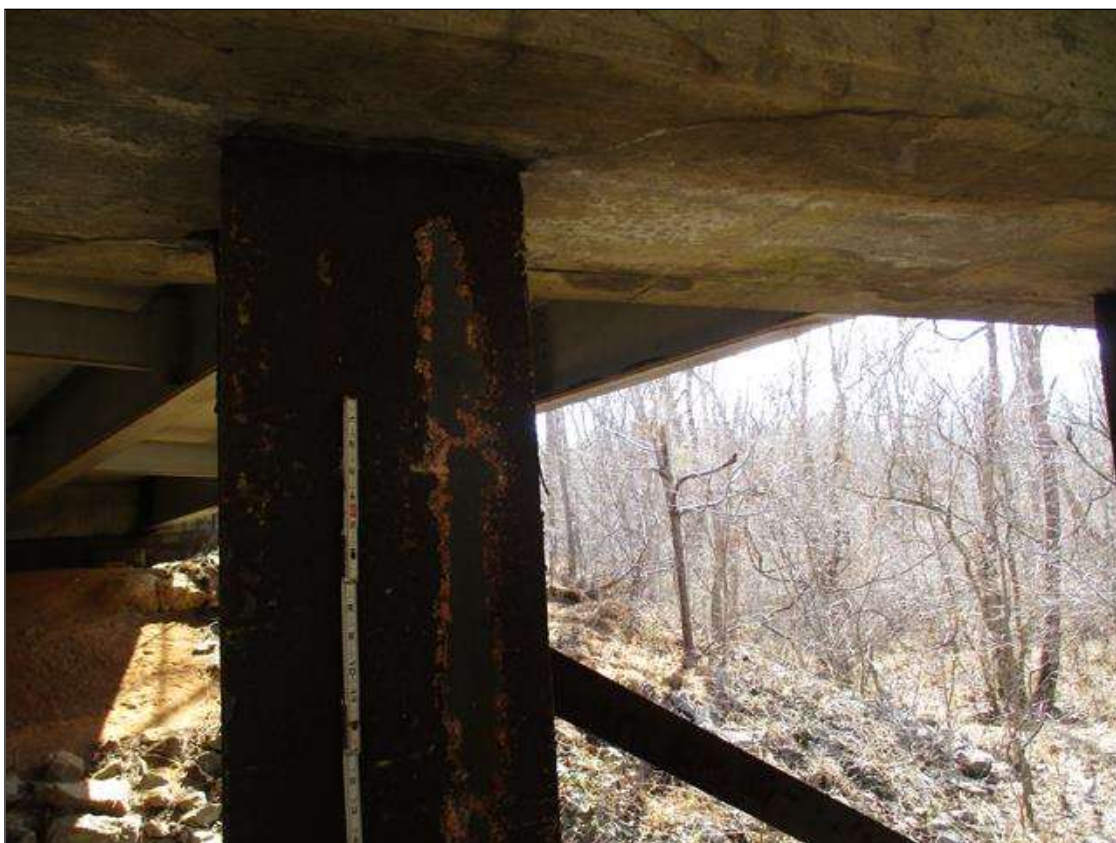
TYPICAL SURFACE CORROSION & DETERIORATED PAINT SYSTEM (BENT 3, PILE 7)

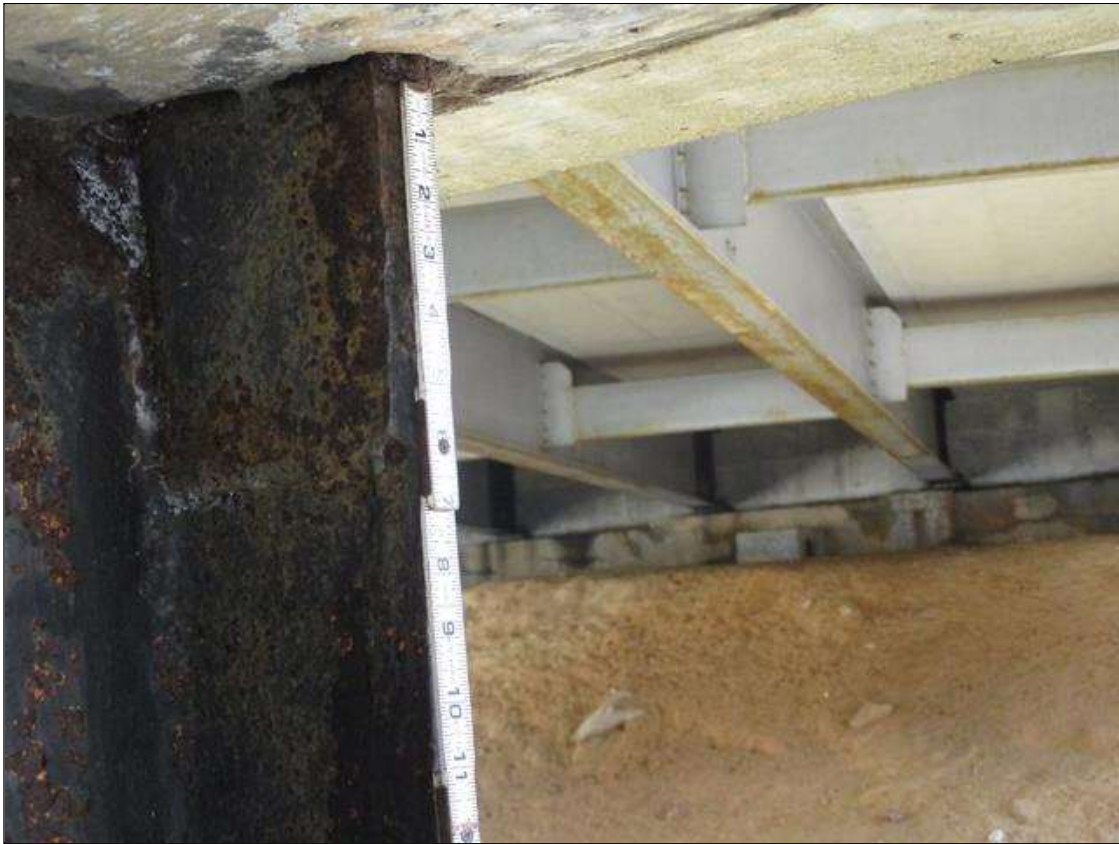
Bent 3 Pile 7: SURFACE CORROSION THROUGHOUT UP TO 12" WIDE X 9" HIGH PLATE REPAIR WELDED TO FACE OF FAR FLANGE AT BOTTOM OF CAP

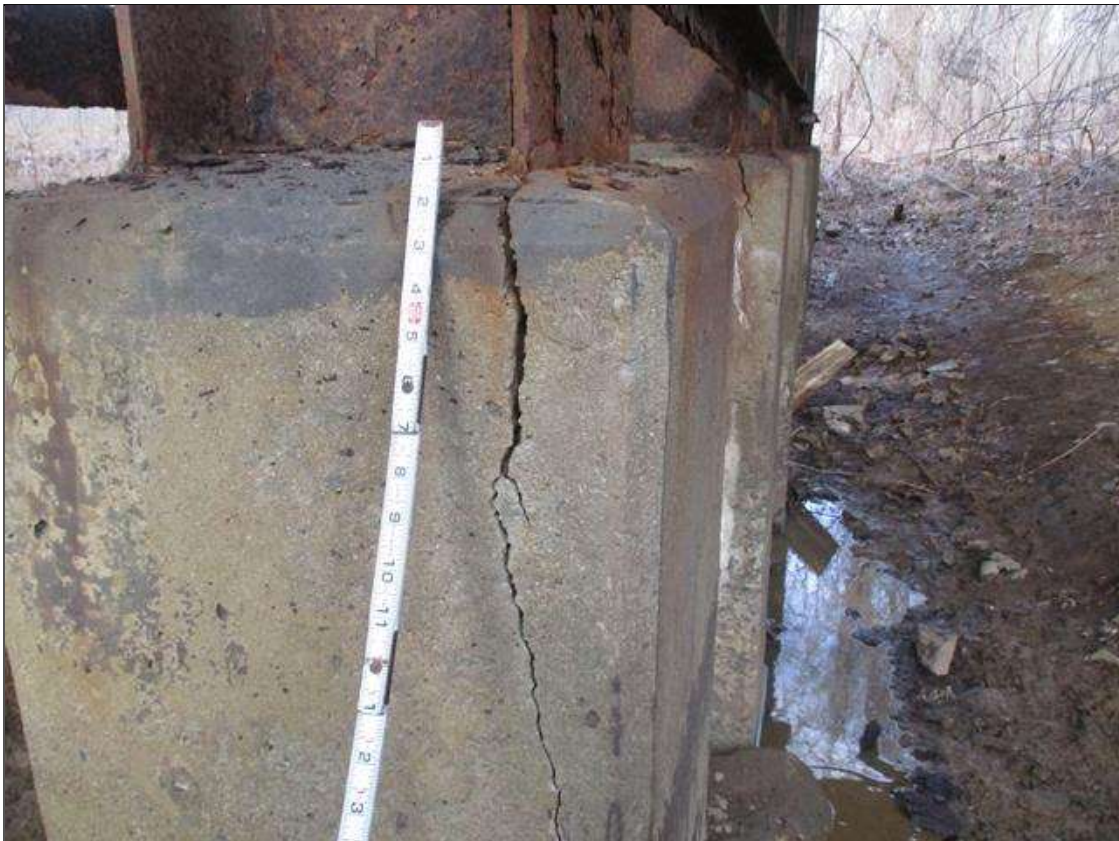
UP TO 3/8" TRANSVERSE AND VERTICAL CRACKS WITH AND WITHOUT EFFLORESCENCE IN ENCASEMENT (BENT 3, PILE 7)

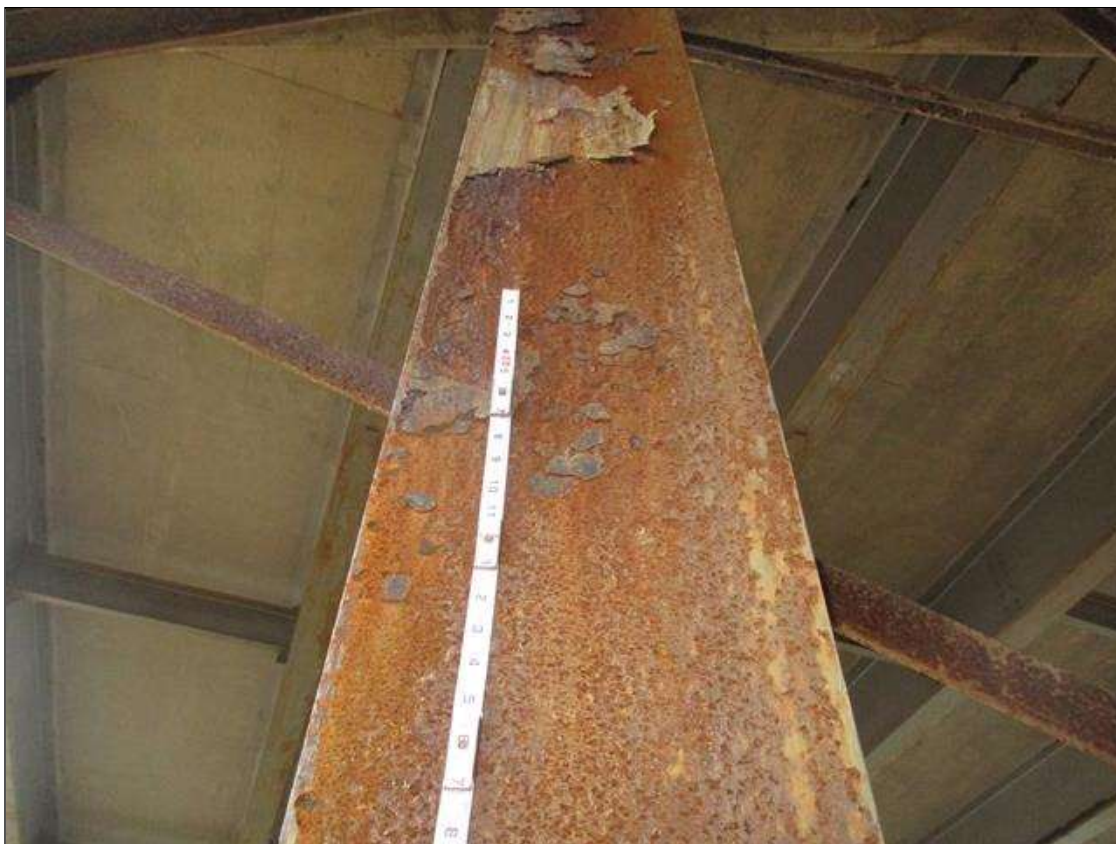
TYPICAL SURFACE CORROSION & DETERIORATED PAINT SYSTEM (BENT 3, PILE 8)

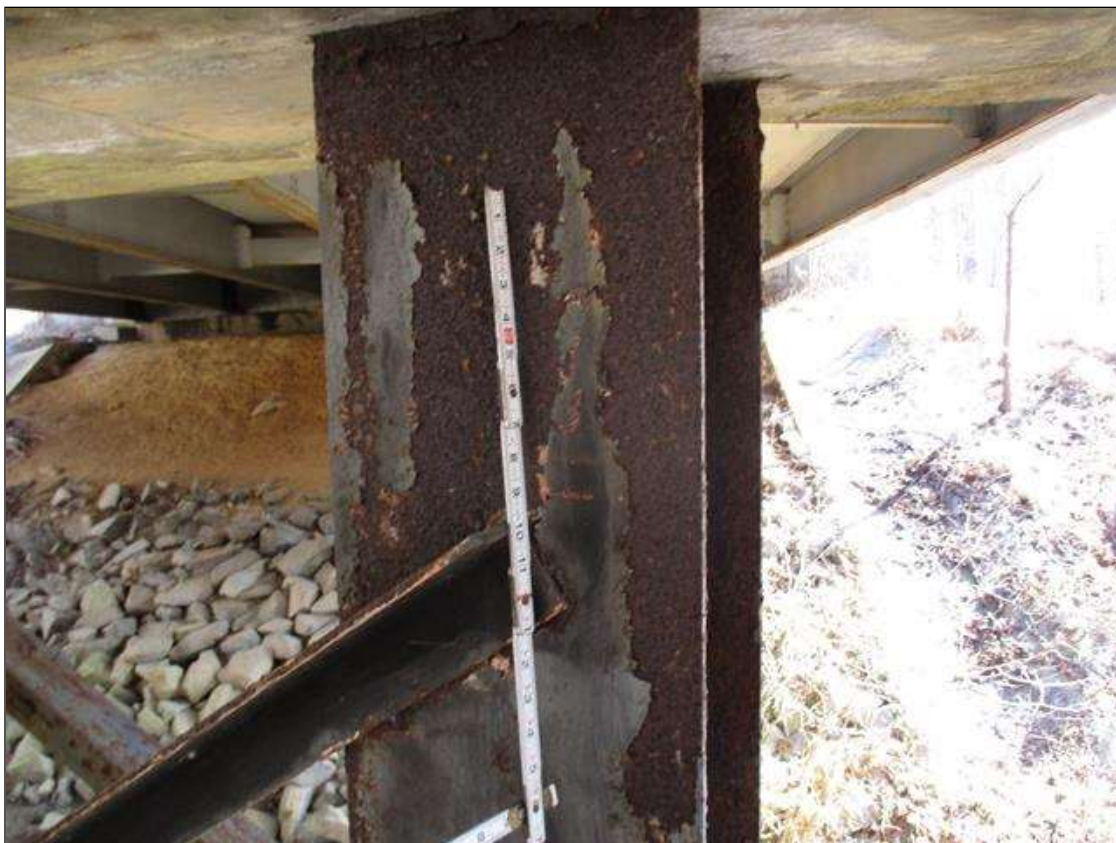
TYPICAL SURFACE CORROSION & DETERIORATED PAINT SYSTEM (BENT 3, PILE 8)

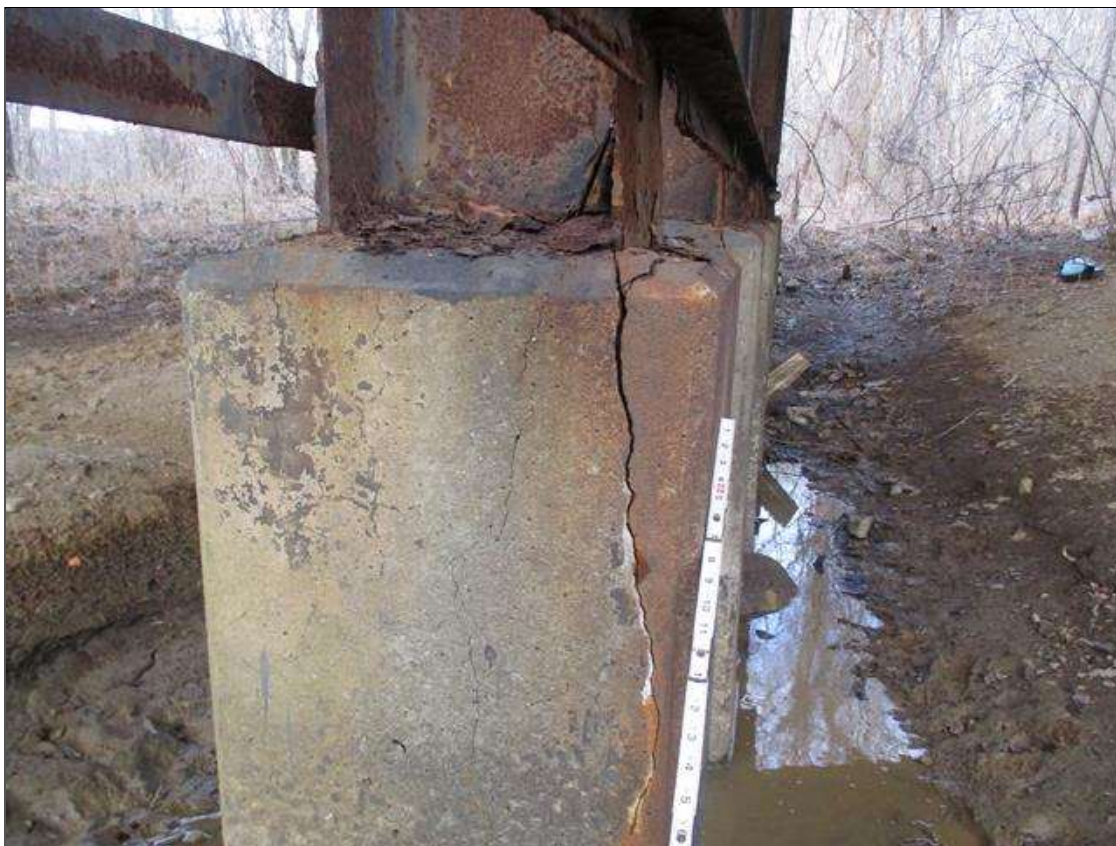
UP TO 1/4" TRANSVERSE & VERTICAL CRACKS WITH & WITHOUT EFFLORESCENCE IN ENCASEMENT. TOP 2' OF EAST FACE BEGINNING TO DELAMINATE

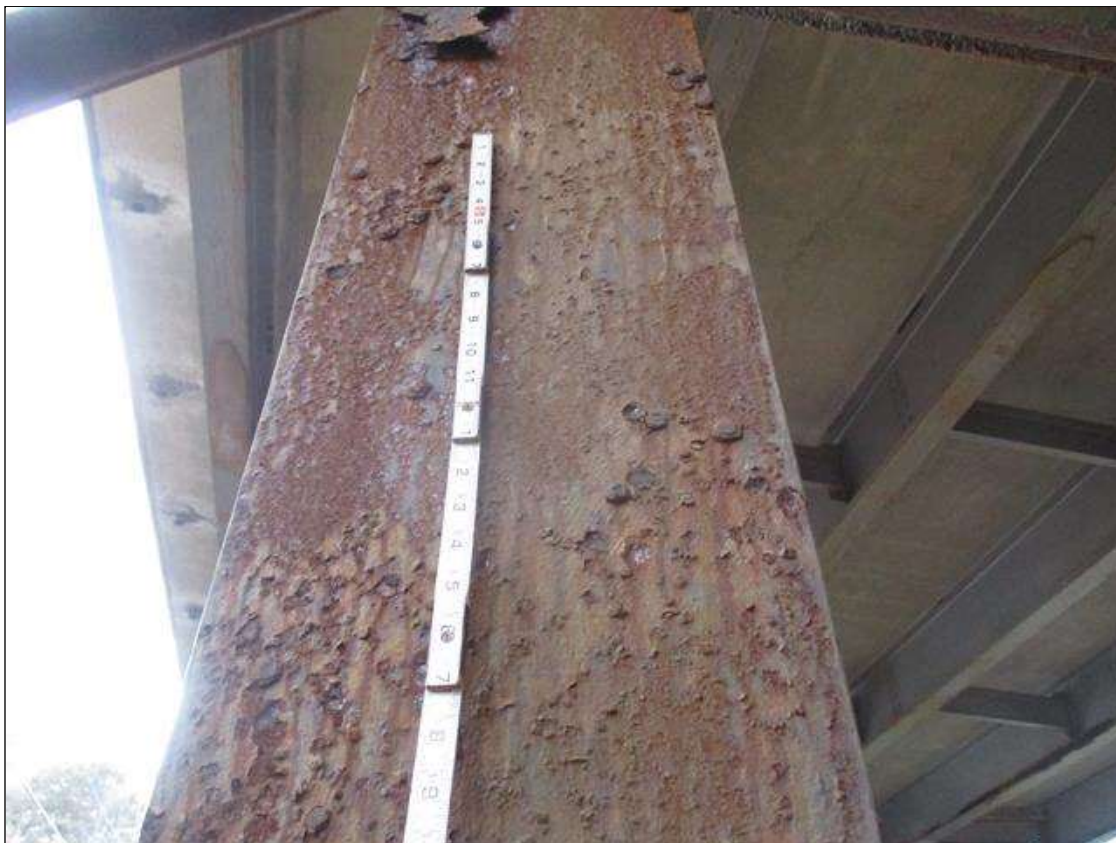
TYPICAL SURFACE CORROSION & DETERIORATED PAINT SYSTEM (BENT 3, PILE 9)

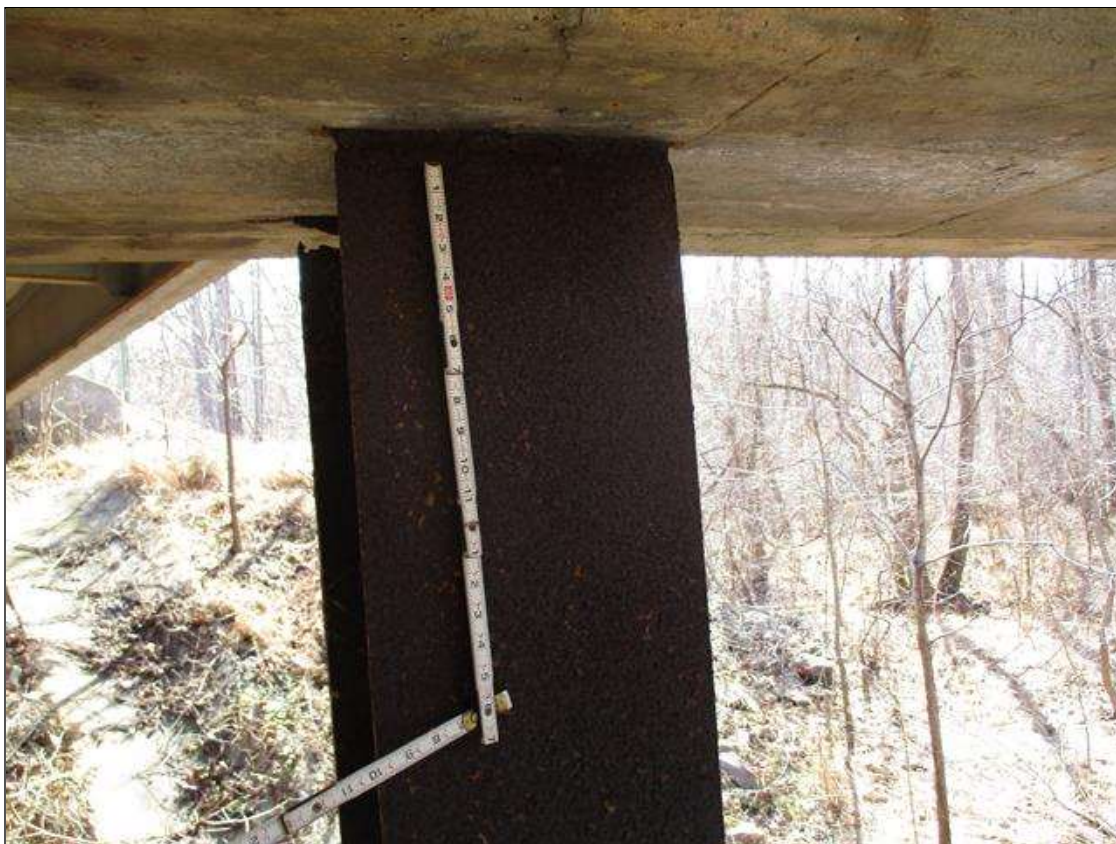
TYPICAL SURFACE CORROSION & DETERIORATED PAINT SYSTEM (BENT 3, PILE 9)

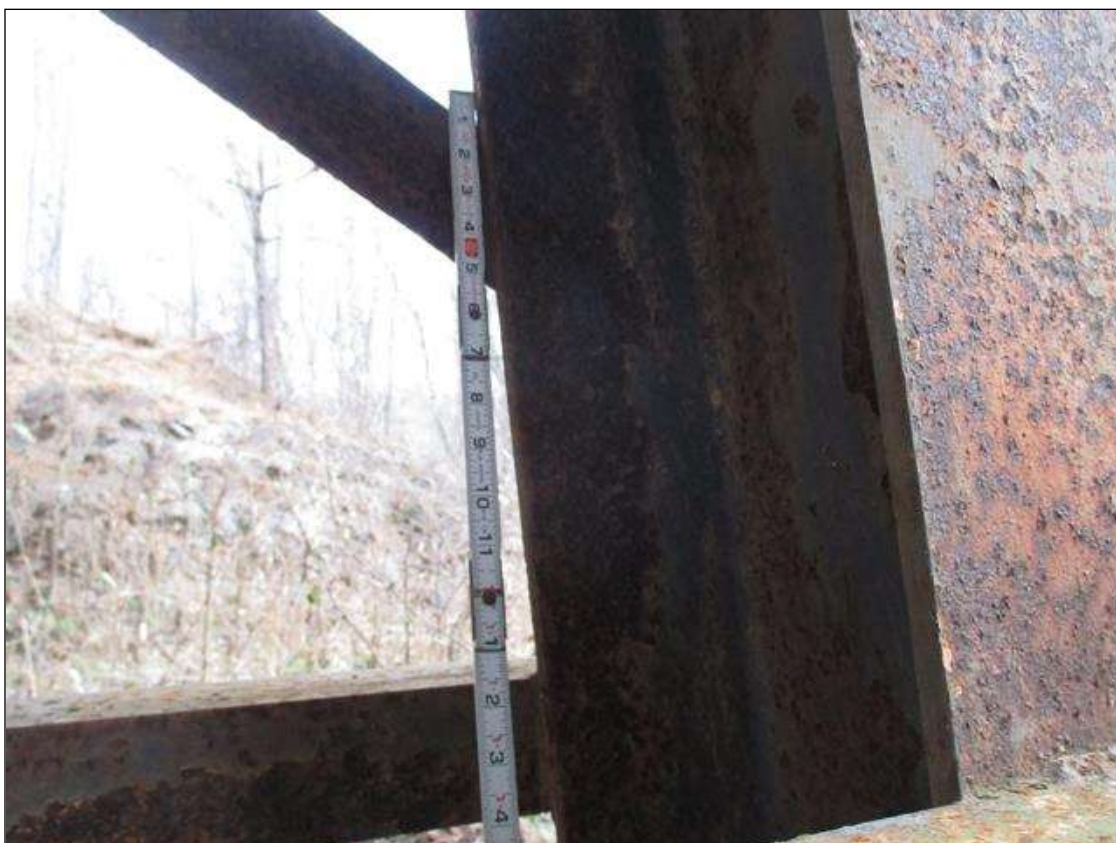
TYPICAL SURFACE CORROSION & DETERIORATED PAINT SYSTEM (BENT 3, PILE 10)

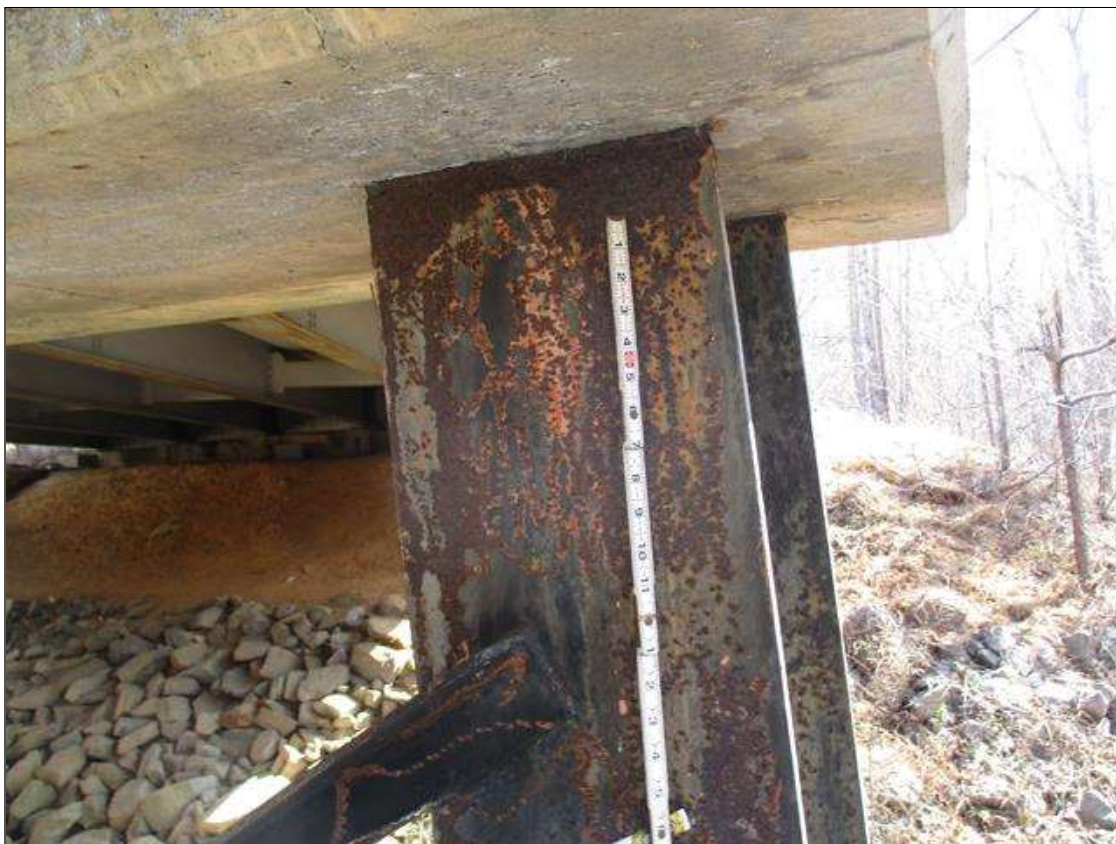
TYPICAL SURFACE CORROSION & DETERIORATED PAINT SYSTEM (BENT 3, PILE 10)

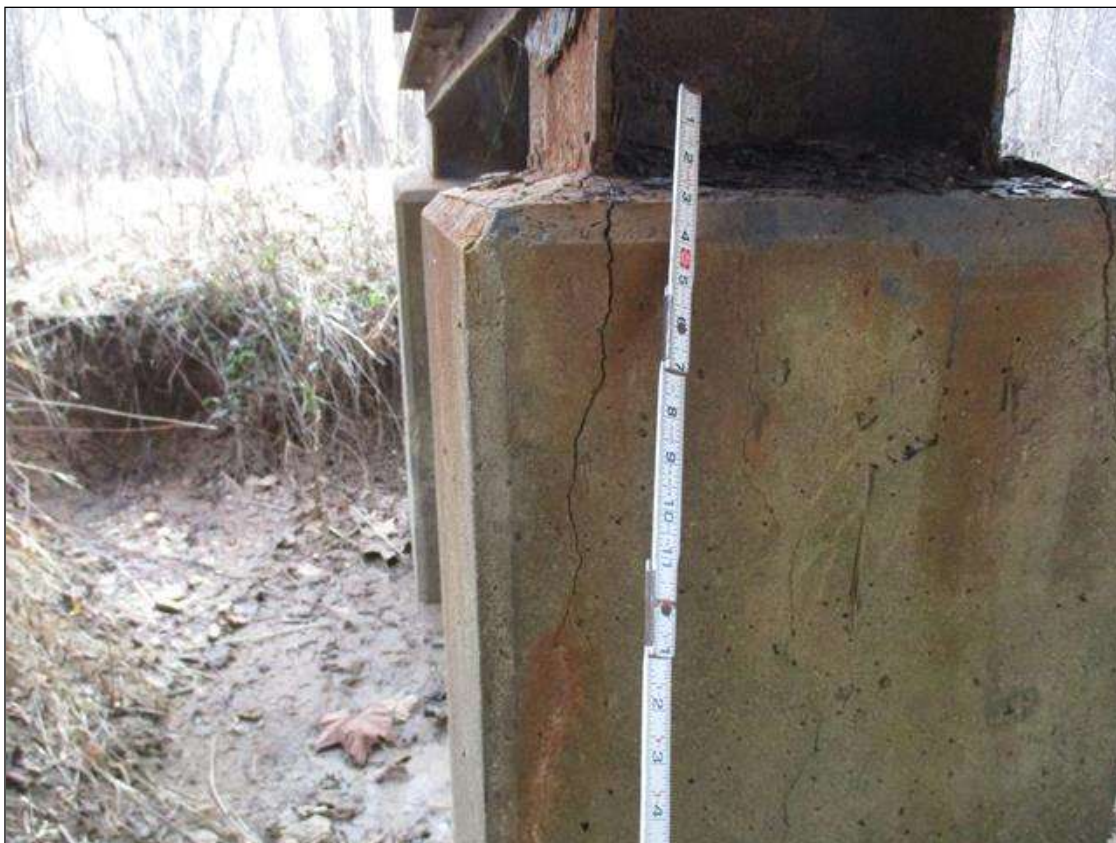
UP TO 1/8" TRANSVERSE & VERTICAL CRACKS WITH AND WITHOUT EFFLORESCENCE IN ENCASEMENT
