NC DEPARTMENT OF TRANSPORTATION  
 DIVISION OF HIGHWAYS  
 STRUCTURE MANAGEMENT UNIT

ATTENTION: PARS SUBMITTED

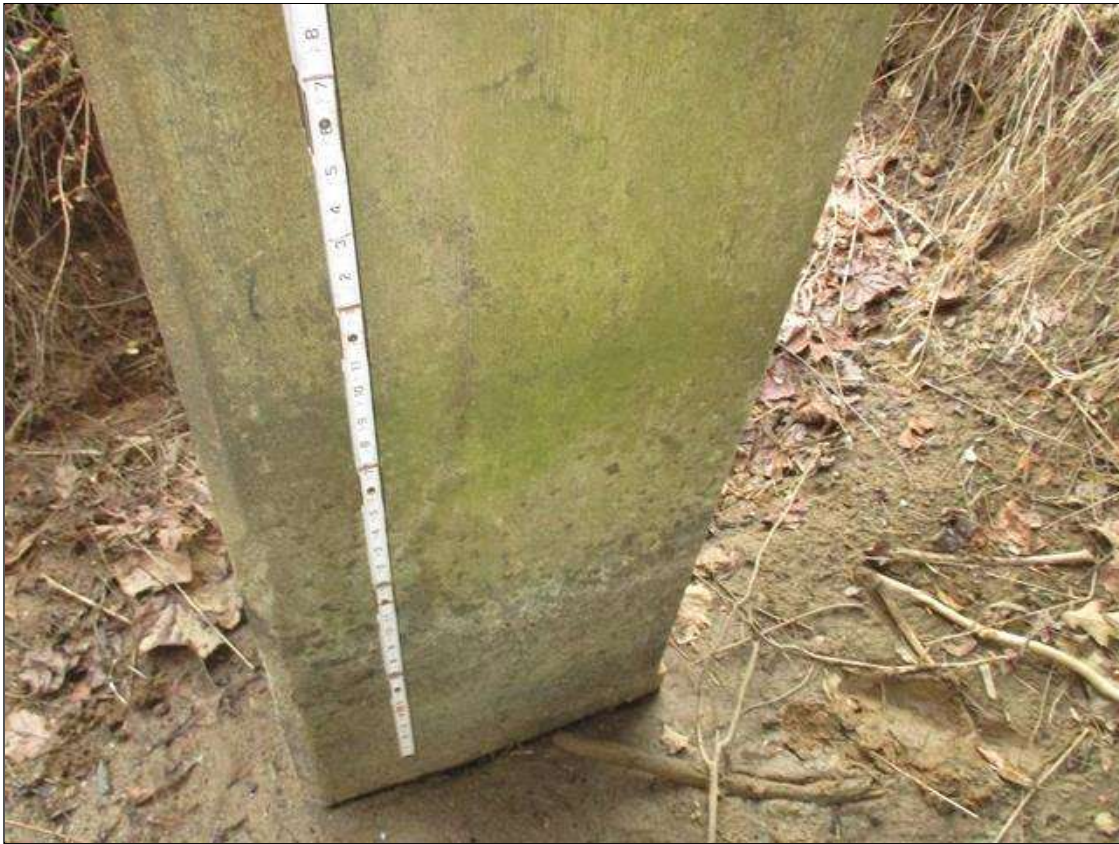
UP TO 0.03" TRANSVERSE & VERTICAL CRACKS IN ENCASEMENT

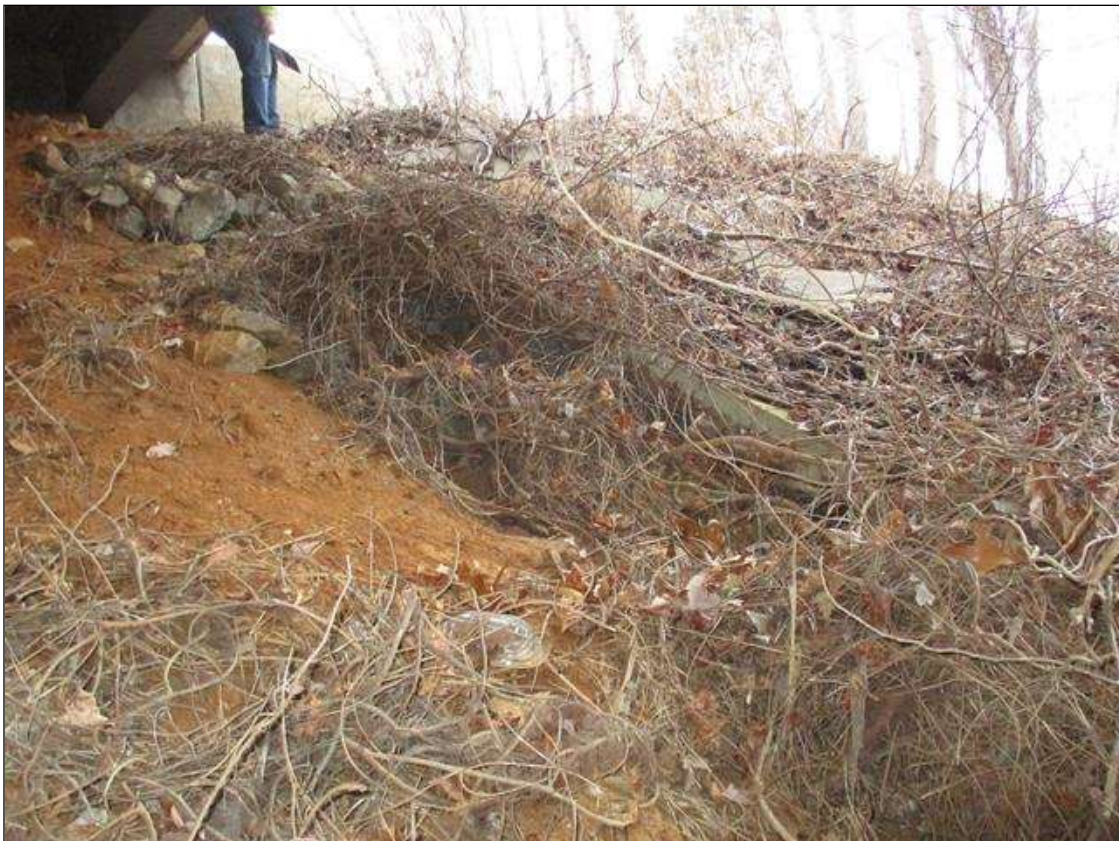
CONCRETE SWALE @ END BENT 1 ON LEFT SIDE IS UNDERMINED FOR ITS ENTIRE LENGTH

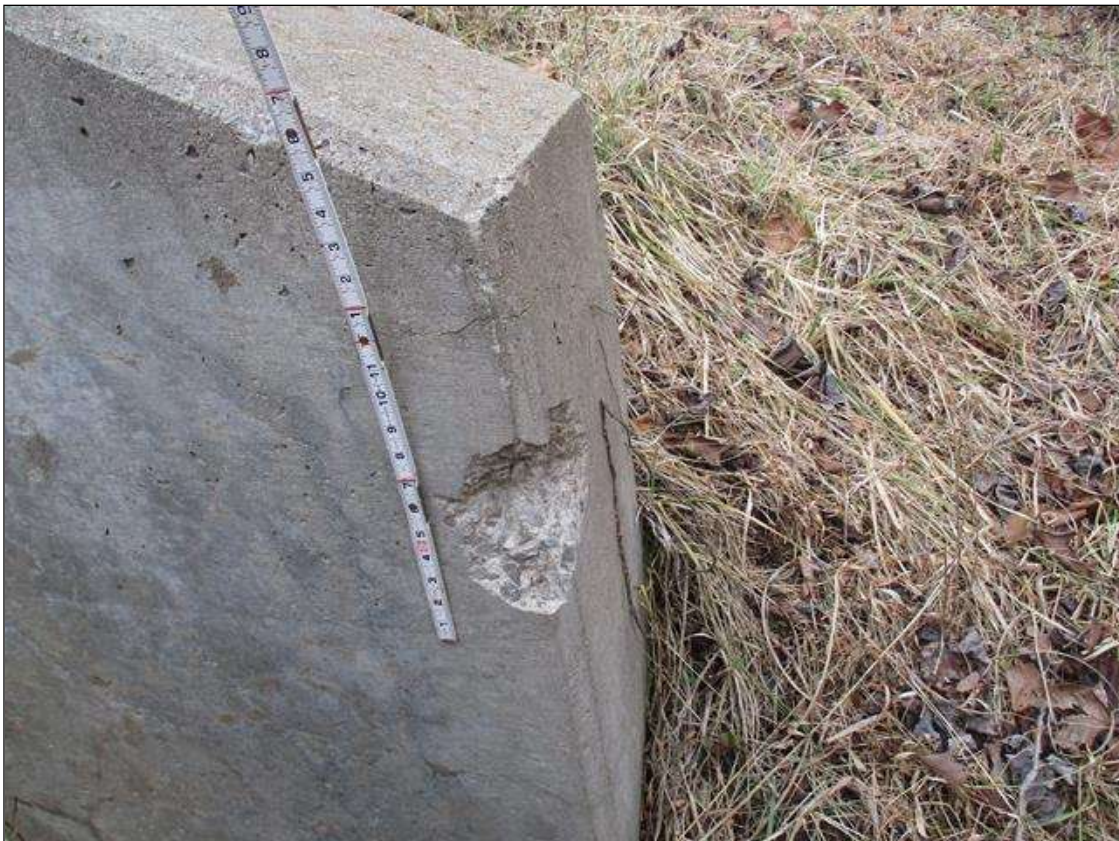
FAR RIGHT WING, 6" DIAMETER X 2" DEEP EDGE SPALL

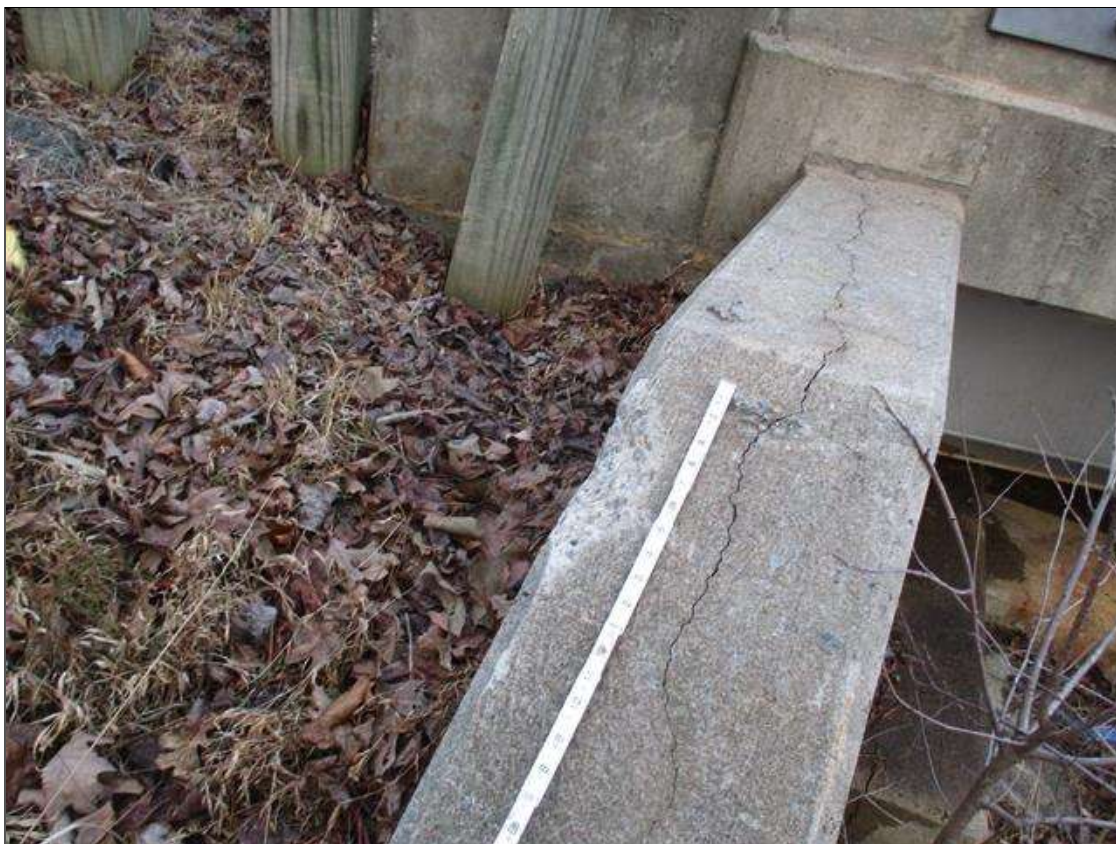
NEAR RIGHT WING, 3' LONGITUDINAL CRACK 0.0625" WIDE AND 6" X 3" X 0.5" DEEP SPALL ALONG TOP OF WALL

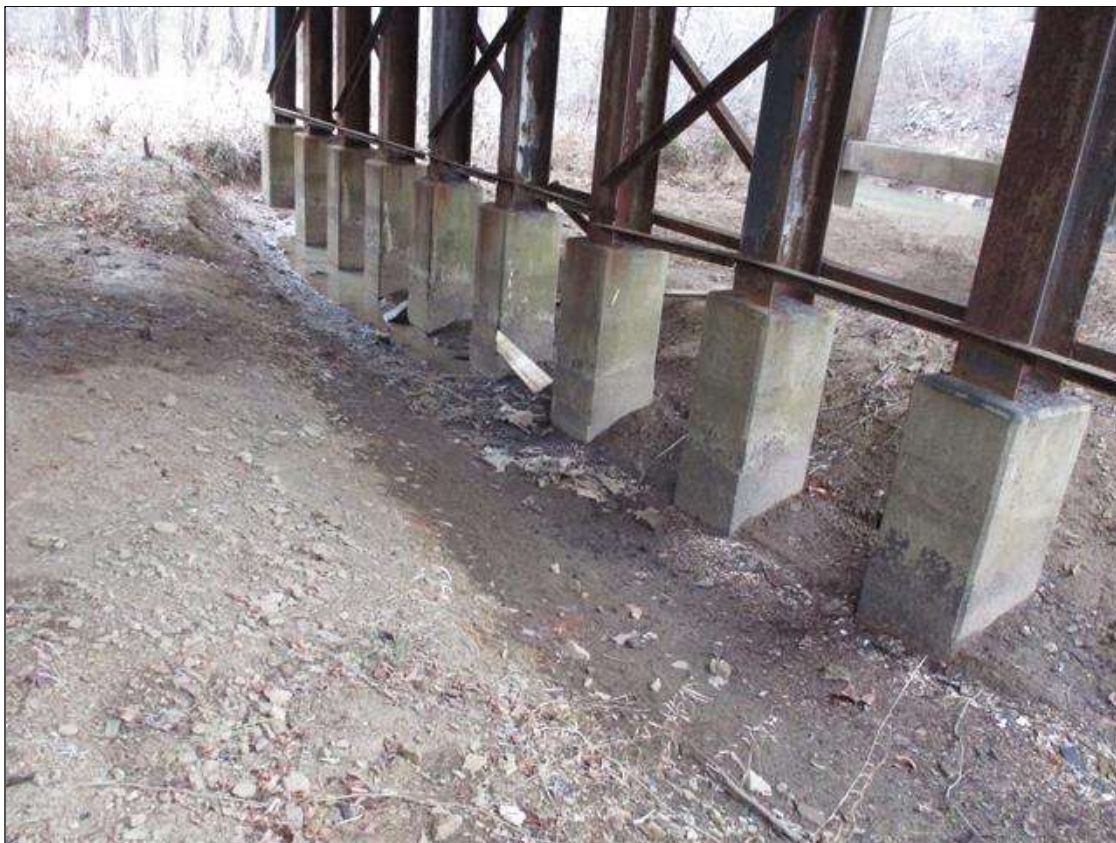
AT BENT 3, SCOUR HOLE AROUND ALL PILES, 50' LONG X 12' WIDE X UP TO 2.5' DEEP

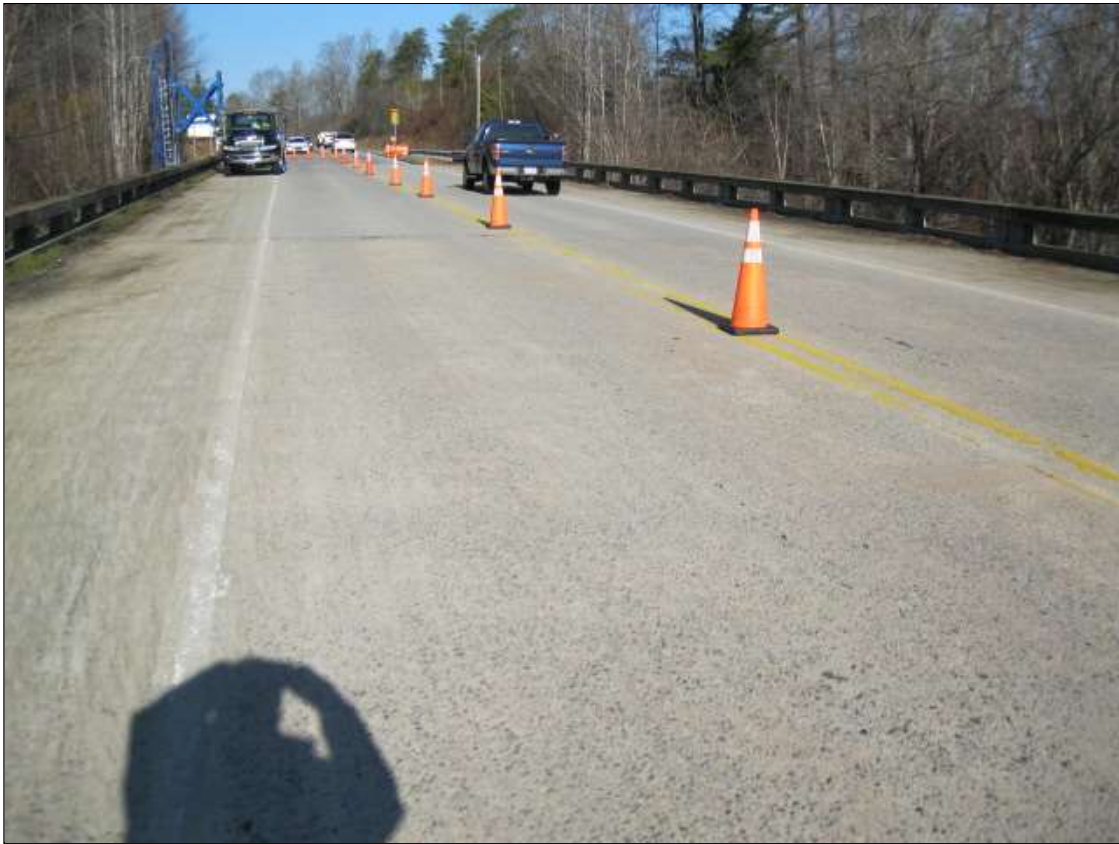
TYPICAL WEARING SURFACE

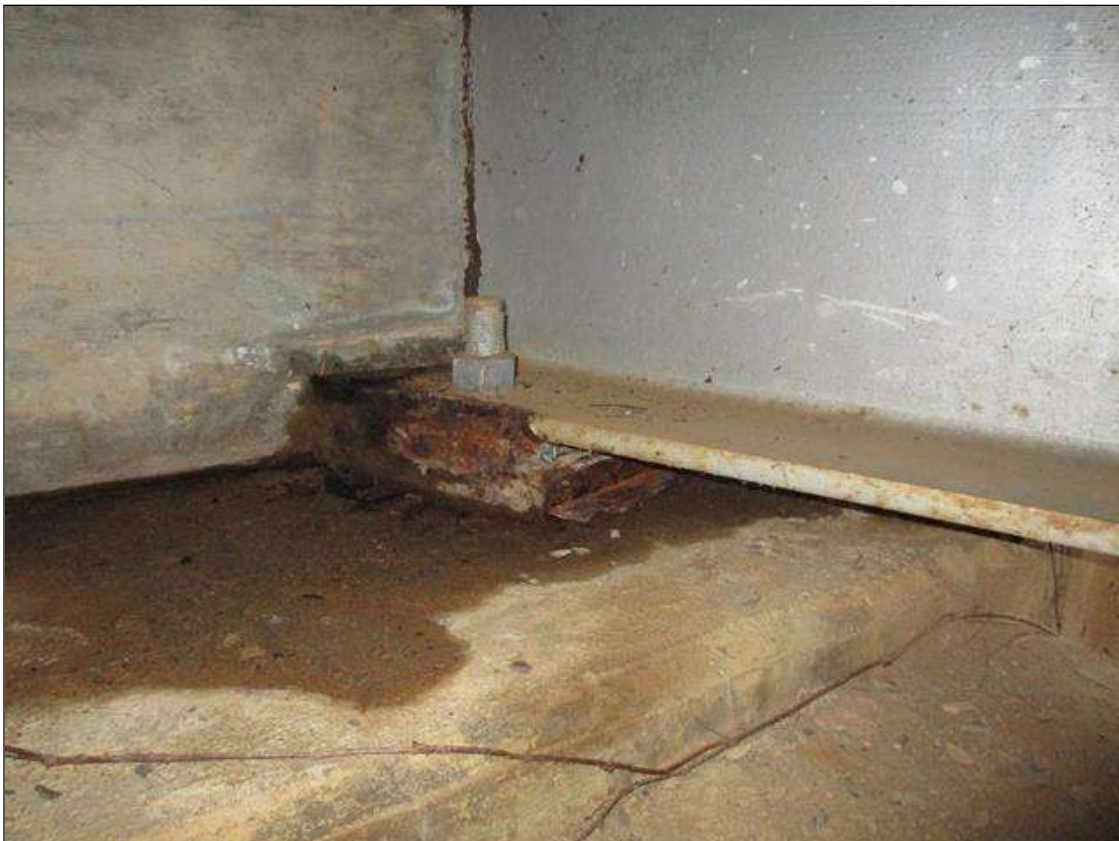
TYPICAL END BENT BEARING (END BENT 1 SHOWN)

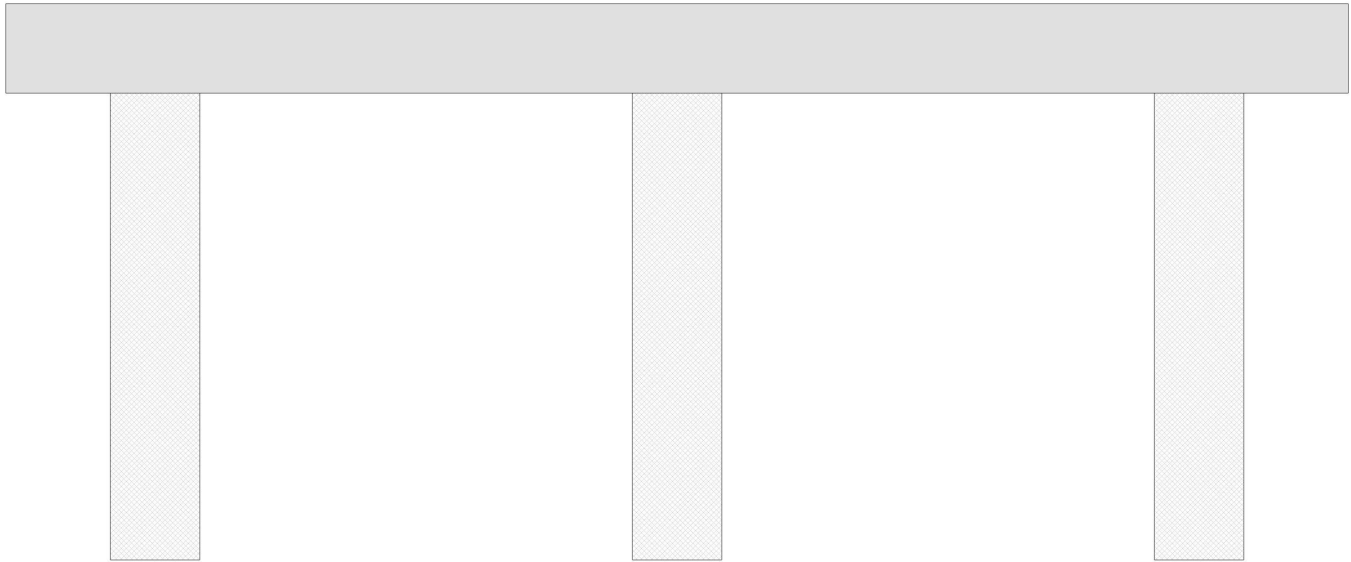
<b>Cap Information</b>			Material Cast-in-Place Concrete							
Length	Width	Height	Left Overhang	Right Overhang	Left Beam to End of Cap.	Right Beam to End of Cap.				
45.0 ft.	2.5 ft.	3.0 ft.	4.5 ft.	4.5 ft.	1.25 ft.	1.25 ft.				
<b>Subcap Information</b>			Material							
Length	Width	Height	Left Overhang	Right Overhang	Left Pile to Splice.					
<b>Sill Information</b>			Material							
Length	Width	Height								
Pile #	Material	Spacing	Width/Dia.	Height	Length	Orientation	Driven?	Replacement?	Removed?	Collar?
1	Concrete	18.0 ft.	2.5 ft.	2.5 ft.			No	No	No	No
2	Concrete	18.0 ft.	2.5 ft.	2.5 ft.			No	No	No	No
3	Concrete		2.5 ft.	2.5 ft.			No	No	No	No
Bent: 1			Similar Bent: 2

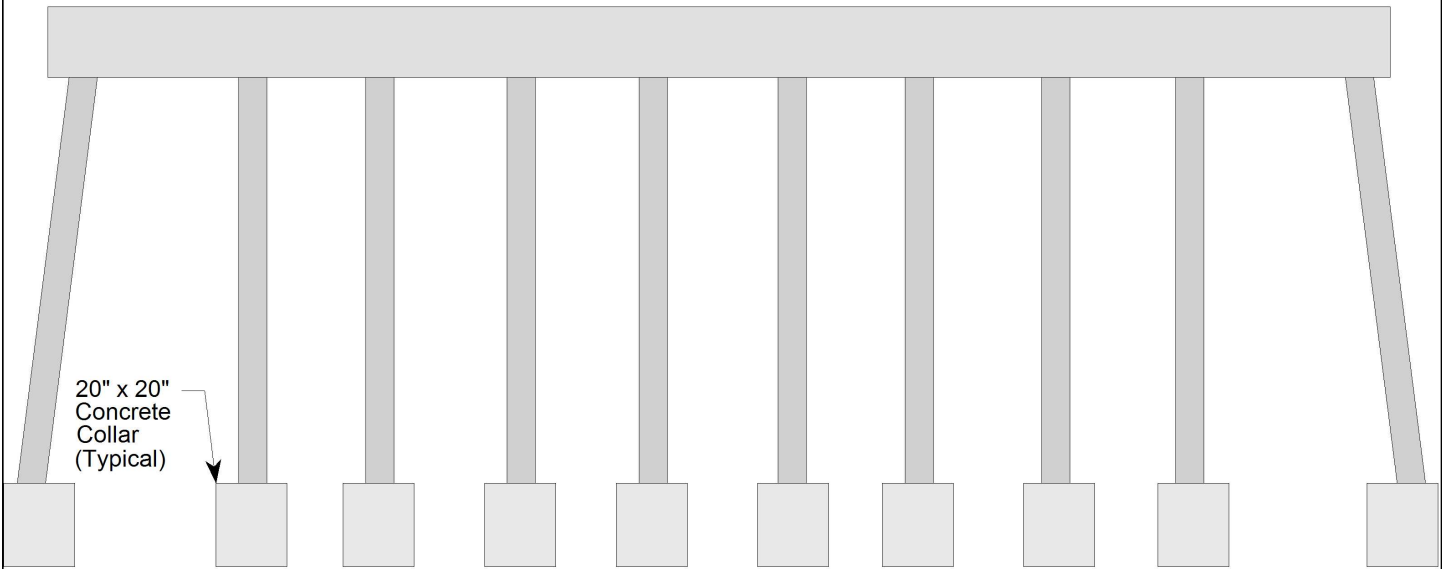
<b>Cap Information</b>			<b>Material</b> Cast-in-Place Concrete							
Length	Width	Height	Left Overhang	Right Overhang	Left Beam to End of Cap.	Right Beam to End of Cap.
