NC DEPARTMENT OF TRANSPORTATION
 DIVISION OF HIGHWAYS
 STRUCTURE MANAGEMENT UNIT

ATTENTION:

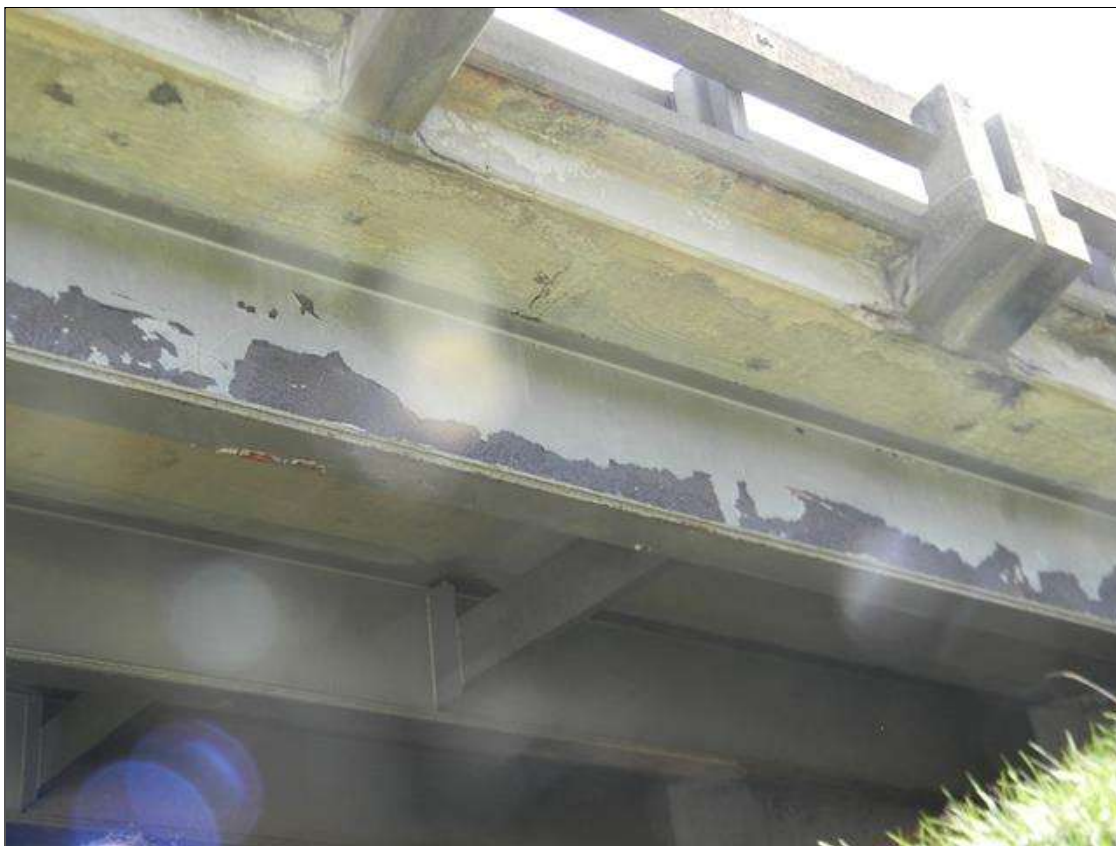
Span 3 Beam 4: PEELING PAINT ALLOWING SURFACE CORROSION ON THE EXTERIOR OF THE WEB.

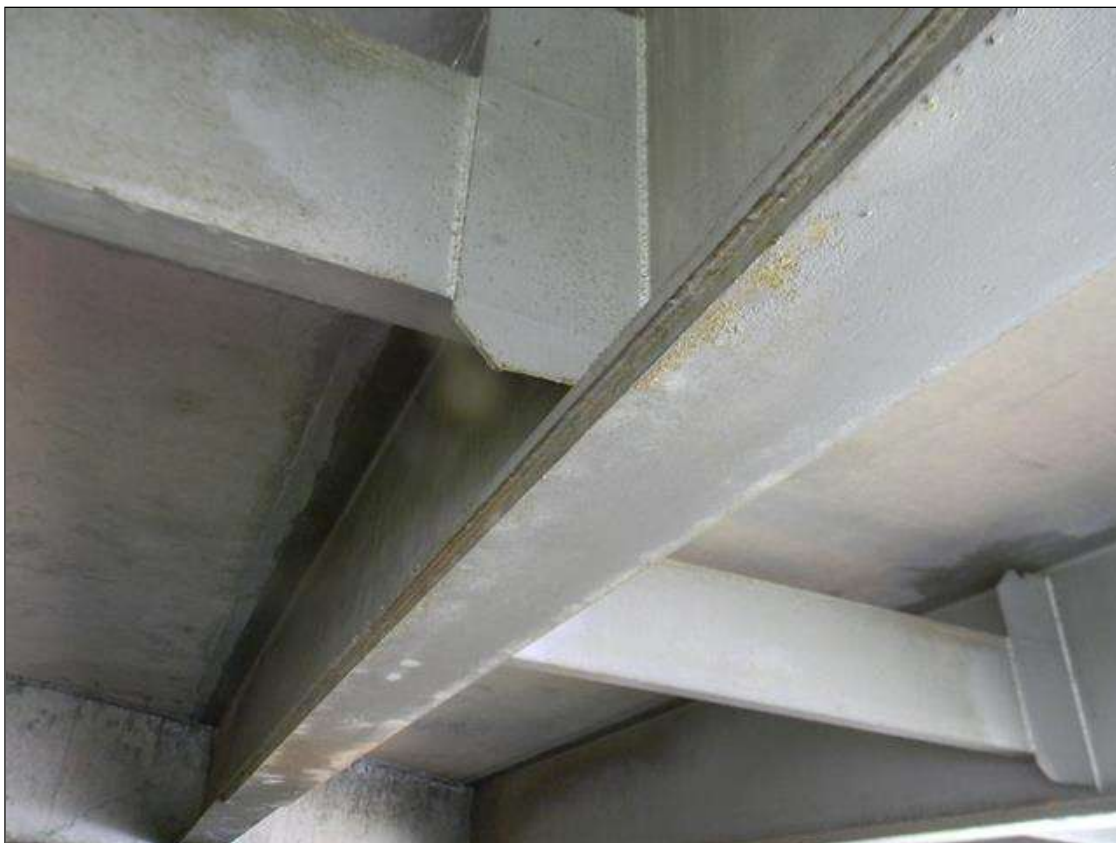
Span 3 Beam 2: FRECKLED RUST ALONG THE BOTTOM FLANGE AND LOWER 2" OF THE WEB.

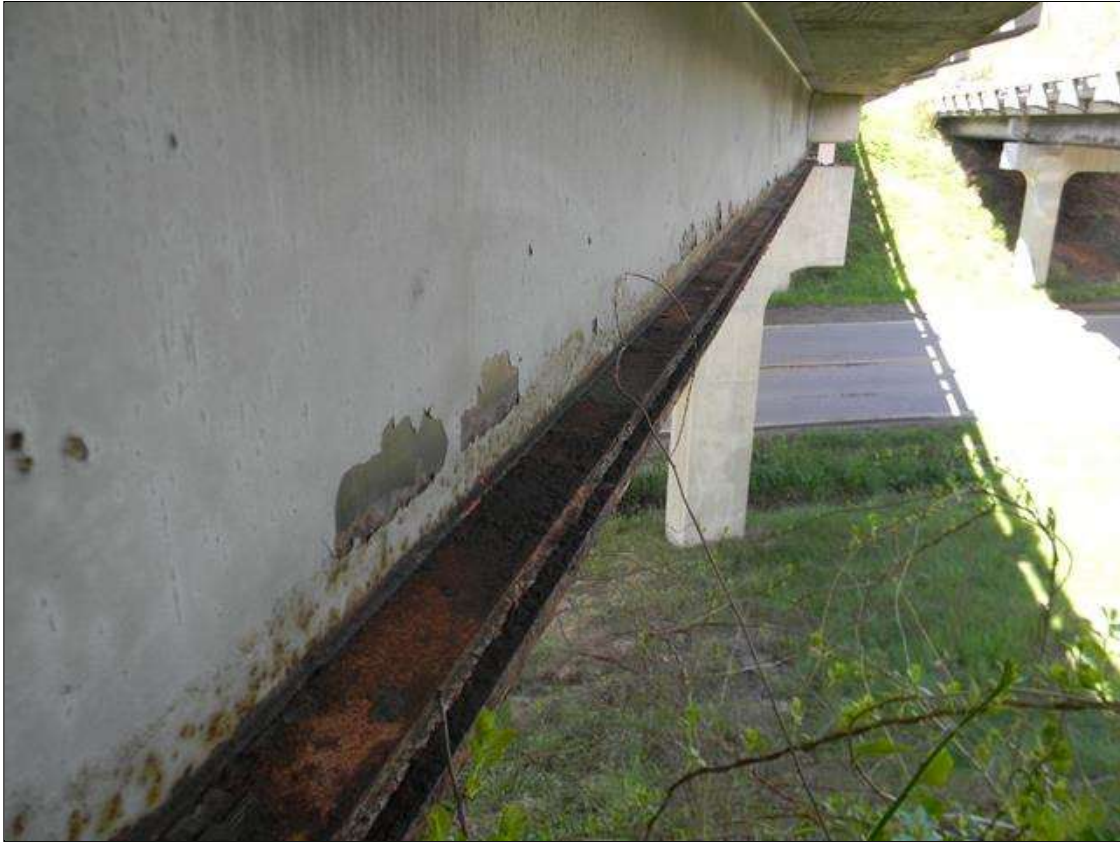
Span 3 Beam 1: LOSS OF PAINT ALONG THE TOP OF THE BOTTOM FLANGE ALLOWING 1/16" PITTING ALONG THE FLANGE AND LOWER WEB.

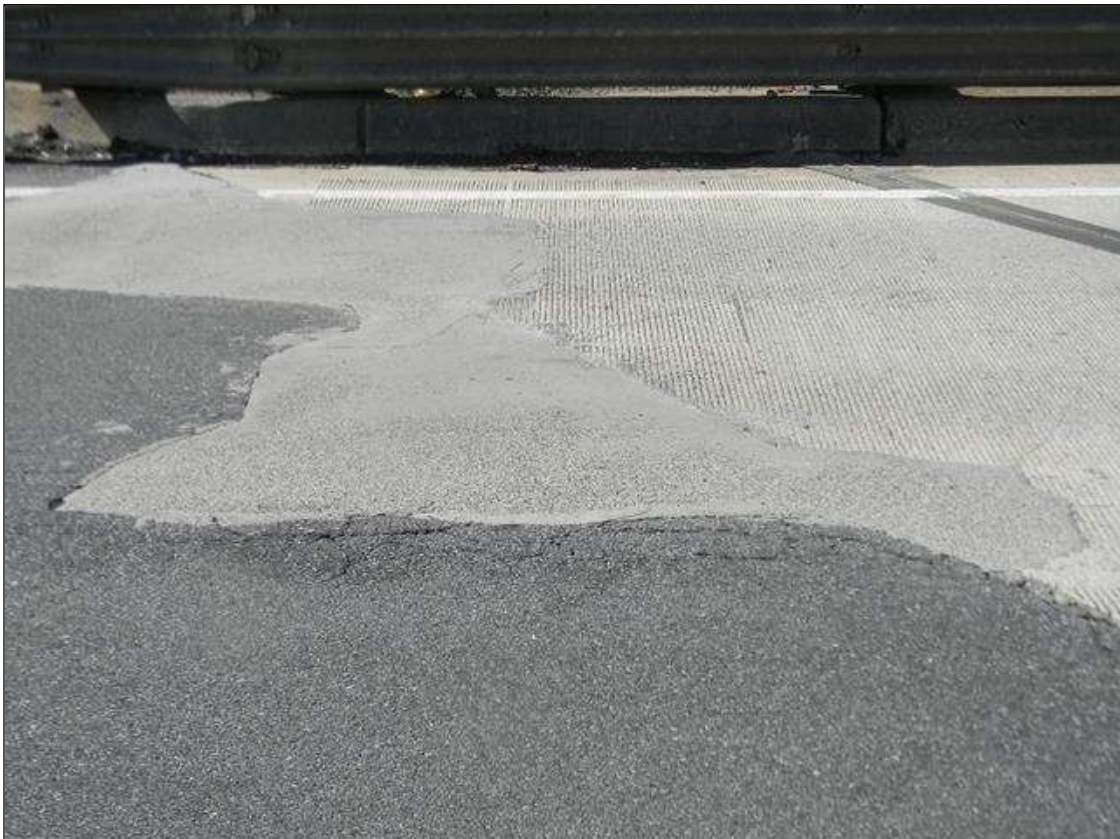
Approach 2: THE EAST APPROACH WEARING SURFACE AND APPROACH SLAB ARE PATCHED IN THE RIGHT LANE. PATCHES ARE IN GOOD CONDITION.

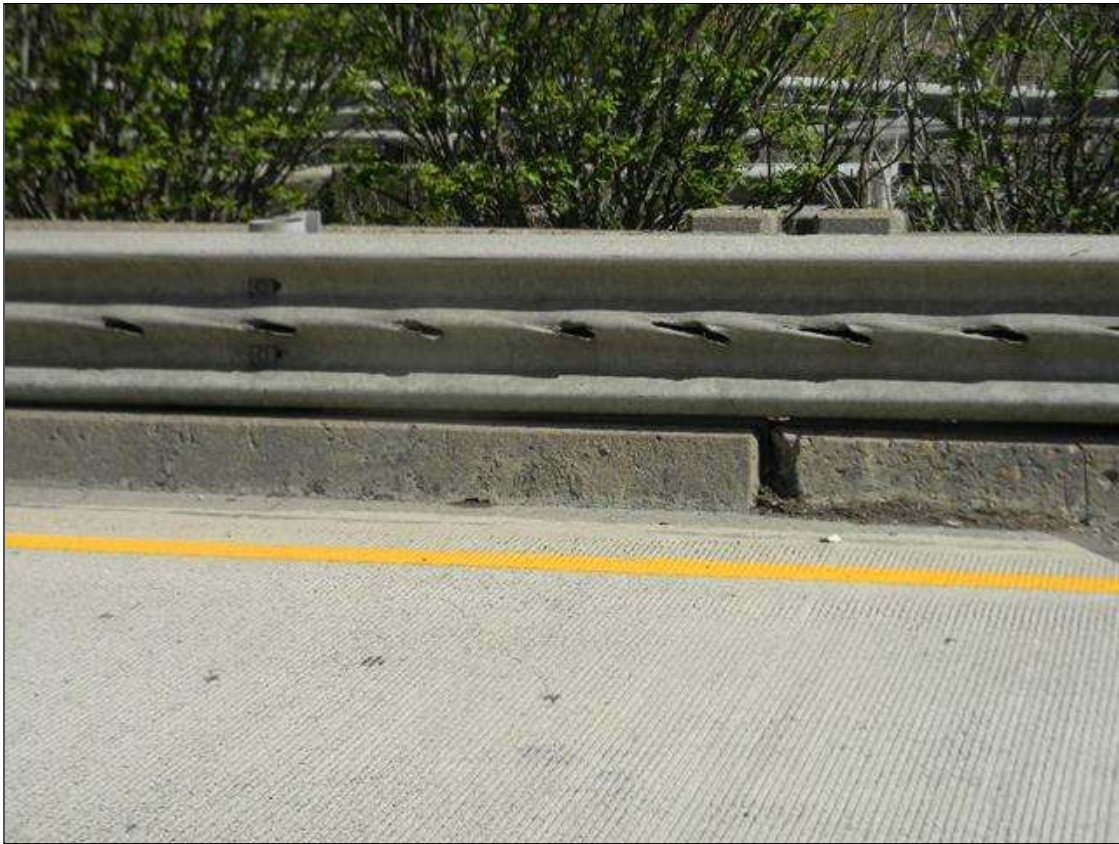
Span 3 Left Bridge Rail: THE LEFT RAIL HAS MINOR SCRAPE DAMAGE, WITH SOME TEARS IN THE STEEL FOR THE FULL LENGTH IN ALL SPANS.

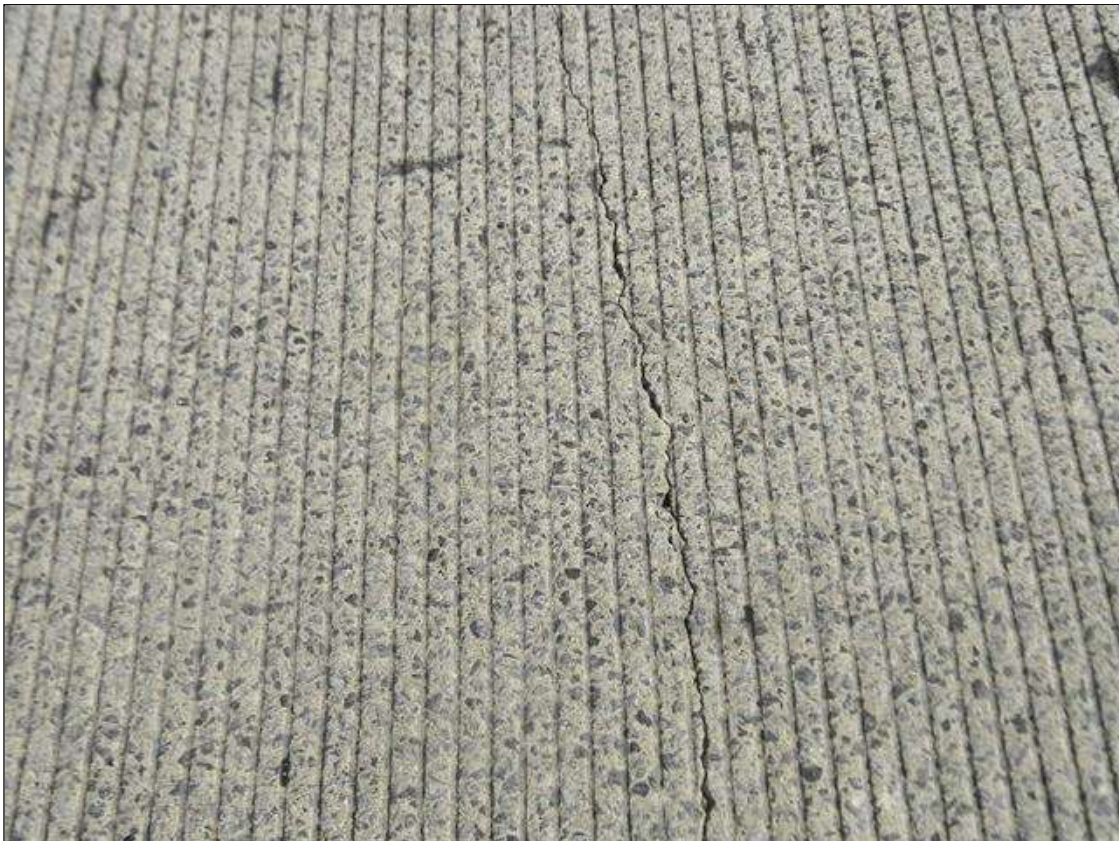
Span 3 Latex Modified Concrete Wearing Surface: WEARING SURFACE HAS SCATTERED MAP CRACKS UP TO 1/16" WIDE.

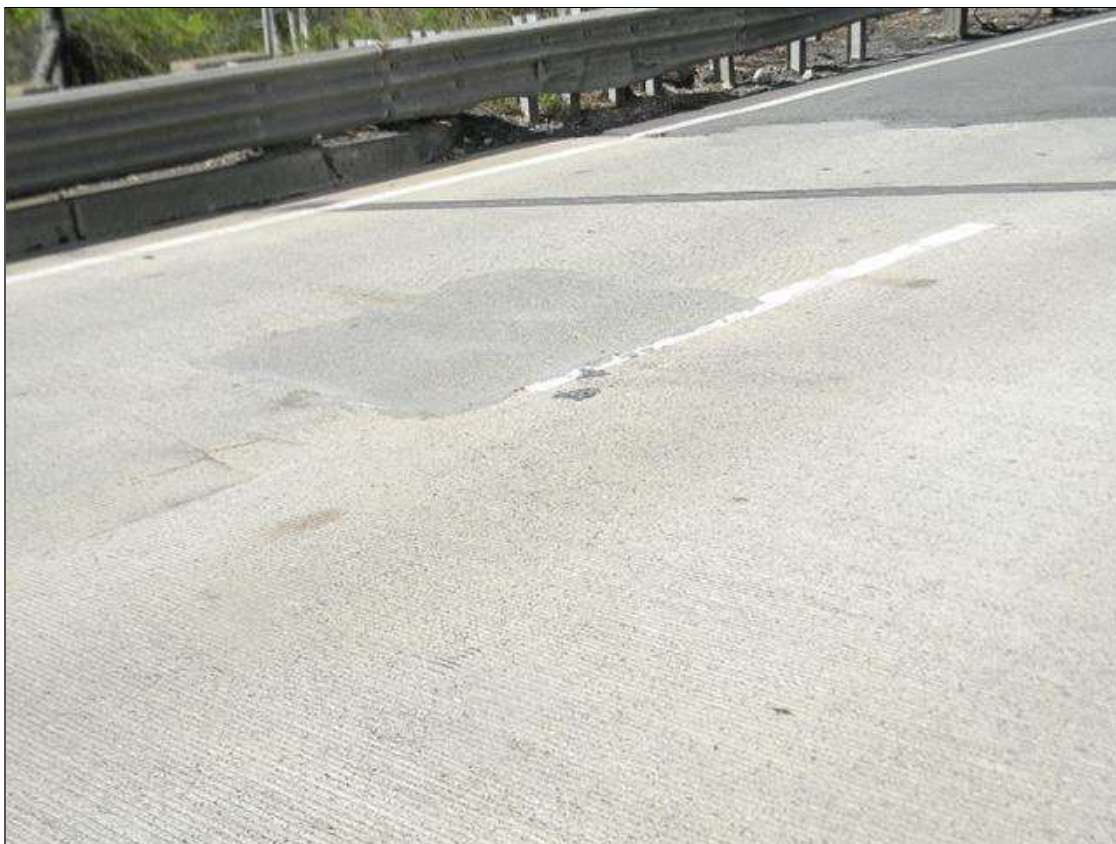
Span 1 Latex Modified Concrete Wearing Surface: RIGHT LANE HAS A 5' WIDE X 6' LONG PATCH IN GOOD CONDITION.

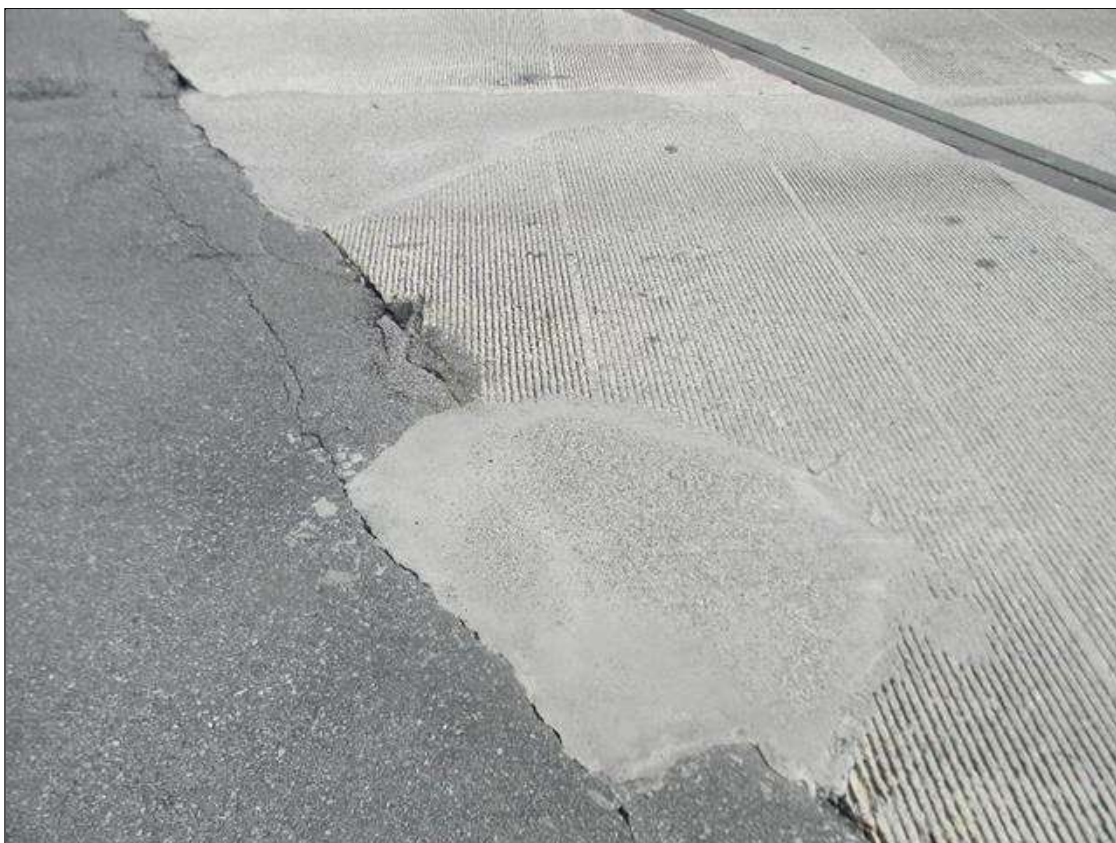
Approach 1: THE EAST APPROACH WEARING SURFACE AND APPROACH SLAB ARE PATCHED IN THE RIGHT LANE. PATCHES ARE IN GOOD CONDITION.

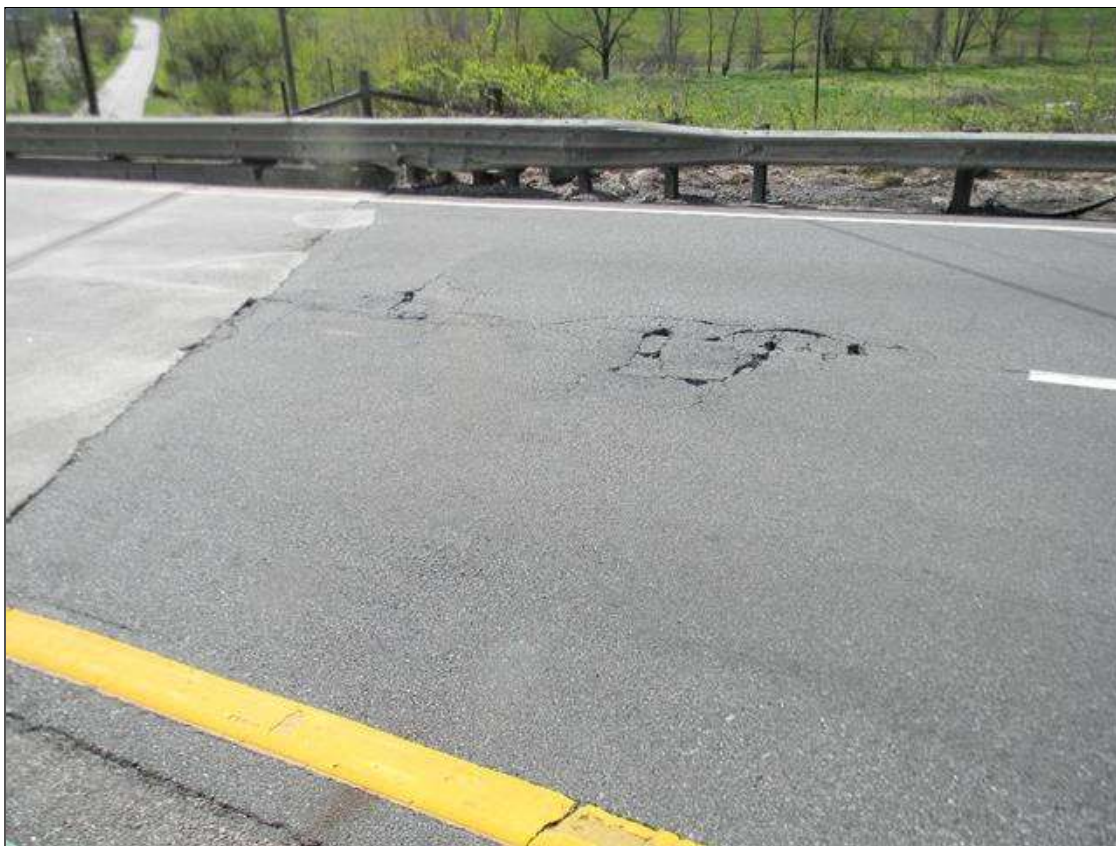
WEST APPROACH ASPHALT WEARING SURFACE IS BREAKING UP IN A 3' WIDE X 9' LONG AREA ALONG THE C/L.

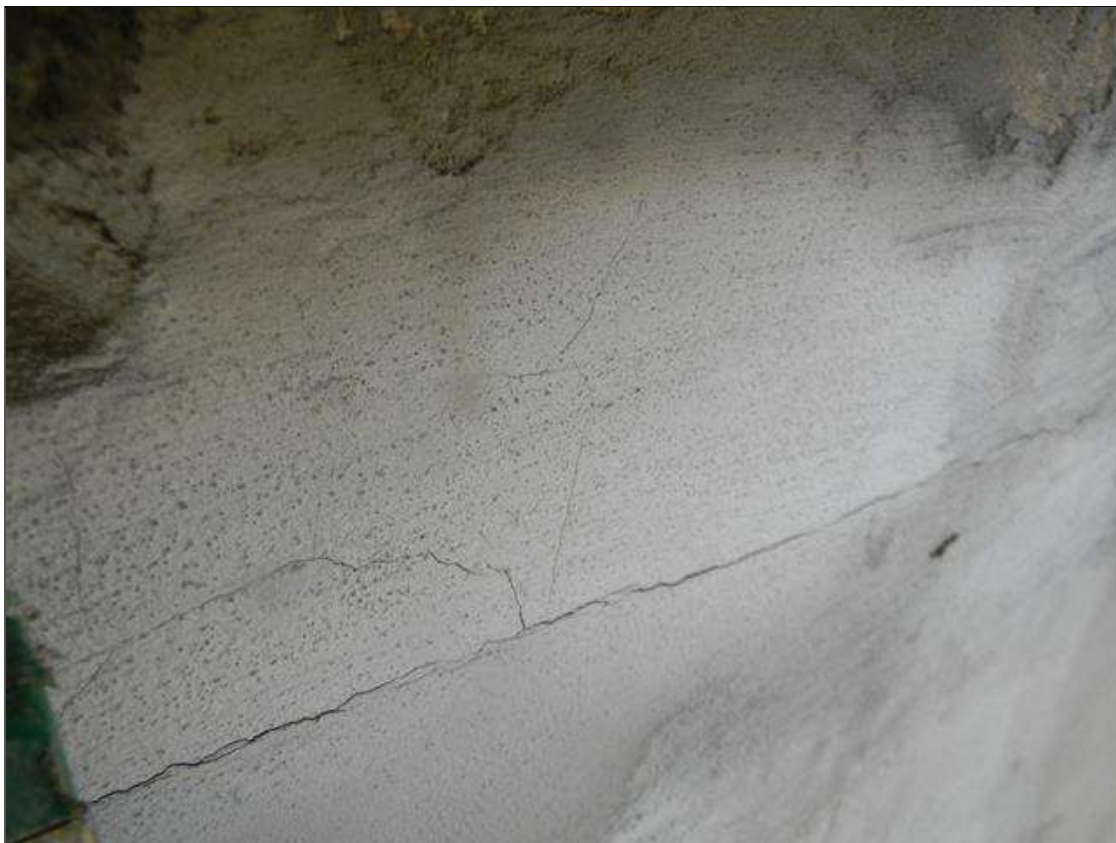
Bent 1 Cap 1: PATCH ON THE EAST FACE UNDER BEAM 1 HAS H/L CRACKING.

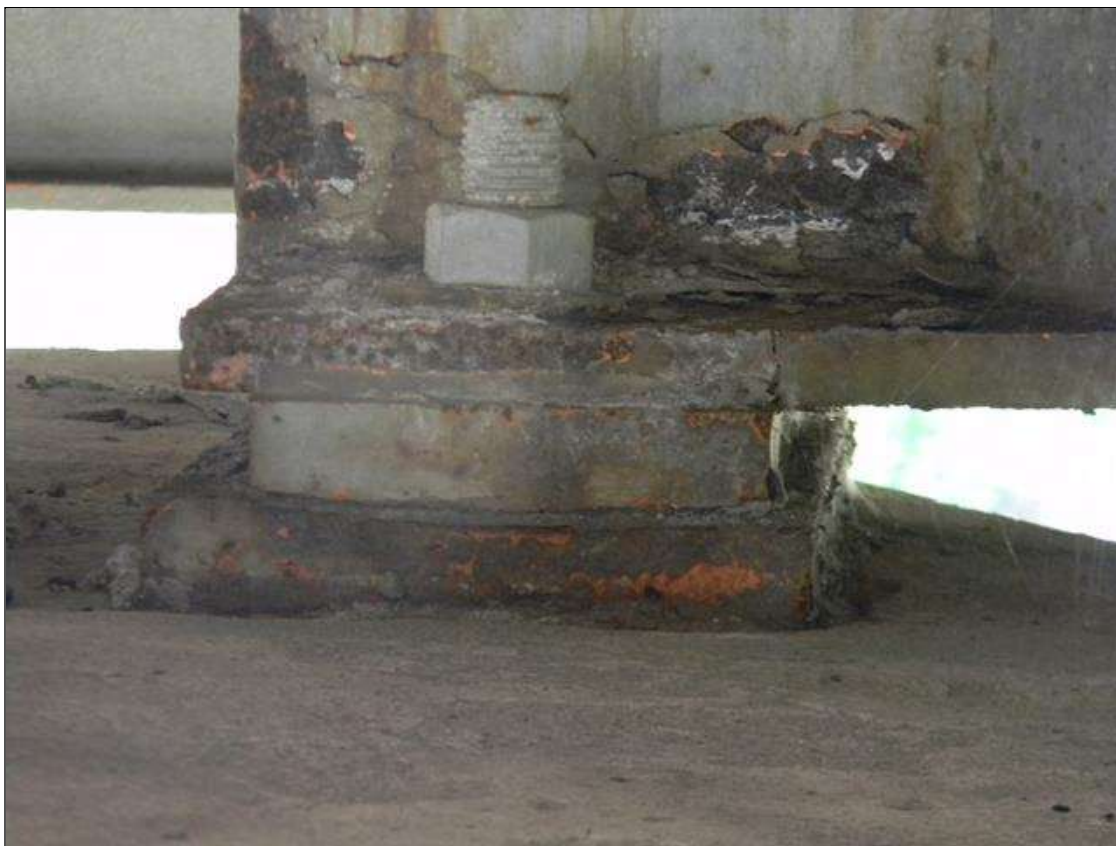
Span 1 Beam 2 Far Bearing: LOSS OF PAINT ALLOWING SURFACE CORROSION ON THE BEARING PLATES.
