NC DEPARTMENT OF TRANSPORTATION  
 DIVISION OF HIGHWAYS  
 STRUCTURE MANAGEMENT UNIT

ATTENTION: **CLEARANCES CHECKED. NEW LATEX MODIFIED CONCRETE WEARING SURFACE. TEMPORARY REPAIRS (CAPS) 2 PRIORITY MAINTENANCES (CAP, BEAM)**

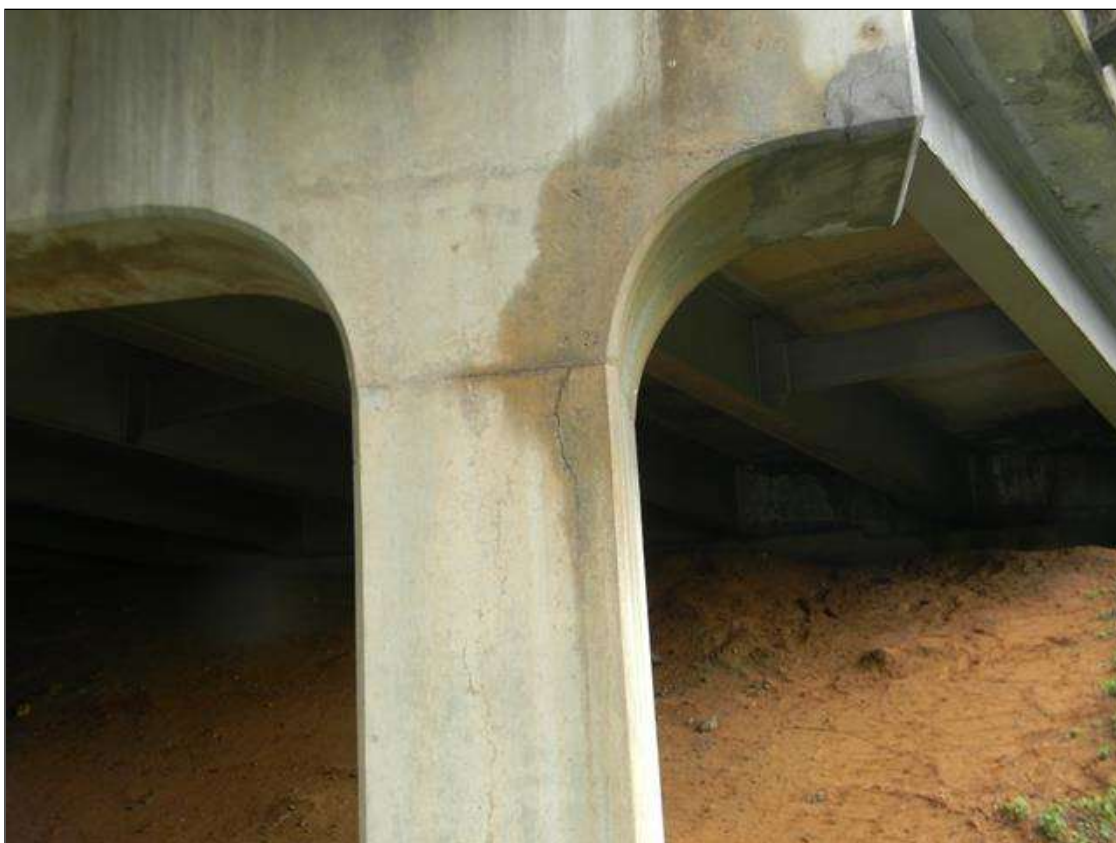
Bent 2 Pile 5: WEST FACE OF THE COLUMN HAS A 3' LONG VERTICAL H/L CRACK JUST BELOW THE HAUNCH.

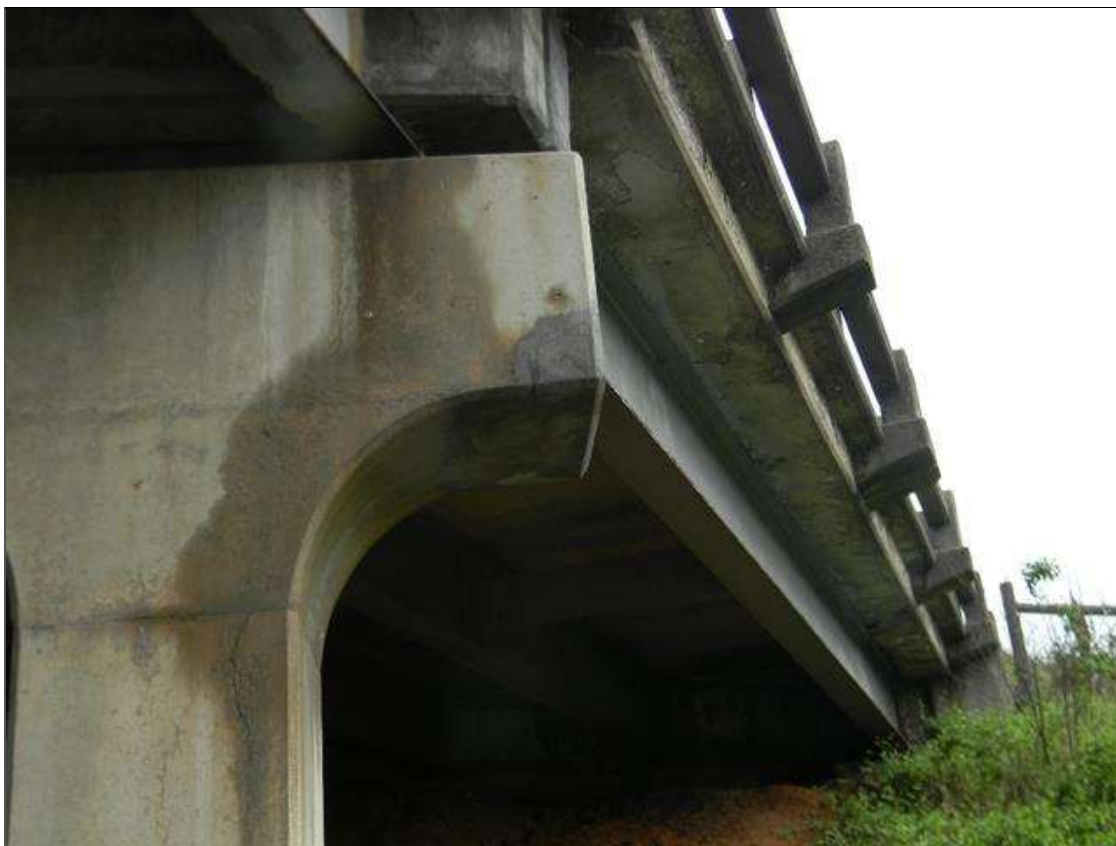
Bent 2 Cap 1: WEST FACE AND RIGHT END OF CAP HAS A PATCH IN GOOD CONDITION. THIS IS CONSIDERED A TEMPORARY REPAIR.

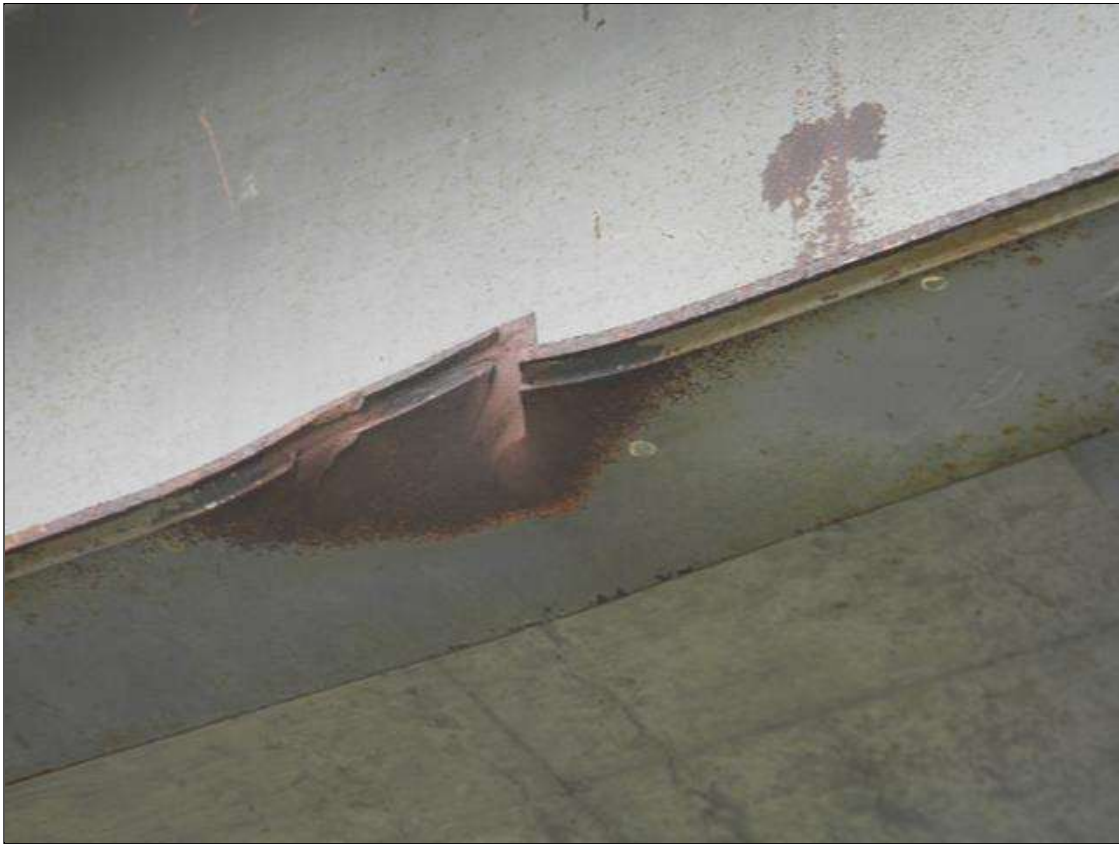
Span 2 Beam 10: IMPACT DAMAGE TO THE RIGHT BOTTOM FLANGE AT 18' 3" FROM THE FACE OF BENT 2 RESULTING IN A TEAR IN THE FLANGE AND COVER PLATE. THERE IS A 9/16" CRACK RUNNING EASTWARD FROM THE TOP OF THE TEAR. THE BOTTOM FLANGE IS BENT 1" TOWARD THE NORTH IN THIS AREA. SEE DAMAGE INSPECTION DATED 8/1/2011 FOR FURTHER DETAILS.

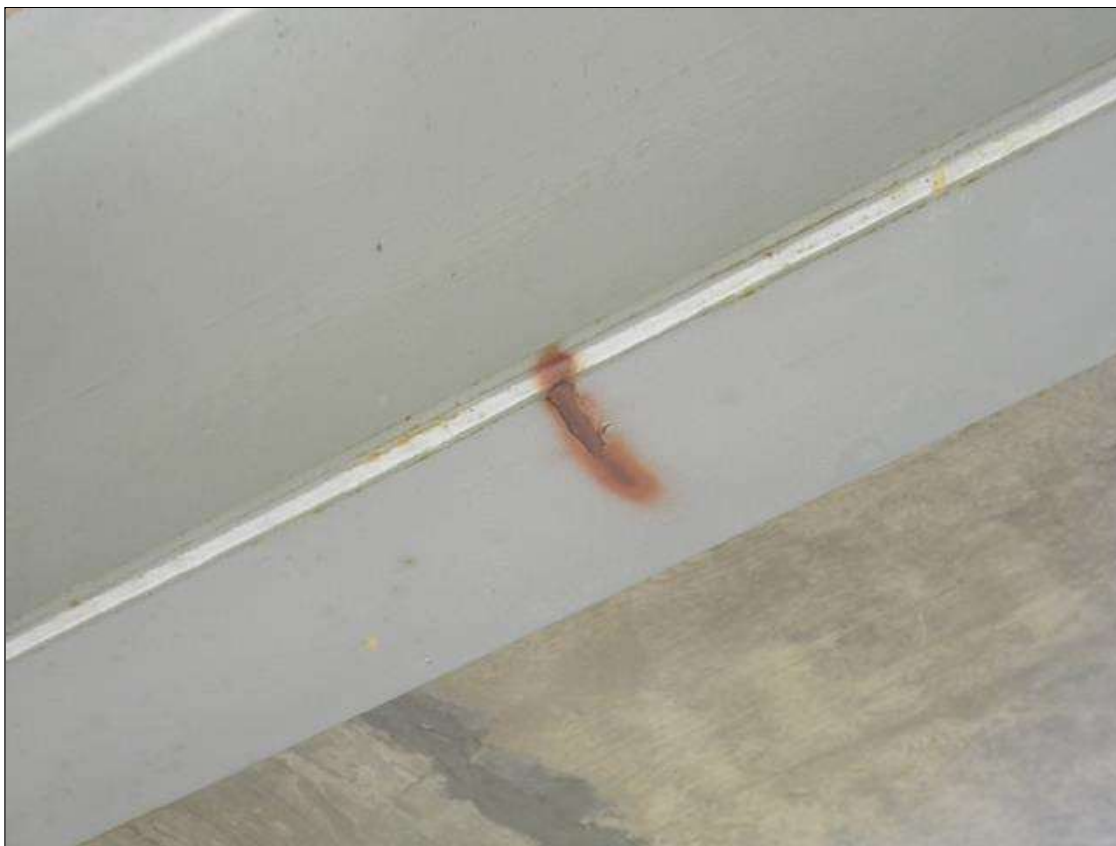
Span 2 Beam 9: RIGHT BOTTOM FLANGE HAS A 4" LONG X 1" WIDE X 1/16" DEEP GOUGE DUE TO IMPACT AT 18" 6" FROM THE FACE OF BENT 2 CAP. SEE DAMAGE INSPECTION DATED 8/1/2011 FOR FURTHER DETAILS.

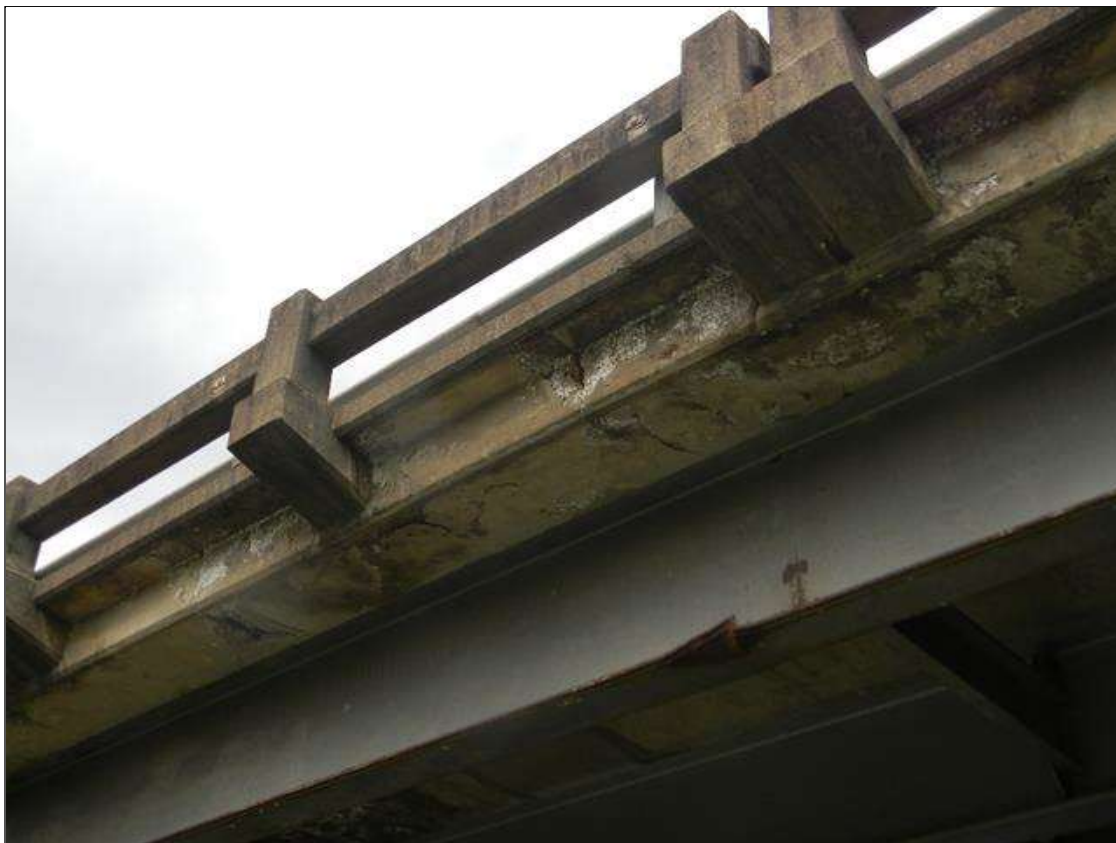
Span 2 Deck: SCATTERED SPALLS, SOME WITH EXPOSED REBAR, ALONG THE UNDERSIDE OF THE OVERHANGS.

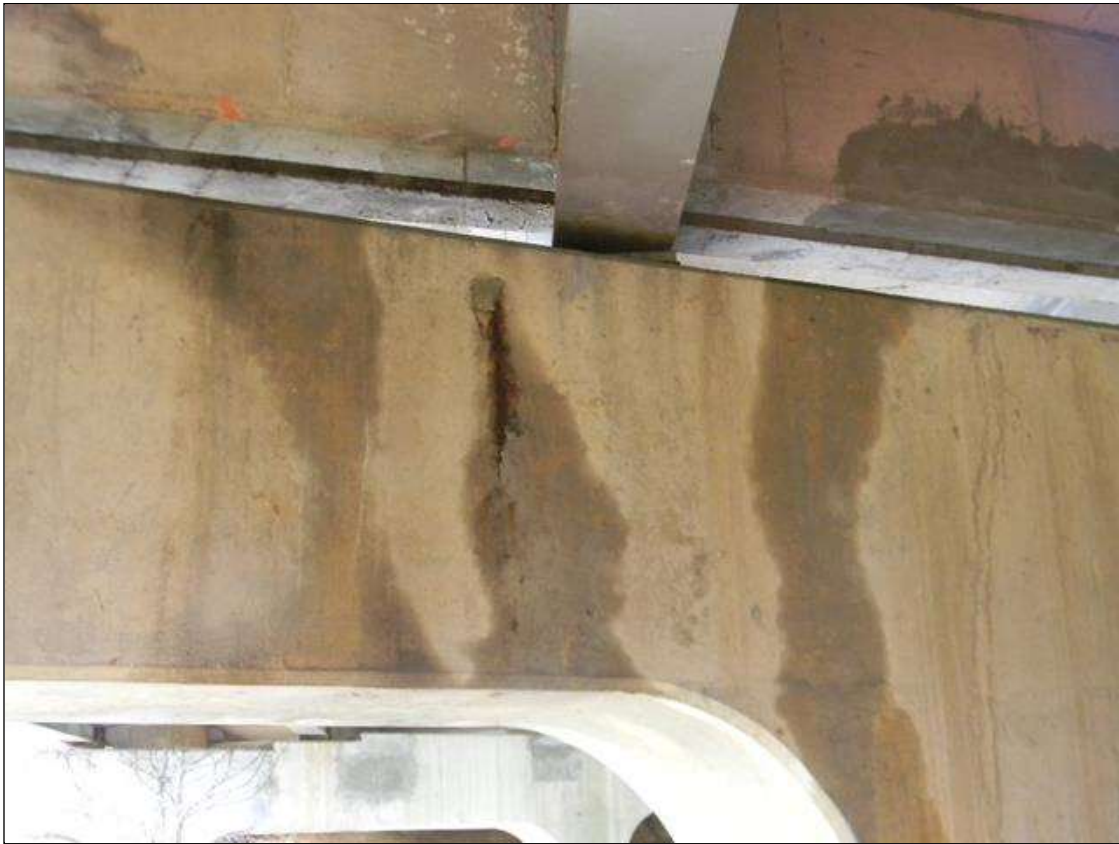
Bent 2 Cap 1: EAST FACE OF THE CAP HAS A 12" LONG EXPOSED REBAR UNDER BEAM 8.

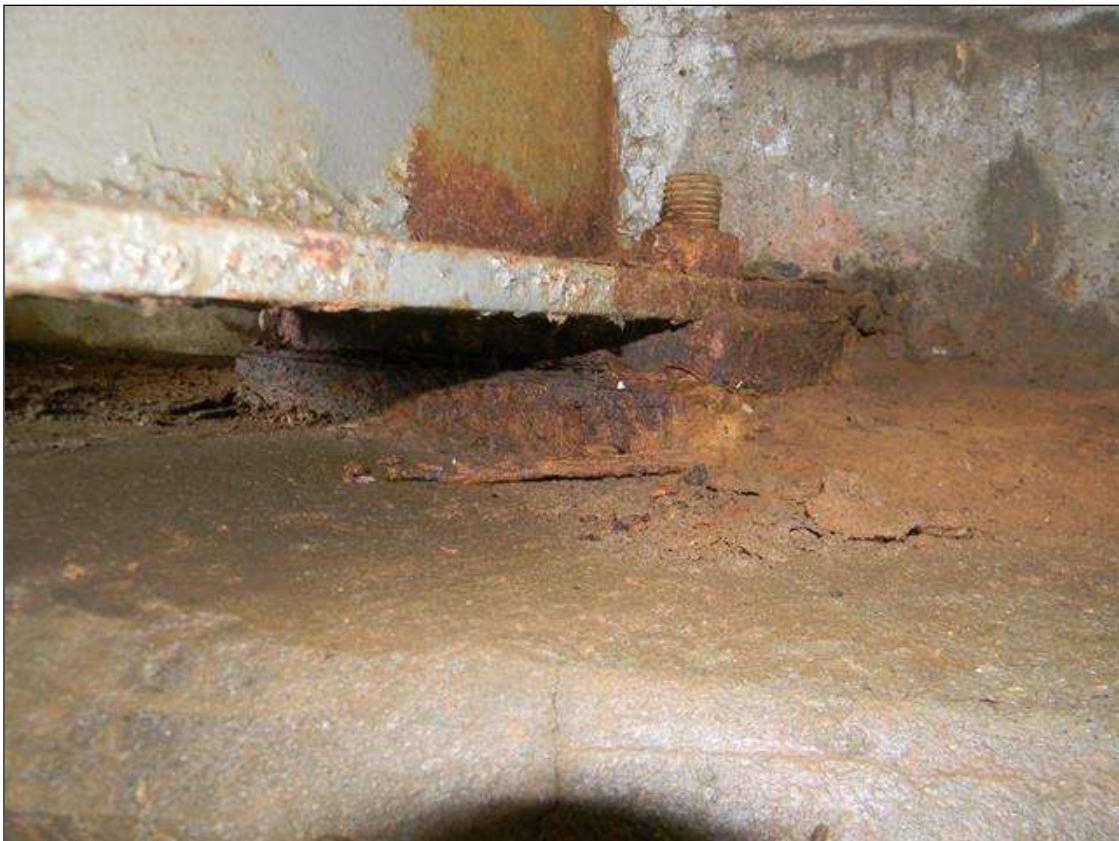
Span 3 Beam 10 Far Bearing: LOSS OF PAINT ALLOWING SURFACE CORROSION OVER THE ENTIRE BEARING.

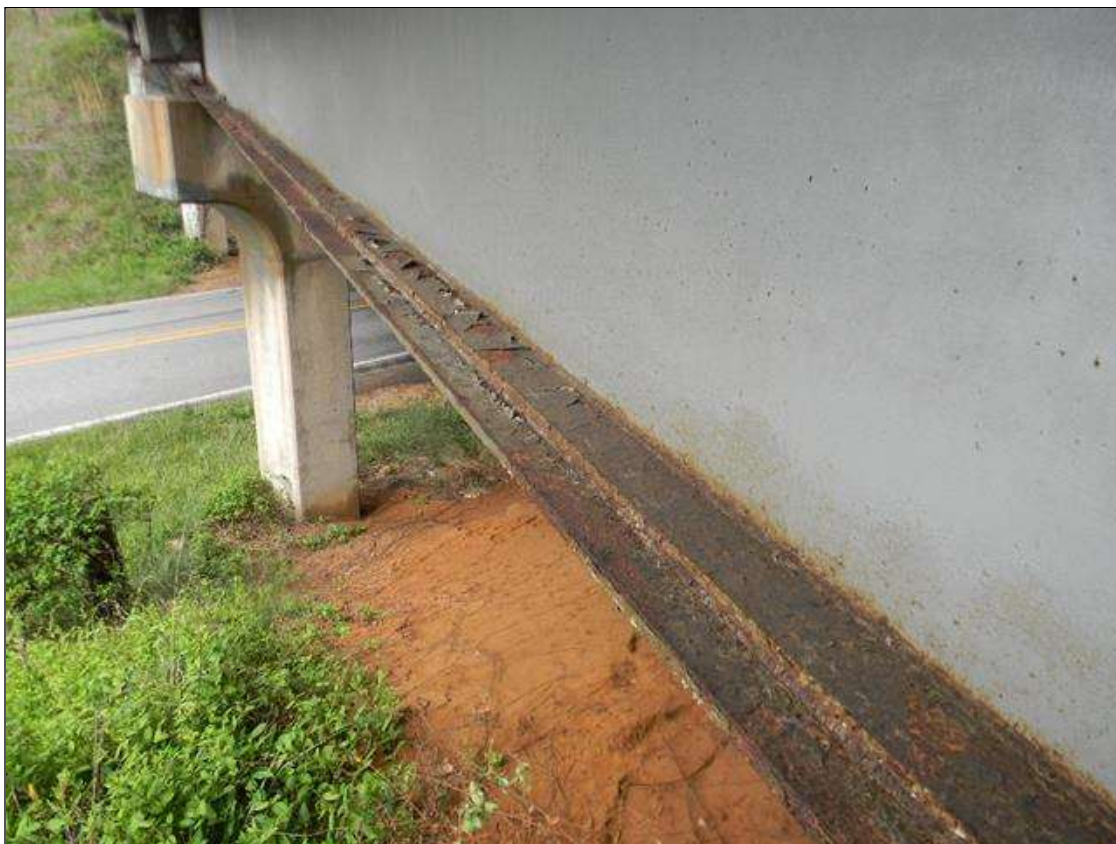
Span 2 Beam 10: PEELING PAINT ALONG THE TOP OF THE BOTTOM FLANGE ALLOWING SURFACE CORROSION.

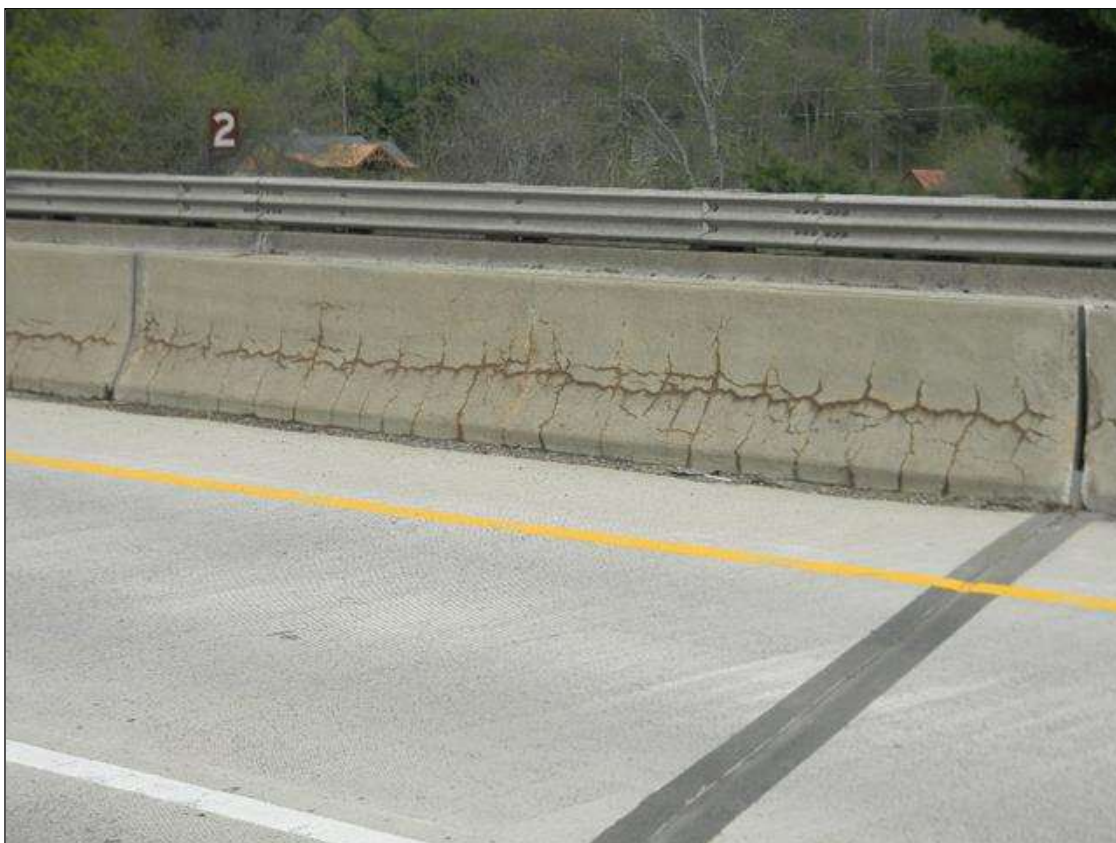
Span 2 Median Rail: H/L MAP AND LONGITUDINAL CRACKS ESPECIALLY ON THE SOUTH FACE.

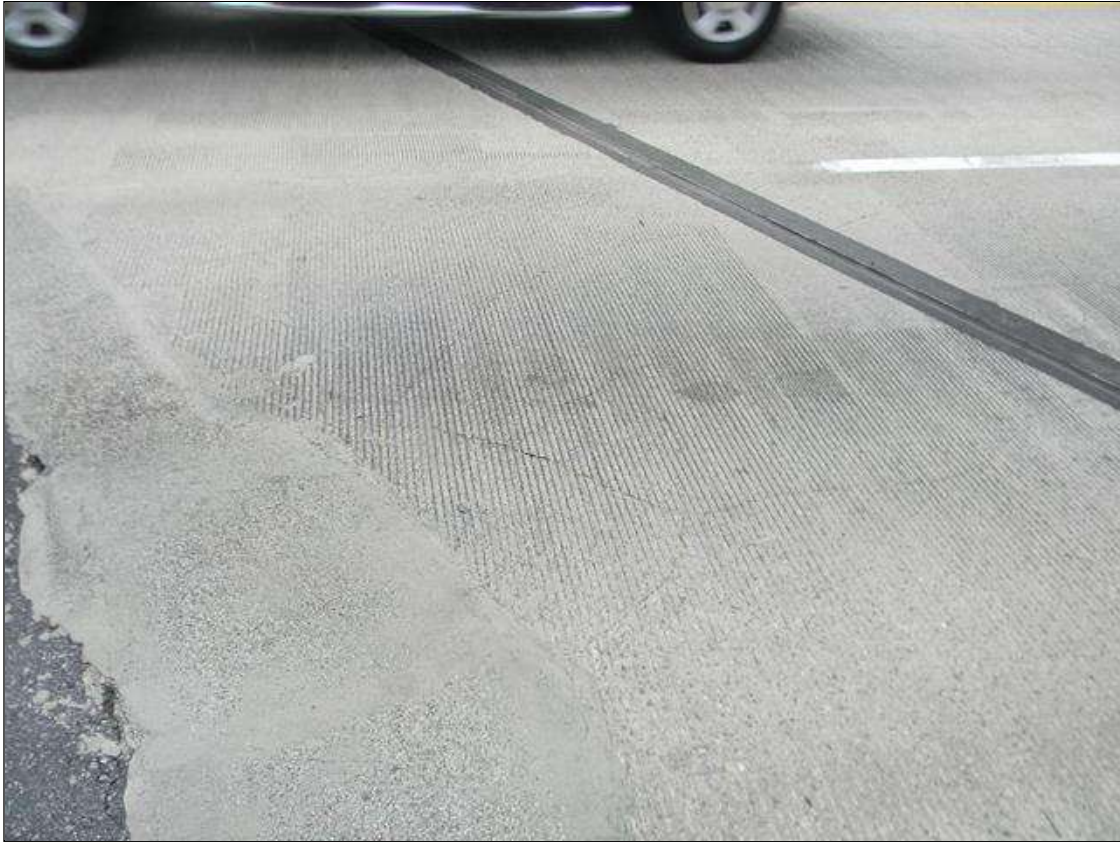
Approach 2: LATEX MODIFIED CONCRETE WEARING SURFACE HAS SCATTERED MAP CRACKS.

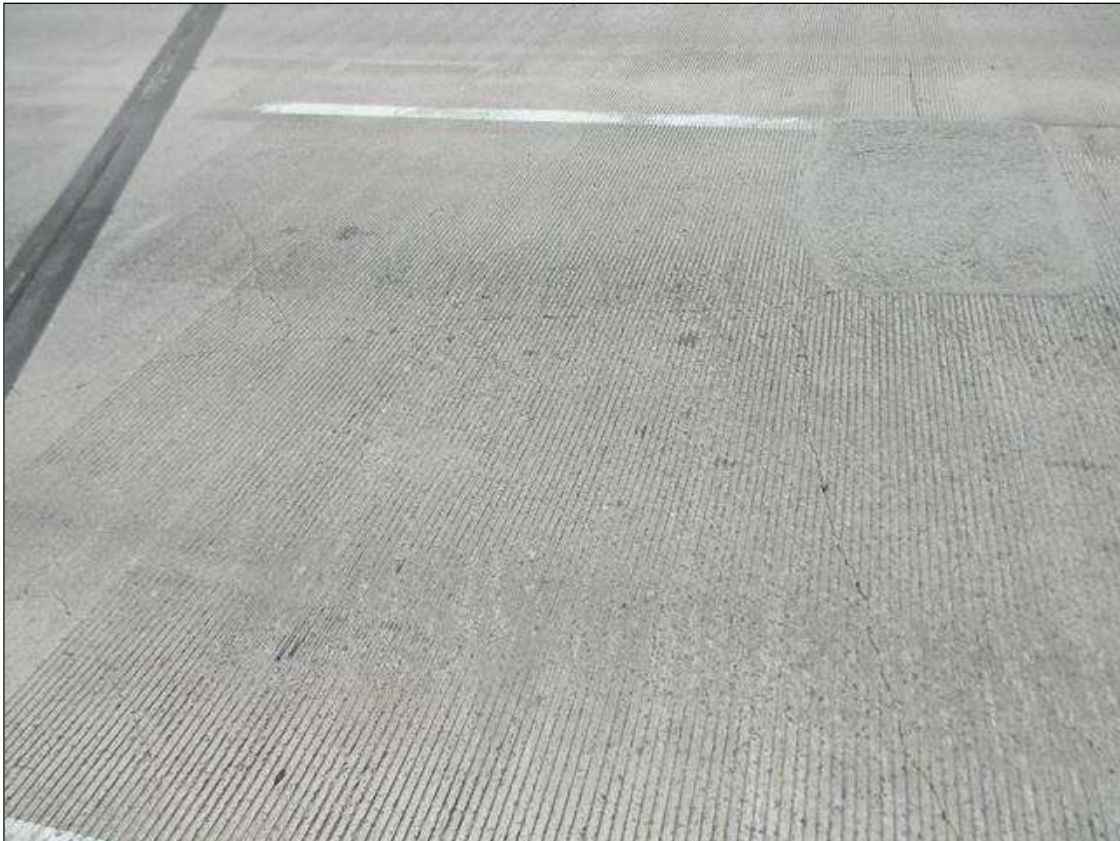
Span 3 Wearing Surface: LATEX MODIFIED CONCRETE WEARING SURFACE HAS SCATTERED MAP CRACKS.

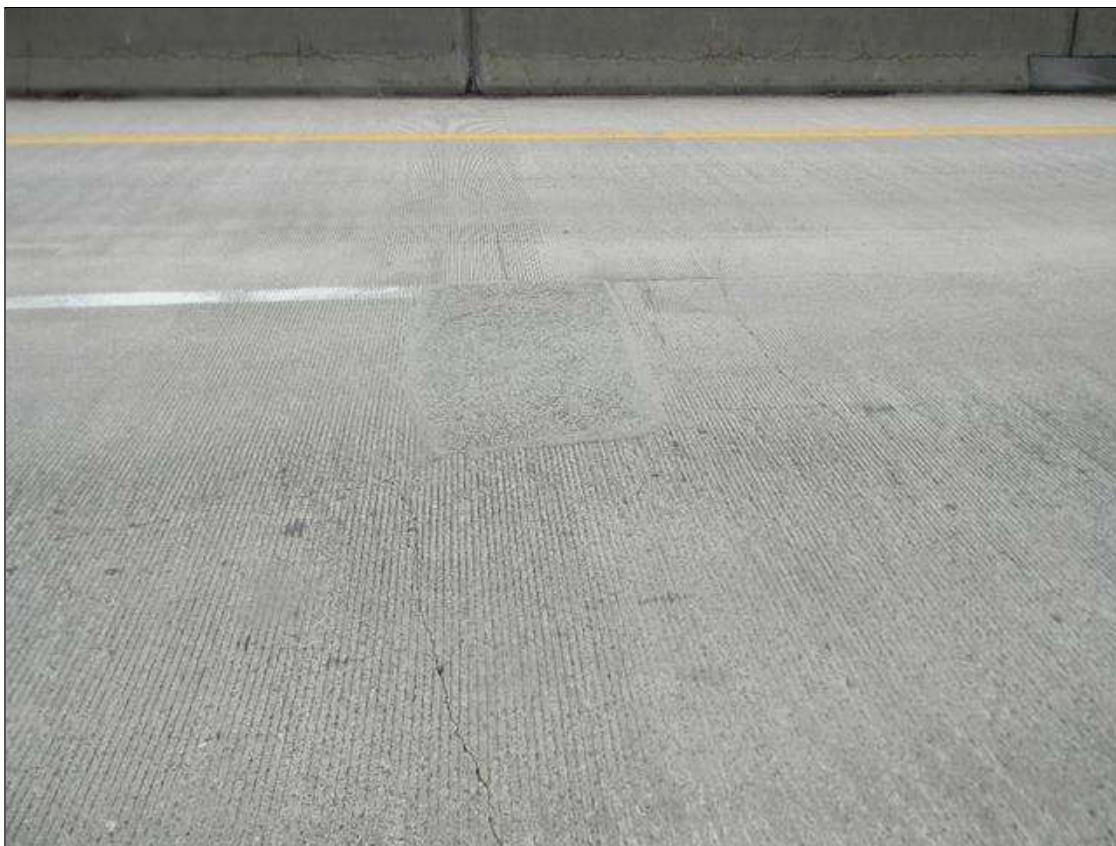
Span 3 Wearing Surface: 2' LONG X 4' WIDE PATCH IN THE WEARING SURFACE IN THE WESTBOUND RIGHT LANE. PATCH IS IN GOOD CONDITION.

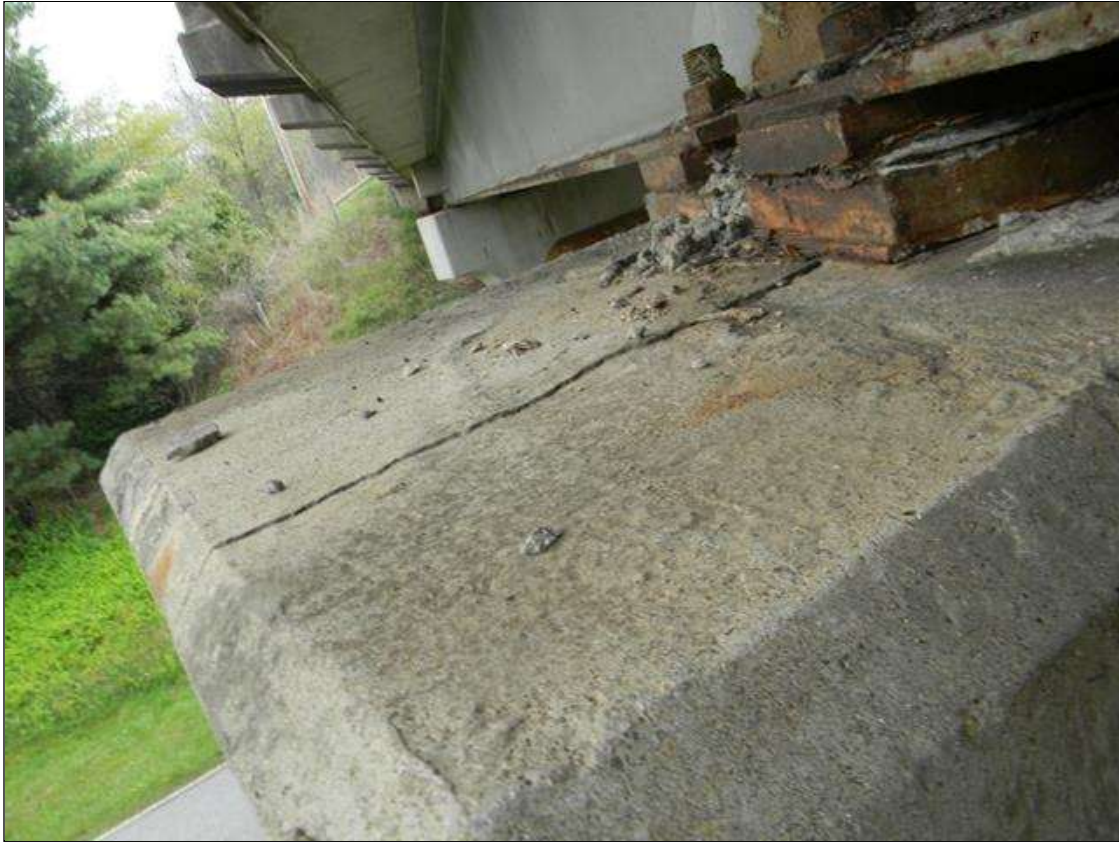
Bent 1 Cap 1: LEFT END OF BENT 1 CAP HAS A CRACK WITH A 30" WIDE X 14" HIGH X 12" DEEP SPALL FORMING UNDER BEAM 1 BEARING. THE CRACK RUNS UNDER THE CENTER OF THE BEARING MASONRY PLATE. A PRIORITY MAINTENANCE WAS ISSUED LAST INSPECTION AND IS BEING RE-ISSUED FOR THIS SPALL.

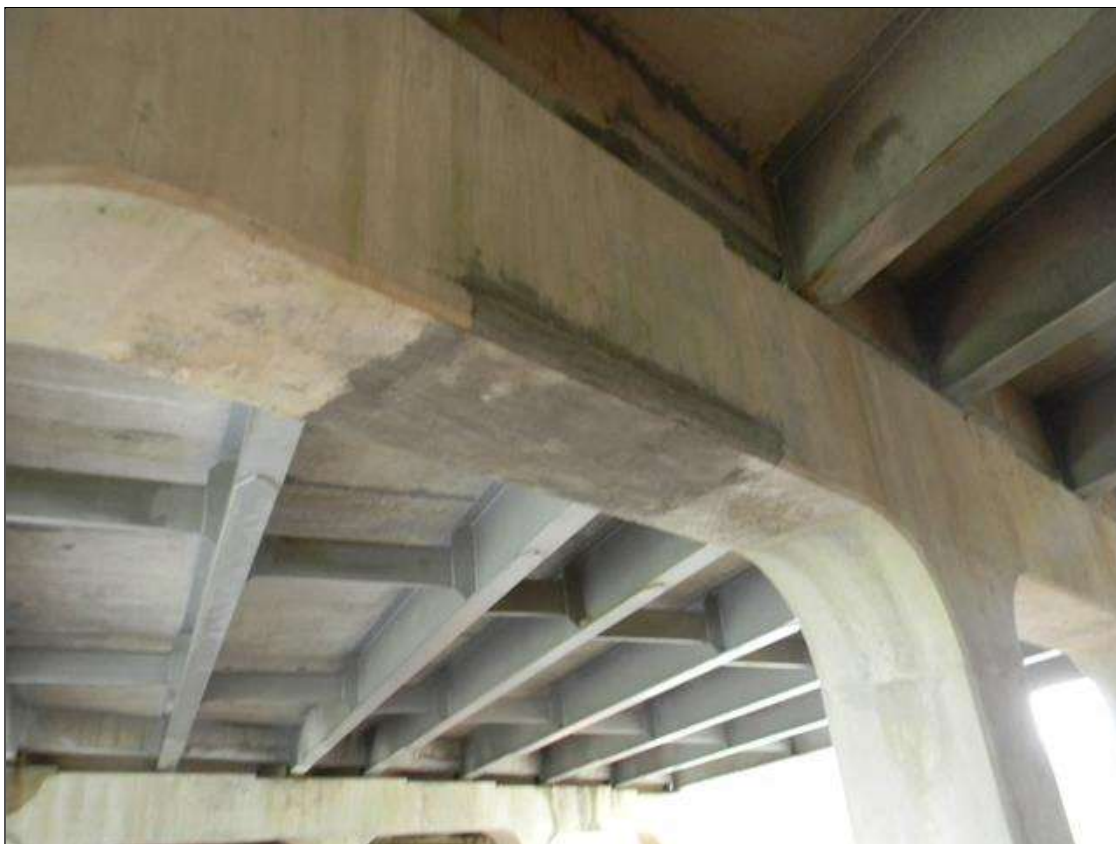
Bent 1 Cap 1: CAP HAS SEVERAL PATCHES IN GOOD CONDITION. THESE ARE CONSIDERED TEMPORARY REPAIRS.

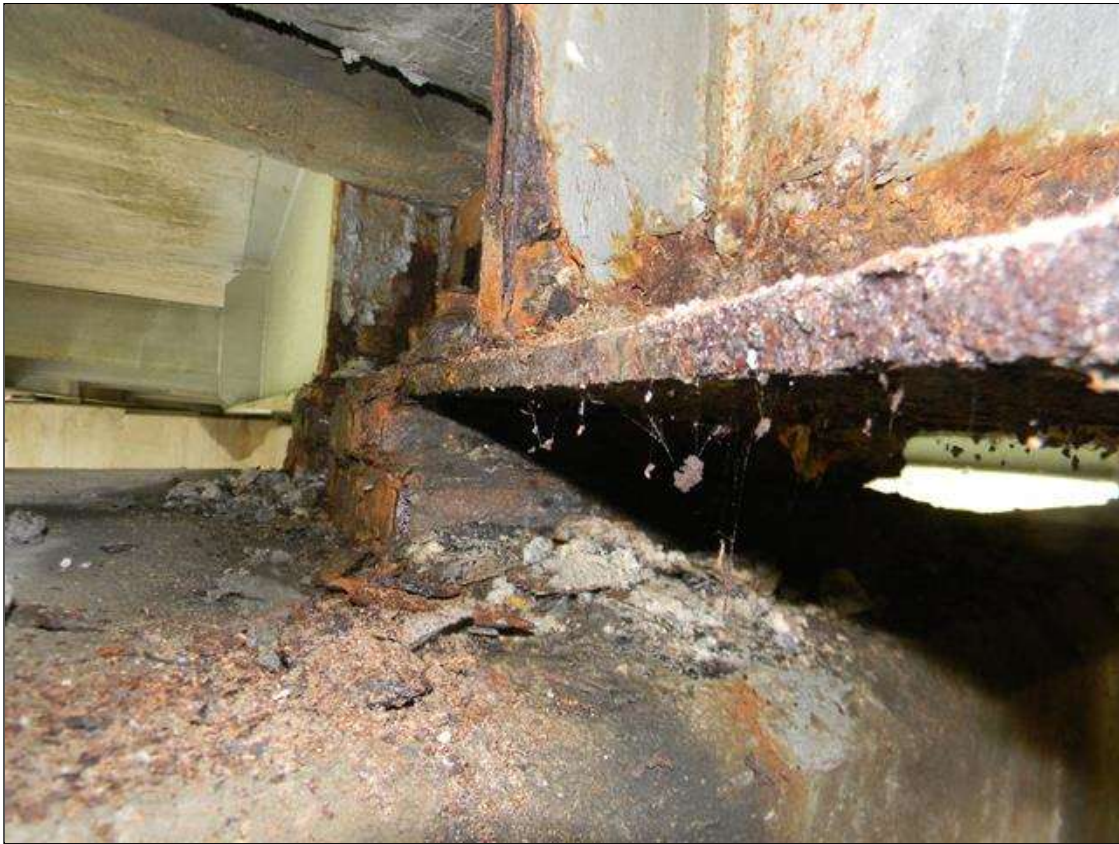
Span 1 Beam 3: LEFT BOTTOM FLANGE AT BENT 1 IS DOWN TO 7/16" FROM THE ORIGINAL 9/16" THICKNESS FOR 1' 3" LONG STARTING AT THE END X FULL WIDTH. A PRIORITY MAINTENANCE IS BEING ISSUED FOR THIS BEAM.

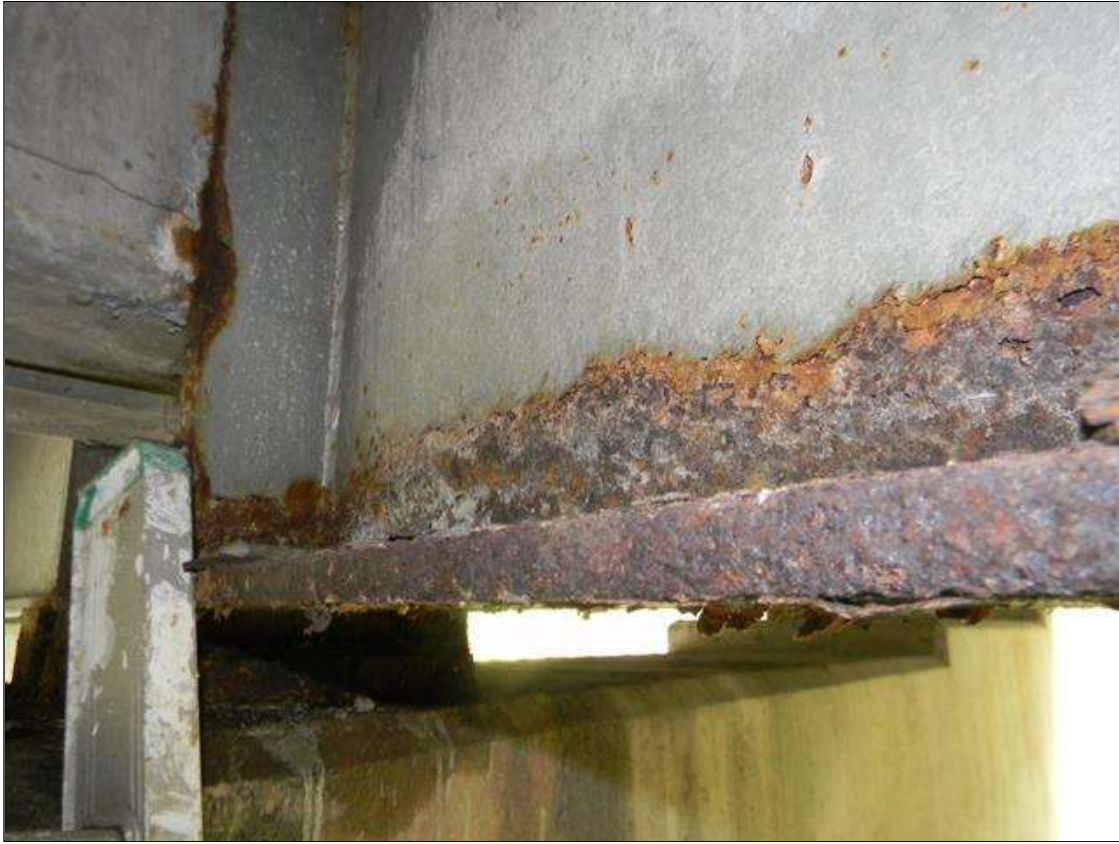
Span 3 Beam 3: RIGHT BOTTOM FLANGE AT BENT 2 HAS FLAKING SURFACE CORROSION WITH NO SIGNIFICANT LOSS FOR 6' LONG.

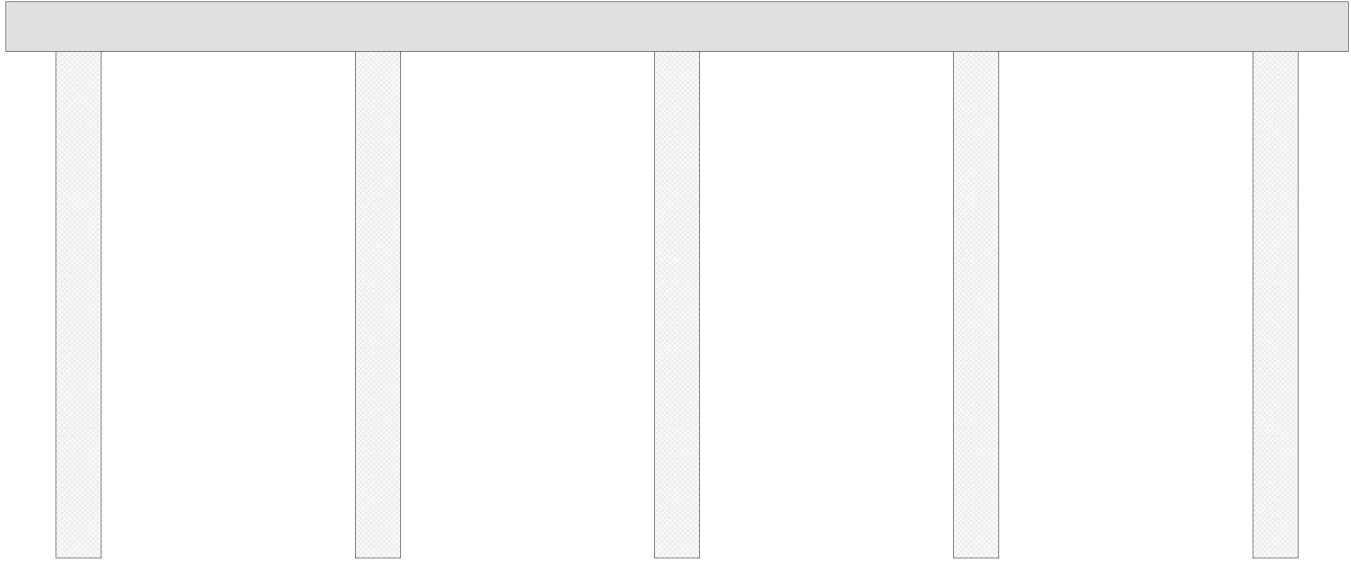
<b>Cap Information</b>			Material Cast-in-Place Concrete							
Length	Width	Height	Left Overhang	Right Overhang	Left Beam to End of Cap.	Right Beam to End of Cap.				
74.000 ft.	2.500 ft.	2.750 ft.	4.000 ft.	4.000 ft.	1.833 ft.	1.833 ft.				
<b>Subcap Information</b>			Material							
Length	Width	Height	Left Overhang	Right Overhang	Left Pile to Splice.					
<b>Sill Information</b>			Material							
Length	Width	Height								
Pile #	Material	Spacing	Width/Dia.	Height	Length	Orientation	Driven?	Replacement?	Removed?	Collar?
1	Concrete	16.500 ft.	2.500 ft.	2.500 ft.		Vertical	No	No	No	No
2	Concrete	16.500 ft.	2.500 ft.	2.500 ft.		Vertical	No	No	No	No
3	Concrete	16.500 ft.	2.500 ft.	2.500 ft.		Vertical	No	No	No	No
4	Concrete	16.500 ft.	2.500 ft.	2.500 ft.		Vertical	No	No	No	No
5	Concrete		2.500 ft.	2.500 ft.		Vertical	No	No	No	No
<b>Bent/Abutment #:</b> 1			<b>Similar Bents:</b> 2
