NC DEPARTMENT OF TRANSPORTATION  
 DIVISION OF HIGHWAYS  
 STRUCTURE MANAGEMENT UNIT

ATTENTION: **PAR, DATA CHANGES**

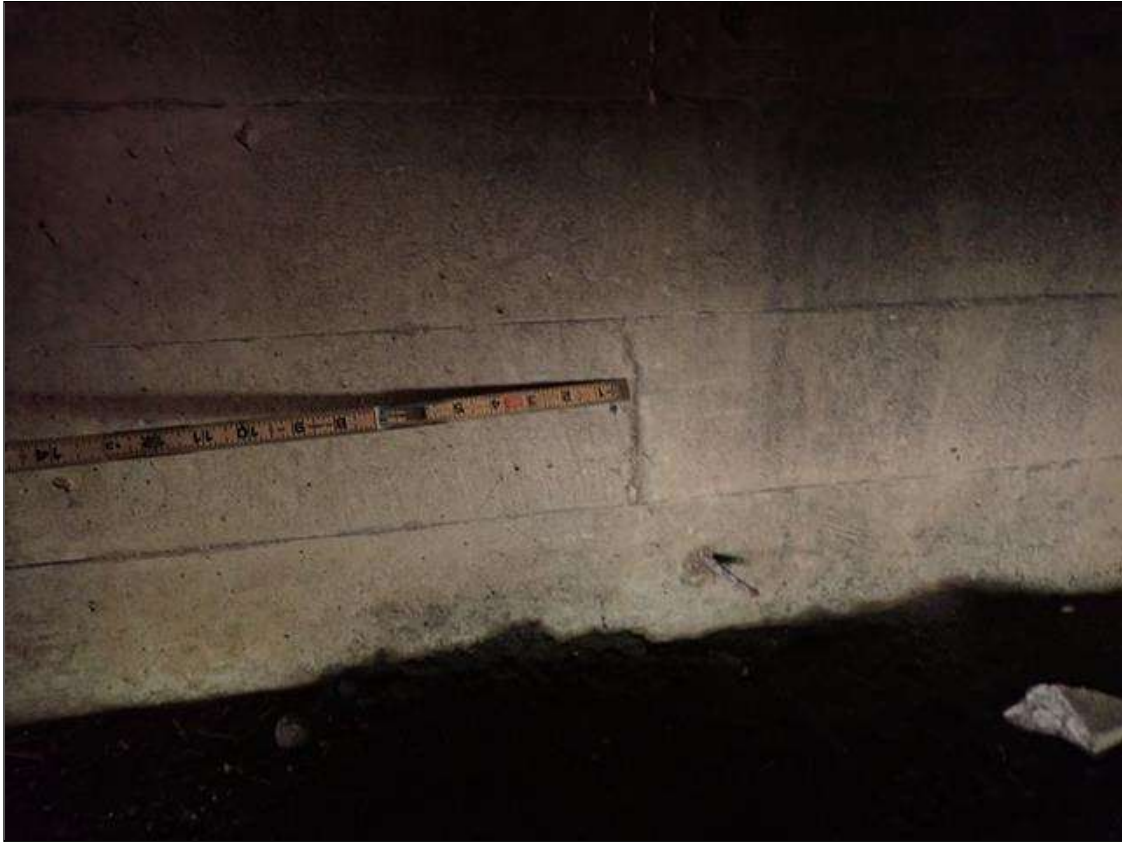
End Bent 1 Abutment: UP TO 1/16 INCH VERTICAL CRACKS IN FACE OF BACKWALL IN VARIOUS LOCATIONS

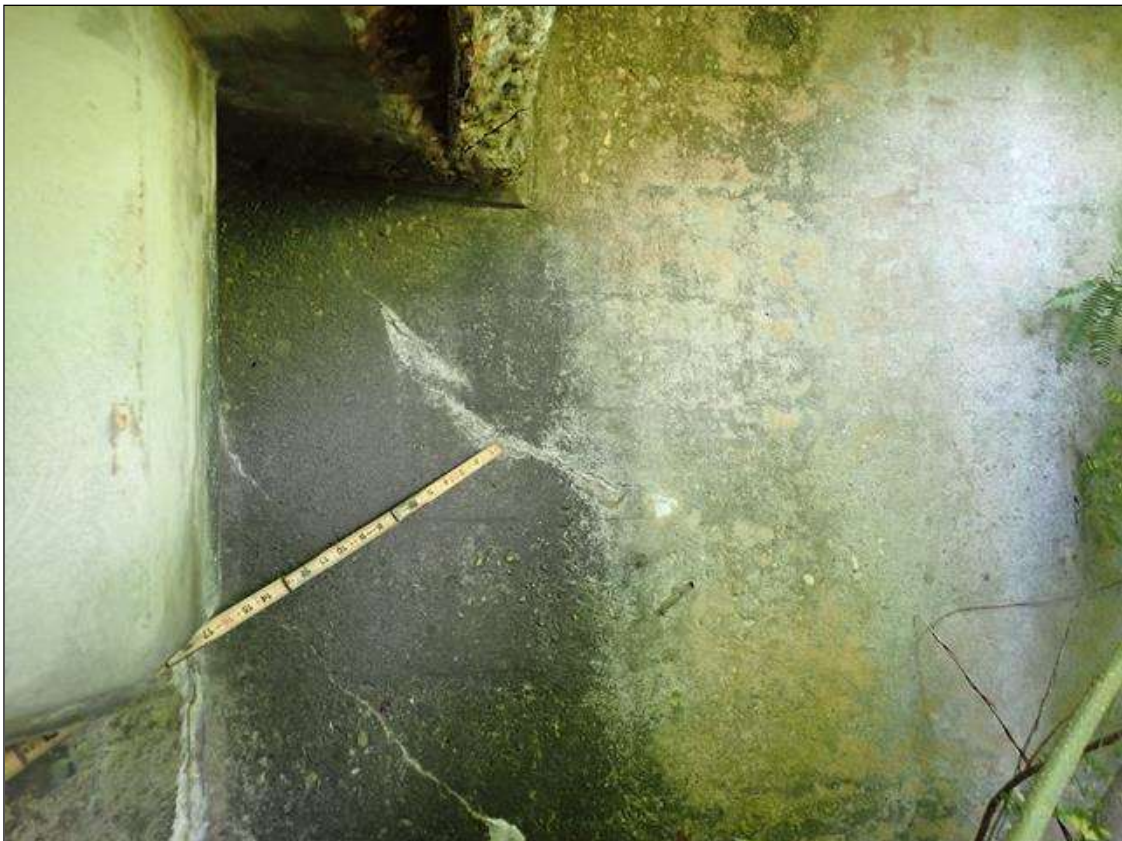
End Bent 1 Abutment: UP TO 0.012 INCH DIAGONAL CRACKS WITH EFFLORESCENCE IN FACE OF BACKWALL BENEATH WEST OVERHANG

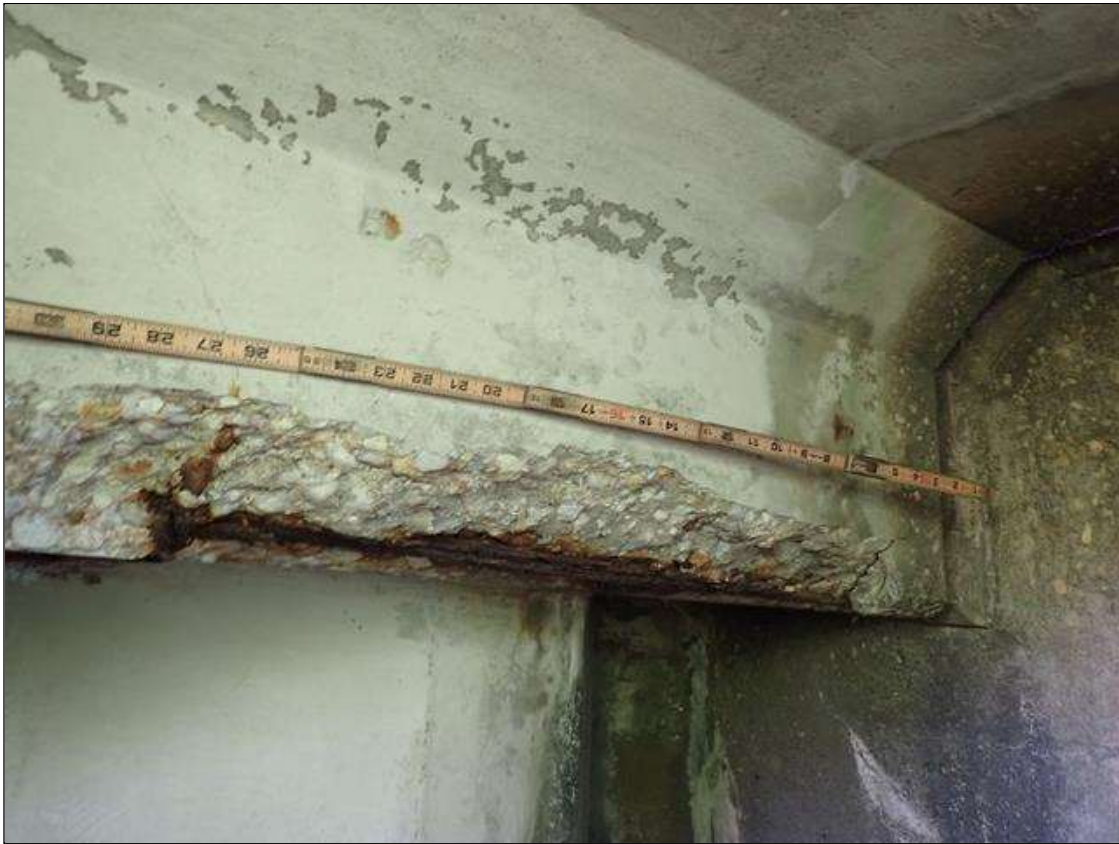
Span 1 Deck: 34 INCH LONG X 7 INCH WIDE X 4 INCH HIGH SPALL WITH EXPOSED REBAR IN BOTTOM AND WEST FACE OF DECK AT END BENT 1

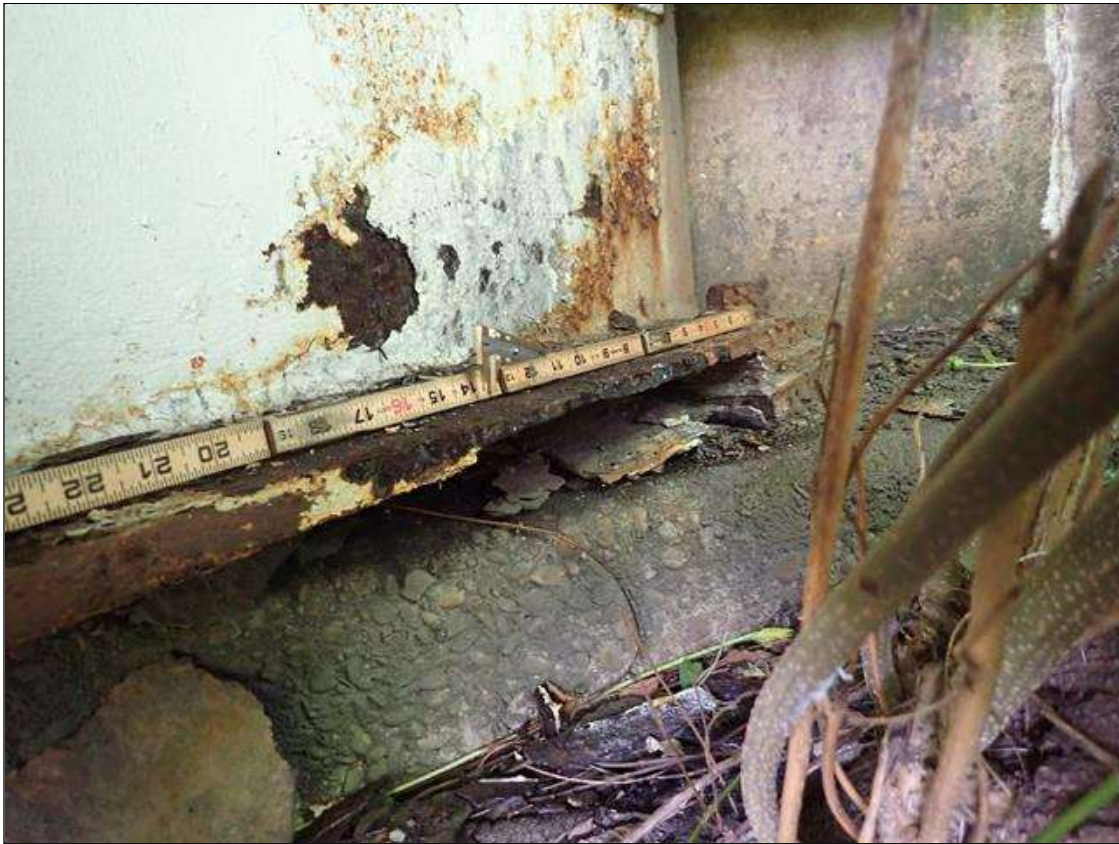
Span 1 Beam 1: PAR: CORROSION ALONG WEB AND BOTTOM FLANGE UP TO 24 INCH LONG X 8 INCH HIGH WITH UP TO 1/16 INCH DEEP PAINTED OVER PITTING IN WEB AND 24 INCH LONG X 6 INCH WIDE DOWN TO 3/8 INCH RESIDUAL BOTTOM FLANGE ON LEFT SIDE EXTENDING FROM END BENT 1

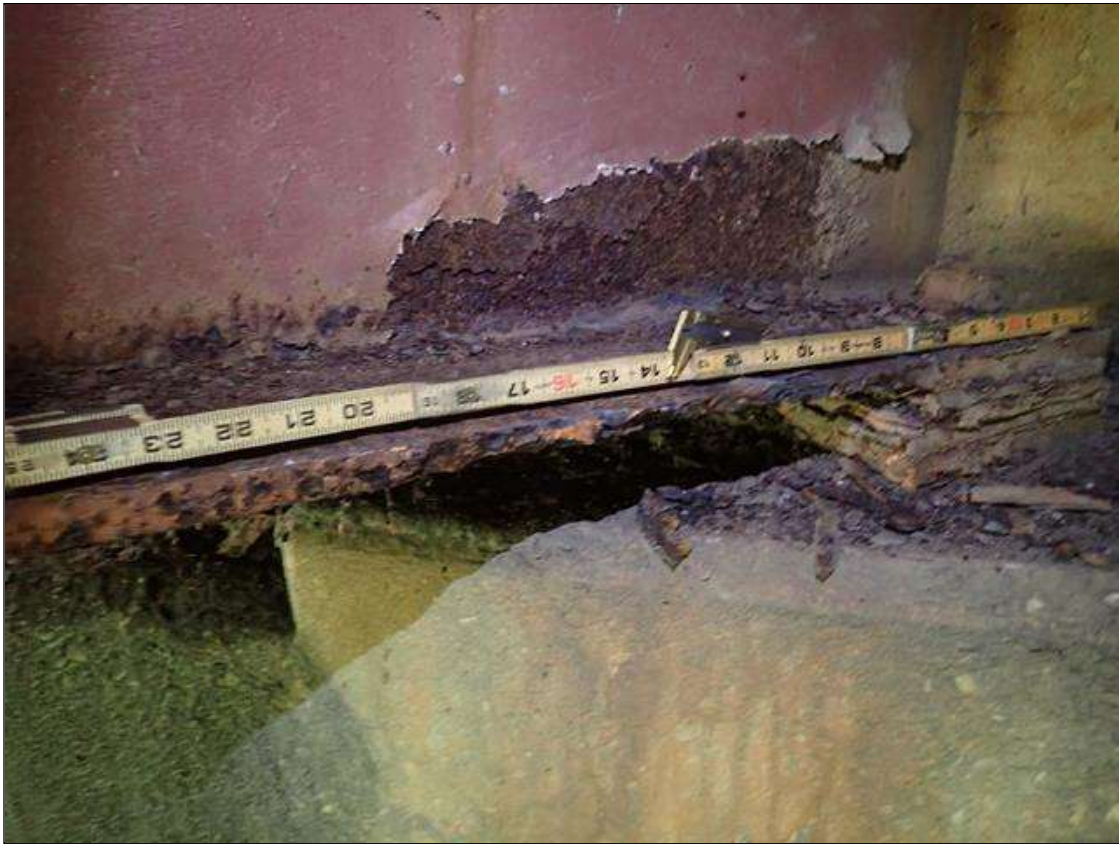
Span 1 Beam 2: PAR: CORROSION ALONG WEB AND BOTTOM FLANGE UP TO 46 INCH LONG X 5 INCH HIGH WITH NO MEASURABLE LOSS OF SECTION IN WEB AND 46 INCH LONG X 6 INCH WIDE DOWN TO 3/8 INCH RESIDUAL BOTTOM FLANGE EXTENDING FROM END BENT 1

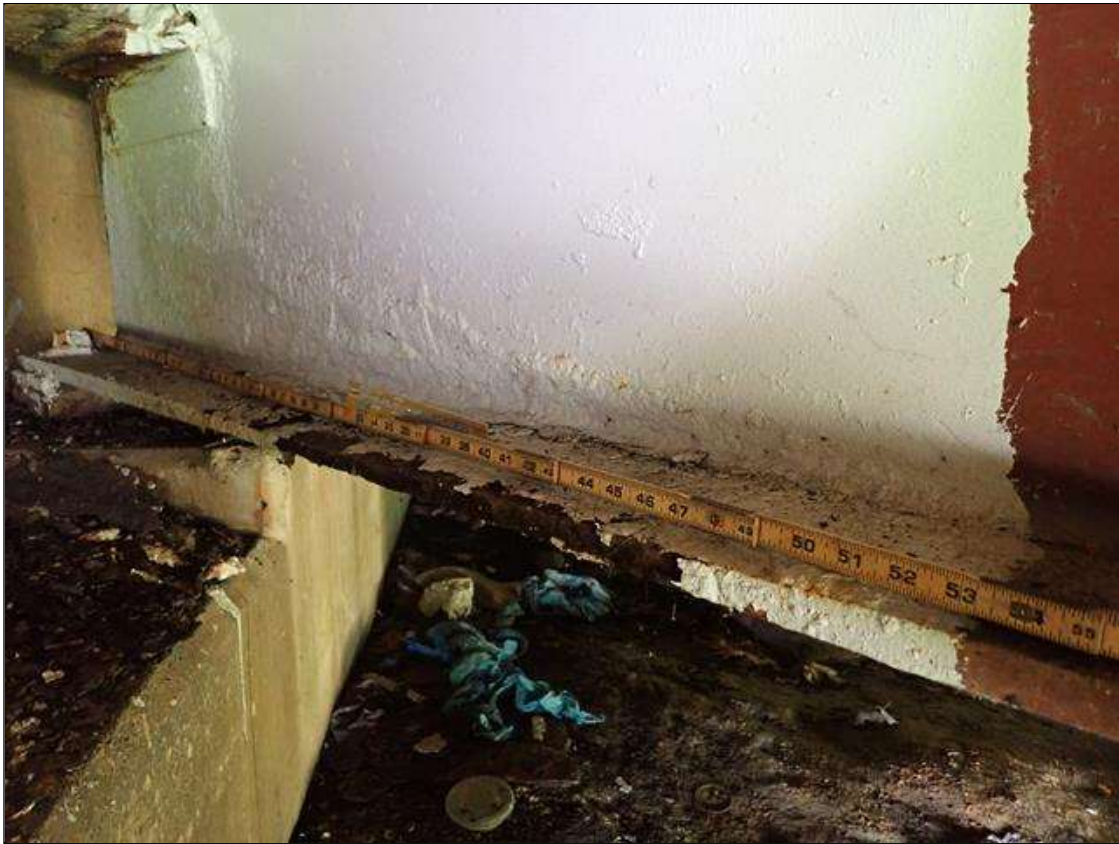
Span 1 Beam 3: PAR: CORROSION ALONG WEB AND BOTTOM FLANGE UP TO 50 INCH LONG X 13 INCH HIGH WITH UP TO 1/16 INCH DEEP PAINTED OVER PITTING IN WEB AND 50 INCH LONG X 6 INCH WIDE DOWN TO 1/2 INCH RESIDUAL BOTTOM FLANGE EXTENDING FROM END BENT 1

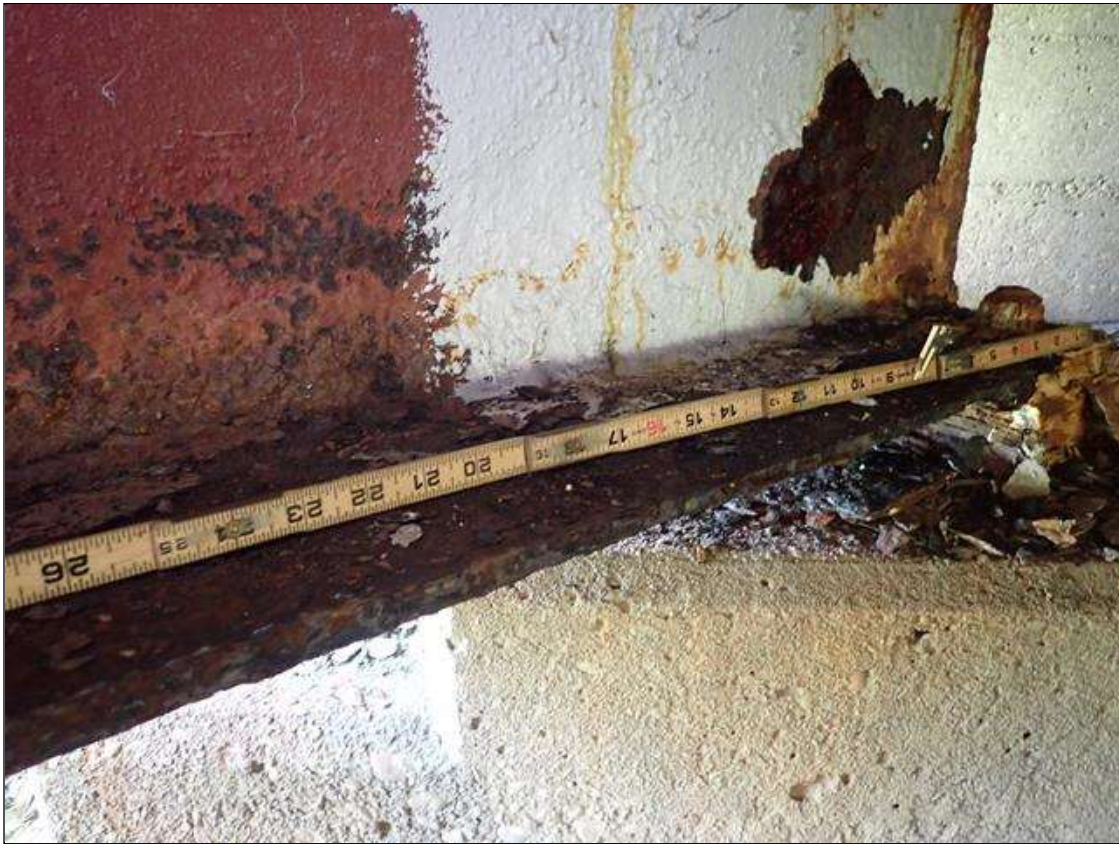
Span 1 Beam 4: PAR: CORROSION ALONG WEB AND BOTTOM FLANGE UP TO 58 INCH LONG X 12 INCH HIGH  
DOWN TO 3/8 INCH RESIDUAL WEB AND 58 INCH LONG X 6 INCH WIDE DOWN TO 5/16 INCH RESIDUAL  
BOTTOM FLANGE EXTENDING FROM END BENT 1

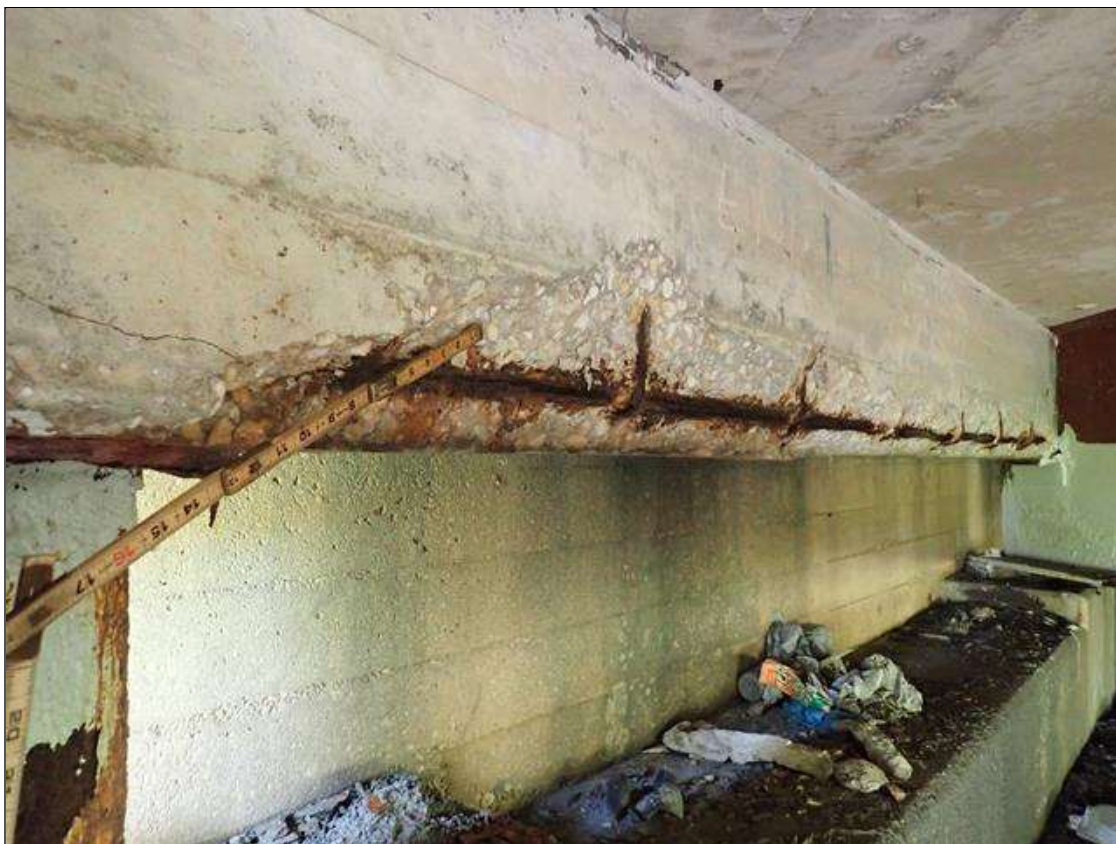
Span 1 Deck: TWO (2) SPALLS WITH EXPOSED REBAR UP TO 11 FOOT LONG X 6 INCH HIGH X 6 INCH WIDE IN END DIAPHRAGMS BETWEEN BEAMS 2 AND 3 AND BEAMS 3 AND 4 AT END BENT 1

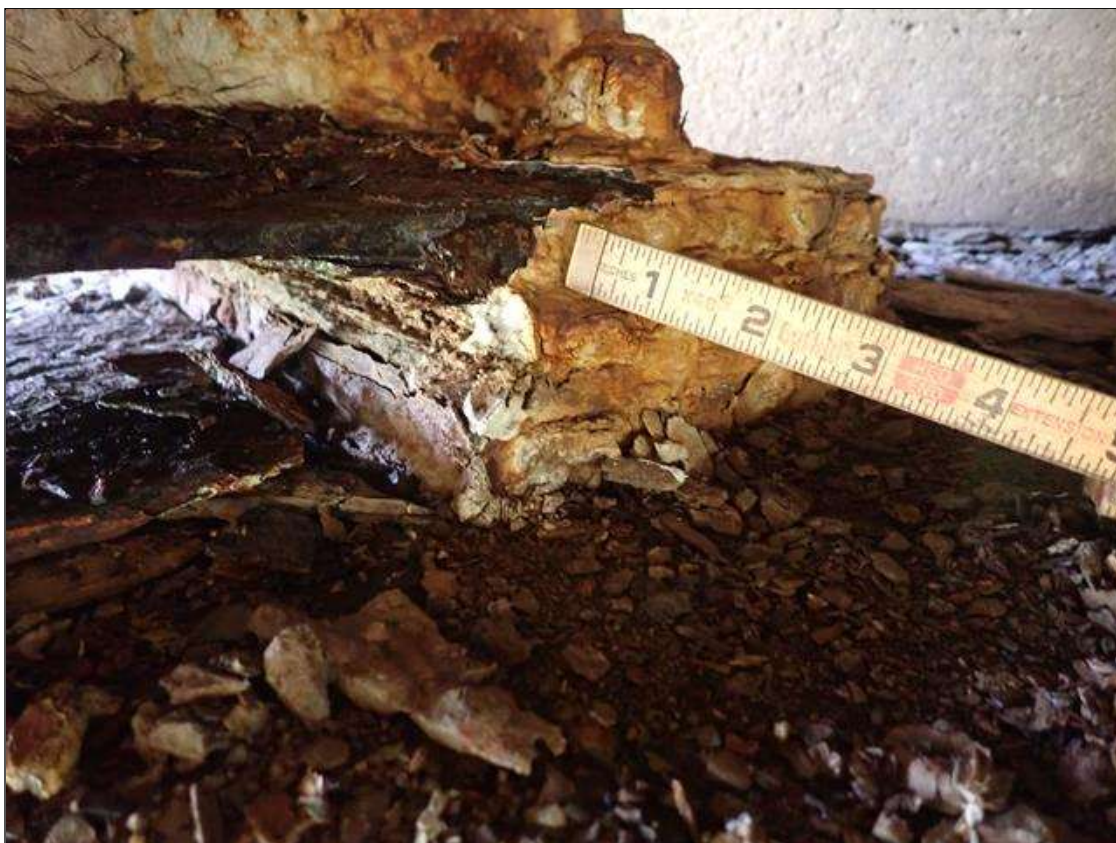
Span 1 Beam 4 - Near Bearing: CORROSION THROUGHOUT

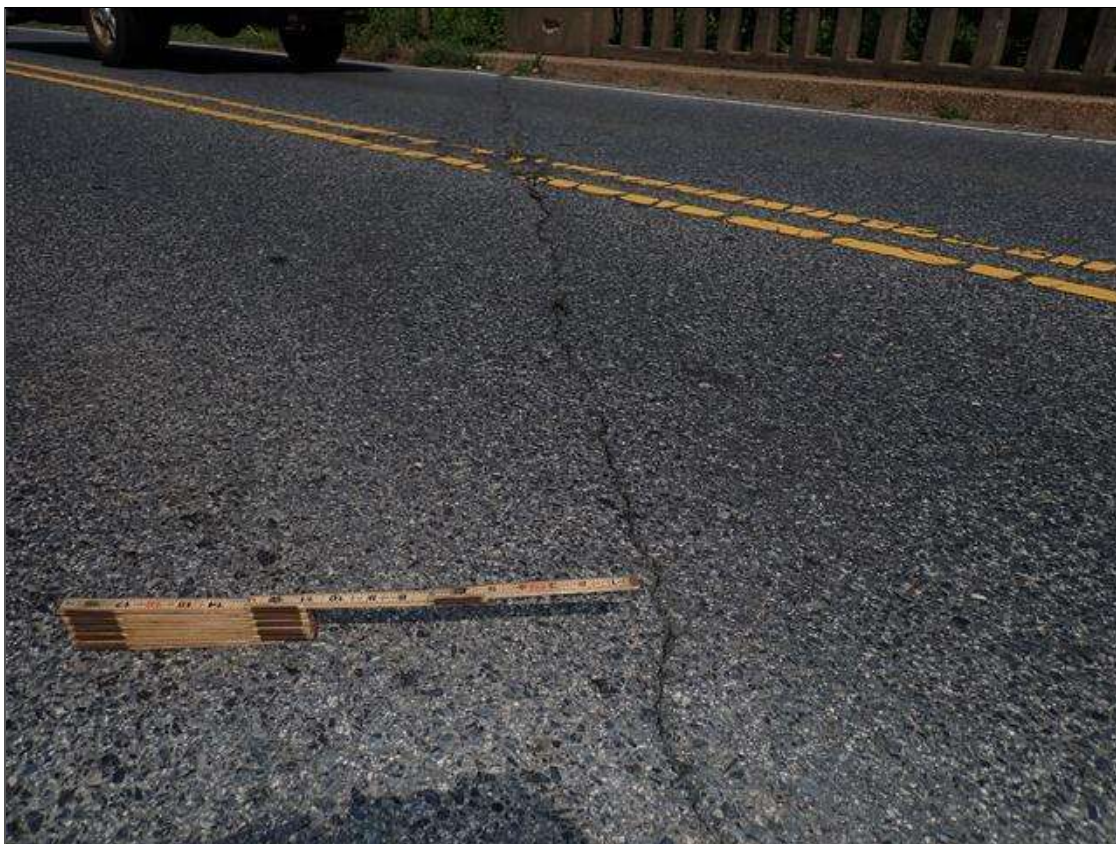
Span 1 Wearing Surface: UP TO 3/4 INCH WIDE TRANSVERSE CRACK ALONG END BENT 1 FILL FACE

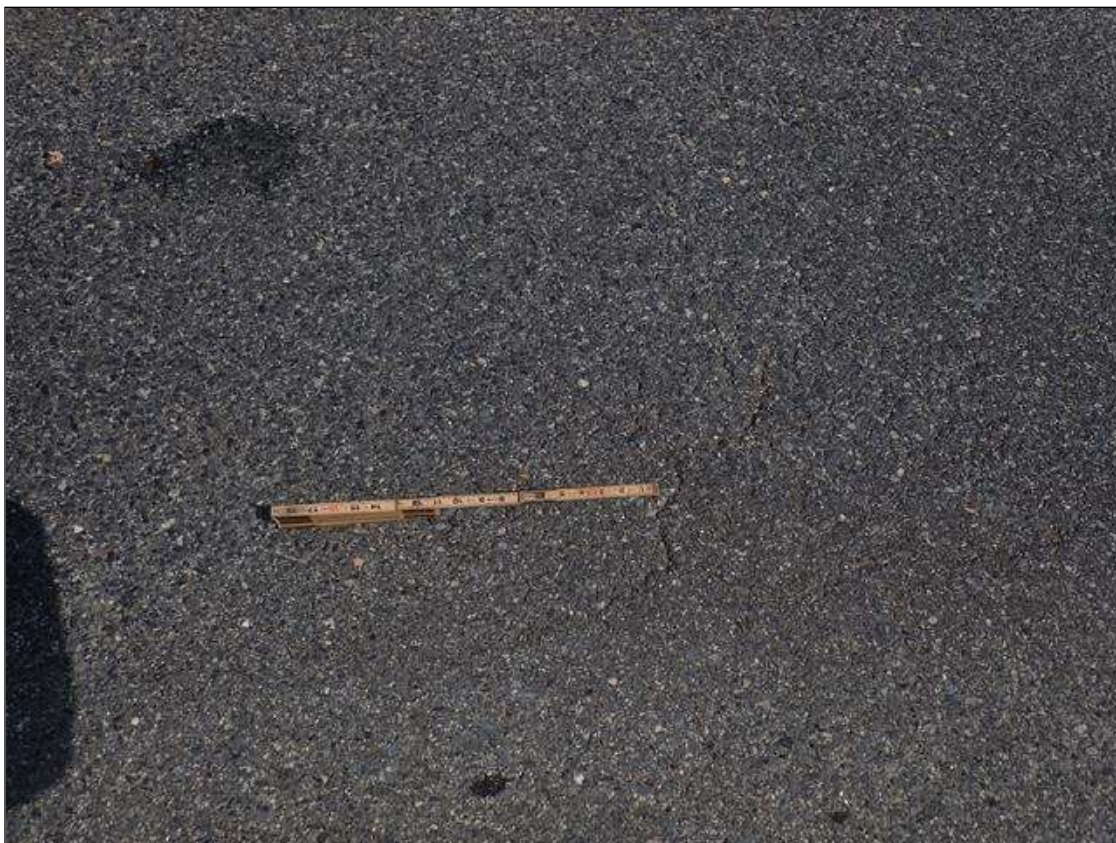
Span 1 Wearing Surface: UP TO 1/16 INCH MAP CRACKING IN VARIOUS LOCATIONS

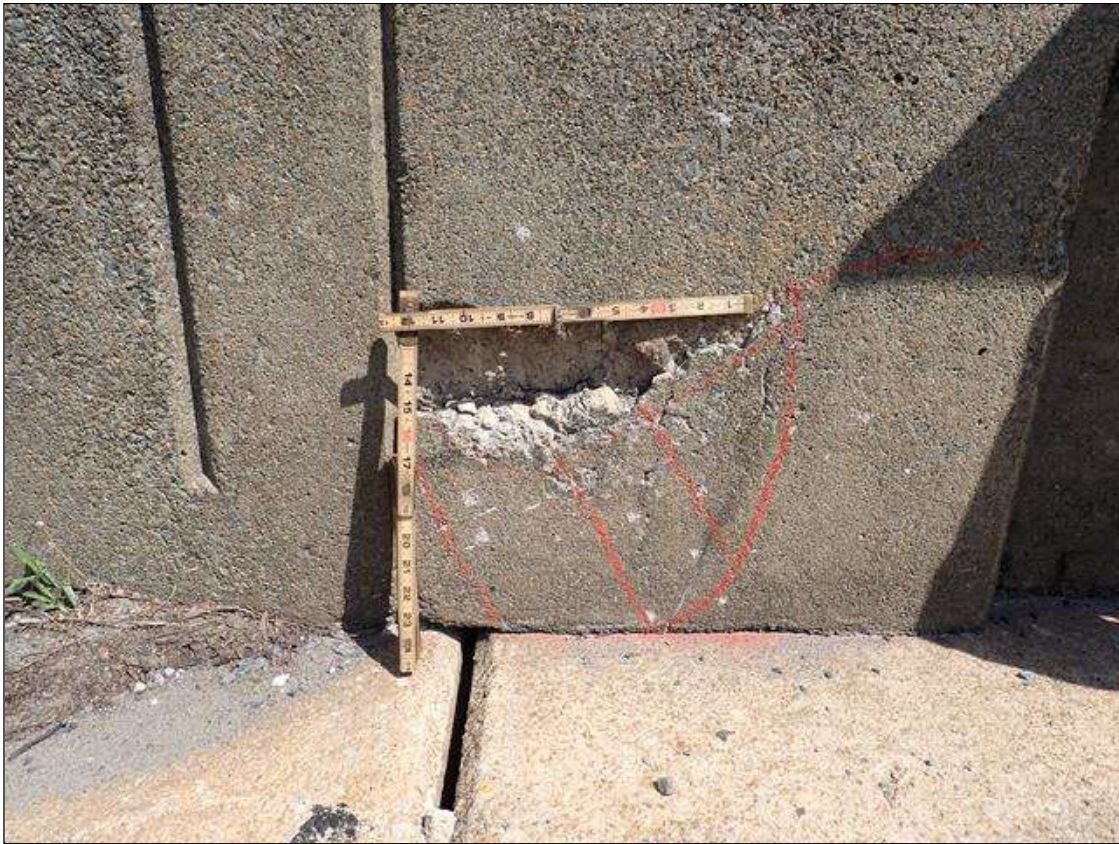
Span 1 Left Bridge Rail: 14 INCH X 12 INCH AREA OF DELAMINATION WITH UP TO 12 INCH X 5 INCH X 2 INCH DEEP SPALL IN FACE OF LEFT RAIL AT END BENT 1

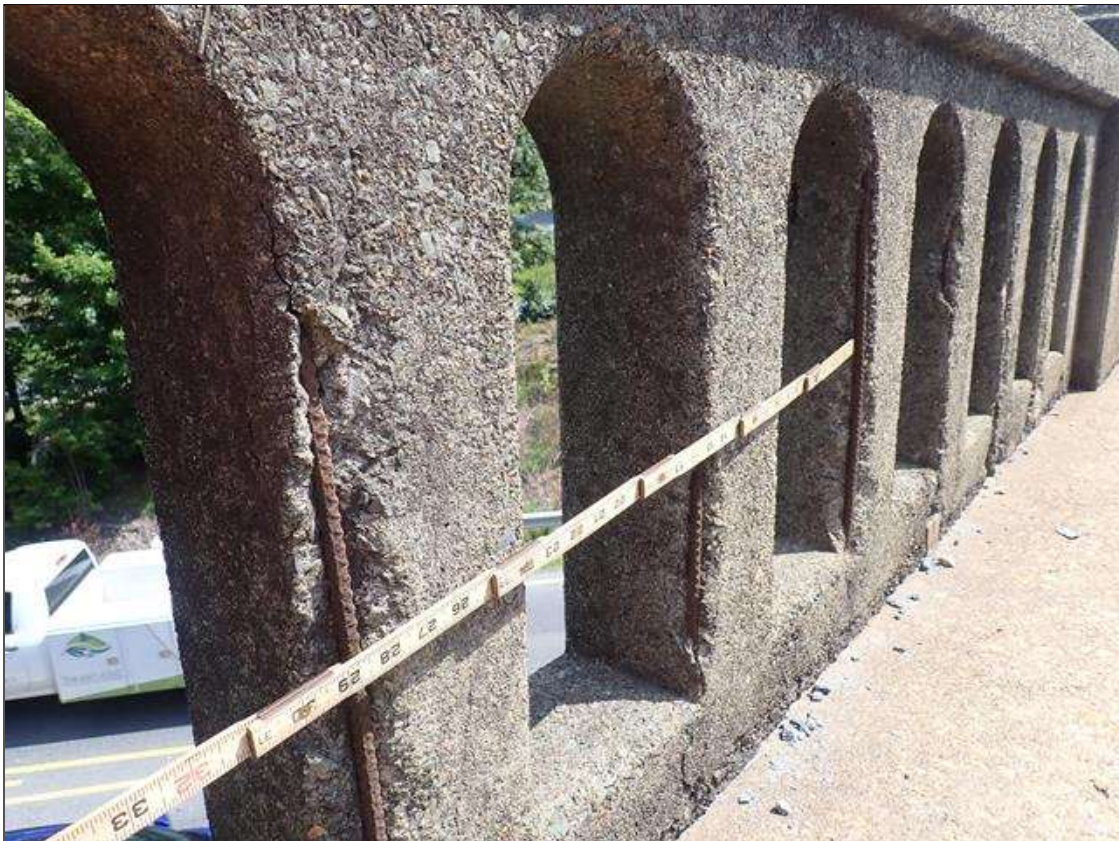
Span 1 Left Bridge Rail: (15) UP TO 3 INCHES X 25 INCHES X 2 INCHES SPALLS WITH EXPOSED REINFORCING AT RANDOM THROUGHOUT RAIL POSTS.

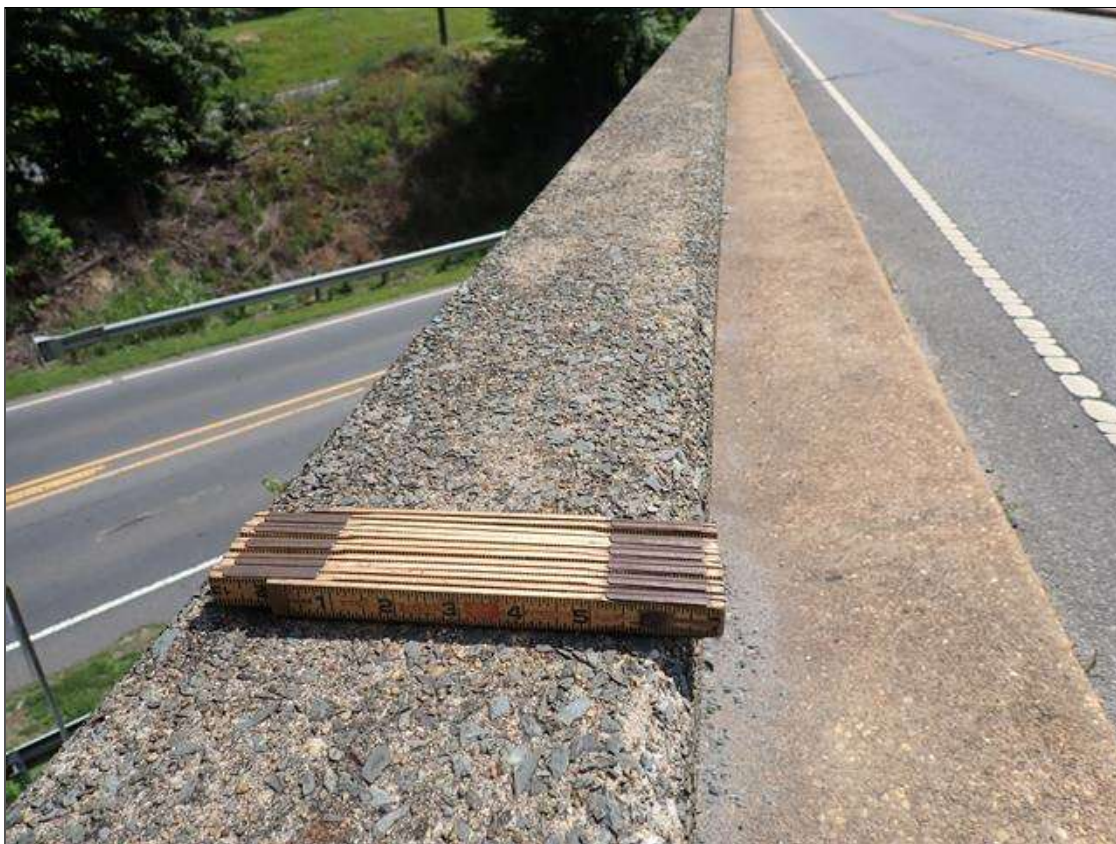
Span 1 Left Bridge Rail: WORN CONCRETE WITH EXPOSED AGGREGATE THROUGHOUT RAIL AND TOP OF CURB

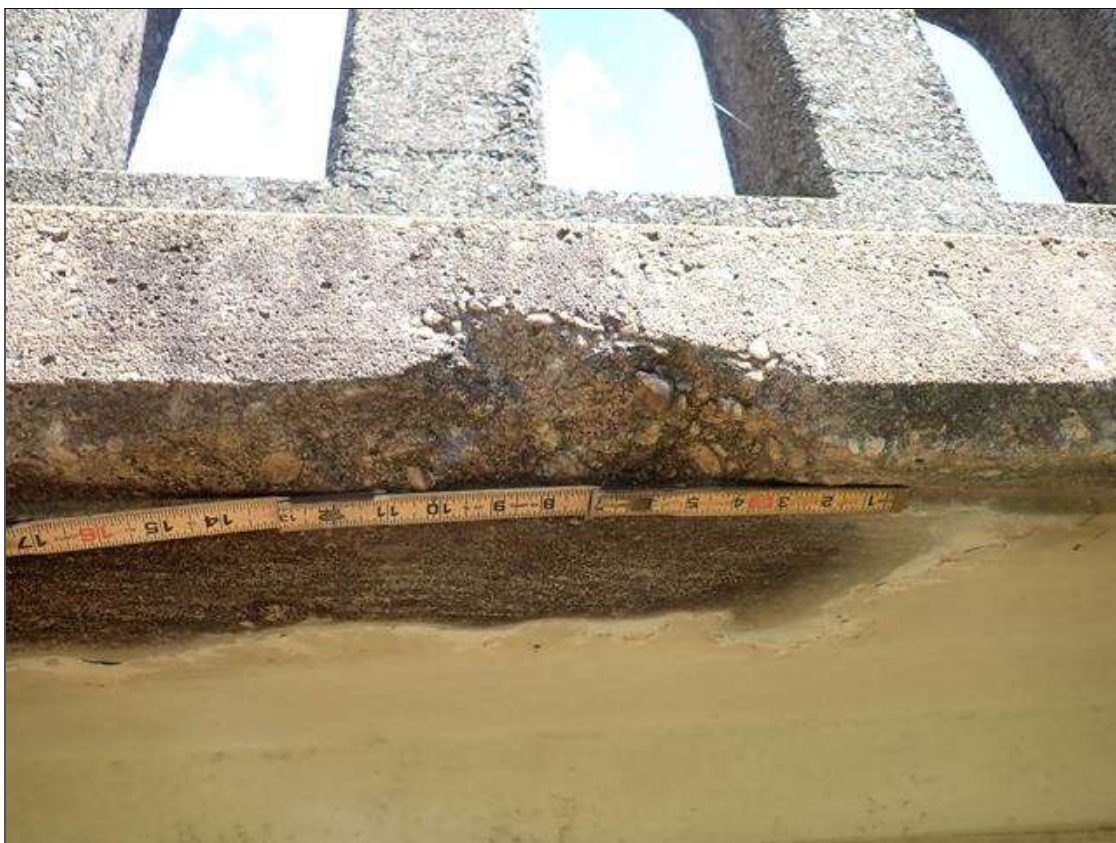
Span 1 Right Bridge Rail: 9 INCHES X 4 INCHES X 2 INCHES DEEP SPALL ON BOTTOM OUTSIDE FACE OF RAIL NEAR MID SPAN

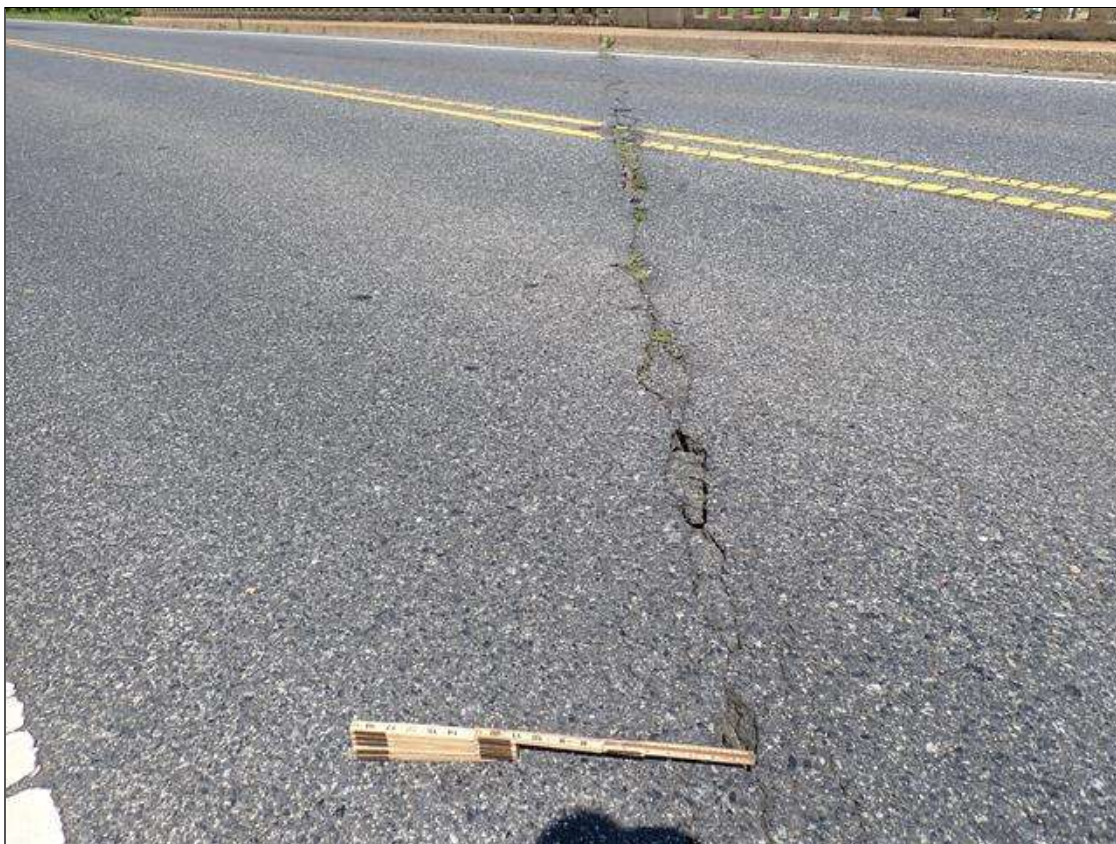
Span 2 Wearing Surface: PAR: UP TO 1/2 INCH WIDE TRANSVERSE CRACKS ALONG BENT 1 WITH (4) SPALLS UP TO 60 INCH X 6 INCH X FULL DEPTH

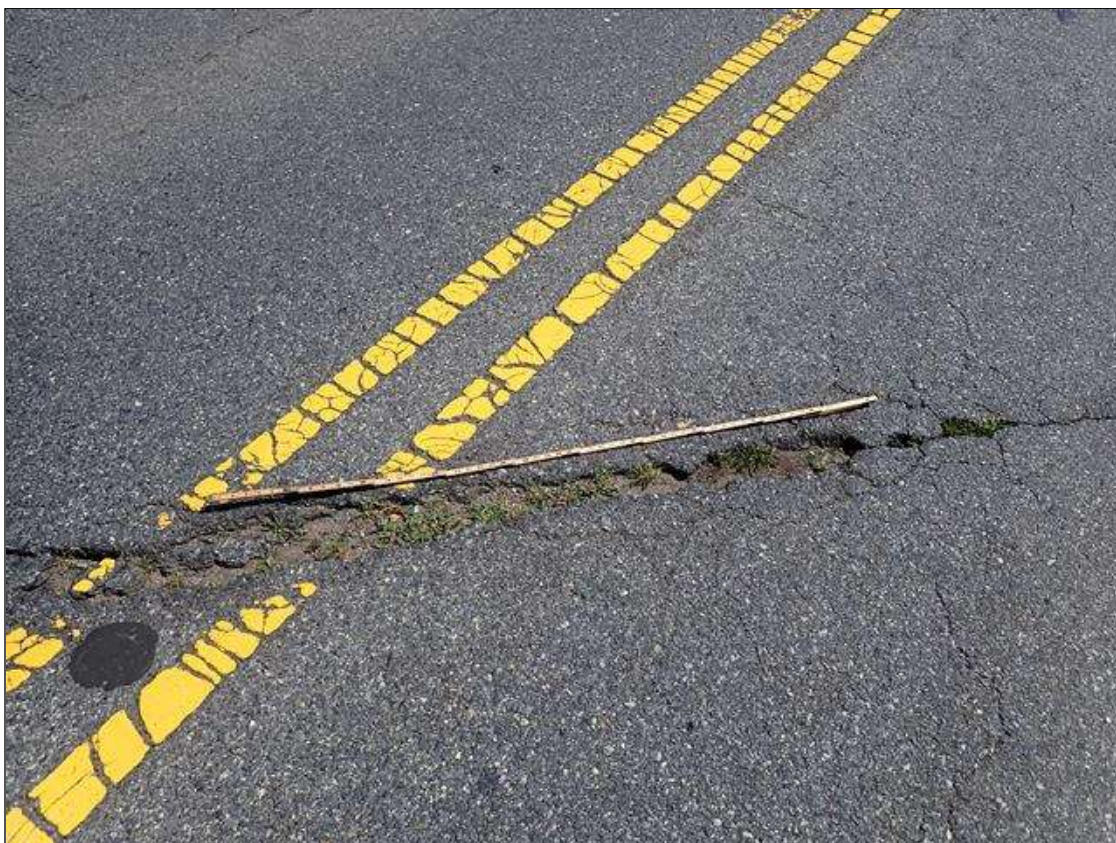
Span 2 Wearing Surface: PAR: UP TO 1/2 INCH WIDE TRANSVERSE CRACKS ALONG BENT 1 WITH (4) SPALLS UP TO 60 INCH X 6 INCH X FULL DEPTH

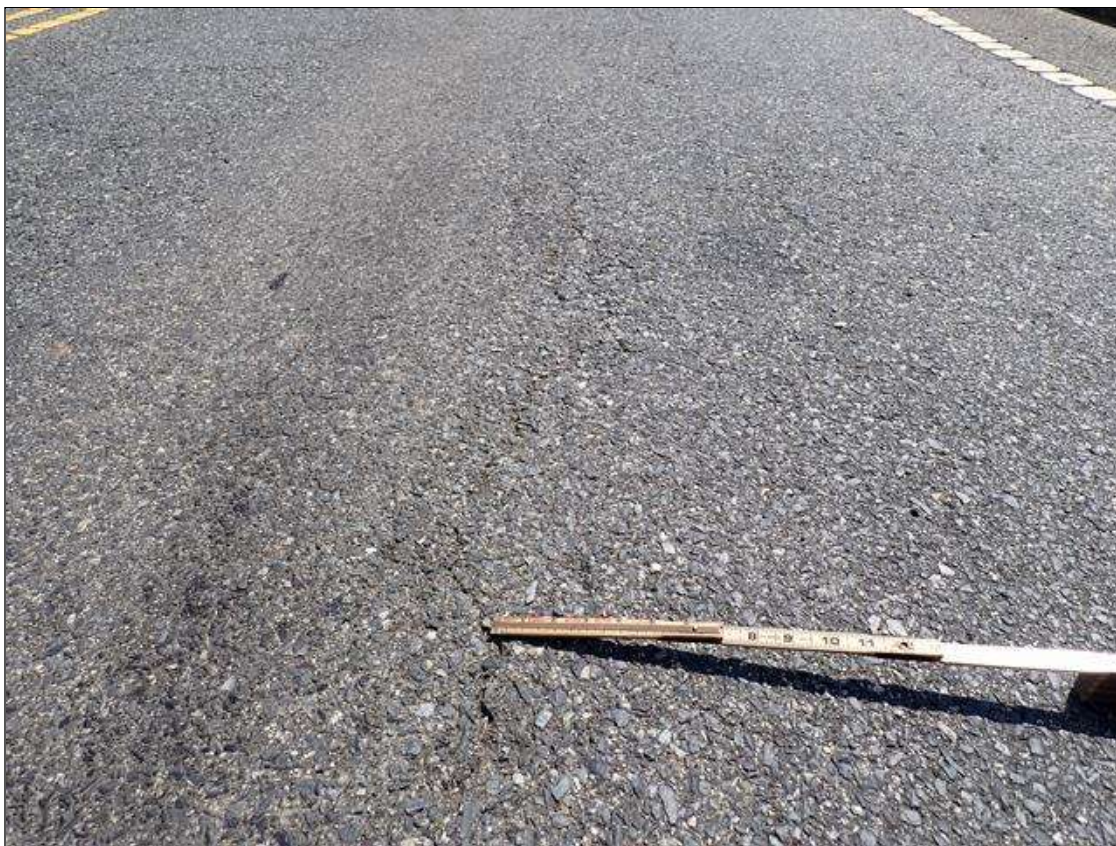
Span 2 Wearing Surface: UP TO 0.016 INCH LONGITUDINAL CRACKS IN VARIOUS LOCATIONS

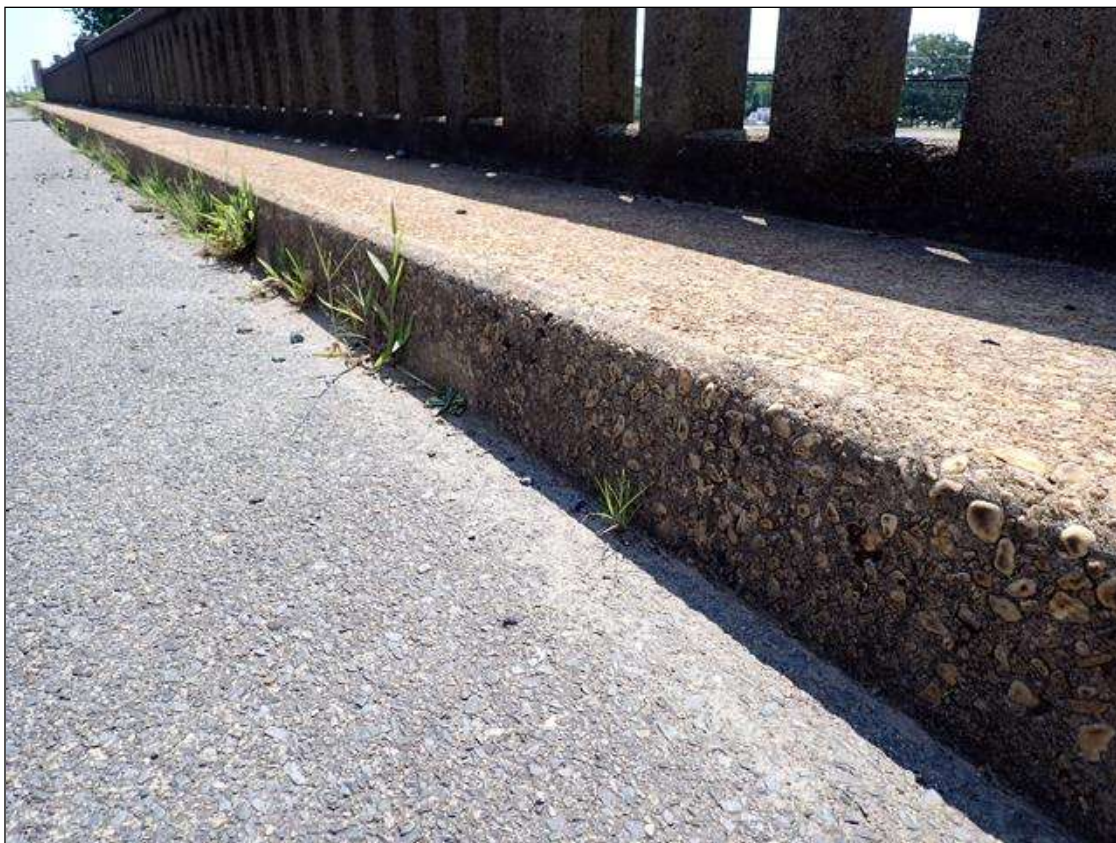
DIRT AND DEBRIS ACCUMULATION WITH VEGETATION GROWTH ALONG BOTH SHOULDERS

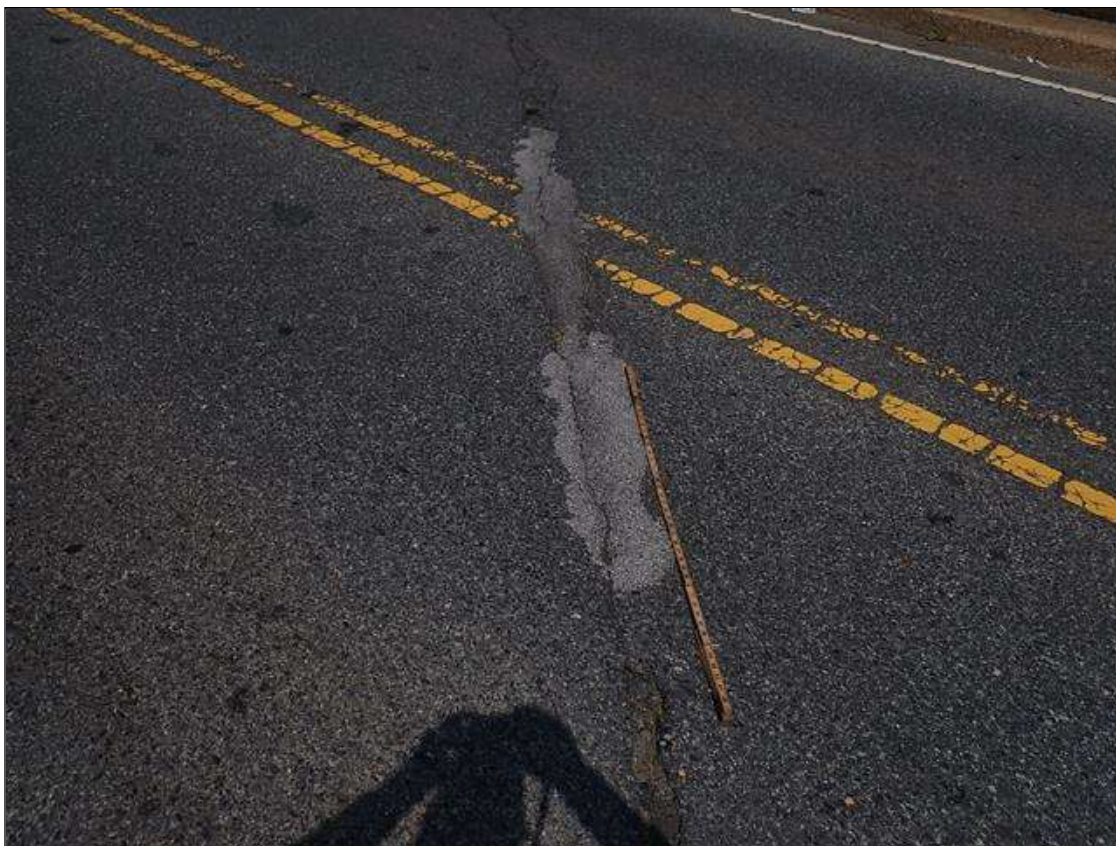
Span 3 Wearing Surface: PRIORITY MAINTENANCE REPAIR, UP TO 108 INCH X 8 INCH AT CENTERLINE ALONG BENT 2

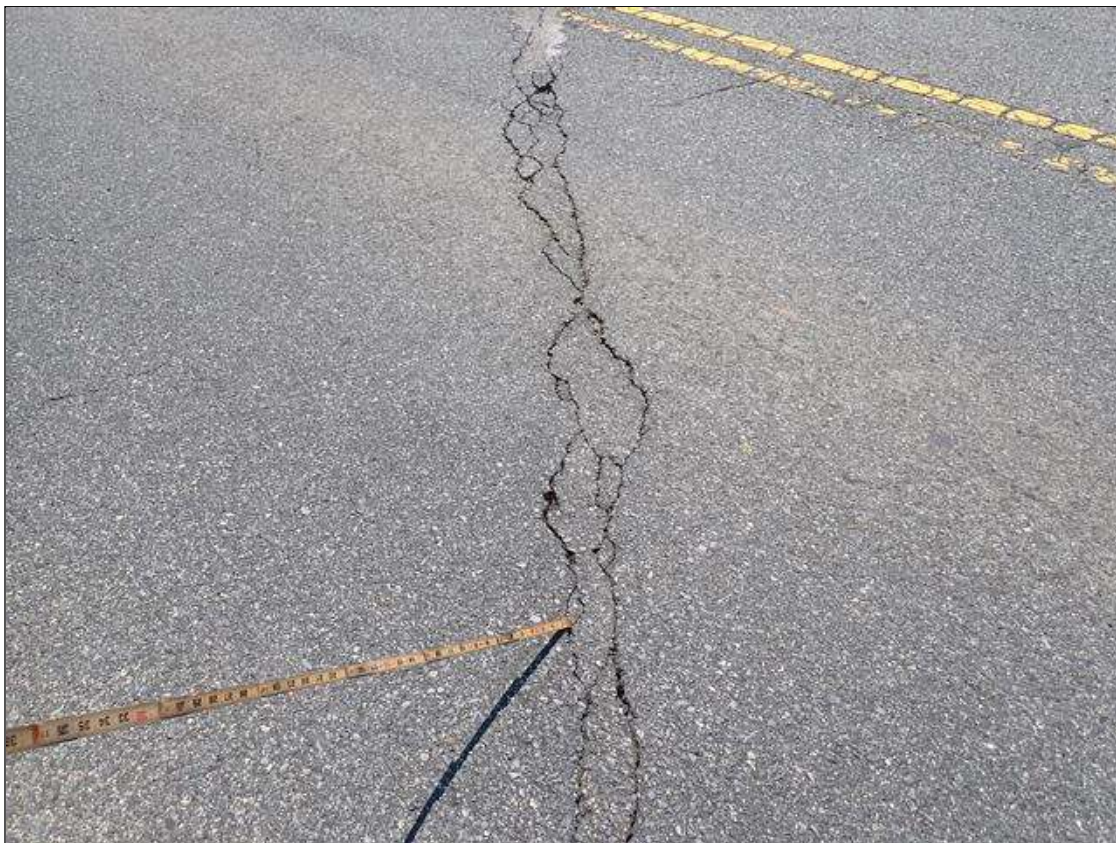
Span 3 Wearing Surface: UP TO 1/2 INCH TRANSVERSE CRACKS AND 96 INCH X 8 INCH AREA OF ALLIGATOR CRACKS ALONG BENT 2

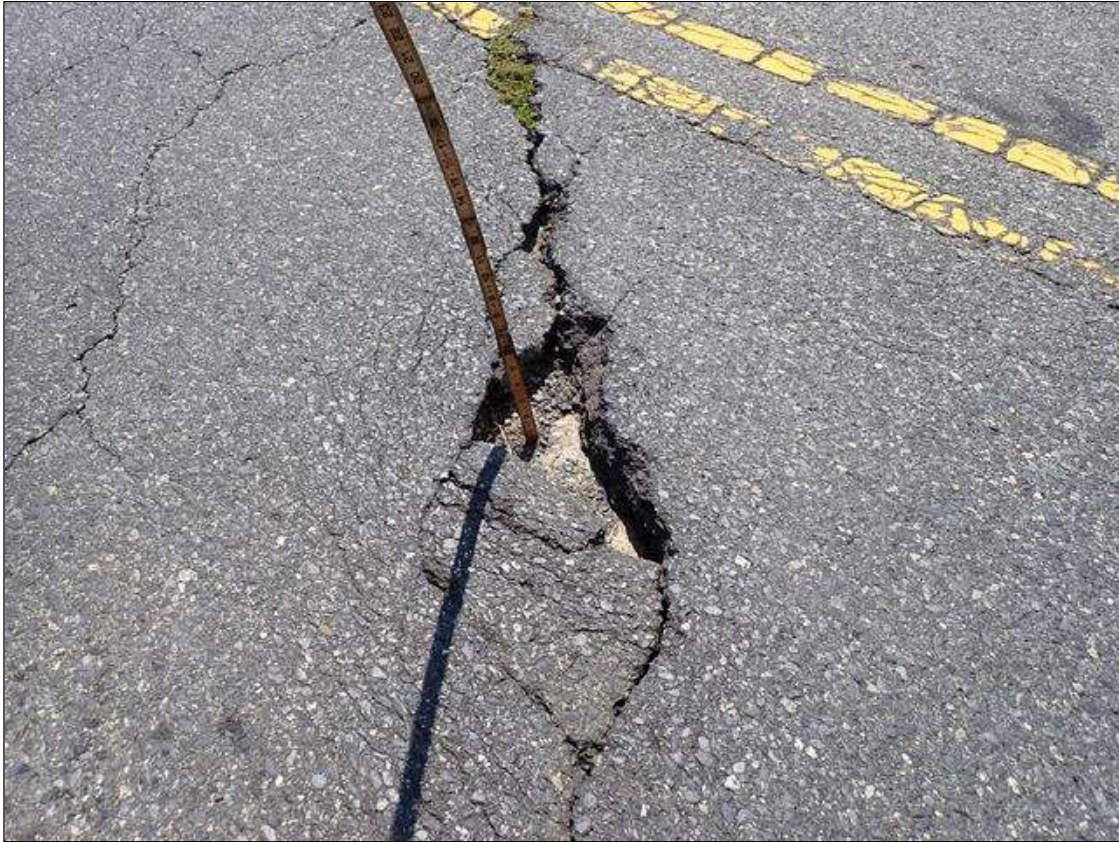
Span 3 Wearing Surface: PAR: UP TO 1/2 INCH WIDE TRANSVERSE CRACKS ALONG END BENT 2 WITH (4) SPALLS UP TO 38 INCH X 5 INCH X FULL DEPTH

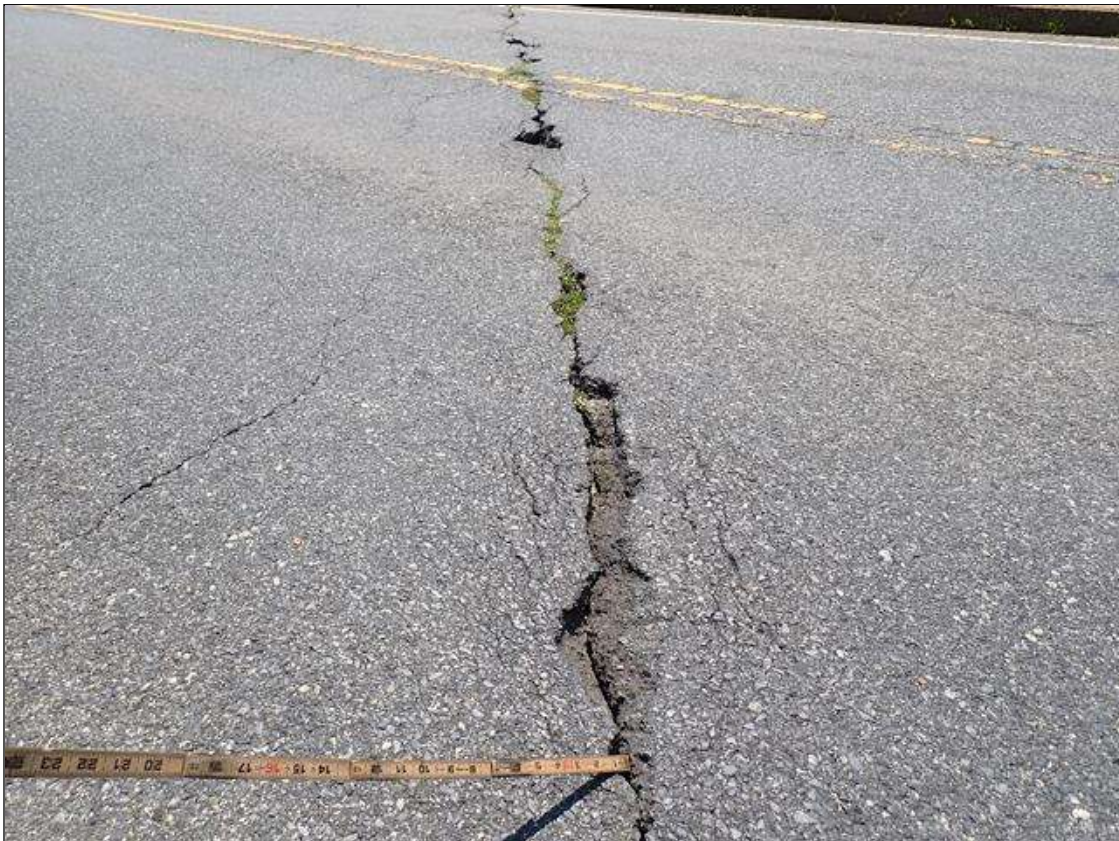
Span 3 Wearing Surface: PAR: UP TO 1/2 INCH WIDE TRANSVERSE CRACKS ALONG END BENT 2 WITH (4) SPALLS UP TO 38 INCH X 5 INCH X FULL DEPTH
