NC DEPARTMENT OF TRANSPORTATION  
 DIVISION OF HIGHWAYS  
 STRUCTURE MANAGEMENT UNIT

ATTENTION: **PAR, DATA CHANGES**

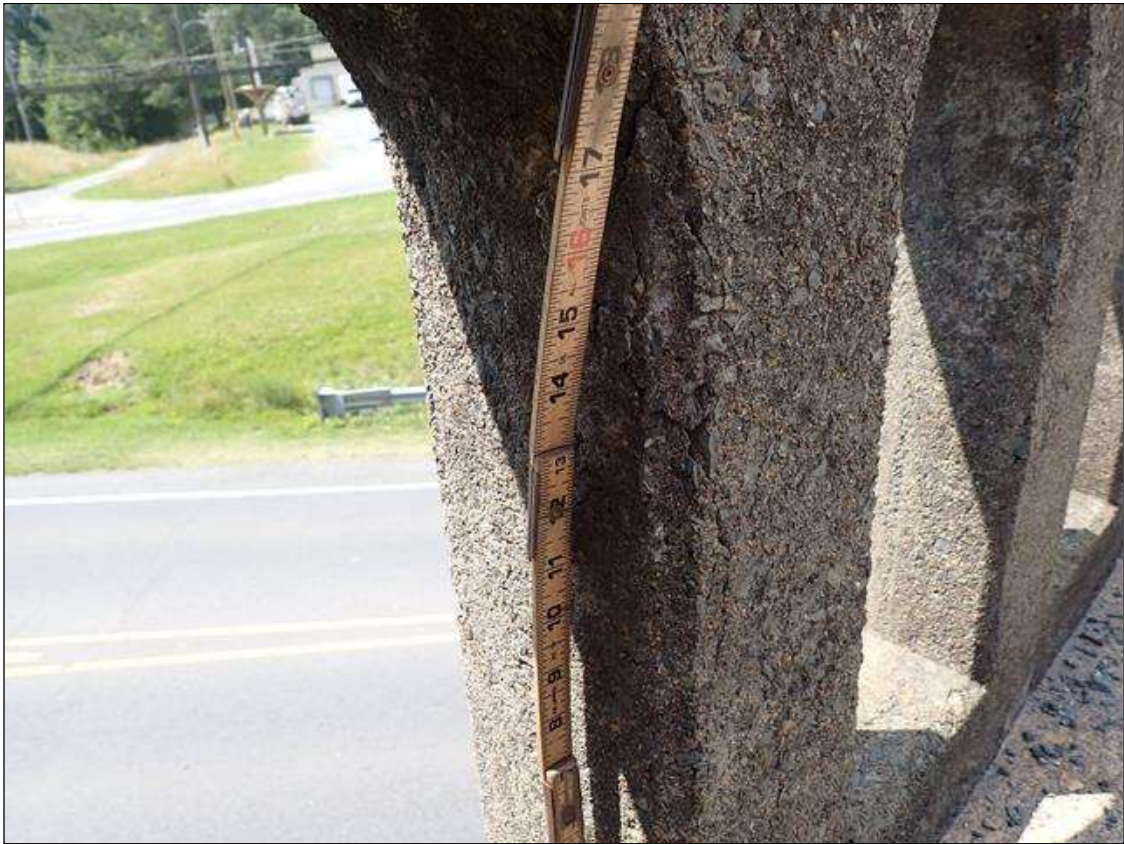
Span 3 Right Bridge Rail: 2 INCHES X 10 INCHES DELAMINATION NORTH FACE RAIL POST 12 FEET FROM BENT 2.

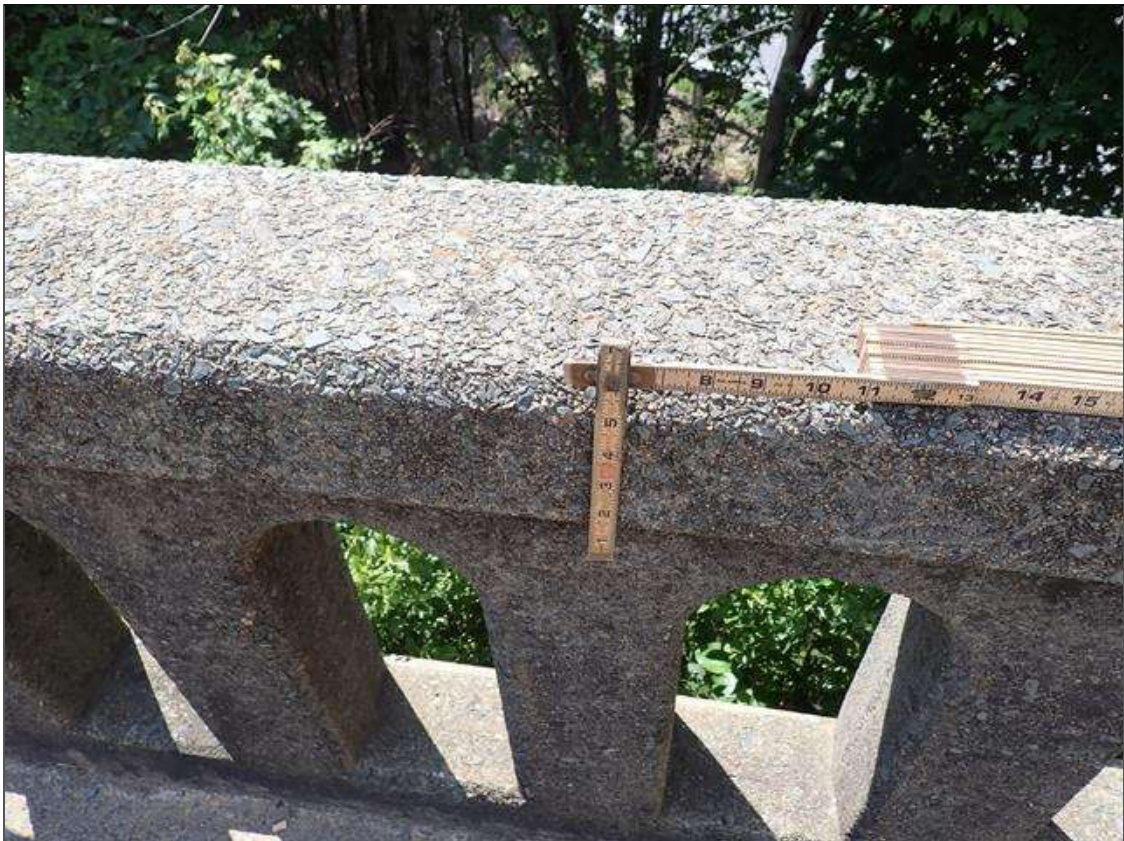
Span 3 Right Bridge Rail: UP TO 0.016 INCH TRANSVERSE AND VERTICAL CRACKS IN TOP AND BOTH FACES OF RAIL IN VARIOUS LOCATIONS

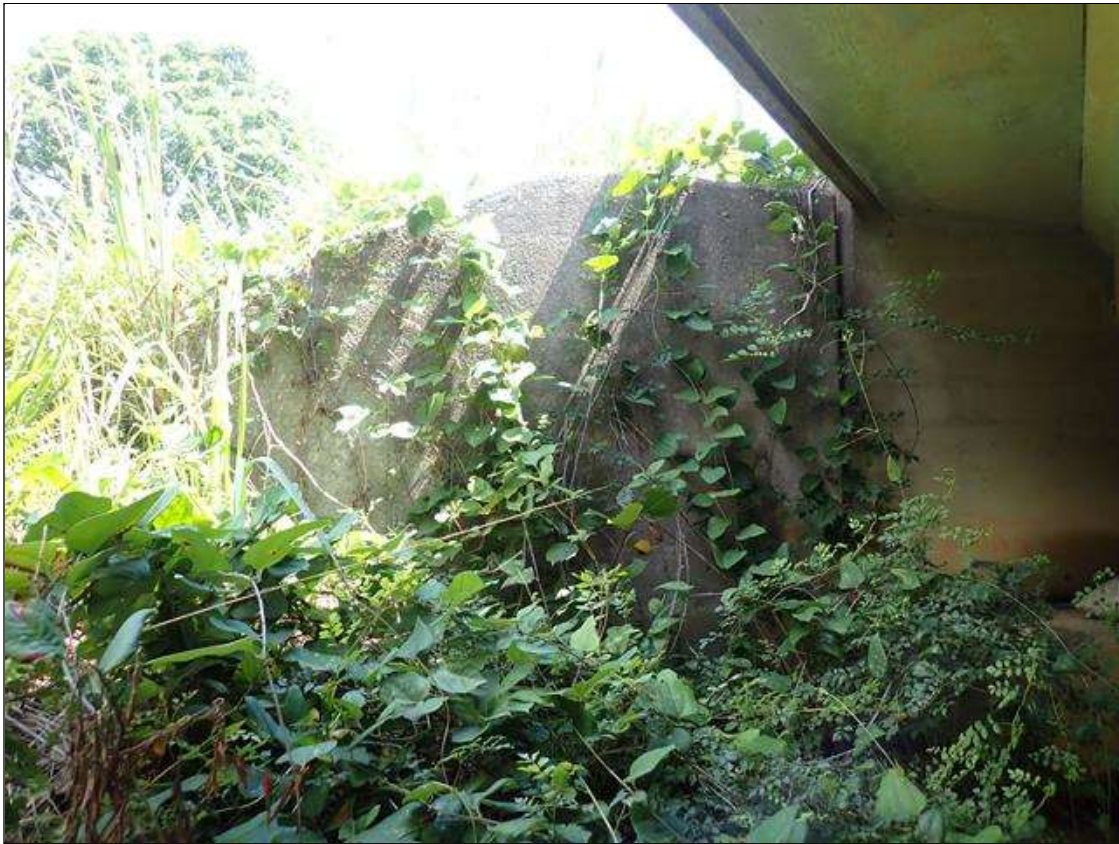
NORTHWEST WINGWALL COVERED IN VEGETATION OVERGROWTH, OTHERS SIMILAR

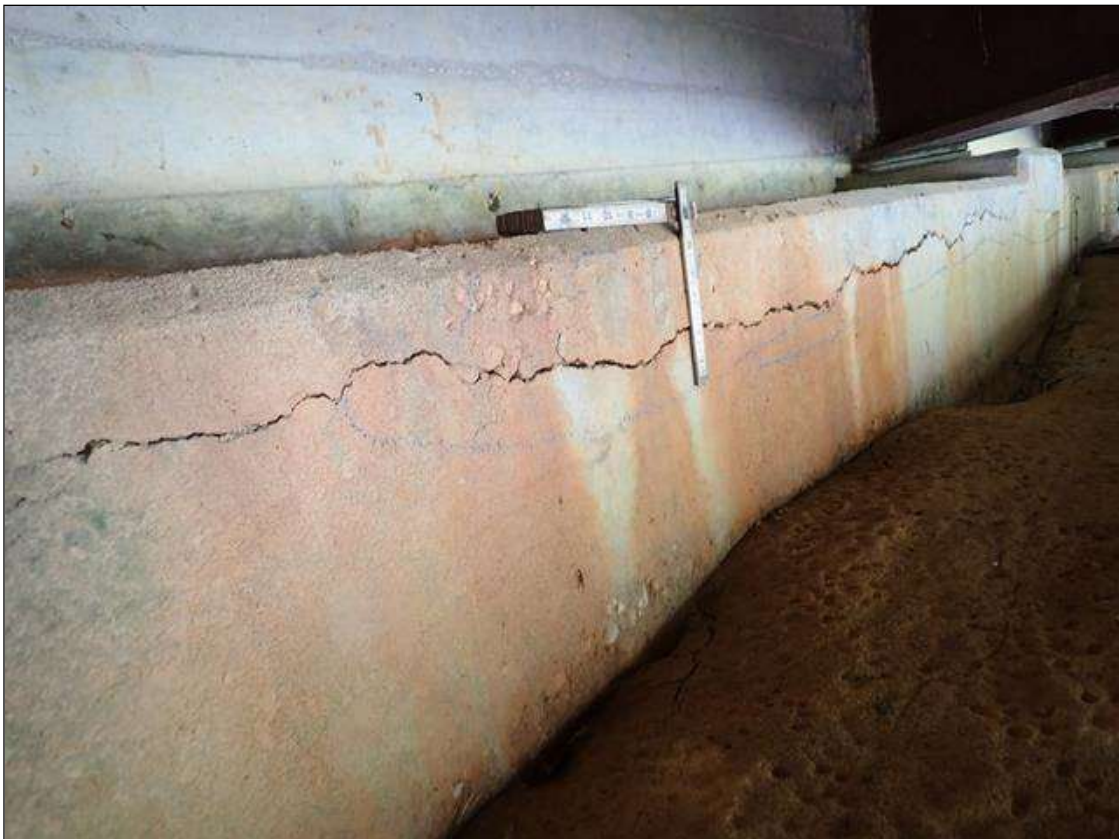
End Bent 2 Cap 1: UP TO 1/4 INCH LONGITUDINAL AND HORIZONTAL CRACKS AND AREA OF DELAMINATION UP TO 20 FOOT LONG X 5 INCH HIGH X 5 INCH WIDE IN TOP AND FACE OF CAP FROM BAY 1 TO BEAM 3

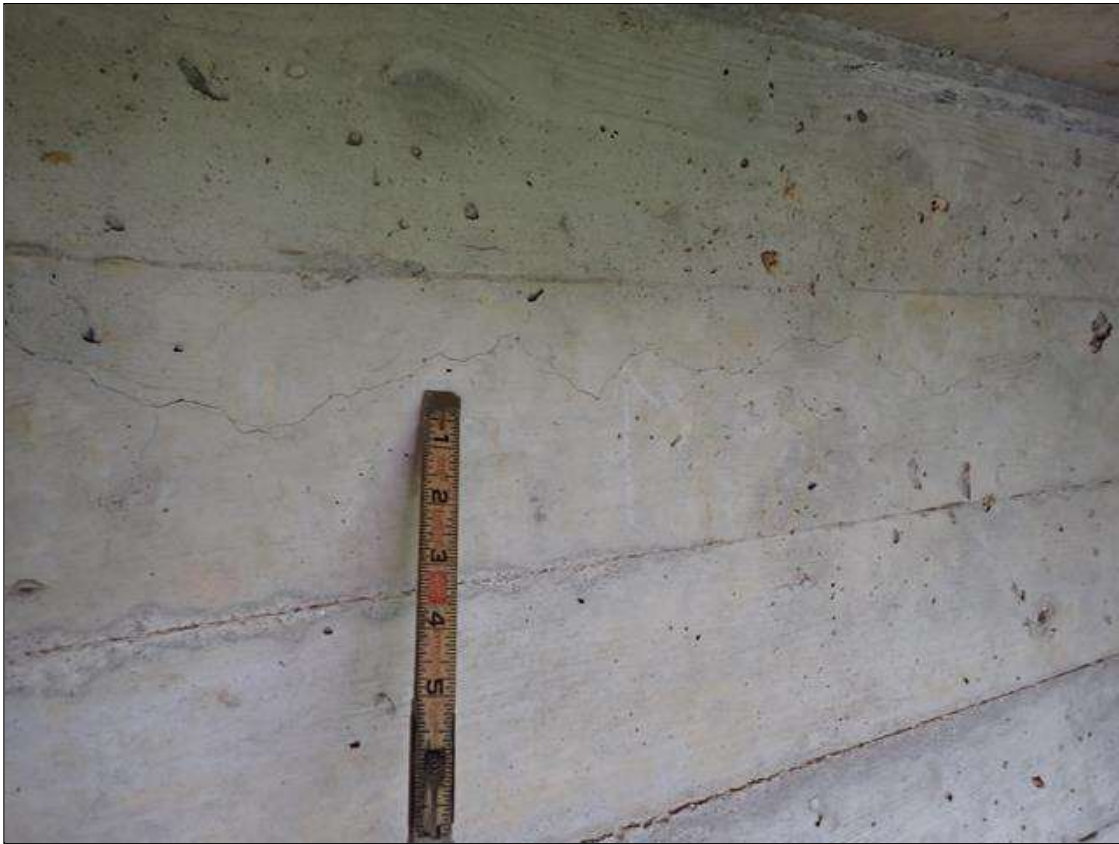
End Bent 2 Abutment: UP TO 0.012 INCH HORIZONTAL CRACKS IN FACE OF BACKWALL IN VARIOUS LOCATIONS

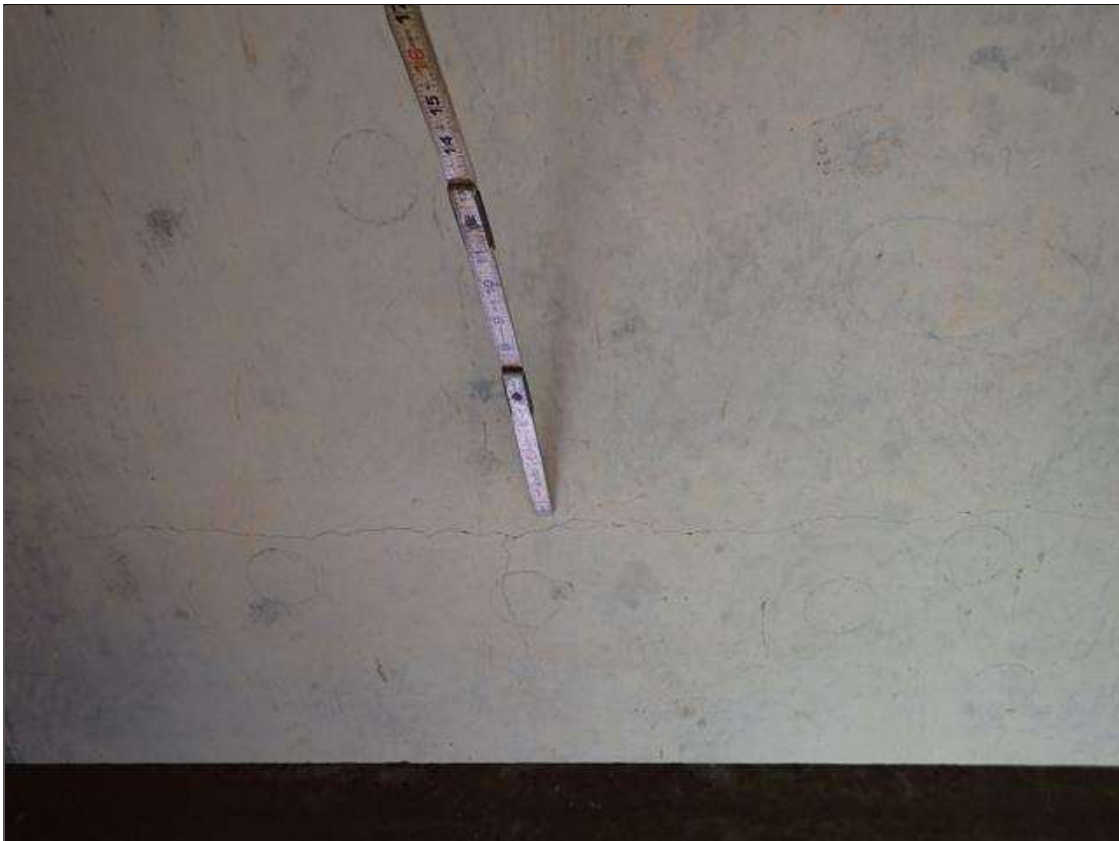
Span 3 Deck: UP TO 0.016 INCH TRANSVERSE CRACKS IN BOTTOM OF DECK IN VARIOUS LOCATIONS

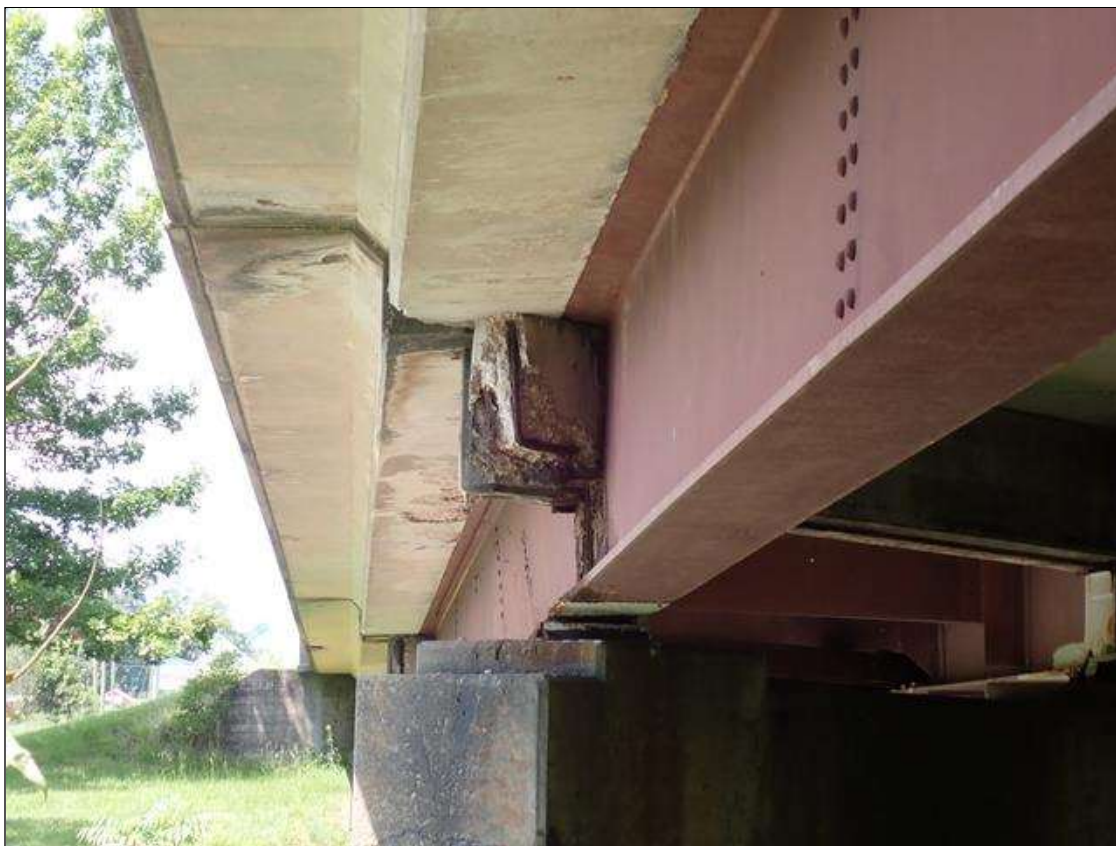
Span 3 Deck: 15 INCHES X 9 INCHES X 4 INCHES DEEP SPALL WITH EXPOSED REBAR AT BENT 2 UNDER EAST OVERHANG.

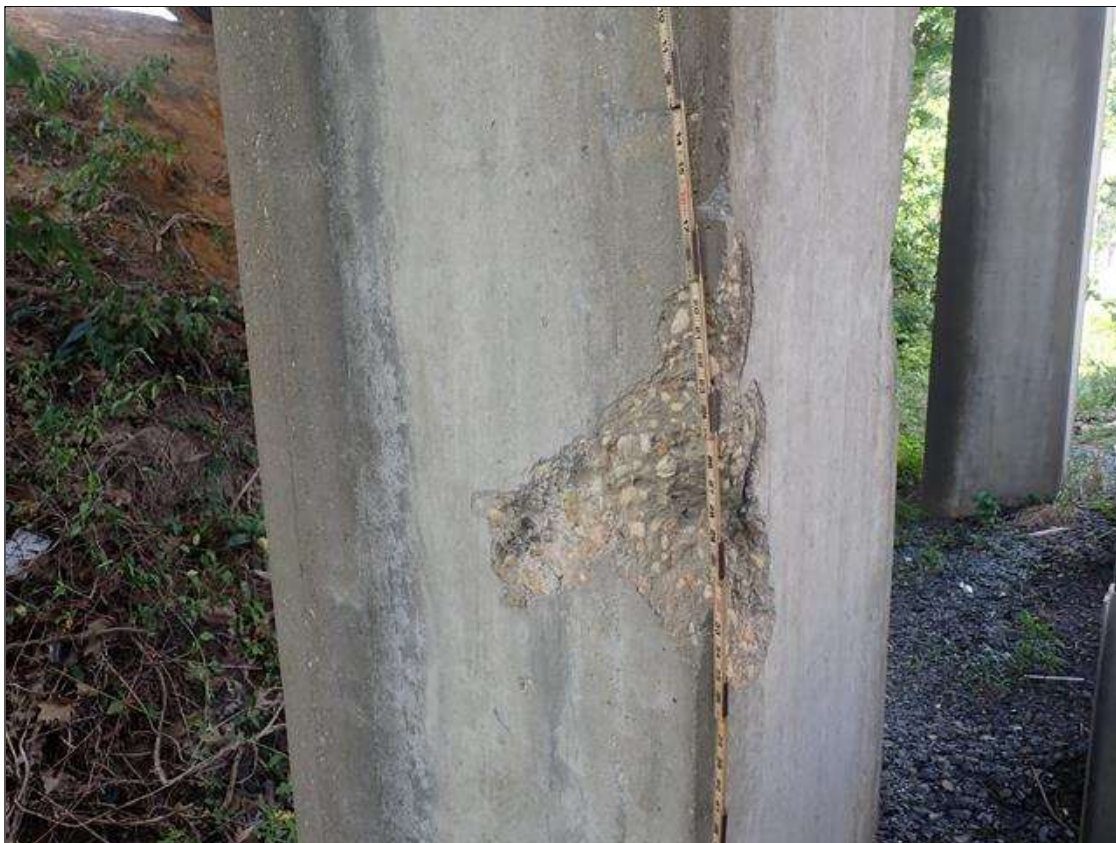
Bent 1 Pile 2: 21 INCHES X 14 INCHES X 6 INCHES SPALL IN NORTHEAST CORNER, APPROXIMATELY 7 FEET FROM BOTTOM OF CAP

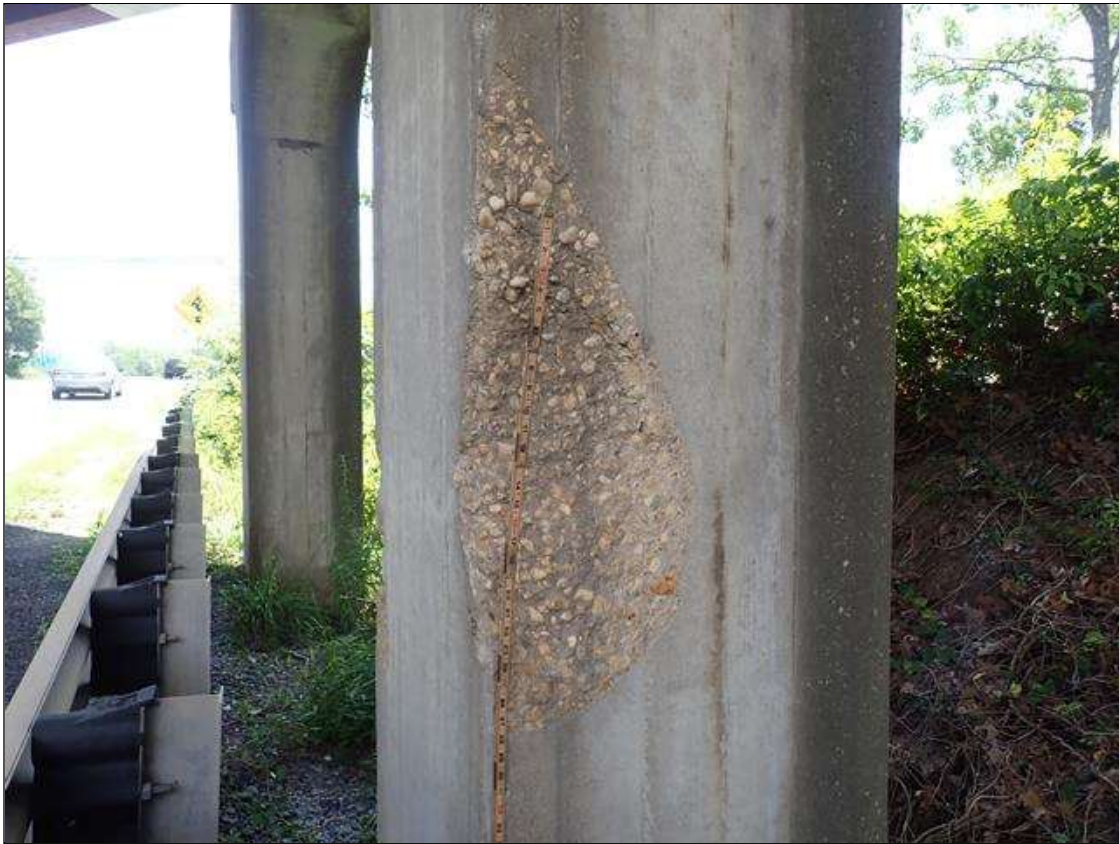
Bent 1 Pile 2: 35 INCH X 15 INCH X 4 INCH SPALL IN NORTHWEST CORNER OF PILE, APPROXIMATELY 6 FOOT FROM BOTTOM OF CAP

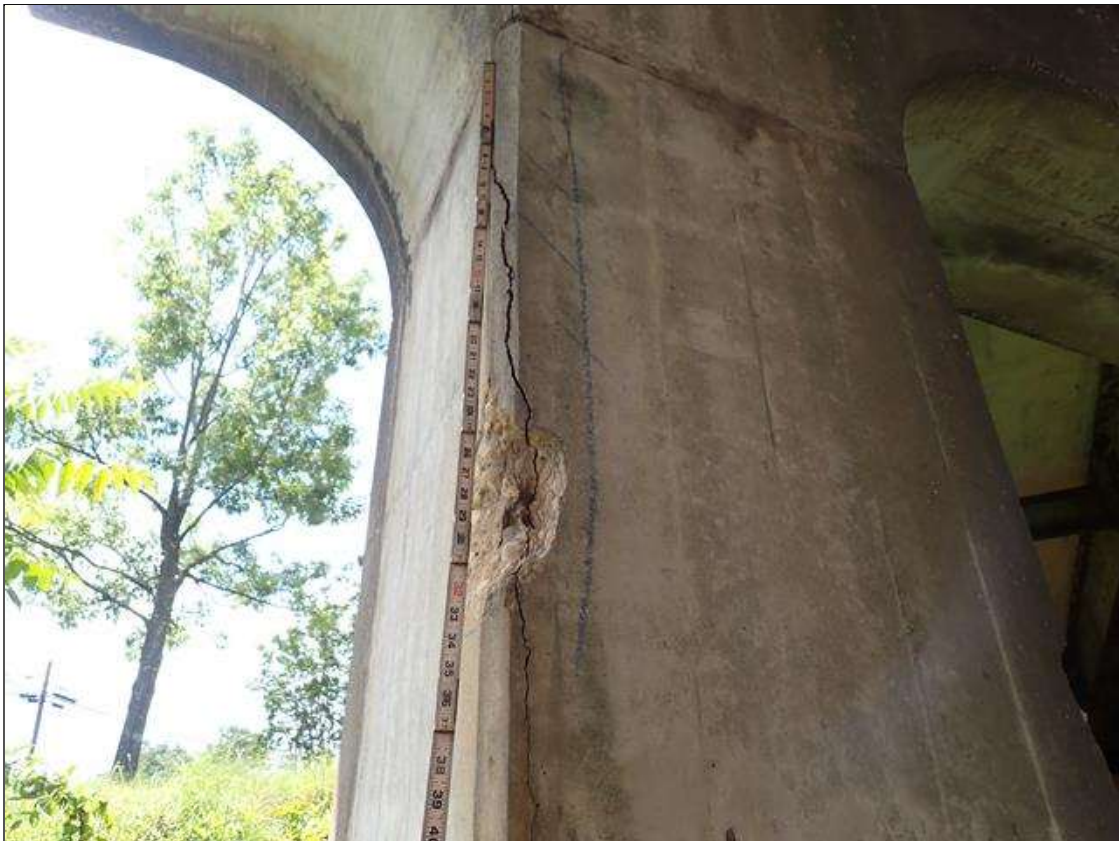
Bent 1 Pile 3: (2) UP TO 10 INCHES X 7 INCHES X 2 INCHES SPALLS WITH UP TO 24 INCHES X 4 INCHES AREA OF DELAMINATION ALONG NORTH CORNERS

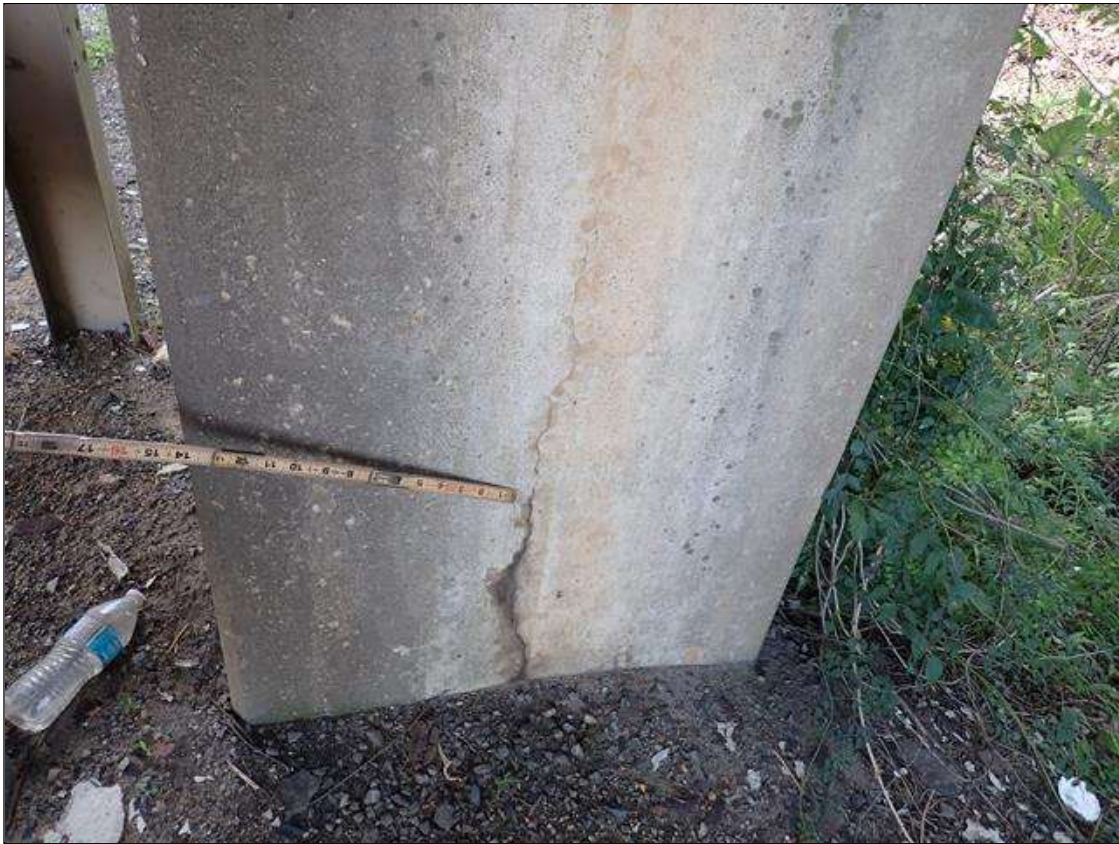
Bent 2 Pile 1: UP TO 0.016 INCH VERTICAL CRACKS IN VARIOUS LOCATIONS

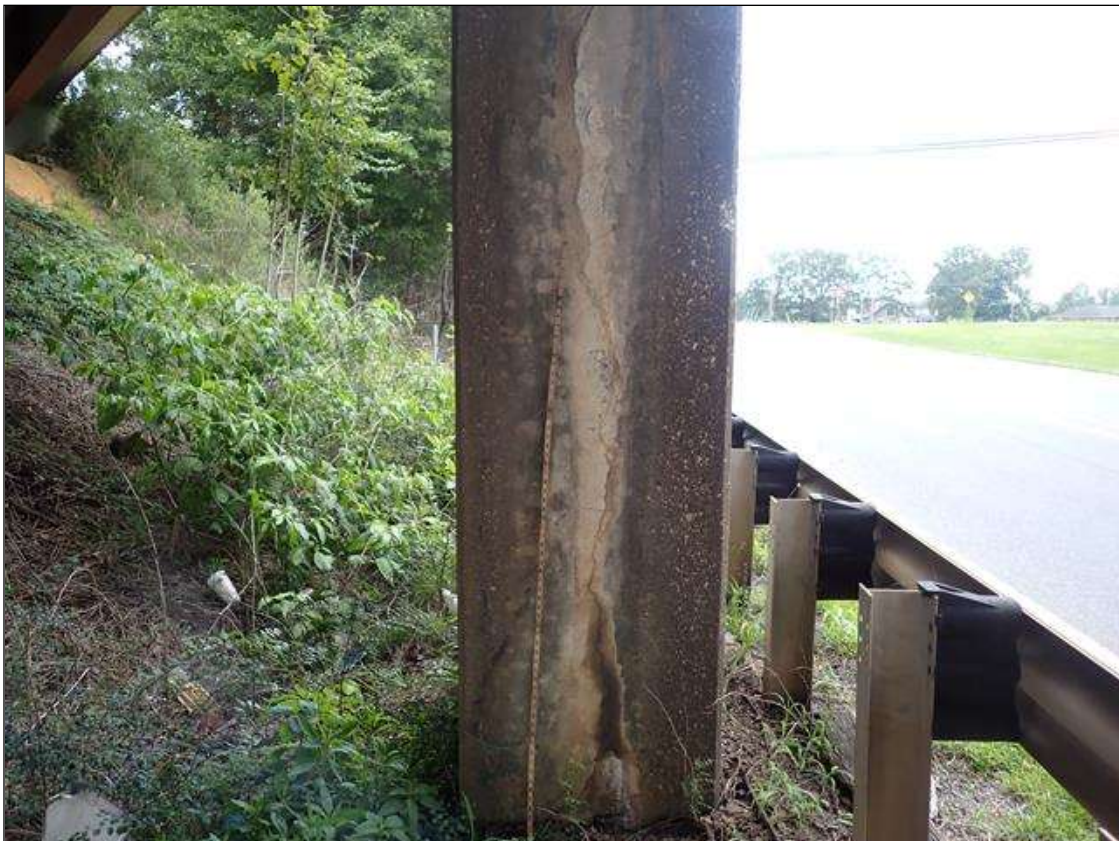
Bent 2 Pile 3: UP TO 0.02 INCH VERTICAL CRACK WITH EFFLORESCENCE BUILD UP AND 96 INCH X 12 INCH AREA OF DELAMINATION IN WEST FACE

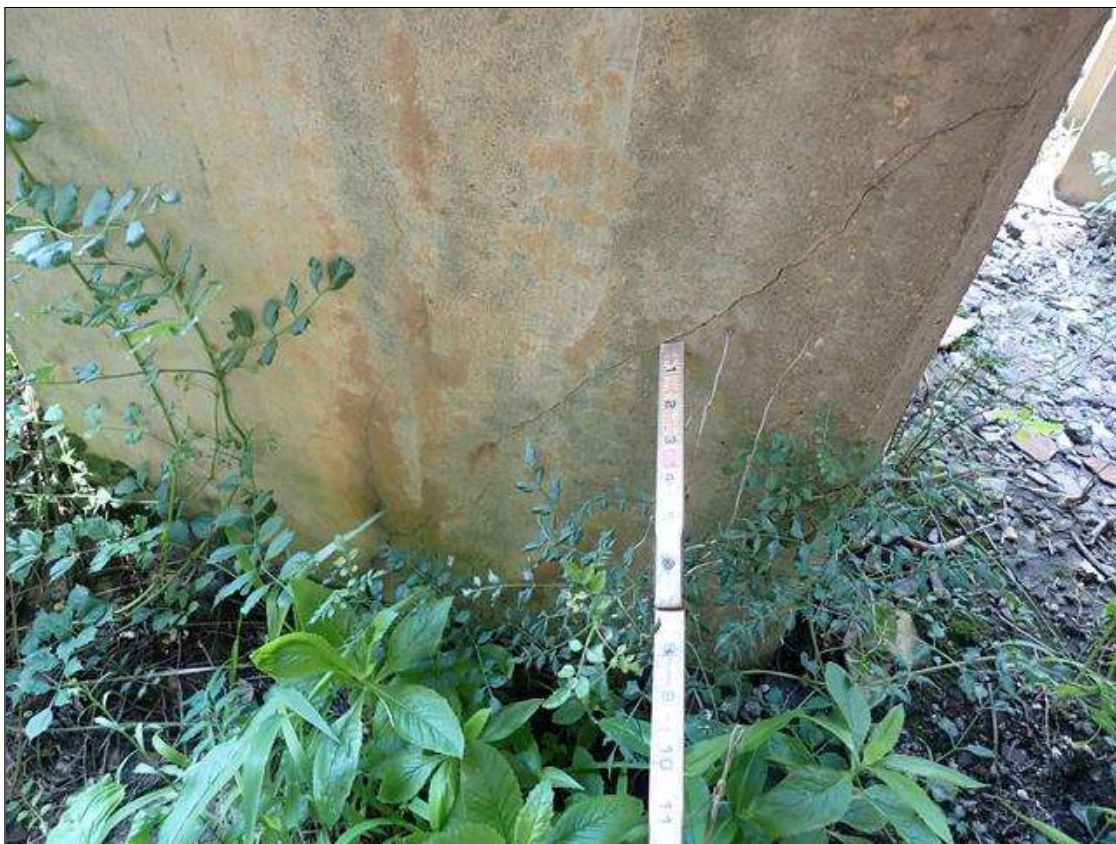
Bent 2 Pile 3: (5) UP TO 1 FEET X 0.016 INCHES DIAGONAL CRACKS AT RANDOM THROUGHOUT NORTH FACE.

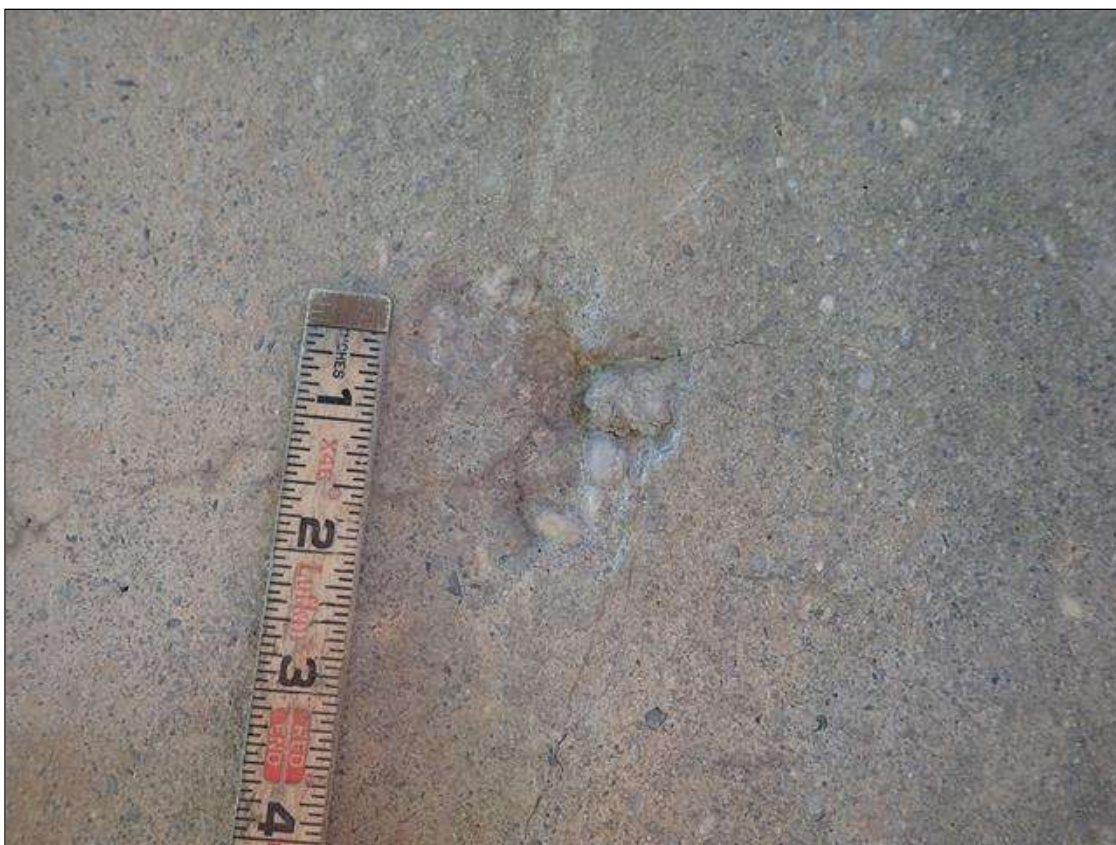
Bent 2 Pile 3: 2 INCHES DIAMETER X 1/2 INCHES DEEP SPALL NORTH FACE 5 FEET FROM BOTTOM OF CAP.

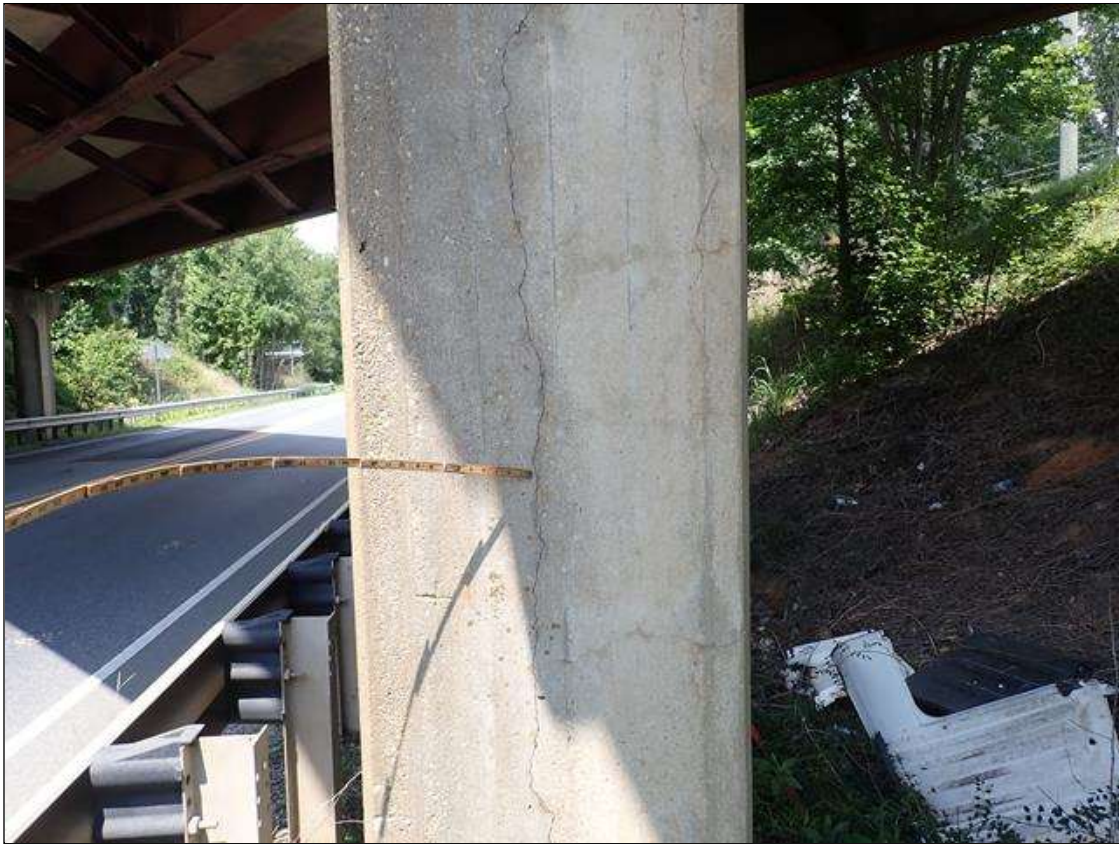
Bent 2 Pile 3: (4) UP TO 9 FEET X 1/16 INCHES VERTICAL CRACKS AT RANDOM THROUGHOUT.

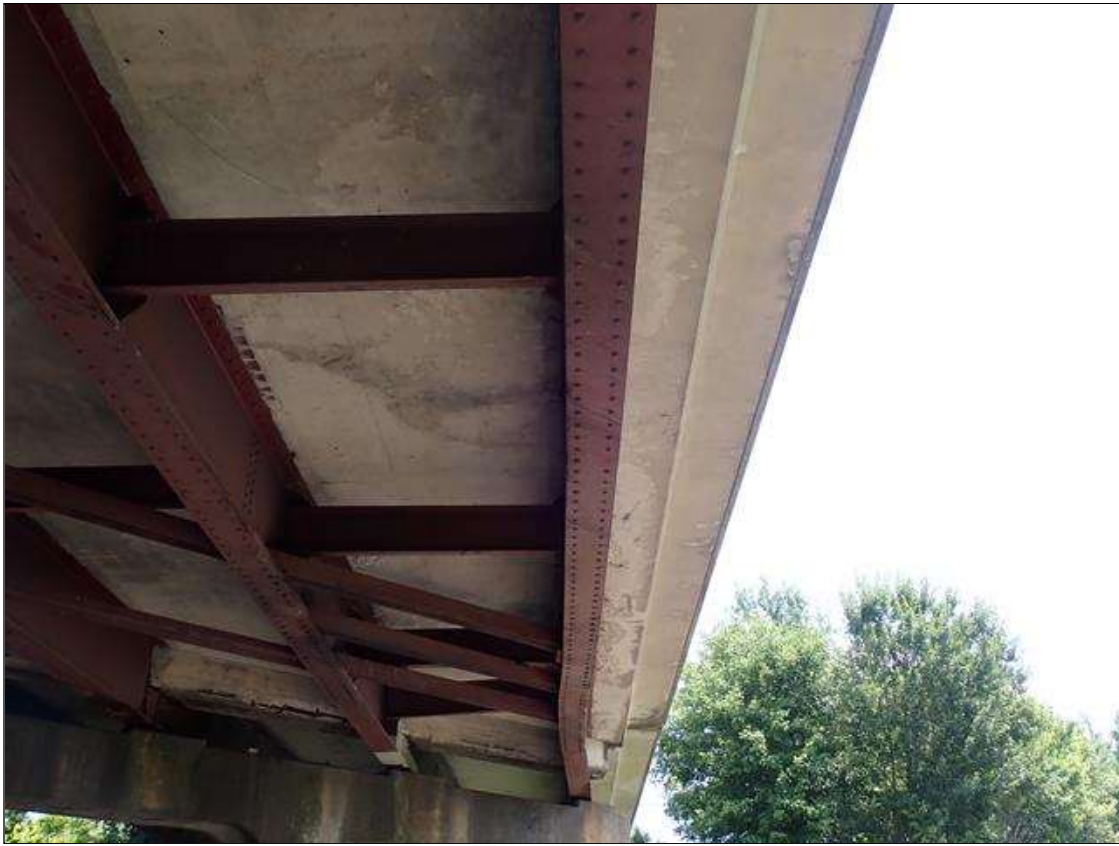
Span 2 Beam 4: IMPACT 9 FEET LONG X UP TO 2 INCHES VERTICAL DISTORTION AND APPROXIMATELY 3 INCHES LATERAL DISTORTION TO BOTTOM FLANGE. NO PAR ISSUED DUE TO LATERAL BRACING ADDED BETWEEN BEAMS PRIOR TO 2021 INSPECTION

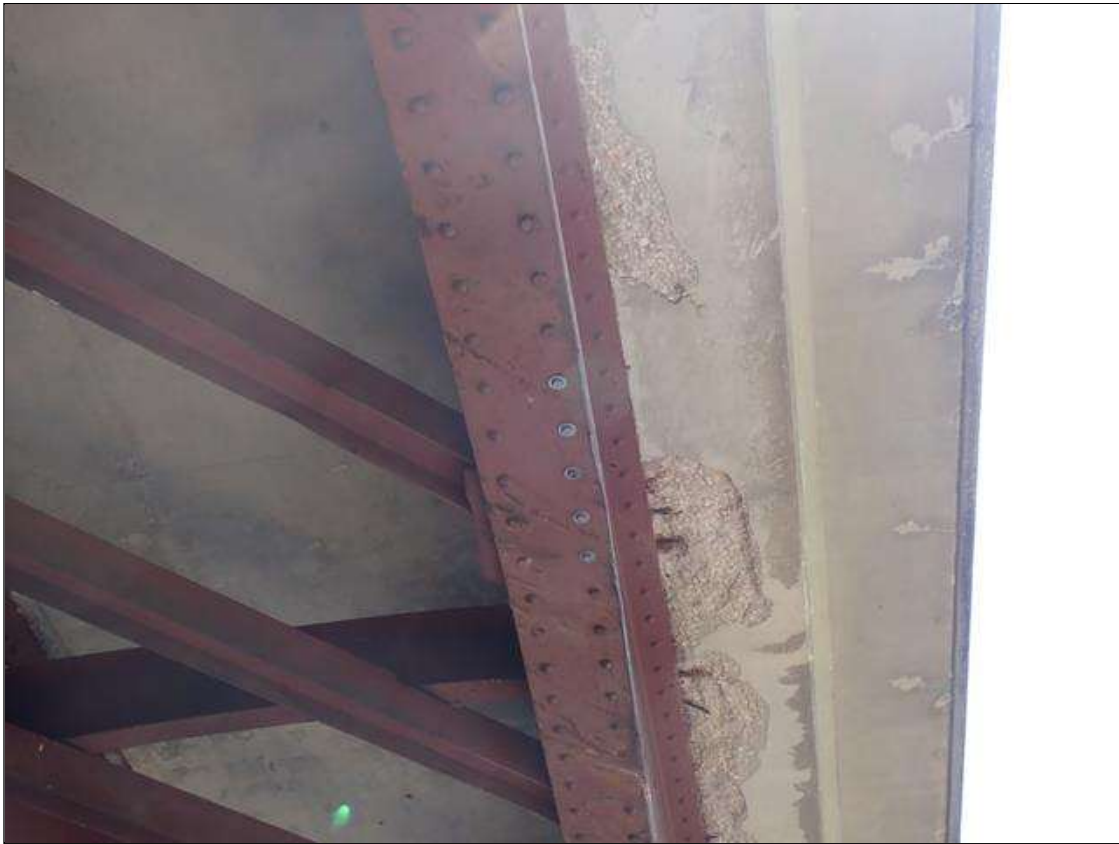
Span 2 Beam 4: RIVETS HAVE BEEN REPLACED WITH BOLTS TO REPAIR PREVIOUS PAR-- (5) MISSING BOLTS IN COVER PLATE CONNECTION AT MID SPAN. PRIOR TO 2021 INSPECTION

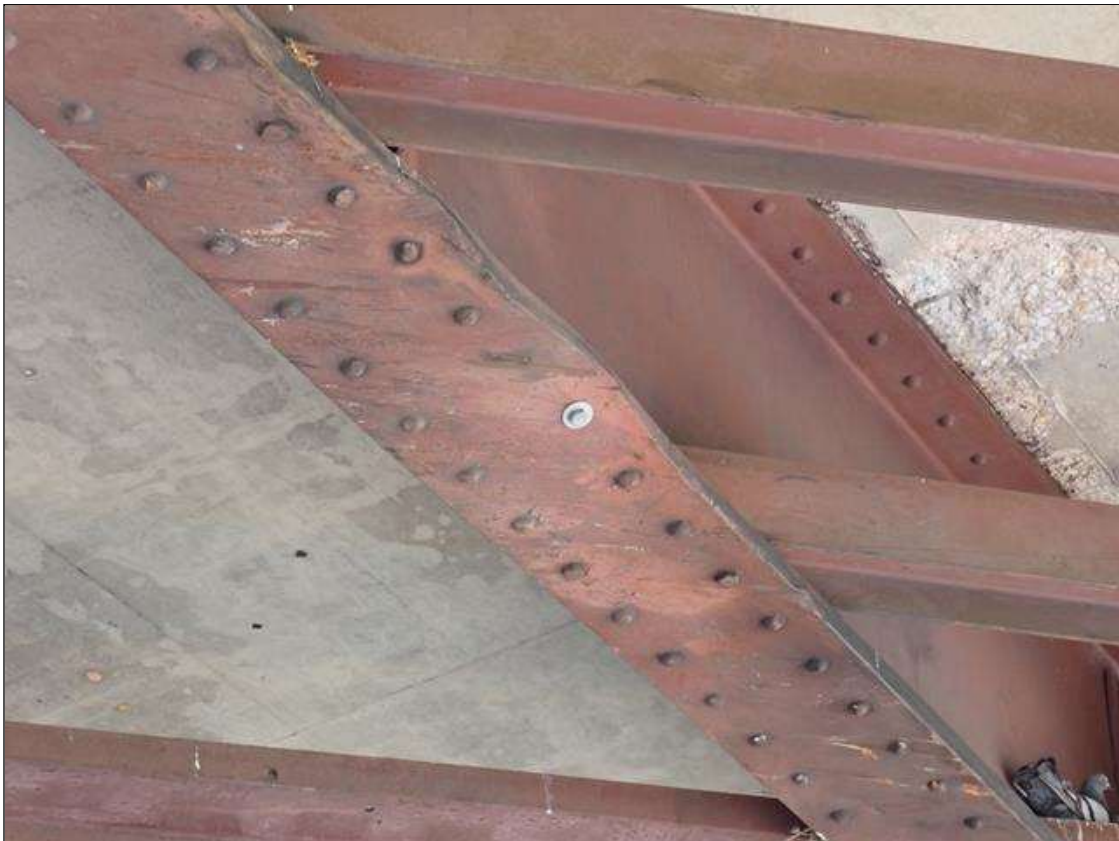
Span 2 Beam 3: MISSING RIVET REPLACED WITH BOLT TO FIX PREVIOUS PAR-- (1) MISSING BOLT IN COVER PLATE CONNECTION 19 FEET FROM BENT 2. PRIOR TO 2021 INSPECTION

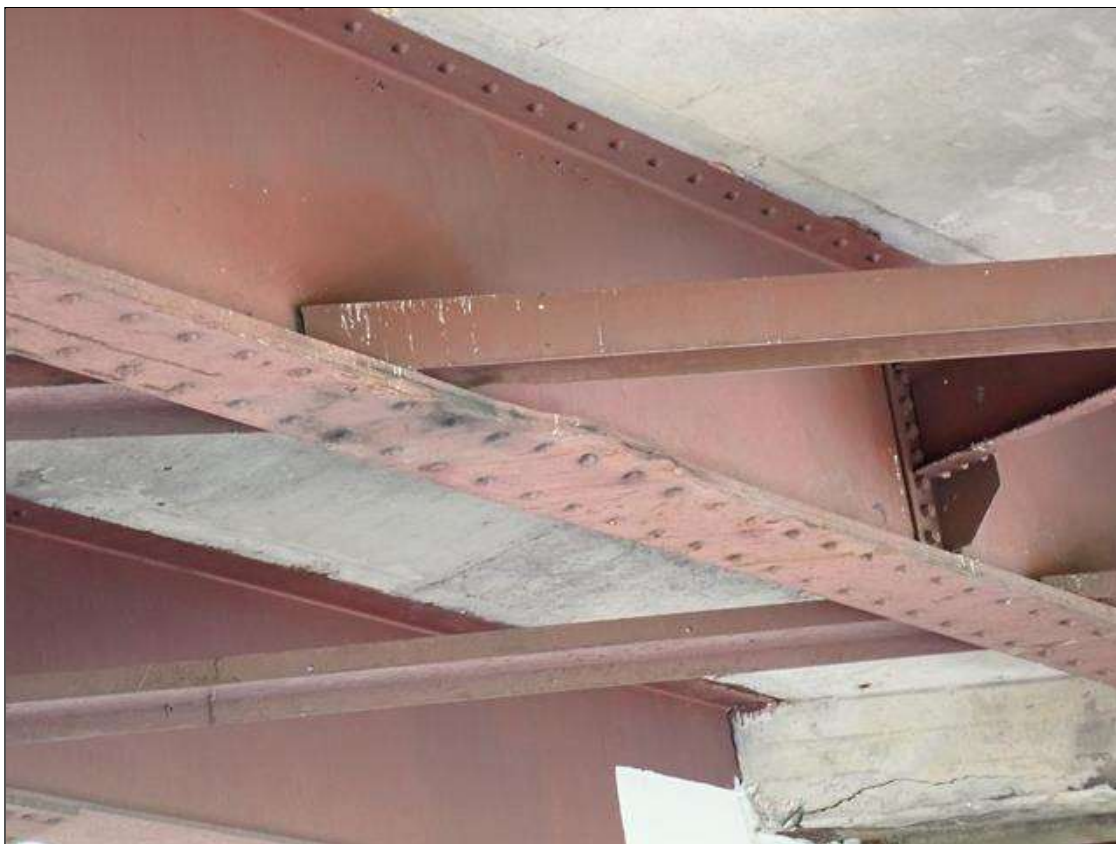
Span 2 Beam 2: 30 INCH LONG X UP TO 1.5 INCHES DISTORTION TO BOTTOM FLANGE 19.5 FEET FROM BENT  
2.

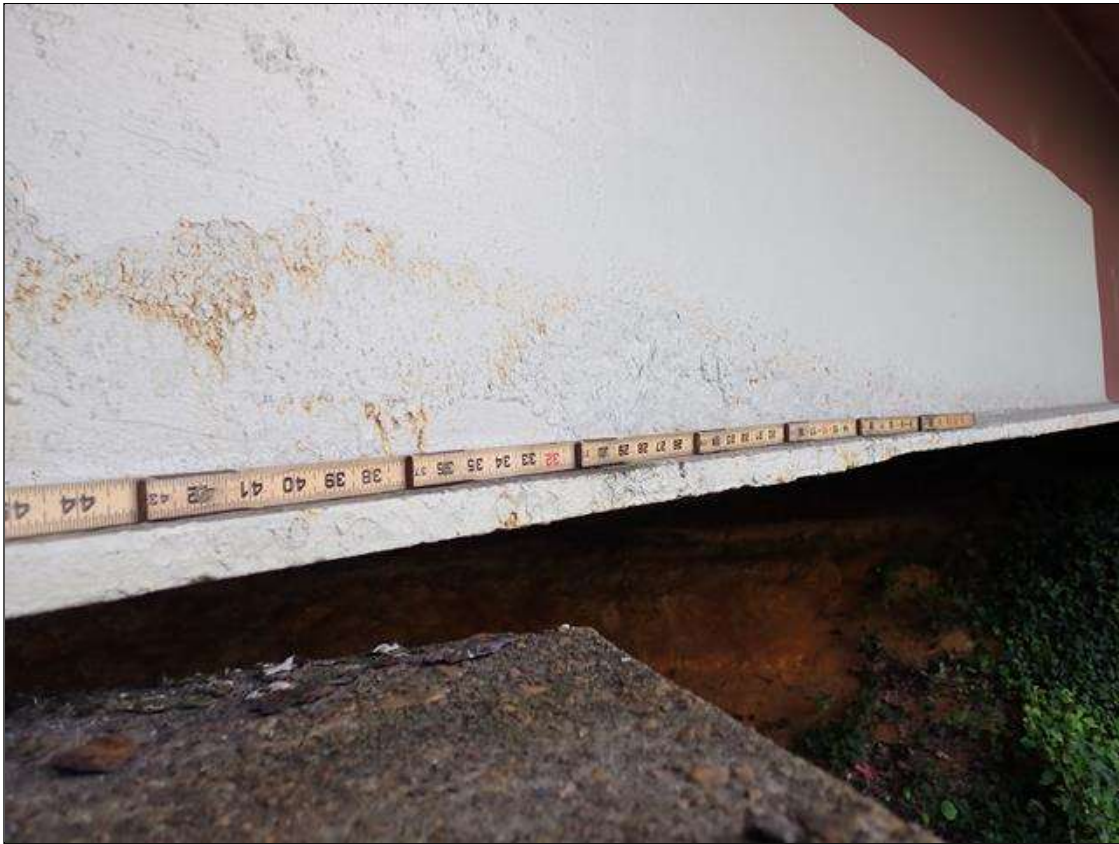
Span 1 Beam 1: PAR: PAINTED OVER AND ARRESTED CORROSION ALONG WEB AND BOTTOM FLANGE UP TO 96 INCH LONG X 8 INCH HIGH DOWN TO 7/16 INCH RESIDUAL WEB AND 96 INCH LONG X 12 INCH WIDE DOWN TO 1/2 INCH RESIDUAL BOTTOM FLANGE, BEGINNING APPROXIMATELY 5 FOOT FROM BENT 1

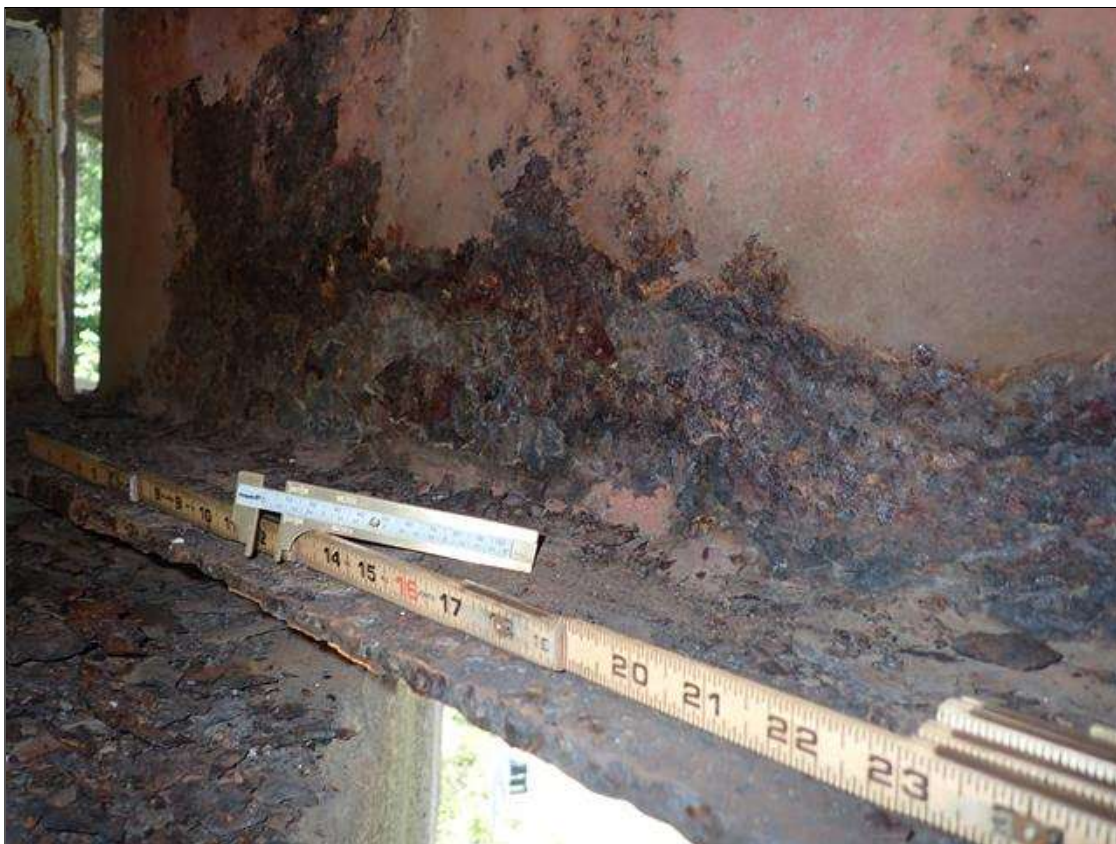
Span 2 Beam 1: PAR: CORROSION ALONG WEB AND BOTTOM FLANGE UP TO 69 INCH LONG X 12 INCH HIGH  
DOWN TO 1/4 INCH RESIDUAL WEB AND 69 INCH LONG X 12 INCH WIDE DOWN TO 3/8 INCH RESIDUAL  
BOTTOM FLANGE EXTENDING FROM BENT 1

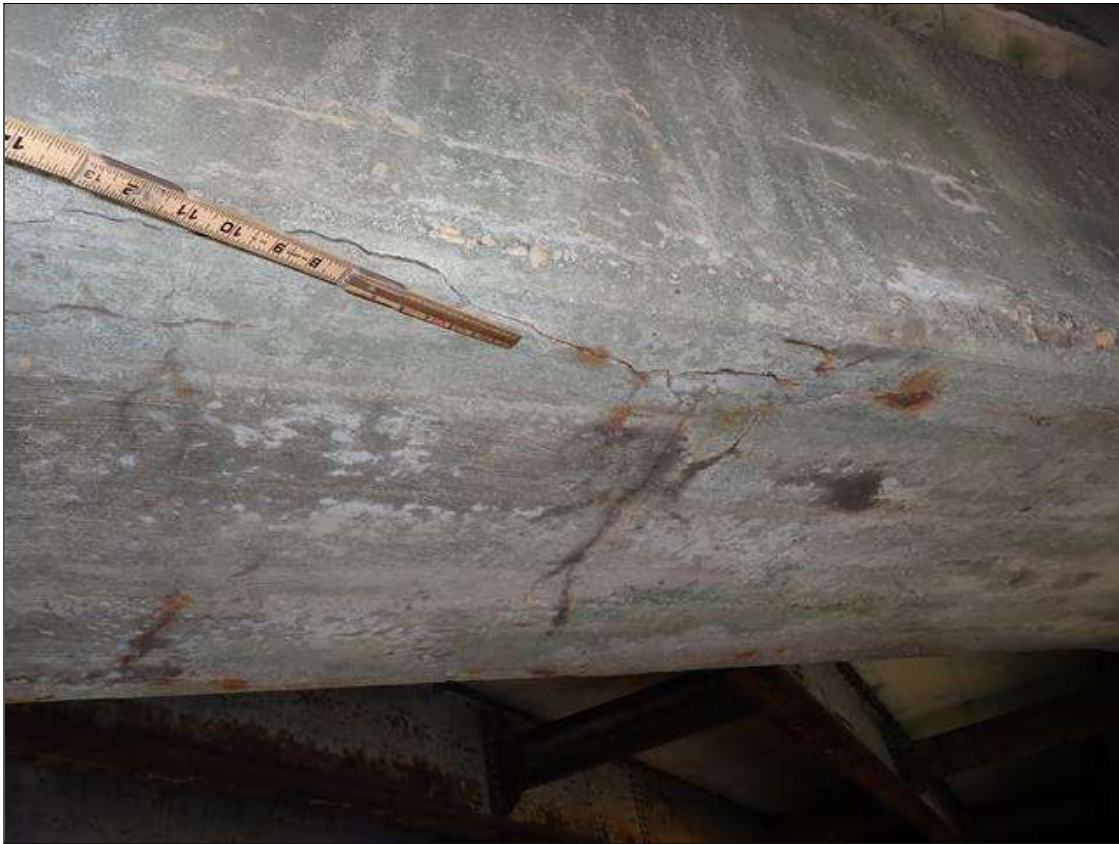
Bent 1 Cap 1: 6 FEET X 12 INCHES DELAMINATION BOTTOM OF CAP BETWEEN PILES 1 AND 2.

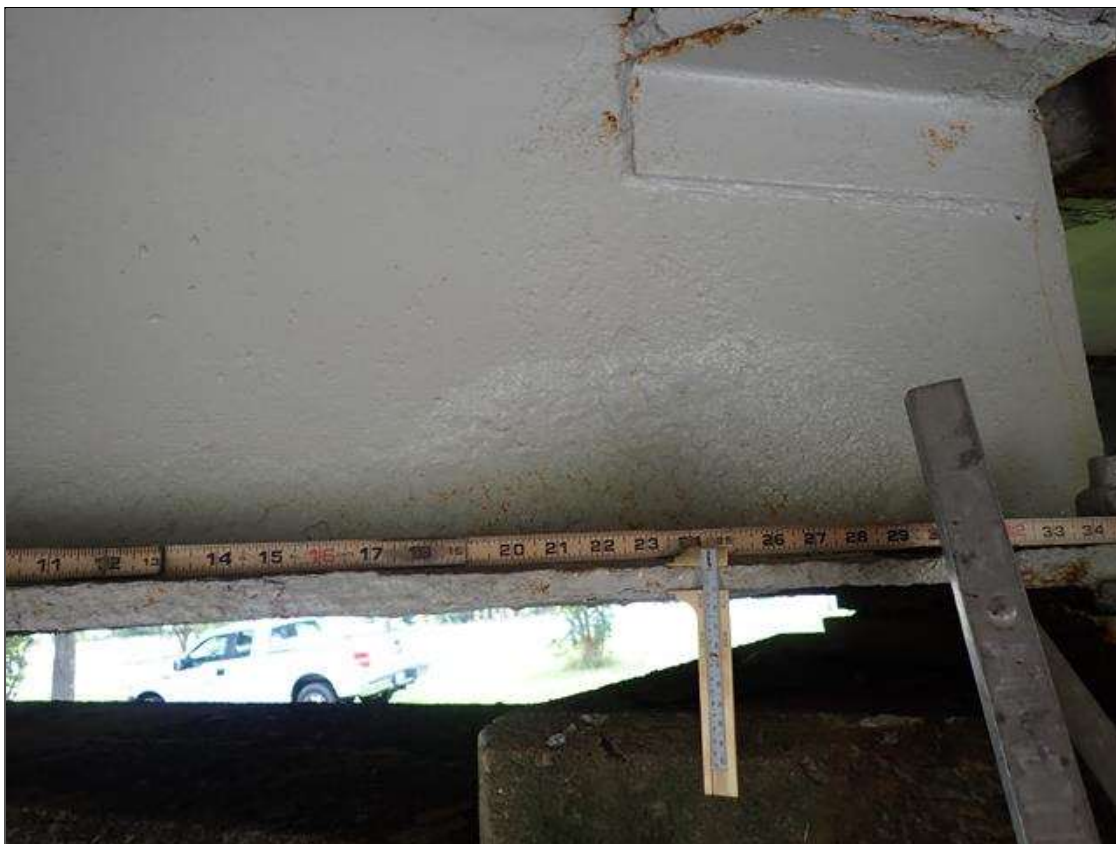
Span 2 Beam 3: PAR: CORROSION ALONG WEB AND BOTTOM FLANGE UP TO 47 INCH LONG X 7 INCH HIGH  
DOWN TO 3/8 INCH RESIDUAL WEB AND 32 INCH LONG X 12 INCH WIDE DOWN TO 1/2 INCH RESIDUAL  
BOTTOM FLANGE EXTENDING FROM BENT 1
