NC DEPARTMENT OF TRANSPORTATION  
 DIVISION OF HIGHWAYS  
 STRUCTURE MANAGEMENT UNIT

ATTENTION: **PAR, DATA CHANGES**

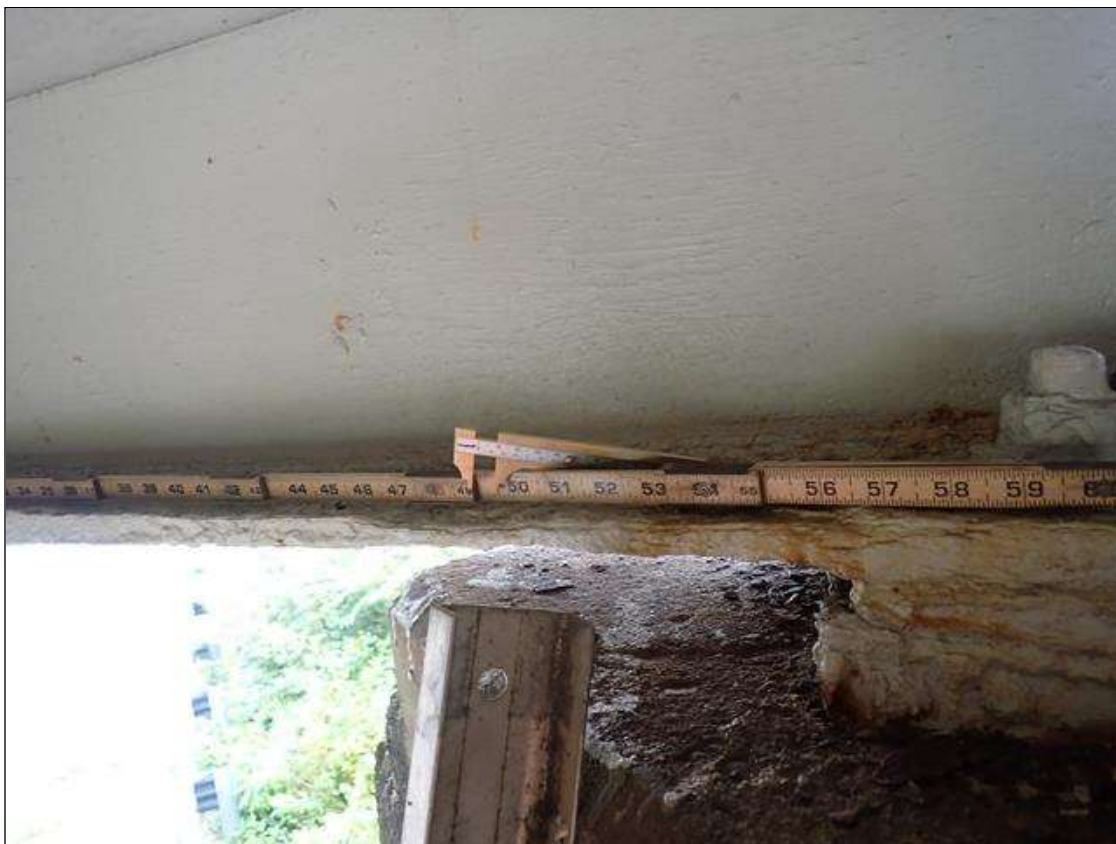
Span 2 Beam 4: PAR: CORROSION ALONG BOTTOM FLANGE UP TO 72 INCH LONG X 12 INCH WIDE DOWN TO 1/2 INCH RESIDUAL BOTTOM FLANGE EXTENDING FROM BENT 1

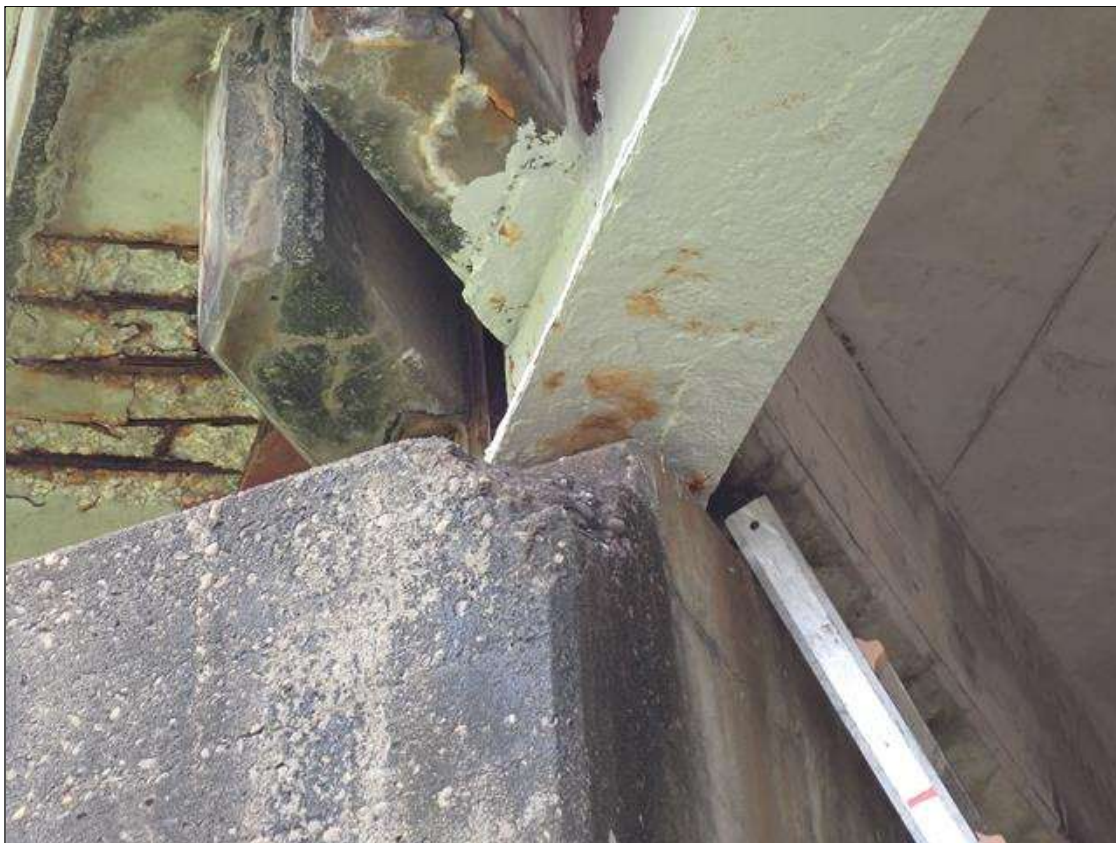
Bent 1 Cap 1: 11 INCHES X 11 INCHES X 5 INCHES SPALL NORTHEAST CORNER.

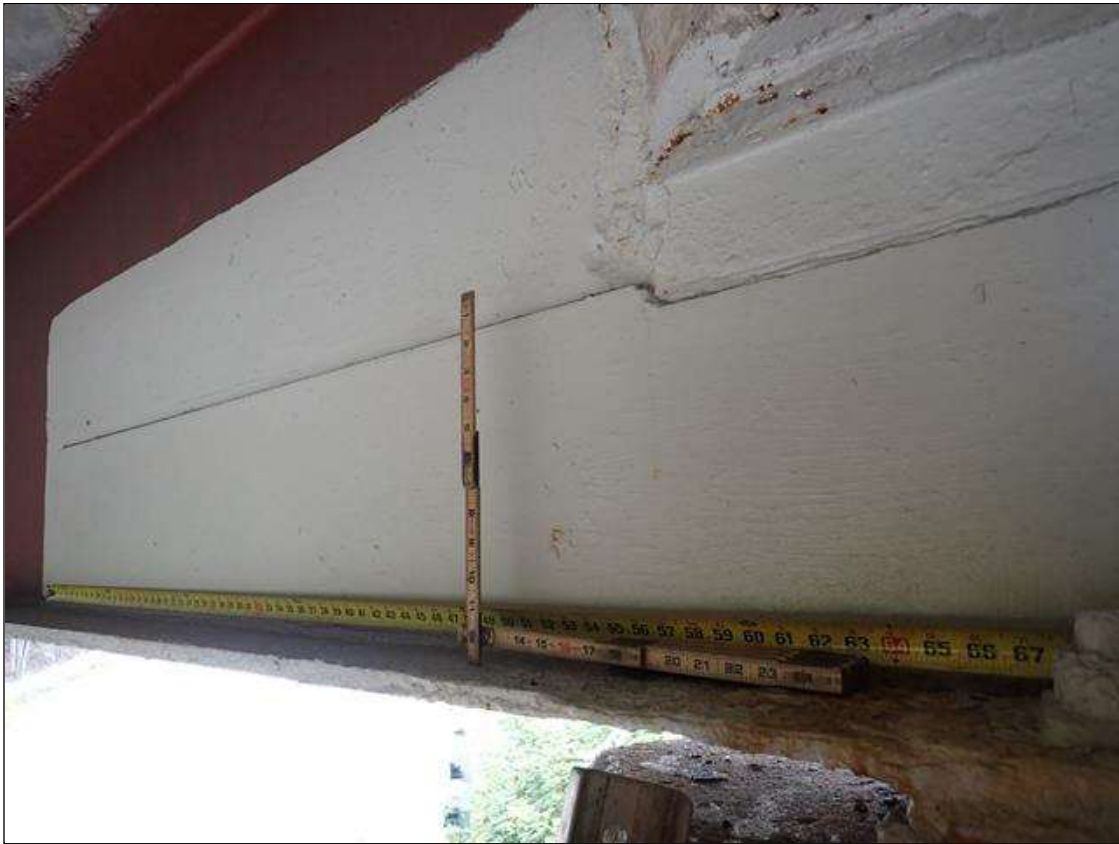
Span 2 Beam 4: 72 INCH X 12 INCH PLATE REPAIR ALONG BOTH FACES OF WEB EXTENDING FROM BENT 1

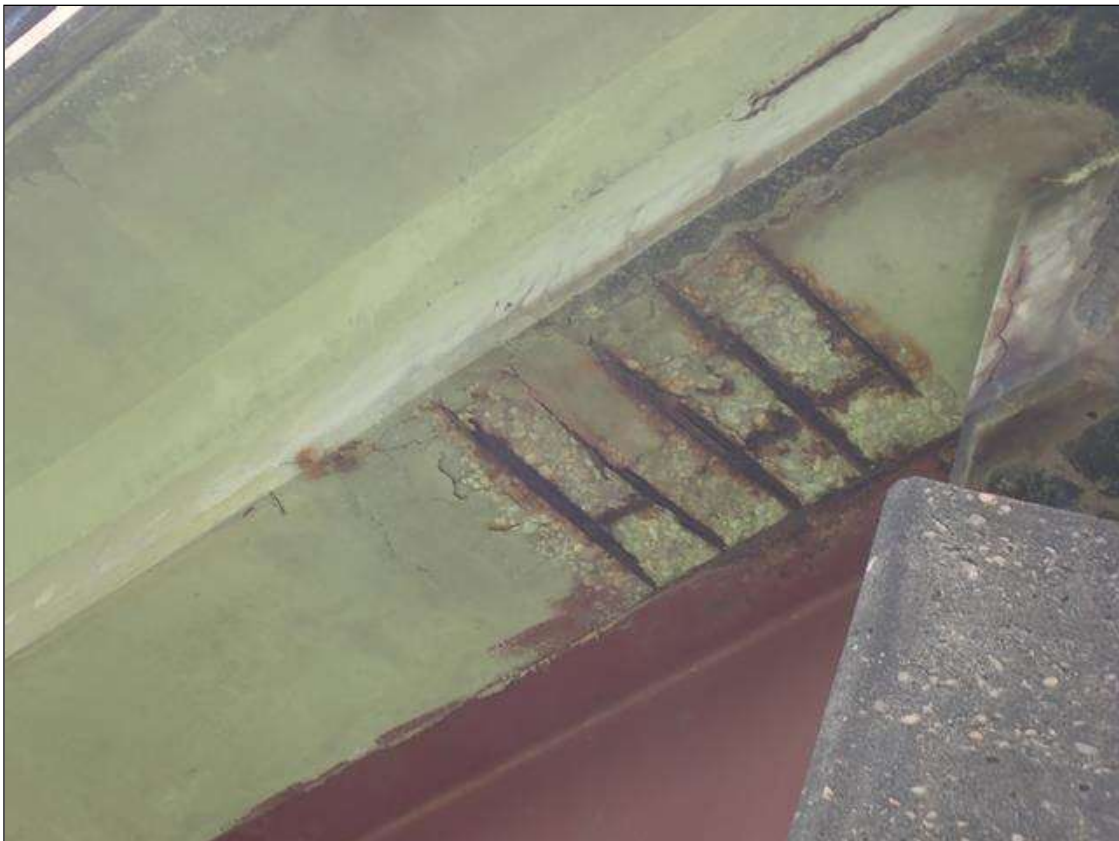
Span 1 Deck: 36 INCH X 30 INCH X 1 INCH DEEP SPALL WITH EXPOSED REBAR IN BOTTOM OF DECK IN EAST OVERHANG AT BENT 1

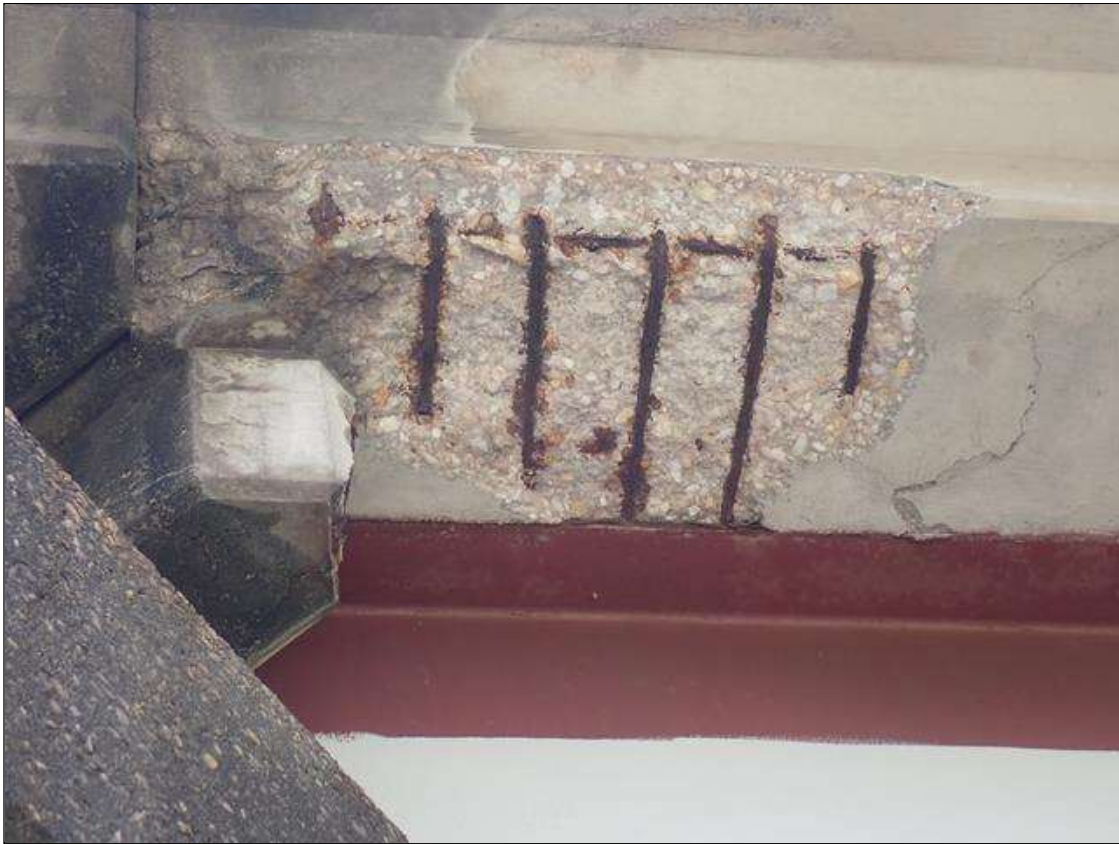
Span 1 Deck: 48 INCH X 30 INCH X 3 INCH SPALL WITH EXPOSED REBAR IN BOTTOM OF DECK IN WEST OVERHANG AT BENT 1.

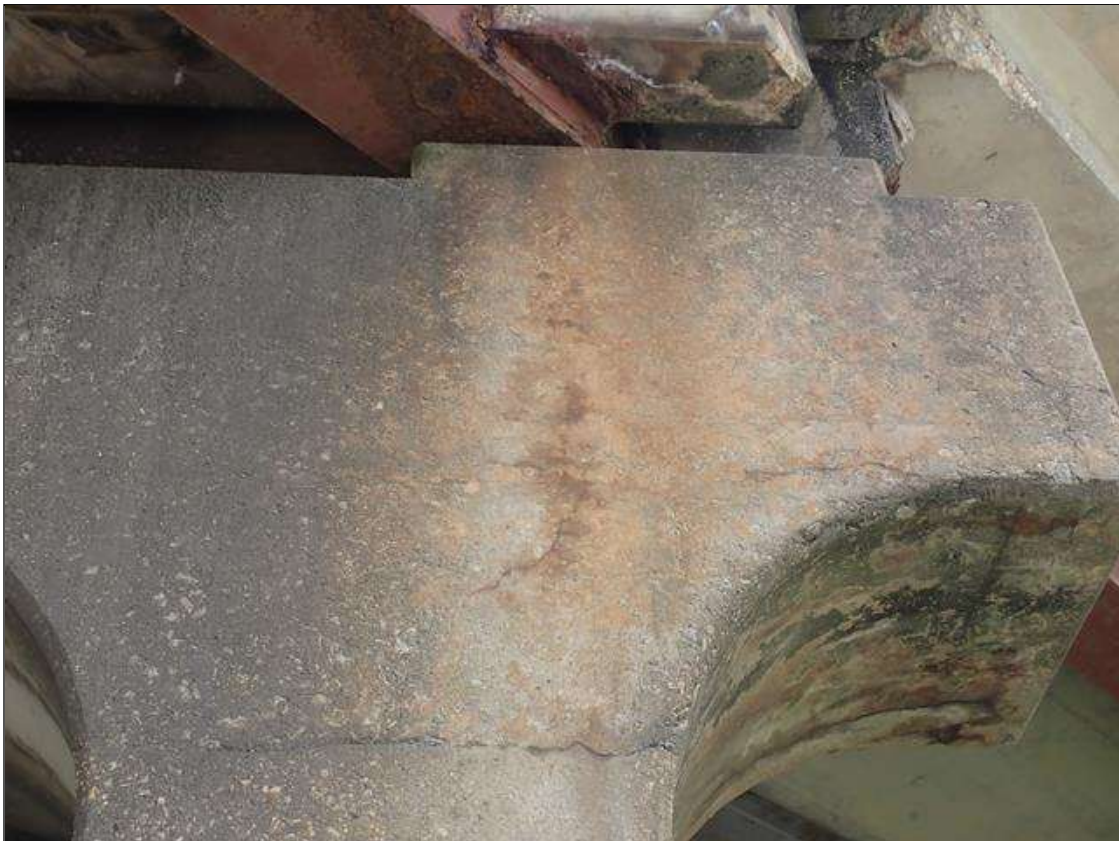
Bent 2 Cap 1: 30 INCH X 30 INCH AREA OF HAIRLINE MAP CRACKING WITH RUST STAINING IN SOUTH FACE AT EAST END.

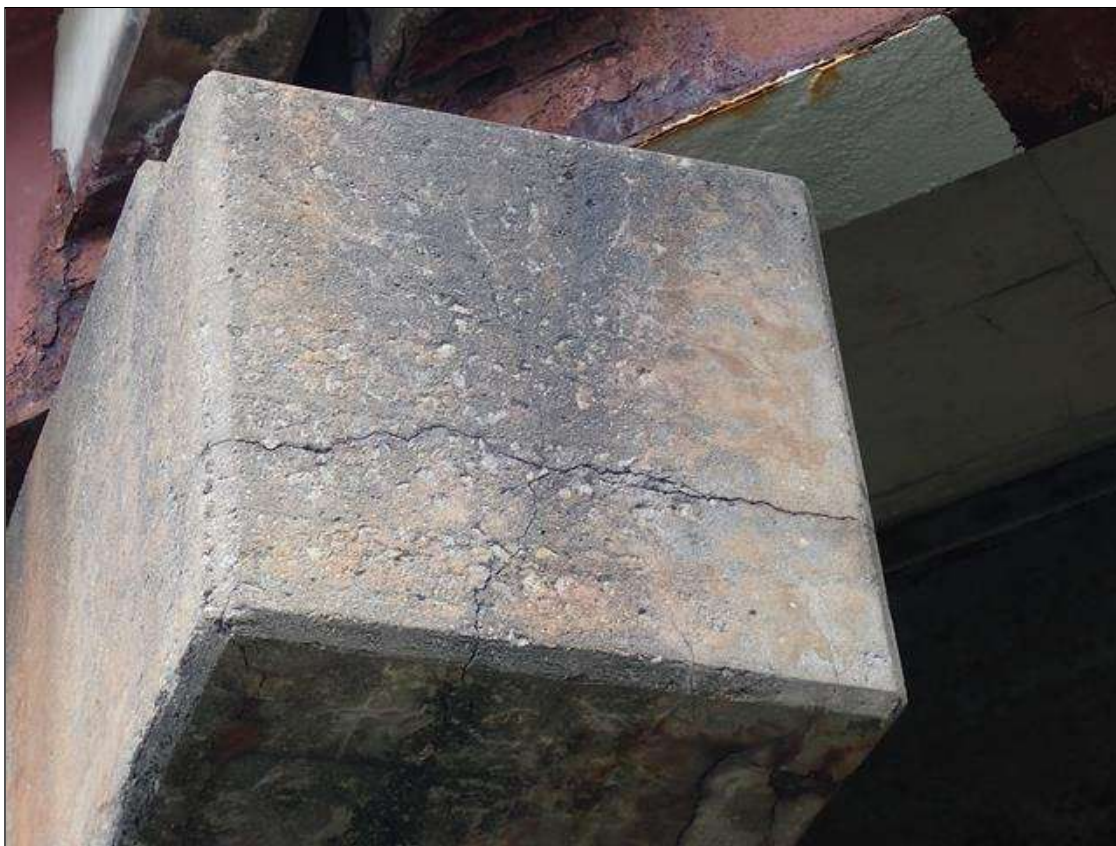
Bent 2 Cap 1: UP TO 0.02 INCH HORIZONTAL AND VERTICAL CRACKS IN EAST AND WEST ENDS OF CAP

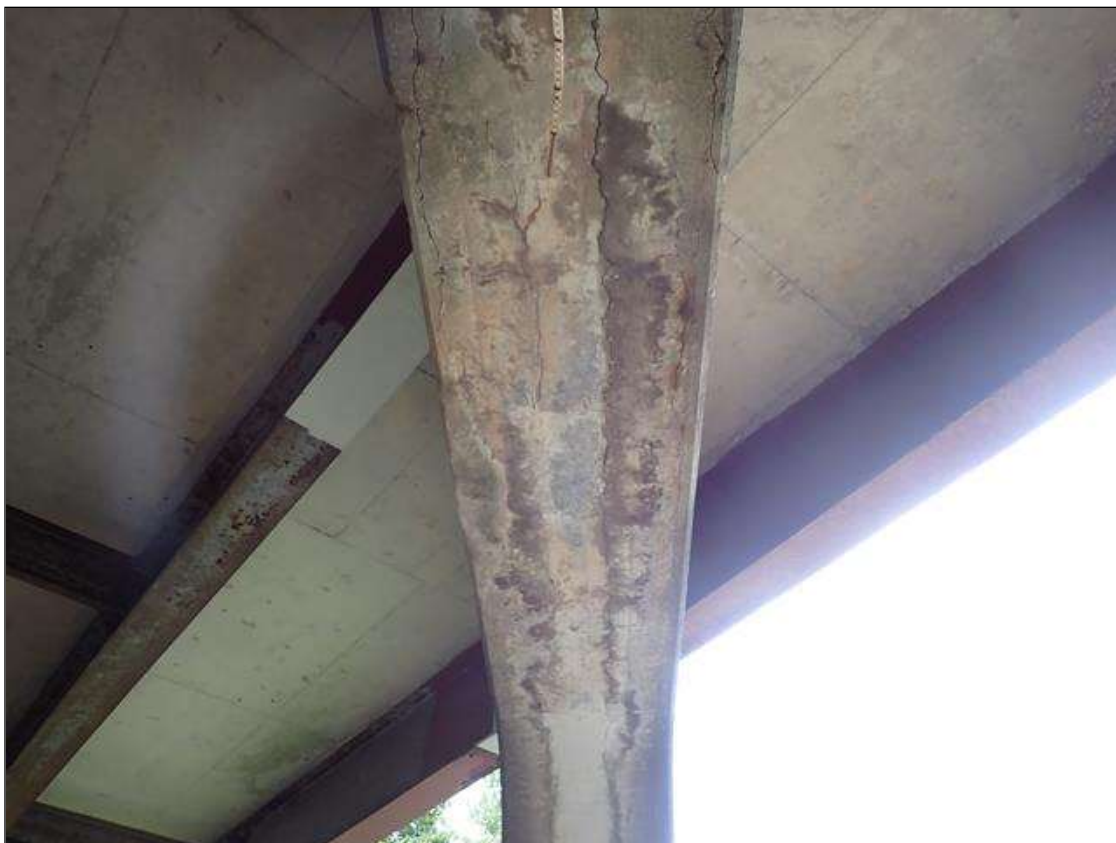
Bent 2 Cap 1: UP TO 1/8 INCH LONGITUDINAL CRACKS AND 13 FOOT LONG X 26 INCH WIDE AREA OF DELAMINATION IN BOTTOM OF CAP BETWEEN COLUMNS 2 AND 3

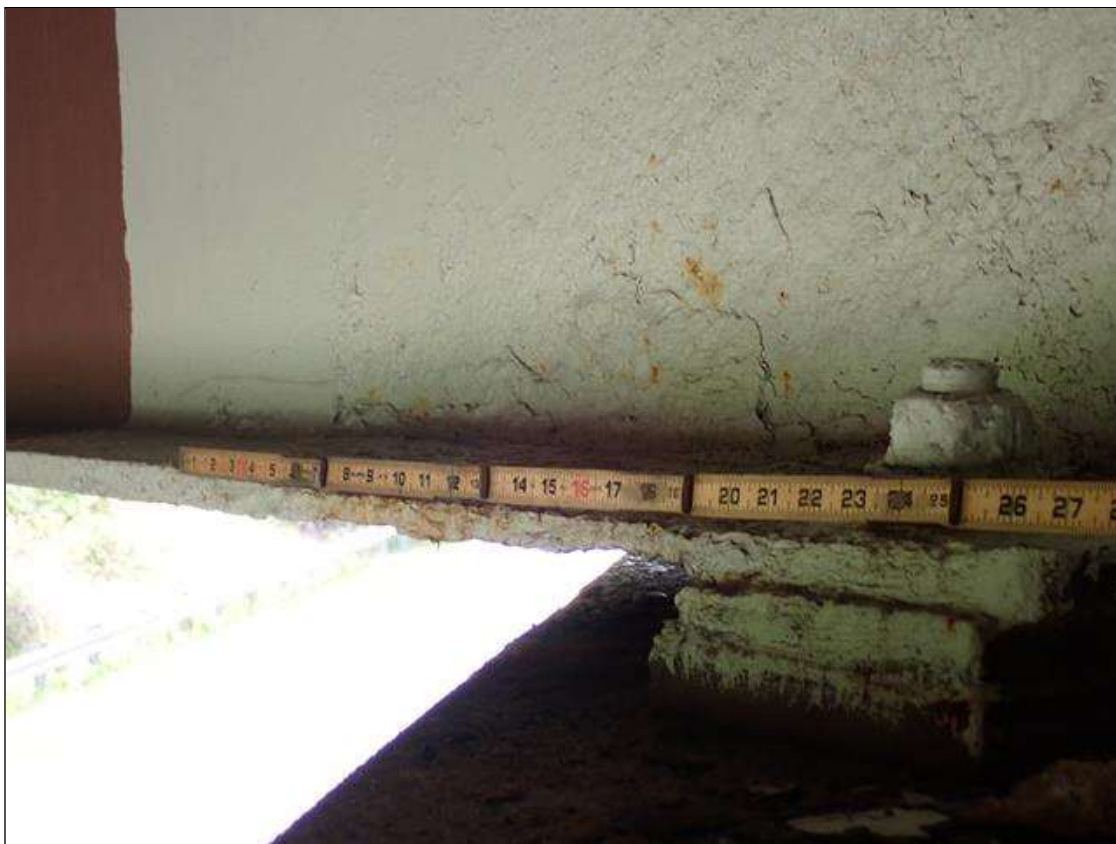
Span 2 Beam 1: PAR: CORROSION ALONG WEB AND BOTTOM FLANGE UP TO 30 INCH LONG X 14 INCH HIGH  
DOWN TO 3/8 INCH RESIDUAL WEB AND 30 INCH LONG X 12 INCH WIDE DOWN TO 1/2 INCH RESIDUAL  
BOTTOM FLANGE EXTENDING FROM BENT 2

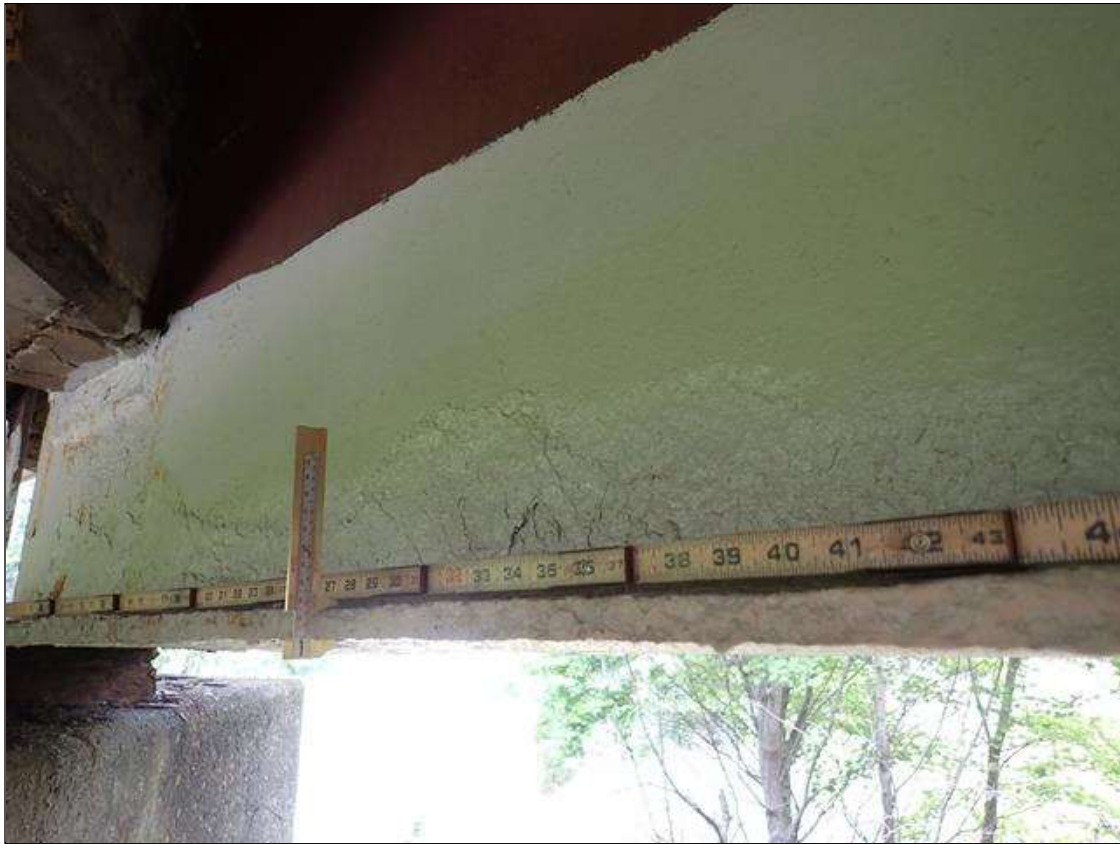
Span 3 Beam 1: PAR: CORROSION ALONG WEB AND BOTTOM FLANGE UP TO 96 INCH LONG X 14 INCH HIGH DOWN TO 3/8 INCH RESIDUAL WEB AND 82 INCH LONG X 12 INCH WIDE DOWN TO 5/8 INCH RESIDUAL BOTTOM FLANGE EXTENDING FROM BENT 2

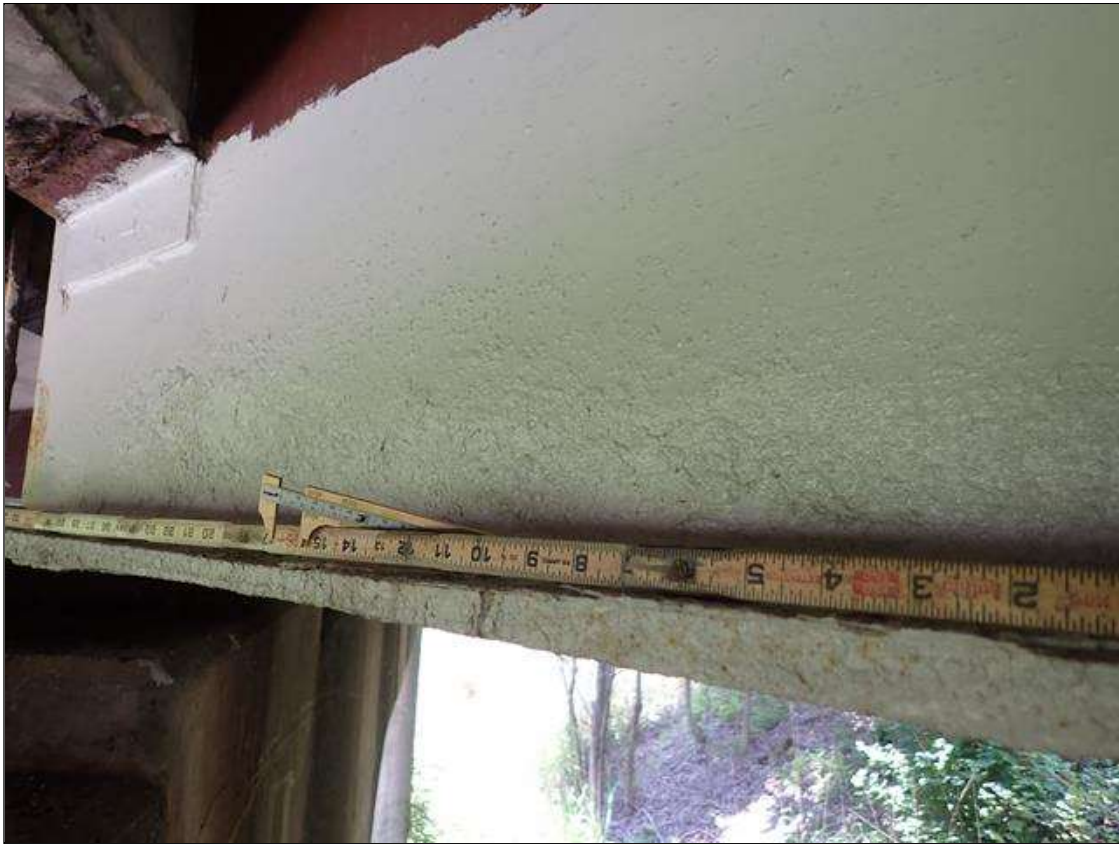
Span 3 Beam 3: PAR: CORROSION ALONG WEB AND BOTTOM FLANGE UP TO 58 INCH LONG X 9 INCH HIGH  
DOWN TO 7/16 INCH RESIDUAL WEB AND 46 INCH LONG X 12 INCH WIDE DOWN TO 5/8 INCH RESIDUAL  
BOTTOM FLANGE EXTENDING FROM BENT 2

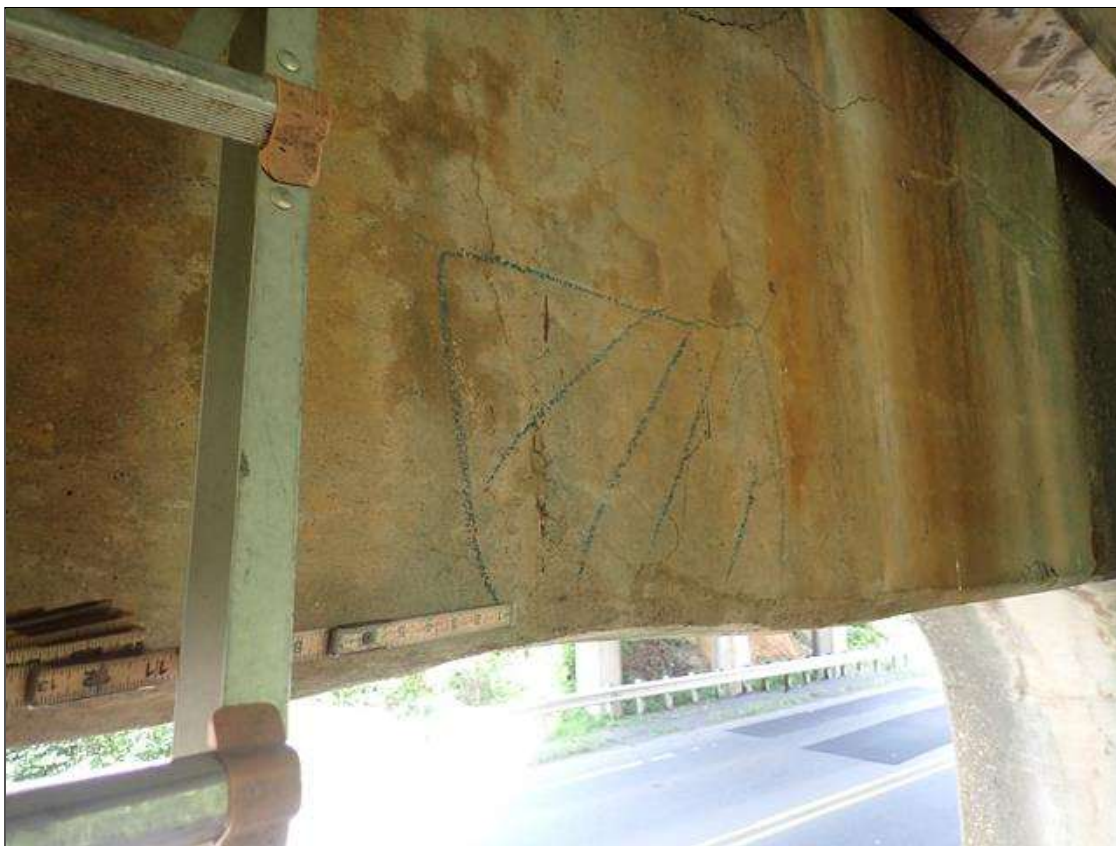
Bent 2 Cap 1: 12 INCHES X 8 INCHES AREA OF DELAMINATION IN NORTH FACE BENEATH BEAM 3.

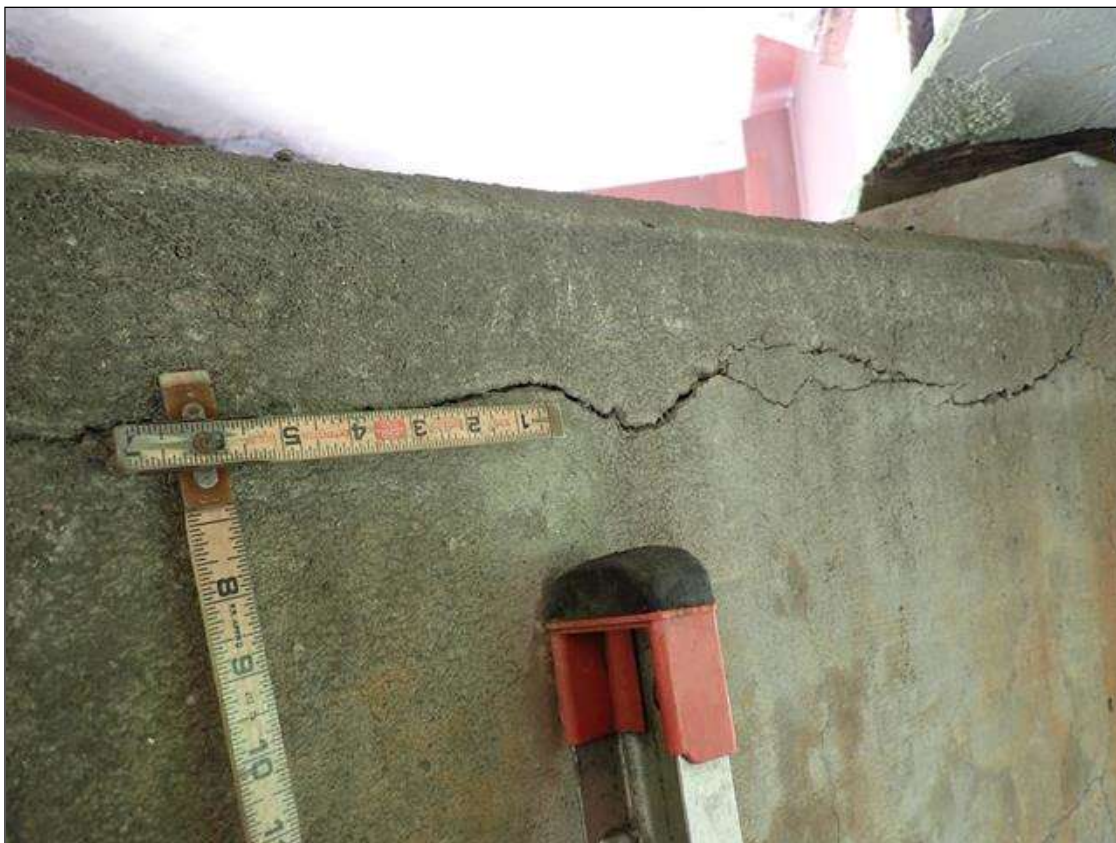
Bent 2 Cap 1: UP TO 1/8 INCH HORIZONTAL CRACKS IN NORTH FACE OF CAP BENEATH BAYS 1 THRU 3

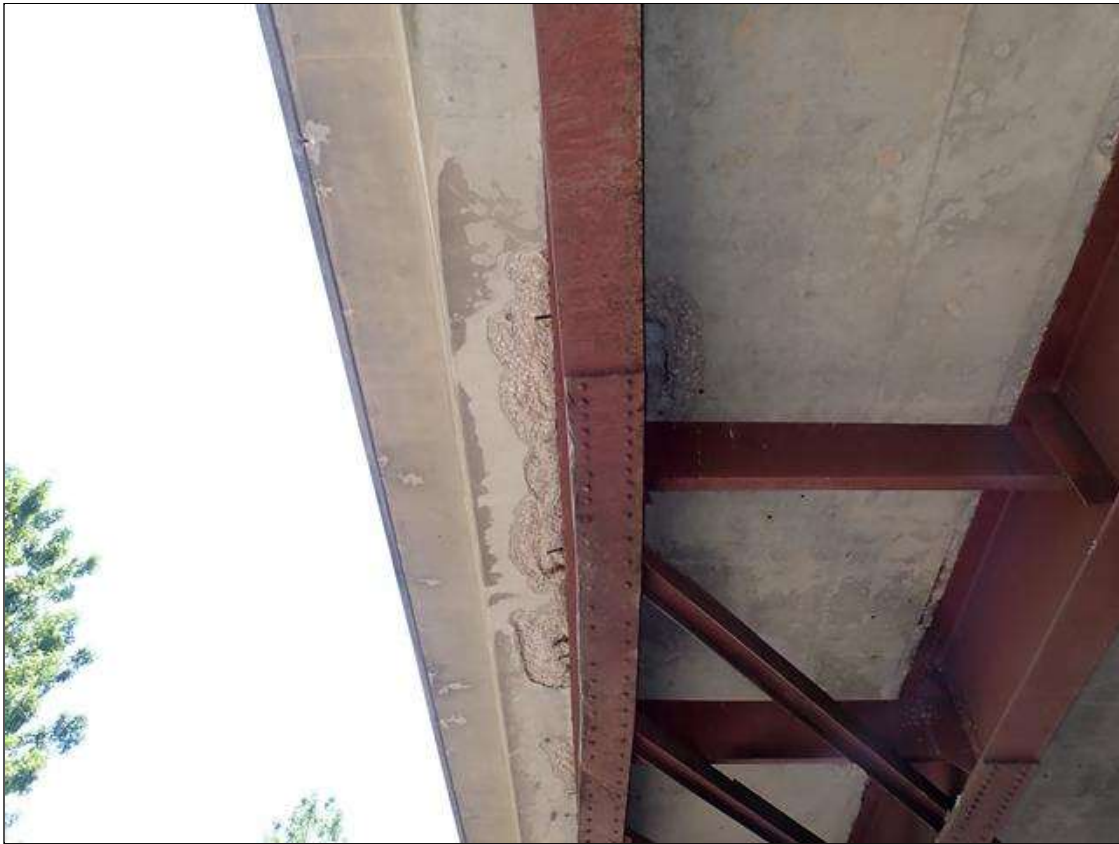
Span 2 Deck: (5) UP TO 48 INCH X 24 INCH X 2 INCHES DEEP SPALLS WITH EXPOSED REBAR IN BOTTOM OF DECK AND EAST OVERHANG ALONG BEAM 3 AND BEAM 4 TOP FLANGE

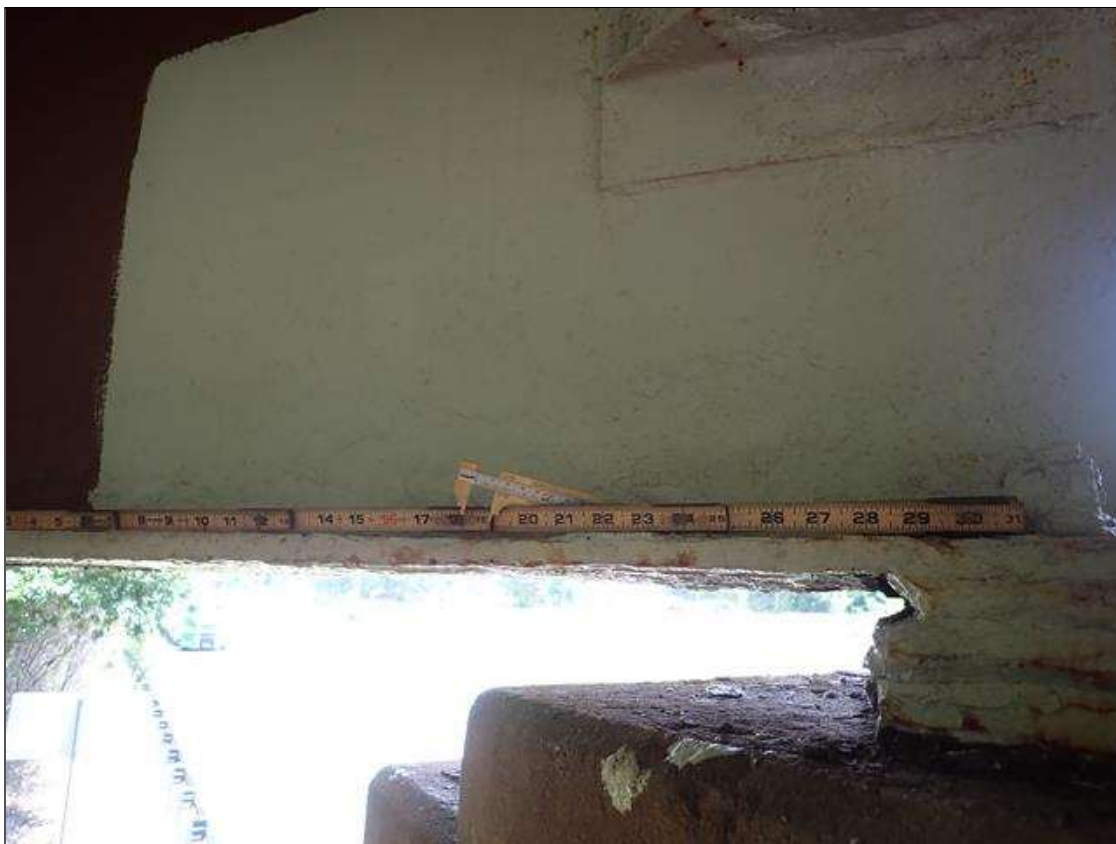
Span 3 Beam 4: PAR: CORROSION ALONG WEB AND BOTTOM FLANGE UP TO 48 INCH LONG X 12 INCH HIGH DOWN TO 7/16 INCH RESIDUAL WEB AND 34 INCH LONG X 12 INCH WIDE DOWN TO 3/8 INCH RESIDUAL BOTTOM FLANGE EXTENDING FROM BENT 2

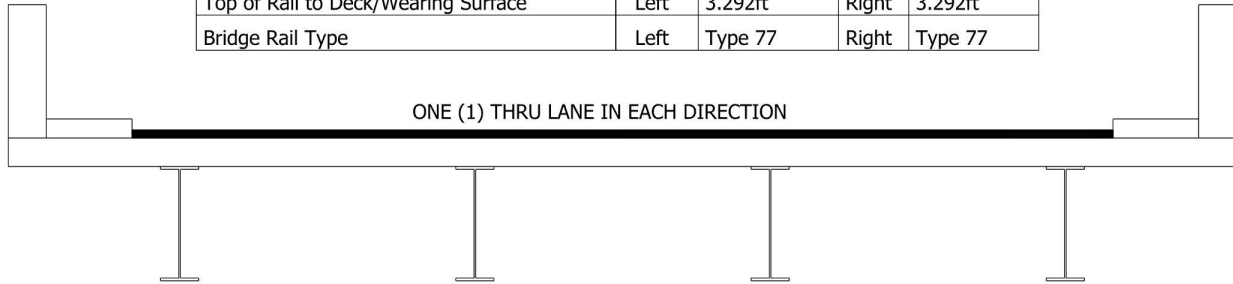
Measurements for Spans	1 thru 3		
Deck Thickness	9.00in	Left Overhang	4.50ft
Top of Rail to Bottom of Beam (Avg)	7.25ft	Right Overhang	4.50ft
