NC DEPARTMENT OF TRANSPORTATION
 DIVISION OF HIGHWAYS
 STRUCTURE MANAGEMENT UNIT

ATTENTION: PRIORITY MAINT (CAP AND GR); DATA AND SKETCHES REVISED;

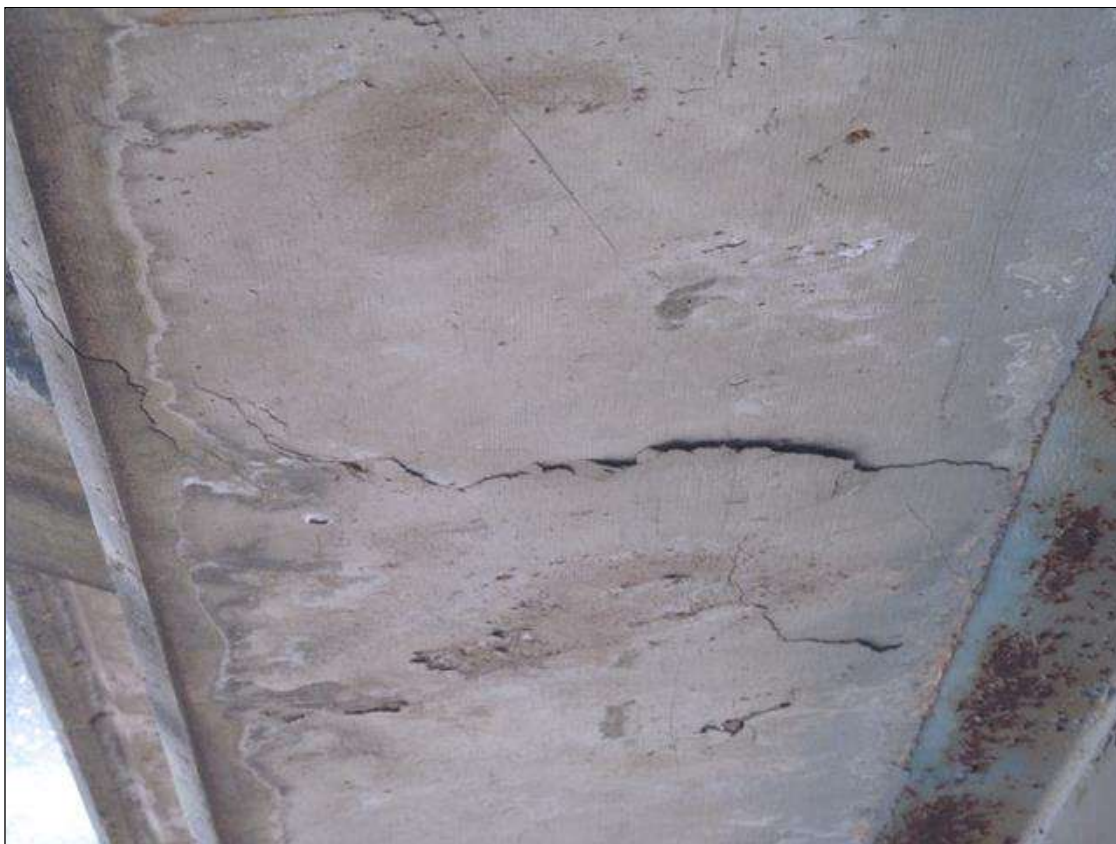
Span 1 Deck: UNDERSIDE OF THE DECK OVERHANGS, SCATTERED DELAM; TYP

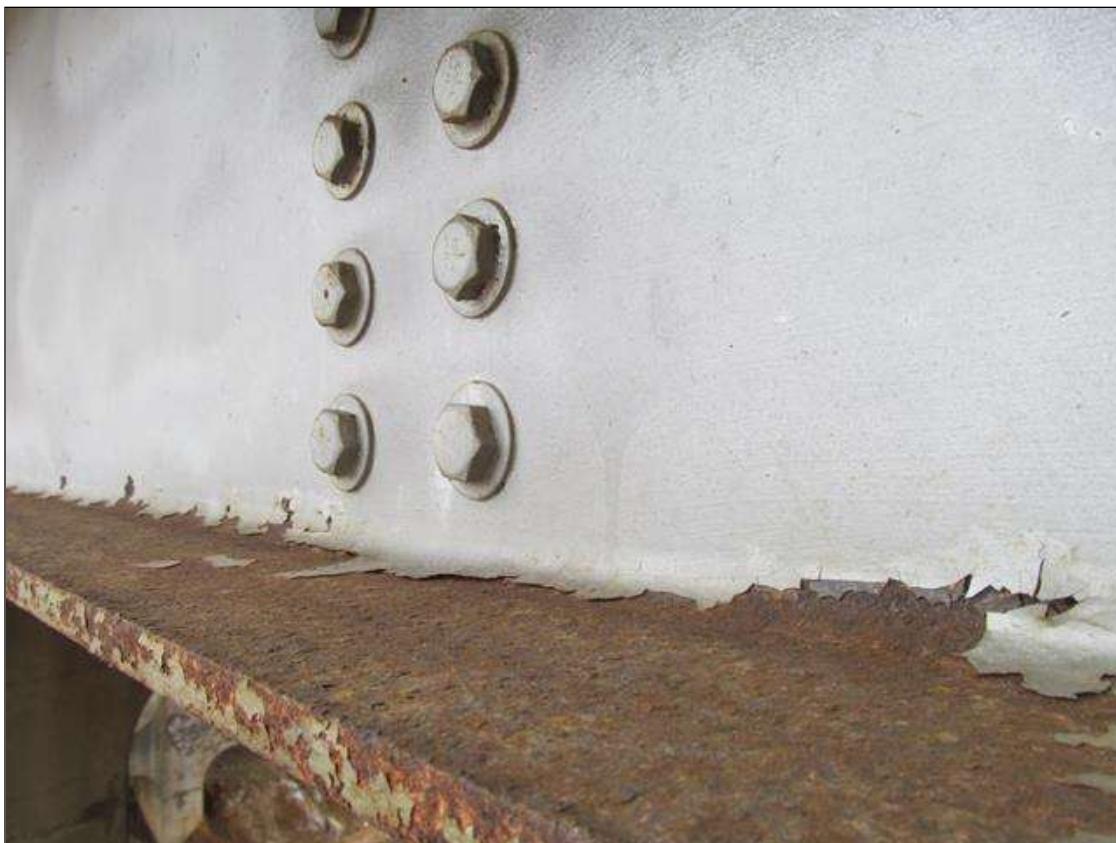
OUTBOARD BEAMS, SURFACE CORROSION ALONG THE LENGTH OF THE LOWER FLANGE IN AREAS OF PC FAILURE

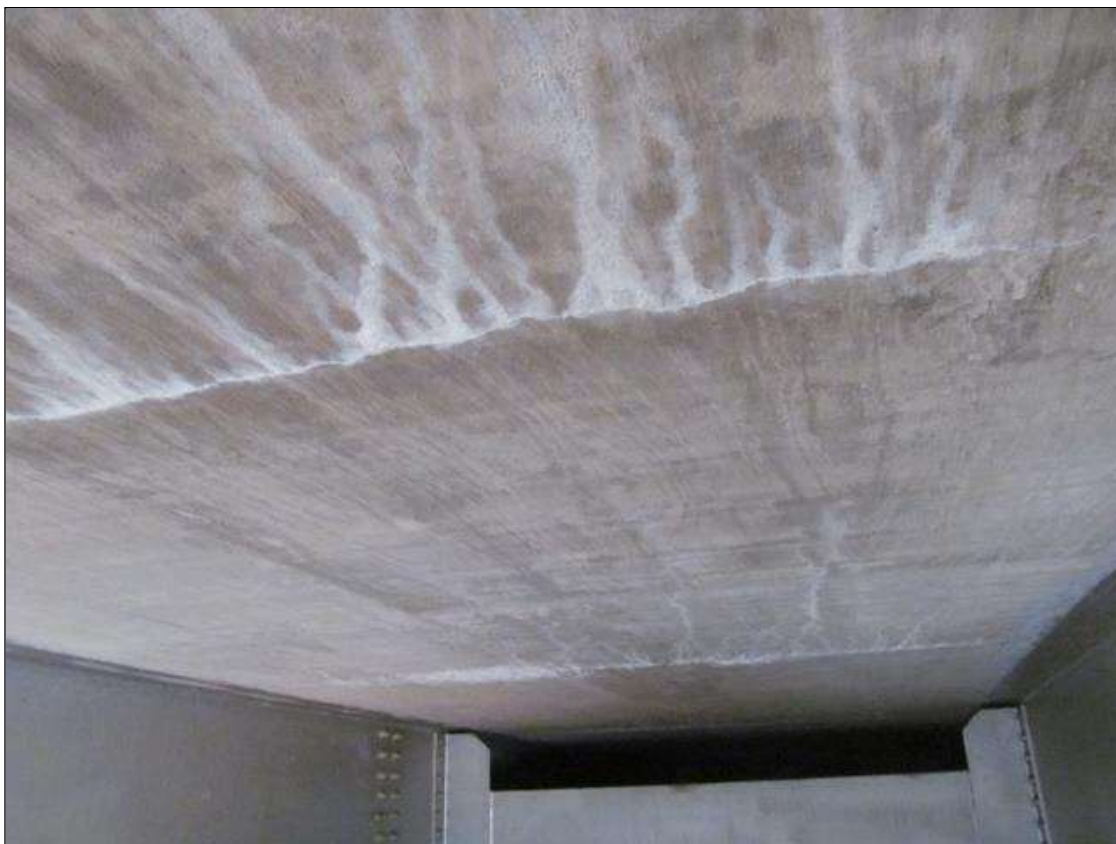
Span 1 Deck: UNDERSIDE OF THE DECK, HL TRANSVERSE CRACKING WITH EFFLO STAINING, SCATTERED;
TYP

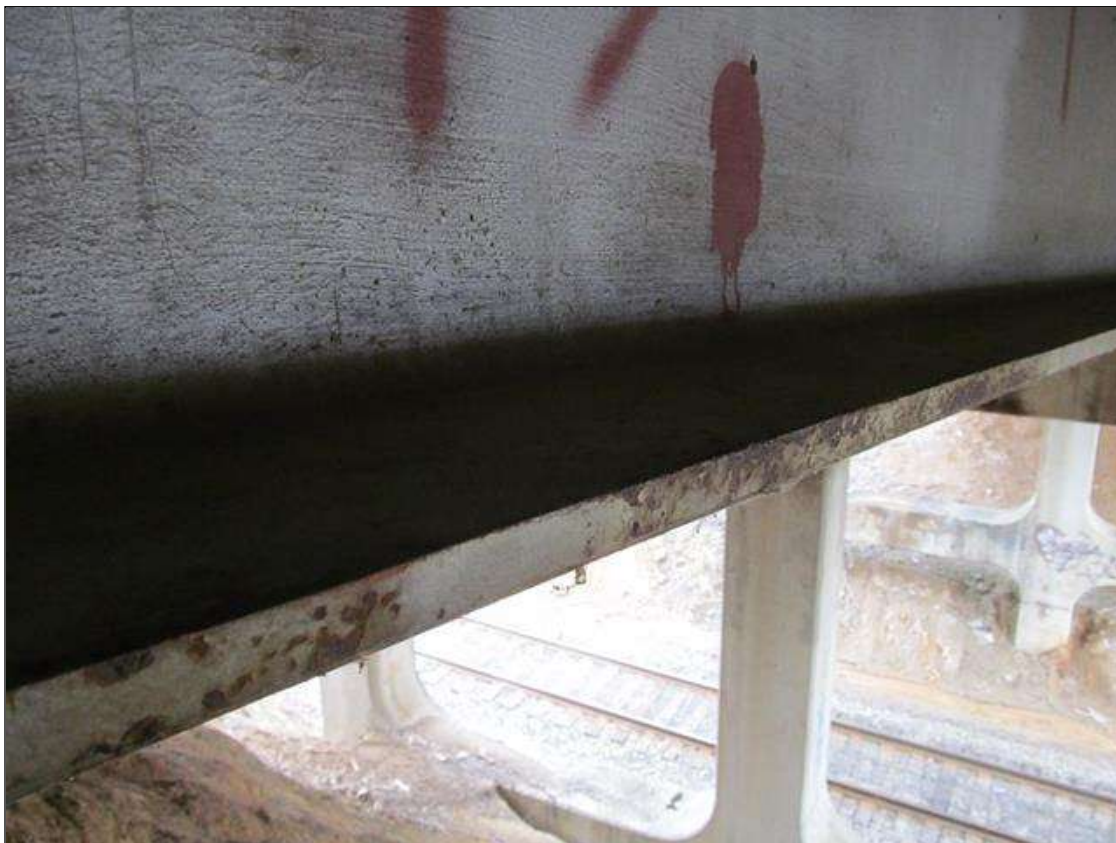
INBOARD BEAMS, SCATTERED FRECKLED CORROSION

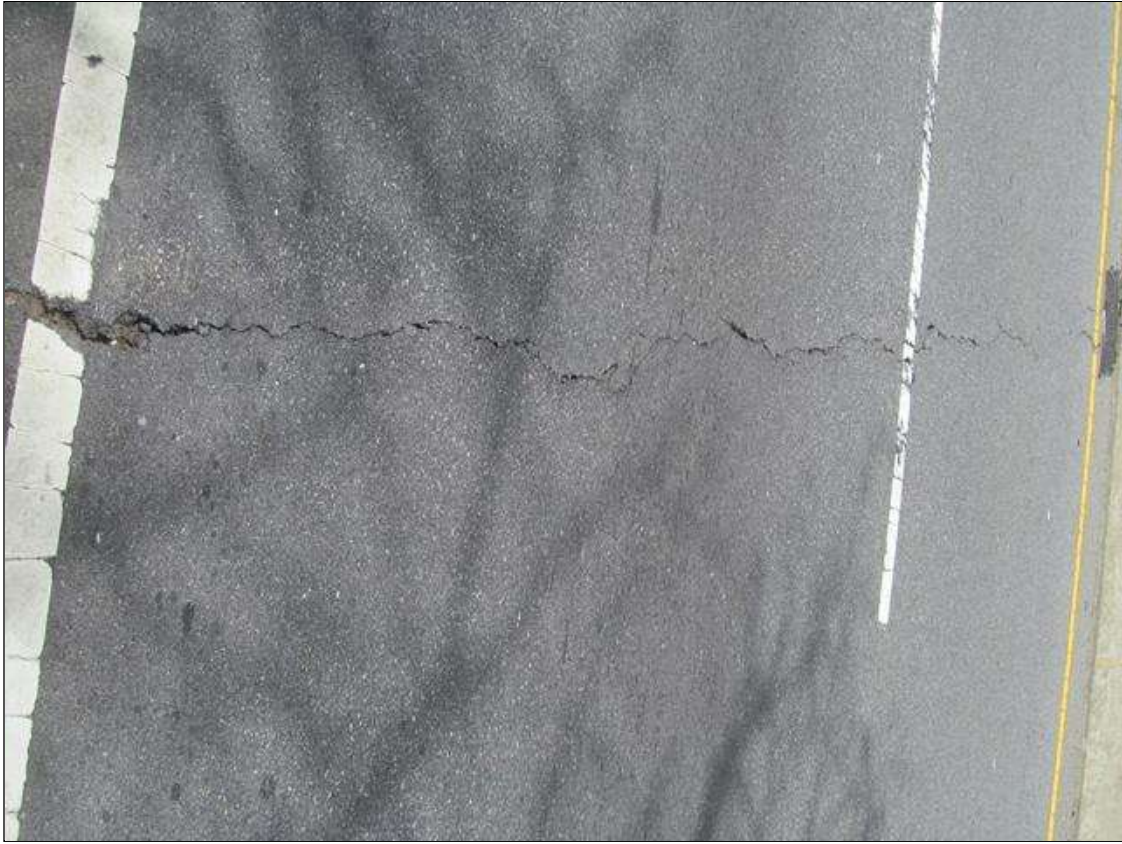
Span 1 Wearing Surface: AT THE SPAN ENDS, FULL WIDTH TRANSVERSE CRACKING UP TO 1/4"W

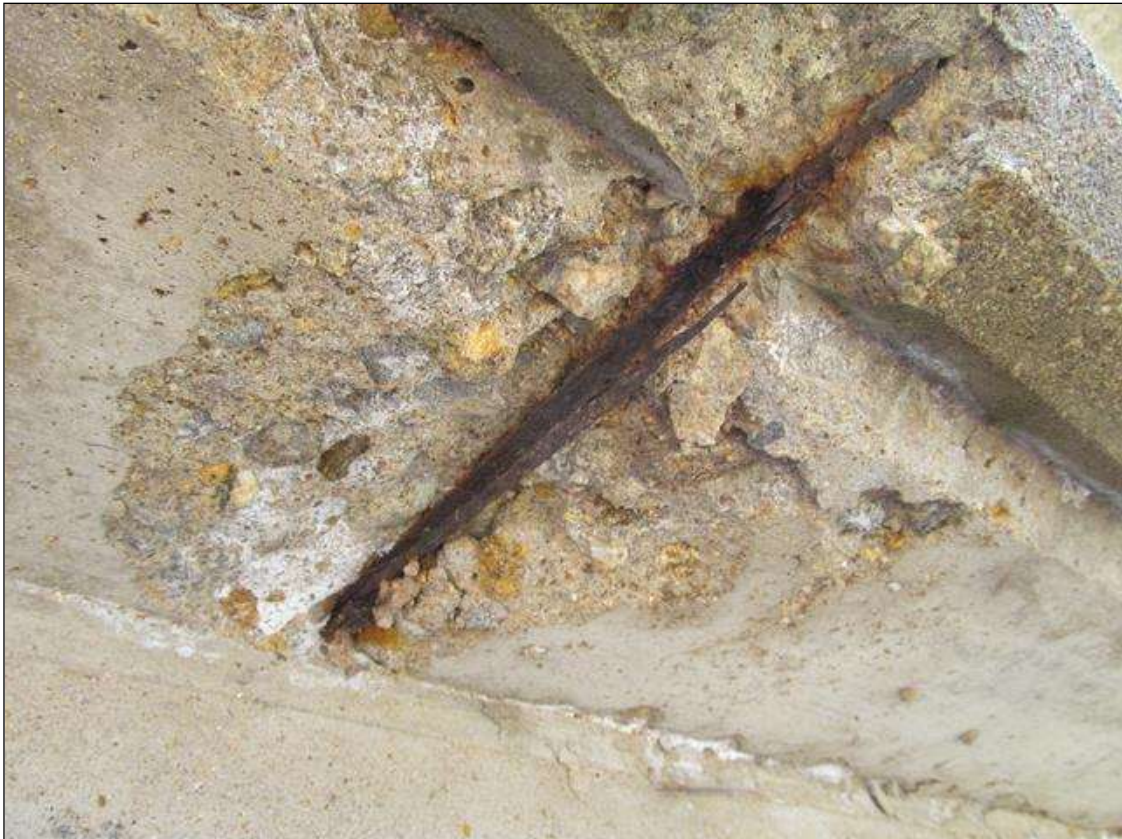
Span 1 Deck: LT DECK OVERHANG, APPROX 1SQFT SPALL WITH EXPOSED RESTEEL, UP TO 1"D.

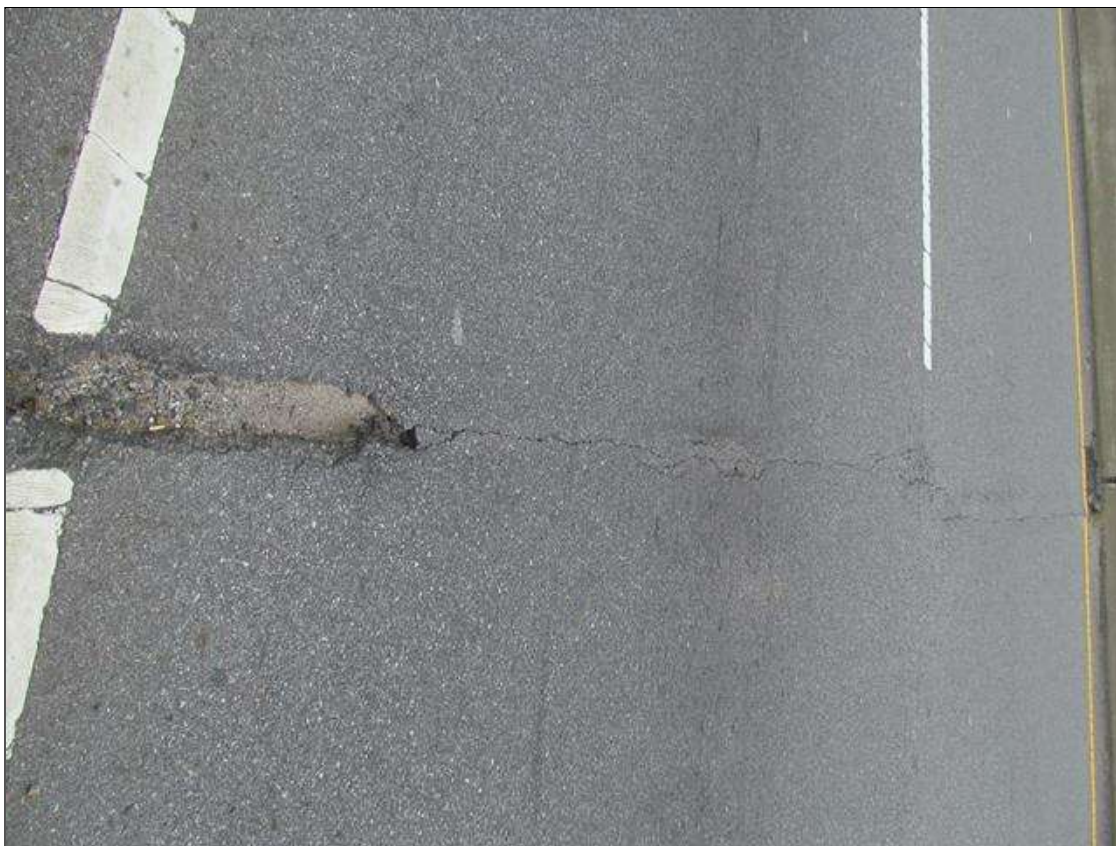
Span 1 Wearing Surface: AT BENT 1, SCATTERED SPALLING UP TO 2"D ALONG THE JOINT

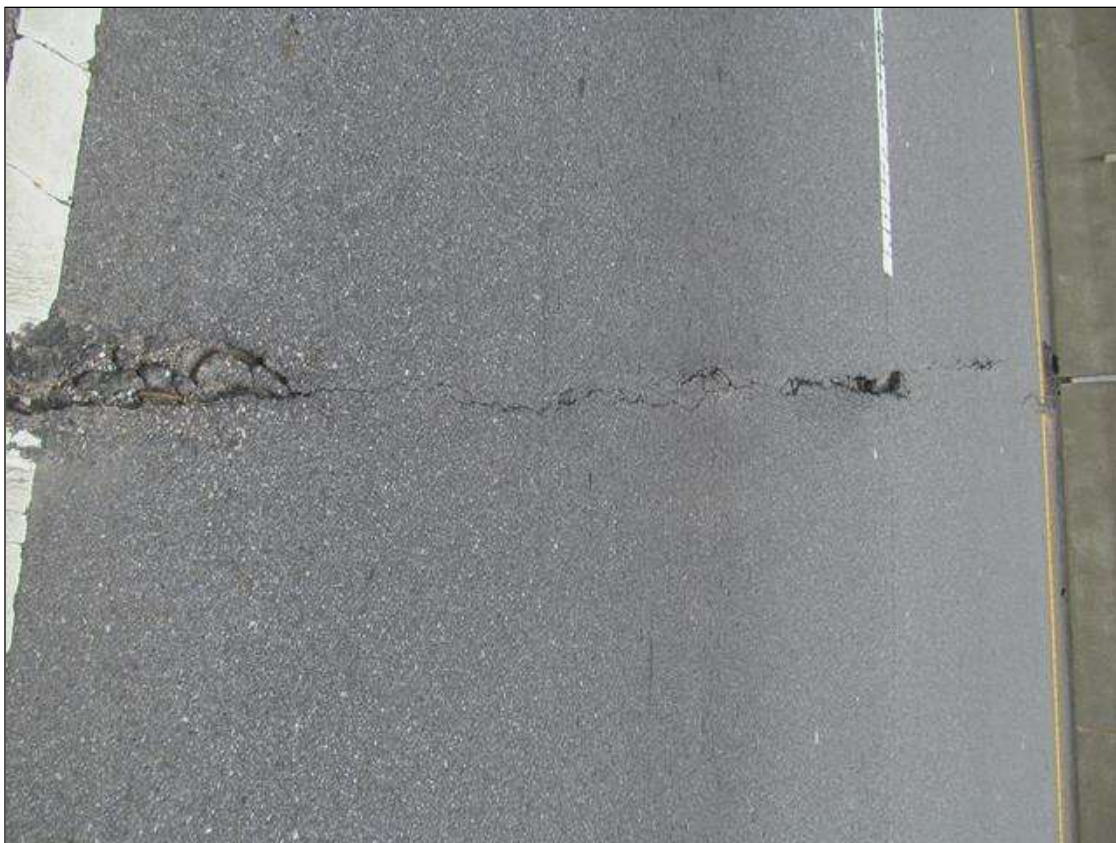
Span 2 Wearing Surface: AT BENT 2, SCATTERED SPALLING UP TO 2"D ALONG THE JOINT TOTALING APPROX 3SQFT

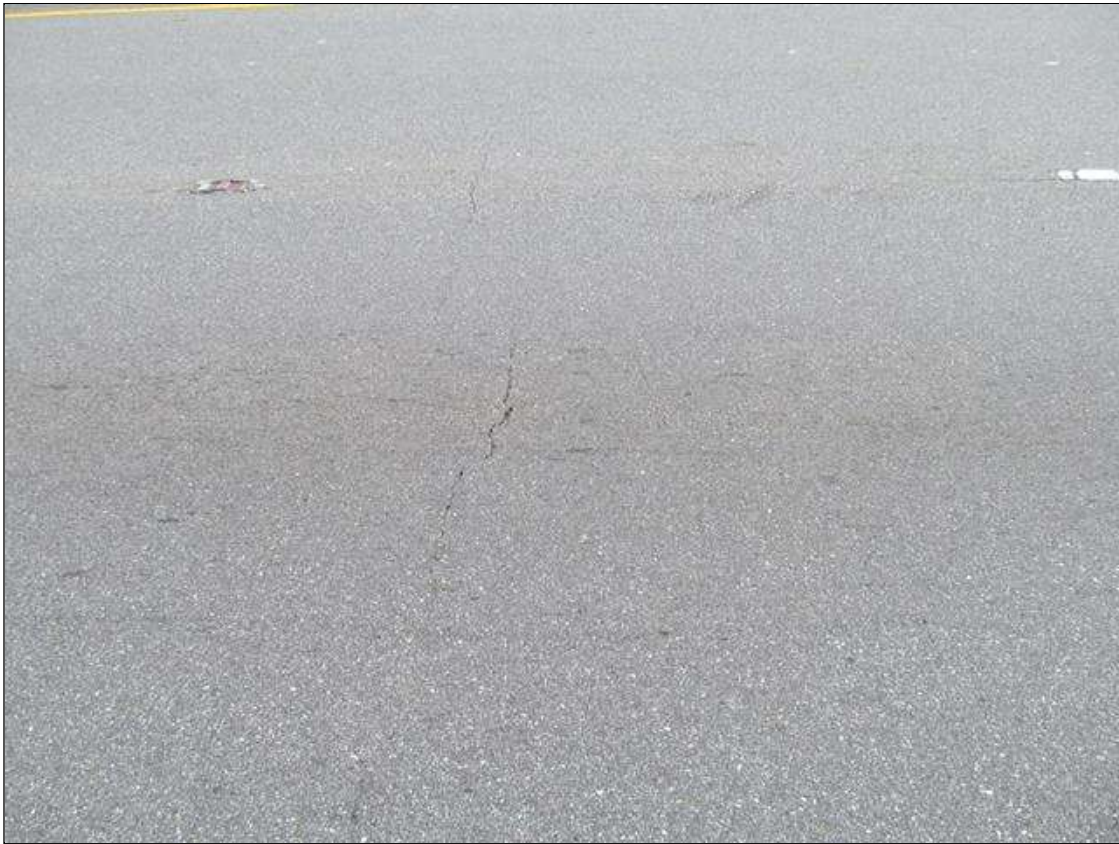
Span 2 Wearing Surface: SCATTERED MAP CRACKING UP TO 1/16"W

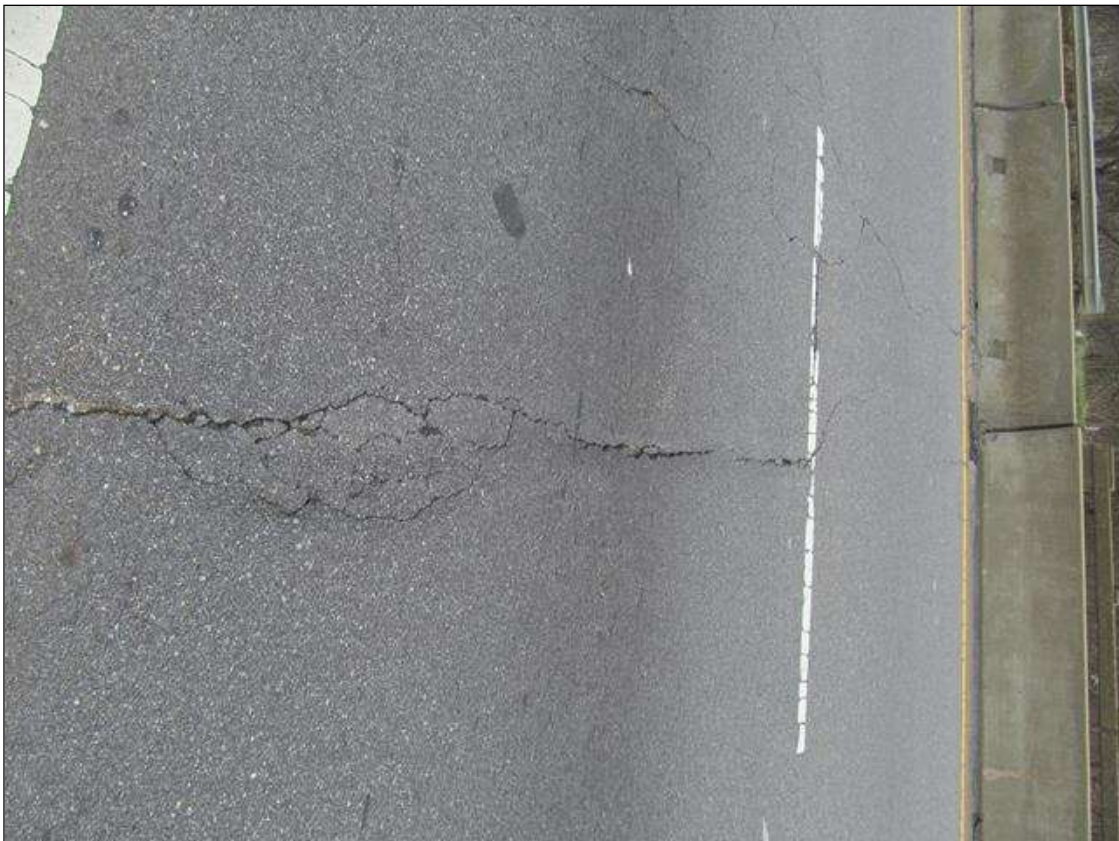
Span 3 Wearing Surface: AT THE NORTH APPROACH, FULL WIDTH TRANSVERSE CRACKING UP TO 1/8"W

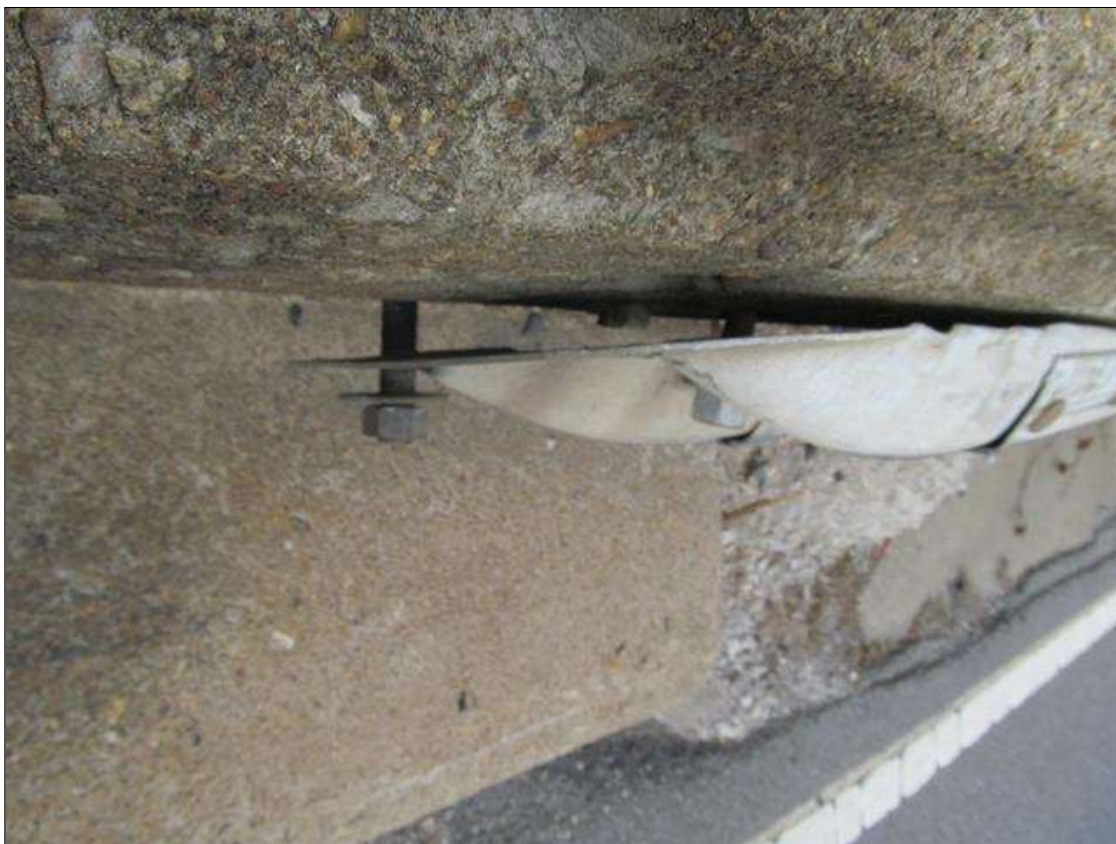
NW CORNER, GR FASTENERS ARE LOOSE OR MISSING.

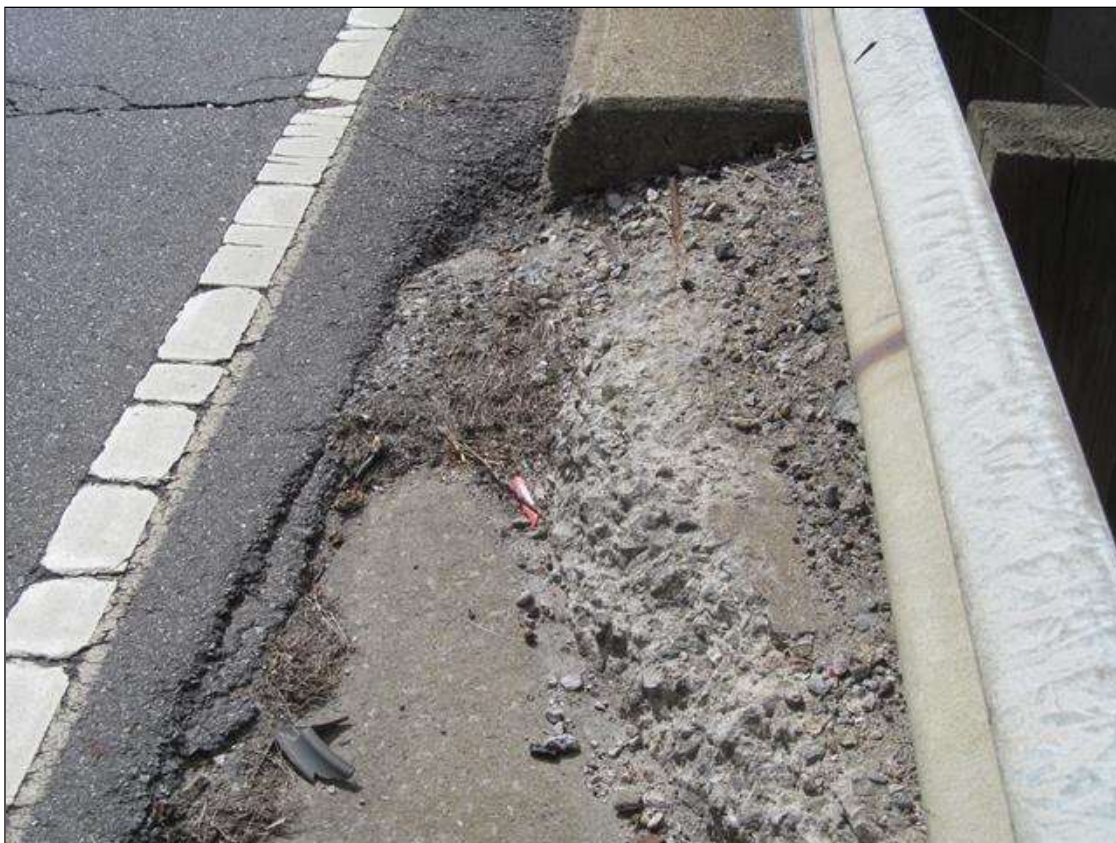
NW CORNER, CONCRETE CURBING HAS DISINTEGRATED EXPOSING RESTEEL FOR APPROX 3'L.

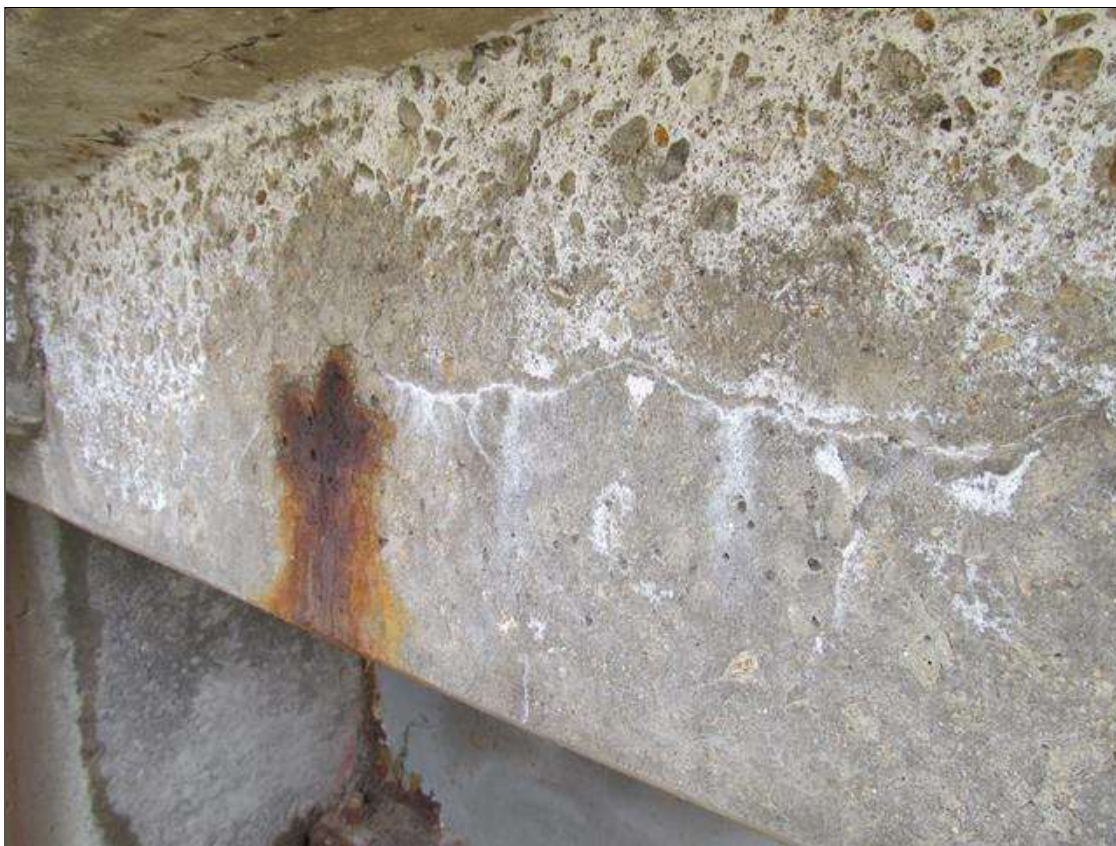
Span 1 Deck: RT & LT ENDS, HORIZONTAL HL CRACKING WITH RUST STAINING, SCATTERED

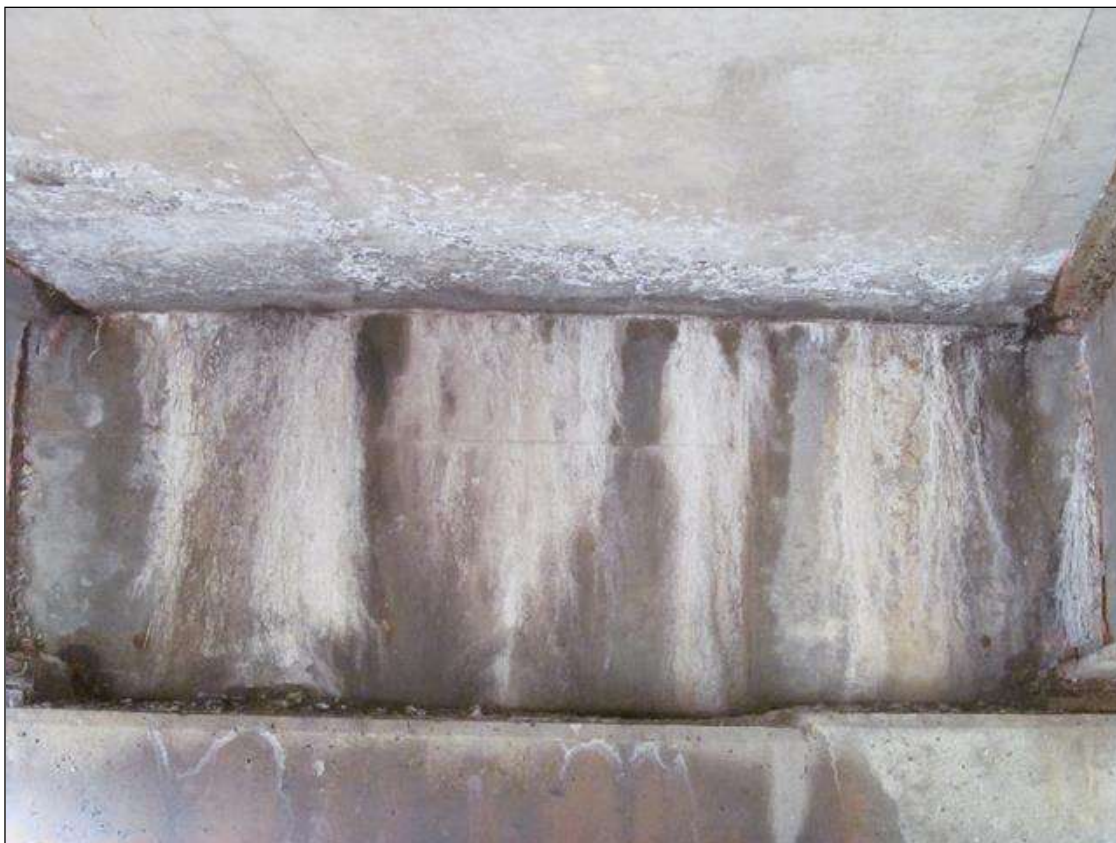
End Bent 2 Abutment/Backwall : BAY 1, SCATTERED EFFLO STAINING

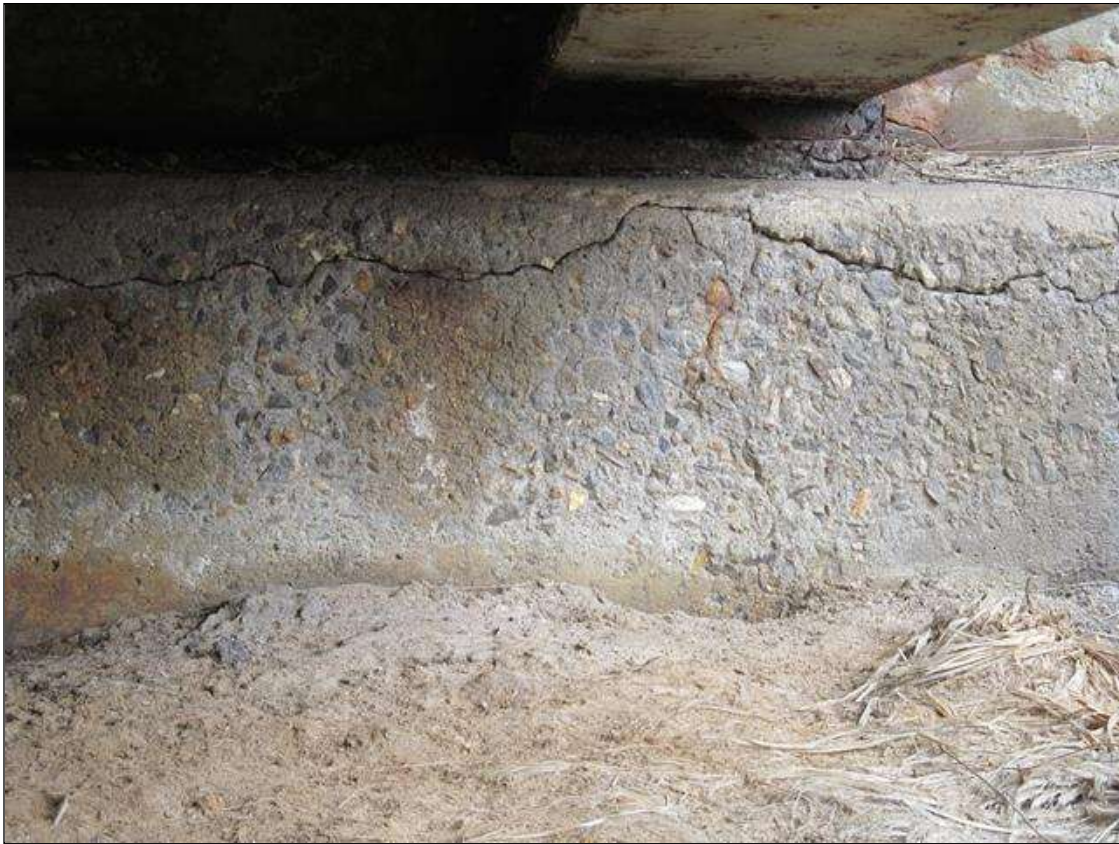
End Bent 2 Cap 1: RT END OF THE CAP FACE, HORIZONTAL CRACKING UP TO 1/8"W

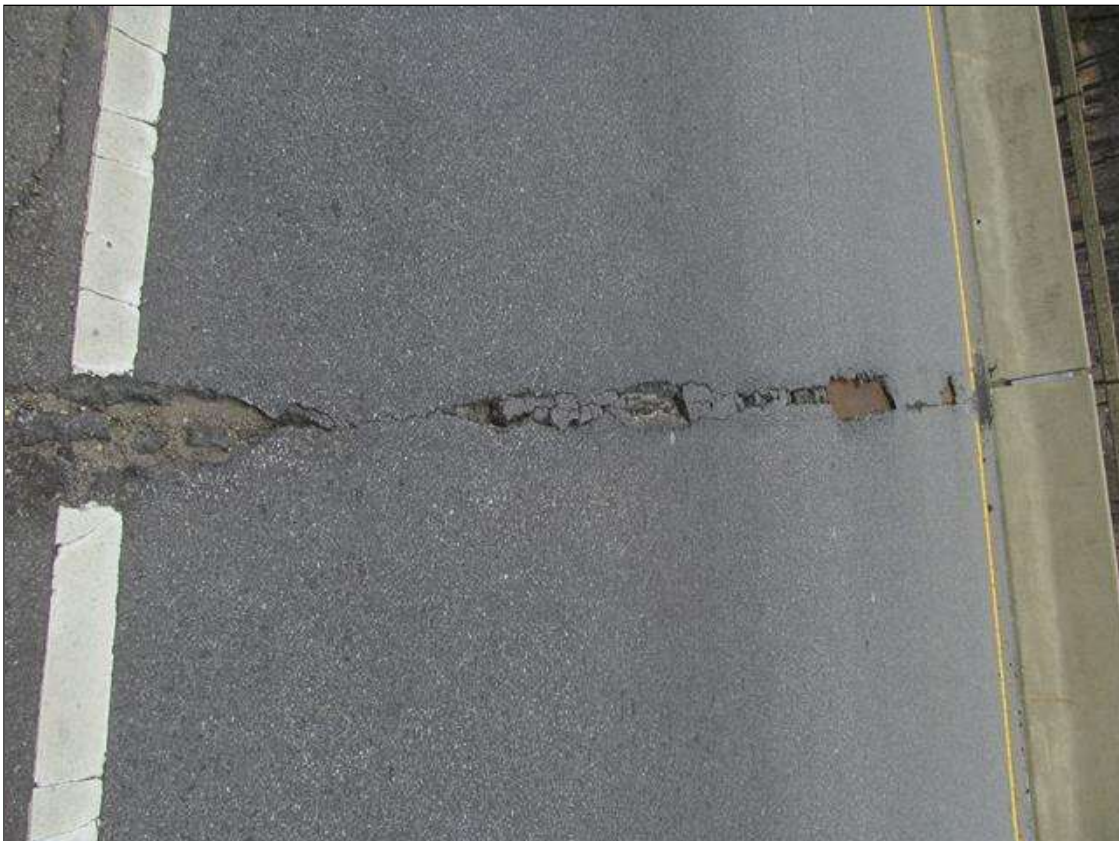
Span 1 Wearing Surface: AT BENT 1, SCATTERED SPALLING UP TO 2"D ALONG THE JOINT TOTALING APPROX 56SQFT

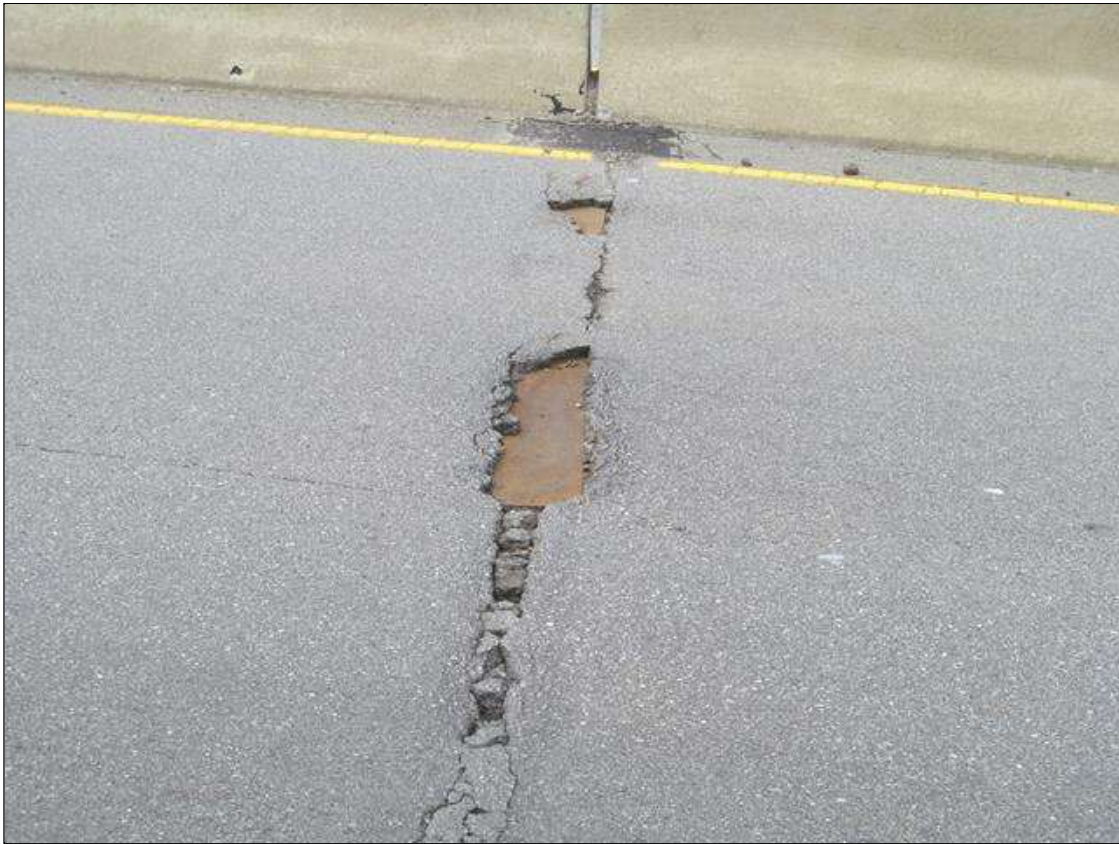
NBL AT BENT 1, METAL PLATE OVER THE JOINT HAS BEEN EXPOSED IN AREAS OF AWS LOSS.

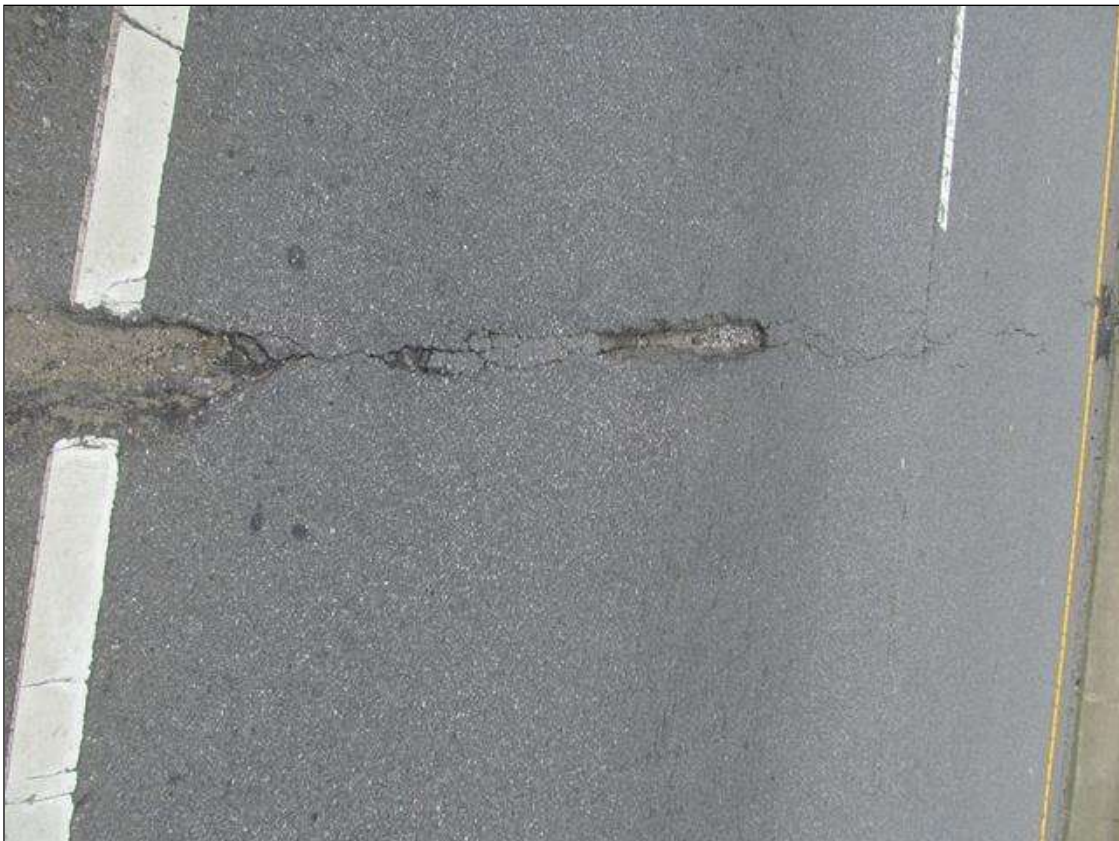
Span 2 Wearing Surface: AT BENT 2, SCATTERED SPALLING UP TO 2" D ALONG THE JOINT TOTALING APPROX 6 SQFT

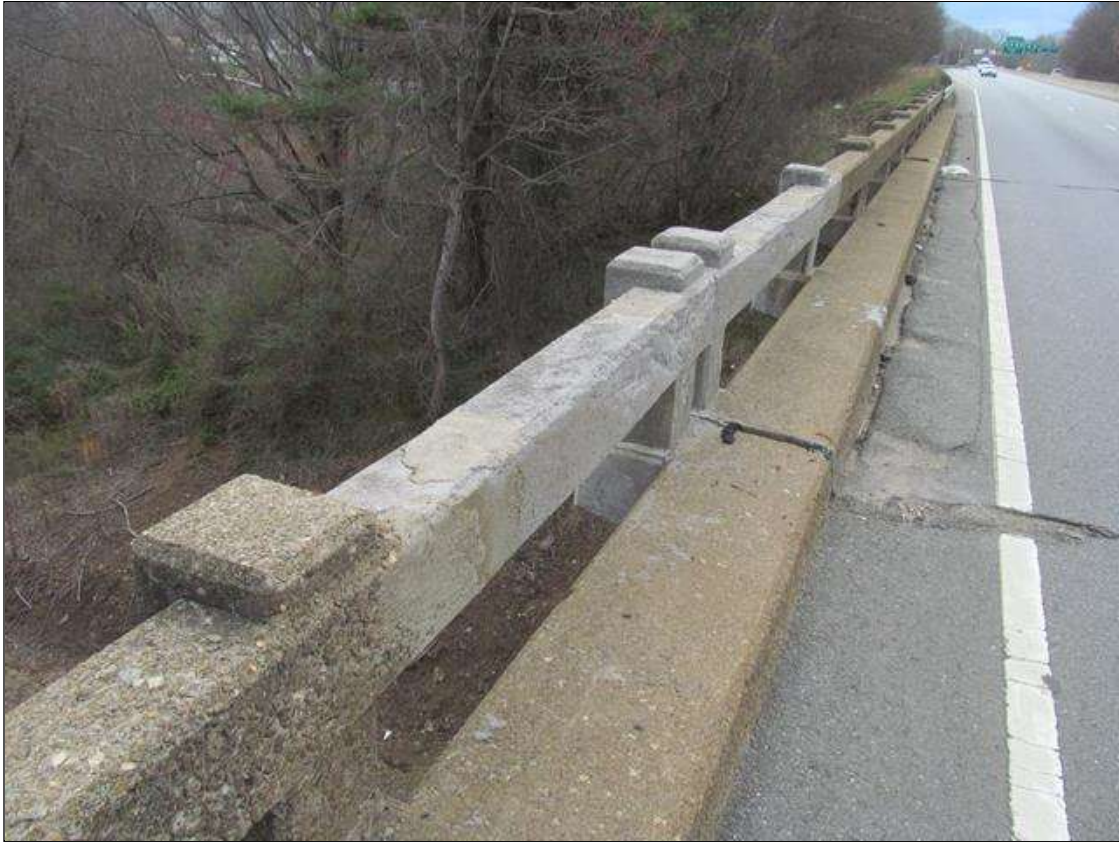
RT RAIL AT BENT 2, RC RAIL REPAIR FOR APPROX 20'L

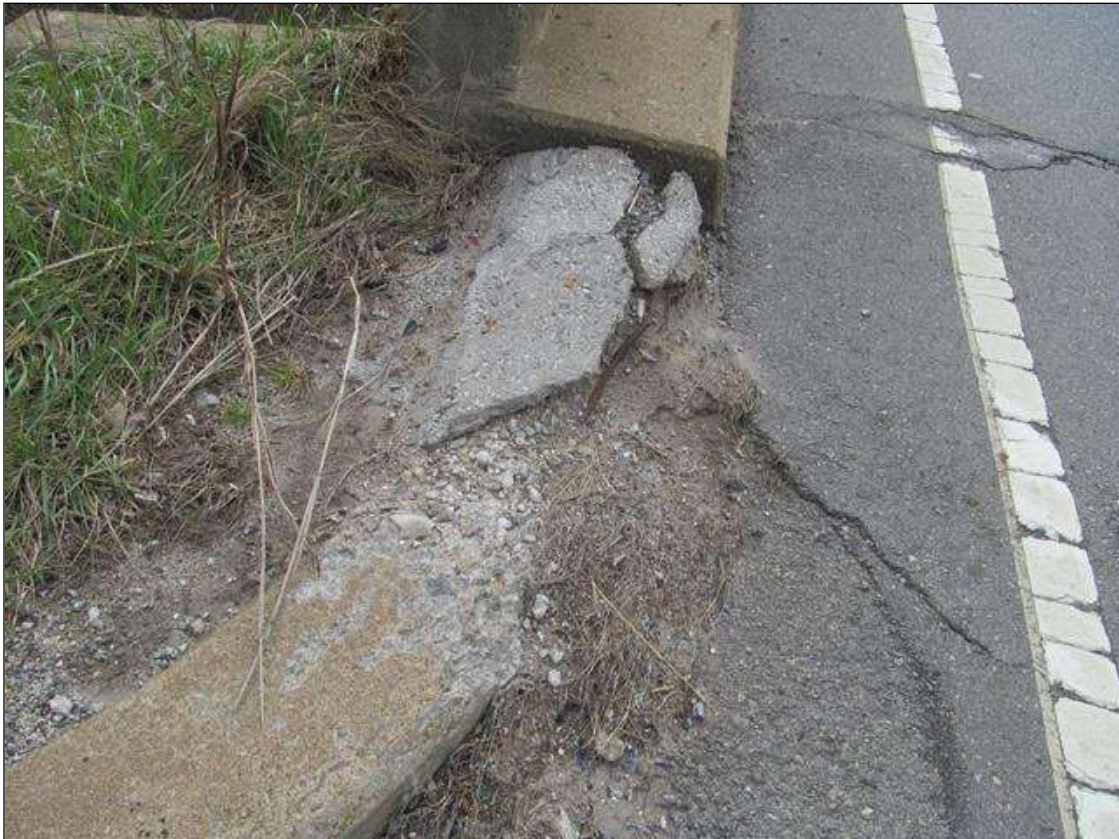
NE CORNER, CONCRETE CURBING HAS BEEN DAMAGED AND BROKEN EXPOSING RESTEEL FOR APPROX 2'L.

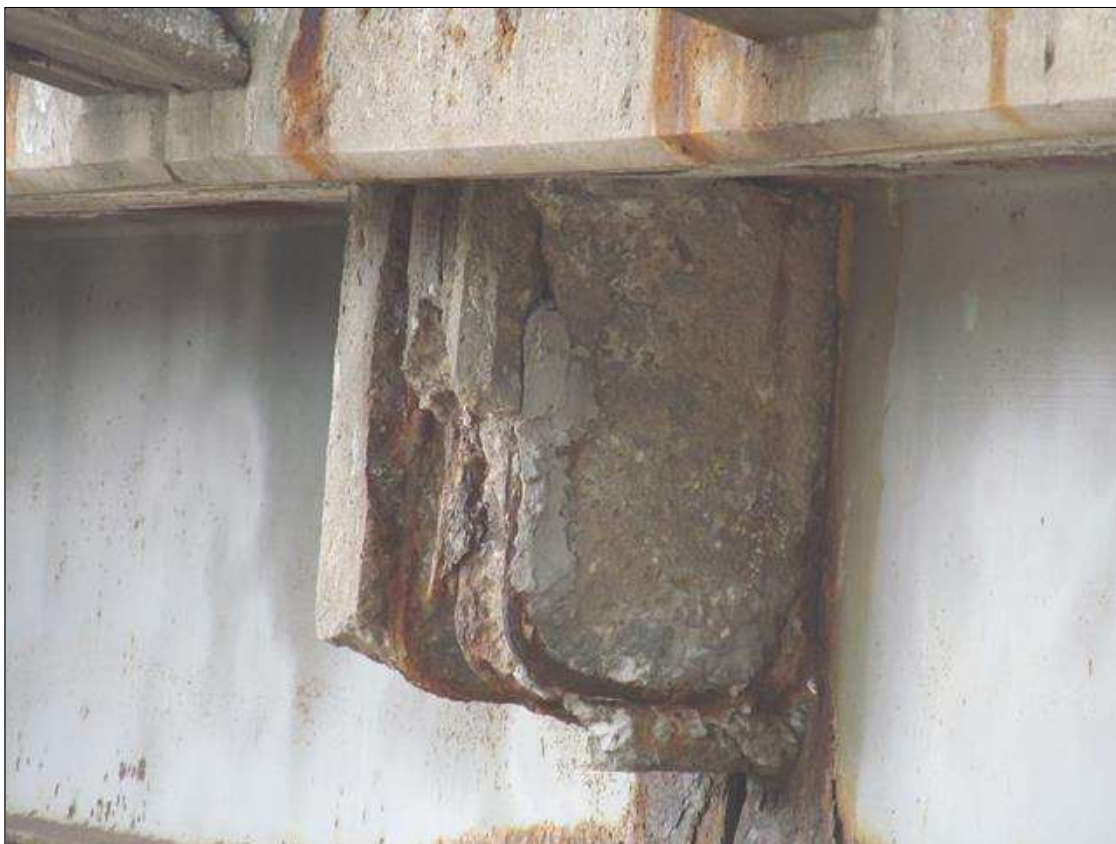
AT BENT 2, CONCRETE END DIAPHRAGMS ARE TYPICALLY CRACKED AND SPALLED EXPOSING RESTEEL. THE OUTBOARD ENDS HAVE DISINTEGRATED EXPOSING THE RESTEEL FULLY.

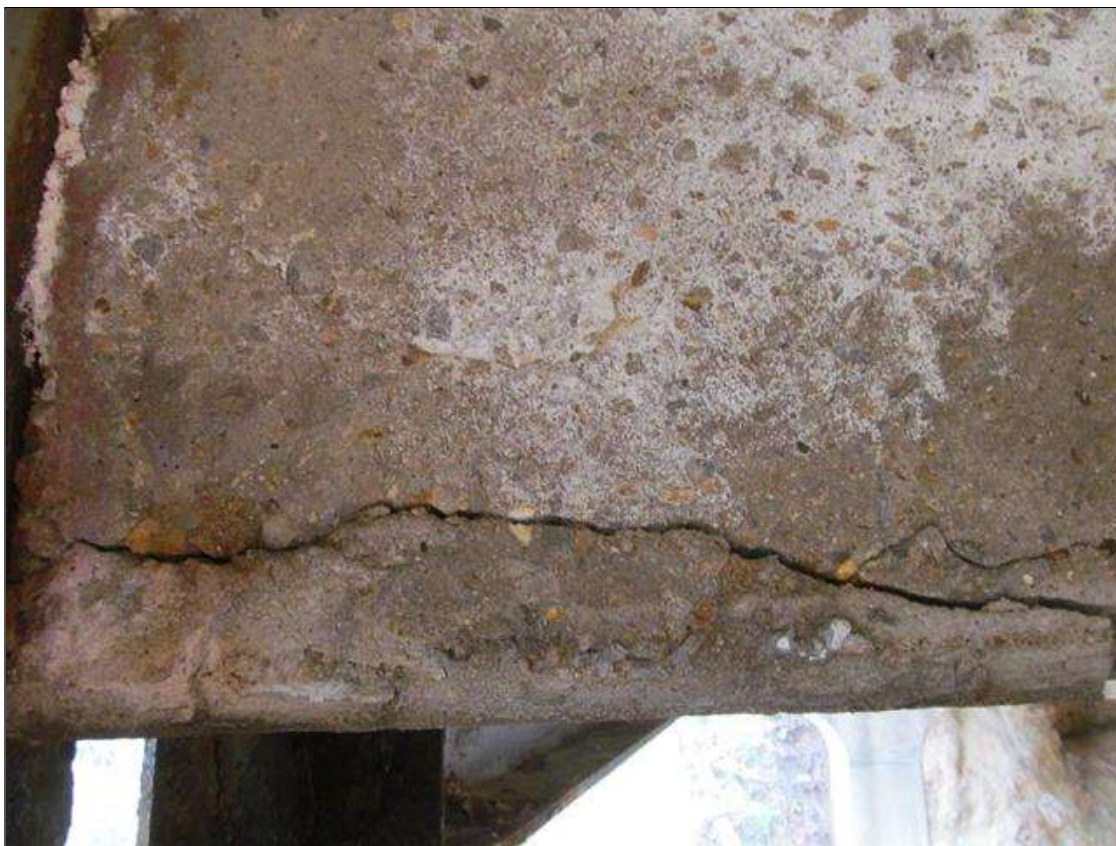
AT BENT 2, CONCRETE END DIAPHRAGMS ARE TYPICALLY CRACKED AND SPALLED EXPOSING RESTEEL. THE OUTBOARD ENDS HAVE DISINTEGRATED EXPOSING THE RESTEEL FULLY (INBOARD VIEW OF CRACKING).

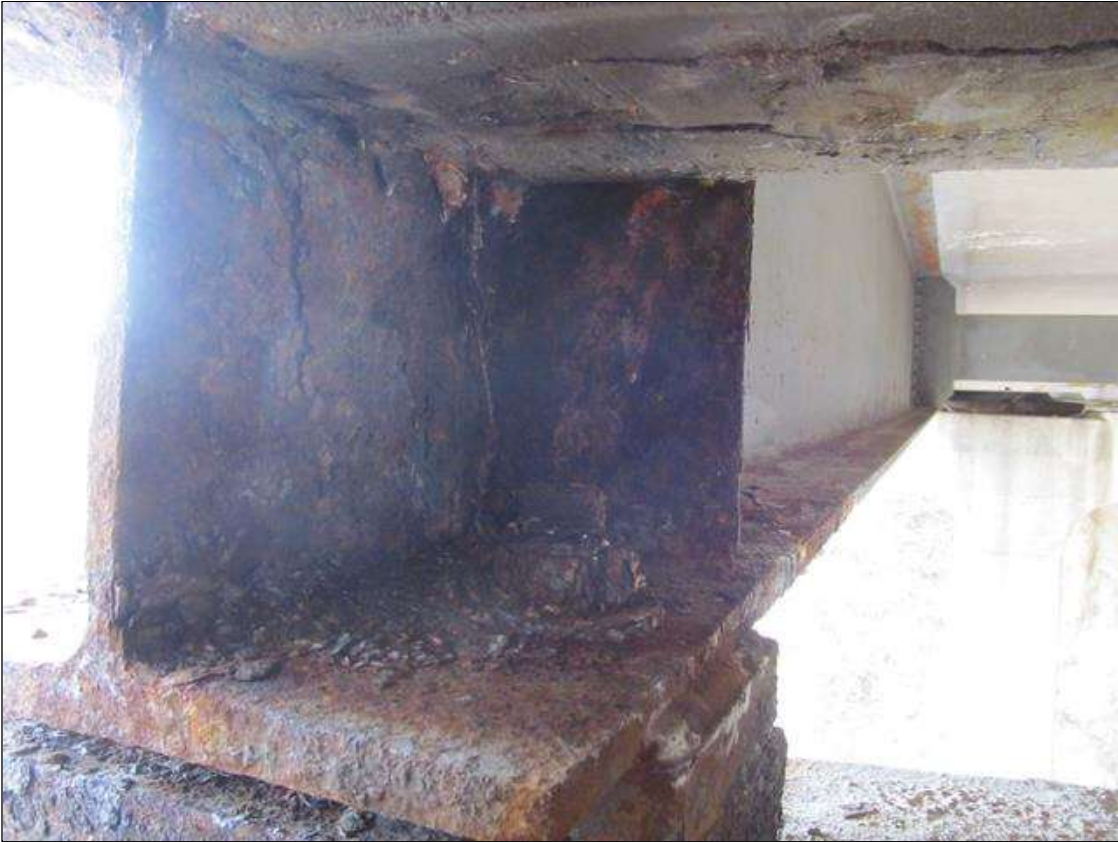
OUTBOARD BEAM ENDS AT BENT 2 HAVE SURFACE CORROSION WITH PITTING UP TO 1/16" AND LAYERED RUST.

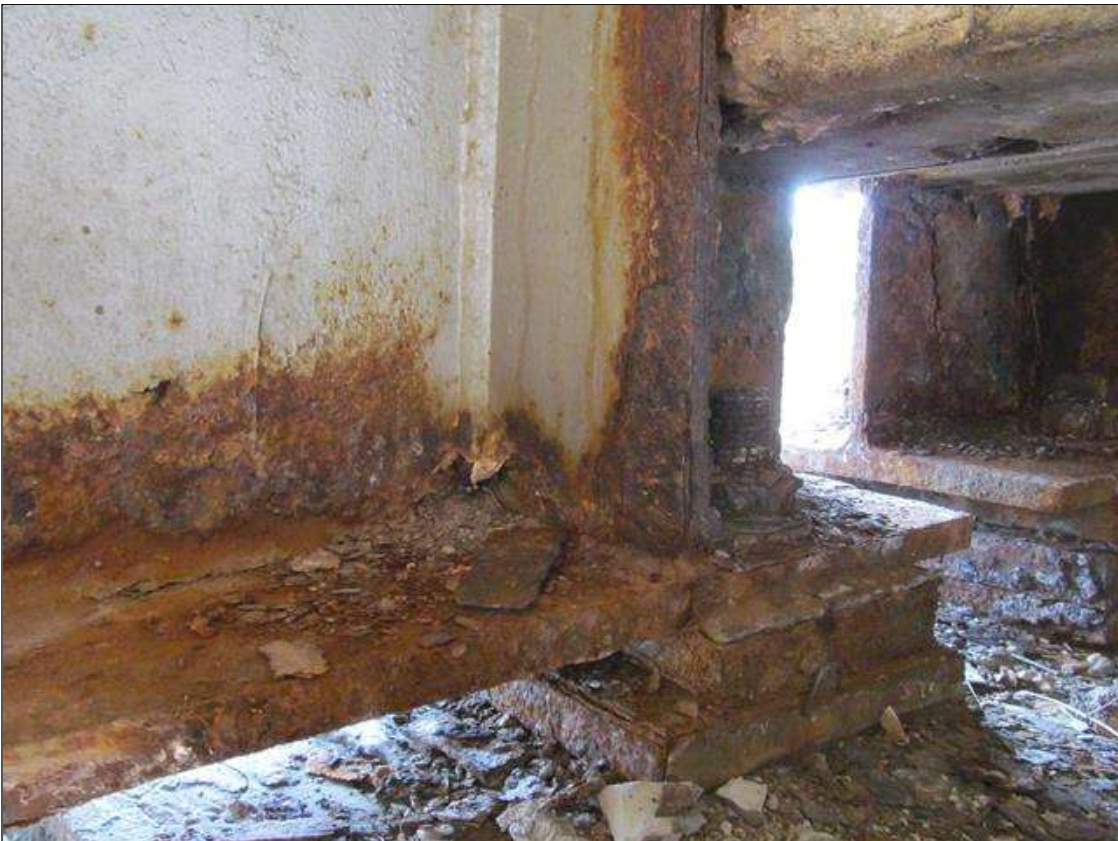
Span 3 Beam 8: BEAM END AT BENT 2 HAS SURFACE CORROSION WITH PITTING UP TO 1/16" AND LAYERED RUST FOR APPROX 2'L.
