NC DEPARTMENT OF TRANSPORTATION
 DIVISION OF HIGHWAYS
 STRUCTURE MANAGEMENT UNIT

ATTENTION: PRIORITY MAINT (CAP AND GR); DATA AND SKETCHES REVISED;

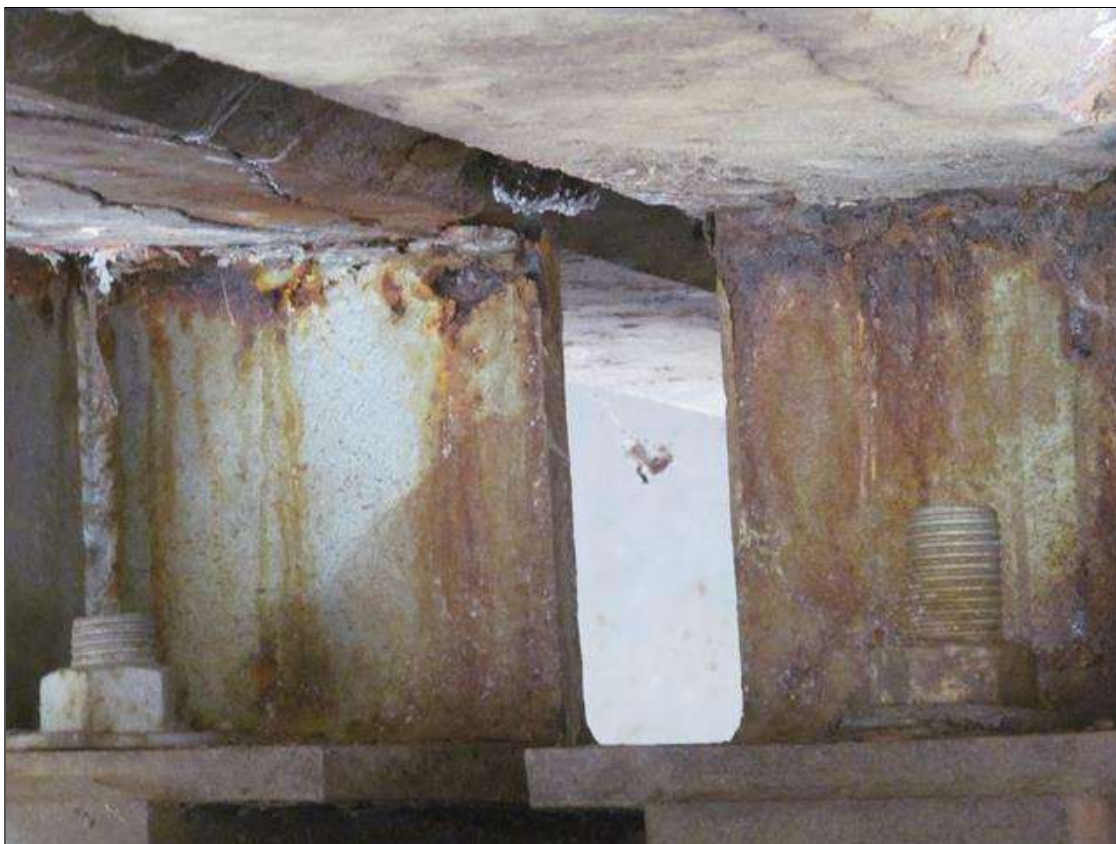
INBOARD BEAM ENDS AT BENT 2 HAVE SCATTERED SURFACE CORROSION

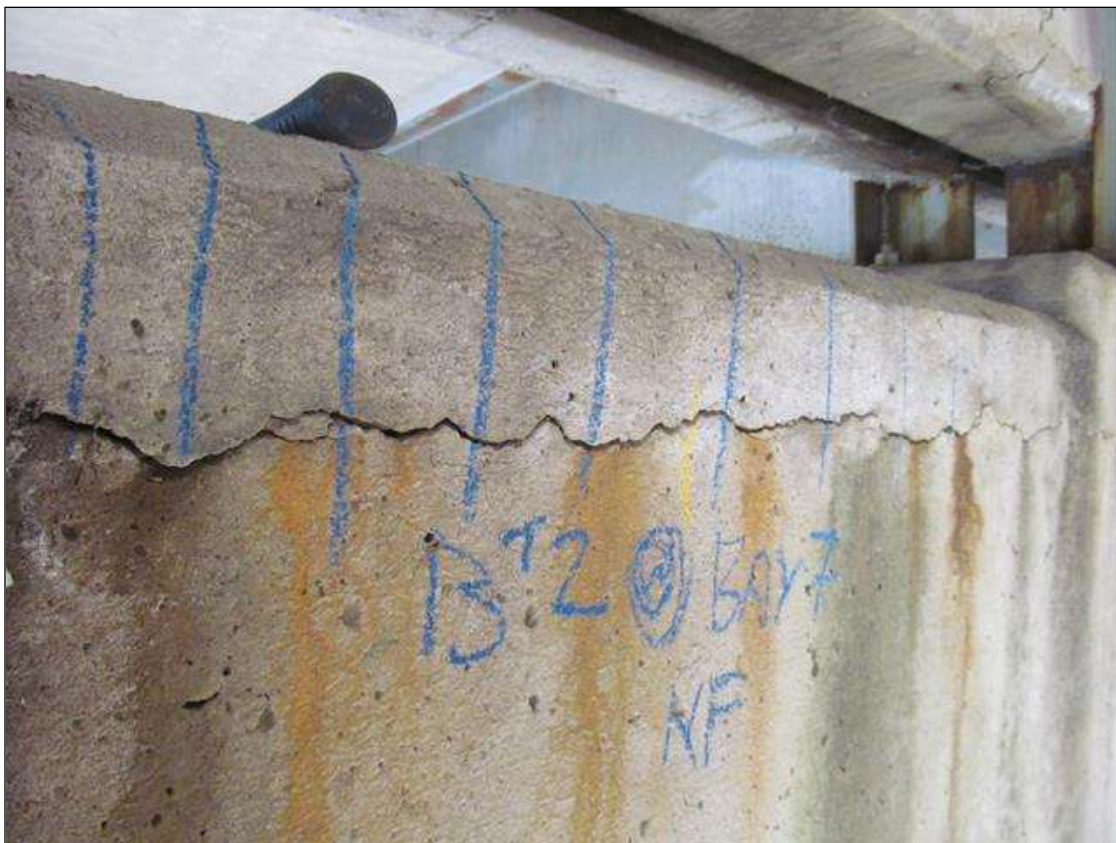
Bent 2 Cap 1: NORTH FACE, TOP 6" OF CAP, HORIZONTAL CRACKING UP TO 3/16"W IS SCATTERED ALONG THE LENGTH OF THE CAP. THE AREA ABOVE THE CRACKING IS DELAMINATED.

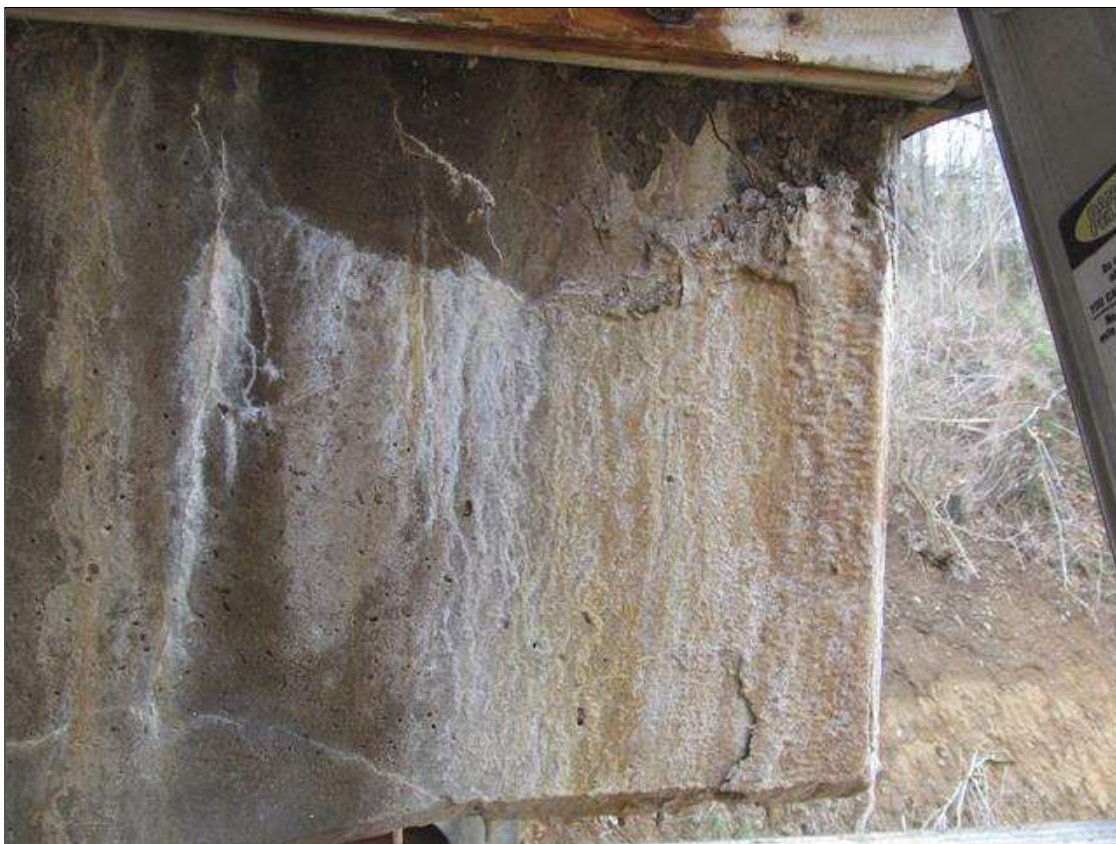
Bent 2 Cap 1: RT AND LT ENDS OF THE CAP, LOWER SIDES, HORIZONTAL AND MAP CRACKING UP TO 1/8"W WITH EFFLO BUILD-UP AND RUST STAINING.

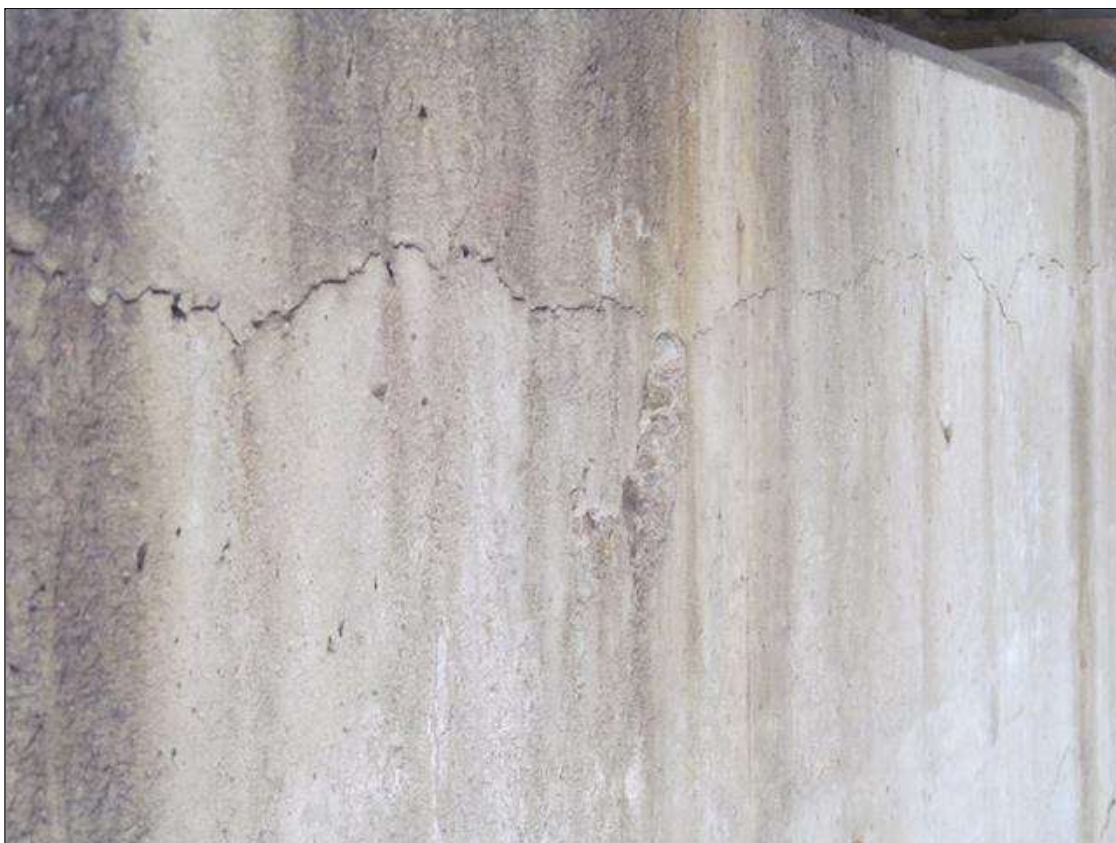
Bent 2 Cap 1: RT AND LT ENDS OF THE CAP, LOWER SIDES, HORIZONTAL AND MAP CRACKING UP TO 1/8"W WITH EFFLO BUILD-UP AND RUST STAINING.

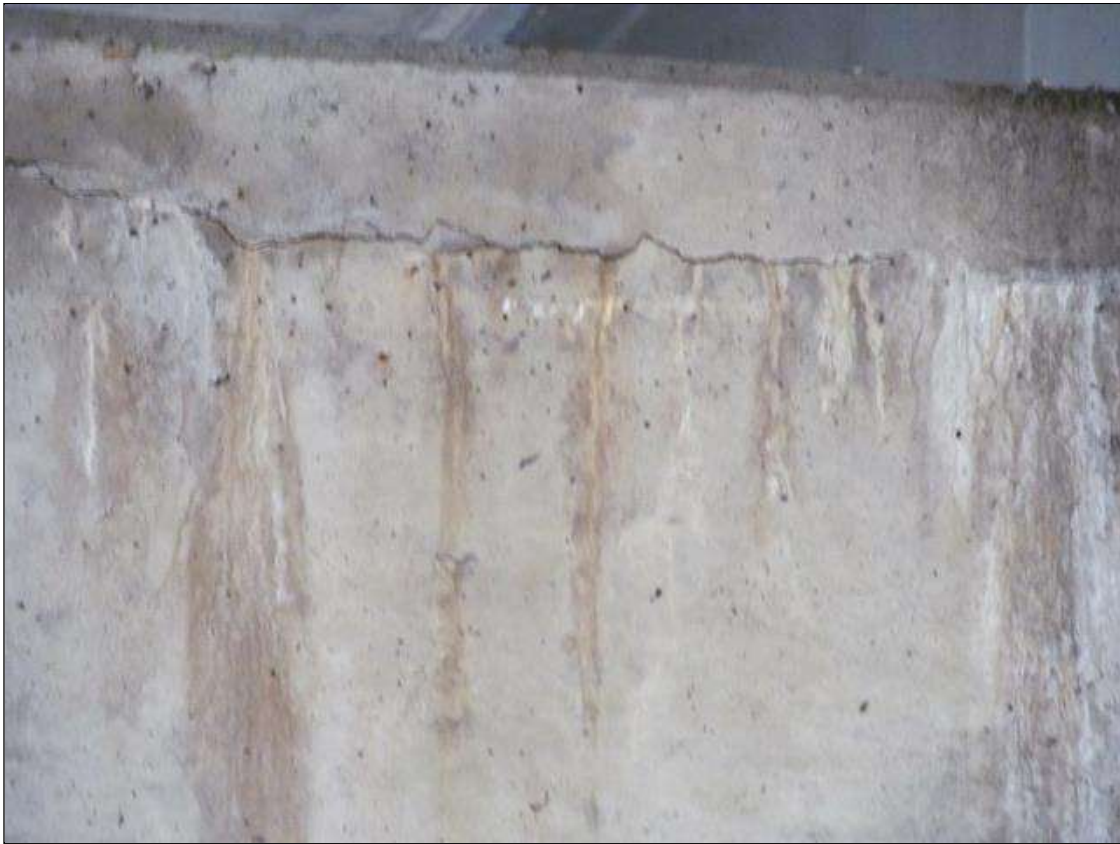
Bent 2 Cap 1: NORTH FACE, TOP 6" OF CAP, HORIZONTAL CRACKING UP TO 3/16"W IS SCATTERED ALONG THE LENGTH OF THE CAP. THE AREA ABOVE THE CRACKING IS DELAMINATED.

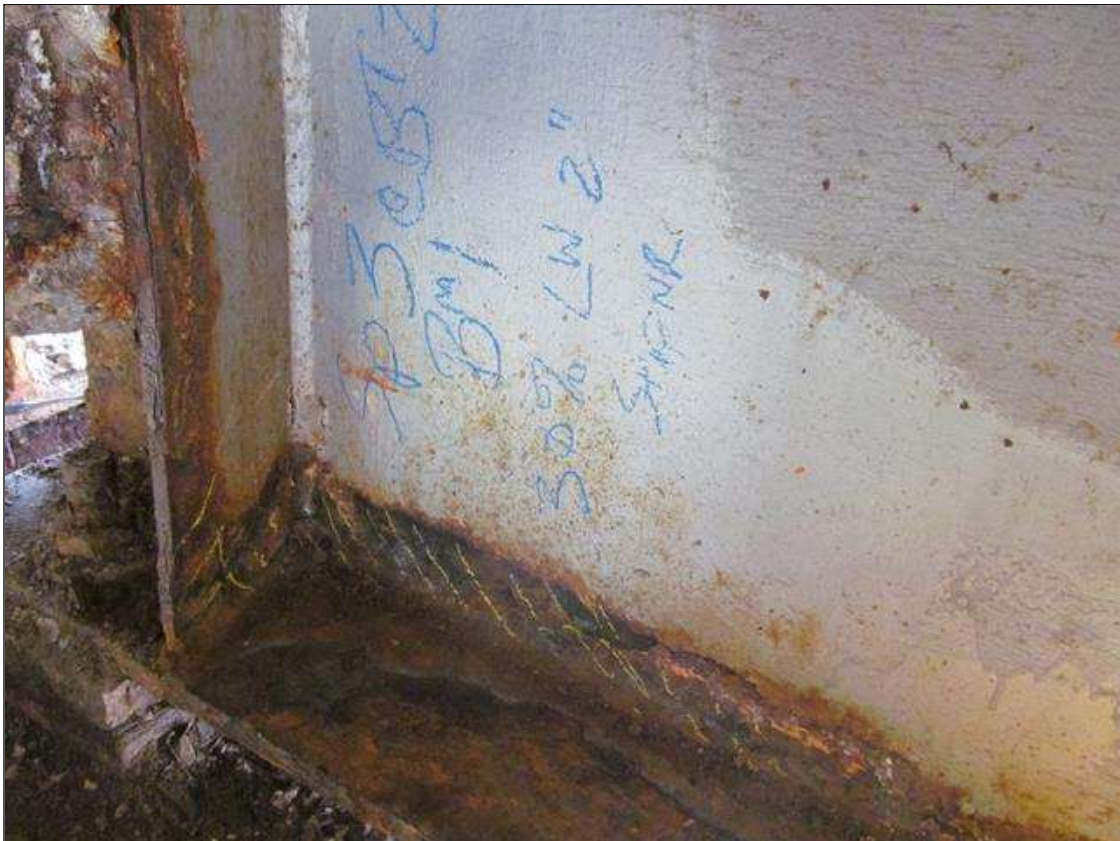
Span 3 Beam 1: BEAM END AT BENT 2, CORROSION WITH APPROX 30% SECTION LOSS (AVG 5/16" REMAINS) IN THE LOWER 2" OF THE WEB FOR APPROX 2'L. PMANT.

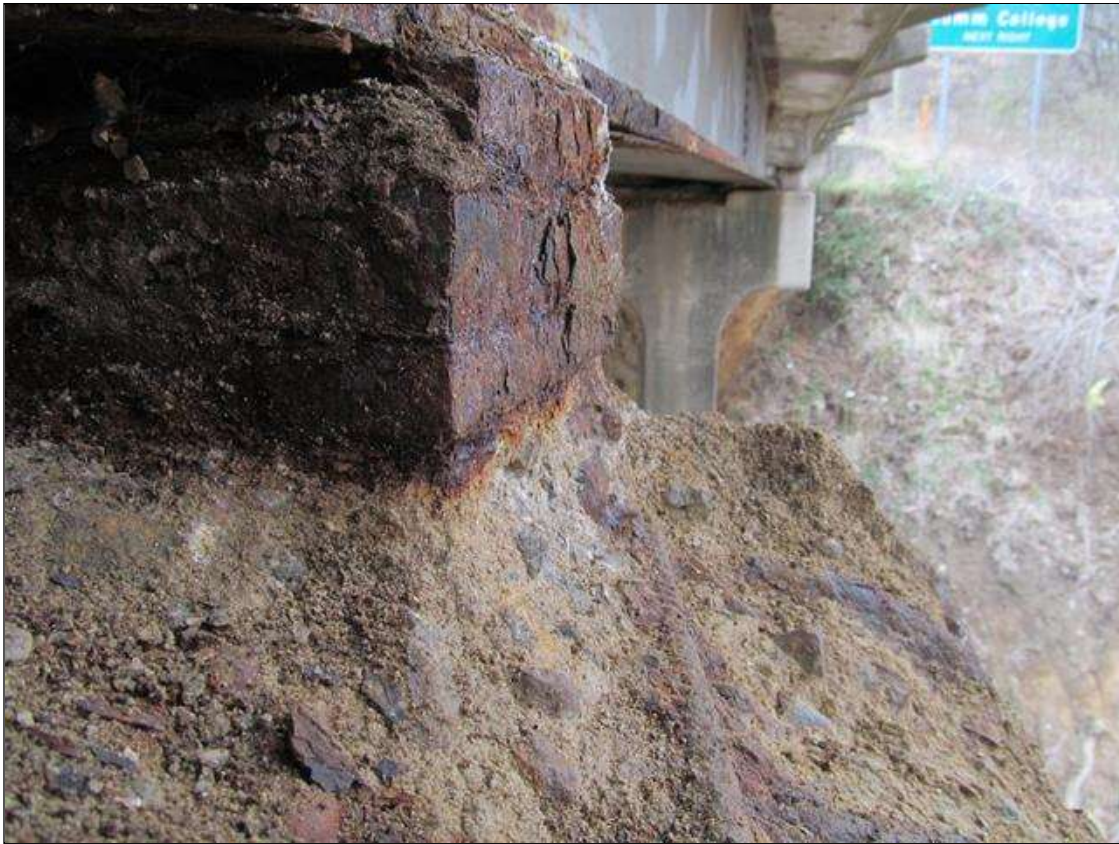
Bent 2 Cap 1: LT END OF THE CAP, PATCHED AREA (FORMERLY SPALLED) HAS FAILED EXPOSING THE RESTEEL. THE RESTEEL HAS PITTING UP TO 1/32". THE SPALLED AREA HAS UNDERMINED APPROX 3SQIN OF THE BEARING AREA OF SPAN 2, BEAM 1. THE SPALLED AREA HAS REACHED THE BEARING AREA OF SPAN 3, BEAM 1, BUT HAS NOT YET UNDERMINED IT. PMAINT.

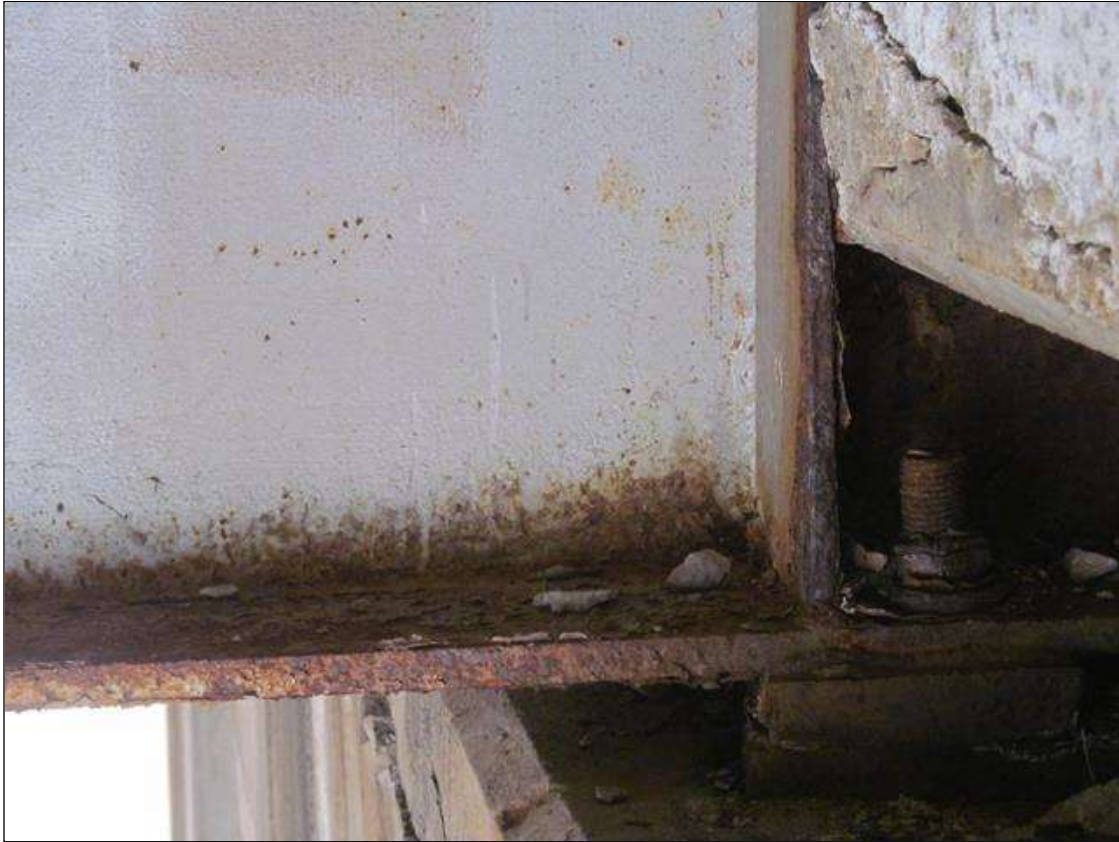
Bent 2 Cap 1: LT END OF THE CAP, PATCHED AREA (FORMERLY SPALLED) HAS FAILED EXPOSING THE RESTEEL. THE RESTEEL HAS PITTING UP TO 1/32". THE SPALLED AREA HAS UNDERMINED APPROX 3SQIN OF THE BEARING AREA OF SPAN 2, BEAM 1. THE SPALLED AREA HAS REACHED THE BEARING AREA OF SPAN 3, BEAM 1, BUT HAS NOT YET UNDERMINED IT. PMAINT.

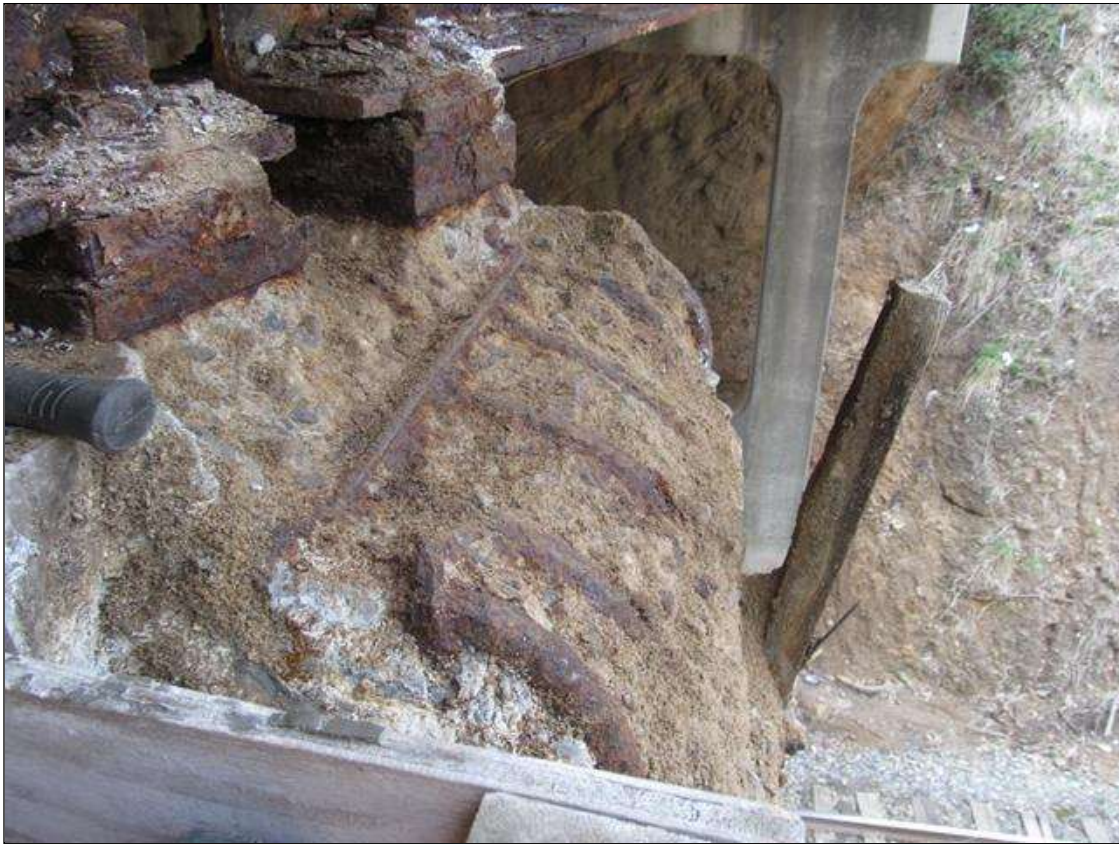
Bent 2 Cap 1: LT END OF THE CAP, PATCHED AREA (FORMERLY SPALLED) HAS FAILED EXPOSING THE RESTEEL. THE RESTEEL HAS PITTING UP TO 1/32". THE SPALLED AREA HAS UNDERMINED APPROX 3SQIN OF THE BEARING AREA OF SPAN 2, BEAM 1. THE SPALLED AREA HAS REACHED THE BEARING AREA OF SPAN 3, BEAM 1, BUT HAS NOT YET UNDERMINED IT. PMAINT.

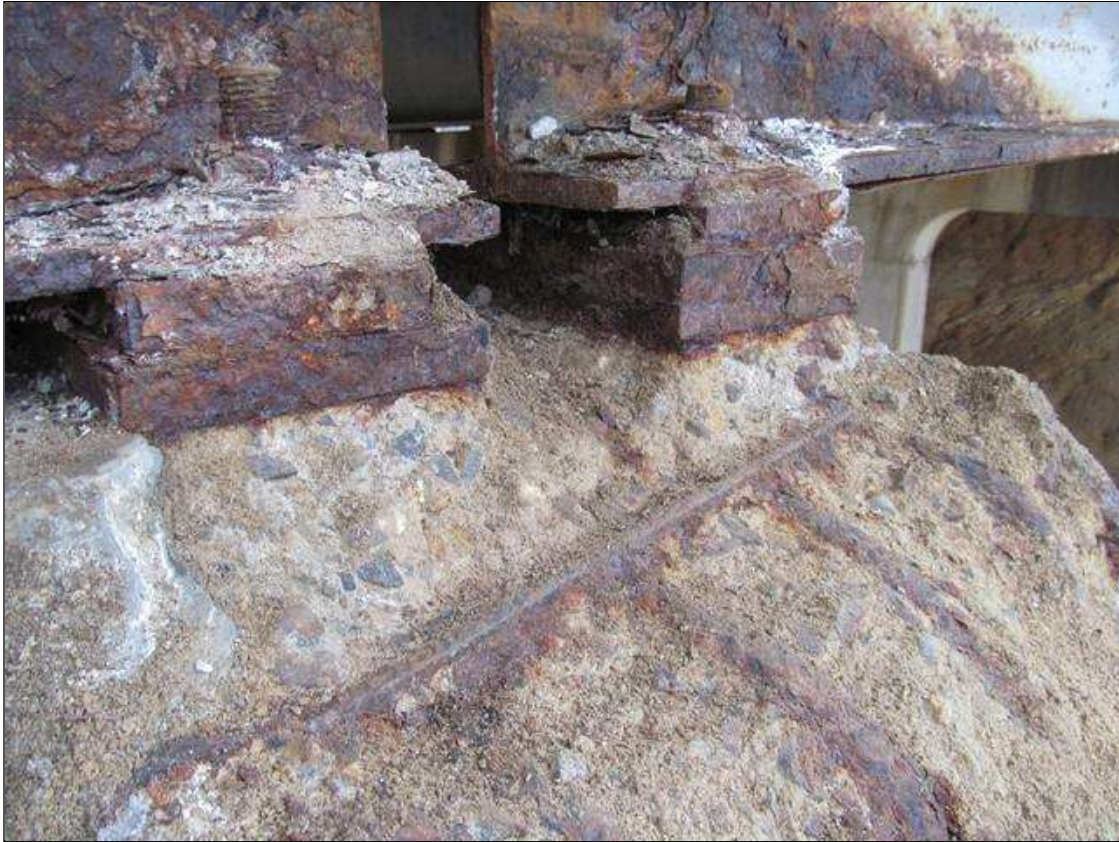
Bent 2 Cap 1: LT END OF THE CAP, PATCHED AREA (FORMERLY SPALLED) HAS FAILED EXPOSING THE RESTEEL. THE RESTEEL HAS PITTING UP TO 1/32". THE SPALLED AREA HAS UNDERMINED APPROX 3SQIN OF THE BEARING AREA OF SPAN 2, BEAM 1. THE SPALLED AREA HAS REACHED THE BEARING AREA OF SPAN 3, BEAM 1, BUT HAS NOT YET UNDERMINED IT. PMAINT.

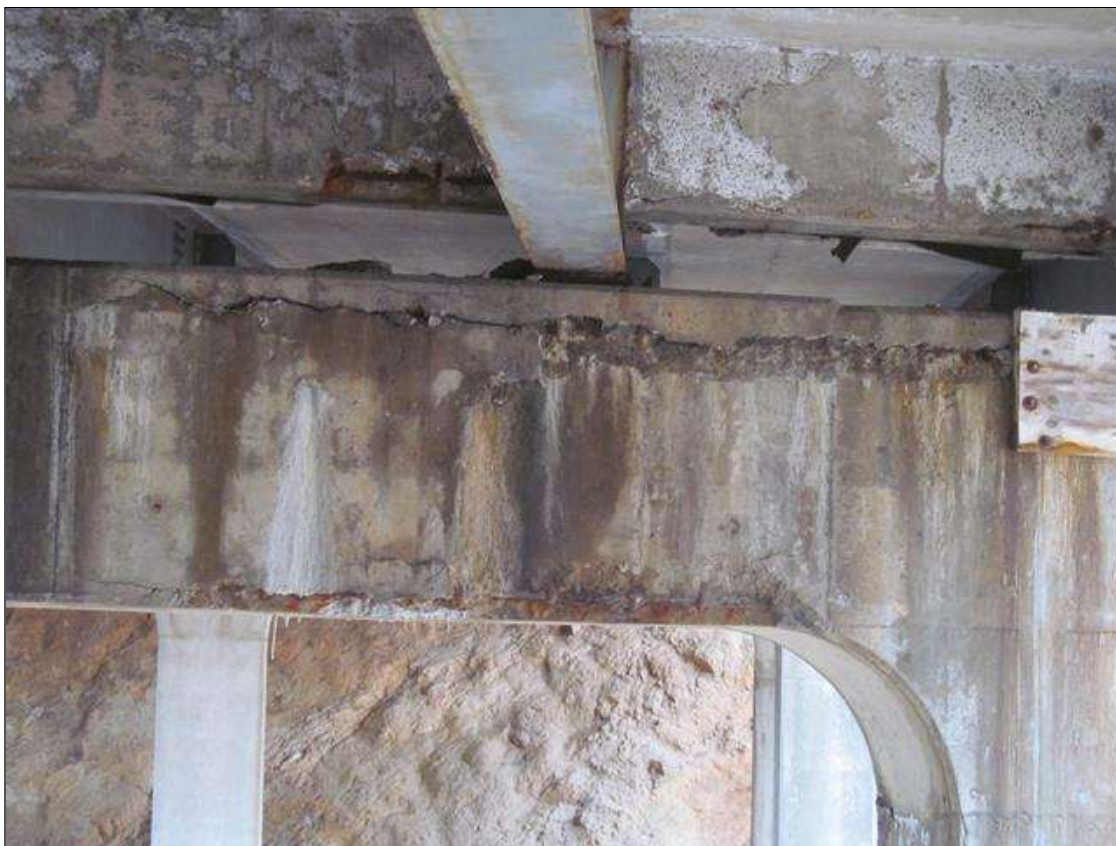
Bent 2 Cap 1: NORTH FACE, TOP 6" OF THE CAP AT BAYS 2-3, HORIZONTAL SPALLING, APPROX 10'L X 3"W X UP TO 2"D. THE AREA ABOVE HAS DELAMINATED.

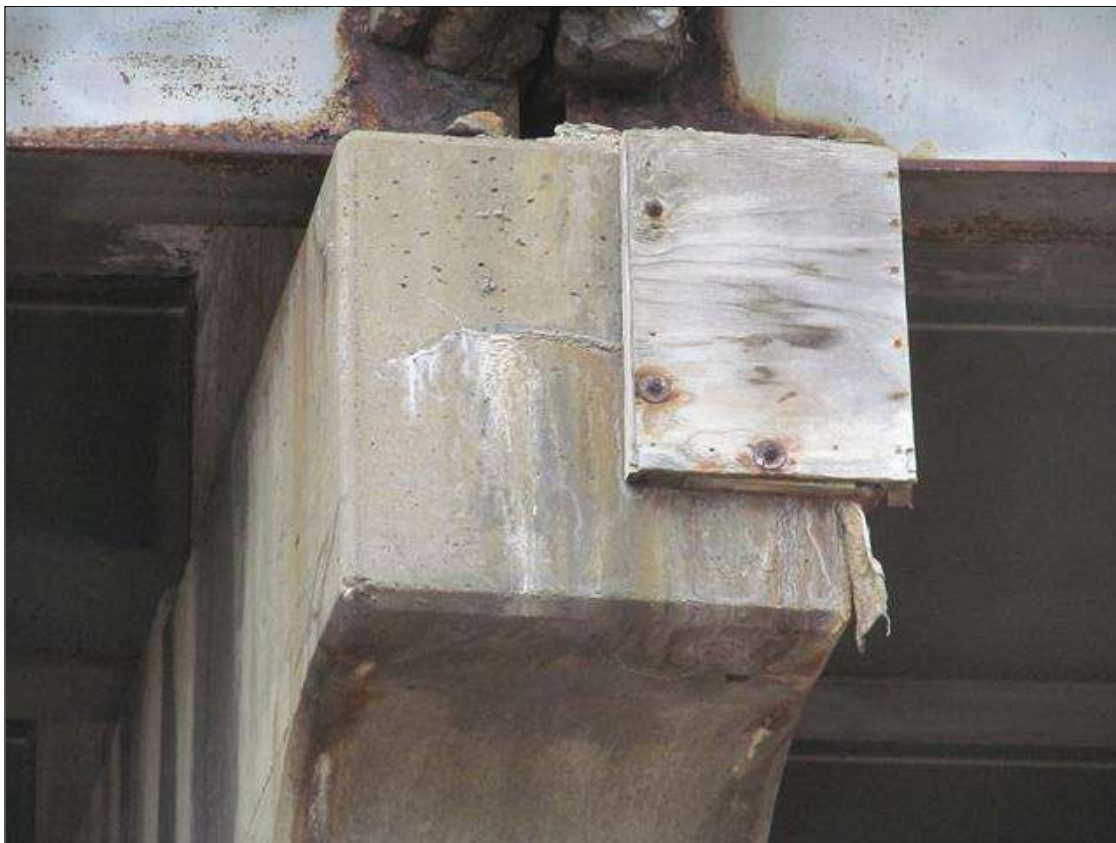
BENT 2 RT END, VIEW OF PREVIOUS REPAIR

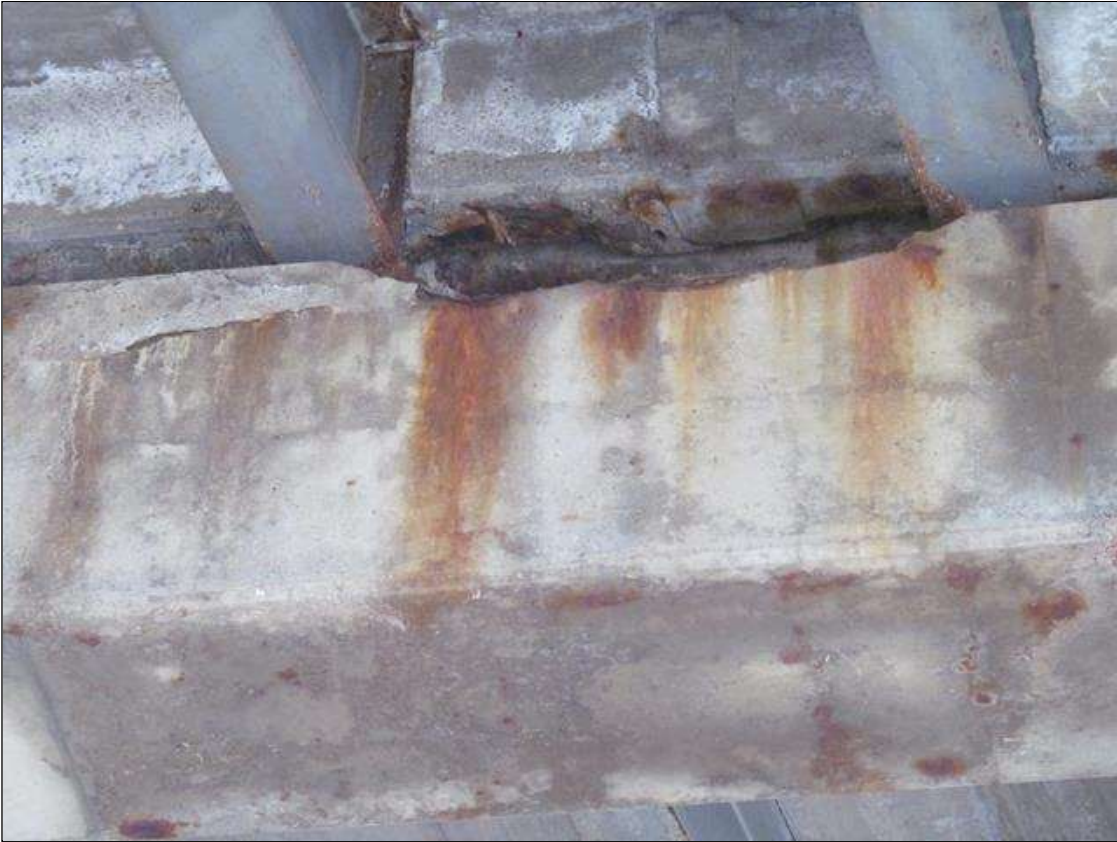
Bent 2 Cap 1: SOUTH FACE, TOP OF THE CAP AT BEAMS 4-5, HORIZONTAL SPALLING, APPROX 5'L X 3"W X UP TO 4"D EXPOSING THE RESTEEL.

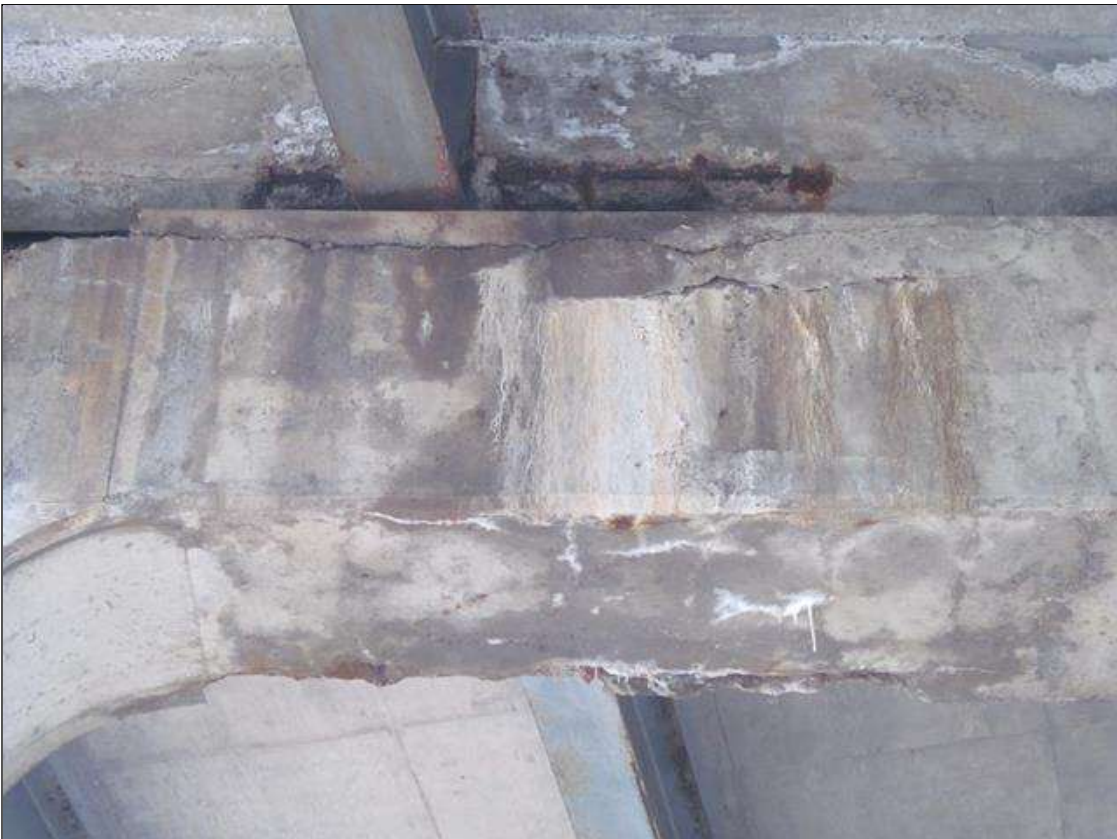
Bent 2 Cap 1: SOUTH FACE OF THE CAP, MAP CRACKING UP TO 1/8"W WITH EFFLOL STAINING, SCATTERED.

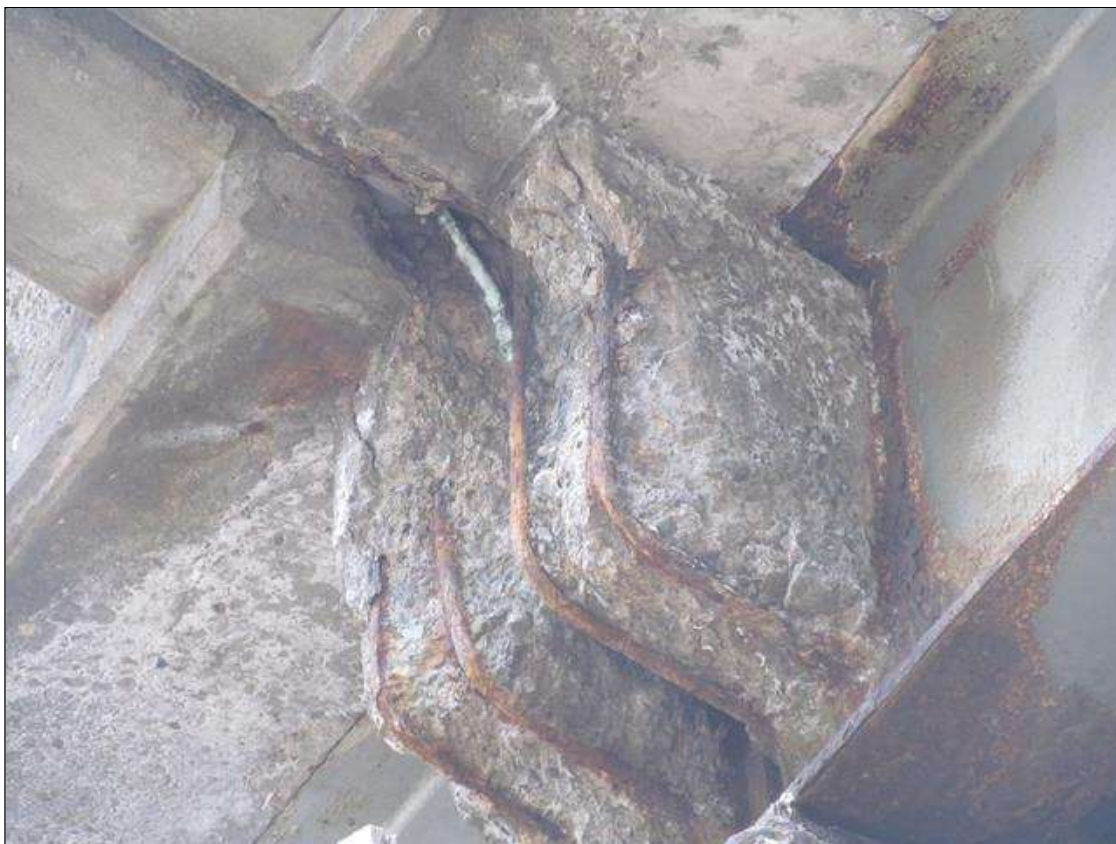
BENT 2, VIEW OF SPALLED CONCRETE END DIAPHRAGMS (LT OUTBOARD END)

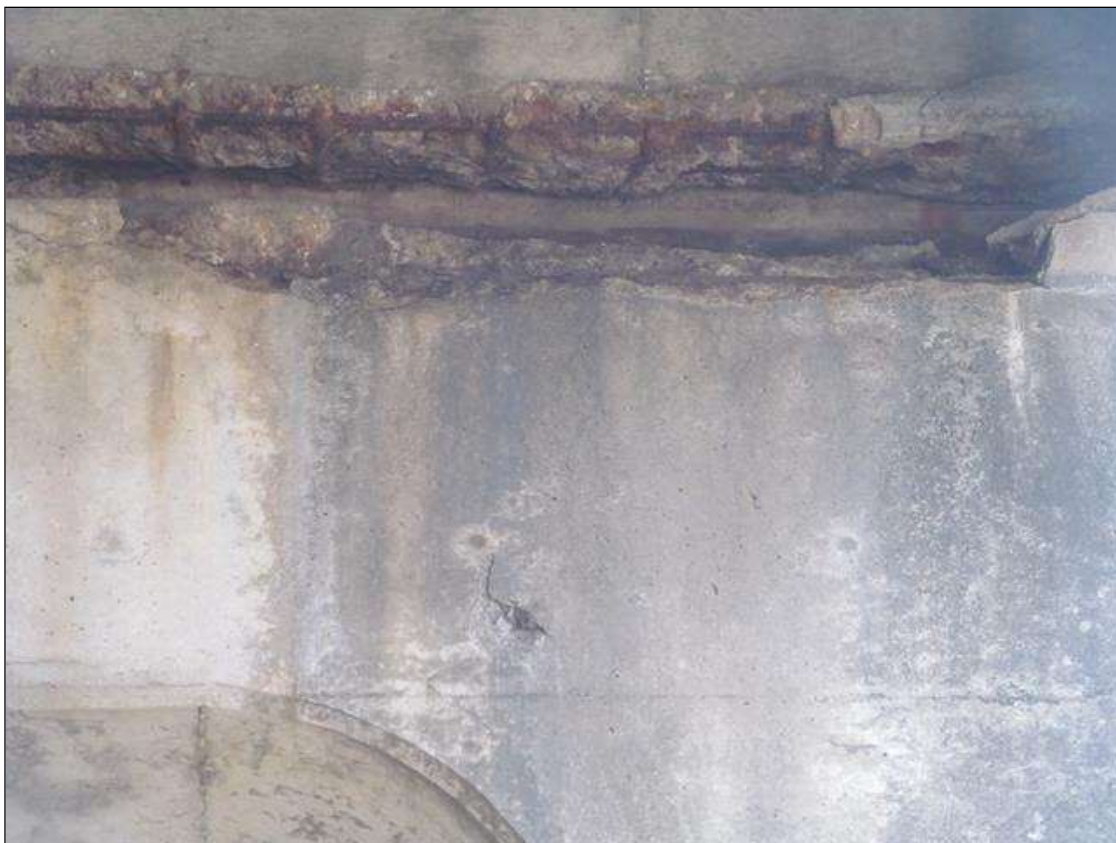
Bent 1 Cap 1: NORTH FACE AT BAY 1, TOP 4" OF THE CAP, HORIZONTAL SPALLING WITH EXPOSED RESTEEL, APPROX 4'LX 3"W X UP TO 3"D.

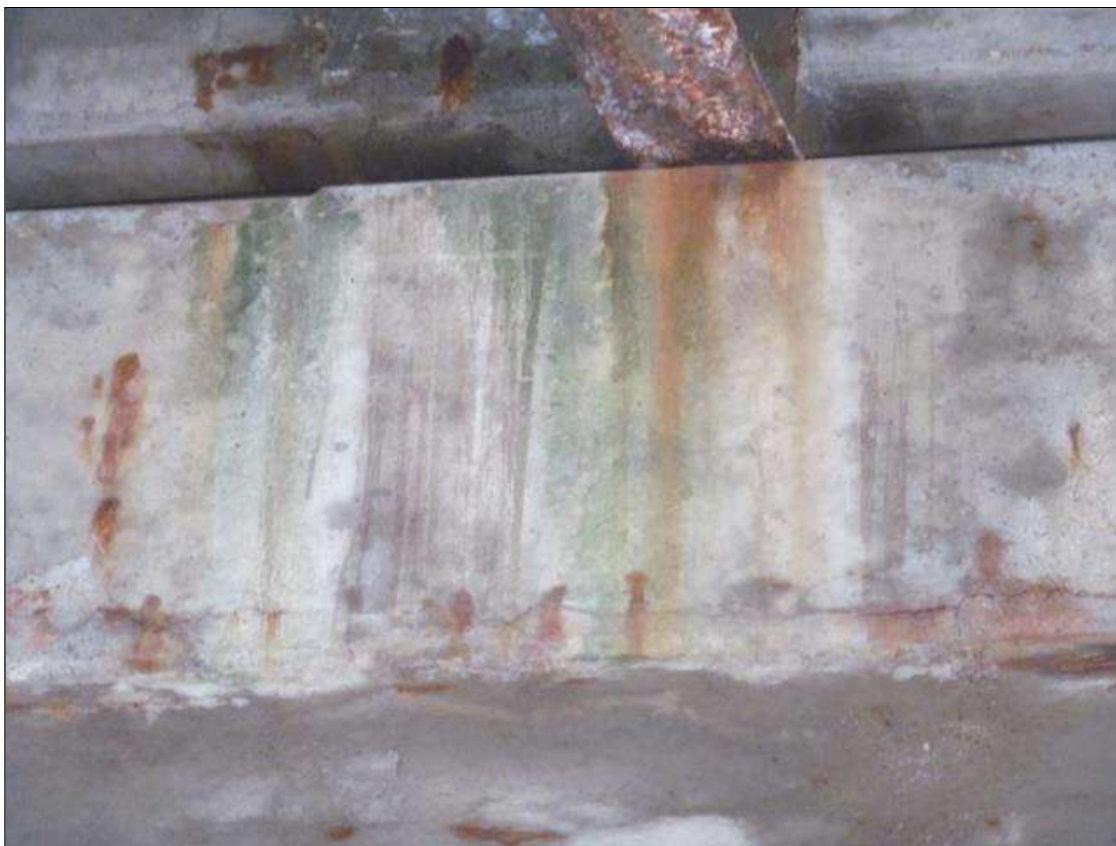
Bent 1 Cap 1: NORTH FACE, HORIZONTAL CRACKING UP TO 3/16"W WITH EFFLO AND RUST STAINING, SCATTERED.

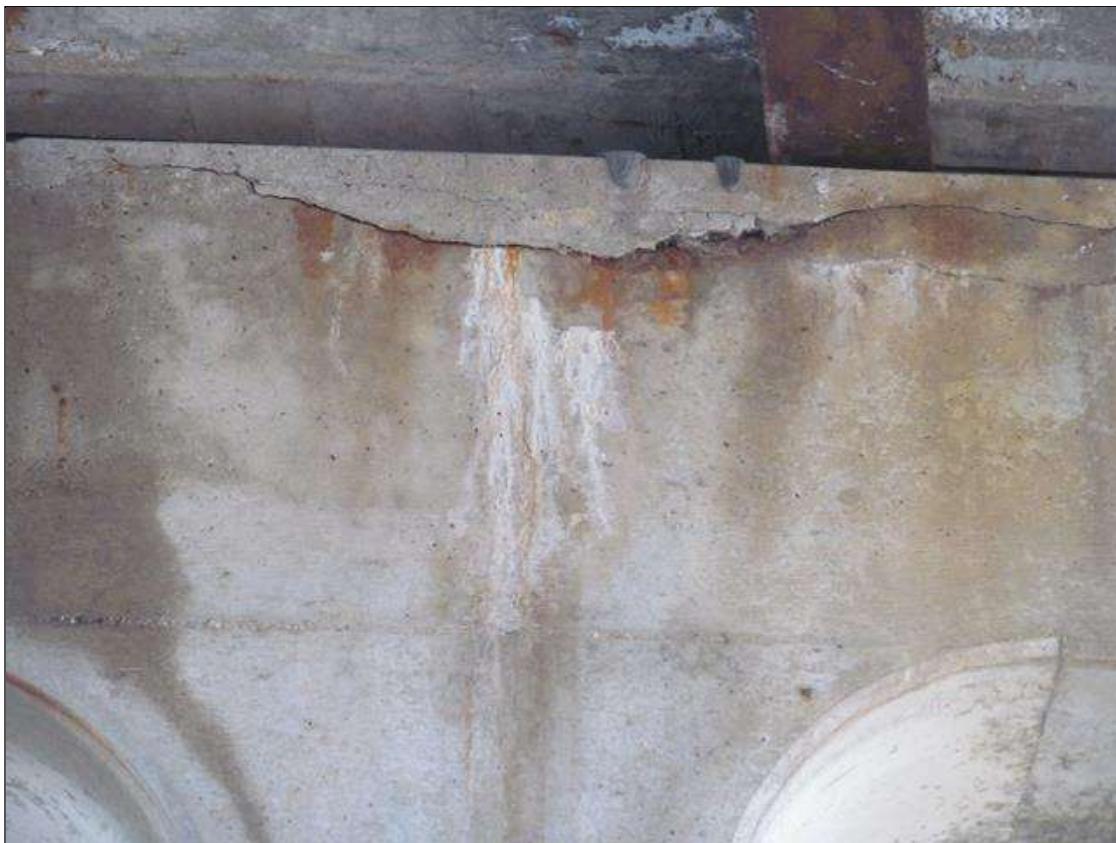
Bent 1 Cap 1: NORTH FACE, HORIZONTAL CRACKING UP TO 3/16"W WITH EFFLO AND RUST STAINING, SCATTERED.

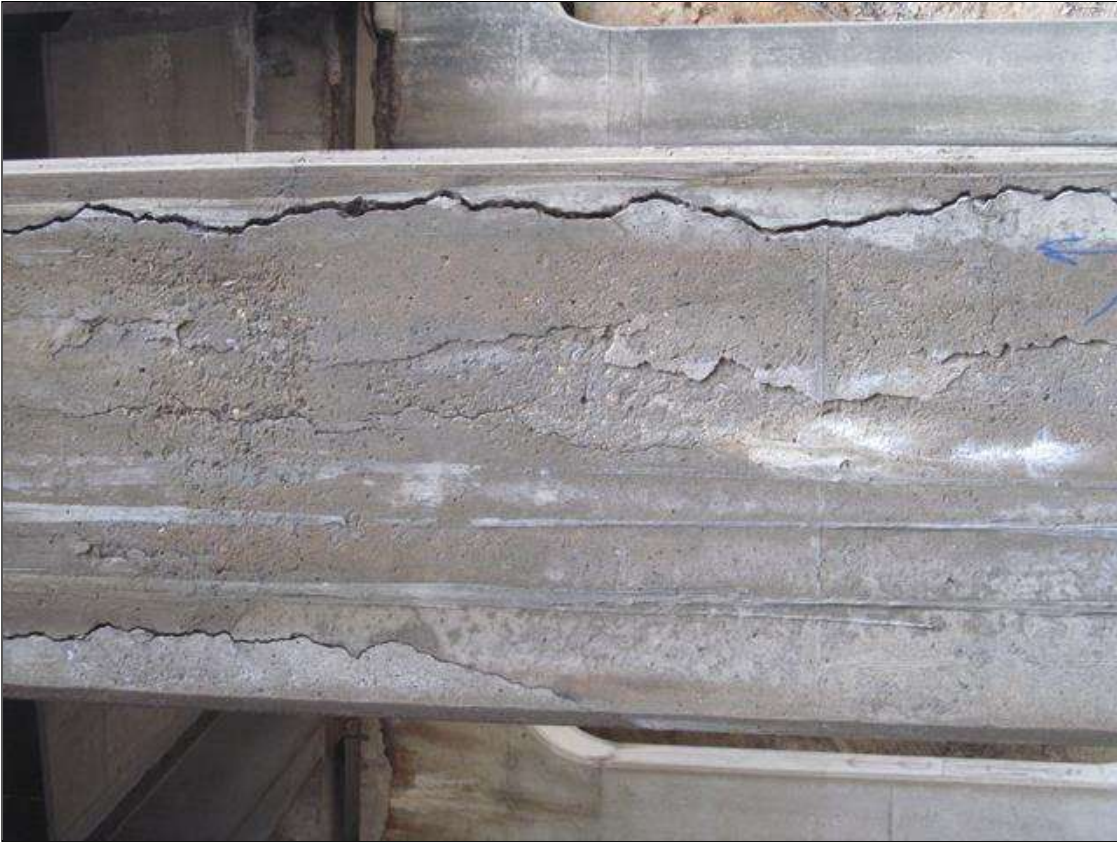
Bent 2 Pile 1: COLUMN CORNERS, VERTICAL CRACKING UP TO 3/8"W RUNS APPROX 3/4 OF THE HEIGHT. APPROX 5SQFT OF DELAM IS ADJACENT TO THE CRACKING.

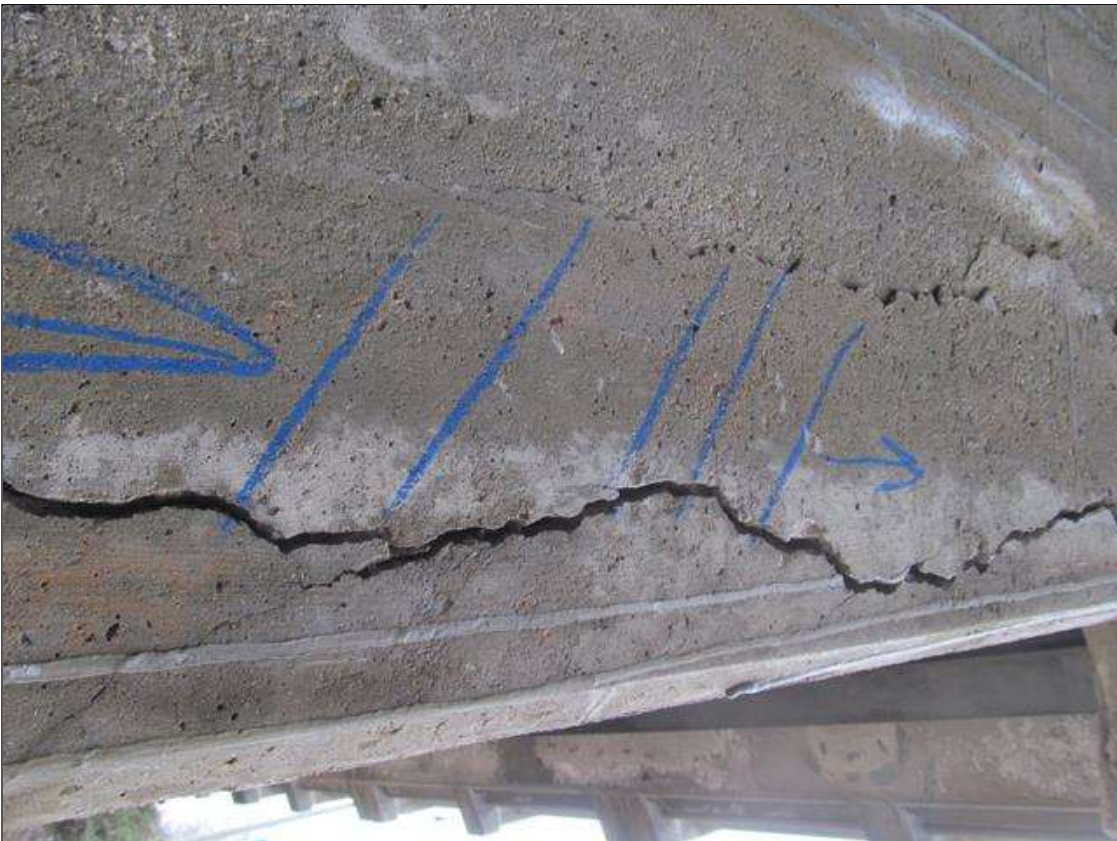
Bent 2 Pile 1: COLUMN CORNERS, VERTICAL CRACKING UP TO 3/8"W RUNS APPROX 3/4 OF THE HEIGHT. APPROX 5SQFT OF DELAM IS ADJACENT TO THE CRACKING.

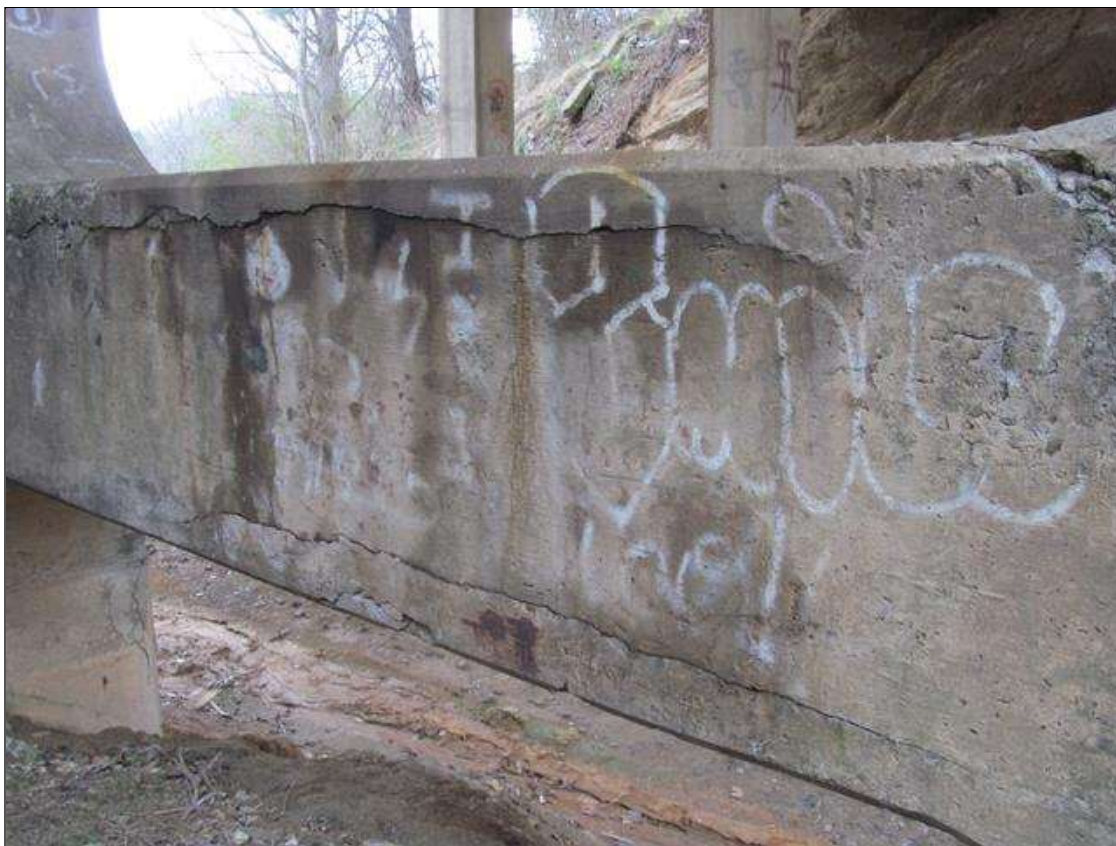
BENT 2, LOWER STRUTS HAVE HORIZONTAL CRACKING UP TO 1/4"W AT THE CORNERS.

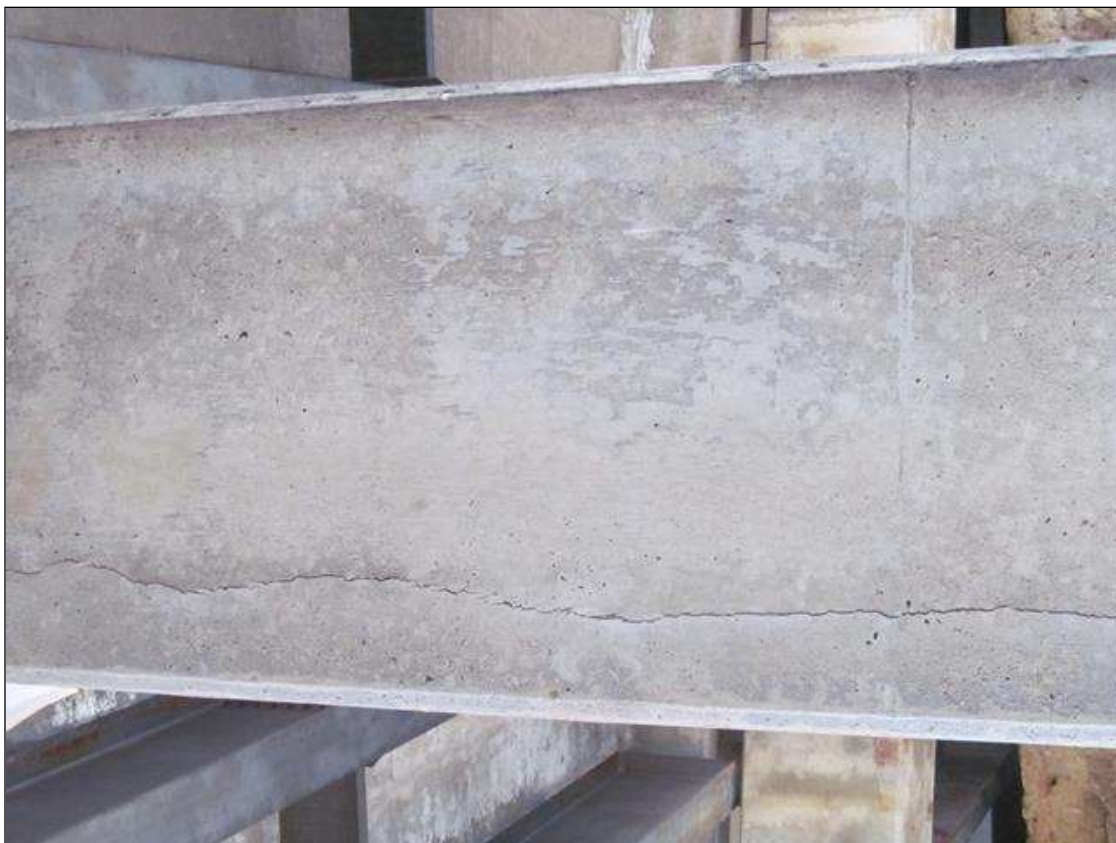
Bent 2 Pile 2: AT THE CORNERS, VERTICAL CRACKING UP TO 1/8"W, SCATTERED ALONG THE HEIGHT.

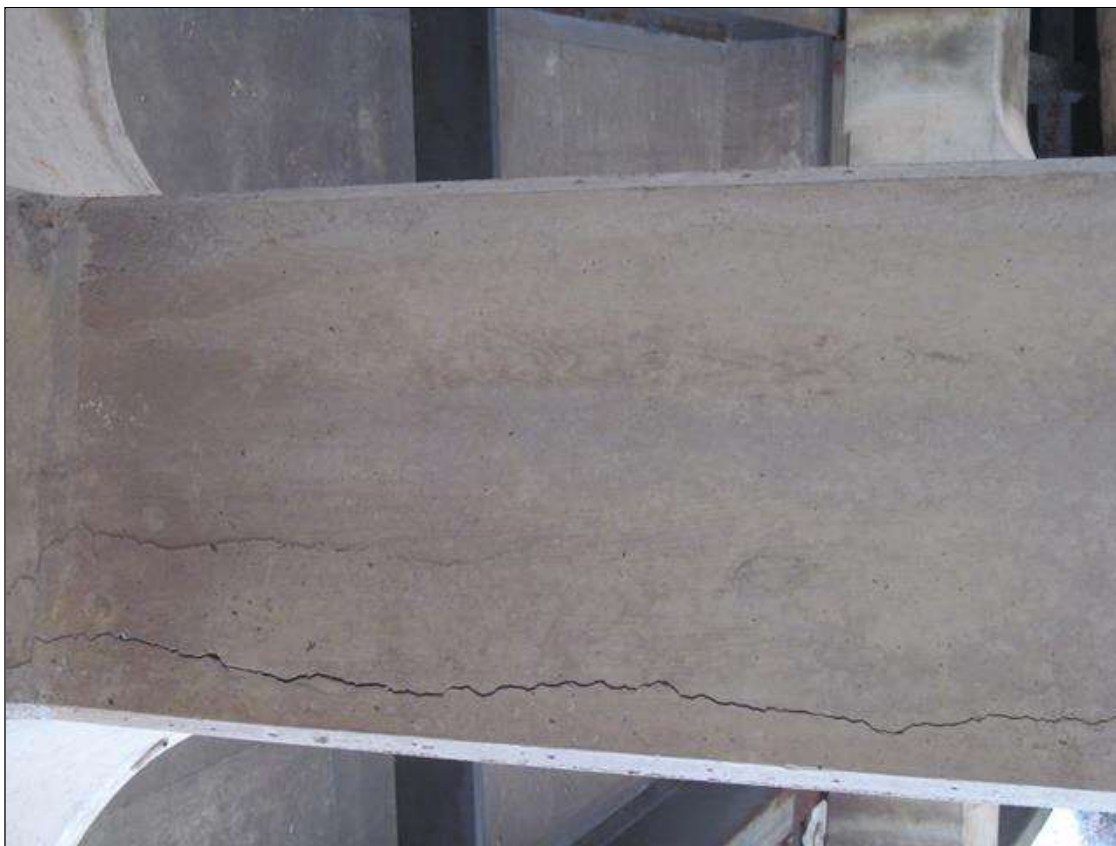
Bent 2 Pile 3: AT THE CORNERS, VERTICAL CRACKING UP TO 1/8"W, SCATTERED ALONG THE HEIGHT.
