NC DEPARTMENT OF TRANSPORTATION
 DIVISION OF HIGHWAYS
 STRUCTURE MANAGEMENT UNIT

ATTENTION: PRIORITY MAINT (CAP AND GR); DATA AND SKETCHES REVISED;

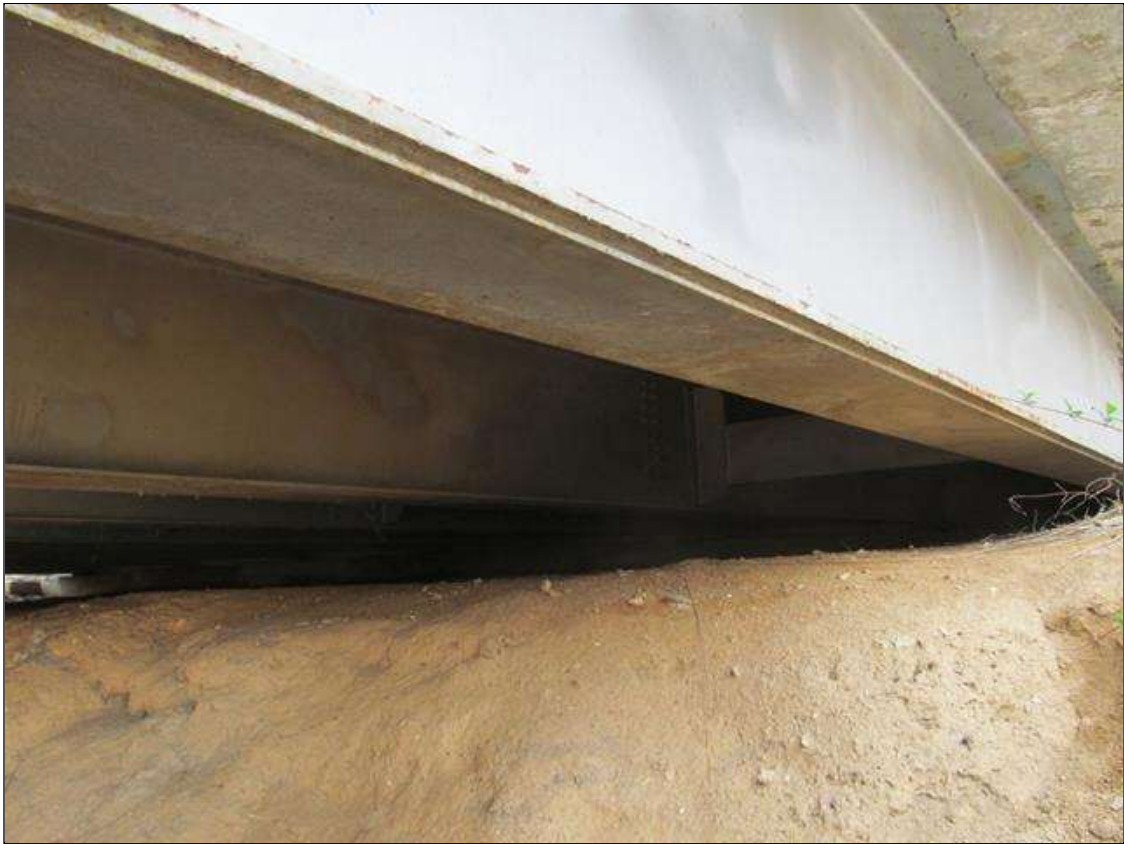
Bent 2 Pile 3: AT THE CORNERS, VERTICAL CRACKING UP TO 1/8"W, SCATTERED ALONG THE HEIGHT.

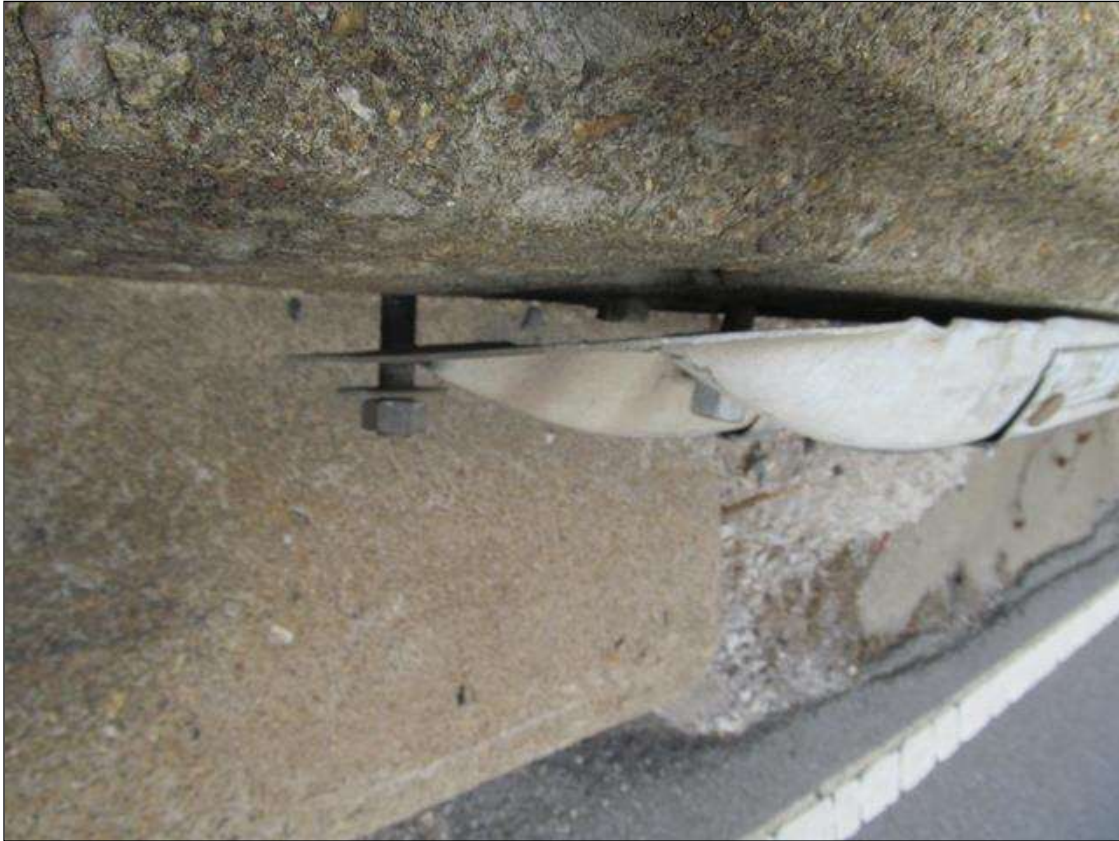
NW CORNER, GR CONNECTION BOLTS (FROM GTO STRUCTURE) ARE MISSING/LOOSE

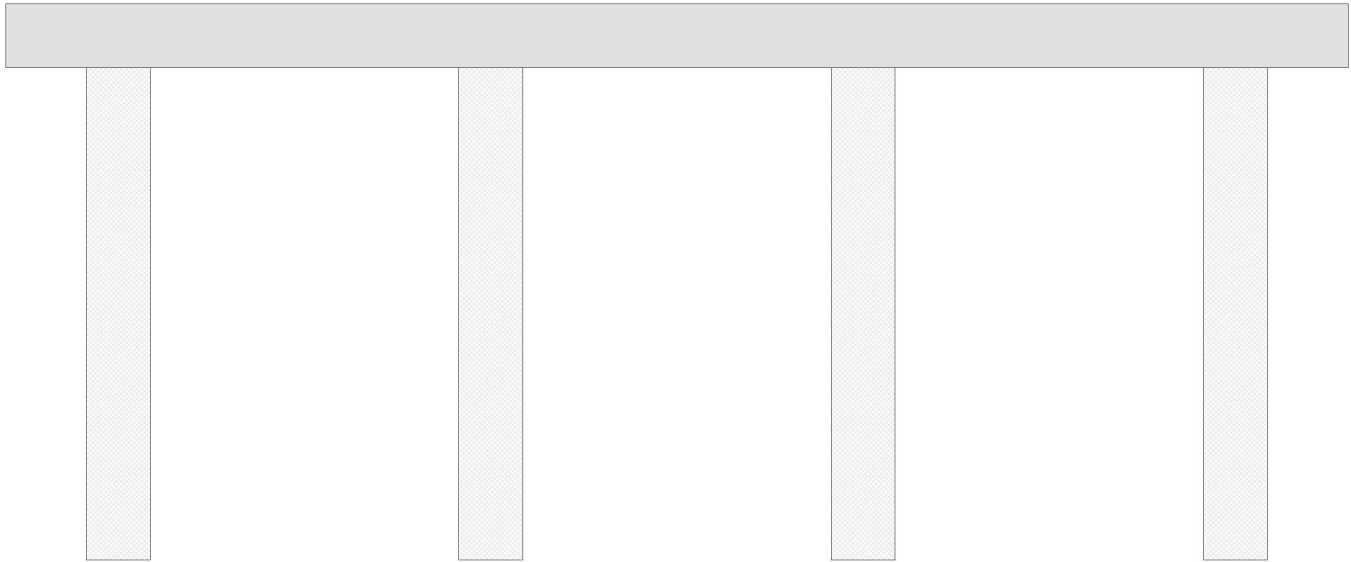
Cap Information			Material Cast-in-Place Concrete							
Length	Width	Height	Left Overhang	Right Overhang	Left Beam to End of Cap.	Right Beam to End of Cap.				
57.667 ft.	2.750 ft.	2.750 ft.	4.830 ft.	4.830 ft.	1.417 ft.	1.417 ft.				
Subcap Information			Material							
Length	Width	Height	Left Overhang	Right Overhang	Left Pile to Splice.					
Sill Information			Material							
Length	Width	Height								
Pile #	Material	Spacing	Width/Dia.	Height	Length	Orientation	Driven?	Replacement?	Removed?	Collar?
1	Concrete	16 ft.	2.75 ft.	2.75 ft.		Vertical	No	No	No	No
2	Concrete	16 ft.	2.75 ft.	2.75 ft.		Vertical	No	No	No	No
3	Concrete	16 ft.	2.75 ft.	2.75 ft.		Vertical	No	No	No	No
4	Concrete		2.75 ft.	2.75 ft.		Vertical	No	No	No	No
Bent/Abutment #: 1			Similar Bents: 2
