NC DEPARTMENT OF TRANSPORTATION
 DIVISION OF HIGHWAYS
 STRUCTURE MANAGEMENT UNIT

ATTENTION: **PRIORITY MAINTENANCE, SHORED**

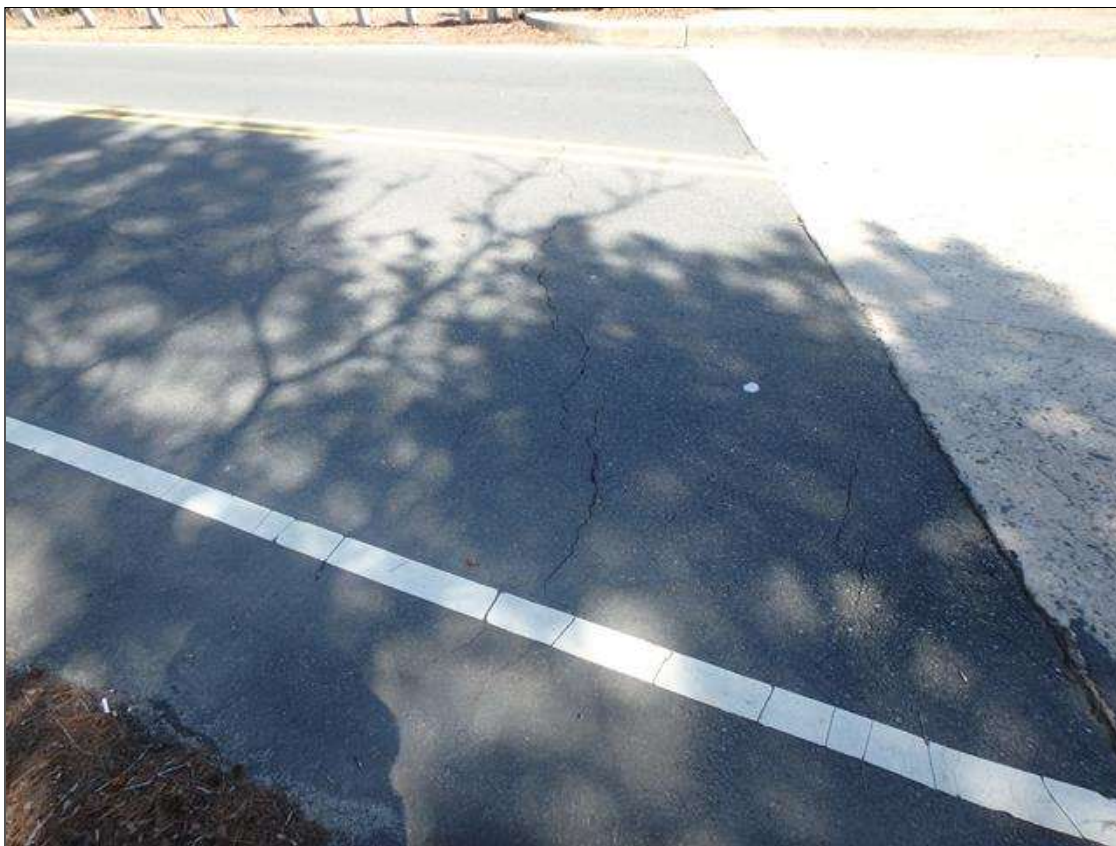
West Approach pavement at bridge has transverse cracks up to 1/8" wide, full width of roadway.

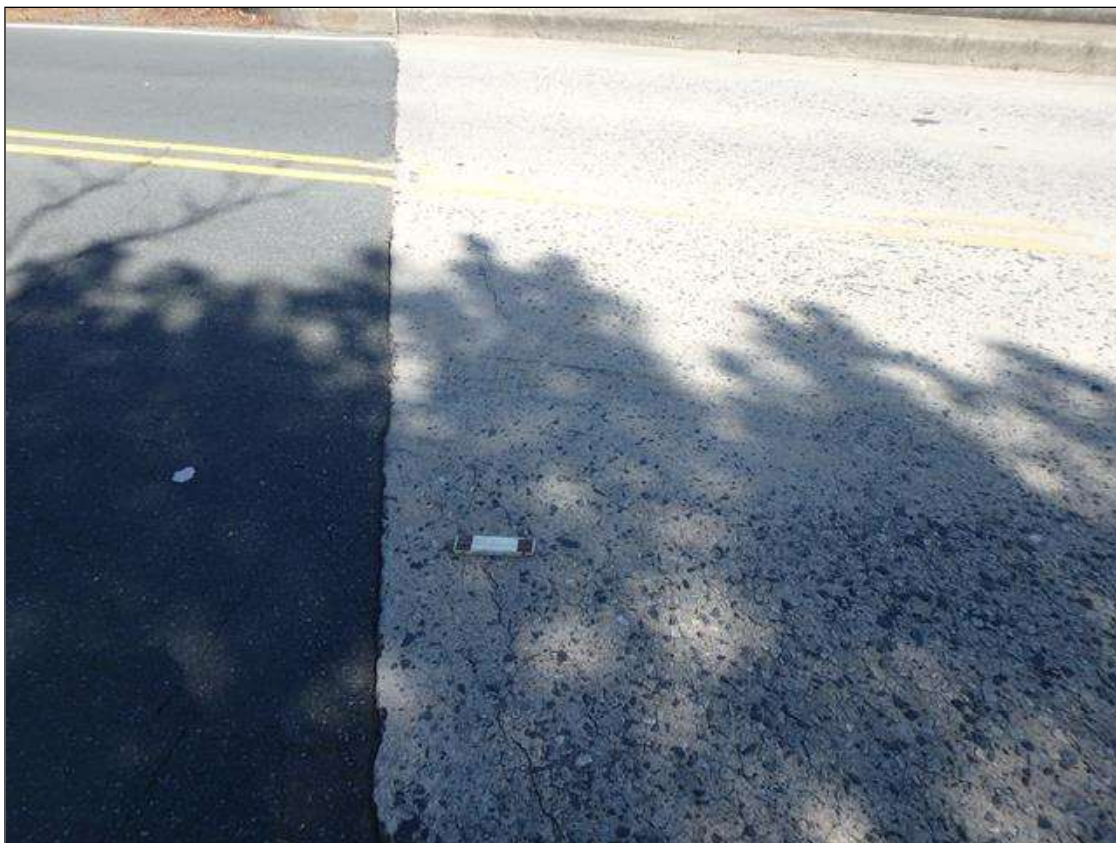
Span 1 RC Deck surface near End Bent 1 has transverse cracks 1/16" wide, abrasion/wear with coarse aggregate exposed and intact in the concrete.

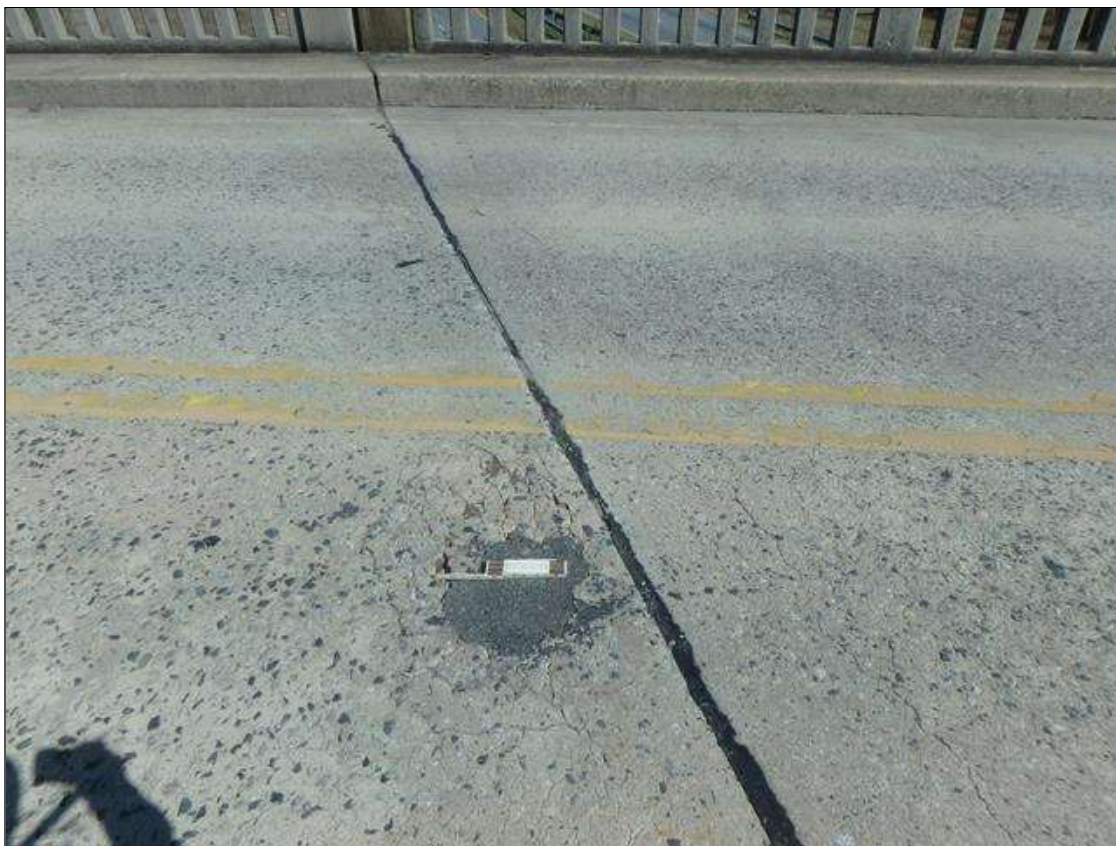
Span 1 Deck surface at Bent 1 joint near c/l, sound patch and spall with alligator cracks, loose concrete.

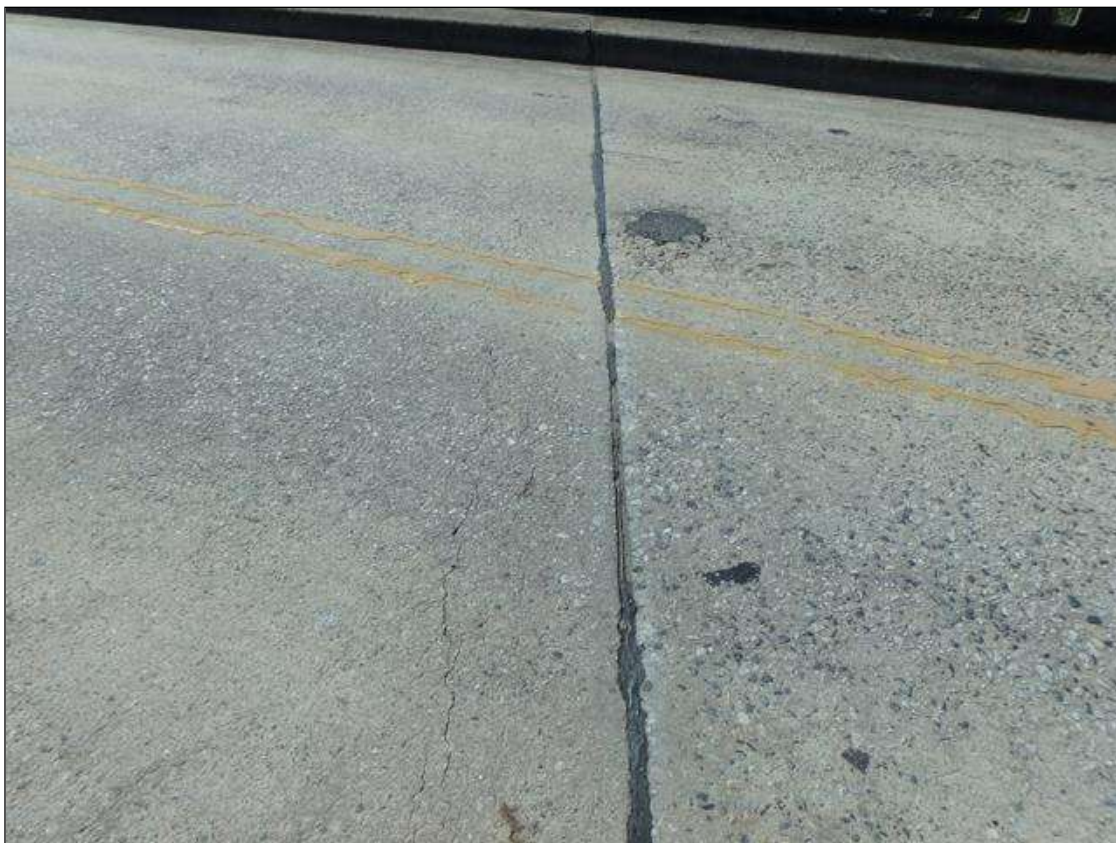
Bent 1 joint pourable seal pulled out exposing backer material near c/l and at curbs.

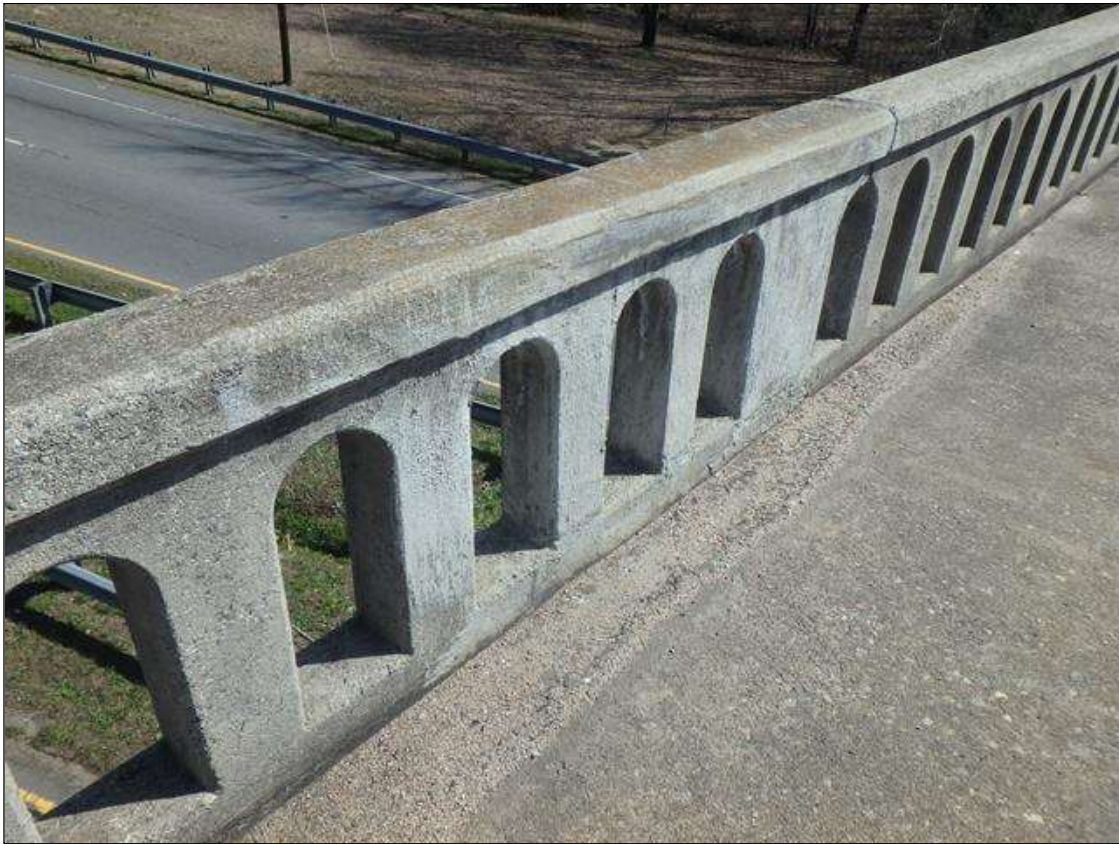
Span 2 left RC rail near mid-Span, sound repair.

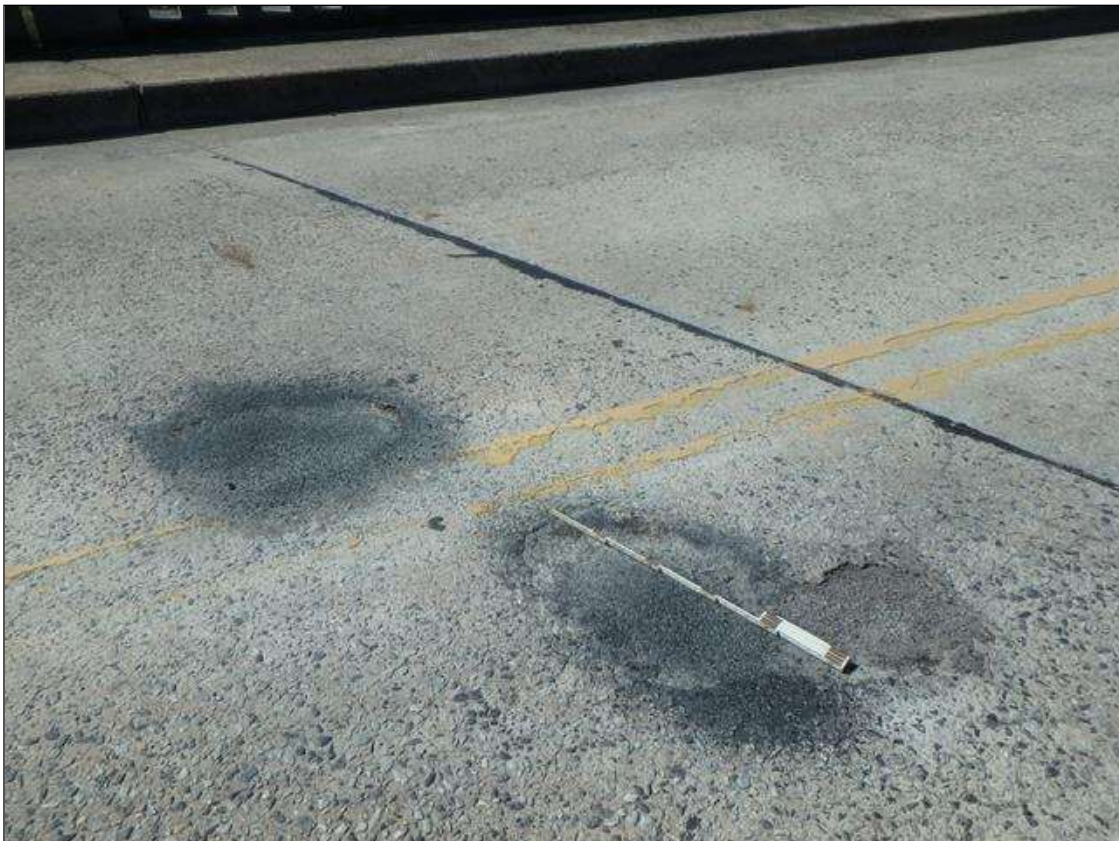
Span 3 Deck surface near Bent 2 joint at c/l, (2) sound patches to spalls.

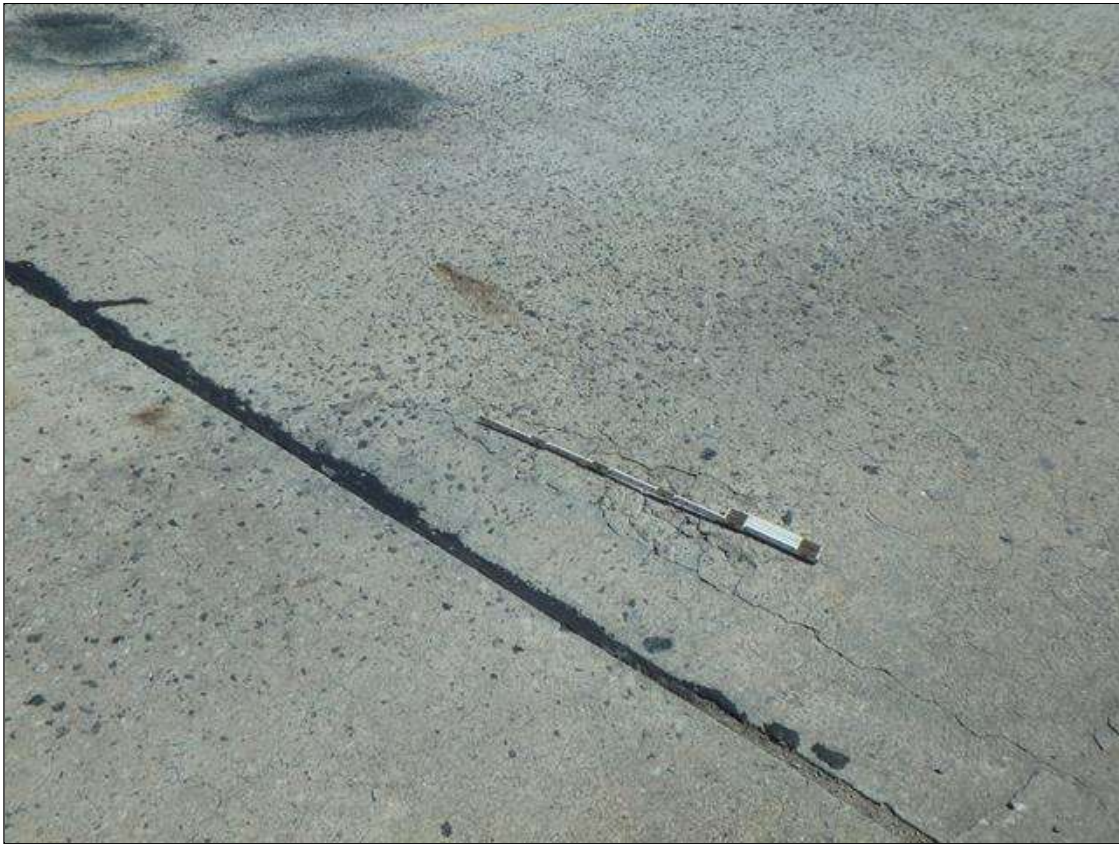
Span 3 Deck surface at Bent 2 joint near right curb, 1/16" cracks and Delamination.

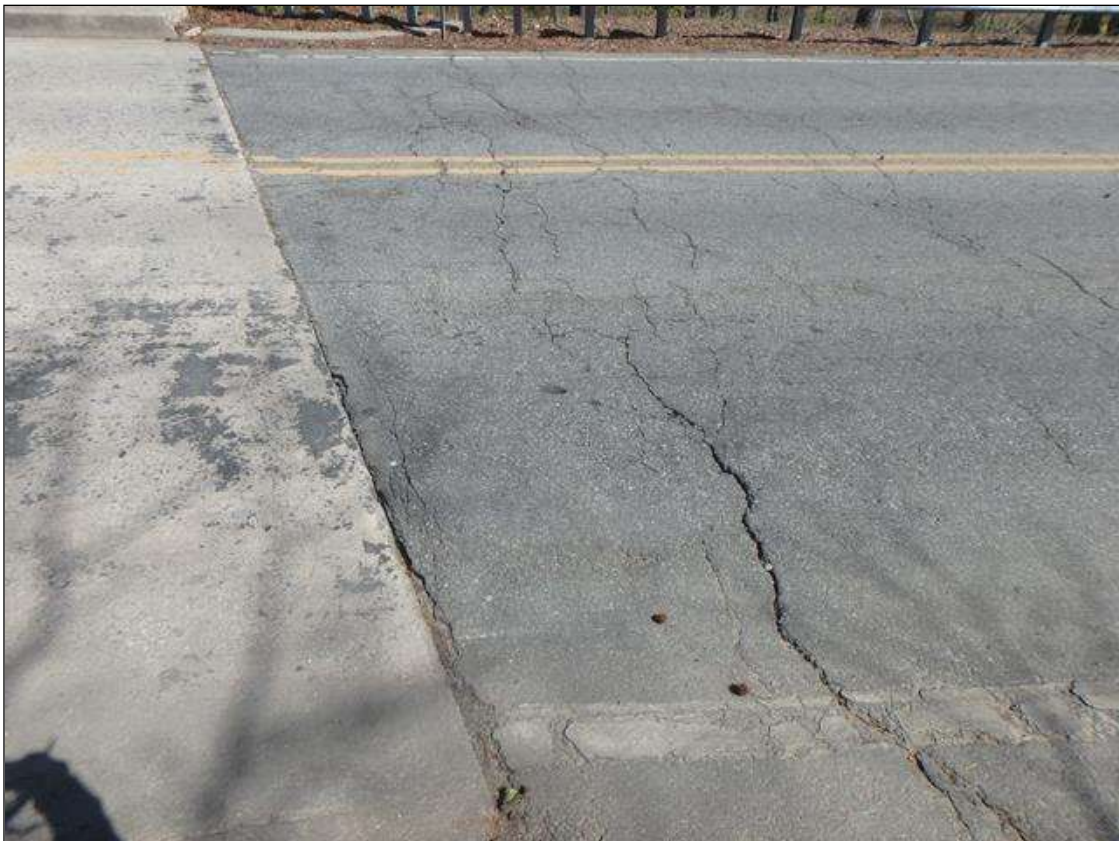
East Approach Pavement at bridge settled up to 1" with transverse cracks 1/8" to 1/2" wide.

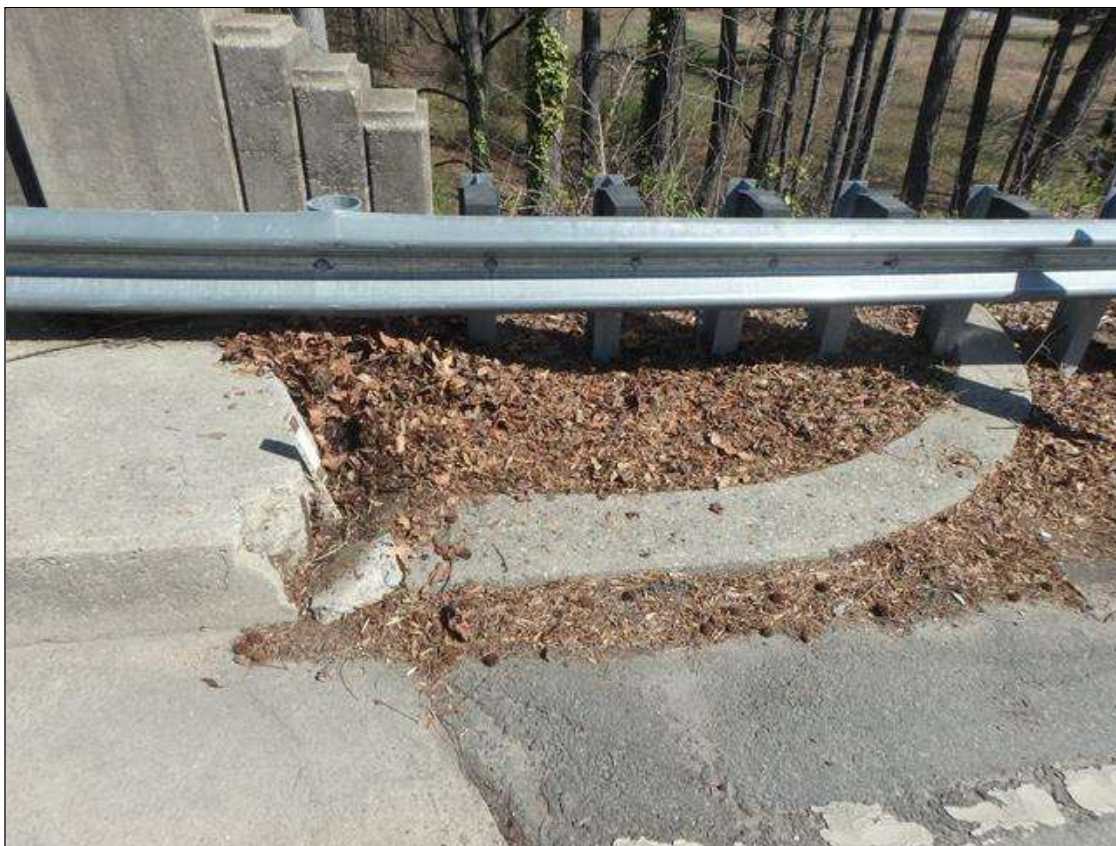
left RC sidewalk at End Bent 2, Spall with Exposed Steel, curb flare at Northeast Corner settled 8".

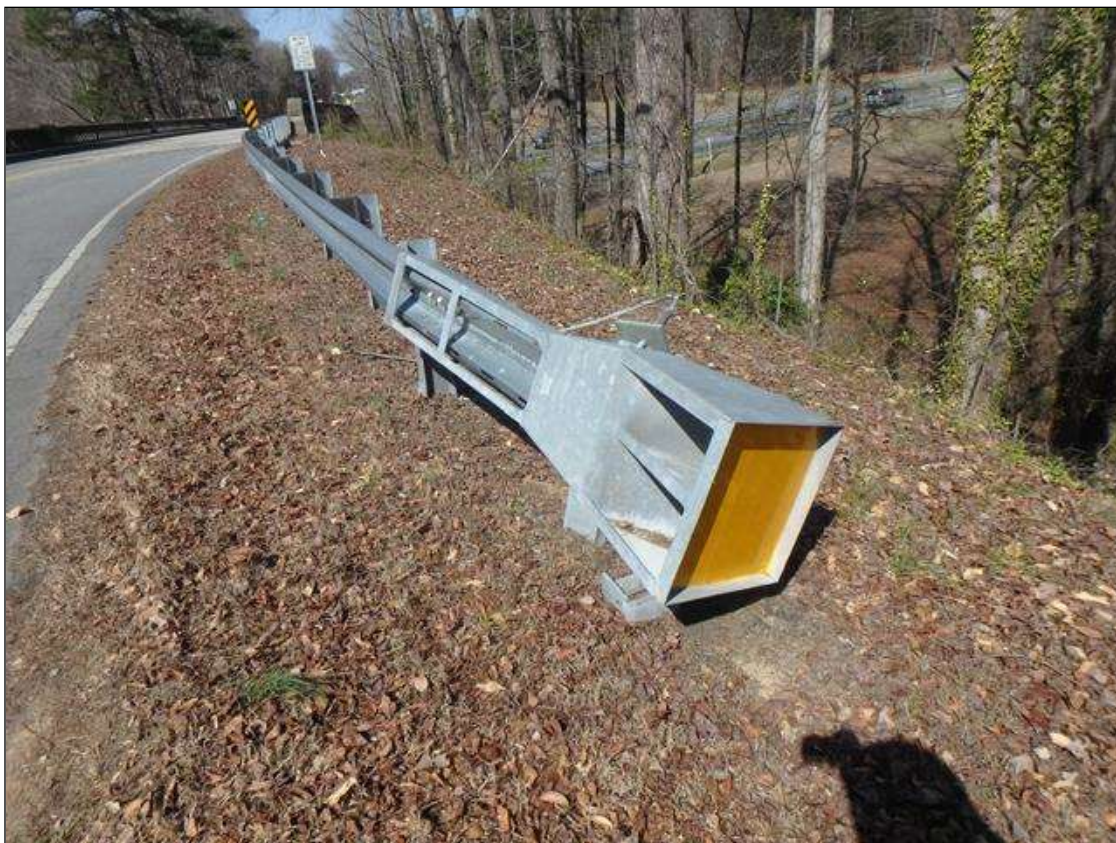
PRIORITY MAINTENANCE: Guardrail end treatment at Northeast Corner has impact damage: cable disconnected, end treatment pushed and leaning over 1'.

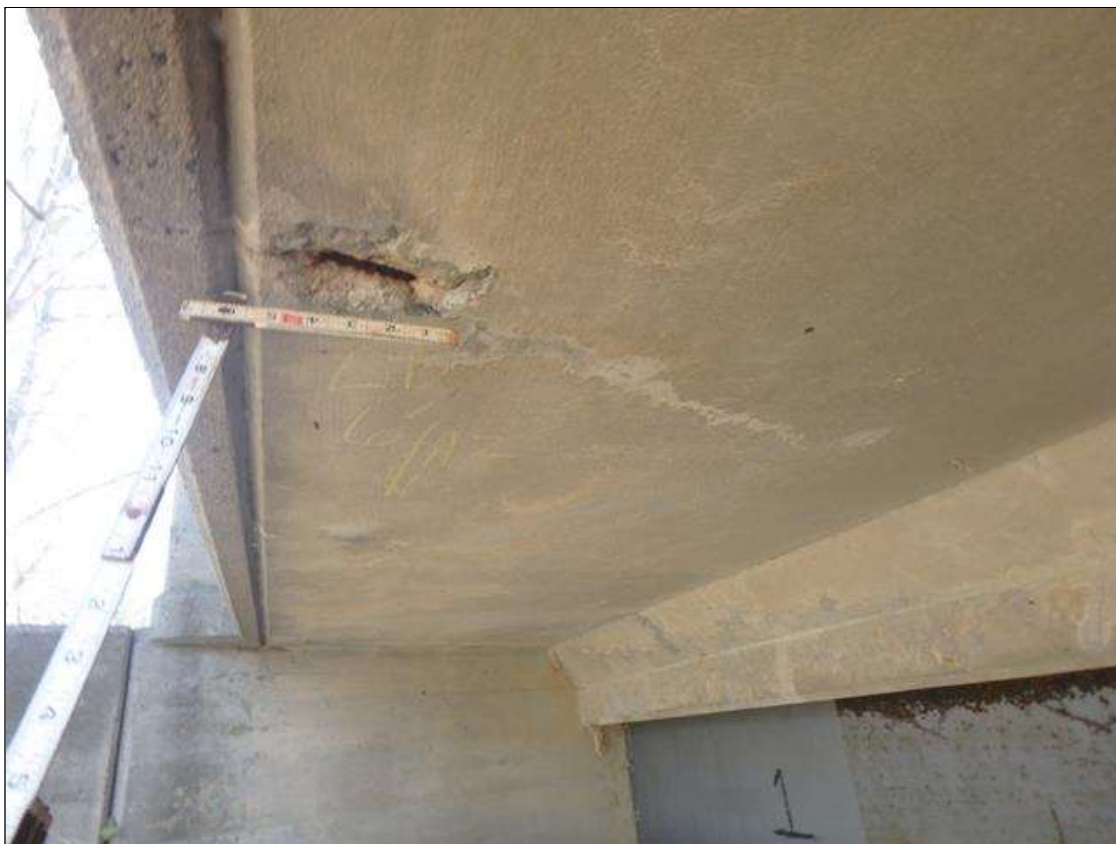
Span 4 Deck underside left overhang 6' from End Bent 2, Spall with Exposed Steel.

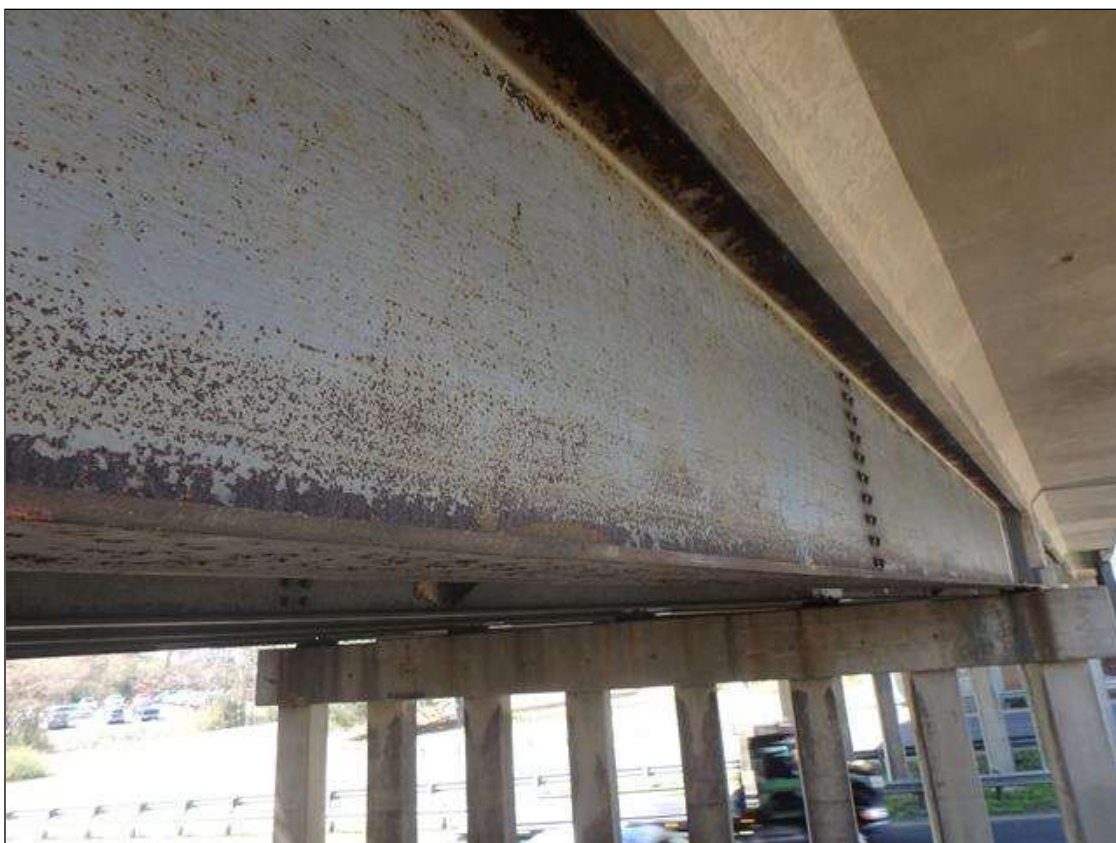
Span 4 Beam 1 Surface Corrosion and peeling paint along length of beam.

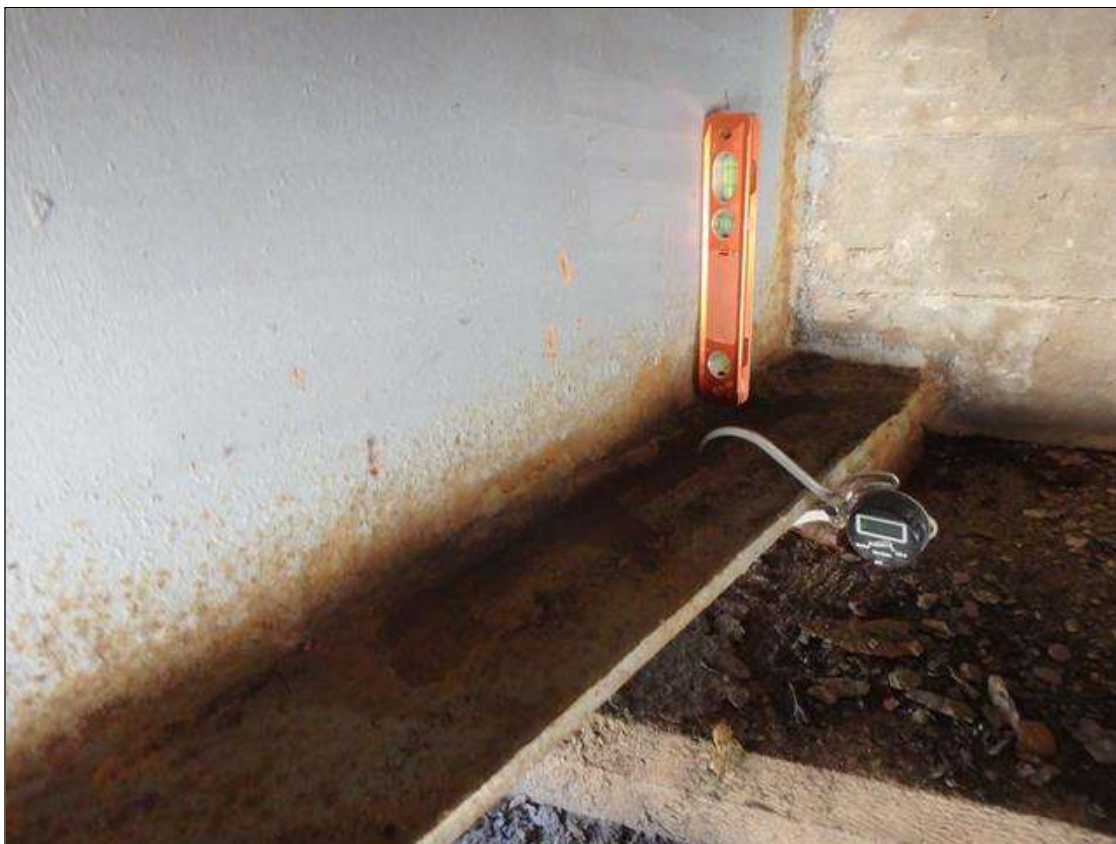
PRIORITY MAINTENANCE: Span 4 Beam 1 right side at End Bent 2, bottom flange has Active Corrosion and scale with Section Loss, Lower web has Section Loss with corrosion initiated.

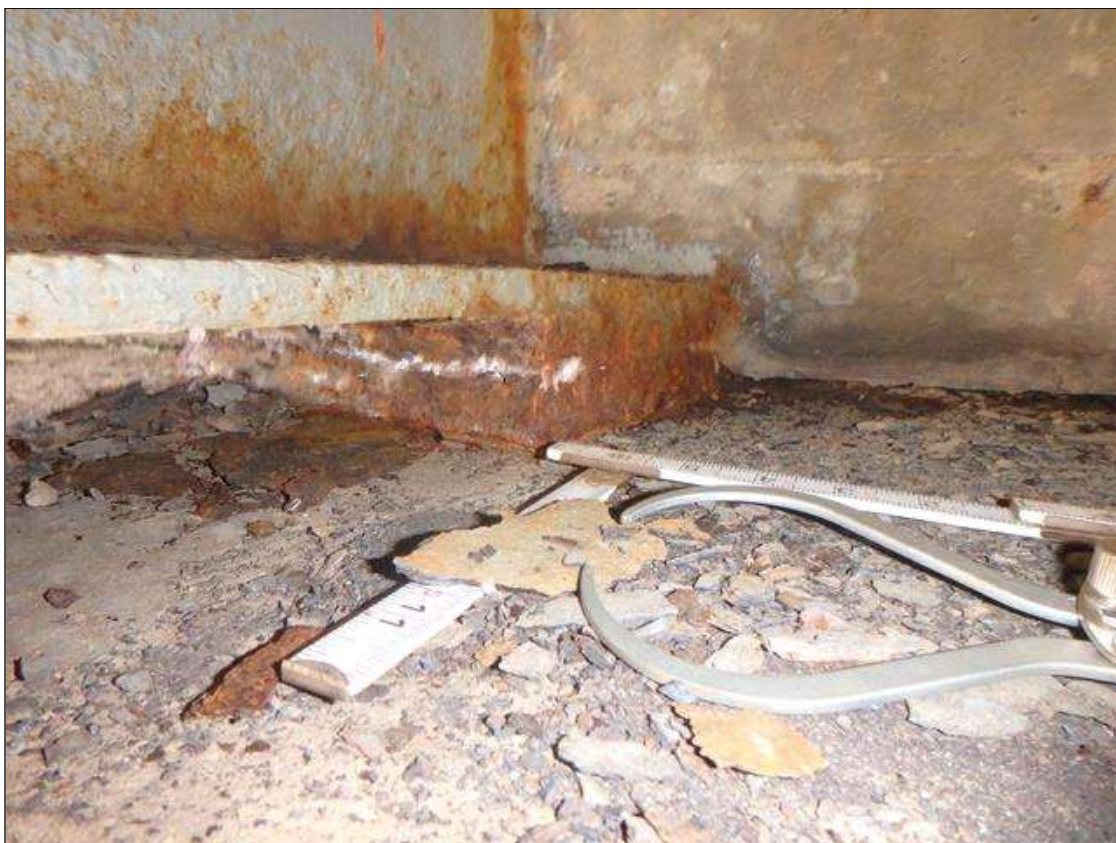
Span 4 Bearing Assembly seat 1 at End Bent 2: Active Corrosion and Section Loss <25% in the plates.

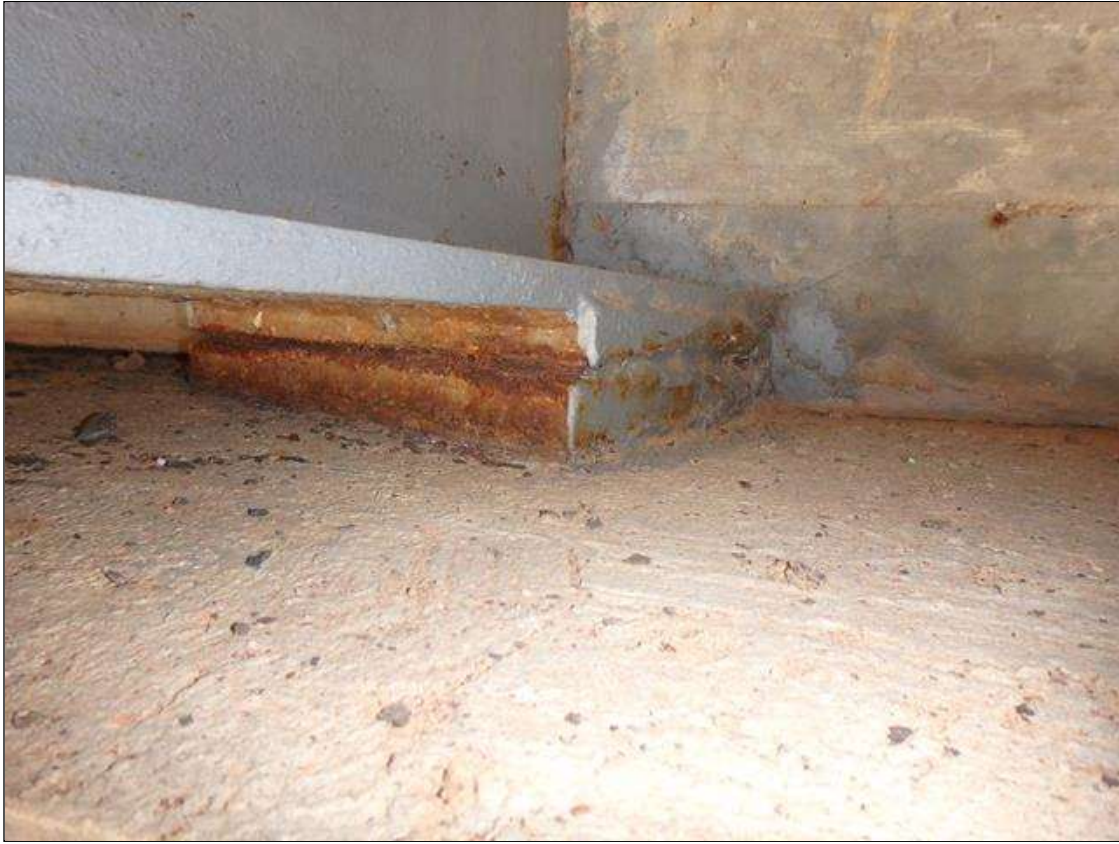
Span 4 Bearing Assembly seat 2 at End Bent 2: Active Corrosion and Section Loss <25% in the plates.

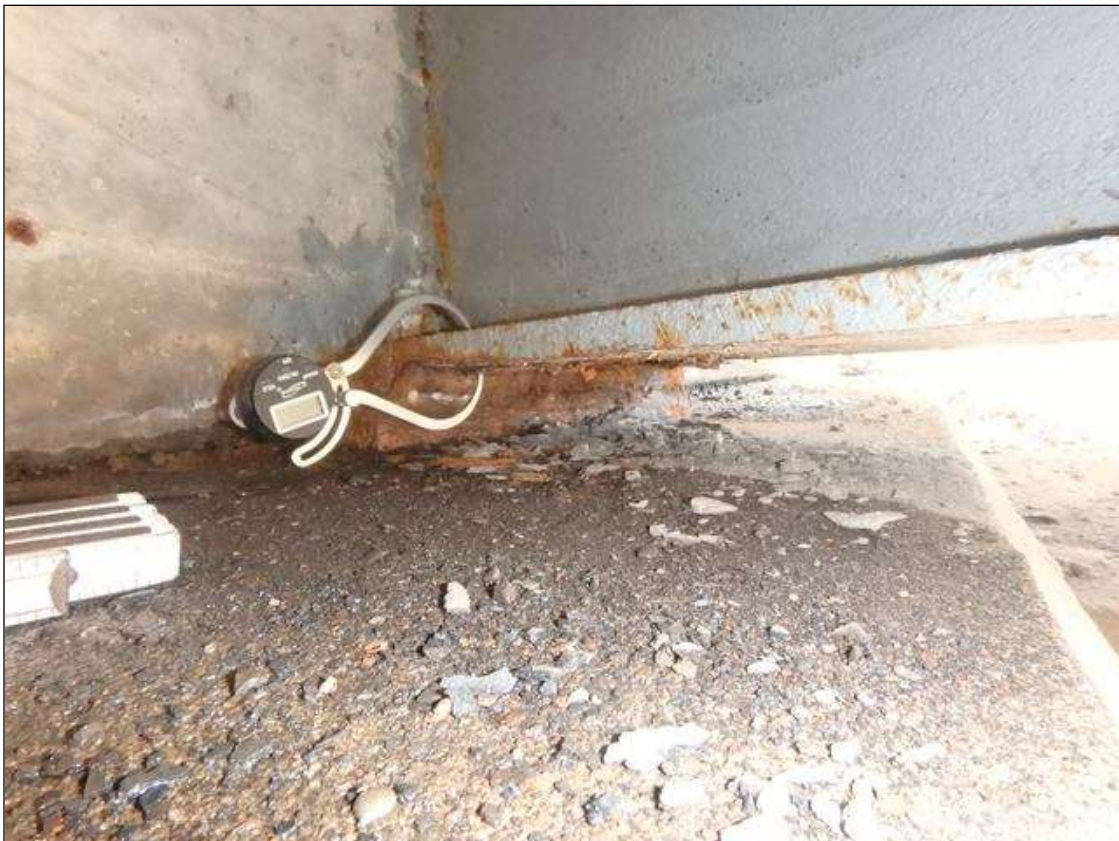
PRIORITY MAINTENANCE: Span 4 Beam 5 at End Bent 2, bottom flange in front of bearing, Active Corrosion and Section Loss.

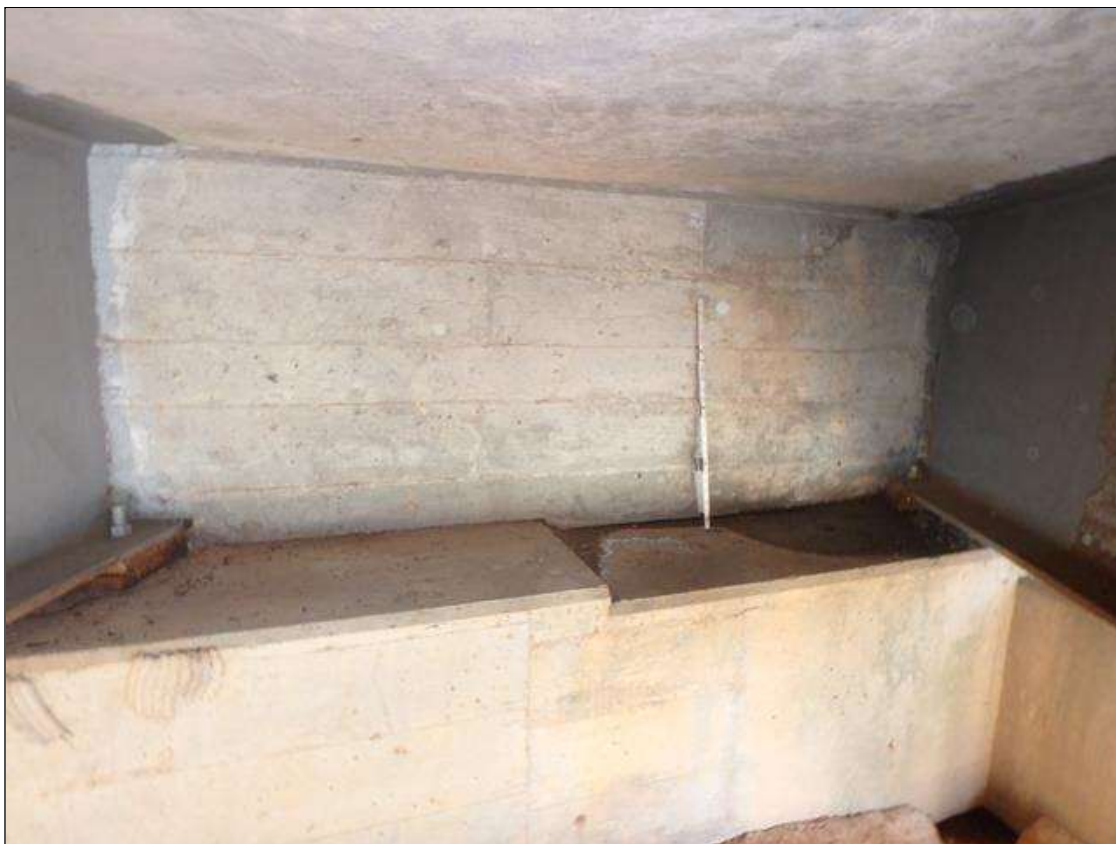
Abutment 2 in bay 4, 1/32" cracks.

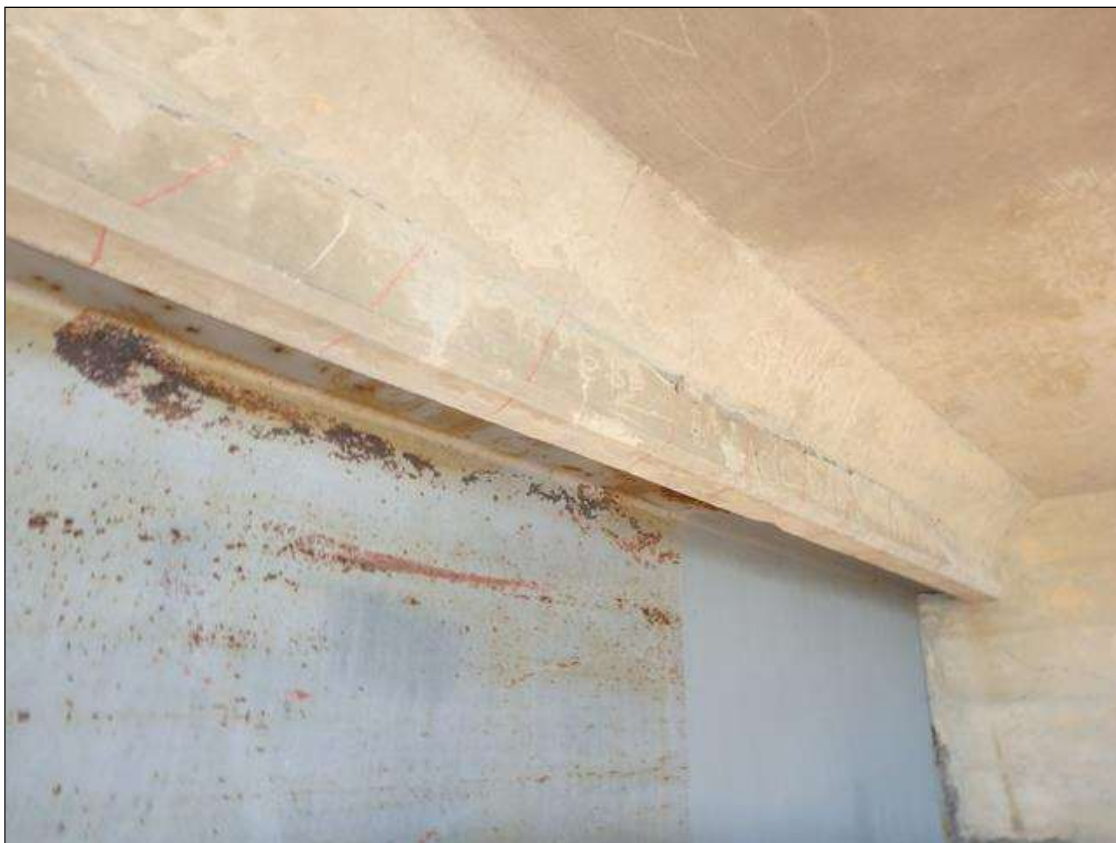
Span 4 Deck underside in right overhang, beginning at End Bent 2, Delamination in build-up adjacent to beam 5.

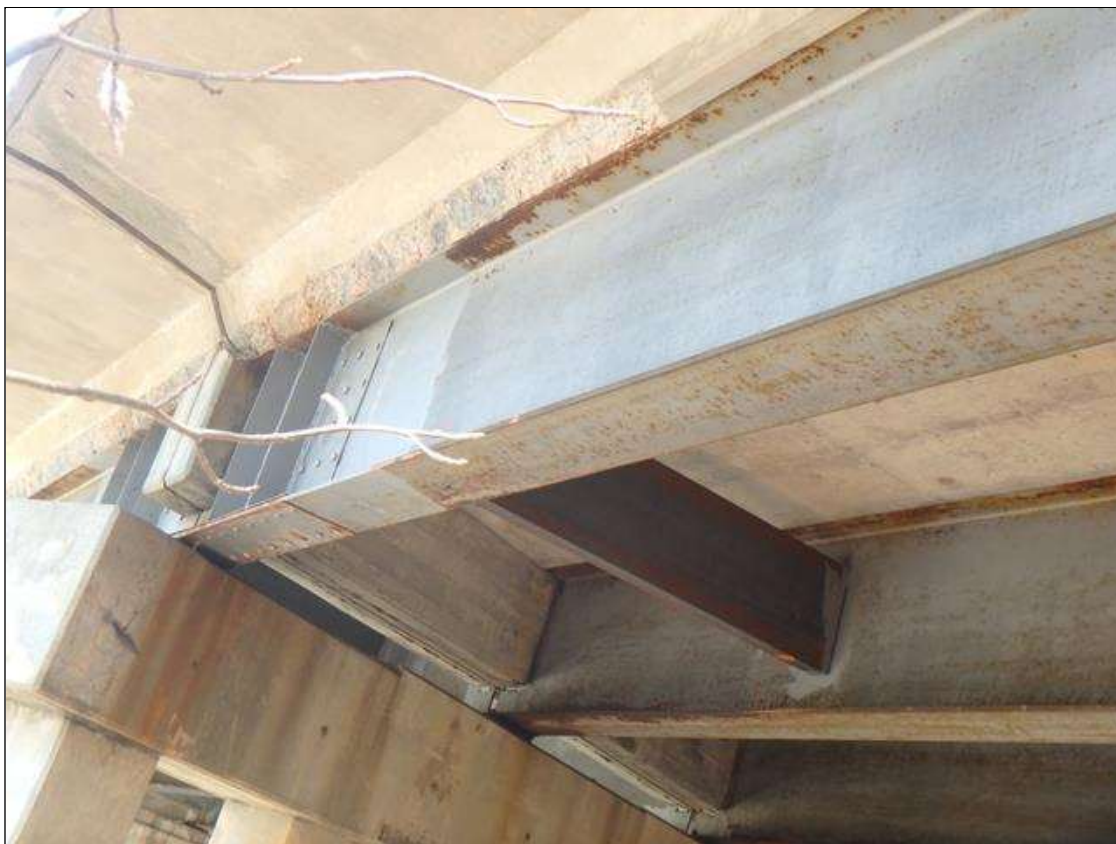
Span 4 Deck underside in right overhang, beginning at Bent 3, spall in build-up adjacent to beam 5.

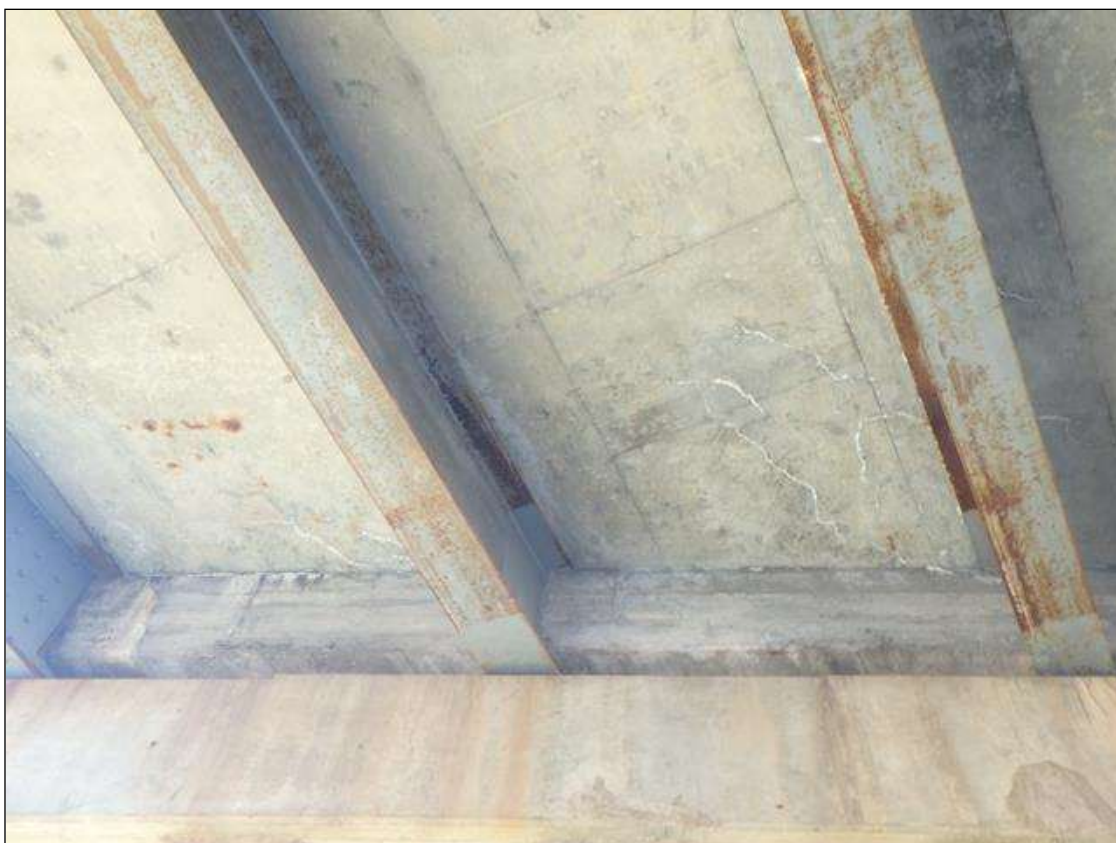
Span 3 Deck underside at Bent 2, 1/32" map cracks with surface efflorescence in bays 2 thru 4.

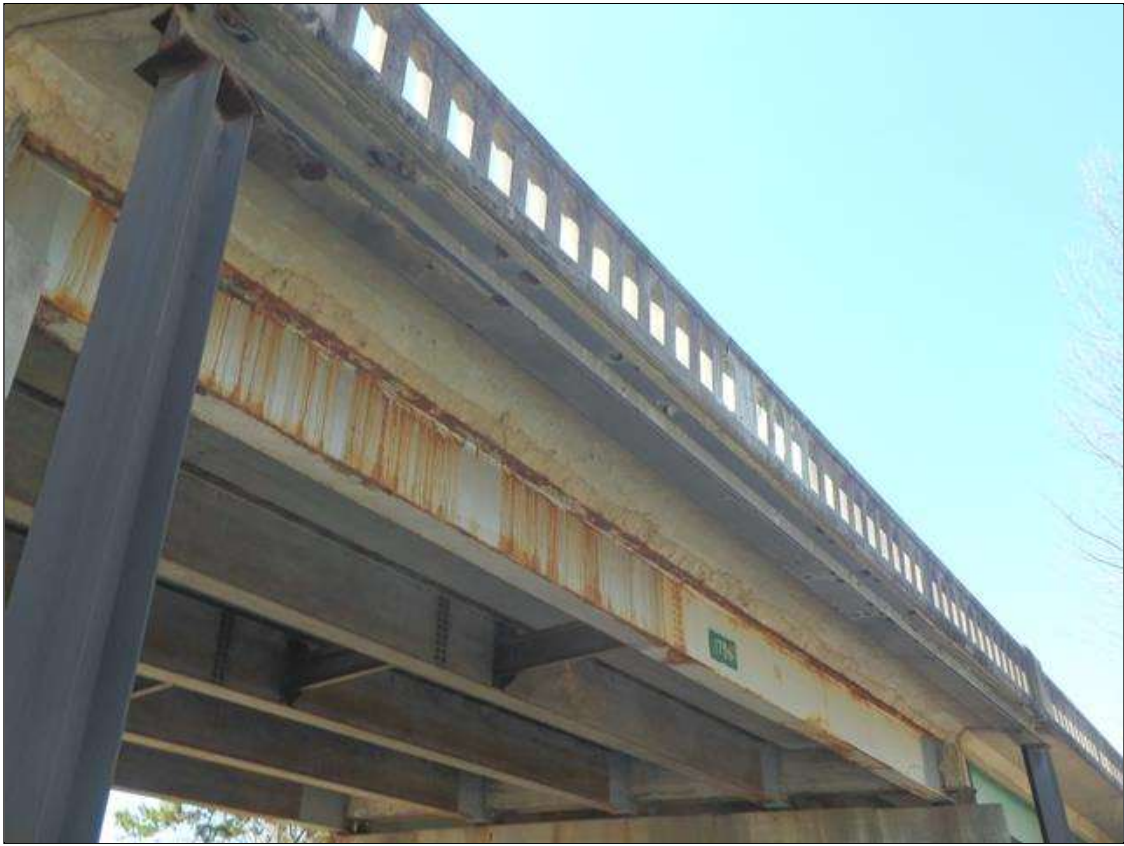
Temporary Repair: Span 2 Deck left overhang supported by steel H-Pile crutch from bents 1 to 2.

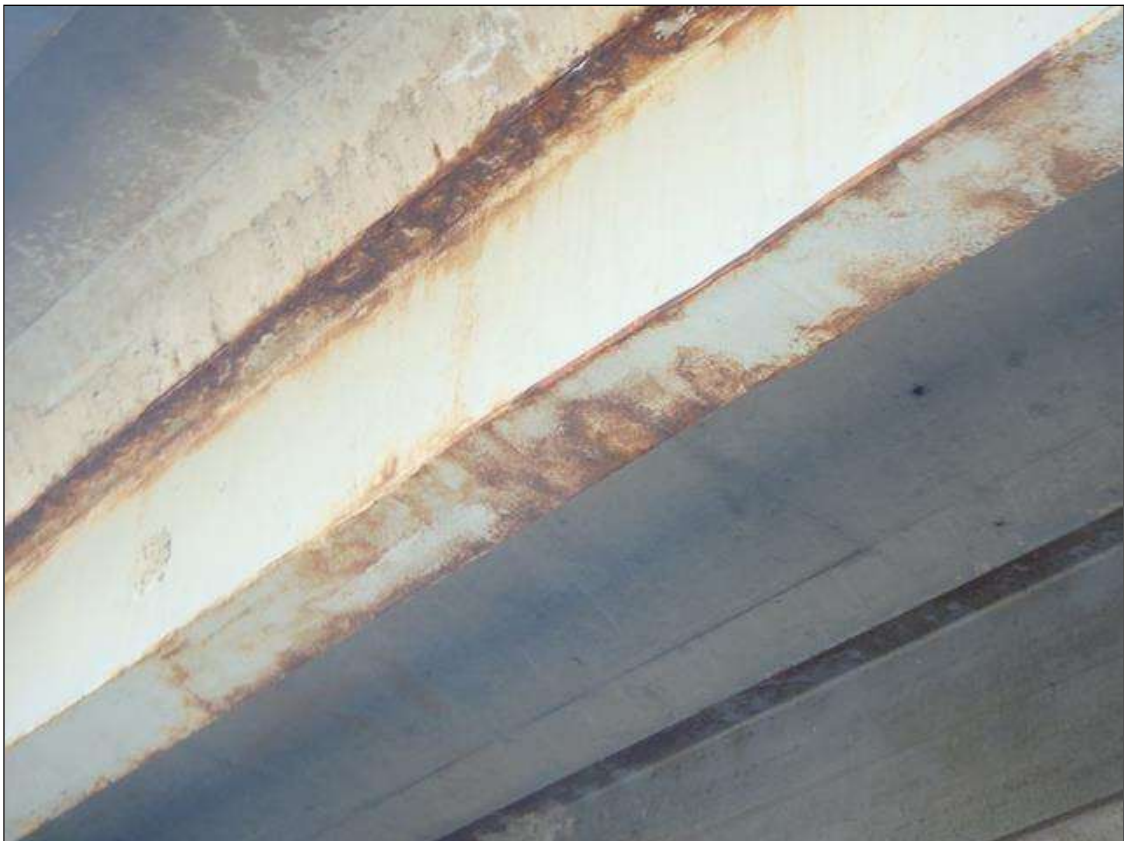
Span 2 Beam 1 above Right South bound lane, impact damage previously straightened/repaired.

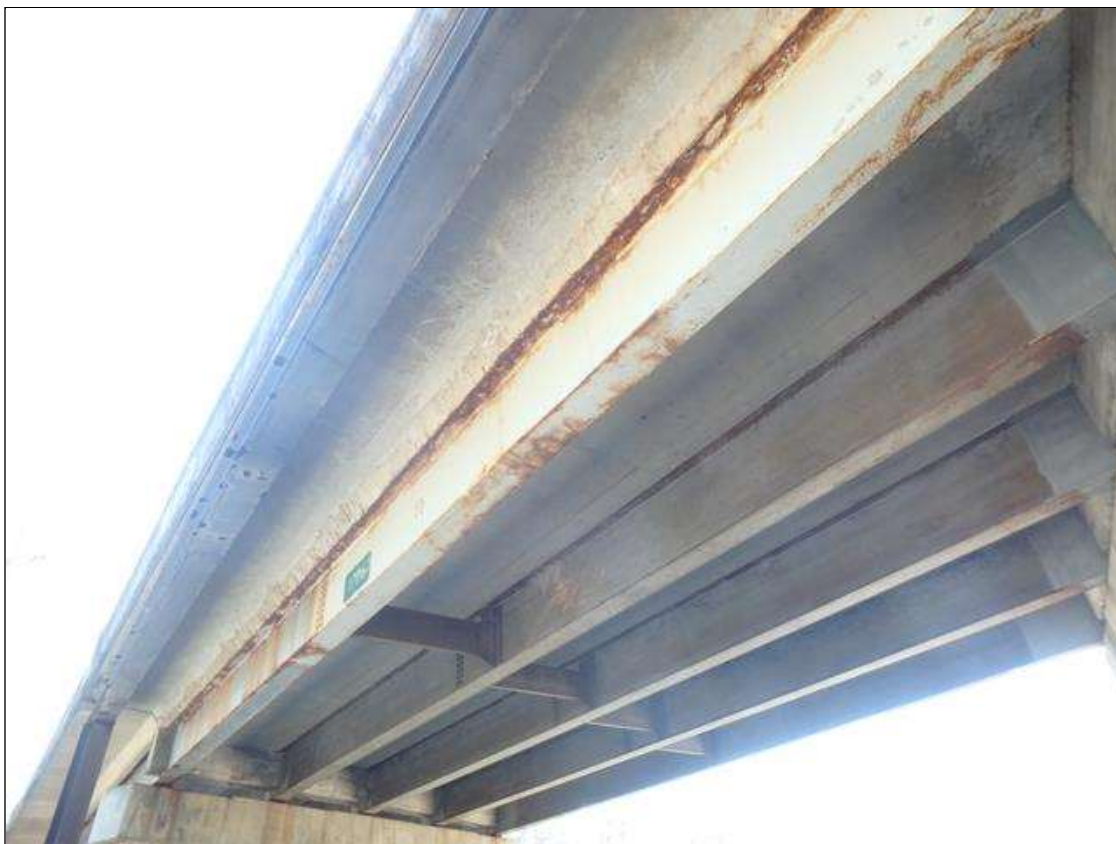
Span 2 Beam 1 above Right South bound lane, impact damage previously straightened/repared.

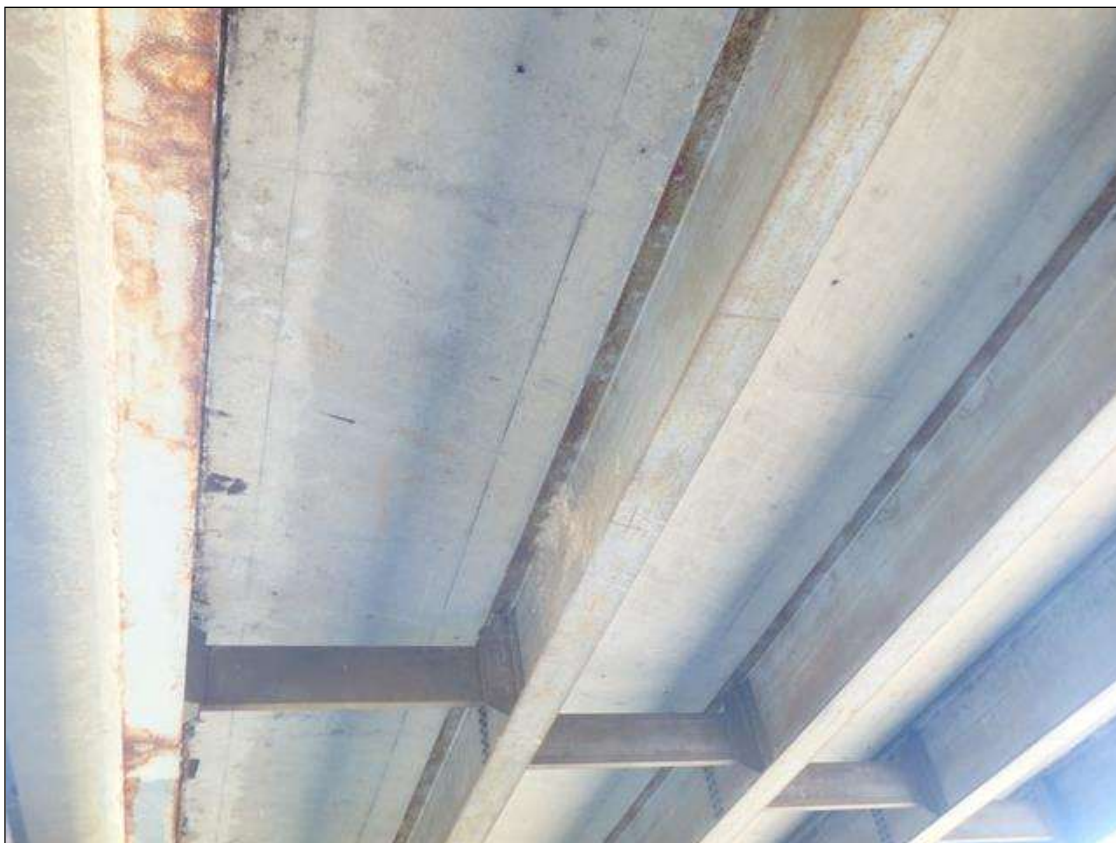
Span 2 Beam 2 above Right South Bound lane, impact scrapes to bottom flange.
