NC DEPARTMENT OF TRANSPORTATION
 DIVISION OF HIGHWAYS
 STRUCTURE MANAGEMENT UNIT

ATTENTION: **PRIORITY MAINTENANCE, SHORED**

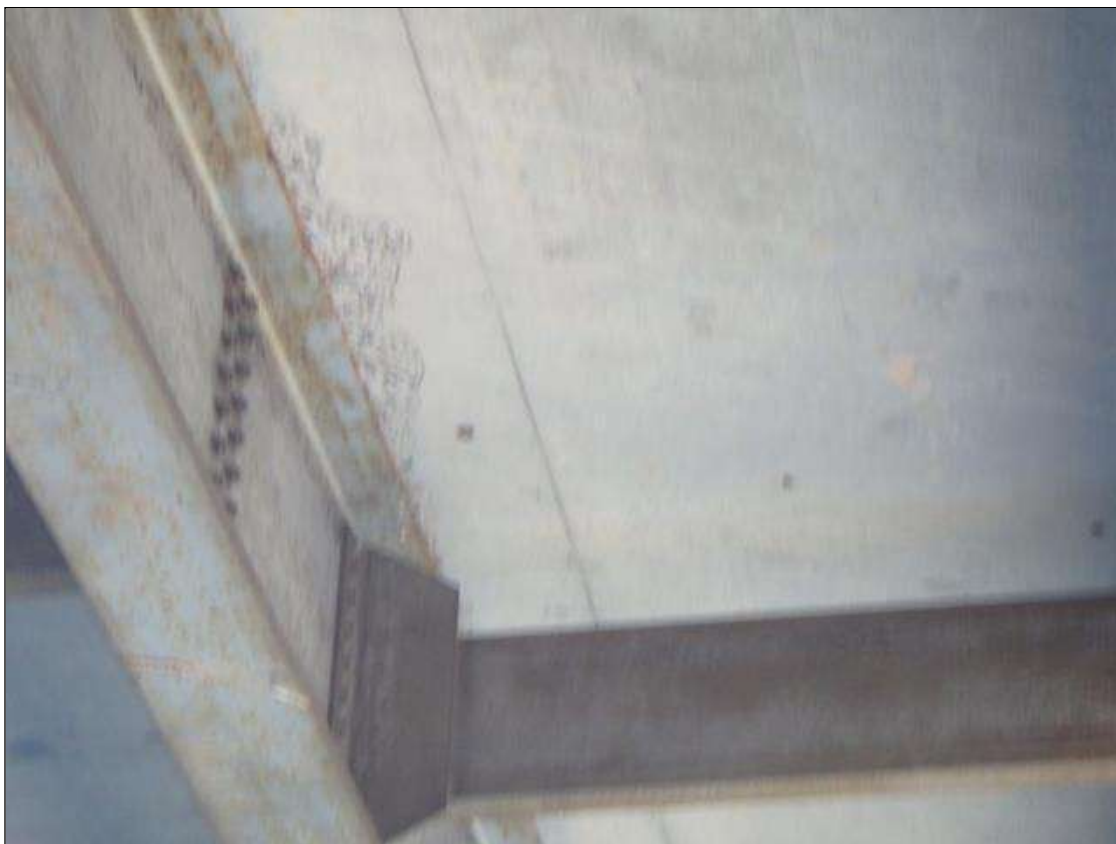
Span 2 Deck underside at mid-Span in bay 2 along beam 2, spall no exposed steel.

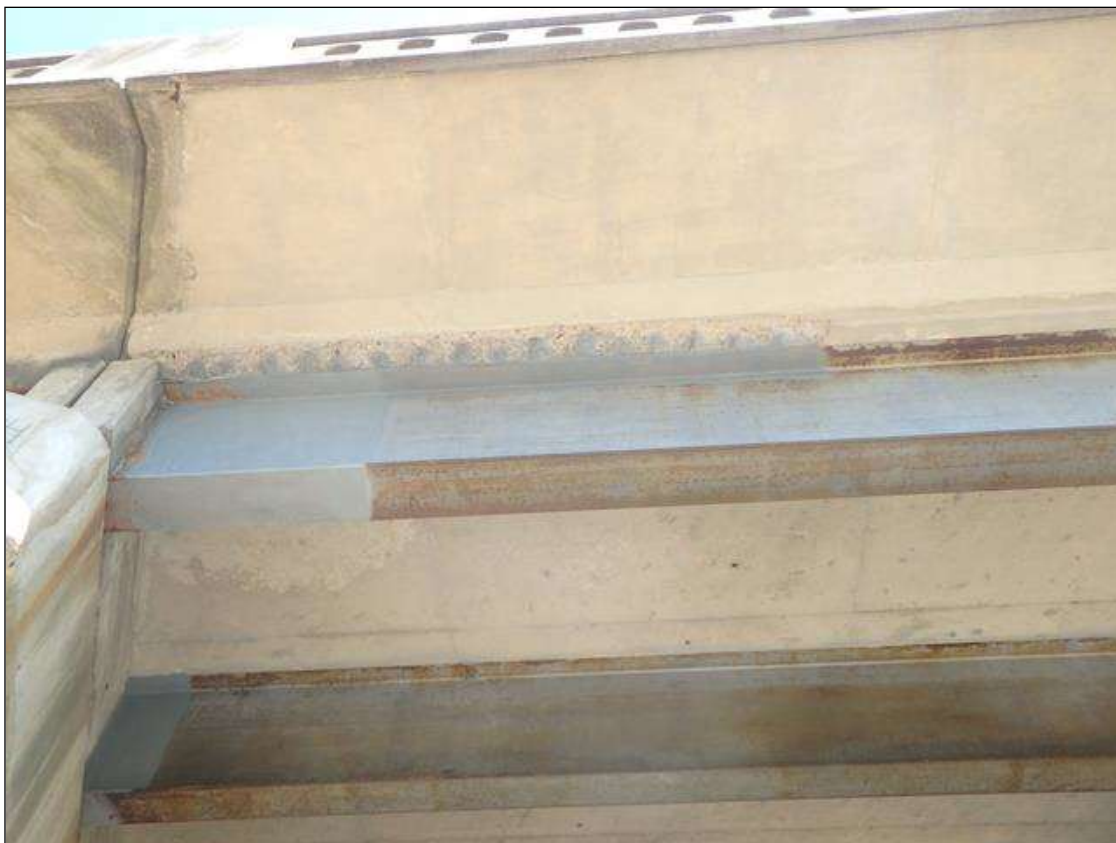
Span 2 Deck underside at Bent 1 in right overhang, spall no exposed steel in build-up along beam 5.

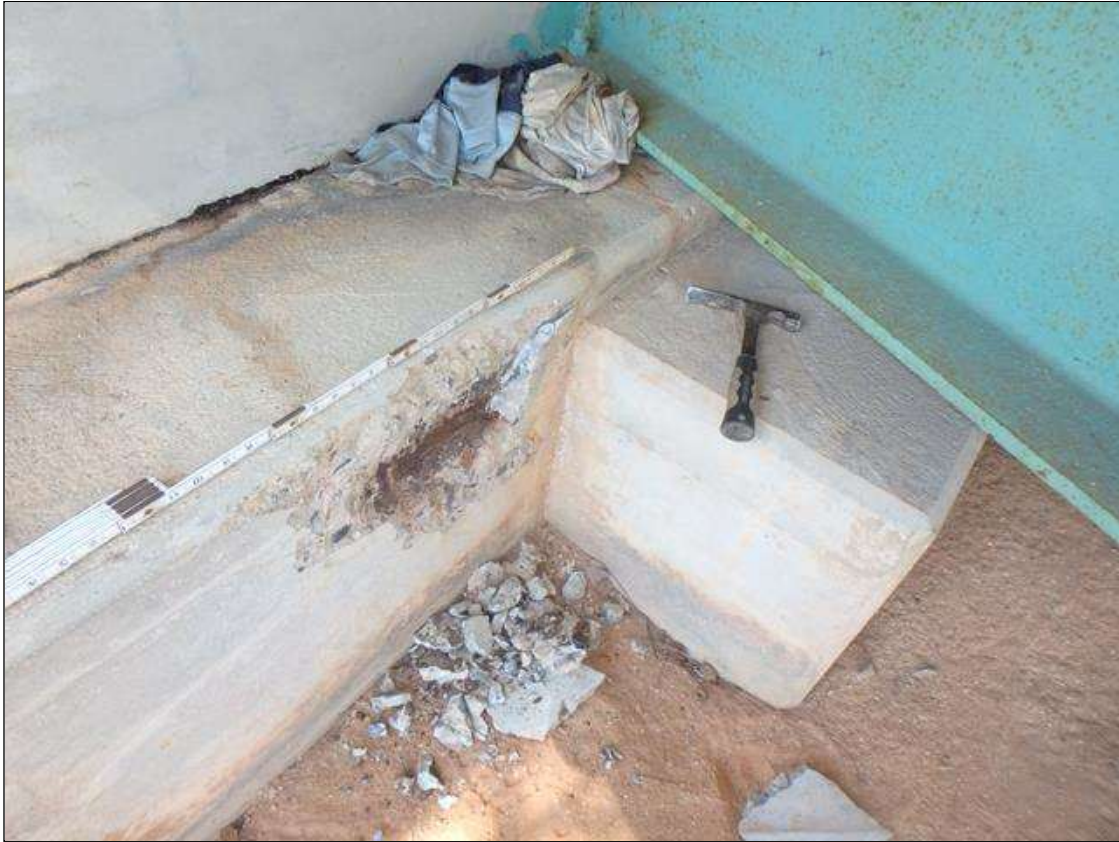
End Bent 1 Cap below right overhang near brace pile, Spall with Exposed Steel.

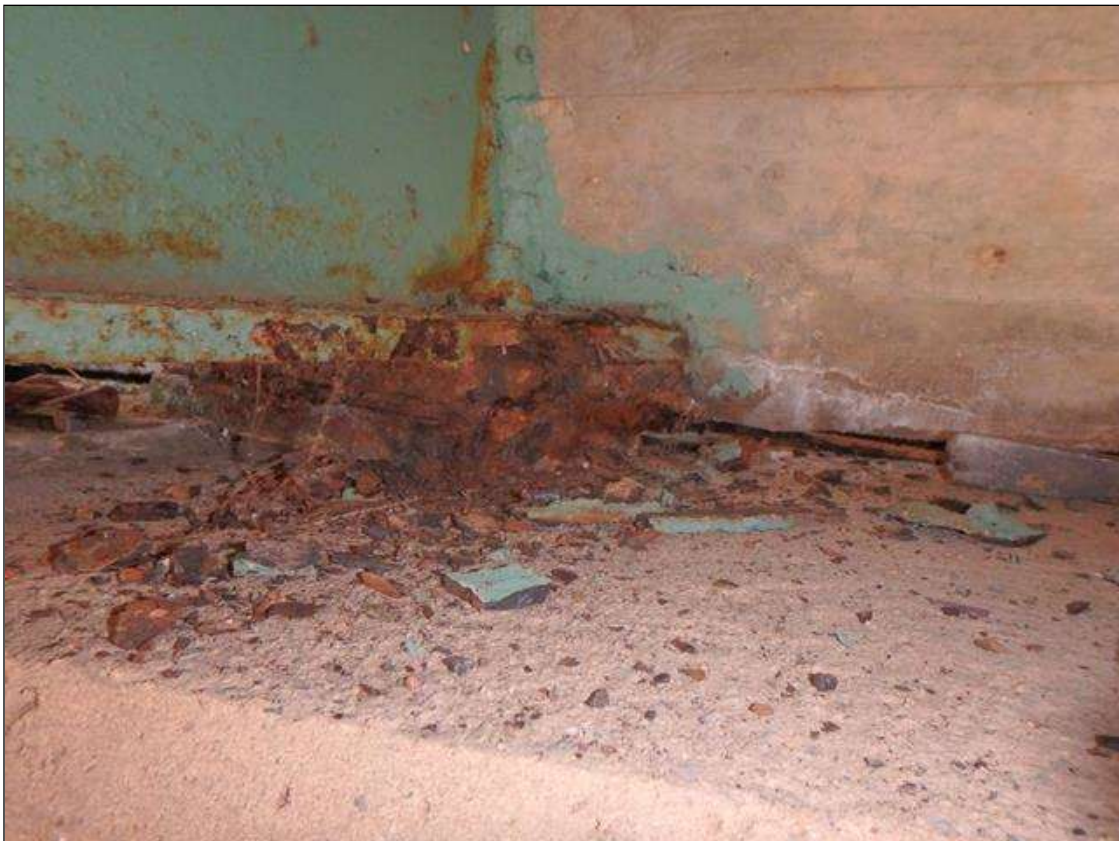
Span 1 Bearing Assembly seat 5 at End Bent 1, Active Corrosion and Section Loss <25% in the plates.

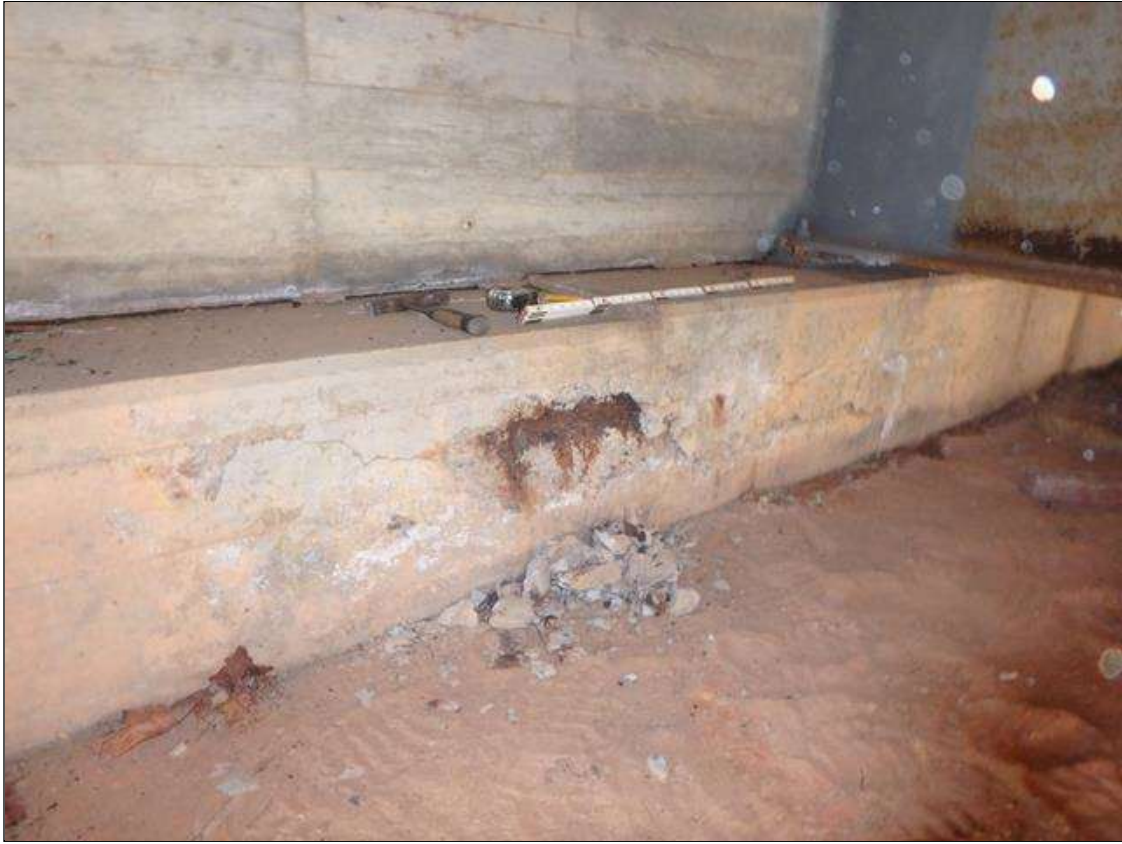
End Bent 1 Cap in bay 4, Spall with Exposed Steel and Delamination with cracks.

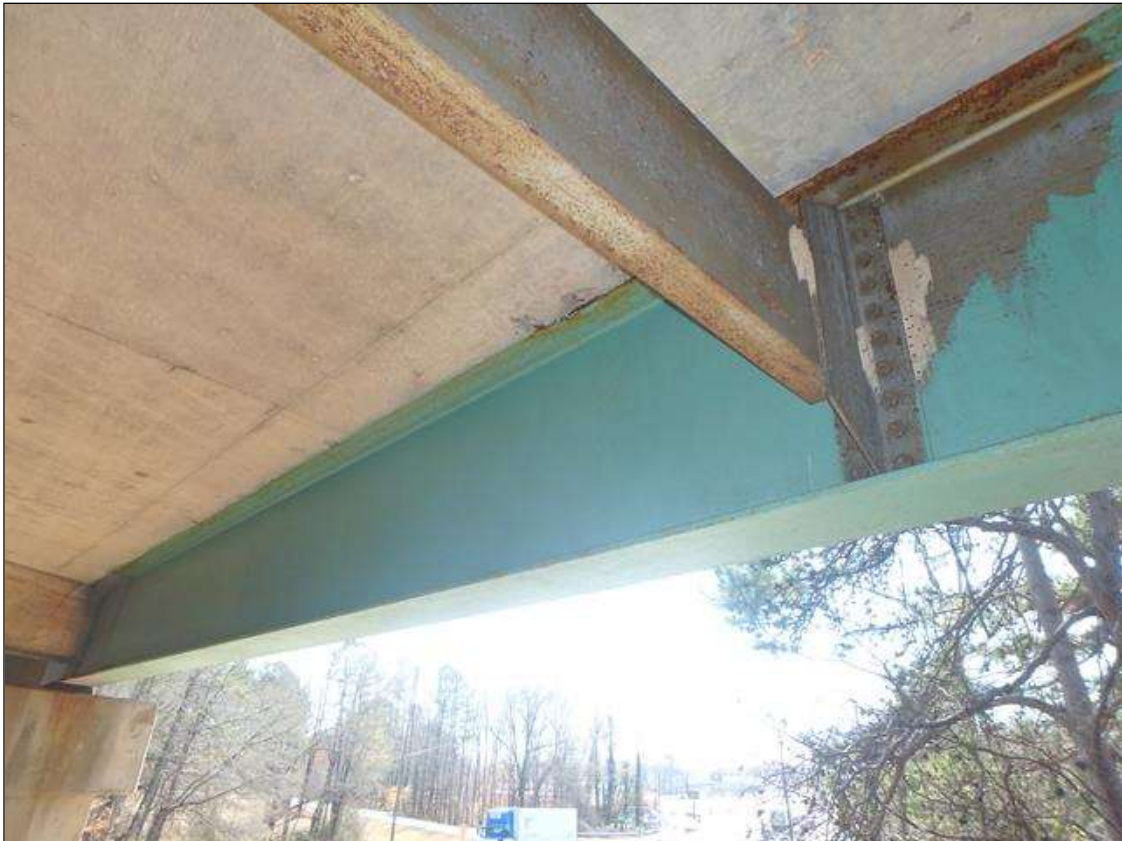
Span 1 Beam 5 Freckled Rust /Surface Corrosion in the flanges and web.

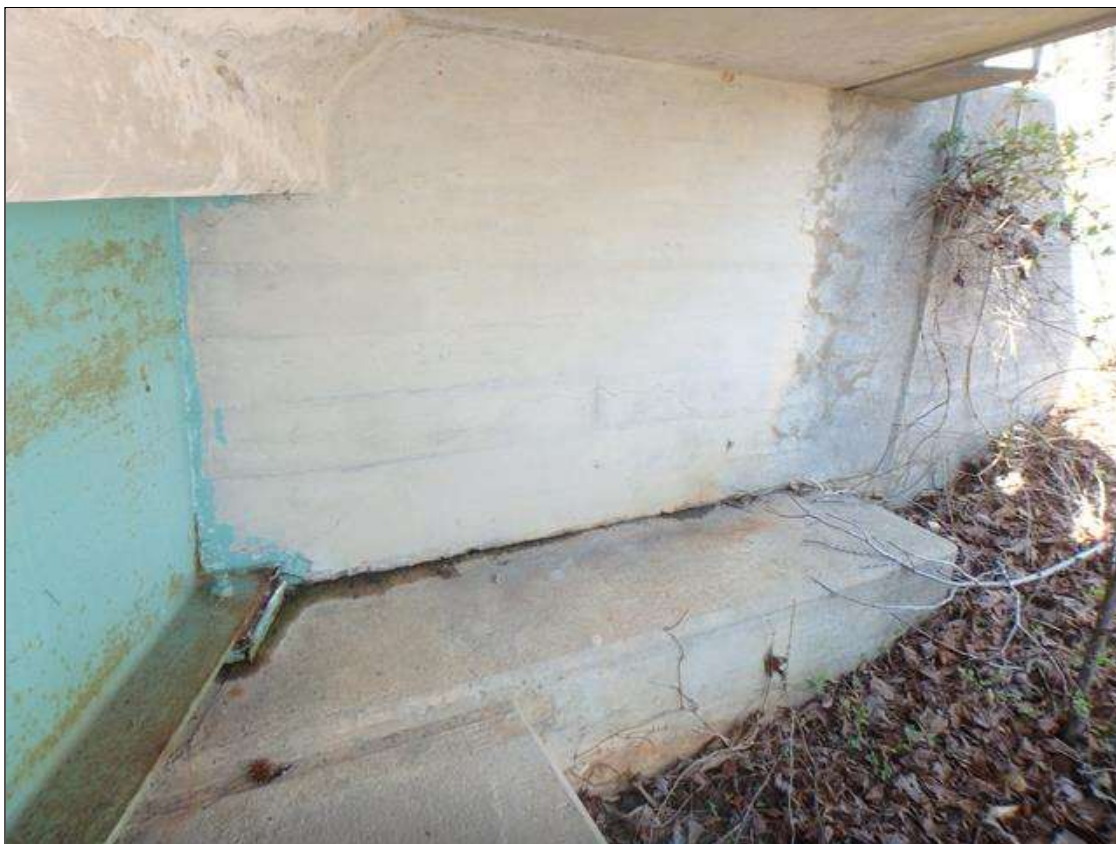
Abutment 1 in left overhang has up to 1/32" cracks.

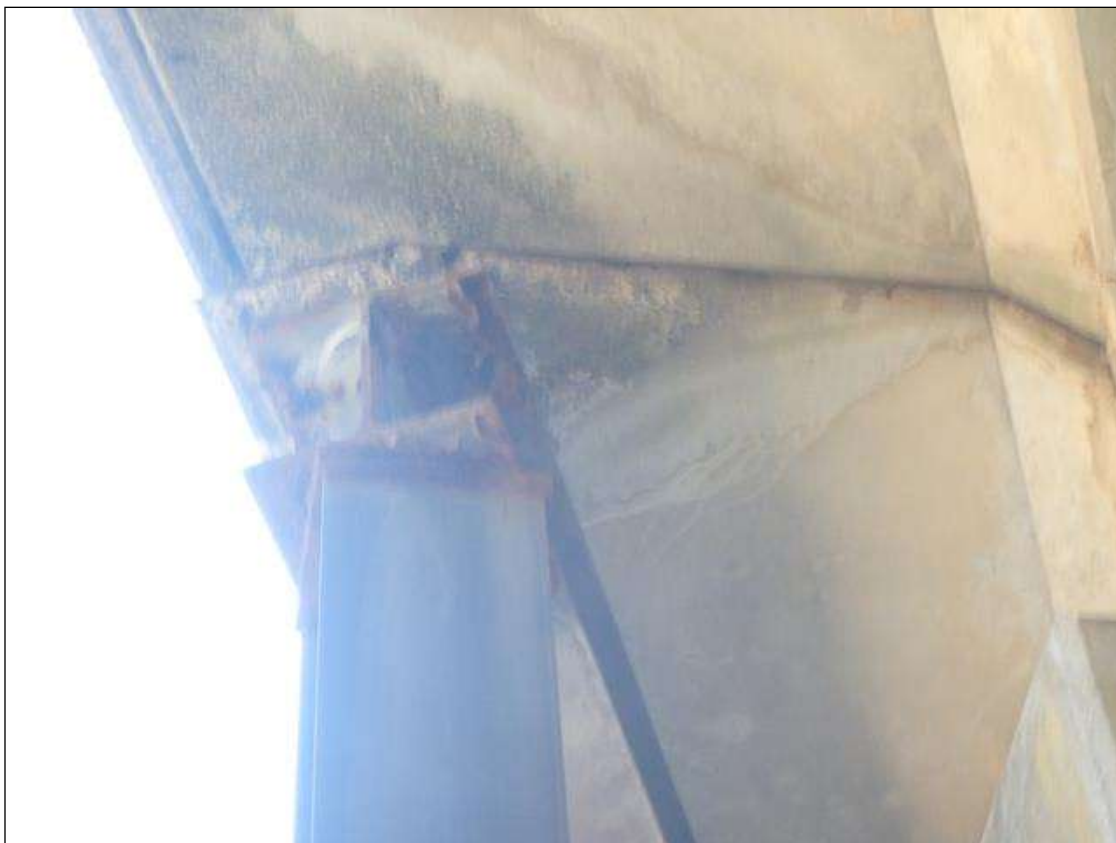
Steel H-Pile supporting Span 2 Deck left overhang at Bent 1, loose bolt thru top right flange with spall in underside of Deck.

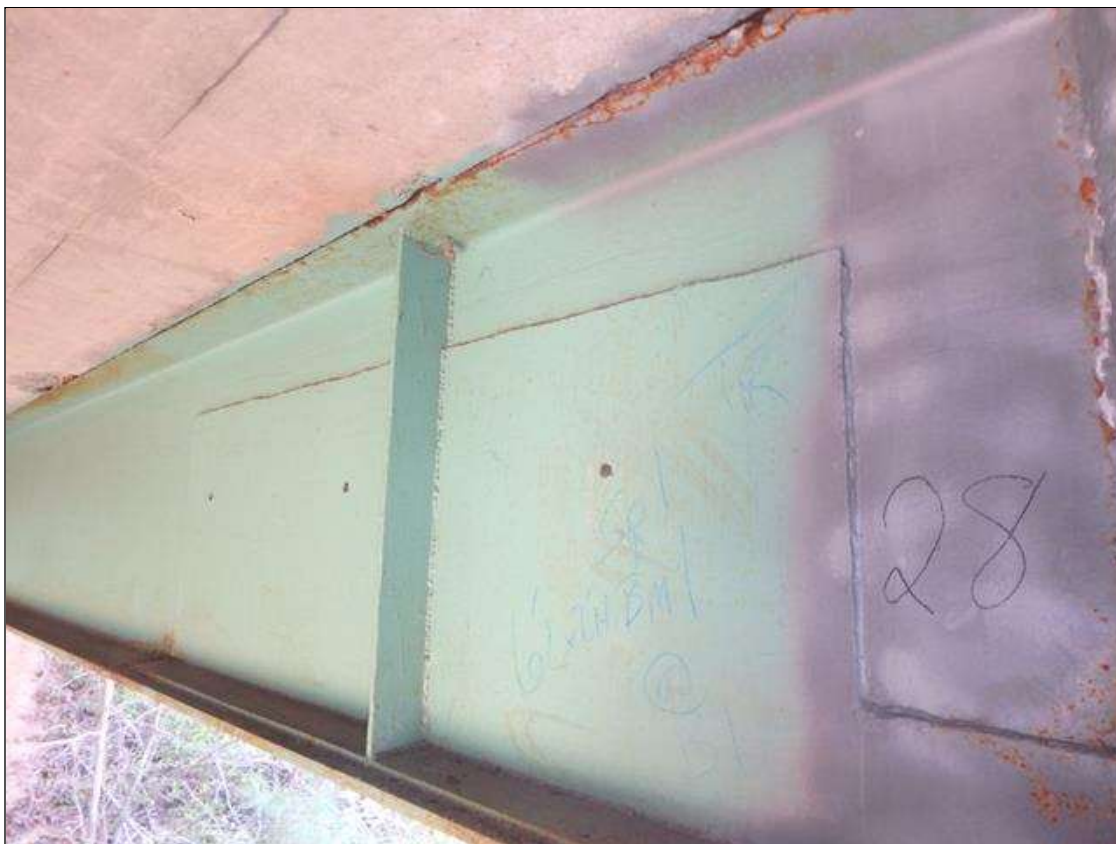
Temporary Repair Plate welded to Beam 1 right side Web and bottom flange at Bent 1.

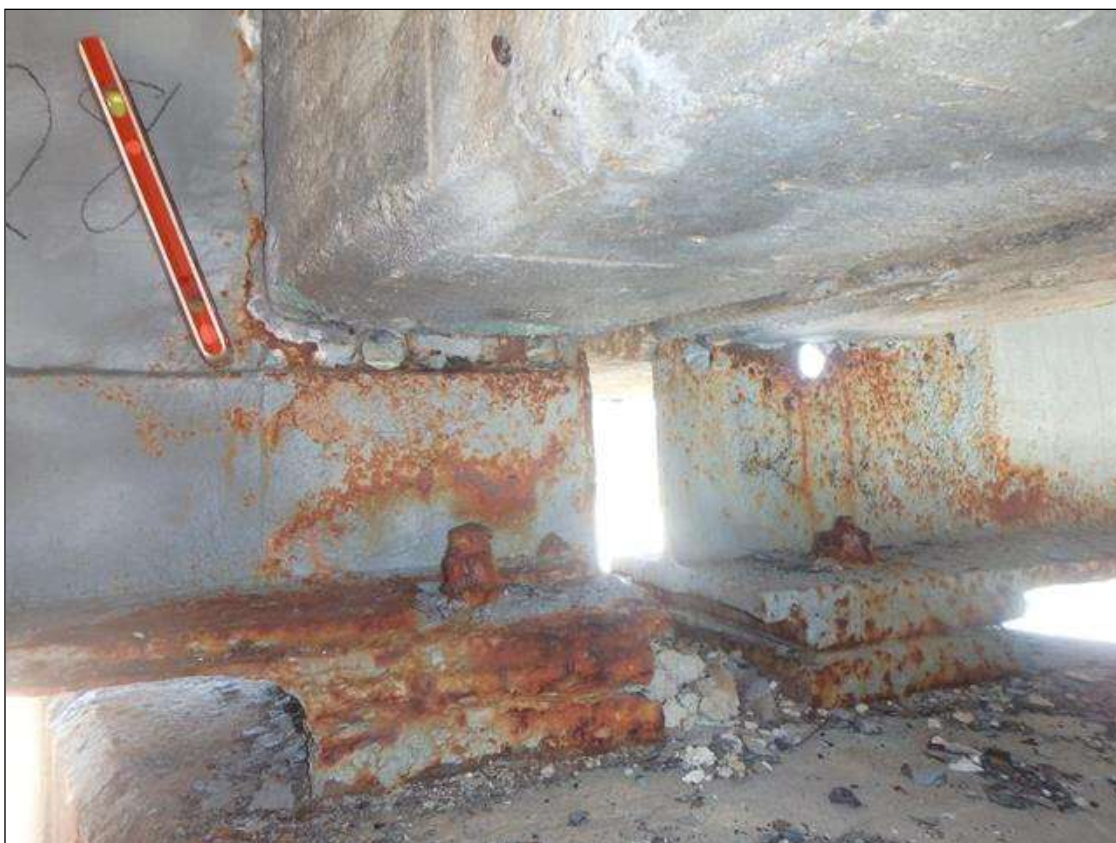
Spans 1 and 2 ends of Beam 1 at Bent 1, Section Loss in the web below the diaphragms, Freckled Rust/ surface corrosion initiated.

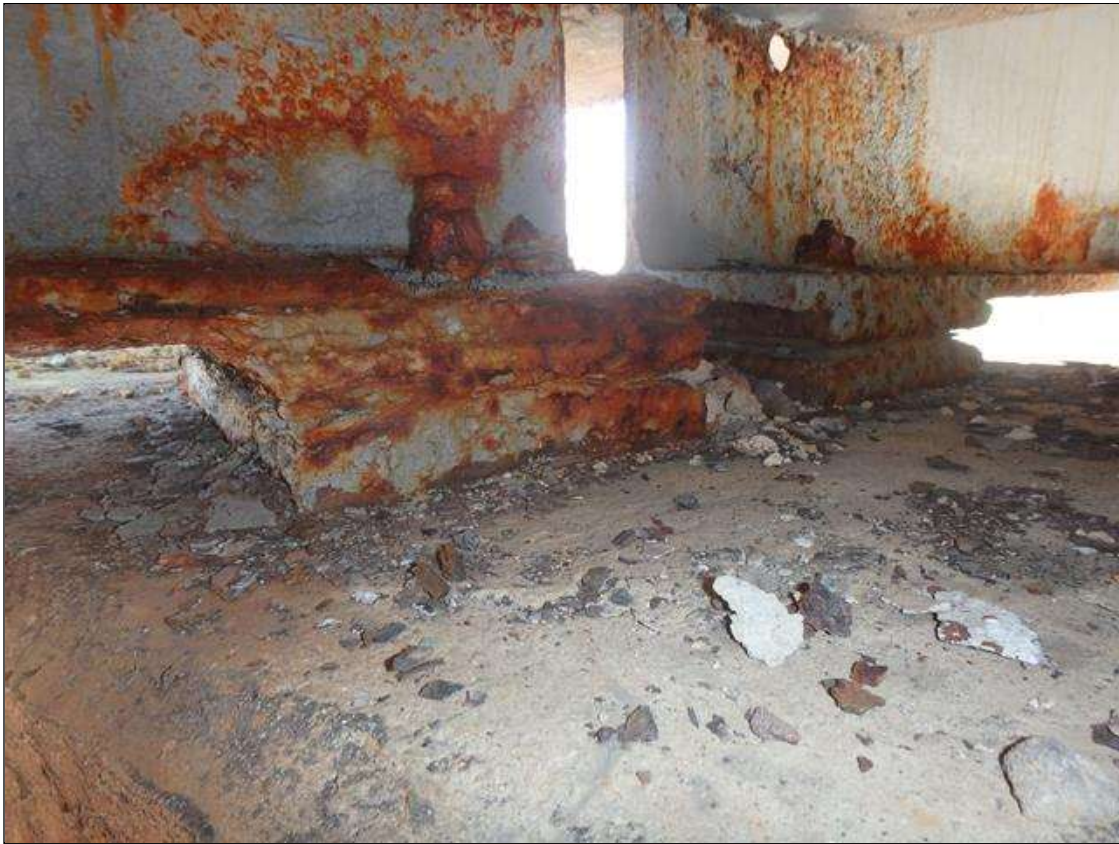
Spans 1 & 2 Bearing Assembly seat 1 at Bent 1, Active Corrosion & Section Loss <25% in the plates, fasteners 1/4" Remaining.

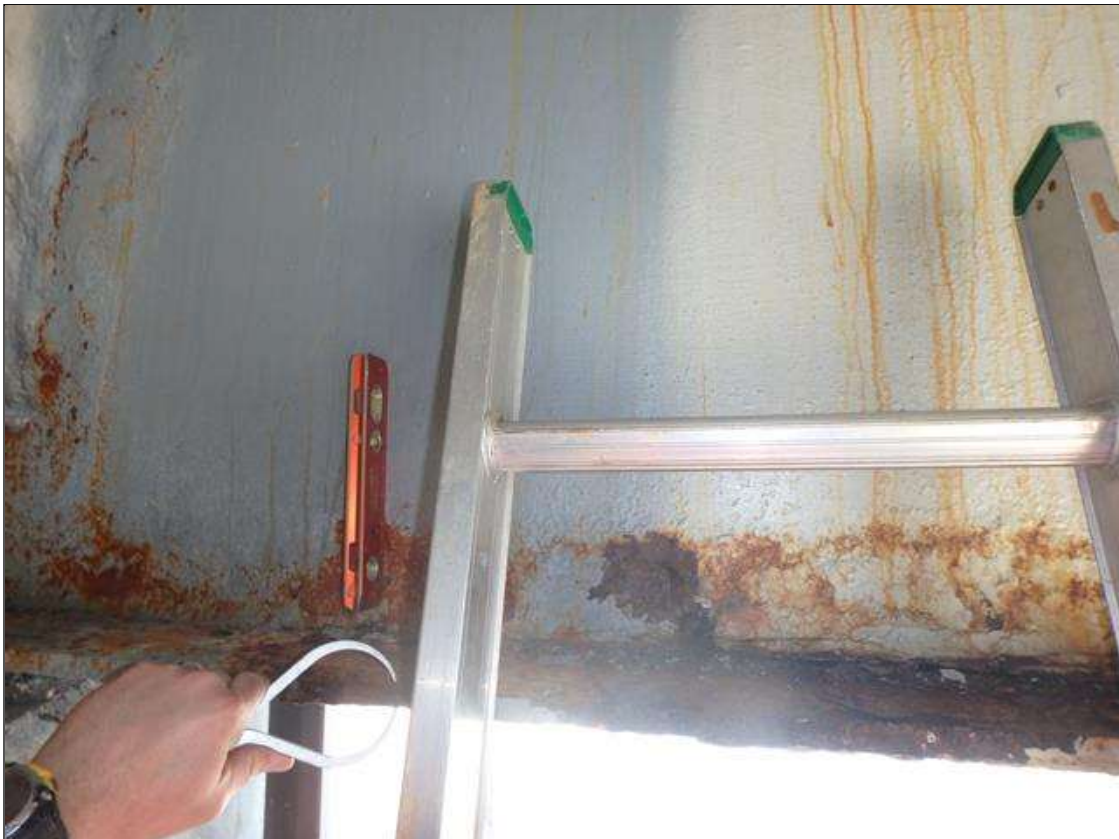
PRIORITY MAINTENANCE: Span 2 beam 1 at Bent 1, Active Corrosion & Section Loss in the lower web and bottom flange.

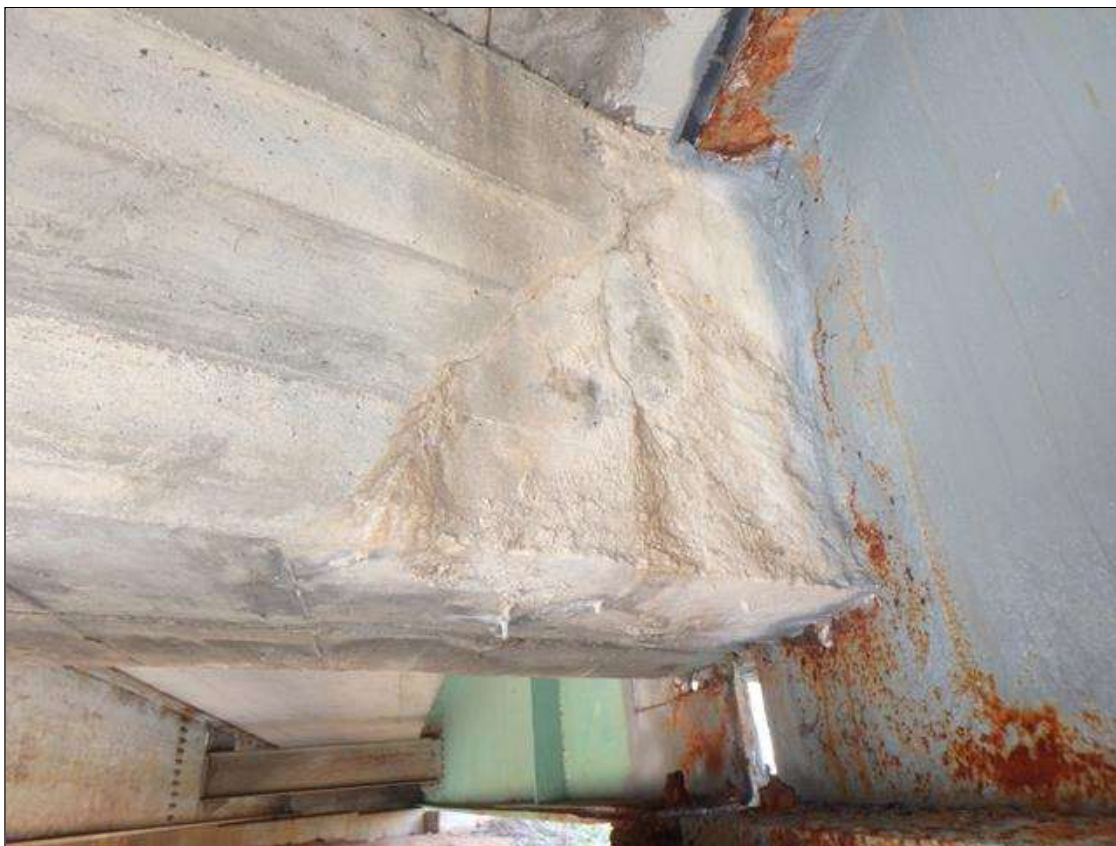
Span 2 RC end diaphragm at Bent 1 bay 1, 1/8" cracks with efflorescence buildup.

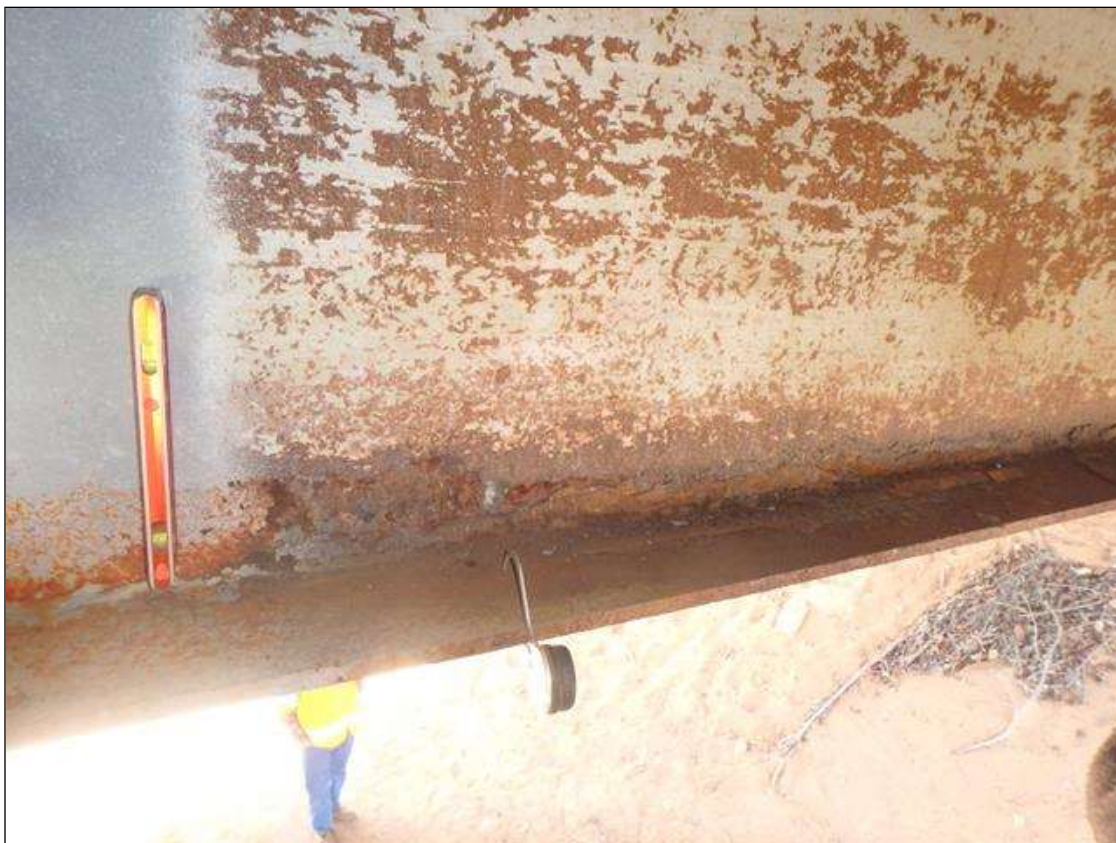
PRIORITY MAINTENANCE: Span 1 Beam 2 near Bent 1, Active Corrosion & Section Loss in the lower web and bottom flange.

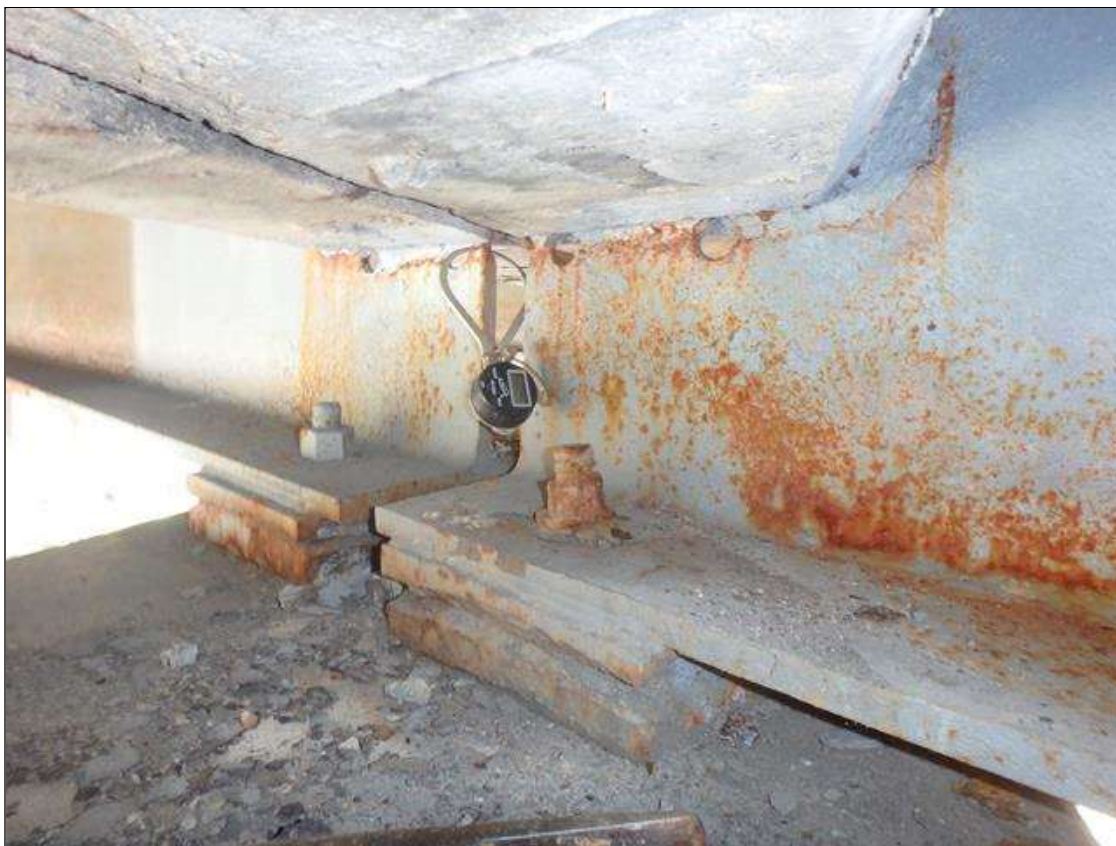
Spans 1 and 2 end of beam 2 at Bent 1, Section Loss in web below diaphragm, Surface Corrosion initiated.

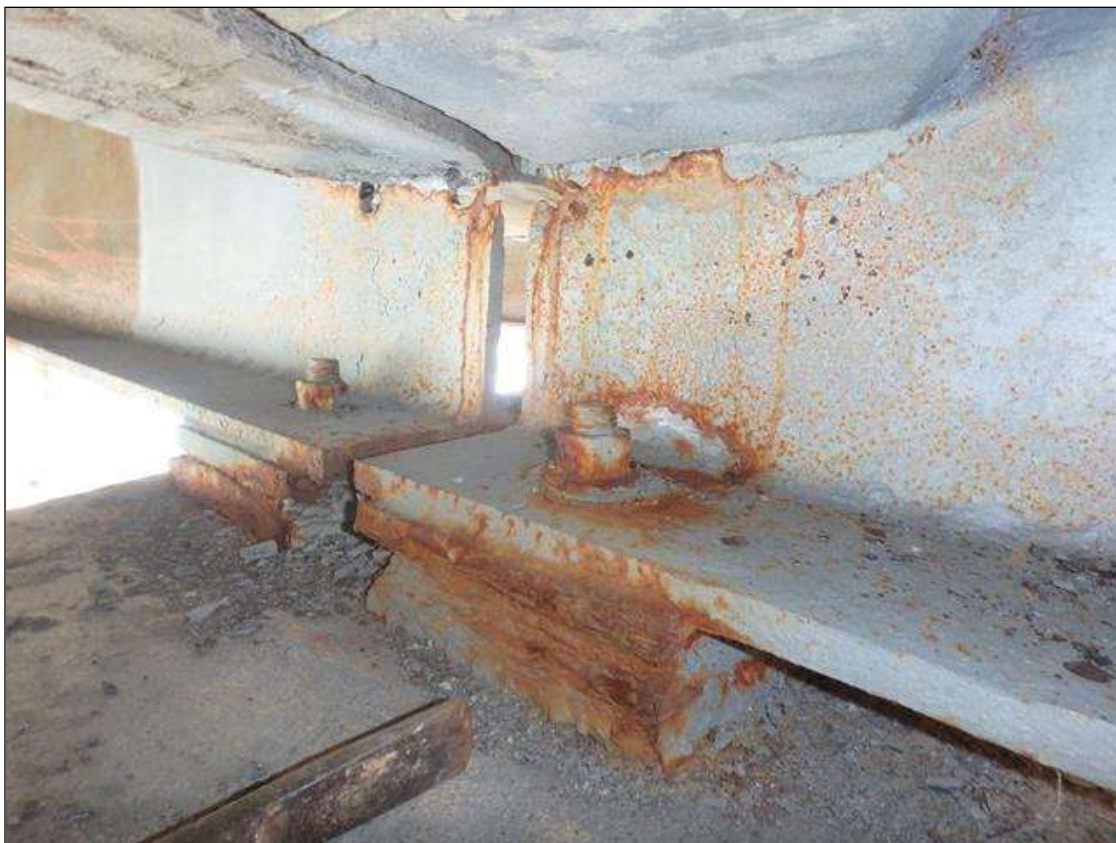
Spans 1 & 2 ends of beam 3 at Bent 1, Section Loss in the web below diaphragm, Freckled Rust/Surface Corrosion initiated since beam was cleaned and painted.

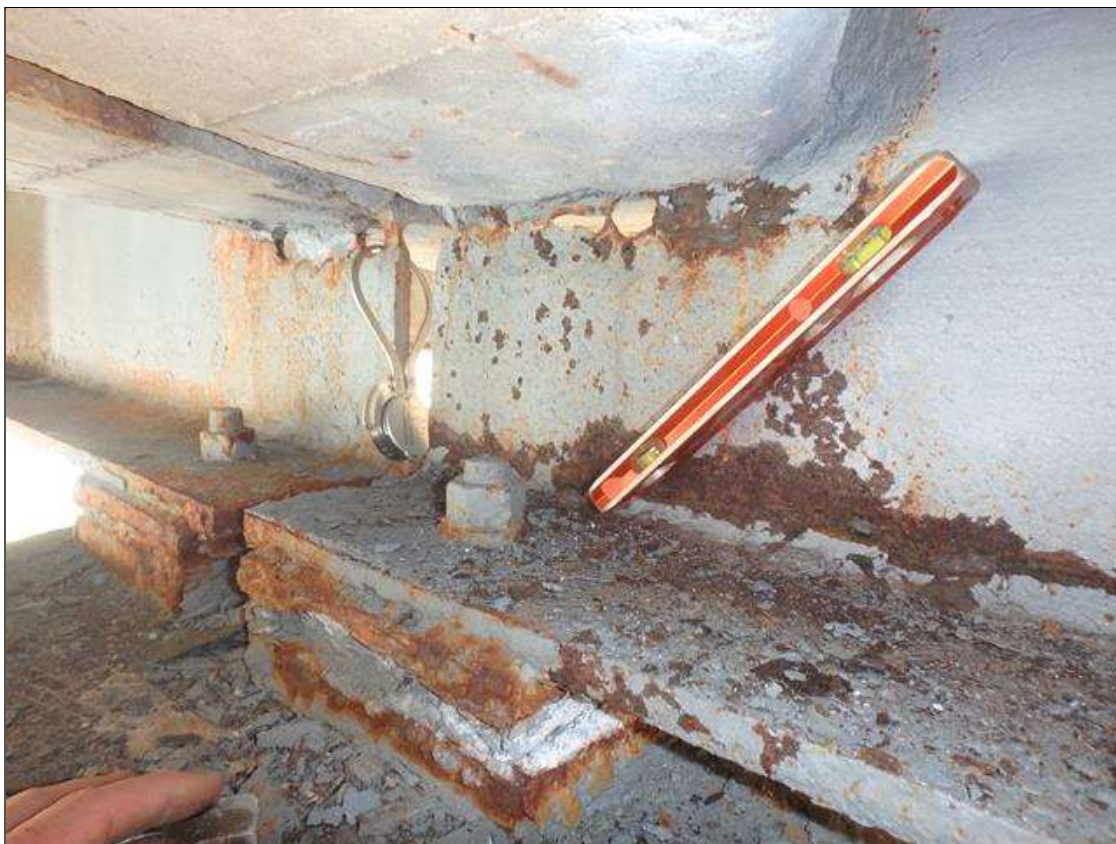
PRIORITY MAINTENANCE: Span 1 Beam 4 at Bent 1, Active Corrosion and Section Loss below end diaphragm and in lower web at bottom flange.

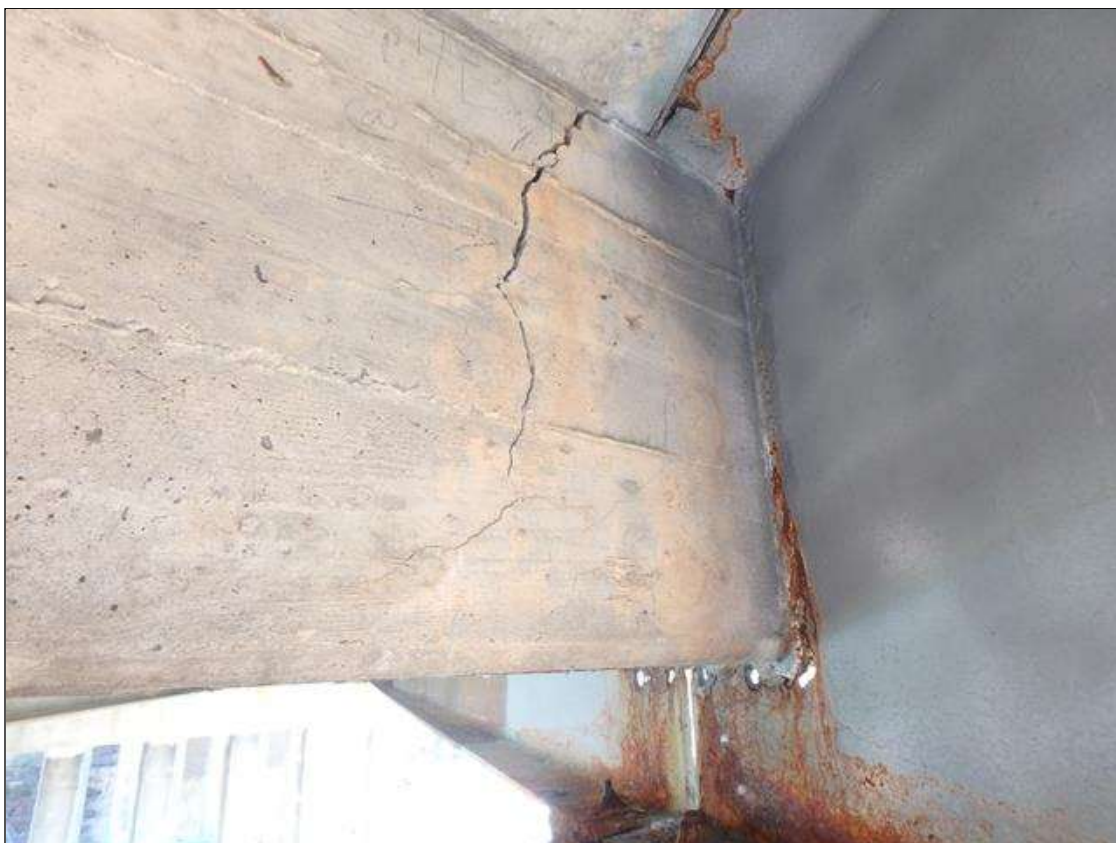
Span 1 RC end diaphragm in bay 4 adjacent beam 5, vertical crack up to 1/4" wide.

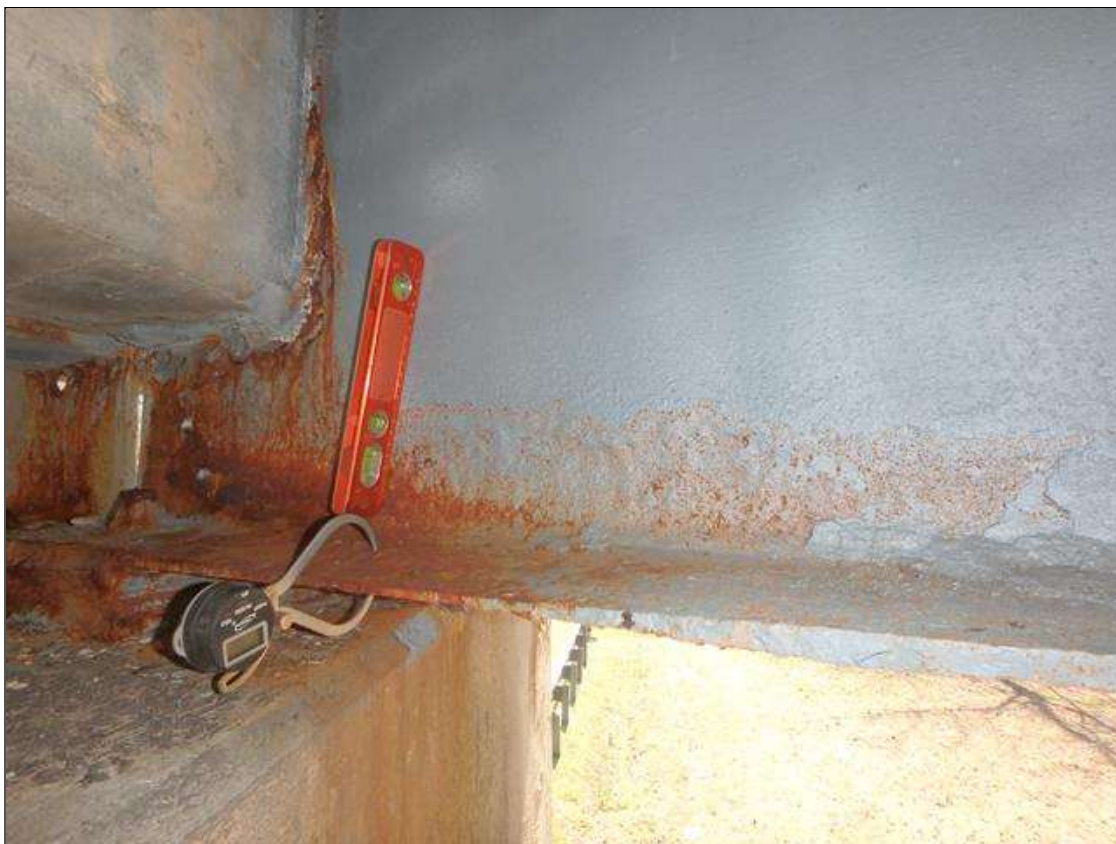
Span 1 Beam 5 at Bent 1, left side, Section Loss in bottom flange and lower web, Surface Corrosion/ Freckled Rust initiated since beam cleaned and painted.

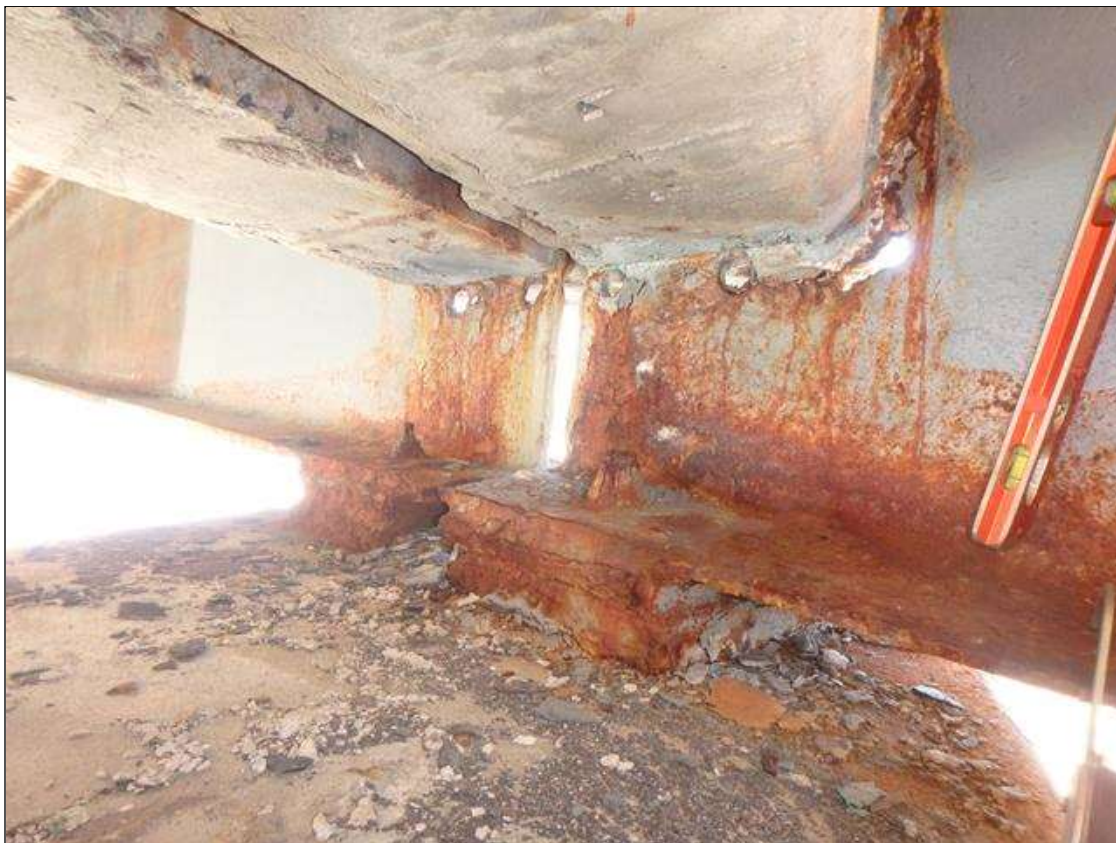
Spans 1 and 2, beam 5 at Bent 1 Section Loss in the web at diaphragm and along bottom flange.

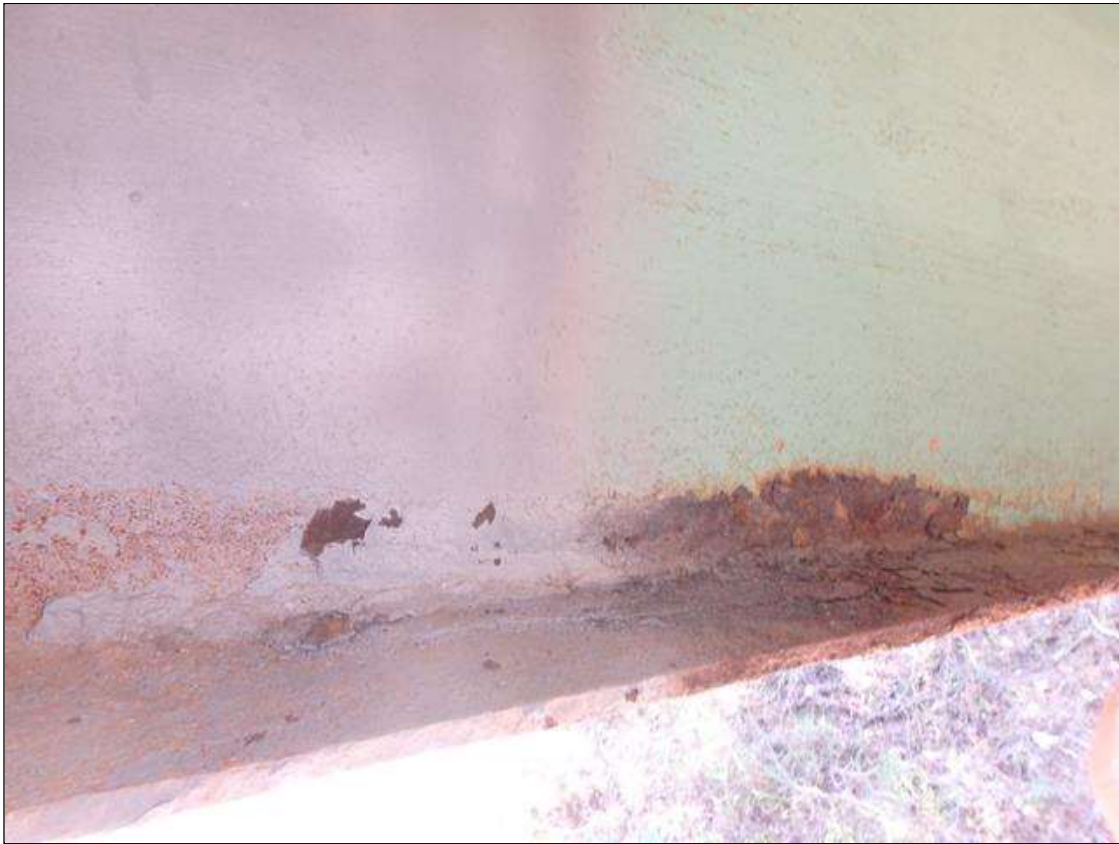
PRIORITY MAINTENANCE: Span 1 Beam 5 at 3' from end of beam at Bent 1, left bottom flange has Active Corrosion and Section Loss.

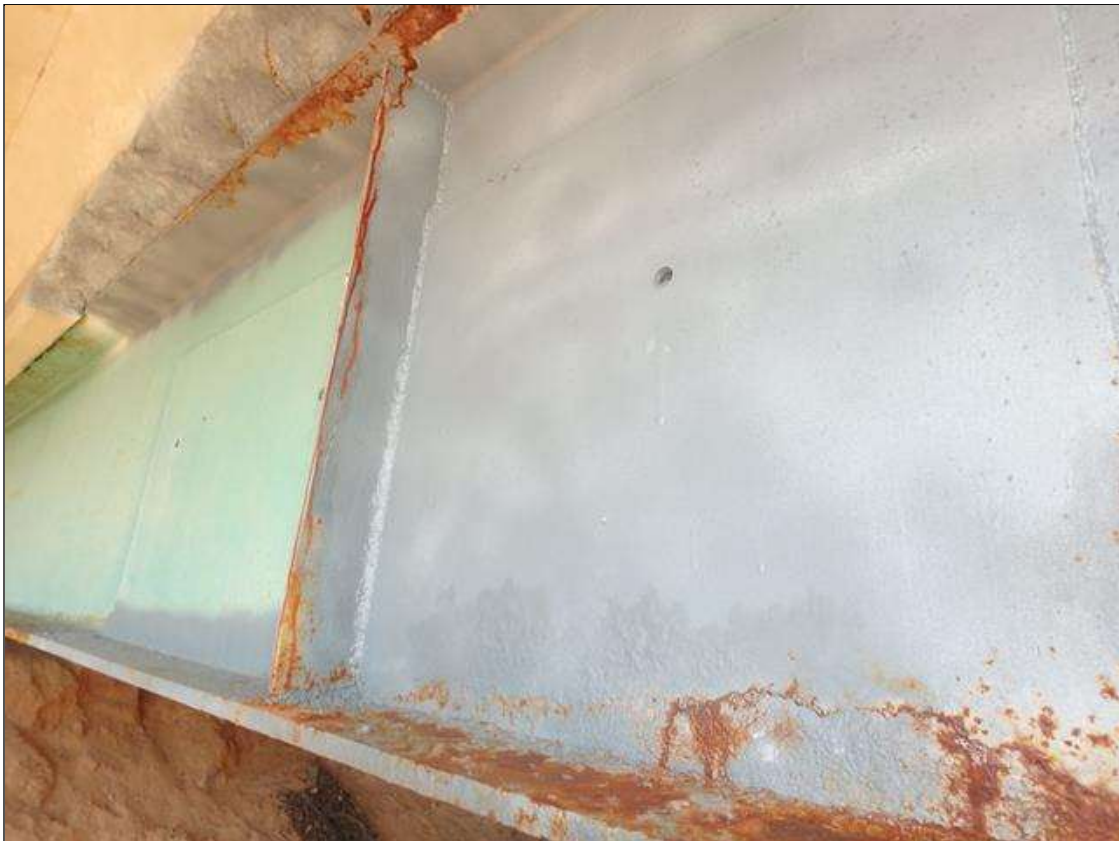
Span 1 Beam 5 at Bent 1, Temporary repair, plates welded to right side of web

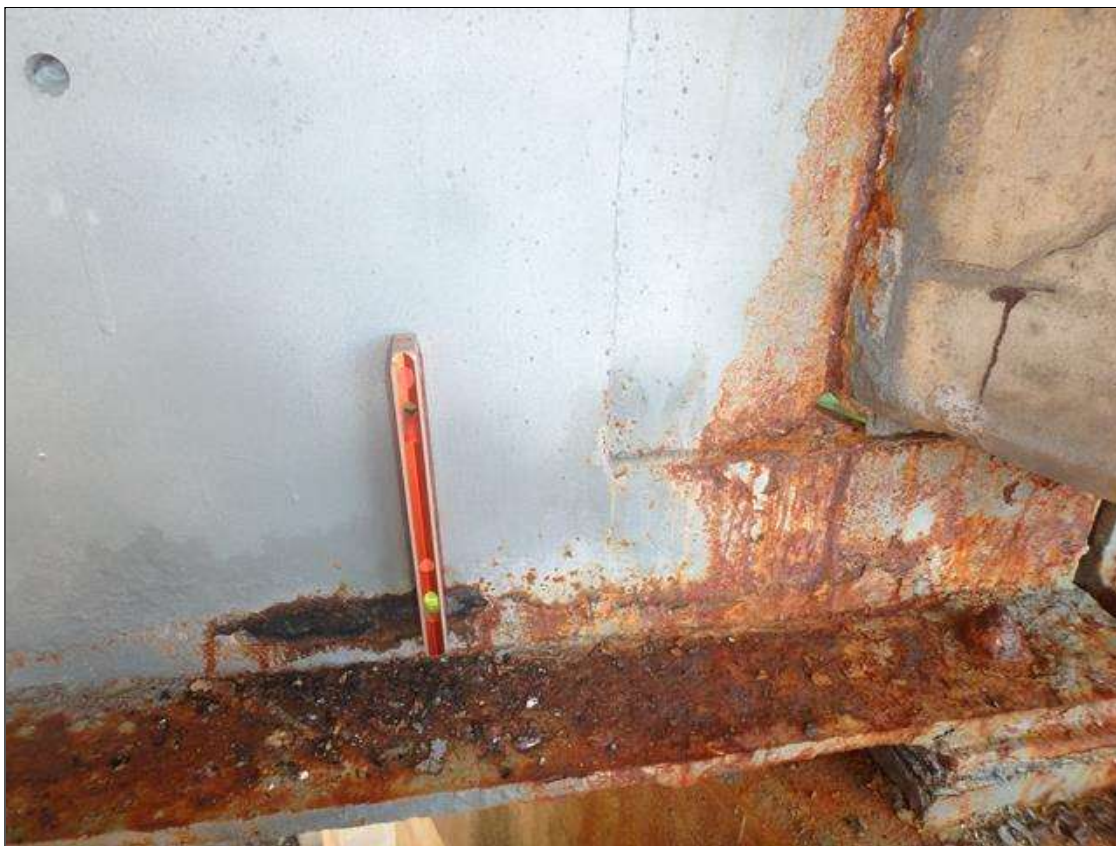
Span 1 Beam 5 at Bent 1, Repair plate welded to right side of web has Active Corrosion and Section Loss in lower web.

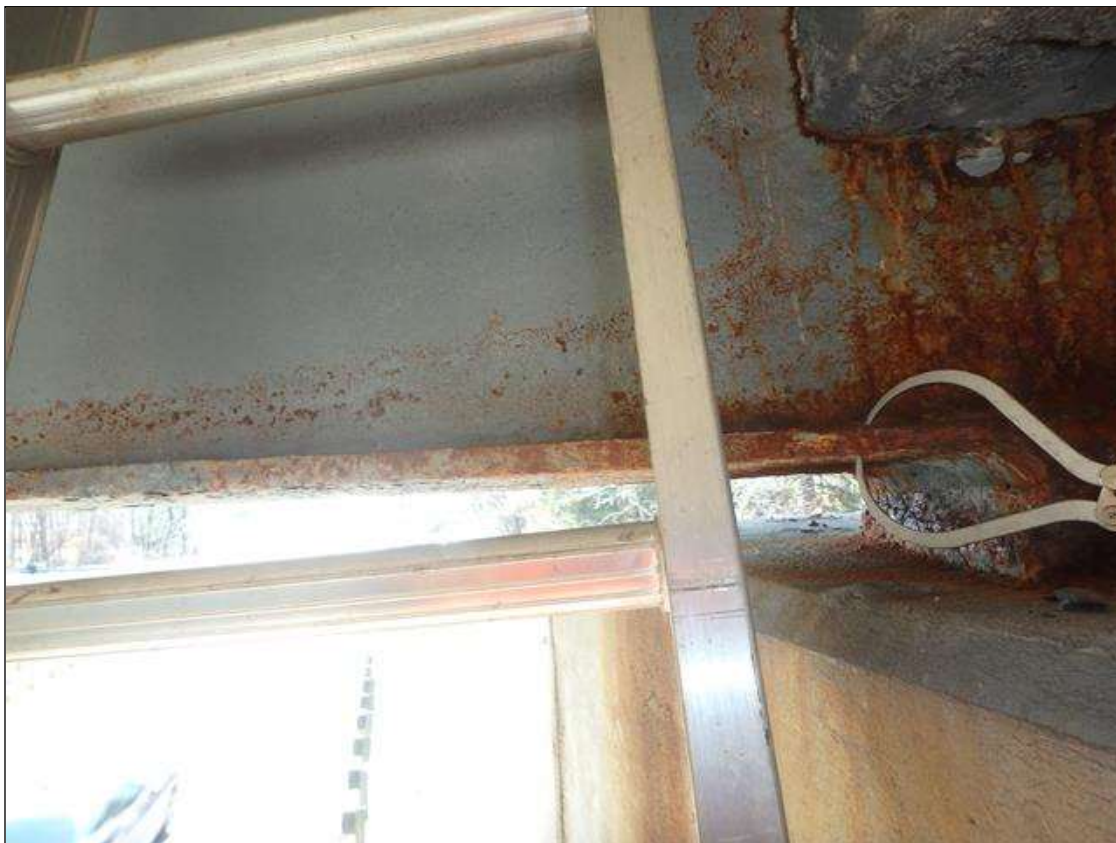
Span 2 Beam 5 at Bent 1, Section Loss in lower web and bottom flange, Surface Corrosion/Freckled Rust initiated since beam was cleaned and painted.
