NC DEPARTMENT OF TRANSPORTATION
 DIVISION OF HIGHWAYS
 STRUCTURE MANAGEMENT UNIT

ATTENTION: **PRIORITY MAINTENANCE, SHORED**

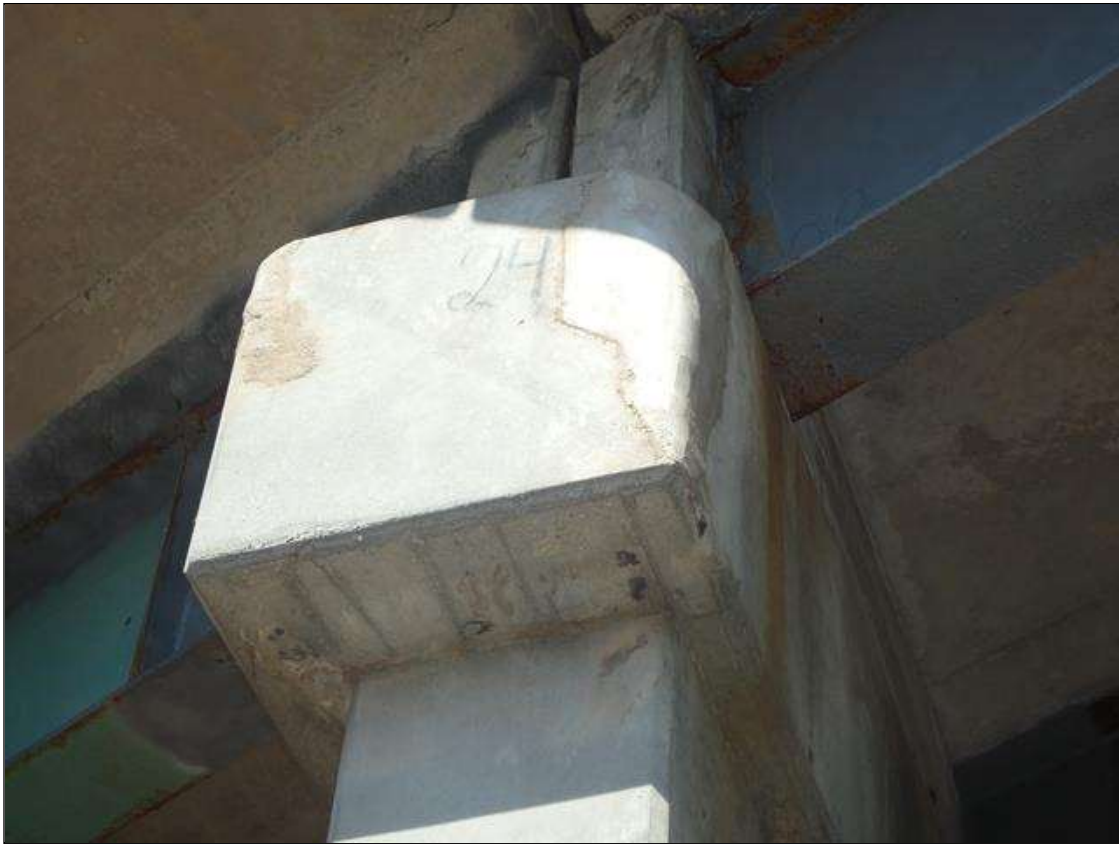
Bent 1 cap right end, sound patches.

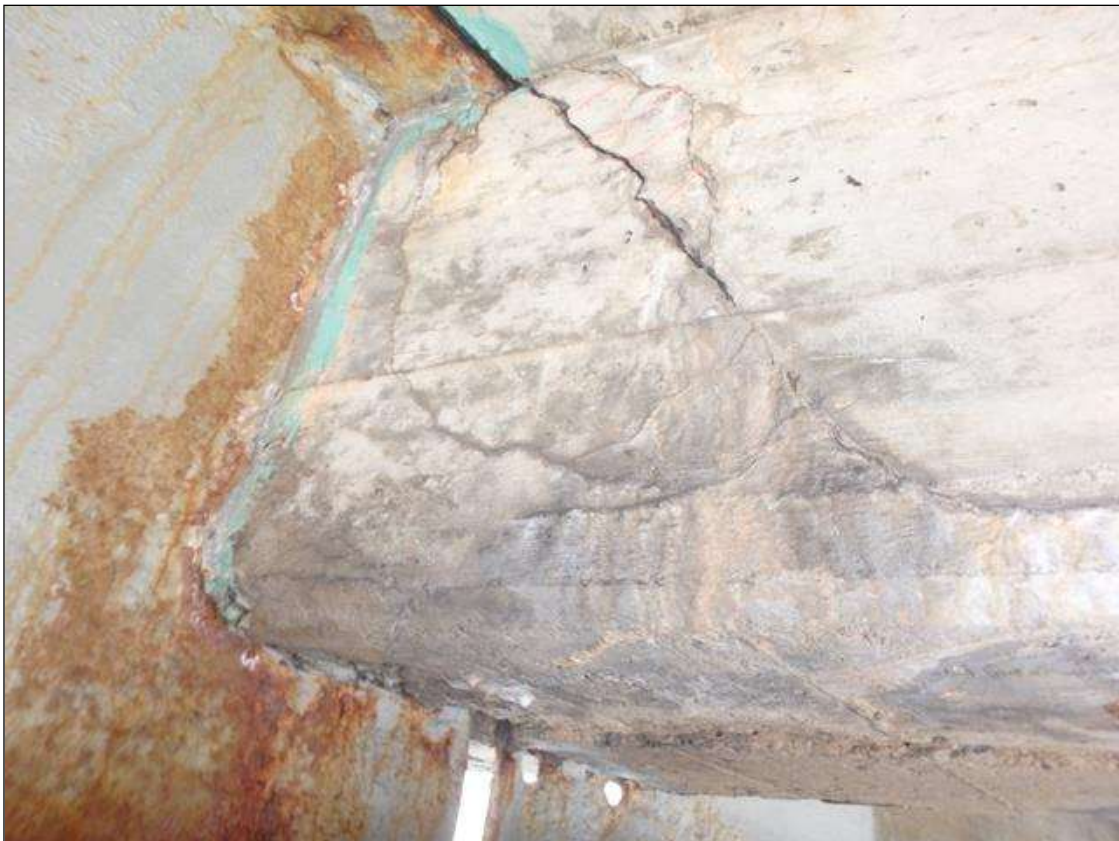
Span 2 RC end diaphragm at Bent 2 in bay 1 diagonal crack 1/8" wide and Delamination.

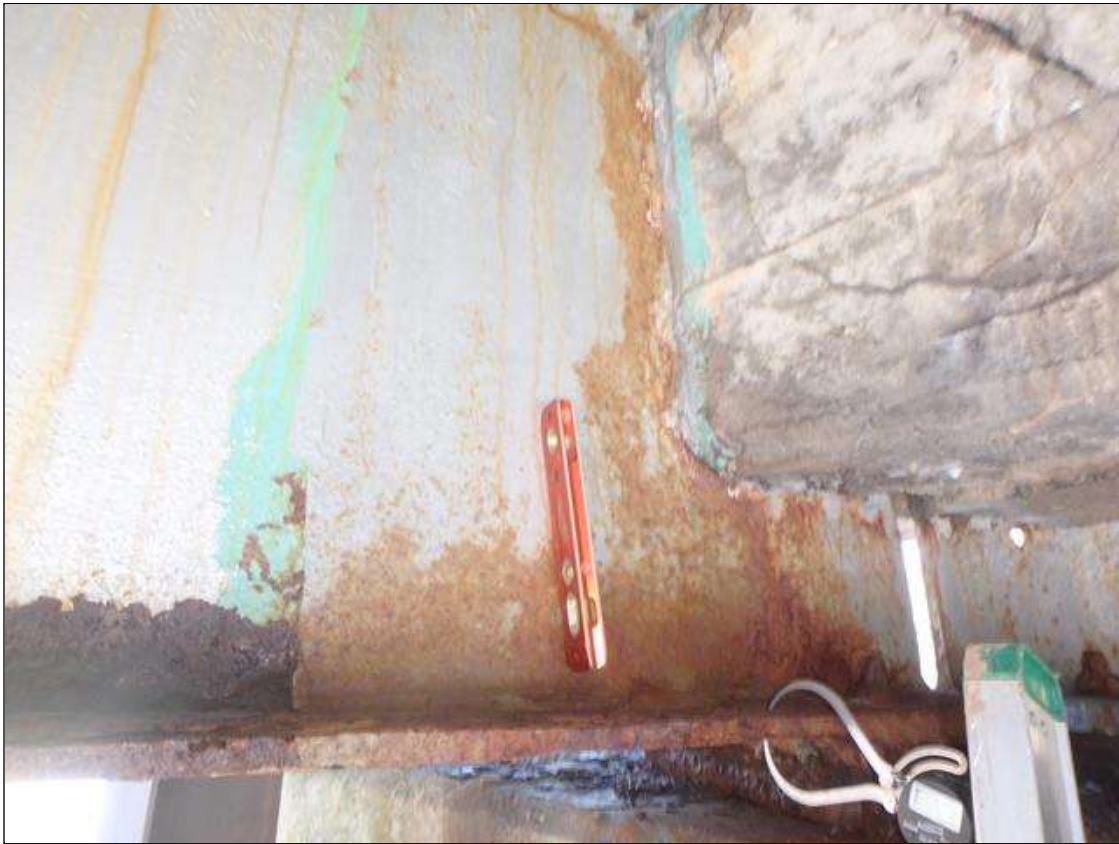
Span 2 Beam 1 at Bent 2, right side, Section Loss in web and bottom flange, Surface Corrosion/ Freckled Rust initiated since beam end was cleaned and painted.

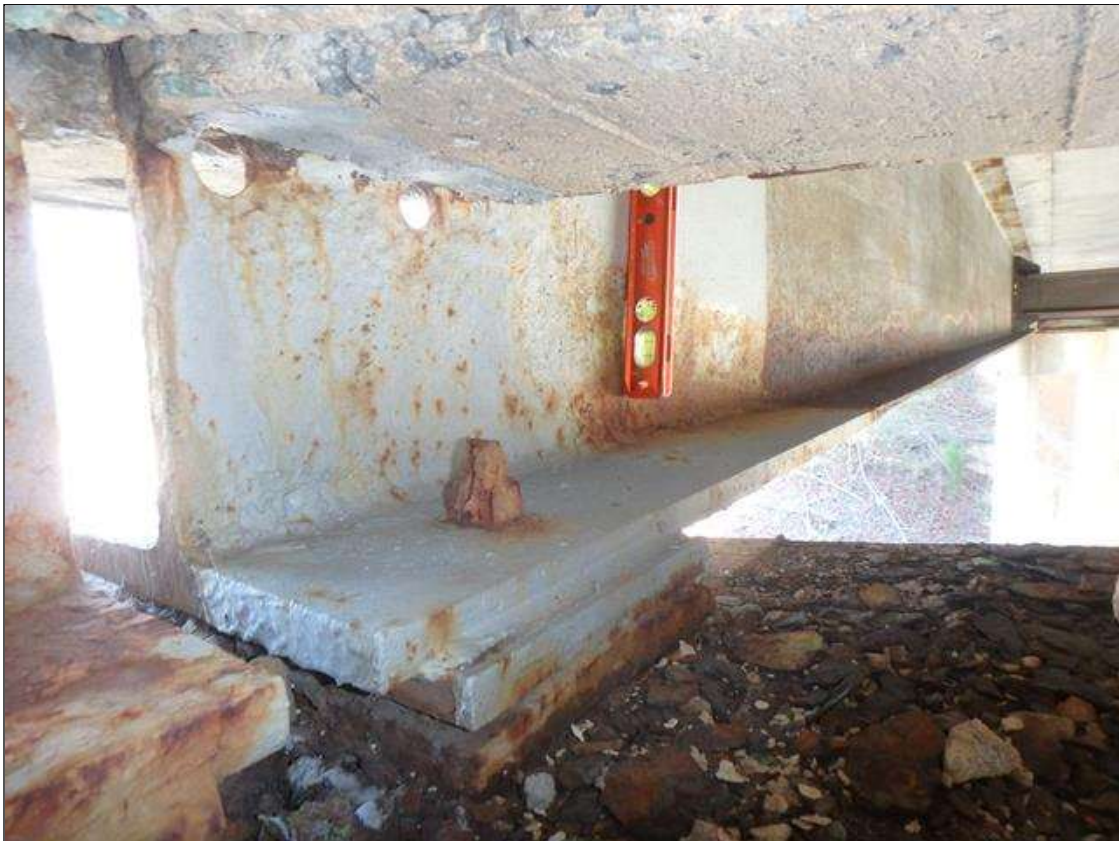
Span 3 Beam 1 at Bent 2, Section Loss in web below diaphragm, Section Loss in lower web along bottom flange.

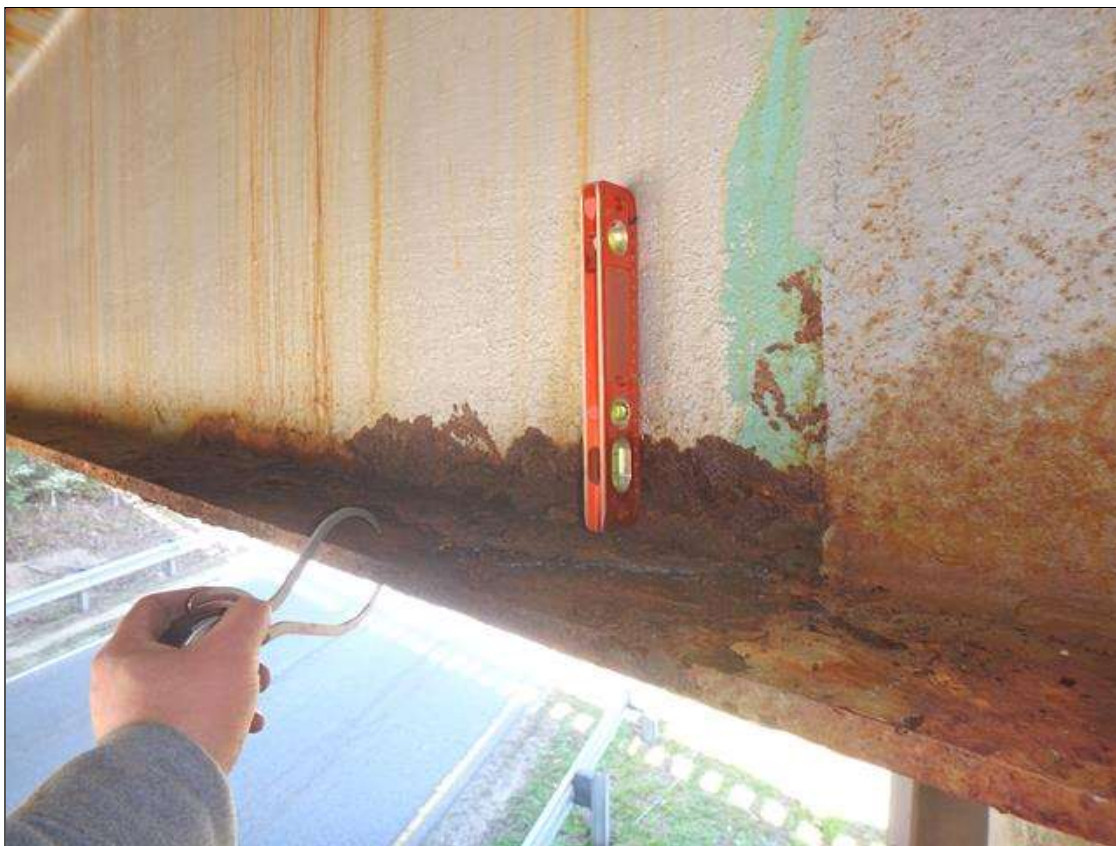
PRIORITY MAINTENANCE: Span 2 Beam 1 at 2' from Bent 2, Active Corrosion and Section Loss in lower web and bottom flange.

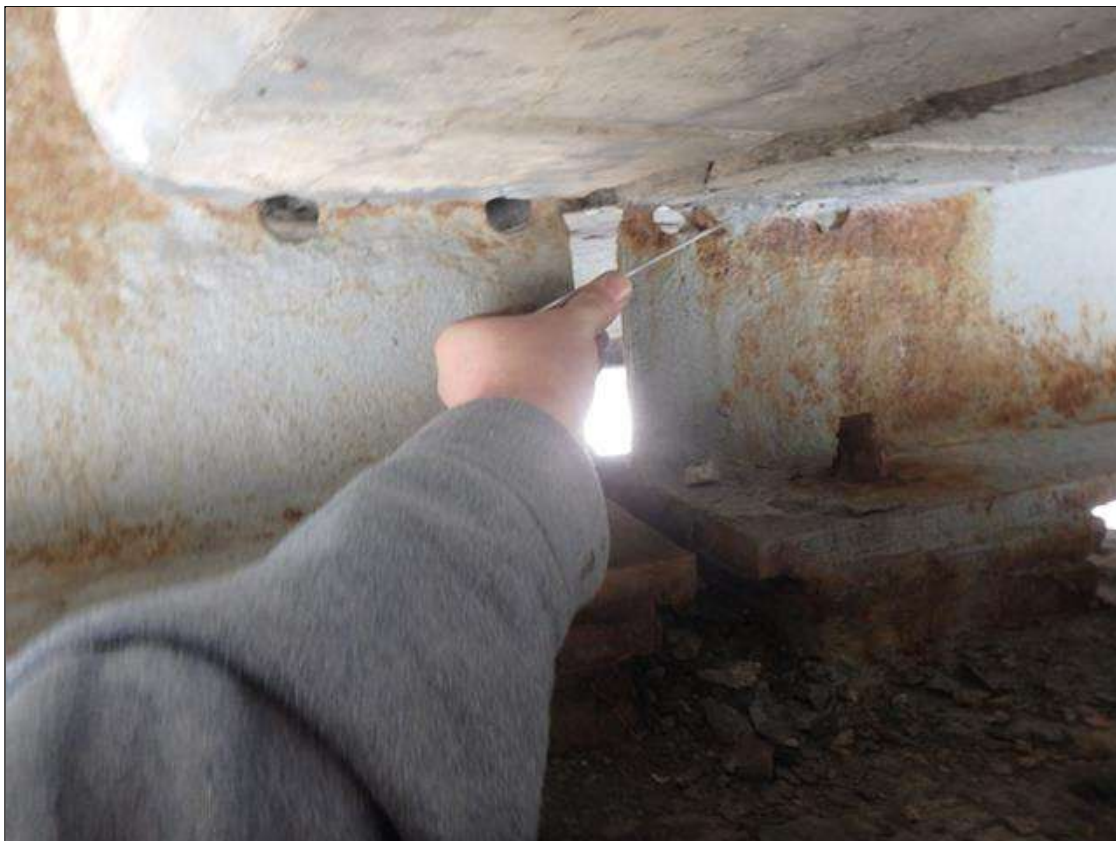
Spans 2 and 3 Beam 2 at Bent 2, end of beams below diaphragm has Section Loss, Surface Corrosion/Freckled Rust initiated since beam was cleaned and painted.

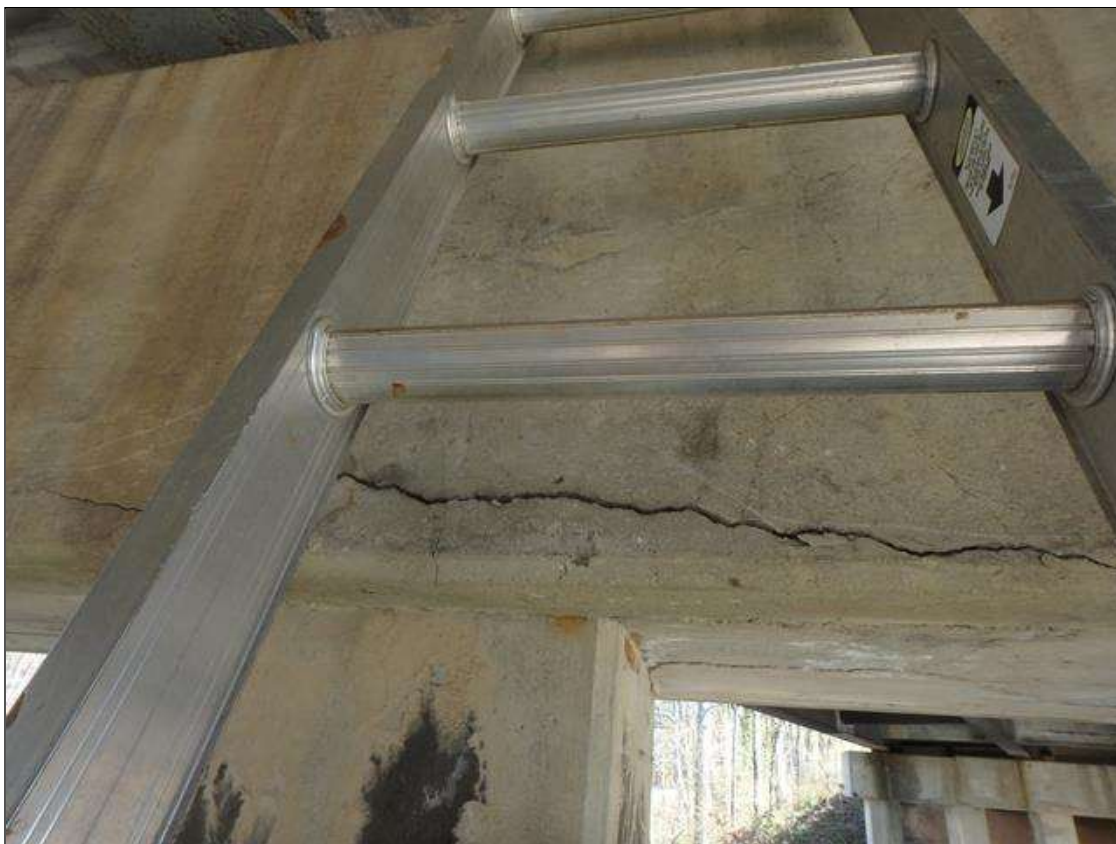
Bent 2 Cap west side bottom corner from column 3 to 4, 1/8" longitudinal crack and Delamination.

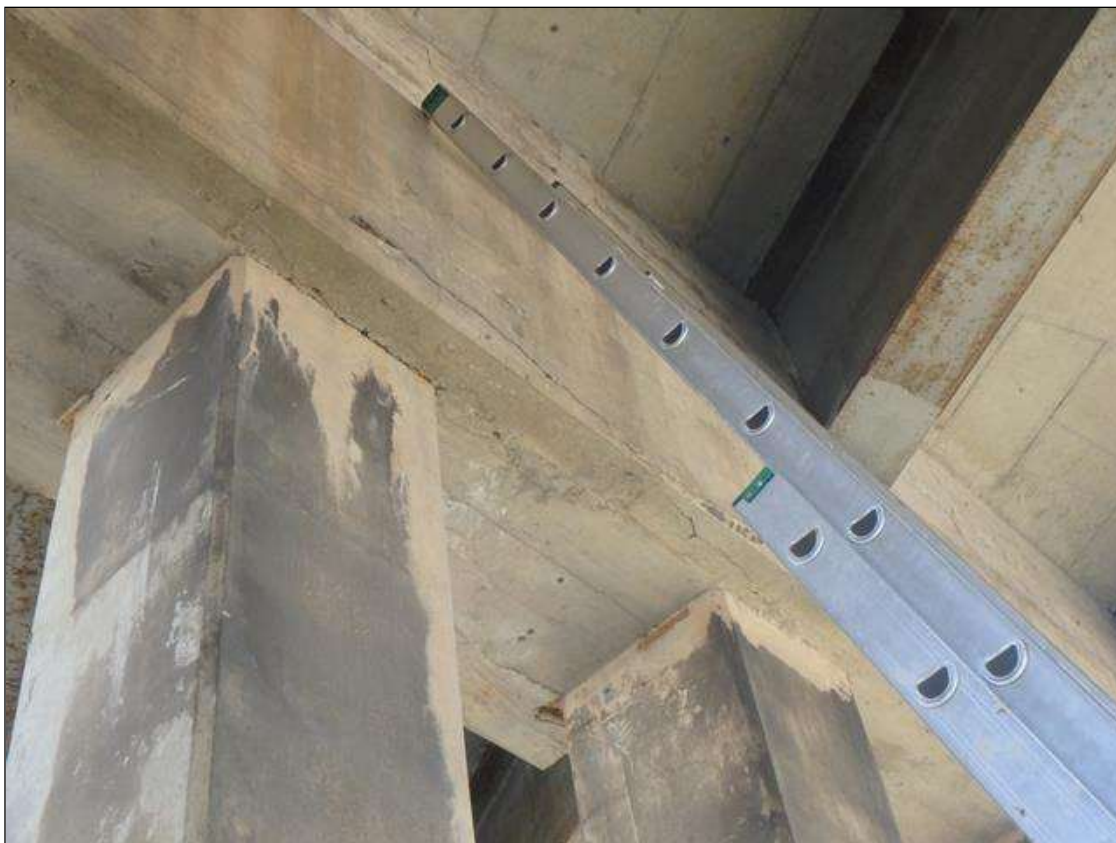
Bent 2 Cap west side bottom corner from column 3 to 4, 1/8" longitudinal crack and Delamination.

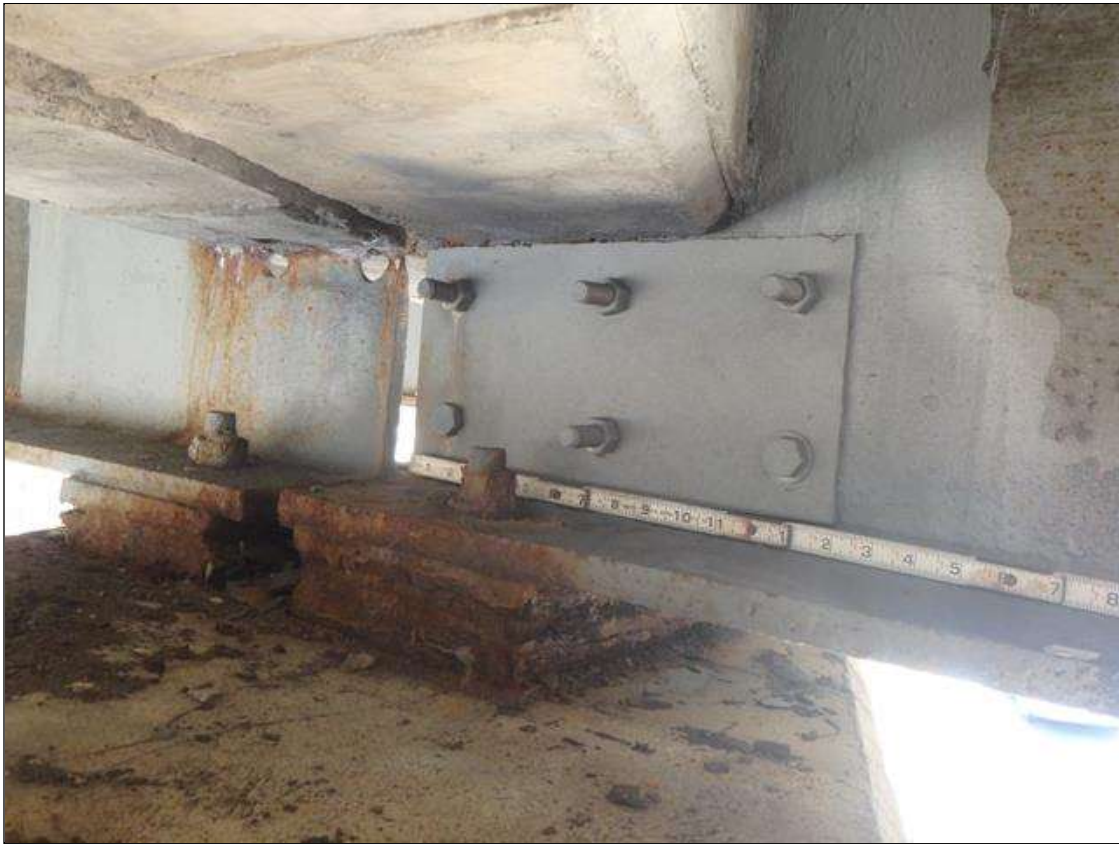
Span 2 Beam 4 at Bent 2, Temporary repair, 1/4" x 7" x 14" plates bolted to web at end of beam, both sides.

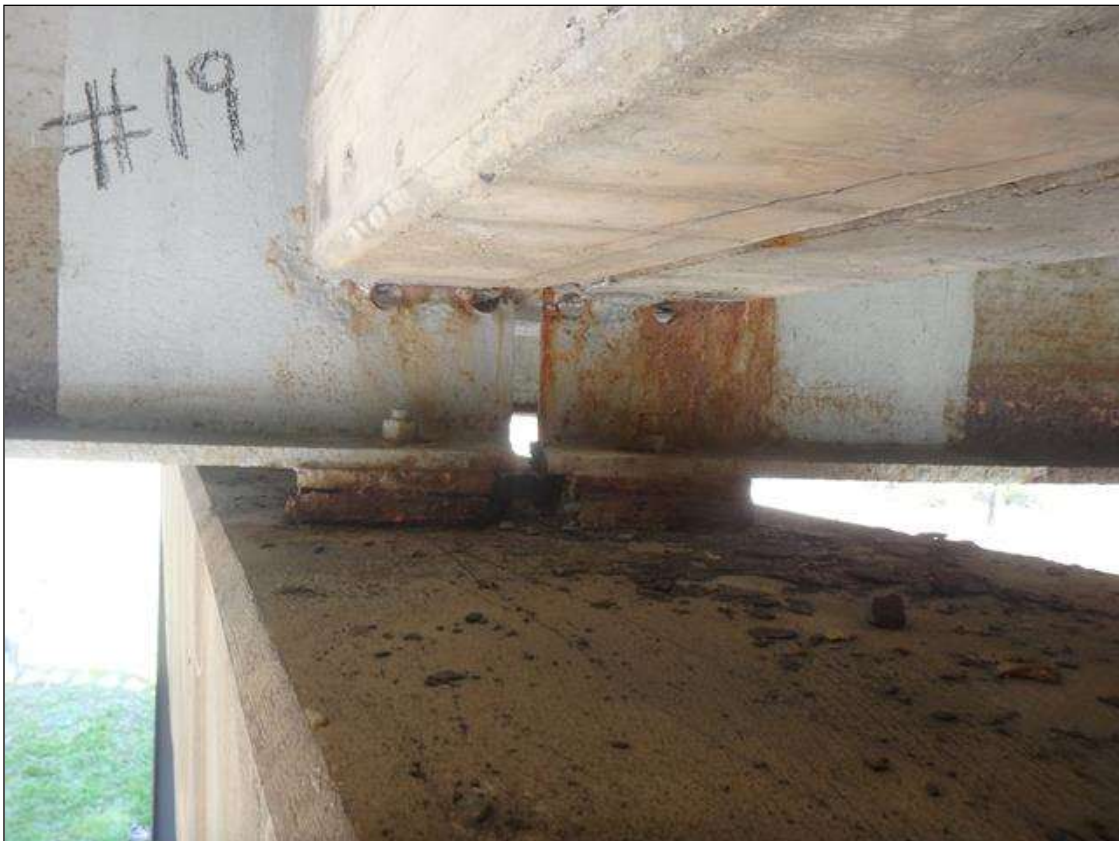
Spans 2 and 3 Beam 3 at Bent 2, end of beams below diaphragm has Section Loss, Surface Corrosion/Freckled Rust initiated since beam was cleaned and painted.

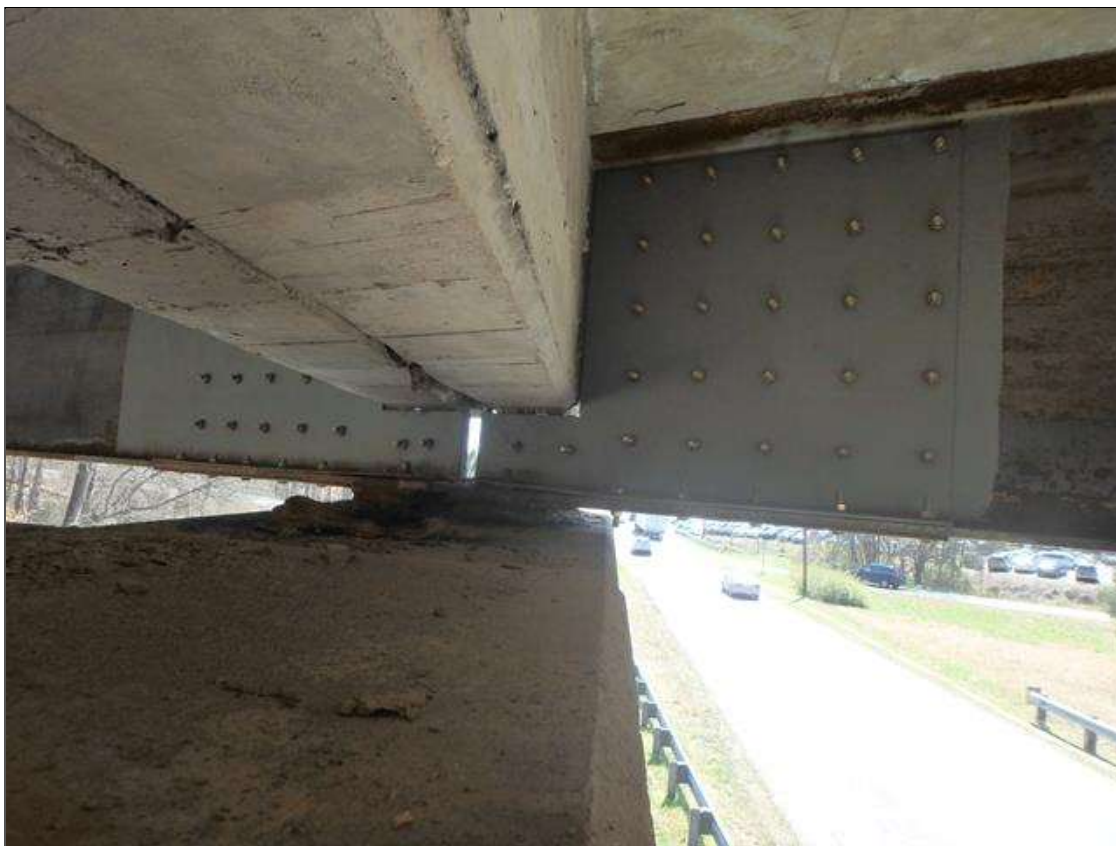
Spans 2 and 3 Beam 5 at Bent 2, Temporary Repair to Section Loss, 1/4" thick plates bolted on both sides of beam in web and bottom flange.

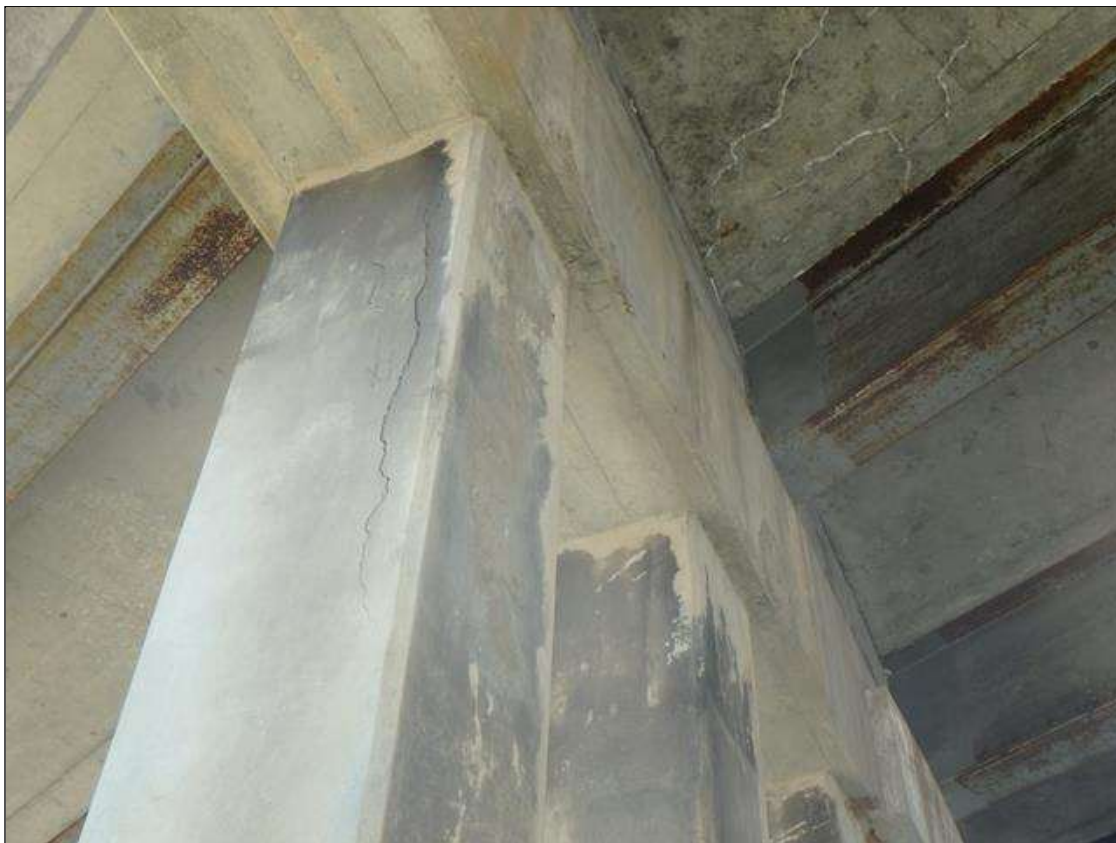
Bent 2 RC column 6 Southeast Corner vertical crack up to 3/16" wide with Delamination

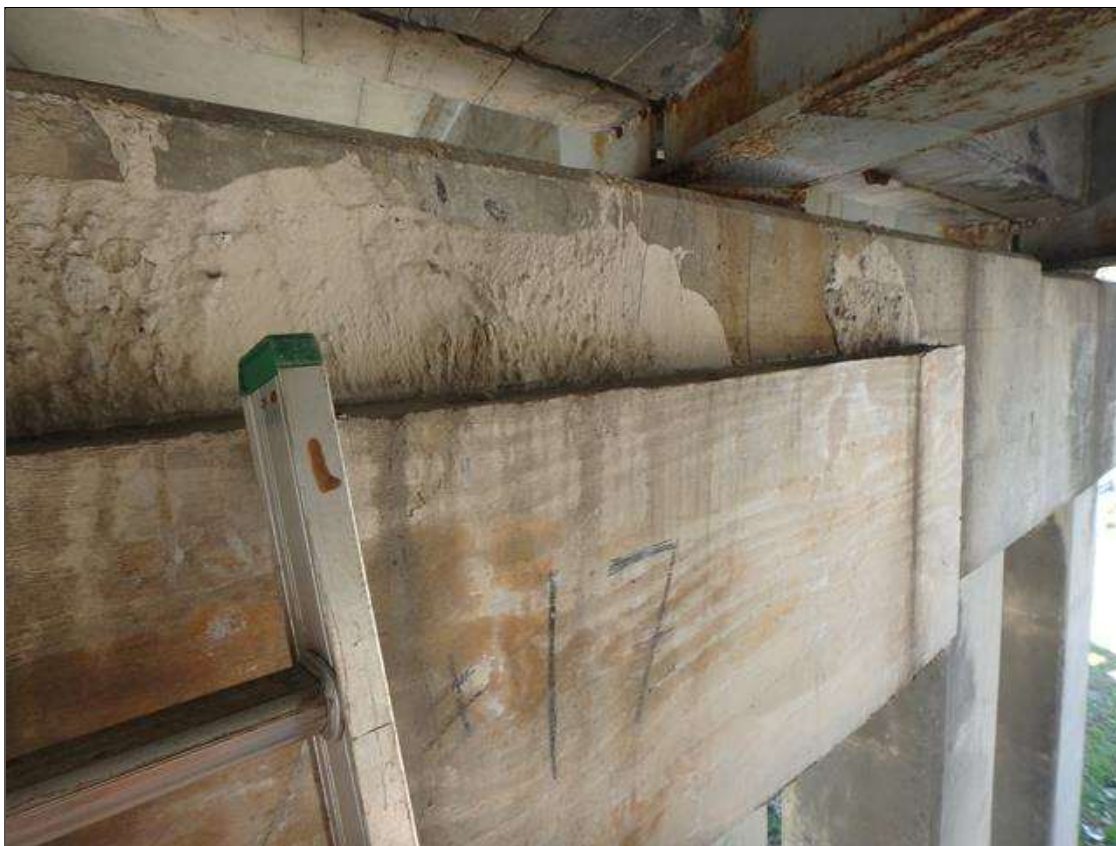
Bent 2 cap East side below bay 2, sound patch.

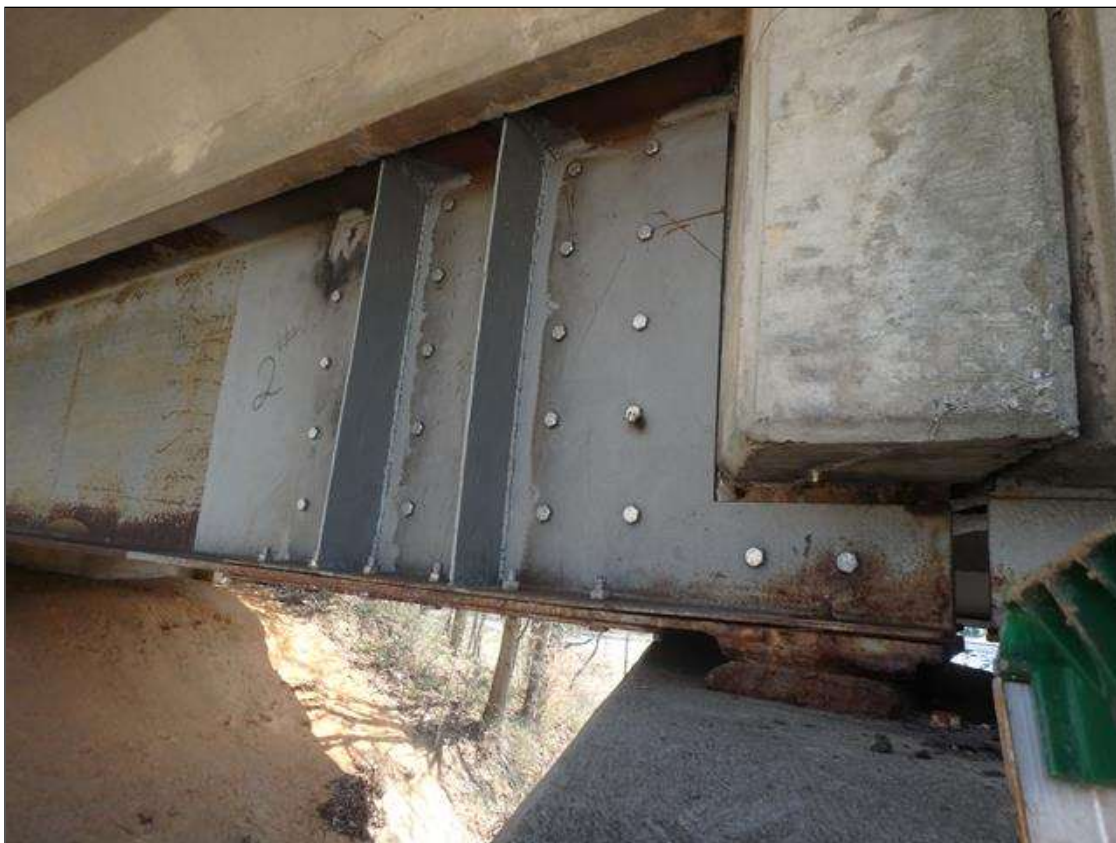
Span 4 Beam 1 at Bent 3, Temporary Repair to Section Loss, 1/4" thick plates bolted to both sides of web and bottom flange.

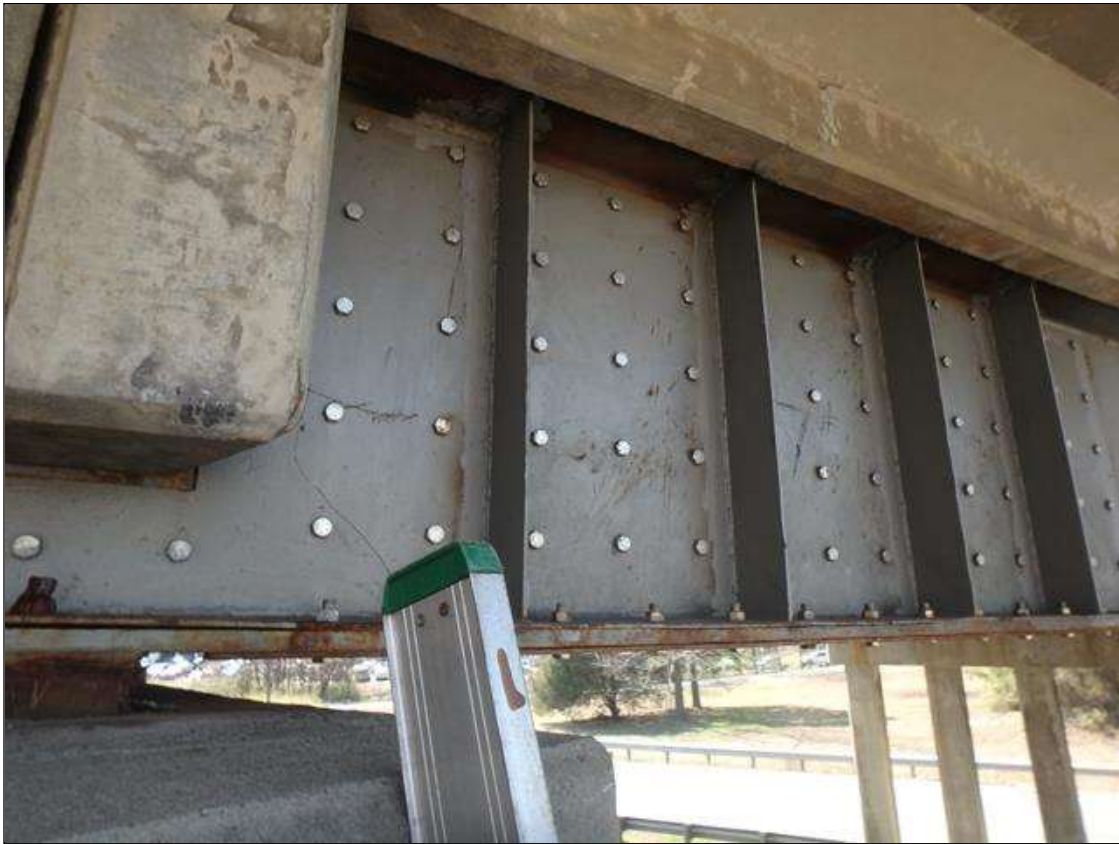
Span 3 Beam 1 at Bent 3, Temporary Repair to Section Loss, 1/4" thick plates bolted to both sides of web and bottom flange.

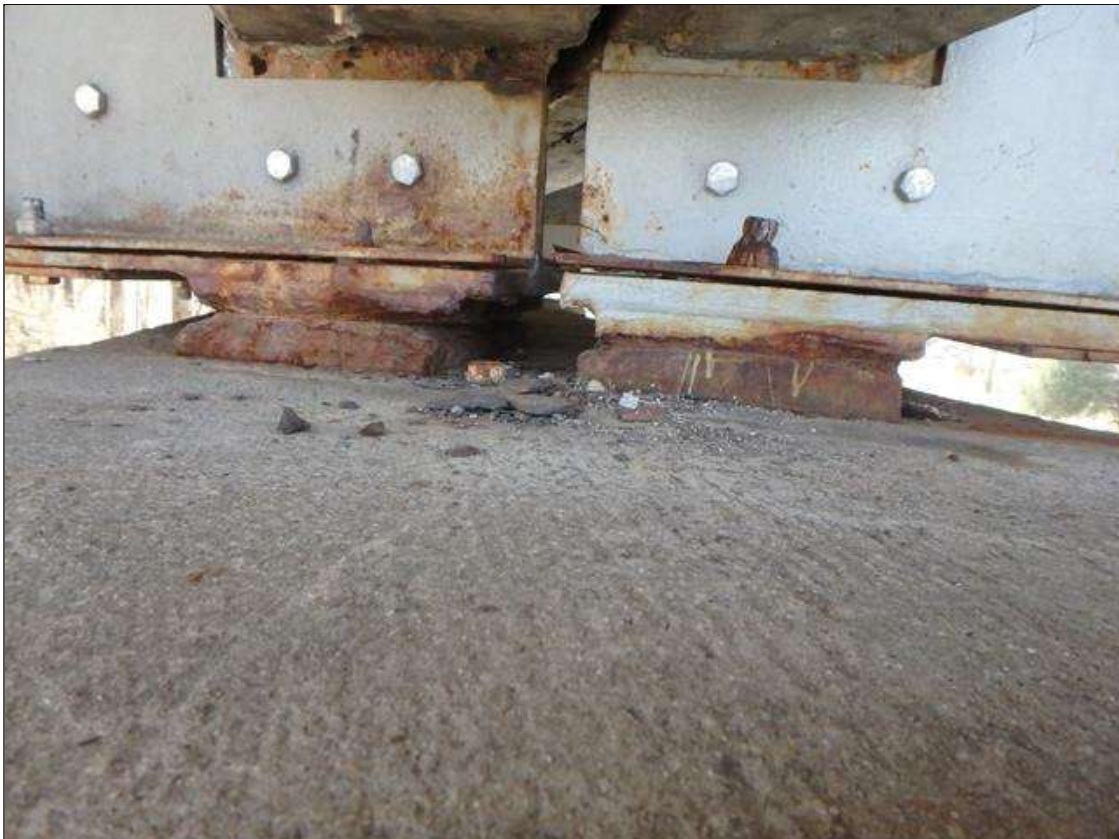
Spans 3 and 4 Bearing Assembly seat 1 at Bent 3, Active Corrosion and Section Loss in plates, Section Loss in anchor rods down to 3/8" Remaining.

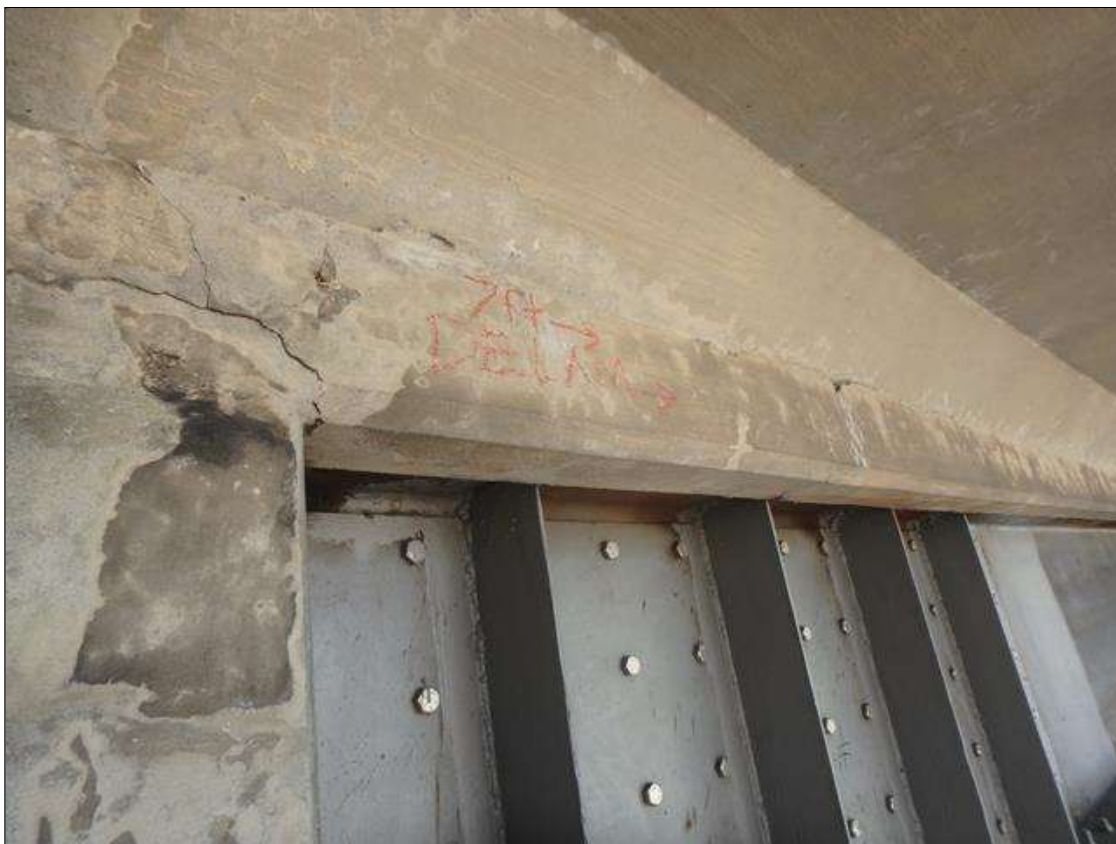
PRIORITY MAINTENANCE: Span 3 RC Deck underside left overhang at Bent 3, Delamination in build up 7' long x 6" x 4".

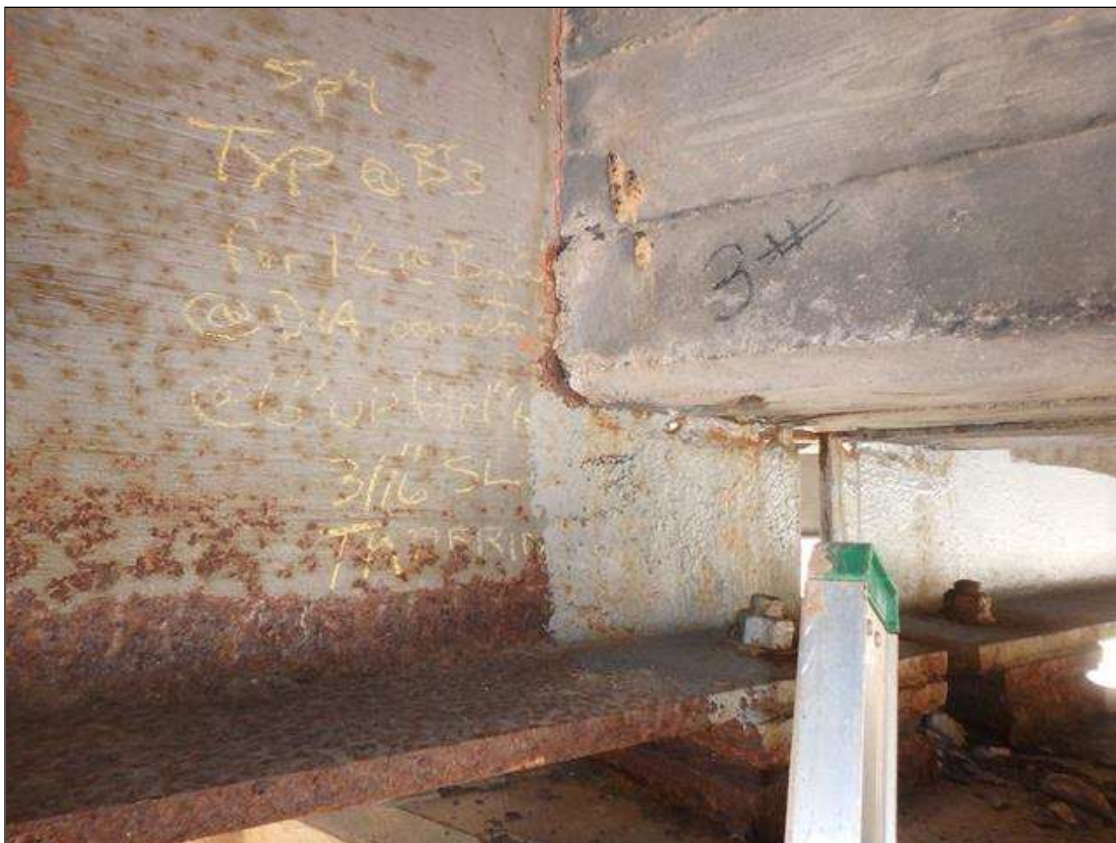
Spans 3 and 4 Beam 2 at Bent 3, end of beams Section Loss in the web below diaphragm, Freckled Rust initiated since beam was painted.

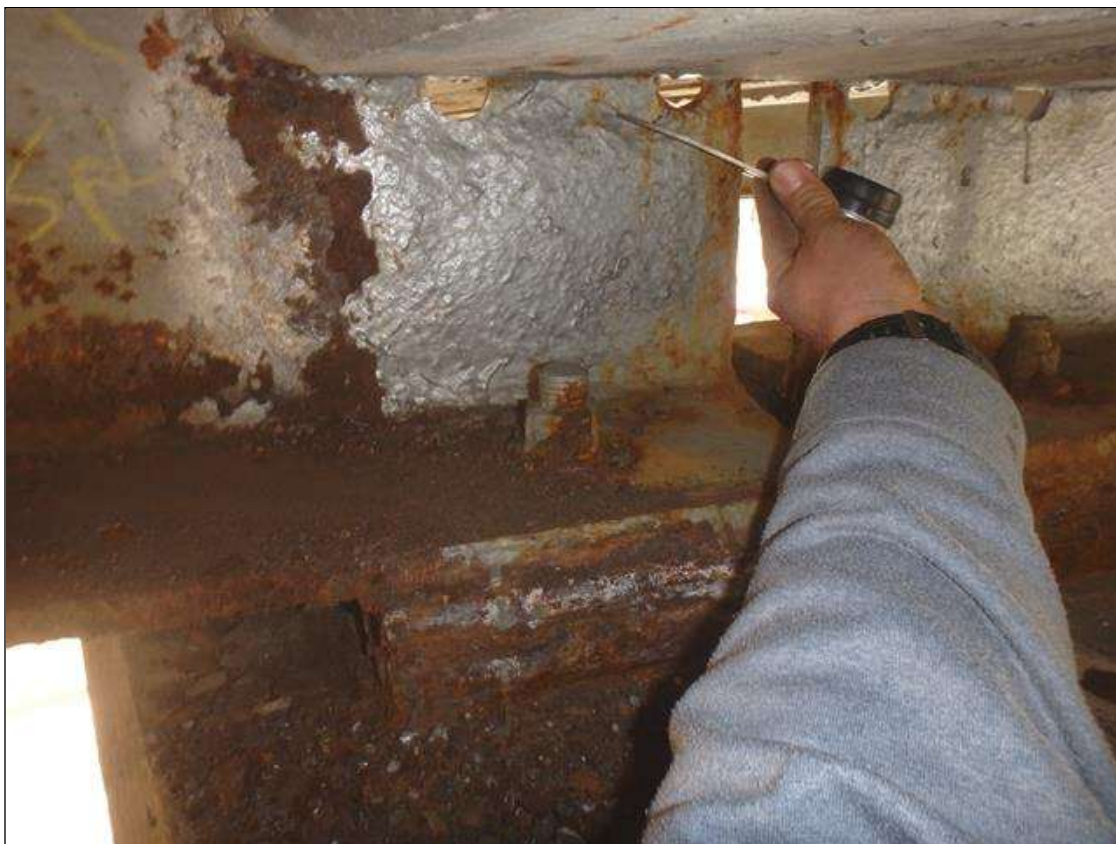
Spans 3 and 4 Beam 3 at Bent 3, end of beams Section Loss in the web below diaphragm, Freckled Rust initiated since beam was painted.

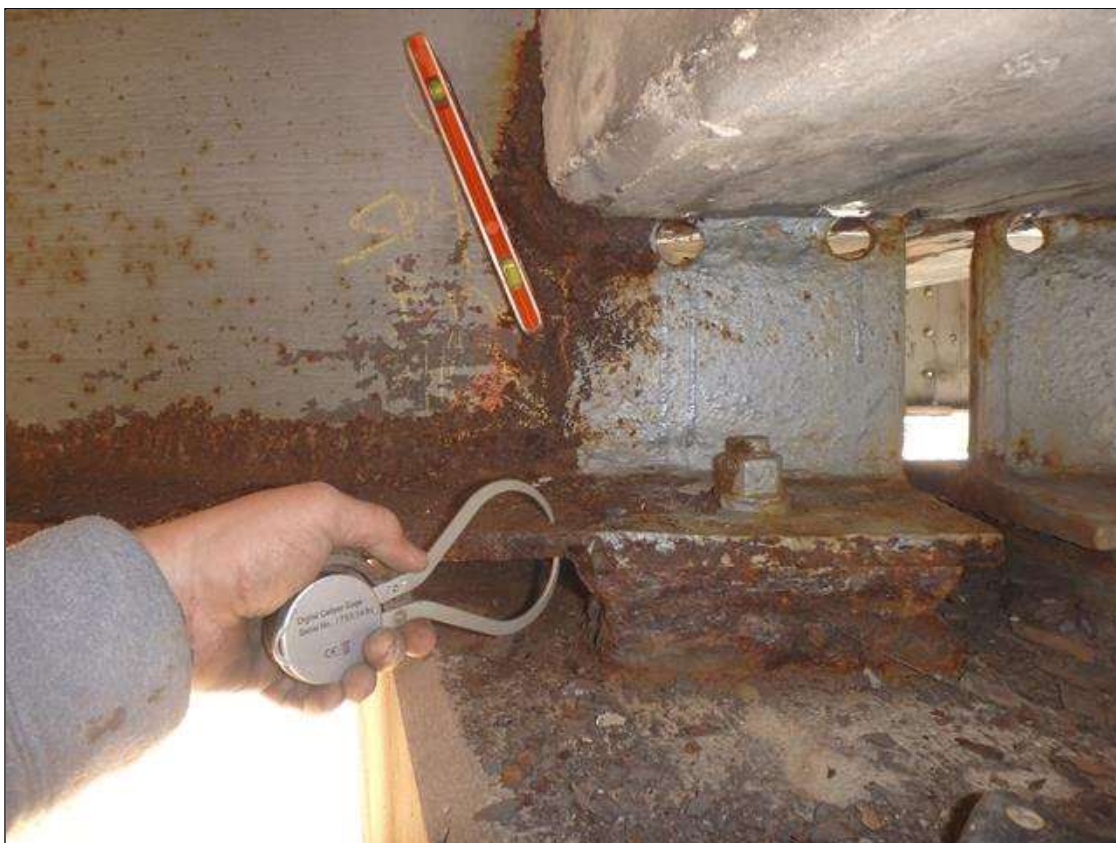
Span 4 Beam 4 at Bent 3 Section Loss in the web below diaphragm and in bottom flange in front of bearing.

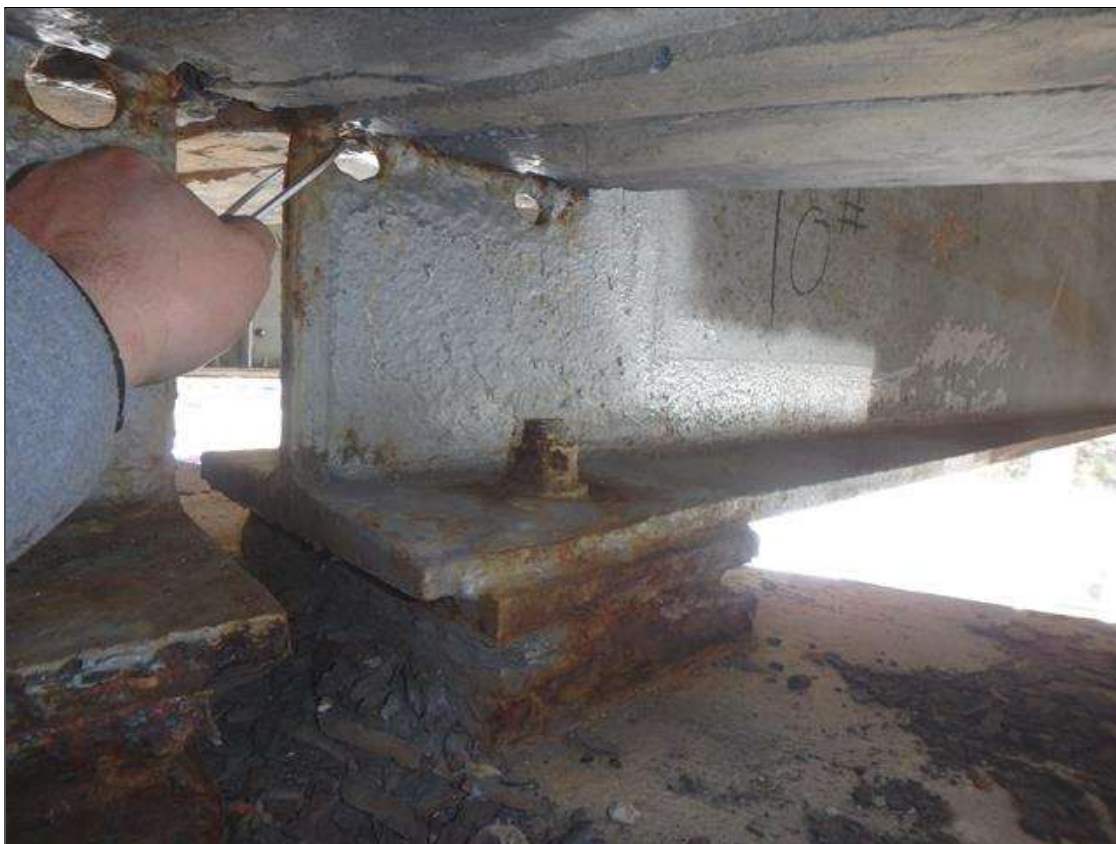
Span 3 Beam 4 at Bent 3 Section Loss in the web below diaphragm, Freckled Rust initiated since beam was cleaned and painted.

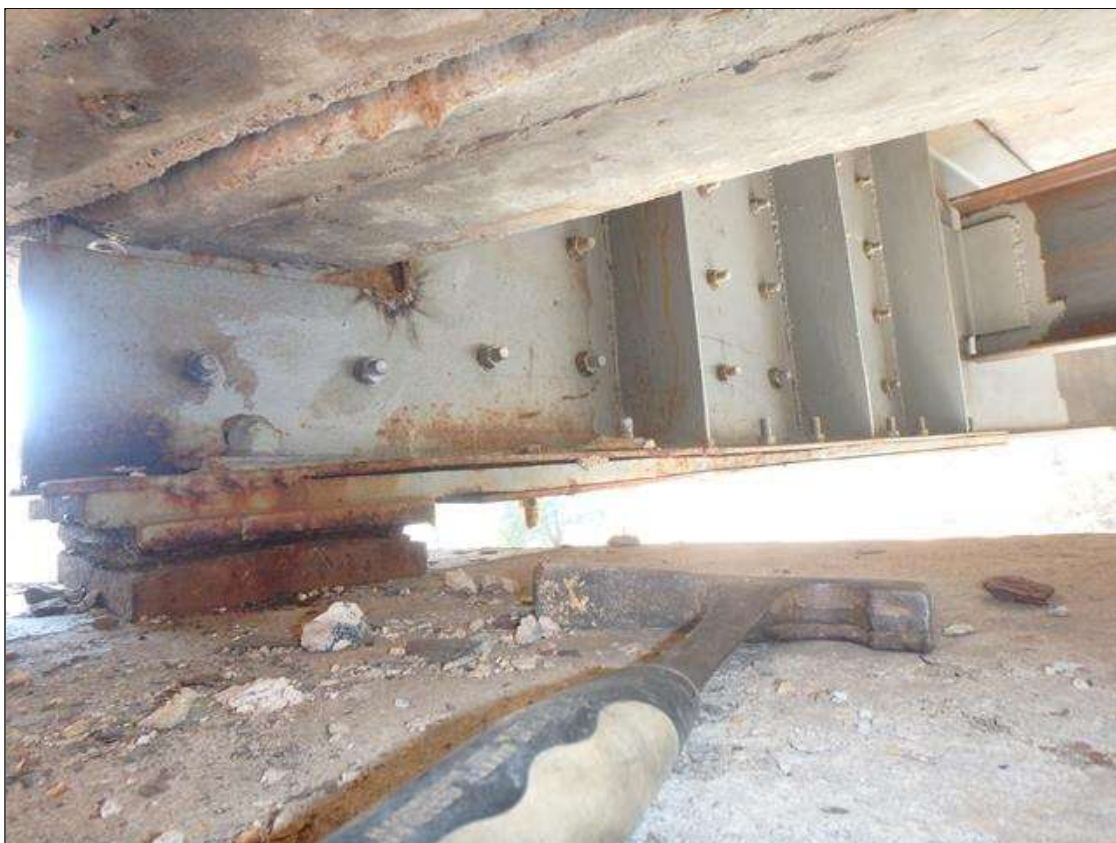
Span 3 Beam 5 at Bent 3, Temporary Repair to Section Loss, 1/4" thick plates bolted to web and bottom flange.

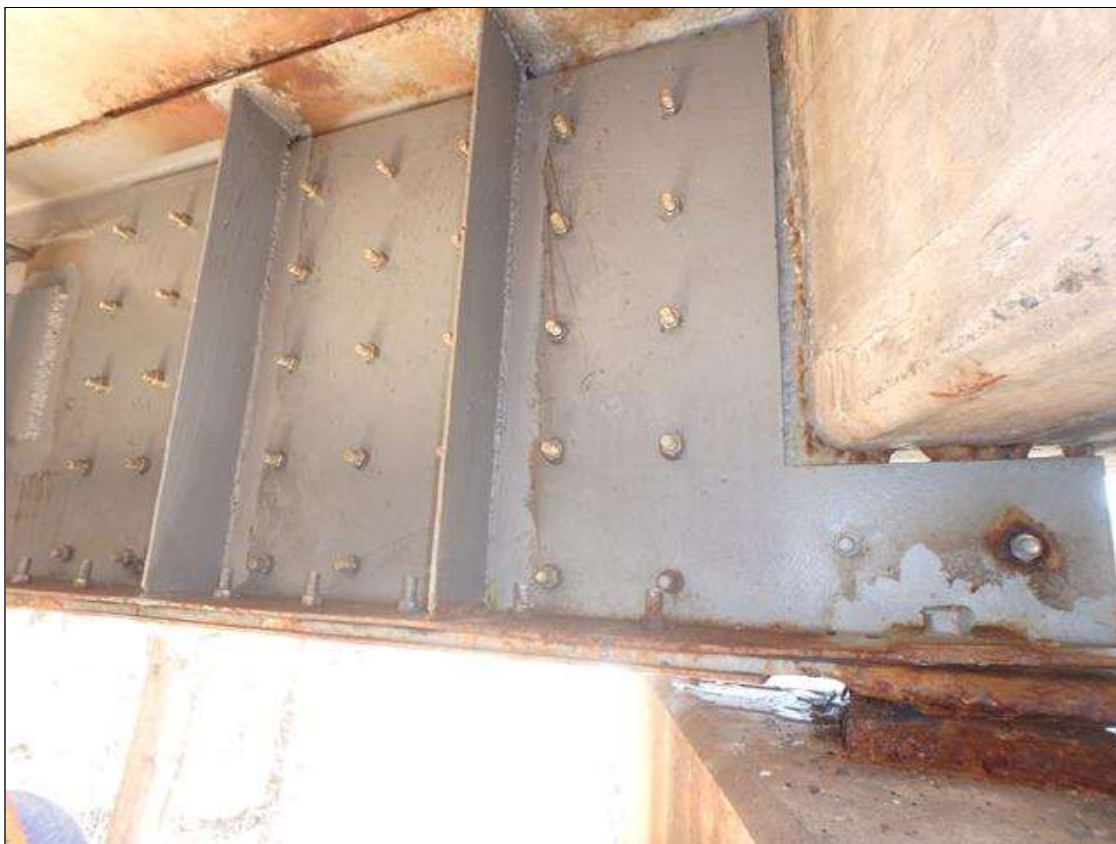
Span 4 Beam 5 at Bent 3, Temporary Repair to Section Loss, 1/4" thick plates bolted to web and bottom flange.

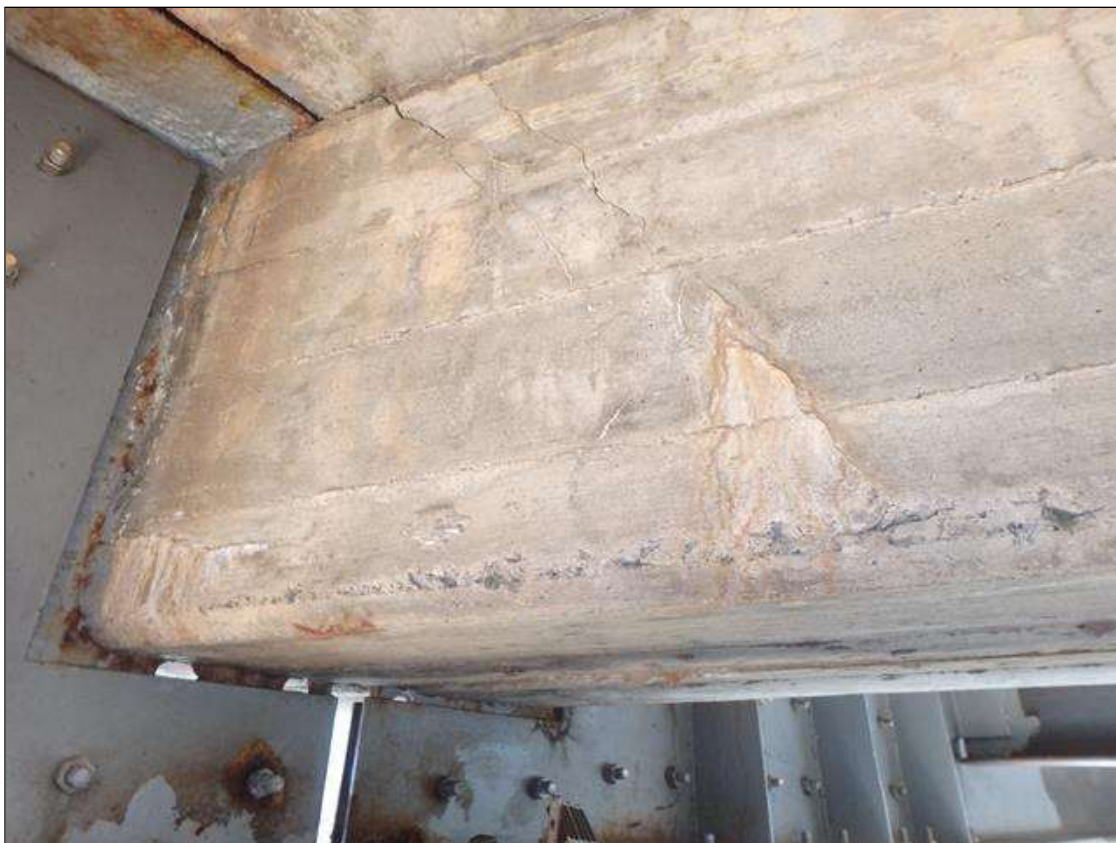
Span 4 RC intermediate diaphragm at Bent 3 in bay 4, Diagonal cracks up to 1/8" wide with efflorescence.
