NC DEPARTMENT OF TRANSPORTATION
 DIVISION OF HIGHWAYS
 STRUCTURE MANAGEMENT UNIT

ATTENTION: **PRIORITY MAINTENANCE, SHORED**

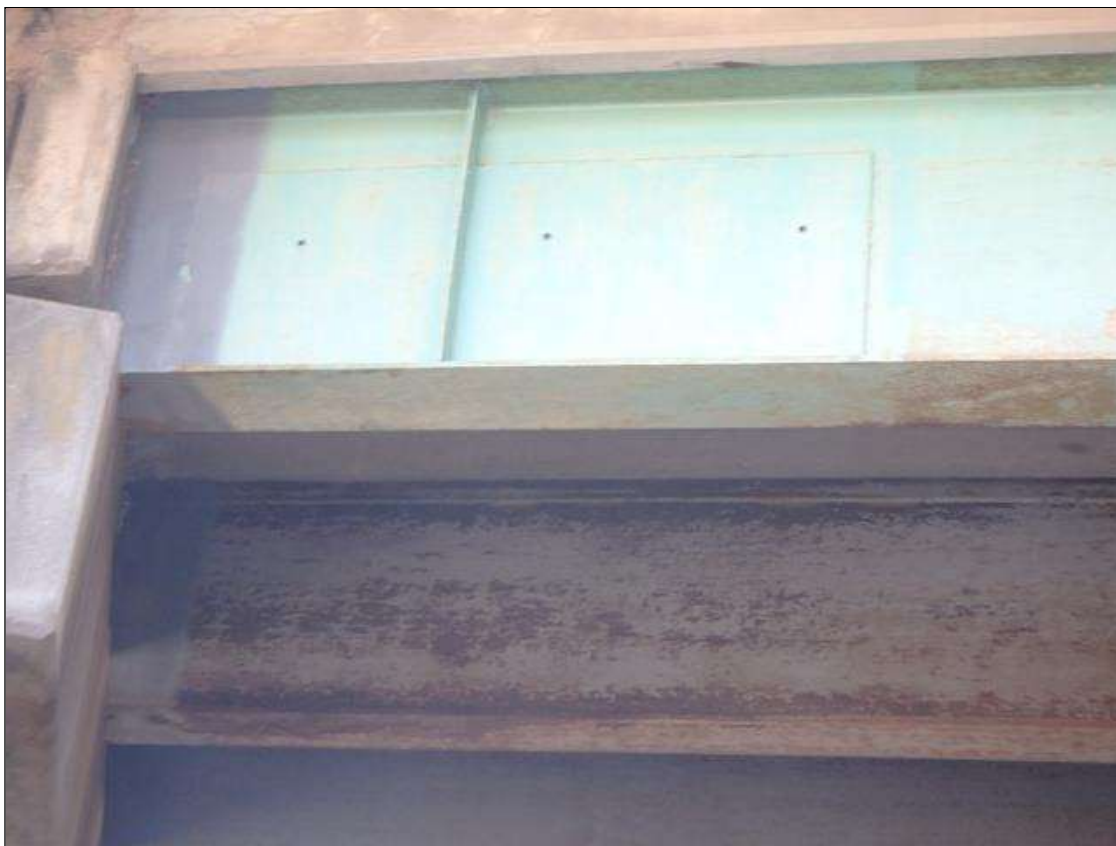
Span 1 Beam 1 at Bent 1, left side, Temporary Repair to Section Loss, 3/8" thick plates welded to web.

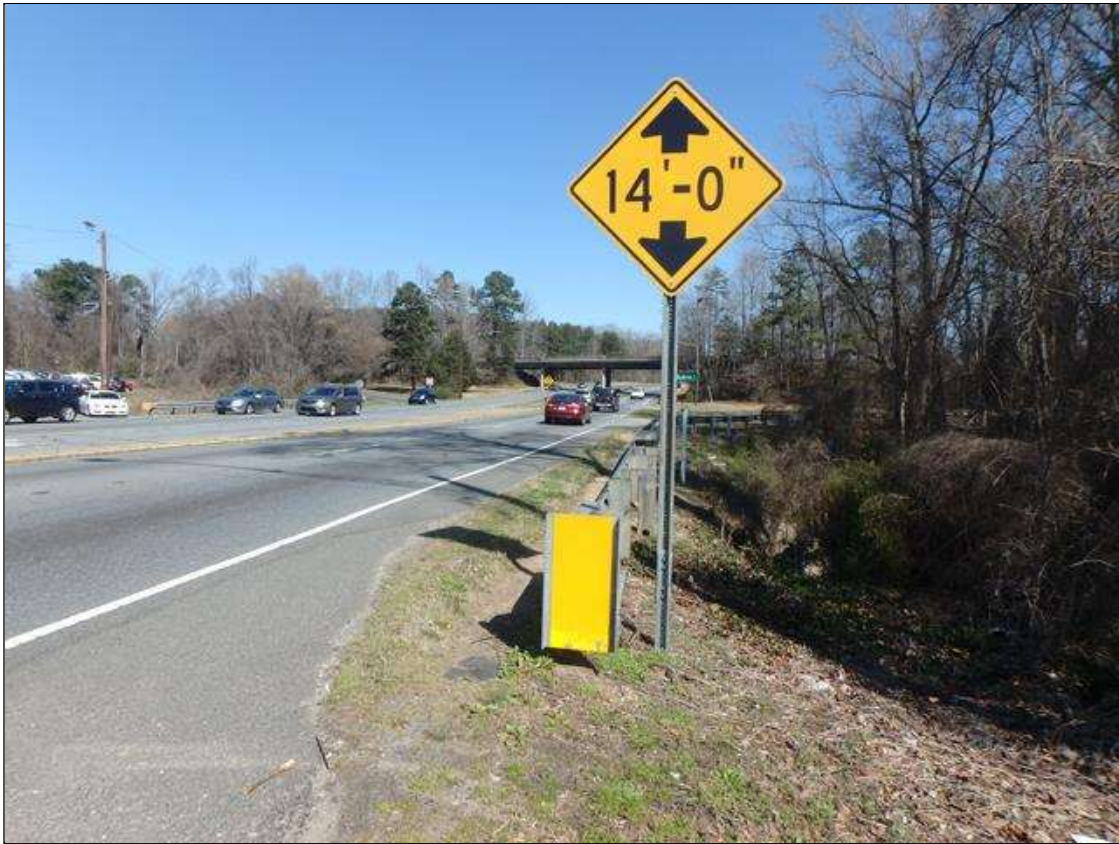
North bound US 29 vertical clearance sign at 450' south of structure

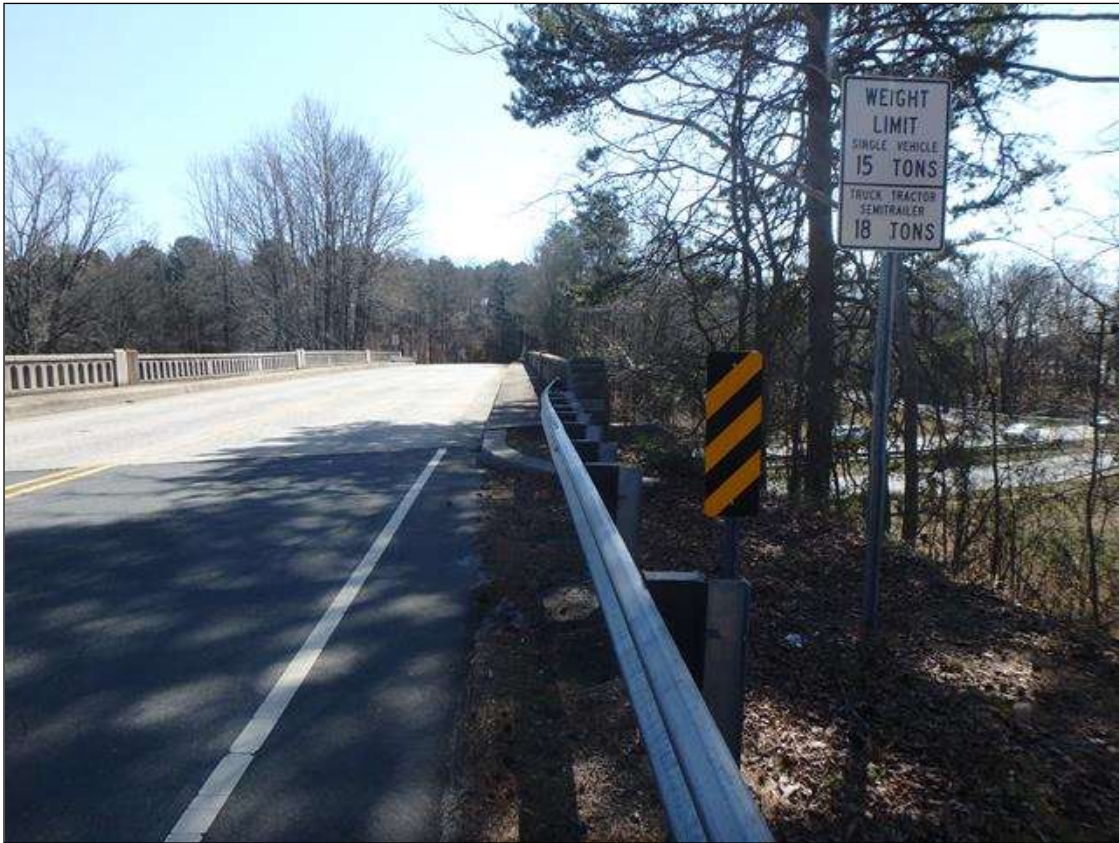
MMS Code	MMS Description	Quantity
3326	Maintain Concrete Deck	7 SF
Location:		
Bent/Span No.		
Priority Level	Status	
Recommended	Routine Maintenance	
Submitted Date:	Submitted By:	Assisted By:
03/21/2018	JASON ROLFSMEYER	
Details		
<p>PRIORITY MAINTENANCE: Span 3 RC Deck underside left overhang at Bent 3, Delamination in build up 7' long x 6" x 4".</p>

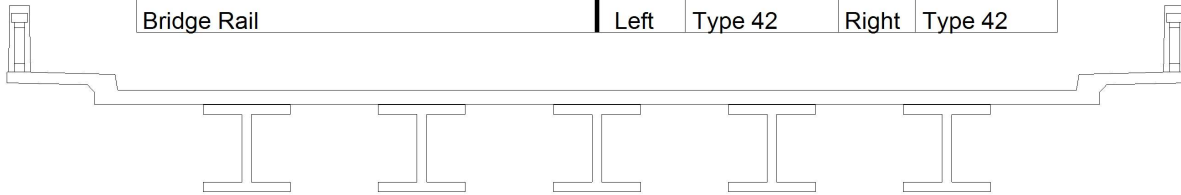
Measurements for Span #	1		
Deck Thickness	0.417	Left Overhang	5.167
Top of Rail to Bottom of Beam	6.917	Right Overhang	5.167

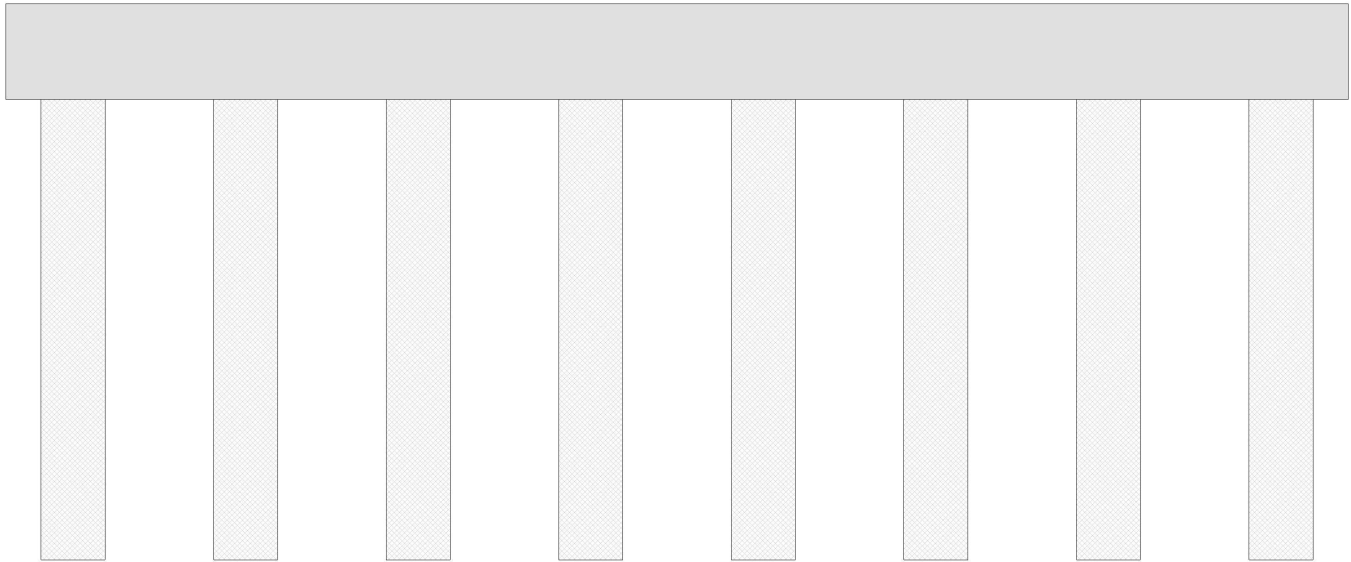
Cap Information			Material Cast-in-Place Concrete							
Length	Width	Height	Left Overhang	Right Overhang	Left Beam to End of Cap.	Right Beam to End of Cap.
