NC DEPARTMENT OF TRANSPORTATION
DIVISION OF HIGHWAYS
STRUCTURE MANAGEMENT UNIT

Structure Safety Report

Routine Element Inspection - Contract

FACILITY CARRIED: I-40 MILE POST: 29.3

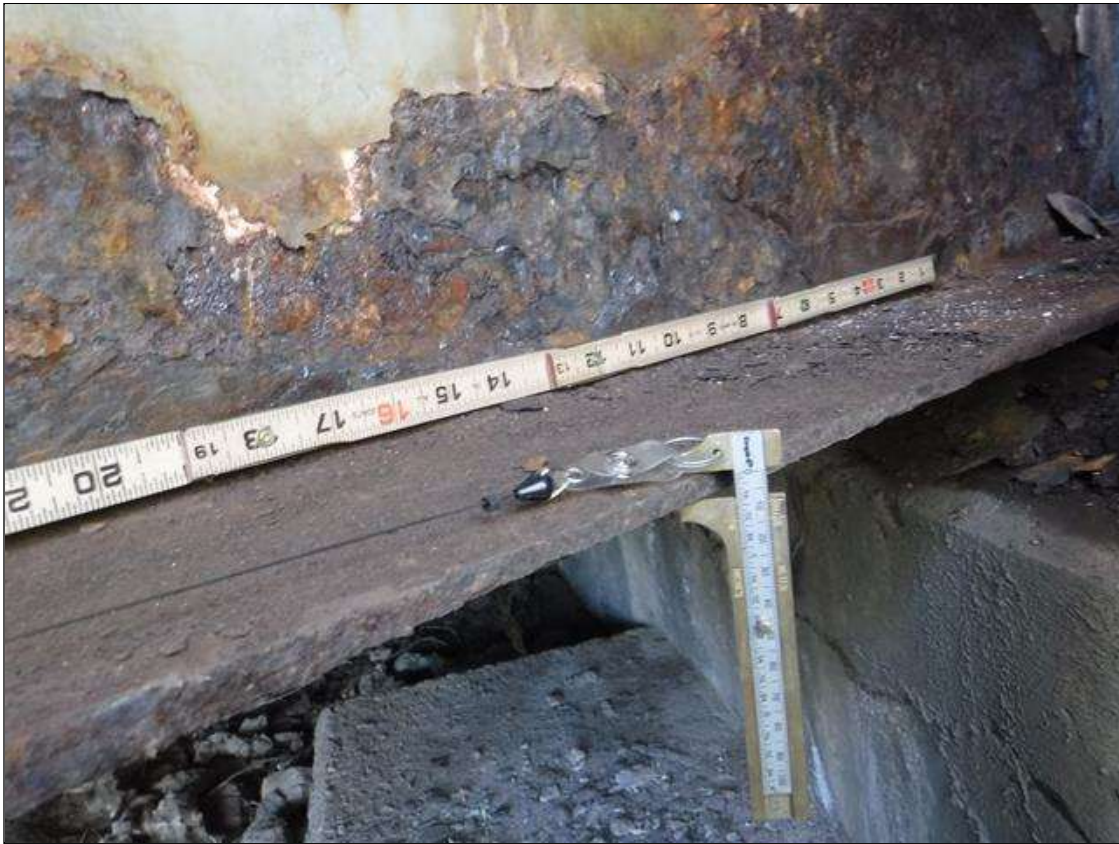
Span 1 Beam 1: PAR: CORROSION ALONG WEB AND BOTH FLANGES UP TO 45" LONG X 14" HIGH DOWN TO 1/4" RESIDUAL WEB, 42" LONG X 6" WIDE WITH NO MEASURABLE LOSS OF SECTION IN TOP FLANGE, AND 46" LONG X 6" WIDE DOWN TO 1/4" RESIDUAL BOTTOM FLANGE EXTENDING FROM END OF BEAM AT END BENT 1, CONDITION ON LEFT SIDE SHOWN

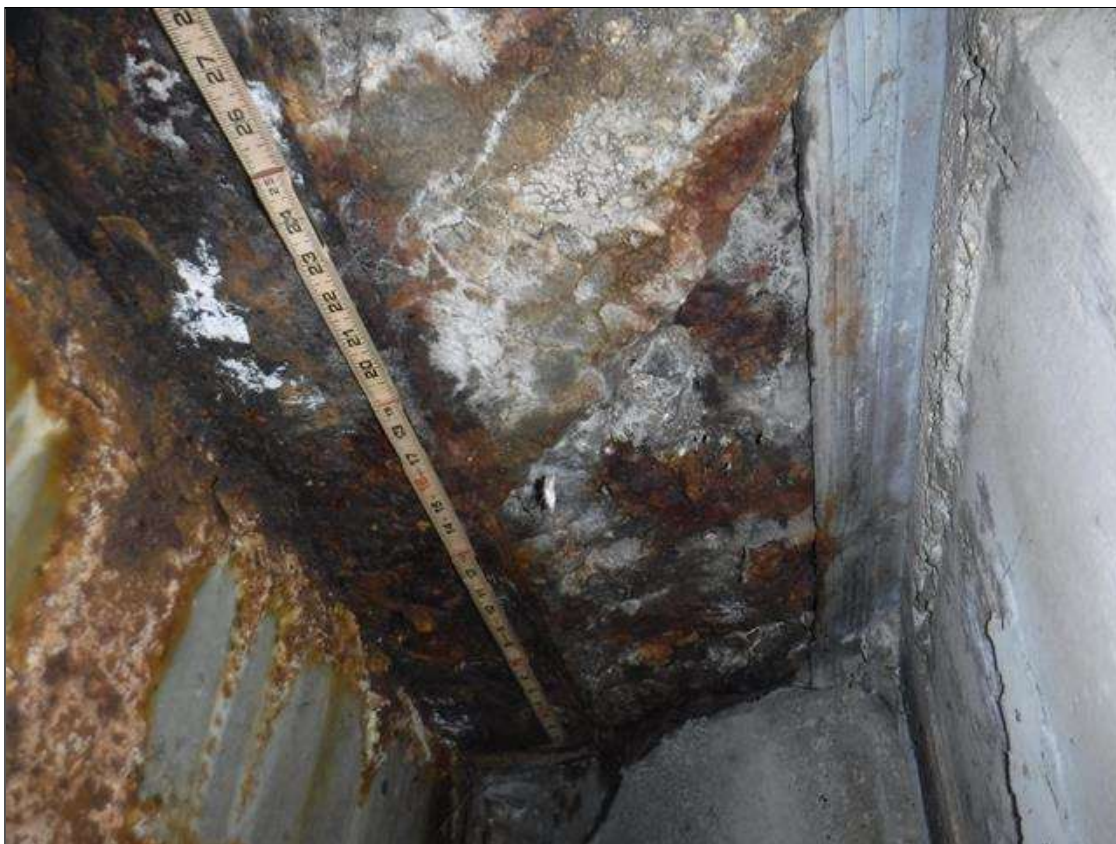
Span 1 Deck: 26" X 11" X 2" DEEP SPALL IN BOTTOM OF DECK TO LEFT OF BEAM 1 AT END BENT 1

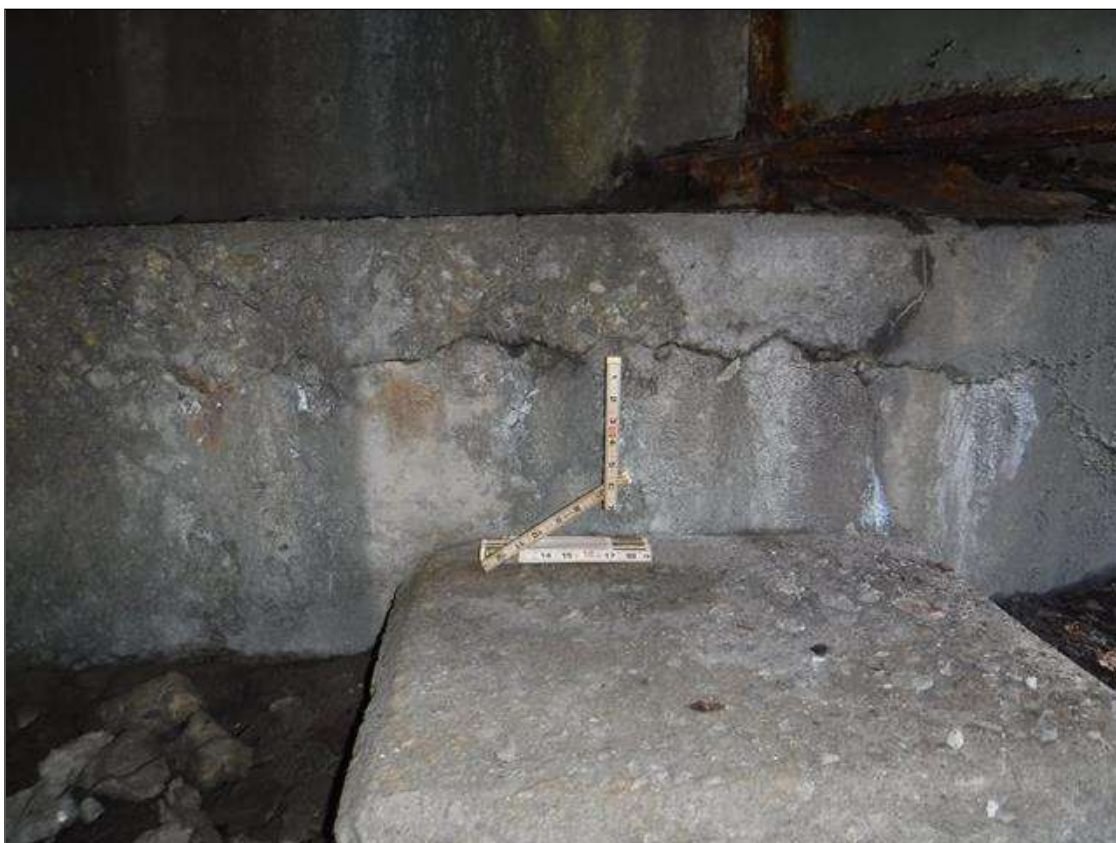
End Bent 1 Cap 1: UP TO 1/4" TRANSVERSE AND VERTICAL CRACKS WITH AND WITHOUT EFFLORESCENCE
IN FACE OF CAP BENEATH BAY 1

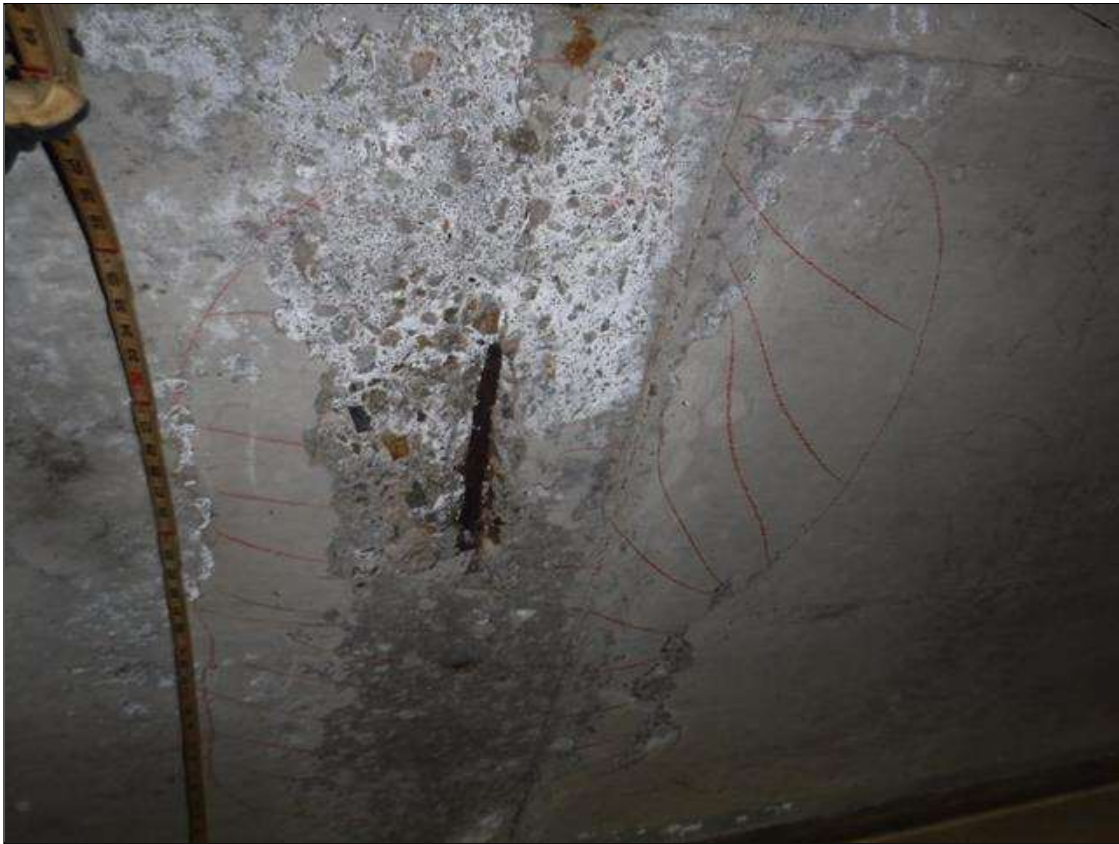
Span 1 Deck: 12" X 6" X 1 1/2" DEEP SPALL WITH EXPOSED REBAR AND 40" X 17" AREA OF DELAMINATION IN BOTTOM OF DECK IN BAY 4, APPROXIMATELY 8' FROM END BENT 1

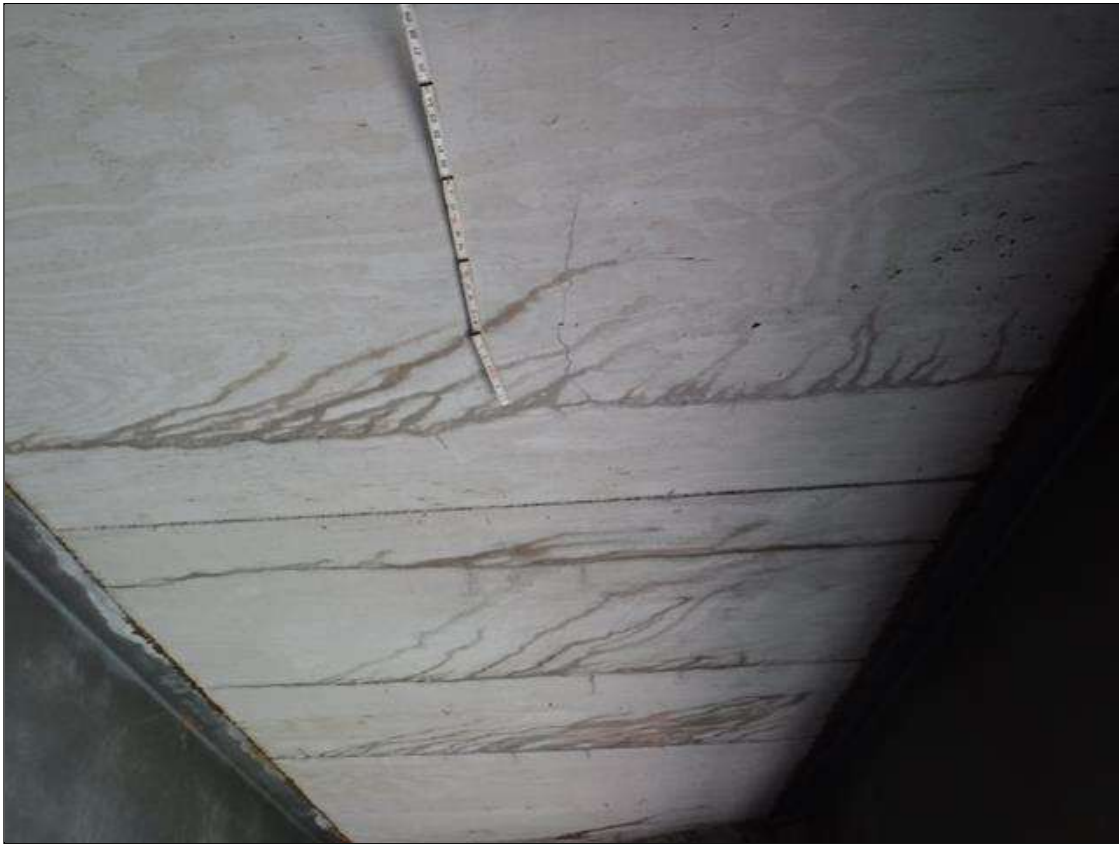
Span 1 Deck: 20' X 78" FAILED PATCH WITH UP TO 0.02" LONGITUDINAL AND TRANSVERSE CRACKS WITH EFFLORESCENCE IN BOTTOM OF DECK IN BAY 8, EXTENDING FROM BENT 1, CONDITION APPROXIMATELY 15' FROM BENT 1 SHOWN

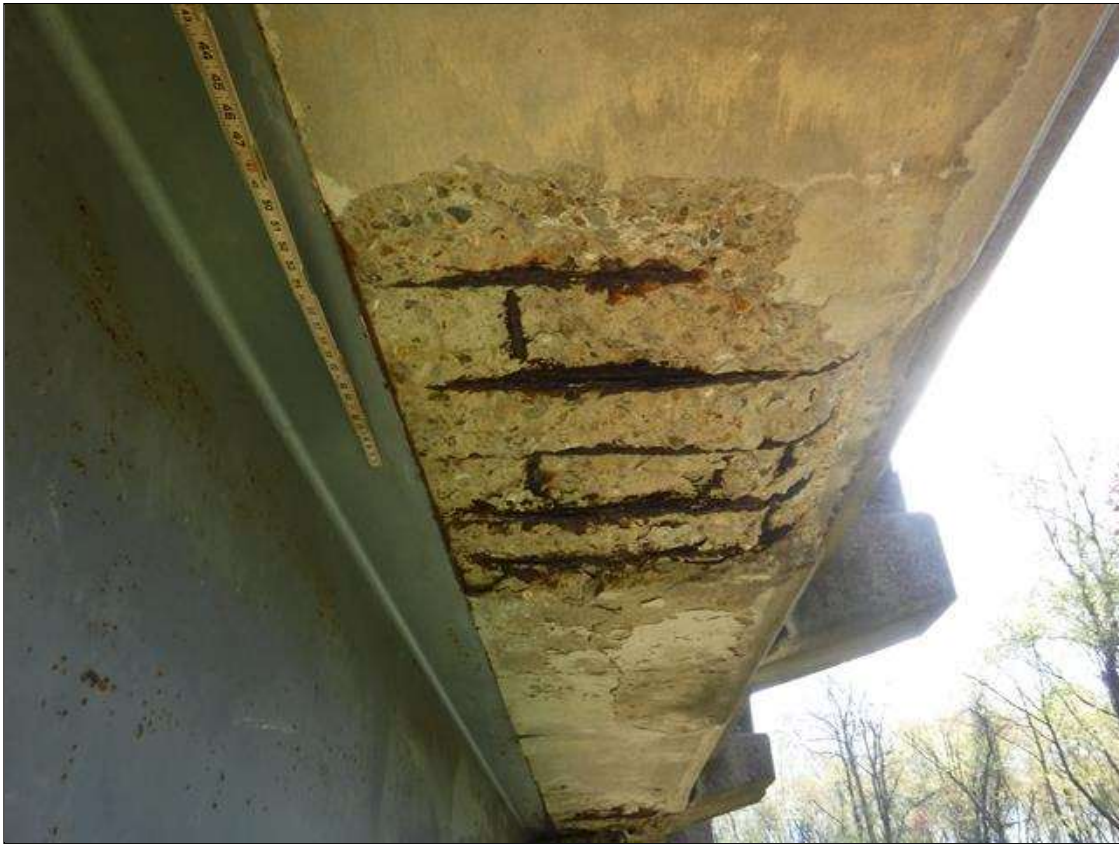
Span 1 Deck: PAR: (6) SPALLS WITH EXPOSED LONGITUDINAL AND TRANSVERSE REBAR UP TO 48" X 24" X 3" DEEP AND AREAS OF DELAMINATION UP TO 60" X 24" ALONG RIGHT OVERHANG, CONDITION APPROXIMATELY 15' FROM BENT 1 SHOWN

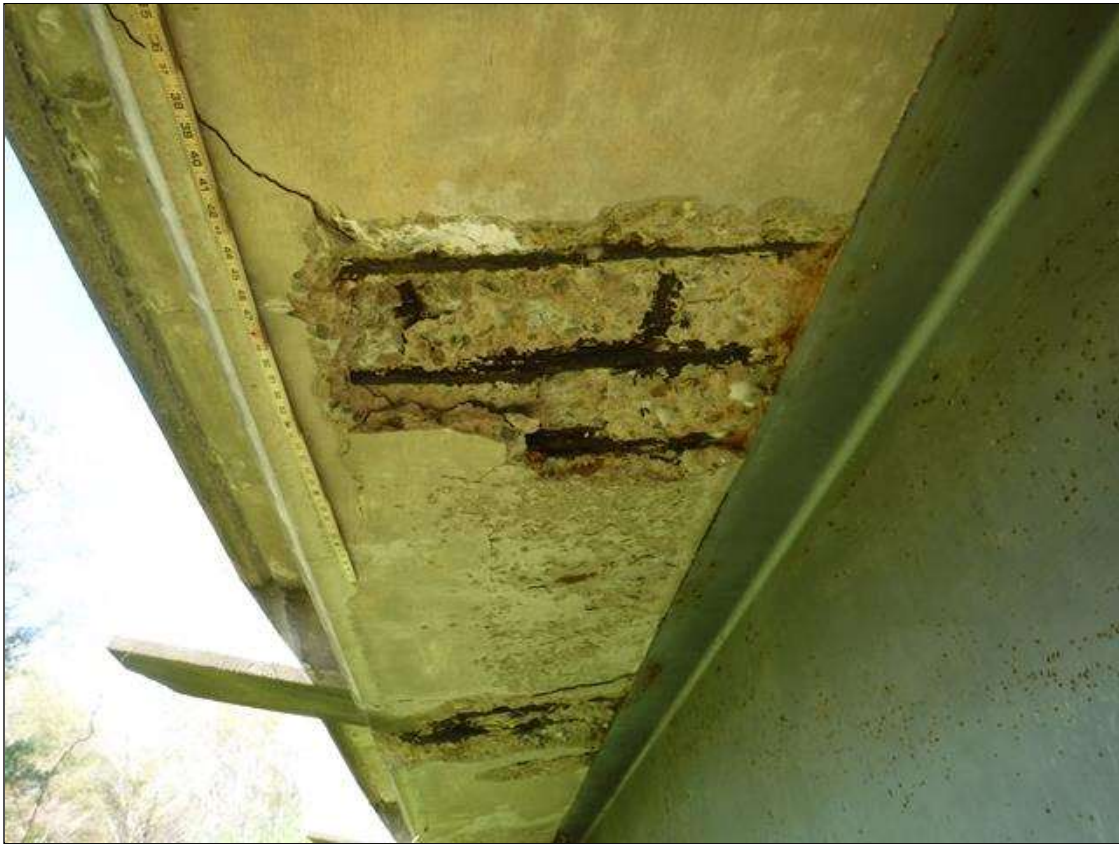
Span 1 Deck: PAR: (6) SPALLS WITH EXPOSED LONGITUDINAL AND TRANSVERSE REBAR UP TO 48" X 24" X 3" DEEP AND AREAS OF DELAMINATION UP TO 60" X 24" ALONG RIGHT OVERHANG, CONDITION APPROXIMATELY 13' FROM END BENT 1 SHOWN

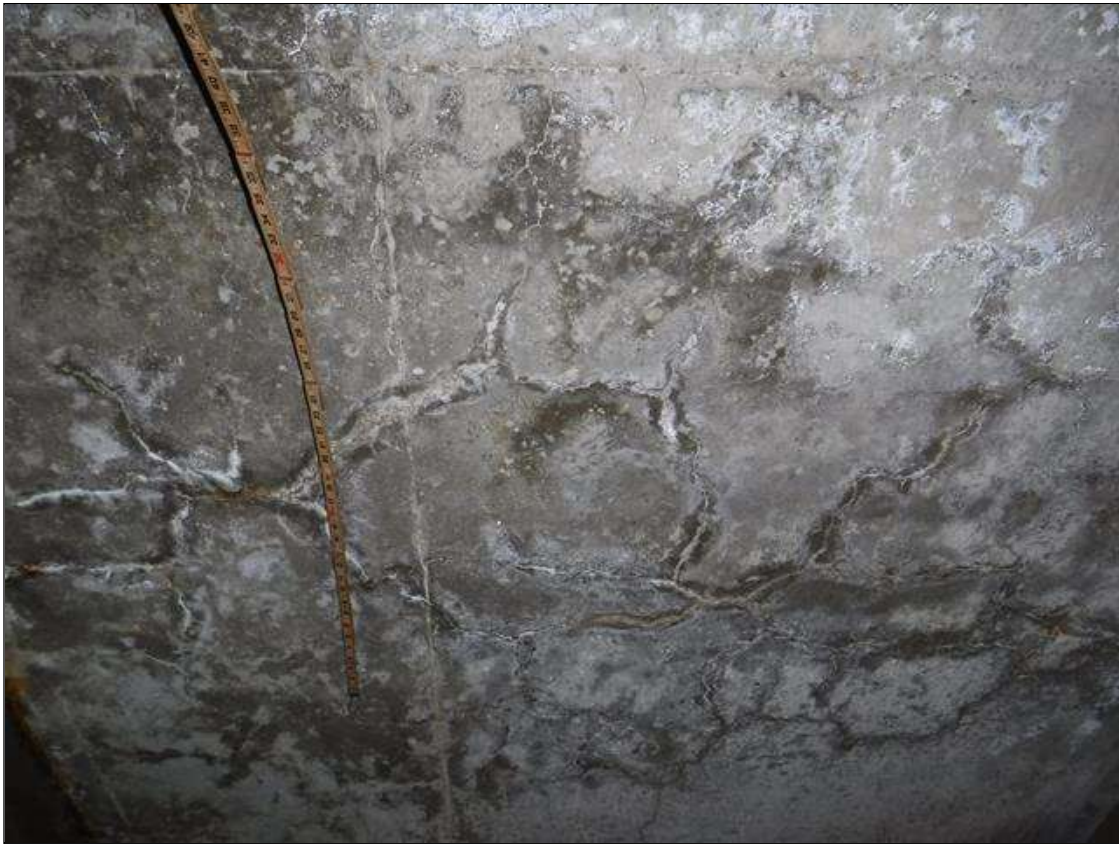
Span 1 Deck: AREAS OF HAIRLINE MAP CRACKING WITH EFFLORESCENCE IN BOTTOM OF DECK IN VARIOUS LOCATIONS, CRACKS IN BAY 2 APPROXIMATELY 17' FROM END BENT 1 SHOWN

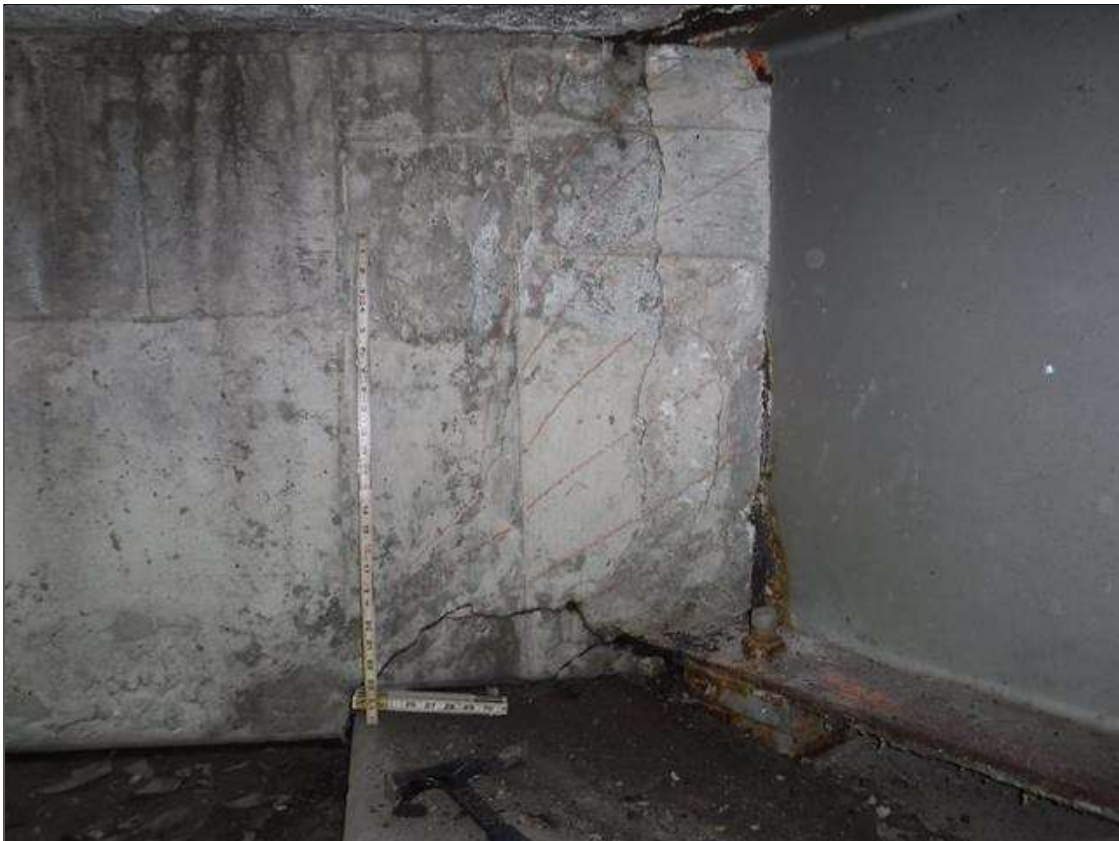
End Bent 1 Abutment/Backwall: FAILED PATCH WITH UP TO 34" X 21" AREA OF DELAMINATION IN FACE OF CURTAIN WALL TO RIGHT OF BEAM 8

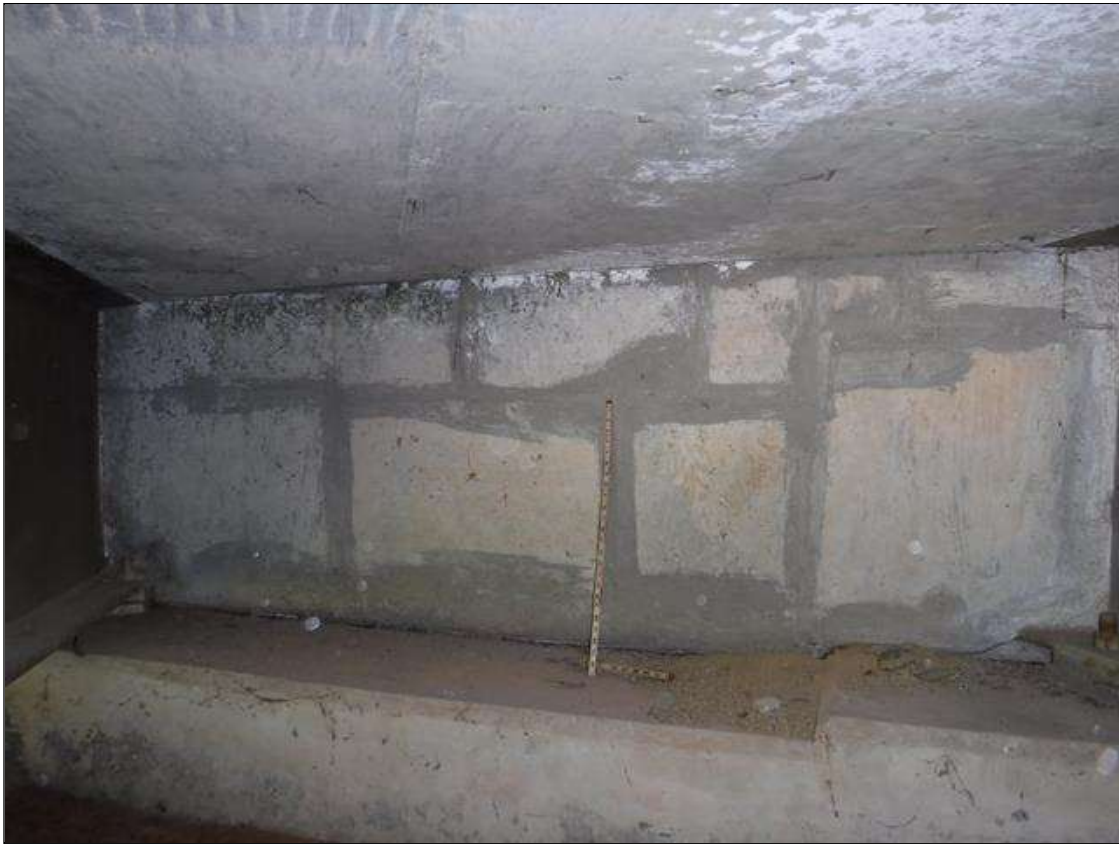
End Bent 1 Abutment/Backwall: UP TO 32" X 16" PATCHES IN FACE OF CURTAIN WALL IN VARIOUS LOCATIONS, CONDITION IN BAY 6 SHOWN

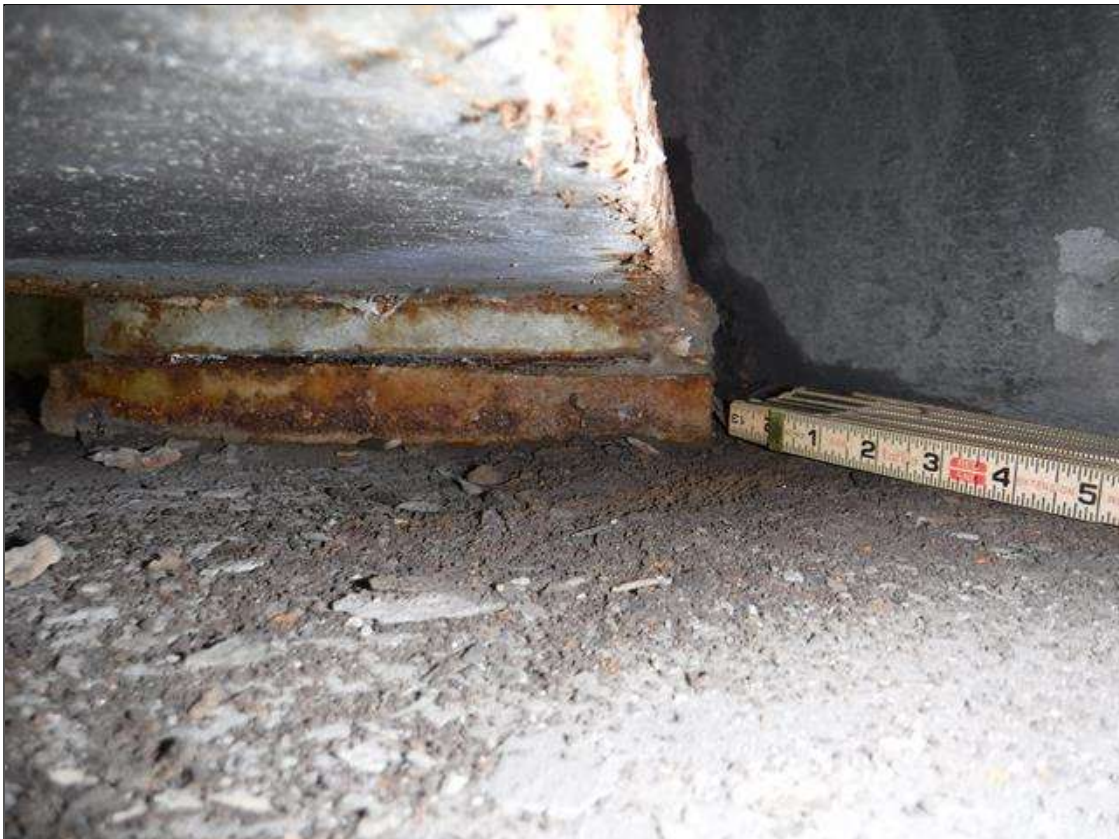
Span 1 Beam 9 Near Bearing: SURFACE CORROSION THROUGHOUT BEAM 9 BEARING

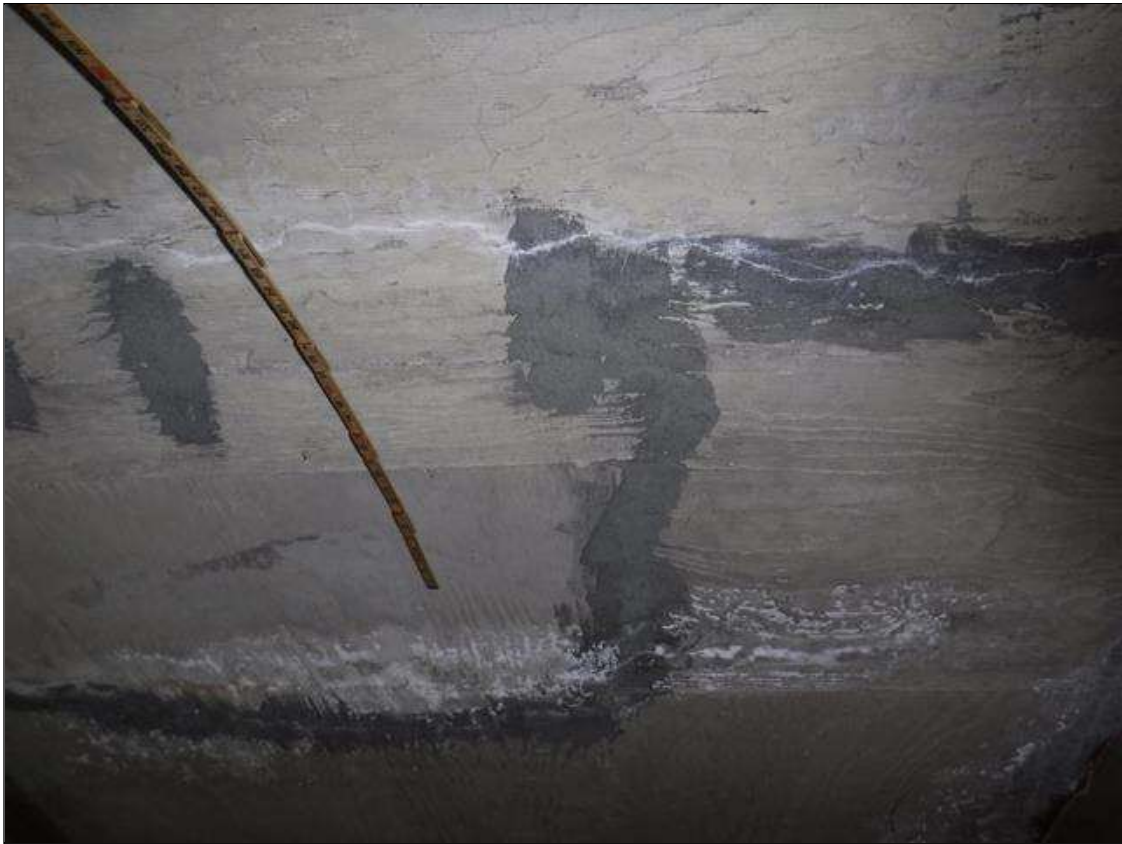
Span 1 Deck: UP TO 0.016" TRANSVERSE CRACKS WITH EFFLORESCENCE AND FAILED SEALED CRACKS IN BOTTOM OF DECK IN BAY 1, CONDITION APPROXIMATELY 6' FROM END BENT 1 SHOWN

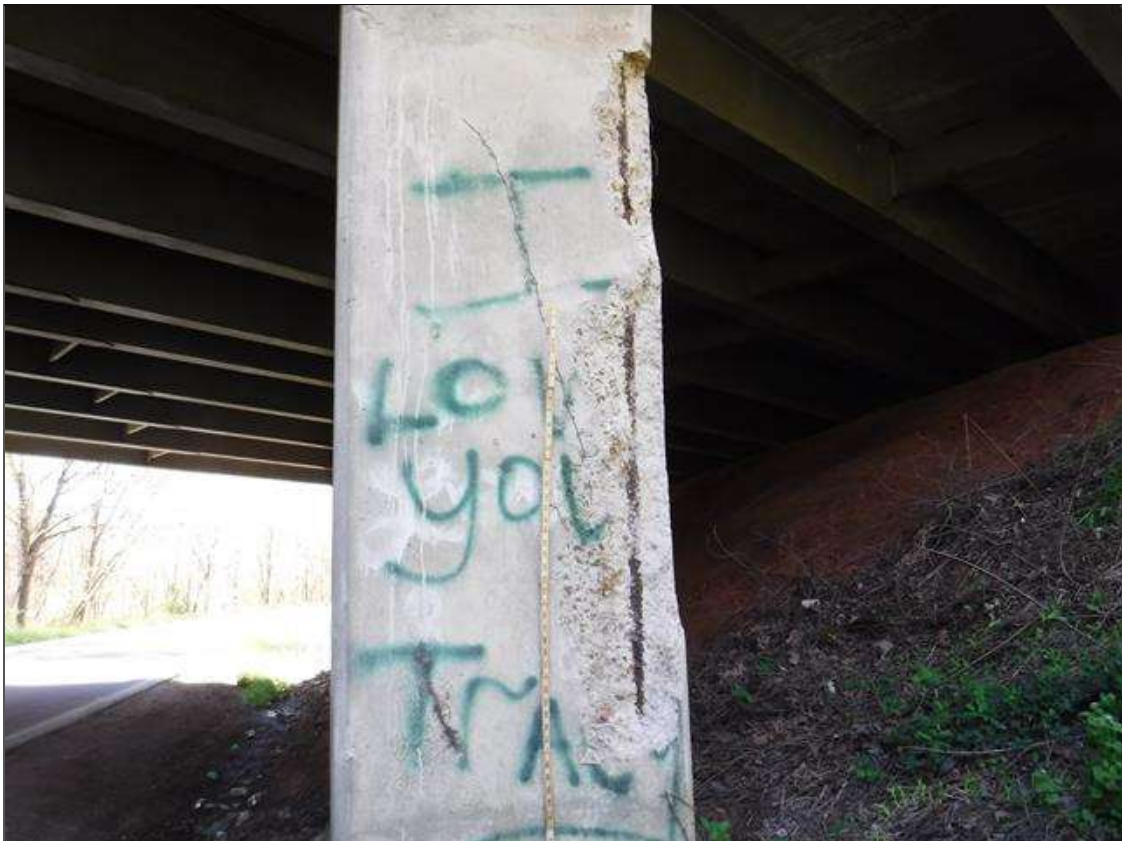
Bent 1 Pile 1: PAR: 65" X 12" X 3" SPALL WITH EXPOSED REBAR IN NORTHWEST CORNER OF COLUMN, BEGINNING APPROXIMATELY 2' FROM GROUND LINE

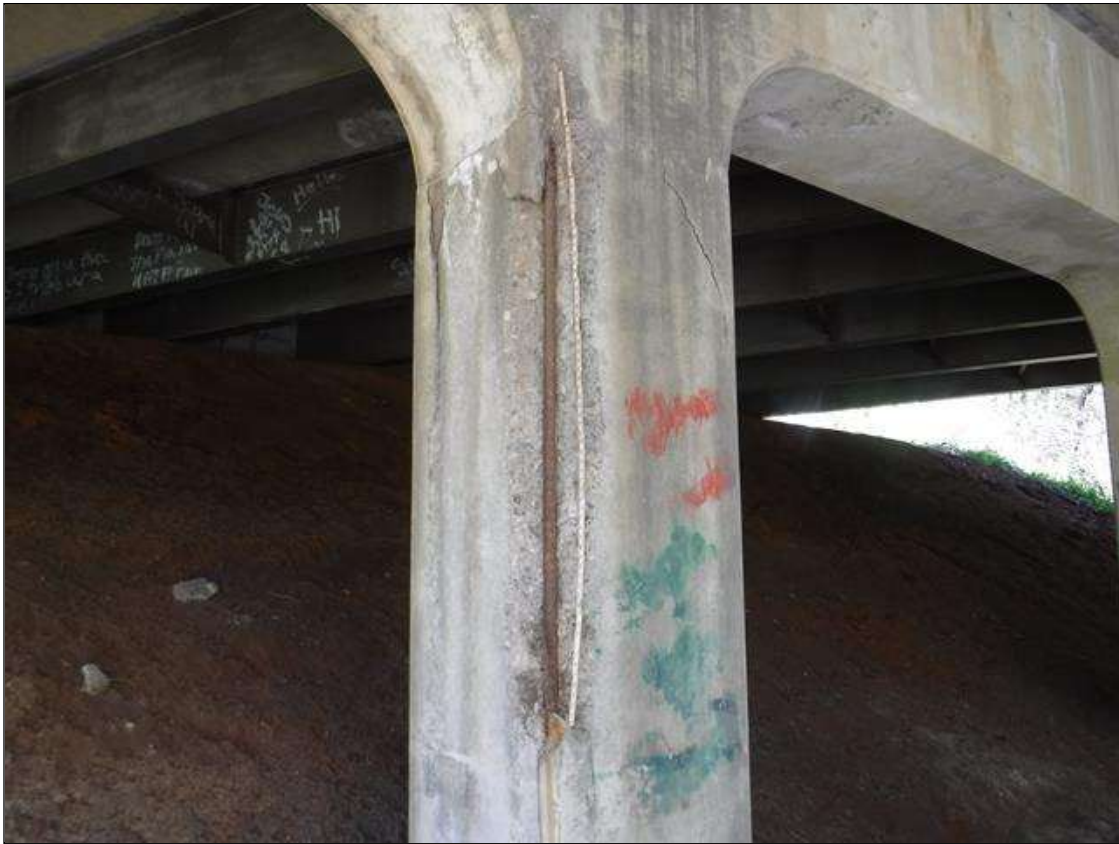
Bent 1 Pile 4: PAR: 96" X 8" X 7" SPALL WITH EXPOSED REBAR IN SOUTHEAST CORNER OF COLUMN
EXTENDING FROM BOTTOM OF CAP

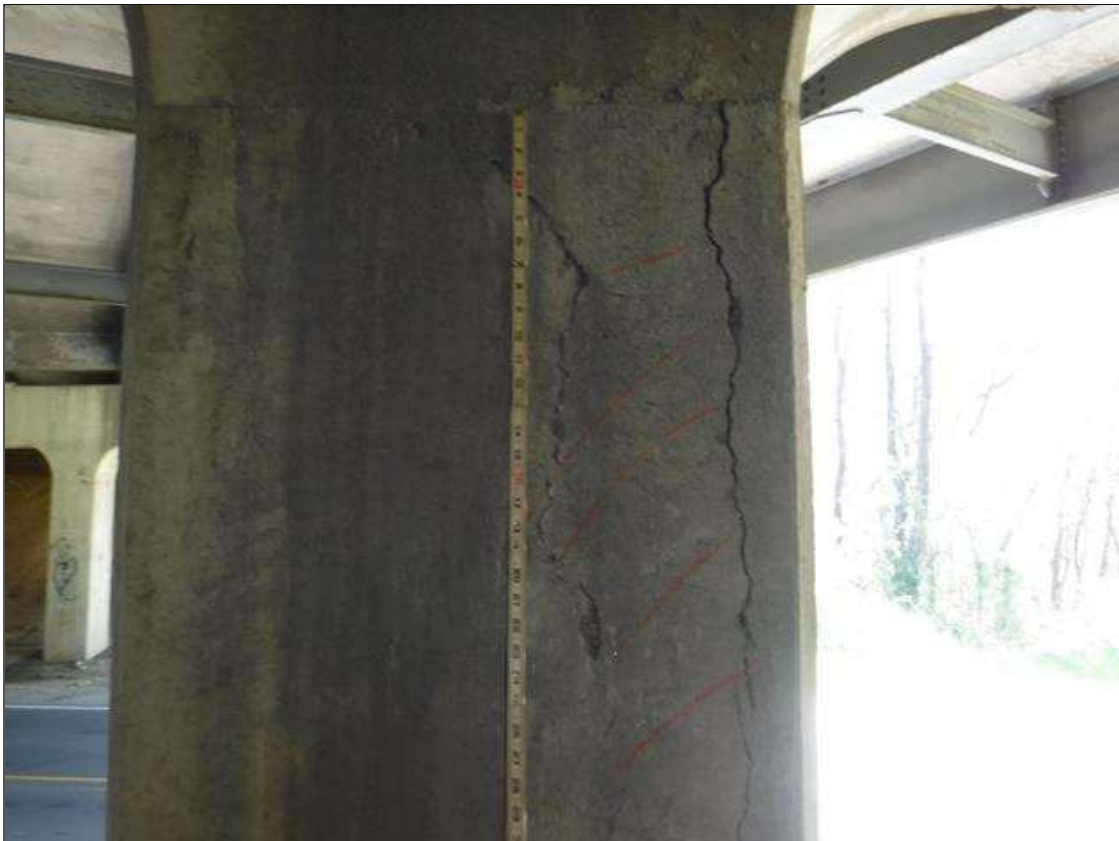
Bent 1 Pile 4: 52" X 8" AREA OF DELAMINATION WITH UP TO 1/4" VERTICAL CRACKS IN SPAN 1 FACE OF
COLUMN EXTENDING FROM BOTTOM OF CAP

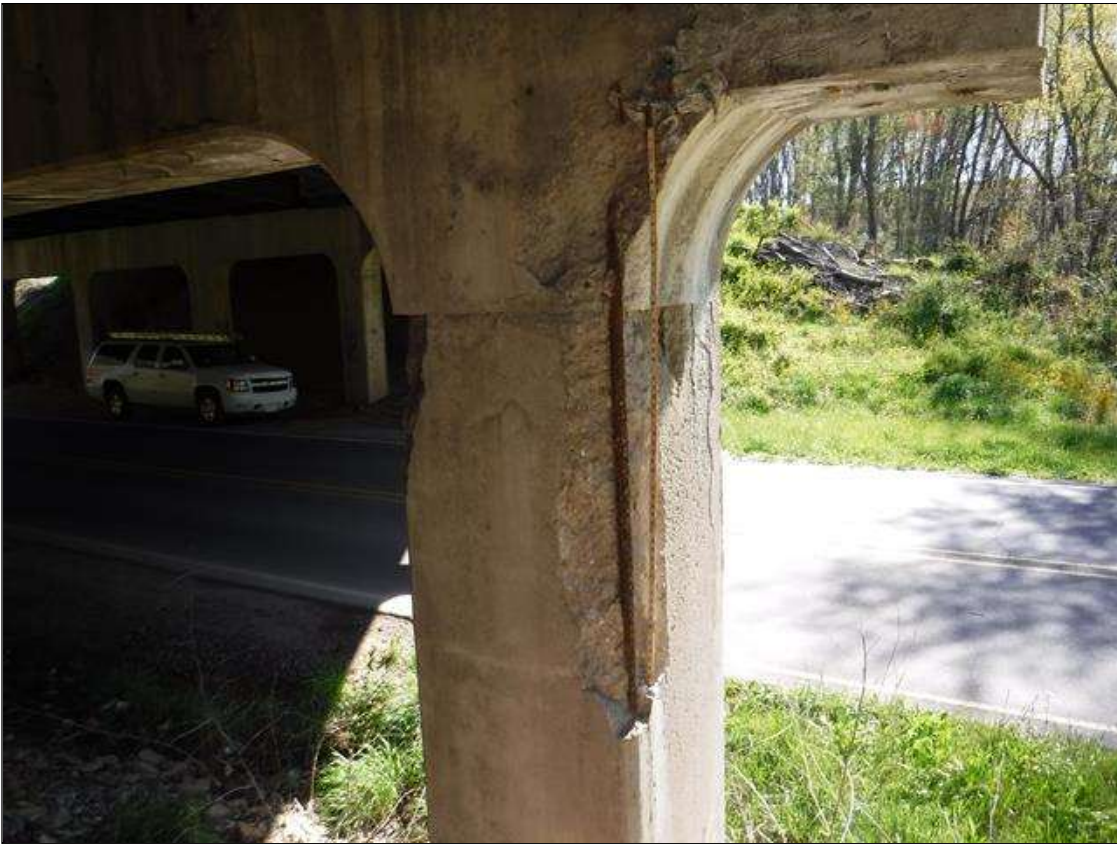
Bent 1 Pile 5: PAR: (3) SPALLS WITH EXPOSED REBAR UP TO 60" X 10" X 10" IN NORTHWEST CORNER, SOUTHWEST CORNER AND RIGHT FACE OF COLUMN EXTENDING FROM BOTTOM OF CAP

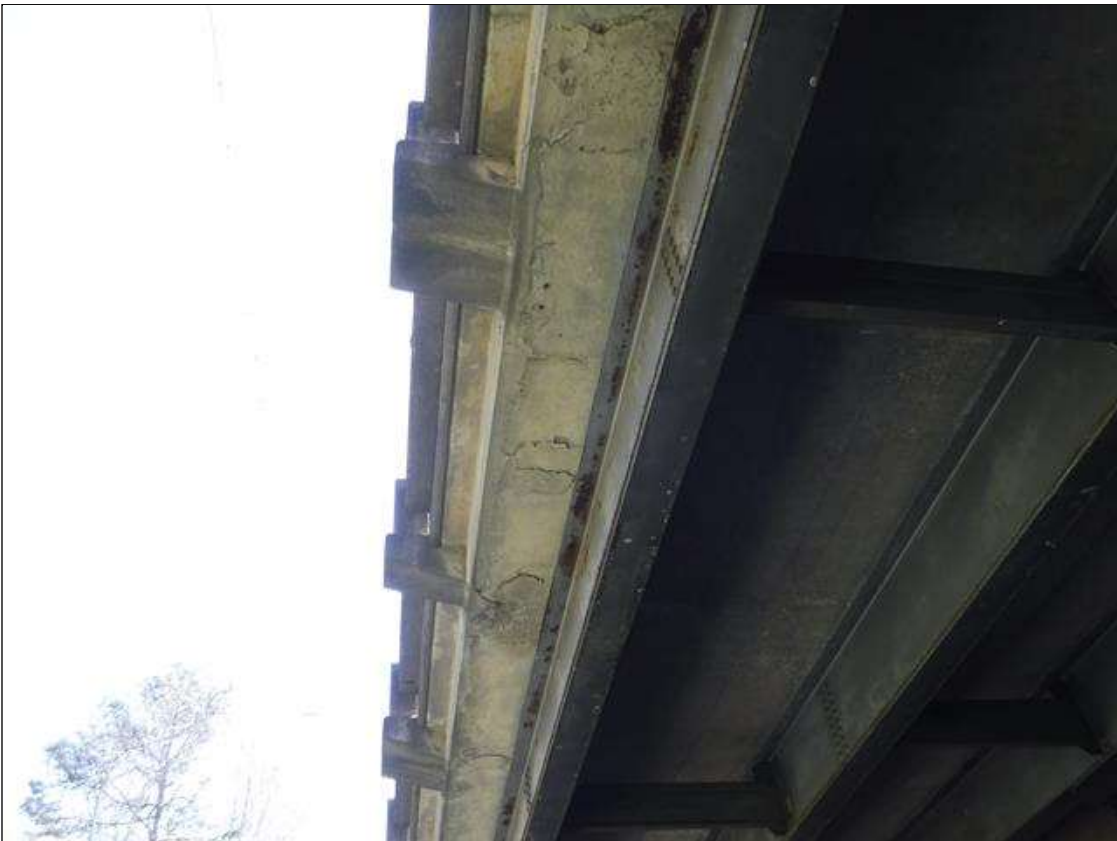
Span 2 Deck: PAR: (4) AREAS OF DELAMINATION UP TO 24" X 24" IN BOTTOM OF LEFT OVERHANG ABOVE ROADWAY

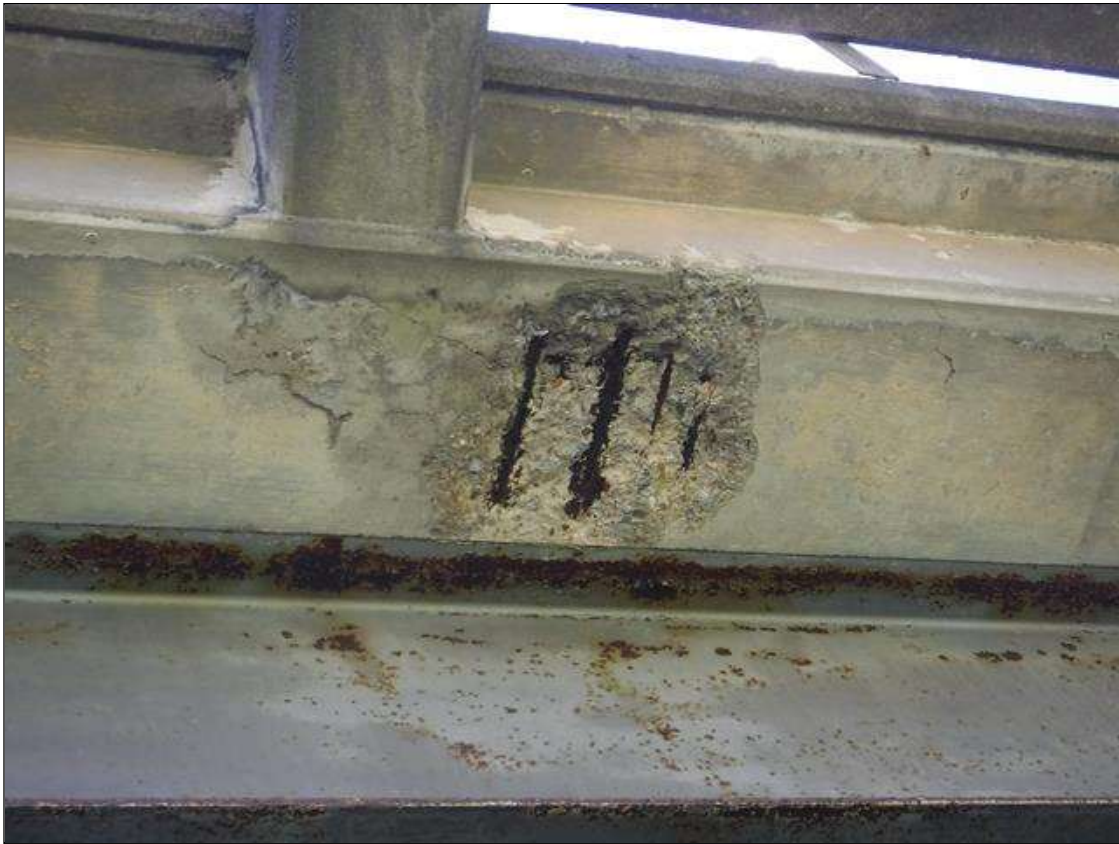
Span 2 Deck: PAR: 26" X 24" X 2" DEEP SPALL WITH EXPOSED REBAR IN BOTTOM OF LEFT OVERHANG, APPROXIMATELY 6' FROM BENT 1

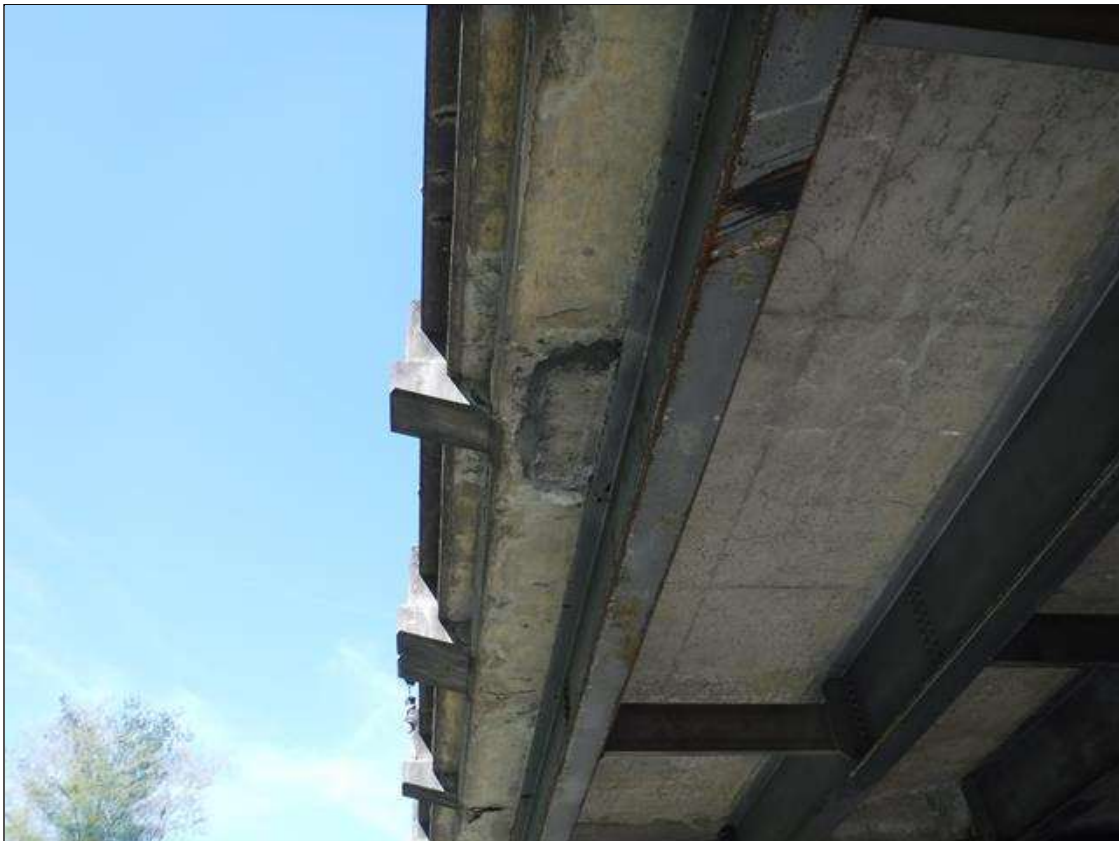
Span 2 Deck: PAR: FAILED REPAIR AND (2) AREAS OF DELAMINATION UP TO 36" X 22" IN BOTTOM OF RIGHT OVERHANG ABOVE ROADWAY

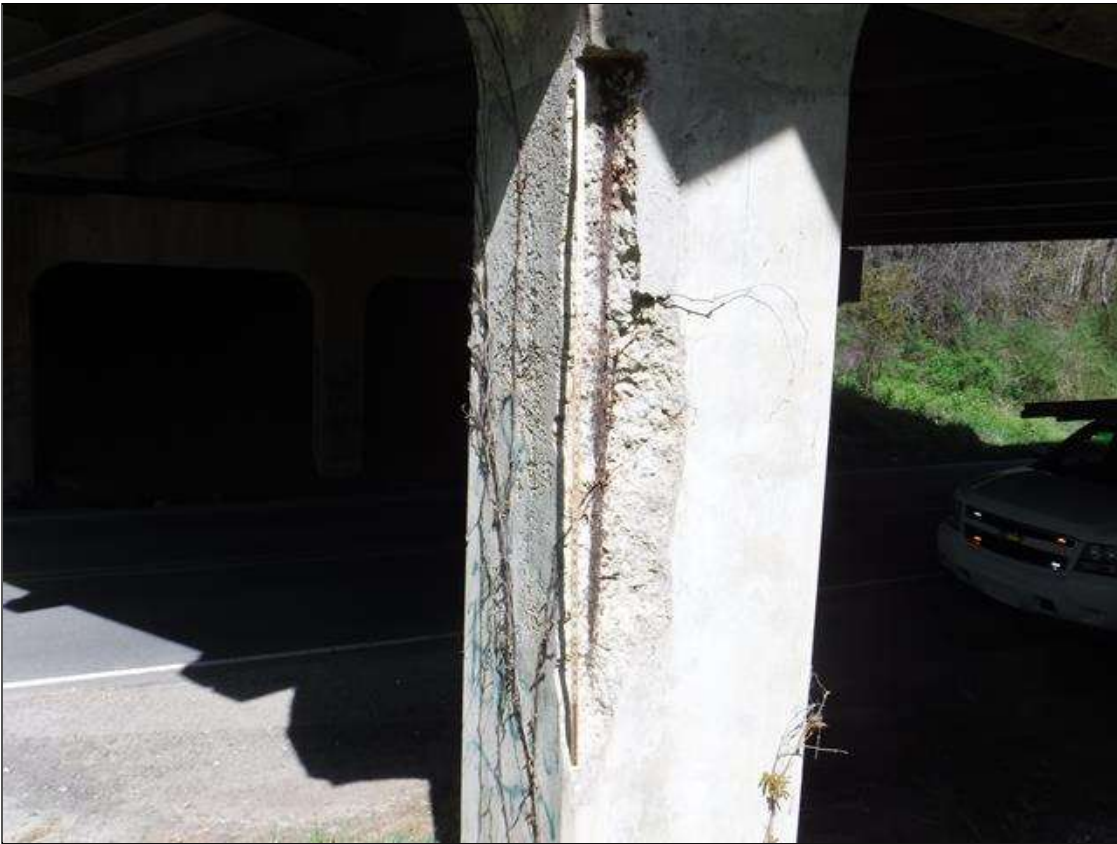
Bent 2 Pile 5: PAR: 66" X 13" X 6" SPALL WITH EXPOSED REBAR IN SOUTHEAST CORNER OF COLUMN
EXTENDING FROM BOTTOM OF CAP

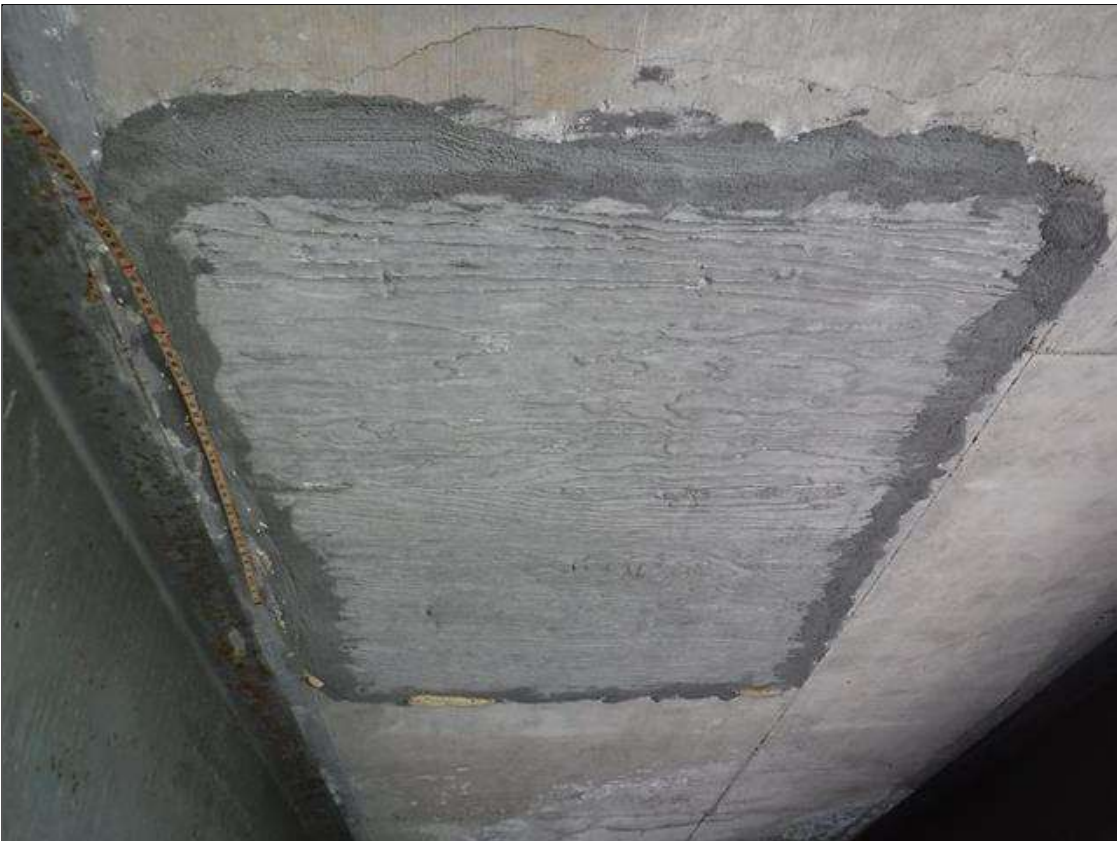
Span 3 Deck: (3) PATCHES UP TO 64" X 48" IN BOTTOM OF DECK IN BAYS 8 AND 9 NEAR END BENT 2, PATCH
IN BAY 9 SHOWN

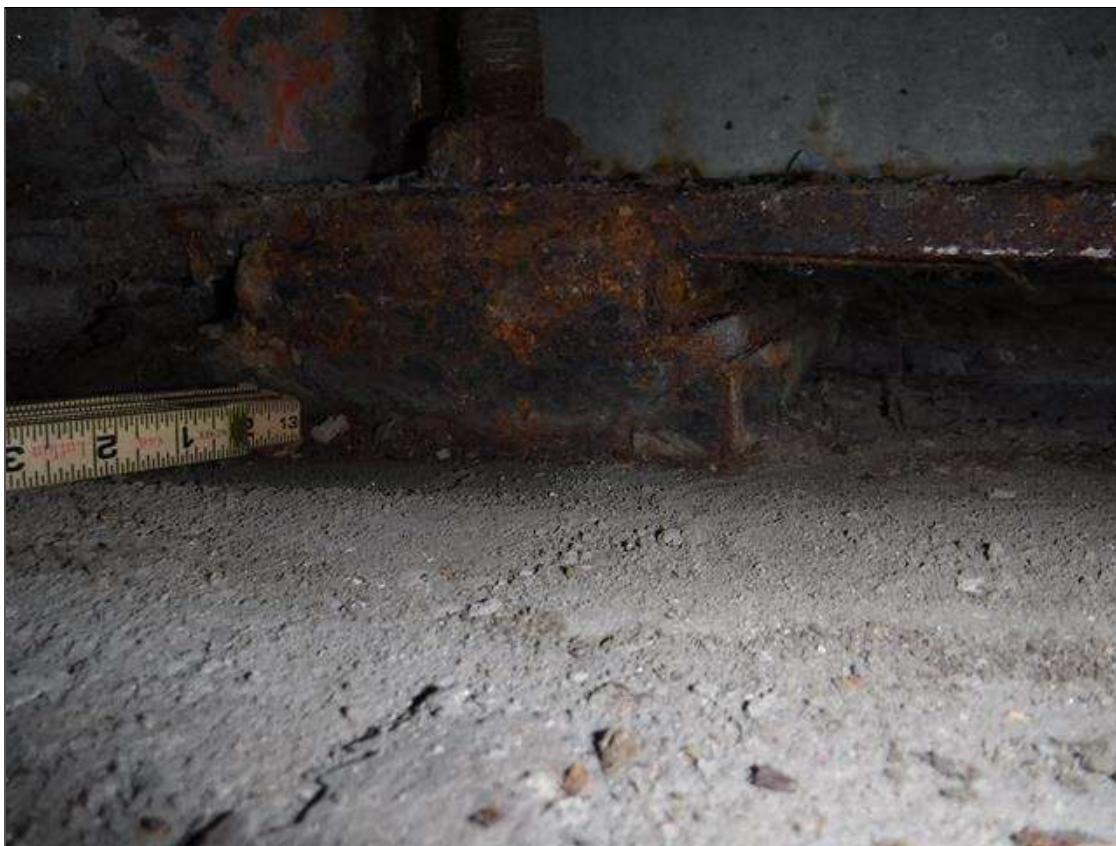
Span 3 Beam 10 Far Bearing: CORROSION THROUGHOUT BEAM 10 BEARING

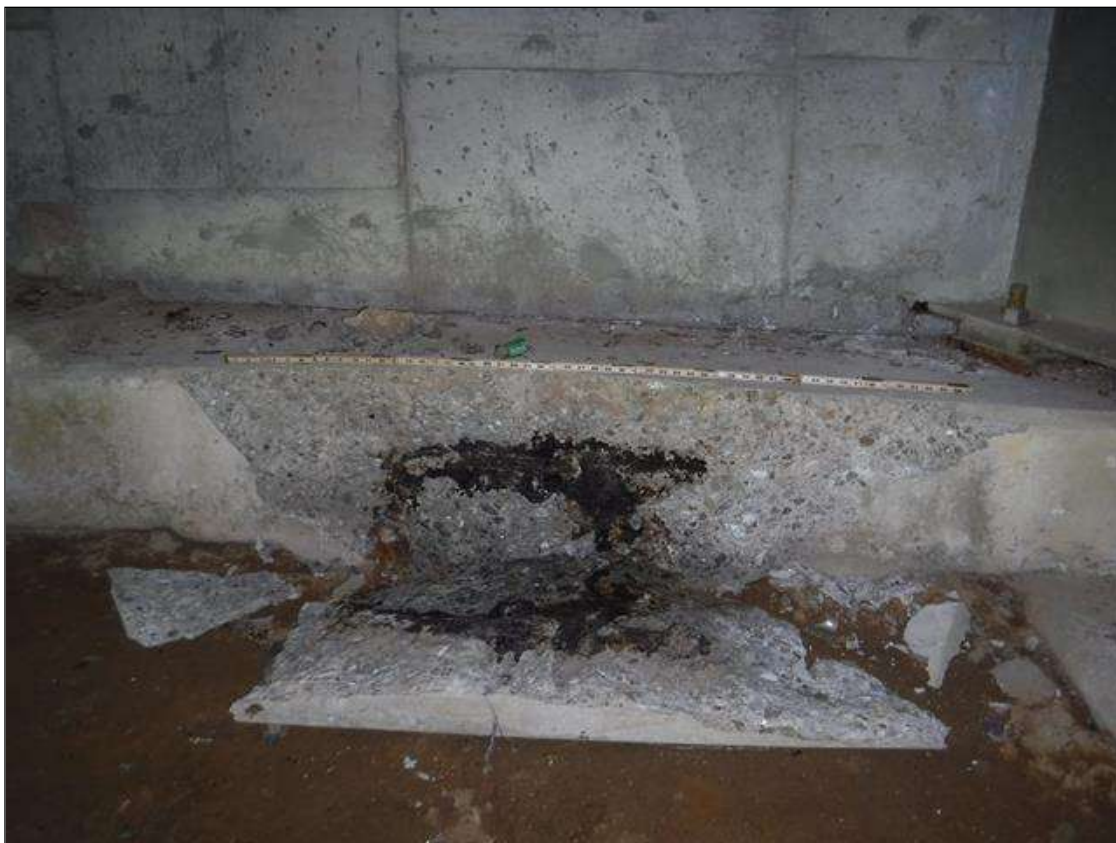
End Bent 2 Cap 1: PAR: 60" X 15" X 3" SPALL WITH EXPOSED REBAR IN TOP AND FACE OF CAP BENEATH BAY
