NC DEPARTMENT OF TRANSPORTATION
DIVISION OF HIGHWAYS
STRUCTURE MANAGEMENT UNIT

Structure Safety Report

Routine Element Inspection - Contract

FACILITY CARRIED: I-40 MILE POST: 29.3

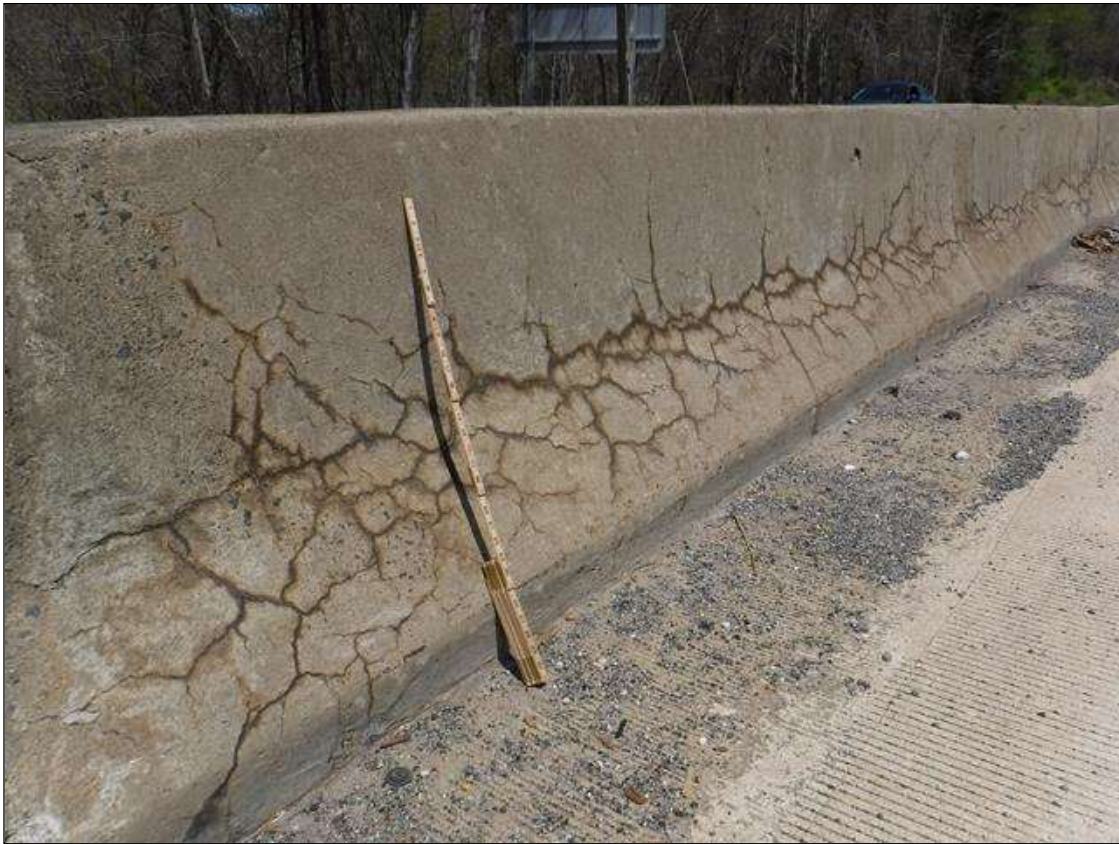
Span 3 Median Bridge Rail: UP TO 1/16" HORIZONTAL AND MAP CRACKING THROUGHOUT BOTH FACES OF RAIL, CRACKS IN RIGHT FACE NEAR MIDSPAN SHOWN

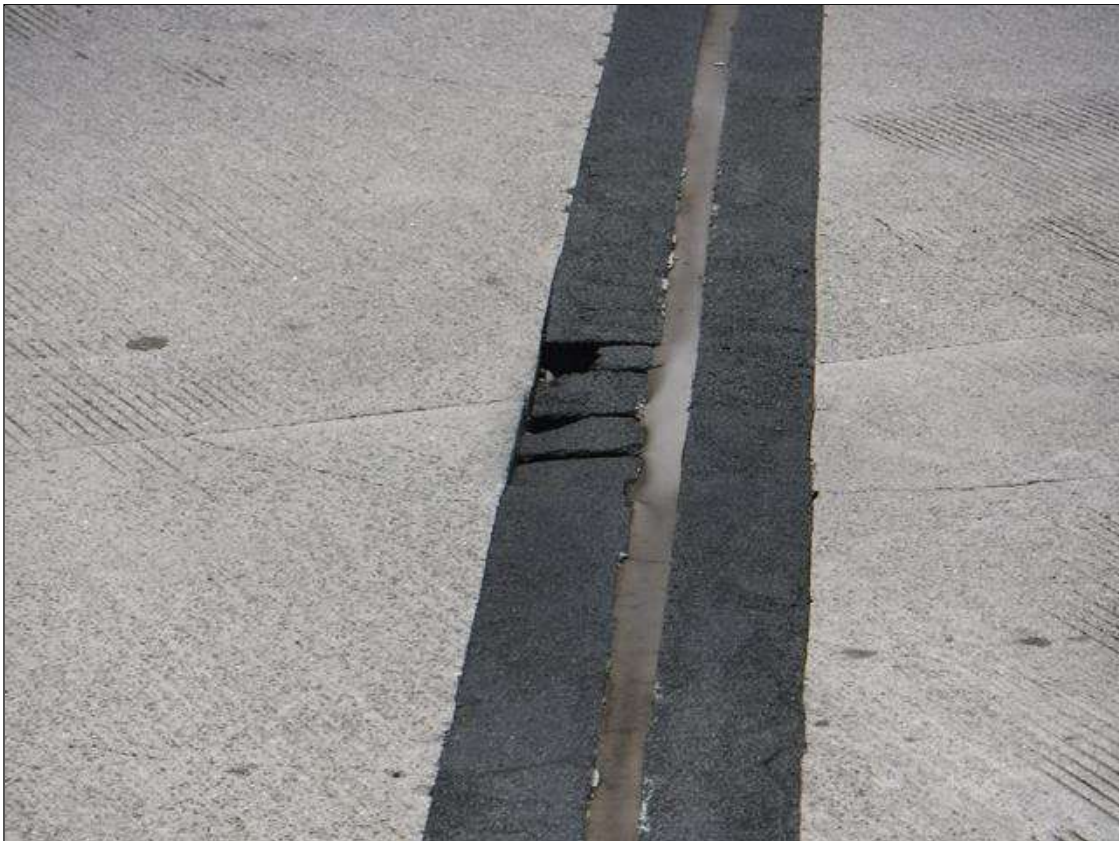
Expansion Joint 3: 14" X 6" AREA OF CRACKED AND BROKEN DECK HEADER ALONG BENT 2 JOINT ALONG CENTERLINE OF EASTBOUND LANES

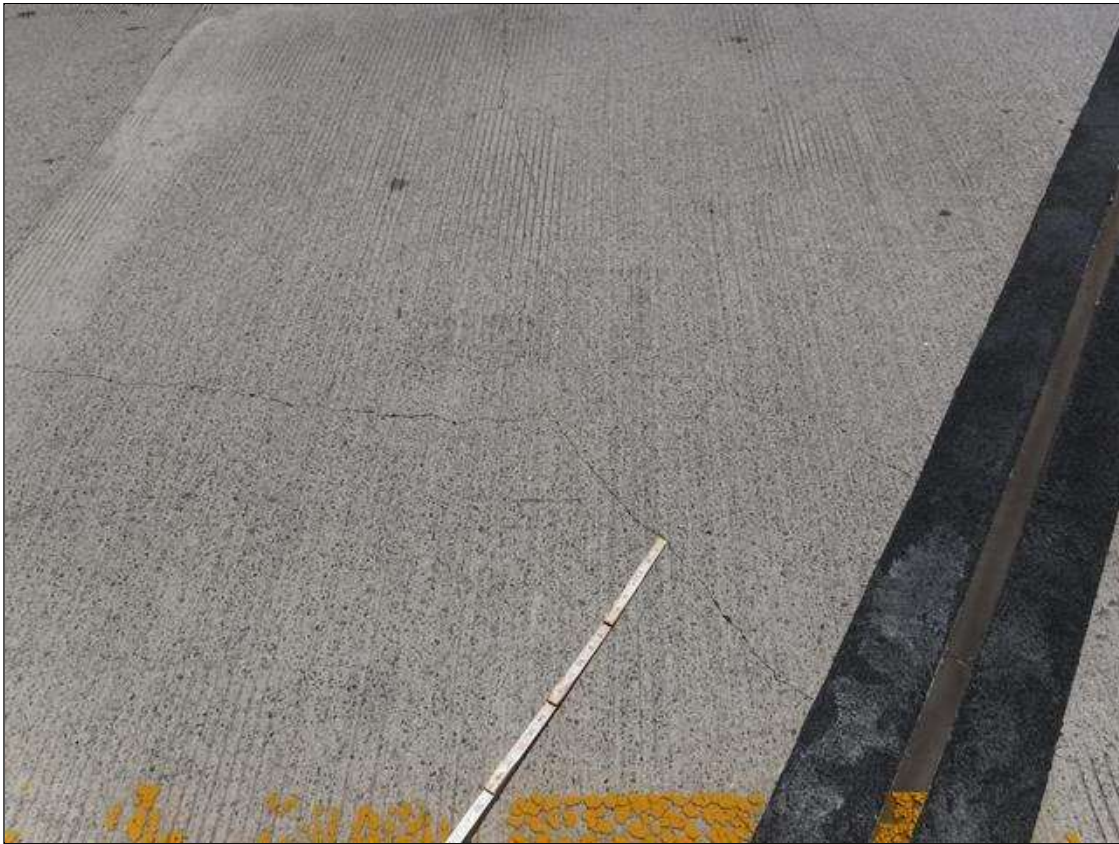
Span 3 Wearing Surface: UP TO 1/16" DIAGONAL, LONGITUDINAL AND TRANSVERSE CRACKS IN VARIOUS LOCATIONS, CRACKS IN INSIDE EASTBOUND LANE AT BENT 3 JOINT SHOWN

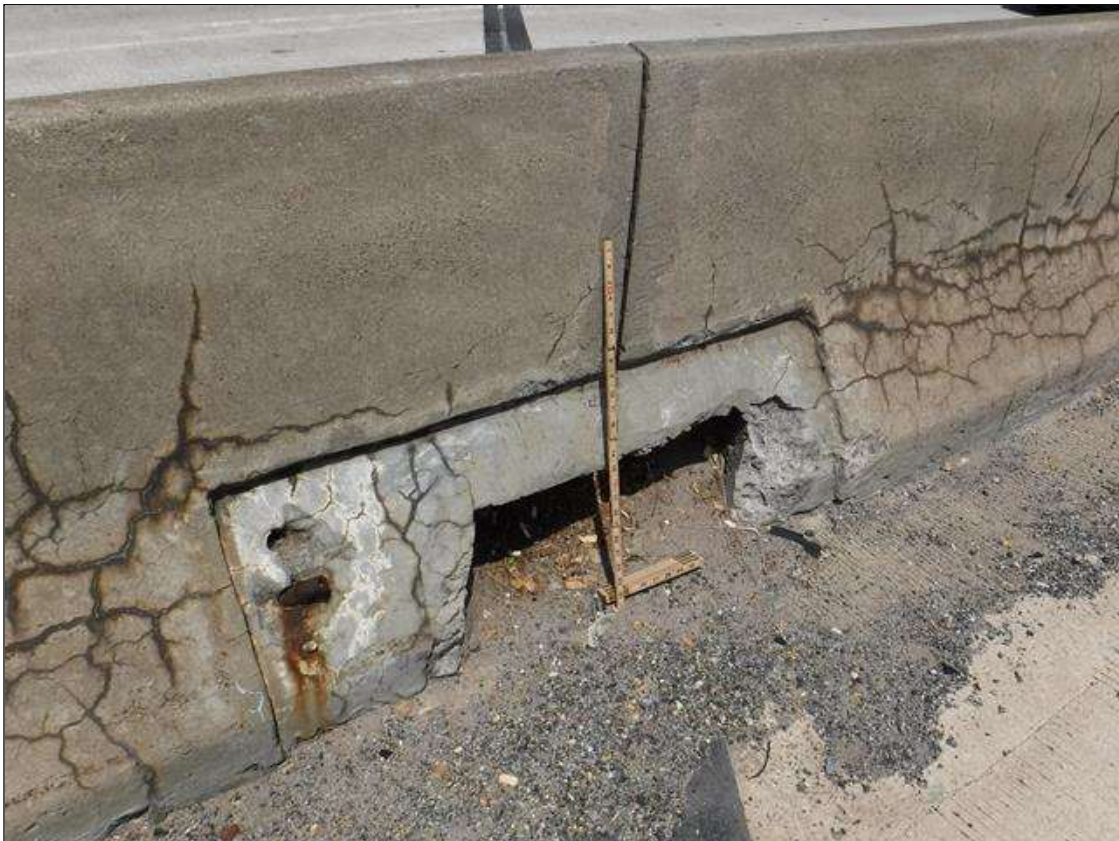
Span 1 Median Bridge Rail: MISSING CONNECTION PLATE ALONG RIGHT FACE OF MEDIAN RAIL AT BENT 1 JOINT

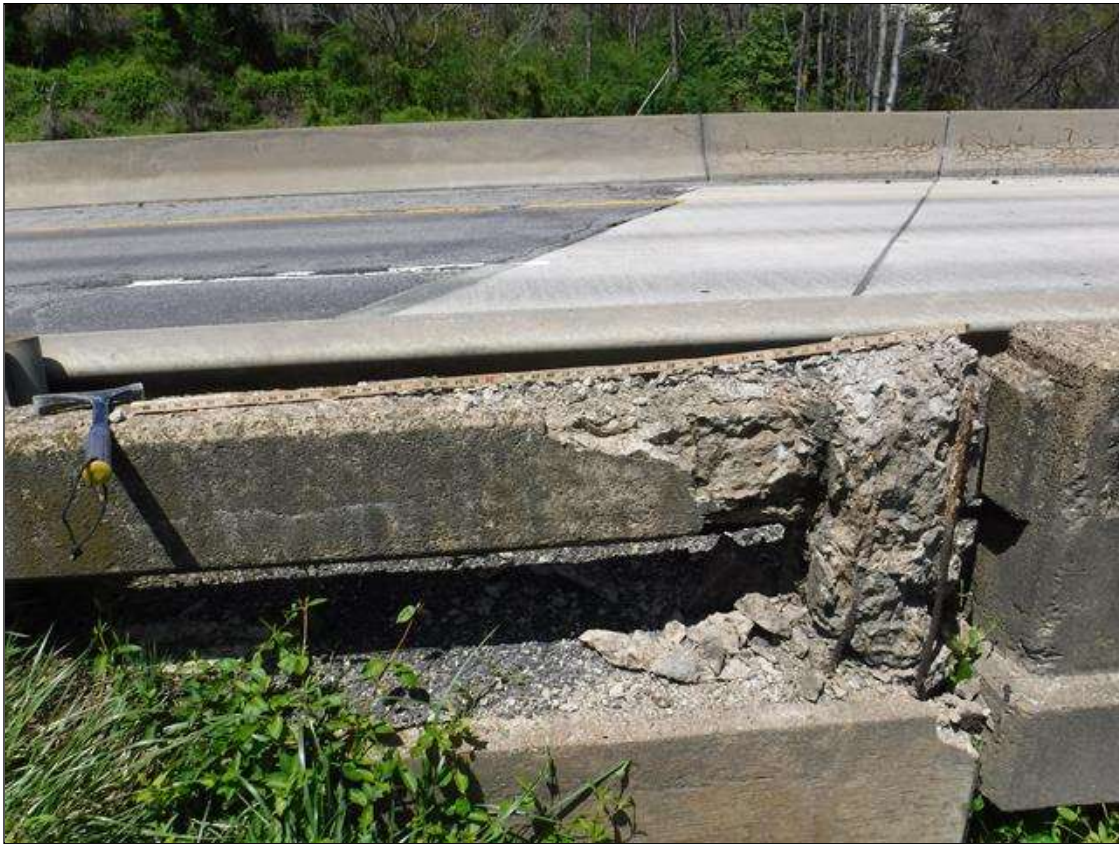
PAR: 42" LONG SPALLED AREA WITH EXPOSED REBAR IN RIGHT APPROACH RAIL AT END BENT 1 JOINT

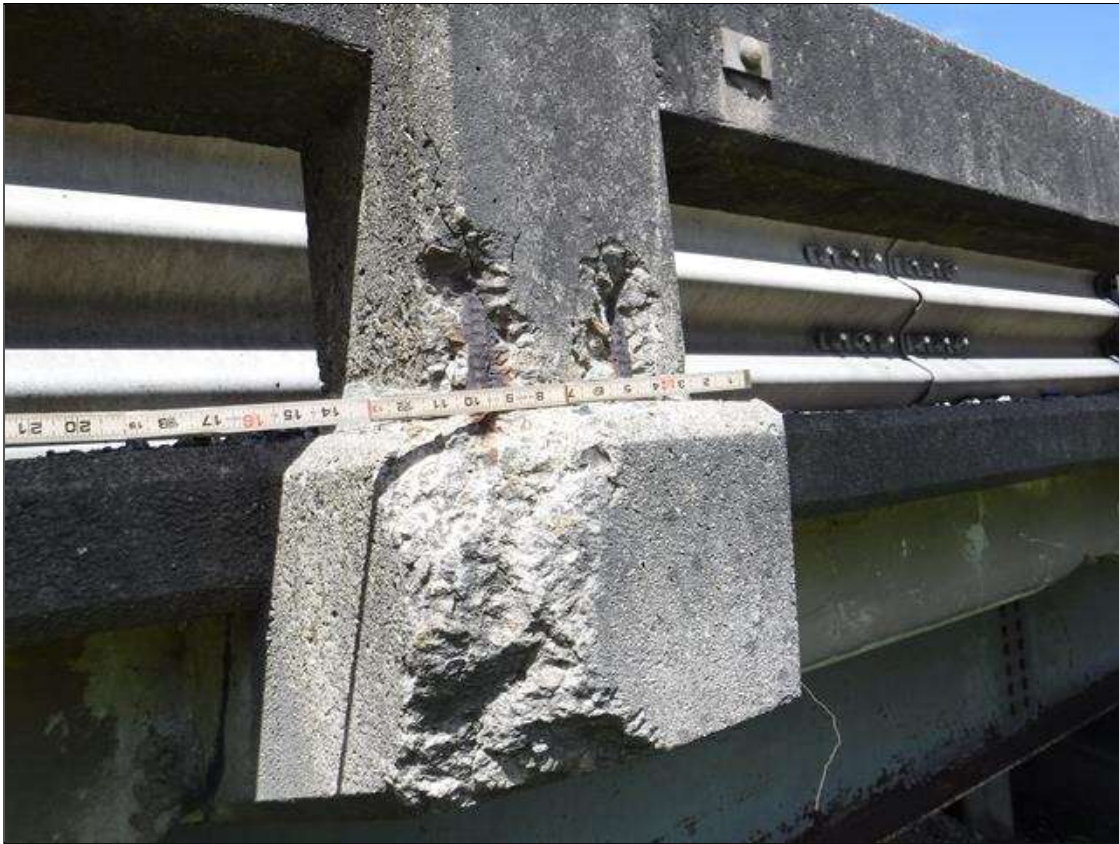
Span 1 Right Bridge Rail: SPALLS WITH EXPOSED REBAR UP TO 18" X 5" X 2" DEEP IN BACK FACE AND BOTTOM OF RAIL AND POSTS IN VARIOUS LOCATIONS, CONDITION APPROXIMATELY 10' FROM END BENT 1 JOINT SHOWN

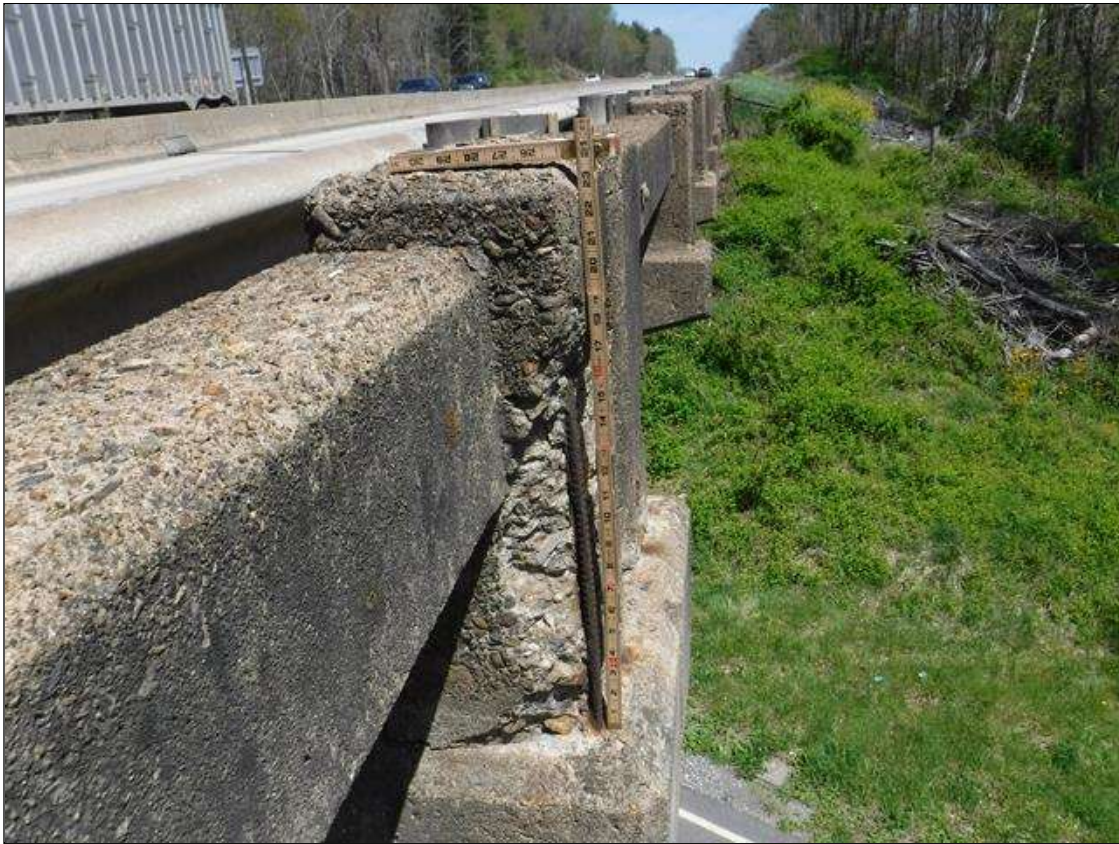
Span 2 Right Bridge Rail: SPALLS WITH EXPOSED REBAR UP TO 17" X 4" X 4" DEEP IN BACK FACE AND BOTTOM OF RAIL AND POSTS IN VARIOUS LOCATIONS, CONDITION NEAR MIDSPAN SHOWN

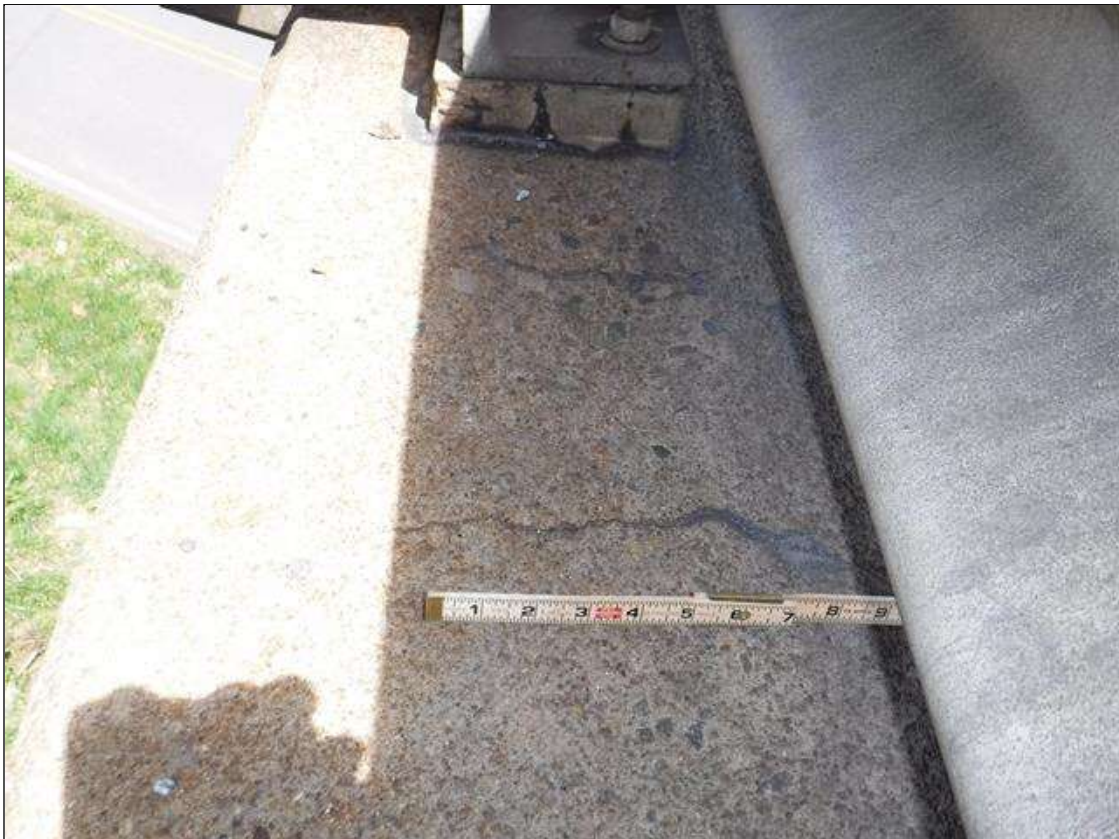
UP TO 0.05" TRANSVERSE AND VERTICAL CRACKS IN TOP AND FACE OF CURBS IN VARIOUS LOCATIONS, CRACK IN SPAN 1 LEFT CURB APPROXIMATELY 5' FROM BENT 1 JOINT SHOWN

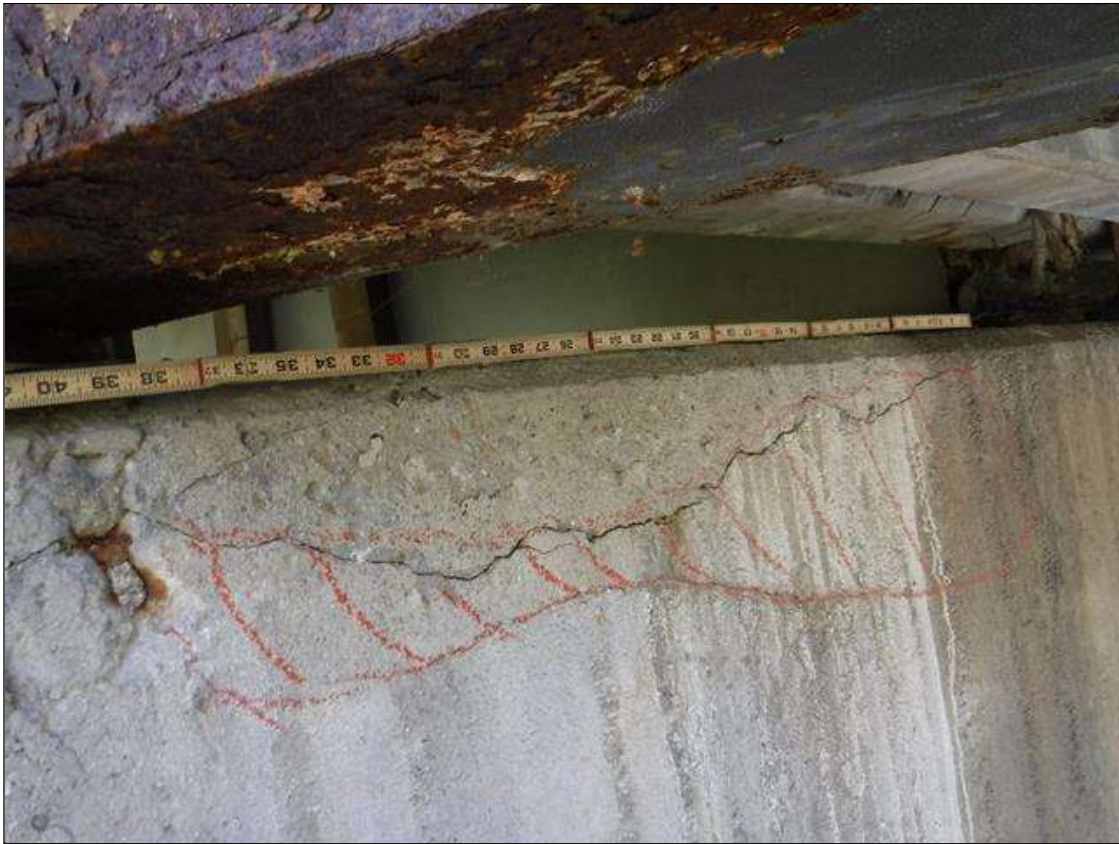
Bent 2 Cap 1: 44" X 8" AREA OF DELAMINATION WITH UP TO 1/16" HORIZONTAL CRACKS IN SPAN 2 FACE OF CAP BENEATH BEAM 1

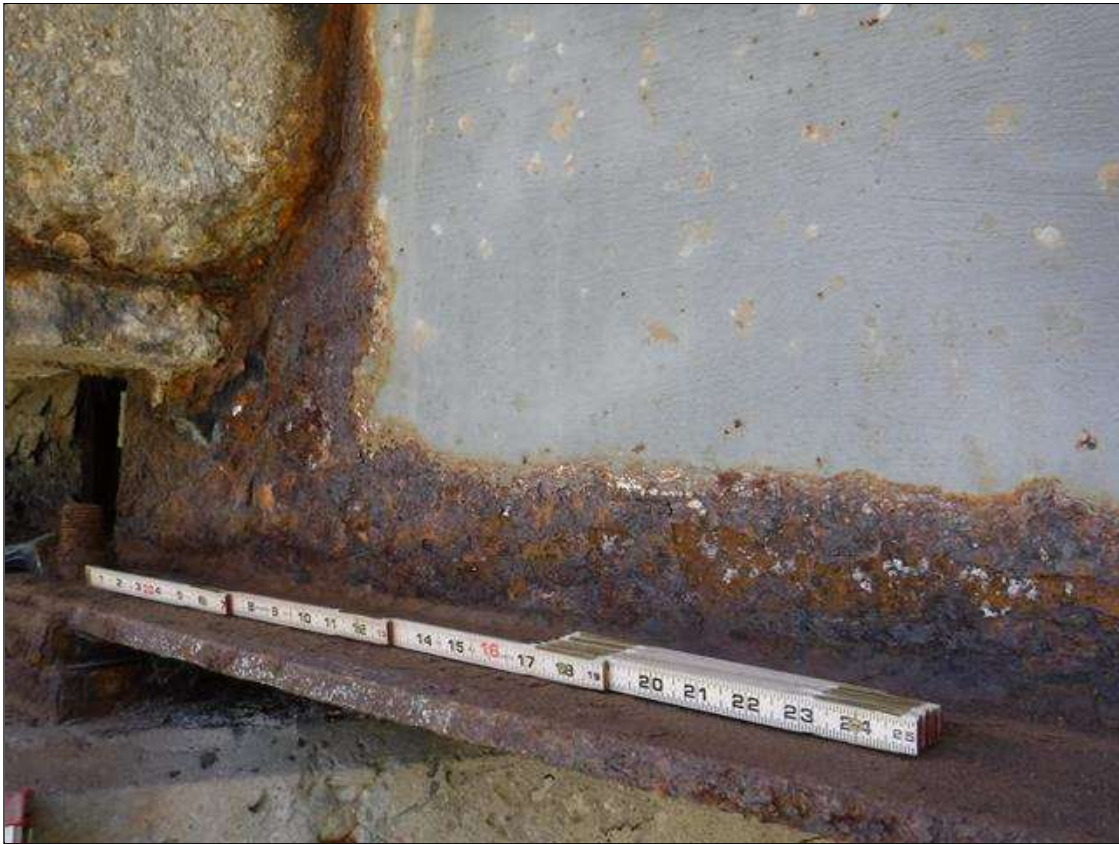
Span 2 Beam 1: CORROSION WITH NO MEASURABLE LOSS OF SECTION ALONG WEB AND BOTTOM FLANGE UP TO 16' LONG X 14" HIGH IN WEB, AND 16' LONG X 11 1/2" WIDE IN FLANGE EXTENDING FROM END OF BEAM AT BENT 2, CONDITION ON LEFT SIDE SHOWN

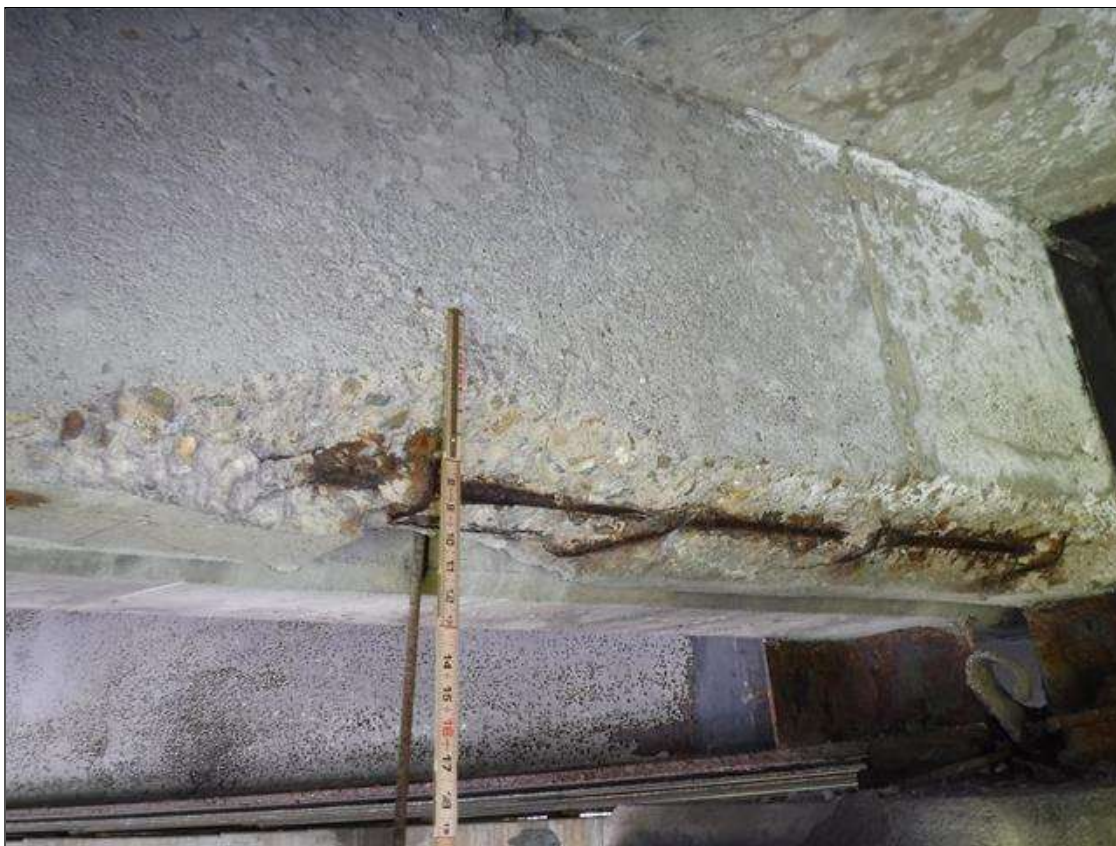
UP TO 60" X 6" X 5" SPALLS WITH EXPOSED REBAR IN BOTTOM AND FACES OF BENT 2 DIAPHRAGMS IN BAYS 2 THRU 9, CONDITION IN SPAN 3 FACE IN BAY 8 SHOWN

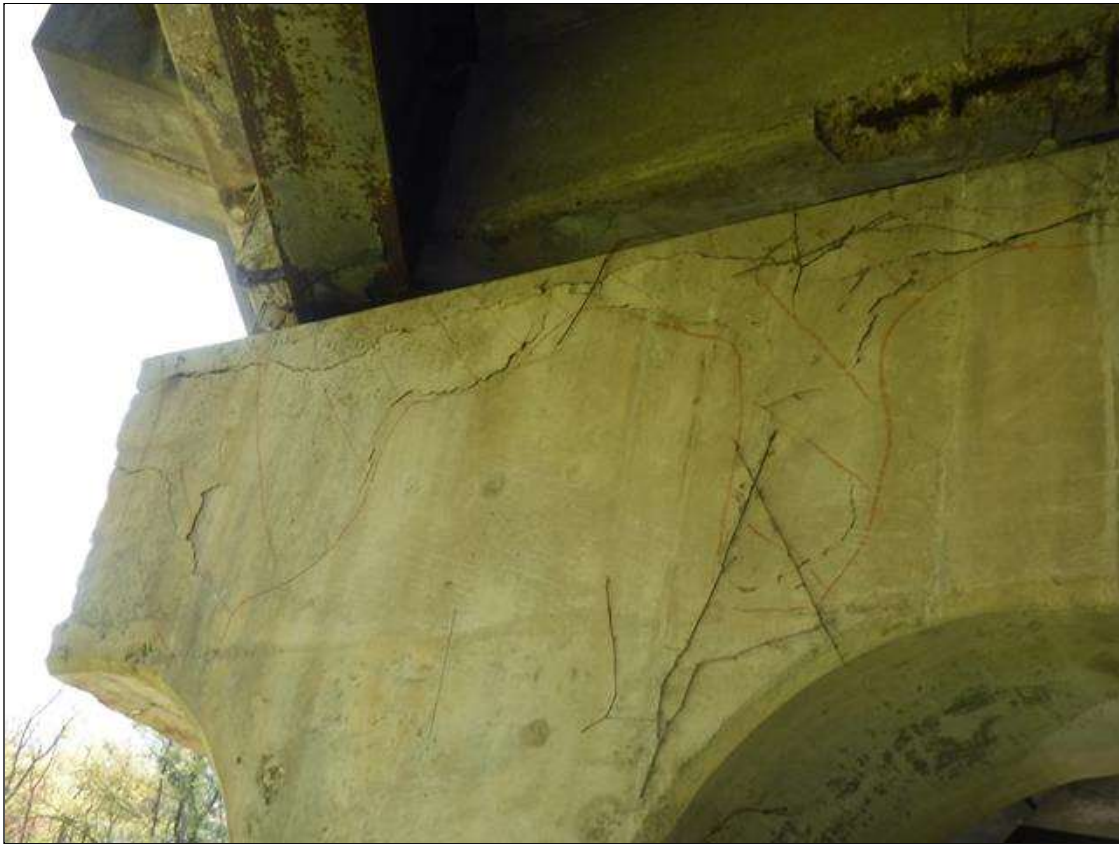
Bent 2 Cap 1: PAR: 103" X 33" X 30" AREA OF DELAMINATION WITH UP TO 1/2" VERTICAL AND HORIZONTAL CRACKS AND 33" X 30" X 5" DEEP SPALL WITH EXPOSED REBAR THROUGHOUT CAP EXTERIOR FROM RIGHT END TO BENEATH BAY 9, CONDITION IN SPAN 2 SHOWN

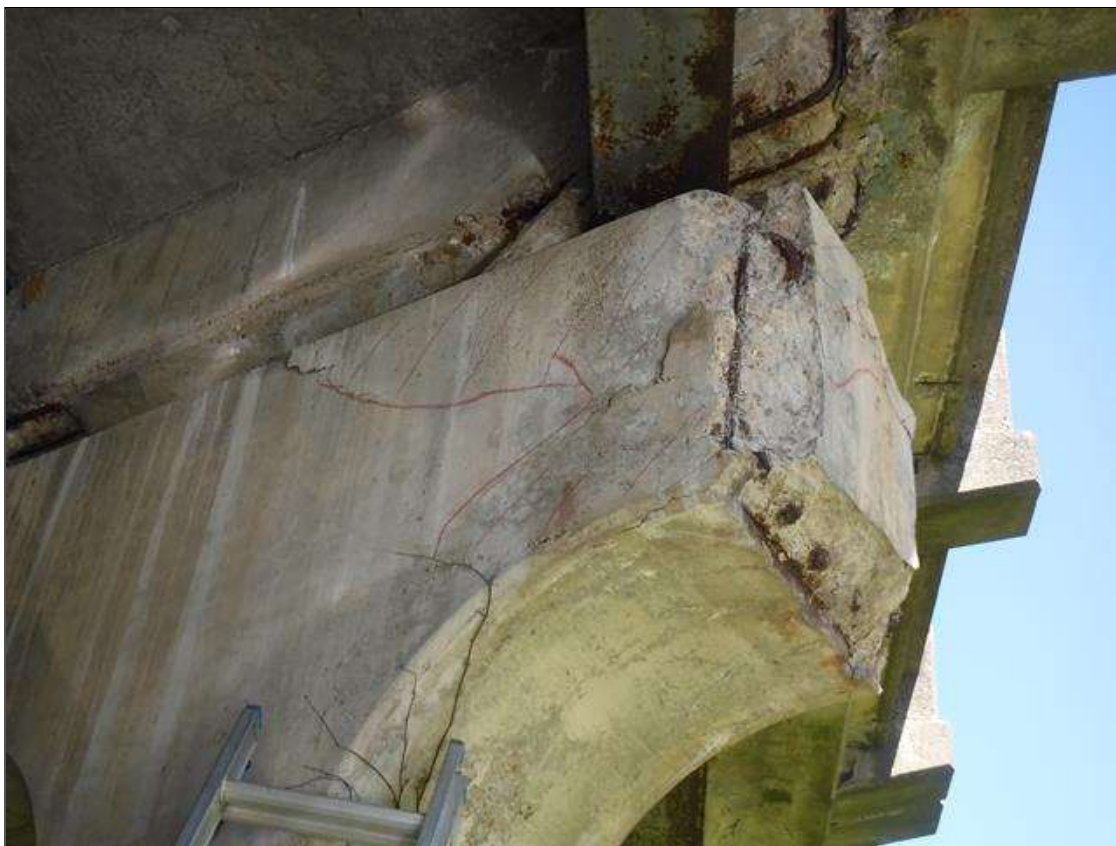
Bent 2 Cap 1: PAR: 103" X 33" X 30" AREA OF DELAMINATION WITH UP TO 1/2" VERTICAL AND HORIZONTAL CRACKS AND 33" X 30" X 5" DEEP SPALL WITH EXPOSED REBAR THROUGHOUT CAP EXTERIOR FROM RIGHT END TO BENEATH BAY 9, CONDITION IN SPAN 3 FACE SHOWN

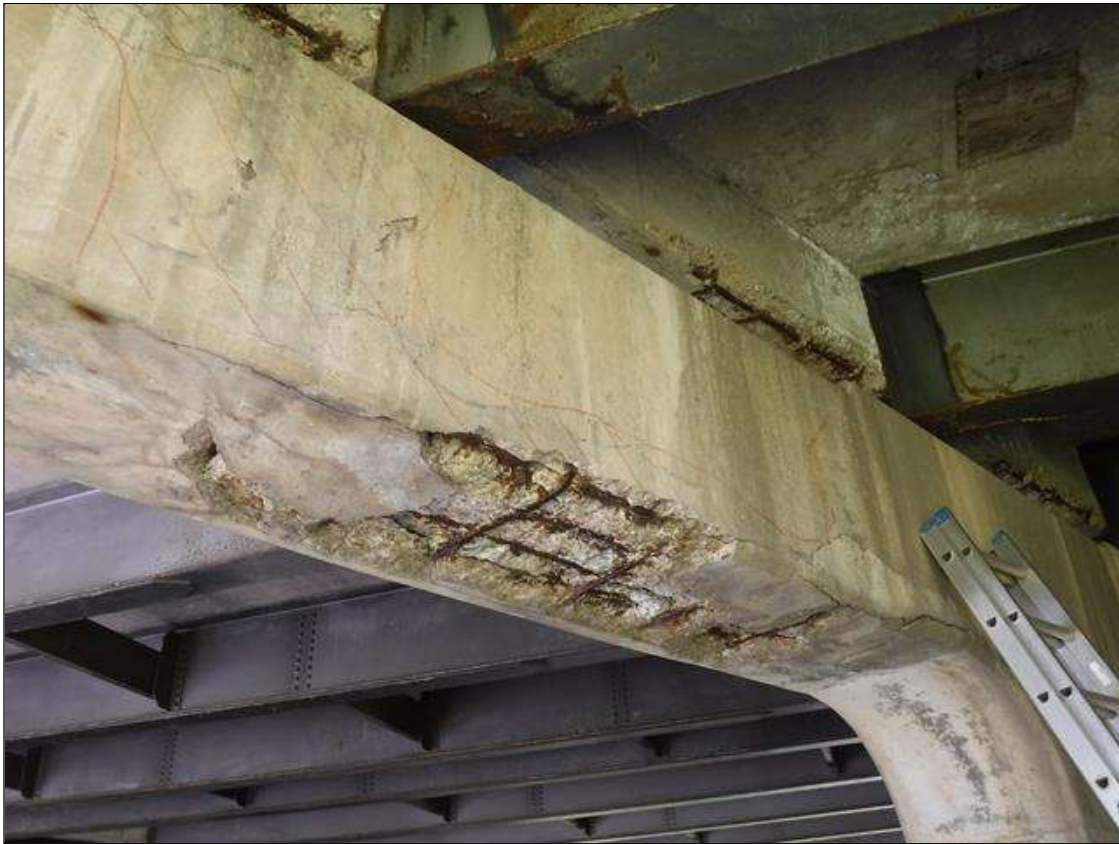
Bent 2 Cap 1: PAR: 125" X 30" X 30" AREA OF DELAMINATION WITH UP TO 1/2" LONGITUDINAL AND HORIZONTAL CRACKS AND 7' X 26" X 4" DEEP SPALL WITH EXPOSED REBAR IN BOTTOM AND BOTH FACES OF CAP TO RIGHT OF COLUMN 4

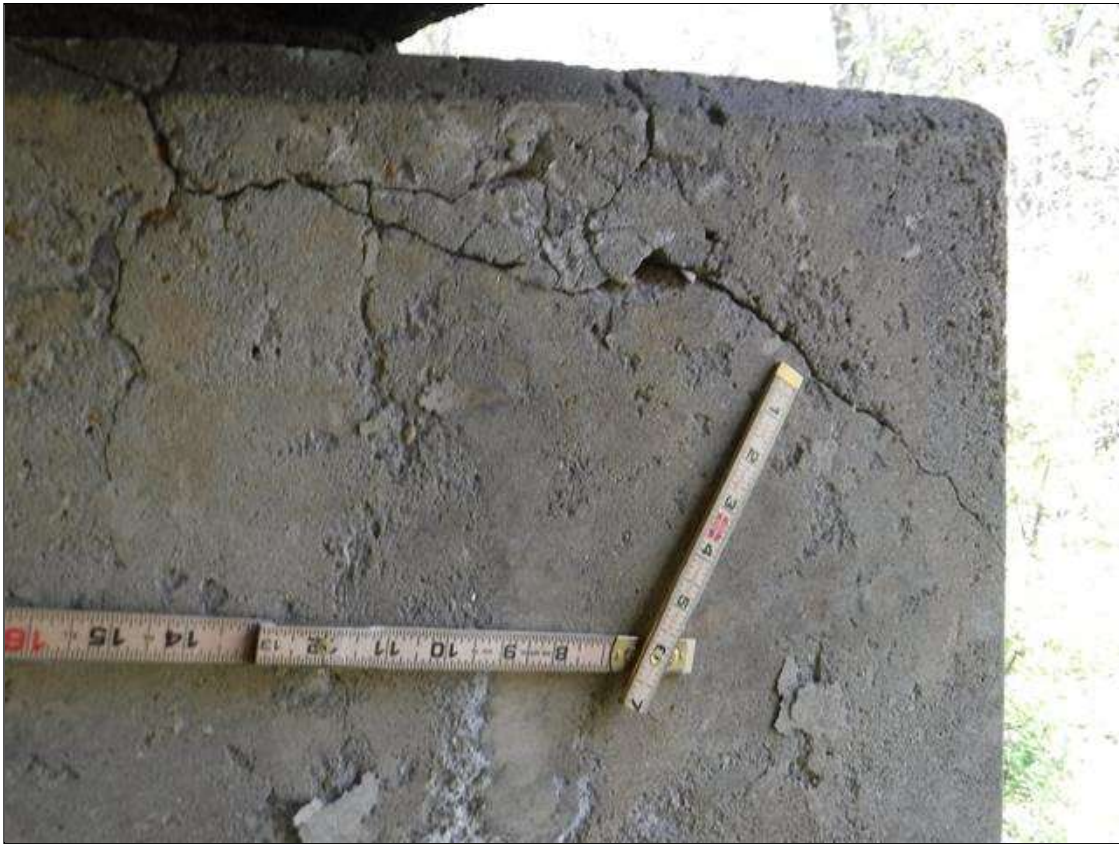
Bent 1 Cap 1: UP TO 1/16" DIAGONAL AND HORIZONTAL CRACKS IN SPAN 2 FACE OF CAP AT LEFT END

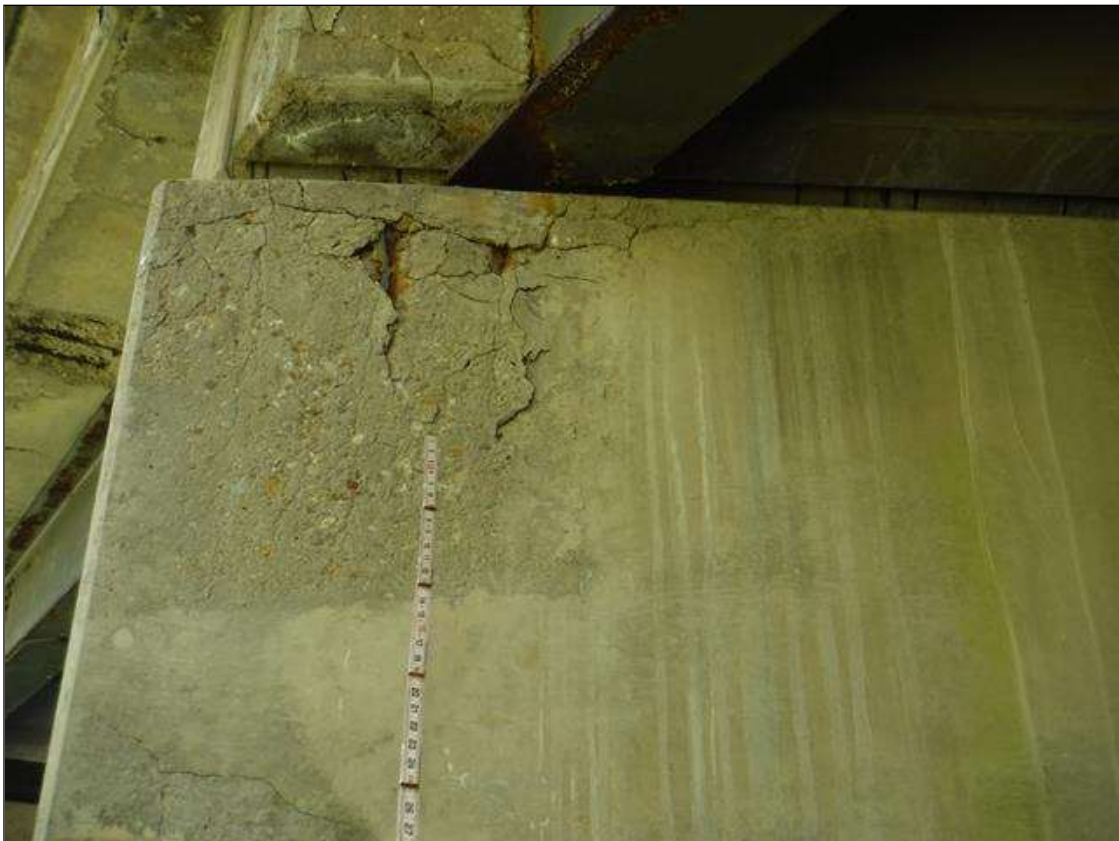
Bent 1 Cap 1: (2) SPALLS WITH EXPOSED REBAR UP TO 7" X 3" X 1" DEEP WITH 32" X 32" AREA OF DELAMINATION AND UP TO 1/8" MAP CRACKING IN SPAN 1 FACE OF CAP AT LEFT END

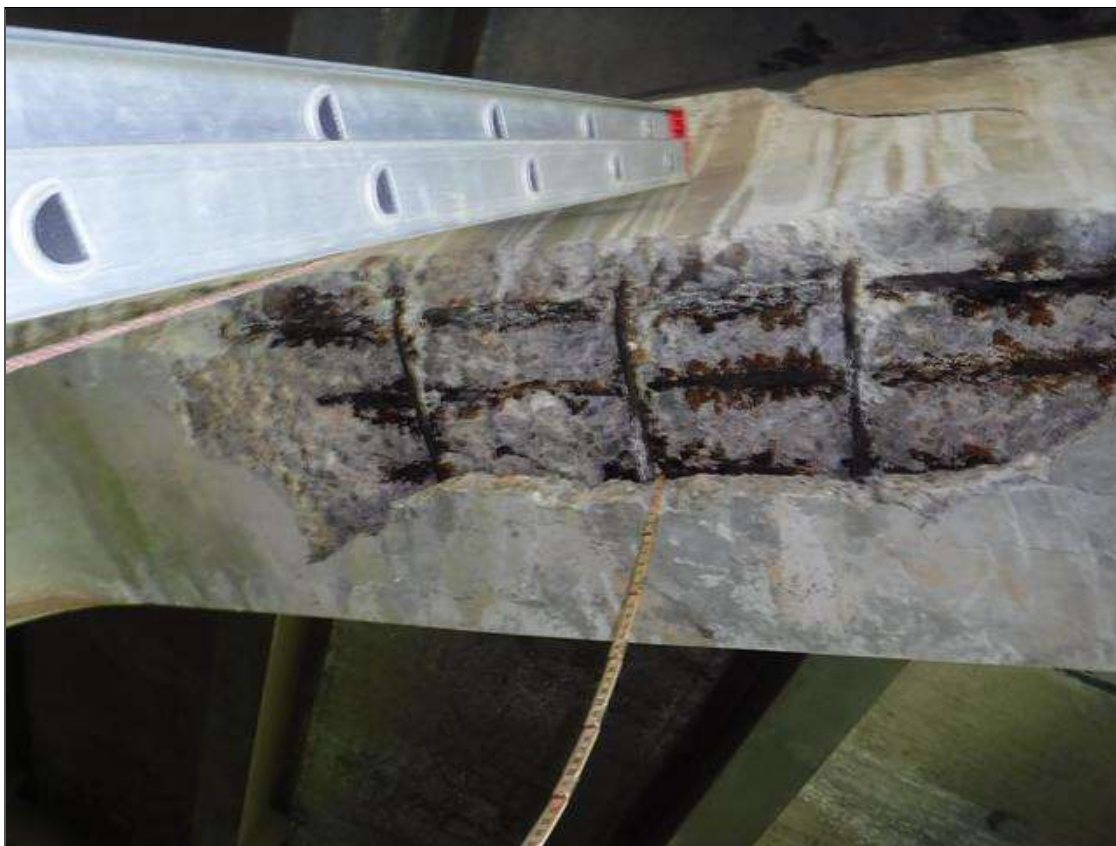
Bent 1 Cap 1: PAR: UP TO 8' X 30" X 3" DEEP SPALLS WITH EXPOSED REBAR, 13' X 6" AREAS OF DELAMINATION AND UP TO 1/2" DIAGONAL AND HORIZONTAL CRACKS IN BOTTOM AND BOTH FACES OF CAP BENEATH BAY 2, CONDITION IN BOTTOM SHOWN

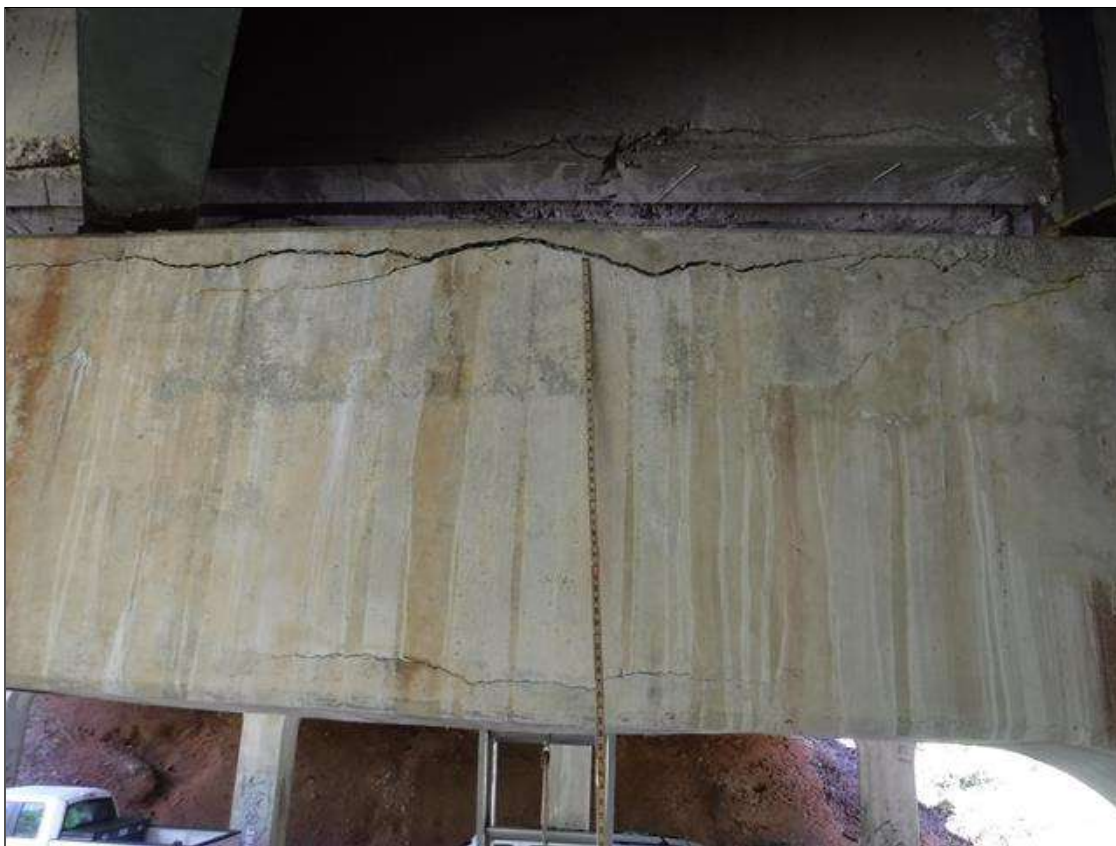
Bent 1 Cap 1: PAR: UP TO 8' X 30" X 3" DEEP SPALLS WITH EXPOSED REBAR, 13' X 6" AREAS OF DELAMINATION AND UP TO 1/2" DIAGONAL AND HORIZONTAL CRACKS IN BOTTOM AND BOTH FACES OF CAP BENEATH BAY 2, CONDITION IN SPAN 1 FACE SHOWN

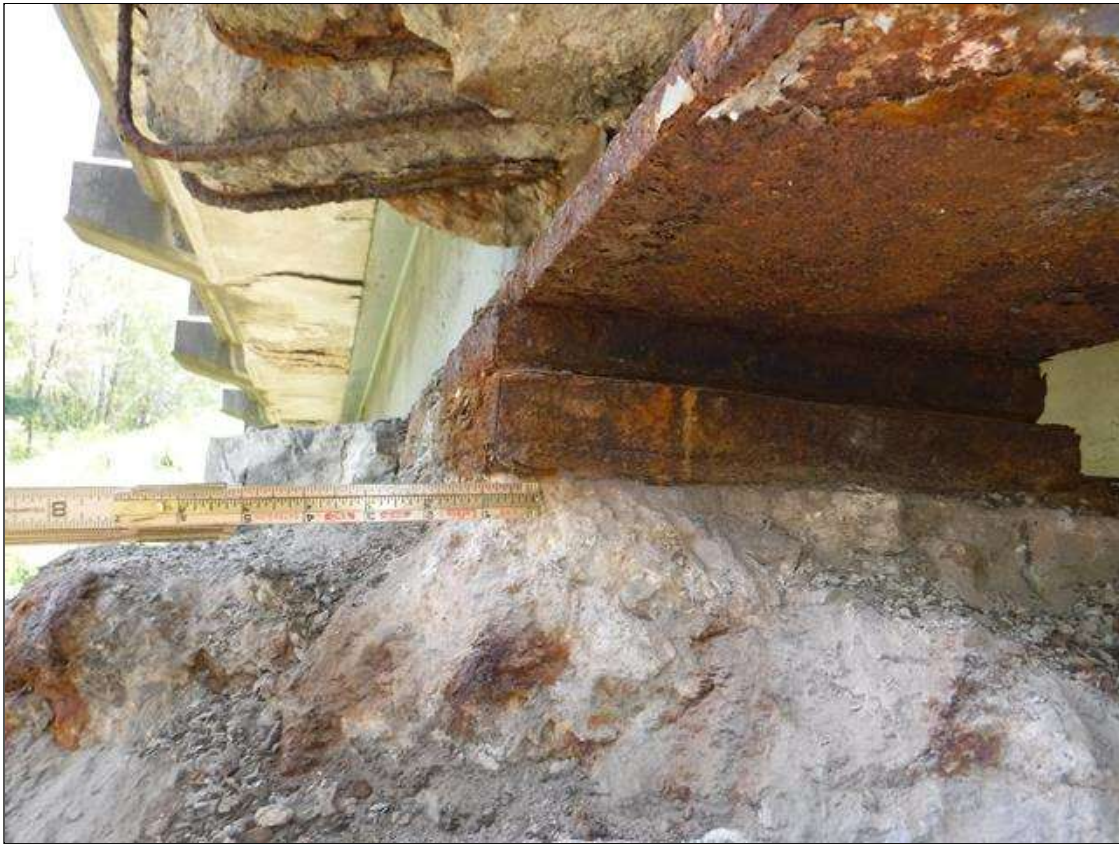
Span 2 Beam 10 Near Bearing: LESS THAN 1% LOSS OF BEARING AREA BENEATH BEAM 10 BEARING

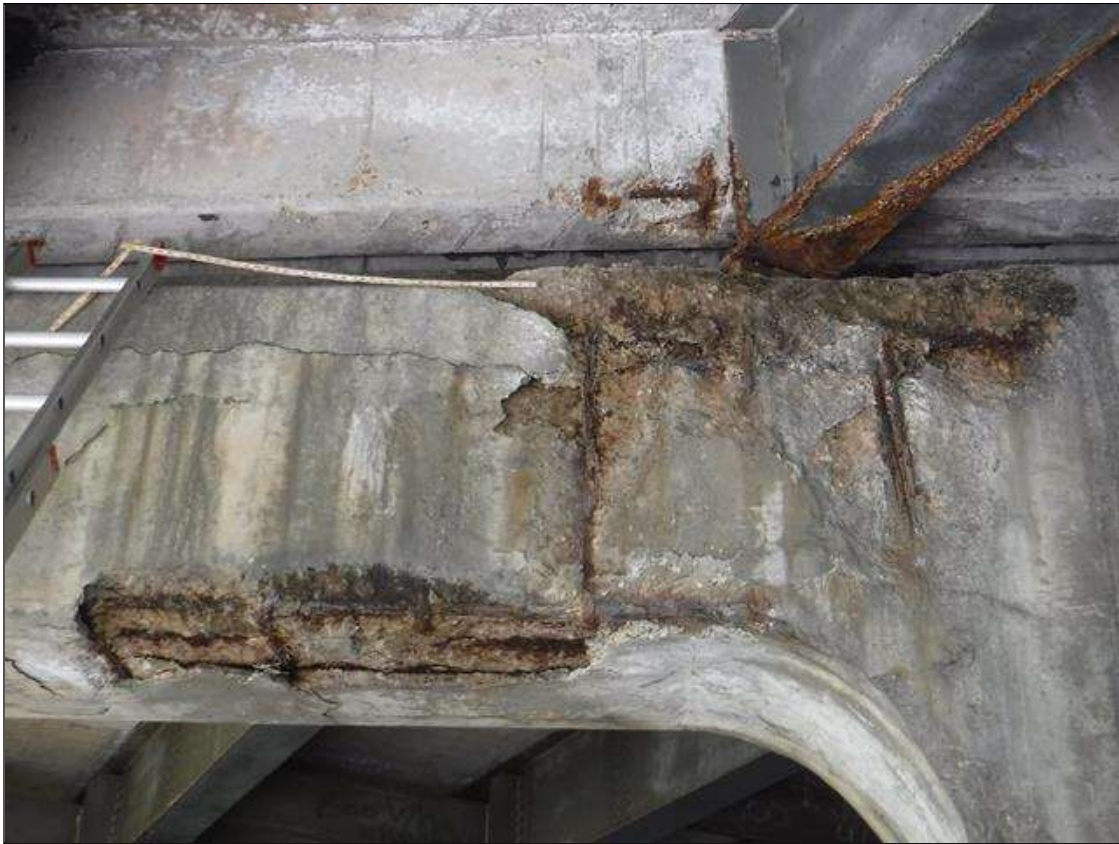
Bent 1 Cap 1: PAR: UP TO 64" X 42" X 3" DEEP SPALLS WITH EXPOSED REBAR, 16' X 24" AREAS OF DELAMINATION AND UP TO 1 1/2" LONGITUDINAL, TRANSVERSE, DIAGONAL AND HORIZONTAL CRACKS IN TOP, BOTTOM, RIGHT END AND BOTH FACES OF CAP FROM BENEATH BEAM 8 TO RIGHT END, CONDITION IN SPAN 2 FACE BENEATH BEAM 8 SHOWN

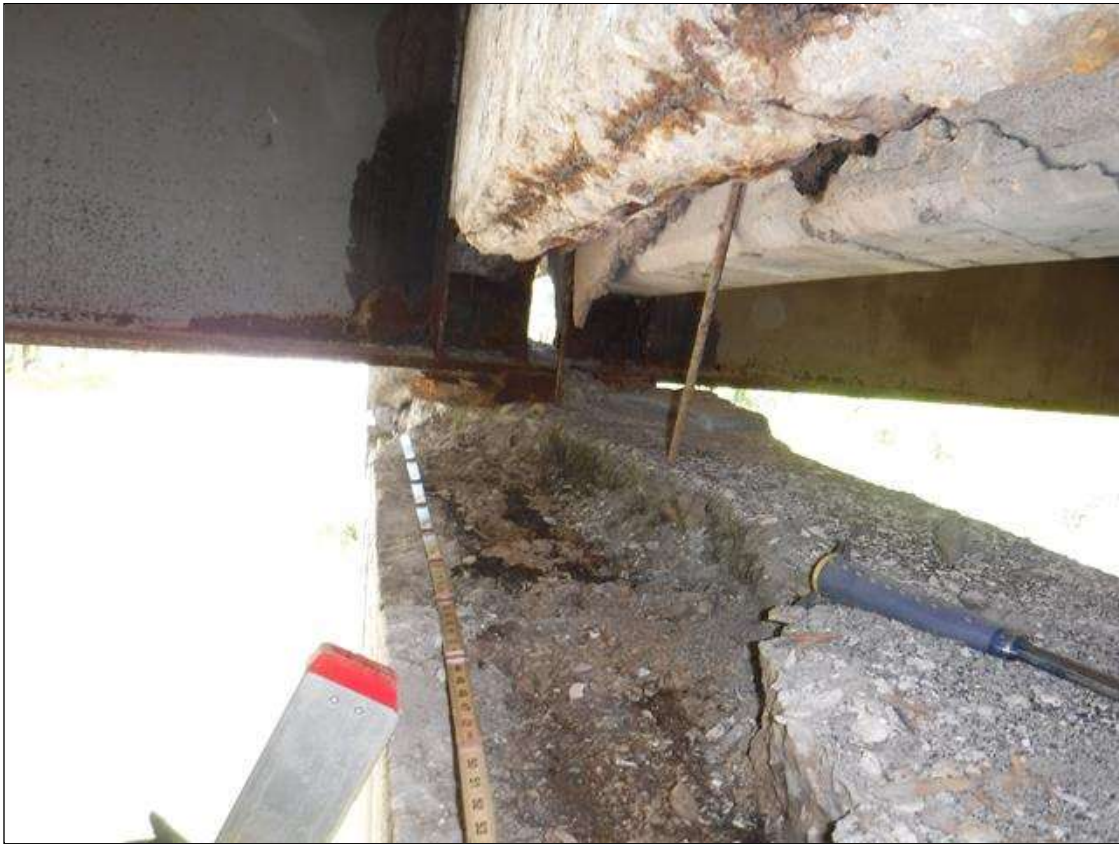
Bent 1 Cap 1: PAR: UP TO 64" X 42" X 3" DEEP SPALLS WITH EXPOSED REBAR, 16' X 24" AREAS OF DELAMINATION AND UP TO 1 1/2" LONGITUDINAL, TRANSVERSE, DIAGONAL AND HORIZONTAL CRACKS IN TOP, BOTTOM, RIGHT END AND BOTH FACES OF CAP FROM BENEATH BEAM 8 TO RIGHT END, CONDITION IN SPAN 2 FACE BENEATH BAY 9 SHOWN

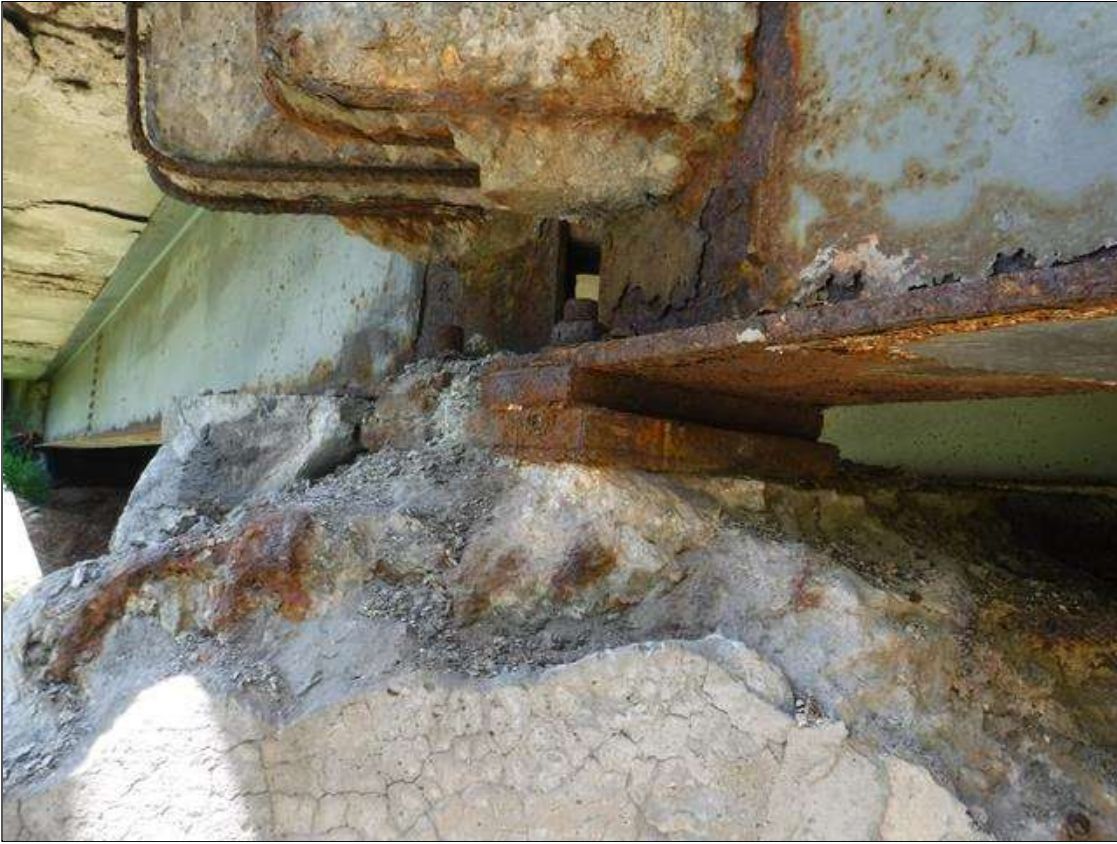
Bent 1 Cap 1: PAR: UP TO 64" X 42" X 3" DEEP SPALLS WITH EXPOSED REBAR, 16' X 24" AREAS OF DELAMINATION AND UP TO 1 1/2" LONGITUDINAL, TRANSVERSE, DIAGONAL AND HORIZONTAL CRACKS IN TOP, BOTTOM, RIGHT END AND BOTH FACES OF CAP FROM BENEATH BEAM 8 TO RIGHT END, CONDITION IN SPAN 2 FACE BENEATH BEAM 10 SHOWN

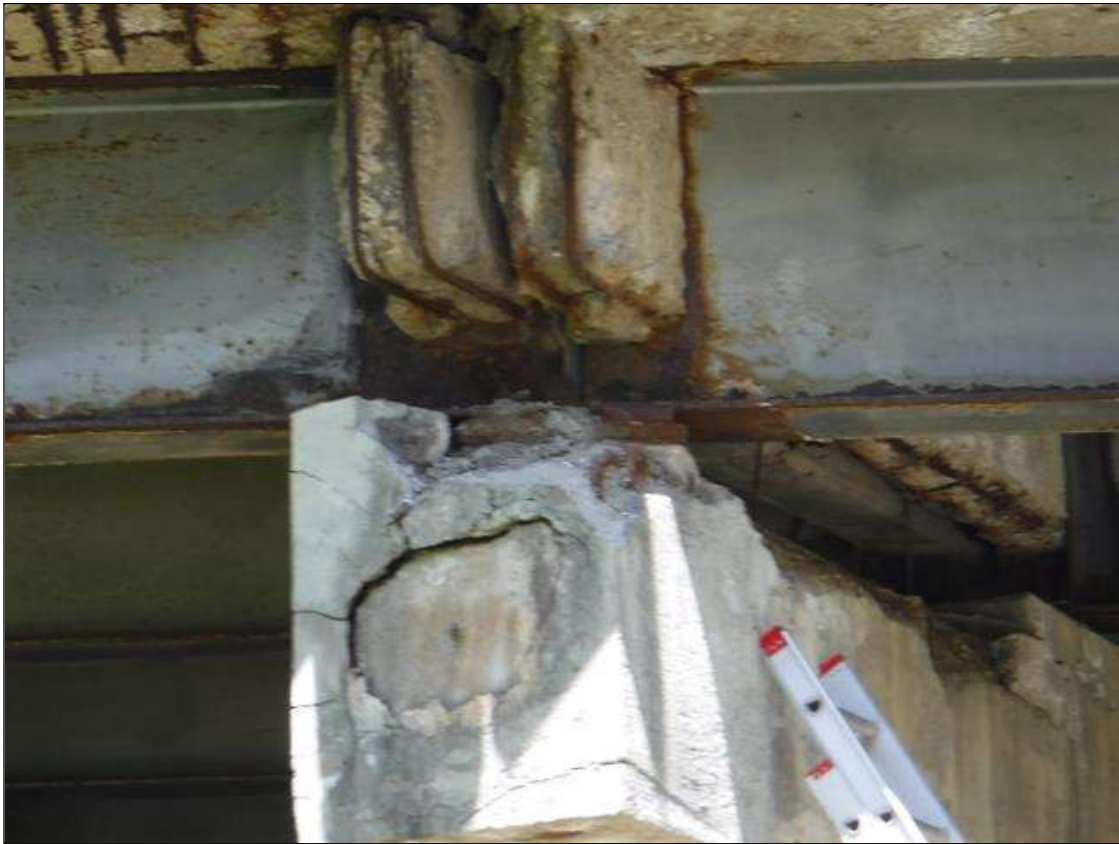
Bent 1 Cap 1: PAR: UP TO 64" X 42" X 3" DEEP SPALLS WITH EXPOSED REBAR, 16' X 24" AREAS OF DELAMINATION AND UP TO 1 1/2" LONGITUDINAL, TRANSVERSE, DIAGONAL AND HORIZONTAL CRACKS IN TOP, BOTTOM, RIGHT END AND BOTH FACES OF CAP FROM BENEATH BEAM 8 TO RIGHT END, CONDITION IN RIGHT FACE SHOWN
