NC DEPARTMENT OF TRANSPORTATION
DIVISION OF HIGHWAYS
STRUCTURE MANAGEMENT UNIT

Structure Safety Report

Routine Element Inspection - Contract

FACILITY CARRIED: I-40 MILE POST: 29.3

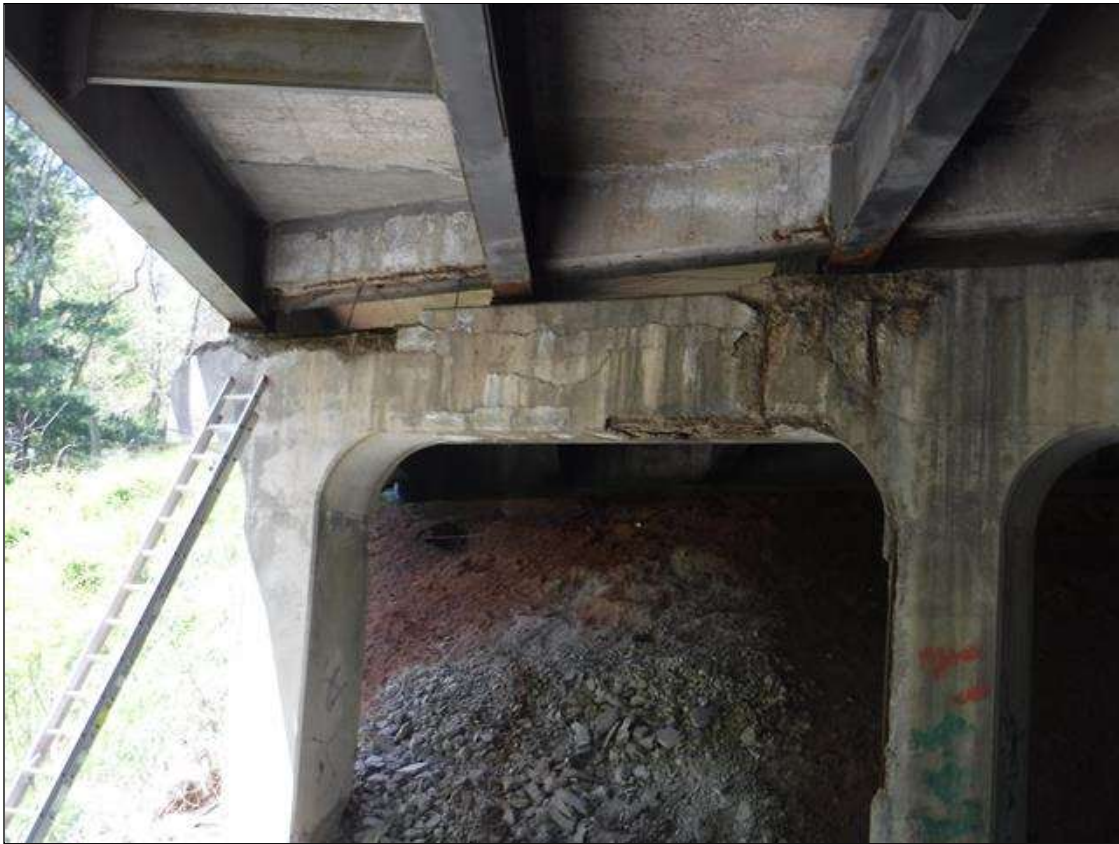
Bent 1 Cap 1: PAR: UP TO 64" X 42" X 3" DEEP SPALLS WITH EXPOSED REBAR, 16' X 24" AREAS OF DELAMINATION AND UP TO 1 1/2" LONGITUDINAL, TRANSVERSE, DIAGONAL AND HORIZONTAL CRACKS IN TOP, BOTTOM, RIGHT END AND BOTH FACES OF CAP FROM BENEATH BEAM 8 TO RIGHT END, CONDITION IN SPAN 2 FACE SHOWN
