STATE OF NORTH CAROLINA DEPARTMENT OF TRANSPORTATION

PROJECT NO. I-5880

SHEET 2 OF 4

DECK UNDERSIDE REPAIR SPAN B

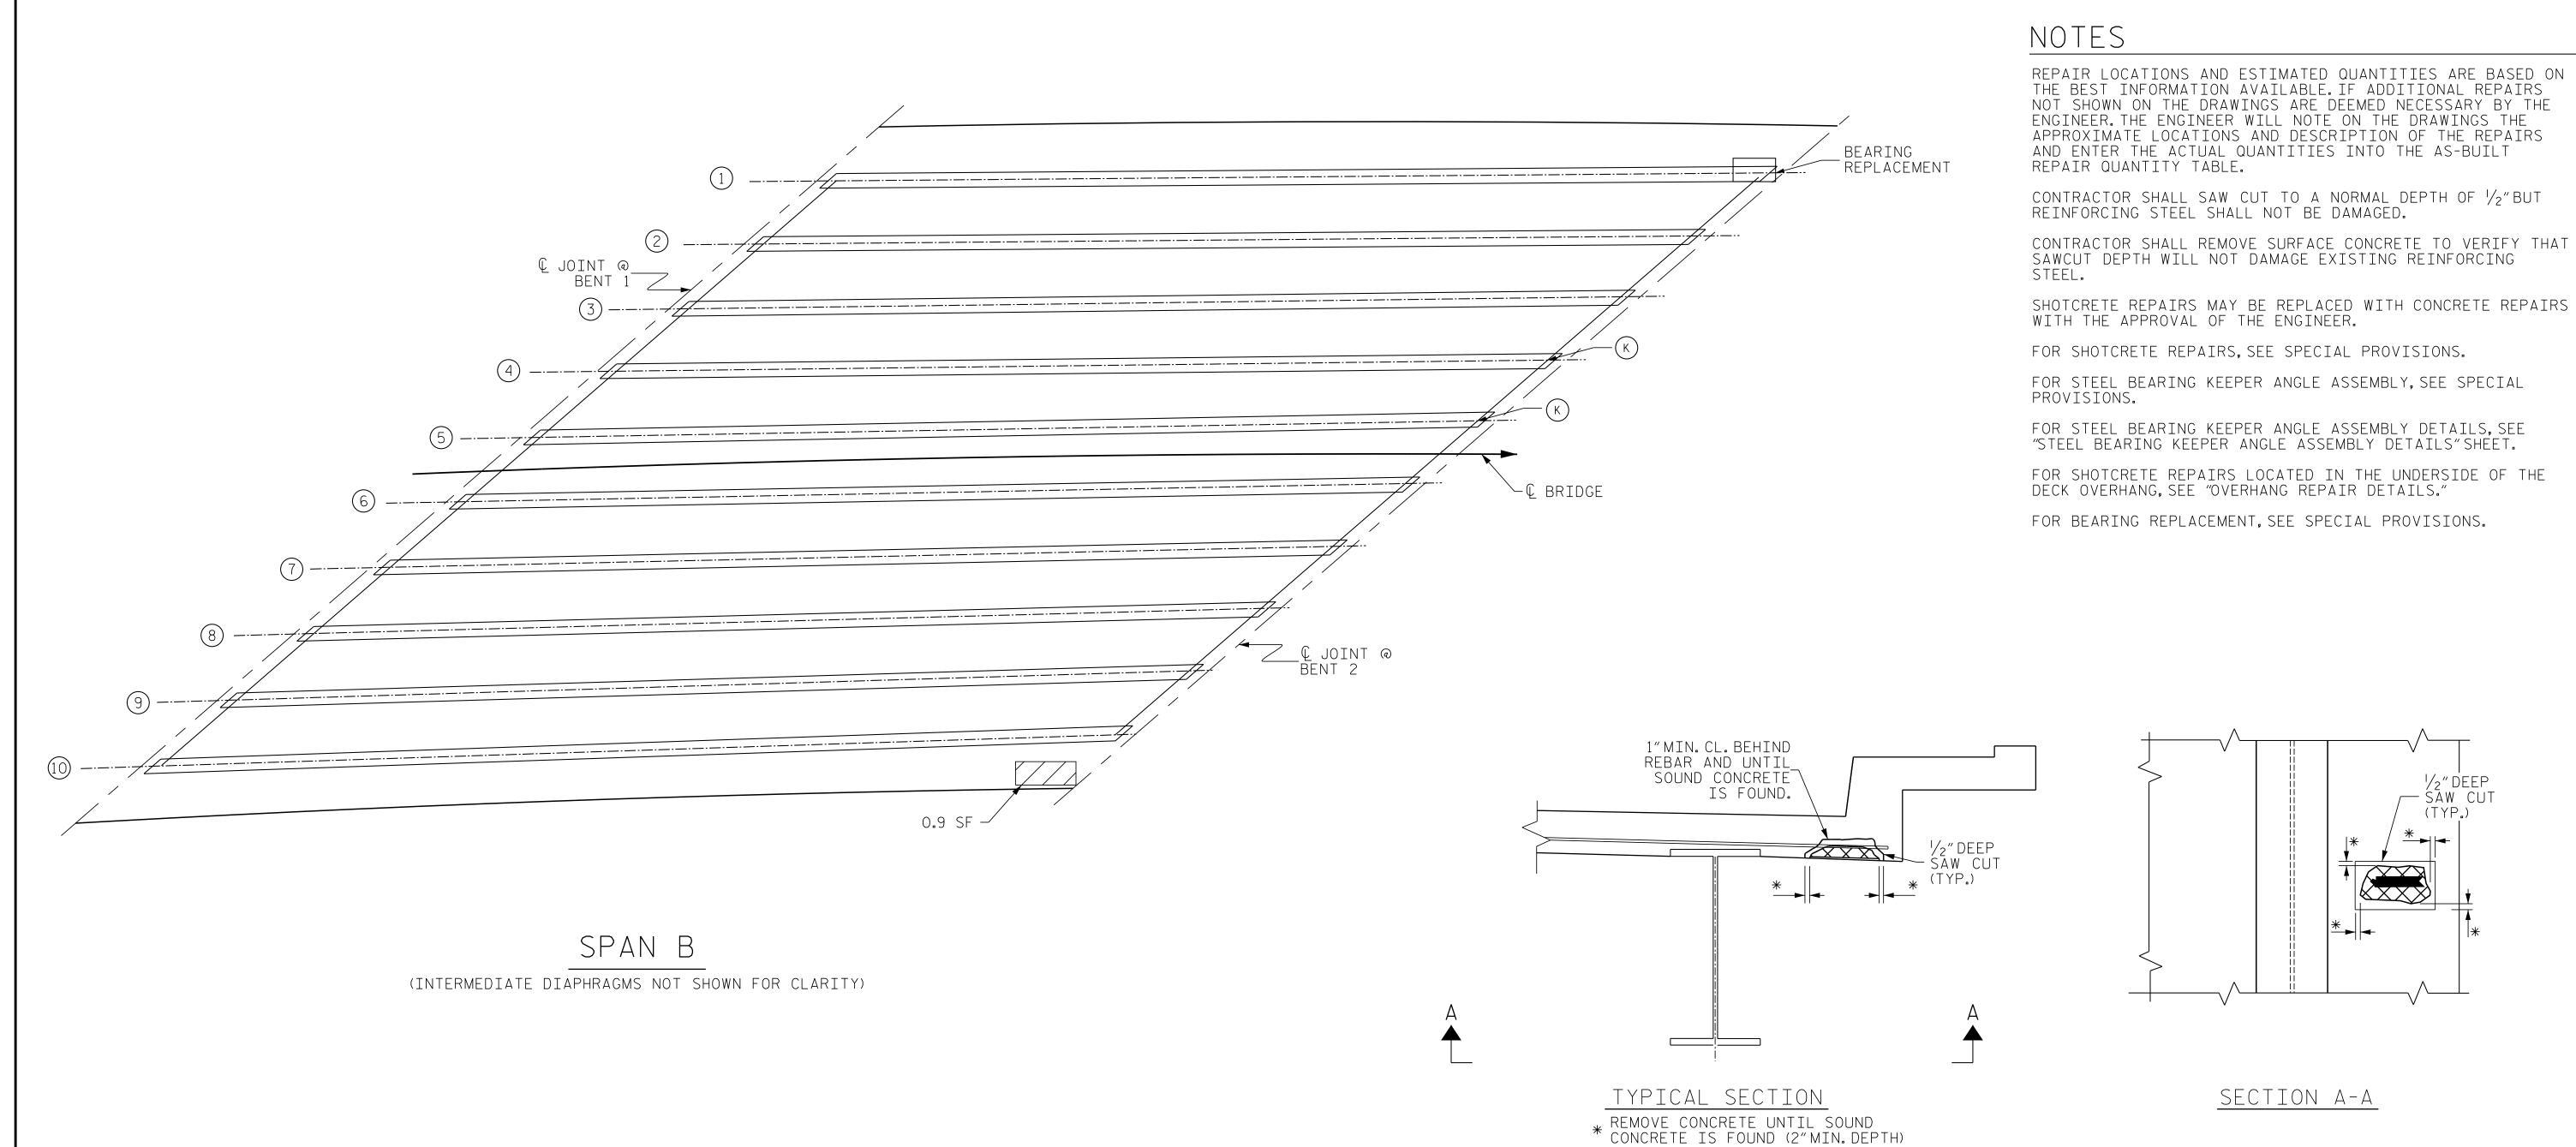
## OVERHANG REPAIR DETAILS

VALUES IN CHART REPRESENT ESTIMATED REPAIR TOTALS AFTER REMOVAL OF UNSOUND CONCRETE, MINIMUM OF 1"BEHIND REBAR AND MINIMUM 2"CLEARENCE TO SAWCUT. SEE REPAIR DETAILS.
