NC DEPARTMENT OF TRANSPORTATION  
DIVISION OF HIGHWAYS  
BRIDGE MANAGEMENT UNIT

# BRIDGE INSPECTION REPORT

COUNTY BERTIE BRIDGE NUMBER 070024 INSPECTION CYCLE 2 YRS  
ROUTE NC11 ACROSS CASHIE RIVER M.P. 0

INSPECTION DATE 07/07/2014

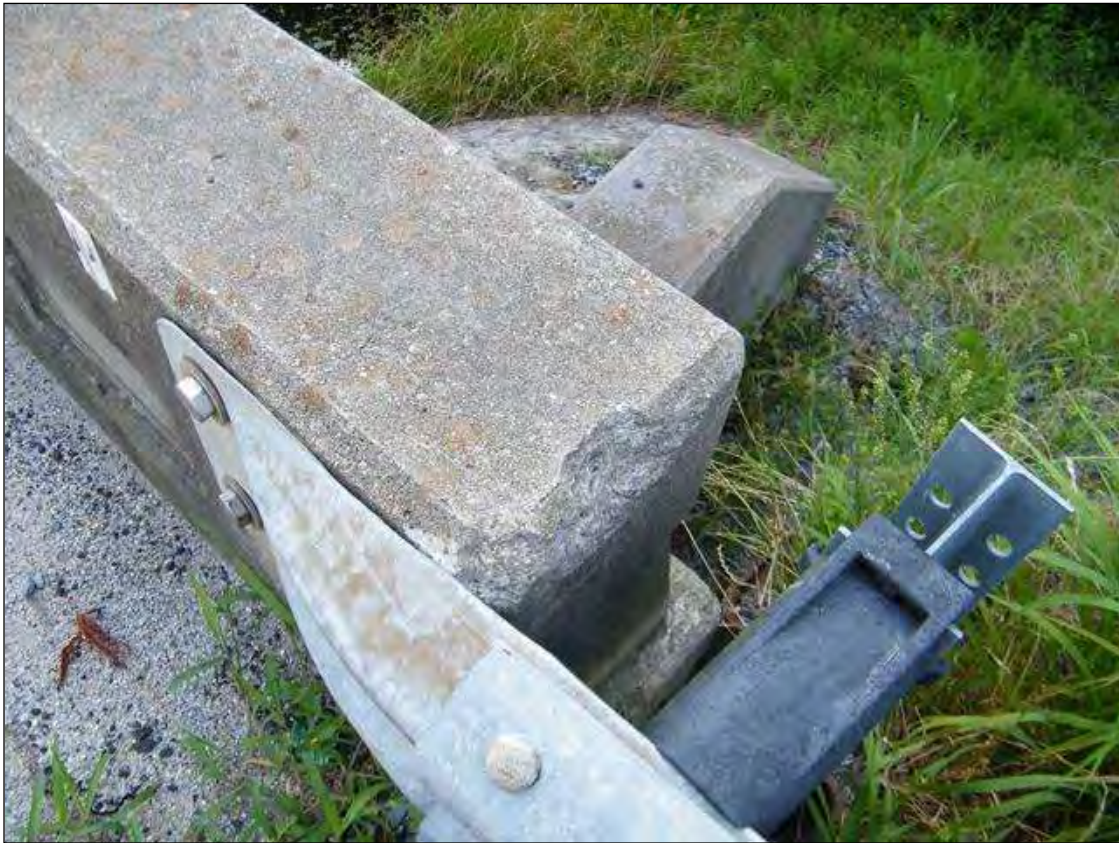
RIGHT RAIL SPALLED AT END BENT 1.

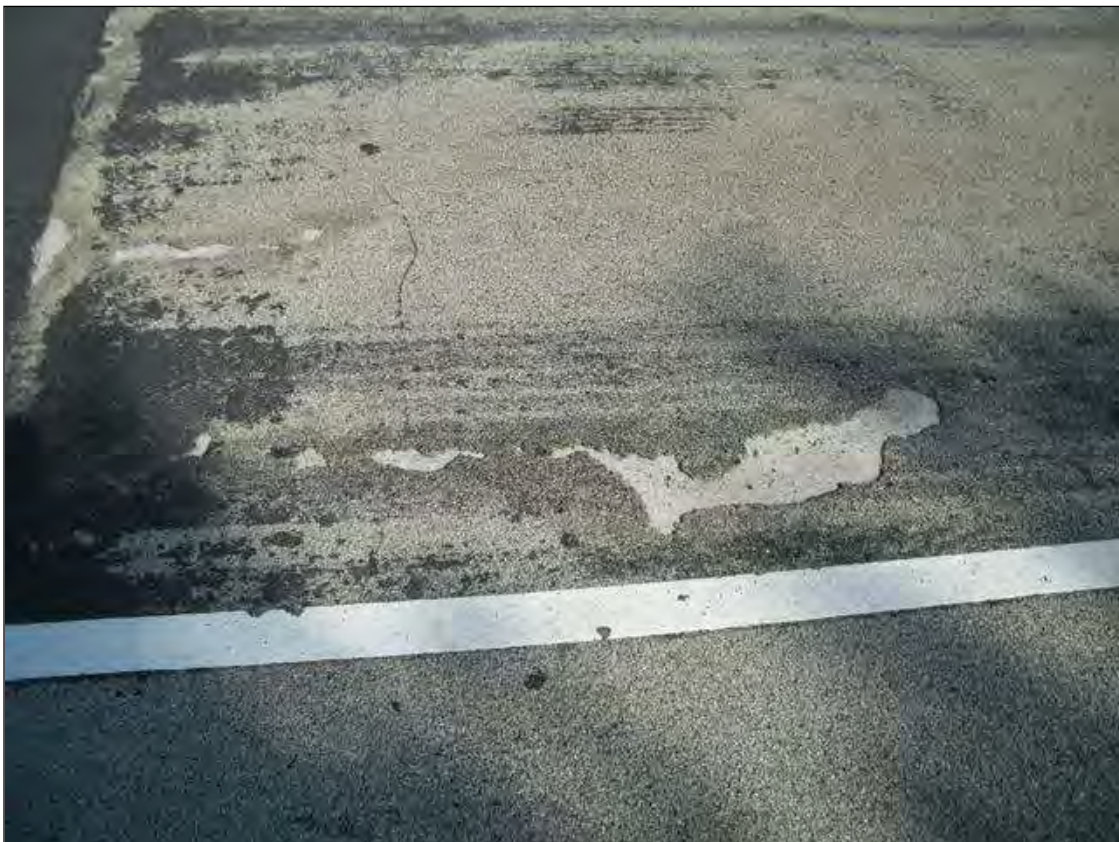
WEARING SURFACE MISSING IN AREAS IN SPAN 1, NORTHBOUND LANE.

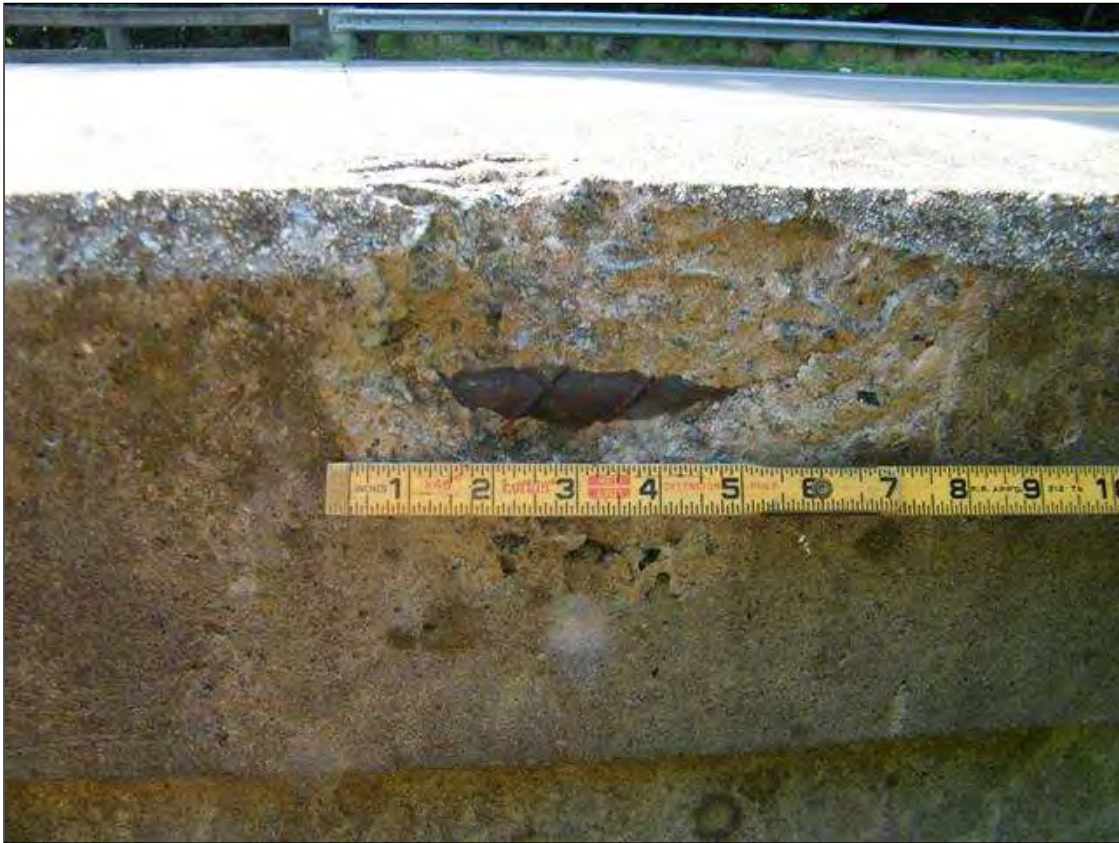
CRACKED, SPALLED, AND DELAMINATED AREA WITH RESTEEL EXPOSED IN EXTERIOR OF LEFT RAIL AT  
END BENT 1.

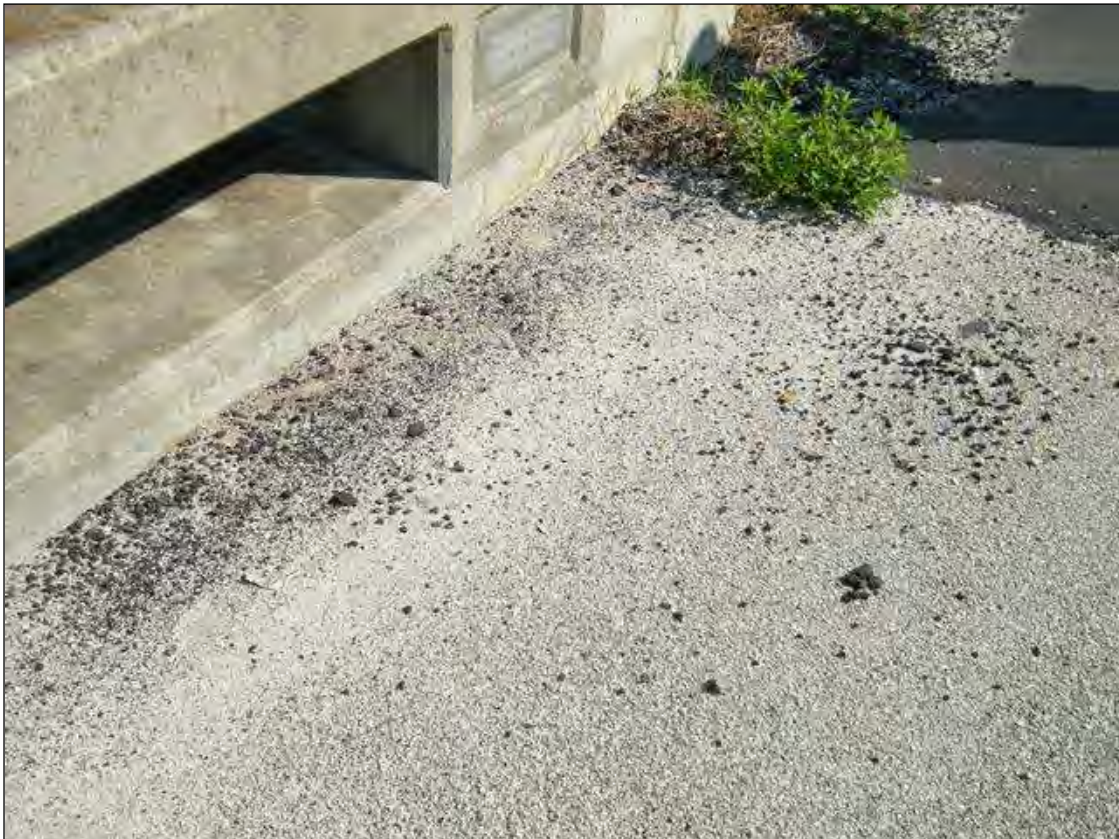
TRASH AND DEBRIS ADJACENT CURBS.

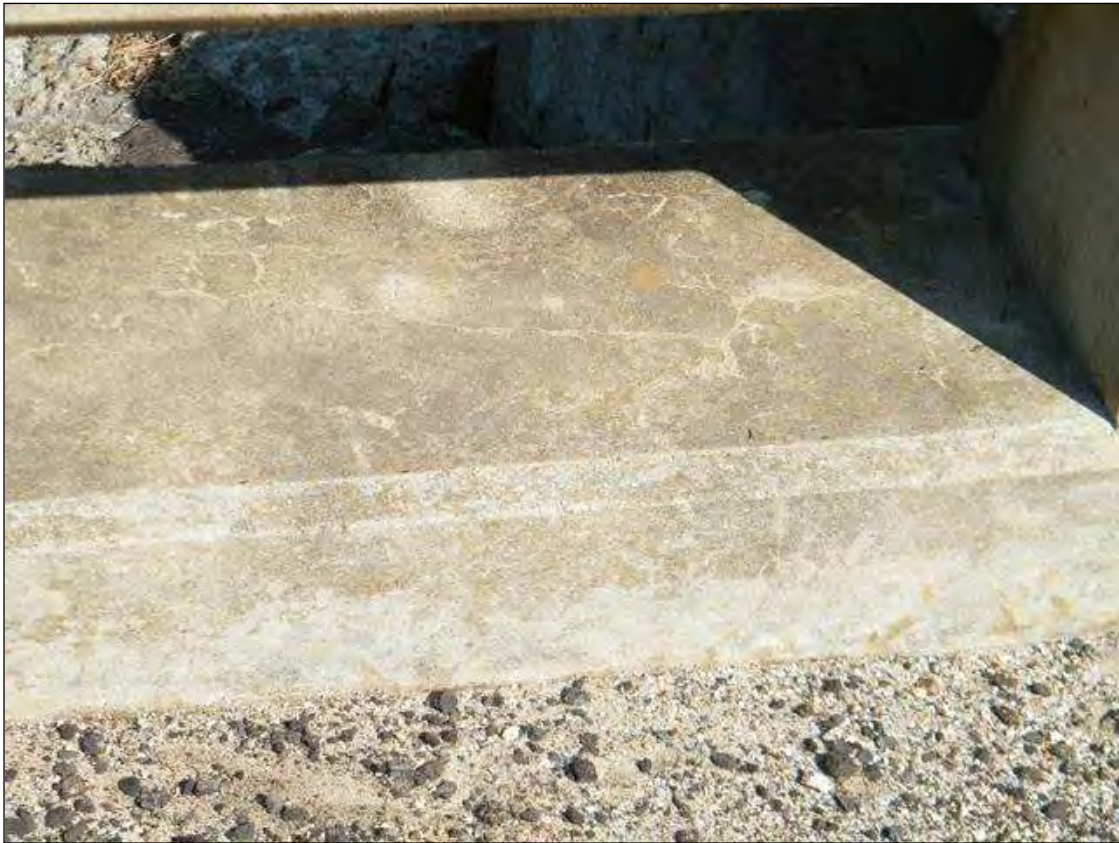
MAP CRACKING WITH EFFLO IN CURBS.

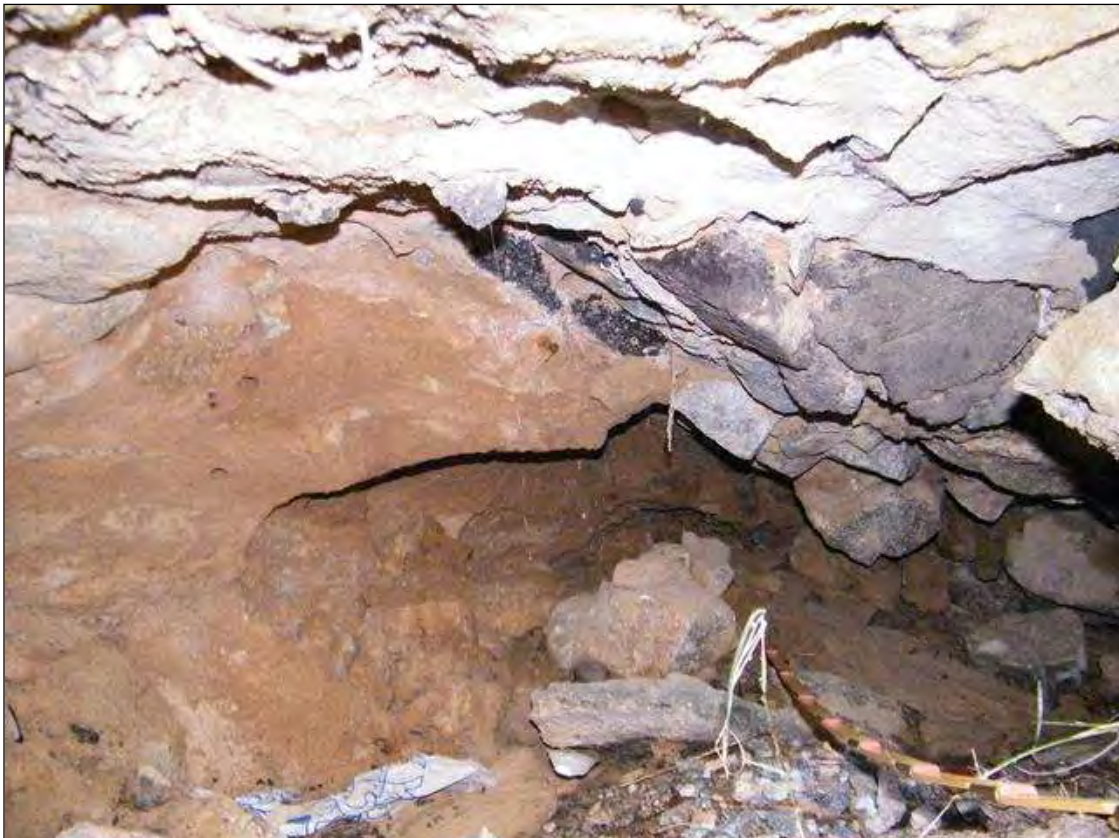
INTERIOR VIEW OF VOID ON LEFT SIDE AT END BENT 2. AREA IS GREATER THAN 6' WIDE AND 1' TALL.  
PRIORITY MAINTENANCE ISSUED.

MMS Code	MMS Description	Quantity
3352	Maint Slope Protection	6 SF
Location:		
Slope                      Bent/Span No.    2                      LEFT SHOULDER		
Priority Level	Status	
Priority Maintenance	SIA Updates in Process	
Submitted Date:	Submitted By:	Assisted By:
07/07/2014	Z.S. DUNLOW	G.L. HARRINGTON
Details		
<p>STRUCTURE HAS NO POSTED WEIGHT LIMIT. INTERIOR VIEW OF VOID ON LEFT SIDE AT END BENT 2. AREA IS GREATER THAN 6' WIDE AND 1' TALL. PRIORITY MAINTENANCE ISSUED. TOP VIEW OF VOID ON LEFT SIDE AT END BENT 2. AREA IS GREATER THAN 6' WIDE, 1' TALL, AND IS LOCATED 18" FROM PAVEMENT.</p>

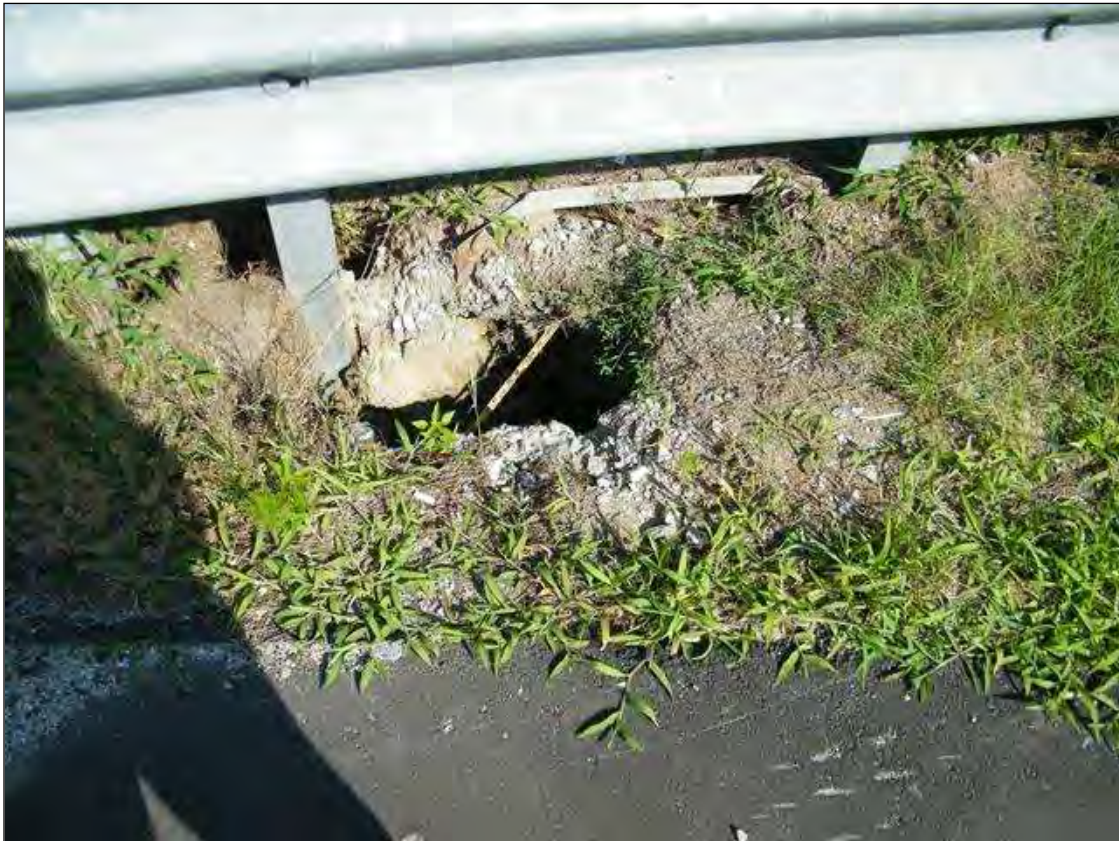
TOP VIEW OF VOID ON LEFT SIDE AT END BENT 2. AREA IS GREATER THAN 6' WIDE, 1' TALL, AND IS LOCATED 18" FROM PAVEMENT.

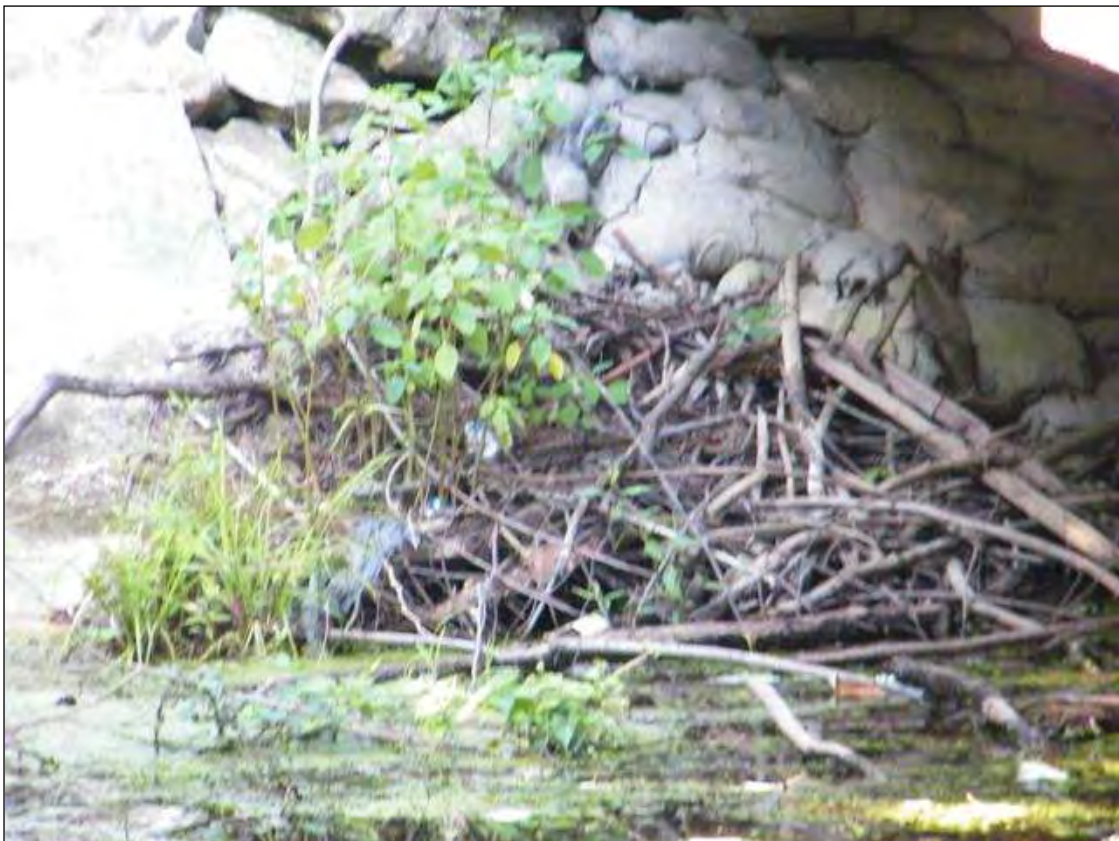
DRIFT AT END BENT 1 ON RIGHT SIDE.

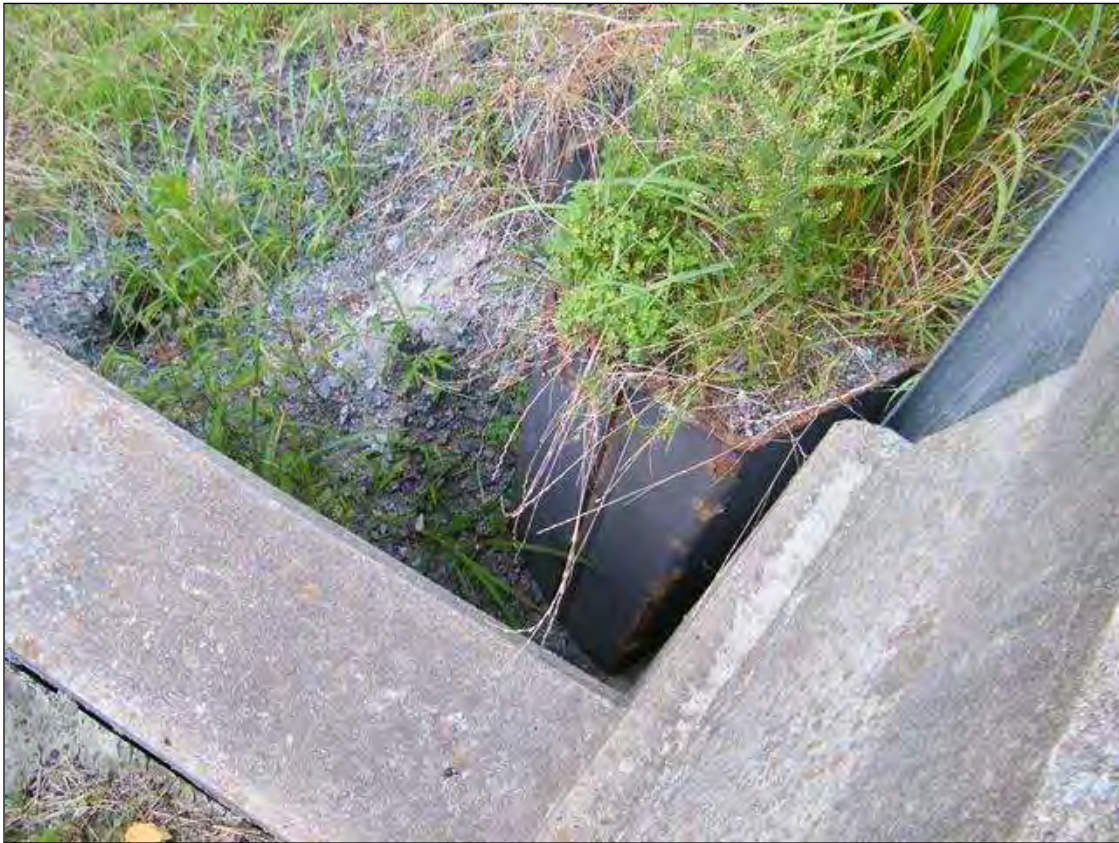
STEEL SHEETING DRIVEN AT END BENT 1.

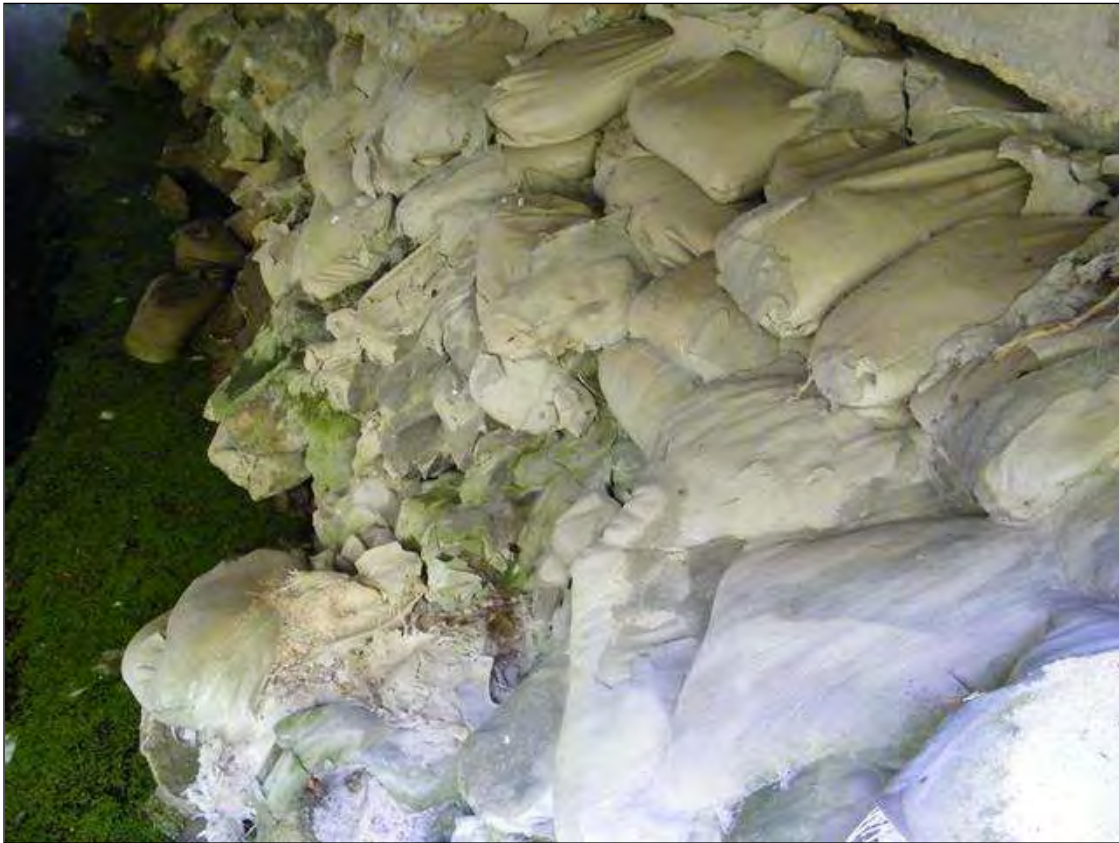
GROUT AND SAND BAGS AT ENDBENTS.

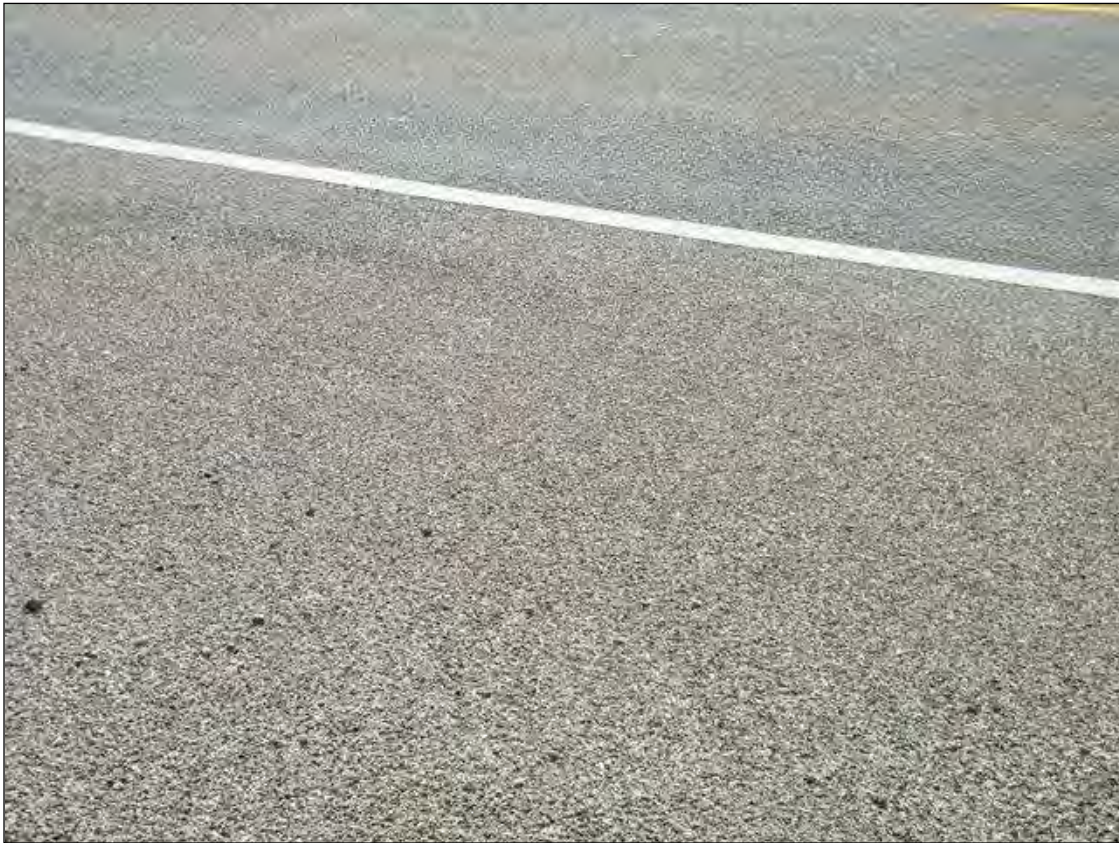
0.010' EPOXY WEARING SURFACE ADDED.

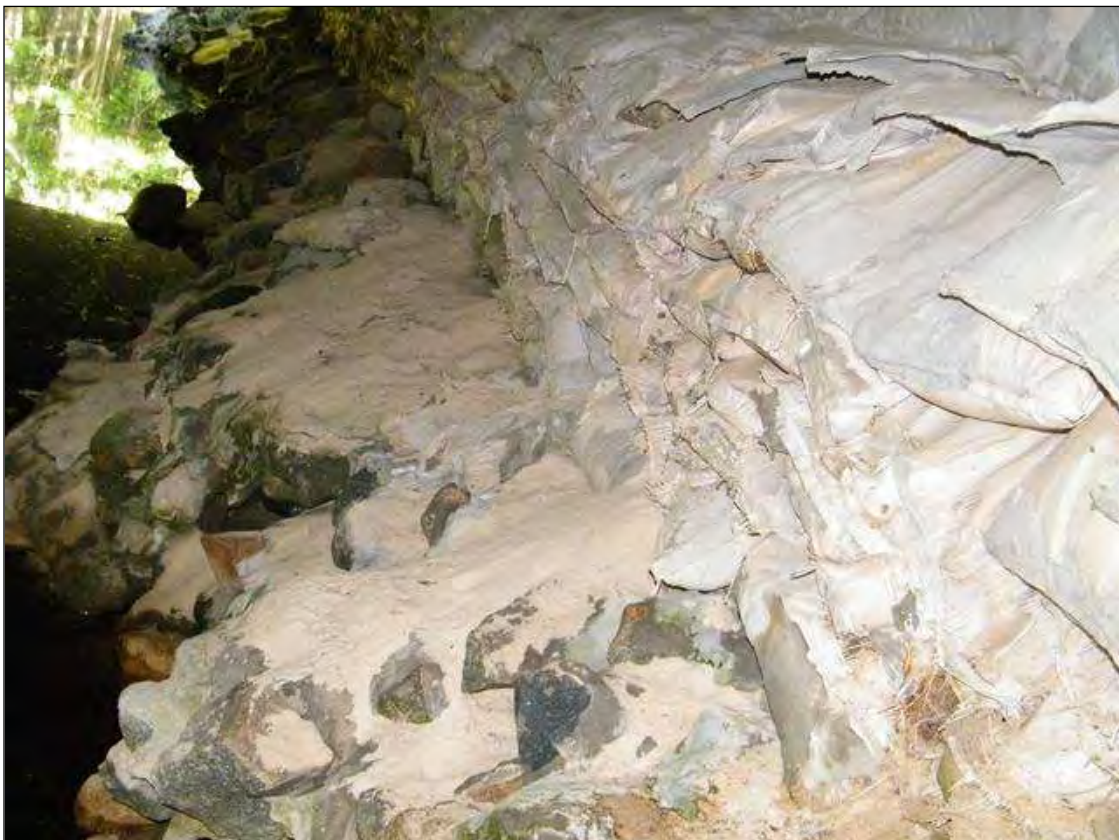
SAND BAGS AND GROUT AT END BENT 1.
