**BRIDGE INSPECTION RECORD AND SUMMARY
FOR SHORED OR TEMPORARY REPAIRED
STRUCTURES TO KEEP A BRIDGE OPEN**

BRIDGE: 780176
3/7/2024

Structure Safety Report

Routine Element Inspection - Contract

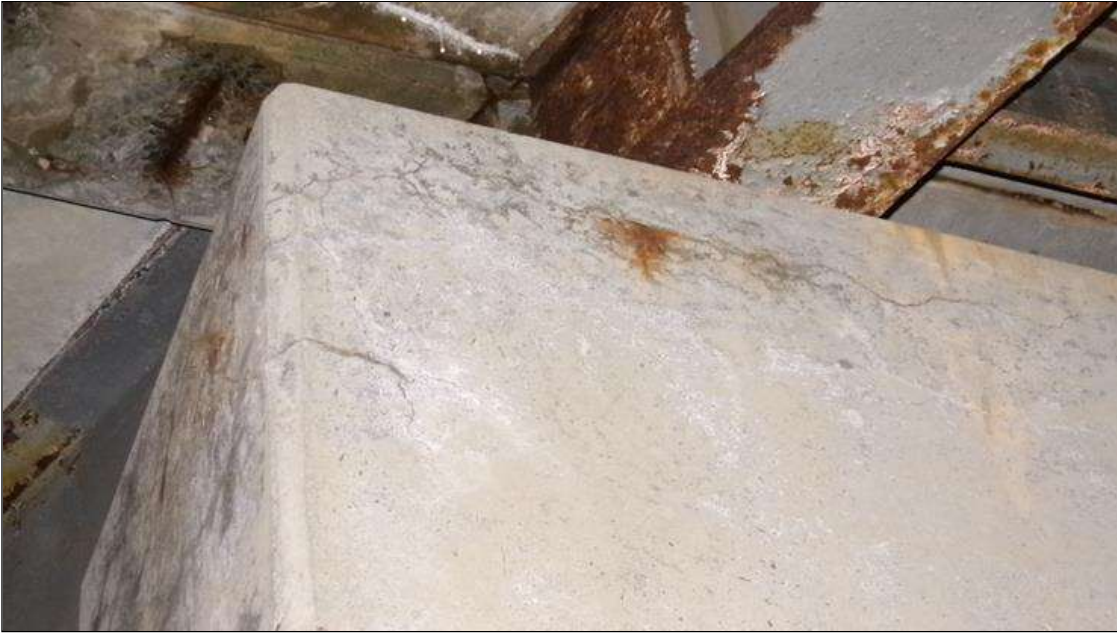
Bent 2 Cap 1: HORIZONTAL OPEN CRACKING (3FEET X 1/8INCH) TOP NEAR FACE AT LEFT END. 5FEET HORIZONTAL OPEN CRACKING (1/16INCH) TO TOP OF CAP UNDER BAY 1. HORIZONTAL OPEN CRACKING (6FEET X 1/8INCH) DELAMINATION TO TOP FAR CORNER AT RIGHT END (DELAMINATION DOES NOT EXTEND UNDER BEARING)

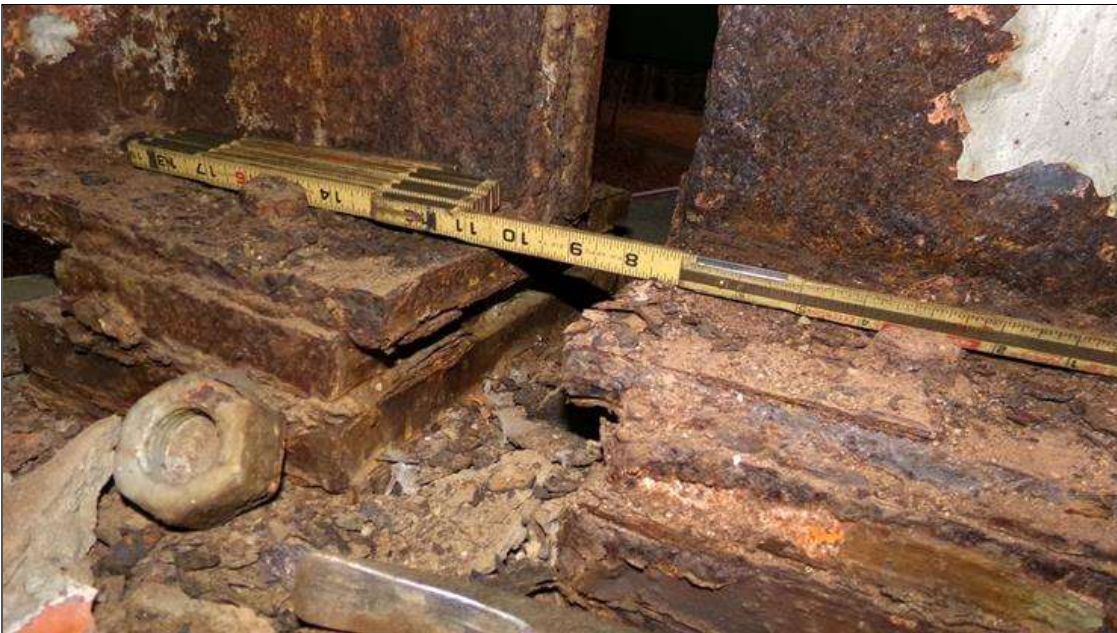
Priority Level	Defect Type	Quantity	Defect Description
2	Corrosion	5	Span 3 Beam 4: BOTTOM FLANGE SECTION LOSS (33 PERCENT SECTION LOSS, 1/4INCH SECTION LOSS, 7/16INCH REMAINS) FULL WIDTH AND WEB PITTING (1/2INCH REMAIN X 4INCHES HIGH) FOR 5FEET AT NEAR END. LEFT STIFFENER HAS UP TO 1/8 INCH SECTION LOSS FOR 3 INCHES HIGH X FULL WIDTH (PAR)
2	Connection	1	Span 3 Near Bearing: SPAN 3 BEAM 4 NEAR BEARING ANCHOR BOLT NUT BROKEN AND MISSING (PAR)

Span 3 Near Bearing: SPAN 3 BEAM 4 NEAR BEARING ANCHOR BOLT NUT BROKEN AND MISSING (PAR)

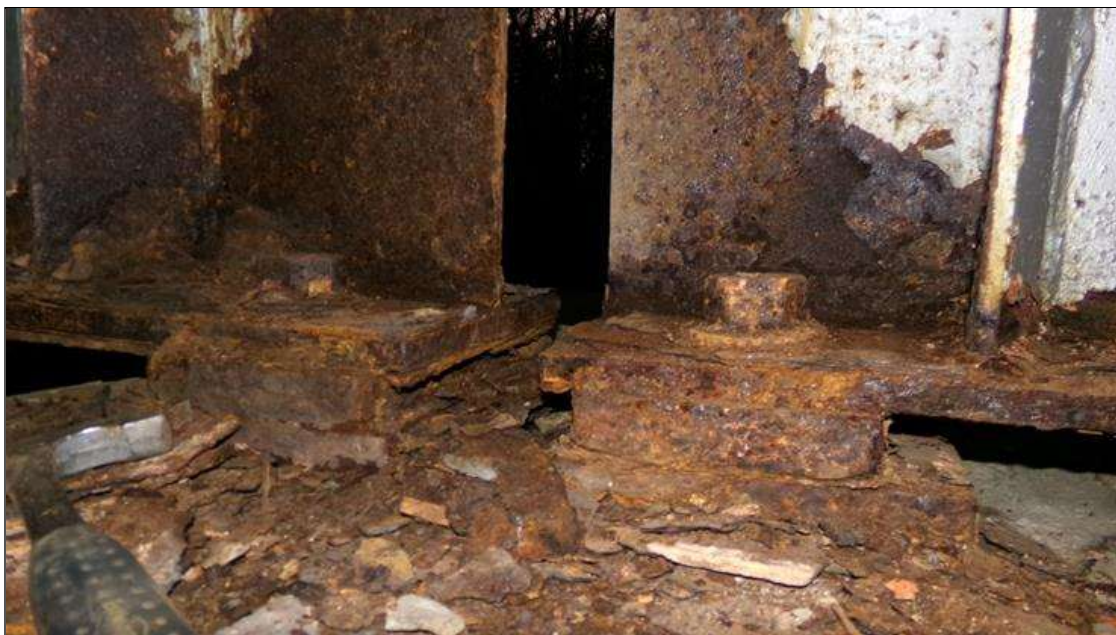
SPAN 2 BEAM 1 FAR BEARING AND SPAN 3 BEAM 1 NEAR BEARING RUST AND SCALE

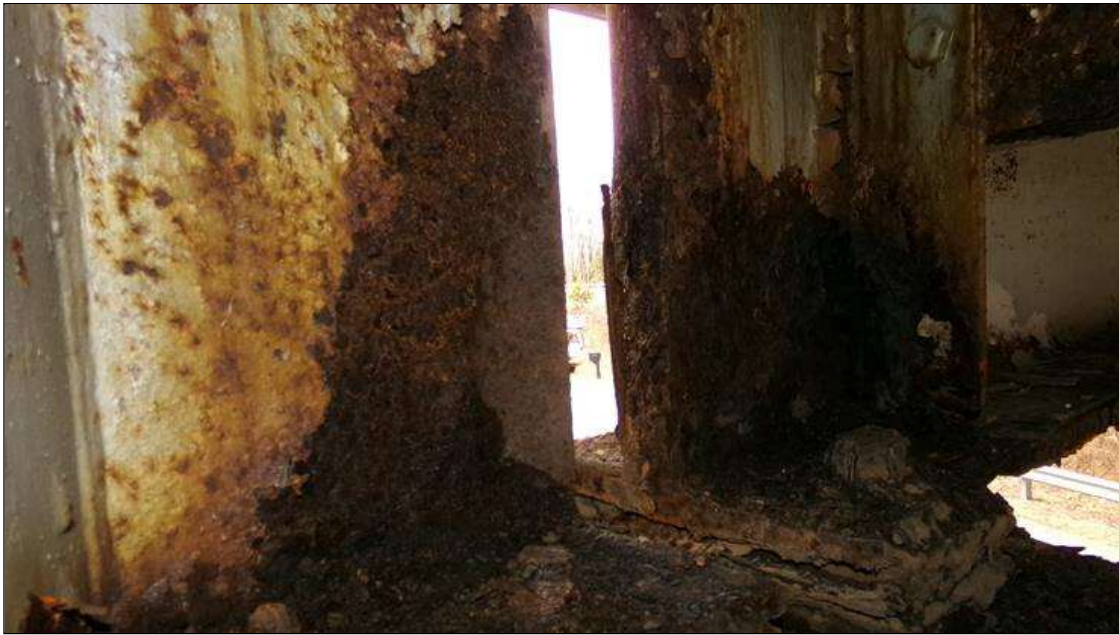
Span 2 Beam 1: WEB SCALING AT BEAM FAR AND NEAR ENDS FOR FULL HEIGHT UP TO 1/16 INCH
LOCALIZED SECTION LOSS (1/2 INCH REMAINS) AT BOTTOM FOR 2 INCH HIGH

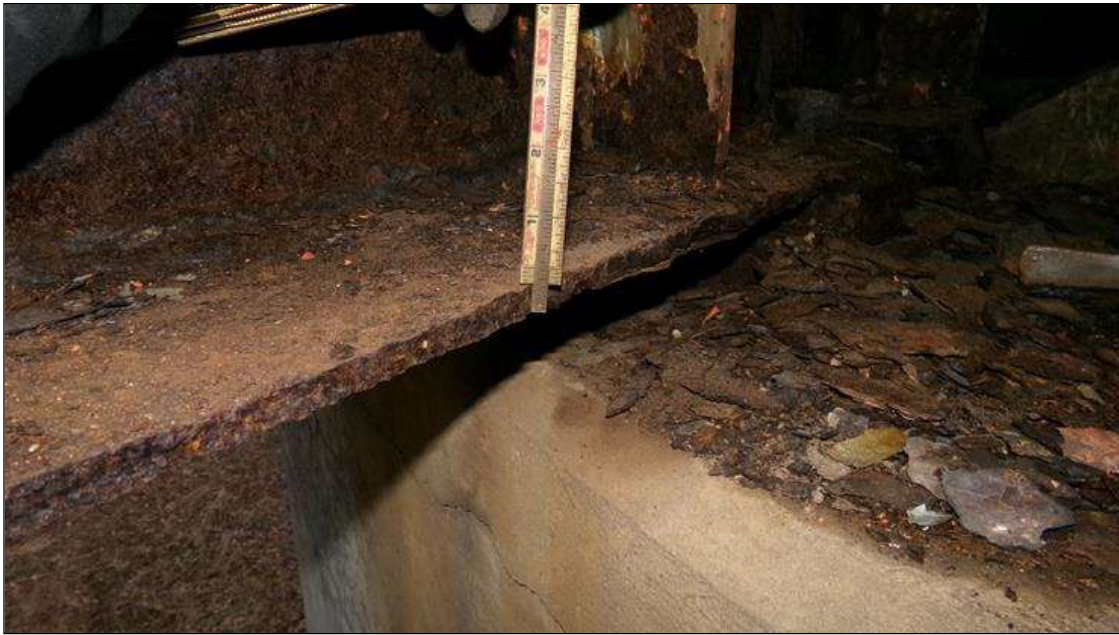
Span 3 Beam 4: BOTTOM FLANGE SECTION LOSS (33 PERCENT SECTION LOSS, 1/4INCH SECTION LOSS, 7/16INCH REMAINS) FULL WIDTH AND WEB PITTING (1/2INCH REMAIN X 4INCHES HIGH) FOR 5FEET AT NEAR END. LEFT STIFFENER HAS UP TO 1/8 INCH SECTION LOSS FOR 3 INCHES HIGH X FULL WIDTH (PAR)

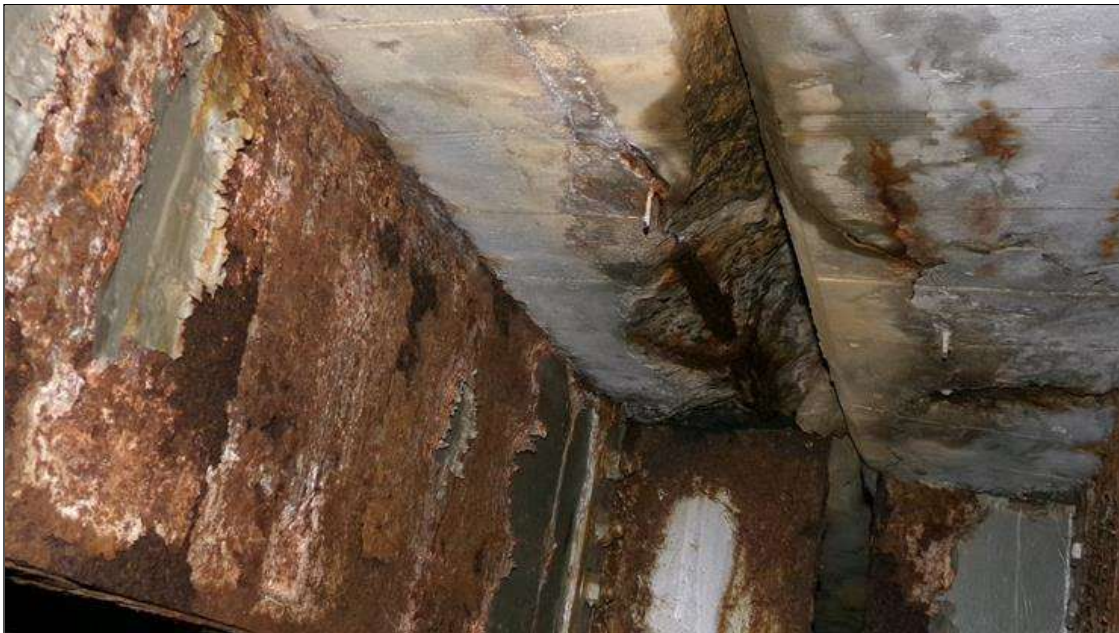
Span 2 Deck: SPALL WITH EXPOSED REBAR TO THE RIGHT SIDE OF BEAM 3 ABOVE BENT 2. UP TO 18 INCHES LONG X 6 INCHES WIDE X 5 INCHES HIGH. EXPOSED REBAR WITH UP TO 70 PERCENT SECTION REMAINING. (PAR)

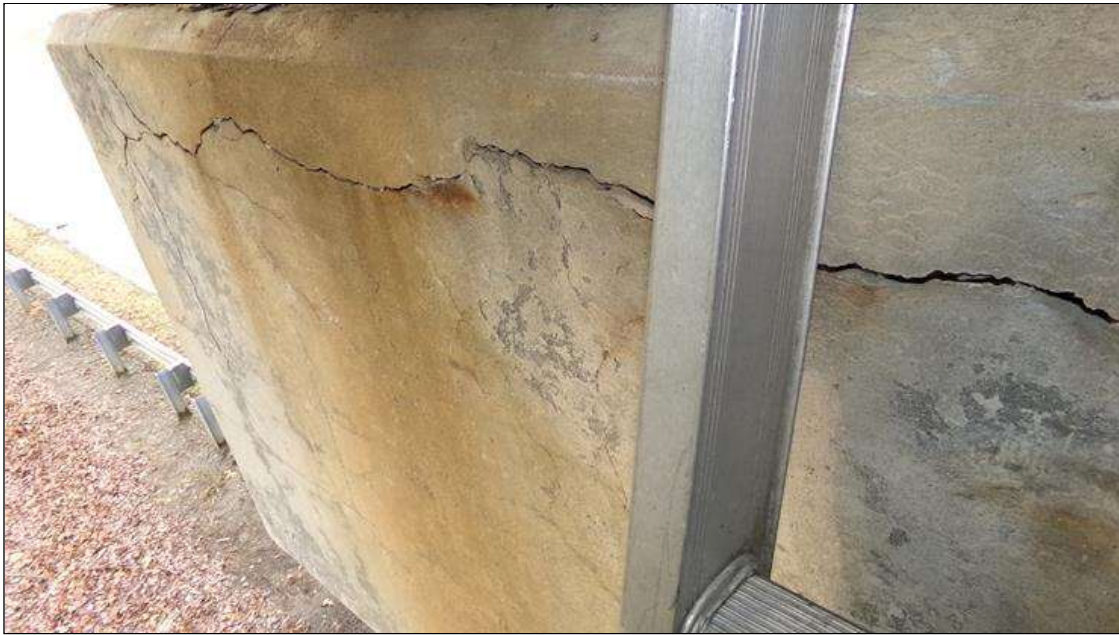
Bent 1 Cap 1: HORIZONTAL OPEN CRACKING (UP TO 5 FEET X 1/8 INCH) AND 3 FEET DELAMINATION TO NEAR AND FAR FACES AT TOP OF CAP AT RIGHT AND LEFT ENDS. (DELAMINATION DOES NOT EXTEND UNDER BEARING)

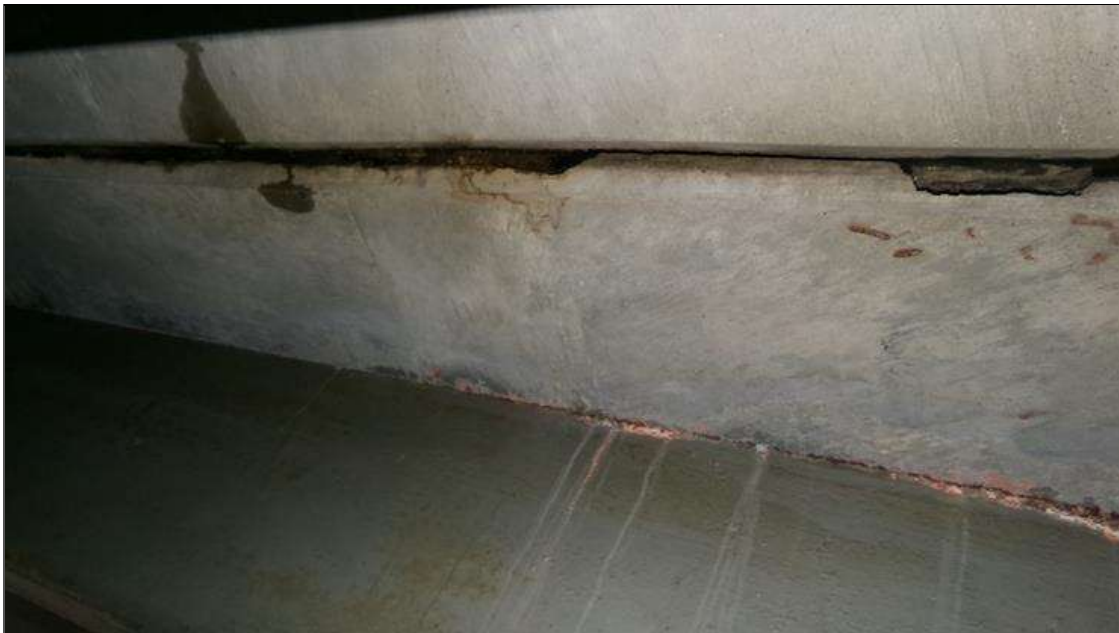
Span 2 Expansion Joint 2: ACTIVE LEAKAGE THROUGH THE JOINT ABOVE BENT IN BAYS 1 AND 3

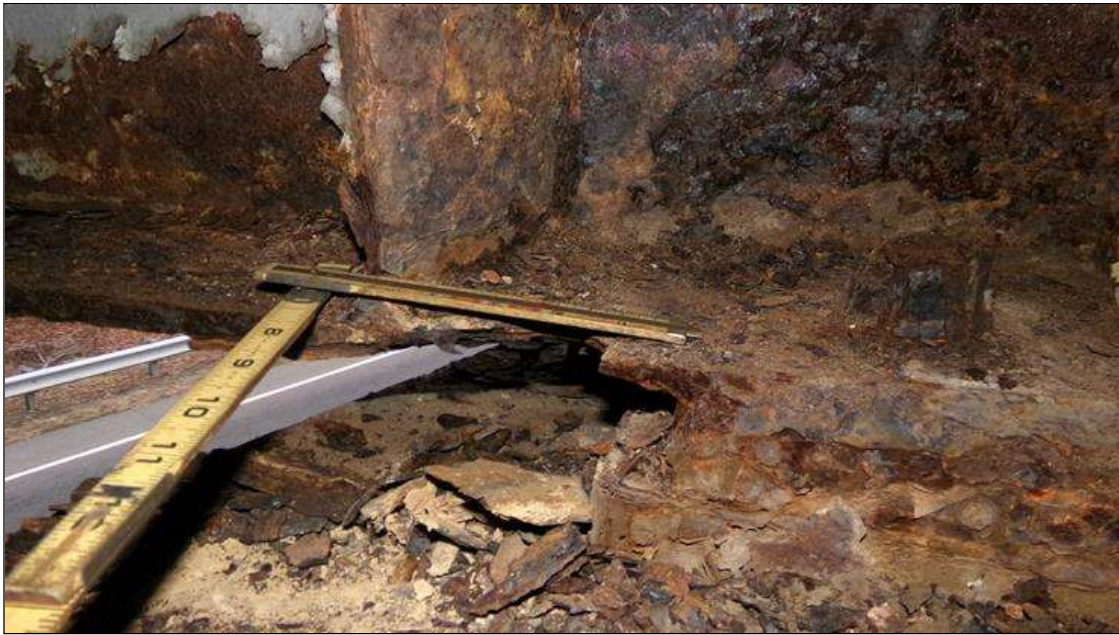
Span 2 Beam 4: BOTTOM FLANGE SECTION LOSS (UP TO 100 PERCENT) FOR 1 INCH DIAMETER. 3/8 (50PERCENT) AVERAGE REMAINING FOR FULL WIDTH FOR 16INCHES AT NEAR END (PAR)

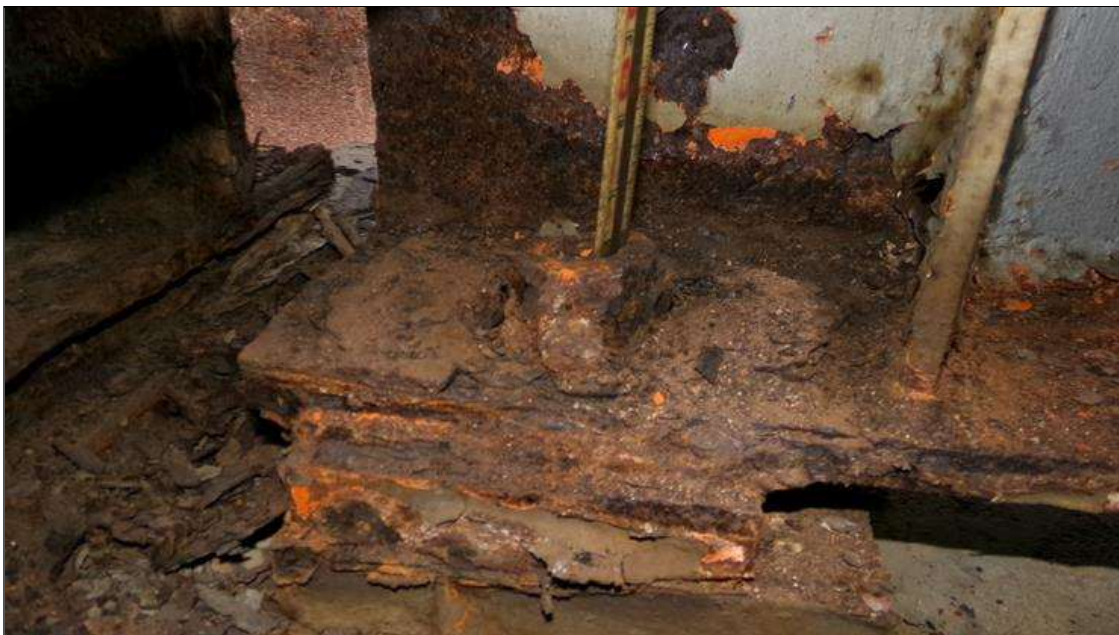
Span 1 Near Bearing: LEFT ANCHOR BOLT IS SHORT AND NOT FULLY THREADED

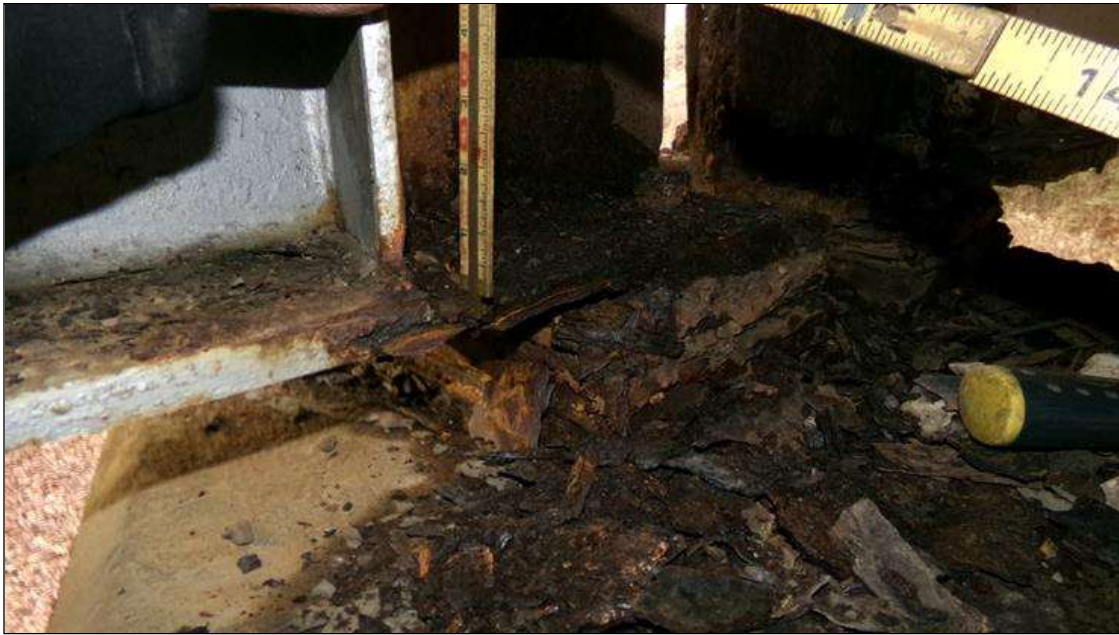
Span 1 Beam 1: WEB SECTION LOSS (33 PERCENT SECTION LOSS, 3/16INCH SECTION LOSS, 3/8INCH REMAINS), 2 INCHES LONG X 8INCHES HIGH AT FAR END (PAR)

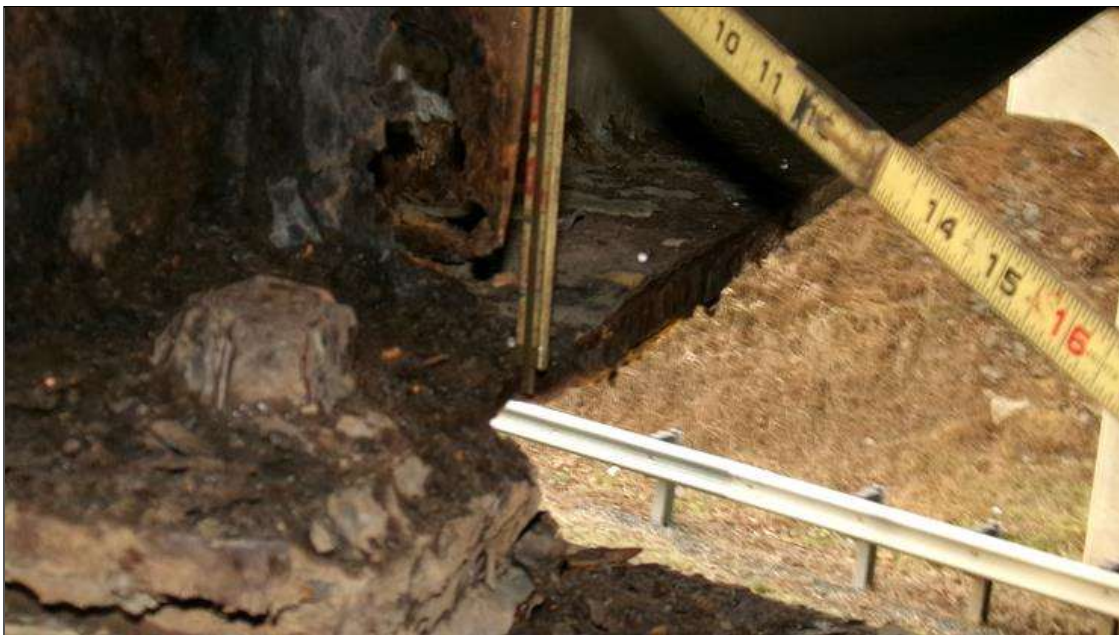
Priority Level	Defect Type	Quantity	Defect Description	
2	Corrosion	2	Span 2 Beam 1: BOTTOM FLANGE SECTION LOSS (3/8INCH REMAINS) FULL WIDTH FOR 16INCHES AT NEAR END. WEB STIFFENER (UP TO 100 PERCENT SECTION LOSS) 4INCHES X 4INCHES (PAR)	
3314	Beam 4	Plate Girder		
Priority Level	Defect Type	Quantity	Defect Description	
2	Corrosion	2	Span 2 Beam 4: BOTTOM FLANGE SECTION LOSS (21 PERCENT SECTION LOSS, 3/16 INCH SECTION LOSS, 11/16 INCH REMAINS) FULL WIDTH FOR 16 INCHES AT FAR END. SECTION LOSS UP TO 1/16 INCH (3/16 INCH REMAINS) ON THE LEFT STIFFENER FOR 2 INCHES HIGH AT BOTTOM. (PAR)

Span 2 Beam 1: BOTTOM FLANGE SECTION LOSS (3/8INCH REMAINS) FULL WIDTH FOR 16INCHES AT NEAR END. WEB STIFFENER (UP TO 100 PERCENT SECTION LOSS) 4INCHES X 4INCHES (PAR)

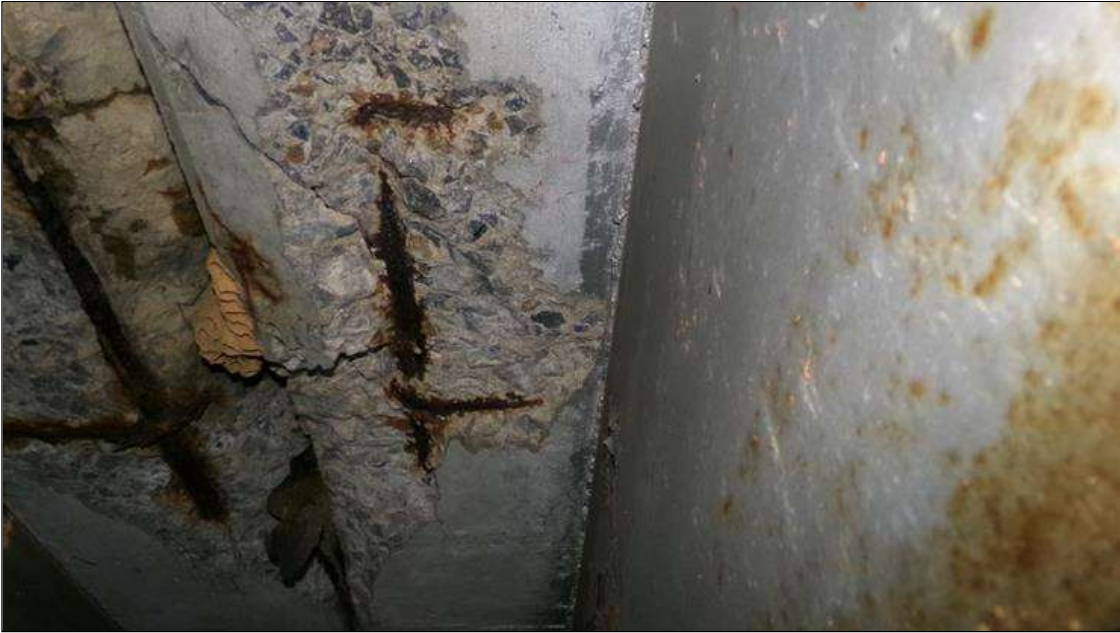
3326	Deck	Reinforced Concrete Deck		
Priority Level	Defect Type	Quantity	Defect Description	
2	Exposed Rebar	3	Span 1 Deck: SPALL (3FEET X 10INCHES X 1INCH SPALL) WITH EXPOSED SCALING TO REBAR TO BOTTOM OF DECK IN BAY 2 OVER BENT 1. UP TO 90 PERCENT SECTION REMAINING IN THE EXPOSED REBAR (PAR)	
2	Exposed Rebar	3	Span 1 Deck: SPALL AND DELAMINATION (UP TO 3FEET X 20INCHES X 1INCH) WITH EXPOSED SCALING REBAR TO LEFT OVERHANG AT FAR END. UP TO 90 PERCENT REMAINING IN THE EXPOSED REBAR. (PAR)	
3314	Beam 1	Plate Girder		
Priority Level	Defect Type	Quantity	Defect Description	
2	Corrosion	1	Span 1 Beam 1: WEB SECTION LOSS (33 PERCENT SECTION LOSS, 3/16INCH SECTION LOSS, 3/8INCH REMAINS), 2 INCHES LONG X 8INCHES HIGH AT FAR END (PAR)

Span 1 Deck: SPALL (3FEET X 10INCHES X 1INCH SPALL) WITH EXPOSED SCALING TO REBAR TO BOTTOM OF DECK IN BAY 2 OVER BENT 1. UP TO 90 PERCENT SECTION REMAINING IN THE EXPOSED REBAR (PAR)

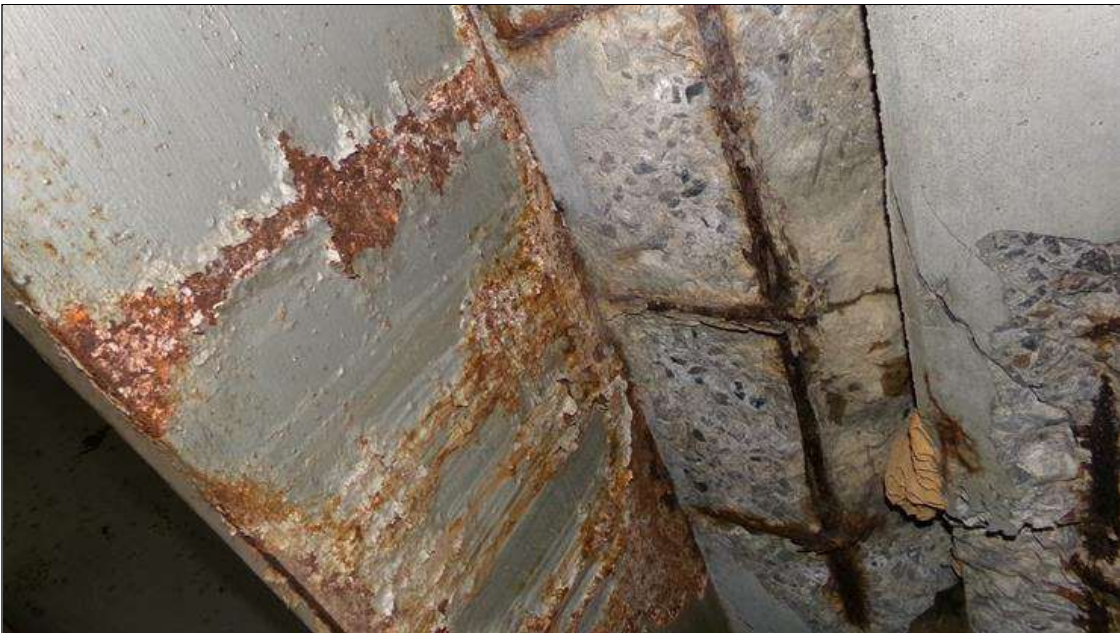
Span 2 Deck: SPALL (4FEET X 12INCHES X 2INCHES SPALL) WITH EXPOSED SCALING TO REBAR TO BOTTOM OF DECK IN BAY 2 OVER BENT 1. UP TO 90 PERCENT SECTION REMAINING IN THE EXPOSED REBAR. (PAR)

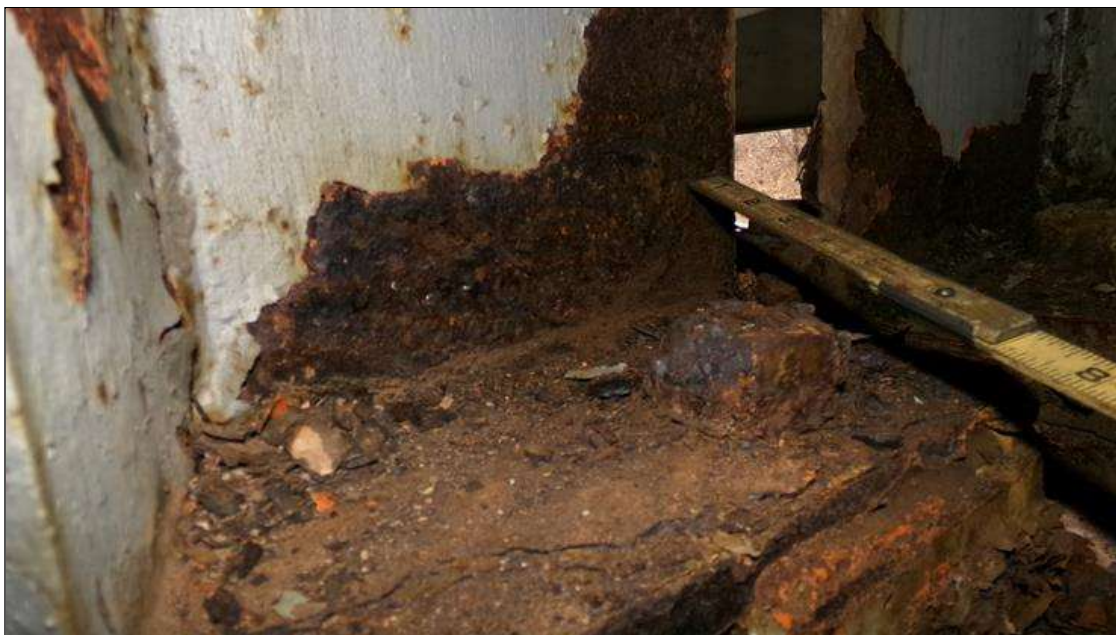
Span 1 Beam 2: BOTTOM FLANGE AND WEB SCALING, 6INCHES HIGH (NO MEASUREABLE SECTION LOSS) FOR 1FOOT AT FAR END.

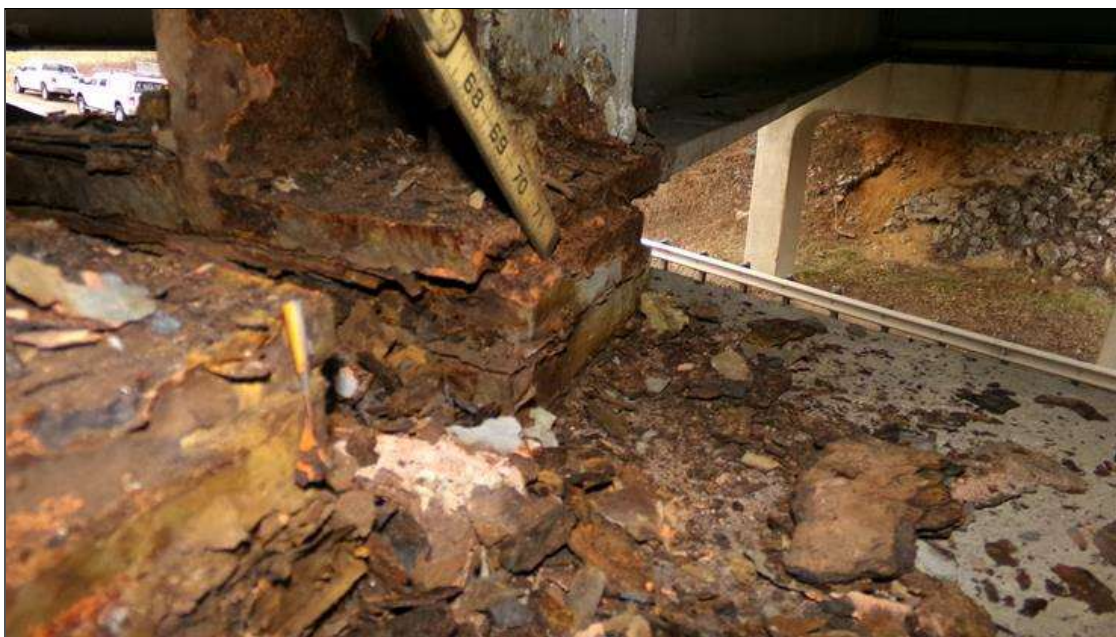
Span 1 Beam 2 - Far Bearing: SURFACE SCALING TO BEARING

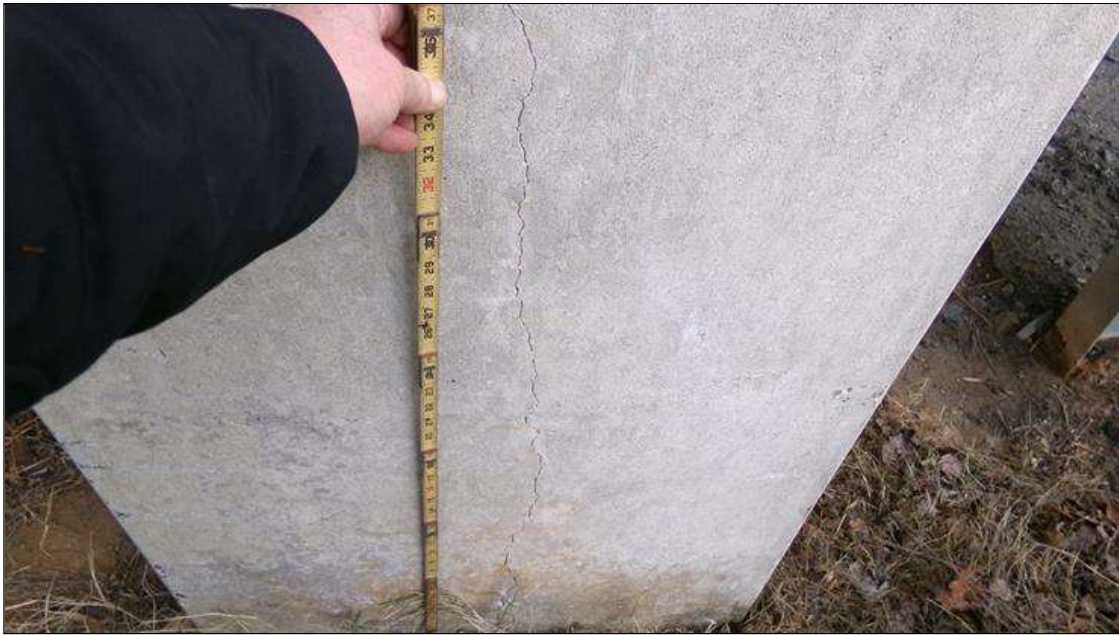
Bent 2 Pile 1: FULL HEIGHT VERTICAL CRACKING (HAIRLINE TO 1/16INCH) THRU OUT ALL FACES OF COLUMN

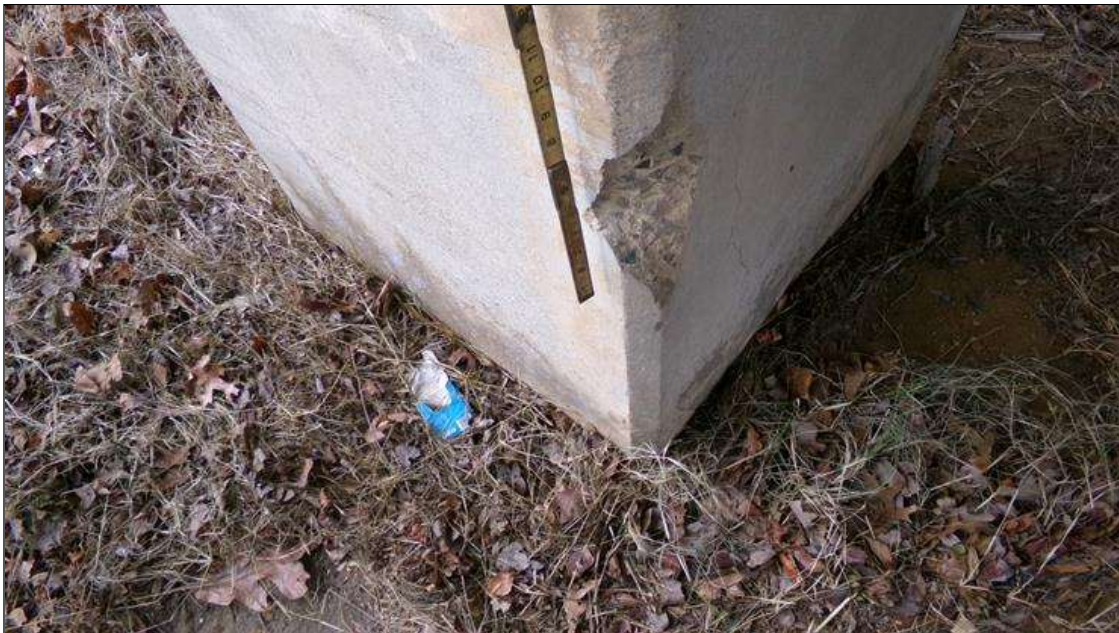
Bent 2 Pile 1: SPALL (9INCHES X 3INCHES X 2INCHES DEEP) TO NEAR RIGHT CORNER AT BASE

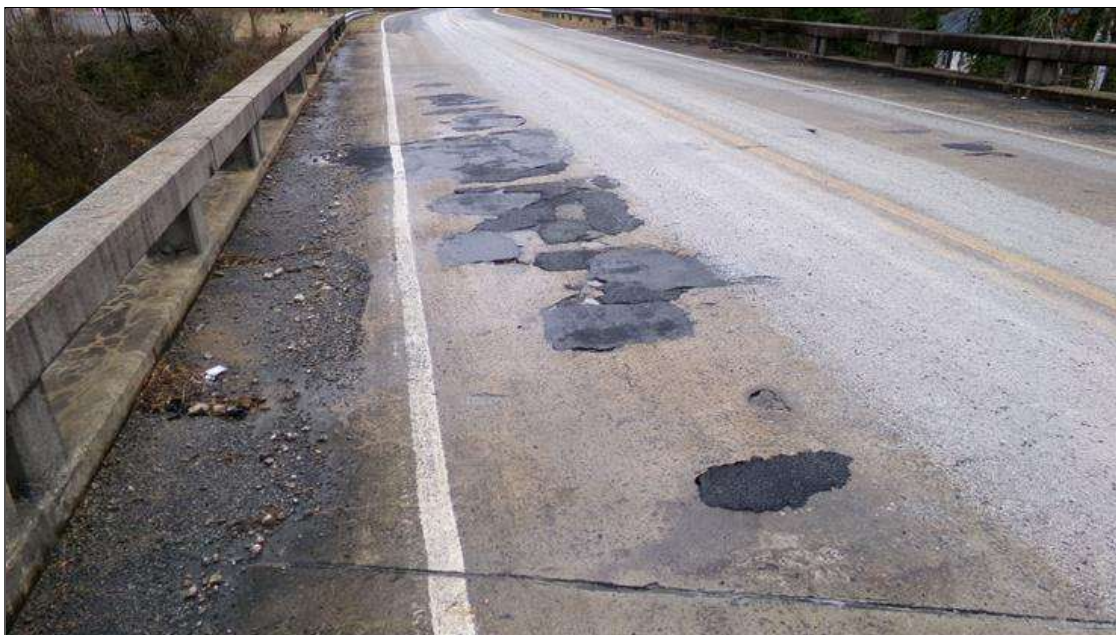
Span 2 Deck: SCATTERED PATCHED AREAS IN TOP OF DECK APPROXIMATELY 20 SQUARE FEET TOTAL

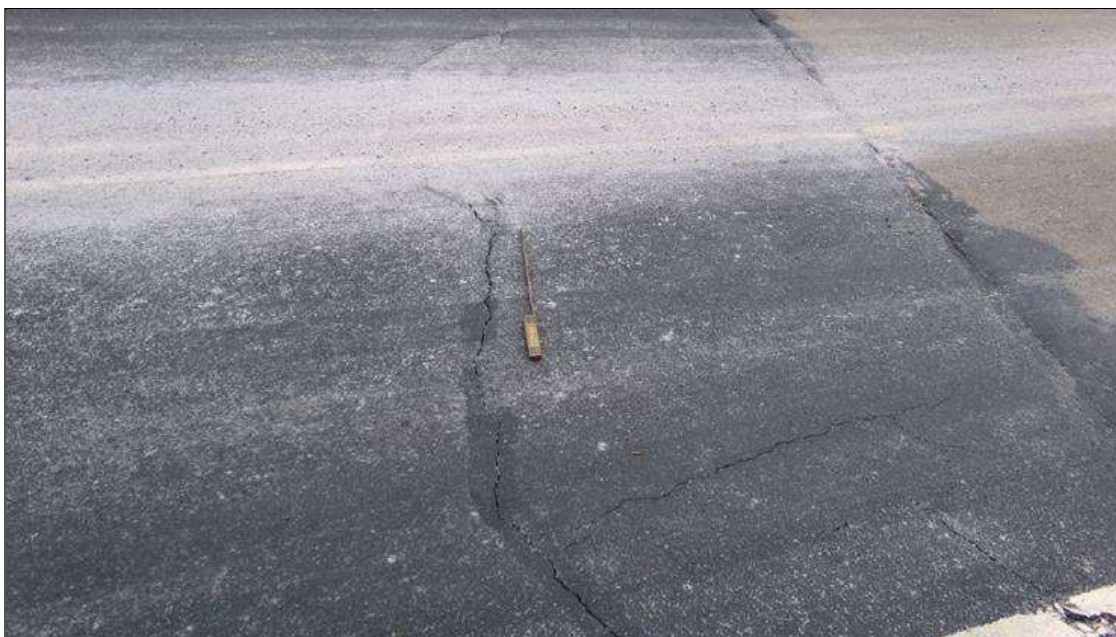
NORTH APPROACH ASPHALT WEARING SURFACE 3/8 INCH WIDE CRACKS

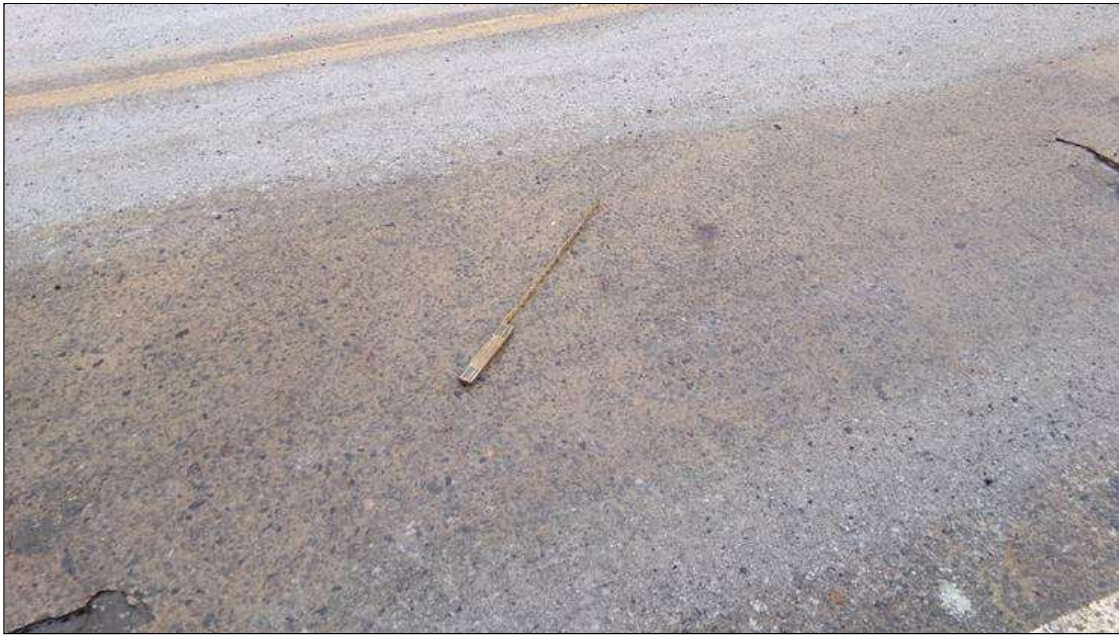
Span 2 Deck: WEAR WITH EXPOSED AGGREGATE THRU OUT DECK

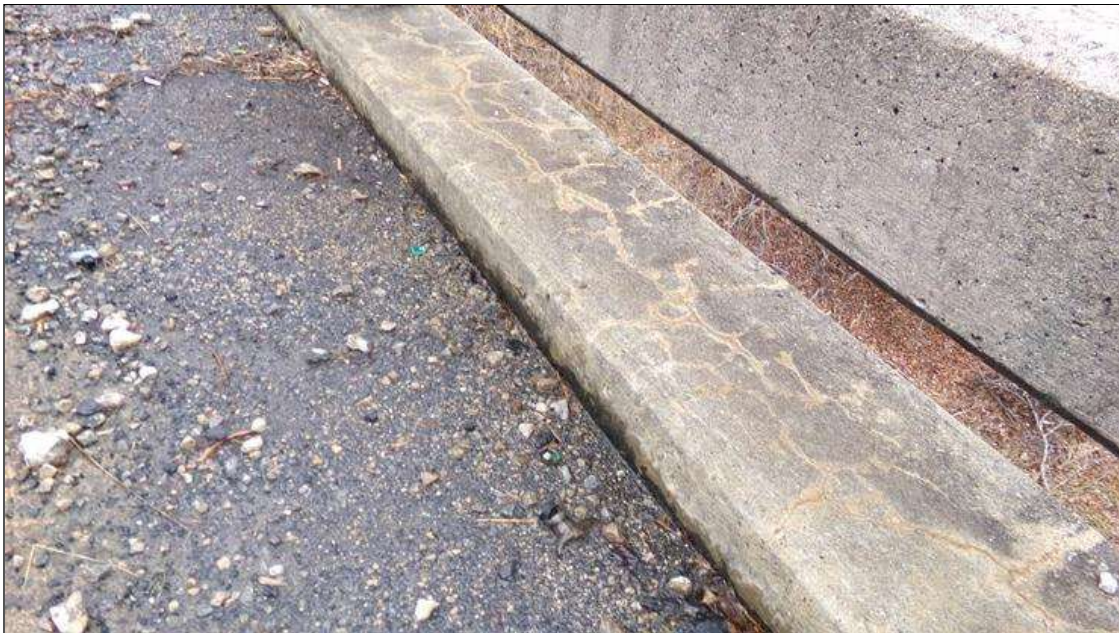
Span 3 Right Bridge Rail: INTERMITTENT TRANSVERSE CRACKING (LESS THAN 1/16INCH) AND WEATHERING WITH EXPOSED AGGREGATE AND MINOR EFFLORESCENCE THRU OUT RAIL.

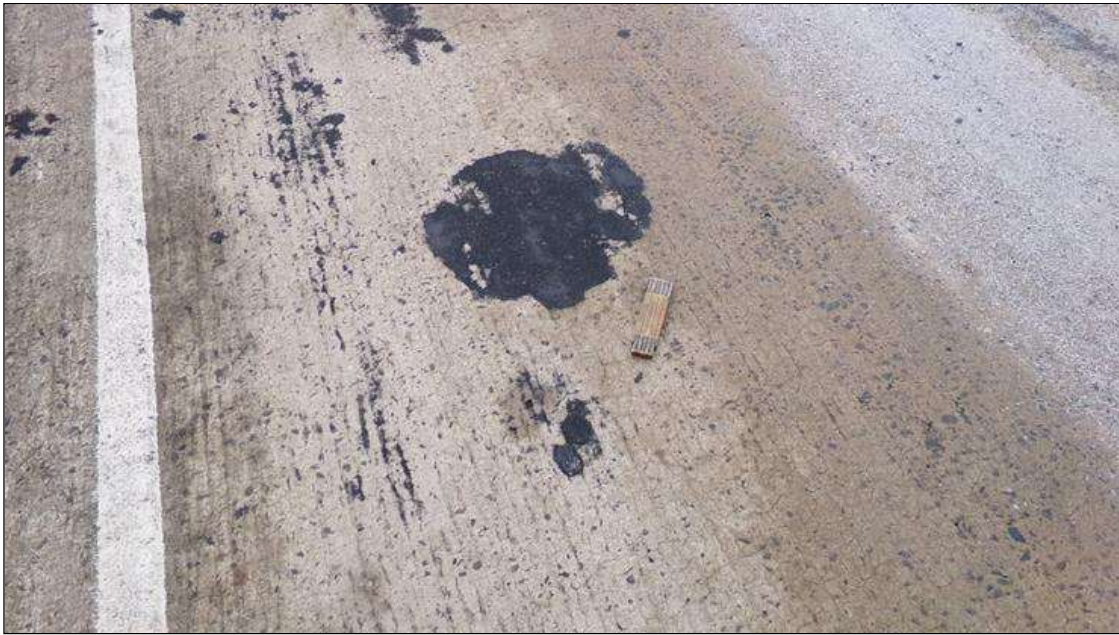
Span 1 Deck: SOUND PATCH (16INCHES DIAMETER) IN RIGHT LANE, 6FEET FROM NEAR END (SIMILAR IN LEFT LANE AT MID SPAN)

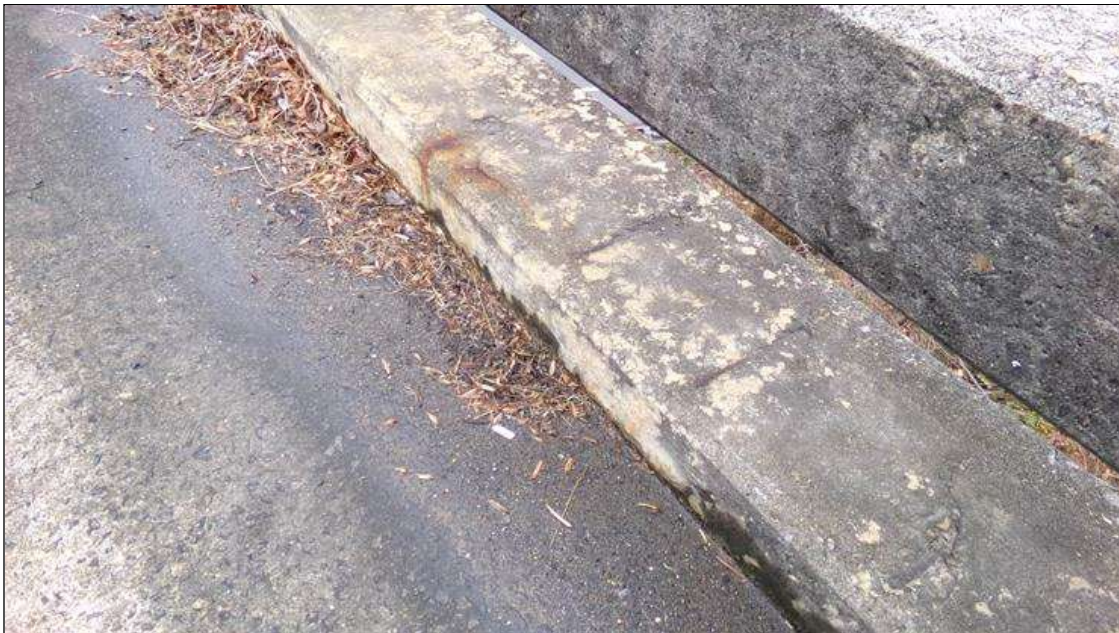
Span 1 Right Bridge Rail: 9 SHALLOW SPALL (UP TO 10INCHES X 3INCHES X 1/4INCH) WITH EXPOSED REBAR TO TOP OF CURB THRU OUT, MOSTLY AT NEAR END. NO MEASUREABLE SECTION LOSS IN THE EXPOSED REBAR.

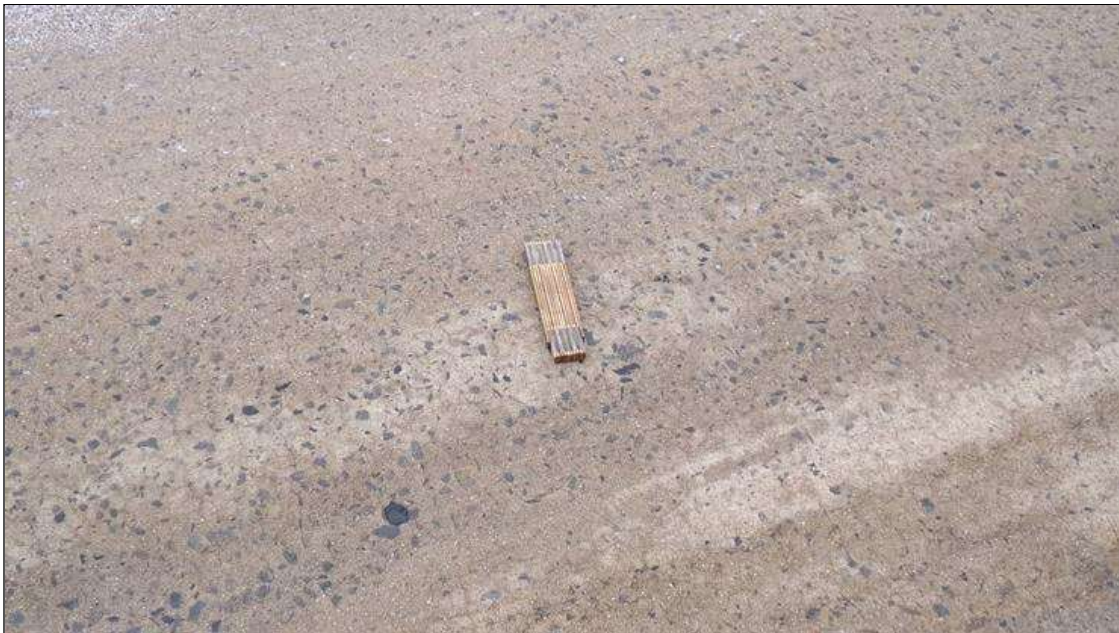
Span 3 Deck: MAP CRACKING (UP TO 1/16INCH) THRU OUT DECK.

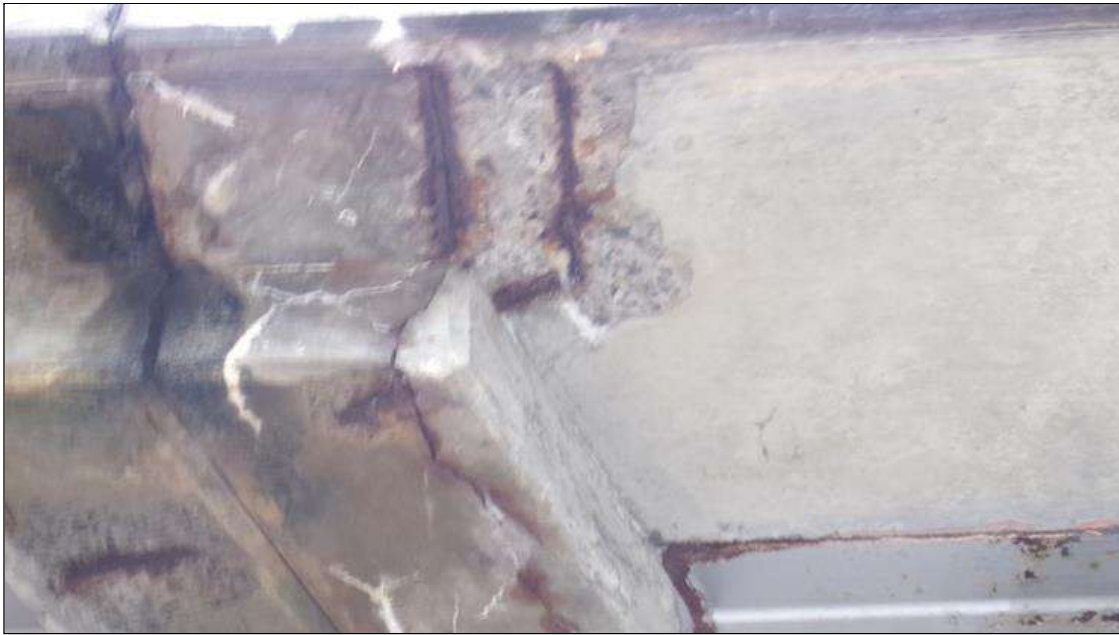
Span 2 Deck: SPALL (20INCHES X 1FOOT X 1INCH) WITH EXPOSED SCALING REBAR AND TRANSVERSE OPEN CRACKING AT LEFT SIDE OVERHANG AT FAR END. UP TO 90 PERCENT REMAINING IN THE EXPOSED REBAR (PAR)

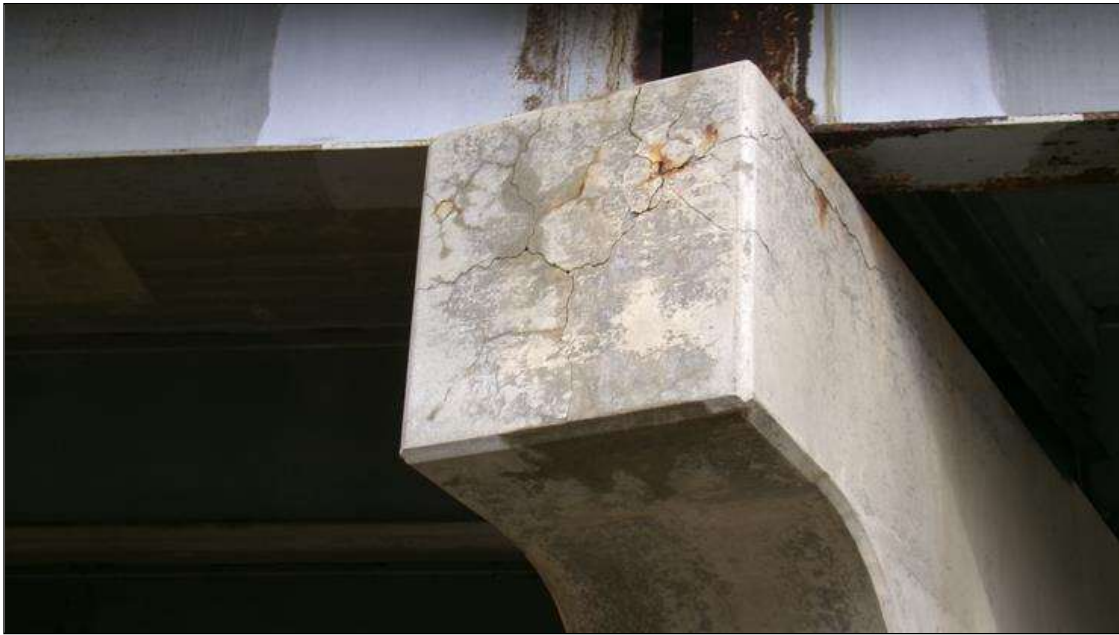
Bent 2 Cap 1: OPEN MAP CRACKING (UP TO 1/8 INCH) TO LEFT FACE OF CAP AND VERTICAL AND HORIZONTAL OPEN CRACKING (UP TO 1/8 INCH) TO RIGHT FACE AND RIGHT SIDE OVERHANG. HAS ACTIVE LEAKAGE ON FACE OF CAP AT TIME OF INSPECTION

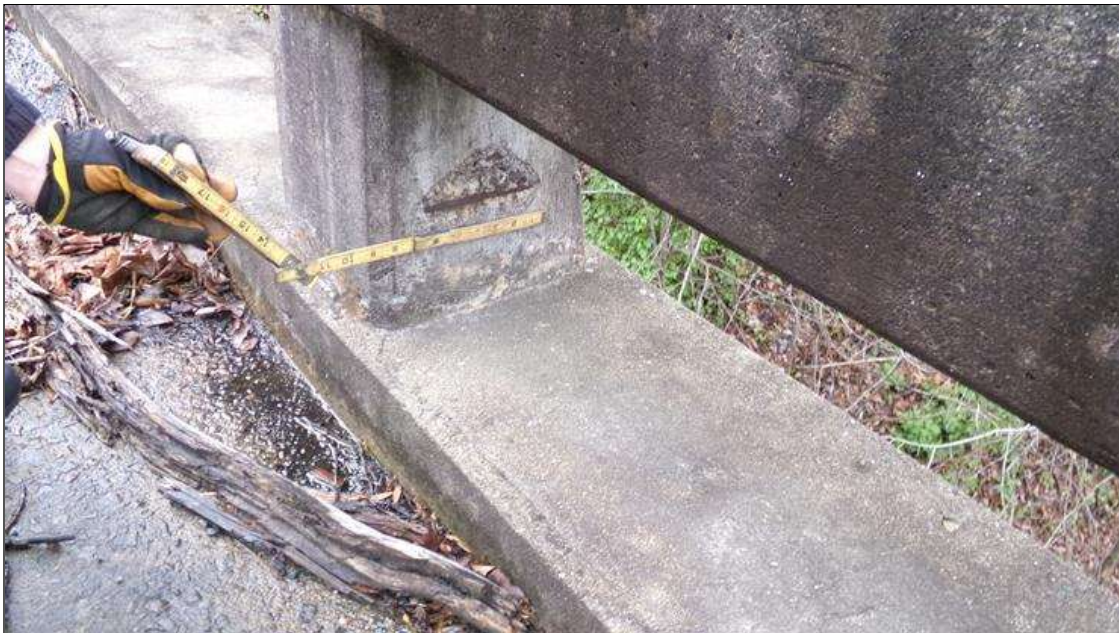
Span 1 Left Bridge Rail: SPALL WITH EXPOSED REBAR UP TO 6 INCHES WIDE X 3 INCHES HIGH X .5 INCHES DEEP IN POST, 8 FEET FROM END OF SPAN.

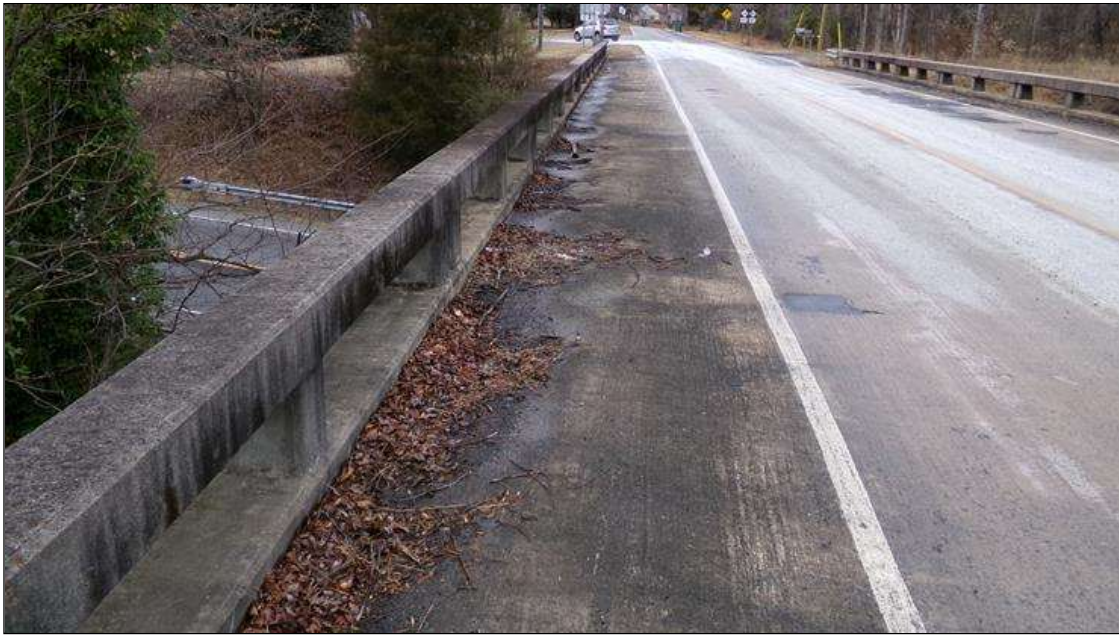
Span 2 Deck: 110 SQUARE FEET ASPHALT PATCHES THRU OUT RIGHT LANE WITH SPALLING AT PATCH PERIMETERS

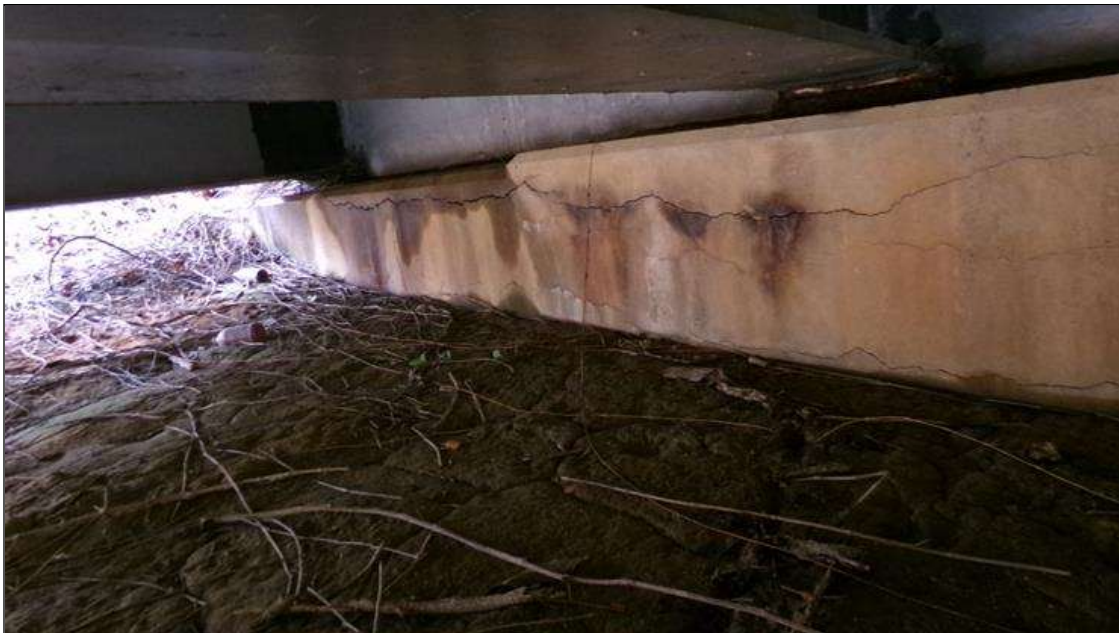
End Bent 1 Cap 1: HORIZONTAL OPEN CRACKING (HAIRLINE TO 1/8 INCH) WITH RUST STAINING THRU OUT FACE OF CAP
