**BRIDGE INSPECTION RECORD AND SUMMARY
FOR SHORED OR TEMPORARY REPAIRED
STRUCTURES TO KEEP A BRIDGE OPEN**

BRIDGE: 780176
3/7/2024

Structure Safety Report

Routine Element Inspection - Contract

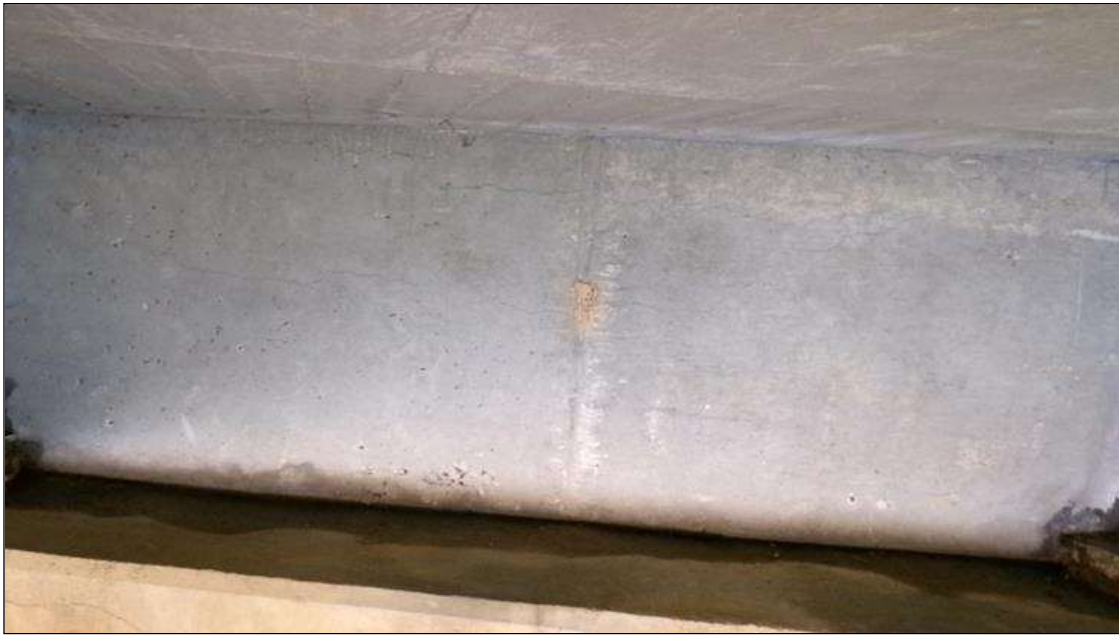
End Bent 1 Abutment: 1FOOT DIAGONAL CRACKING (LESS THAN 1/16INCH) TO ABUTMENT AT FAR ENDS.
HORIZONTAL HAIRLINE CRACKING THRU OUT ABUTMENT IN ALL BAYS

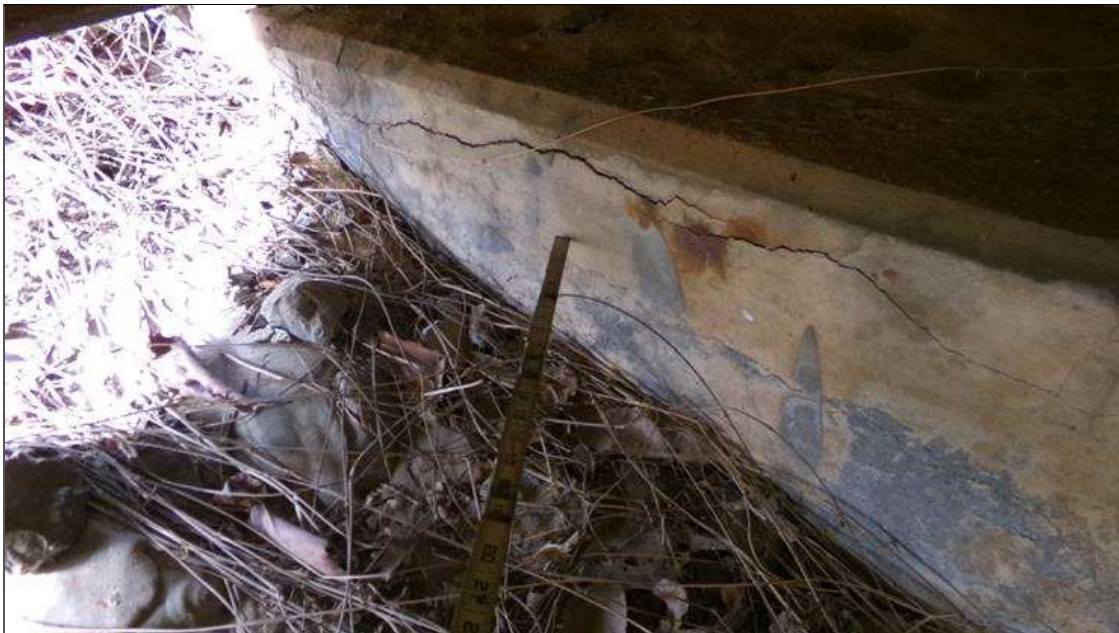
End Bent 2 Cap 1: HORIZONTAL OPEN CRACKING (HAIRLINE TO 1/8INCH) WITH RUST STAINING THRU OUT
FACE OF CAP

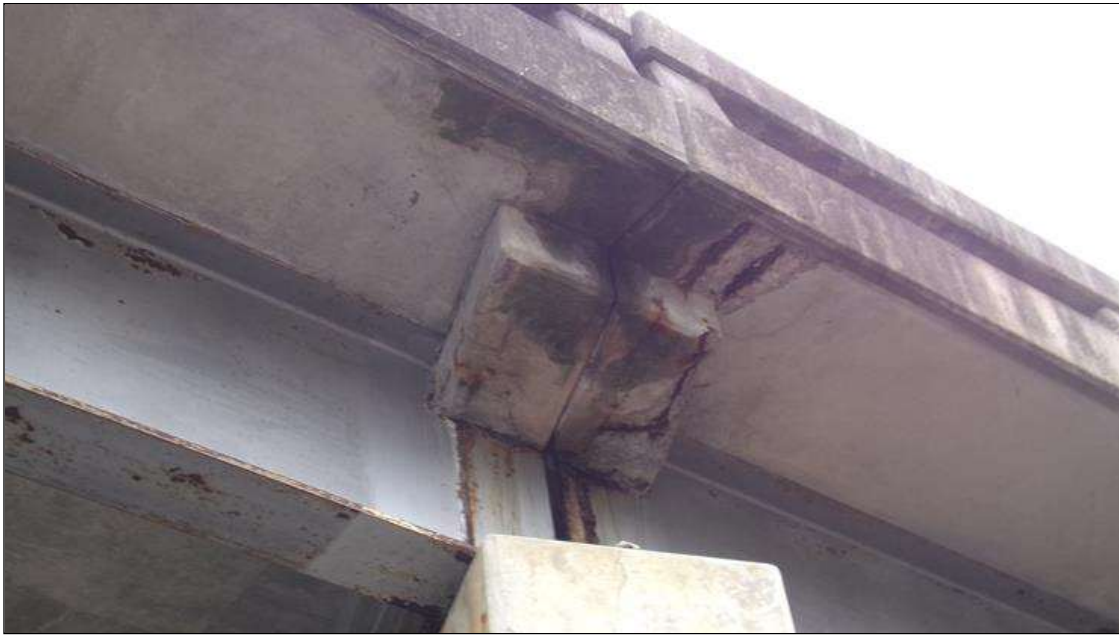
Span 1 Deck: SPALL AND DELAMINATION (UP TO 3FEET X 20INCHES X 1INCH) WITH EXPOSED SCALING REBAR TO LEFT OVERHANG AT FAR END. UP TO 90 PERCENT REMAINING IN THE EXPOSED REBAR. (PAR)

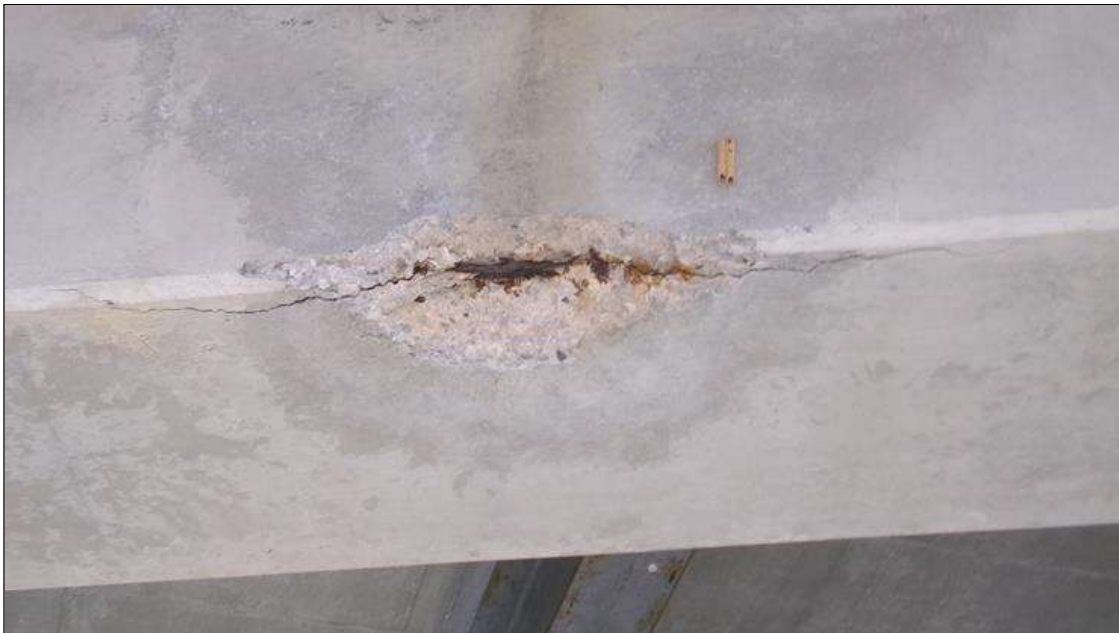
Priority Level	Defect Type	Quantity	Defect Description
2	Exposed Rebar	2	Bent 1 Cap 1: SPALL (2.5FEET X 1FOOT X 6INCHES) WITH EXPOSED SCALING REBAR TO FAR BOTTOM CORNER OF CAP UNDER BAY 2. UP TO 60 PERCENT REMAINING IN THE EXPOSED REBAR. (PAR)

Bent 1 Cap 1: SPALL (2.5FEET X 1FOOT X 6INCHES) WITH EXPOSED SCALING REBAR TO FAR BOTTOM CORNER OF CAP UNDER BAY 2. UP TO 60 PERCENT REMAINING IN THE EXPOSED REBAR. (PAR)

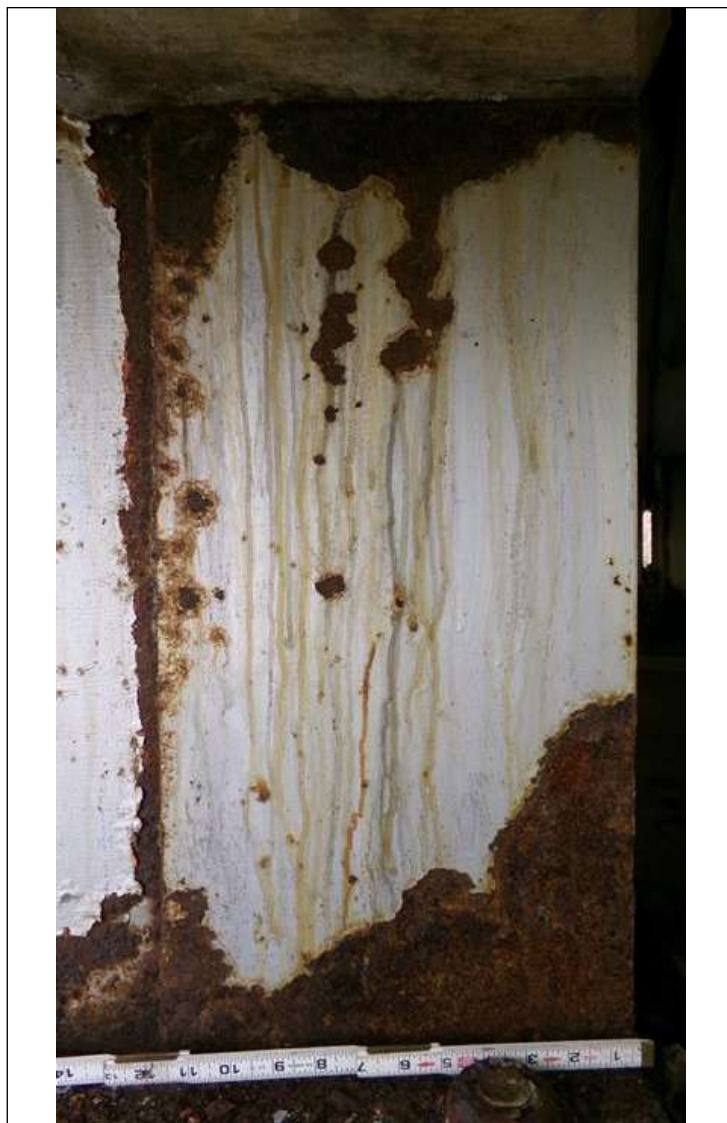
Span 2 Beam 1: WEB PLATE REPAIR (1FOOT X FULL HEIGHT X 1/2INCH THICK) AT NEAR END

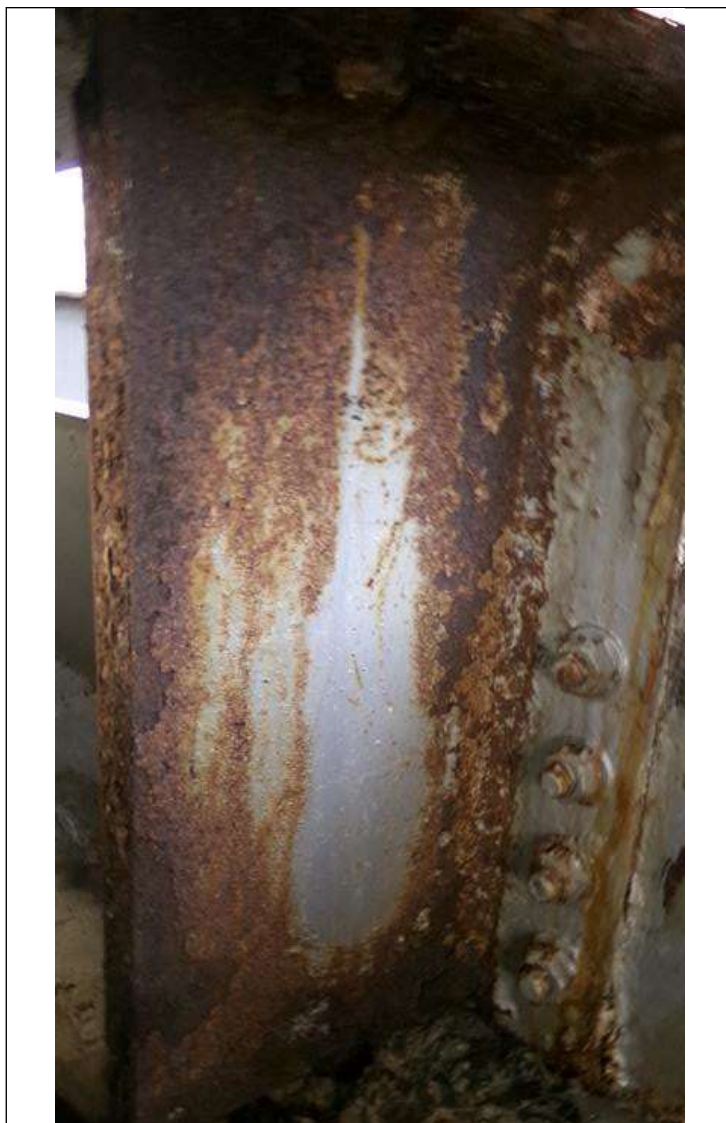
Span 2 Beam 3: WEB PLATE REPAIR RIGHT SIDE (1FOOT X FULL HEIGHT X 1/2INCH THICK) AT FAR END

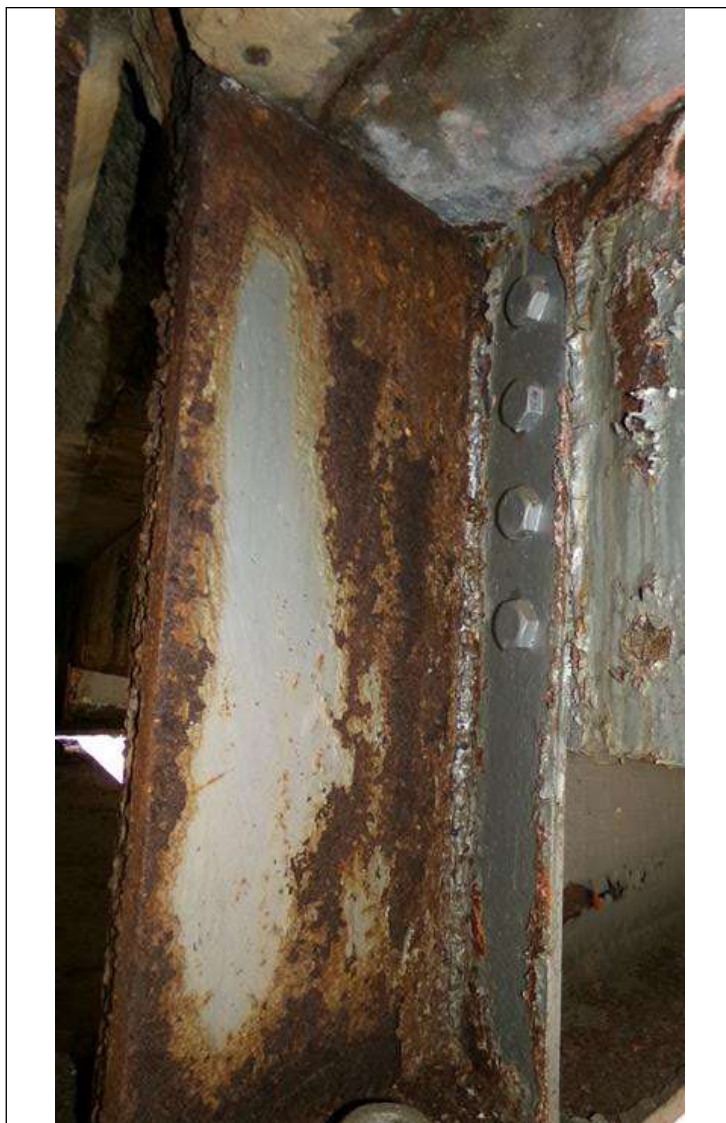
Span 2 Beam 3: WEB PLATE REPAIR LEFT SIDE (1FOOT X FULL HEIGHT X 1/2INCH THICK) AT FAR END

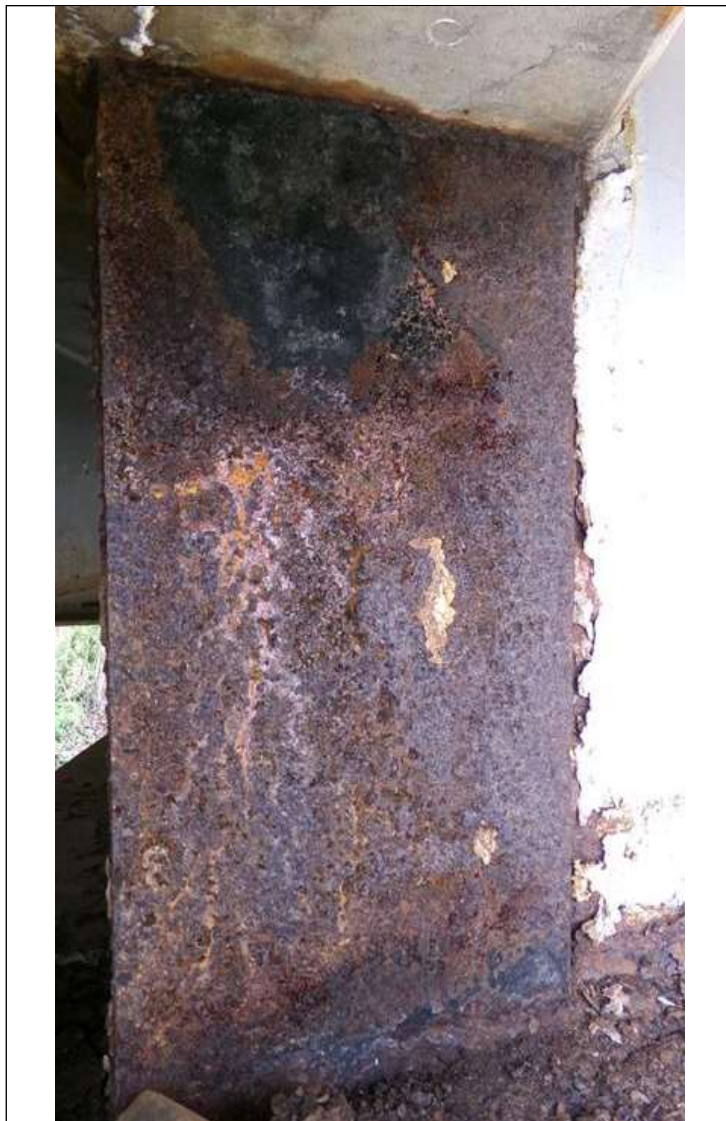
Span 2 Beam 4: WEB PLATE REPAIR (1FOOT X FULL HEIGHT X 1/2INCH THICK) AT NEAR END

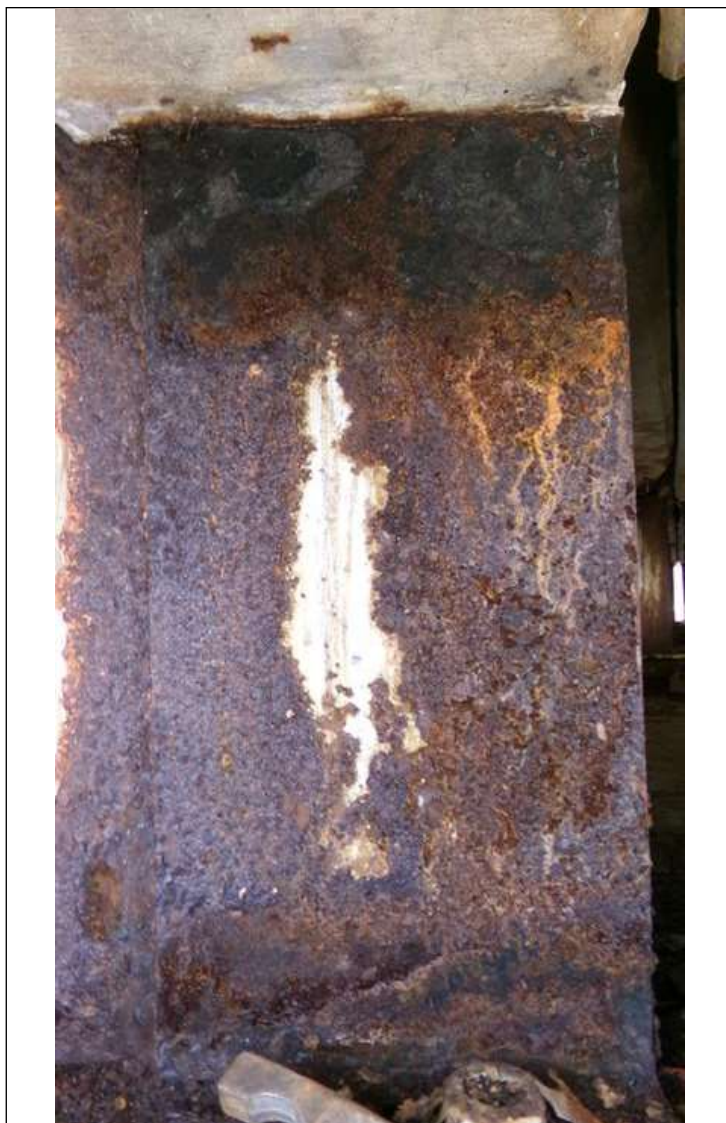
Span 2 Beam 4: WEB PLATE REPAIR (1FOOT X FULL HEIGHT X 1/2INCH THICK) AT FAR END

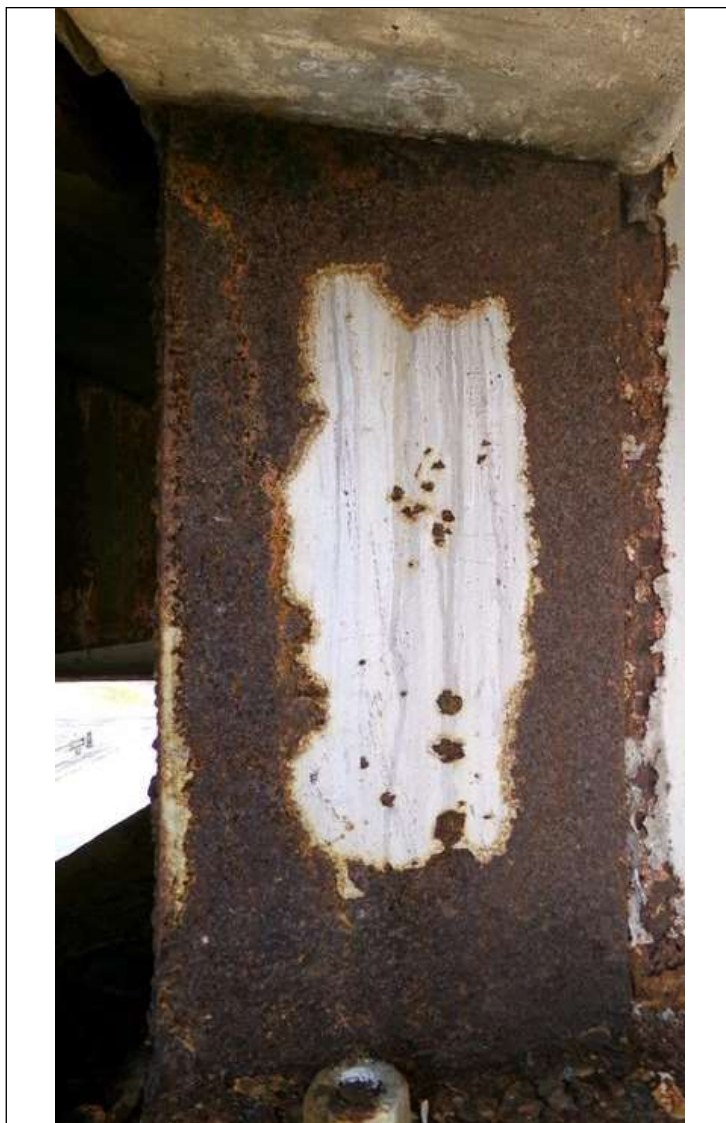
Span 3 Beam 4: WEB PLATE REPAIR (1FOOT X FULL HEIGHT X 1/2INCH THICK) TO NEAR END

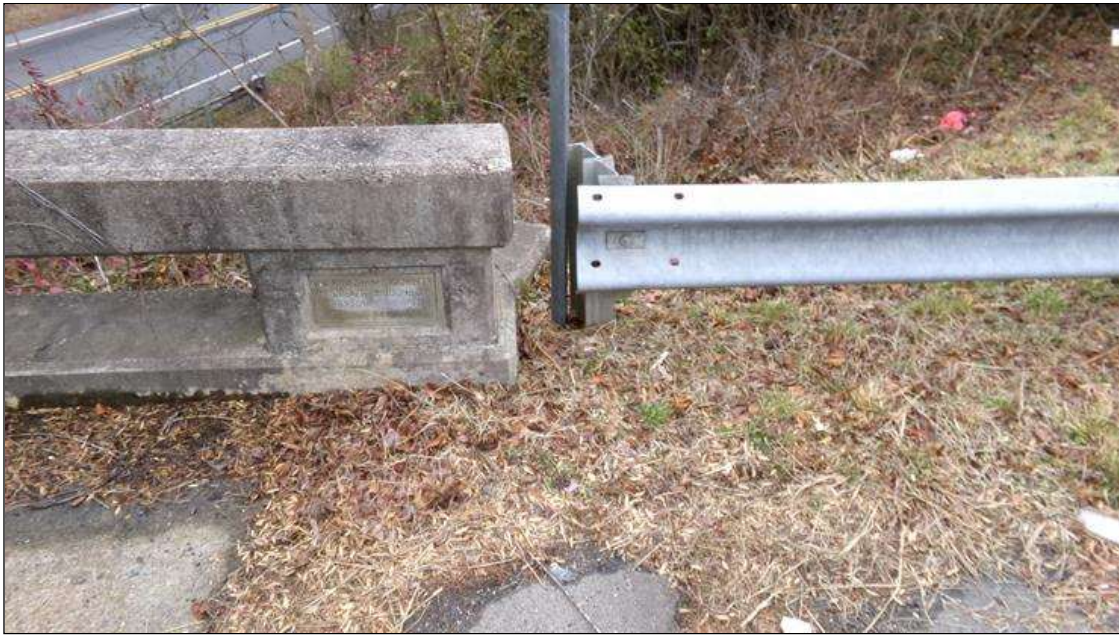
GUARDRAIL DOES NOT ATTACH TO RAIL AT SOUTHEAST CORNER

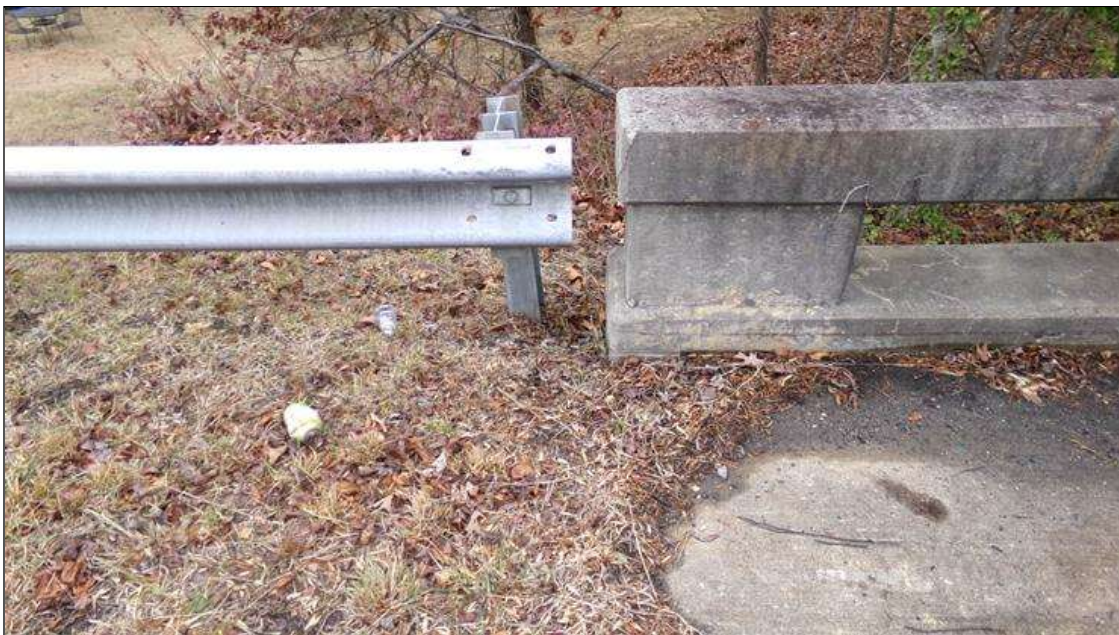
GUARDRAIL DOES NOT ATTACH TO RAIL AT SOUTHWEST CORNER

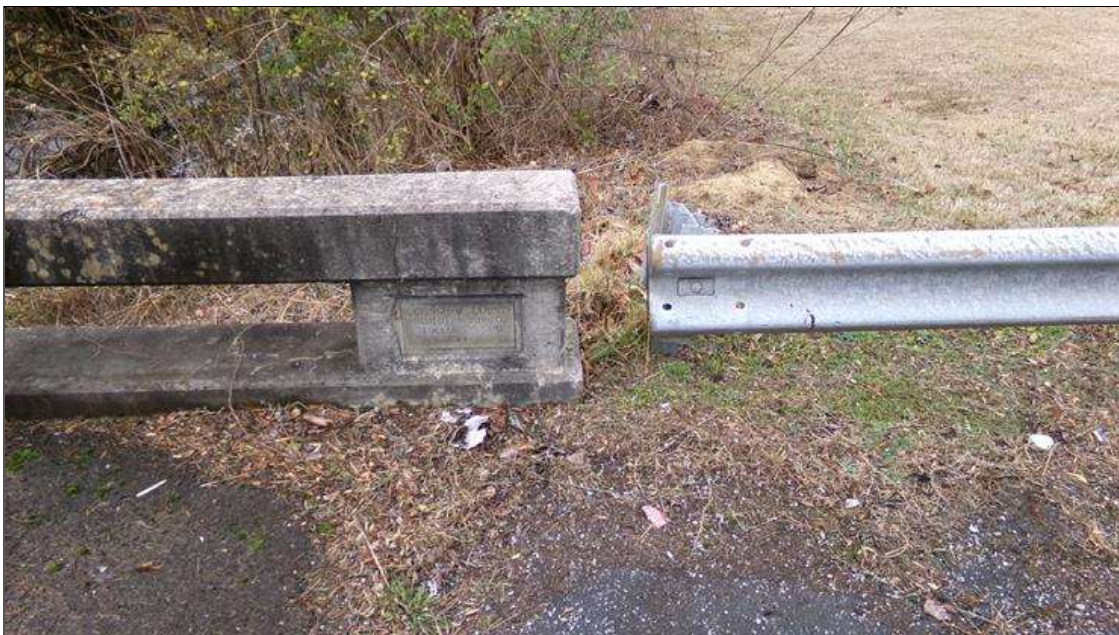
GUARDRAIL DOES NOT ATTACH TO RAIL AT NORTHWEST CORNER

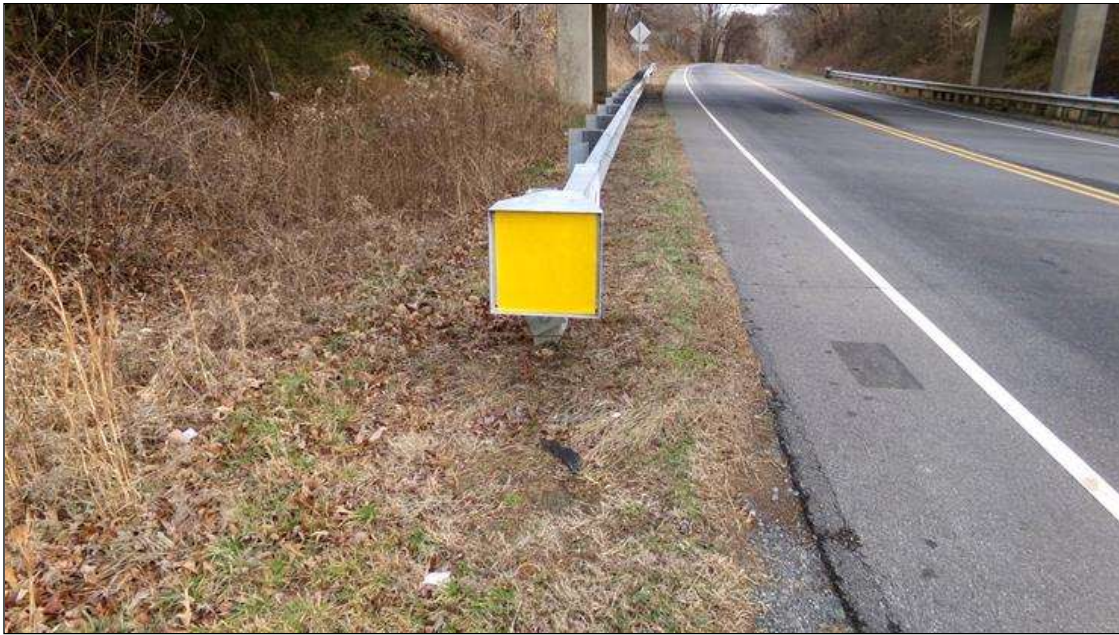
GUARDRAIL END TERMINAL FOR WEST BOUND LANE UNDERNEATH BRIDGE REPAIRED SINCE LAST INSPECTION (2024 INSPECTION)

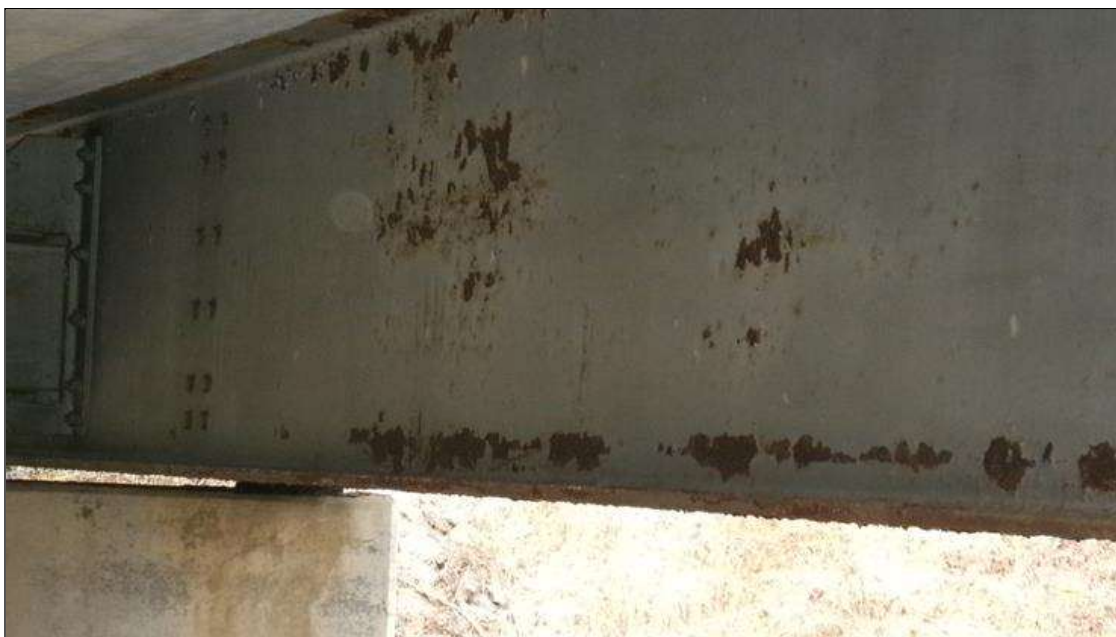
SCATTERED FRECKLED RUST ALONG THE LENGTH OF BEAMS

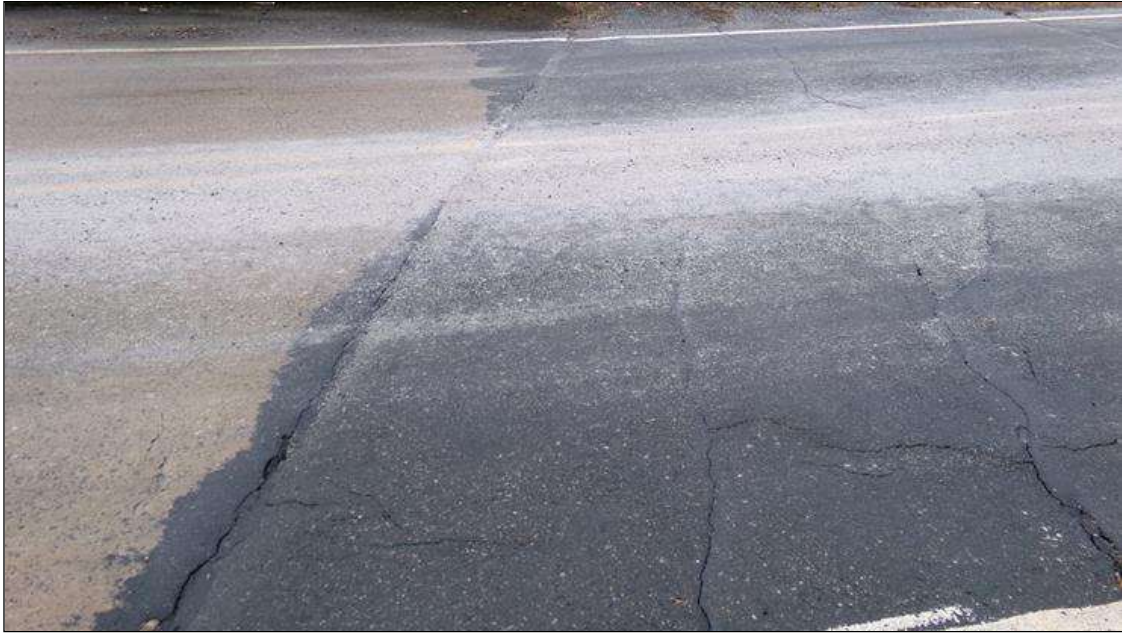
SOUTH APPROACH ASPHALT WEARING SURFACE 3/8 INCH WIDE CRACKS
