## **Phase II Site Assessment Report**

**State Project: R-5759**

**Parcel #003**

**Janet & James Hartley Property**

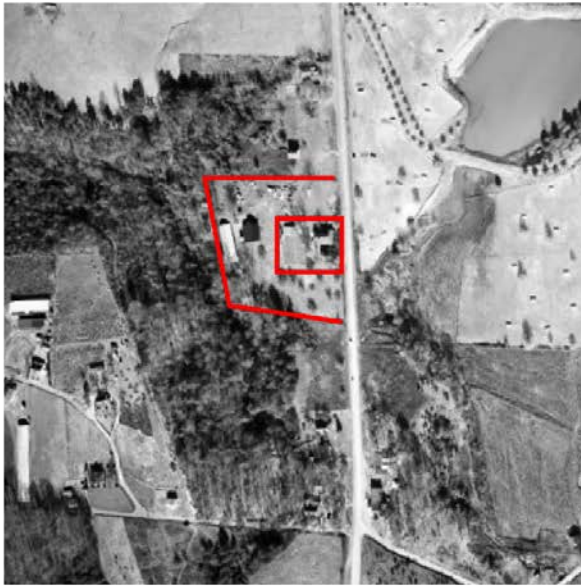
Parcel #003 is currently an empty lot with tall grass and woods. Historic aerial photographs show that the property was developed with numerous structures in 1960 (Plate 1, Photo 1). Some of these structures appear to have been in the proposed E, C/A and R/W (Plate 1, Photo 2). It is not possible to determine the use of these structures because of the quality of the image. The NCDEQ databases do not indicate that this property operated as a gas station or as any other type of facility that may have used hazardous substances. There are no incident reports mapped on or near the property. These databases typically do not list sites that were active prior to the 1980's. Deed records for the property were searched to look for evidence of prior use. Parcel #003 seems to have been owned by individuals rather than commercial businesses back to at least the 1960's.

Photo 1. 1960 Aerial Photograph showing structures on Parcel #003. Note that Highway 421 has not been built in its current alignment and the pond across Statesville Road is farther to the north.

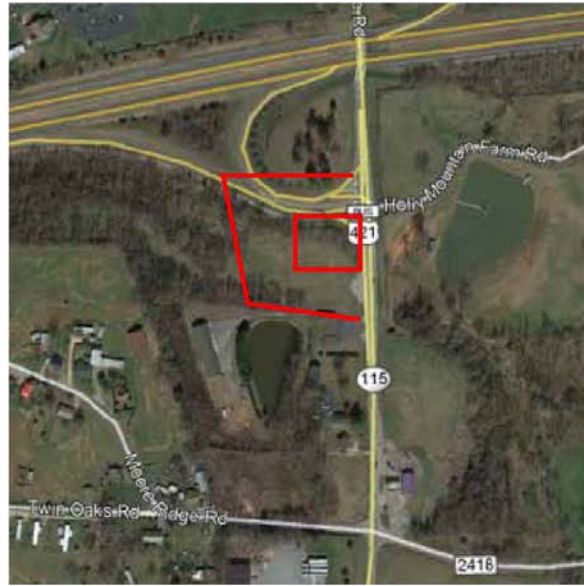
Photo 2. Recent Aerial Photograph of Parcel #003.

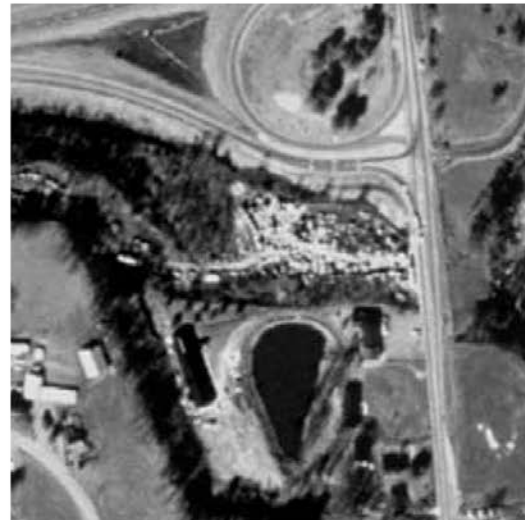
Historic aerial photographs from the 1980's until as recent as 1998 (Plate 1, Photo 3) show Parcel #003 covered in what appears to be junk cars. The property was cleared of these vehicles by 2005. Parcel #003 likely operated as a salvage yard which could have resulted in surface spills and possible contaminated soil. Stained soil was not observed during our reconnaissance, but vegetation obstructed our view of much of the ground surface.

Photo 3. 1998 Aerial Photograph showing what appears to be numerous vehicles scattered across Parcel #003. No structures appear to be present on the eastern side of the property.

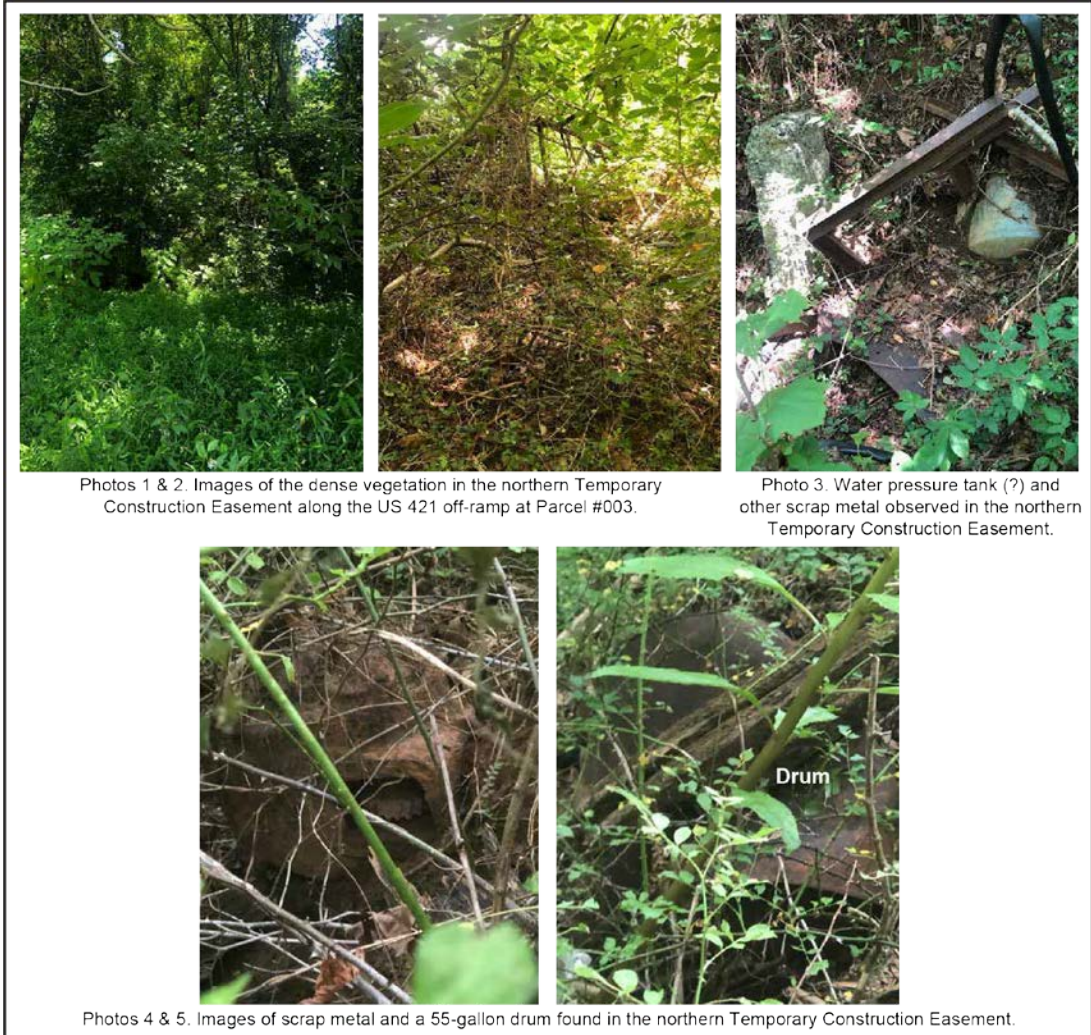
### 3.5 Plate 3 – Photographs of Parcel #003

Photos 1 and 2 in Plate 3 show an example of some of the dense vegetation encountered within the E. Photos 3, 4 and 5 show examples of discarded scrap metal, what appears to be a water pressure tank, a 55-gallon drum and old vehicle parts. It is possible that these objects have been dumped here from the off ramp over the last few decades, but it would seem likely that these objects are material discarded when the property was used as a junk yard. Photo 2 in Plate 1 shows what may be a house and possibly a chicken house in the vicinity of the E.

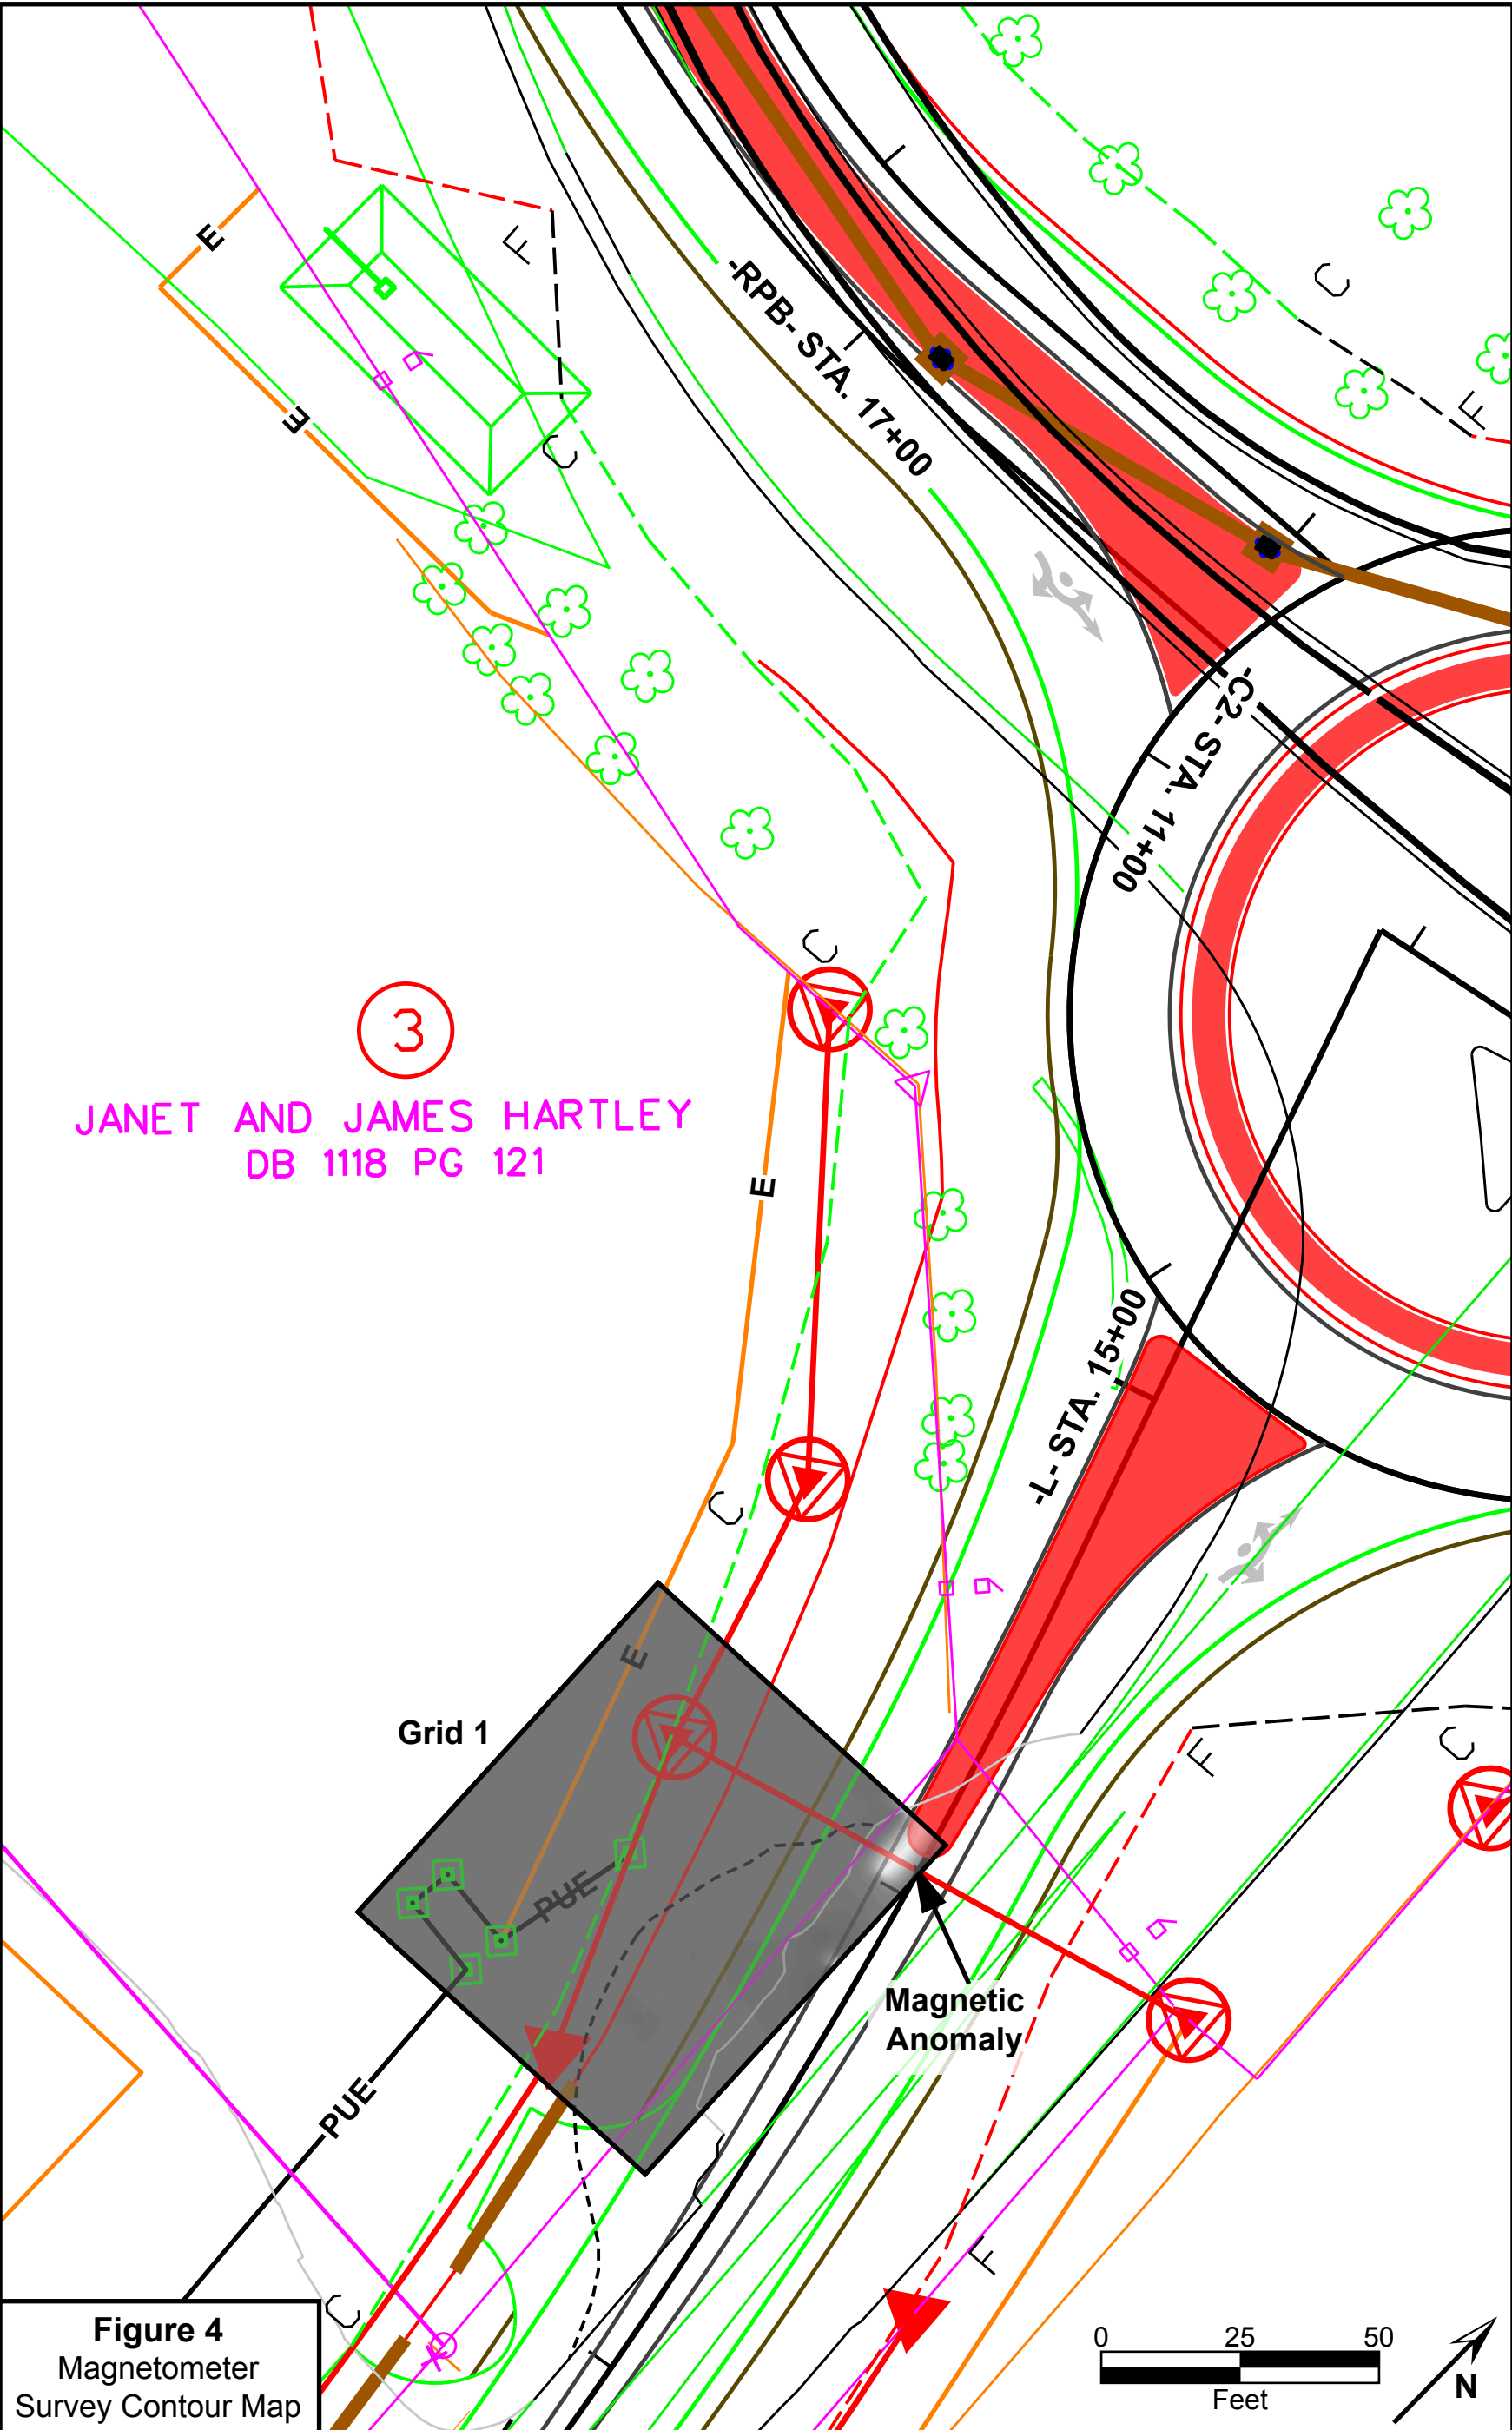
| <b>Figure 4</b><br>Magnetometer<br>Survey Contour Map | | | |

A grid of magnetometer data was collected along the eastern edge of the property parallel to Statesville Road (Figure 4). A small area of elevated readings in the northeast corner was later identified as a piece of scrap metal and should not be of concern. Four additional magnetometer transects were run over an area where GPR anomalies were observed (Transects 4 through 7). The results were reviewed and showed no evidence of magnetic anomalies characteristic of a UST system.

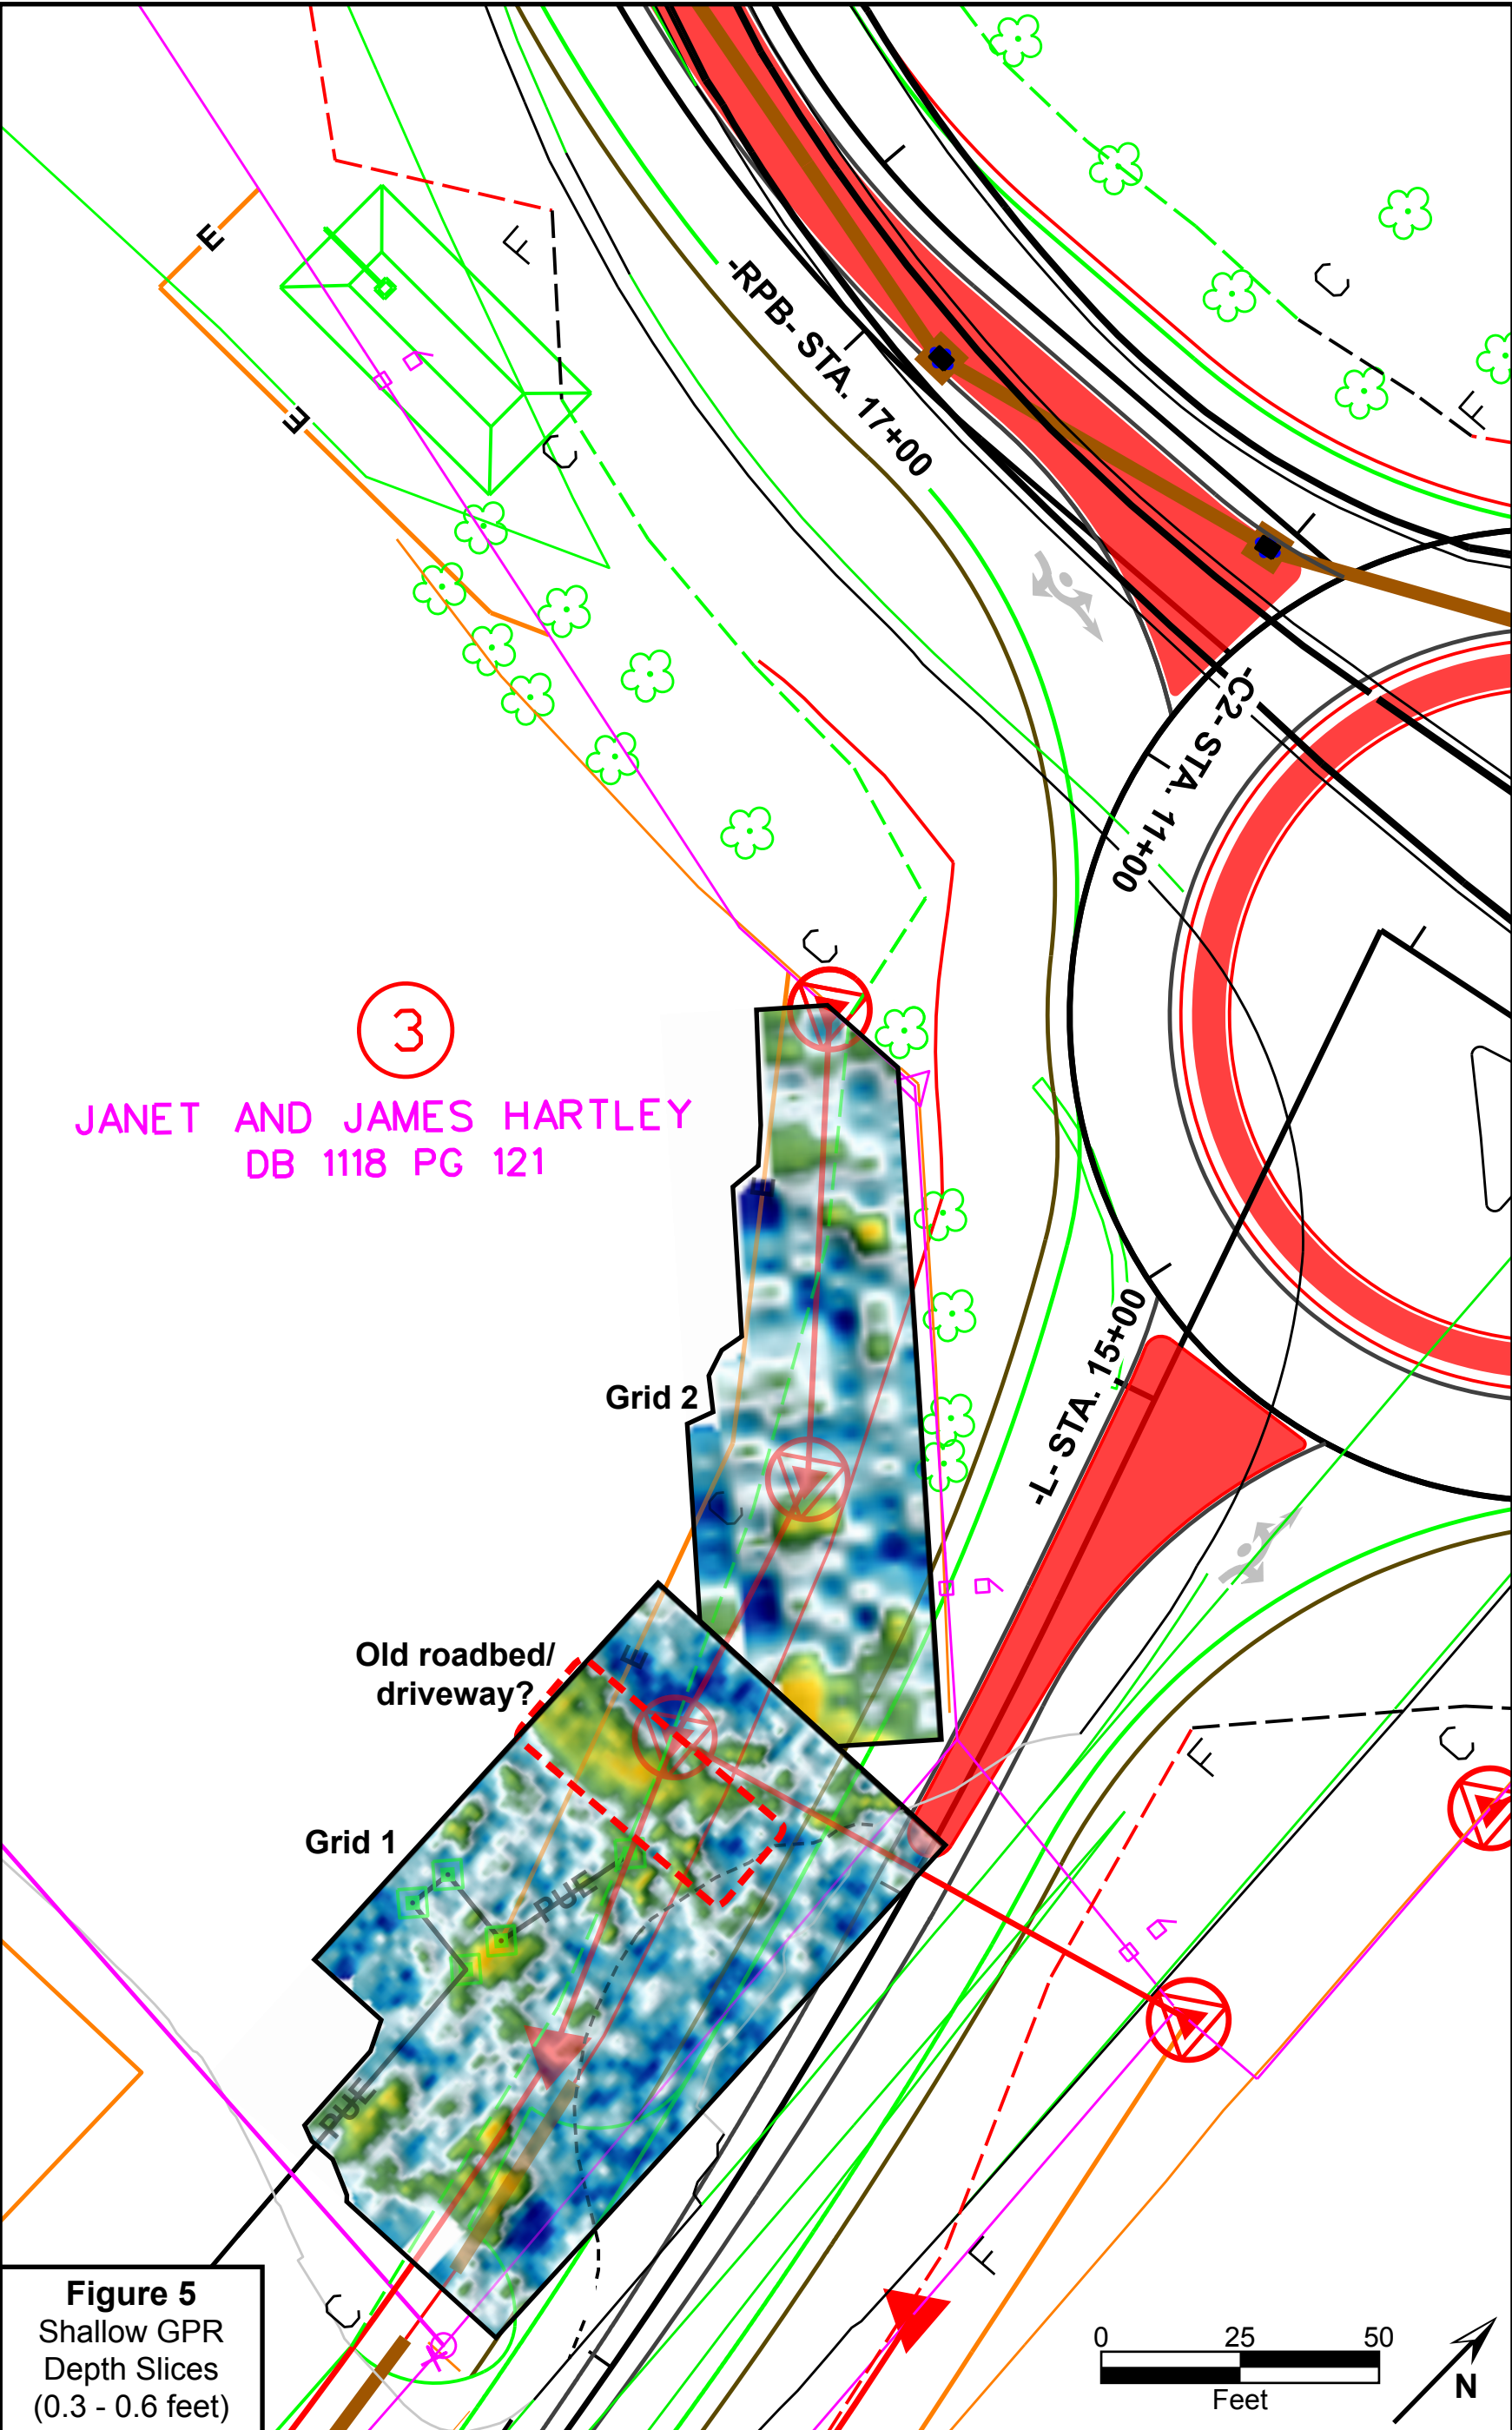
**Figure 5**  
Shallow GPR  
Depth Slices  
(0.3 - 0.6 feet)

The shallow GPR depth slice (0.3-0.6 feet) for Grid 1 shows a rectangular higher amplitude reflection that could be an old roadbed/driveway that led to the west side of the property. Scattered reflections were detected across Grids 1 and 2, but these reflections are not characteristic of remnant infrastructure of a former UST system. Magnetic readings were not elevated in the areas of these scattered reflections.

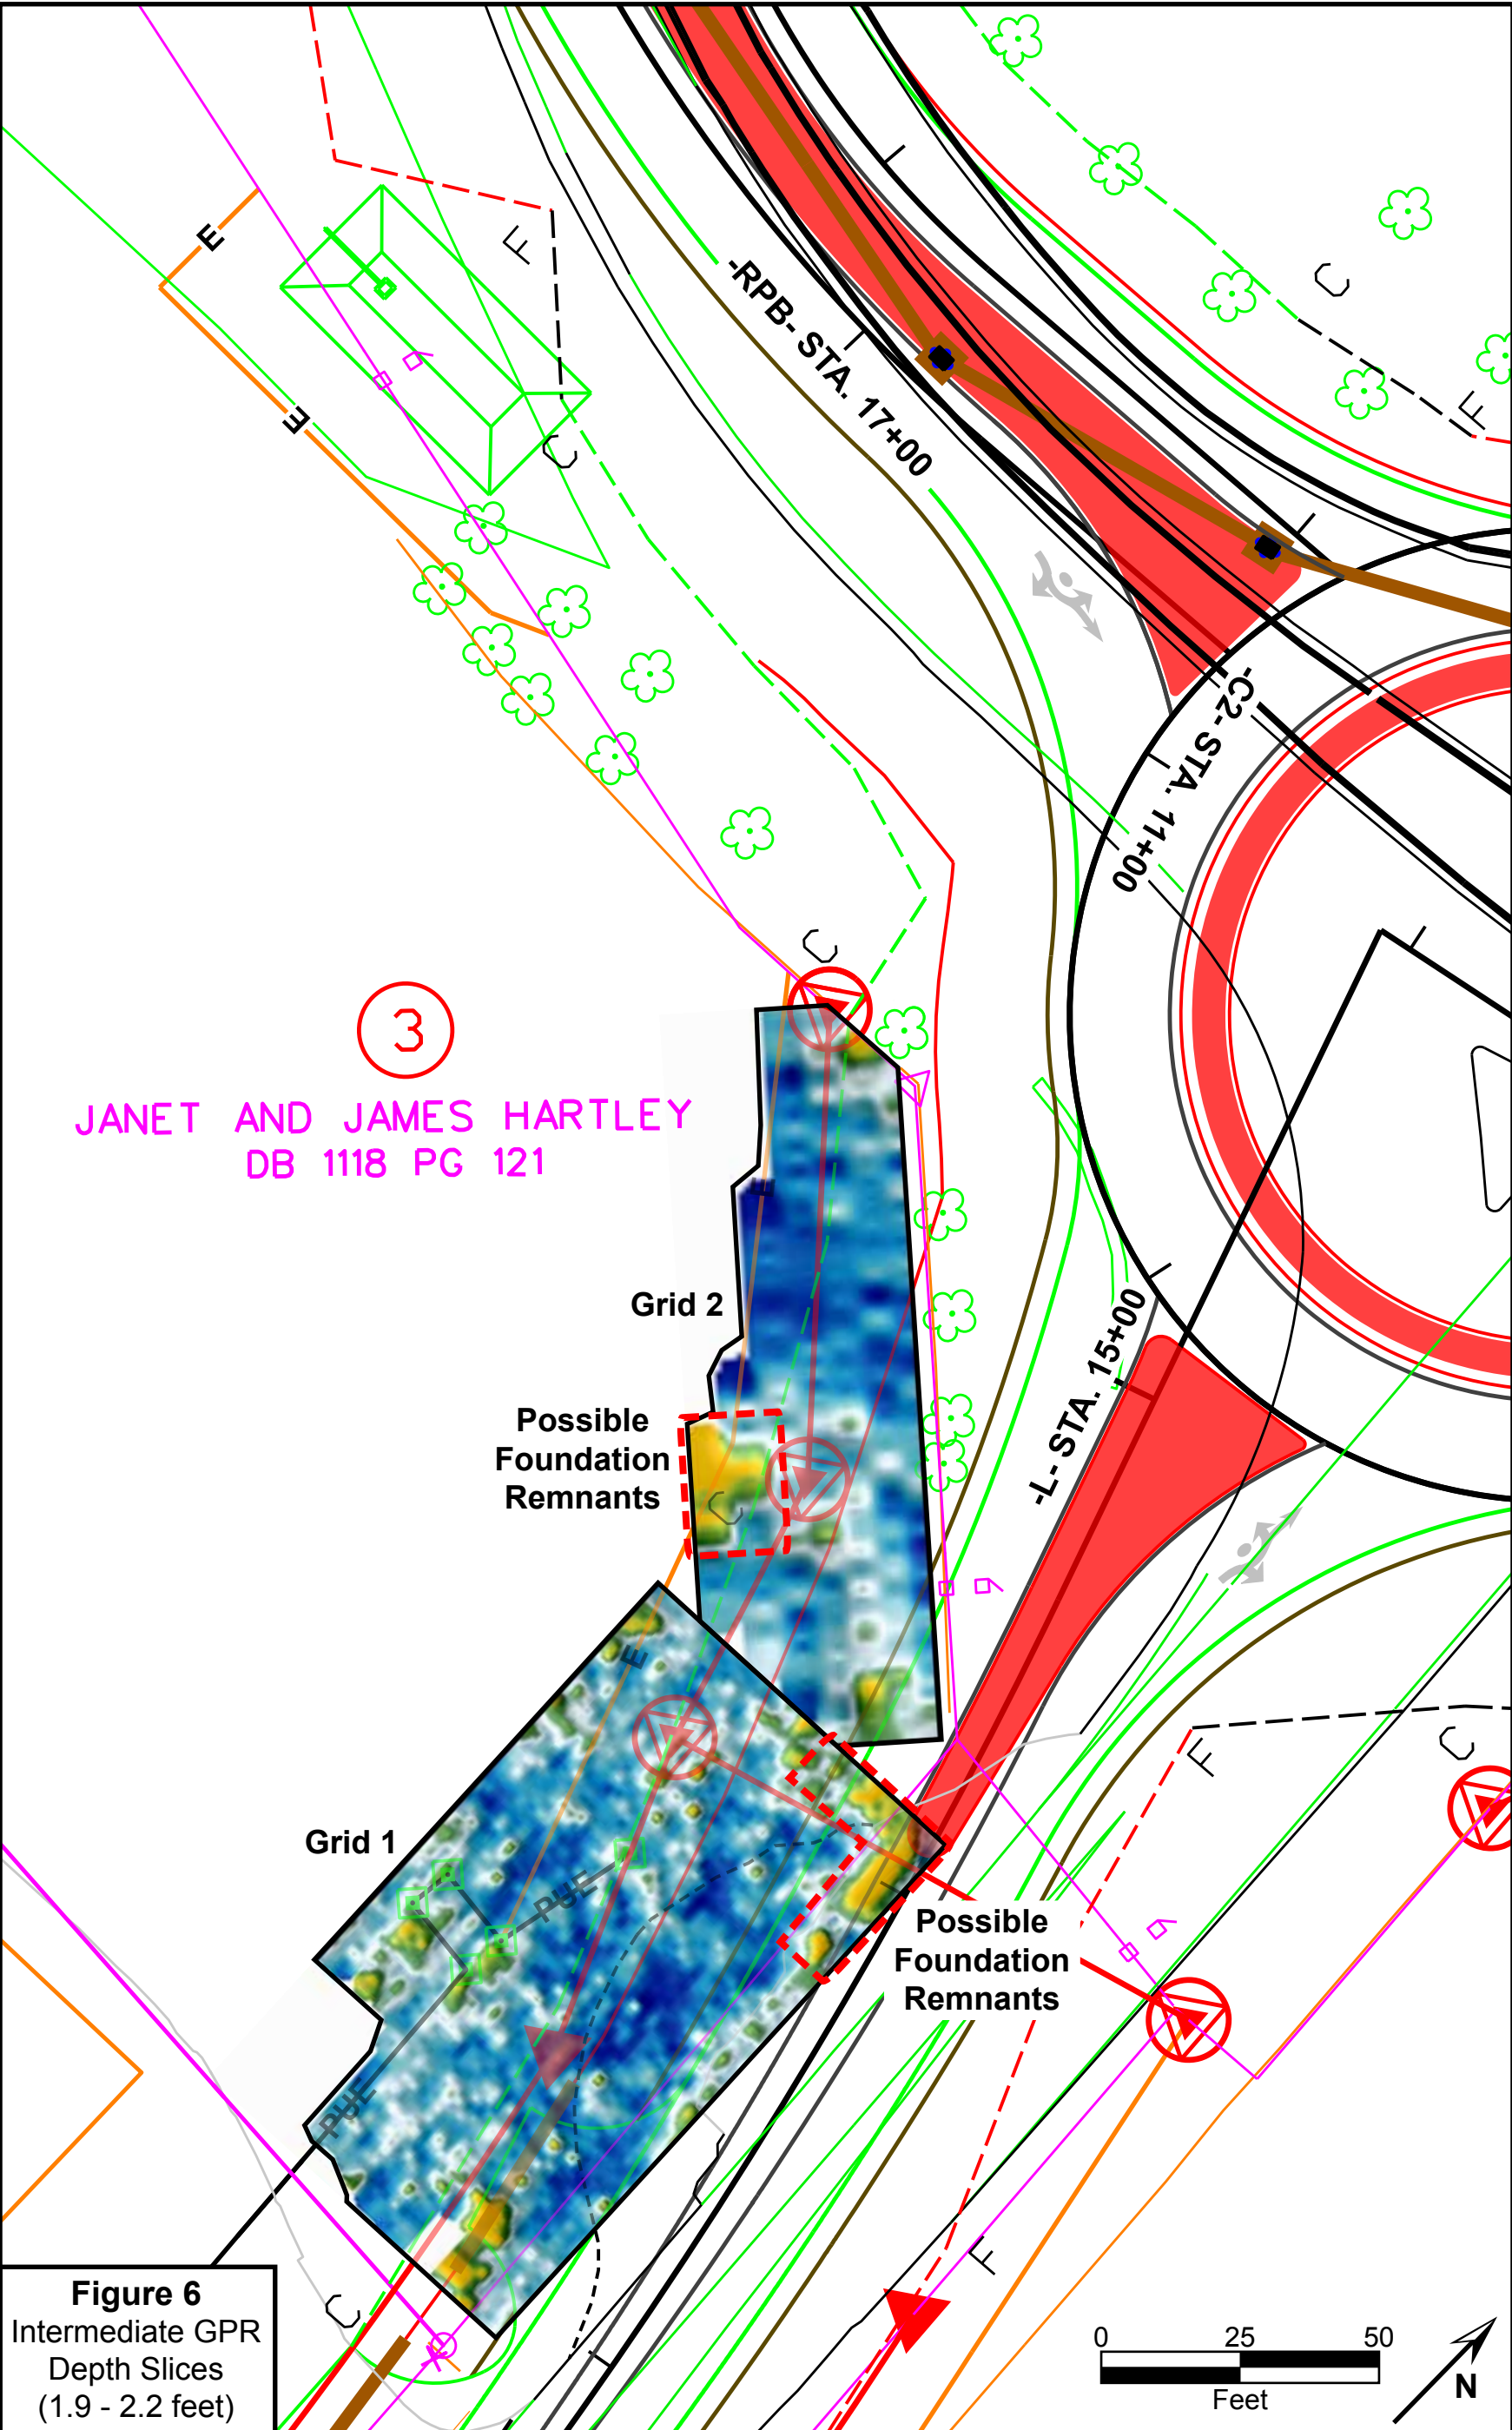
**Figure 6**  
Intermediate GPR  
Depth Slices  
(1.9 - 2.2 feet)

The intermediate GPR depth slice (1.9-2.2 feet) for Grid 1 (Figure 6) shows some scattered reflections. The two high amplitude sets of reflections are observed on the east side of the grid. These are interpreted as likely foundation remnants from the buildings observed in the 1960 aerial photograph (Plate 1, Photo 1). There is a set of high amplitude reflections along the west side of Grid 2. This reflector extends over a distance of at least 10 feet. This set of reflections is not interpreted as a UST system as elevated magnetic readings were not recorded across this anomaly. This set of reflections could also be foundation remnants, or a rubble filled basement of one of the former structures.

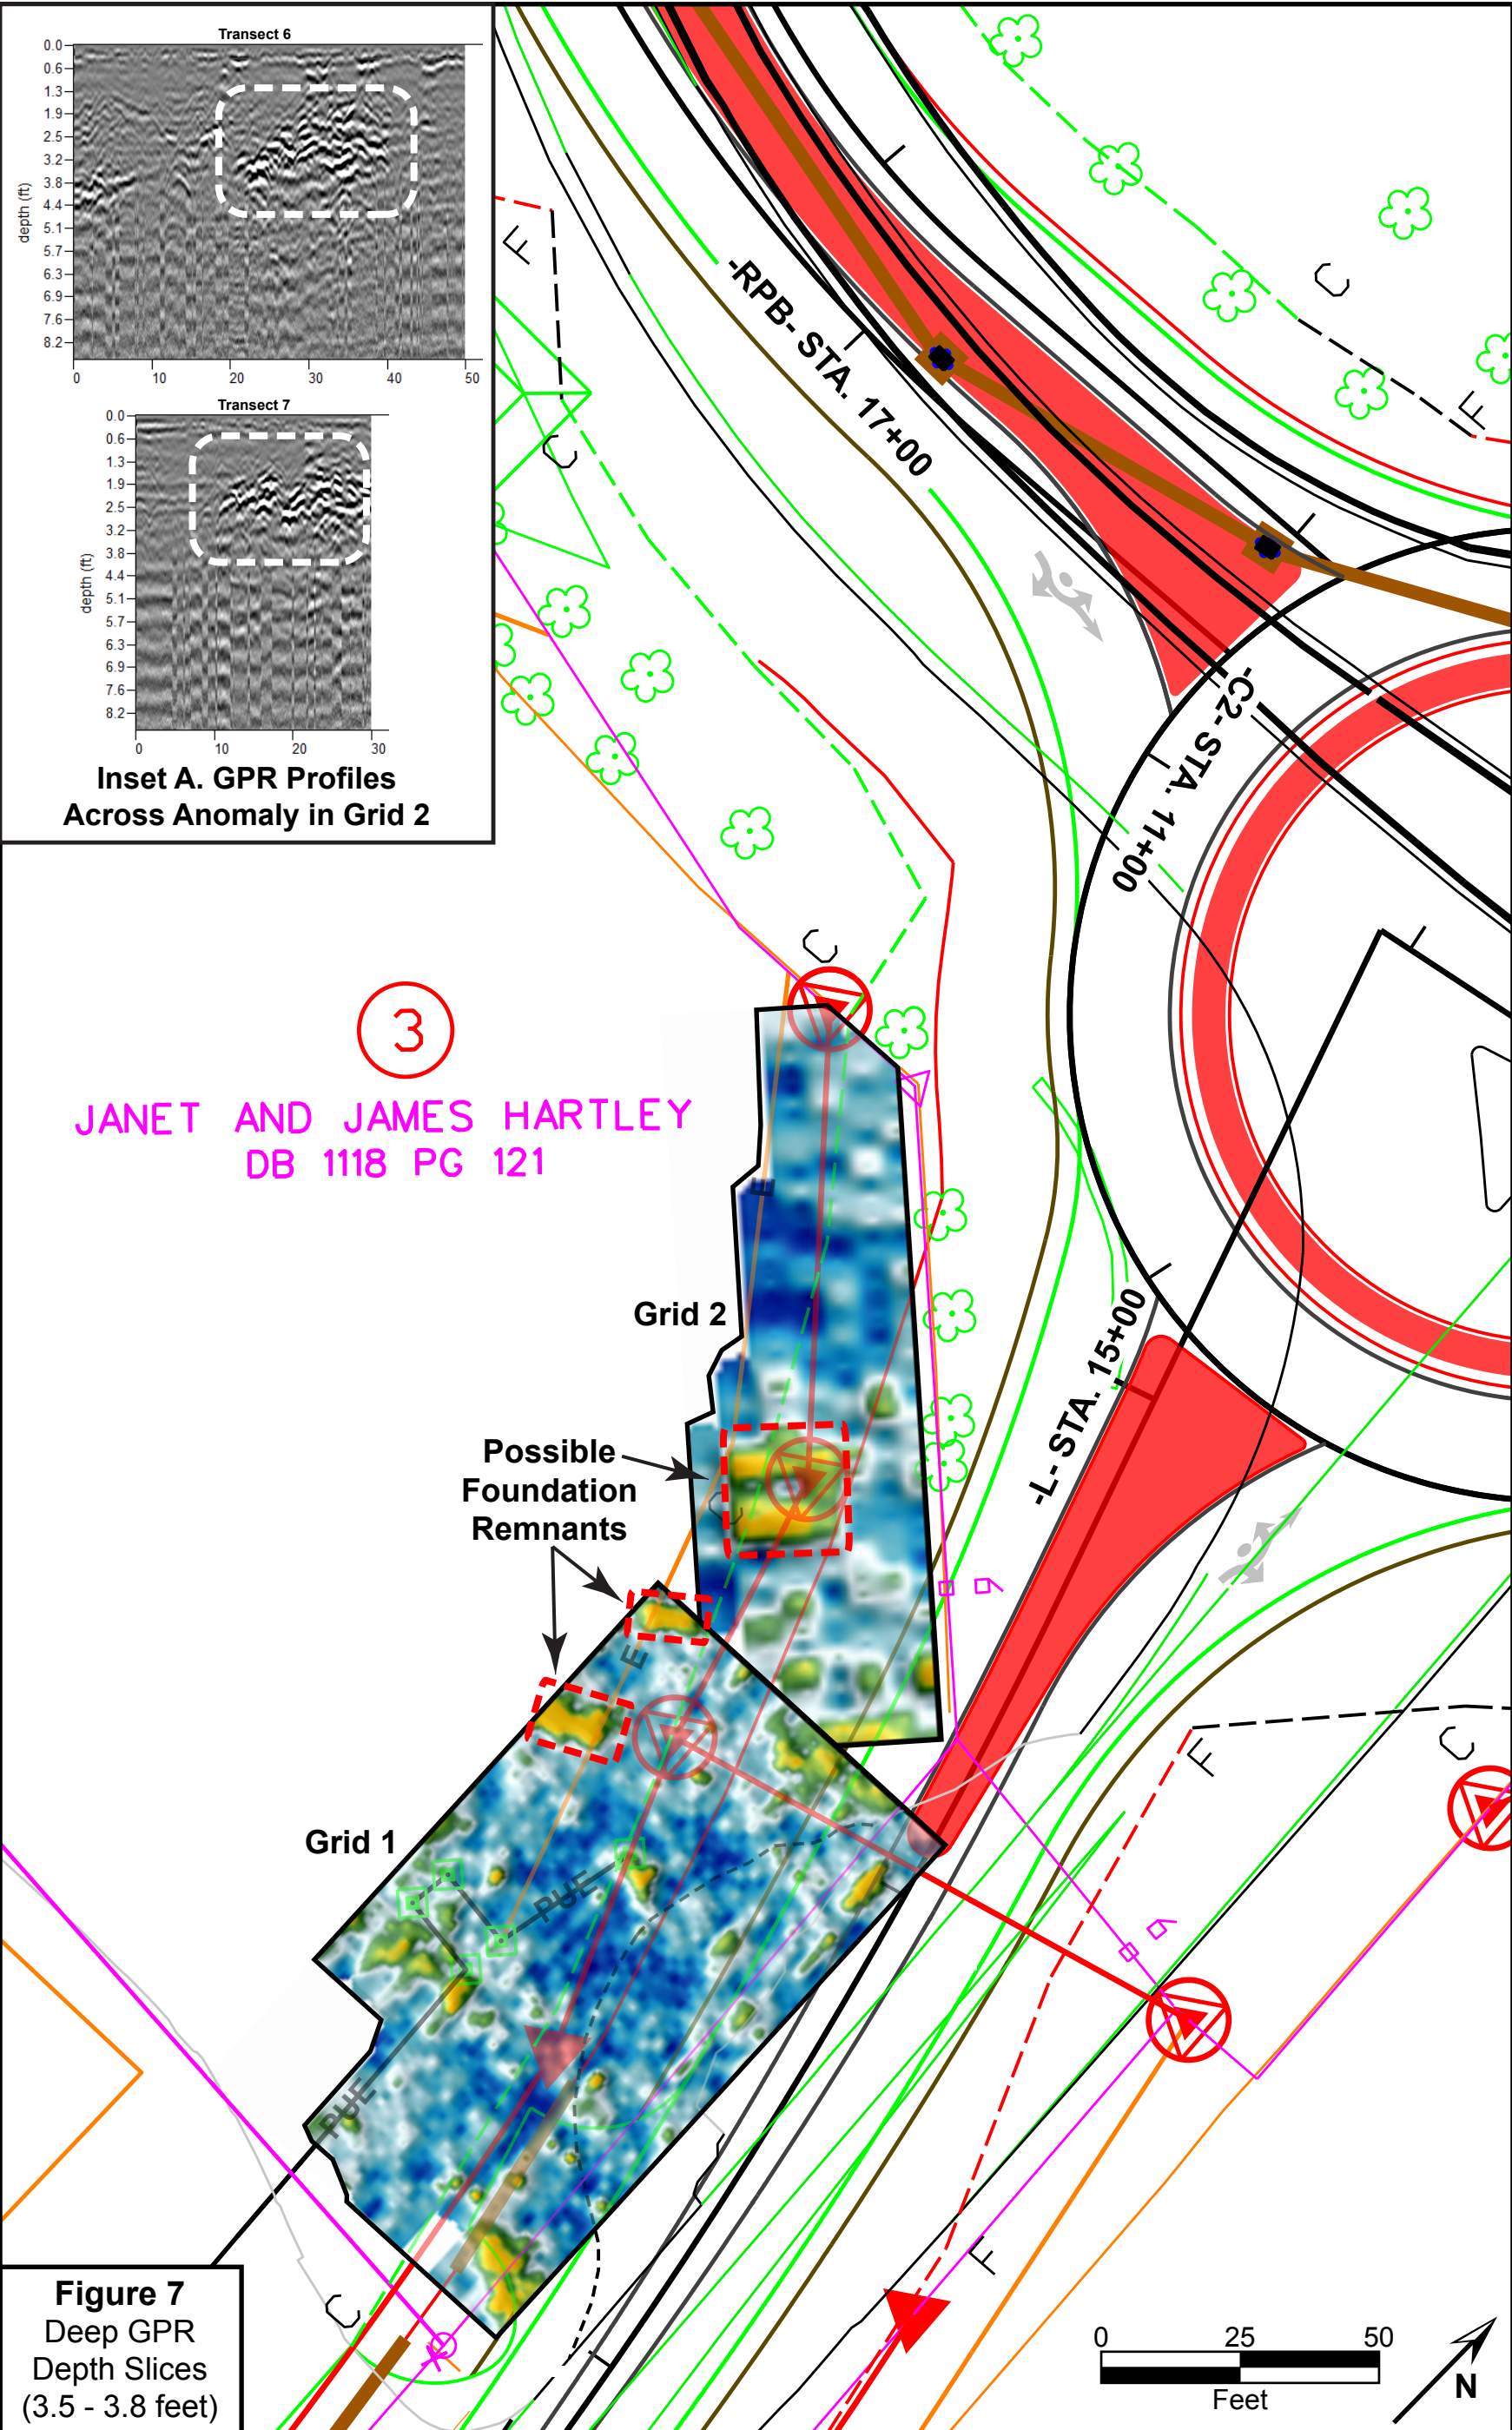
**Figure 7**  
Deep GPR  
Depth Slices  
(3.5 - 3.8 feet)

The deep GPR depth slice (3.5-3.8 feet) for Grid 1 (Figure 7) shows three areas of high amplitude reflections. Elevated magnetic readings were not detected these anomalies, so they are not likely to be related to a former UST system. The high amplitude set of reflections on the GPR depth slice in Grid 2 appears as an area of discontinuous to chaotic, high amplitude reflections on the GPR profiles (Inset A on Figure 7). These reflections occur at a depth of about 2 feet and extend for 20 feet across the profiles. These reflection characteristics are not consistent with USTs in a tank pit. Additionally, elevated magnetic readings were not detected across this anomaly. This anomaly is likely related to the former structures on Parcel #003.
