GEOTECHNICAL UNIT BORING LOG

PROJECT NO: 8.1910203 (R-977A)
 CHEROKEE COUNTY
 BRIDGE 4

EBL EB1-A

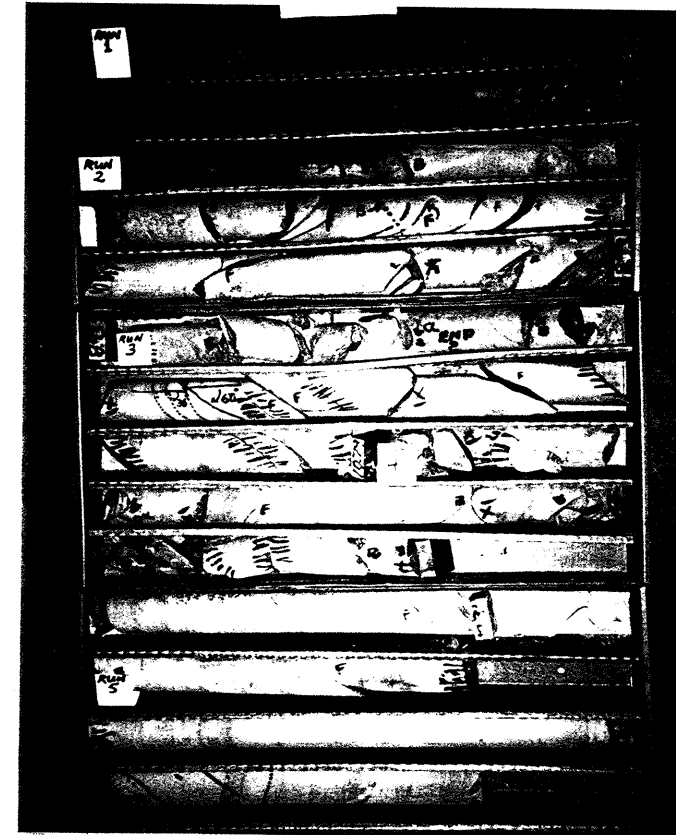
COR 1: 5.33-6.23	REC=98%	RQD=0%
COR 2: 6.23-8.93	REC=63%	RQD=32%
COR 3: 8.93-10.79	REC=73%	RQD=51%
COR 4: 10.79-12.31	REC=98%	RQD=62%
COR 5: 12.31-13.83	REC=98%	RQD=98%

LAYER 1: 5.33-6.49 Soft to hard weathered rock: olive brown, highly weathered, moderately to extremely fractured phyllite; yellow clay from 6.30 to 6.48. 40 pieces plus rubble, longest piece 8cm. Joints indeterminate. REC=98% RQD=0%

LAYER 2: 6.49-9.28 Moderately hard, slightly weathered, moderately fractured, gray to yellow-brown phyllite. 25 pieces, longest piece 19cm. Core broken and weathered 9.0-9.20m; core loss includes machine grinding. Bedding dips 35°. 6 joints on bedding, ADS=27cm, ADT=0.01cm, moderately rough, with Fe and Mn oxide coating. REC=64% RQD=32%
