NC DEPARTMENT OF TRANSPORTATION
DIVISION OF HIGHWAYS
BRIDGE MAINTENANCE UNIT

BRIDGE INSPECTION REPORT

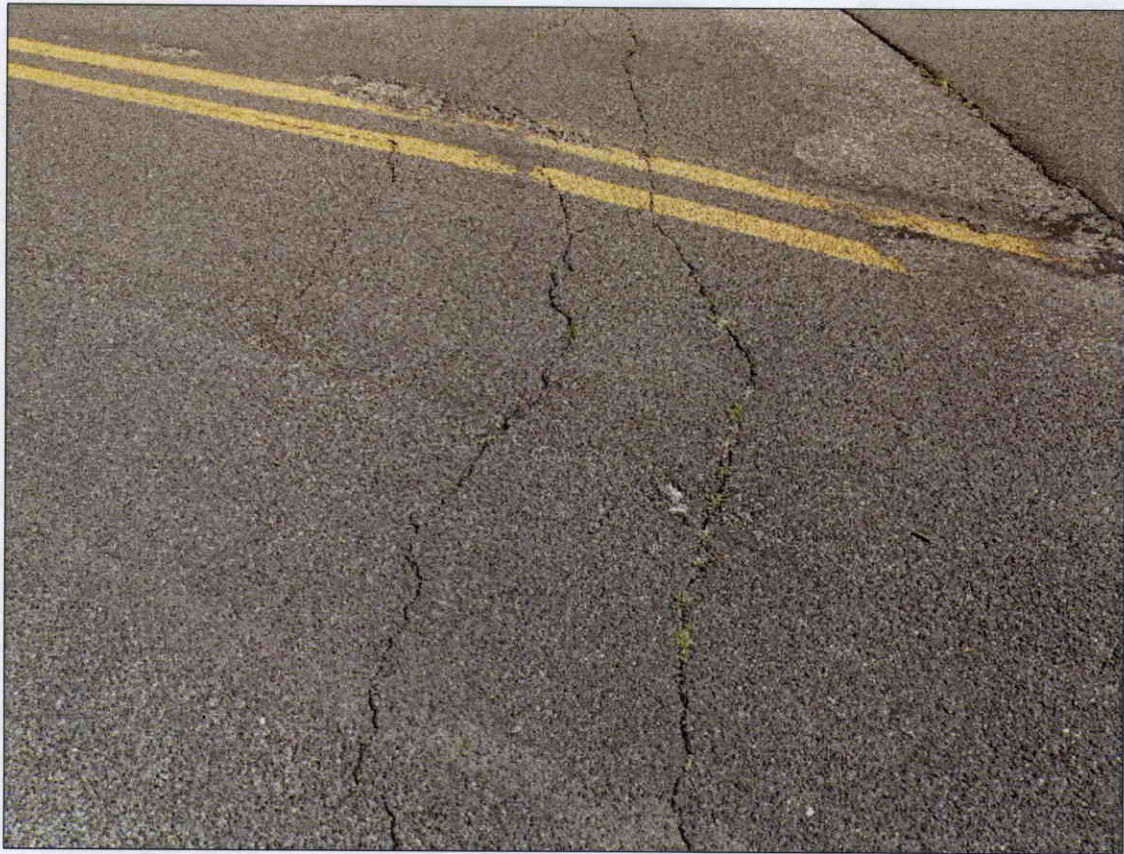
TRANSVERSE CRACKS IN ASPHALT WEARING SURFACE AT WEST APPROACH

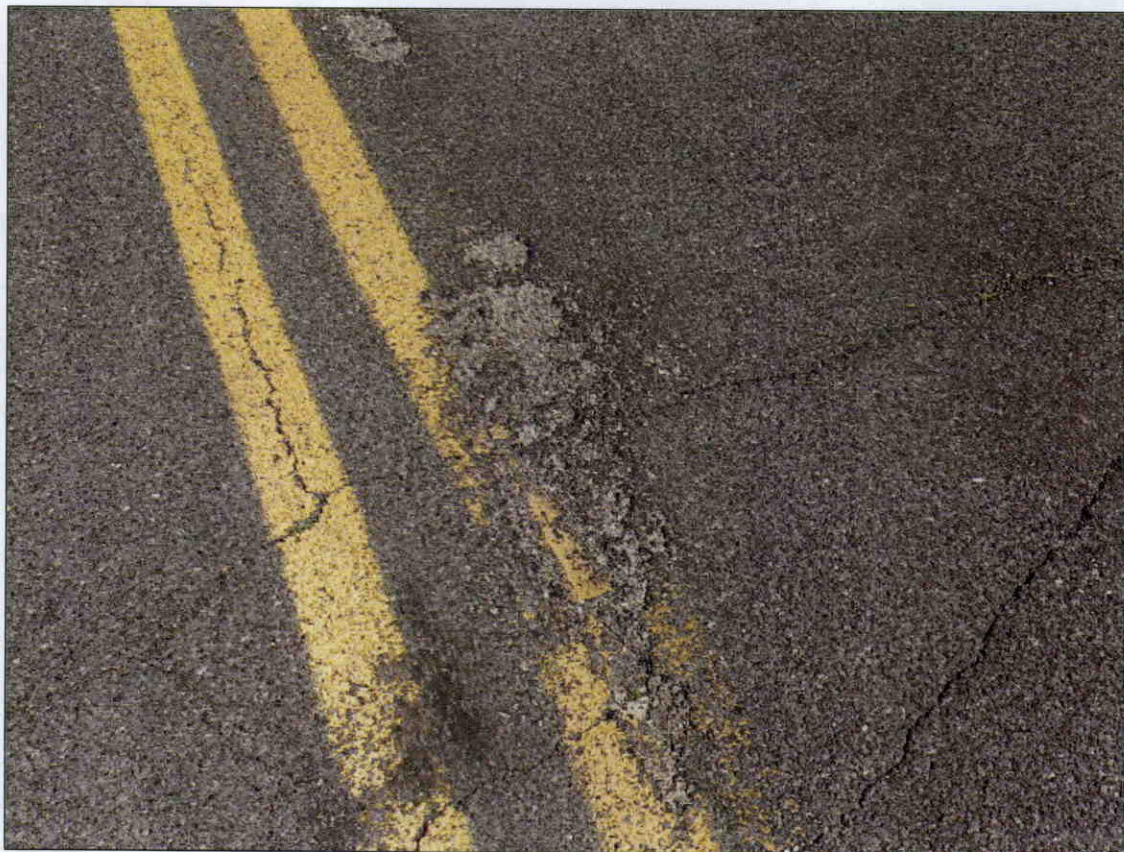
AREAS OF 1/2 IN DEEP SCARED PAVEMENT AT WEST APPROACH

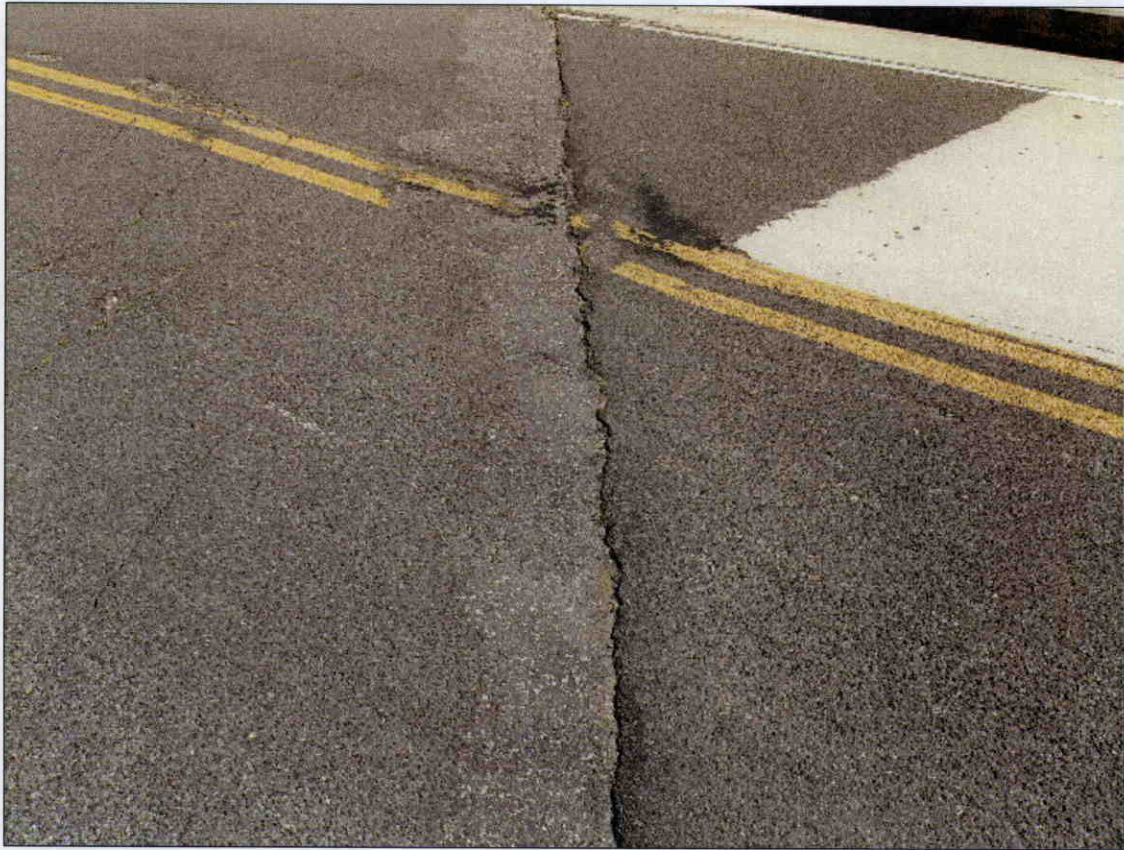
TRANSVERSE CRACK IN ASPHALT WEARING SURFACE ALONG END BENT 1 FILL FACE WITH 1/2 IN OF SETTLEMENT

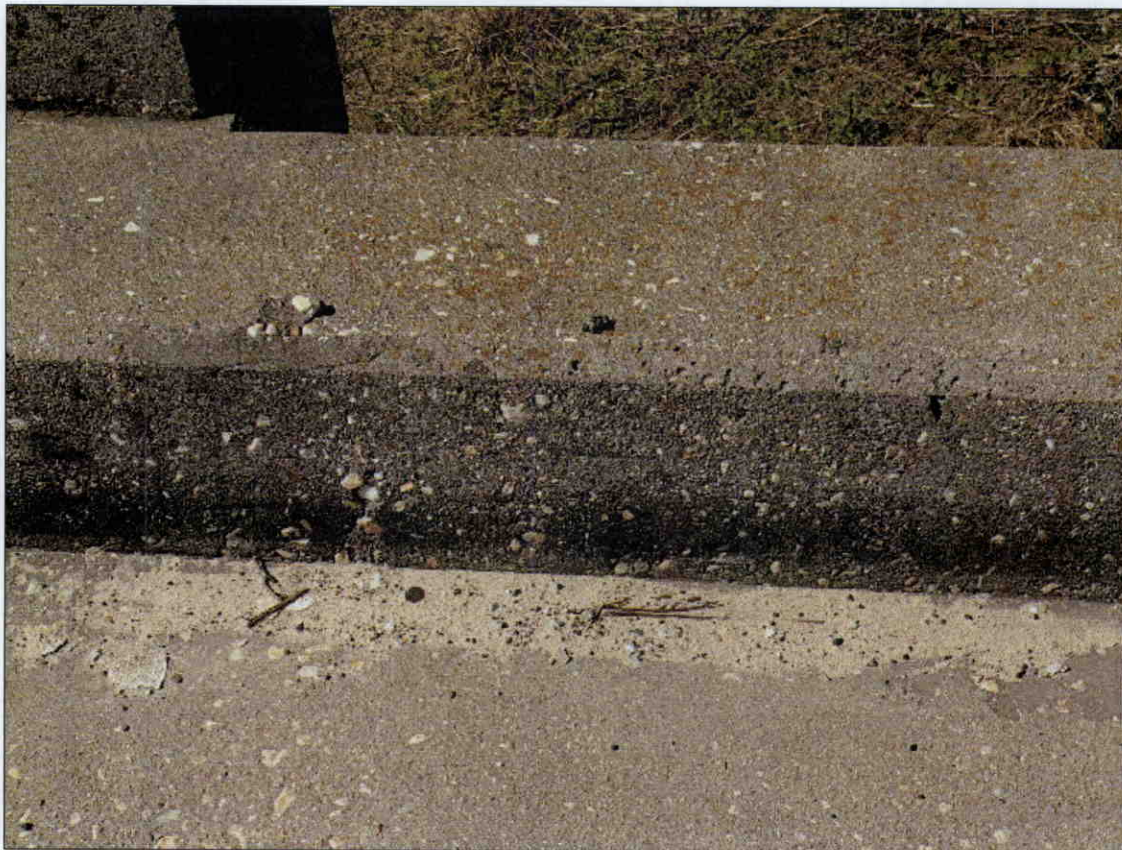
WEATHERING AND SCALING OF CURB WITH EXPOSED AGGREGATE

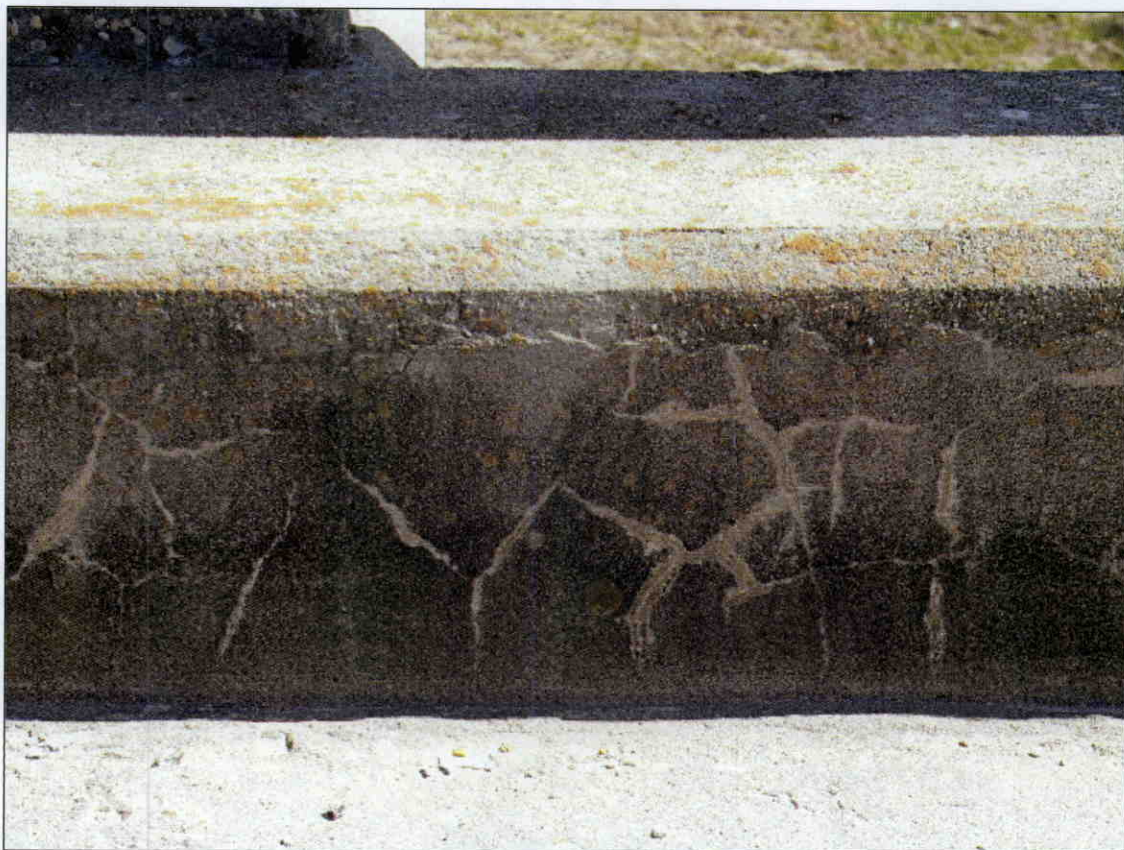
HAIRLINE MAP CRACKING WITH EFFLORESCENCE IN FACE OF CURB AT VARIOUS LOCATIONS THROUGHOUT

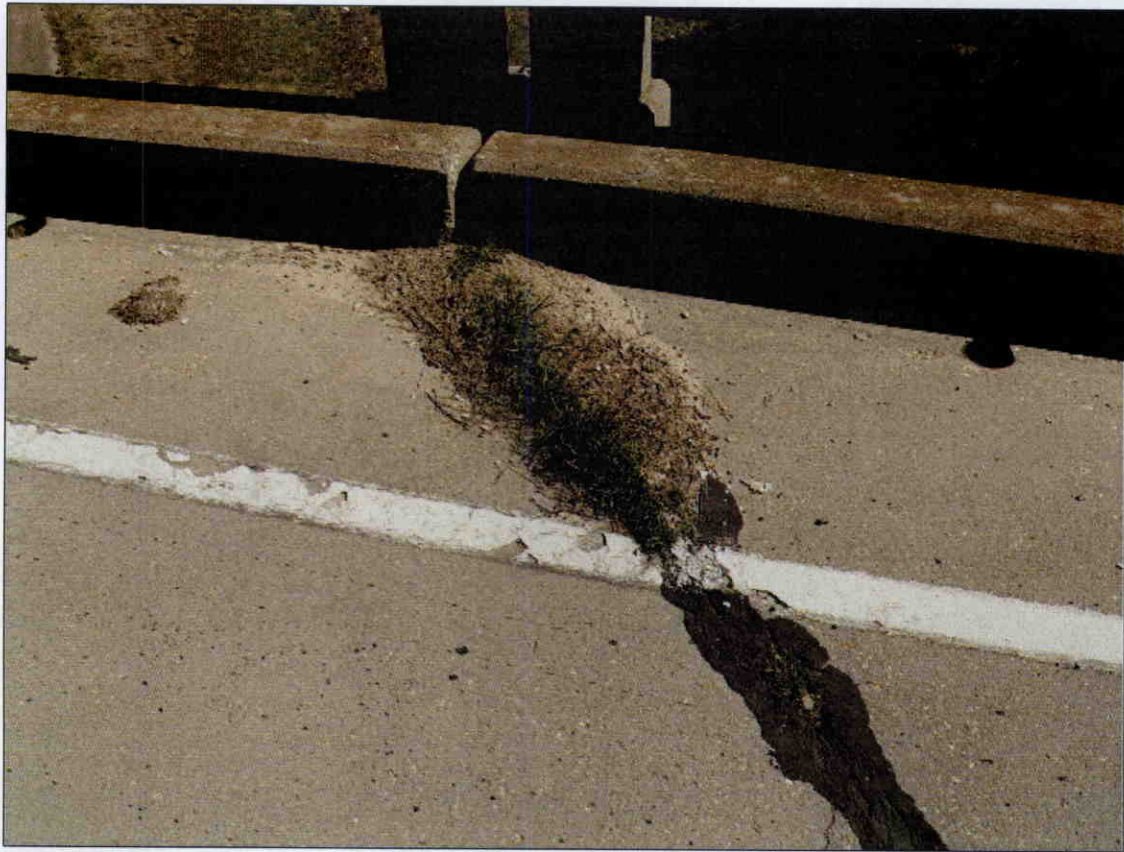
DIRT AND DEBRIS WITH VEGETATION GROWING IN SHOULDER AREA OF DECK EXPANSION JOINT AT BENT 3, SIMILAR CONDITION AT ALL DECK EXPANSION JOINTS

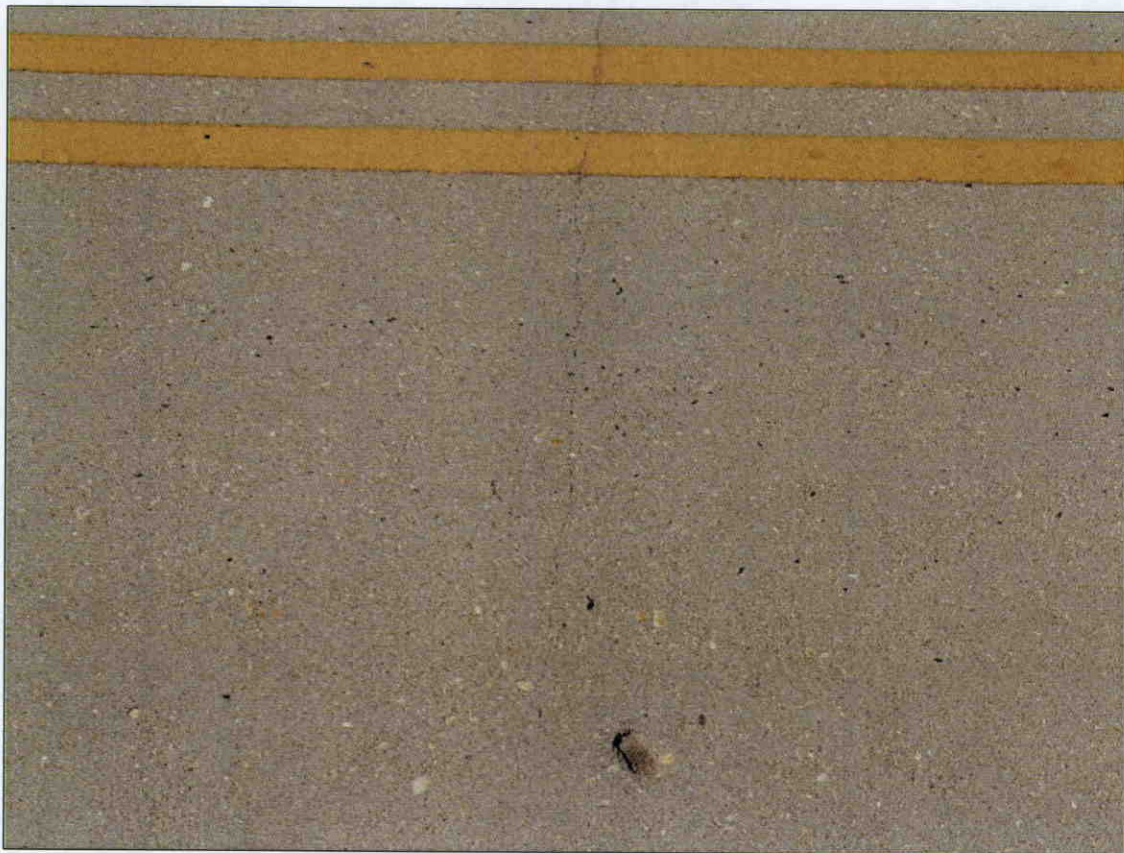
TRANSVERSE HAIRLINE CRACK IN TOP OF DECK, SPAN 2, SIMILAR CRACKS THROUGHOUT

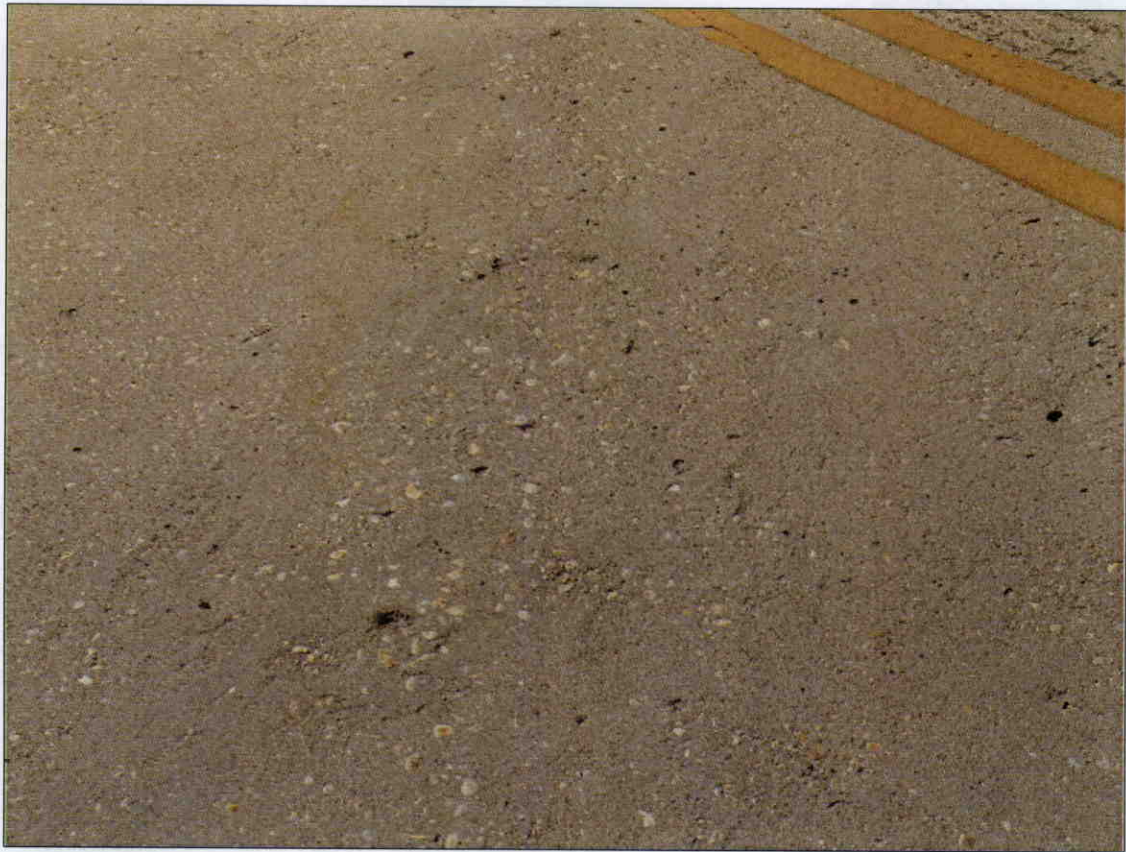
ROUGH AND WORN SURFACE WITH EXPOSED AGGREGATE IN TOP OF DECK, SPAN 1 SHOWN, SIMILAR CONDITION THROUGHOUT

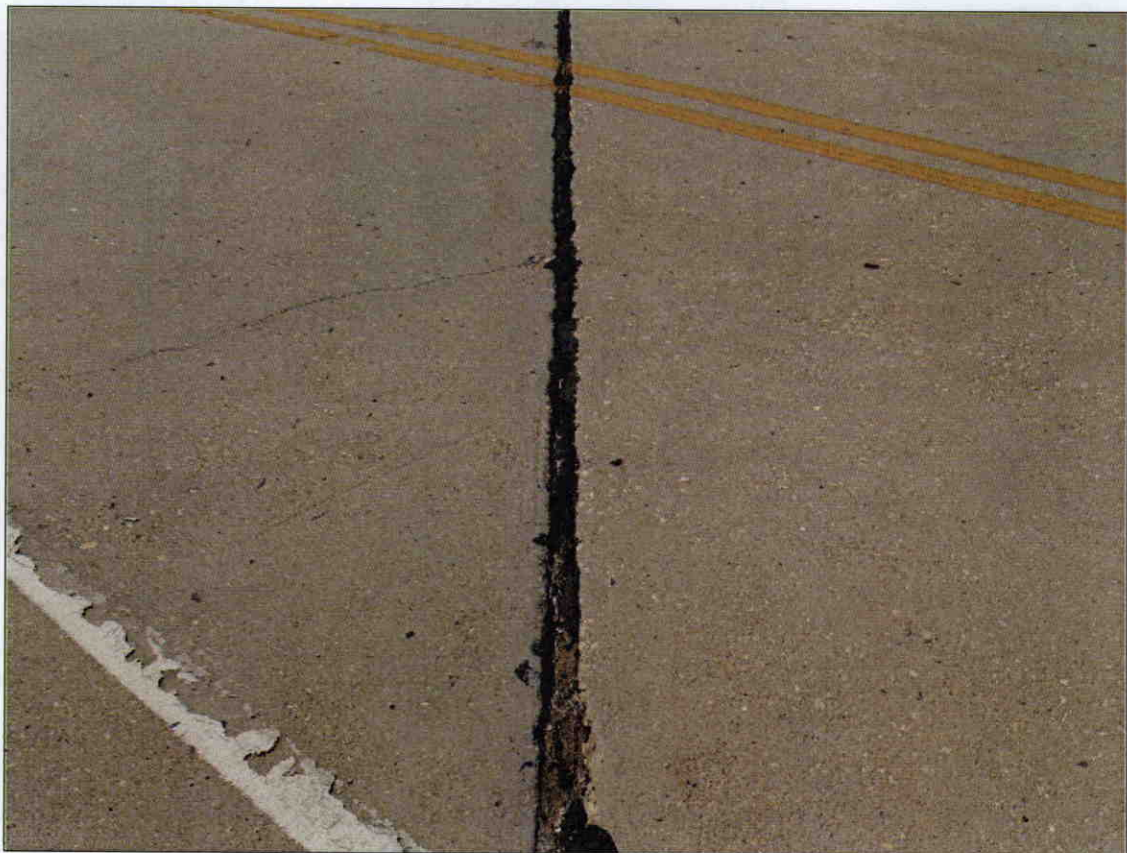
DRIED AND MISSING JOINT SEALER ALONG DECK EXPANSION JOINT AT BENT 1

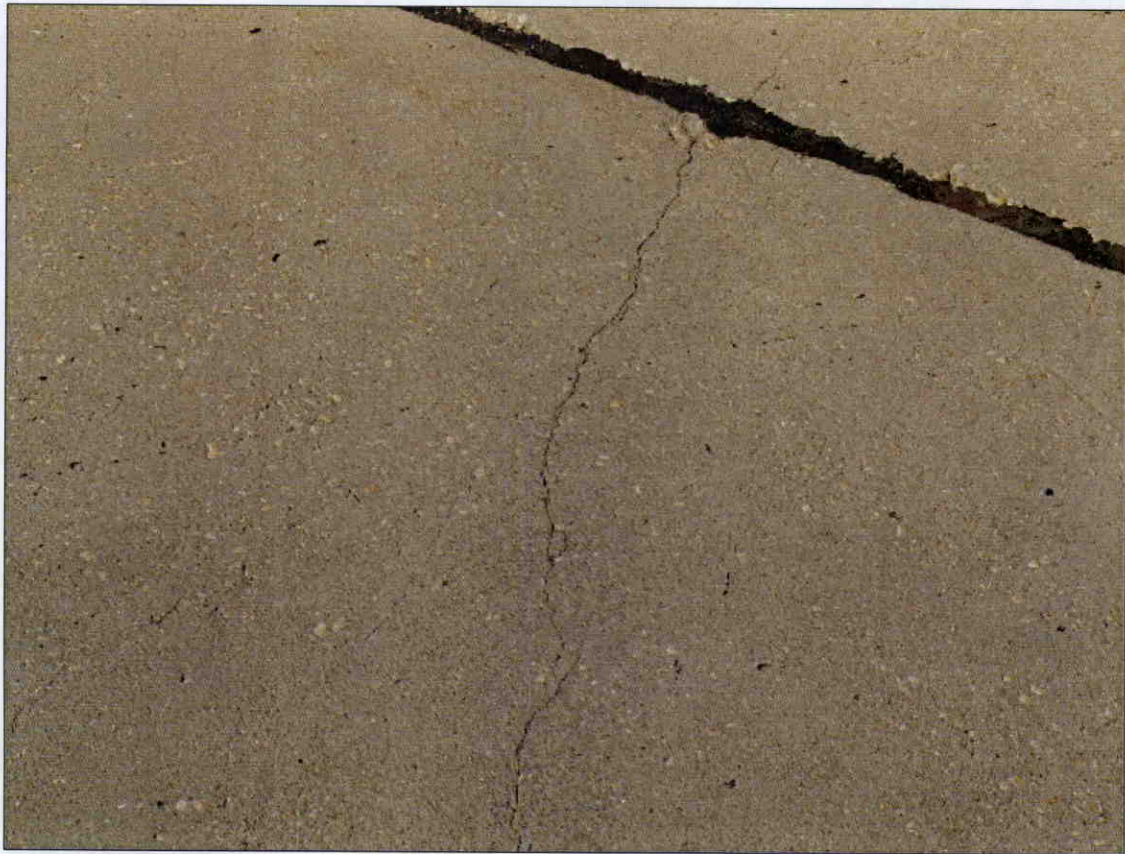
HAIRLINE TO 1/16 IN CRACK IN TOP OF DECK, EXTENDING 6 FT FROM DECK EXPANSION JOINT AT BENT 1,
SIMILAR CRACKS AT ALL DECK EXPANSION JOINTS

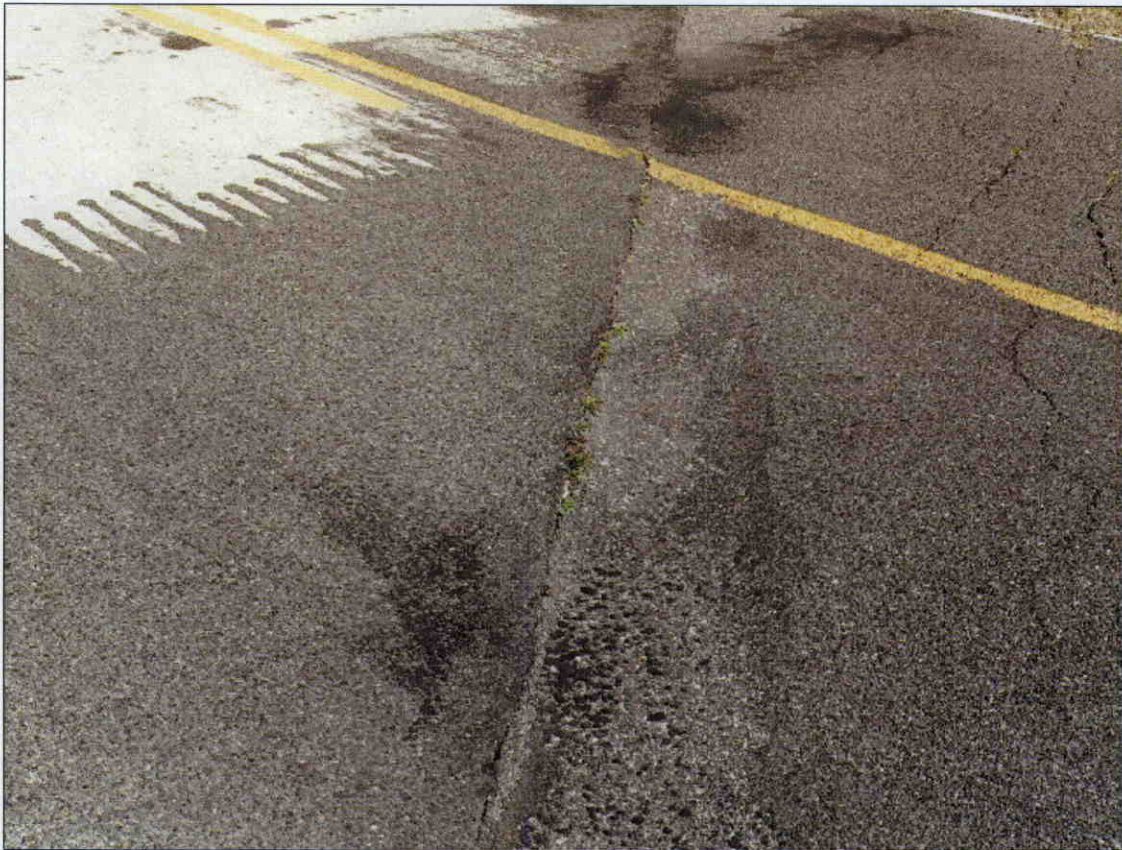
TRANSVERSE CRACK IN ASPHALT WEARING SURFACE ALONG END BENT 2 FILL FACE WITH 1/2 IN OF SETTLEMENT

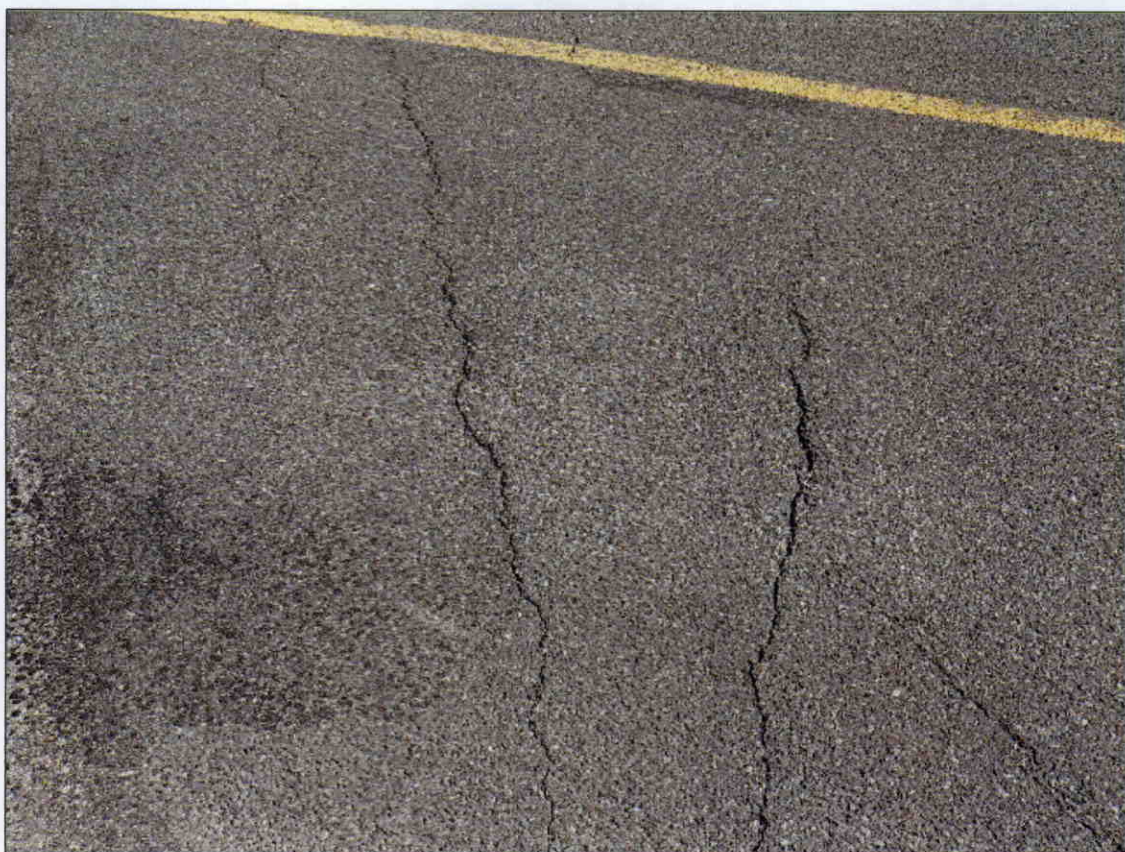
TRANSVERSE CRACKS IN ASPHALT WEARING SURFACE AT EAST APPROACH

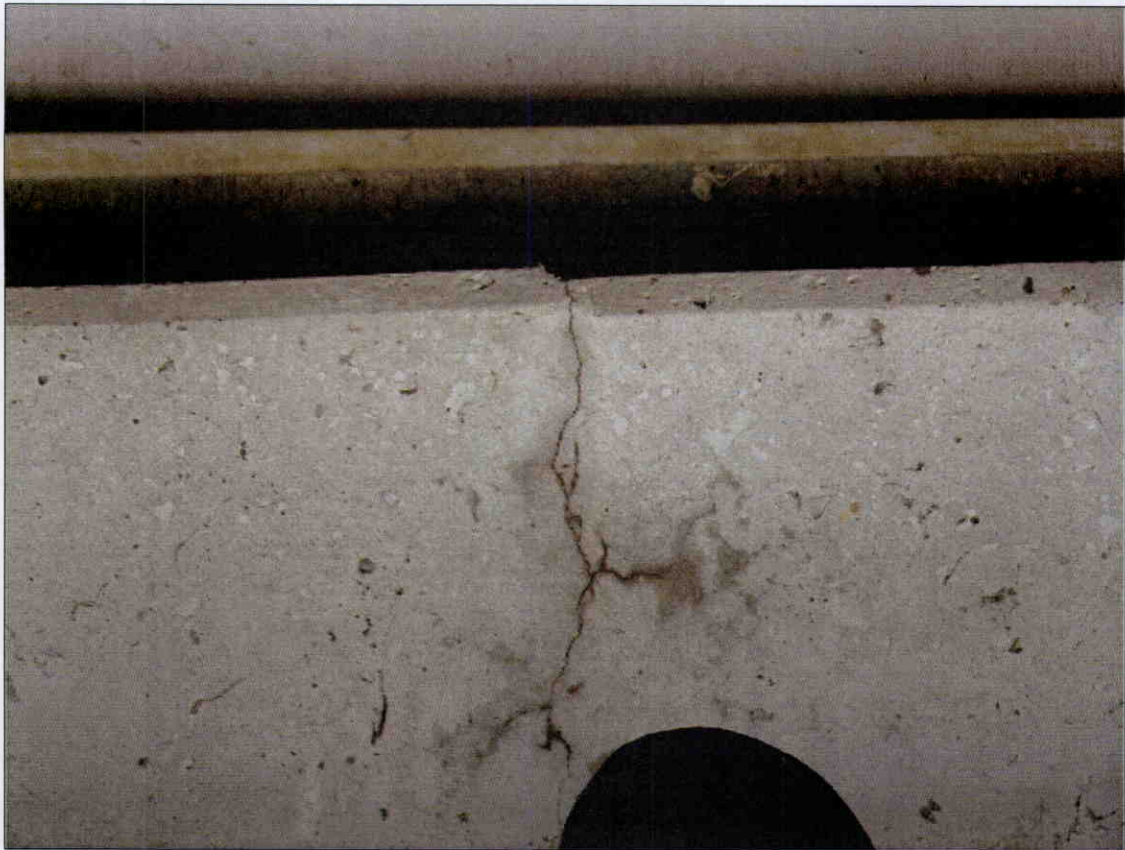
VERTICAL HAIRLINE CRACK IN FACE OF END BENT 2 CAP AT STEP, SIMILAR CRACKS AT STEPS AT END BENTS 1 AND 2.

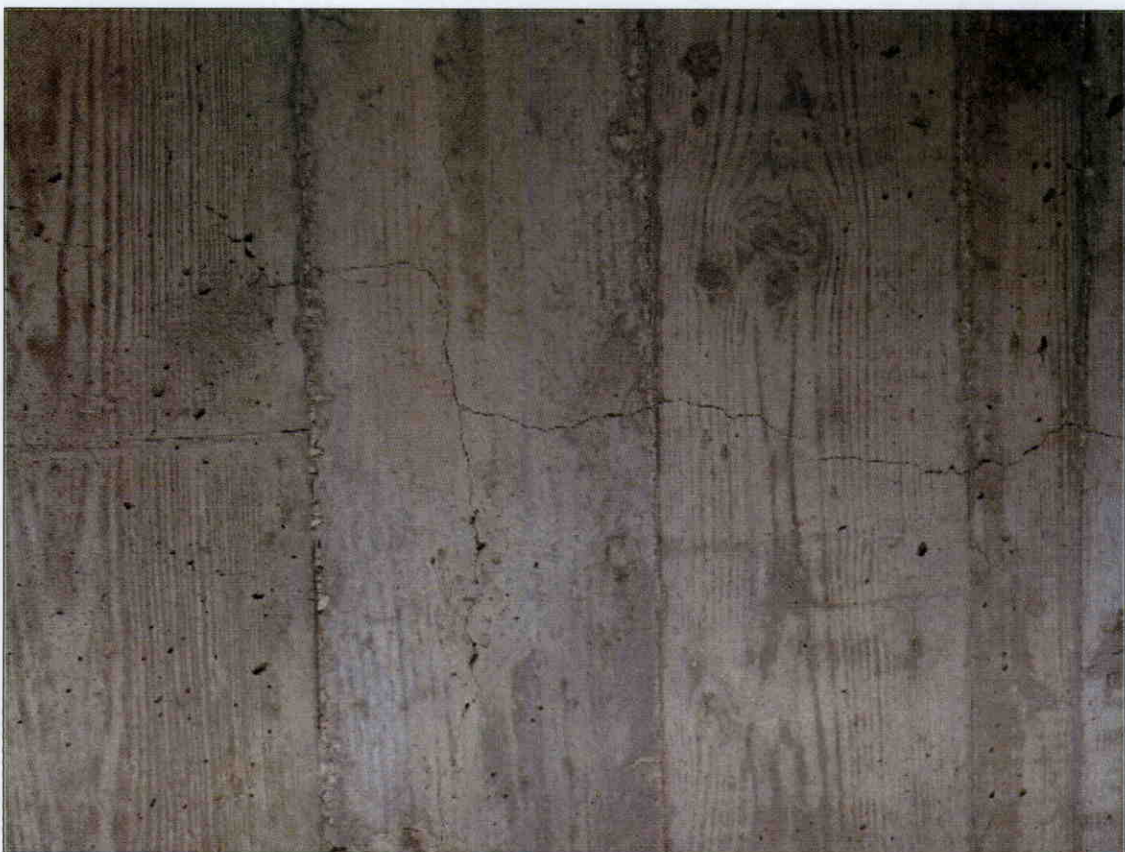
HORIZONTAL HAIRLINE CRACK IN END BENT 2 CURTAINWALL IN BAY 2, SIMILAR CRACKS IN BAYS 1 AND 3

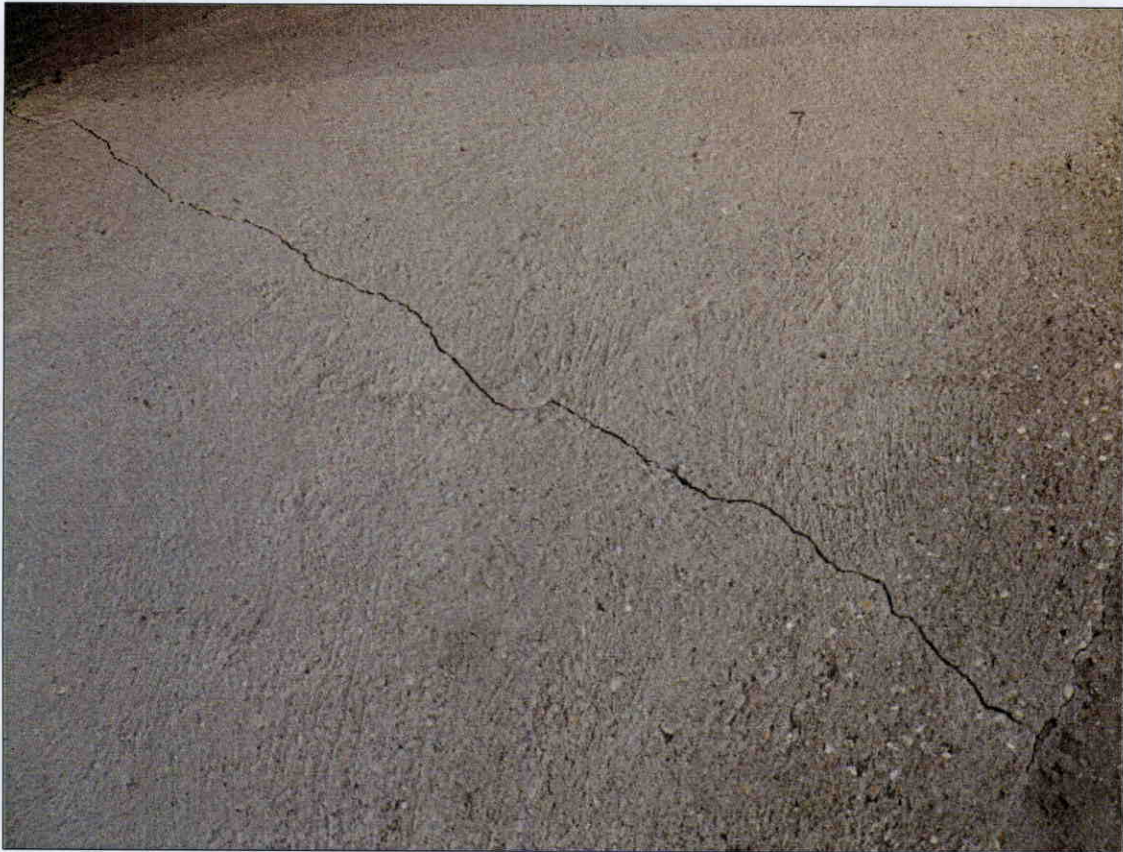
5 FT LONG X 1/8 IN HORIZONTAL CRACK IN SLOPE PROTECTION AT END BENT 2

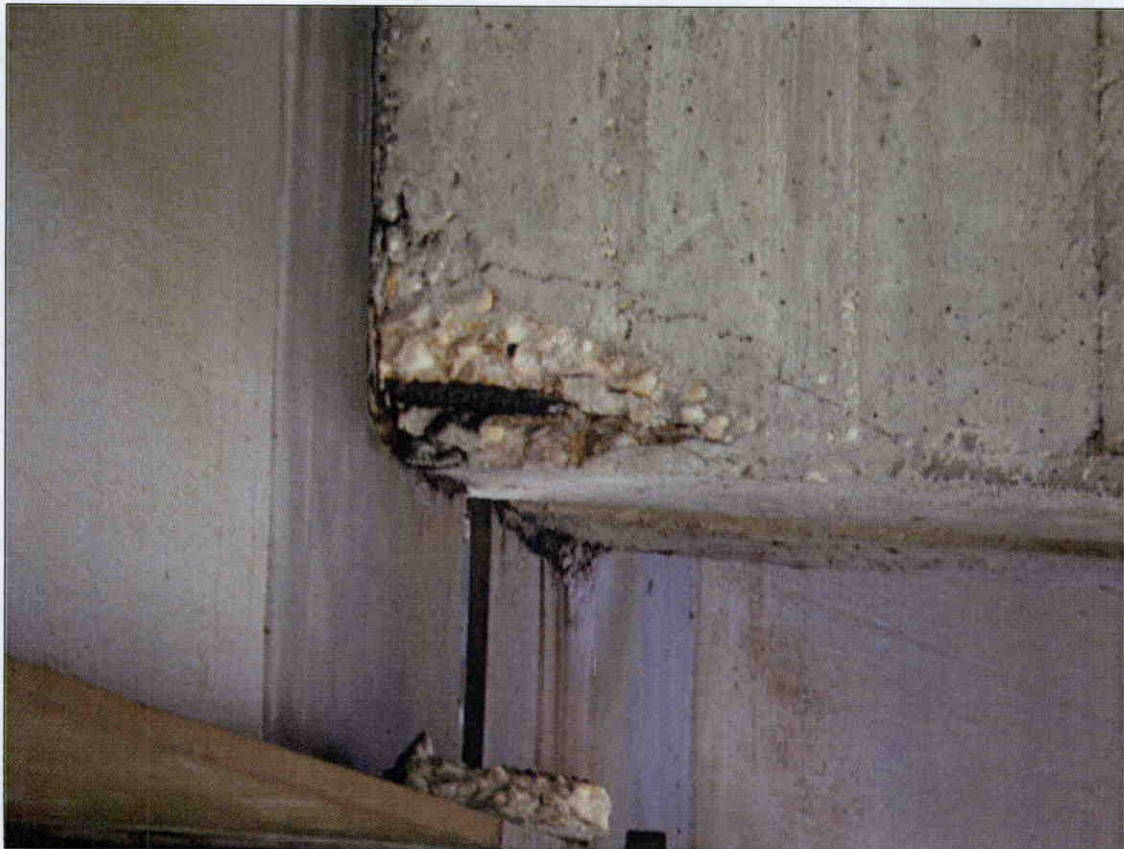
6 IN X 10 IN X 2 IN SPALL WITH EXPOSED REBAR IN BOTTOM OF END DIAPHRAGM AT BENT 3, SPAN 4 SIDE, BAY 2

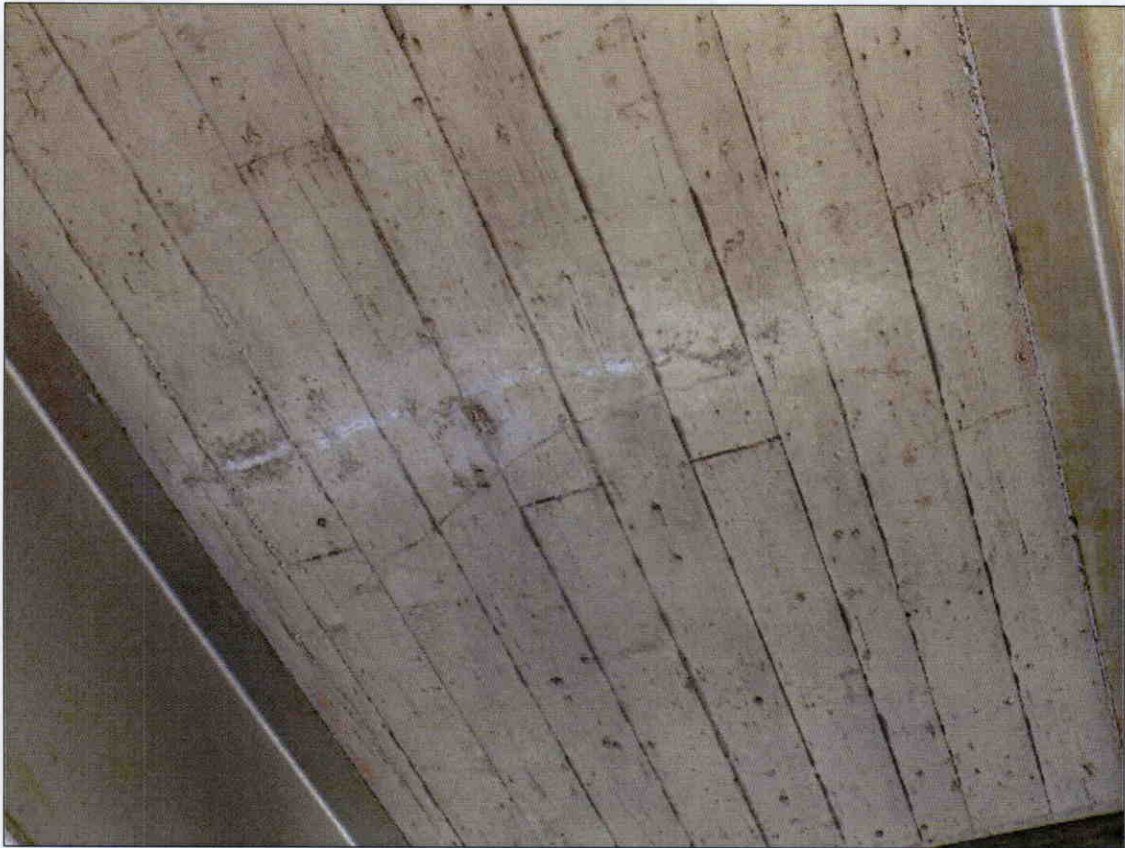
TRANSVERSE HAIRLINE CRACK WITH EFFLORESCENCE IN BOTTOM OF DECK, SPAN 4, SIMILAR CRACKS THROUGHOUT

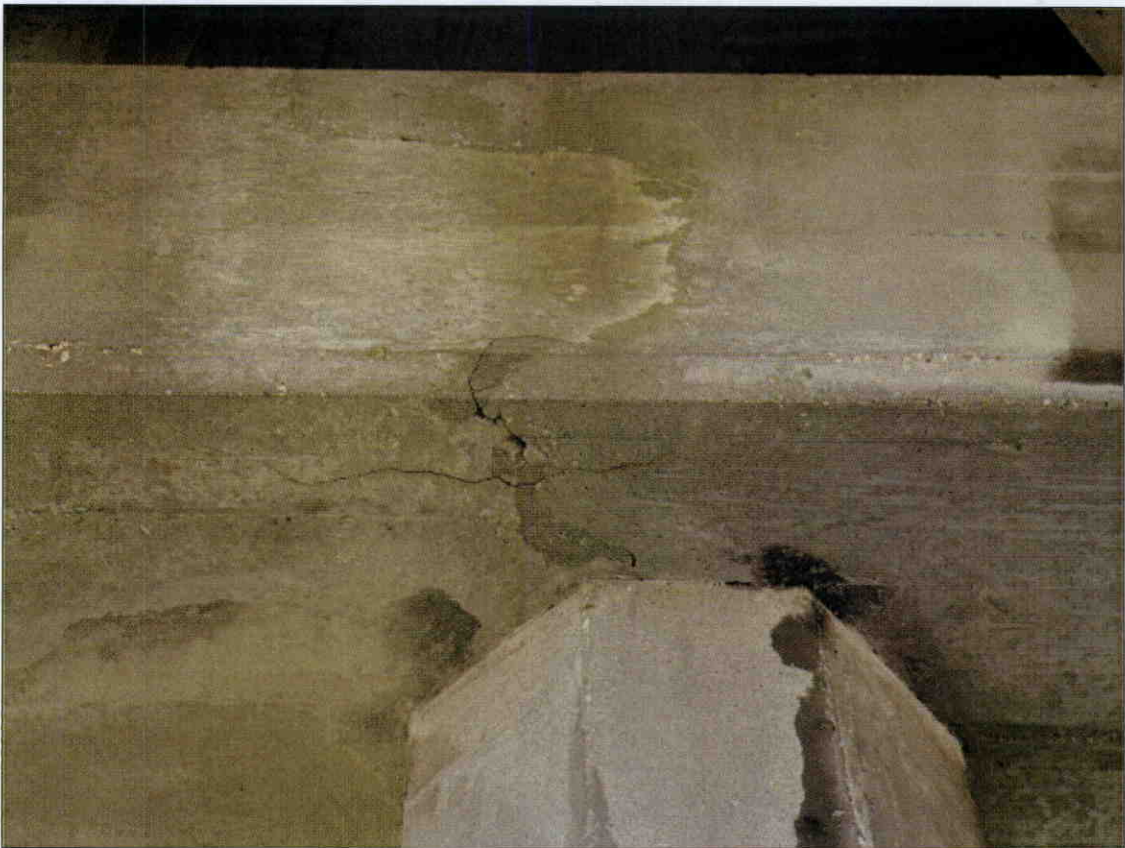
LONGITUDINAL HAIRLINE CRACK IN BOTTOM OF BENT 3 CAP AT PILE 2, SIMILAR CRACK AT BENT 1, PILE 1

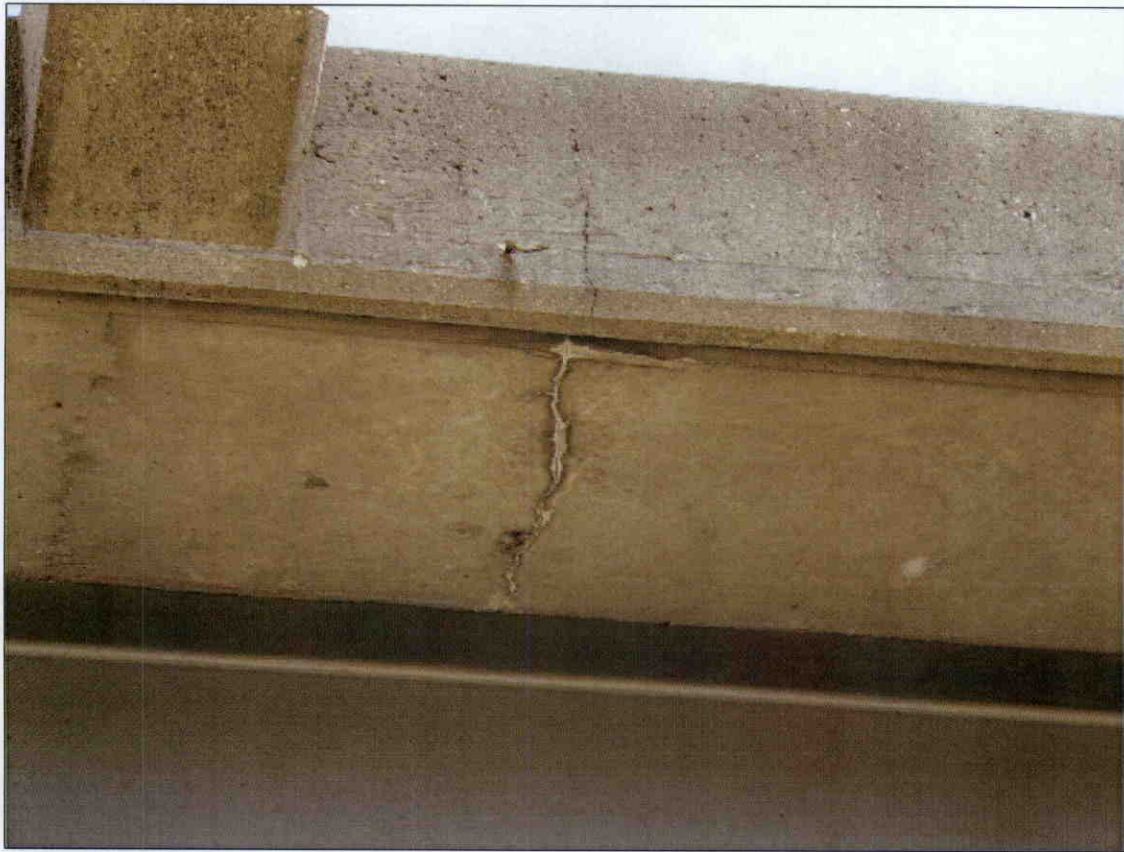
TRANSVERSE HAIRLINE CRACK WITH EFFLORESCENCE IN BOTTOM OF DECK OVERHANG BOTH SIDES AT VARIOUS LOCATIONS

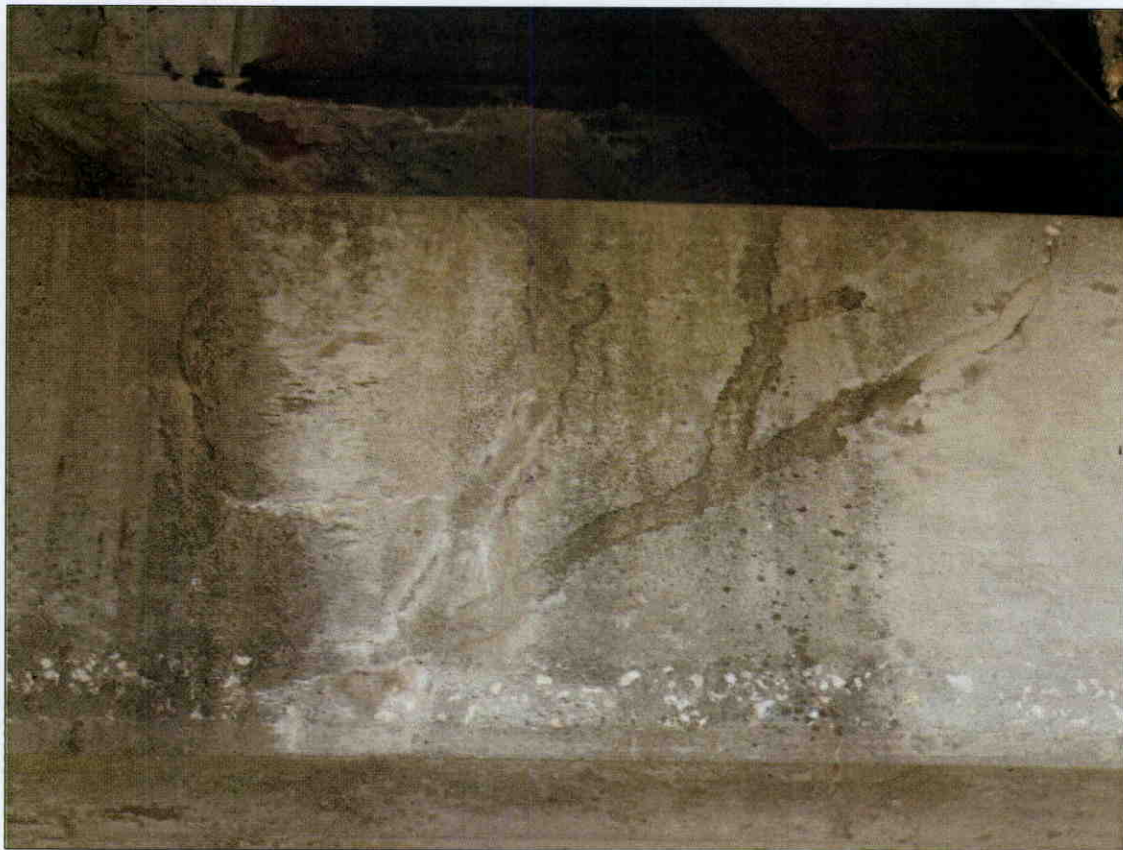
DIAGONAL HAIRLINE CRACK IN FACE OF BENT 1 CAP AT BEAM 2, SPAN 2 SIDE

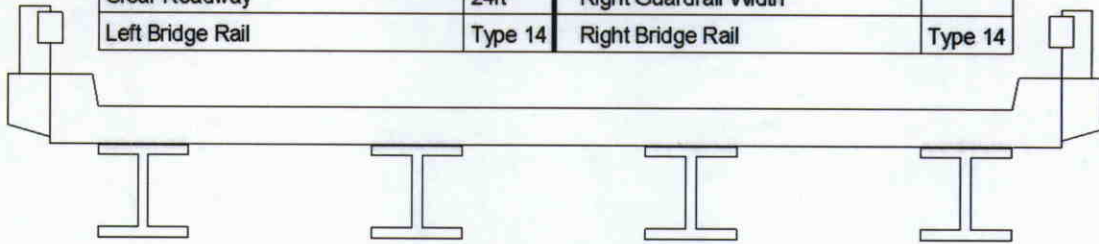
Measurements for Span #	1		
Deck Thickness	0.583	Left Overhang	2.75
Top of Rail to Bottom of Beam	6.167	Right Overhang	2.75
