NC DEPARTMENT OF TRANSPORTATION  
DIVISION OF HIGHWAYS  
BRIDGE MAINTENANCE UNIT

# BRIDGE INSPECTION REPORT

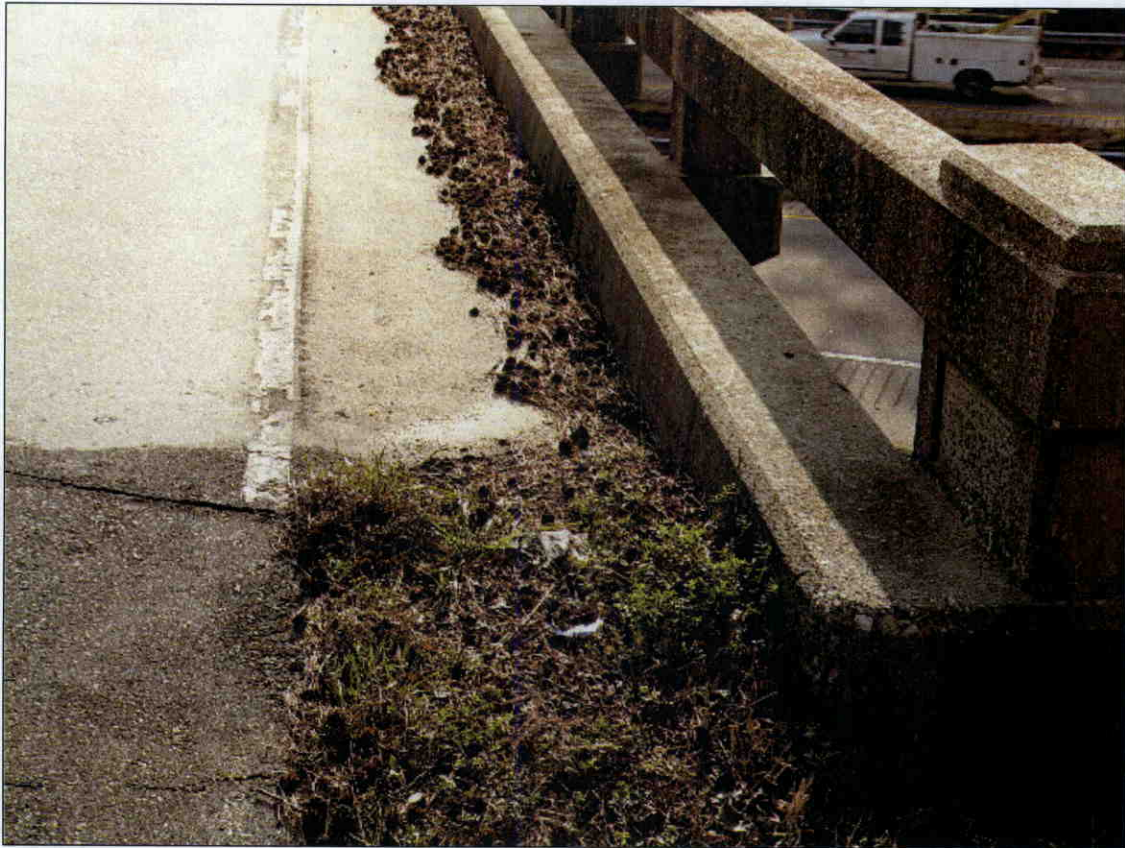
DIRT AND DEBRIS WITH VEGETATION GROWING ALONG SOUTH CURB, SIMILAR CONDITION AT NORTH CURB

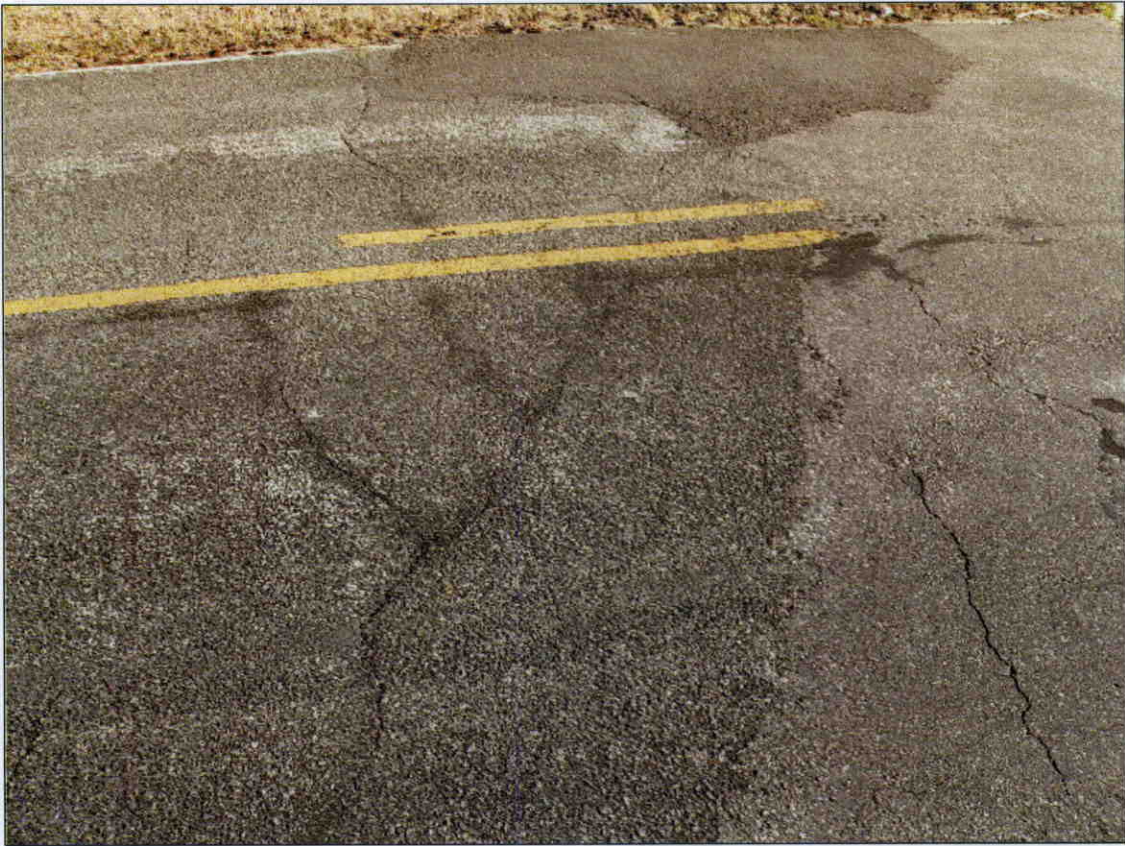
TRANSVERSE CRACKS IN ROUGH AND PATCHED ASPHALT WEARING SURFACE AT WEST APPROACH WITH 1/2 IN OF SETTLEMENT

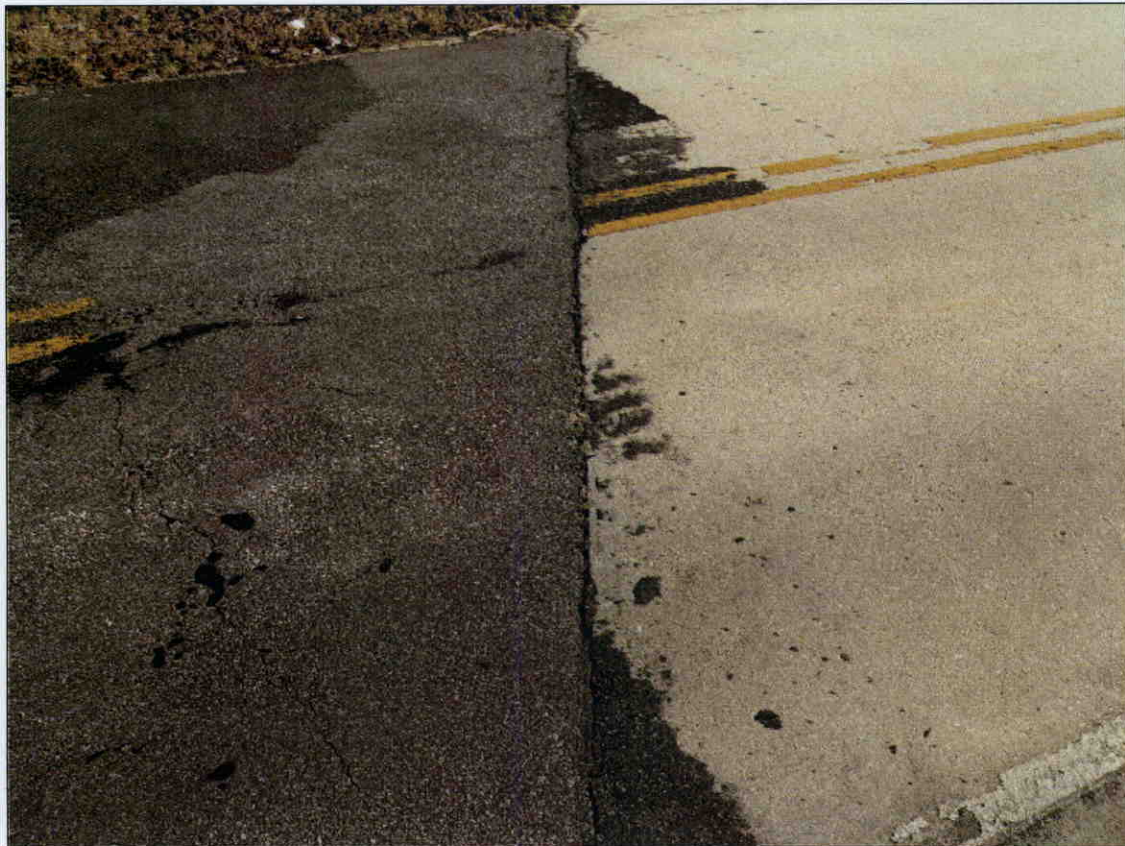
TRANSVERSE CRACK IN ASPHALT WEARING SURFACE ALONG END BENT 1 FILL FACE

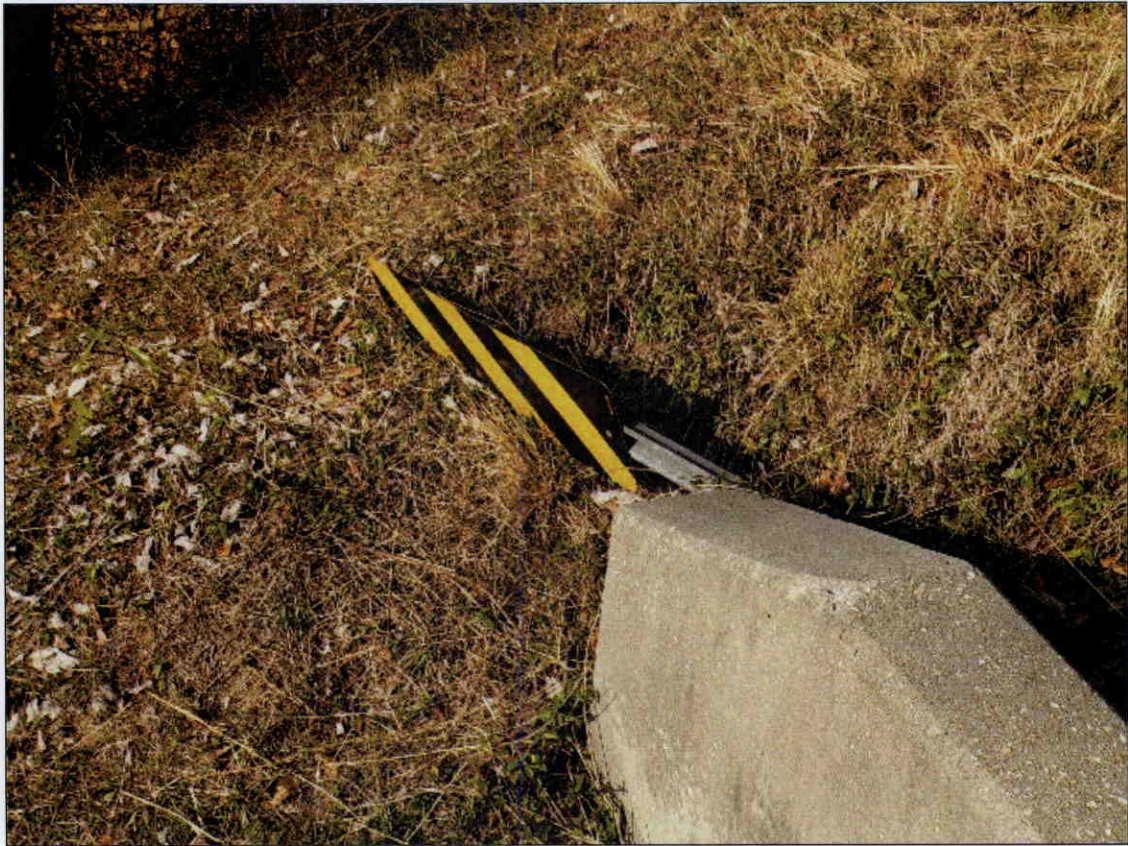
DAMAGED DELINEATOR AT SOUTHWEST CORNER

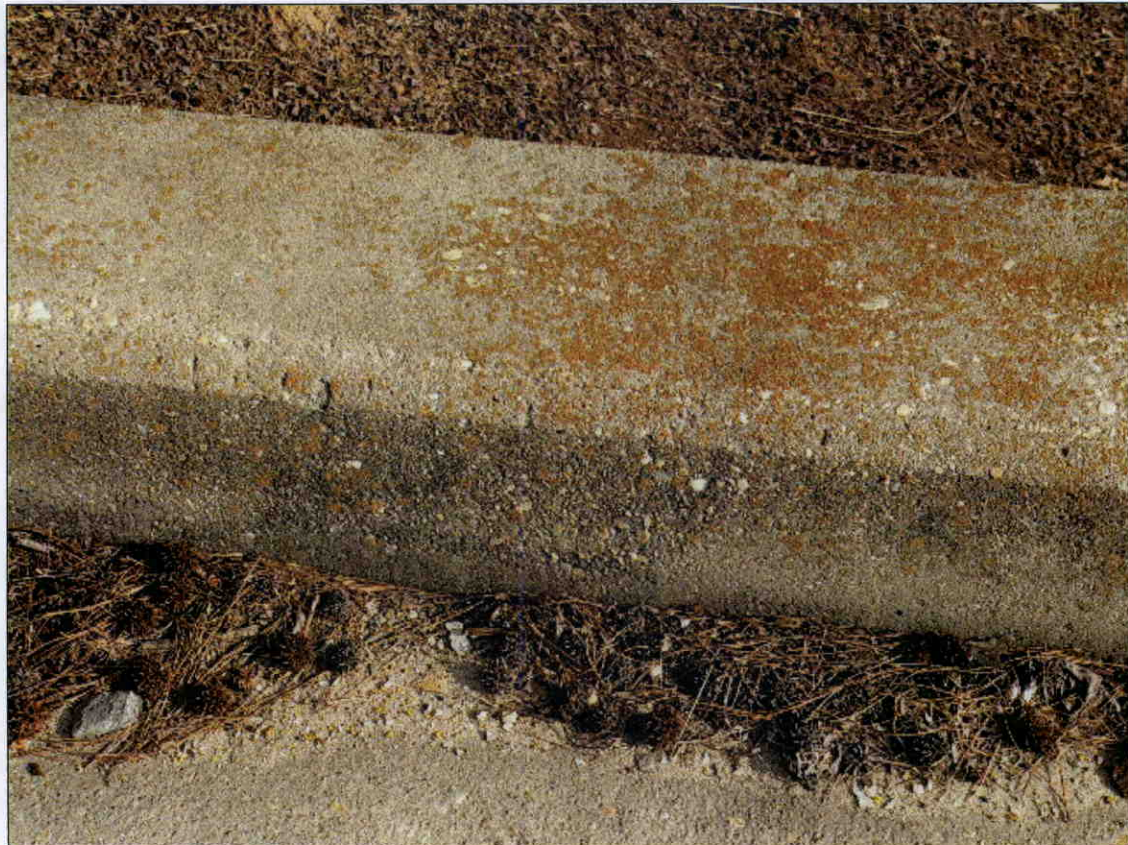
WEATHERING AND SCALING OF CURB WITH EXPOSED AGGREGATE

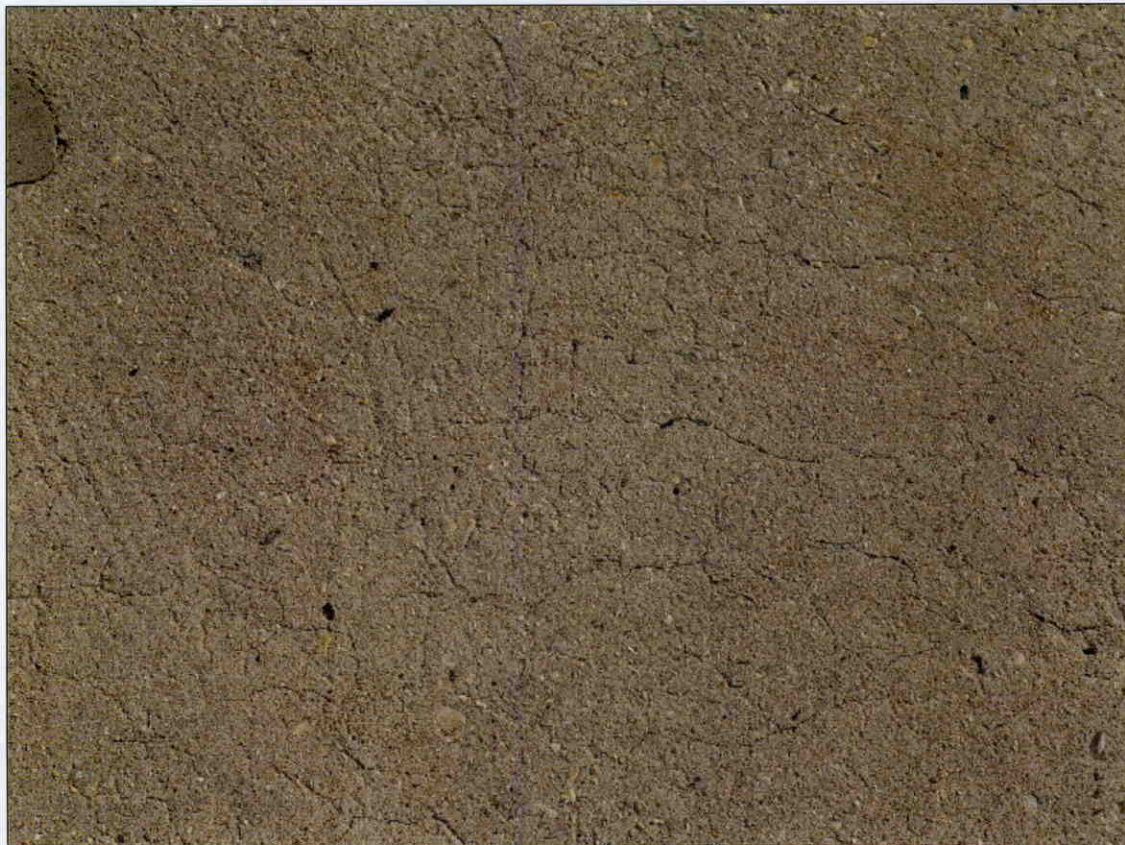
ROUGH AND WORN SURFACE WITH EXPOSED AGGREGATE AND HAIRLINE MAP CRACKING IN TOP OF DECK, SPAN 3 SHOWN, SIMILAR CONDITION THROUGHOUT

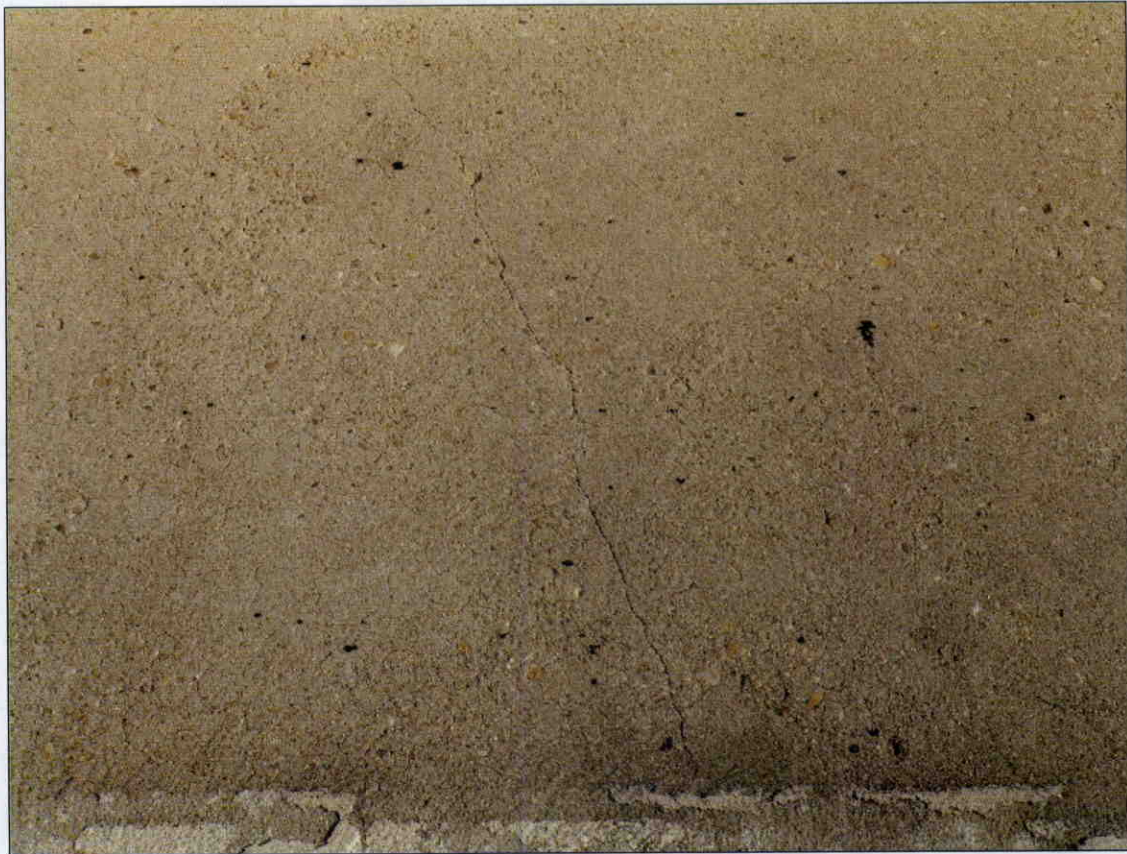
TRANSVERSE HAIRLINE CRACK IN TOP OF DECK AT VARIOUS LOCATIONS THROUGHOUT, SPAN 1 SHOWN

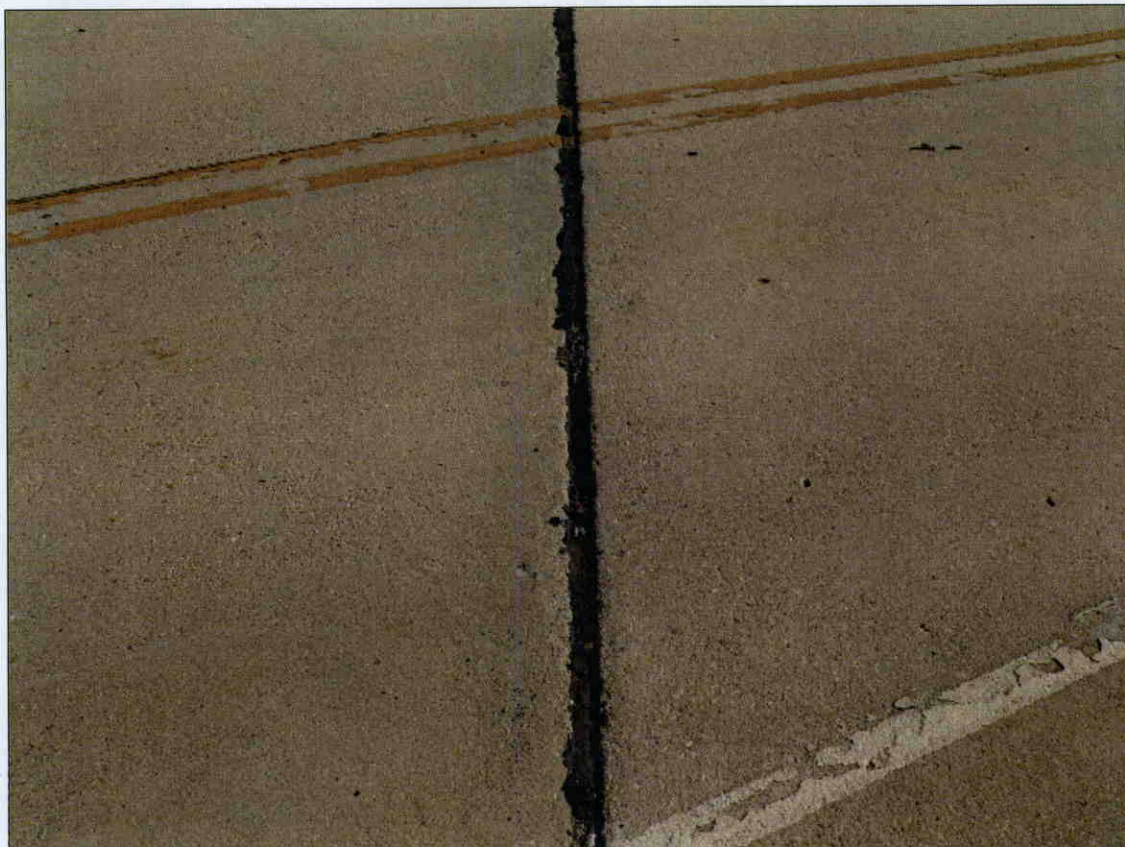
DRIED AND MISSING JOINT MATERIAL AND JOINT SEALER ALONG DECK EXPANSION JOINT AT BENT 1,  
SIMILAR CONDITION AT DECK EXPANSION JOINT AT BENTS 2 AND 3

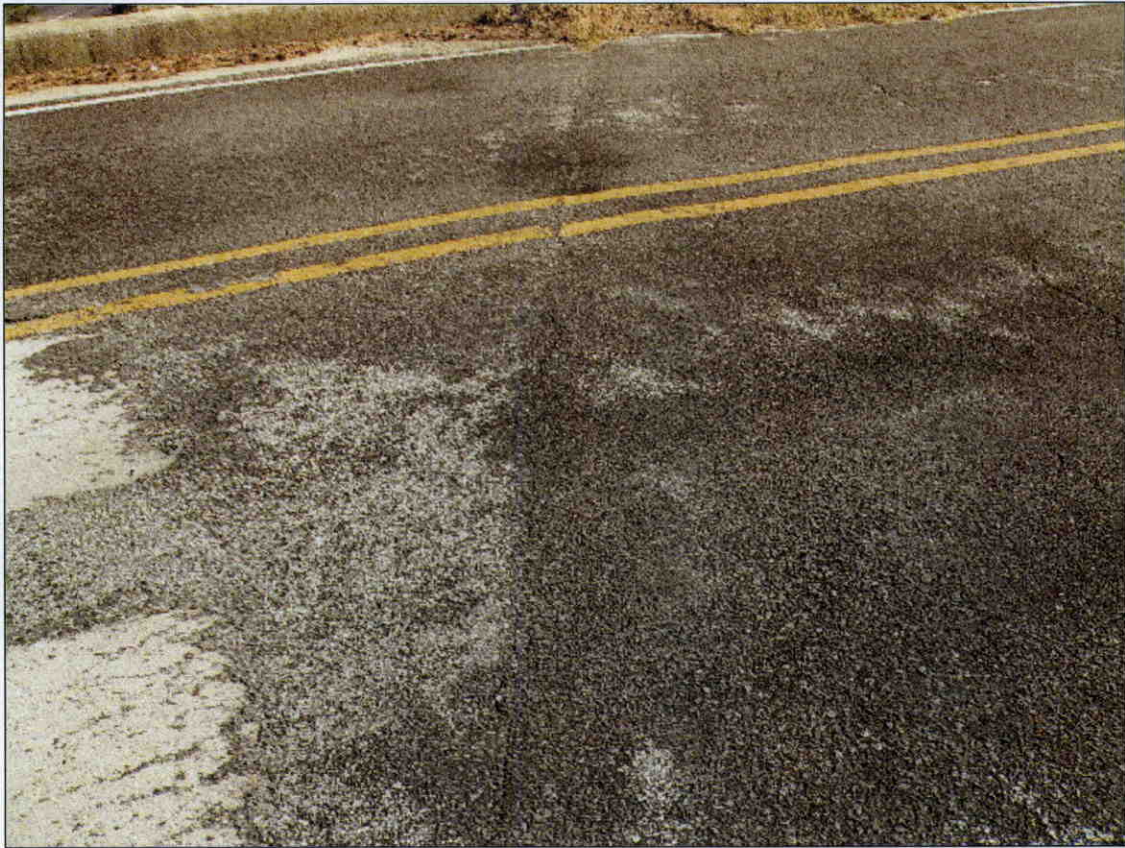
TRANSVERSE CRACK IN ASPHALT WEARING SURFACE ALONG END BENT 2 FILL FACE

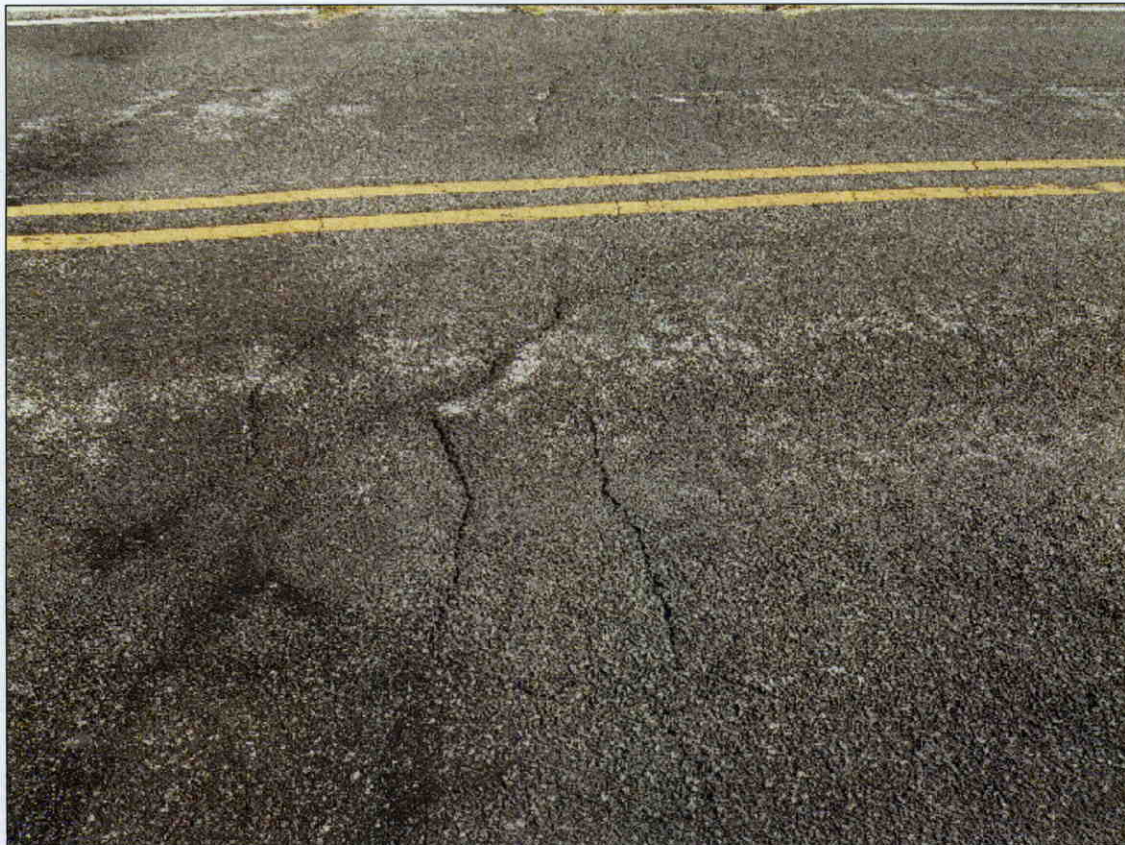
TRANSVERSE CRACKS IN ASPHALT WEARING SURFACE AT EAST APPROACH WITH 1/2 IN OF SETTLEMENT

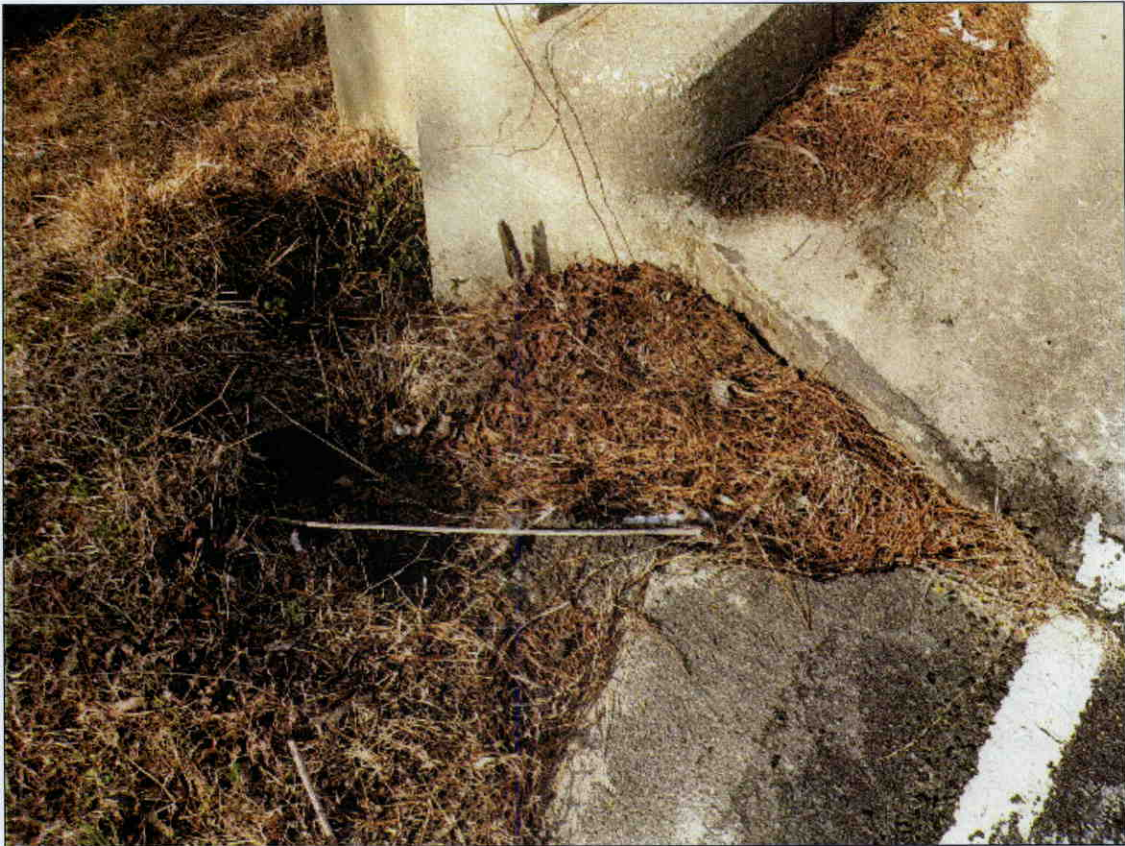
2.5 FT X 10 FT X 2.5 FT DEEP AREA OF SLOPE EROSION AT SOUTHEAST APPROACH

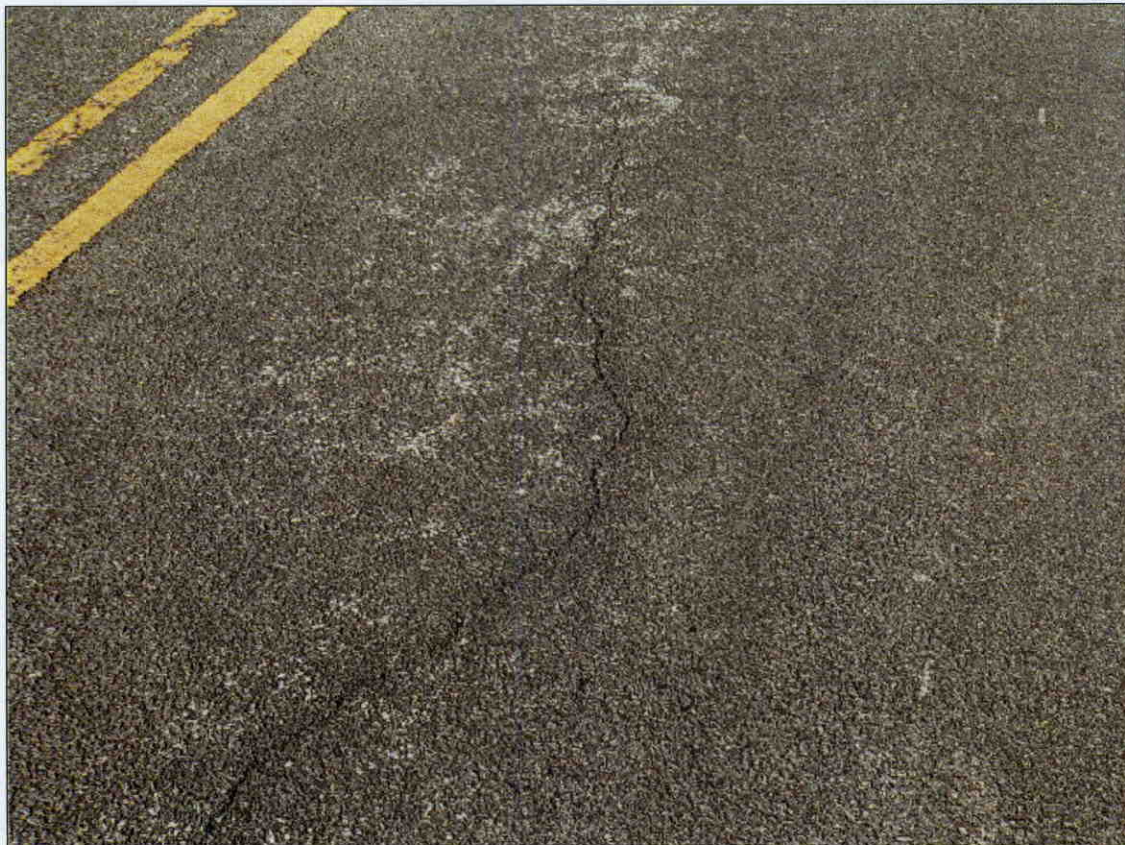
LONGITUDINAL CRACK IN ASPHALT WEARING SURFACE AT EAST APPROACH

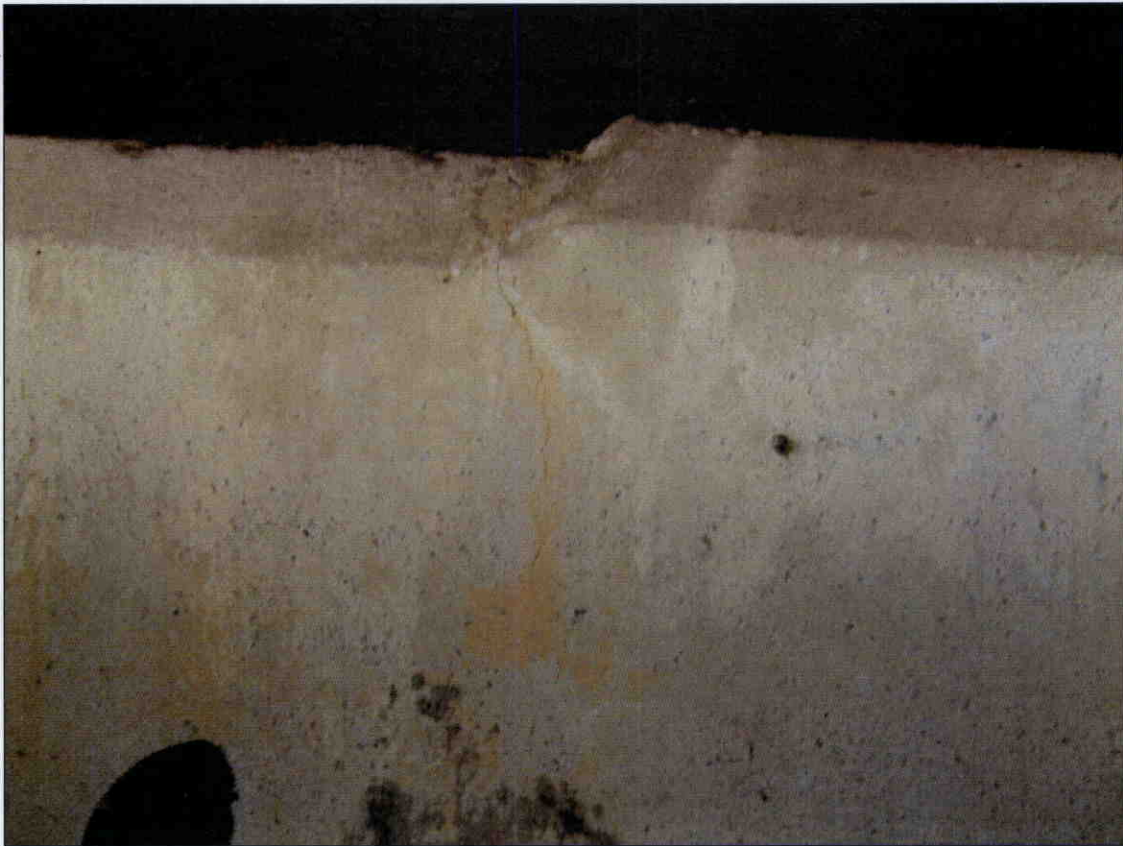
VERTICAL HAIRLINE CRACK IN FACE OF END BENT 1 CAP AT STEP, SIMILAR CRACKS AT END BENT 2

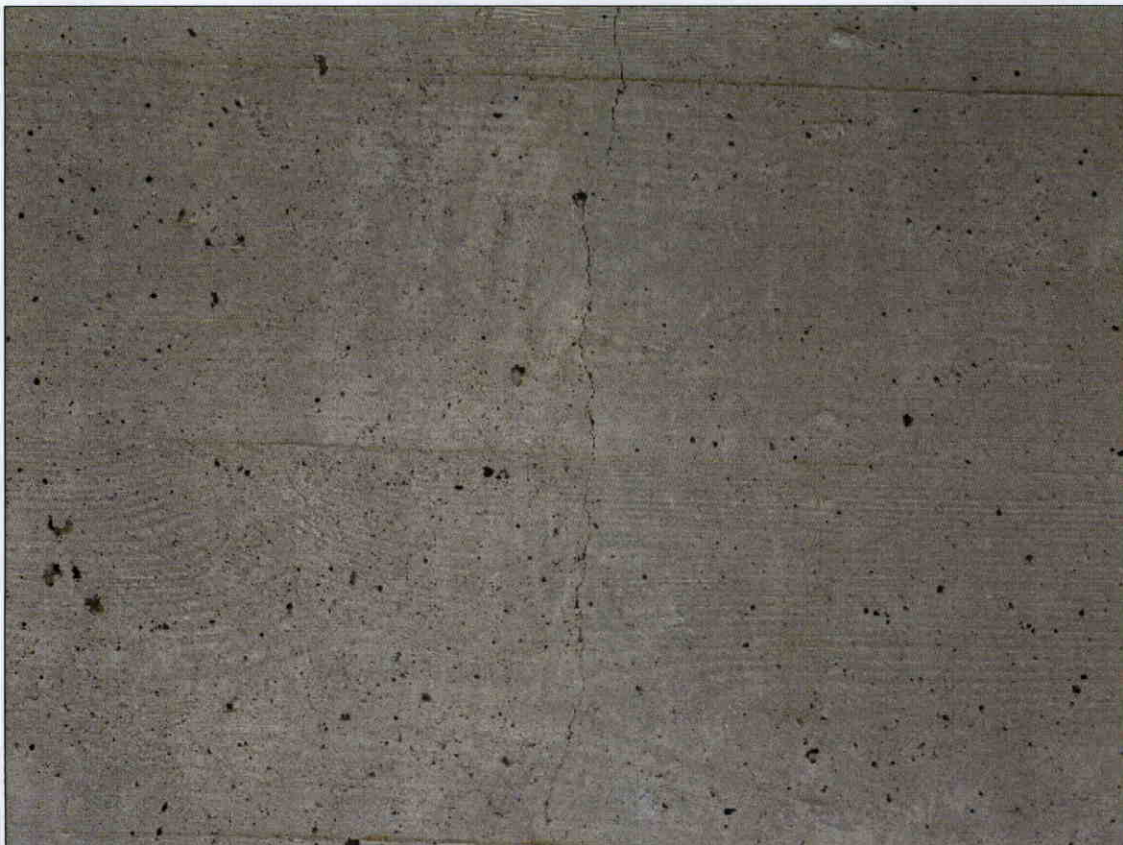
VERTICAL HAIRLINE CRACK IN FACE OF GIRDER 4 IN SPAN 1, SIMILAR CRACKS AT VARIOUS LOCATIONS THROUGHOUT

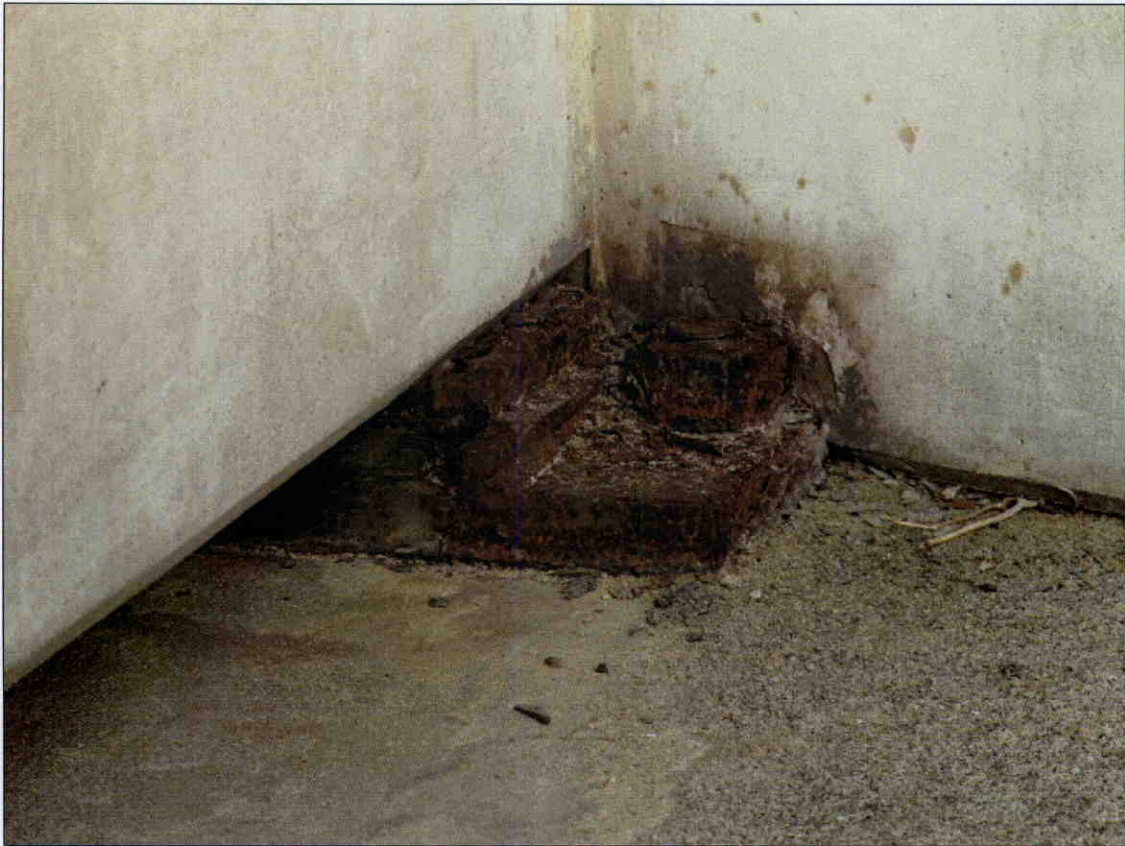
RUST AND DELAMINATION IN BEARING AT GIRDER 1 AT END BENT 1, BEARING AT GIRDER 4 SIMILAR

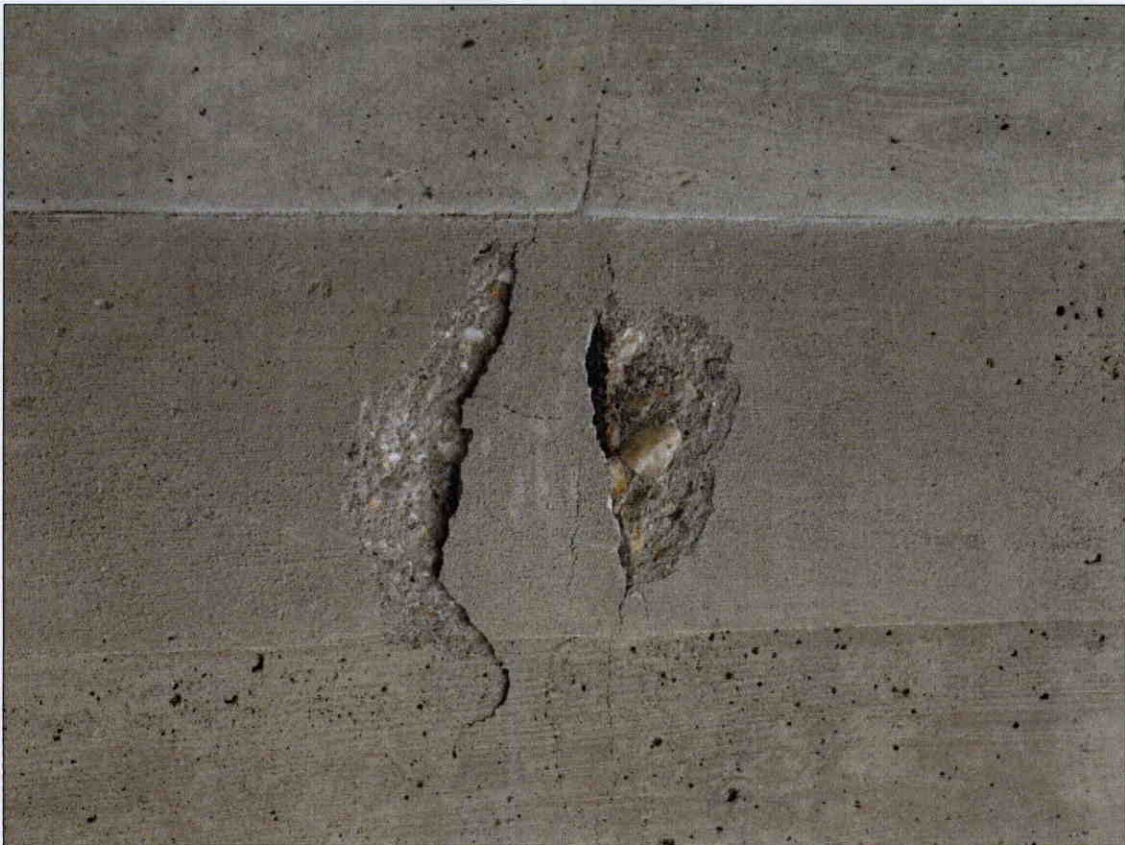
7 IN X 7 IN X 1/2 IN DEEP SPALL WITH EXPOSED REBAR IN FACE OF GIRDER 1 NEAR END BENT 1

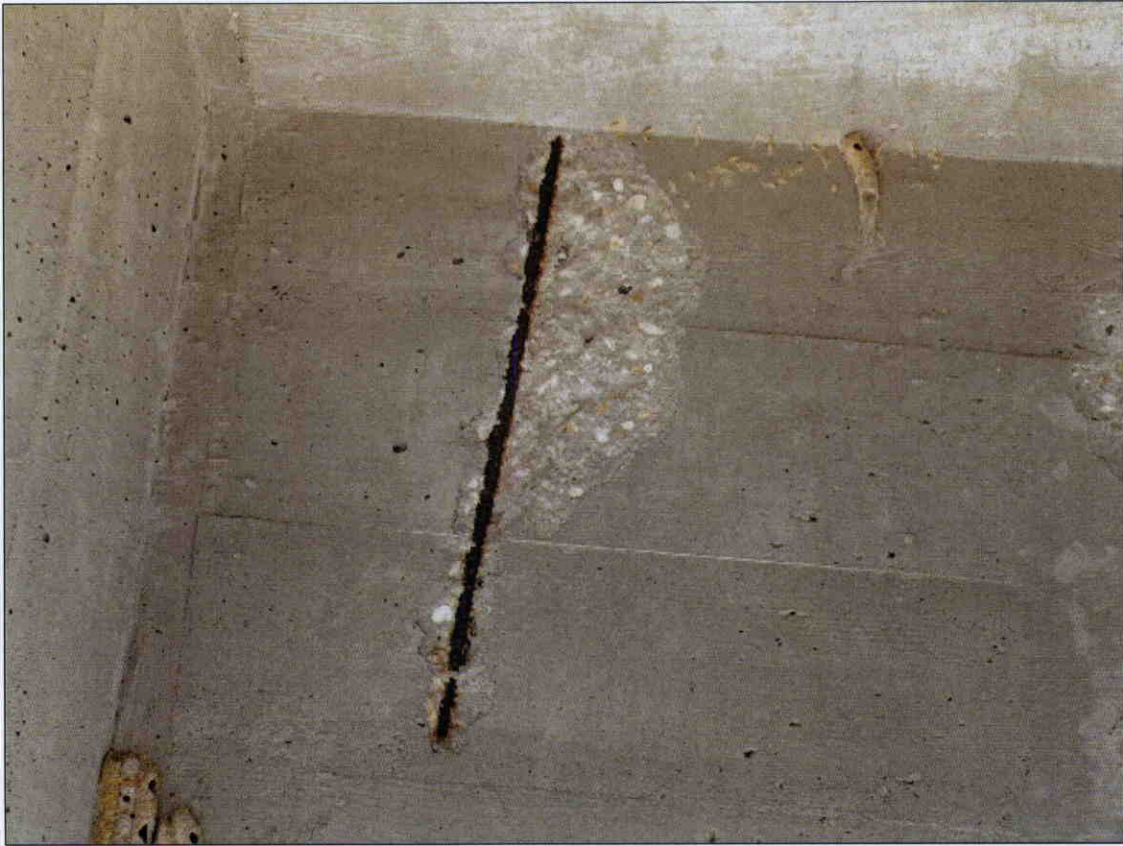
6 IN X 21 IN X 1/2 IN DEEP SPALL WITH EXPOSED REBAR IN FACE OF GIRDER 4 IN SPAN 1, SIMILAR SPALLS IN GIRDERS 1 AND 4 THROUGHOUT SPAN 1

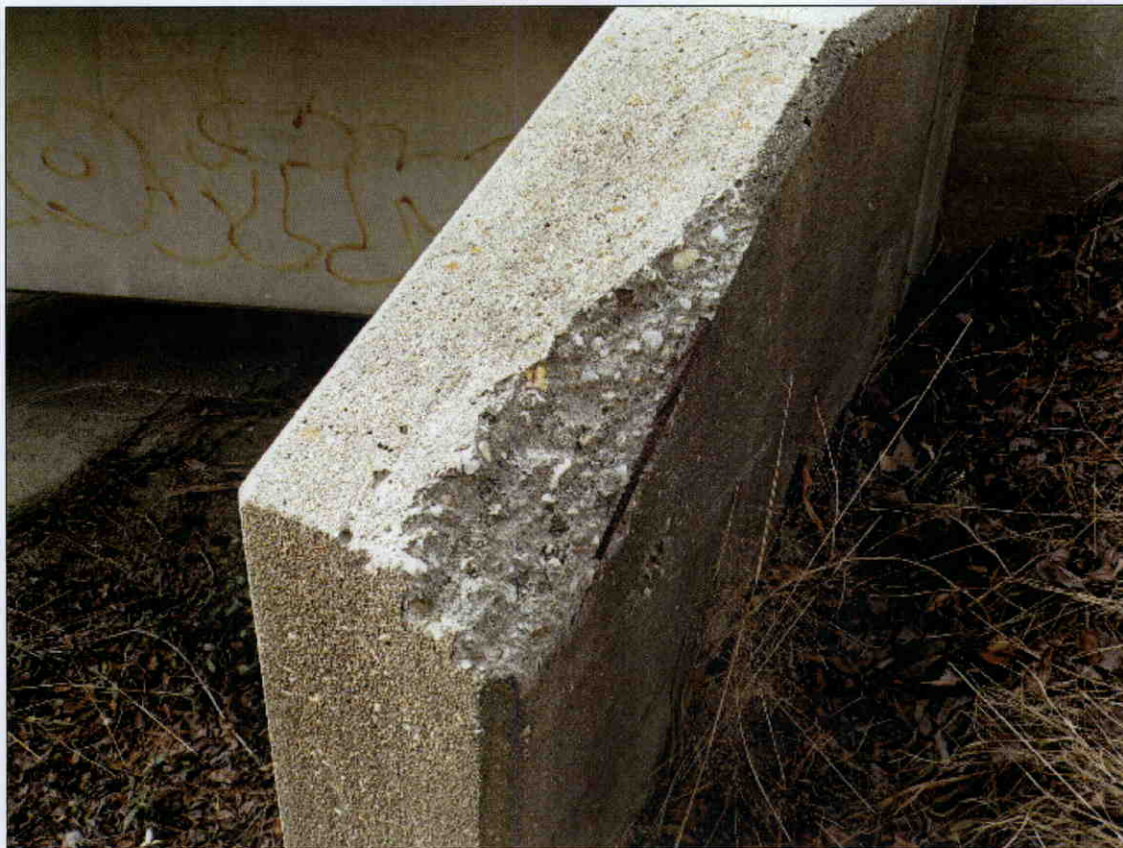
5 IN X 19 IN X 3 IN DEEP SPALL WITH EXPOSED REBAR IN NORTHWEST WINGWALL

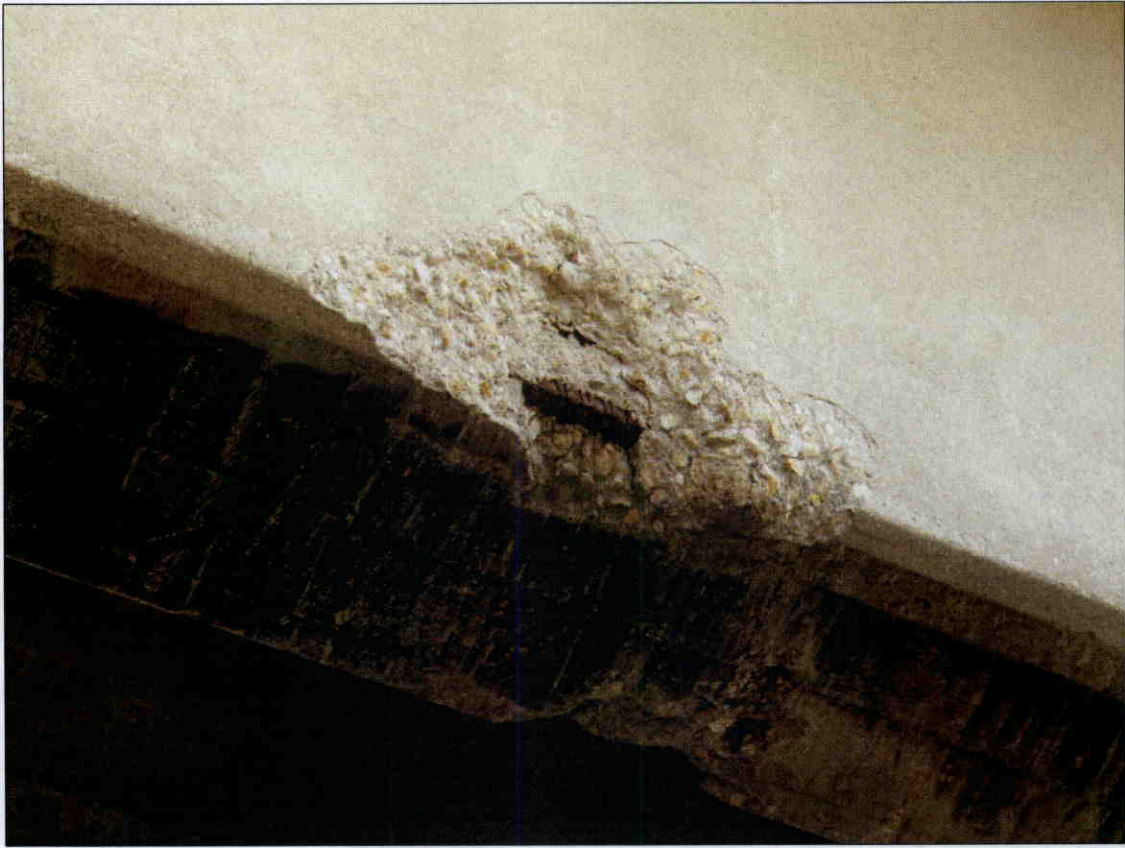
12 IN X 18 IN X 2 IN DEEP SPALL WITH EXPOSED REBAR IN BOTTOM EDGE OF GIRDER 4 IN SPAN 2, PROMPT ACTION

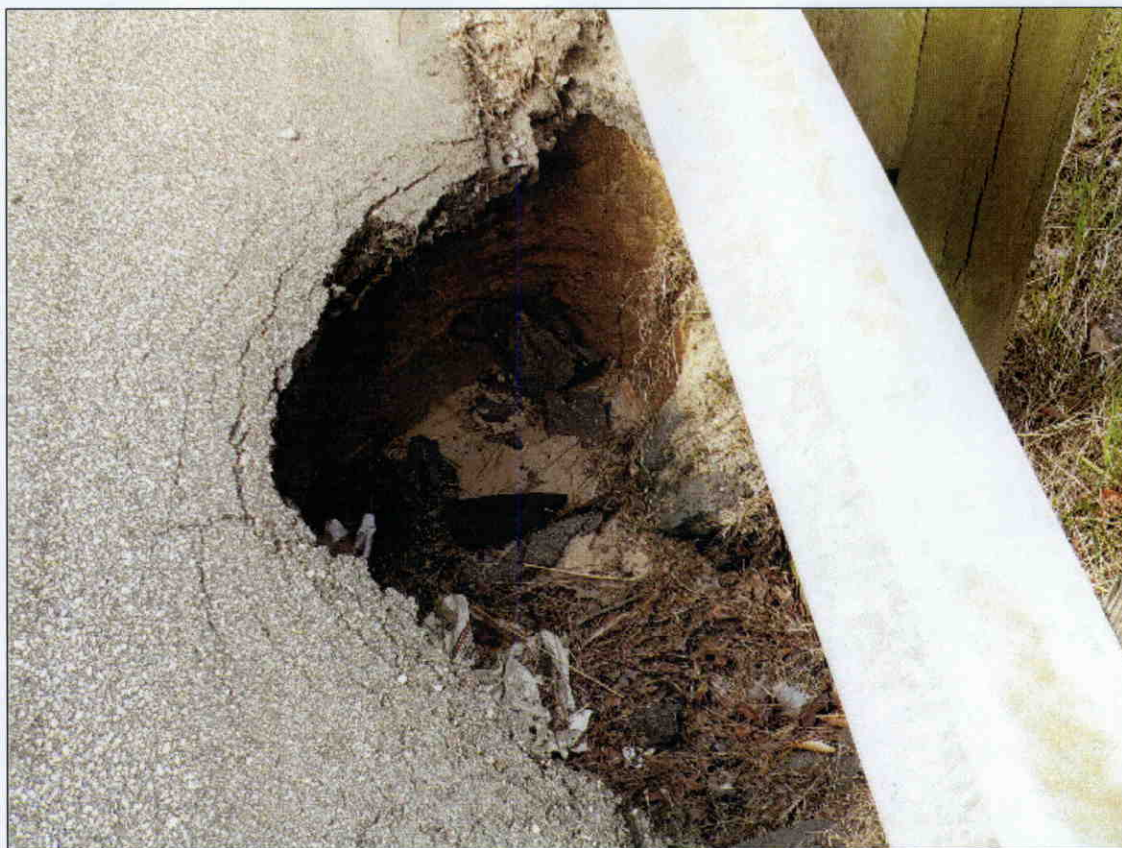
5 FT X 4.5 FT X 2 FT DEEP AREA OF SHOULDER EROSION AT GURDRAIL POST APPROACHING BENT 1 ON  
SBL I 95

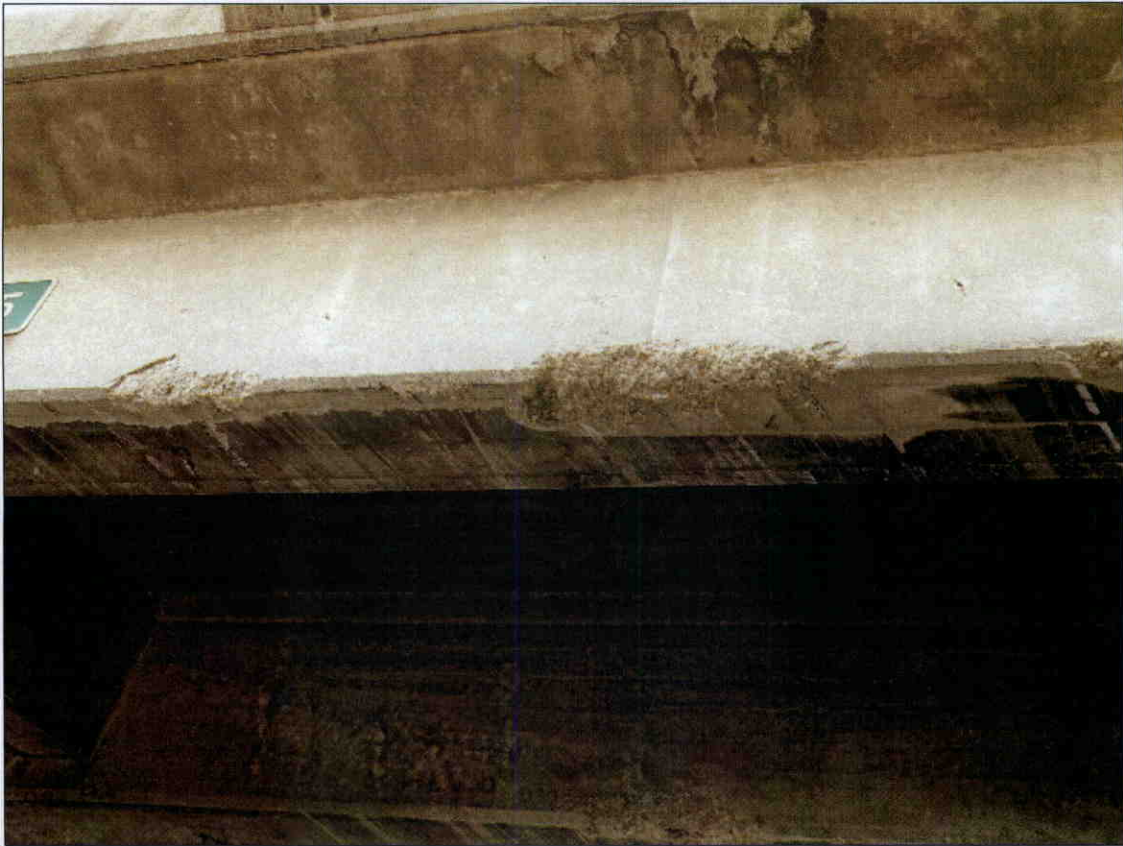
CHIPPING AND SPALLING OF GIRDER 1 DUE TO IMPACT DAMAGE IN SPAN 2, SIMILAR CONDITION IN GIRDERS 2, 3, AND 4

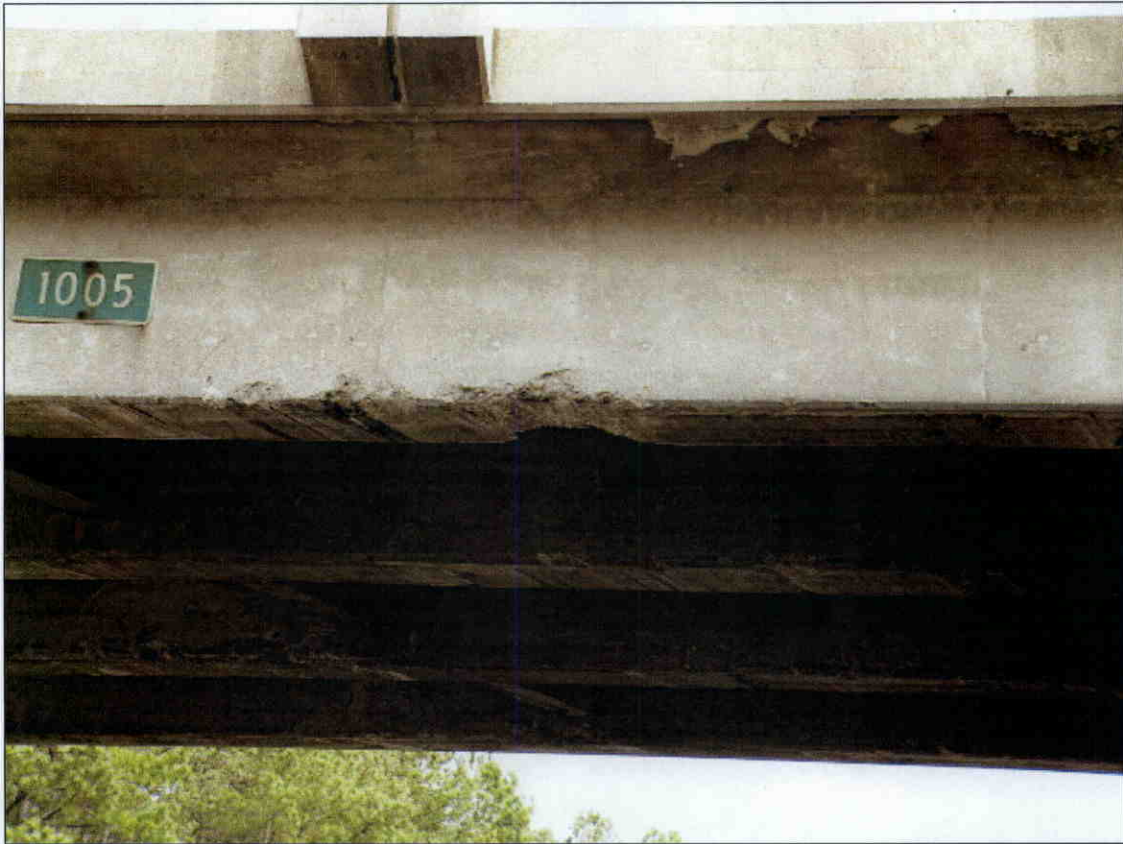
CHIPPING AND SPALLING OF GIRDER 4 DUE TO IMPACT DAMAGE IN SPAN 3, SIMILAR CONDITION AT GIRDERS 2 AND 3

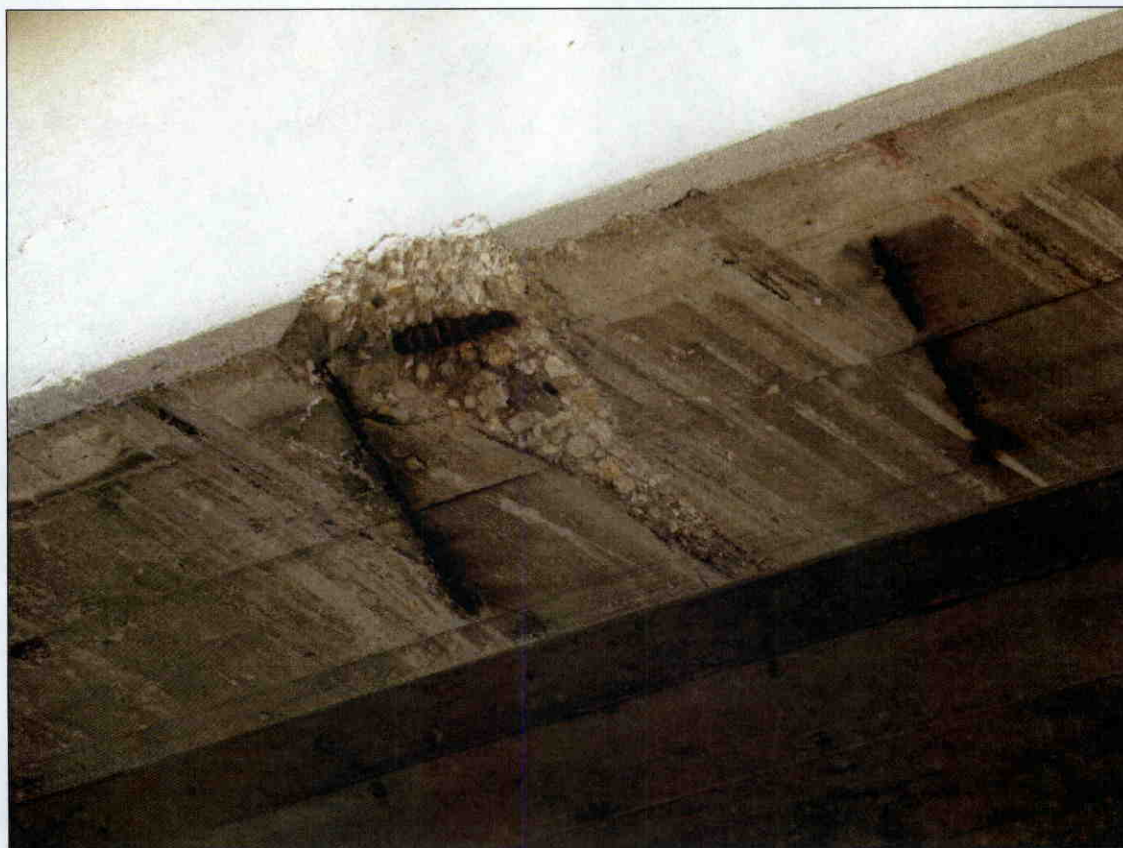
6 IN X 18 IN X 2 IN DEEP SPALL WITH EXPOSED REBAR IN BOTTOM EDGE OF GIRDER 4 IN SPAN 3, PROMPT ACTION
