NC DEPARTMENT OF TRANSPORTATION  
DIVISION OF HIGHWAYS  
BRIDGE MAINTENANCE UNIT

# BRIDGE INSPECTION REPORT

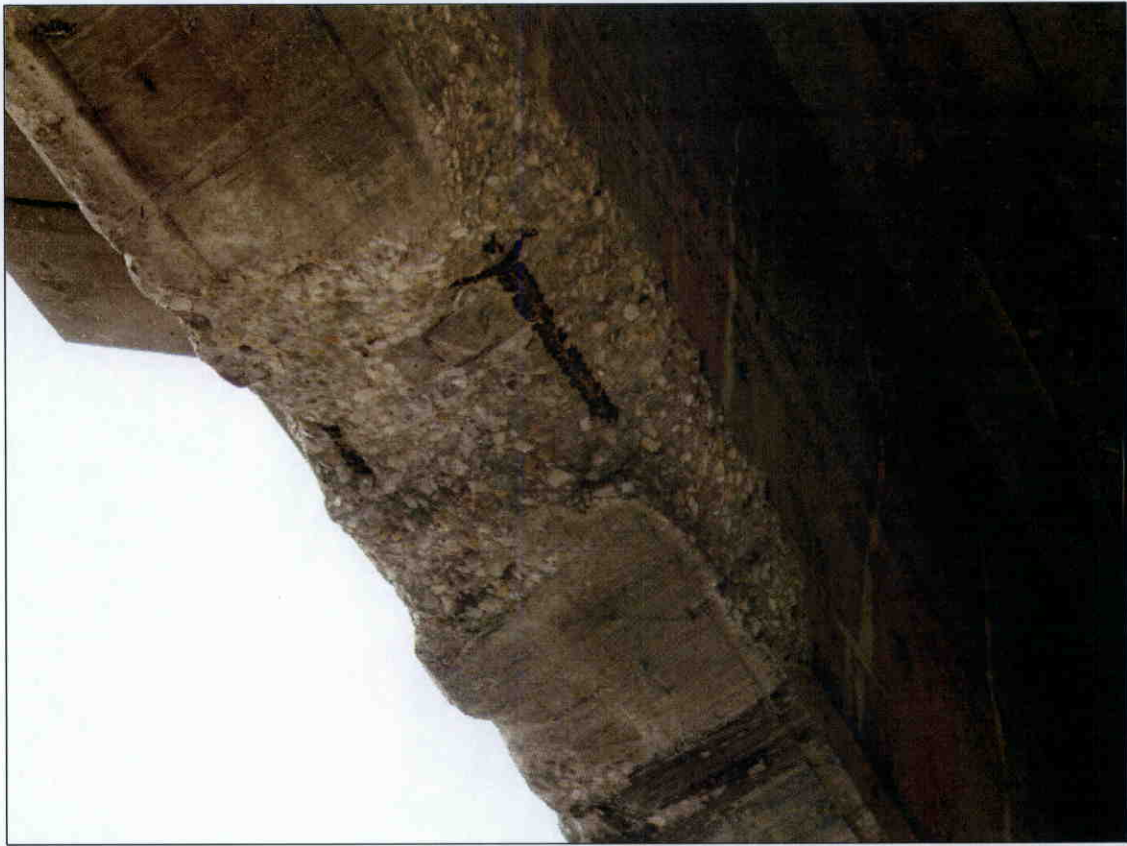
18 IN X 36 IN X 2 IN DEEP SPALL WITH EXPOSED REBAR IN BOTTOM OF GIRDER 4 IN SPAN 3, PROMPT ACTION

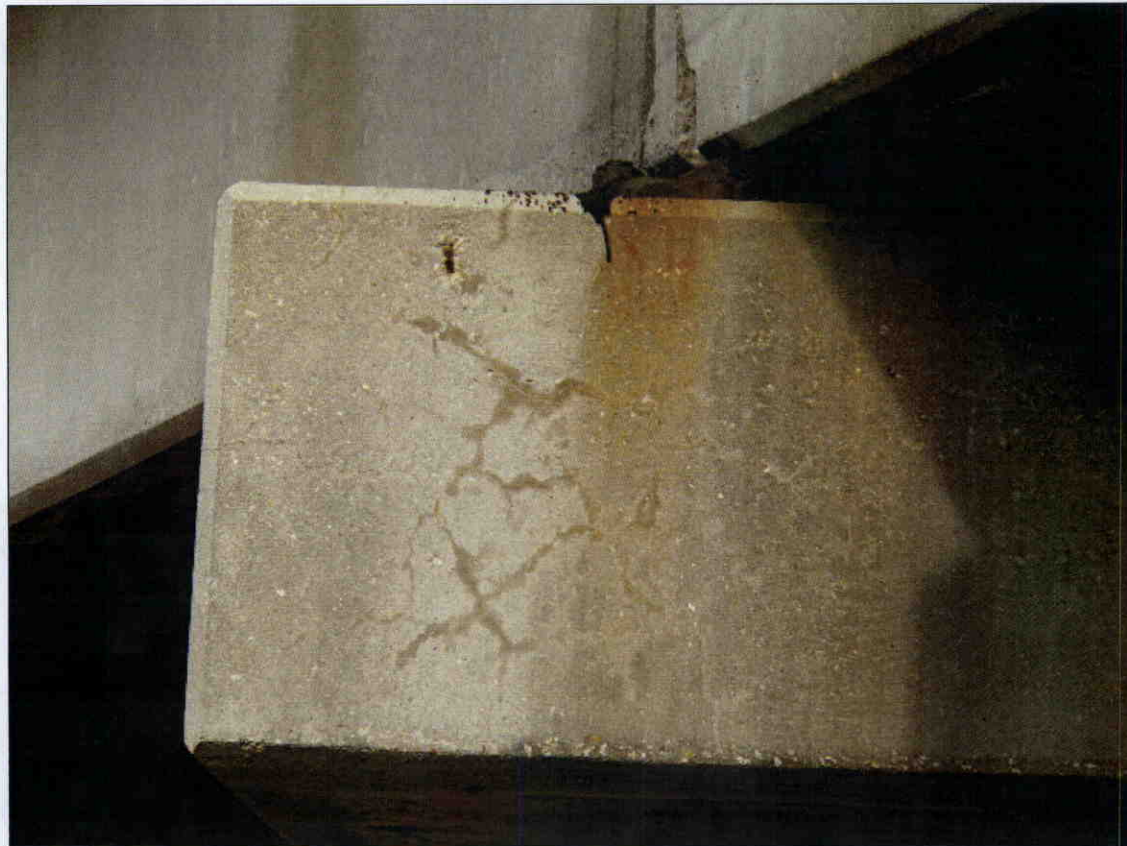
HAIRLINE MAP CRACKING WITH EFFLORESCENCE IN FACE OF BENT 2 CAP, SPAN 3 SIDE UNDER GIRDER 4

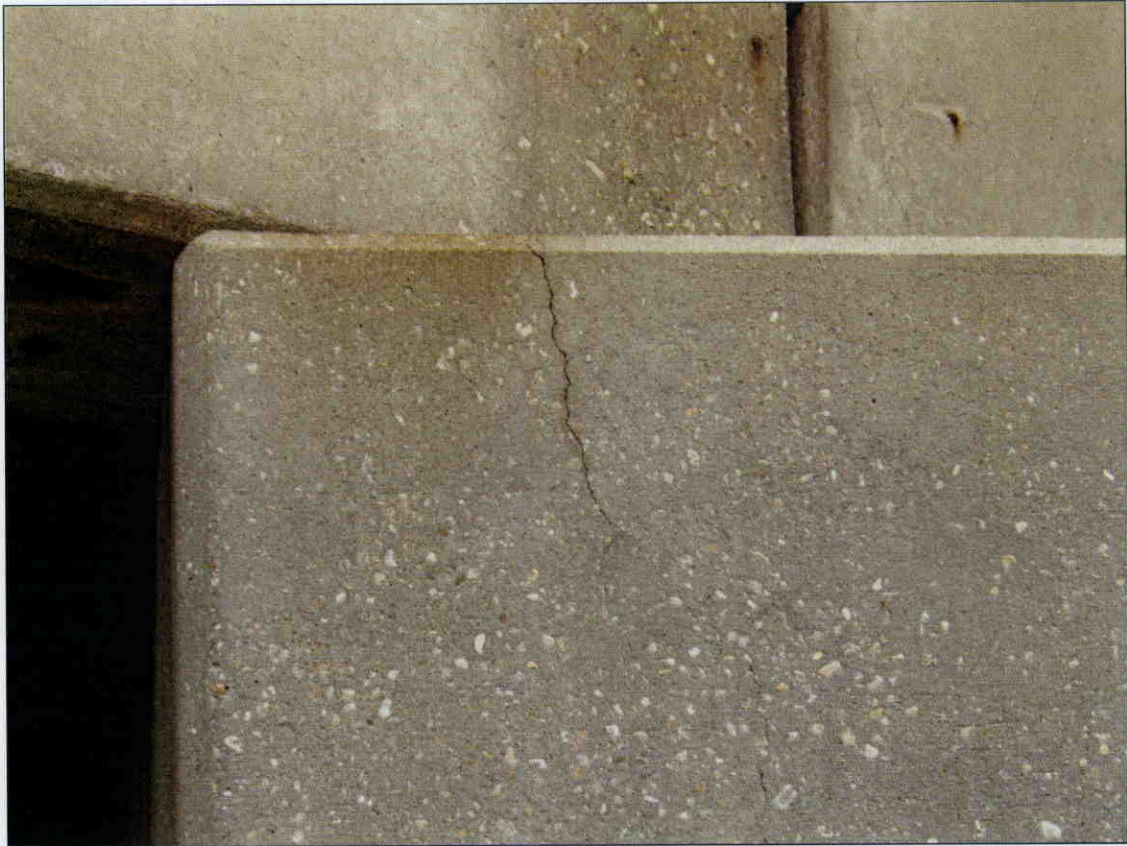
VERTICAL HAIRLINE CRACK IN SOUTH END OF BENT 3 CAP

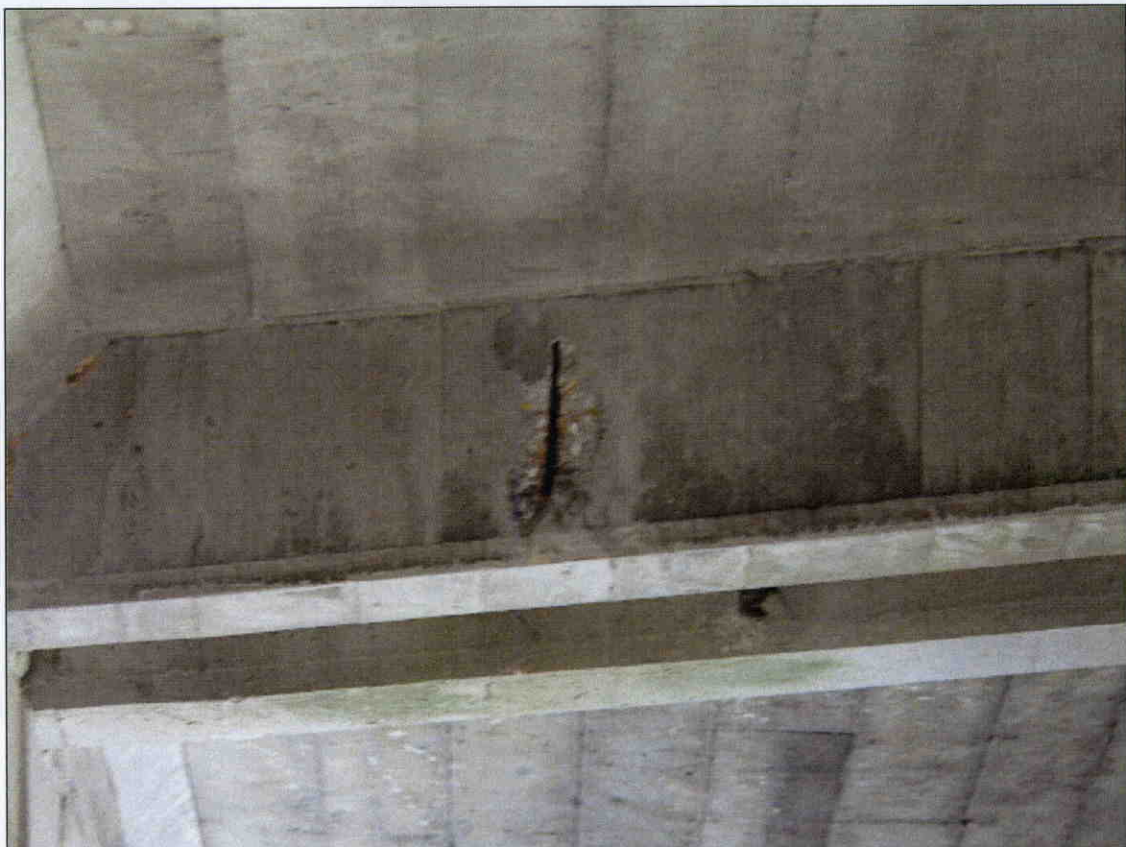
4 IN X 8 IN X 1/2 IN DEEP SPALL WITH EXPOSED REBAR IN END DIAPHRAGM AT BENT 3, BAY 1, SPAN 4 SIDE

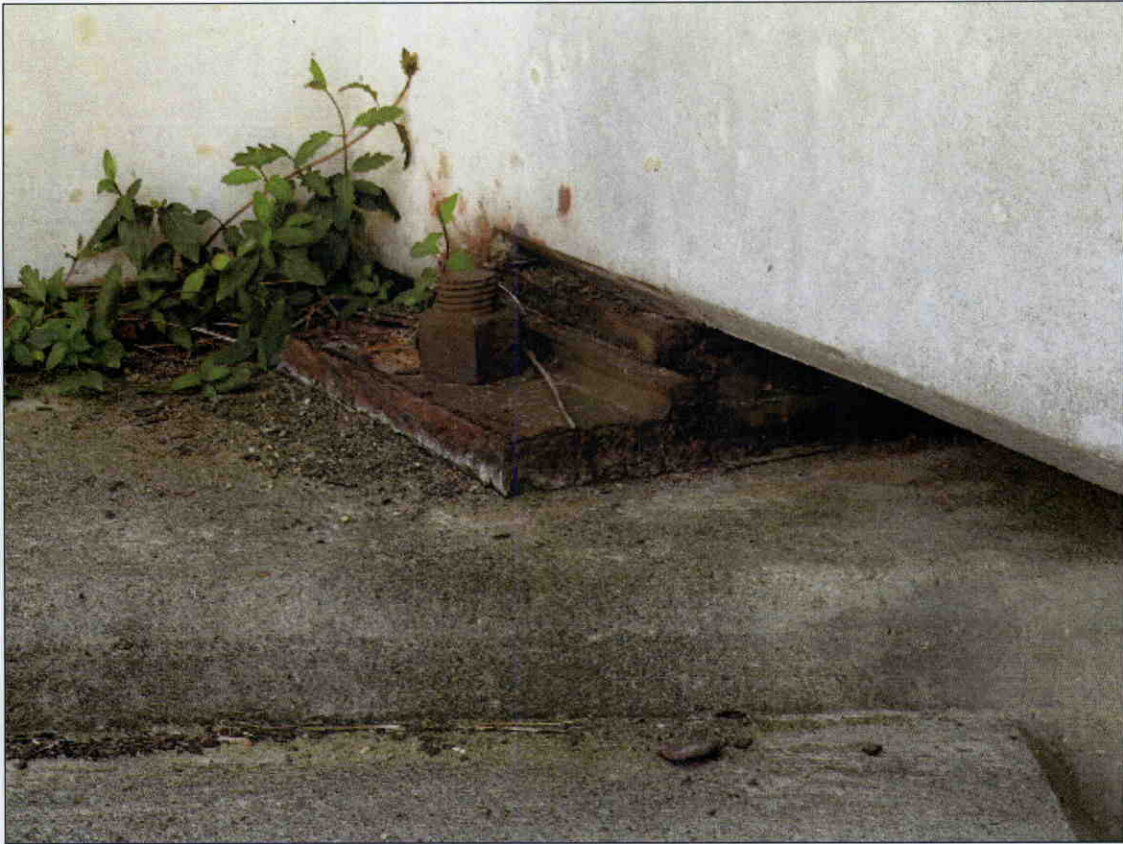
RUST AND DELAMINATION OF BEARING AT GIRDER 1 AT END BENT 2, BEARING AT GIRDER 4 SIMILAR

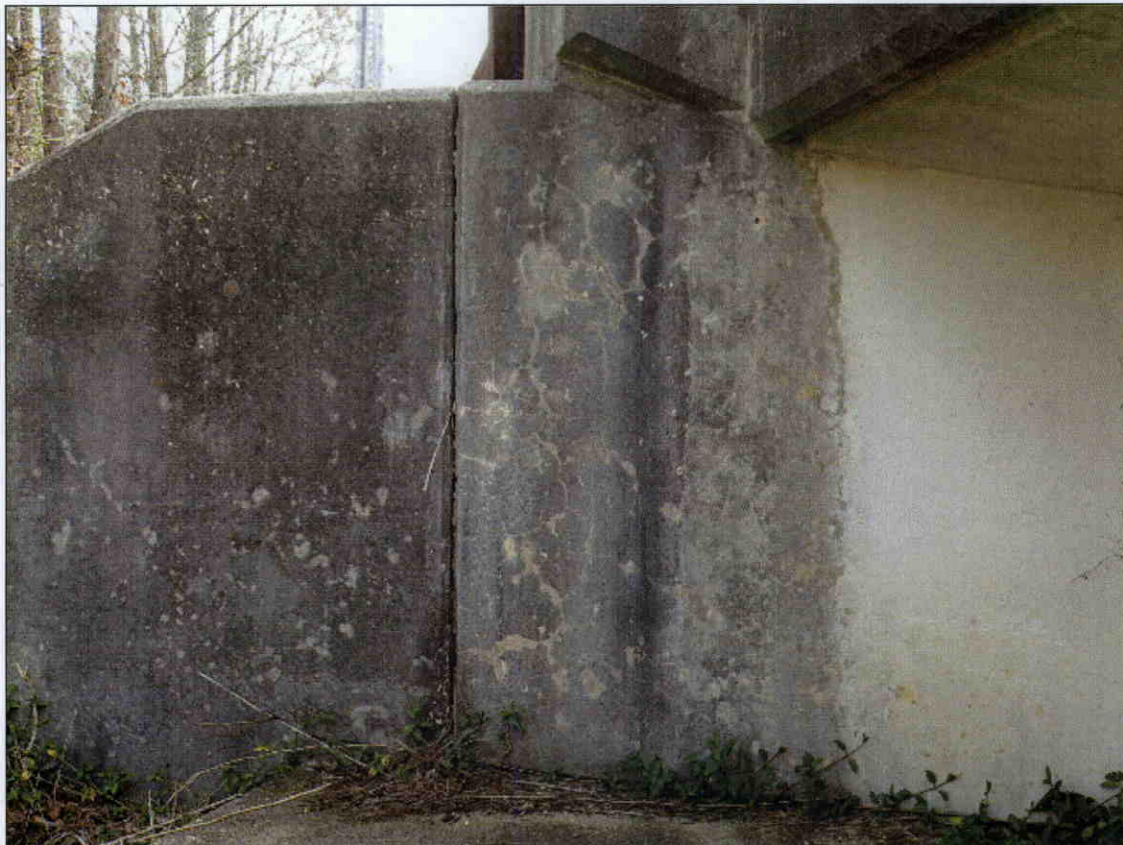
HAIRLINE MAP CRACKING WITH EFFLORESCENCE IN LEFT SIDE OF END BENT 2 CURTAINWALL

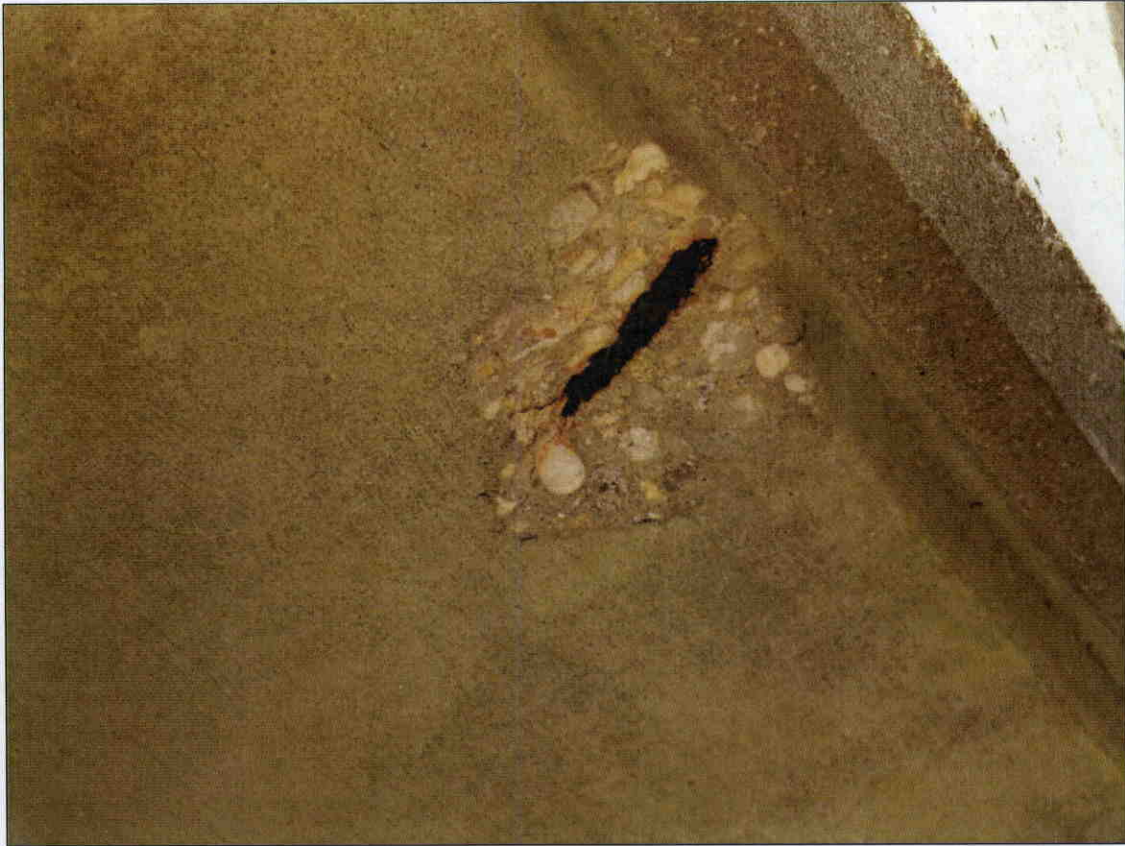
6 IN X 6 IN X 1 IN DEEP SPALL WITH EXPOSED REBAR IN BOTTOM DECK OVERHANG, AT VARIOUS LOCATIONS ALONG SOUTH OVERHANG IN SPAN 4

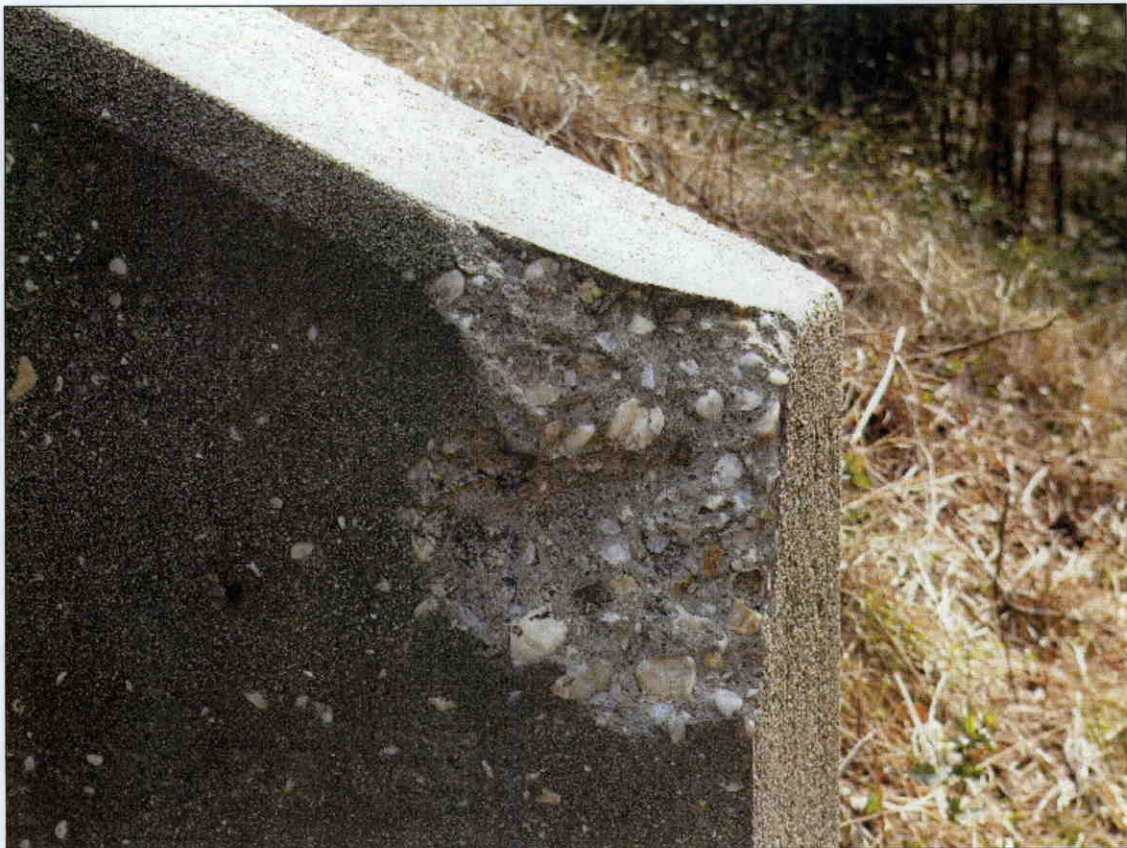
6 IN X 8 IN X 2 1/2 IN DEEP SPALL IN SOUTHEAST WINGWALL

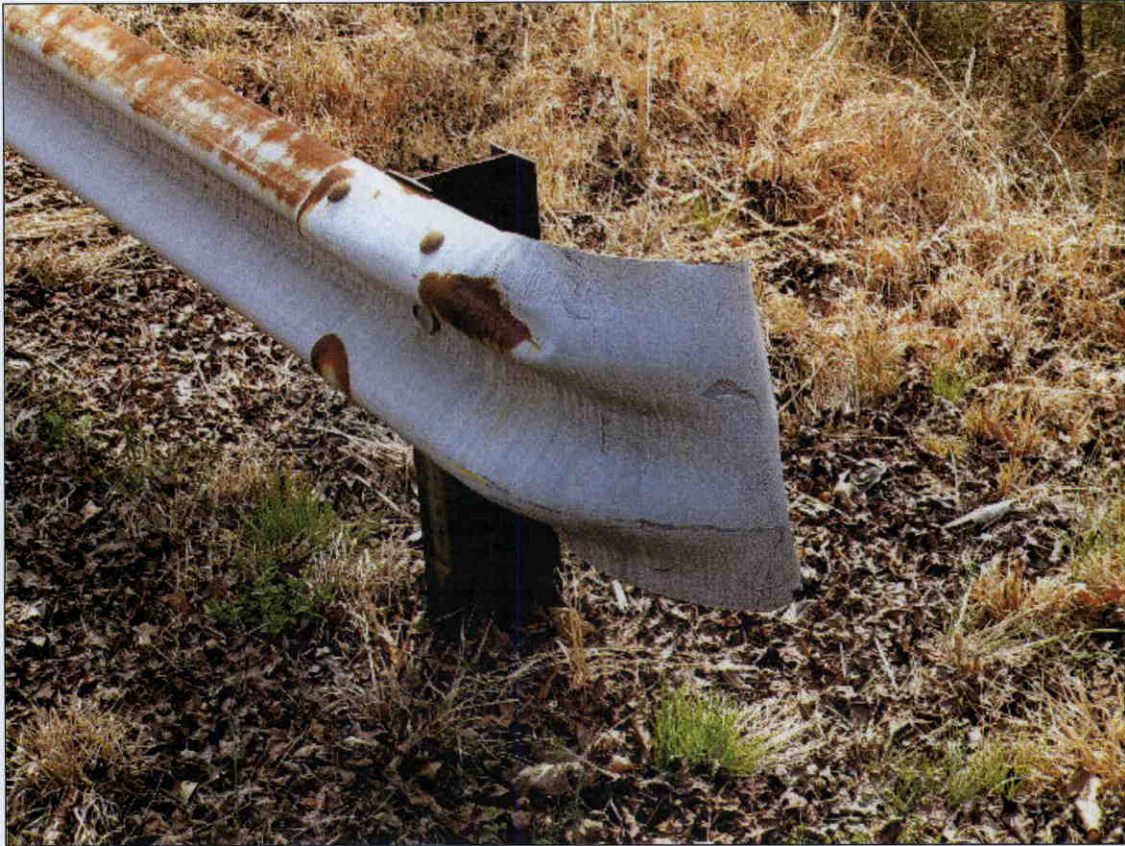
IMPACT DAMAGE TO APPROACH GUARDRAIL END TREATMENT AT SOUTHWEST CORNER

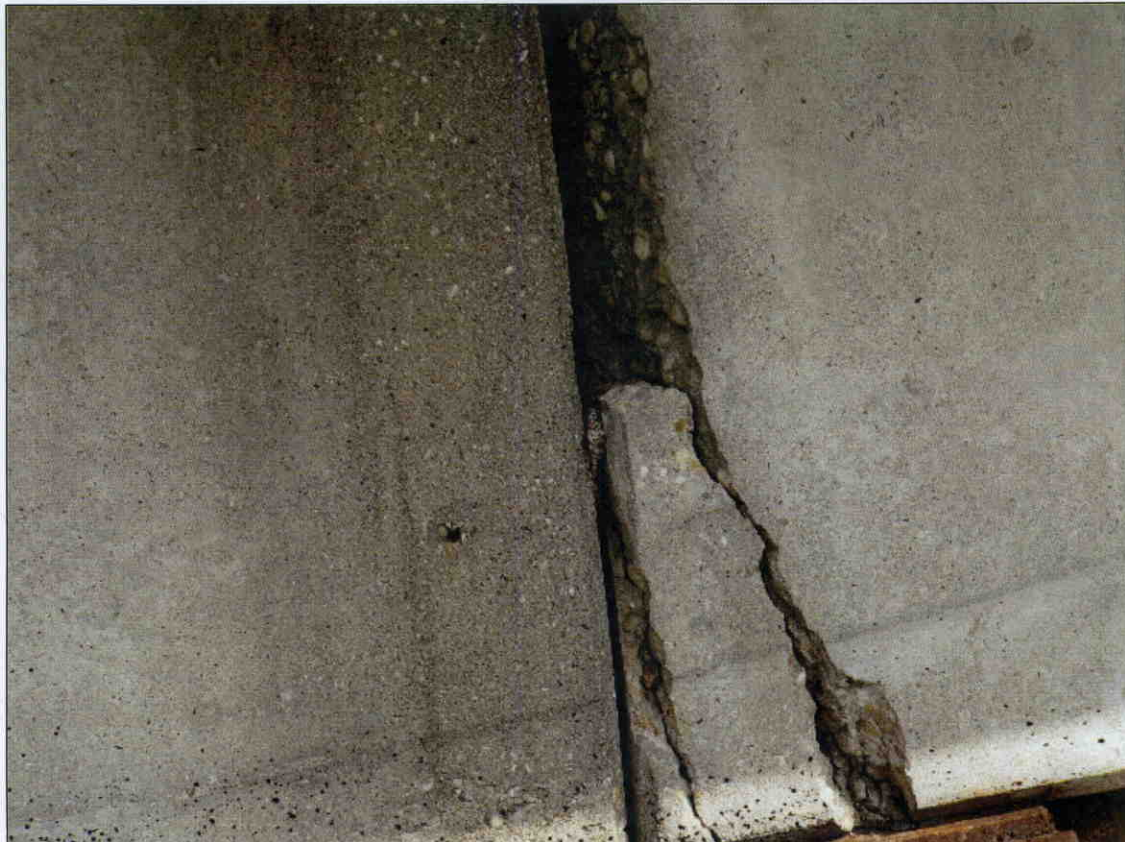
36 IN X 10 IN X 10 IN DEEP SPALL IN END OF GIRDER 4 AT BENT 2 IN SPAN 3

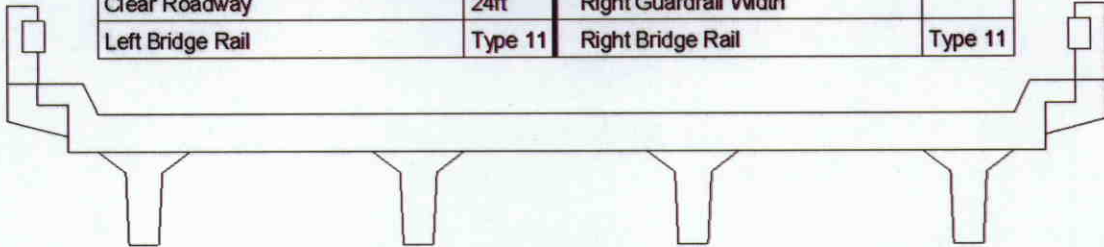
Measurements for Span #	1		
Deck Thickness	0.583	Left Overhang	2.75
Top of Rail to Bottom of Beam	6.583	Right Overhang	2.75
