N.C. DEPARTMENT OF TRANSPORTATION
 DIVISION OF HIGHWAYS
 BRIDGE MAINTENANCE UNIT

Attention:

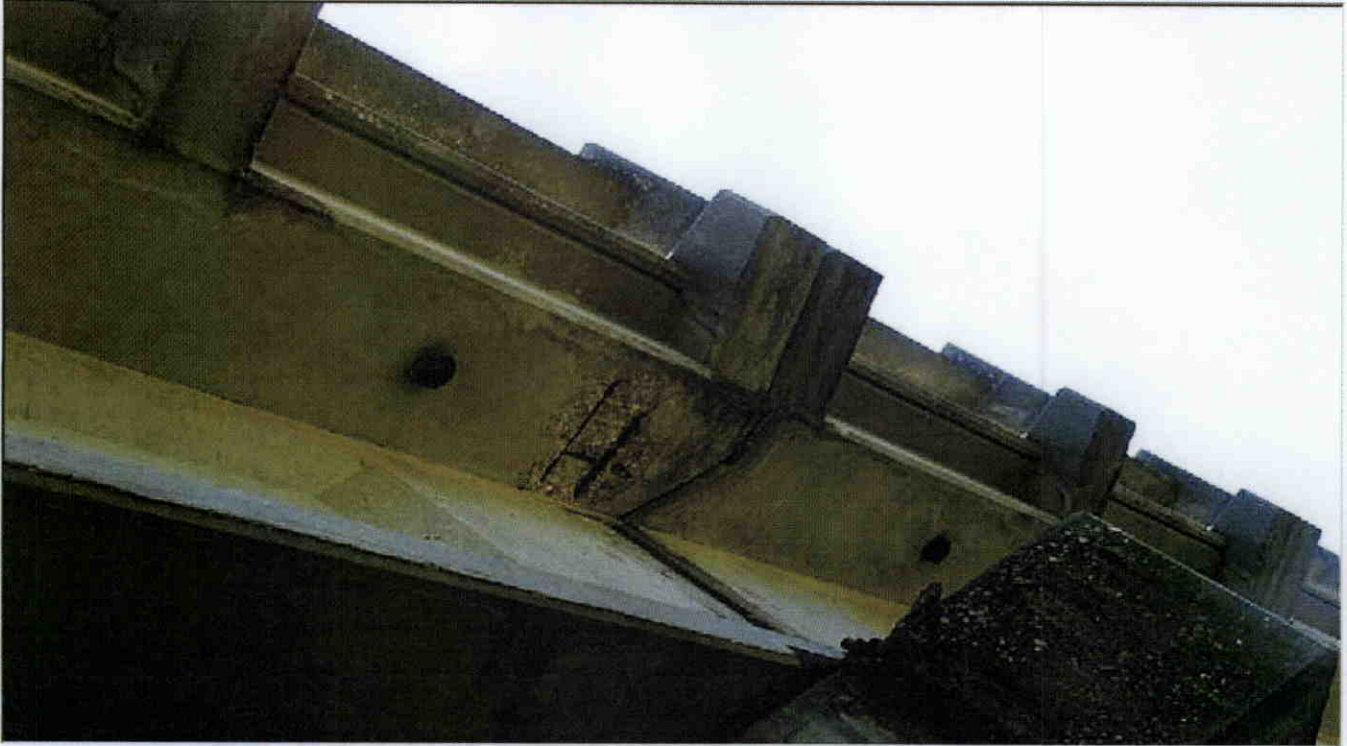
BOTTOM OF DECK SPAN 1, RIGHT OVERHANG SPALLED WITH REBAR EXPOSED, OTHER SPANS SIMILAR

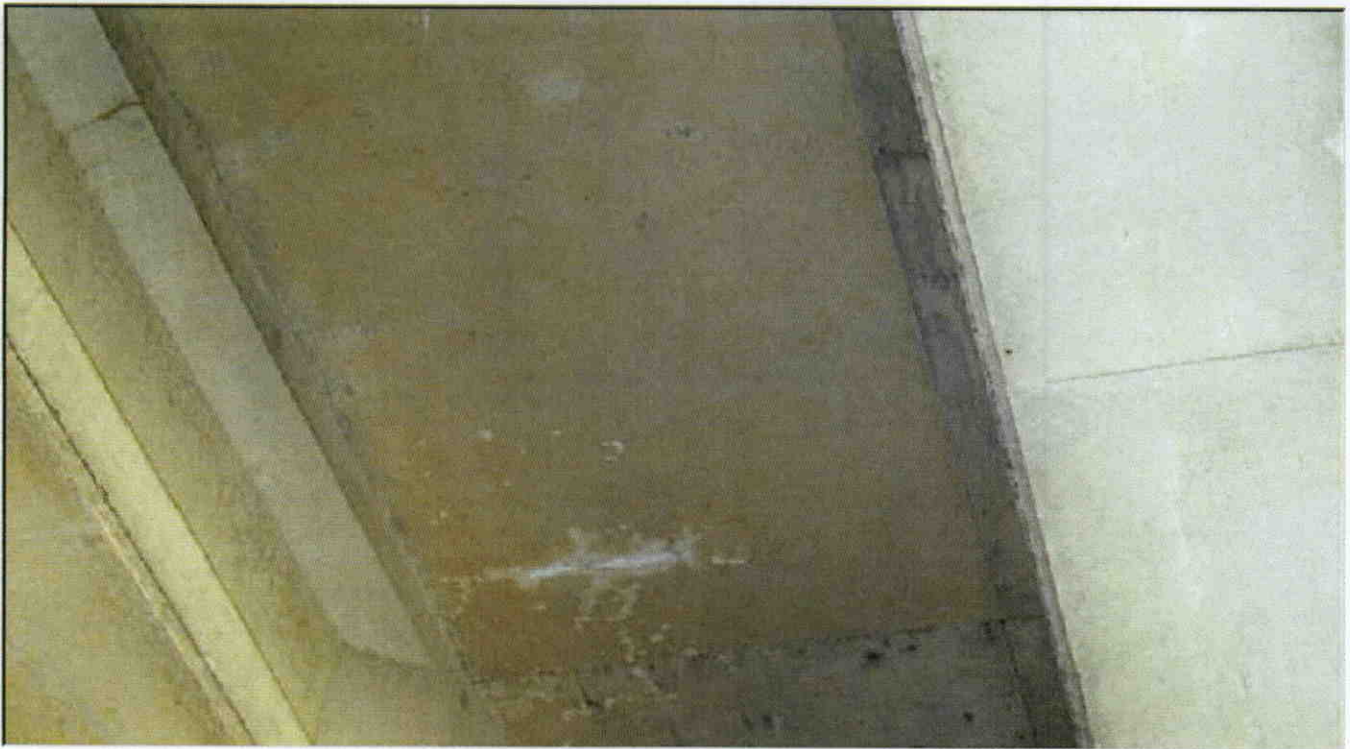
BOD, SPAN 1, BAY 4 TRANS CRACKS WITH EFFLO OTHER BAYS SIMILAR

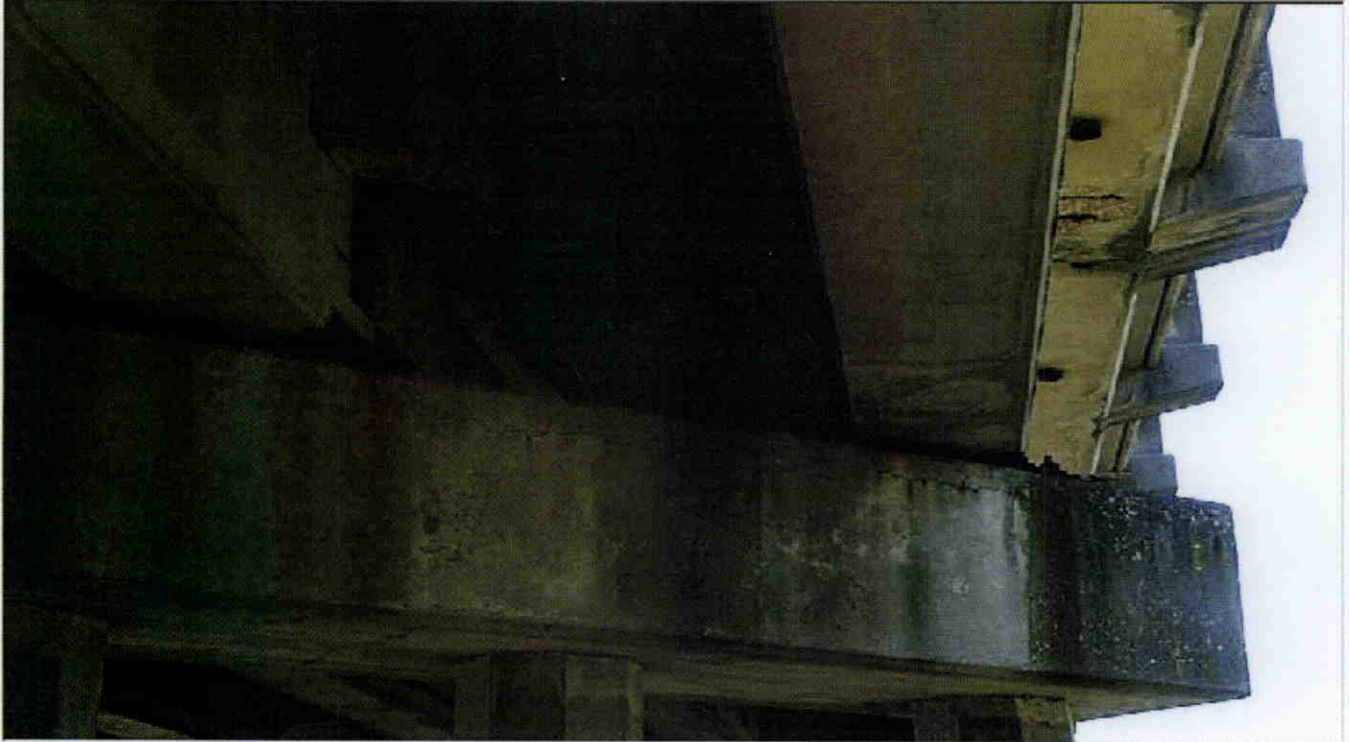
PIER 1 CAP SPAN 1 FACE LONGIT CRACKS, ALL CAPS SIMILAR

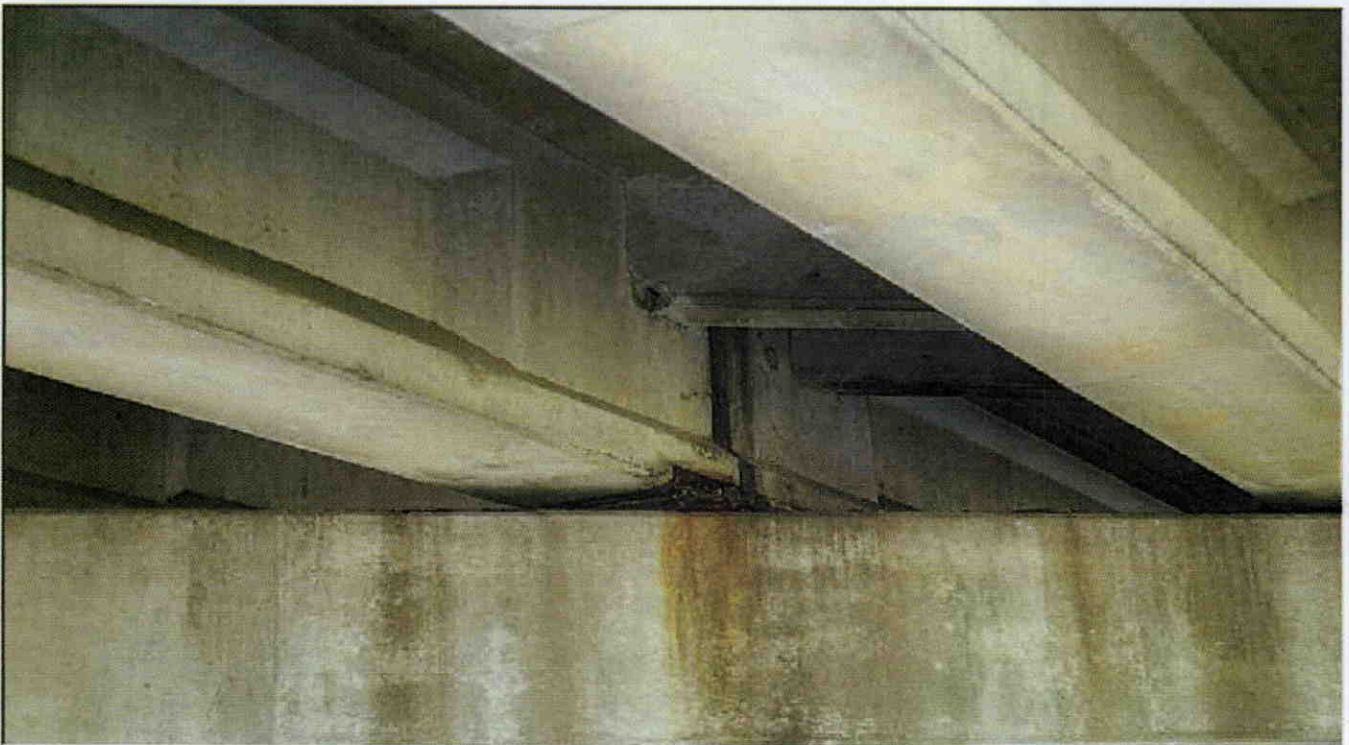
BEARING 3 AT PIER 1, HEAVY RUSTING AND FLAKING, ALL SIMILAR

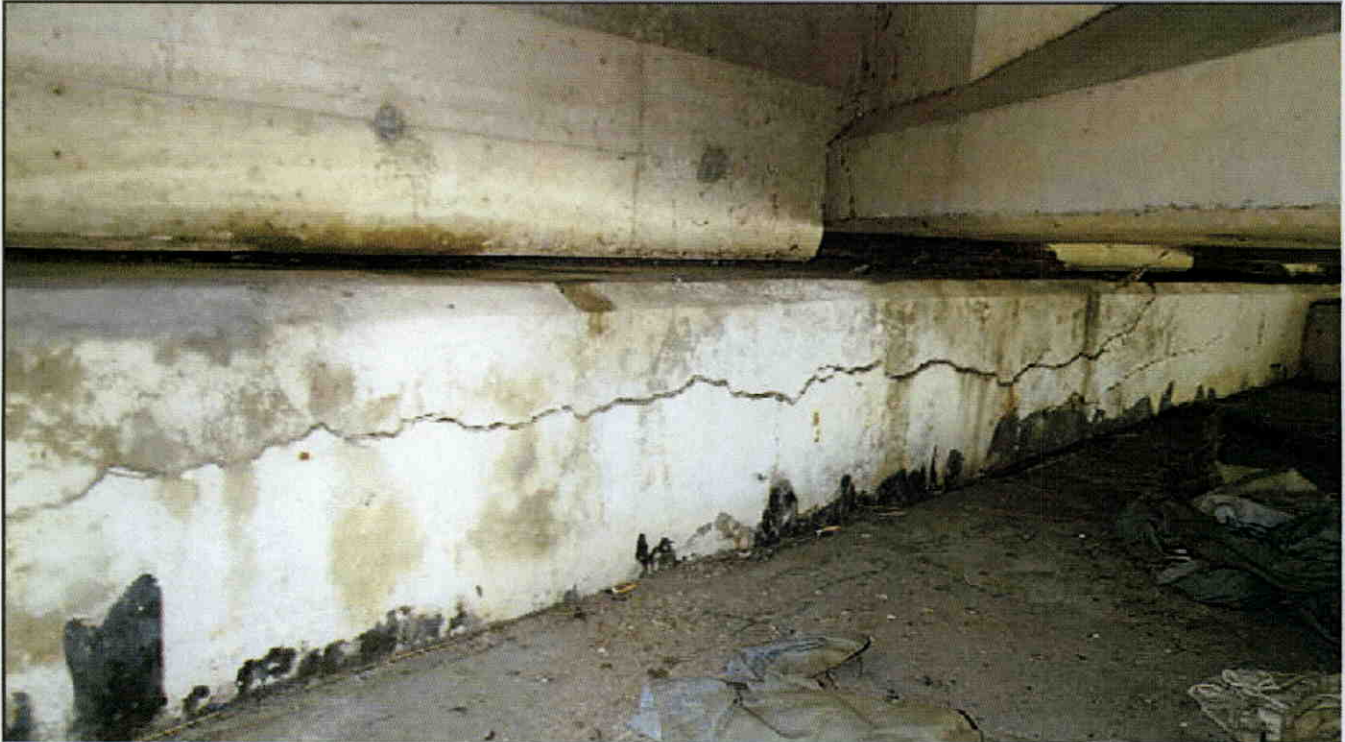
ABUTMENT 1 CAP LONGIT CRACK UP TO 1/2 INCH WIDE UNDER BAY 4

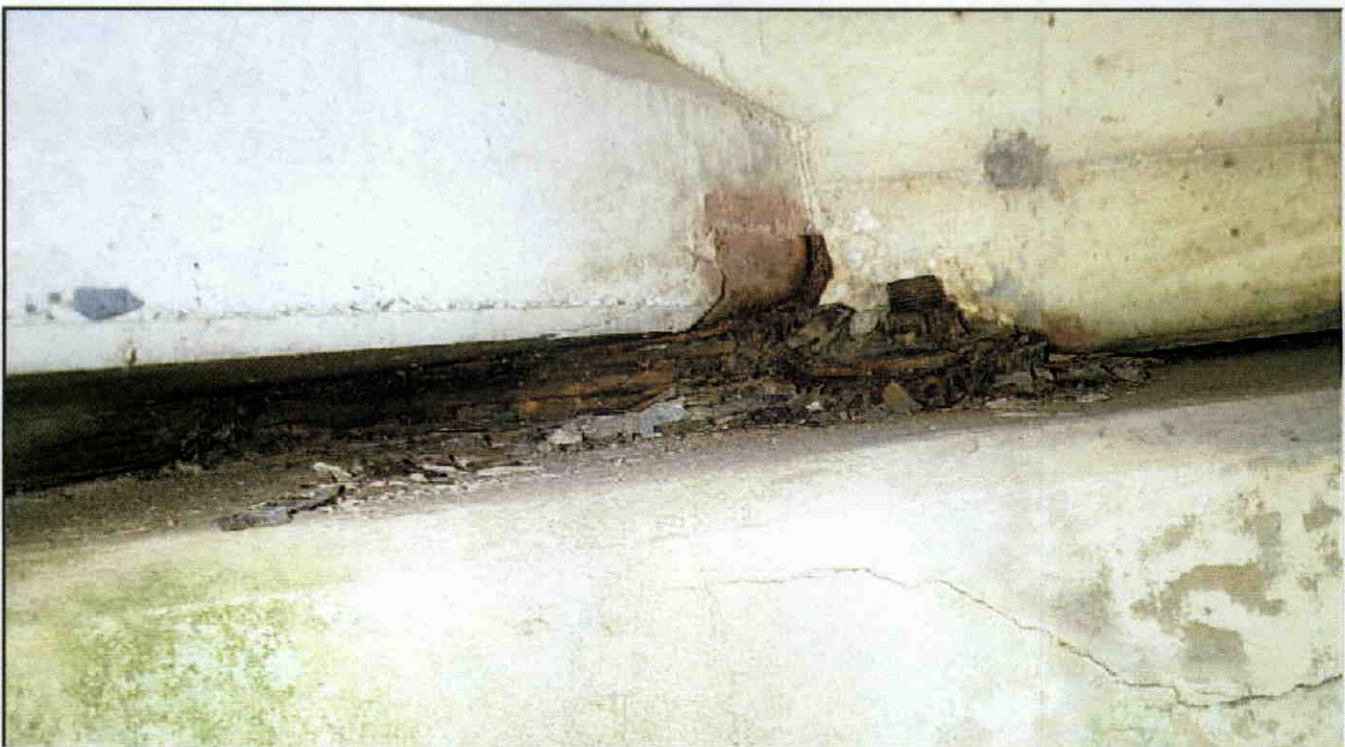
BEARING 5, ABUTMENT 1, HEAVY RUST WITH SECTION LOSS, ALL BEARINGS AT ABUTMENTS SIMILAR.

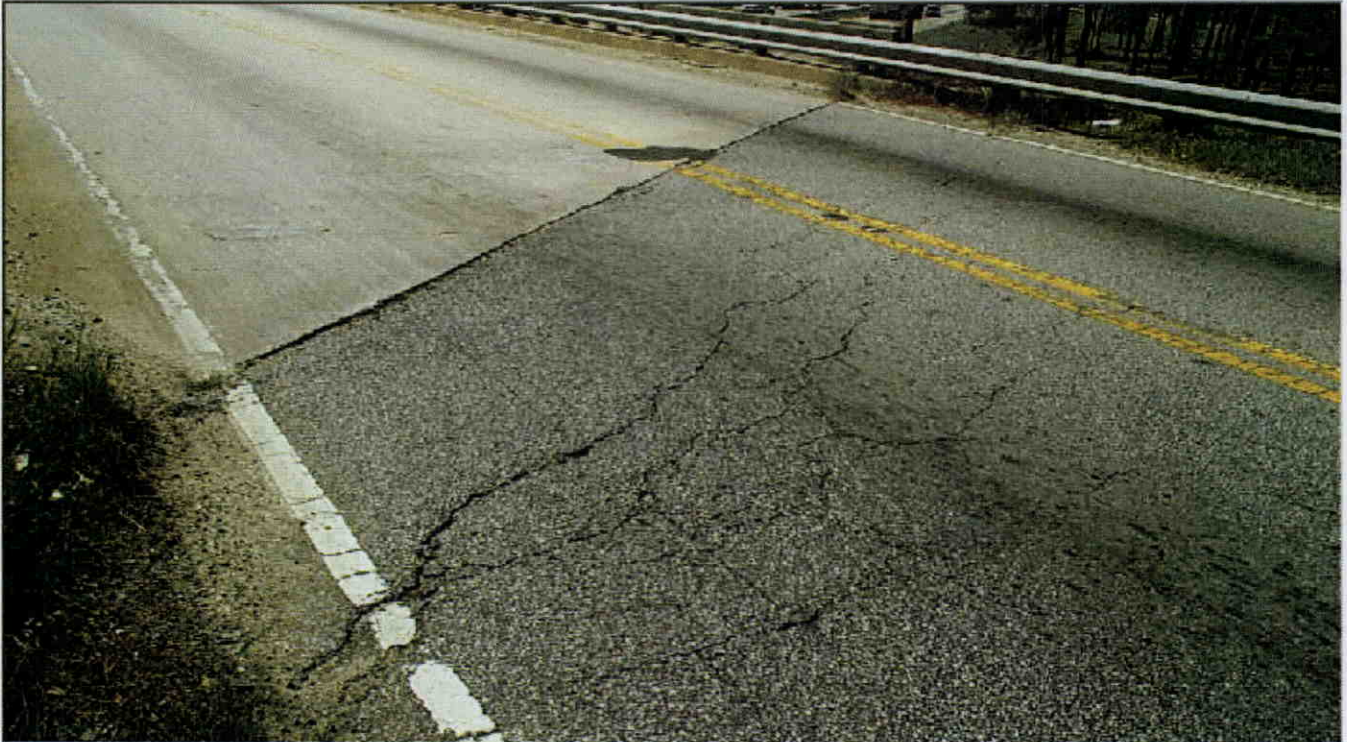
WEST APPROACH CRACKED AND SETTLED UP TO 1 IN. WITH ROUGH PAVEMENT

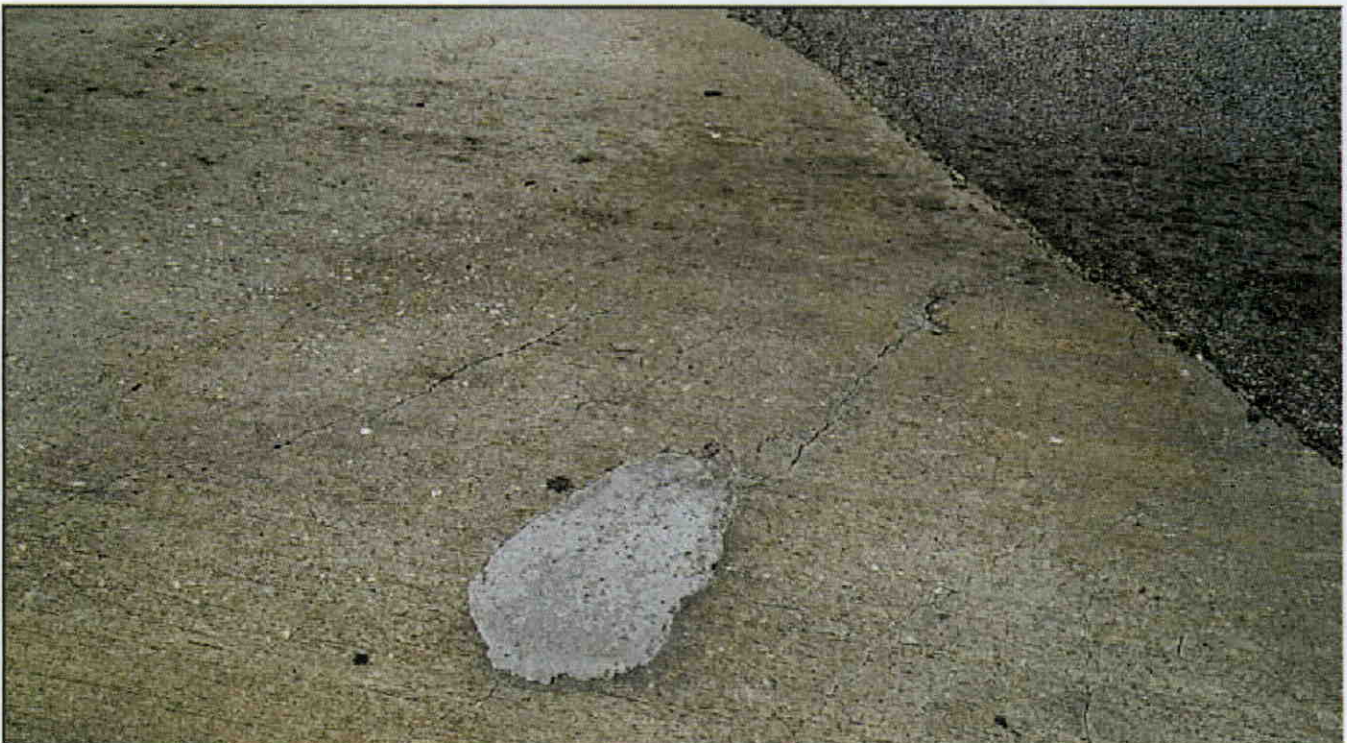
TOP OF DECK SPAN 1, DIAGONAL CRACKS, OTHER SPANS SIMILAR

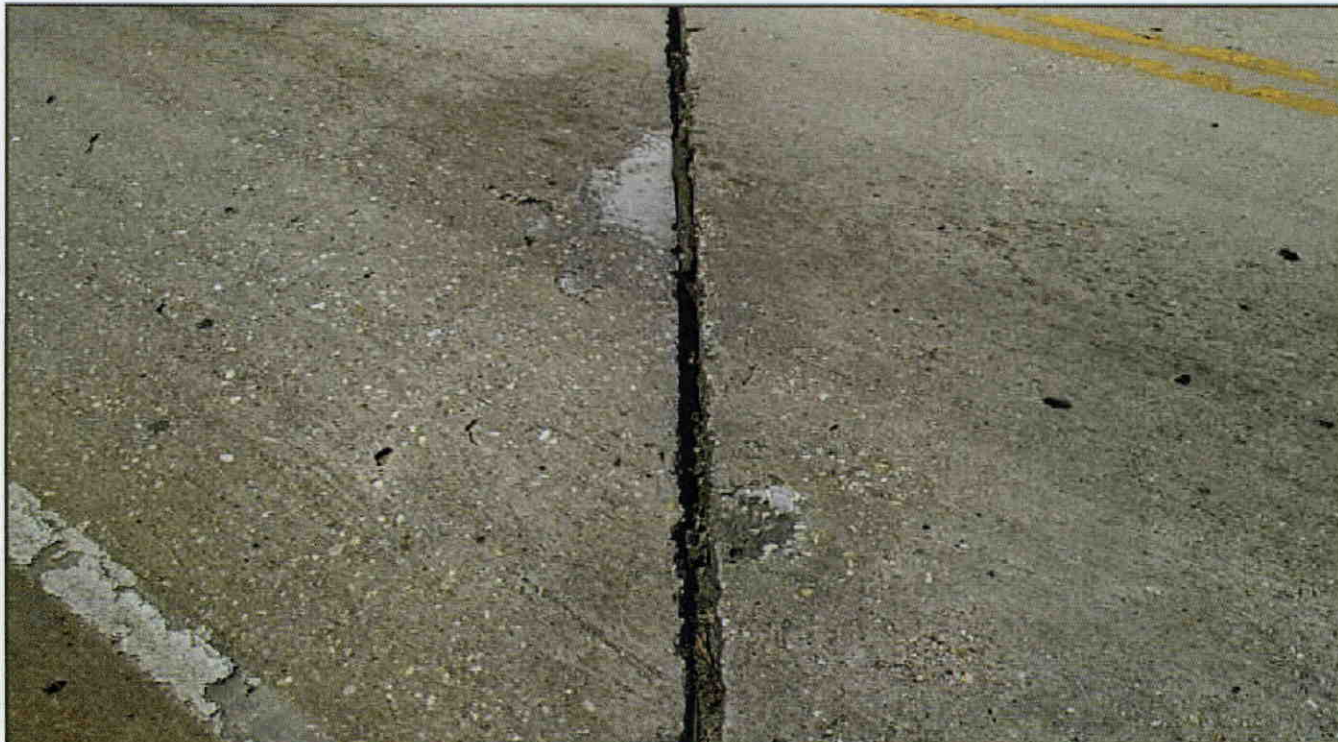
PIER 1 , EXPANSION JOINT MATERIAL MISSING, OTHERS SIMILAR

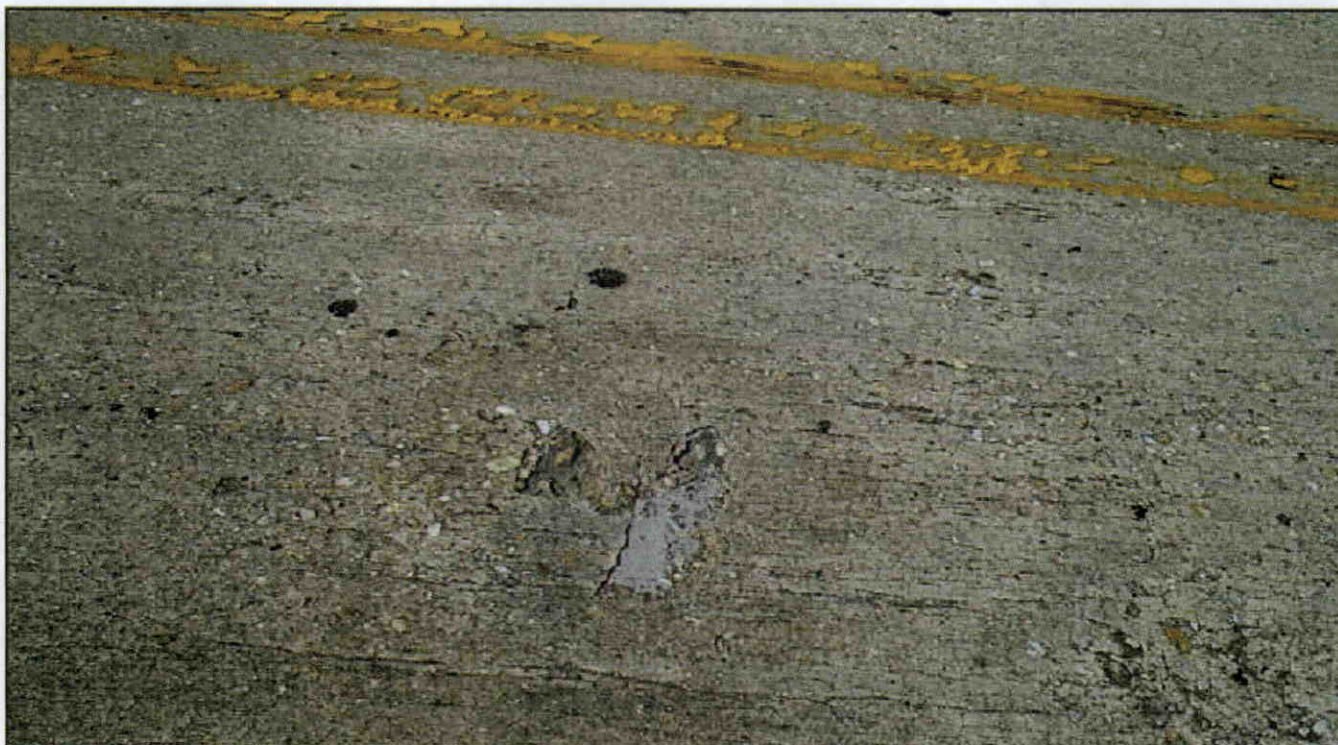
TOP OF DECK SPAN 1, CRACKS, SCALING ROUGH WITH SMALL VOIDS, ALL SPANS SIMILAR

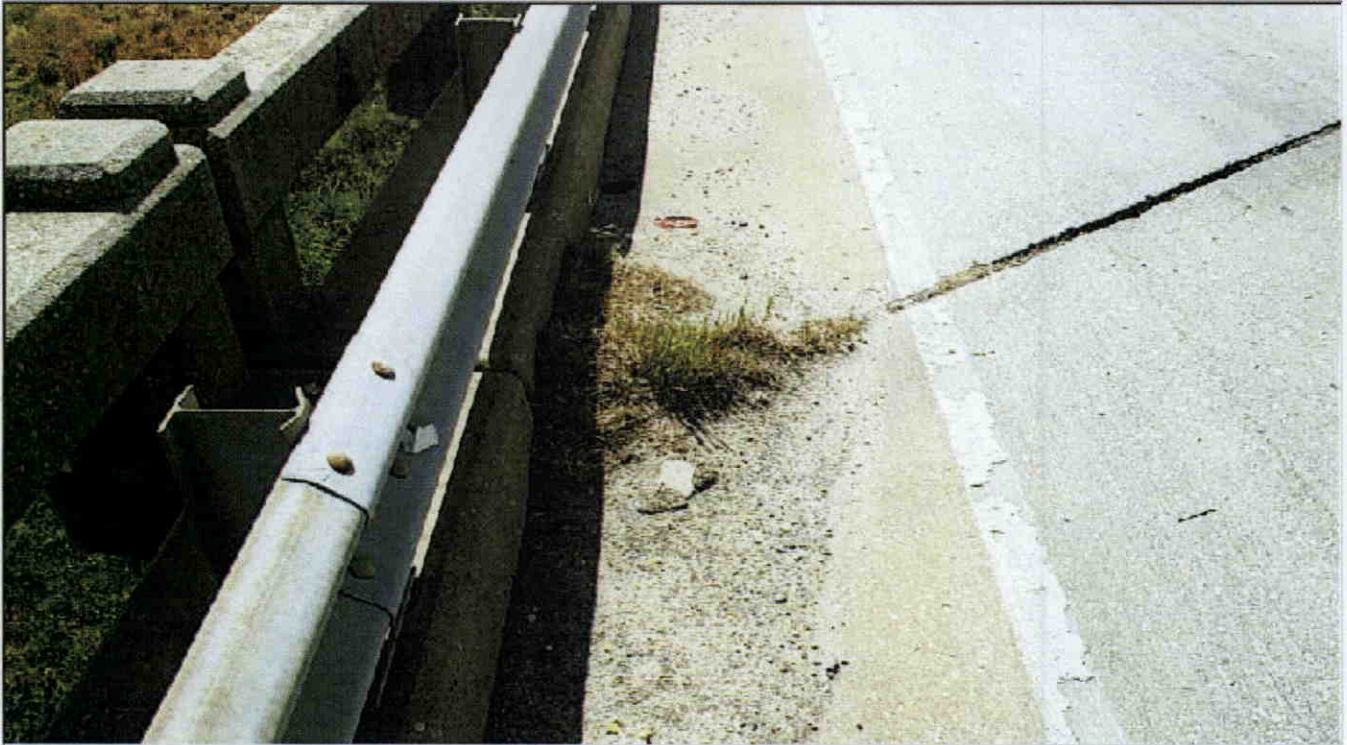
DEBRIS ALONG CURBS, SAND AND GRAVEL UP TO 4 INCHES DEEP SOME AREAS.

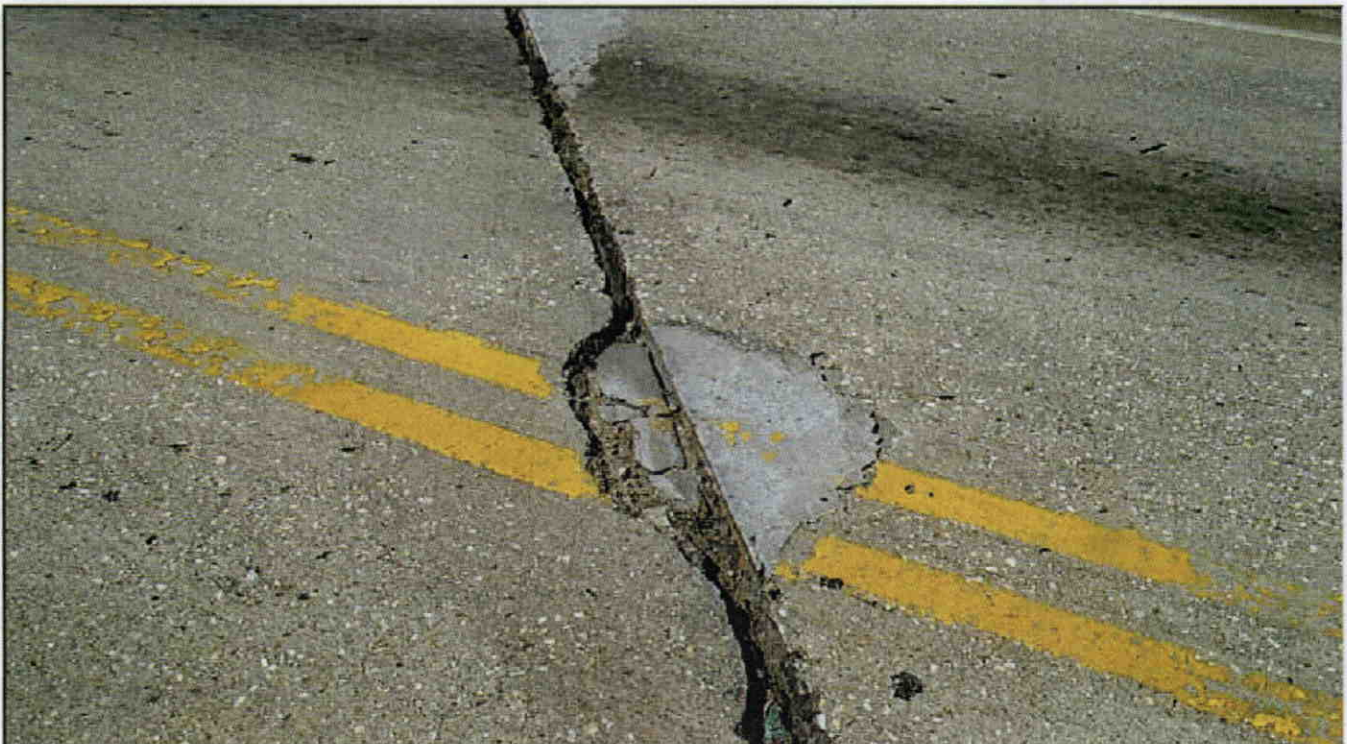
TOP OF DECK SPAN 4 AT PIER 3 JOINT IN.D IN.SPALLED

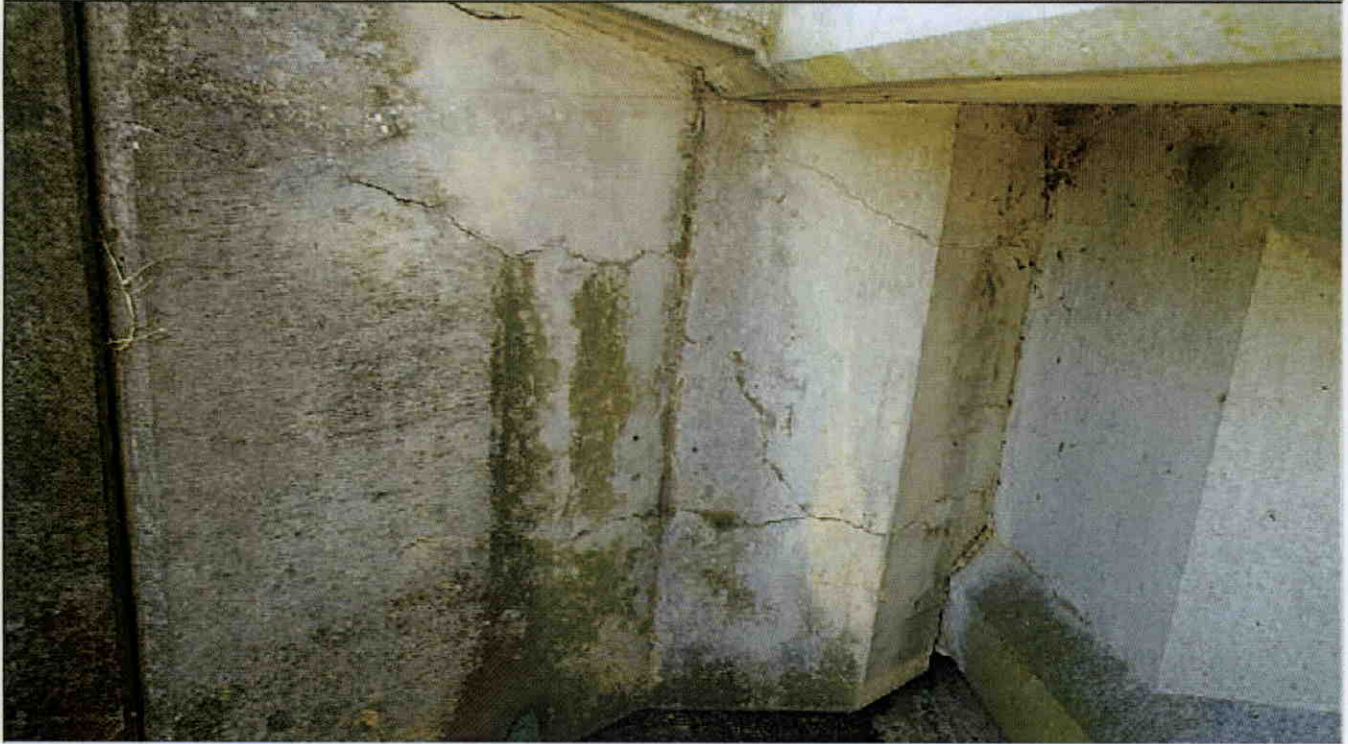
BACKWALLS ABUTMENT 1, LEFT OF GIRDER 1 MAP CRACKS WITH EFFLO, OTHERS SIMILAR.

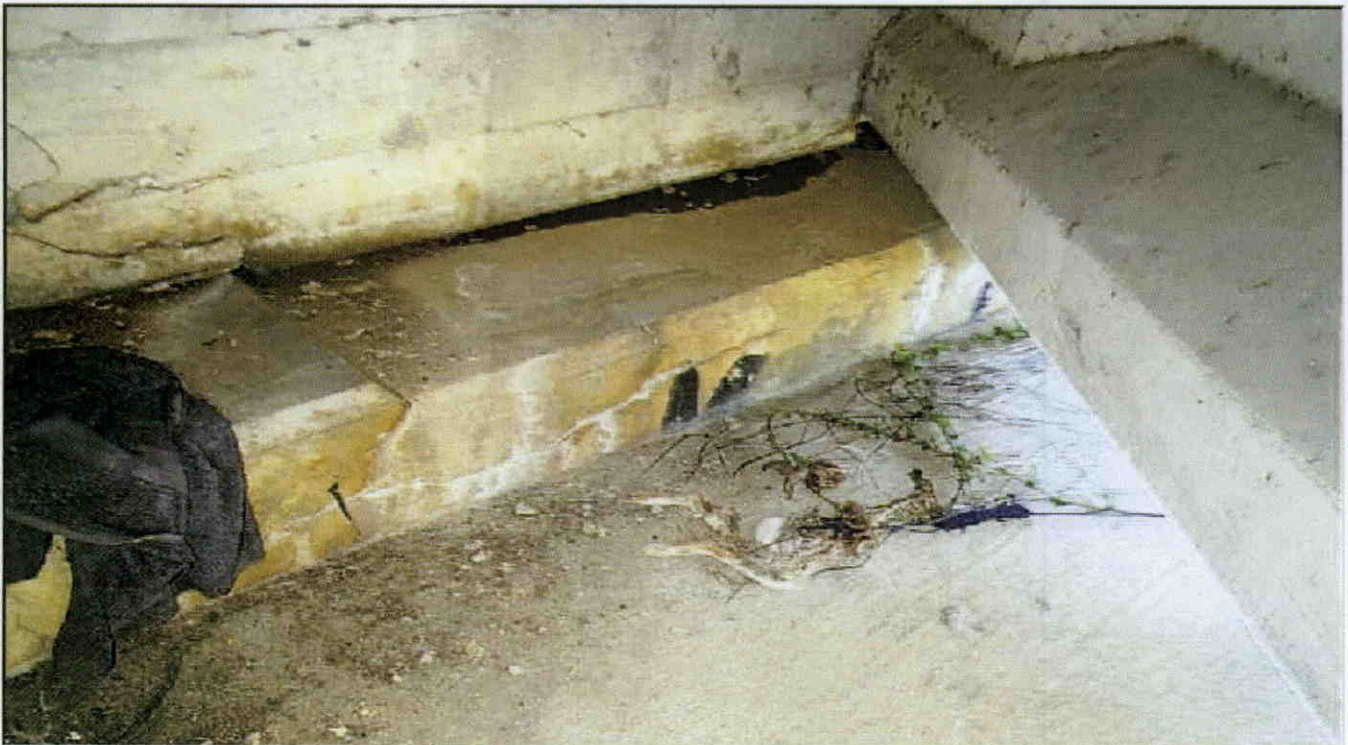
ABUTMENT 2 CAP IN BAY 4 MAP CRACKING WITH EFFLO

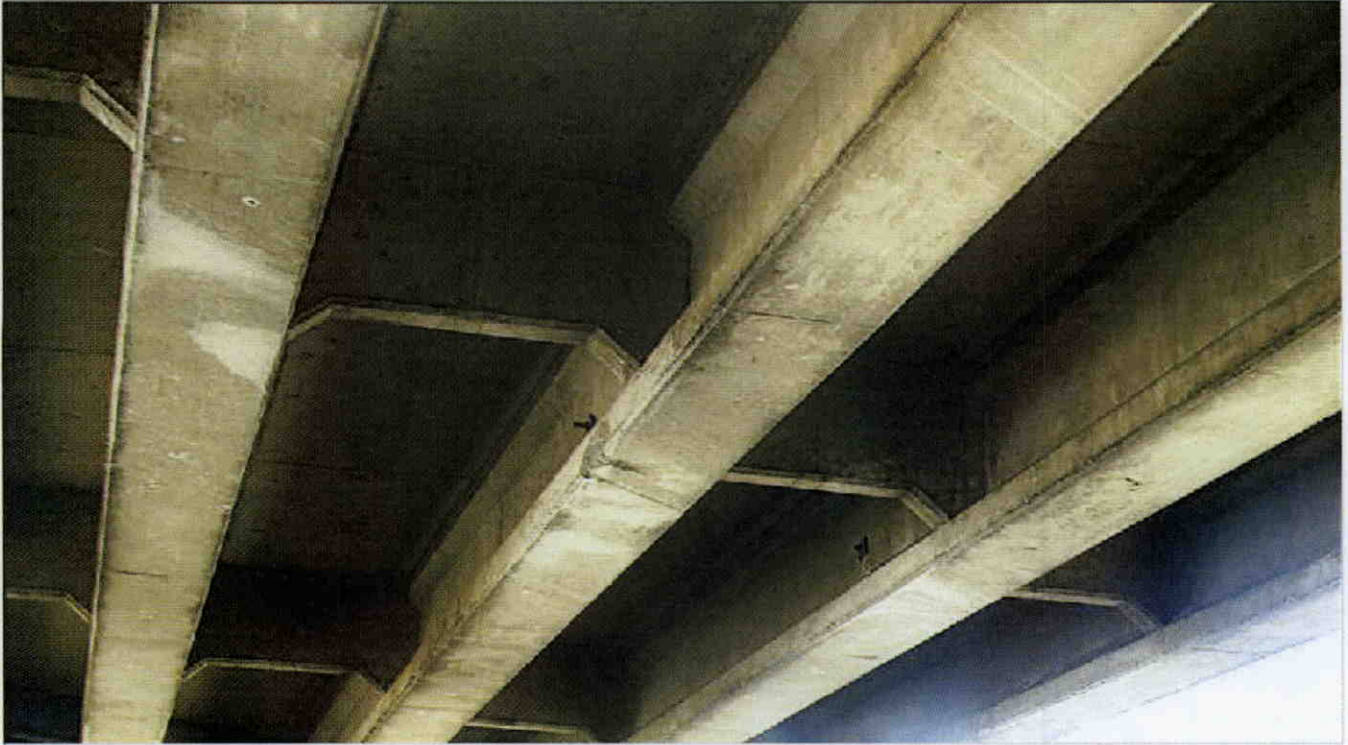
GIRDER 3, SPAN 3 SPALLED ON BOTTOM FROM HIGH LOAD..

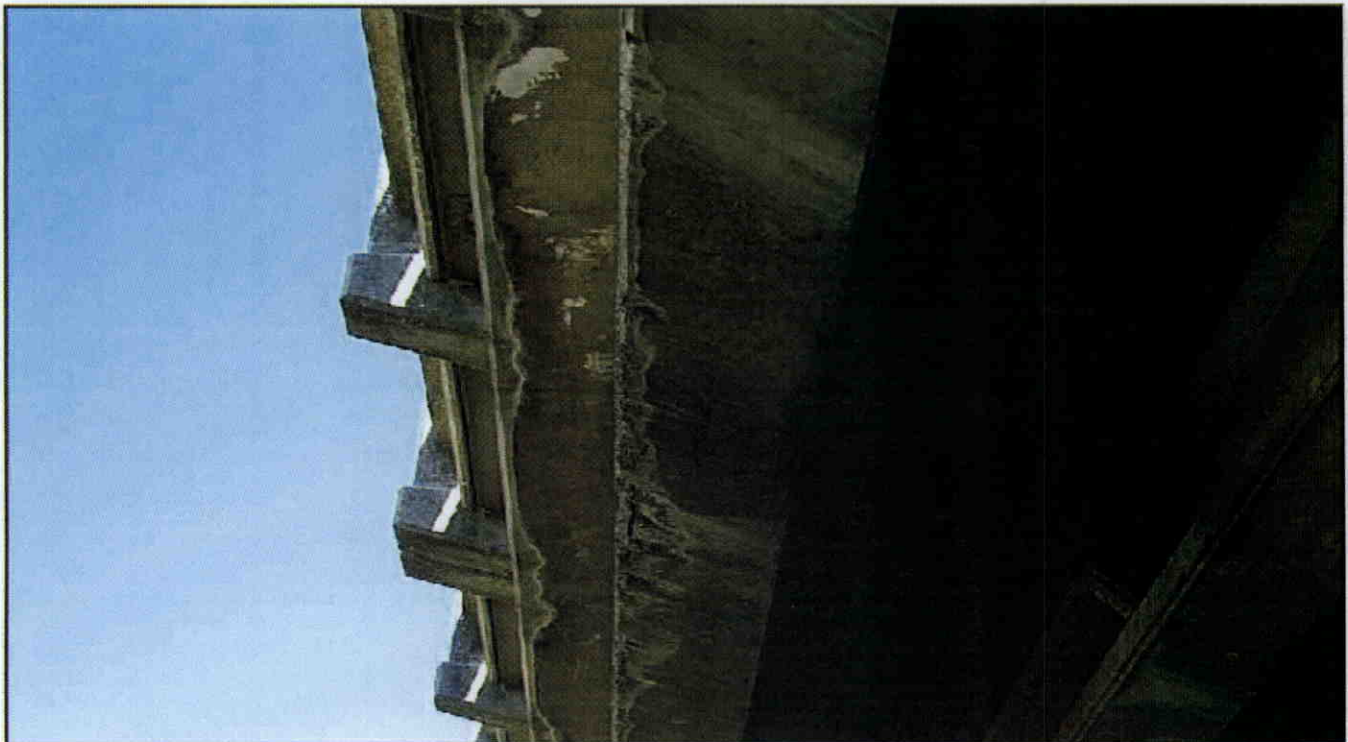
GIRDER 5, SPAN 3, SPALLS FROM HIGH LOADS. UP TO 10 IN. LONG CABLE EXPOSED AND BROKEN ON CORNER.

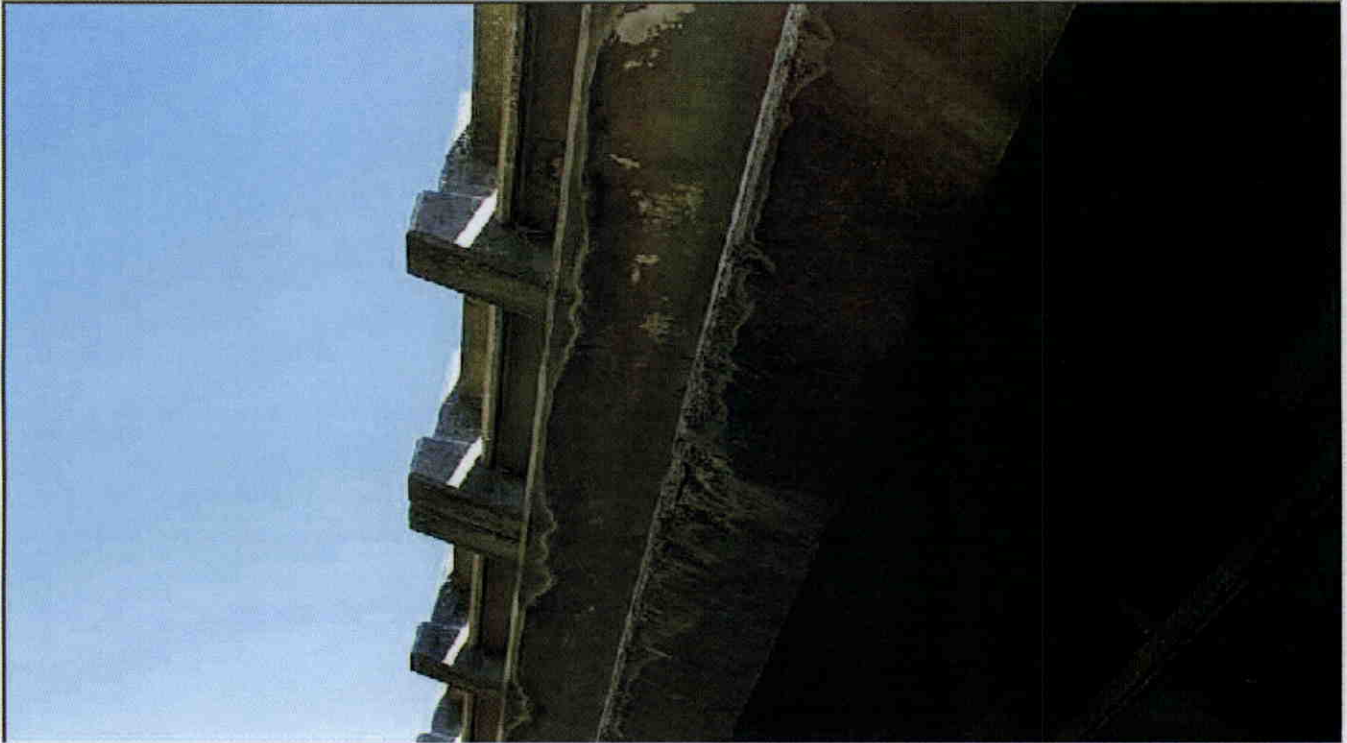
GIRDER 5, SPAN 3, SPALLS IN BOTTOM OF GIRDER.

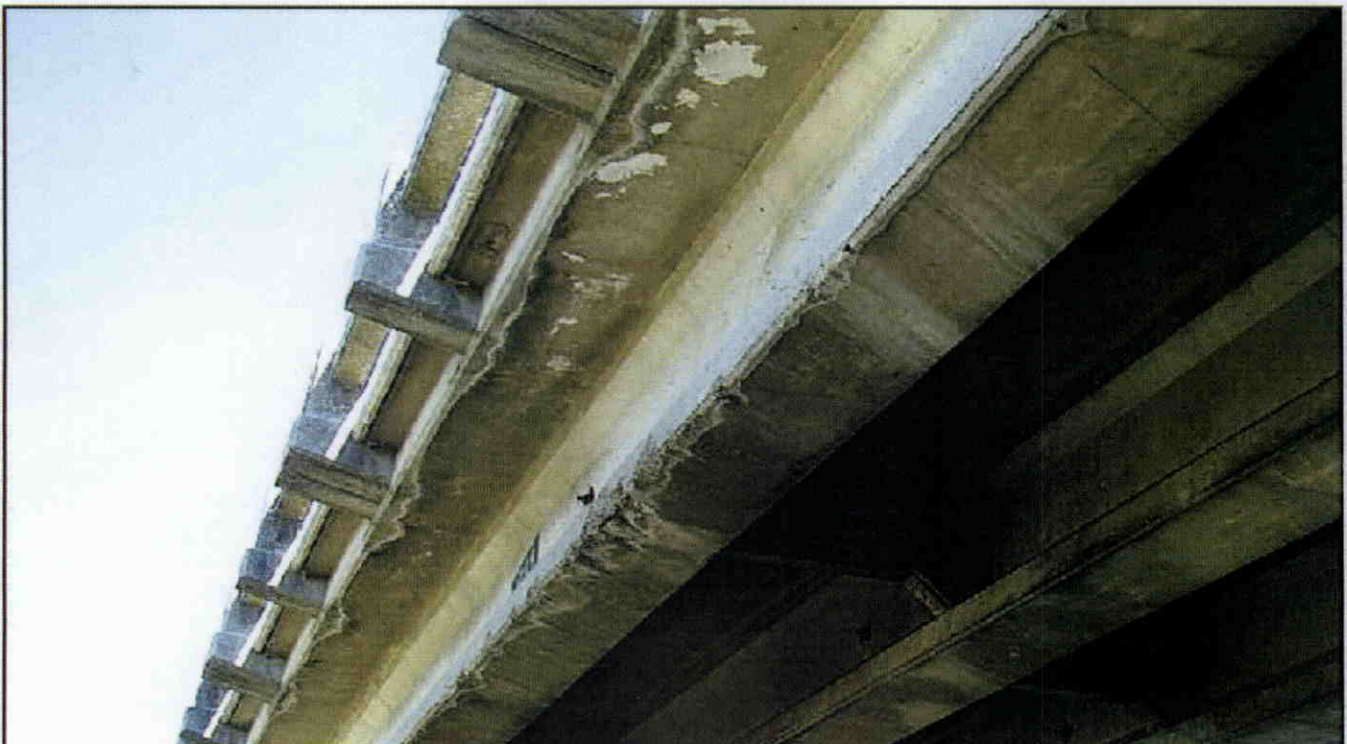
GIRDER 5, SPAN 3 BOTTOM RIGHT EDGE OF GIRDER SPALLED AND CHIPPED BBY HIGH LOADS.

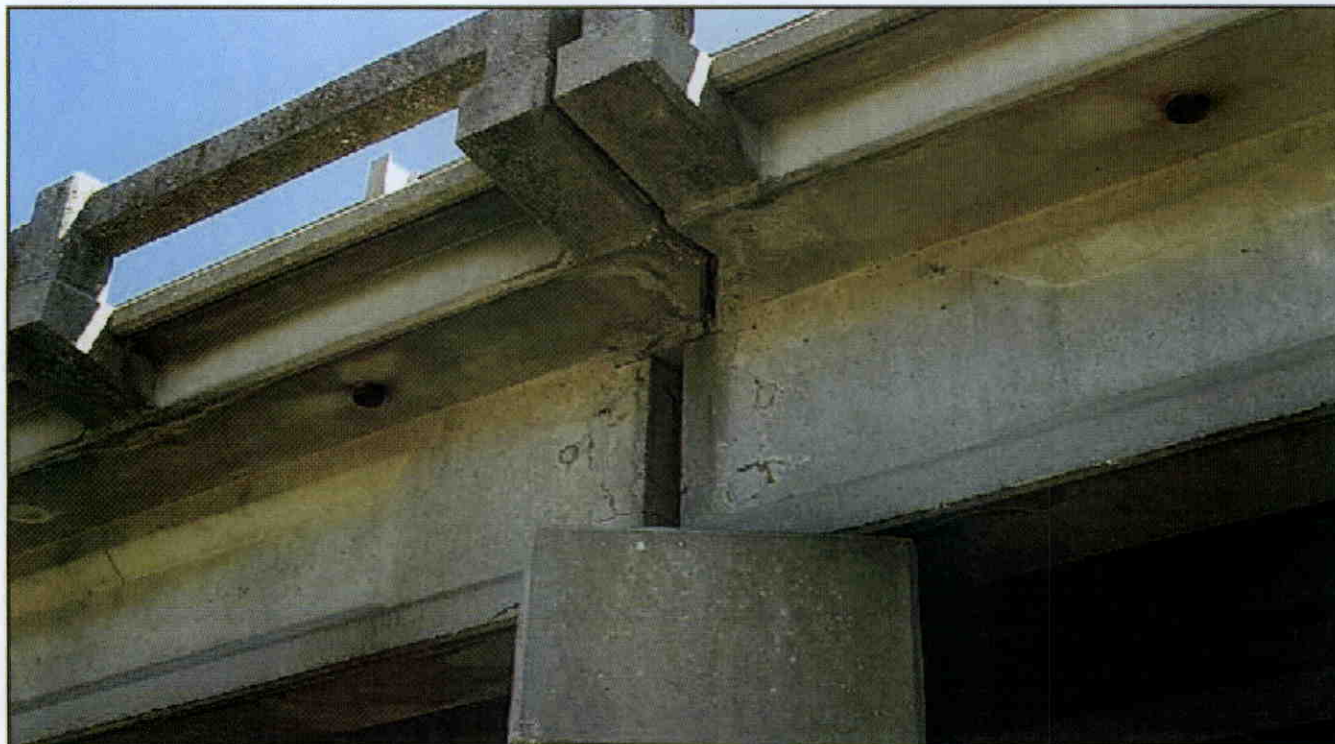
GIRDERS 5, SPANS 3 AND 4 AT PIER 3 MAP CRACKING ON ENDS WITH EFFLO STAINS.

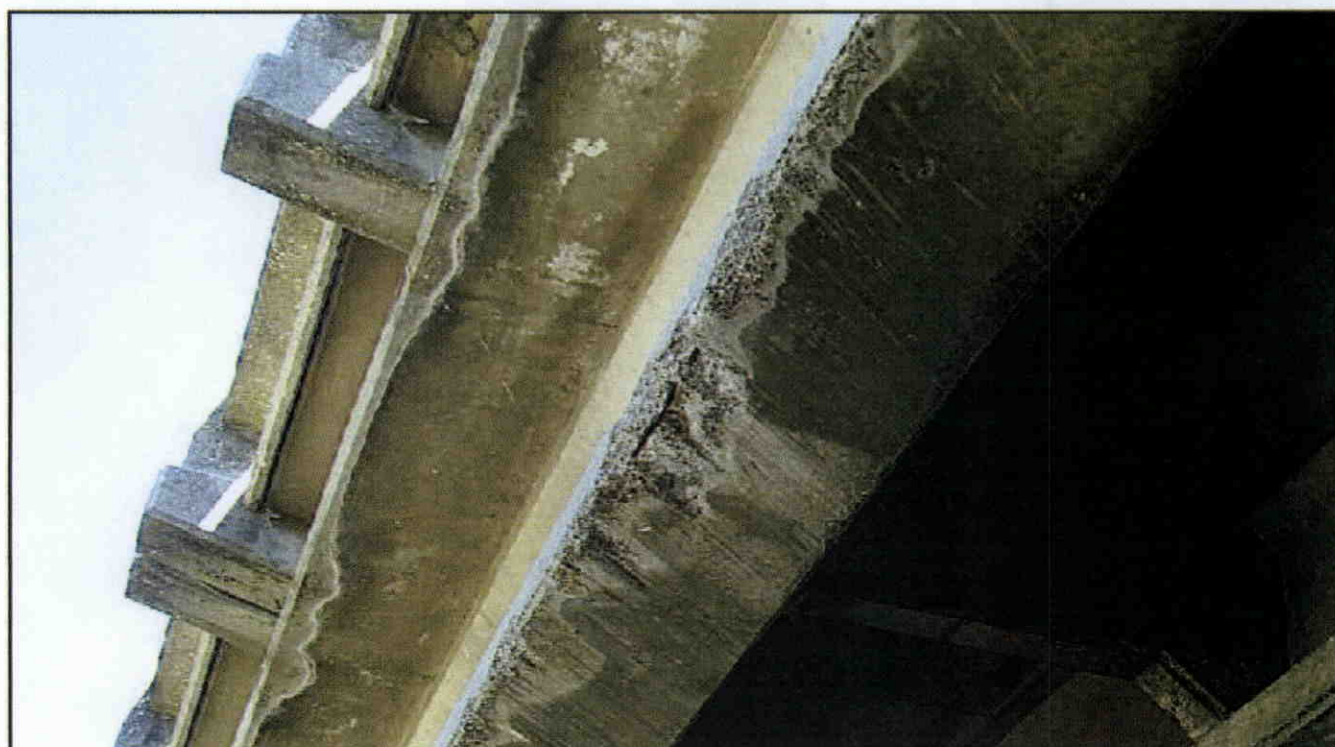
GIRDER 5 SPAN 3 WITH CABLE BROKEN ON BOTTOM RIGHT EDGE.

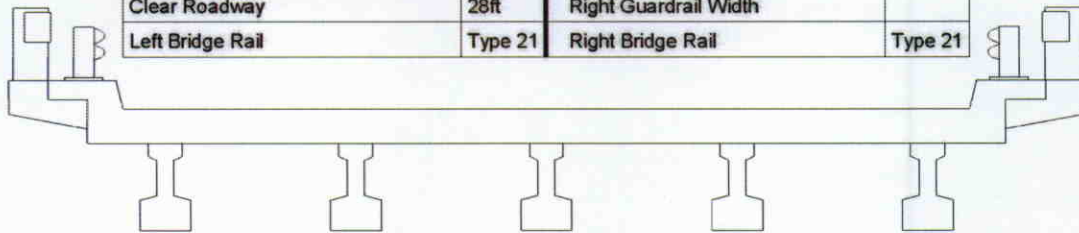
Measurements for Span #	1	SPANS 2, 3 AND 4 SIMILAR	
Deck Thickness	0.563	Left Overhang	3.375
Top of Rail to Bottom of Beam		Right Overhang	3.375
