Fracture Critical	No
Temporary Shoring	No
Scour Critical	No
Scour POA	No

SIGN NOT		NUMBERED REQUIRED
No	WEIGHT LIMIT	
No	DELINEATORS	
No	NARROW BRIDGE	
No	ONE LANE BRIDGE	
No	LOW CLEARANCE

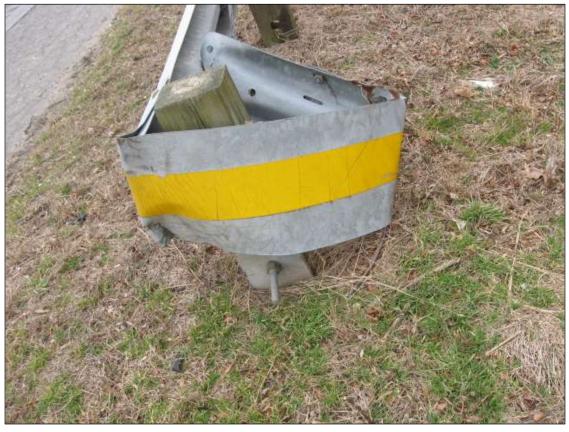
DAMAGED GUARDRAIL TERMINAL @ NORTH WEST CORNER

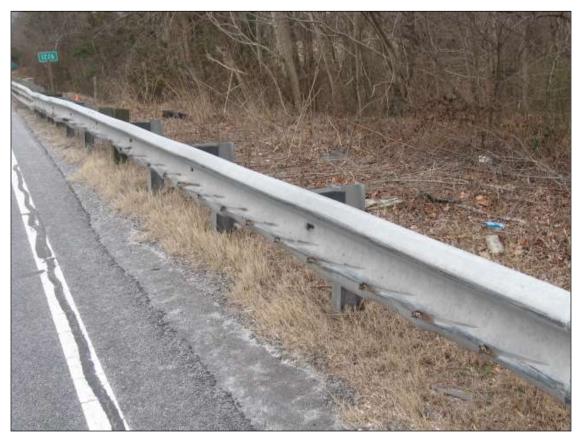
DAMAGED GUARDRAIL @ WEST SIDE THROUGH OUT BRIDGE

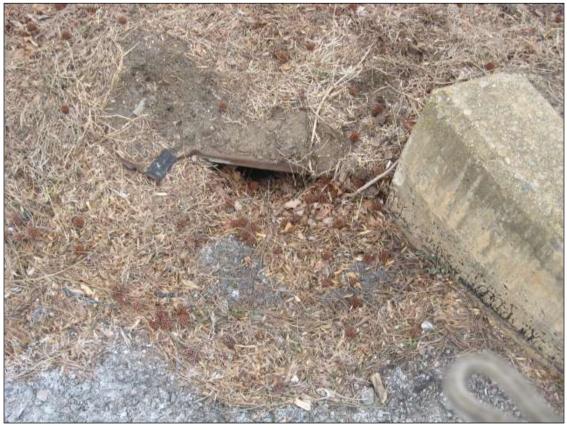
DRAIN BLOCKED WITH DIRT AND DEBRIS @ SOUTH WEST CORNER

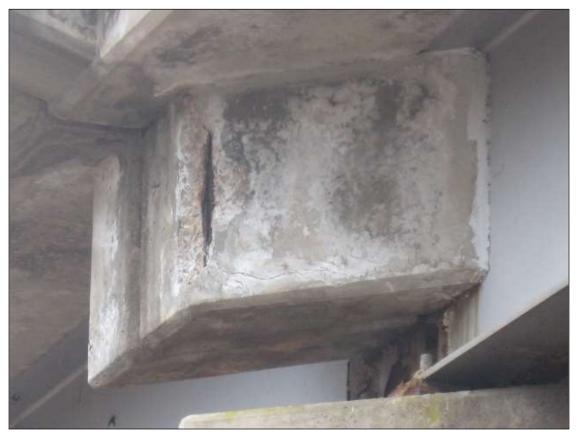
SPALL IN DIAPHRAGM OVER INTERIOR BENT 1 RIGHT SIDE WITH EXPOSED STEEL

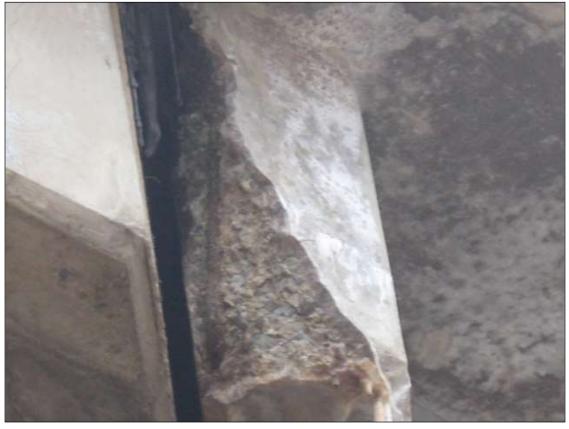
SPALL IN DIAPHRAGM WITH EXPOSED STEEL OVER INTERIOR BENT 2 RIGHT SIDE

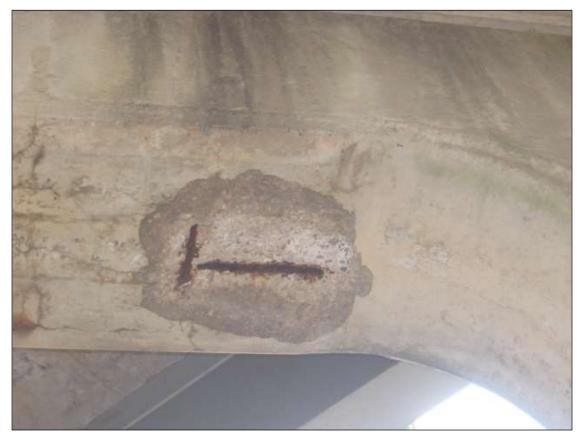
SPALL IN BOTTOM OF CAP WITH EXPOSED STEEL @ INTERIOR BENT 3 BETWEEN COLUMN 2 AND COLUMN 3 ( 10 IN DIAMETER X 2 IN DEEP )

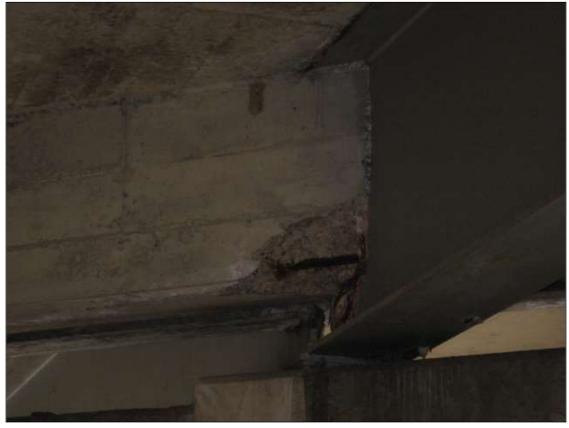
SPALL IN DIAPHRAGM WITH EXPOSED STEEL OVER INTERIOR BENT 3 SPAN 4 SIDE BAY 2

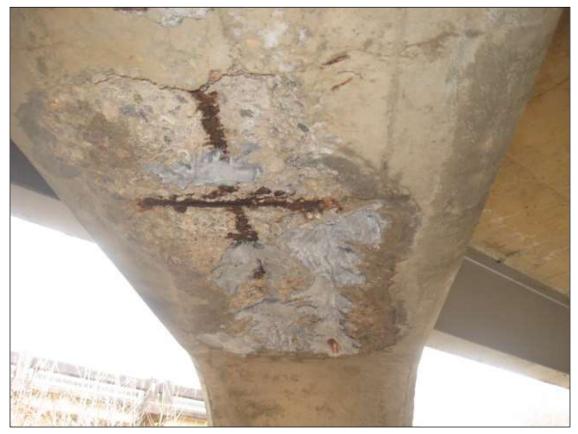
SPALL UNDER BOTTOM OF CAP WITH EXPOSED STEEL @ INTERIOR BENT 4 BETWEEN COLUMN 2 AND COLUMN 3 ( 4FT LONG X 2FT WIDE X 3 IN DEEP )

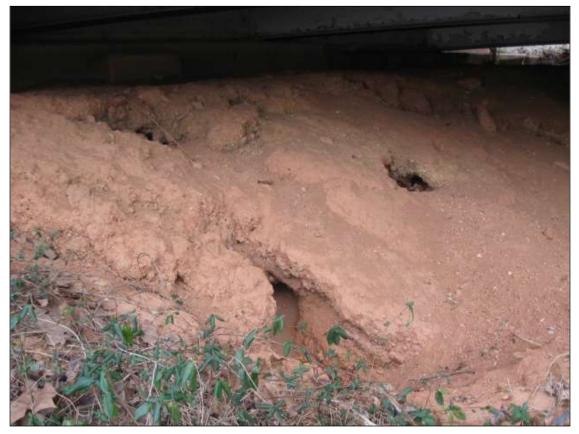
RODENT HOLES IN SLOPE @ END BENT 2

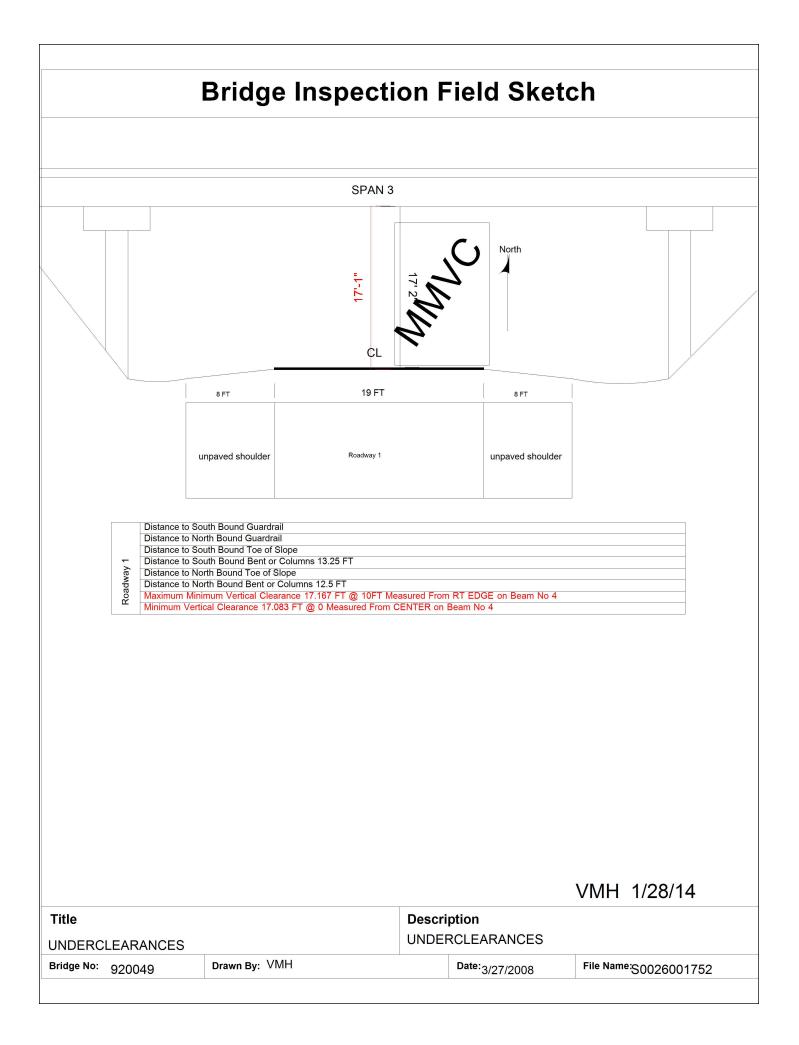
Bri	dge l	nsp	oectio	n Fie	ld S	ketch		
Cap Inf Length	ormation Width	Height	Material Left Over		Place Concre Right Overh		eam to Er	nd of Cap. Righ	it Beam to Er	nd of Cap.

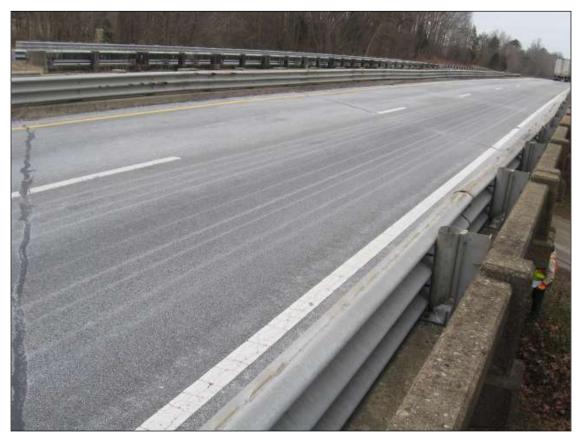
ASPHALT WEARING SURFACE SPAN 5 TOP OF DECK ( ALL OTHER SPANS SIMILAR )

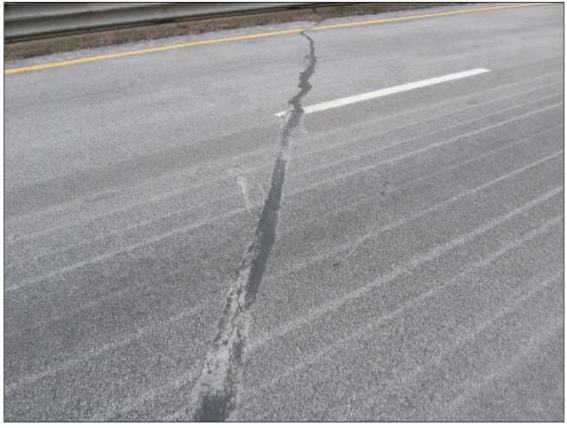
JOINT OVER INTERIOR BENT 4 ( ALL OTHERS SIMILAR )
