NC DEPARTMENT OF TRANSPORTATION
 DIVISION OF HIGHWAYS
 STRUCTURE MANAGEMENT UNIT

ATTENTION: **PAR SUBMITTED
 CHANGES TO STRUCTURE DATA**

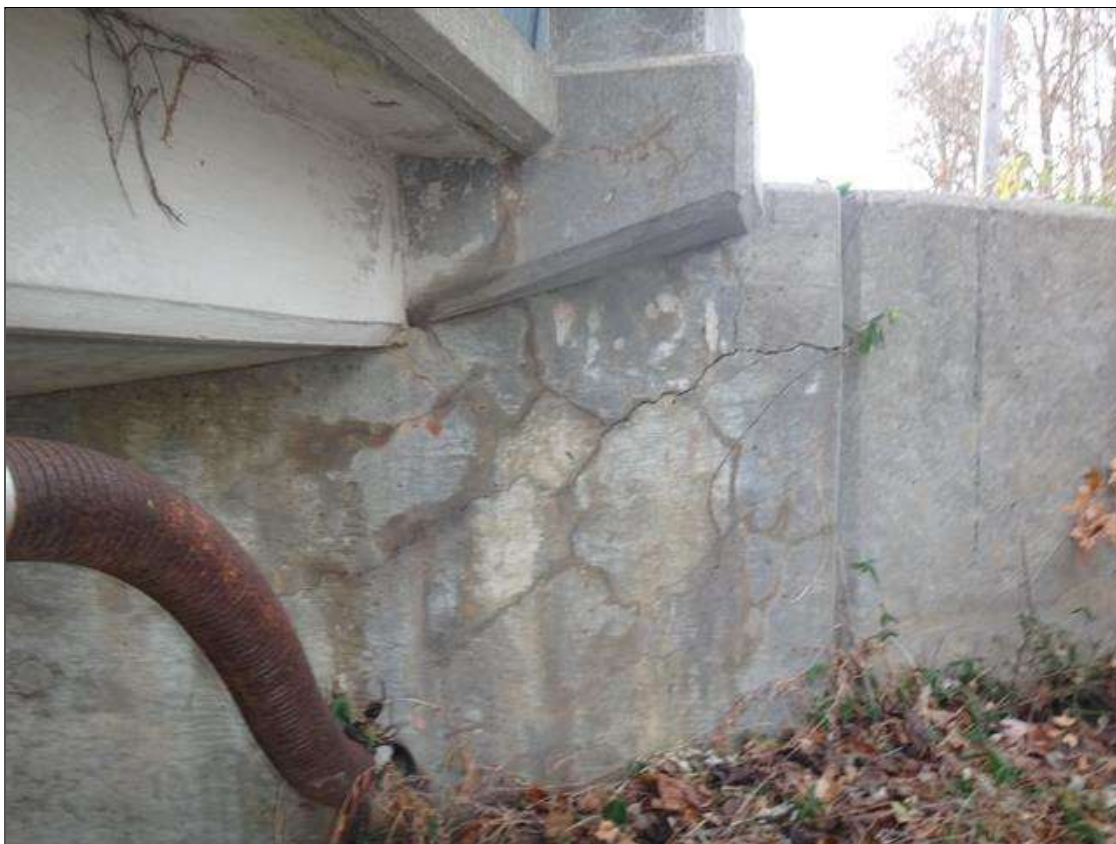
End Bent 1 Abutment: at west end of abutment, (1/16" to 1/4" wide) cracking with efflorescence.

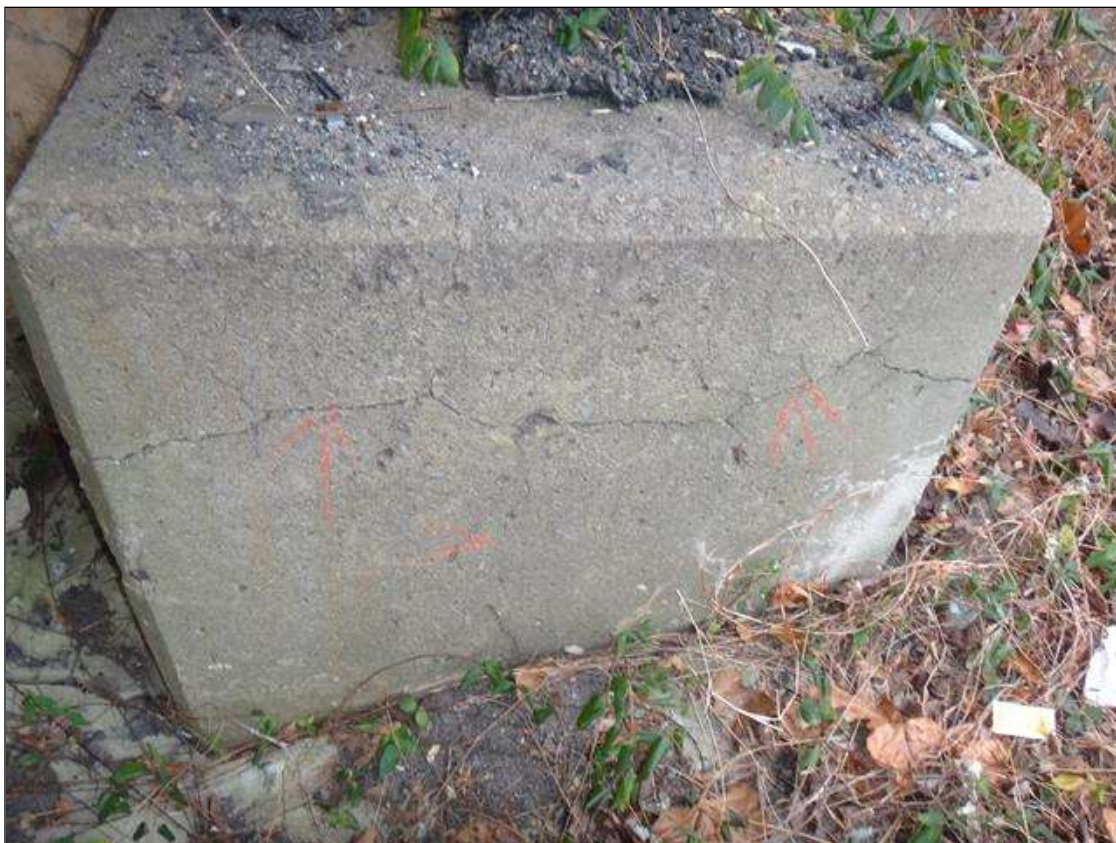
End Bent 1 Cap 1: Cap for Brace pile at west end of End Bent 1, cracks (1/16" to 1/8" wide.)

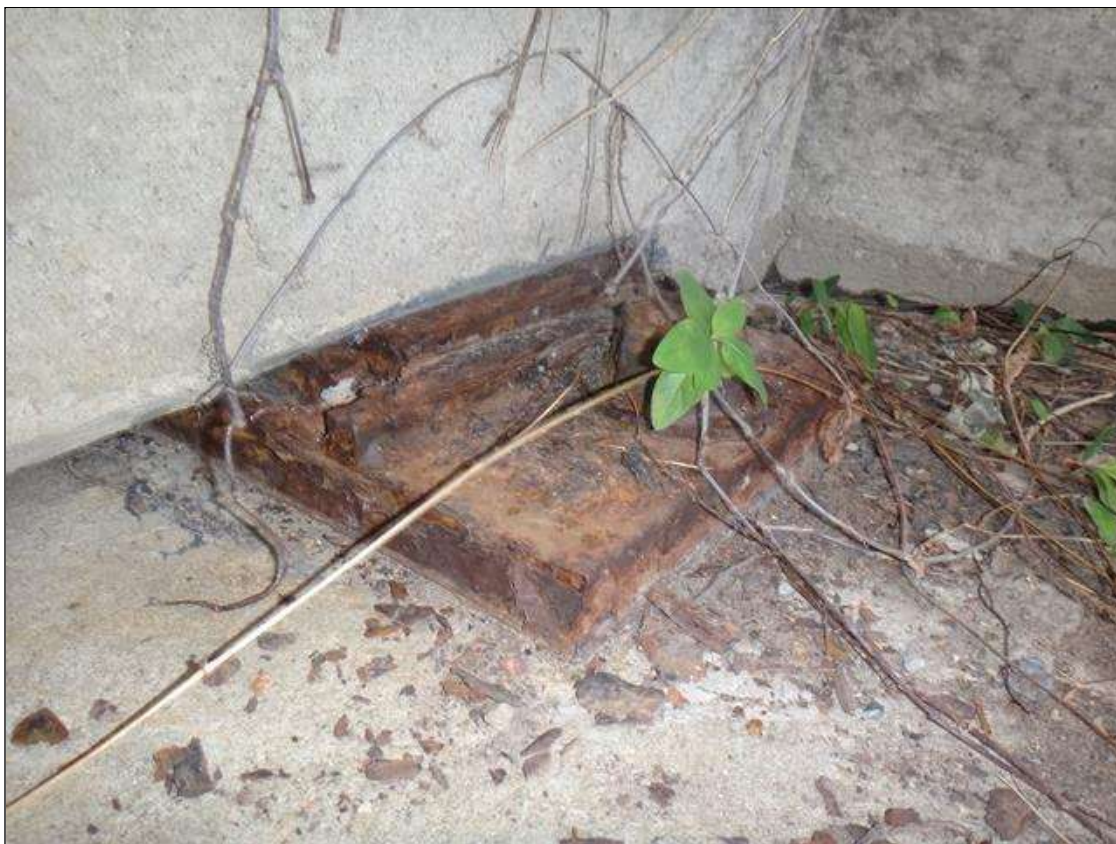
Span 1 Beam 1 - Near Bearing: Active Corrosion and Section Loss up to 1/16" deep, in plates.

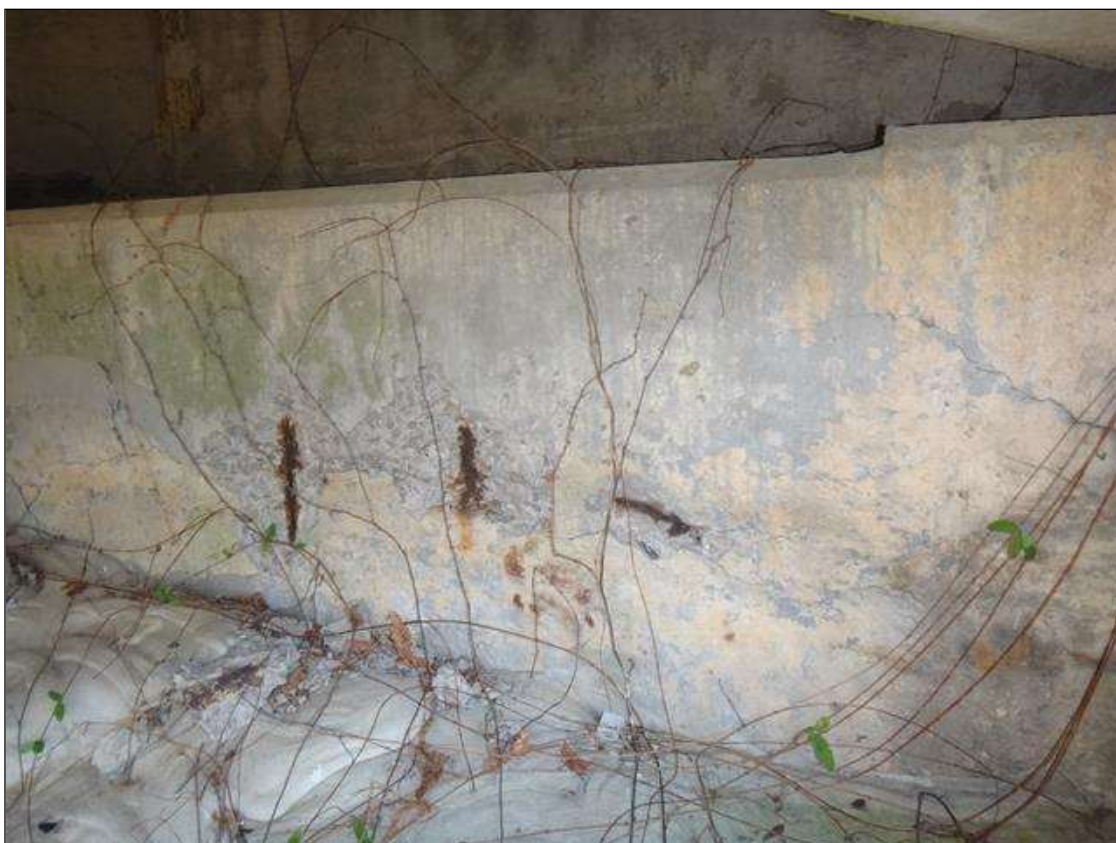
End Bent 1 Cap 1: below bay 1, Delamination/ spalling with exposed rebar, no Section Loss, (3' long x 1' high x 3/4" deep)

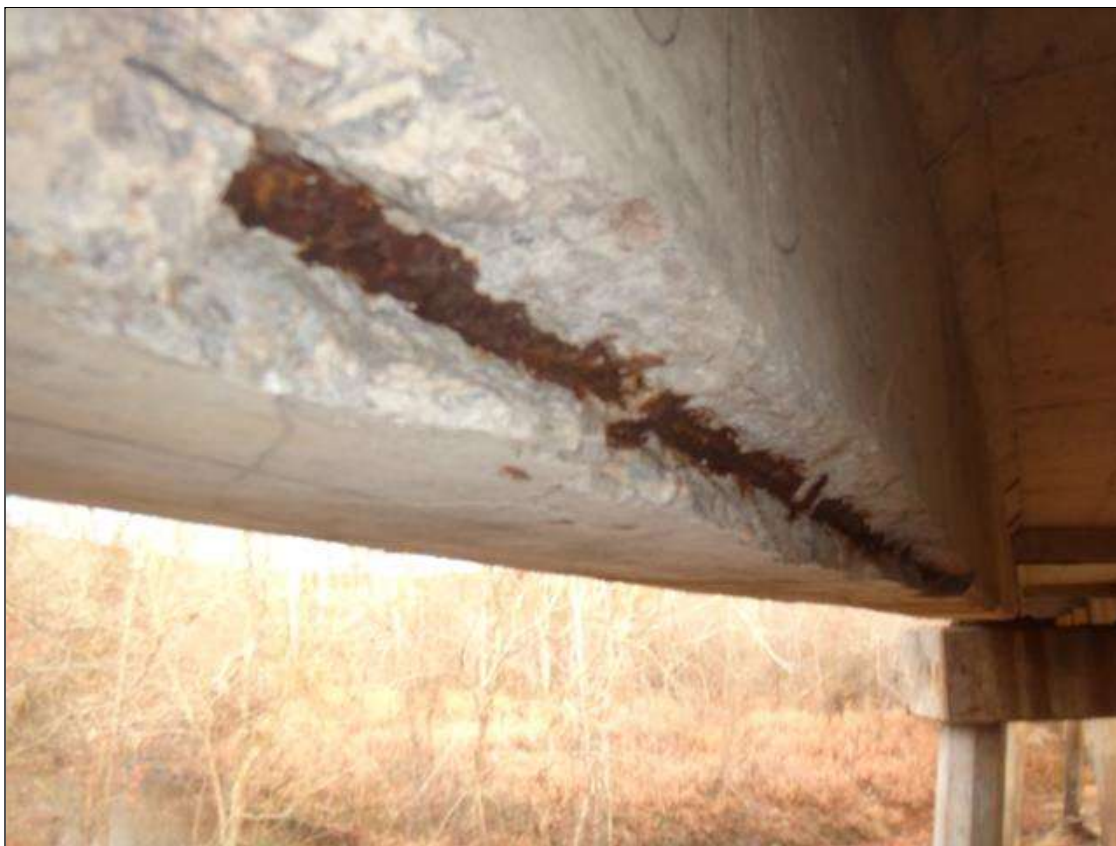
Span 1 Beam 1: PAR: at 7' from End Bent 1, bottom of girder has Delamination/ Spall with Exposed Steel with Section Loss 1/16" deep, (6'-10" x 10" wide. x 4" deep.)

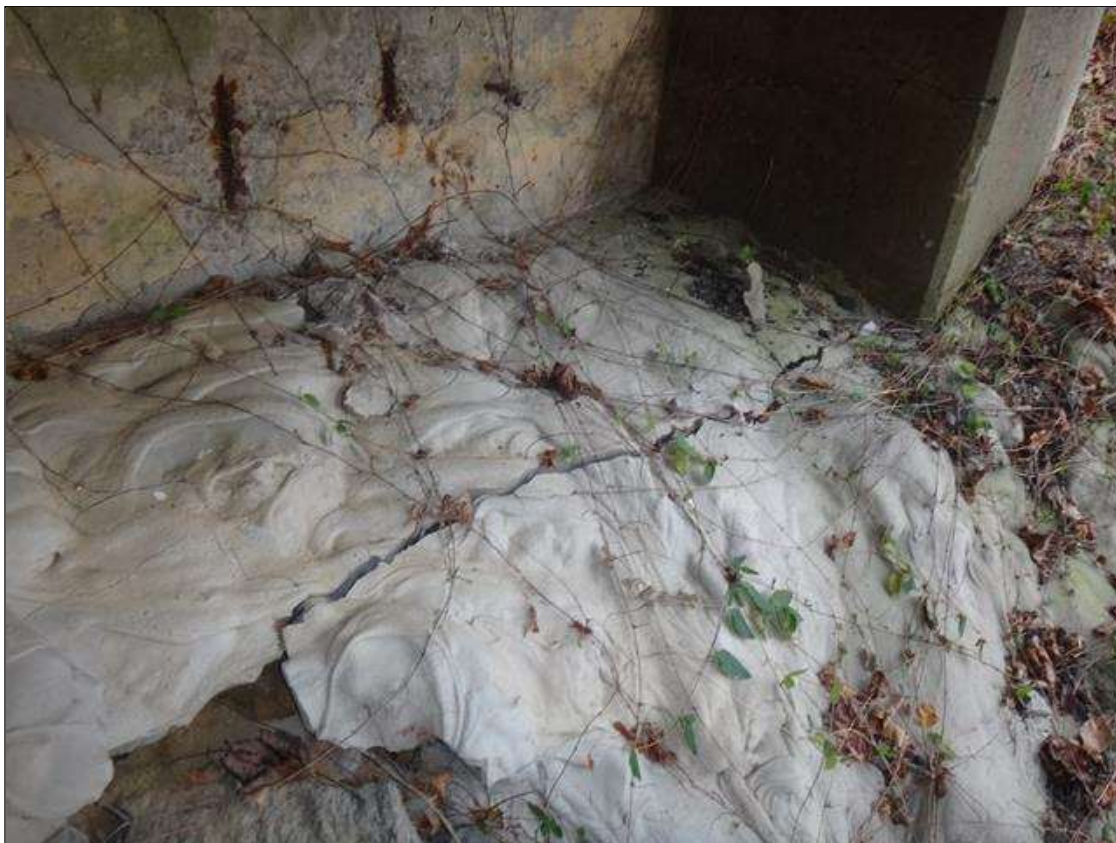
epc slope protection at west end previous repaired, transverse crack (5ft x up to 1/2in)

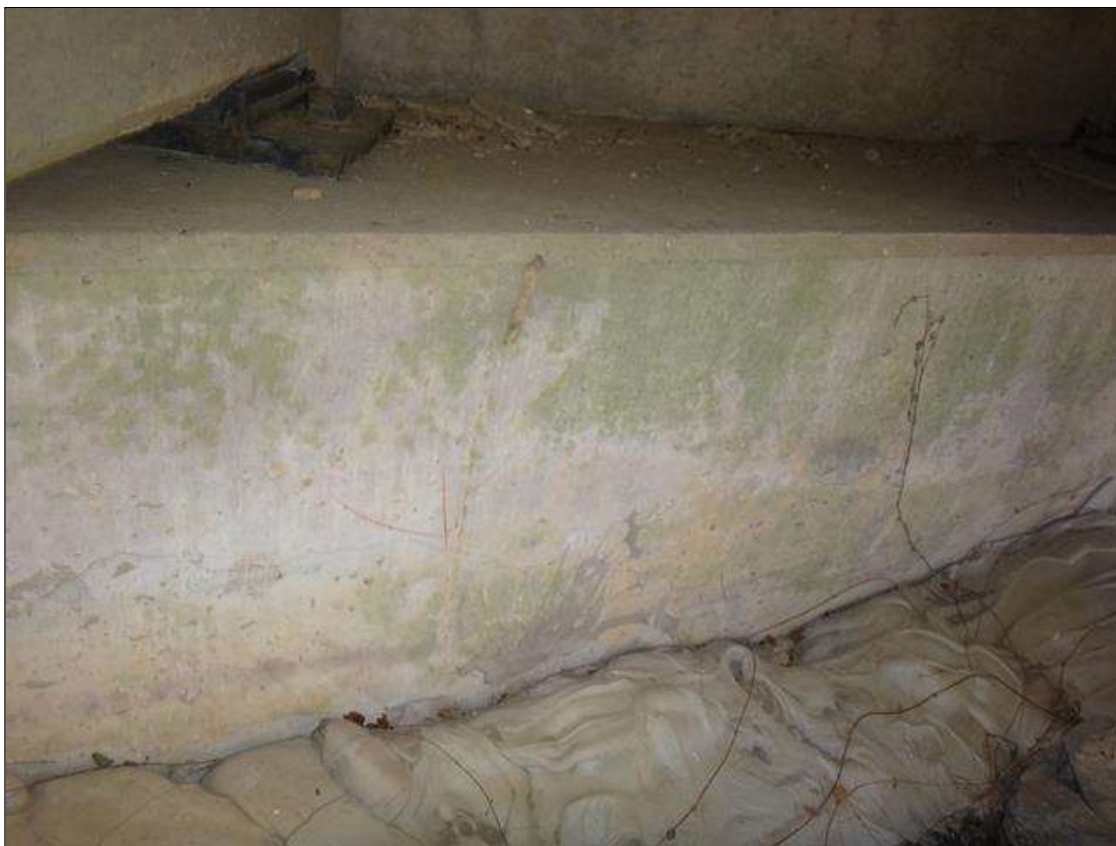
End Bent 1 Cap 1: 1/32" horizontal cracking 20' long in front face of cap under beams 1-3.

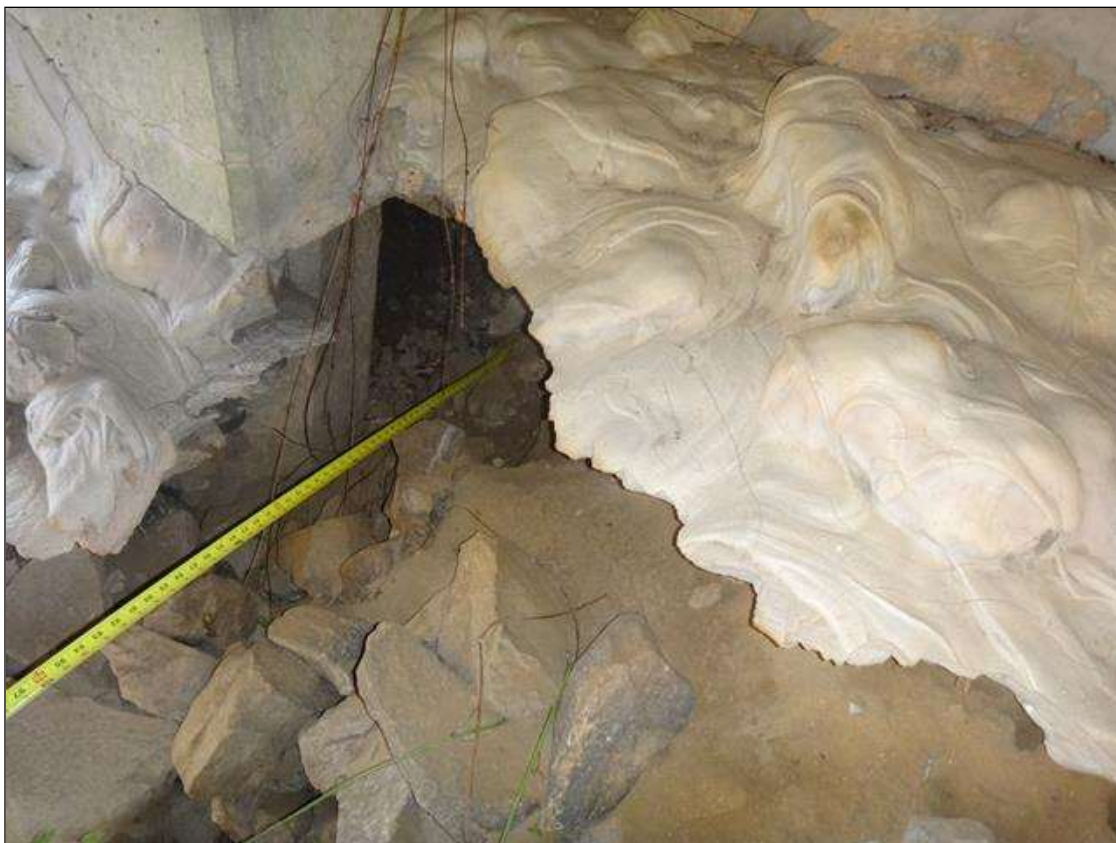
(PAR) end slope protection east end, erosion (10ft x 5ft x up to 2ft) undermining cap (up to 4ft) (photo 1 of 2)

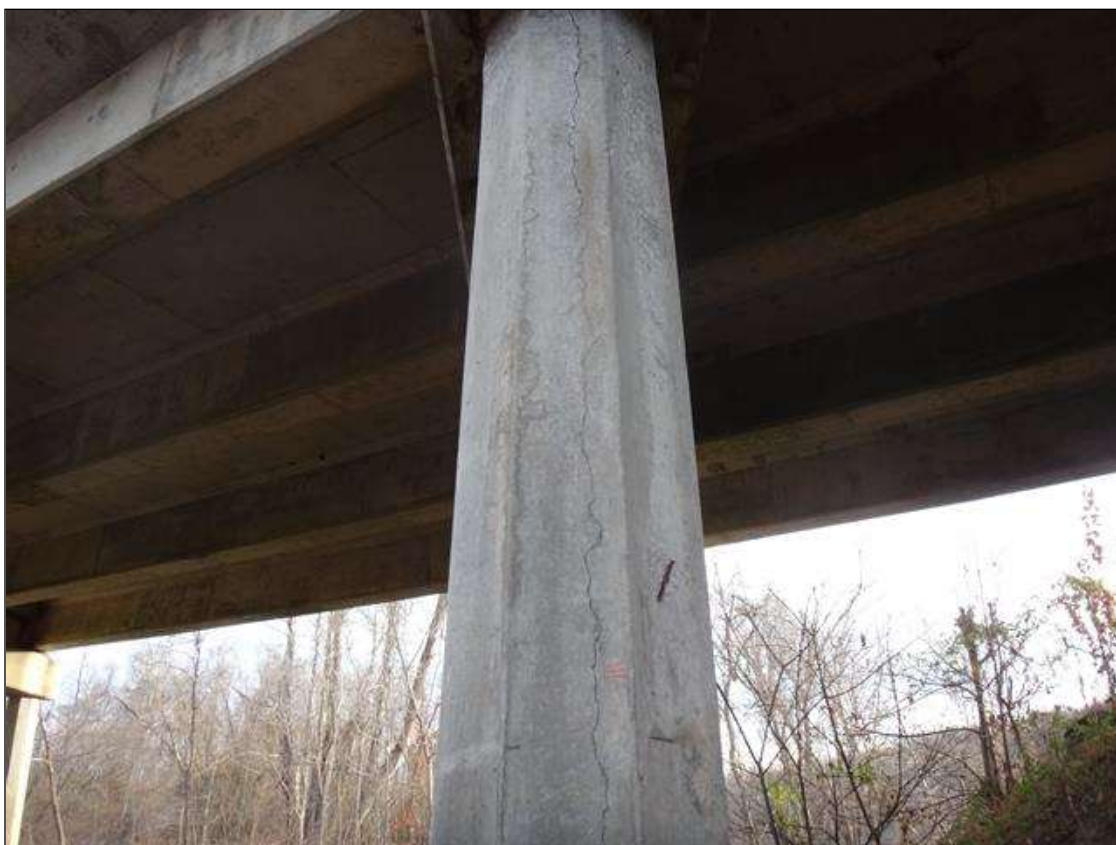
Bent 1 Pile 1: 1/32" vertical/horizontal cracks up to full height on south and north faces of column starting at bottom of cap.

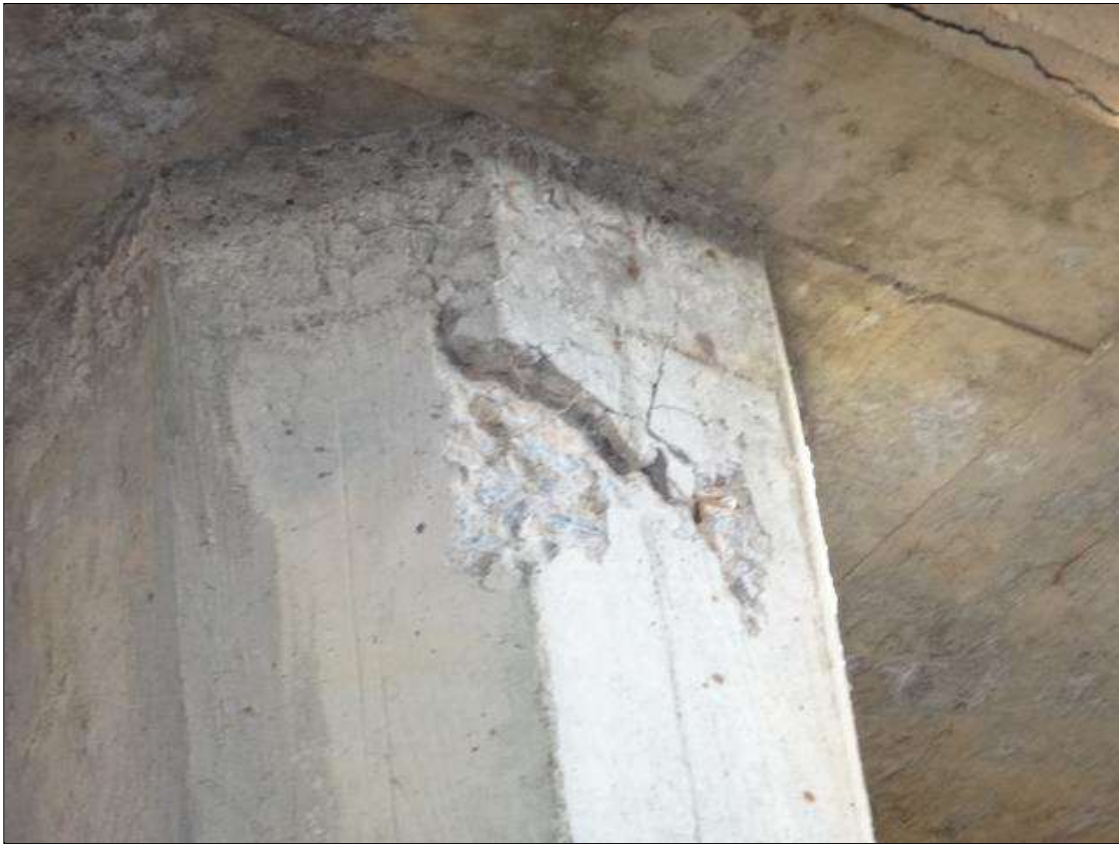
Bent 1 Pile 3: 6" high x 8" wide x 1" deep Delamination/ spall no exposed steel, at top of south face of column.

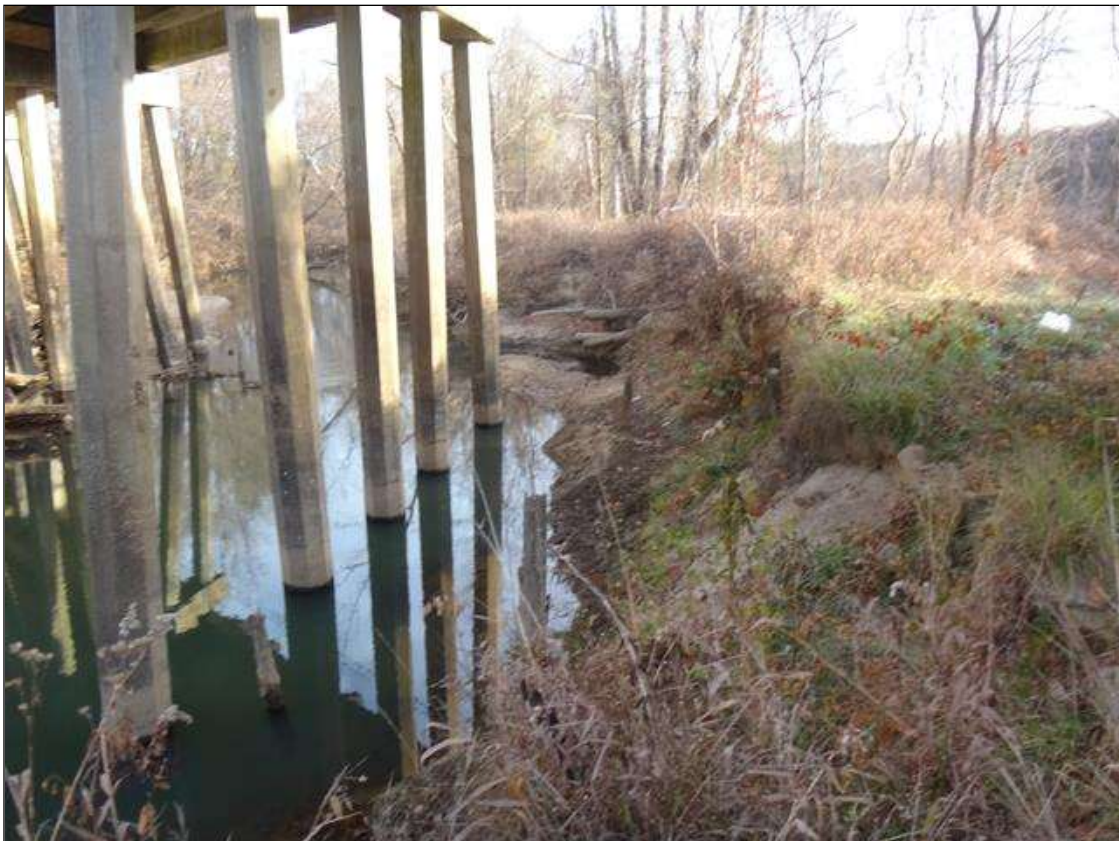
south streambank at bent, scour (75ft x 10ft x 8ft)

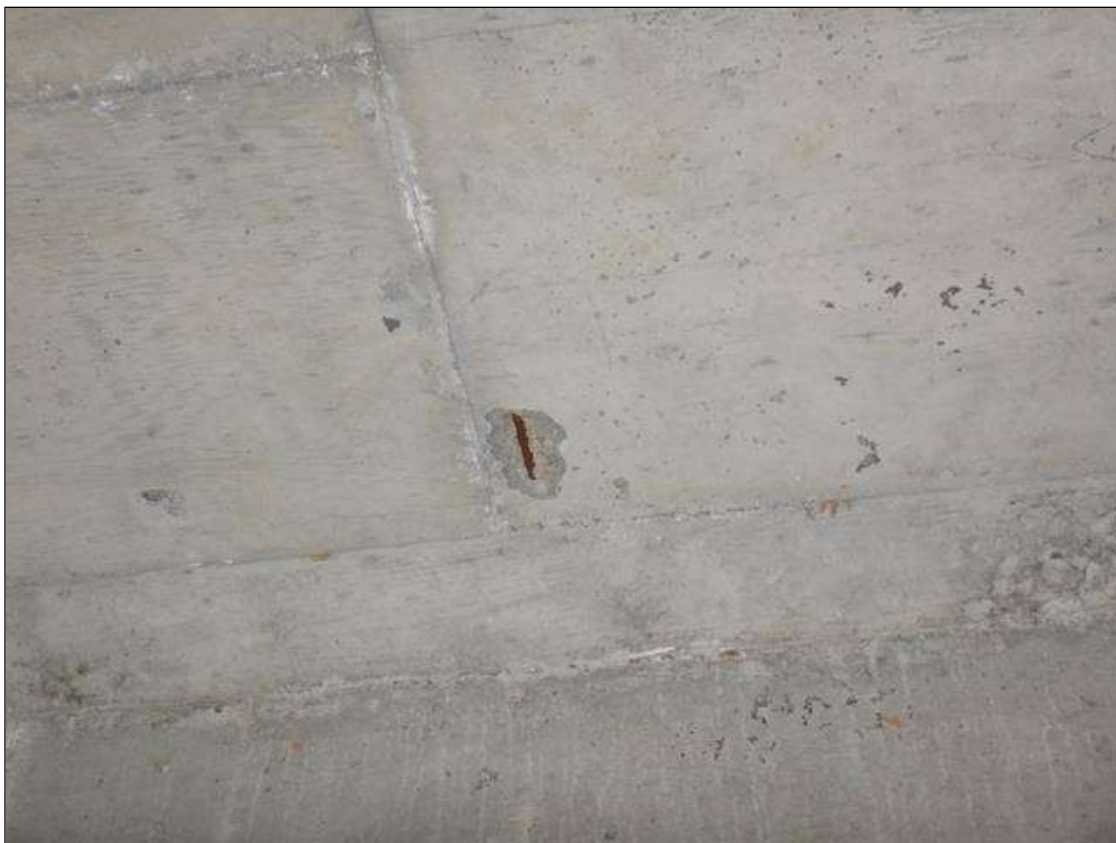
Span 1 Deck: Bottom of deck, bay 3, 12' from End Bent 1, Spall with Exposed Steel, no Section Loss in rebar, (5" x 3" x 1/2" deep.)

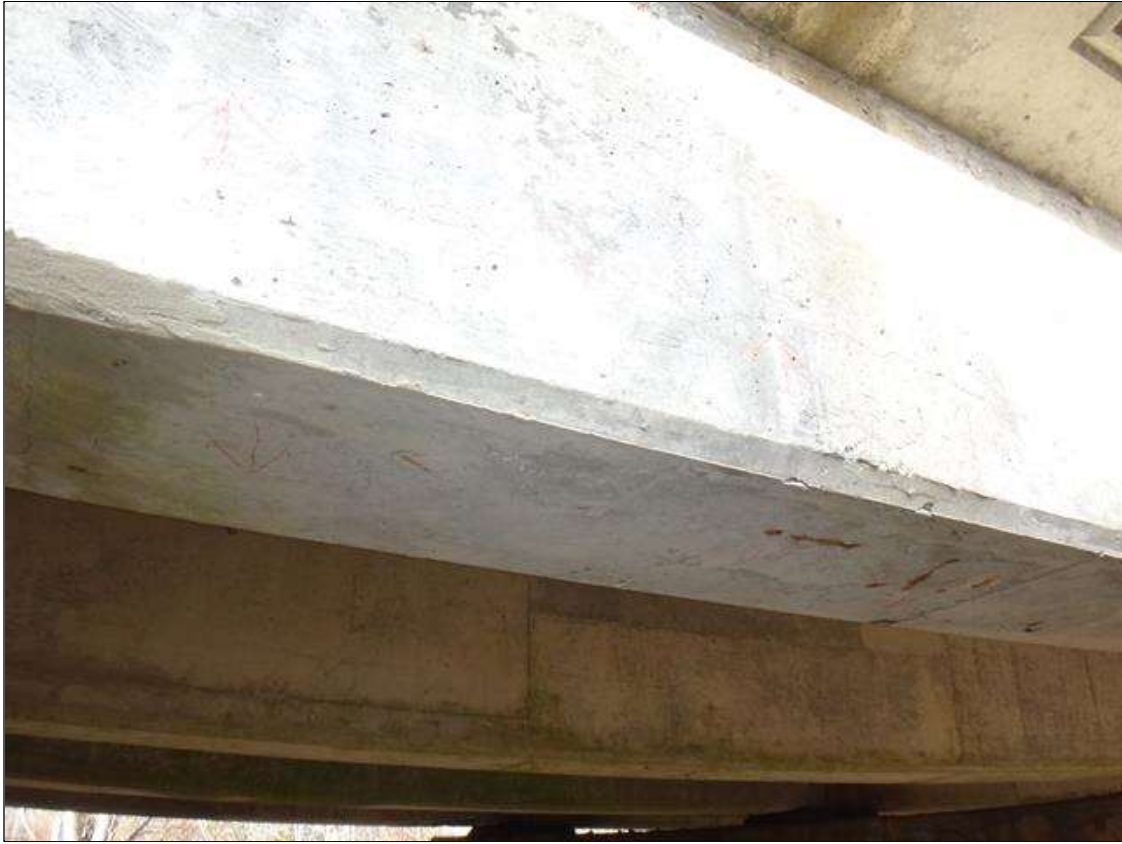
Span 1 Beam 4: underside and east face near end bent 1, multiple longitudinal and horizontal cracks (up to 6ft x 1/32in)

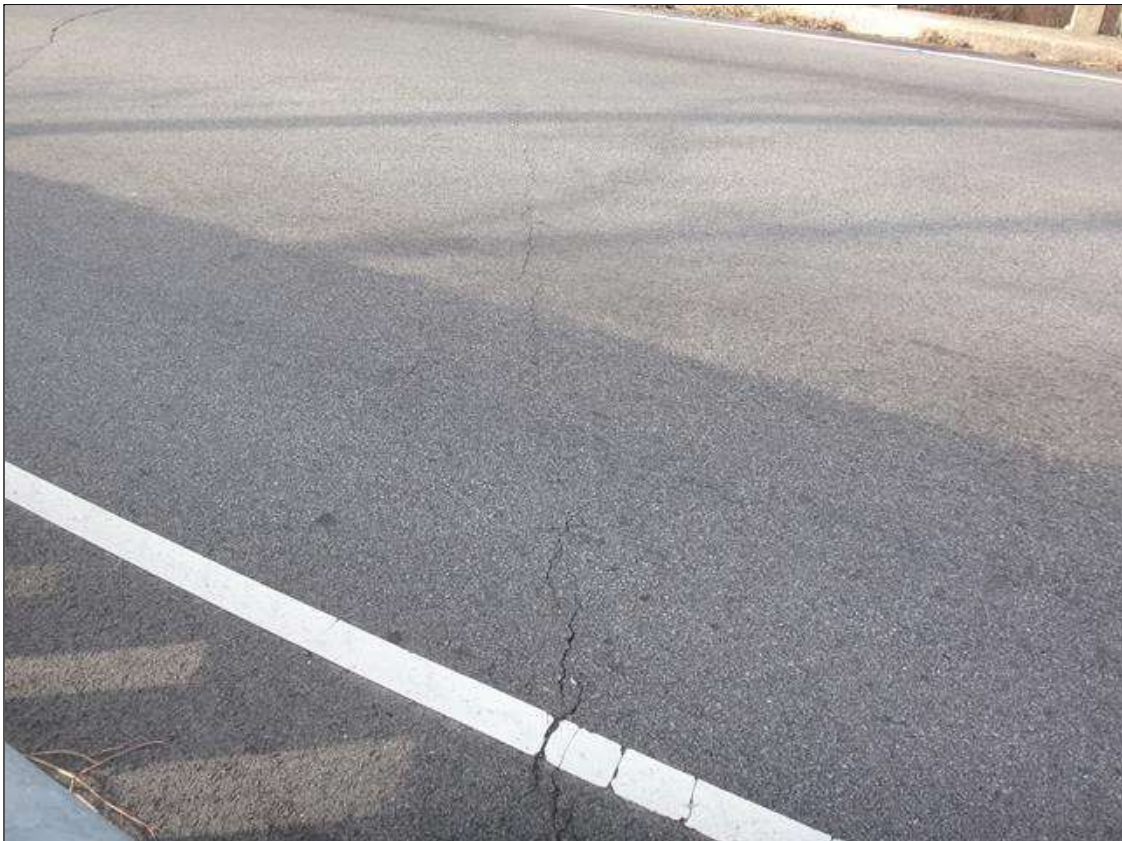
Span 1 Wearing Surface: at end bent 1, transverse crack (full width x 1/16in)

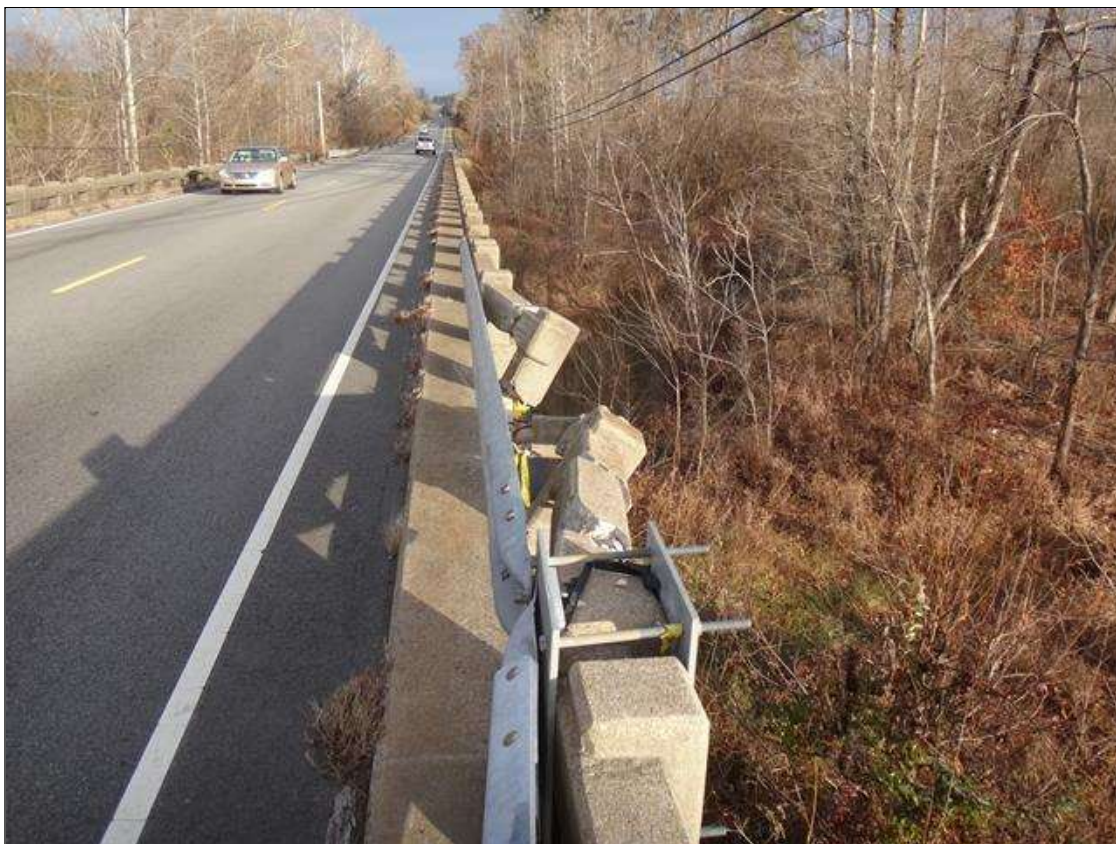
Span 1 Right Bridge Rail: (PAR) near end bent 1, impact damage (18ft) steel guardrail in place but no post

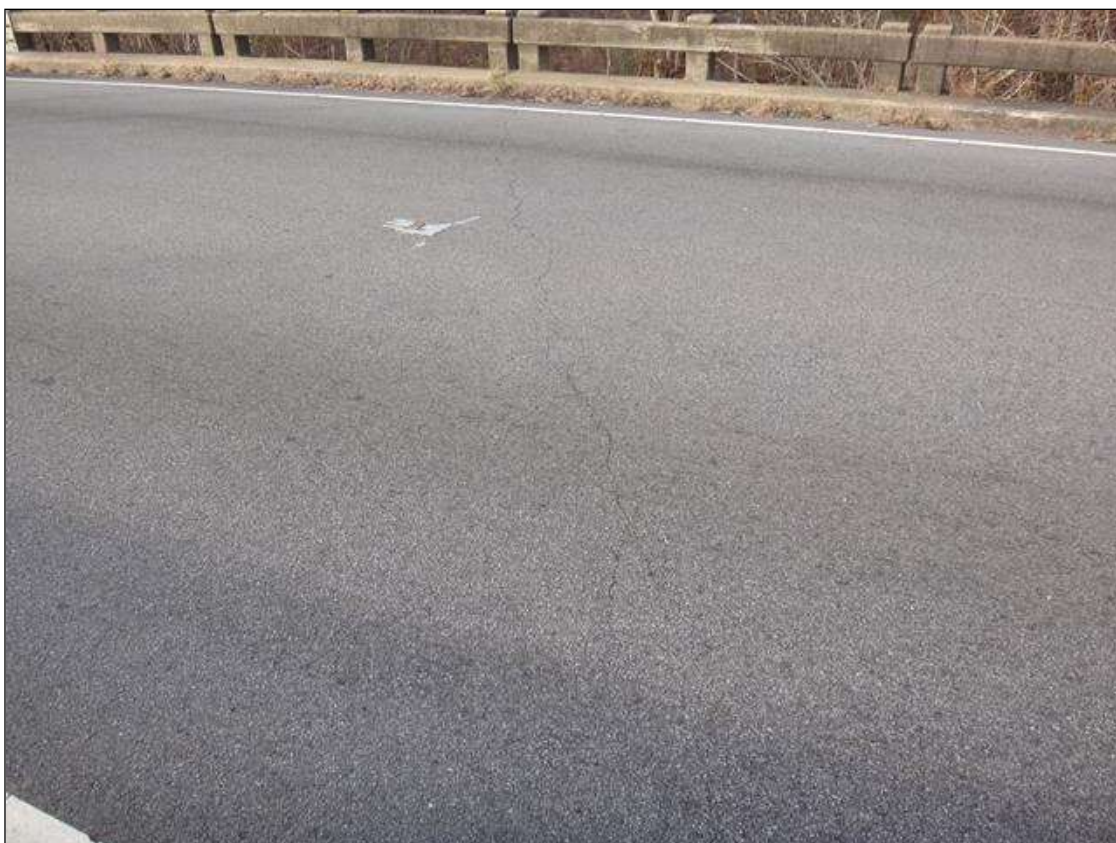
Span 2 Wearing Surface: bent 1, transverse crack (full width x 1/16in)

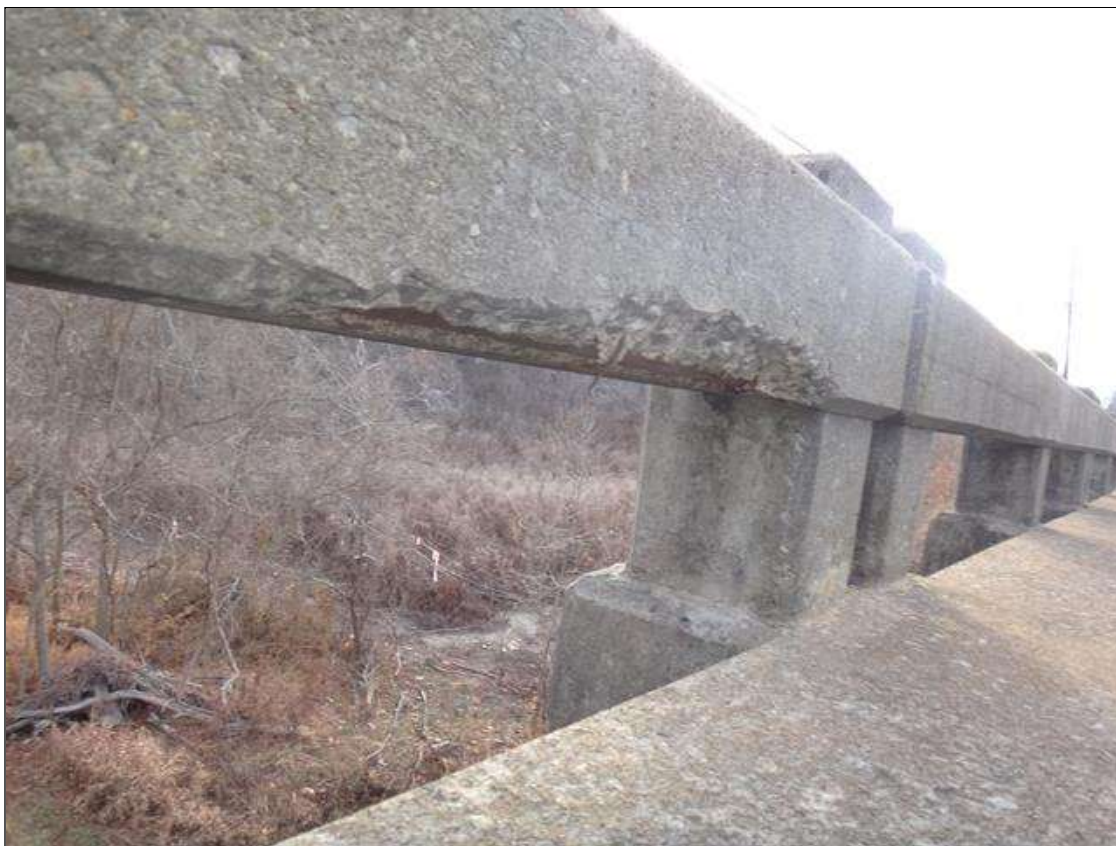
Span 2 Right Bridge Rail: 32" x 3" x 2 1/2" deep spall with exposed rebar with no measurable section loss on underside of top rail, 10' from pier 2.

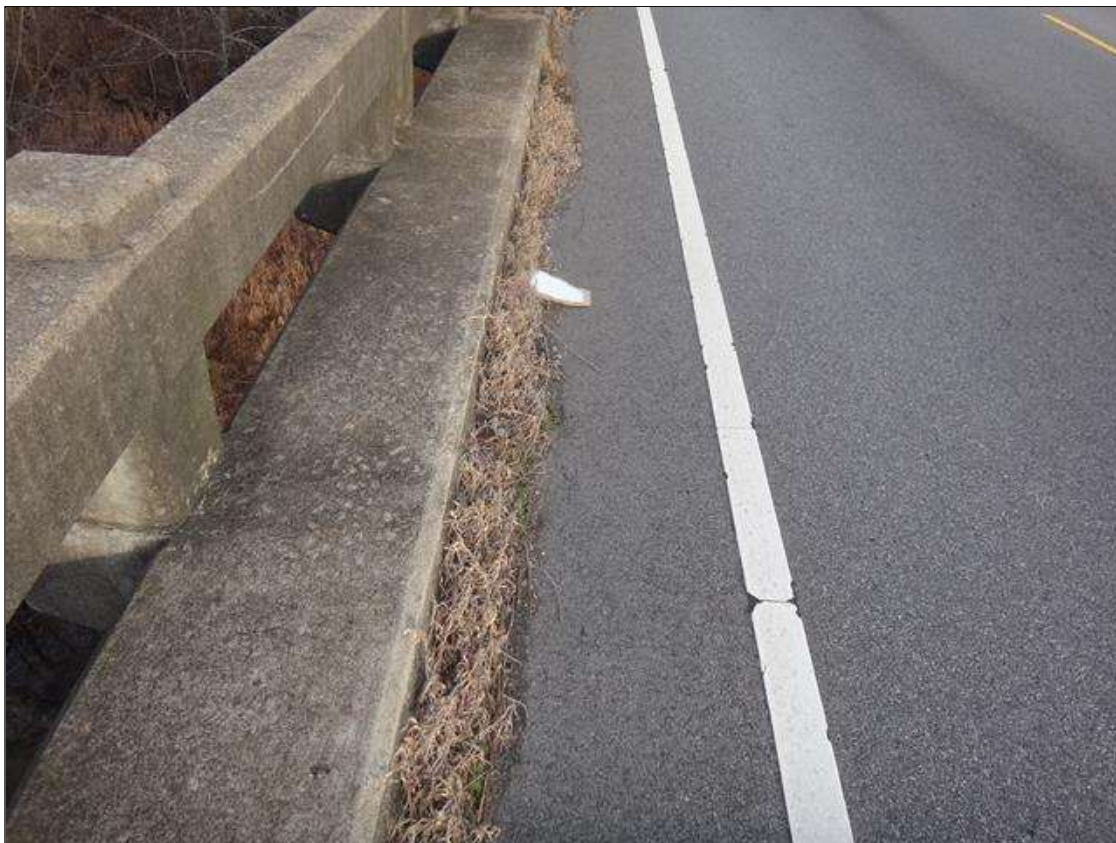
west shoulder, debris accumulation/vegetation growth (full length x 1ft) partially blocking drains

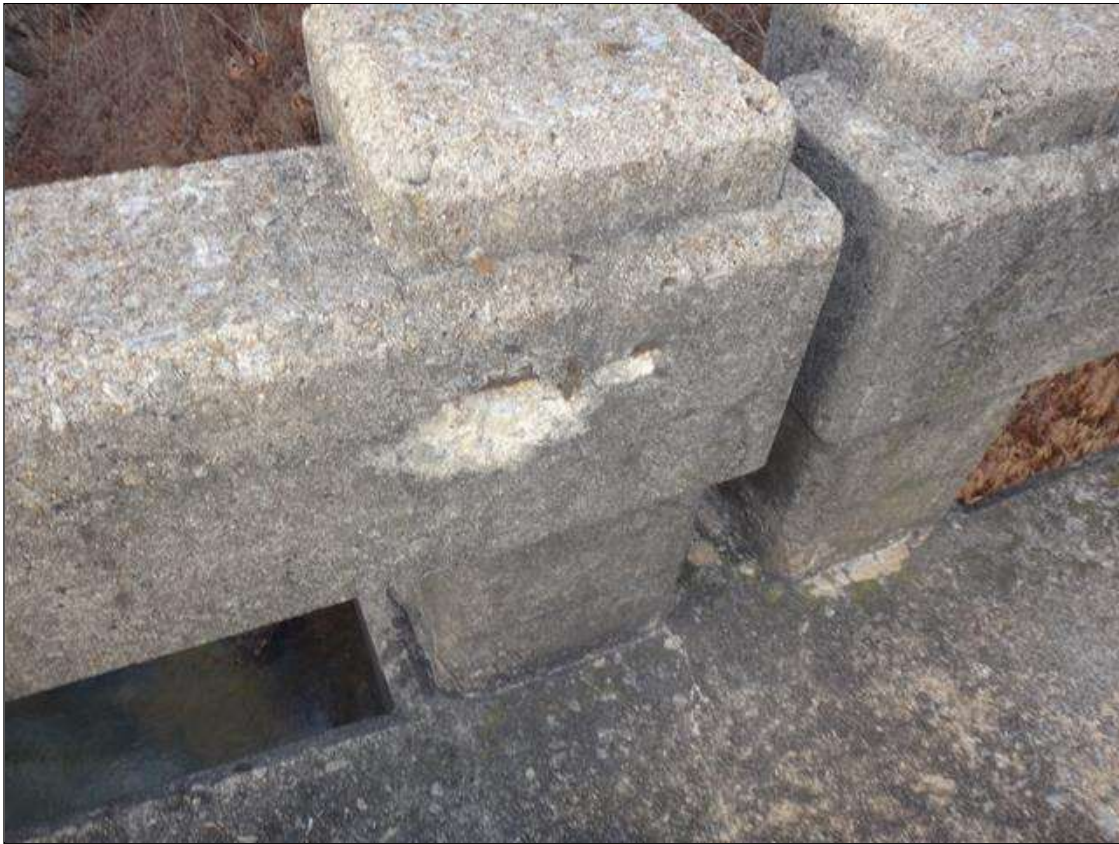
Span 3 Left Bridge Rail: 6" x 3" x 1" deep spall with exposed rebar with no measurable section loss in rail at Post 6.

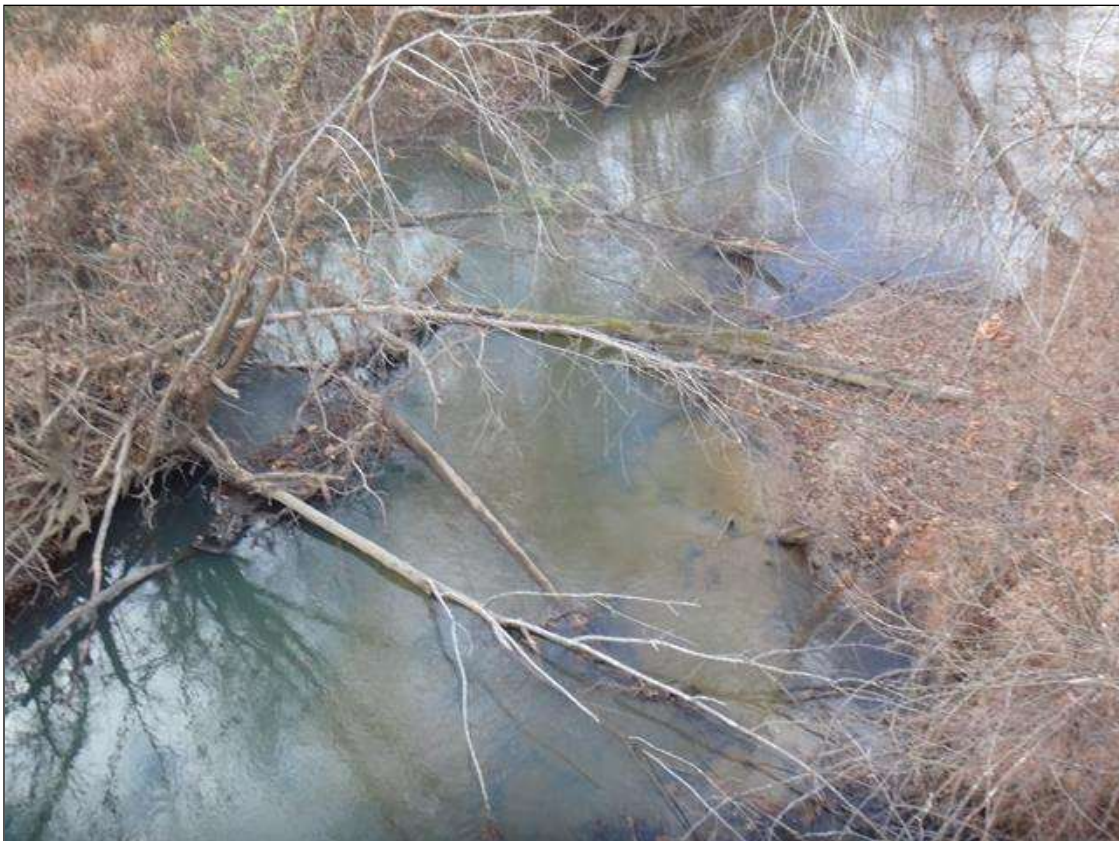
75ft upstream, multiple trees blocking waterway

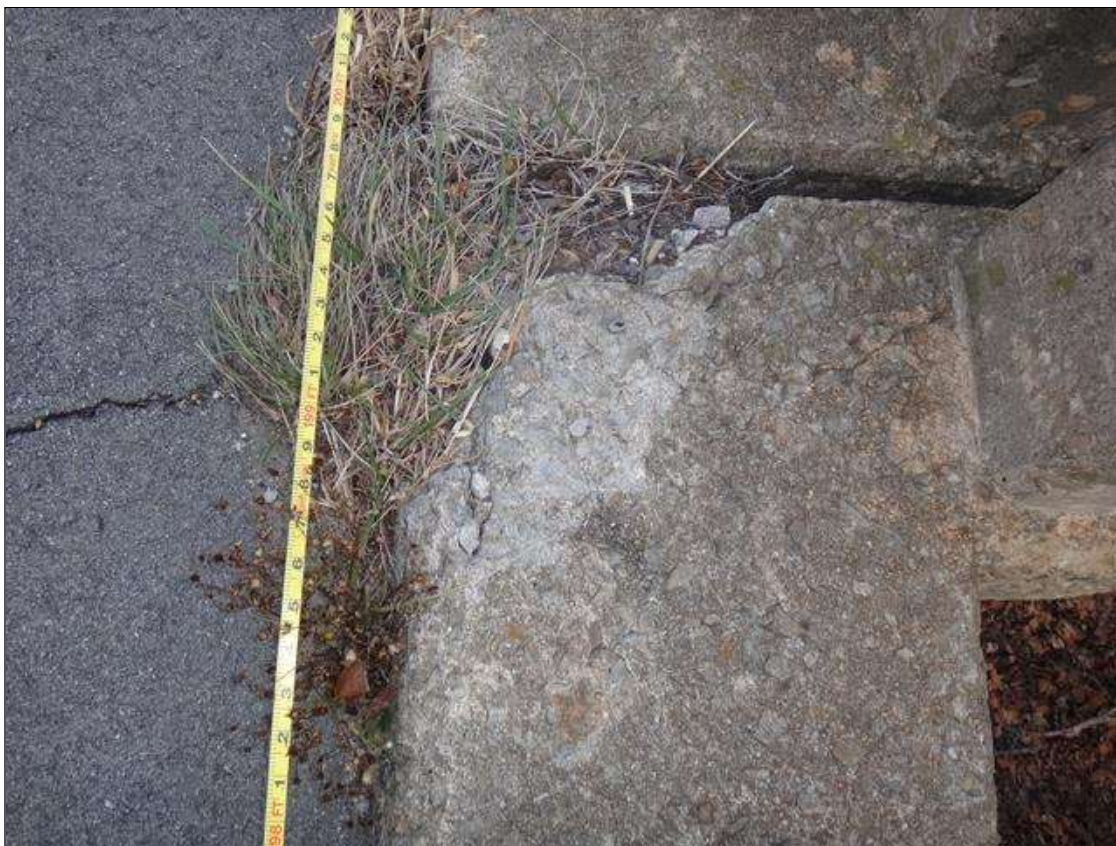
Span 5 Right Bridge Rail: 14" x 13" x 2 1/2" deep spall with exposed rebar with no measurable section loss in curb at pier 5.

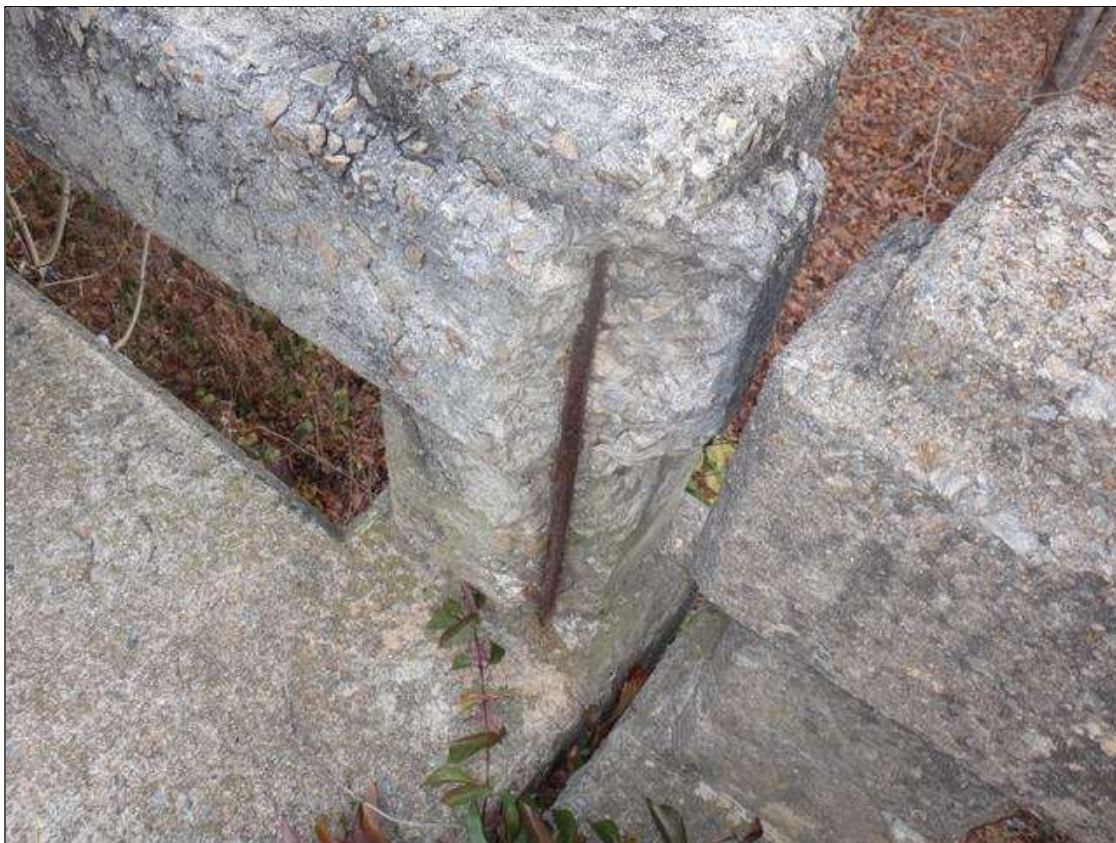
Span 7 Right Bridge Rail: 2' high x 4" x 2" deep spall with exposed rebar with no measurable section loss in rail post at pier 6.

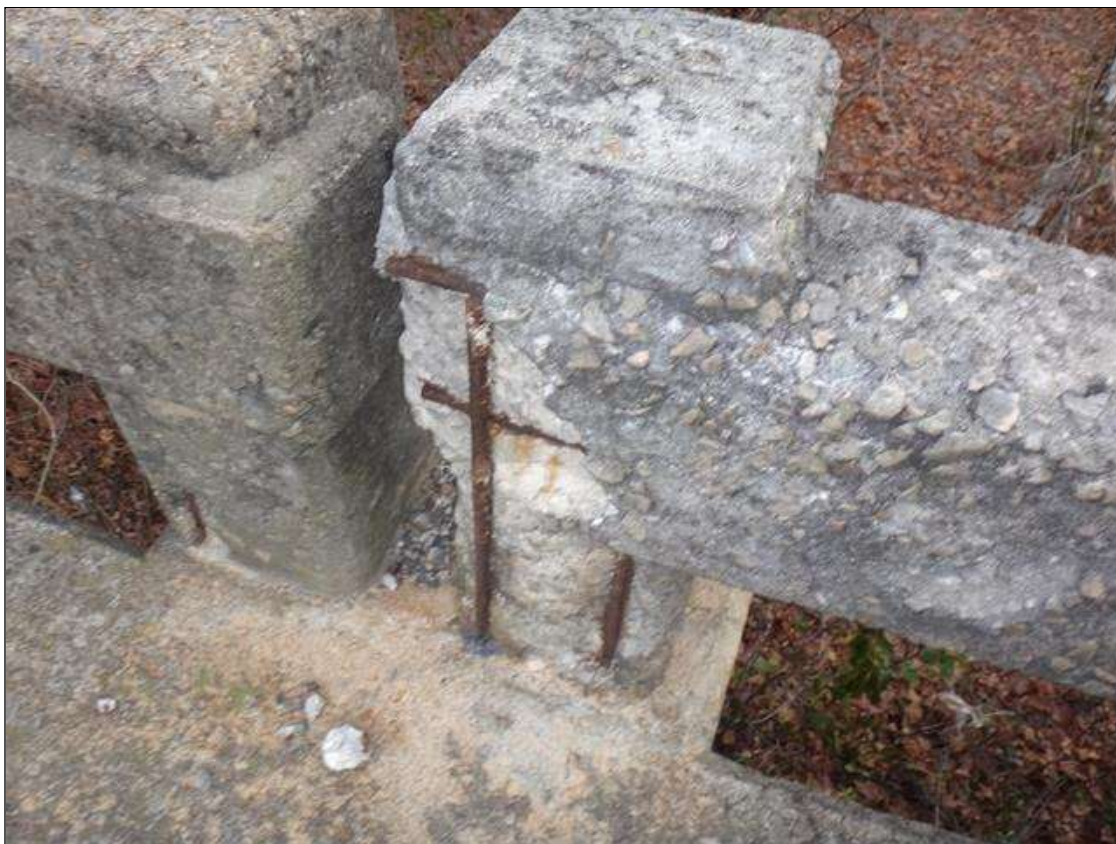
Span 7 Right Bridge Rail: Post #3, Spall with Exposed Steel with Section Loss in rebar 3/8" Remaining, (1.5' high x 9" wide x 2" deep.)

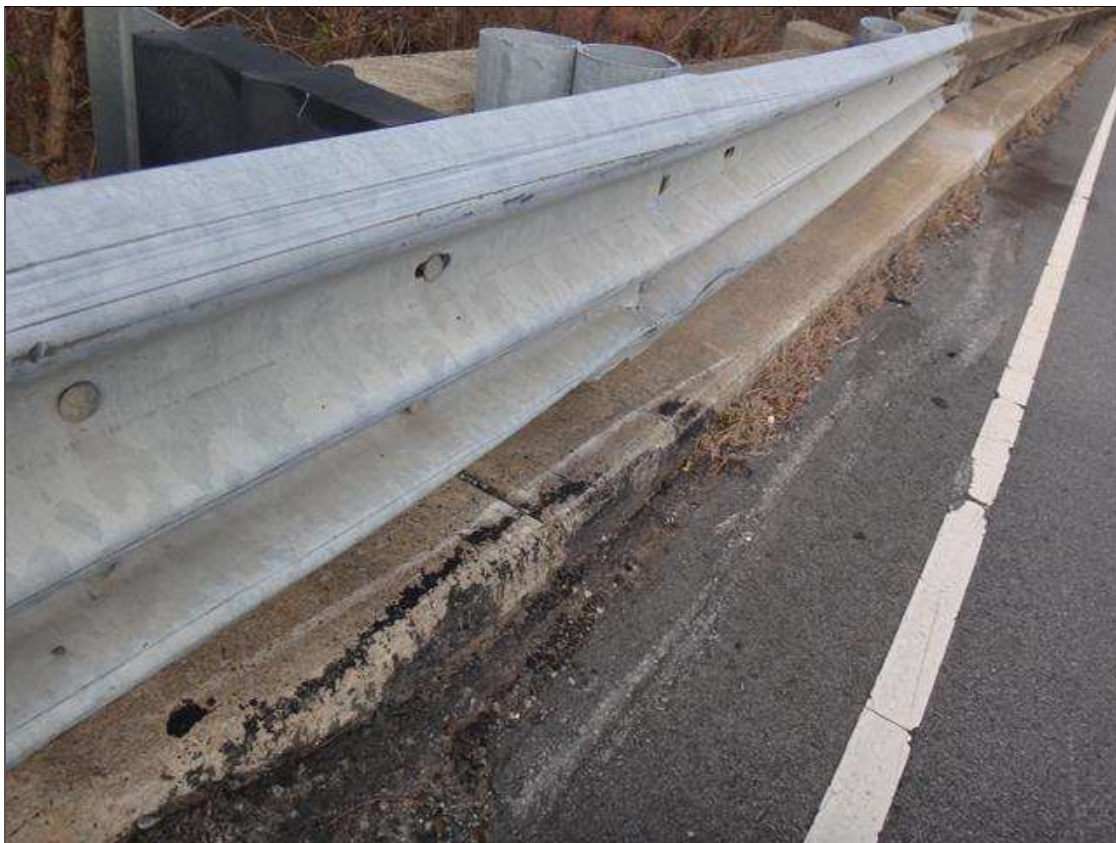
southwest guardrail at end bent 1, impact damage (6ft)
