NC DEPARTMENT OF TRANSPORTATION
 DIVISION OF HIGHWAYS
 STRUCTURE MANAGEMENT UNIT

ATTENTION: **PAR SUBMITTED
 CHANGES TO STRUCTURE DATA**

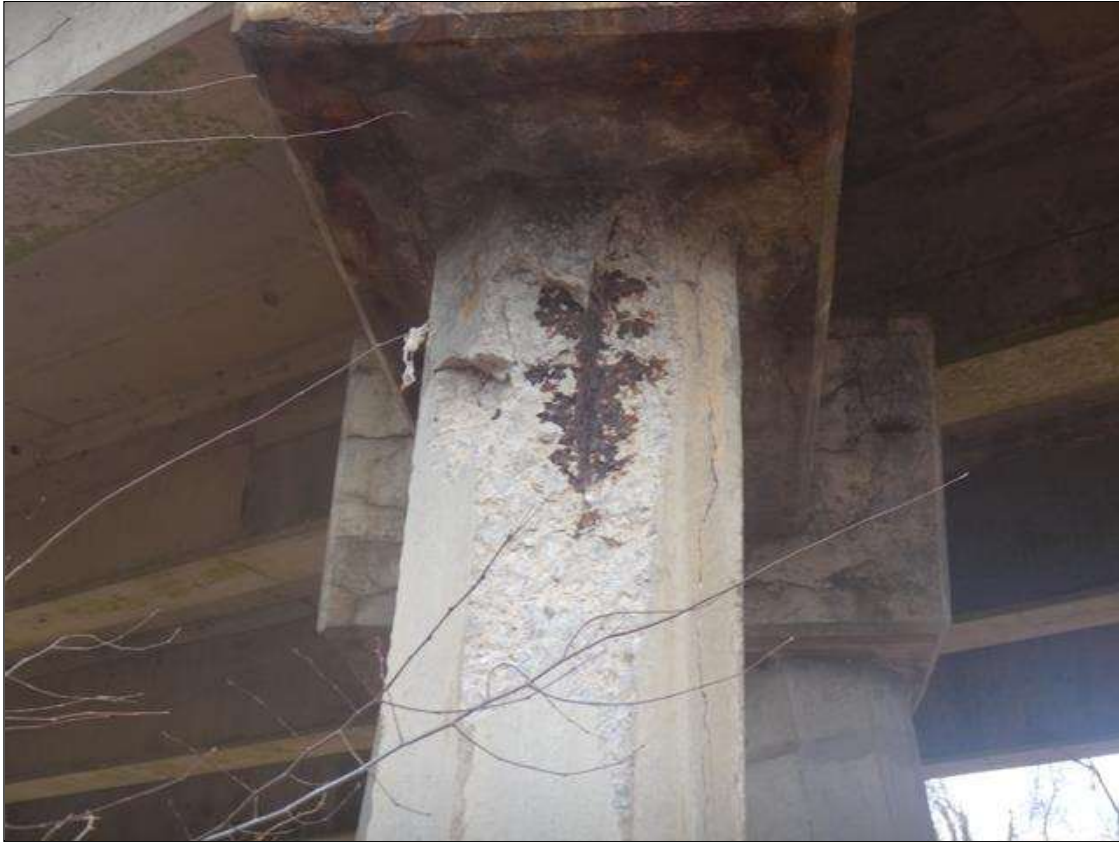
Bent 4 Pile 1: (PAR) starting at bottom of cap, West face, Spall with Exposed Steel with Section Loss 1/8" deep, (20" h. x 12" wide. x 2-1/2" deep,) South face has Delamination (5' long x 20" wide) with 1/8" wide cracking.

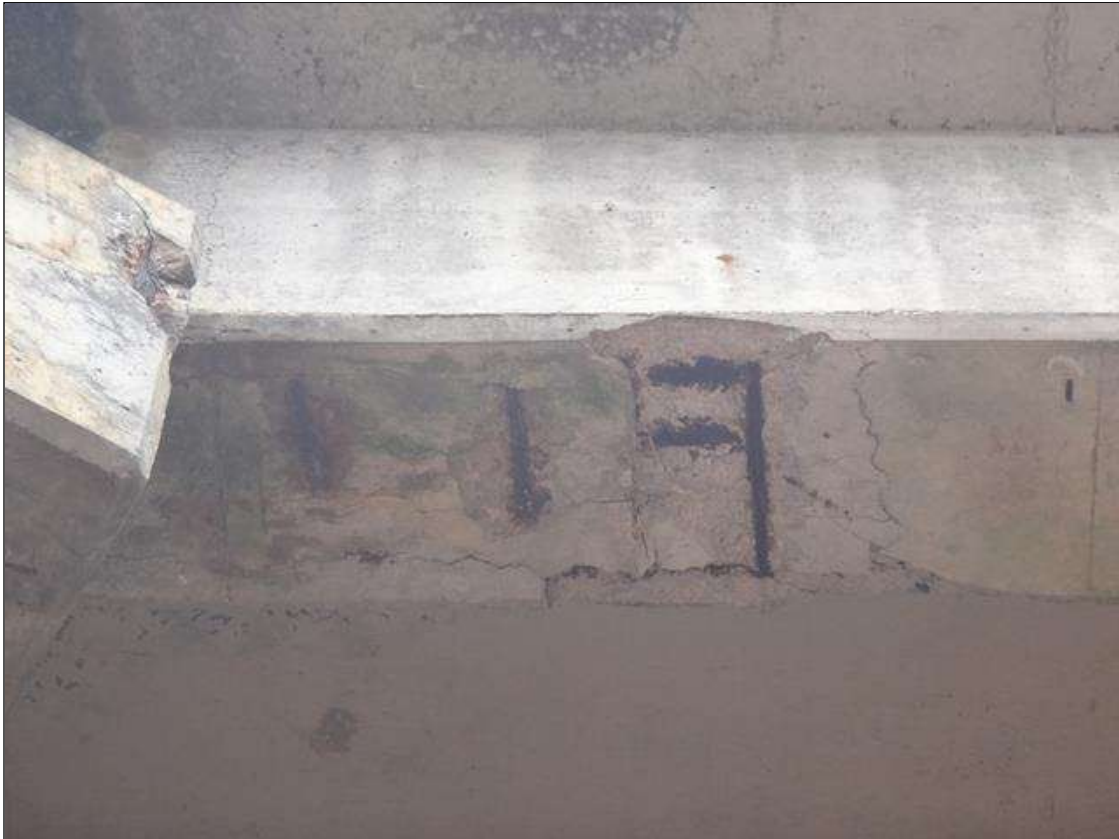
Span 5 Beam 4: (PAR) at pier 4, (5' long x 1.5' wide x 4" deep,) area of Delamination/ Spall with exposed rebar with section loss 1/8" deep.

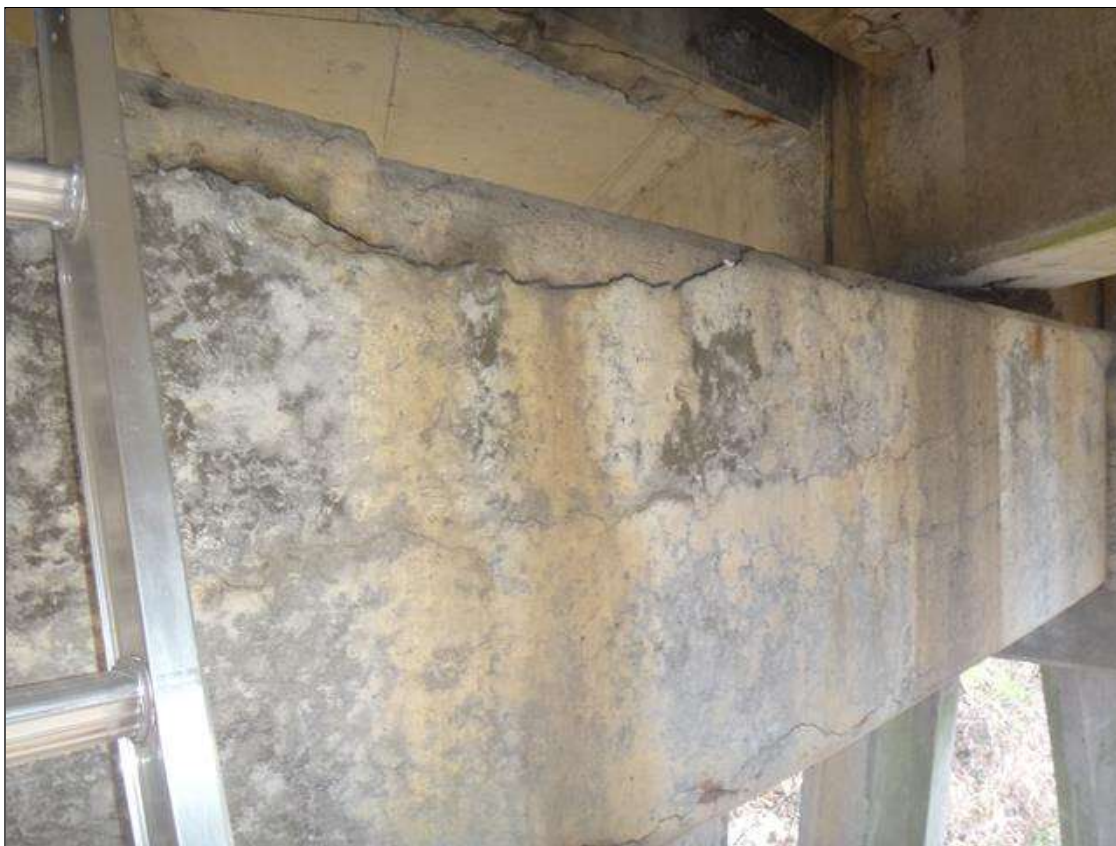
Bent 4 Cap 1: Several 1/8" to 1/4" horizontal cracks up to 10' long scattered throughout south and north faces of cap and cross caps.

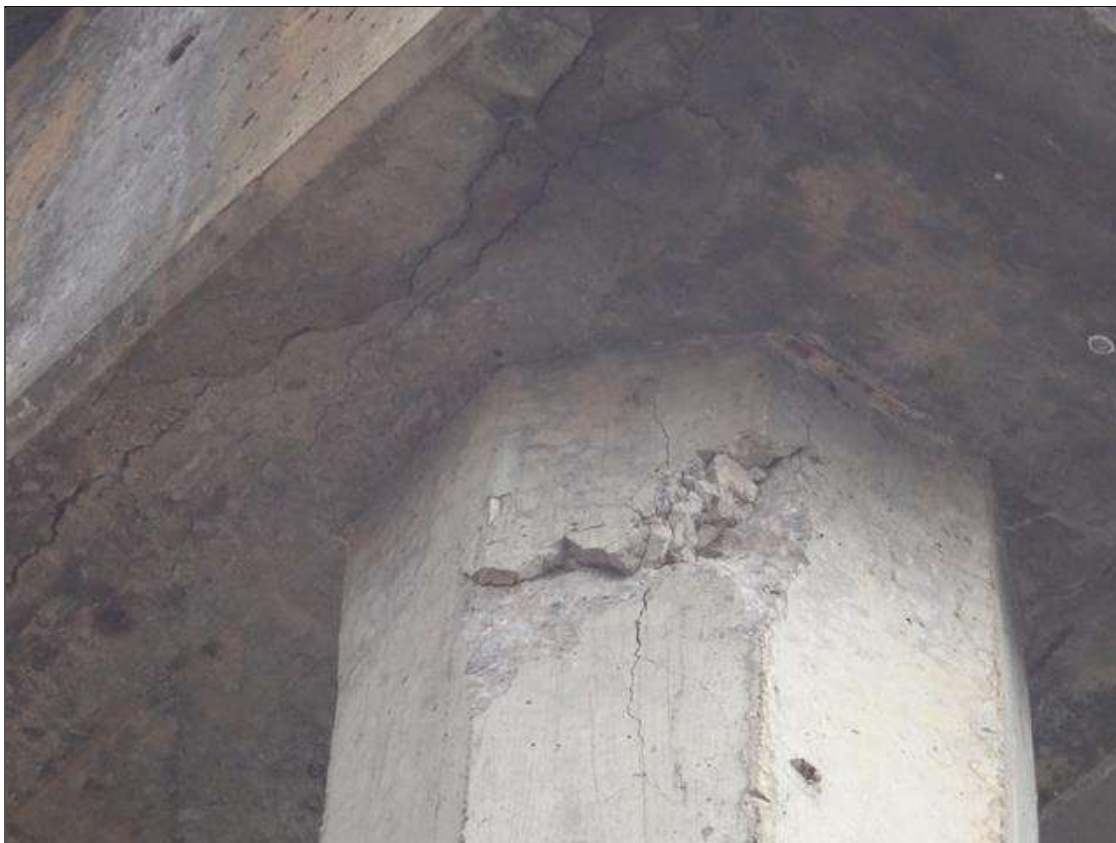
Bent 3 Pile 1: top of pile, west face, Spall no exposed steel, (8" h. x 10" wide. x 1" deep.)

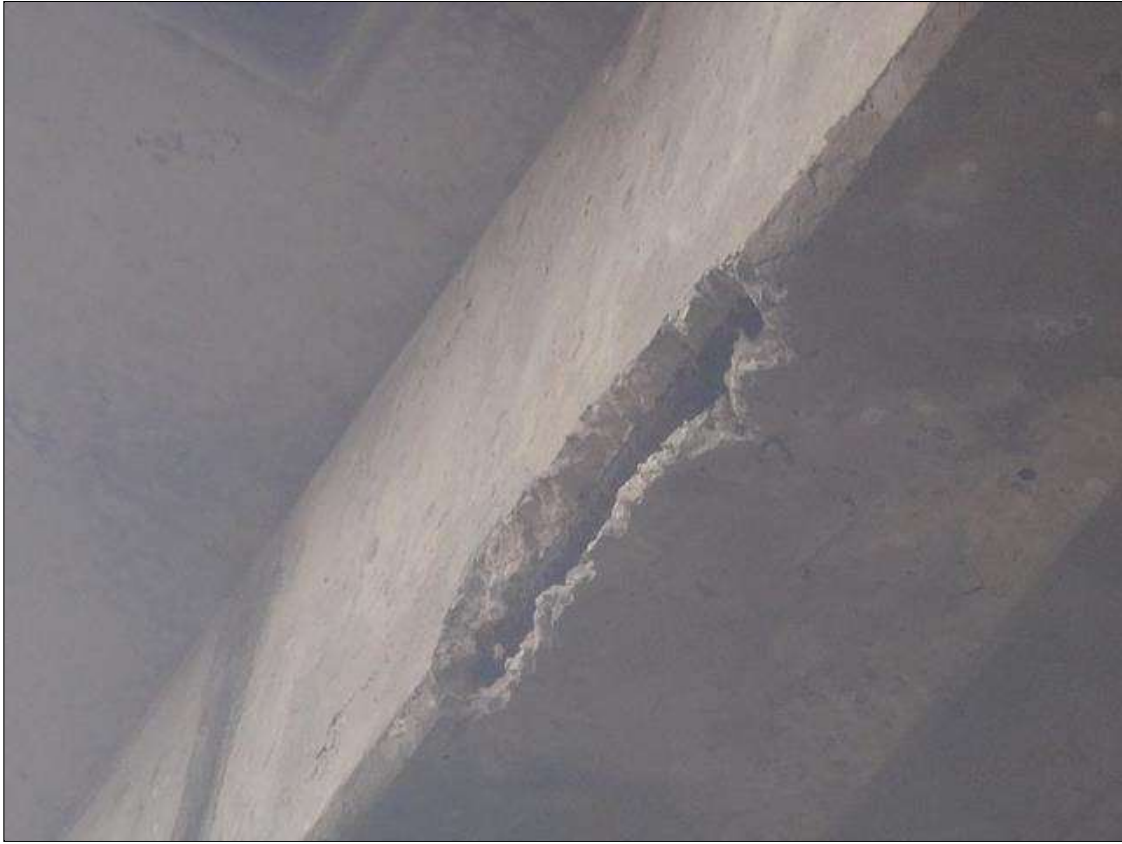
Span 3 Beam 4: (PAR) 3' long x 4" wide x 1" deep spall with exposed rebar with no measurable section loss at mid span bottom east corner.

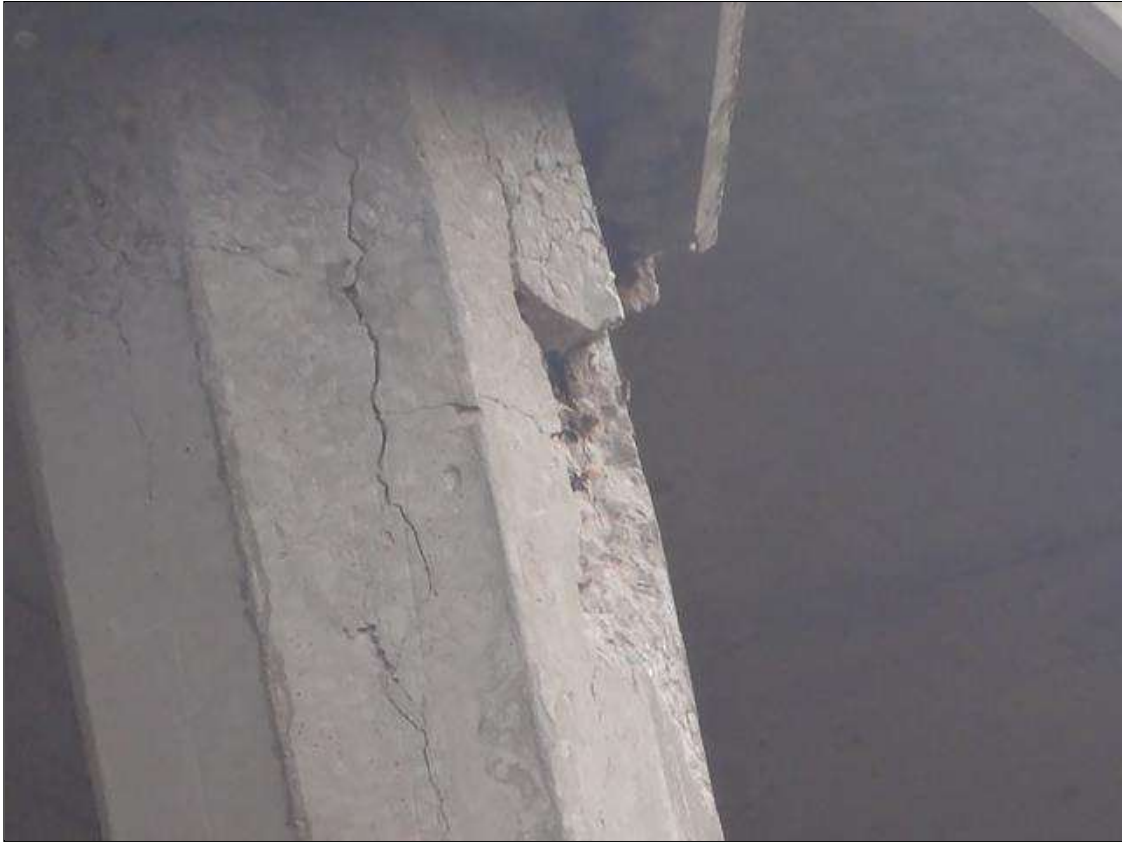
Bent 2 Pile 1: (PAR) west/south faces of column starting at bottom of cap, 5' long x 20" wide area of delamination with cracks up to 1/8" wide and a 2' high x 10" wide x 1.5" deep spall with exposed rebar with section loss 1/8" deep. (photo 1 of 2)

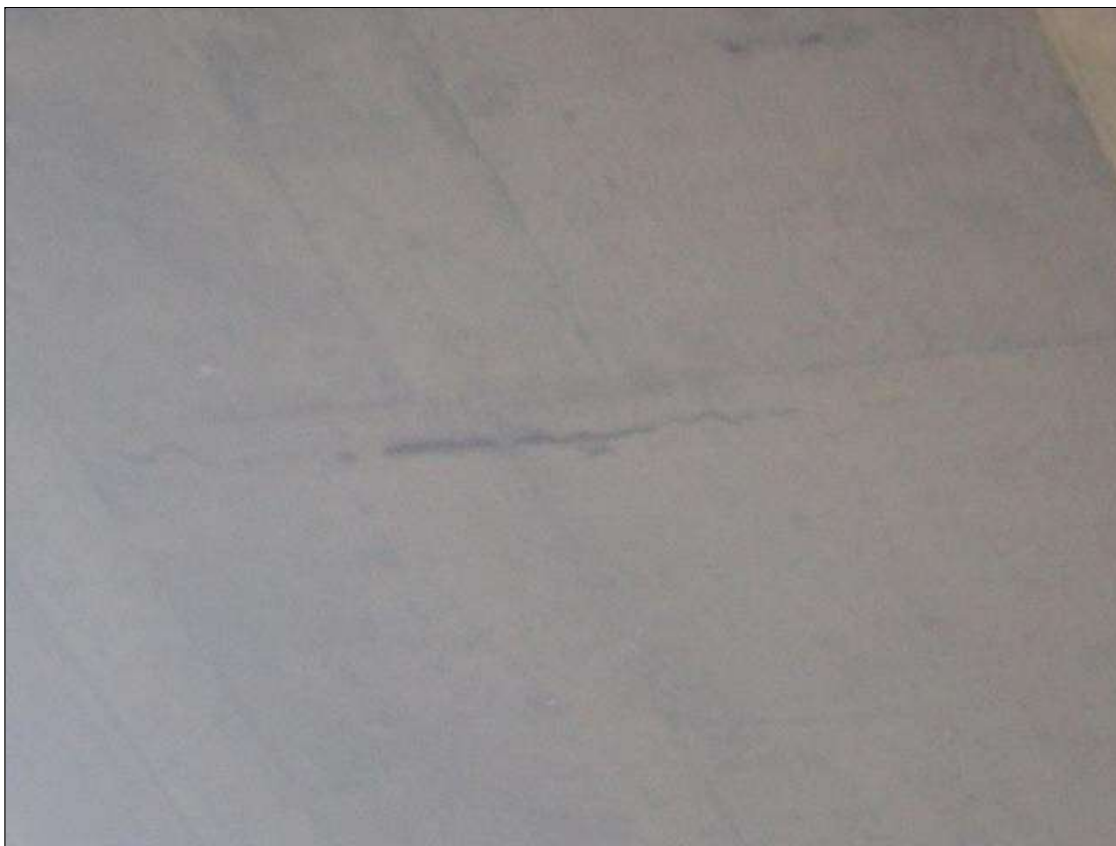
Span 3 Deck: bay 3 underside 15ft from bent 2, spall/delamination (6ft x 2in x 1/2in) with exposed rusted rebar

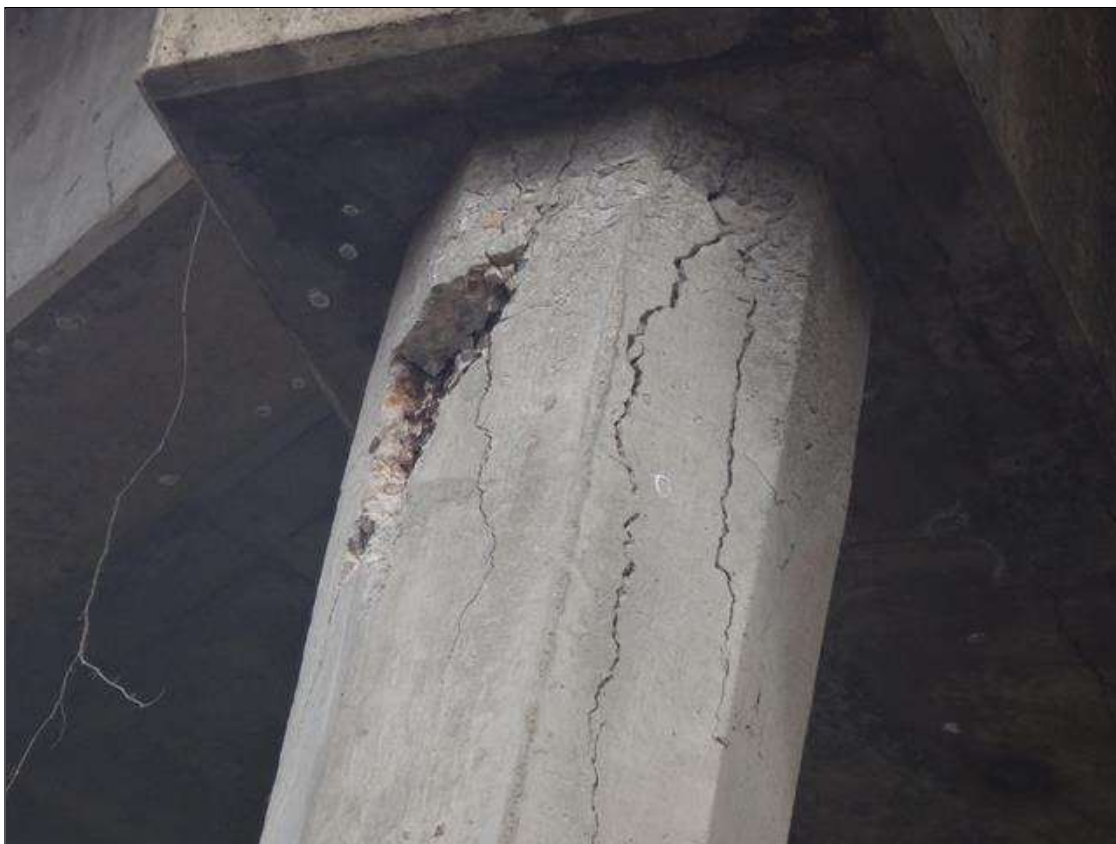
Bent 2 Pile 1: (PAR) west/south faces of column starting at bottom of cap, 5' long x 20" wide area of delamination with cracks up to 1/8" wide and a 2' high x 10" wide x 1.5" deep spall with exposed rebar with section loss 1/8" deep. (photo 2 of 2)

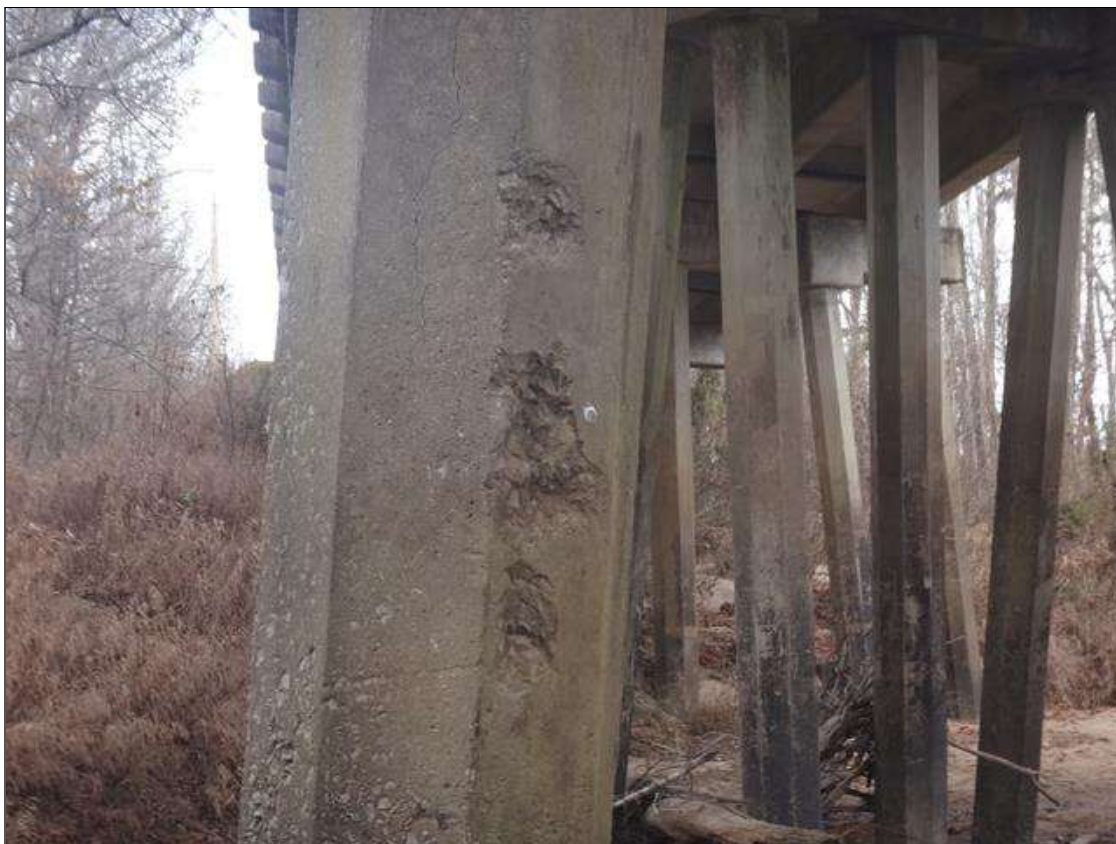
Bent 2 Pile 1: south face near mid height, multiple spalls (up to 8in diameter x 1in)

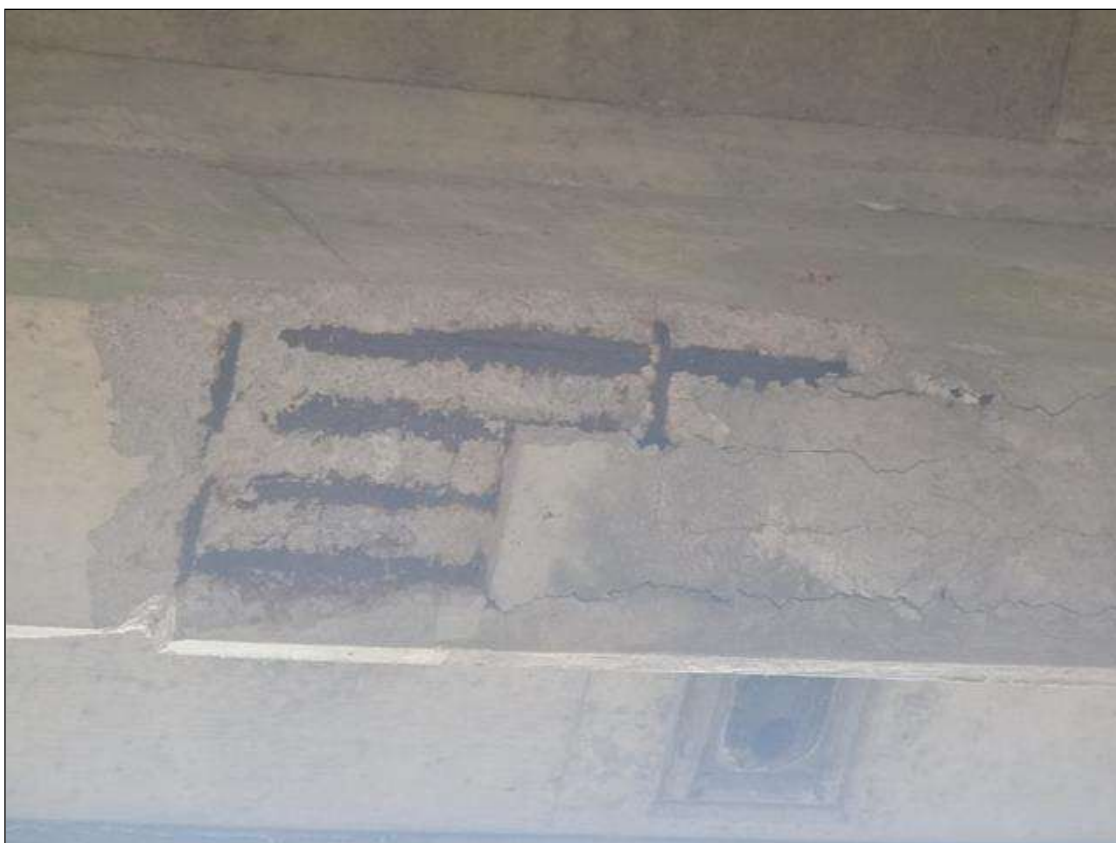
Span 2 Beam 1: (PAR) at 12' from pier 2, bottom of girder has Delamination (5' long x 1.5' wide x 2" deep,) and Spall with Exposed Steel, no measurable section loss, (30" long. x 4"h. x 2" wide.)

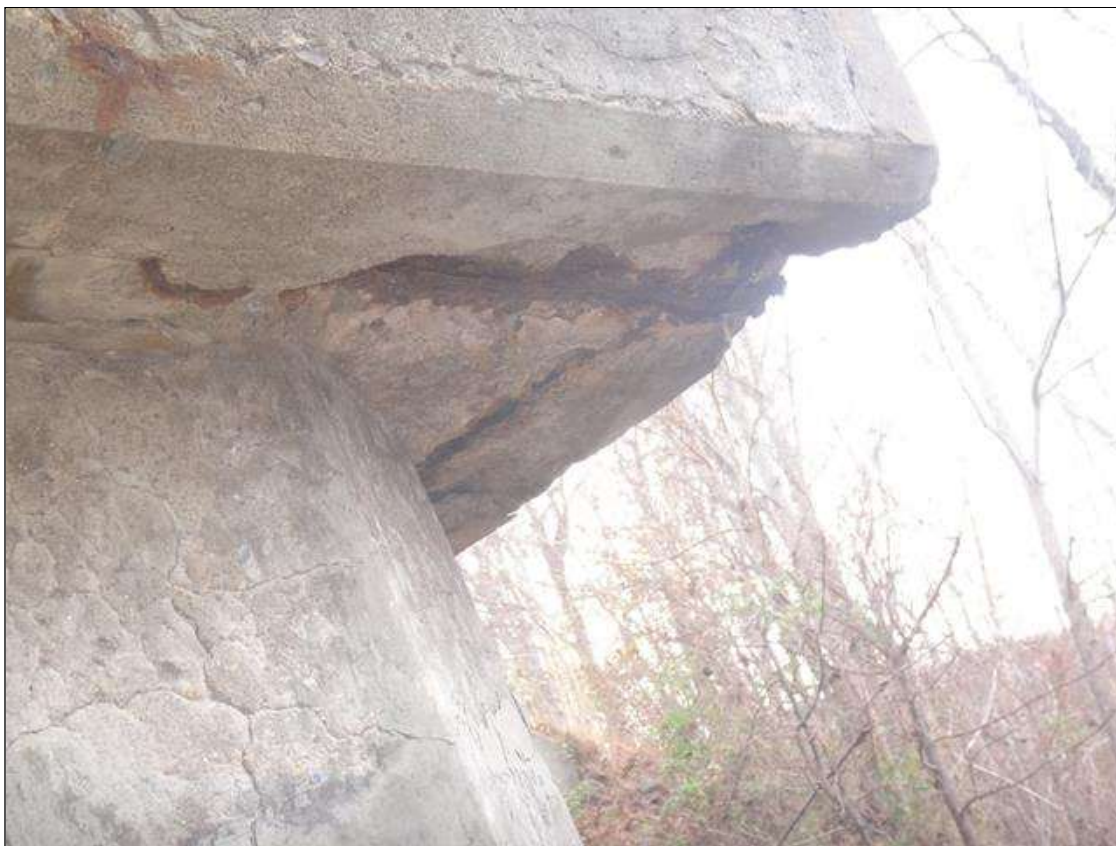
Bent 1 Cap 1: 4" diameter spall 1/4" deep in bottom of cap bay 1 at column 1.

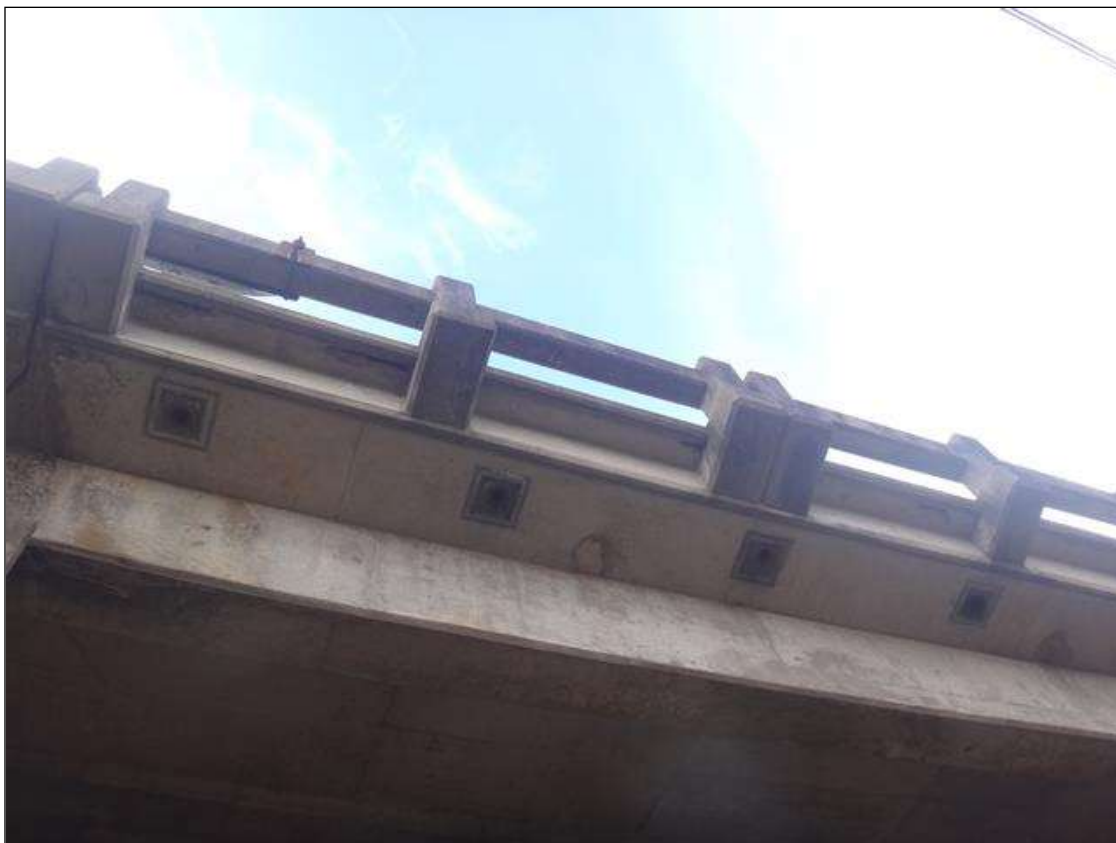
Span 2 Deck: Bottom of deck, East overhang near Bent 1,(4) spalls with exposed rebar, no Section Loss, (2' long x 4" wide. x 1" deep.)

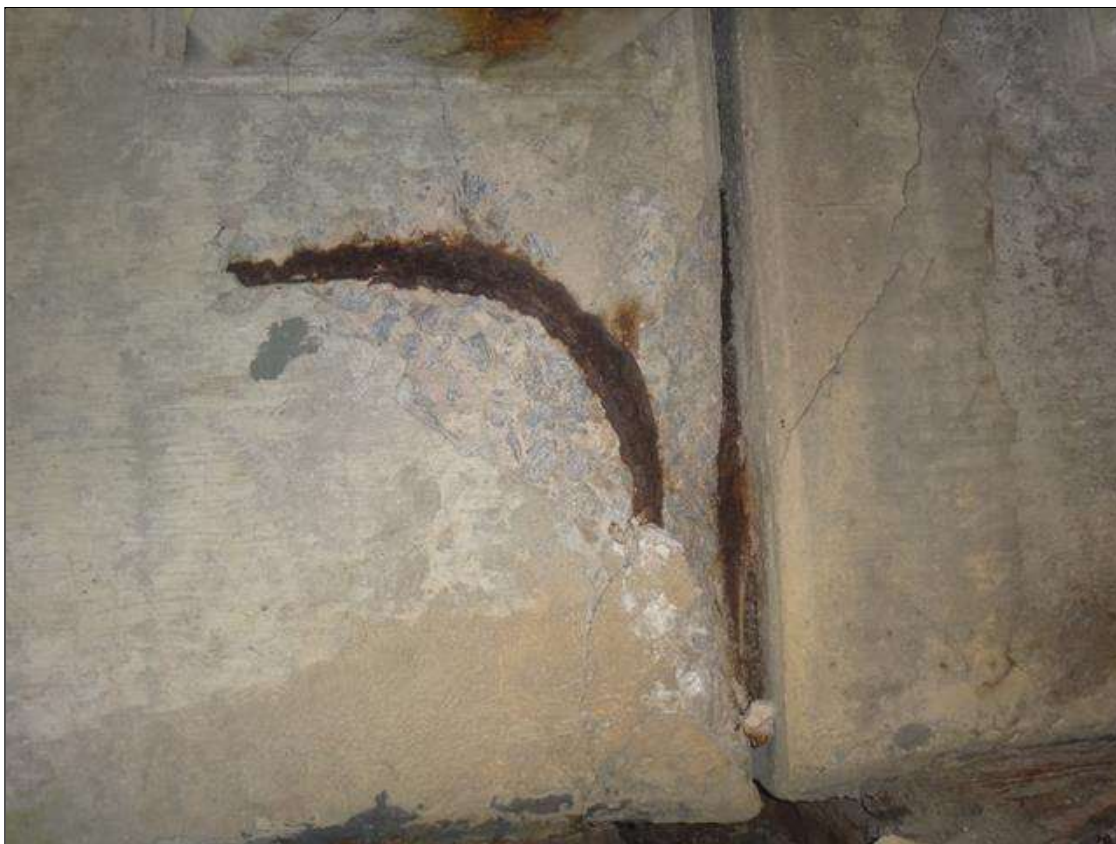
Span 2 Beam 3: over pier 1, west face of girder, Spall with exposed rebar with no measurable section loss (12" x 8" x 1" deep,) and Delamination (12" h. x 5" long x 2" deep.)

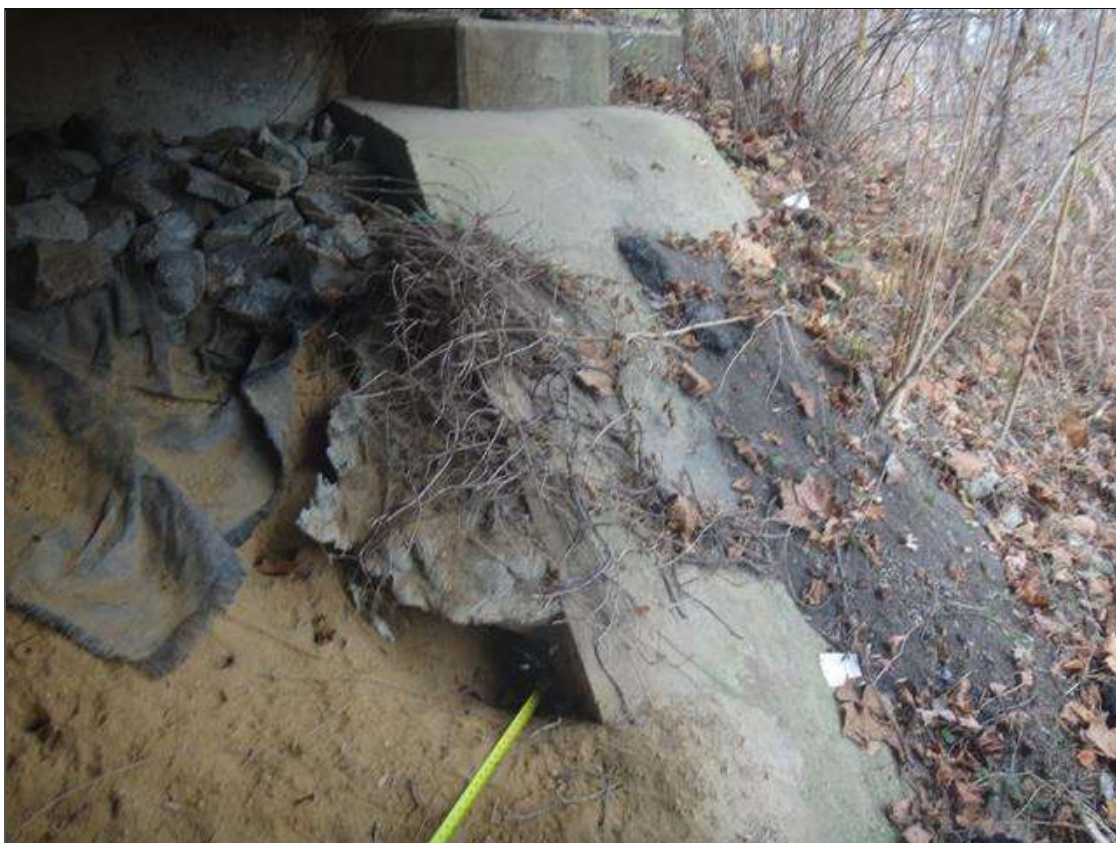
end bent 2 slope protection flume, undermining (up to 3ft x 1ft)

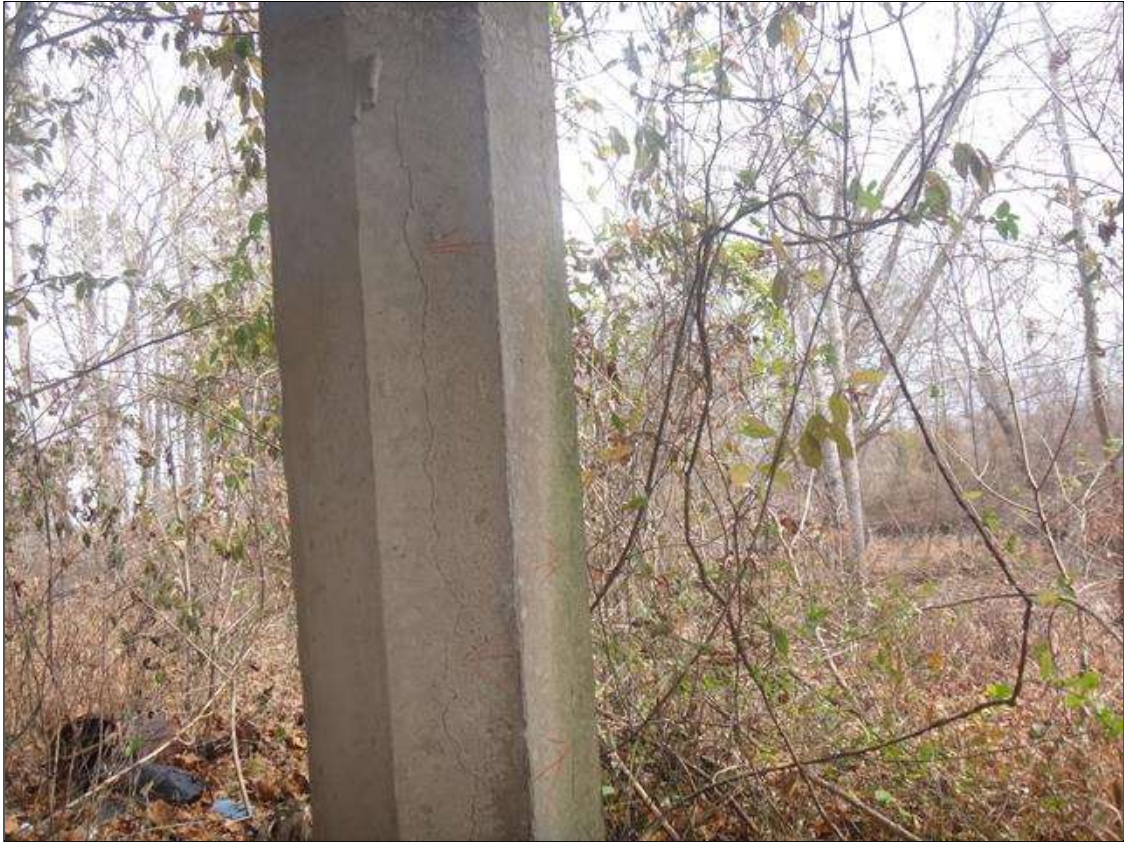
Bent 6 Pile 5: all faces, multiple vertical cracks (full height x up to 1/16in)

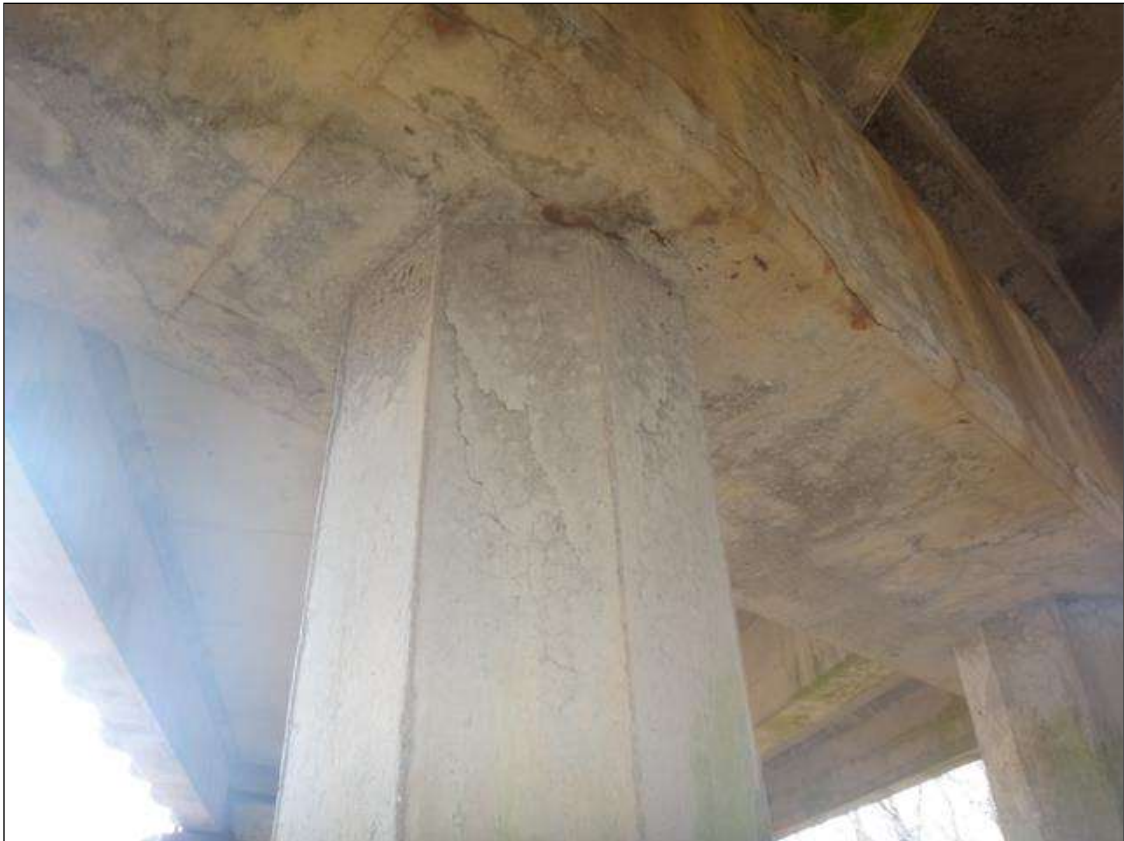
Bent 6 Pile 4: top of pile, north side, Delamination (12" h. x 8" wide.)

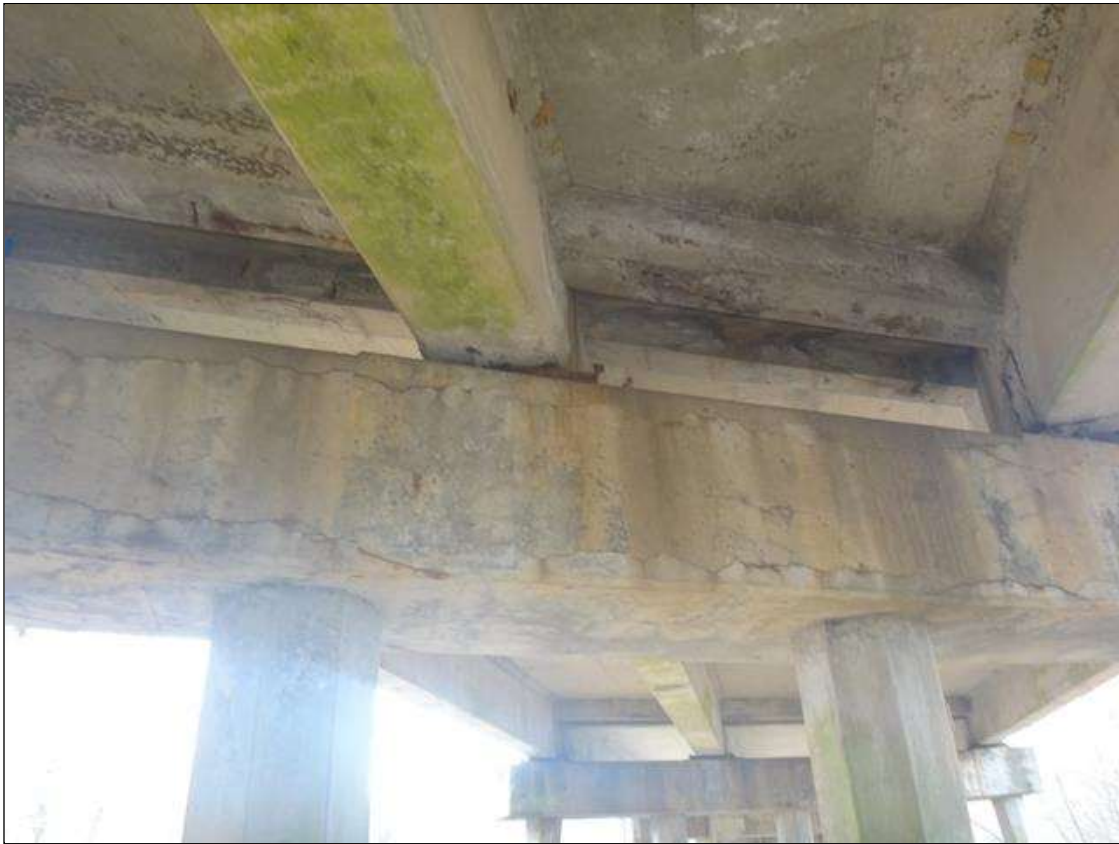
Bent 6 Cap 1: 1/8" horizontal cracks up to 25' long near top and bottom of north and south faces of cap, with rust staining. Bottom of cap, between piles 4 and 5, cracking 1/16" wide with rust staining and efflorescence.

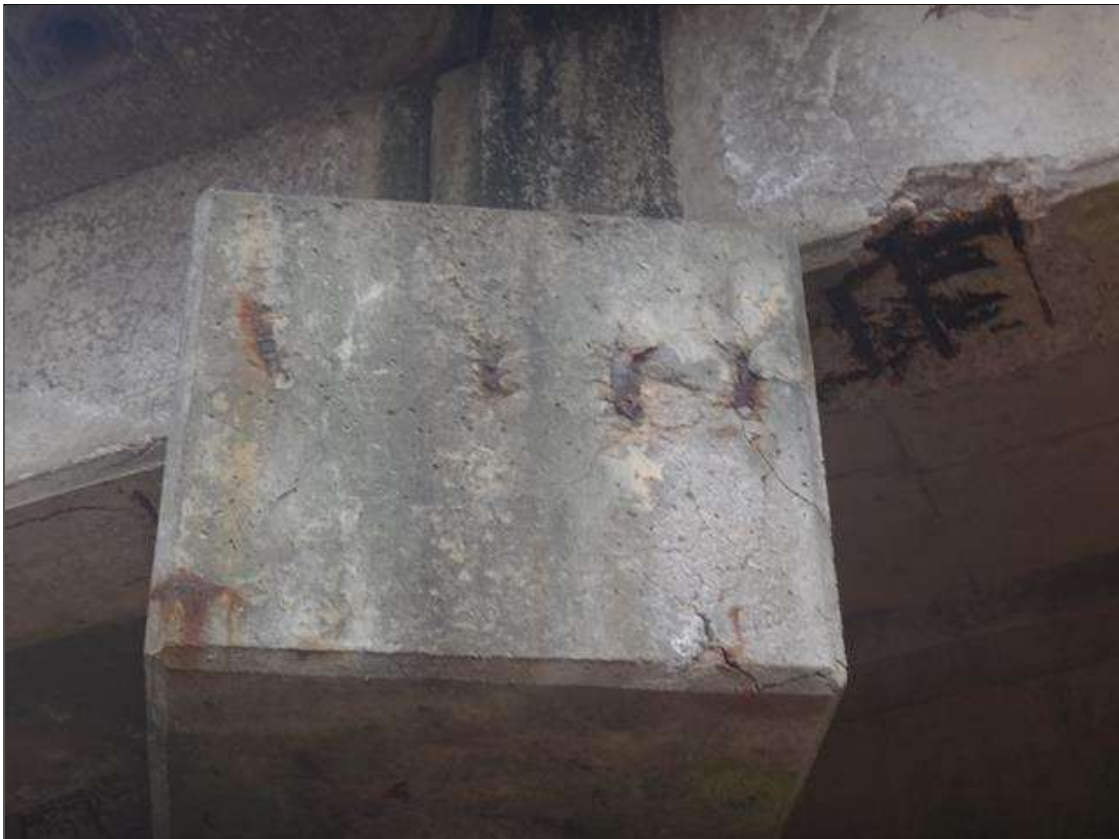
Bent 6 Cap 1: at west face of cap, several spalls with exposed rebar with no measurable section loss (4" high x 2" wide x 1/2" deep.)

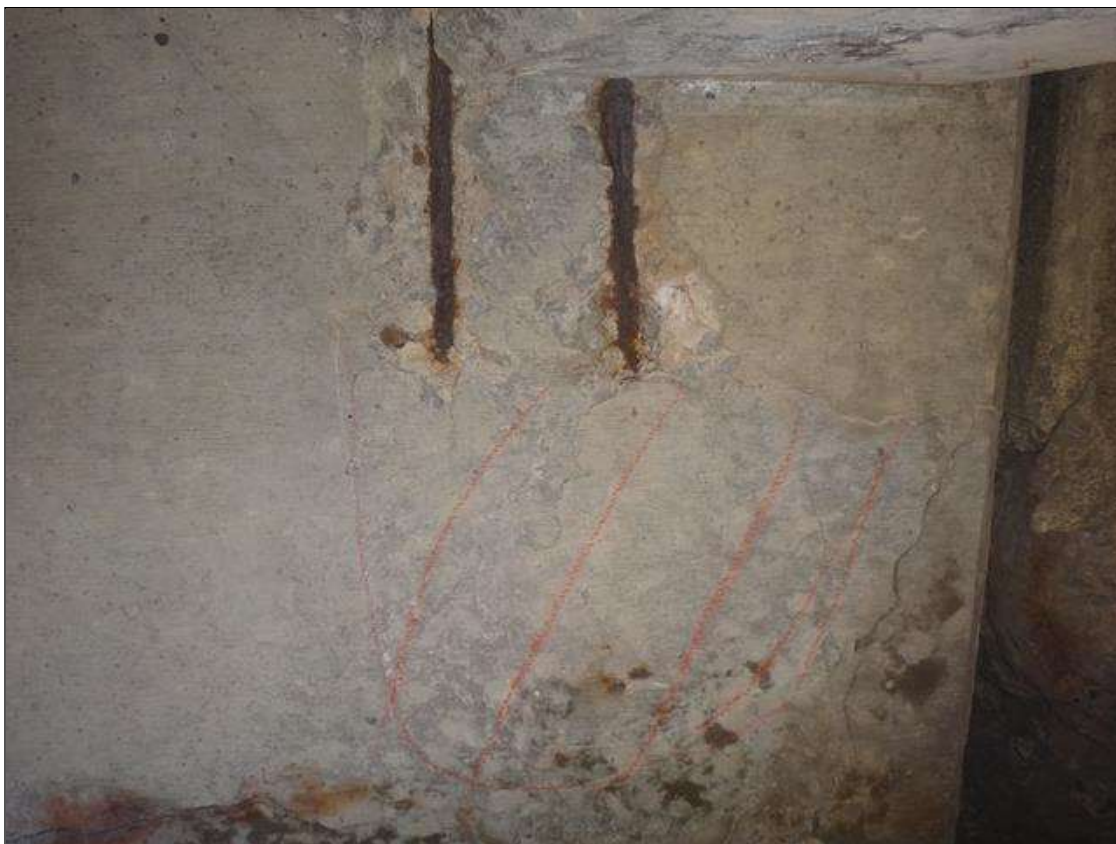
Span 7 Beam 4: 24" x 8" x 1/2" spall/delamination with exposed rebar with no measurable section loss on west face of girder at pier 6 end.

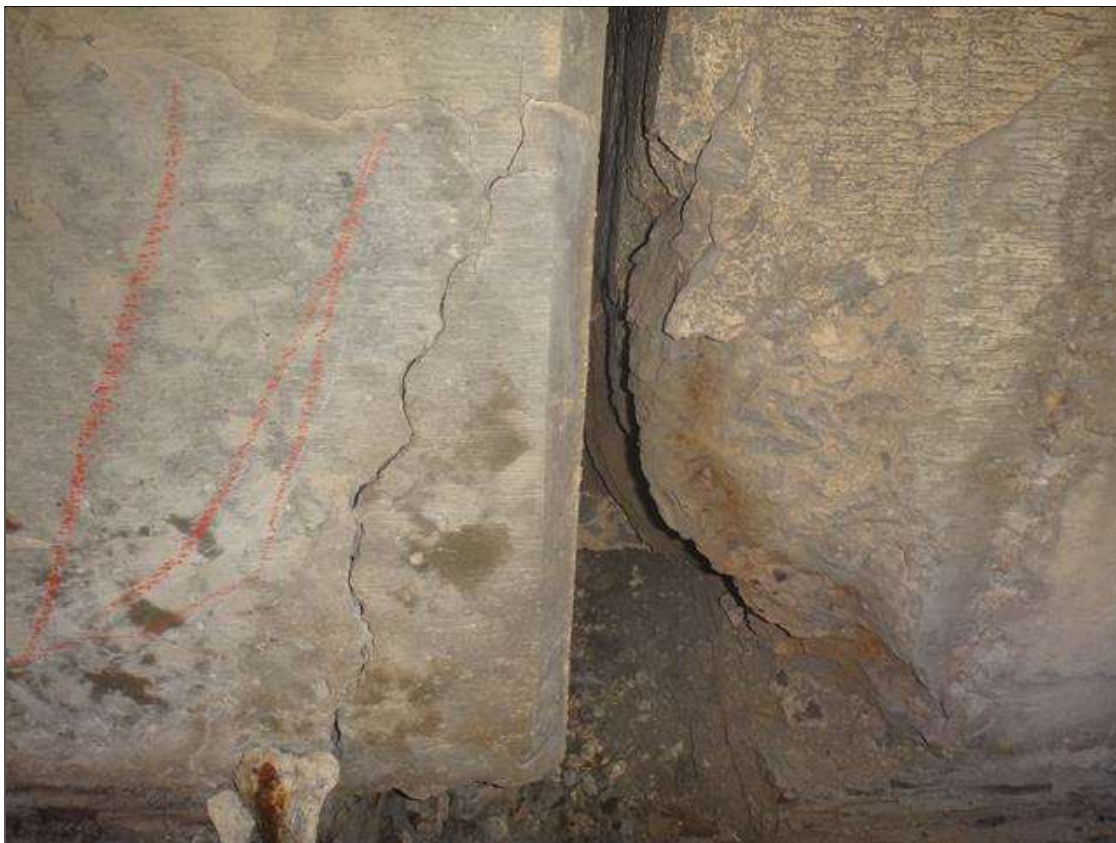
Span 6 Beam 4: at bent 6, spall (12in x 6in x 10in)

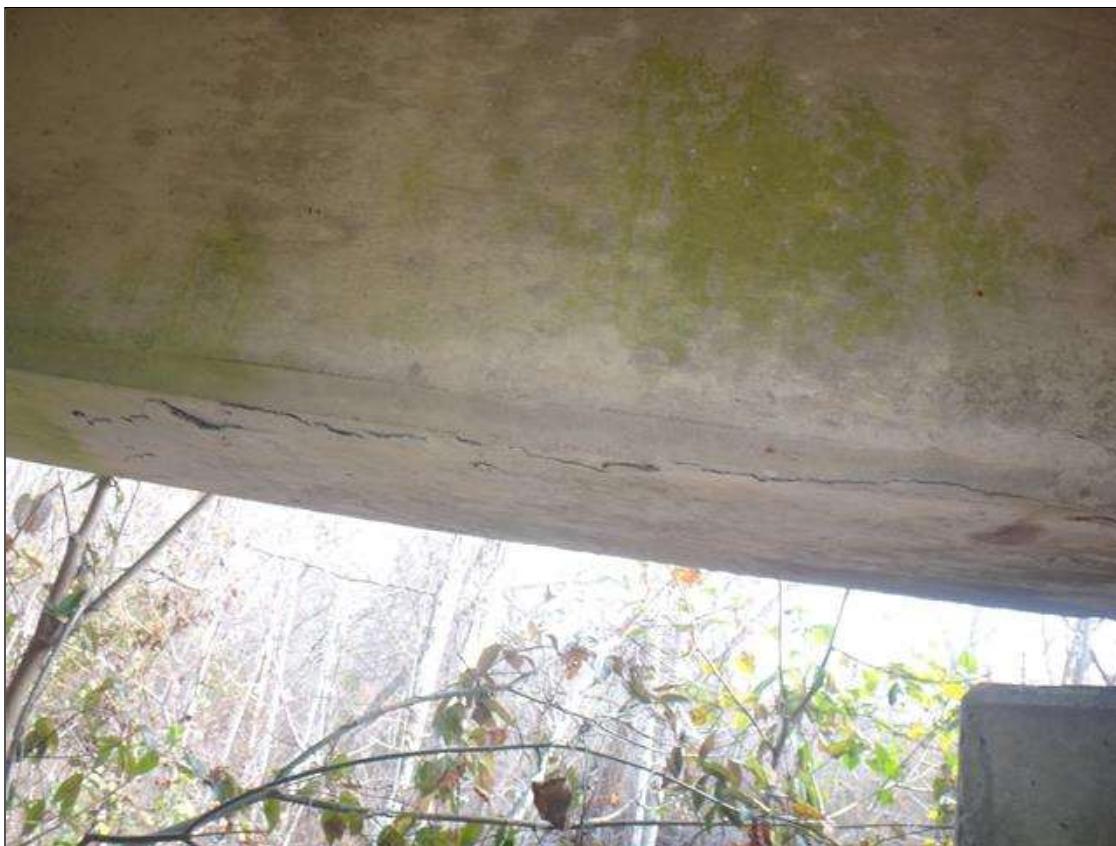
Span 7 Beam 4: underside at bent 6, delamination (3ft x full width)

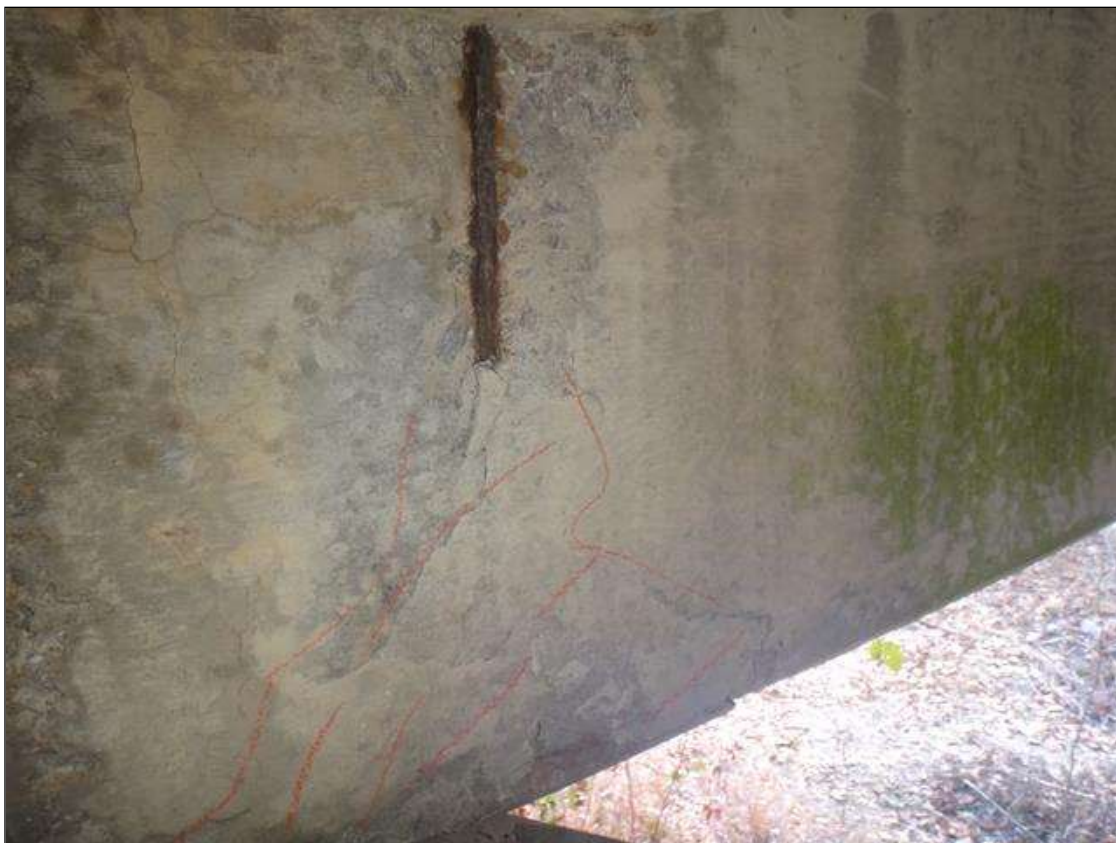
Span 6 Beam 4: west face at bent 6, spall/delamination (24in x 24in x 1/2in) with exposed rusted rebar

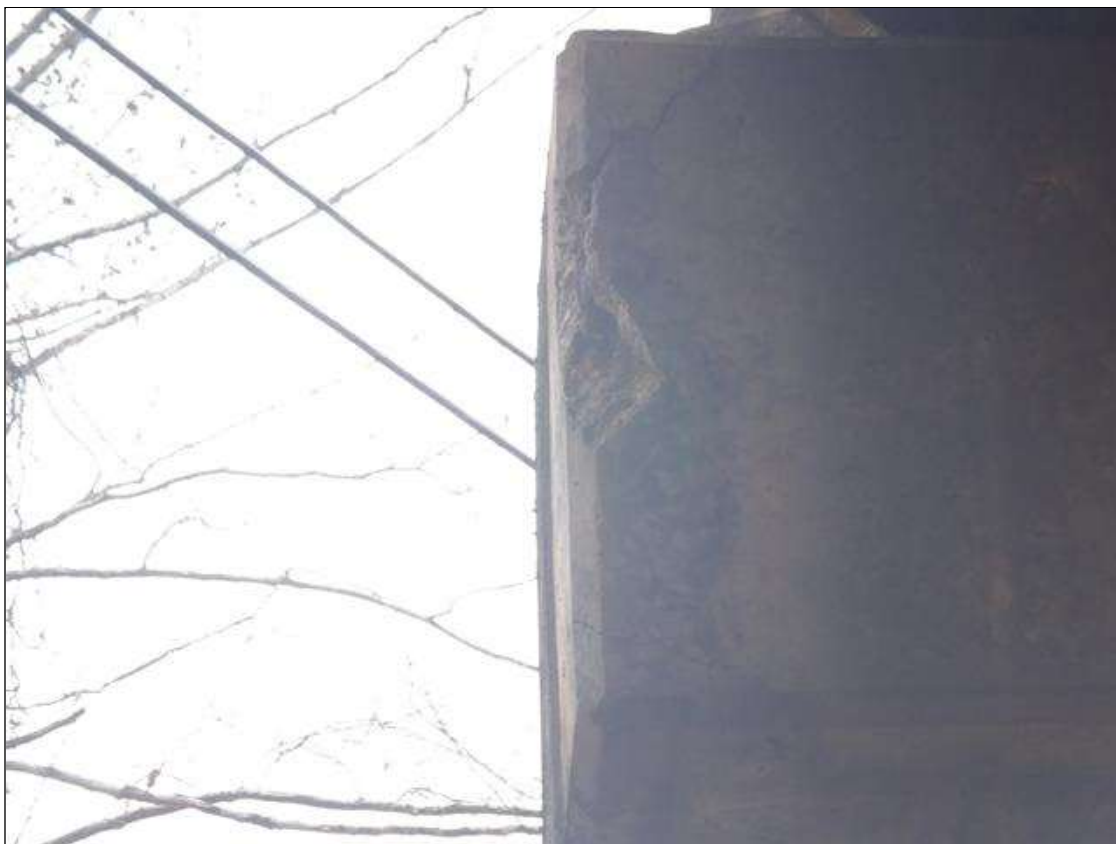
Bent 4 Cap 1: on northeast corner, no measurable section loss, (12" high x 6" wide x 1-1/2" deep,) and Delamination 6" x 6" x 7".
