NC DEPARTMENT OF TRANSPORTATION
 DIVISION OF HIGHWAYS
 STRUCTURE MANAGEMENT UNIT

ATTENTION: **PAR SUBMITTED
 CHANGES TO STRUCTURE DATA**

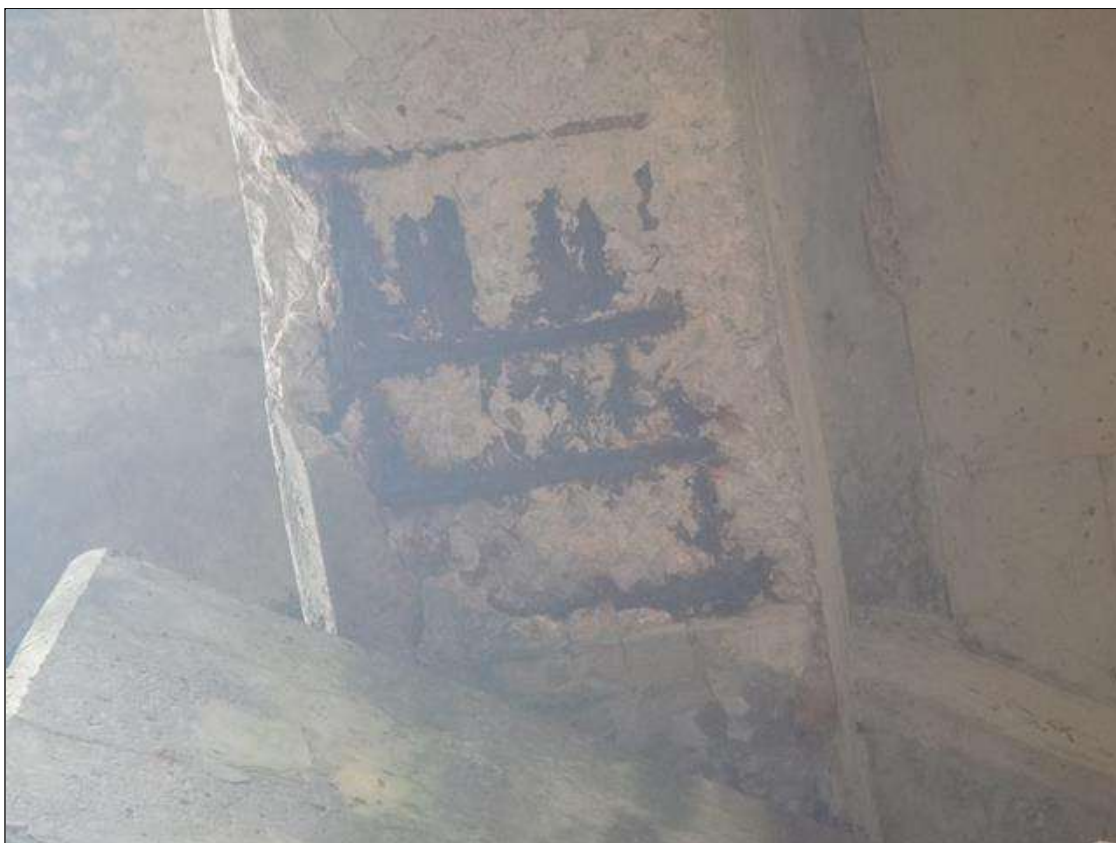
Span 5 Beam 4: (PAR) at pier 4, (5' long x 1.5' wide x 4" deep,) area of Delamination/ Spall with exposed rebar with section loss 1/8" deep. (photo 1 of 2)

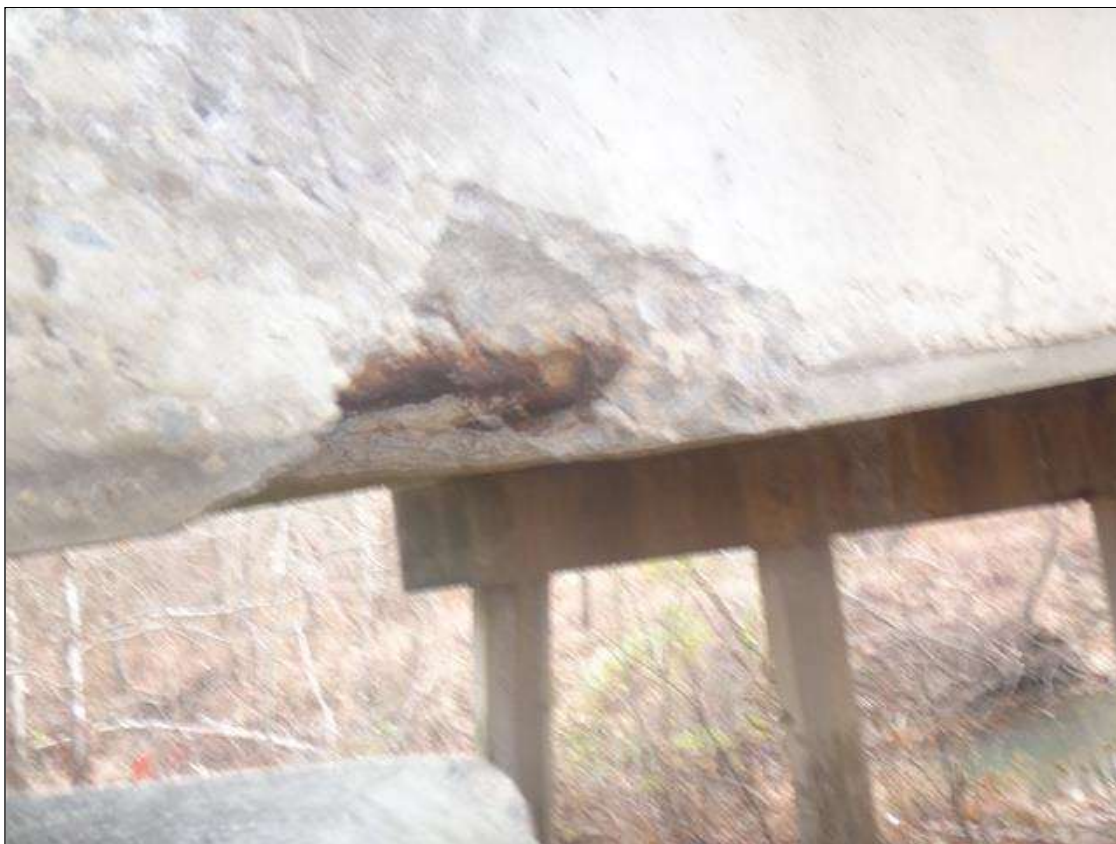
Span 5 Beam 4: (PAR) at pier 4, (5' long x 1.5' wide x 4" deep,) area of Delamination/ Spall with exposed rebar with section loss 1/8" deep. (photo 2 of 2)

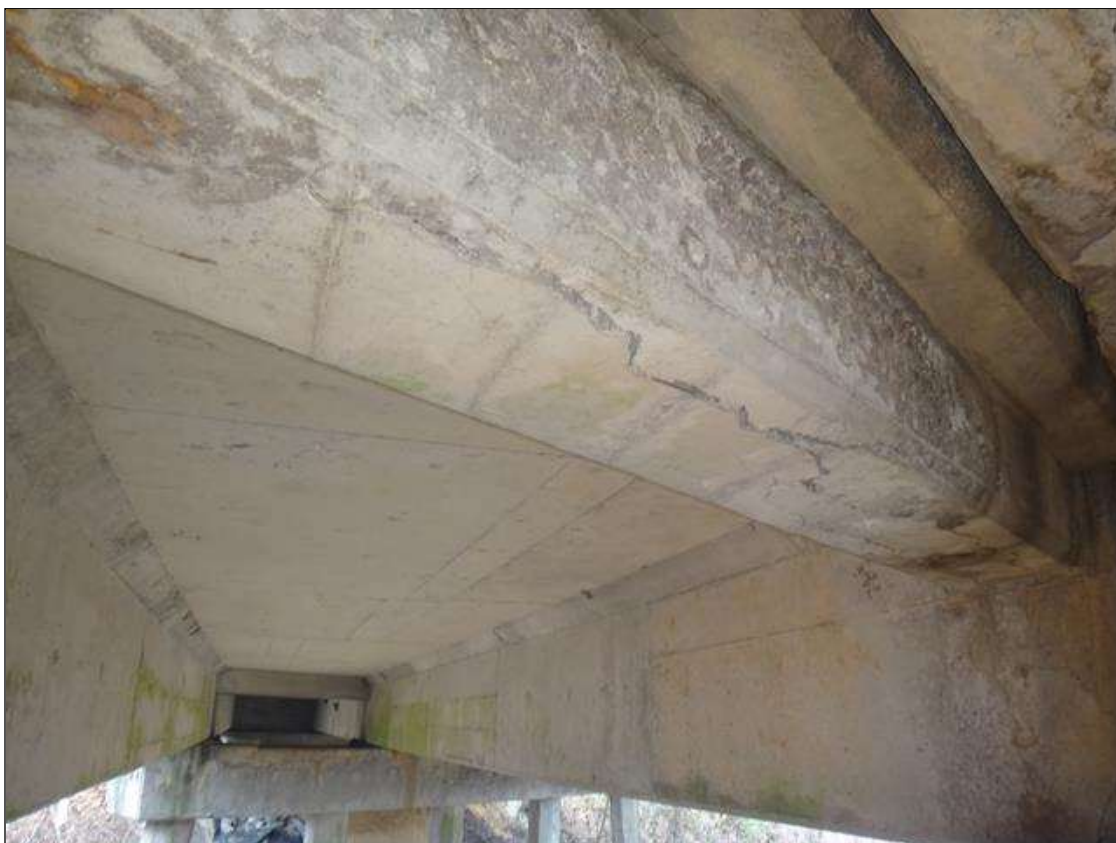
end diaphragm at bay 3 at bent 4, multiple longitudinal cracks with rust staining (full length x up to 1/8in)

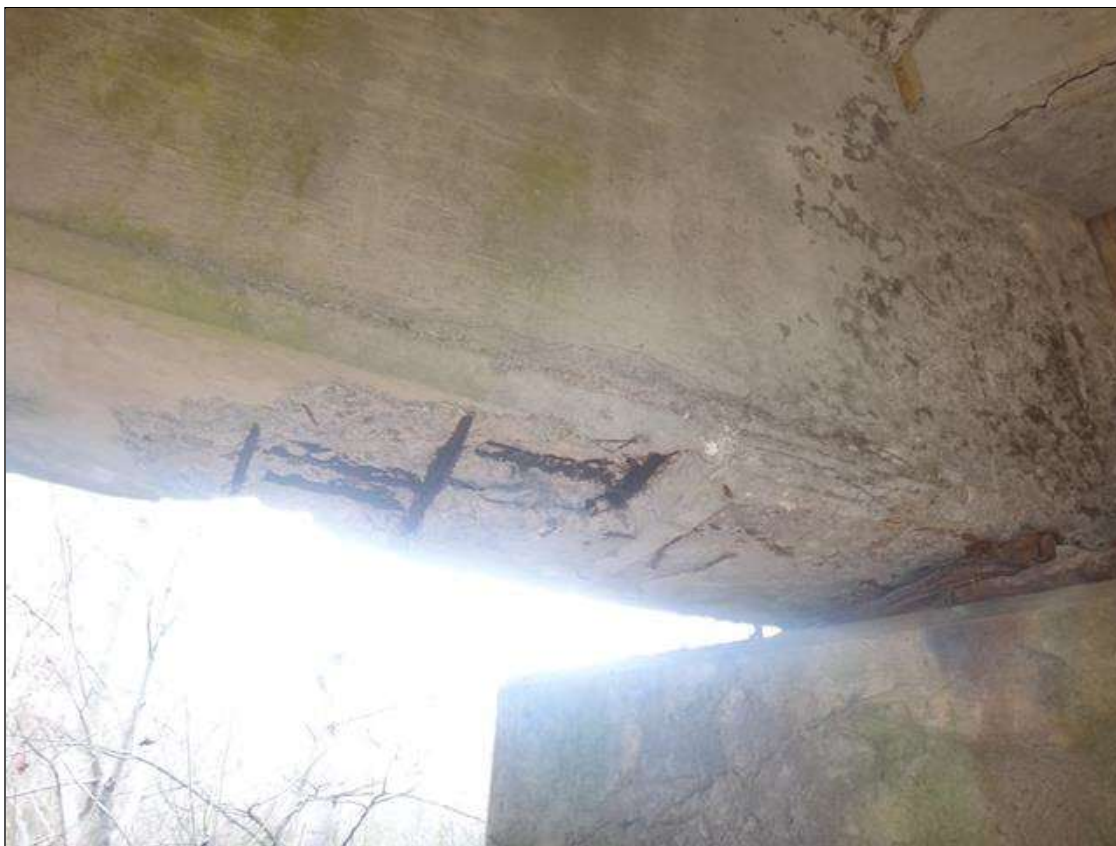
Span 5 Beam 1: (PAR) at pier 5, (3' long x 1.5' wide x 3" deep,) area of Delamination/ spall with exposed rebar with section loss 1/8" deep, on bottom of girder.

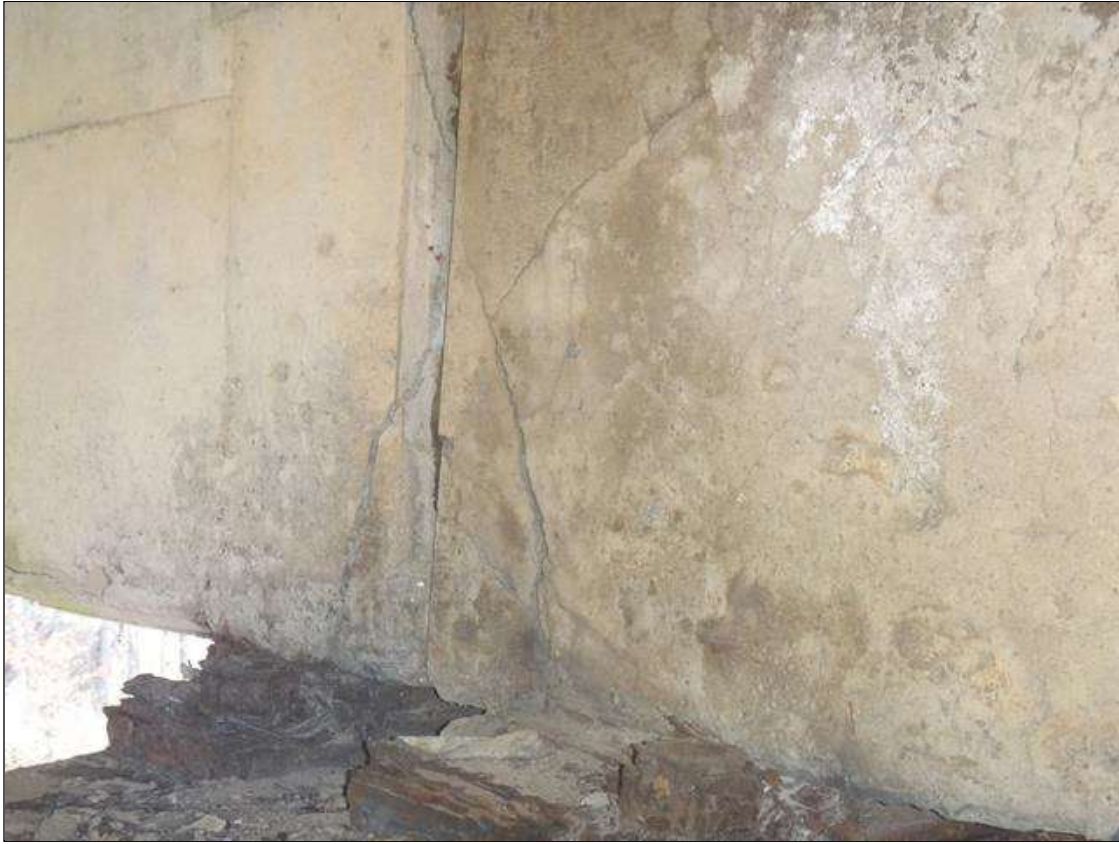
Span 7 Beam 2: at pier 6, east face, cracking 1/8" wide and Delamination (12" x full height) and Spall with Exposed Steel with Section Loss 1/16" deep (3' high x 1' long x 1-1/2" deep,) spall wraps around under bottom of girder (1' wide x 1' long x 1" deep.)

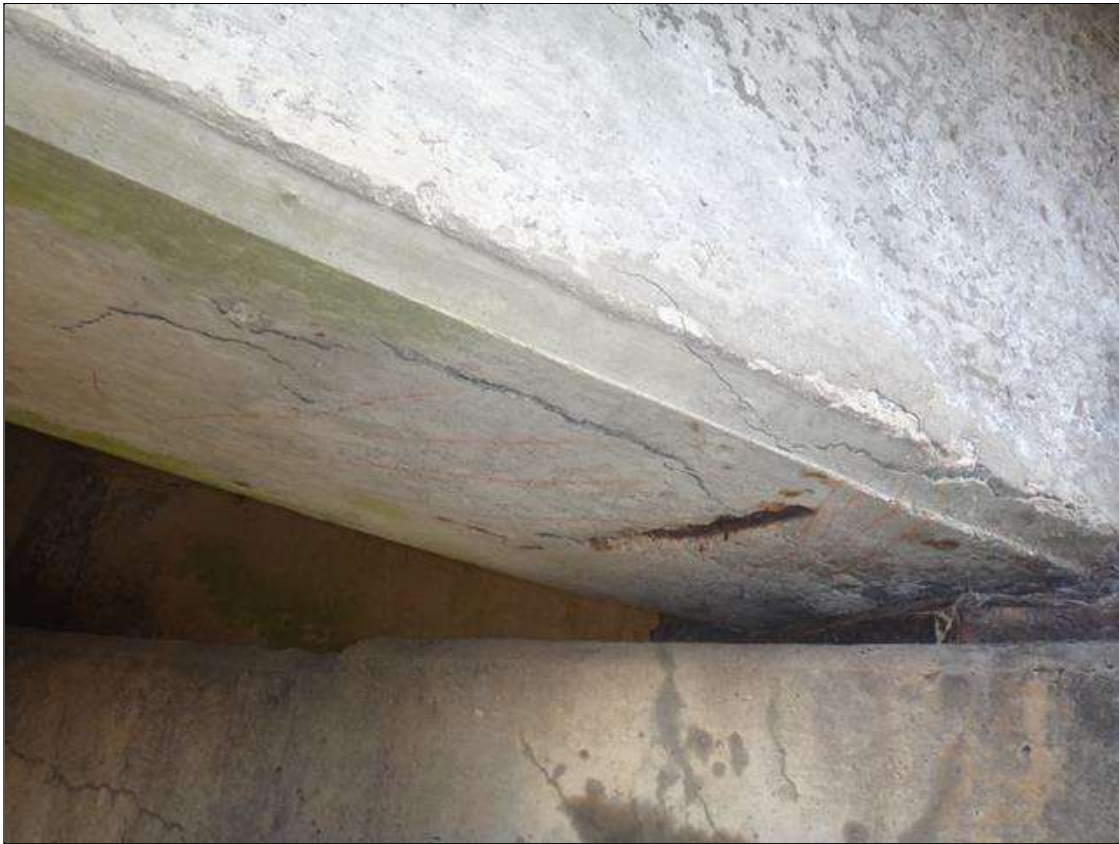
Span 6 Beam 4: 2' high x 2' wide delamination on west face of beam that extends 1' on bottom of beam at pier 5.

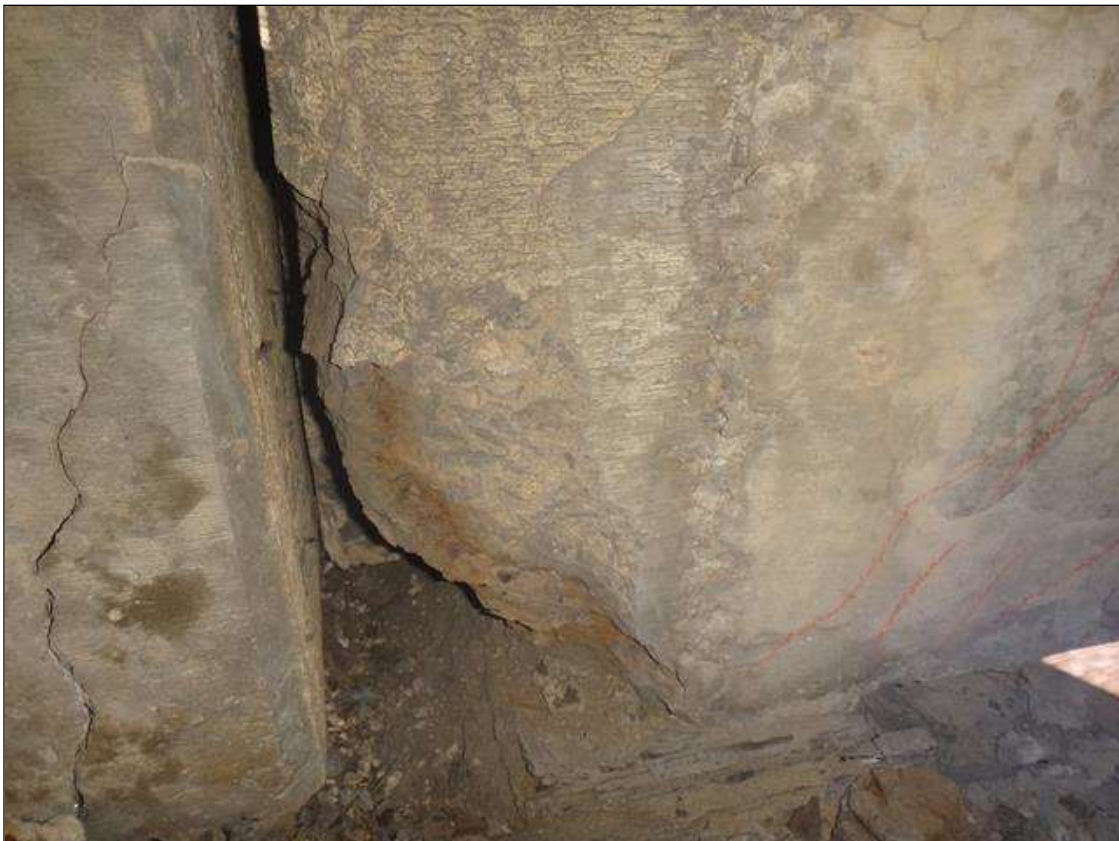
Span 6 Beam 4: at bent 6, spall (12in x 6in x 10in)

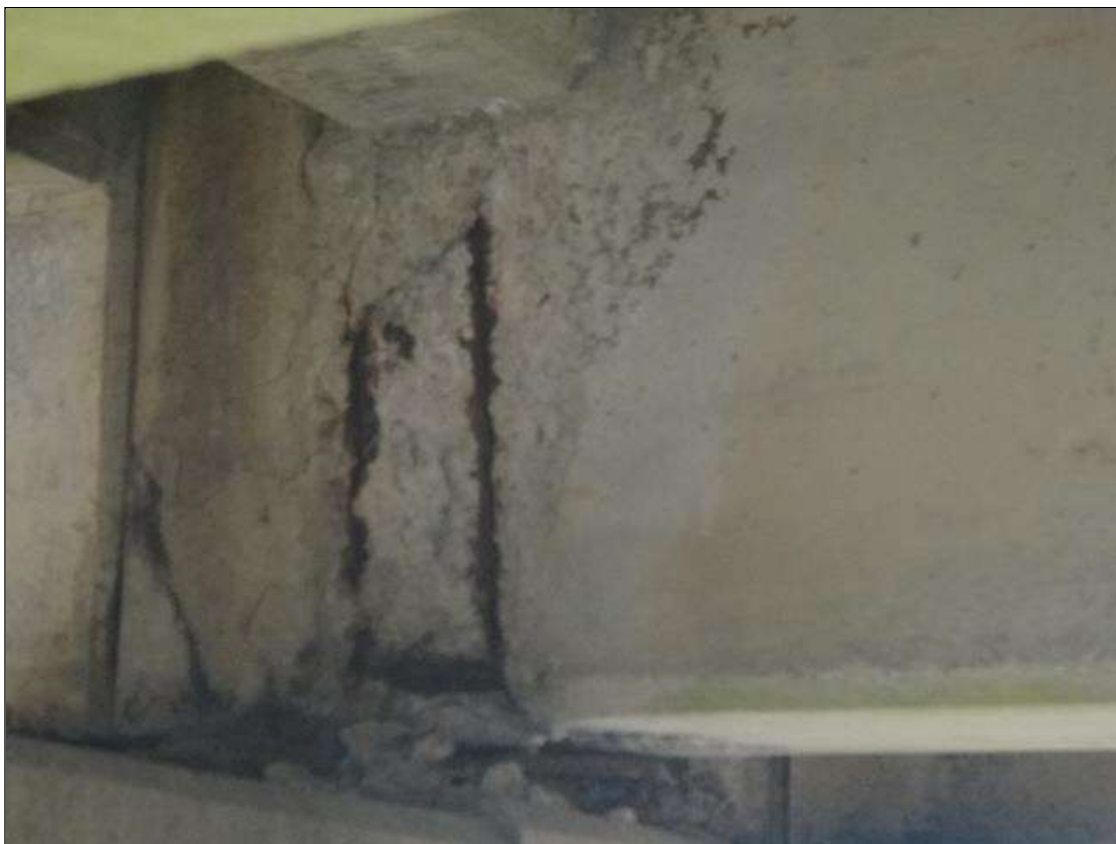
Span 6 Beam 1: (PAR) at pier 6, 3' long x 1.5' wide x 3" deep Delamination/ spall with exposed reinforcing with minor section loss up to 1/8" deep on bottom of girder.

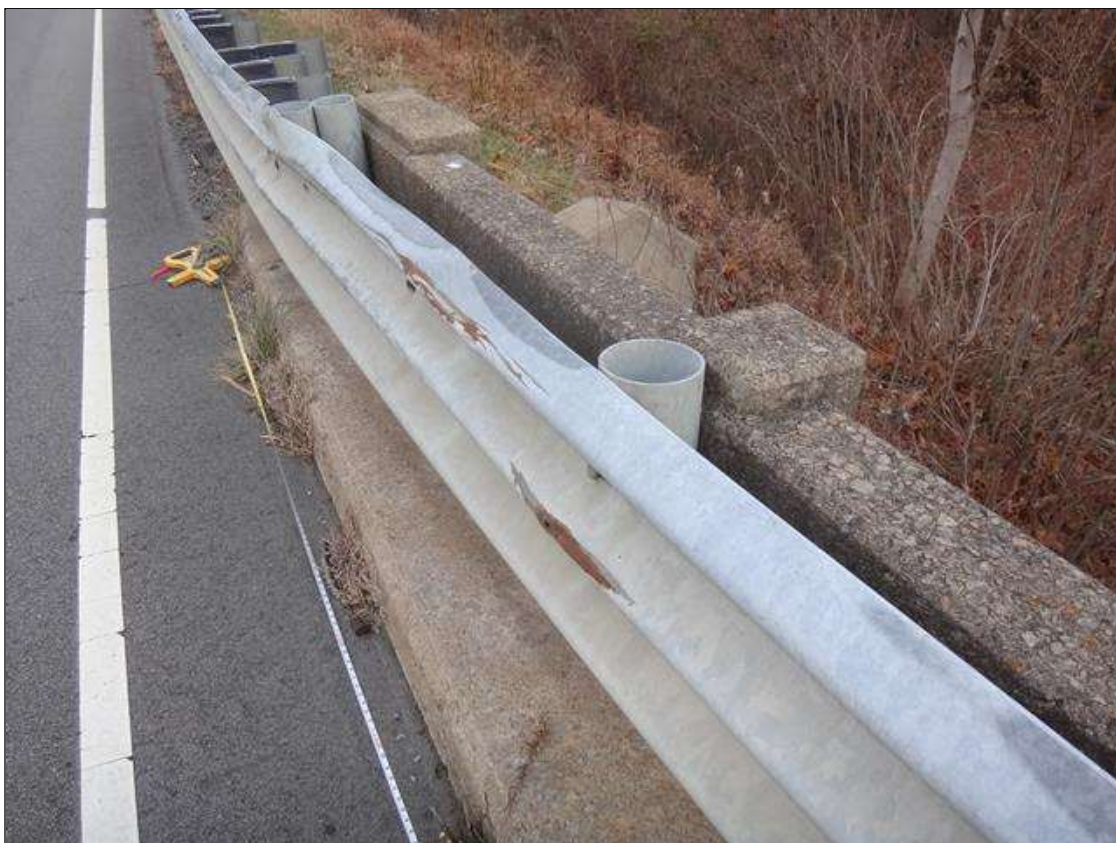
northeast guardrail at end bent 2, impact damage (10ft)

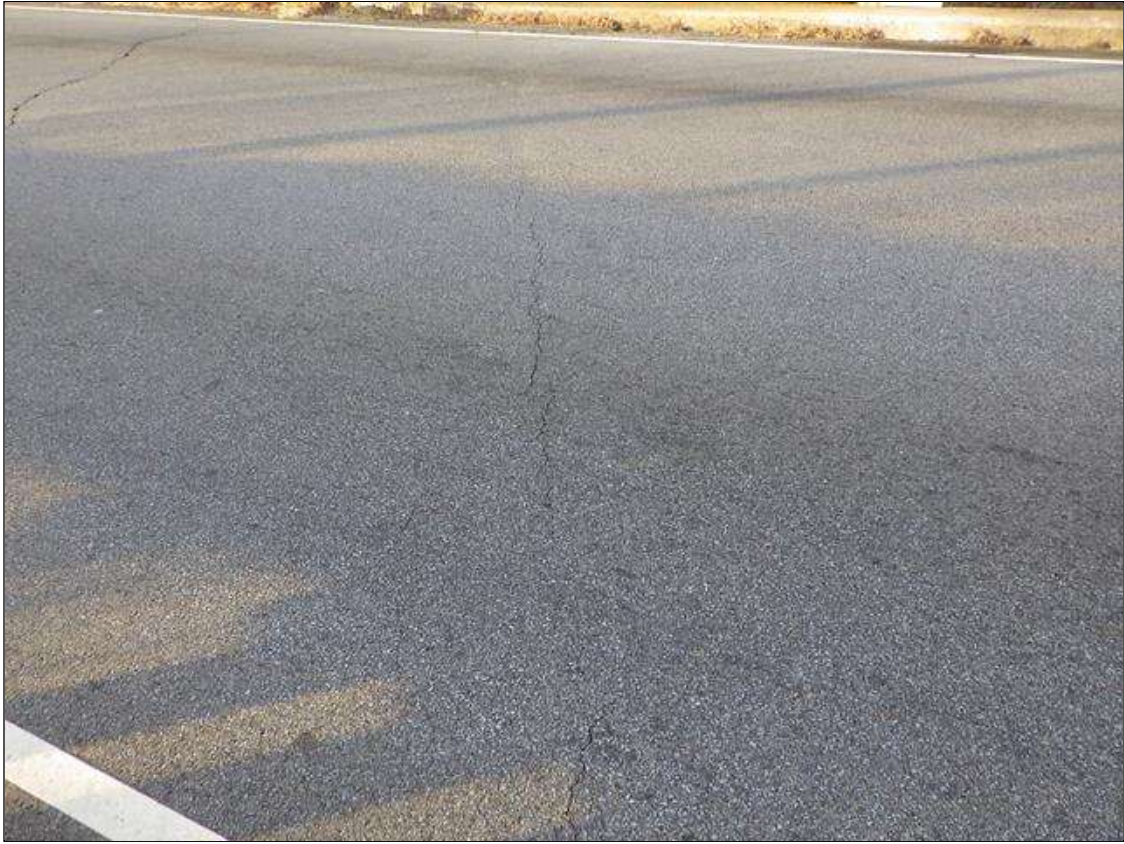
asphalt wearing surface over end bent 1

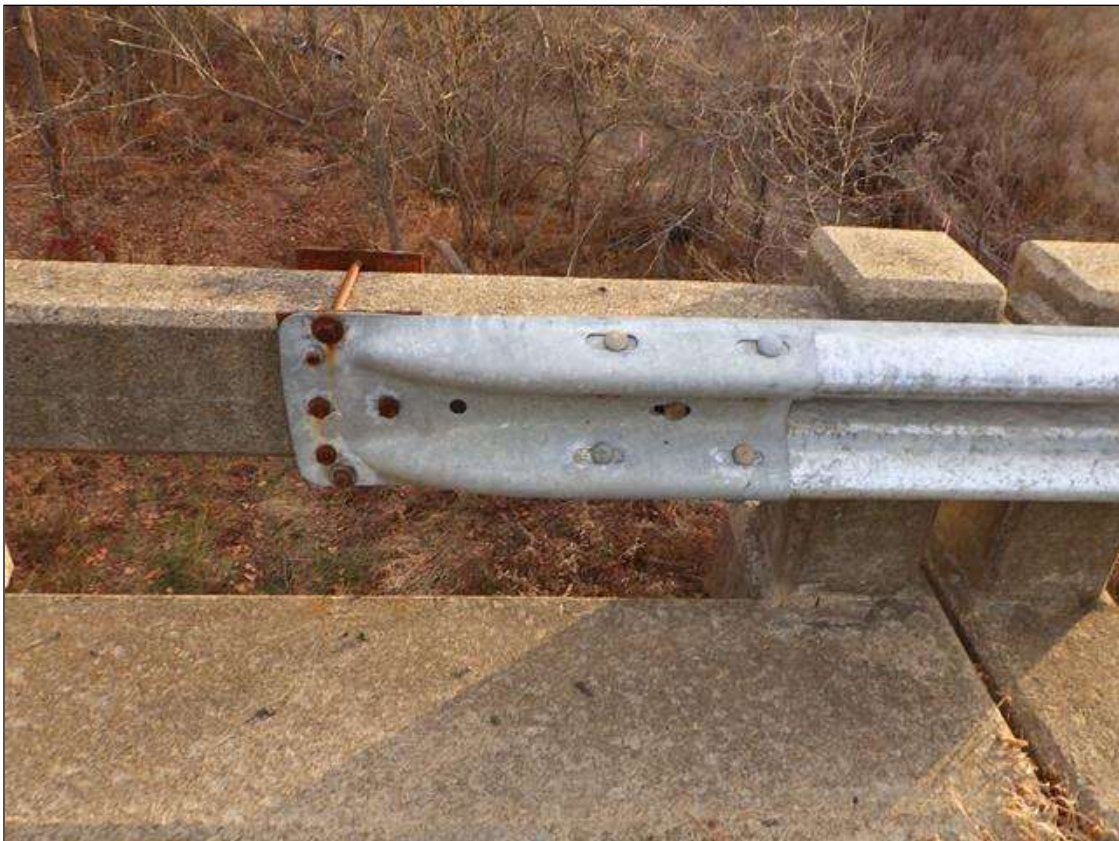
southeast guardrail attachment (damaged area)

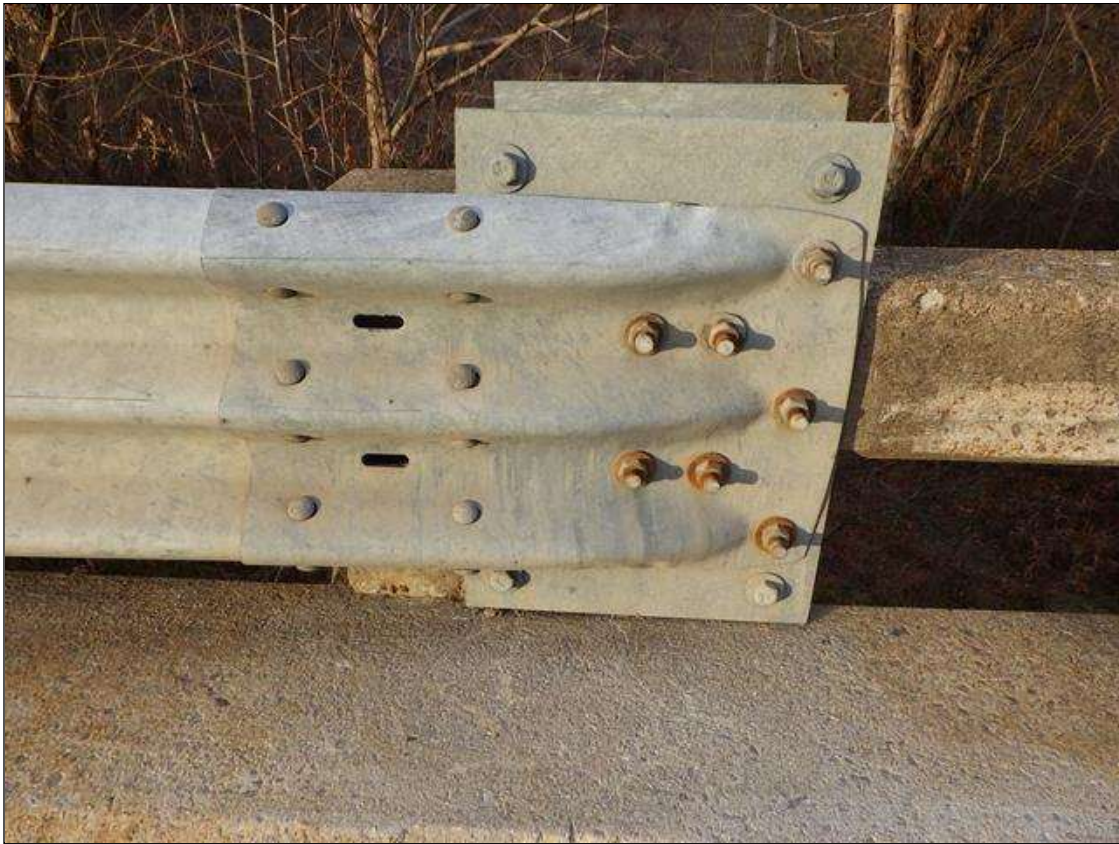
southwest guardrail attachment

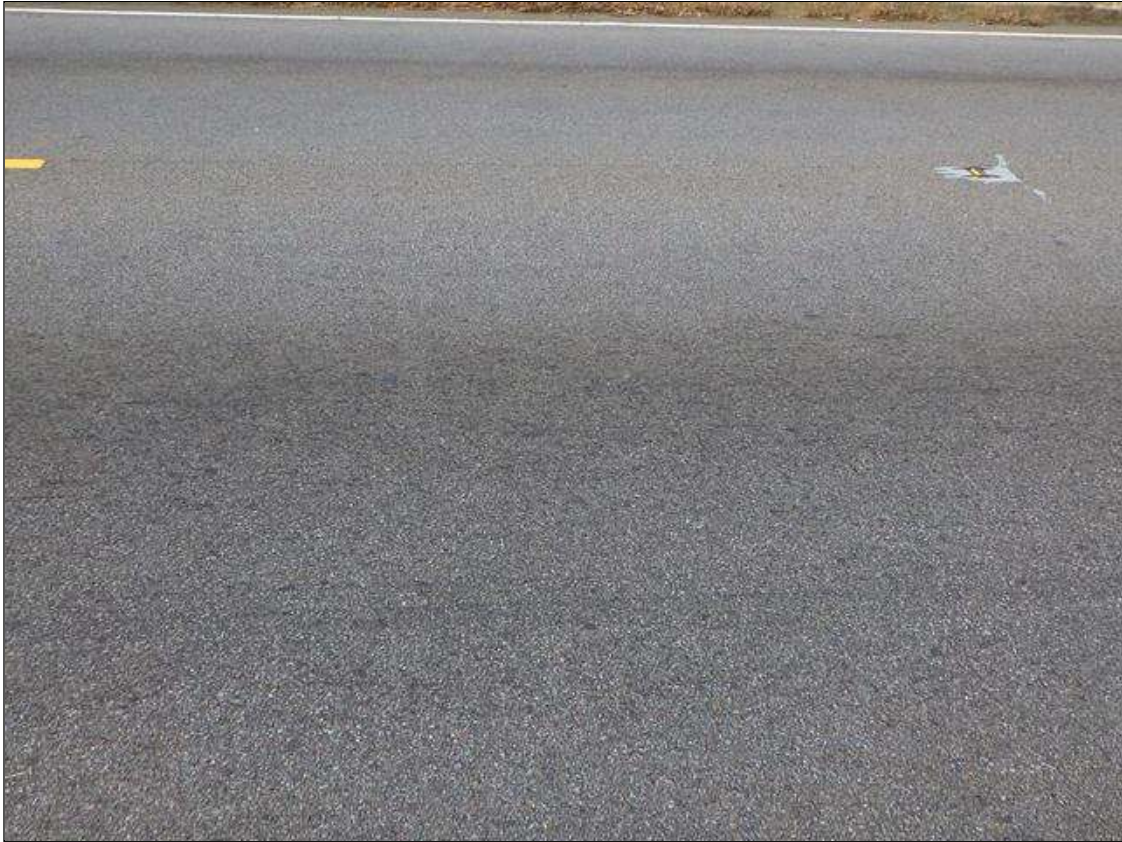
asphalt wearing surface

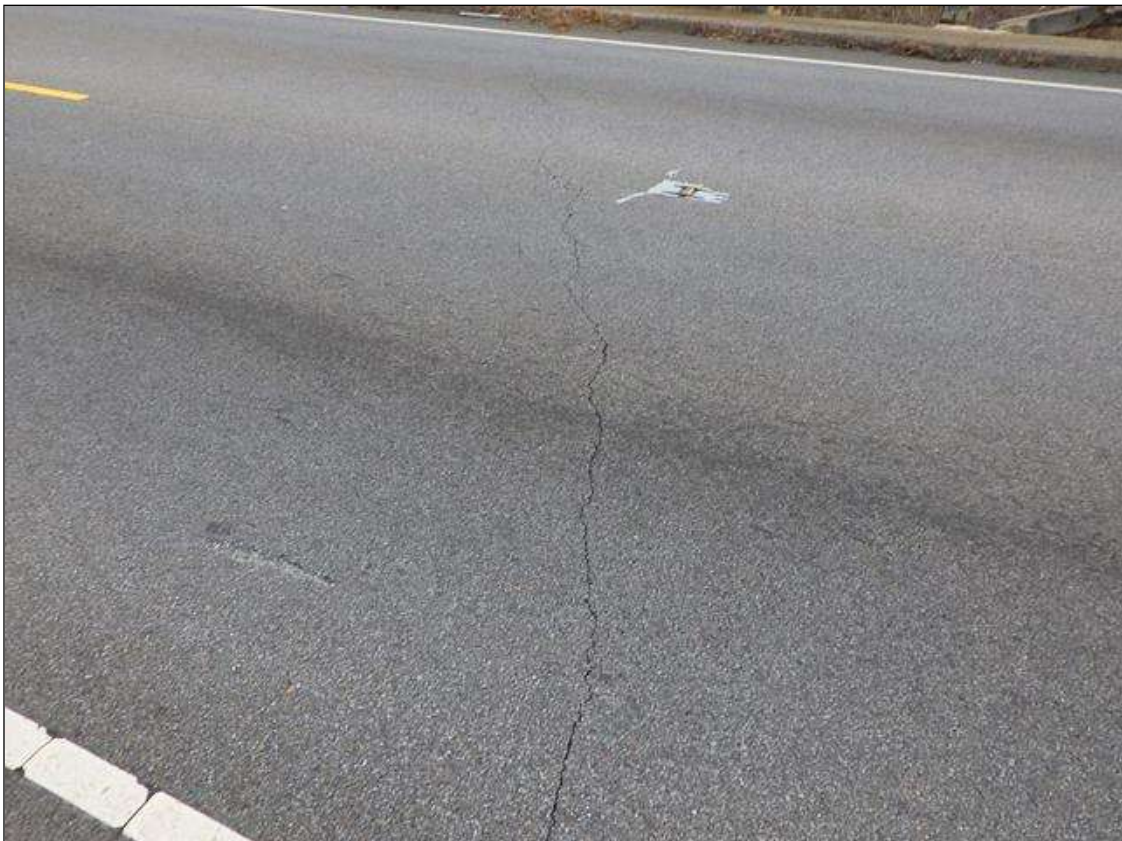
asphalt wearing surface over bent 1

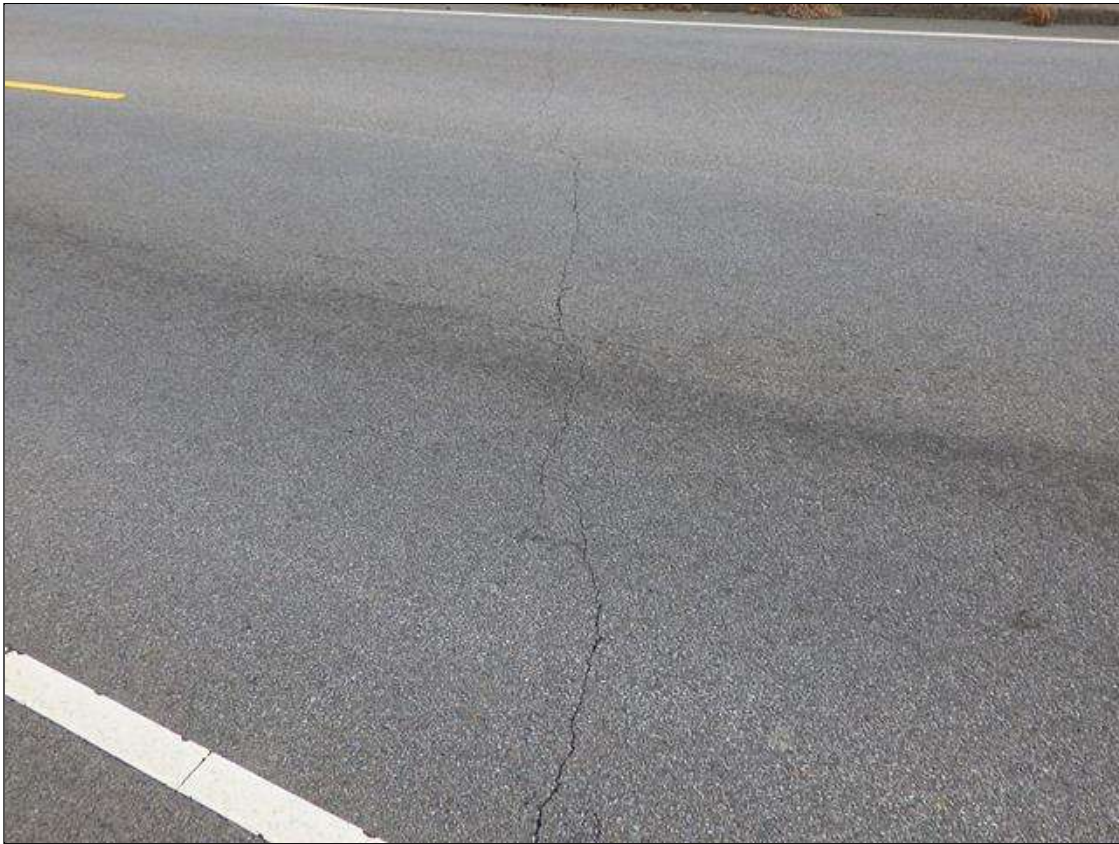
asphalt wearing surface over bent 2

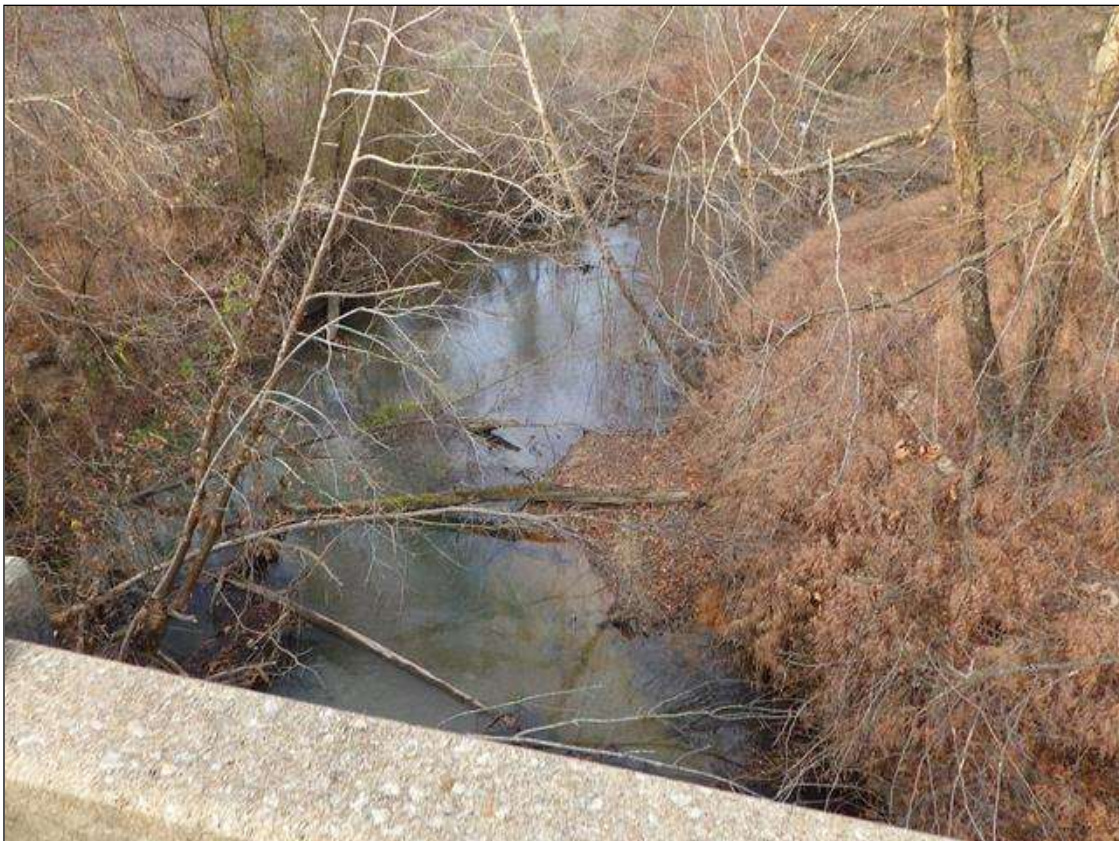
looking upstream, west

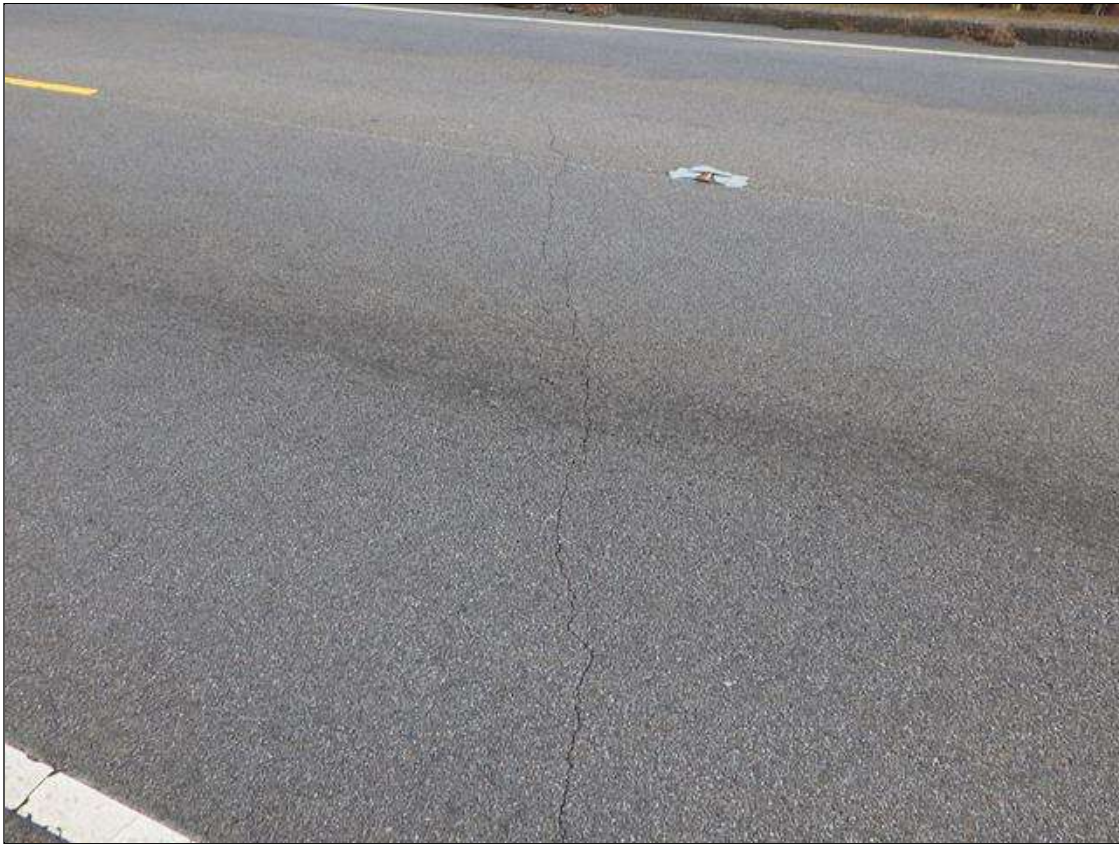
asphalt wearing surface over bent 3

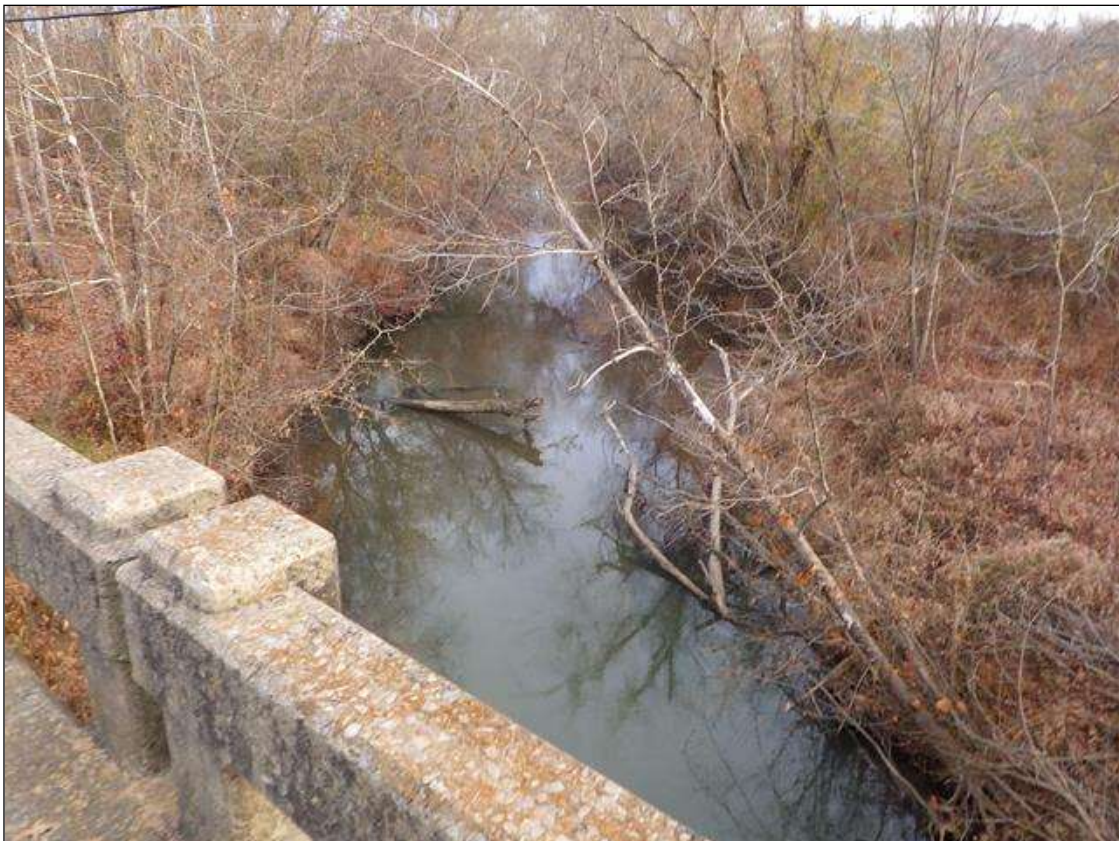
looking downstream, east

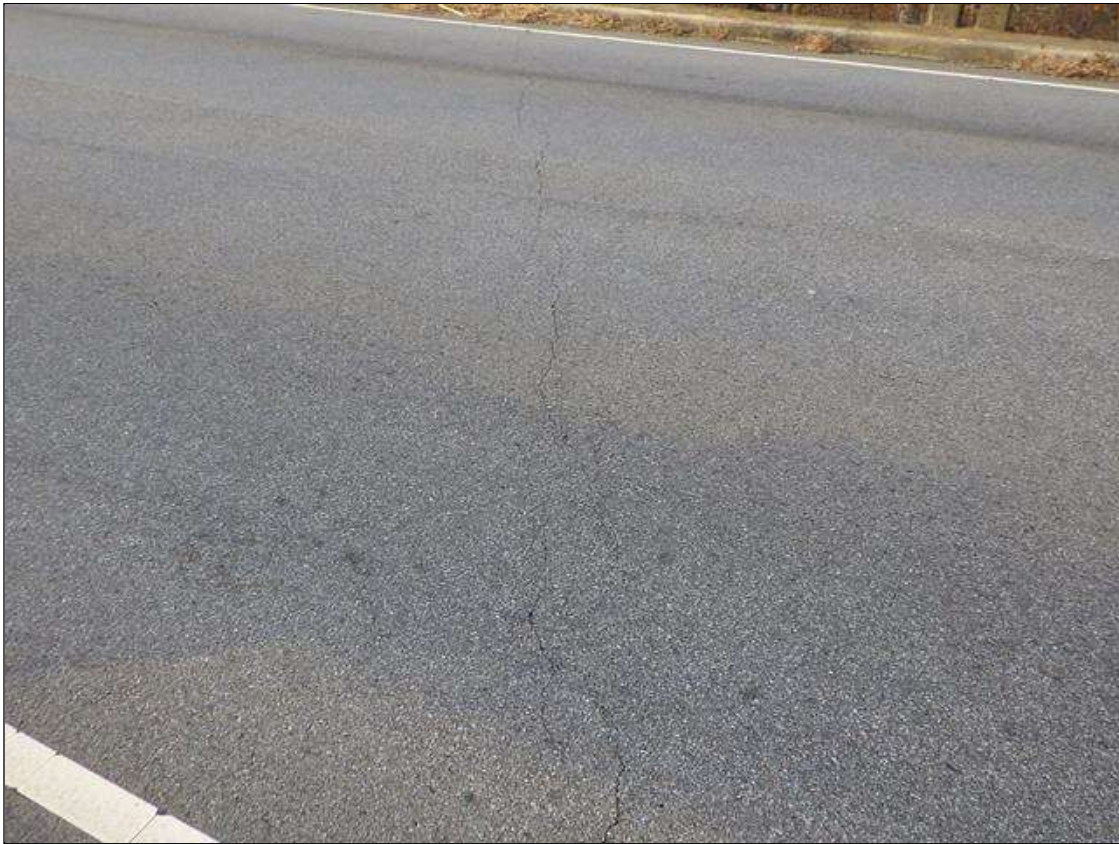
asphalt wearing surface over bent 4

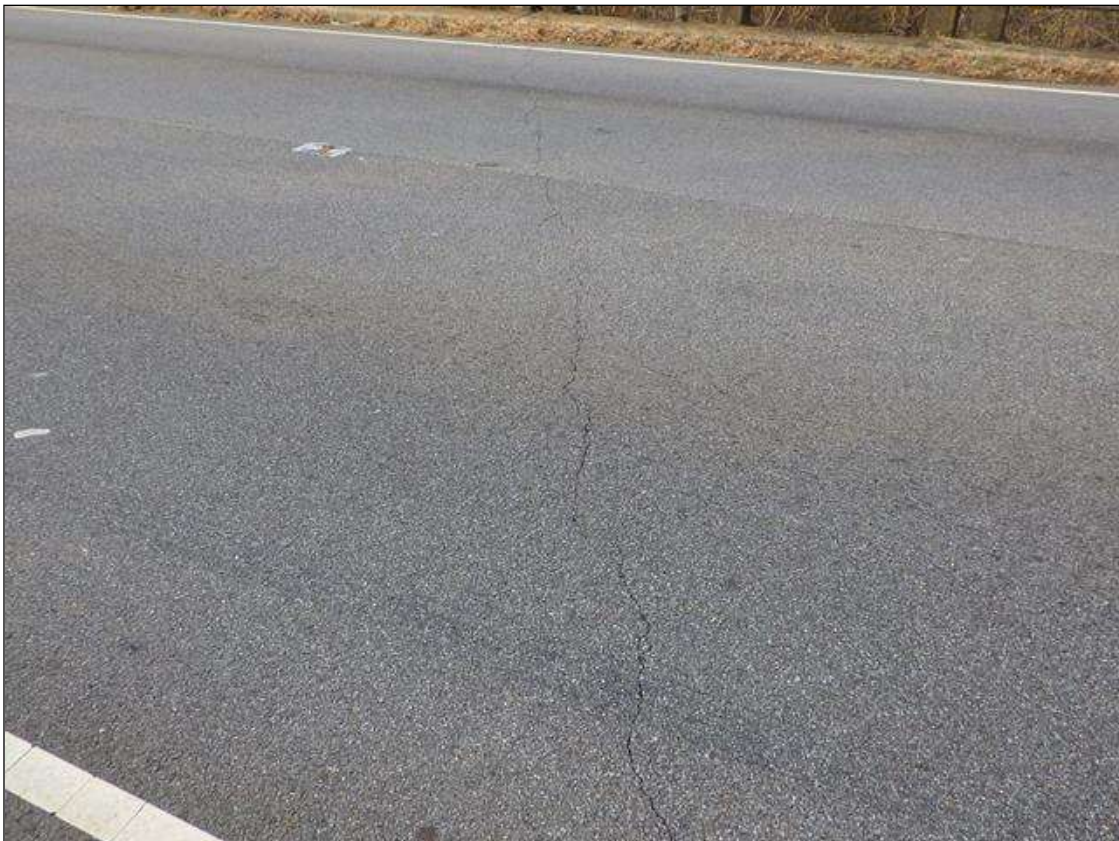
asphalt wearing surface over bent 5

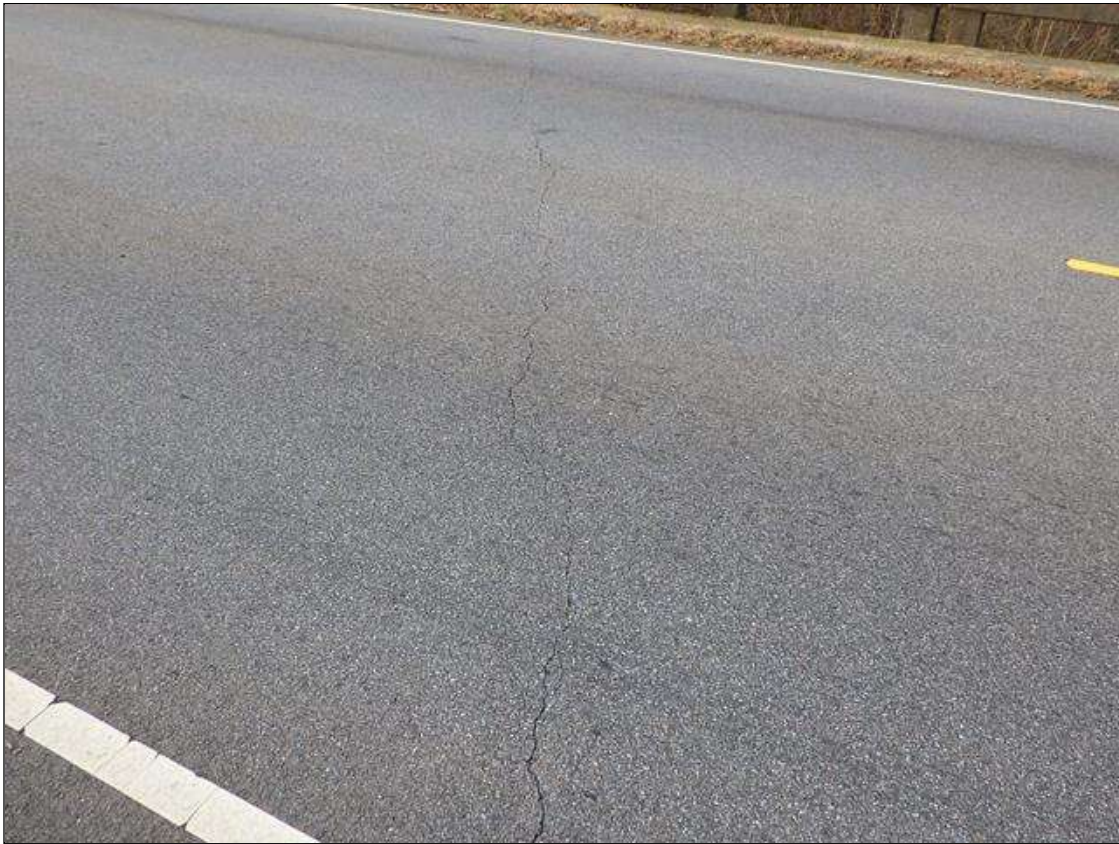
asphalt wearing surface over bent 6

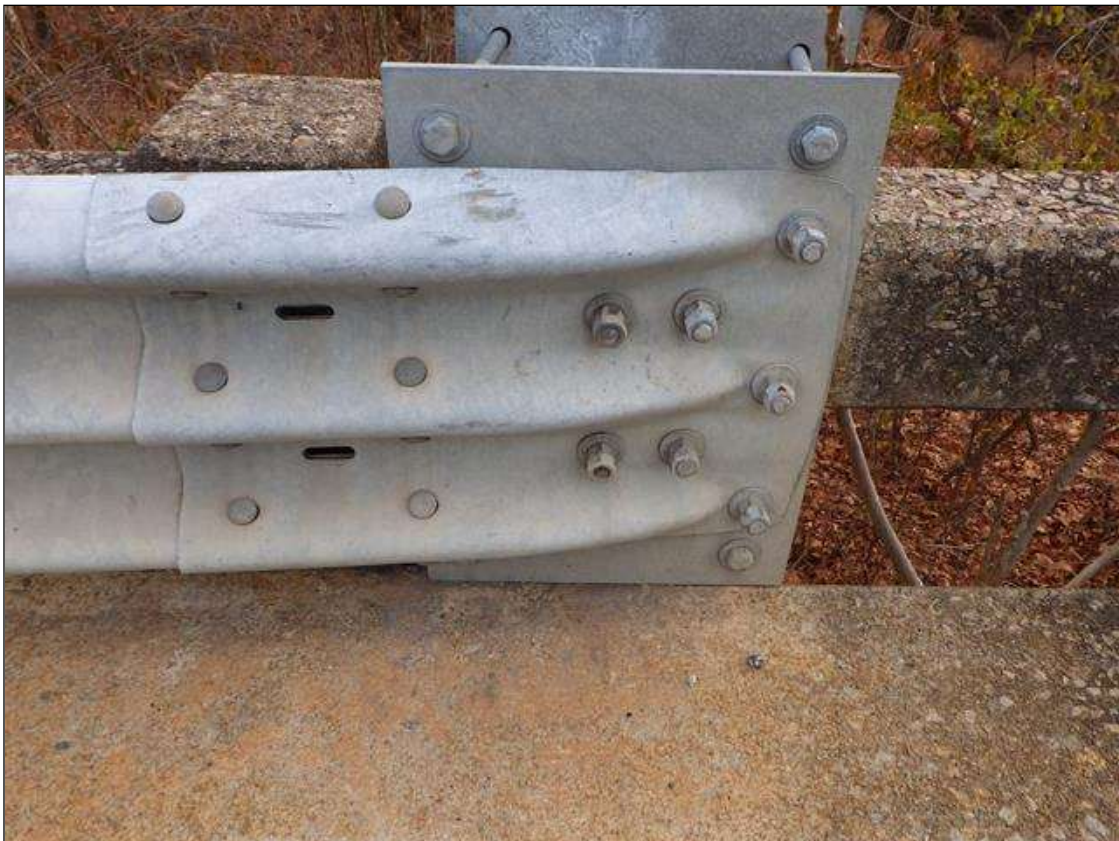
northeast guardrail attachment

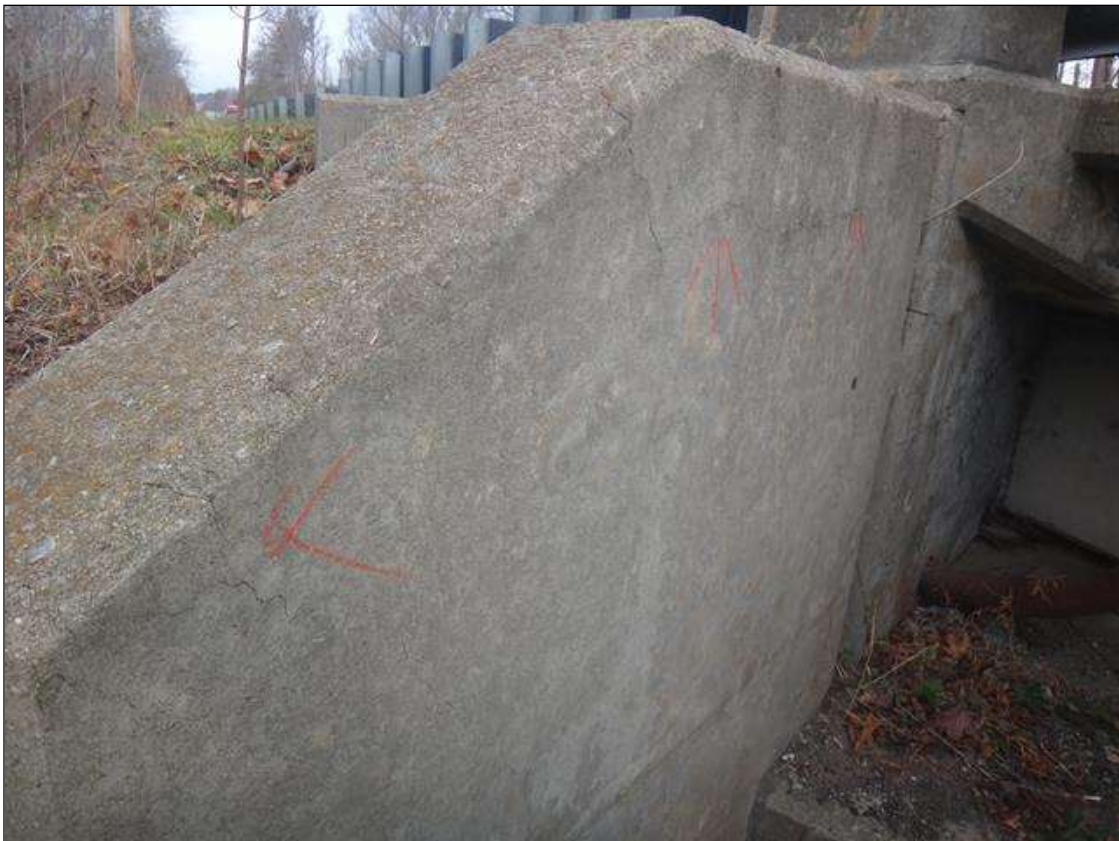
southeast wingwall, horizontal and vertical cracks (up to 2ft x 1/32in)

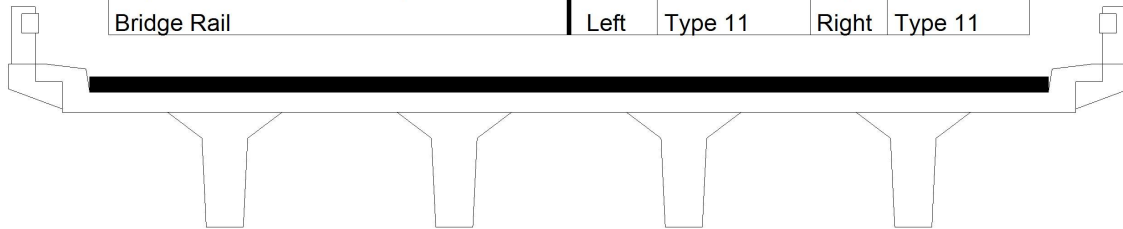
Measurements for Span #	1	ALL SPANS SIMILAR	
Deck Thickness	0.583ft	Left Overhang	4.709ft
Top of Rail to Bottom of Beam	5.833ft	Right Overhang	4.709ft

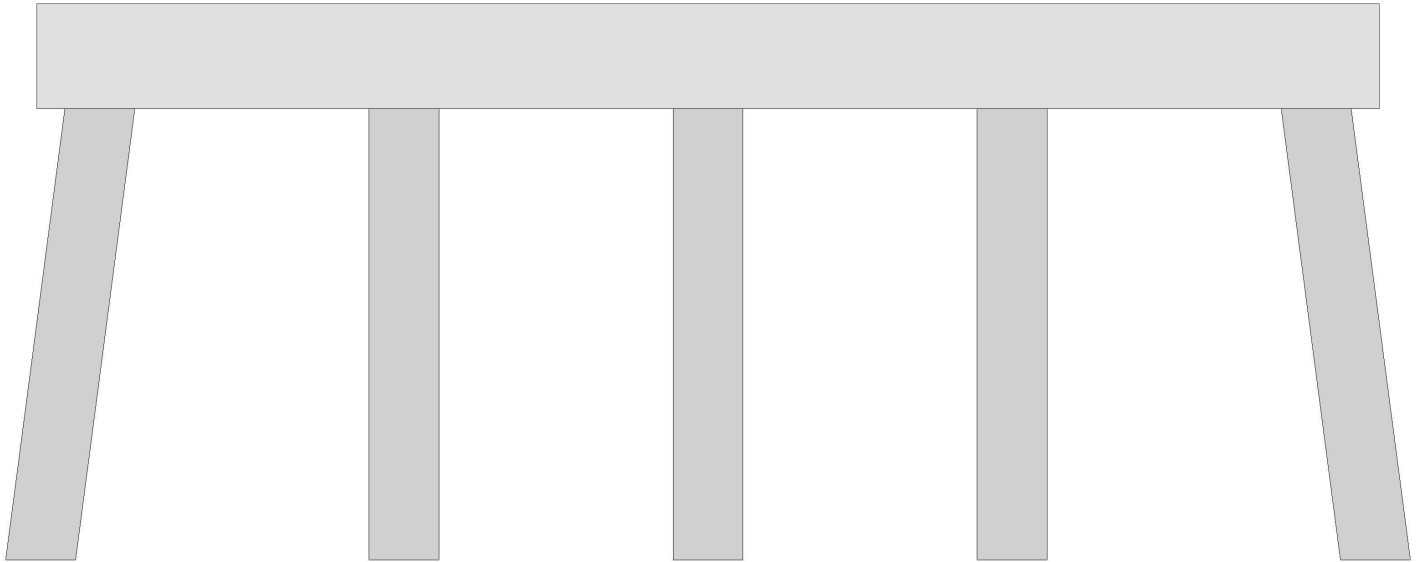
Cap Information			Material Cast-in-Place Concrete							
Length	Width	Height	Left Overhang	Right Overhang	Left Beam to End of Cap.	Right Beam to End of Cap.
