NC DEPARTMENT OF TRANSPORTATION
 DIVISION OF HIGHWAYS
 STRUCTURE MANAGEMENT UNIT

ATTENTION: **PAR SUBMITTED
 CHANGES TO STRUCTURE DATA**

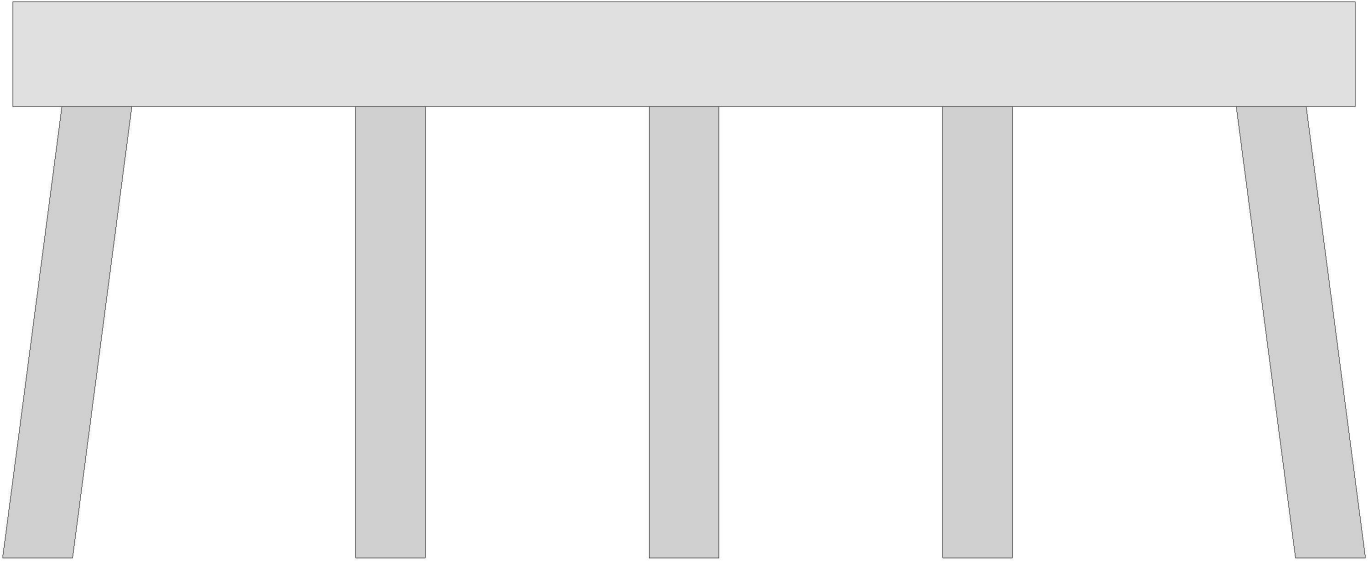
Cap Information			Material Cast-in-Place Concrete							
Length	Width	Height	Left Overhang	Right Overhang	Left Beam to End of Cap.	Right Beam to End of Cap.				
32.000 ft.	3.000 ft.	2.500 ft.	2.000 ft.	2.000 ft.	3.000 ft.	2.000 ft.				
Subcap Information			Material							
Length	Width	Height	Left Overhang	Right Overhang	Left Pile to Splice.					
Sill Information			Material							
Length	Width	Height								
Pile #	Material	Spacing	Width/Dia.	Height	Length	Orientation	Driven?	Replacement?	Removed?	Collar?
1	Concrete	7 ft.	1.667 ft.			Battered	*Yes	No	No	No
2	Concrete	7 ft.	1.667 ft.			A-Frame	*Yes	No	No	No
3	Concrete	7 ft.	1.667 ft.			Vertical	*Yes	No	No	No
4	Concrete	7 ft.	1.667 ft.			A-Frame	*Yes	No	No	No
5	Concrete		1.667 ft.			Battered	*Yes	No	No	No
NOTE: PILES ARE OCTAGONAL SHAPE										
*REVISED BY: S. GURME 12/01/2021										
Bent/Abutment #: 3			Similar Bents: 4
