NC DEPARTMENT OF TRANSPORTATION
 DIVISION OF HIGHWAYS
 STRUCTURE MANAGEMENT UNIT

ATTENTION: **RED LEAD UNDERCOAT, PAR ISSUED, SALVAGE BEAMS.**

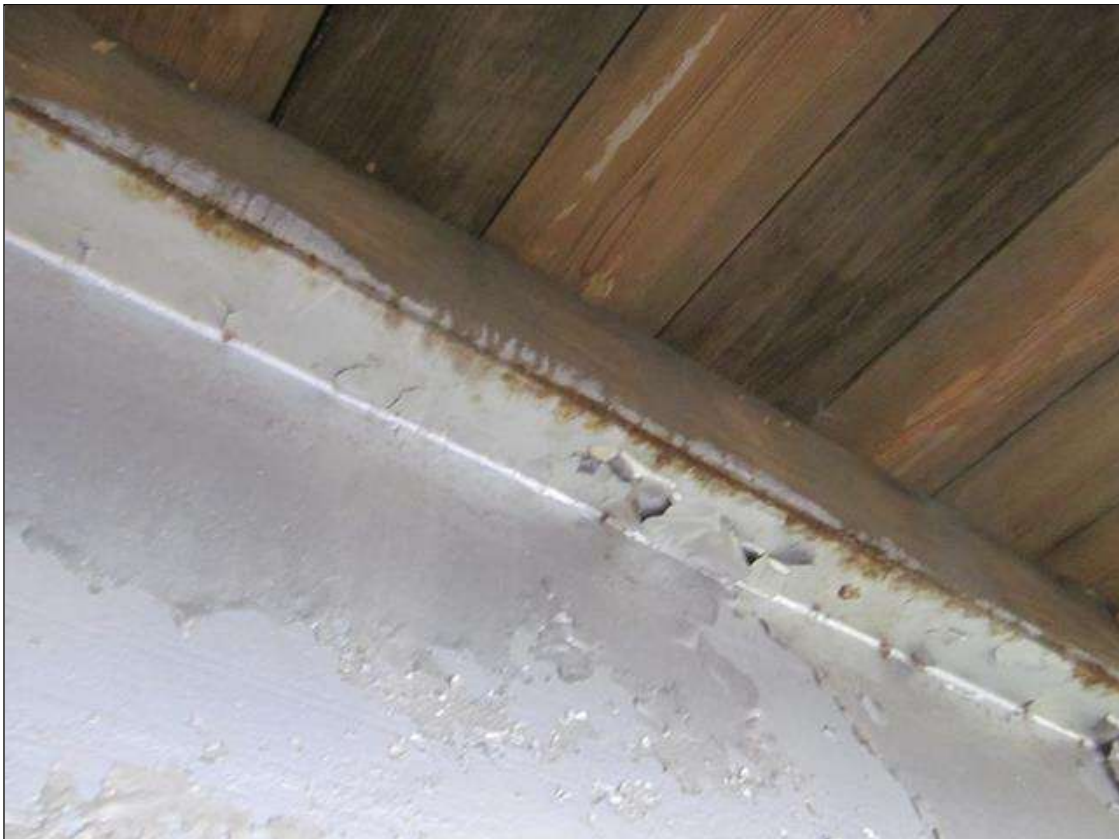
Span 1 Beam 2: SURFACE RUST SCATTERED THROUGH OUT TOP AND BOTTOM FLANGES. NO LOSS OF SECTION

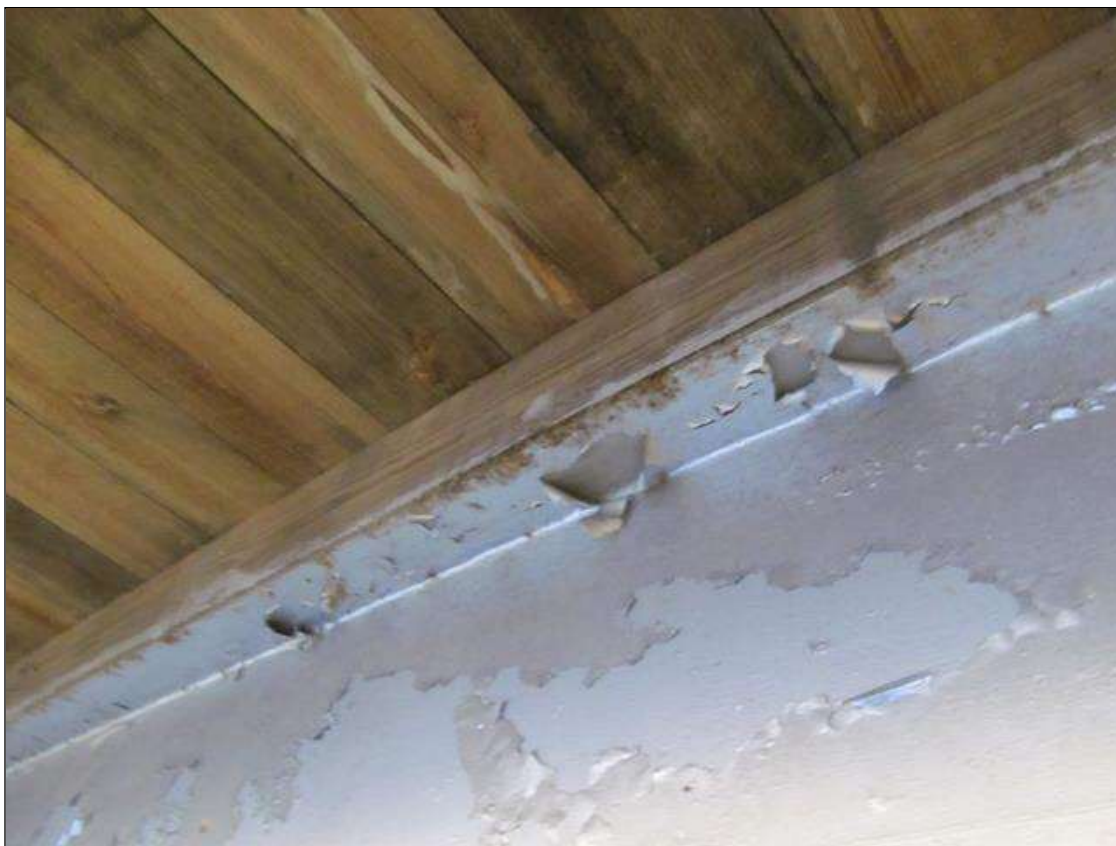
Span 1 Beam 7: SURFACE RUST SCATTERED THROUGH OUT TOP AND BOTTOM FLANGES. NO LOSS OF SECTION

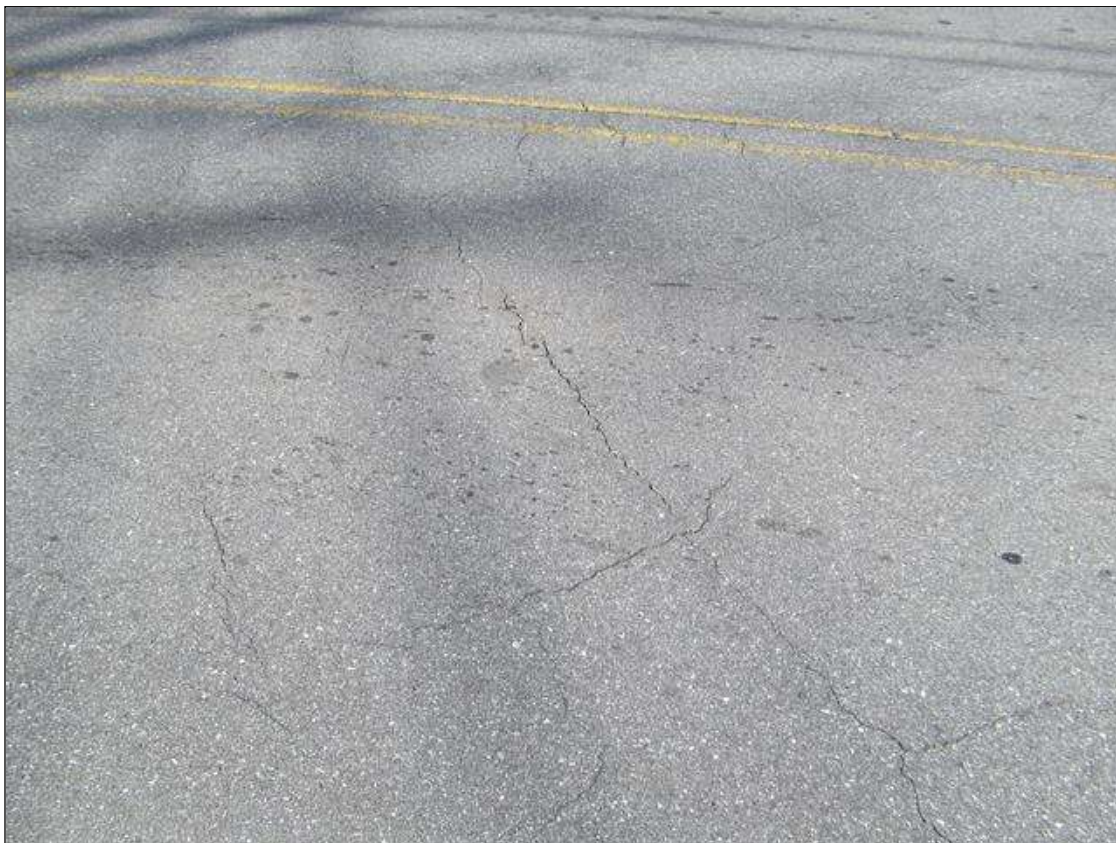
Span 1 Wearing Surface: SCATTERED CRACKING THROUGH OUT WEARING SURFACE. CRACKING IS UP TO .0104.

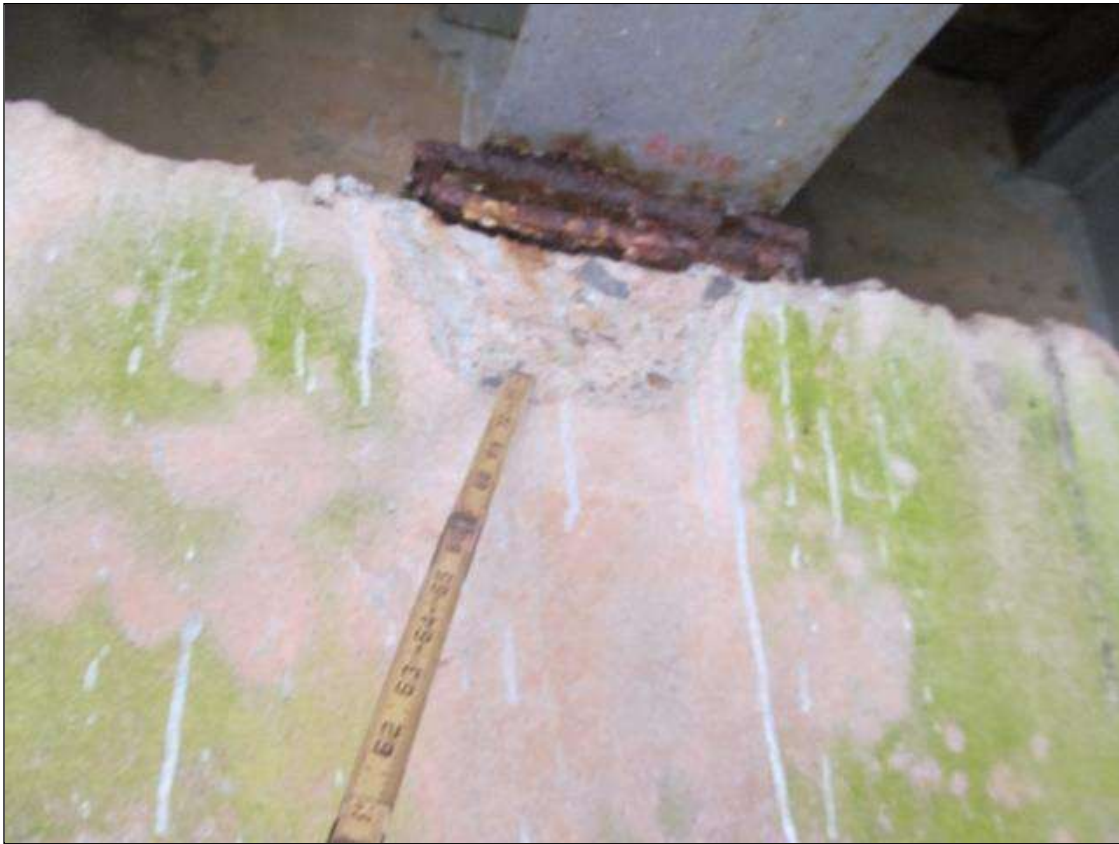
Bent 1 Abutment: 1" DEEP X 5" ROUND AREA OF SPALLING UNDER BEAM 6
