NC DEPARTMENT OF TRANSPORTATION
 DIVISION OF HIGHWAYS
 STRUCTURE MANAGEMENT UNIT

ATTENTION: **CHANGE TO GREENWAY UNDERCLEARANCE**

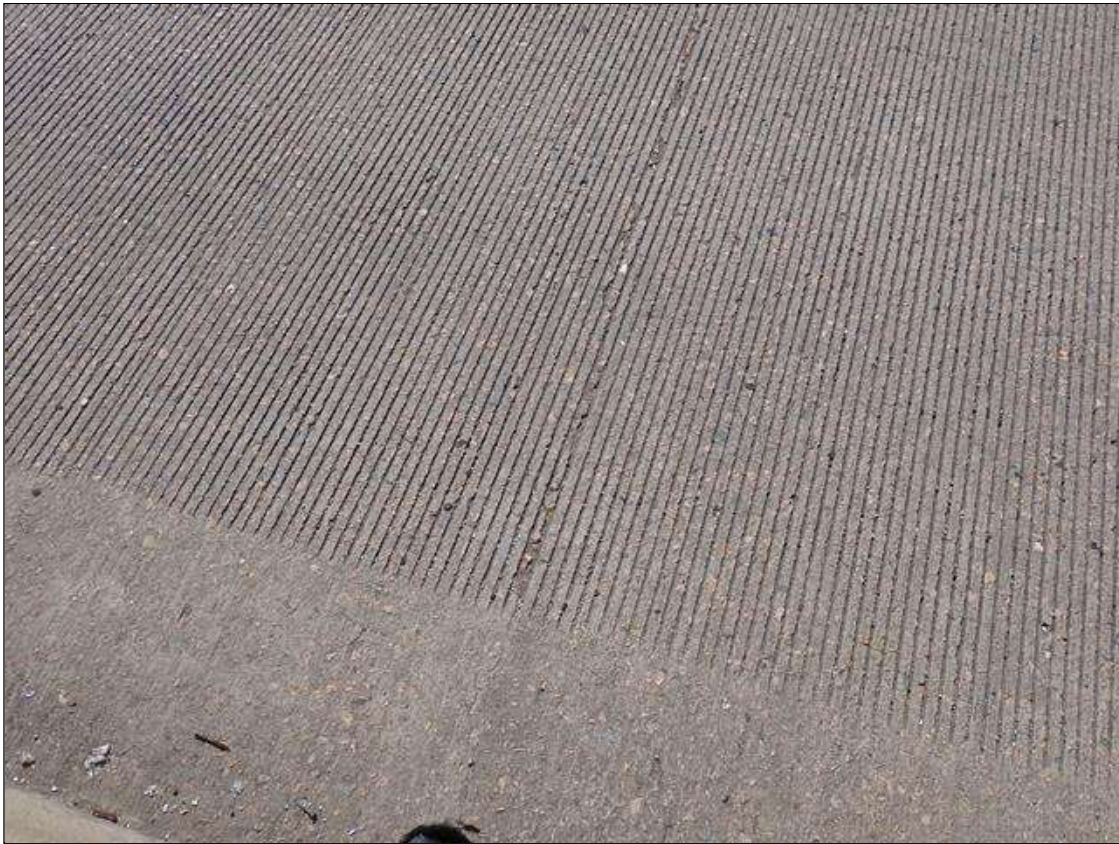
Span 1 Deck: SEVERAL FULL/PARTIAL WIDTH TRANSVERSE CRACKS UP TO 1/32 INCH AT VARIOUS LOCATIONS IN TOP OF DECK

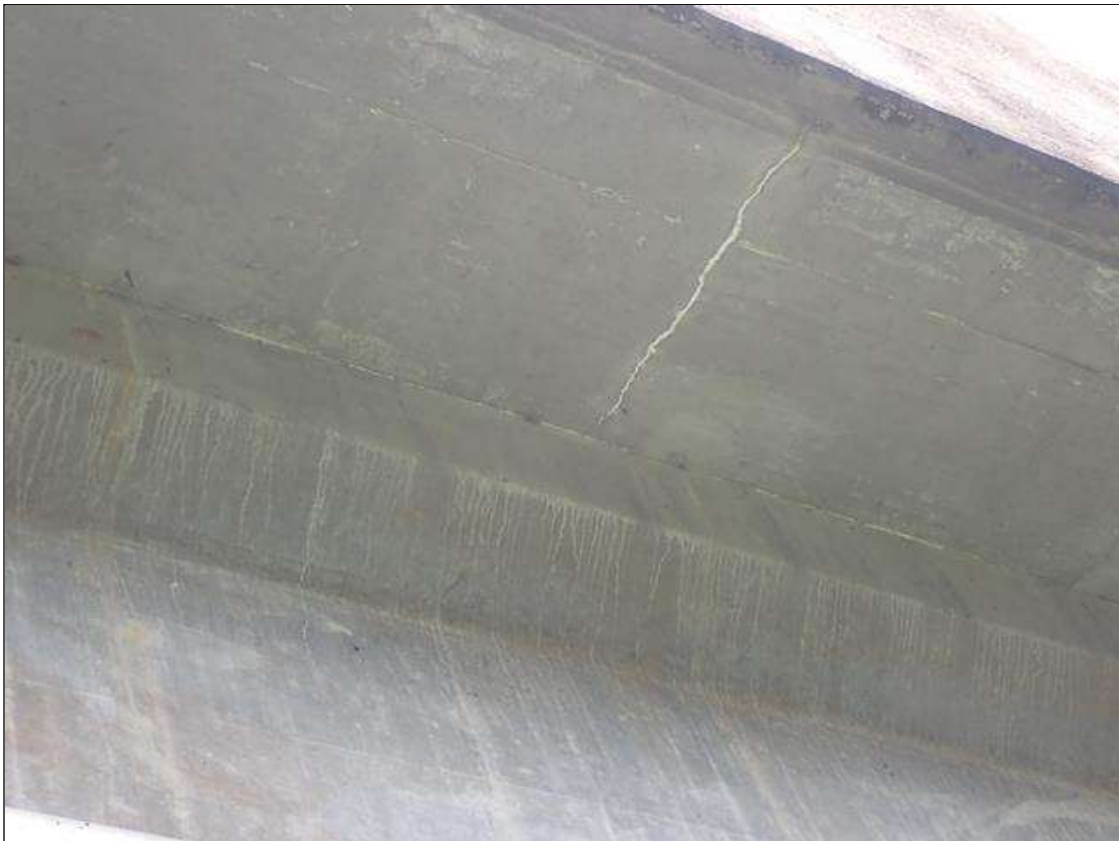
Span 1 Deck: EAST OVERHANG SCATTERED THROUGHOUT, TRANSVERSE CRACKS (2 FEET X HAIRLINE) WITH EFFLORESCENCE

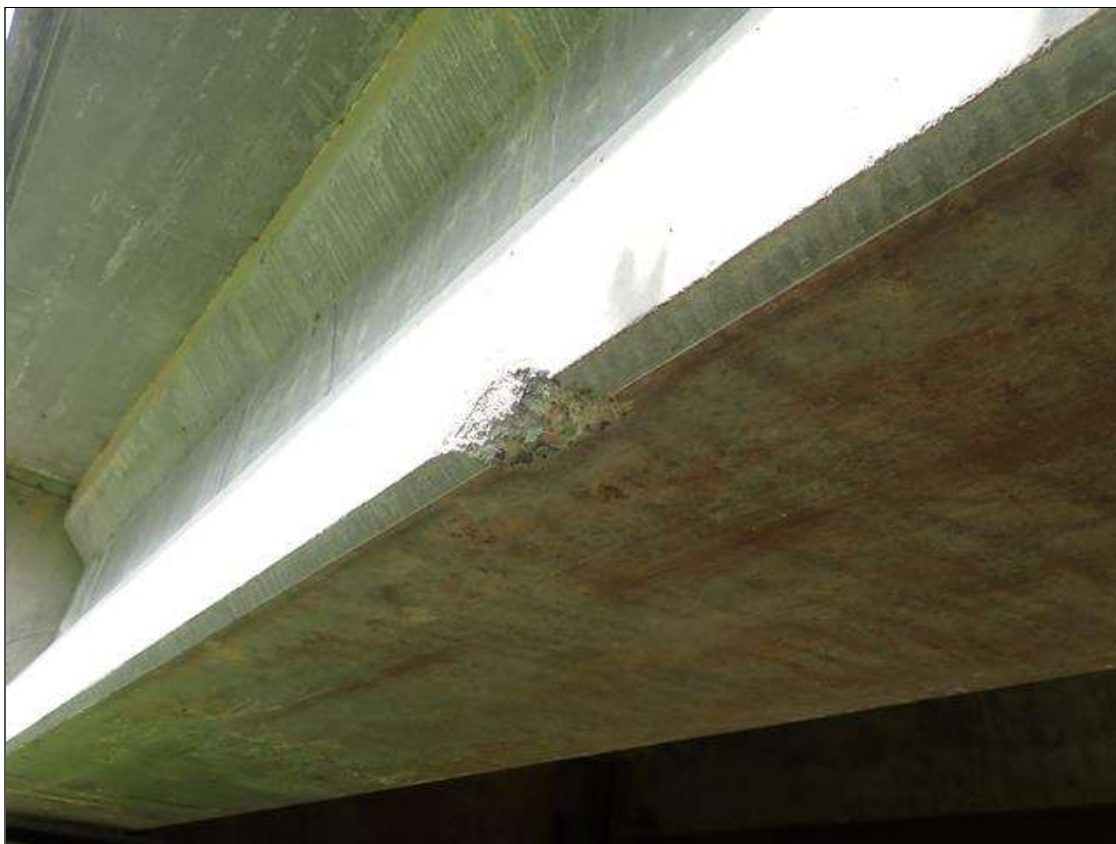
Span 1 Beam 5: 8 FEET FROM ABUTMENT 1 IN BOTTOM FLANGE ON BOTTOM EAST CORNER, SPALL (4 INCHES X 3 INCHES X 1 INCH DEEP) NO EXPOSED REBAR

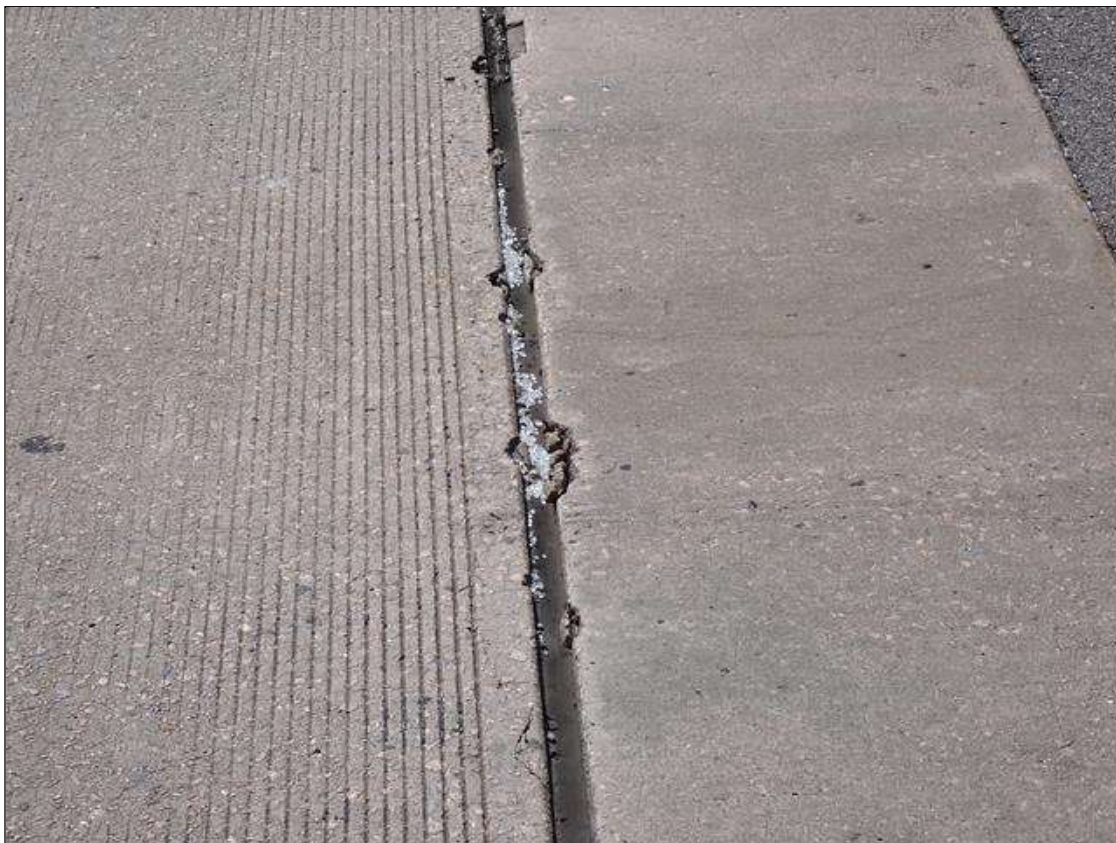
Span 1 Expansion Joint 1: ALL LANES SCATTERED THROUGHOUT, EDGE SPALLING (UP TO 18 INCHES X 2 INCHES X 1/2 INCH) NO EXPOSED REBAR

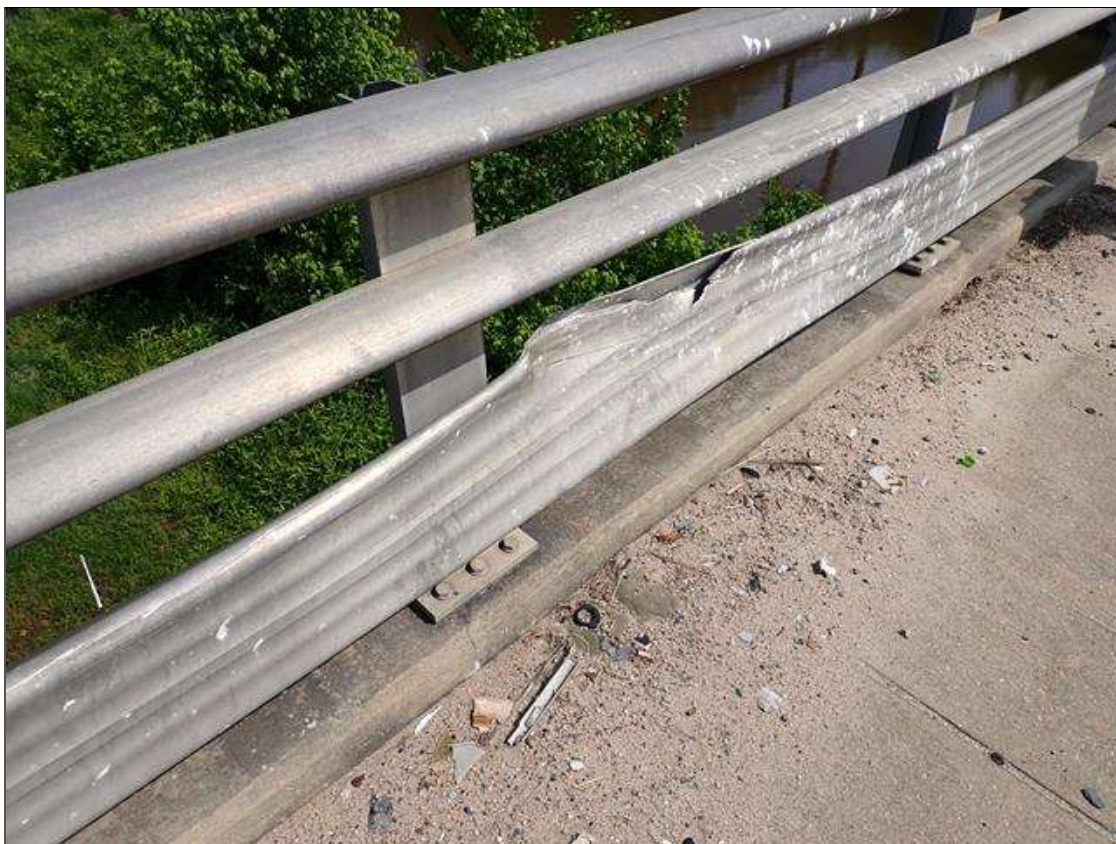
Span 1 Left Bridge Rail: AT 45 FEET FROM END BENT 1, IMPACT DAMAGE BOTTOM RAIL (3-1/2 LINEAR FEET) WITH TEARING (30 INCHES X UP TO 3 INCHES) NO DAMAGE TO POSTS

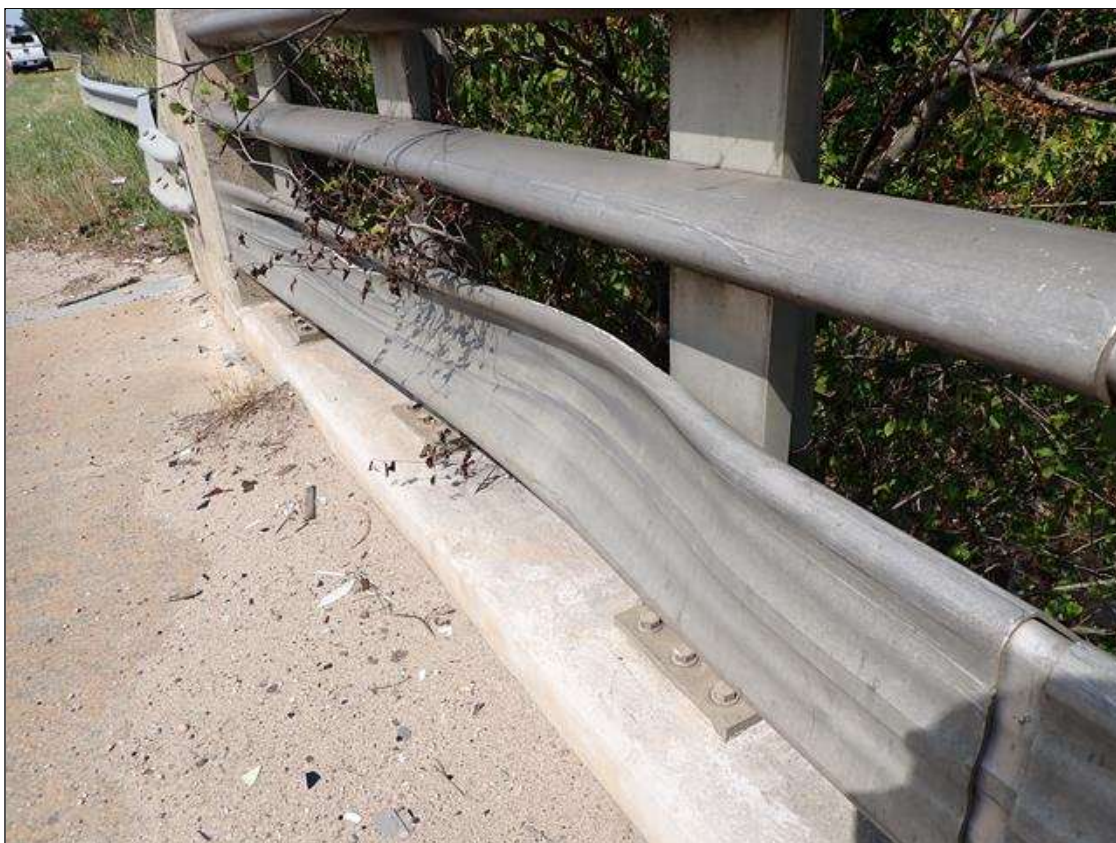
Span 1 Left Bridge Rail: AT END BENT 1, IMPACT DAMAGE TO BOTTOM RAIL (9-1/2 LINEAR FEET) WITH TEARING (5 FEET X UP TO 2 INCHES) NO DAMAGE TO POSTS

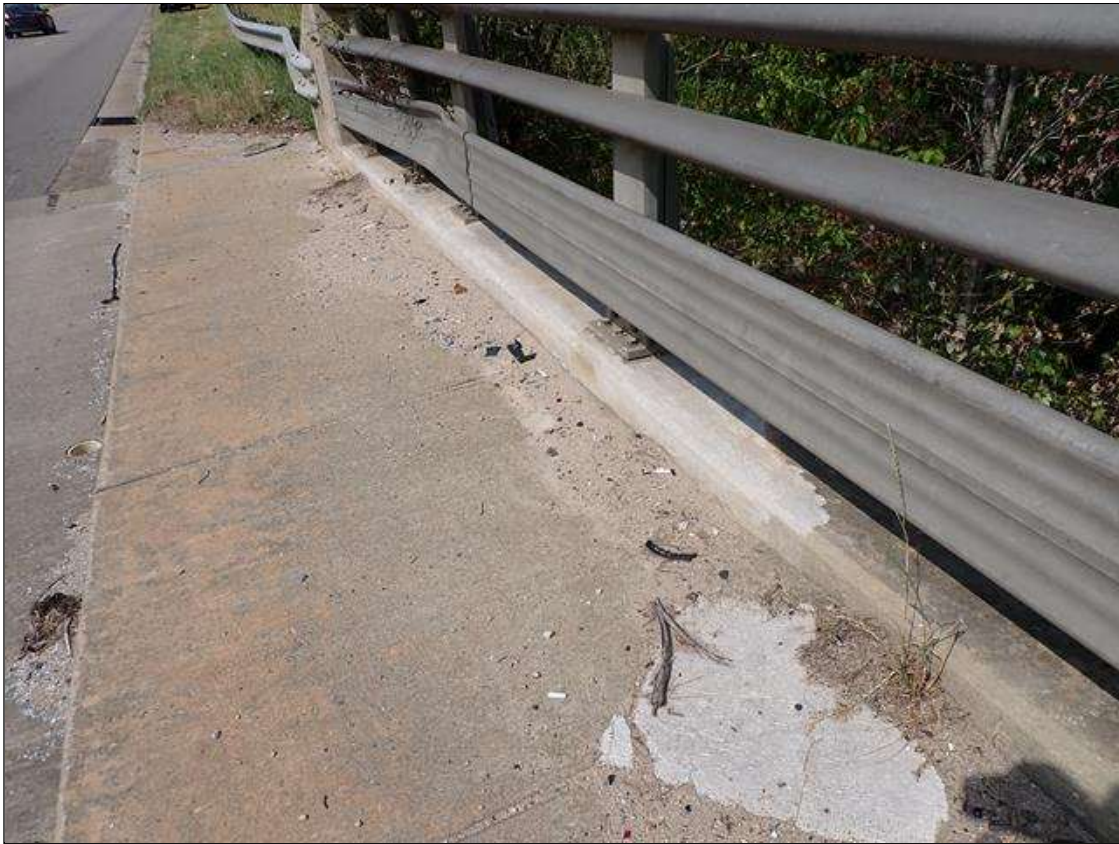
Span 1 Left Bridge Rail: PARAPET AT END BENT 1, REPAIR AREA (13 LINEAR FEET)

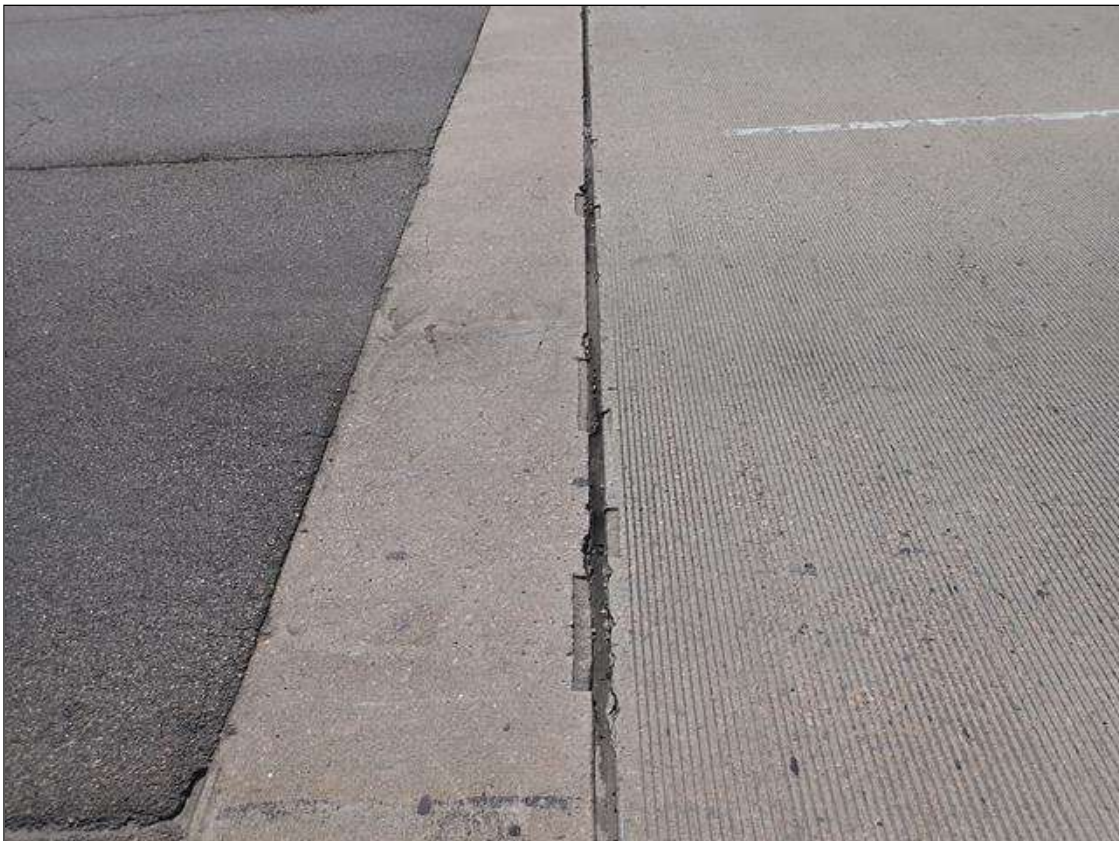
Span 4 Expansion Joint 5: NUMEROUS SOUND PATCHES UP TO 1 FOOT LONG X 2 INCHES WIDE AT VARIOUS LOCATIONS BOTH SIDES OF JOINT

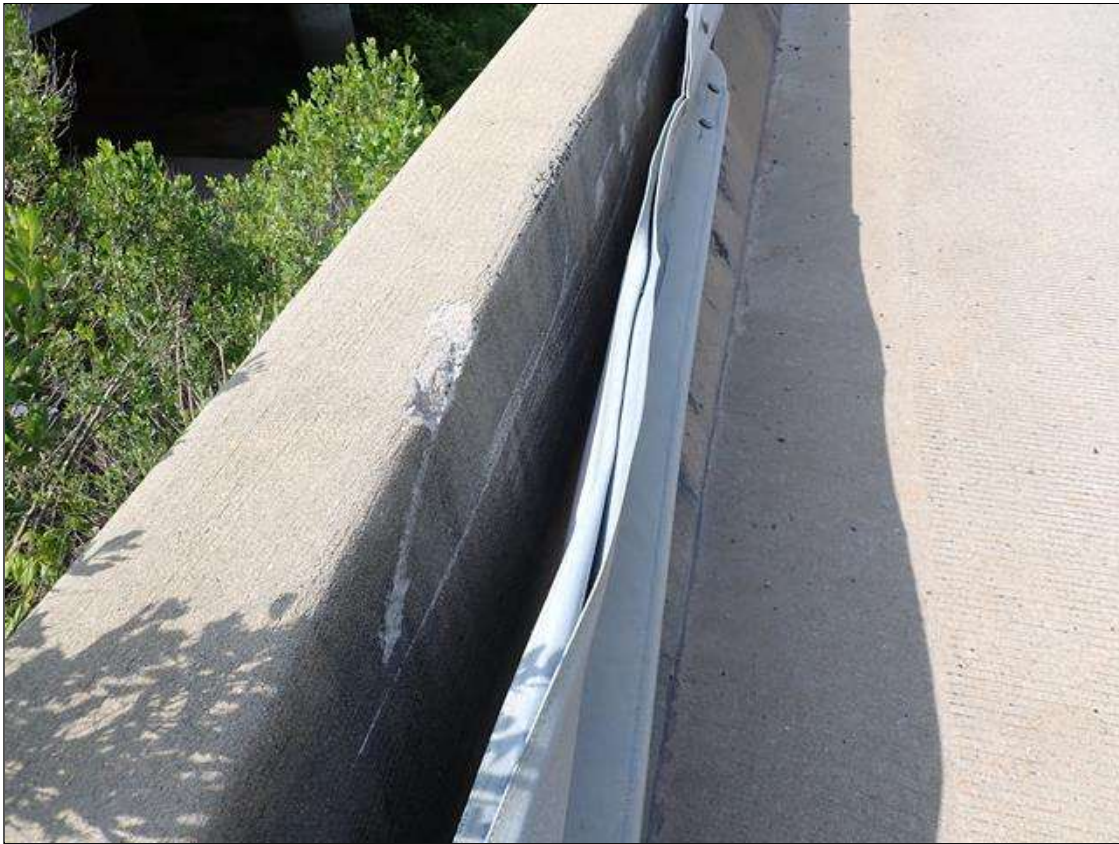
Span 4 Right Bridge Rail: TOP OF RAIL AT END BENT 2, SPALL (6 INCHES LONG X 1 INCH TALL X 1/2 INCH DEEP) NO EXPOSED REBAR

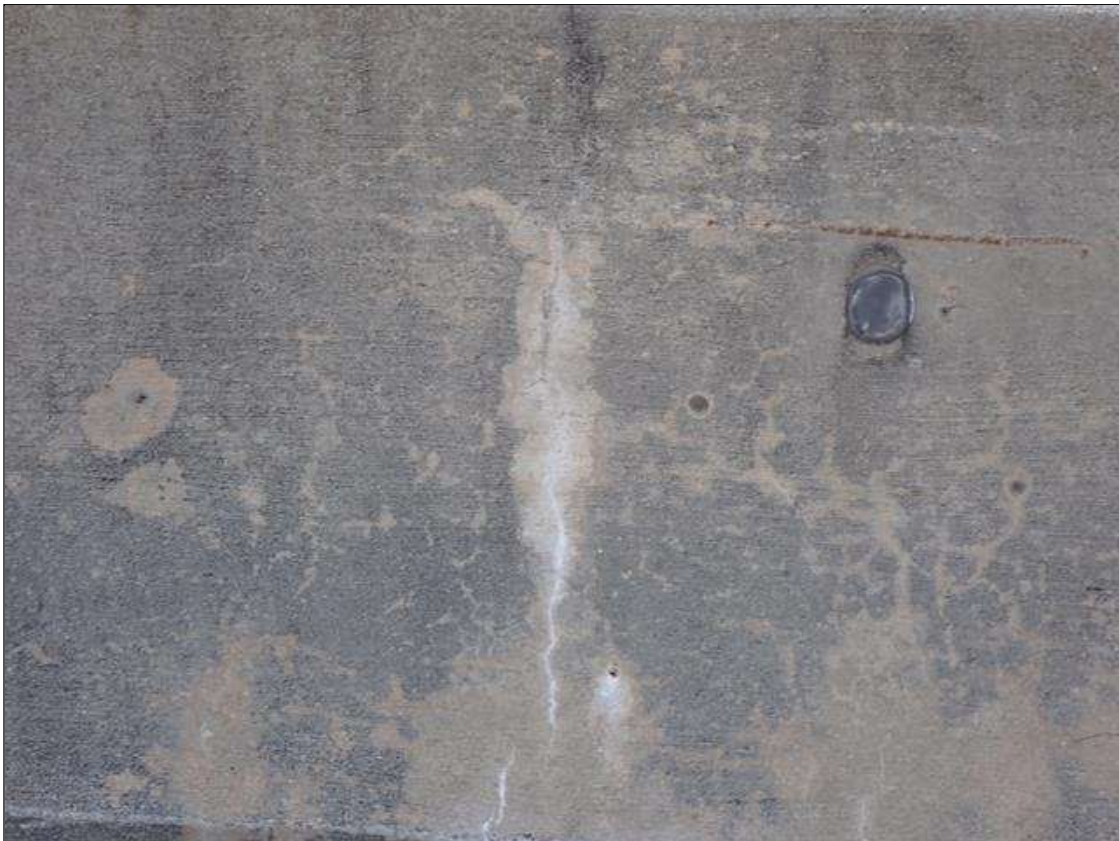
Span 1 Right Bridge Rail: BOTH FACES SCATTERED THROUGHOUT, VERTICAL CRACKS (FULL HEIGHT X HAIRLINE) WITH EFFLORESCENCE EXTENDING ONTO TOP FACE (FULL WIDTH X UP TO 1/32 INCH)

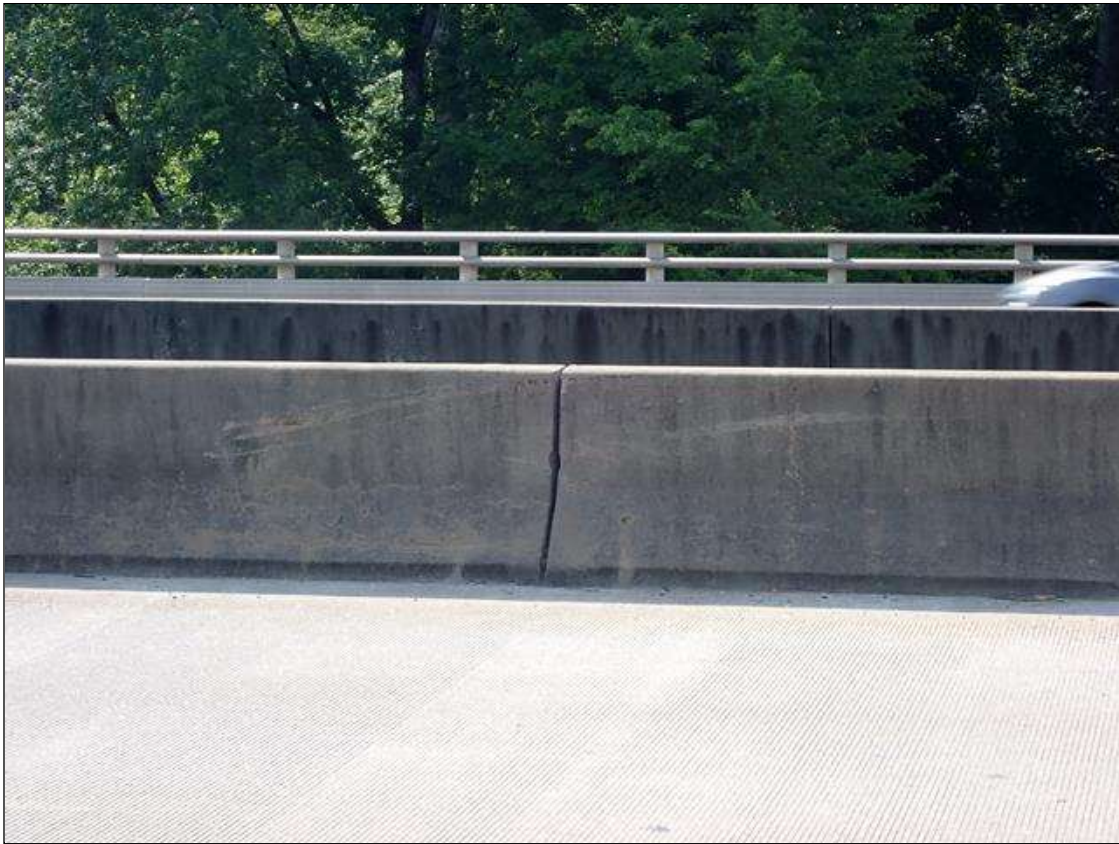
TYPICAL IMPACT SCRAPE IN RIGHT BRIDGE RAIL, NO SECTION LOSS

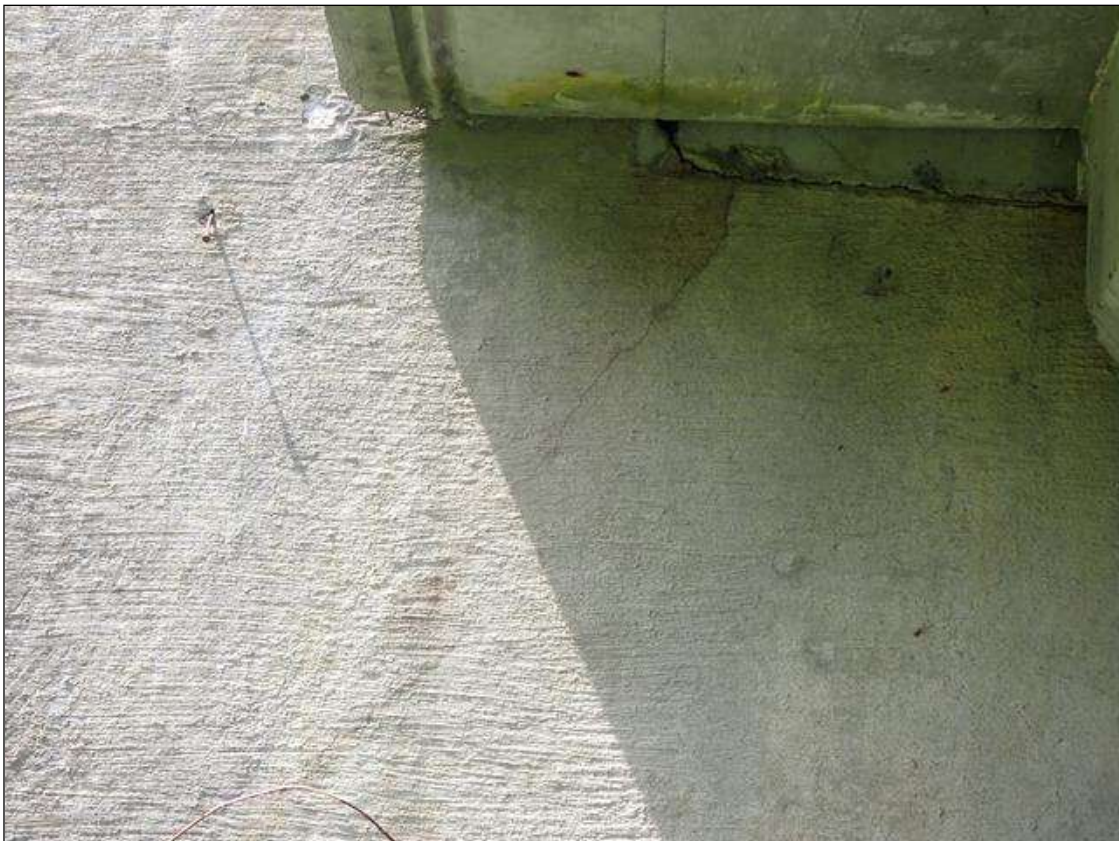
End Bent 1 Abutment: EAST END OF ABUTMENT, 4 FOOT LONG DIAGONAL 1/32 INCH CRACK

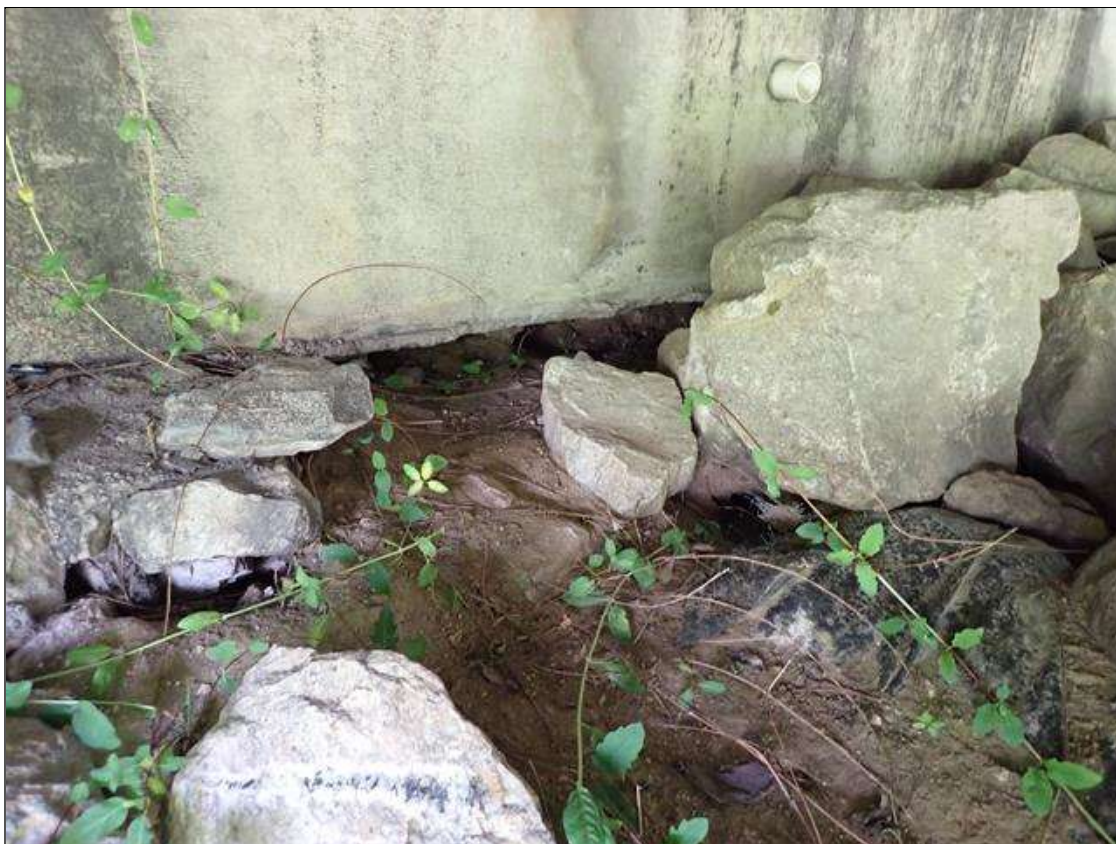
End Bent 2 Abutment: BAY 2, AREA OF MISSING RIP RAP WITH VOID (5 FEET X UP TO 9 INCHES) NO UNDERMINING

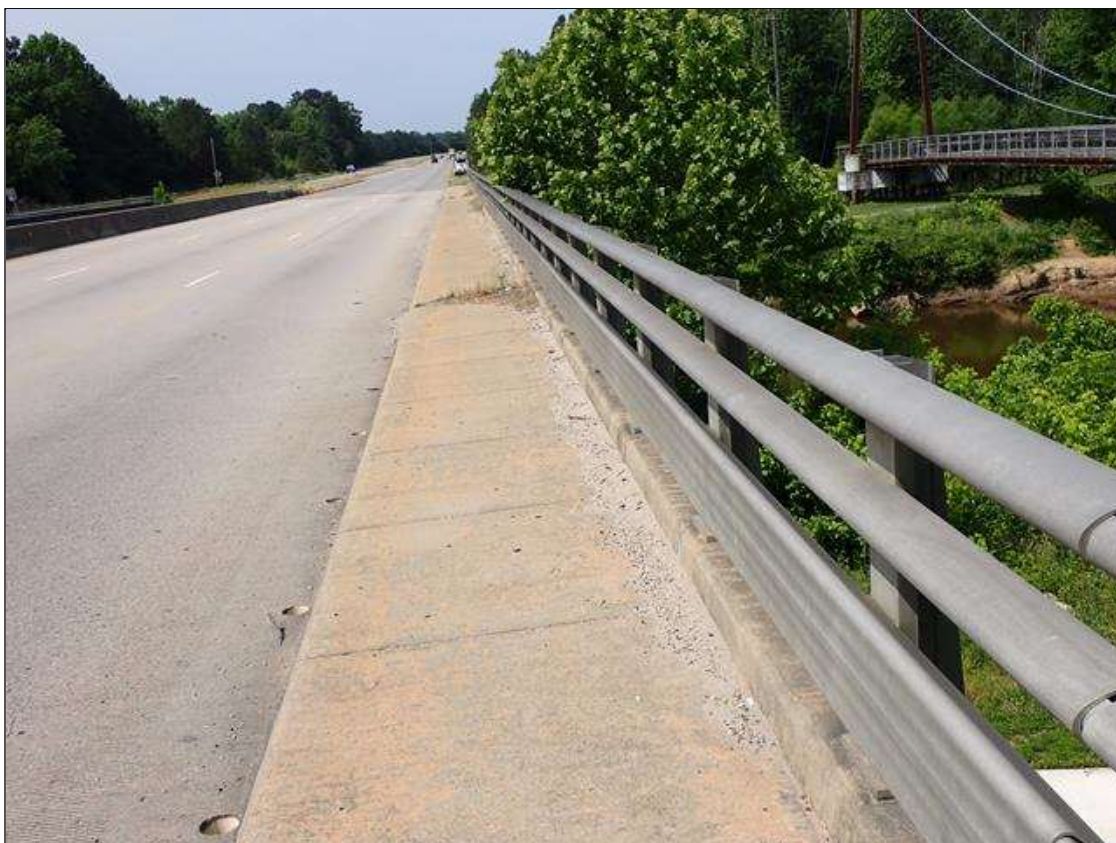
DEBRIS OVER BENT 3 JOINT

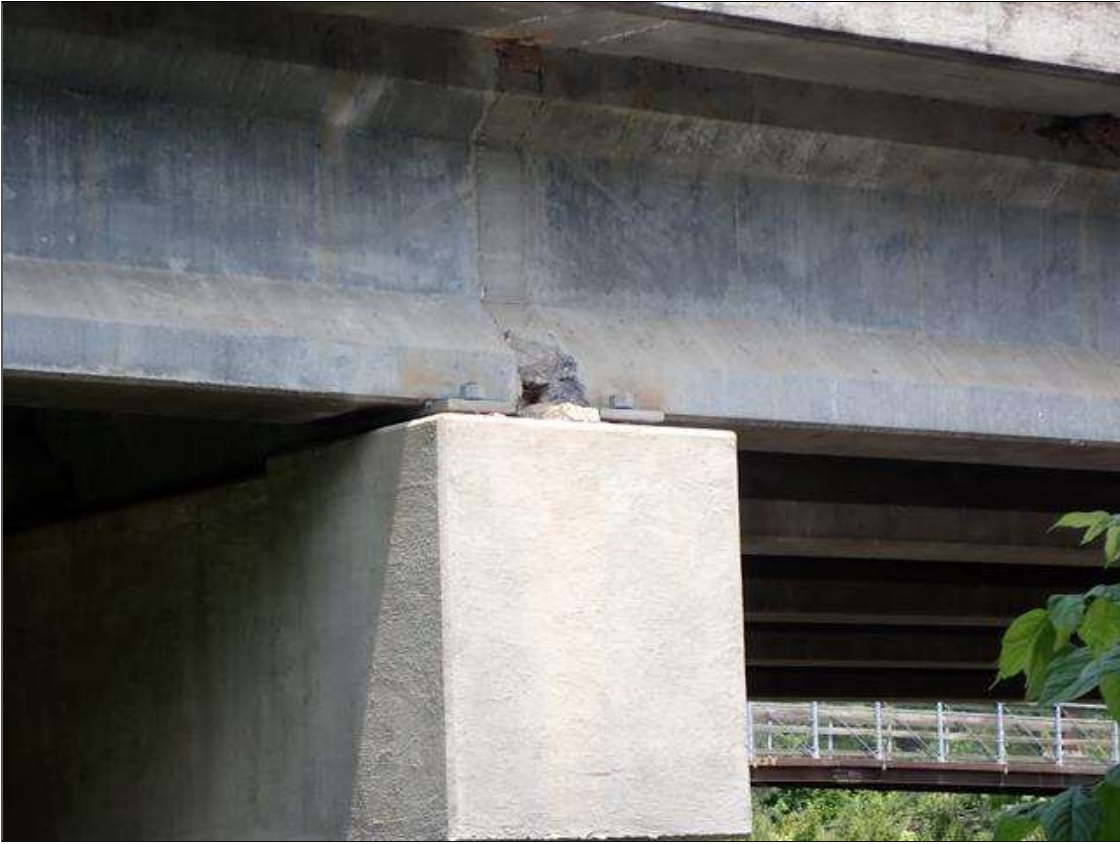
END DIAPHRAGM AT BENT 1 BEAM END, SPALL (1 FOOT TALL X 9 INCHES LONG X UP TO 4 INCHES DEEP) WITH EXPOSED RUSTED REBAR, NO MEASURABLE SECTION LOSS

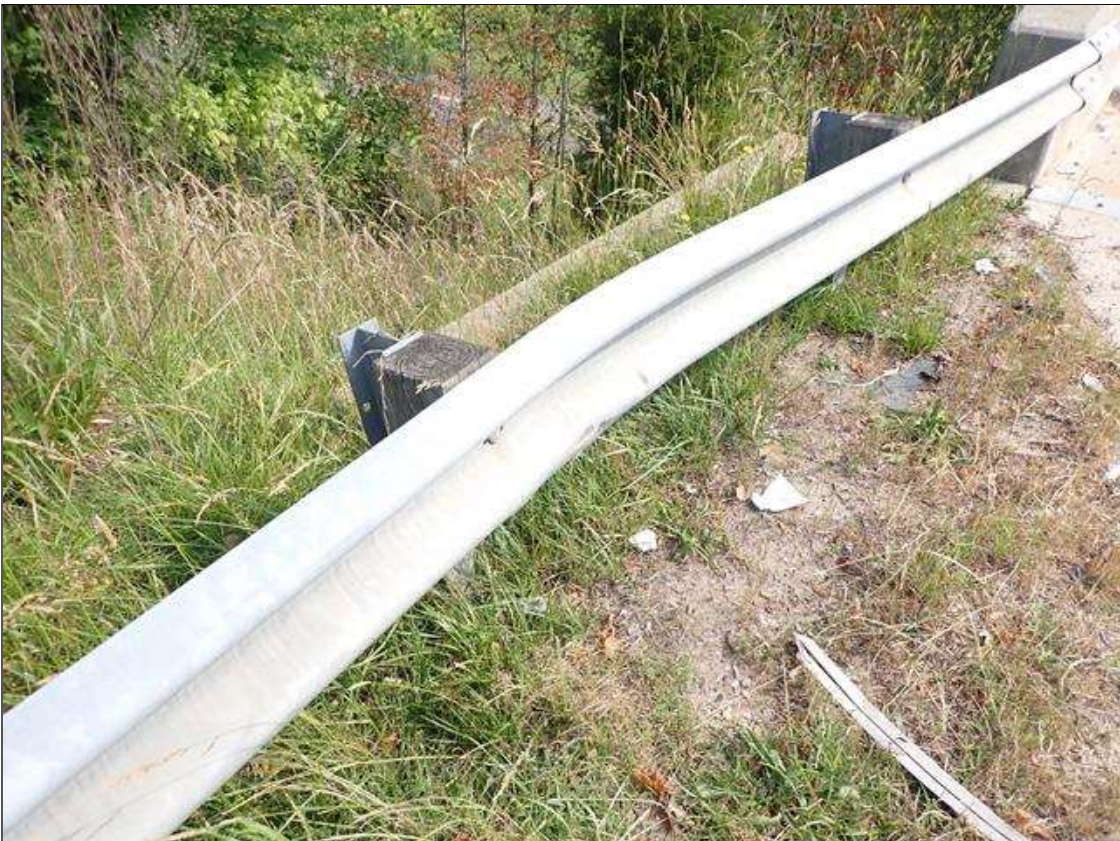
STARTING AT SOUTHWEST CORNER OF BRIDGE, IMPACT DAMAGE TO APPROACH GUARDRAIL FOR 10 FEET WITH POSTS ROTATED AND PUSHED BACK UP TO 1 FOOT, GUARDRAIL IS FUNCTIONING AS INTENDED

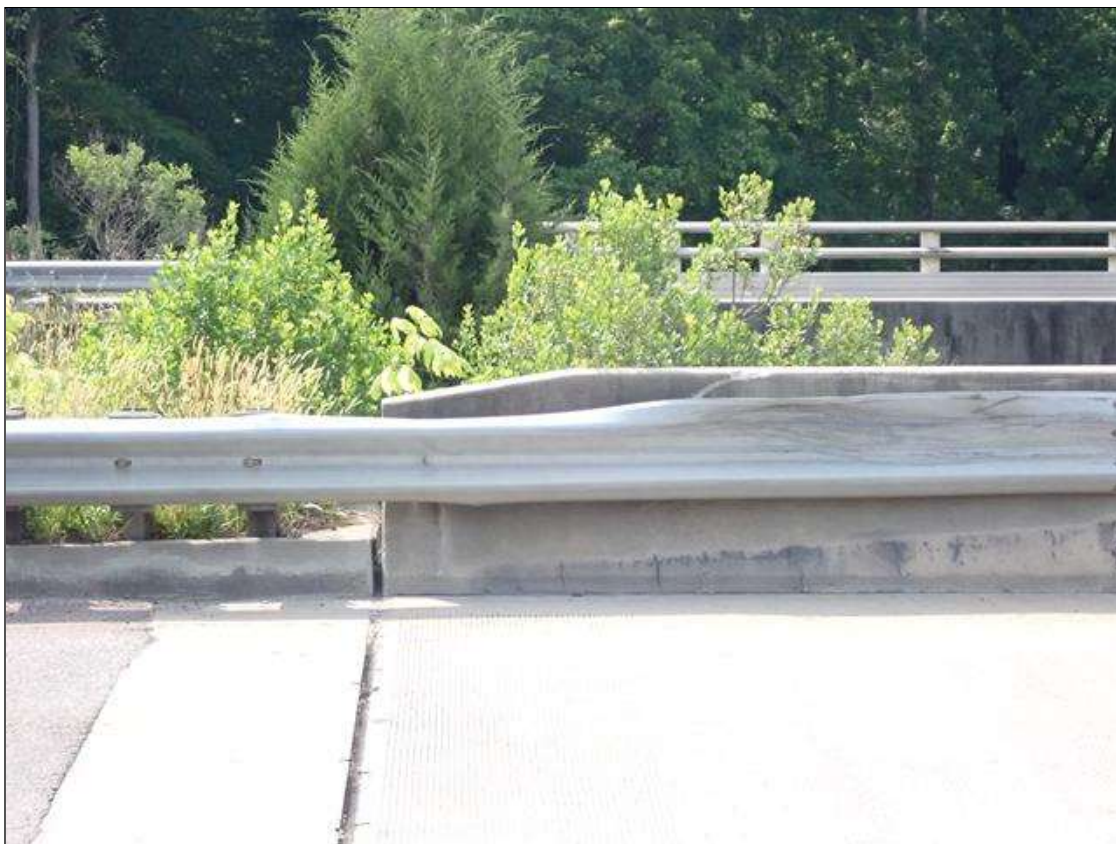
AT NORTHEAST CORNER OF BRIDGE, IMPACT DAMAGE TO APPROACH GUARDRAIL FOR 6 FEET WITH RAIL DEFLECTED DOWN UP TO 2 INCHES, GUARDRAIL IS FUNCTIONING AS INTENDED

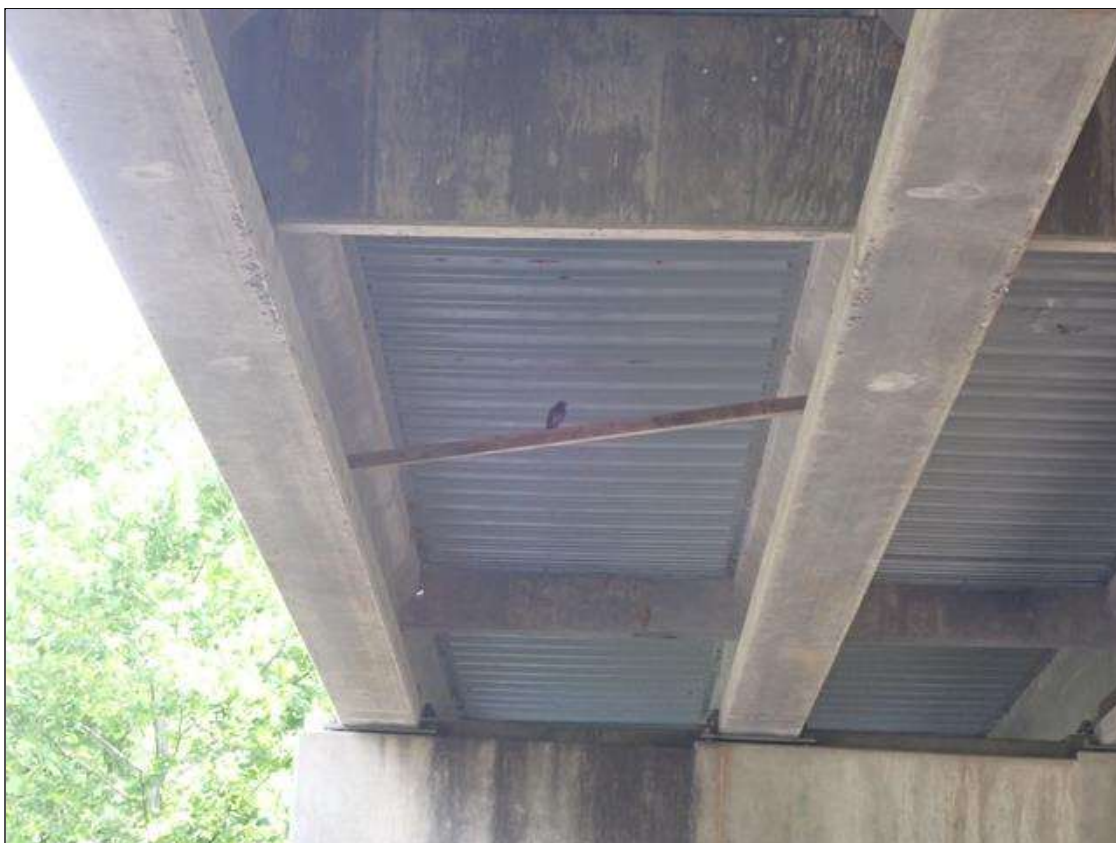
BOARDS WEDGED BETWEEN GIRDERS IN BAYS 1 AND 4 OF SPAN 2, 3 TOTAL

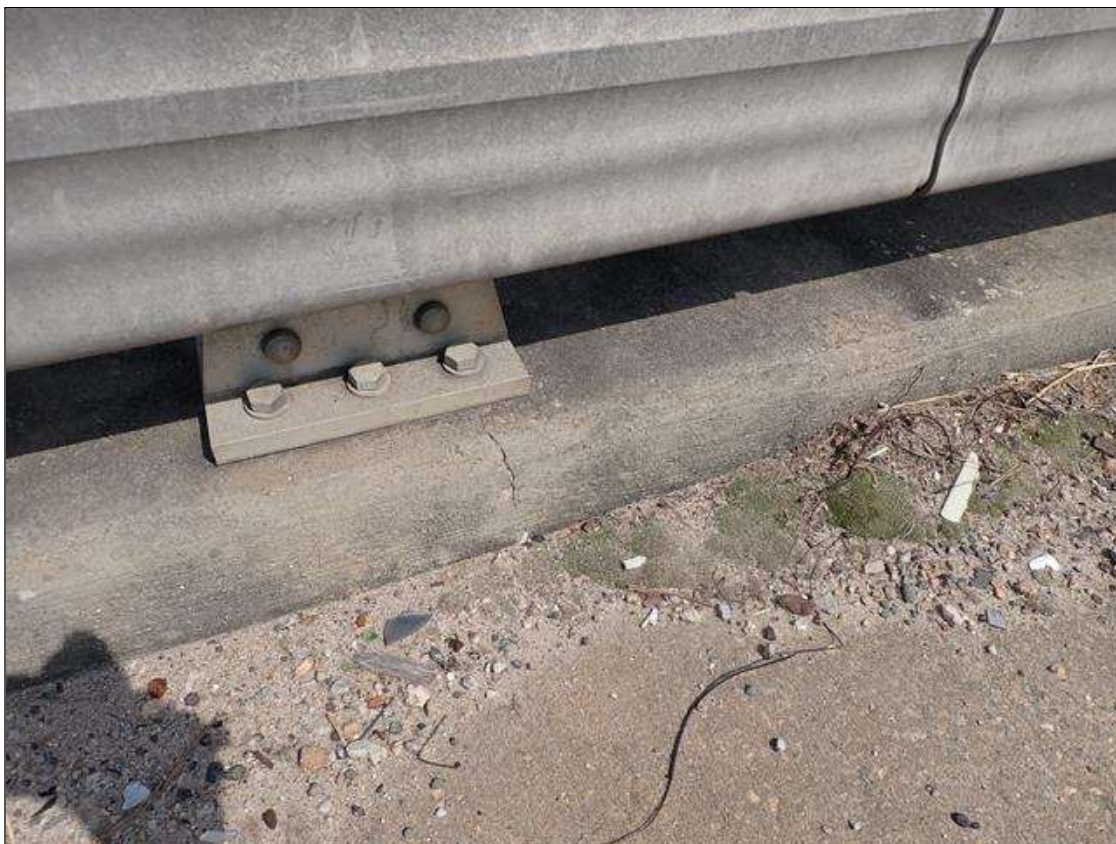
Span 2 Left Bridge Rail: BOTH FACES AND TOP OF PARAPET AT APPROXIMATELY 5 FOOT CENTERS, VERTICAL HAIRLINE CRACKS UP TO 1 FOOT HIGH, SOME WITH EFFLORESCENCE

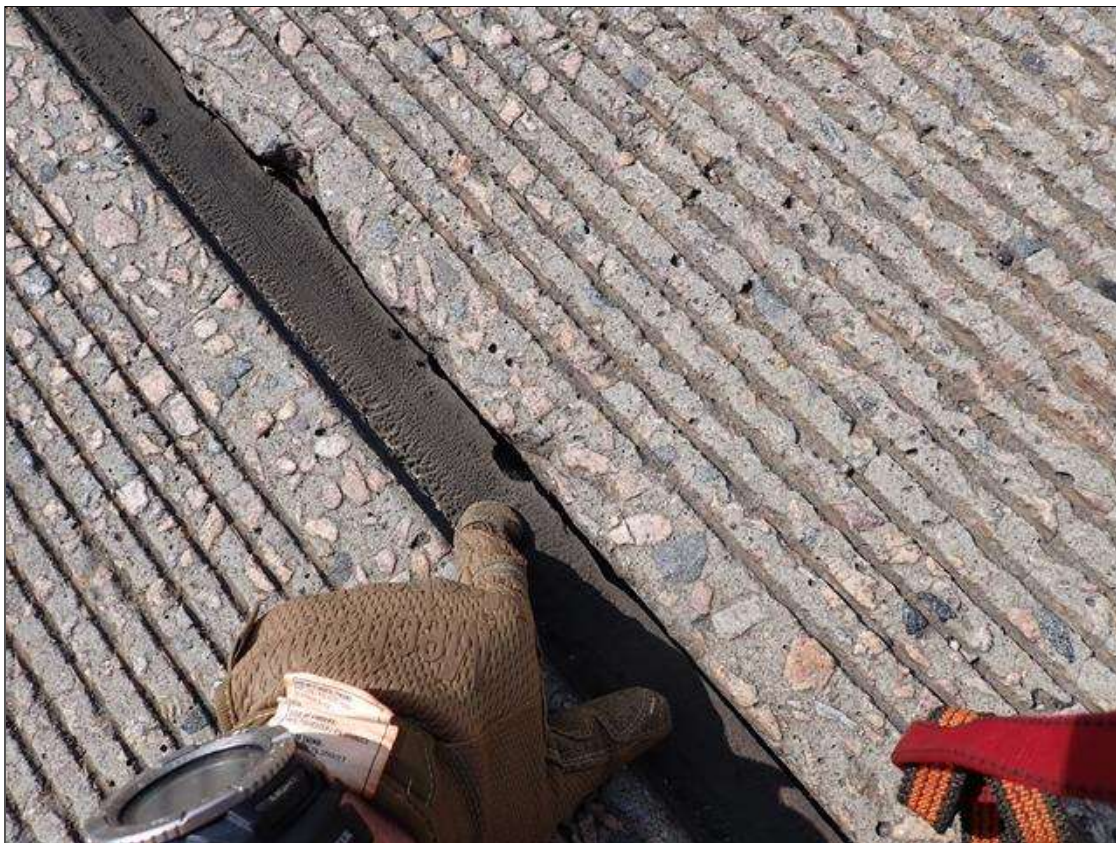
Span 3 Expansion Joint 3: IN LEFTMOST LANE, PARTIAL DEPTH ADHESION LOSS

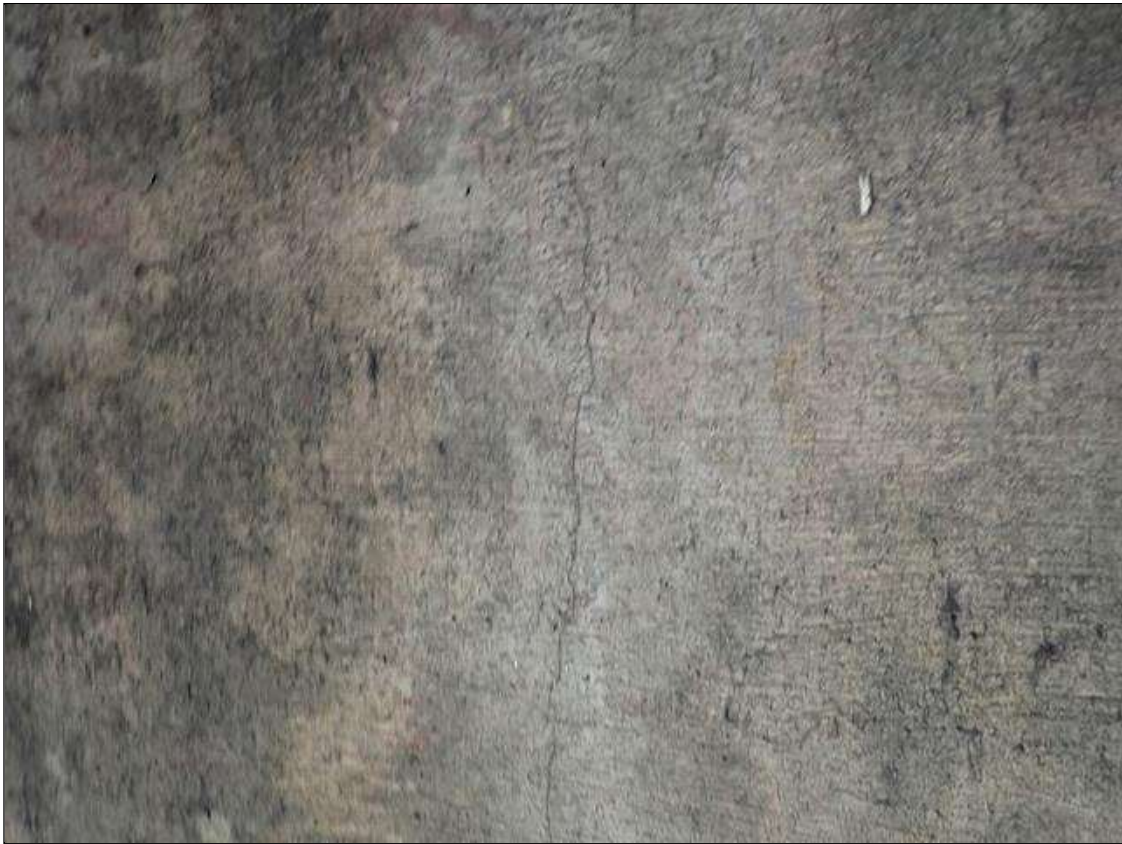
End Bent 1 Abutment: VERTICAL HAIRLINE CRACKS IN THE BACKWALL BETWEEN GIRDERS

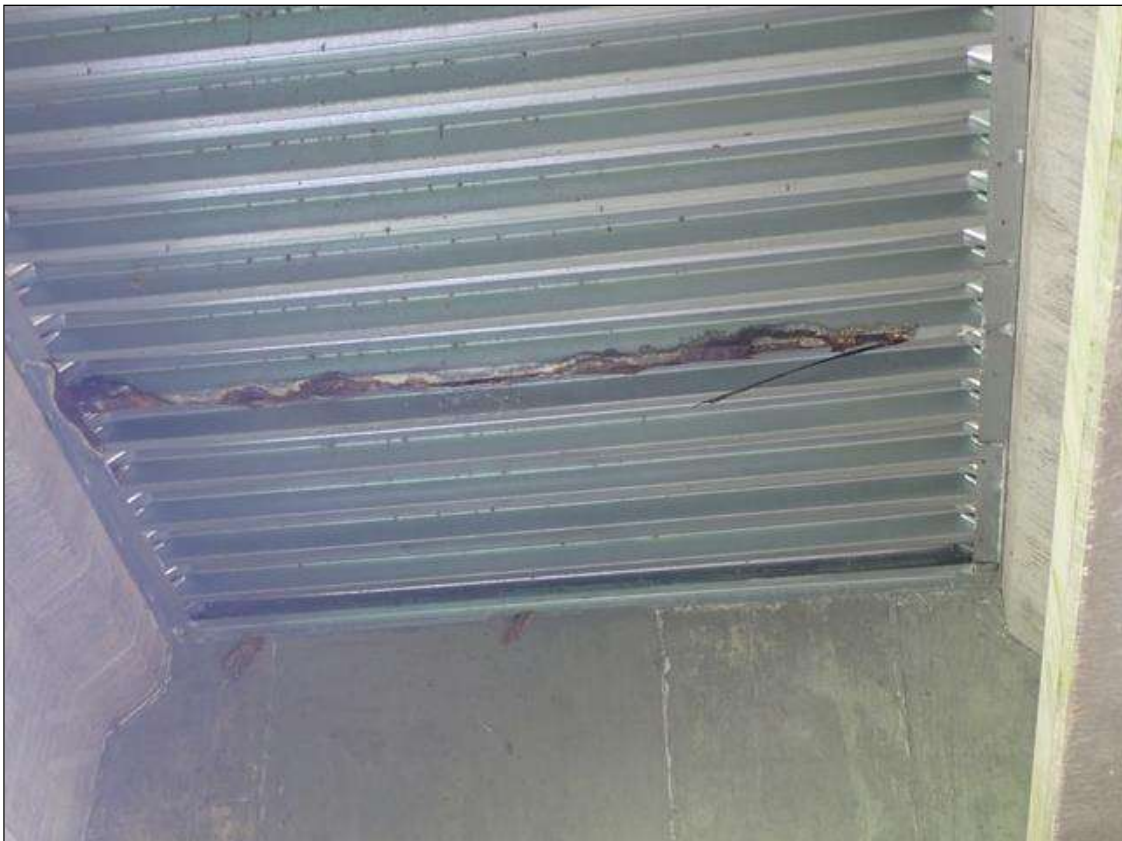
Span 1 Deck: 4 FEET FROM BENT 1 IN BAY 1, CORROSION ON STAY IN PLACE FORM (8 FEET WIDE X 8 INCHES LONG)

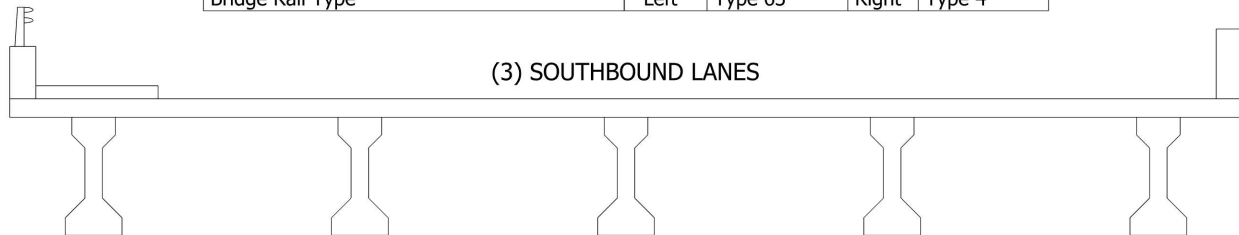
Measurements for Span #	1	SPANS 2-4 SIMILAR*	
Deck Thickness	8.5in	Left Overhang	3.208ft
Top of Rail to Bottom of Beam (Left)	9.708ft	Right Overhang	3.208ft
Top of Rail to Bottom of Beam (Right)	8.25ft
