NC DEPARTMENT OF TRANSPORTATION
 DIVISION OF HIGHWAYS
 STRUCTURE MANAGEMENT UNIT

ATTENTION: **PAR SUBMITTED, CHANGE IN STRUCTURE DATA,
 CHANGE IN UNDERCLEARANCE.**

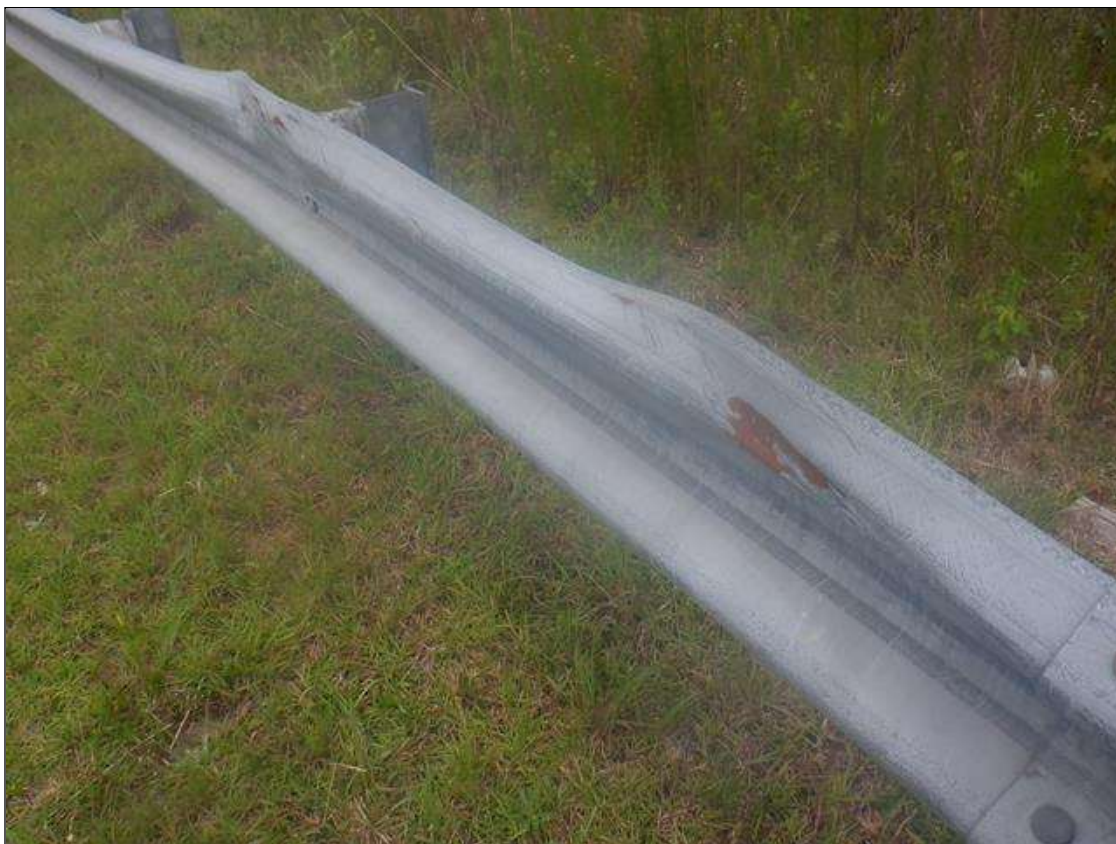
MODERATE IMPACT DAMAGE TO NORTHEAST GUARDRAIL AT MID SPAN FOR UP TO 13 FT LONG WITH RAIL DEFLECTED INWARD FOR 4 INCHES. (PAR)

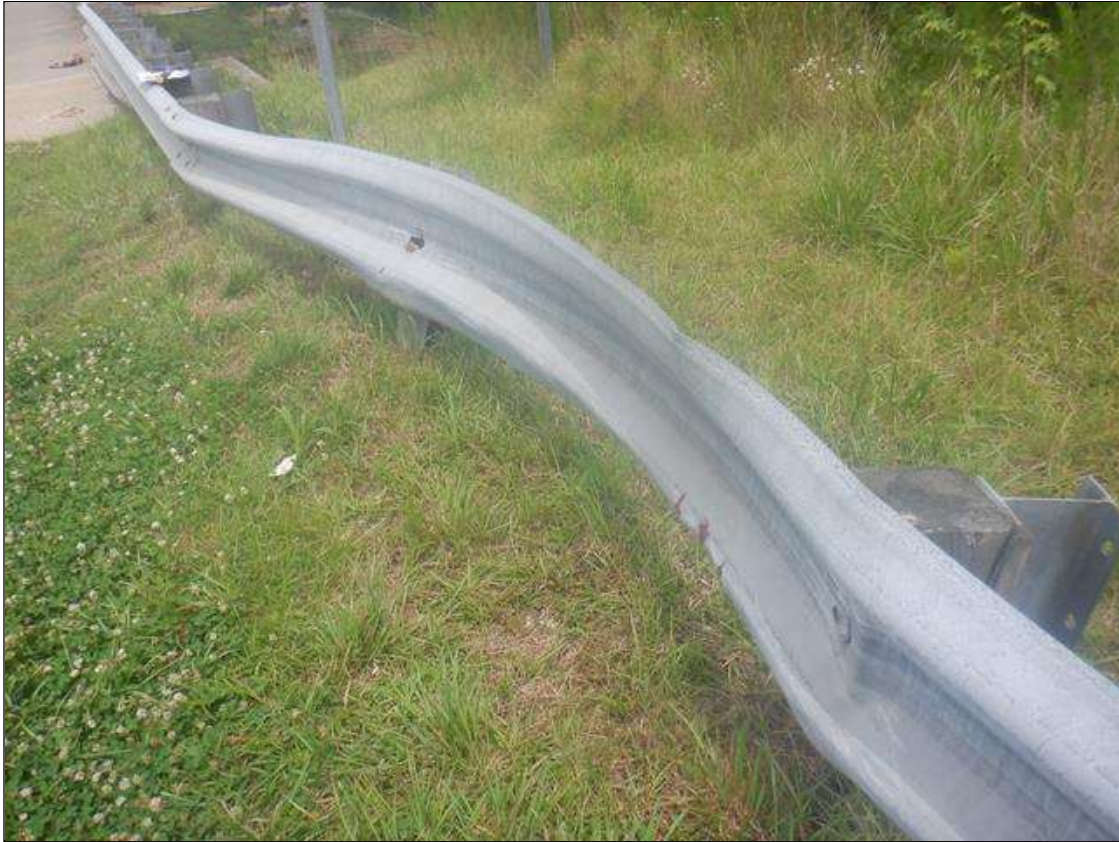
HEAVY IMPACT DAMAGE TO SOUTHEAST GUARDRAIL FOR 13 FROM LONG STARTING 24 FT FROM BEGINNING OF BRIDGE. RAIL IS DEFLECTED INWARD UP TO 24 INCHES AND VERTICAL POST ARE LEANING EAST AND TWISTED. (PAR)

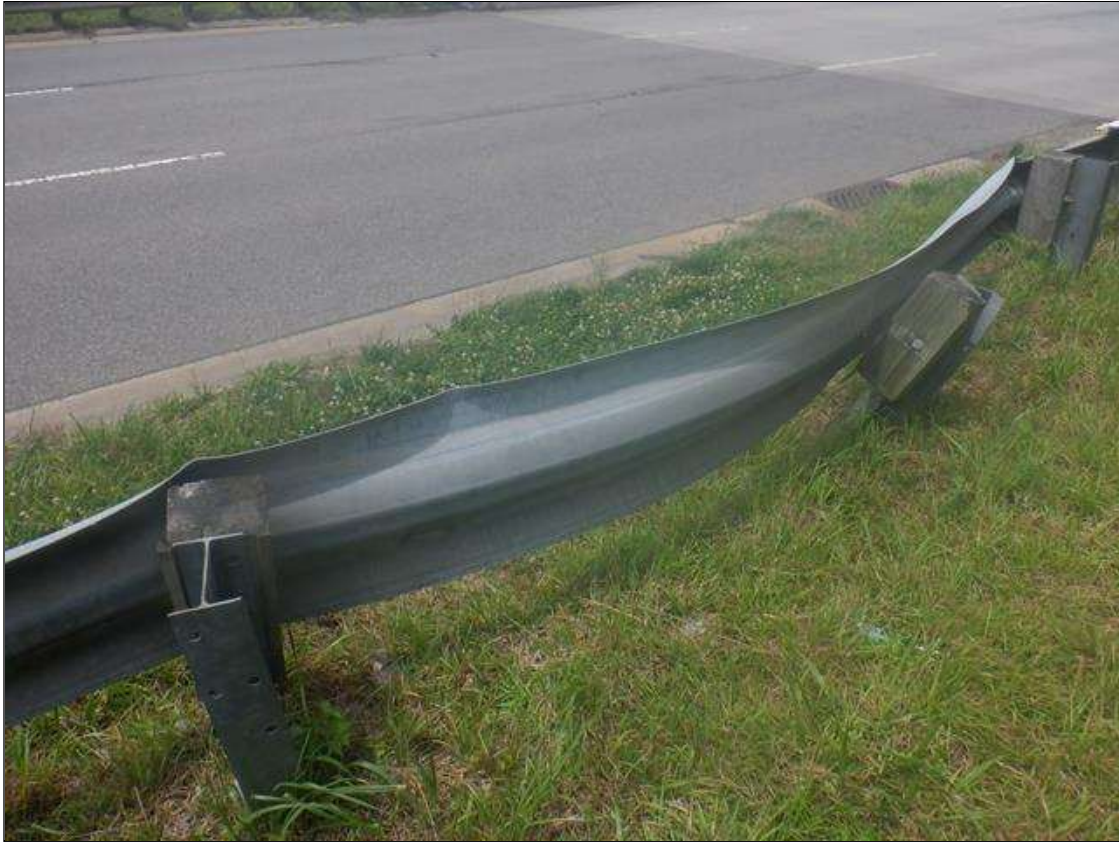
HEAVY IMPACT DAMAGE TO SOUTHEAST GUARDRAIL FOR 13 FROM LONG STARTING 24 FT FROM BEGINNING OF BRIDGE. RAIL IS DEFLECTED INWARD UP TO 24 INCHES AND VERTICAL POST ARE LEANING EAST AND TWISTED. (PAR)

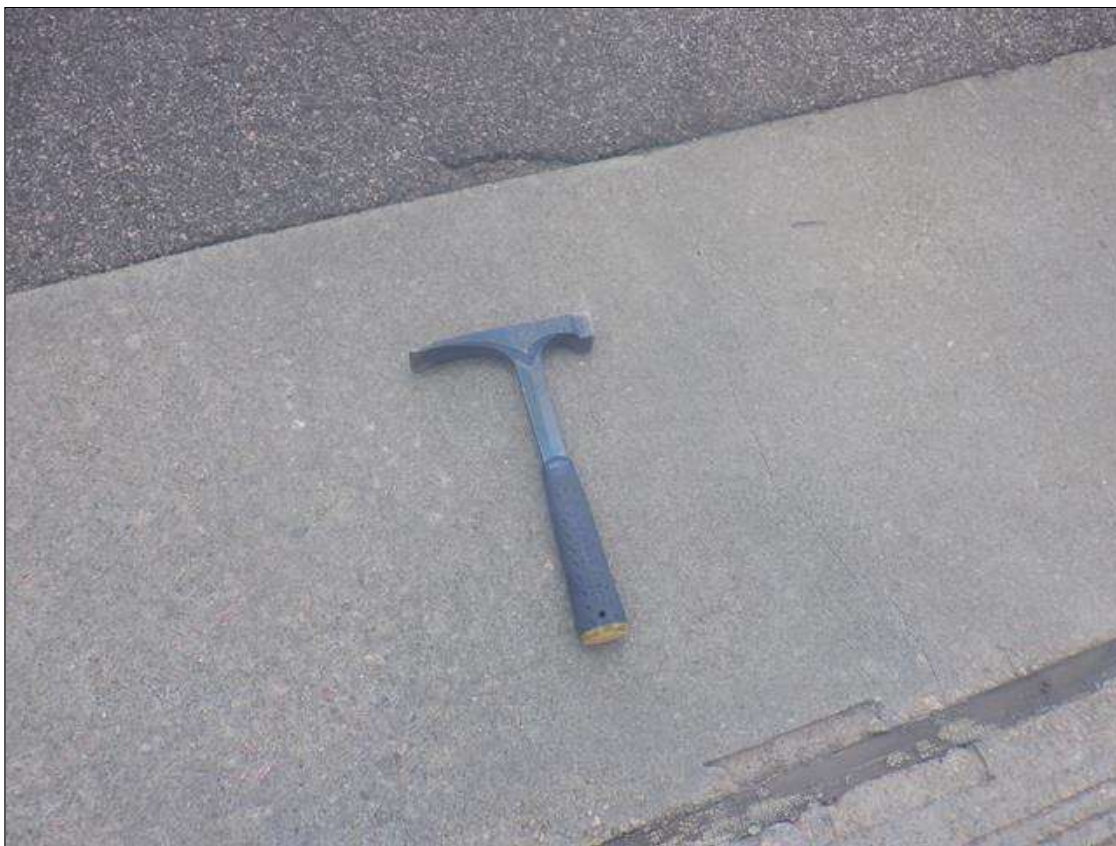
Approach 1 : 16 SQUARE FEET UP TO 1/32" LONGITUDINAL CRACKS, AT RANDOM THROUGHOUT ALL TRAVEL LANES.

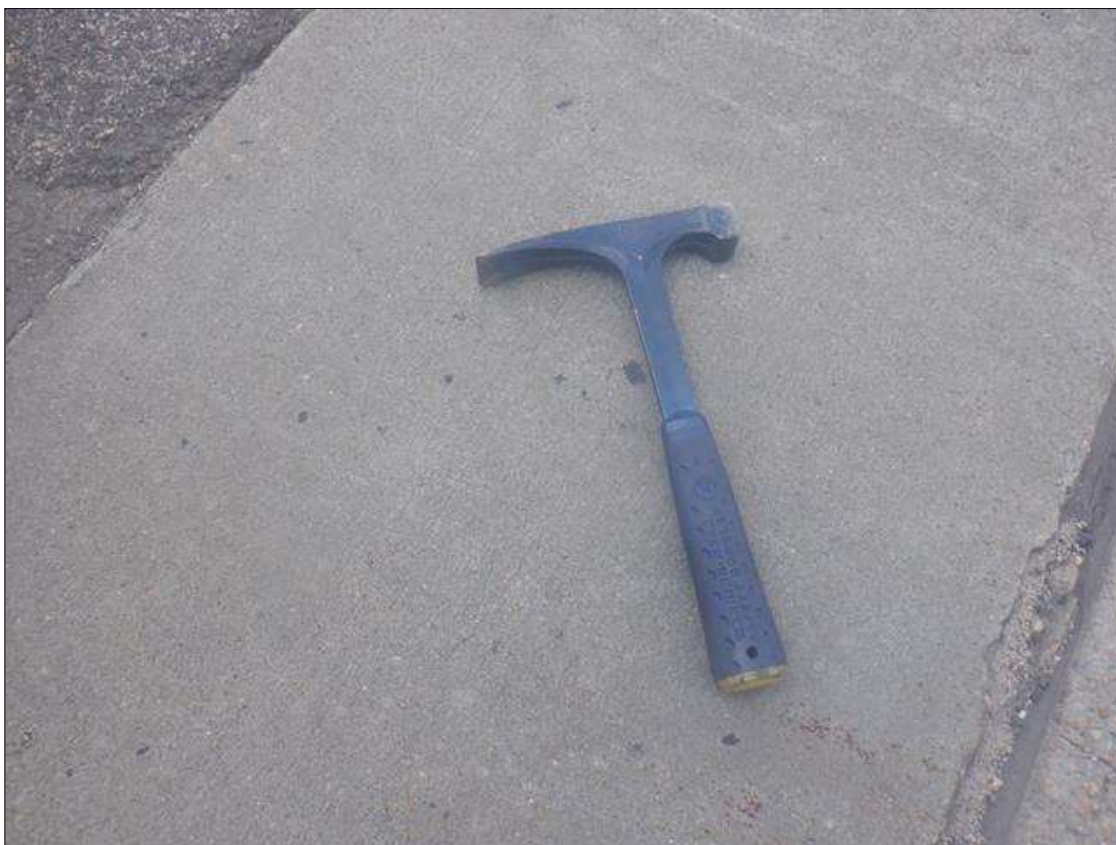
Approach 1 : HAIRLINE MAP CRACKING ALONG FULL LENGTH OF APPROACH.

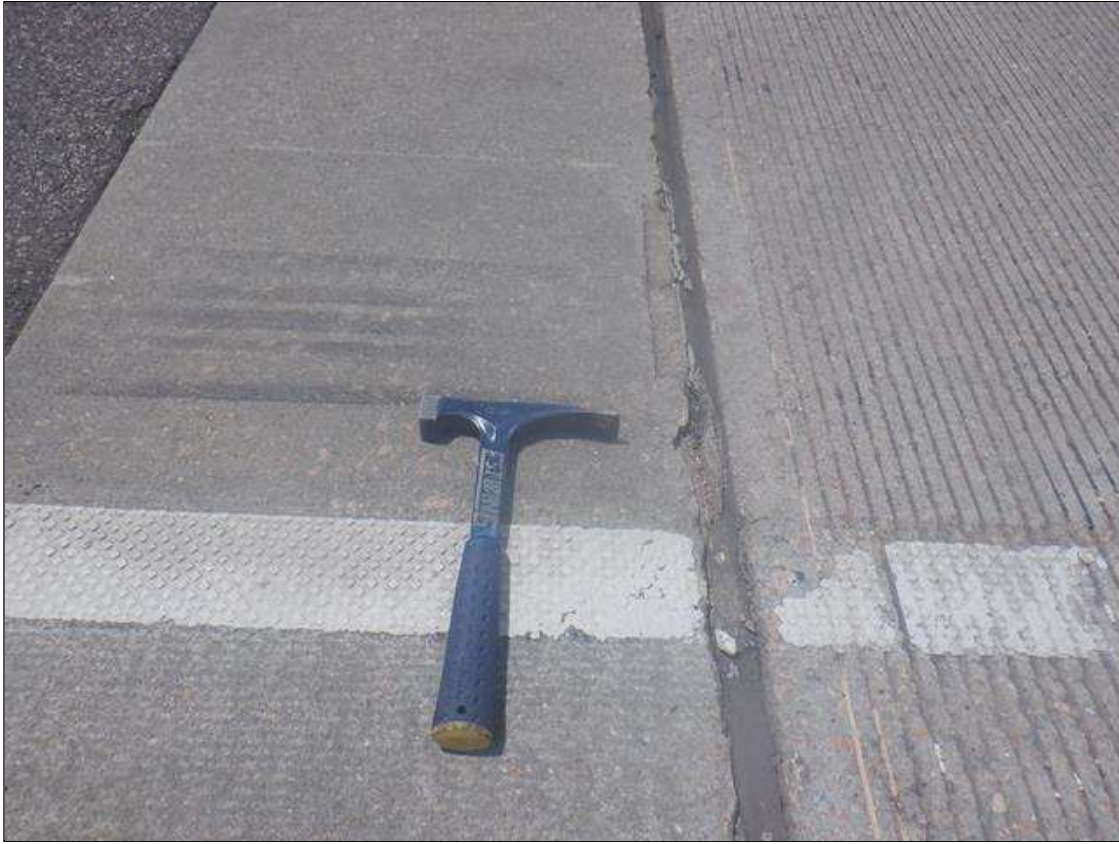
Span 1 Expansion Joint: SCATTERED ALONG THE LENGTH, EDGE CHIPPING UP TO 3/4" WIDE X 3/4" DEEP WITH LOSS OF SEAL ADHESION [LOSS OF SEAL ADHESION IS ALSO PRESENT IN SCATTERED AREAS OF EDGE PATCHING]

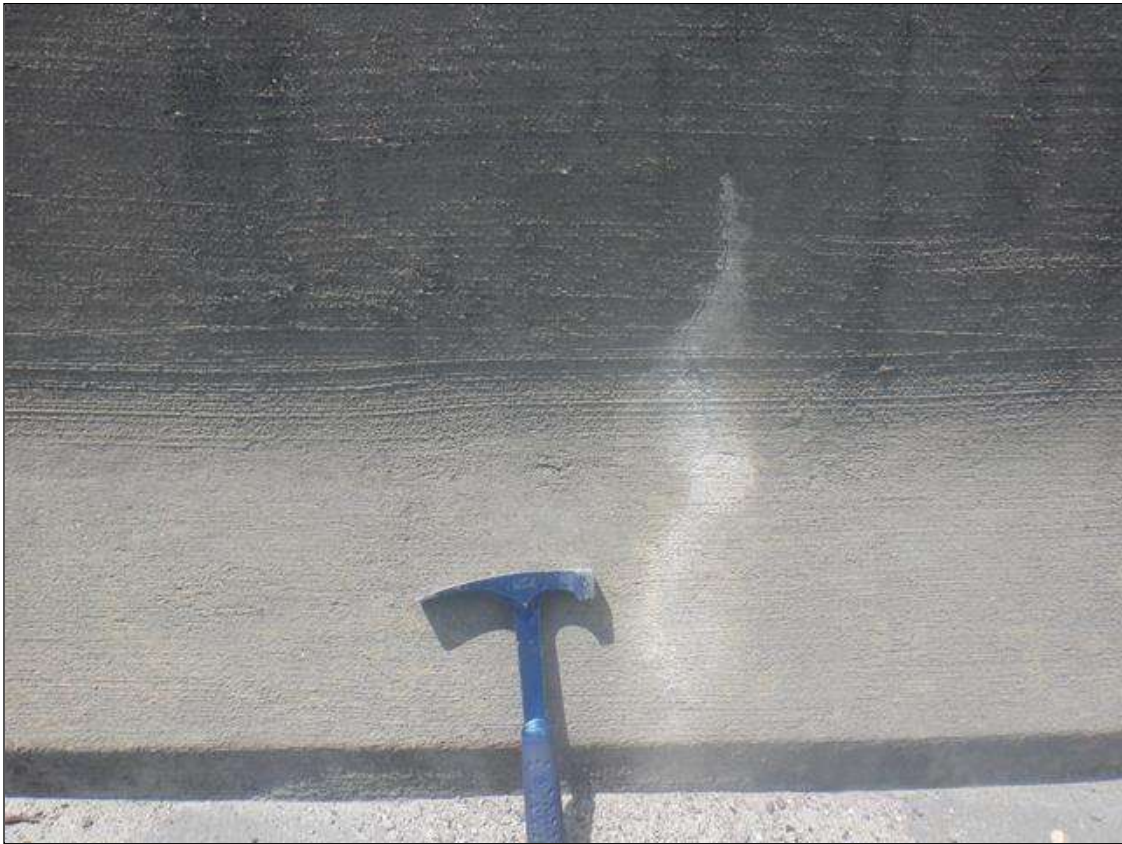
Span 1 Left Bridge Rail: (7) UP TO 1/32 IN WIDE WRAP-AROUND CRACKS, WITH EFFLORESCENCE, AT RANDOM THROUGHOUT.

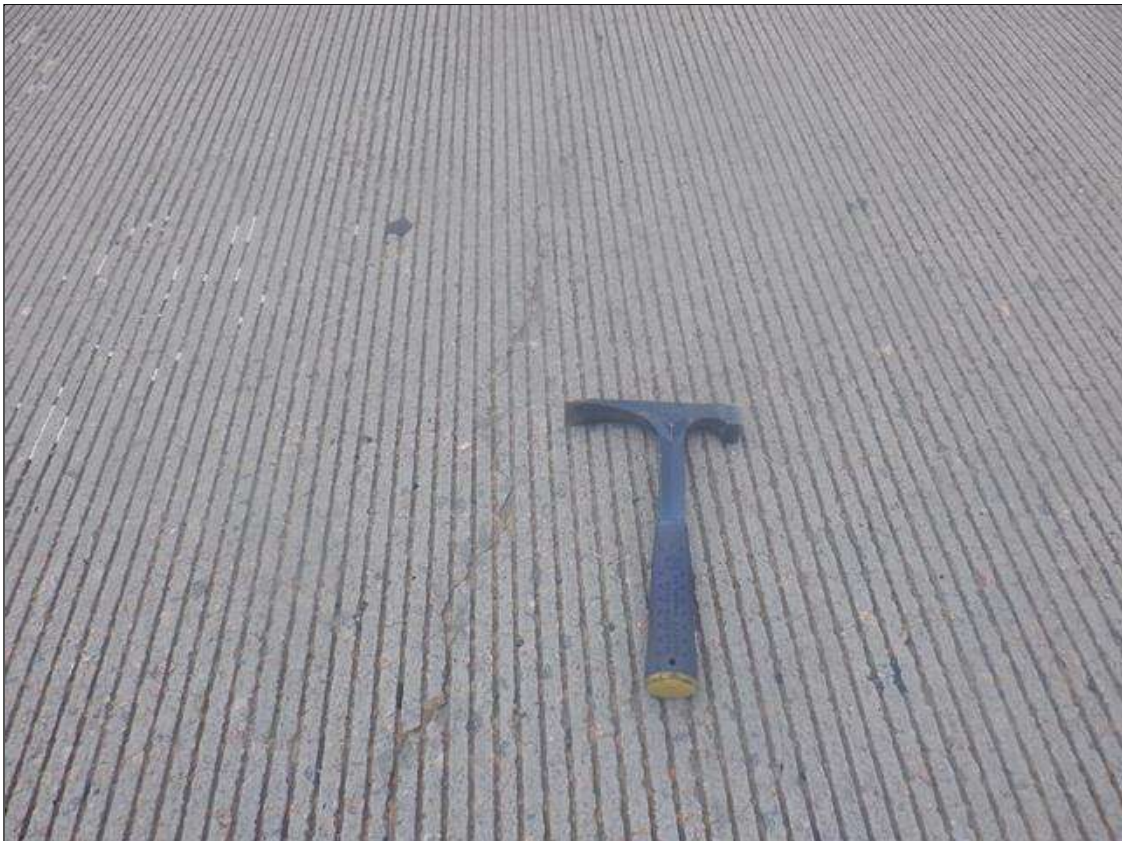
Span 1 Deck: SCATTERED TRANSVERSE CRACKING TO 1/16" WIDE AT AVERAGE 6' SPACING FOR FULL WIDTH.

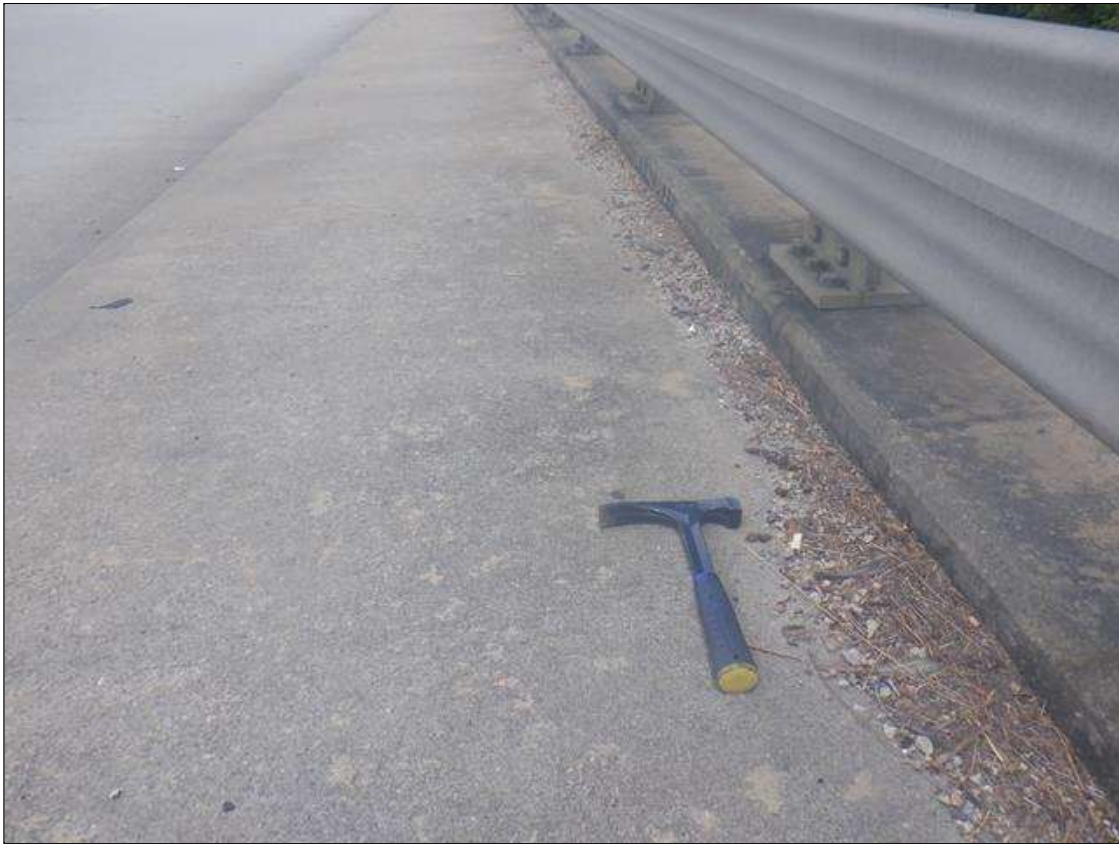
MINOR DECK DEBRIS ALONG THE EDGE OF THE SIDEWALK IN ALL SPANS

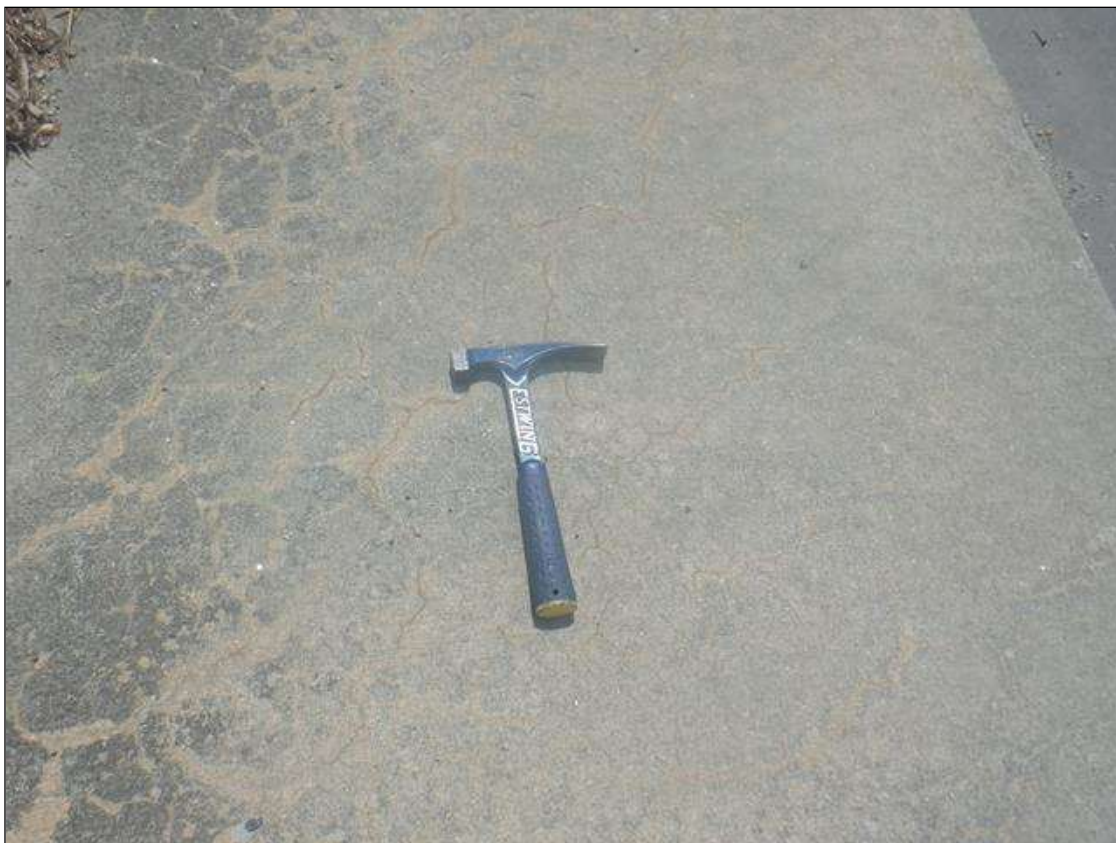
Span 3 Deck: MAP CRACKING WITH EFFLORESCENCE UP TO 1/64 IN WIDE SCATTERED ALONG THE LENGTH OF THE SIDEWALK

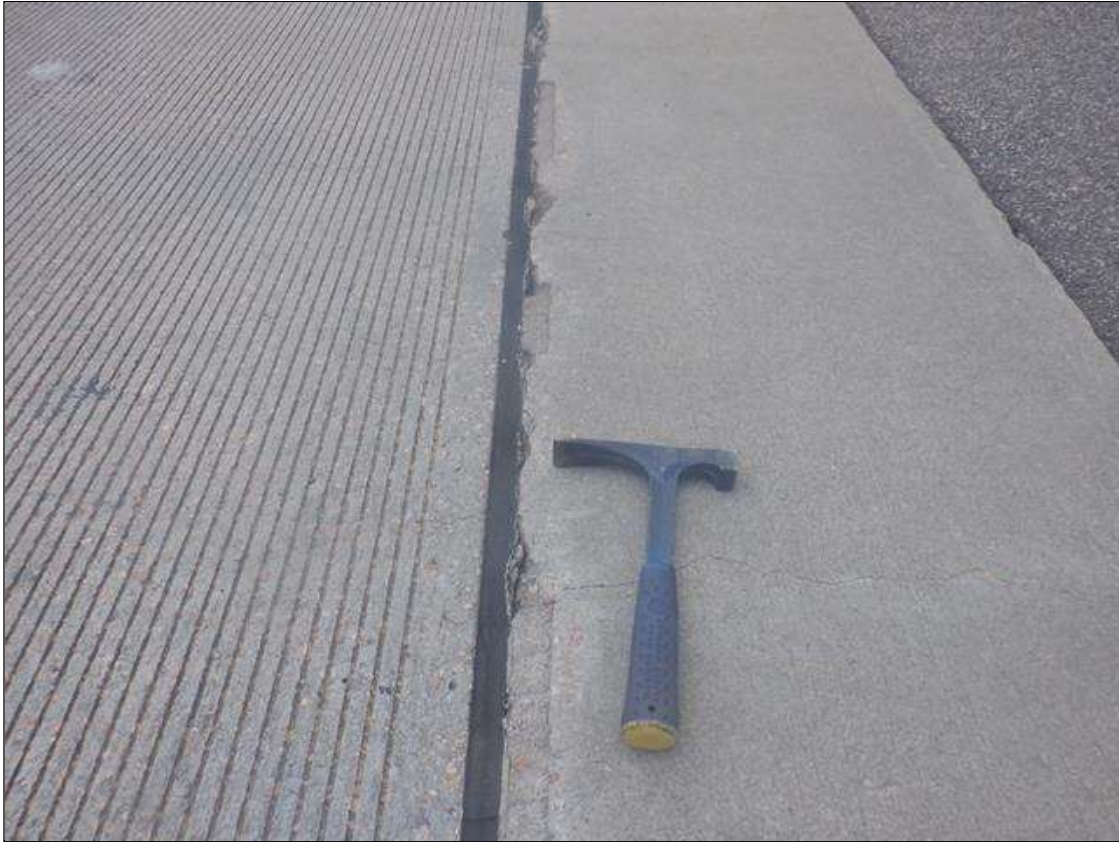
Span 4 Expansion Joint: SCATTERED ALONG THE LENGTH, EDGE CHIPPING UP TO 3/4" WIDE X 3/4" DEEP WITH LOSS OF SEAL ADHESION [LOSS OF SEAL ADHESION IS ALSO PRESENT IN SCATTERED AREAS OF EDGE PATCHING]

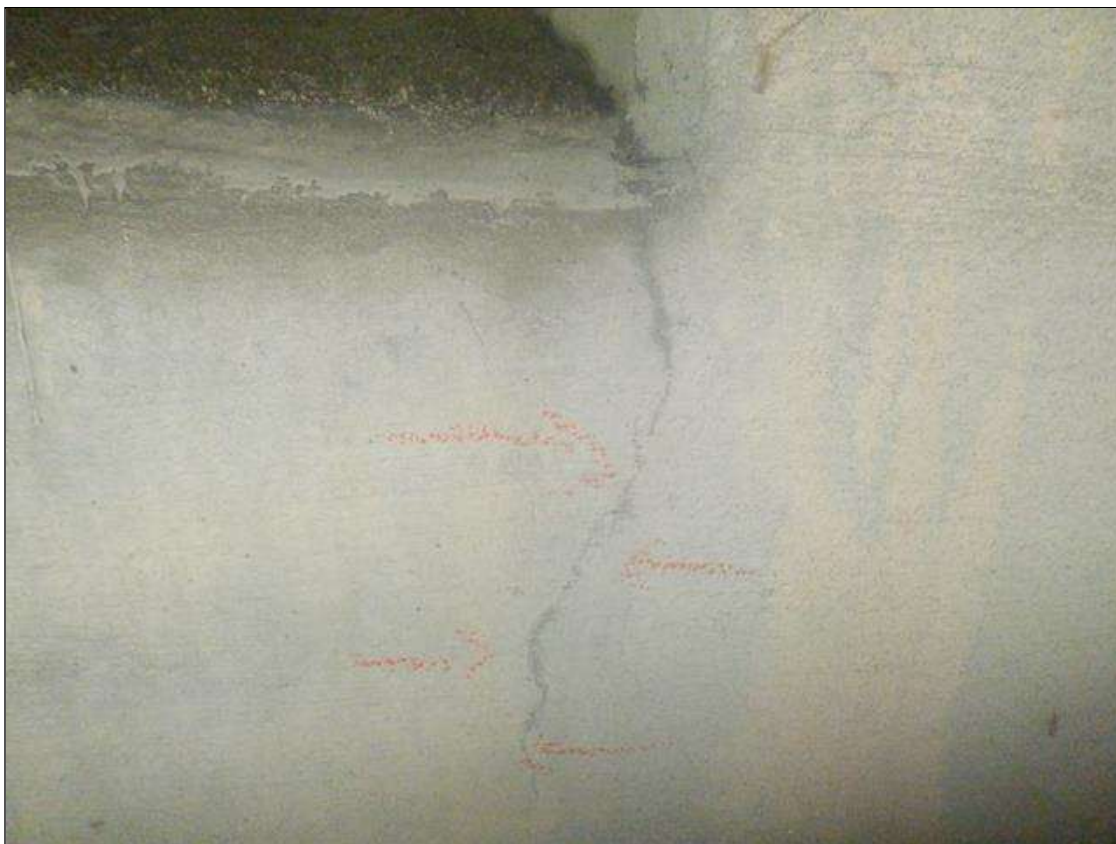
End Bent 1 Cap 1: 12 IN LONG X 1/64 IN WIDE VERTICAL CRACK, NORTH FACE, BETWEEN BEAMS 3 AND 4, NEAR BEAM 3.

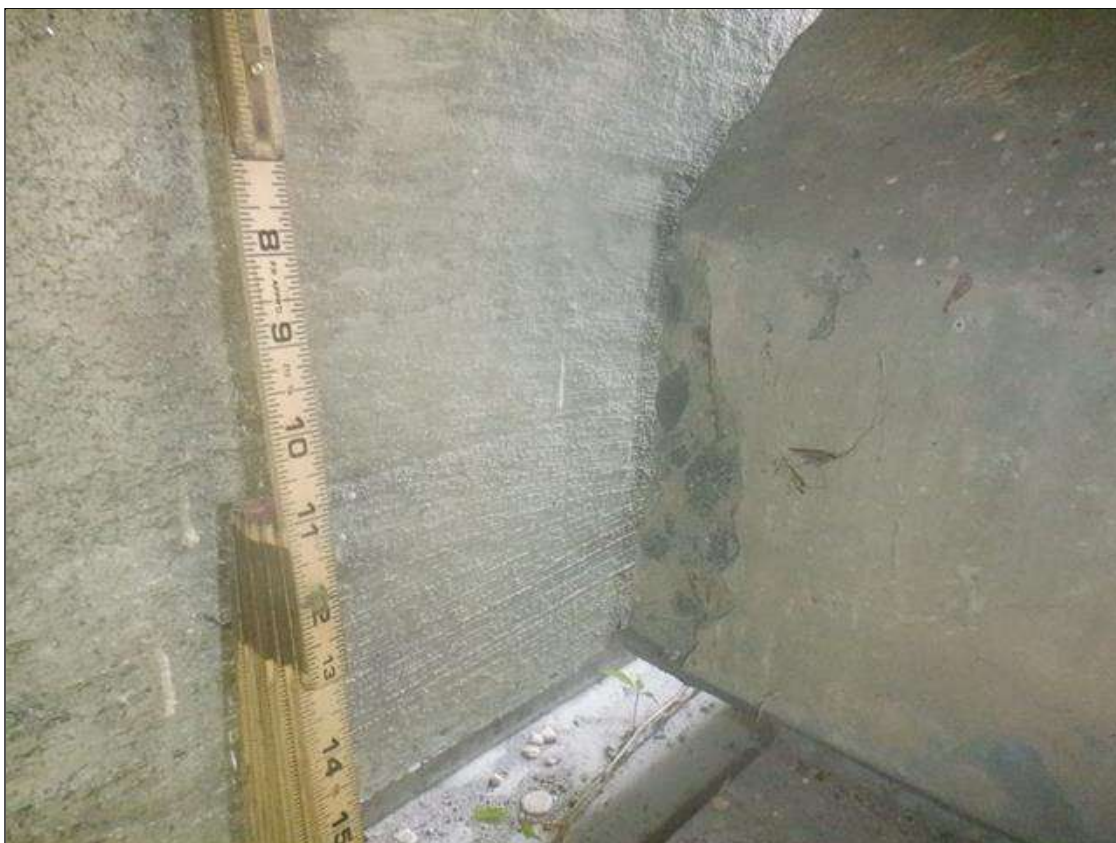
Span 1 Beam 1: RIGHT BOTTOM FLANGE AT ABUTMENT 1, SPALL APPROXIMATELY 2 IN LONG X 8 IN HIGH X UP TO 1/2 DEEP

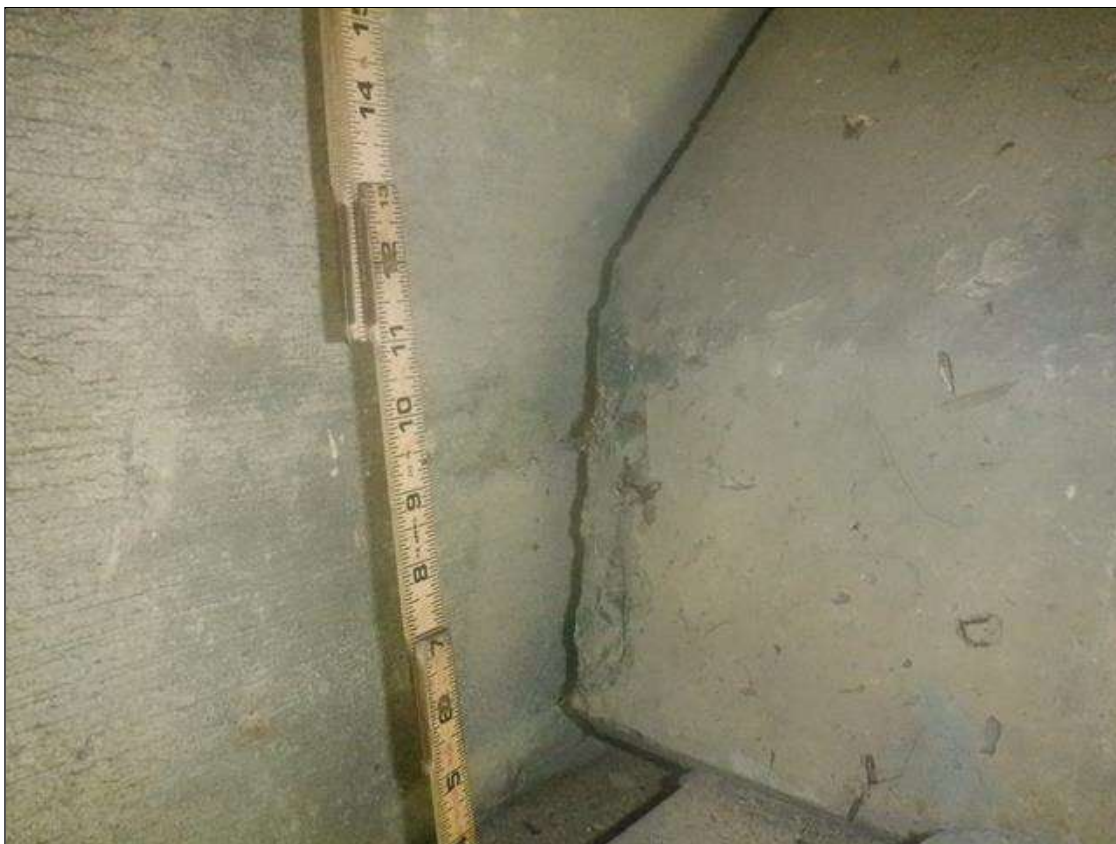
Span 1 Beam 2: RIGHT BOTTOM FLANGE AT ABUTMENT 1, SPALL APPROXIMATELY 2 IN LONG X 8 IN HIGH X UP TO 3/4 DEEP

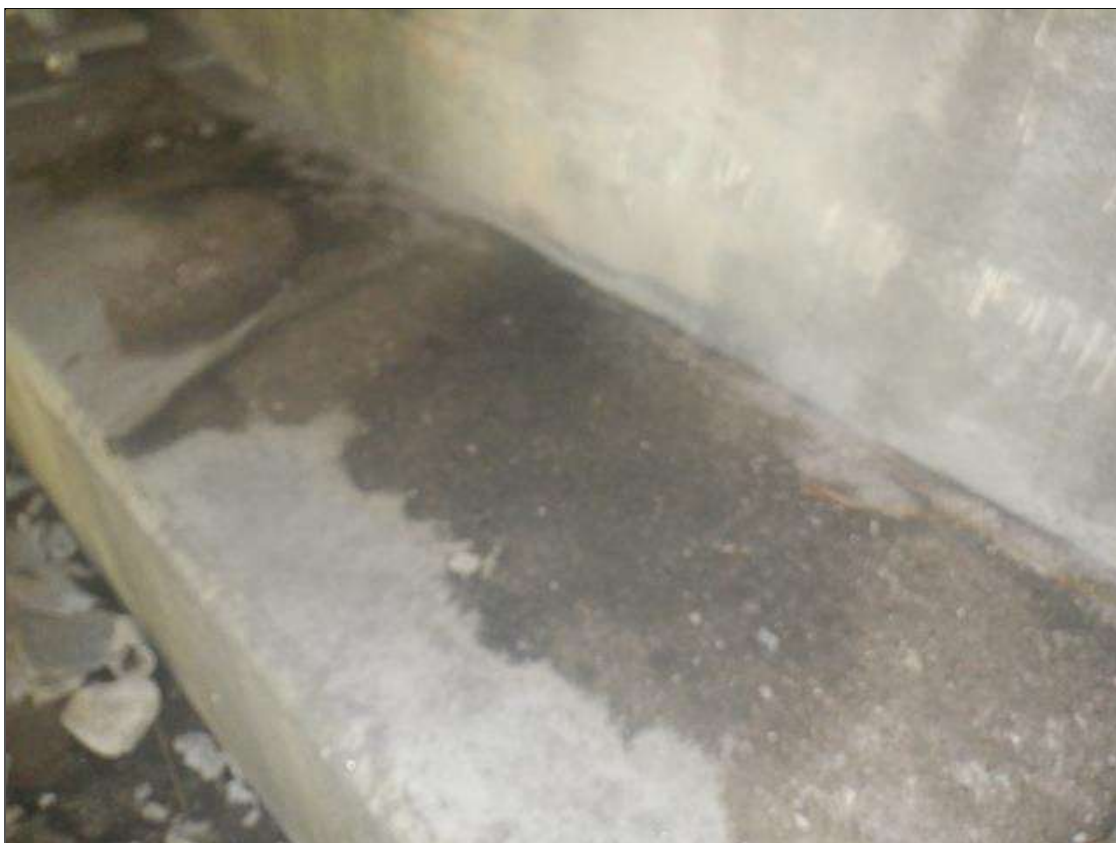
DEBRIS ON TOP OF THE CAP FOR FULL LENGTH

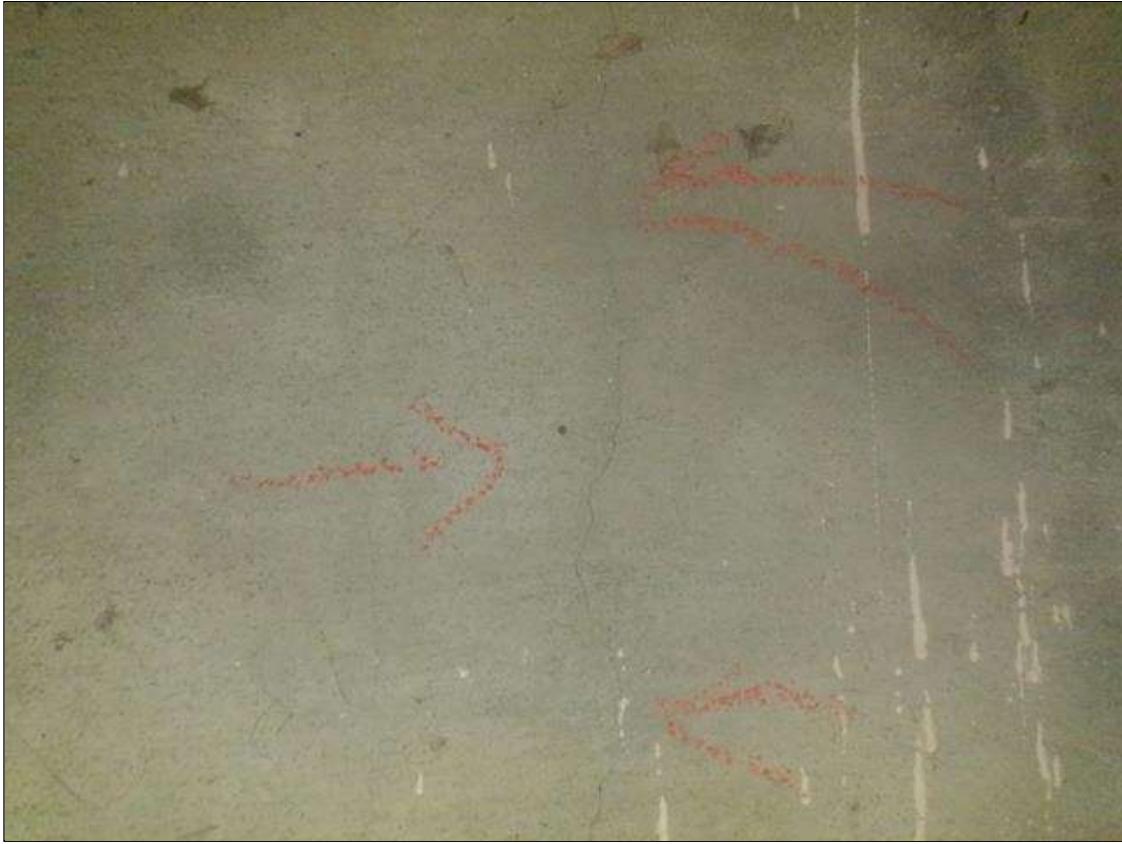
End Bent 1 Abutment: TWO (2) FULL HEIGHT X 1/64 IN WIDE VERTICAL CRACKS IN THE BACKWALL AT RANDOM.

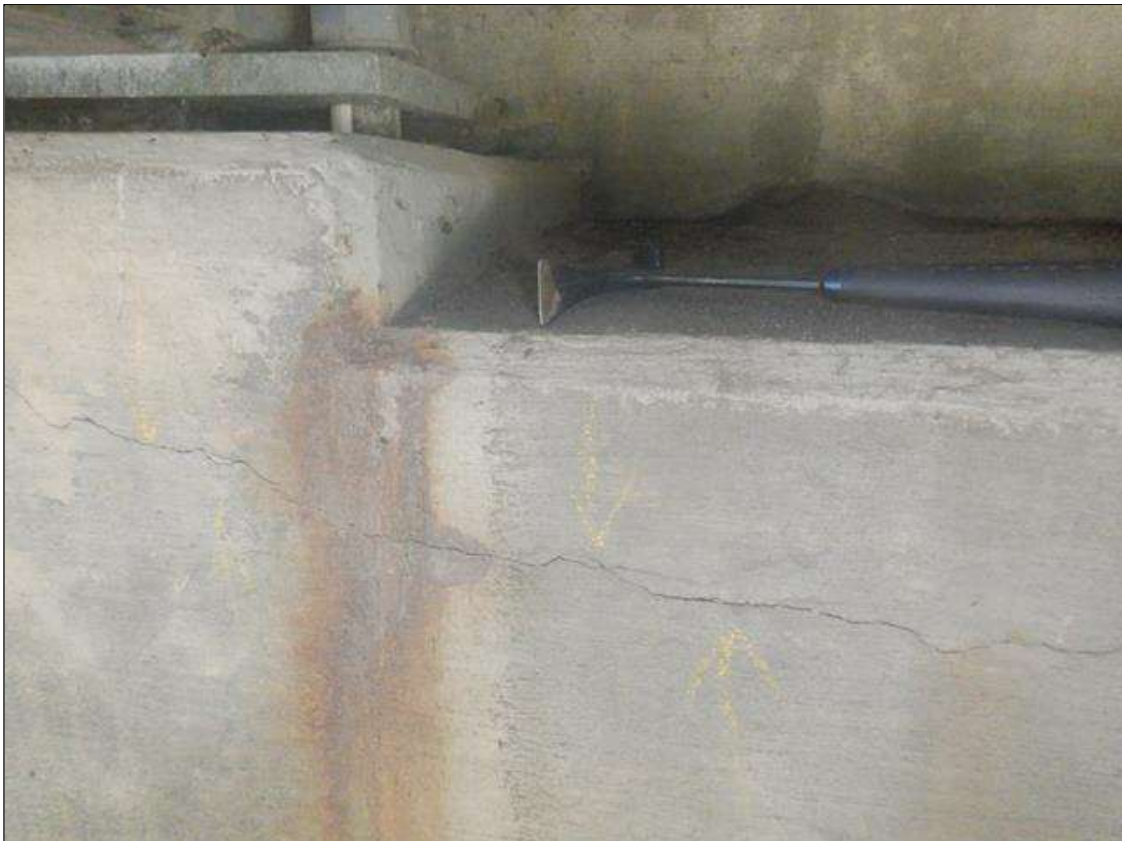
End Bent 2 Cap 1: 3' X UP TO 1/32" LONGITUDINAL CRACK, SOUTH FACE, BENEATH BEAM 3.

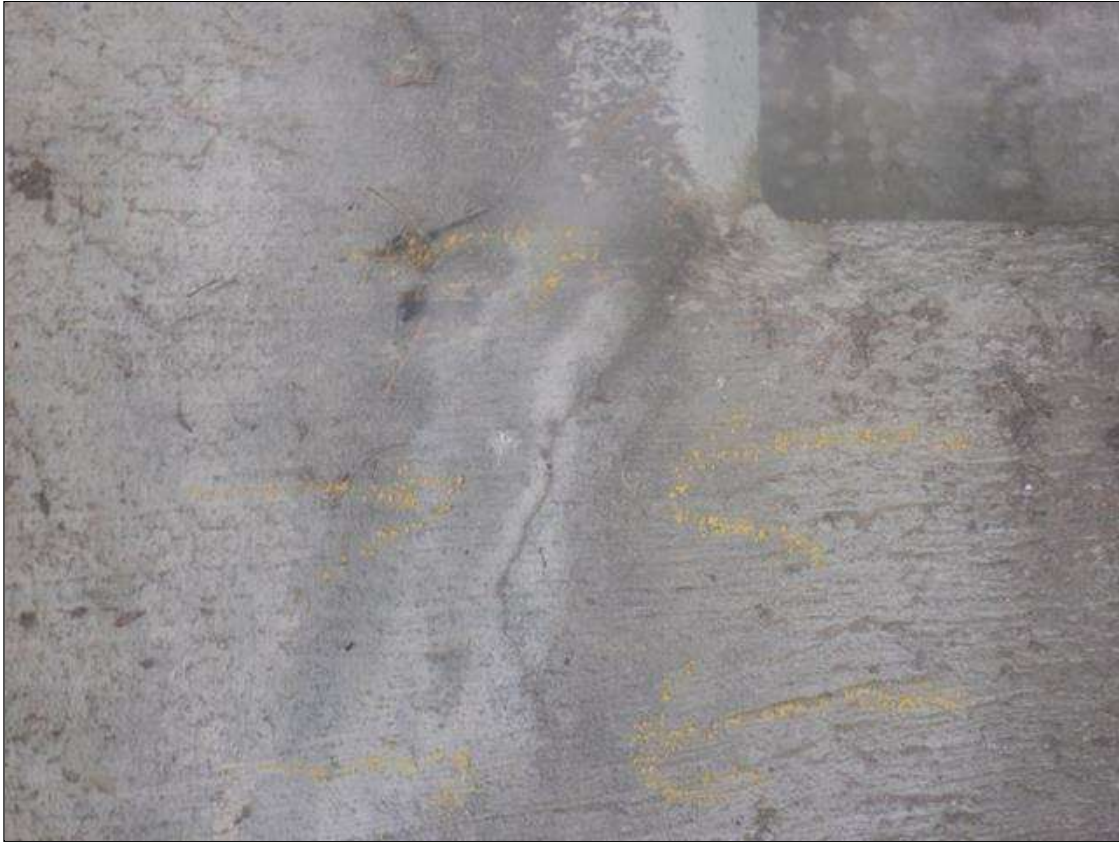
End Bent 2 Cap 1: (2) UP TO 12" X 1/64" DIAGONAL CRACKS, SOUTH FACE, EXTENDING FROM EAST AND WEST SIDES OF BEAM 4 BEAM SEAT.

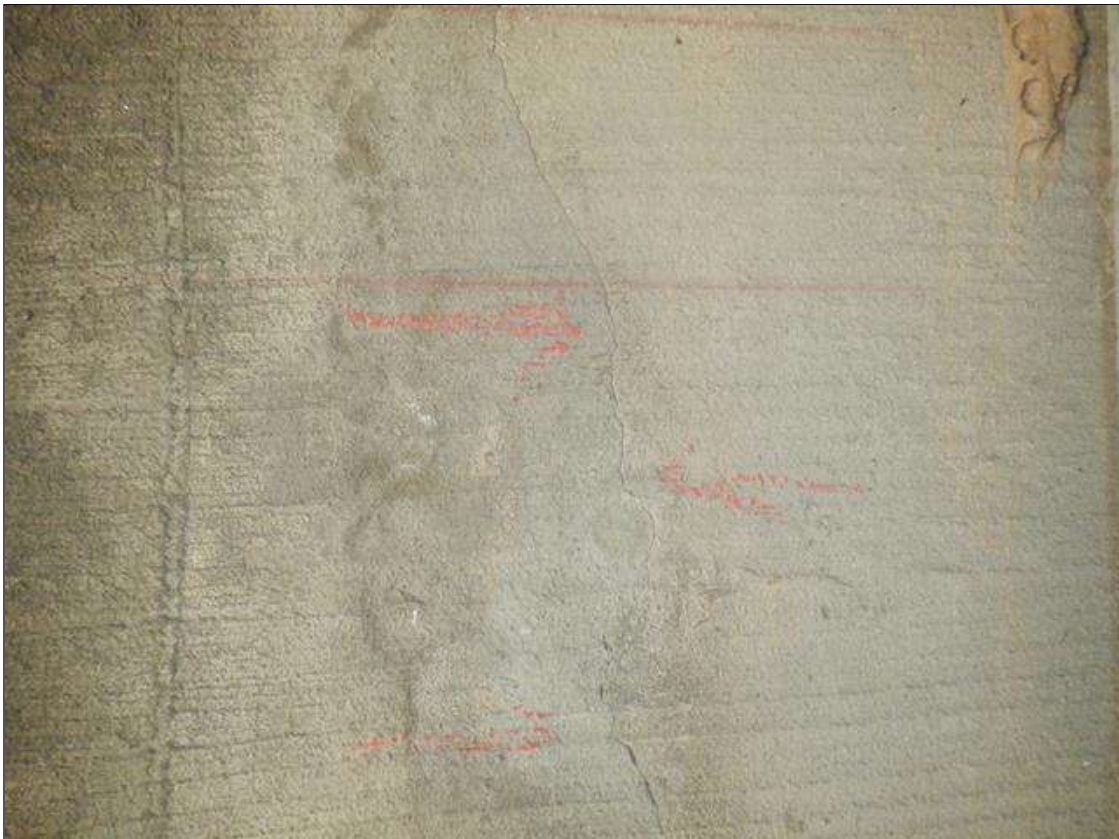
End Bent 2 Abutment: TWO (2) UP TO 36 IN LONG X 1/64 IN WIDE DIAGONAL AND VERTICAL CRACKS, SCATTERED THROUGHOUT LENGTH OF ABUTMENT.

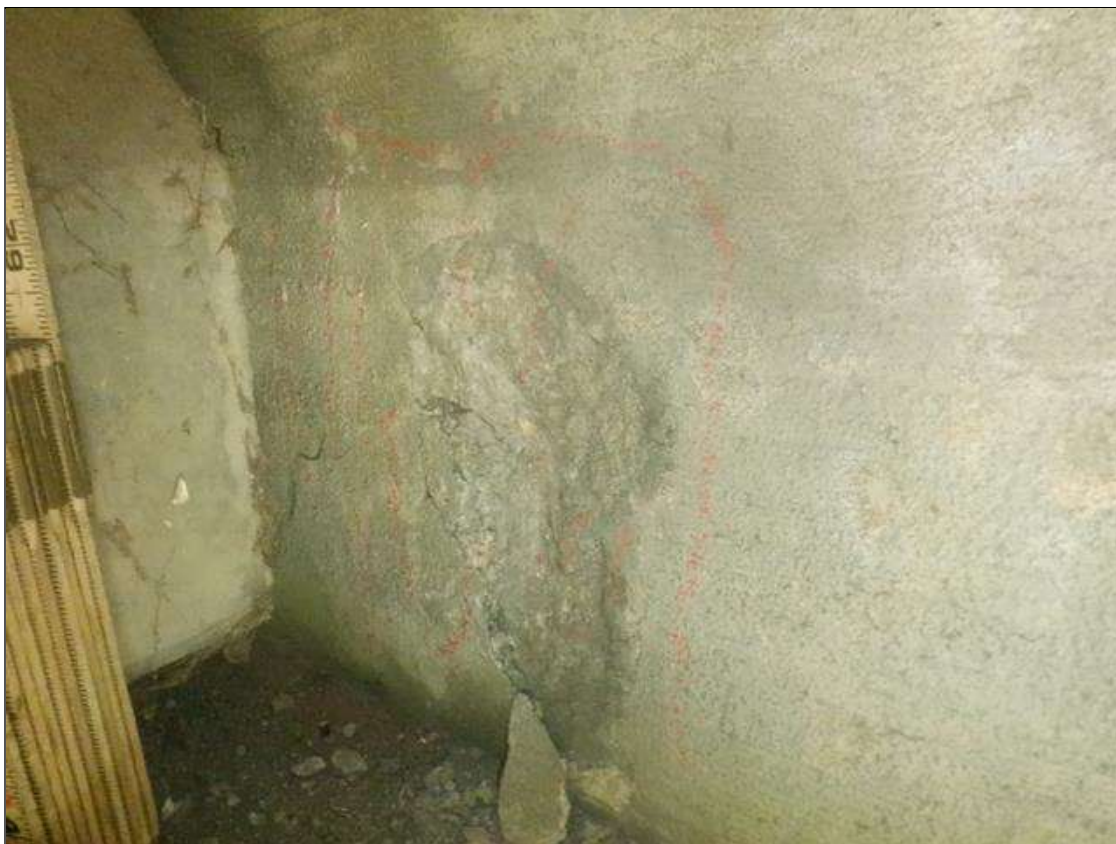
End Bent 2 Cap 1: UP TO 10 IN WIDE X 8 IN HIGH X UP TO 3/4 IN DEEP SPALL TO THE RIGHT SIDE OF BEAM 2
BOTTOM FLANGE

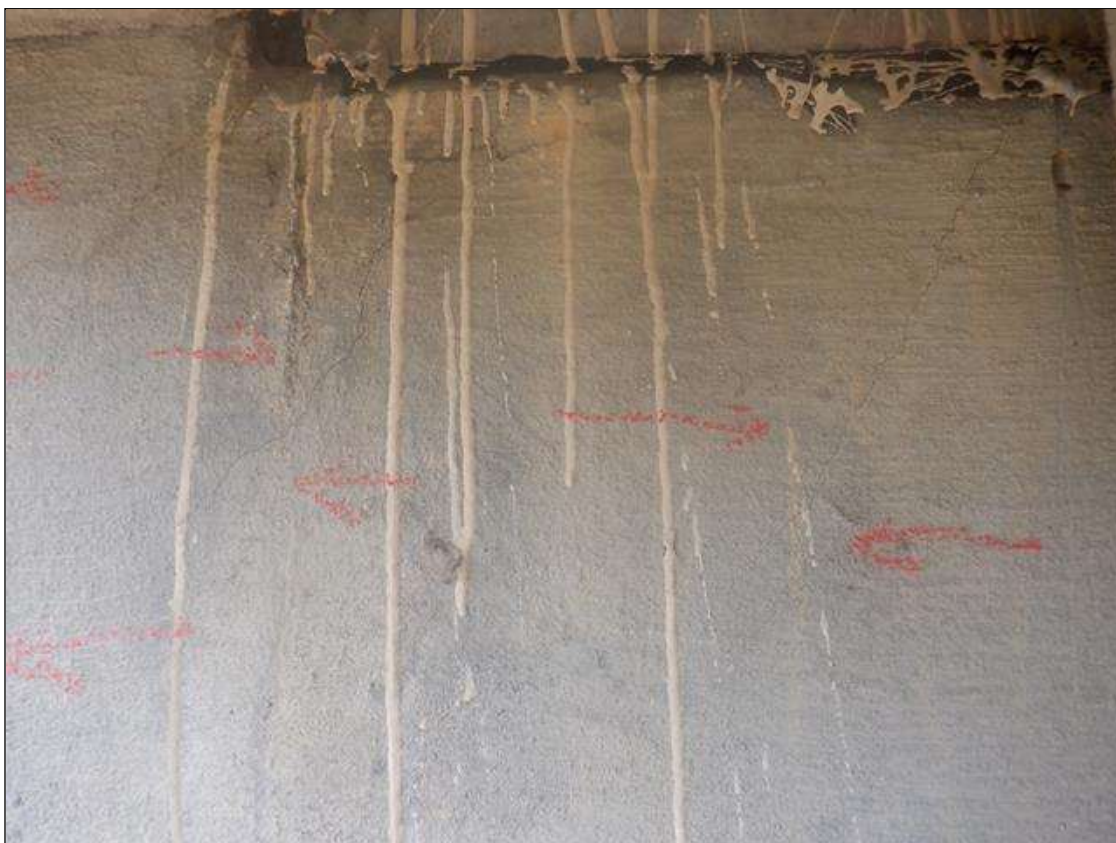
End Bent 2 Abutment: THREEE (3) UP TO 2 FT LONG X 1/64 IN WIDE DIAGONAL CRACKS TO THE LEFT OF
BEAM 1 NEAR THE TOP OF THE WALL

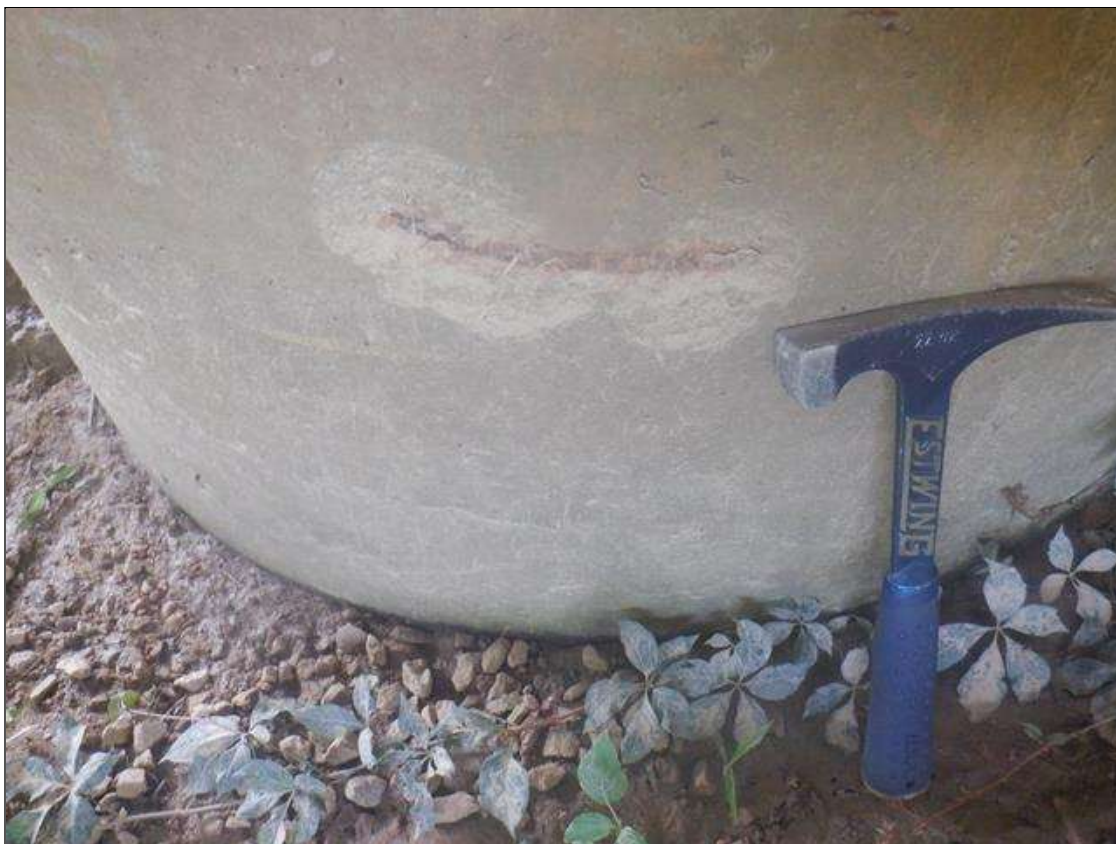
Bent 3 Pile 2: 8 IN LONG X UP TO 4 IN WIDE X 1/2 IN DEEP SPALL, WITH EXPOSED REINFORCING, EAST FACE, 8' FROM BOTTOM OF CAP [NO MEASURABLE SECTION LOSS]

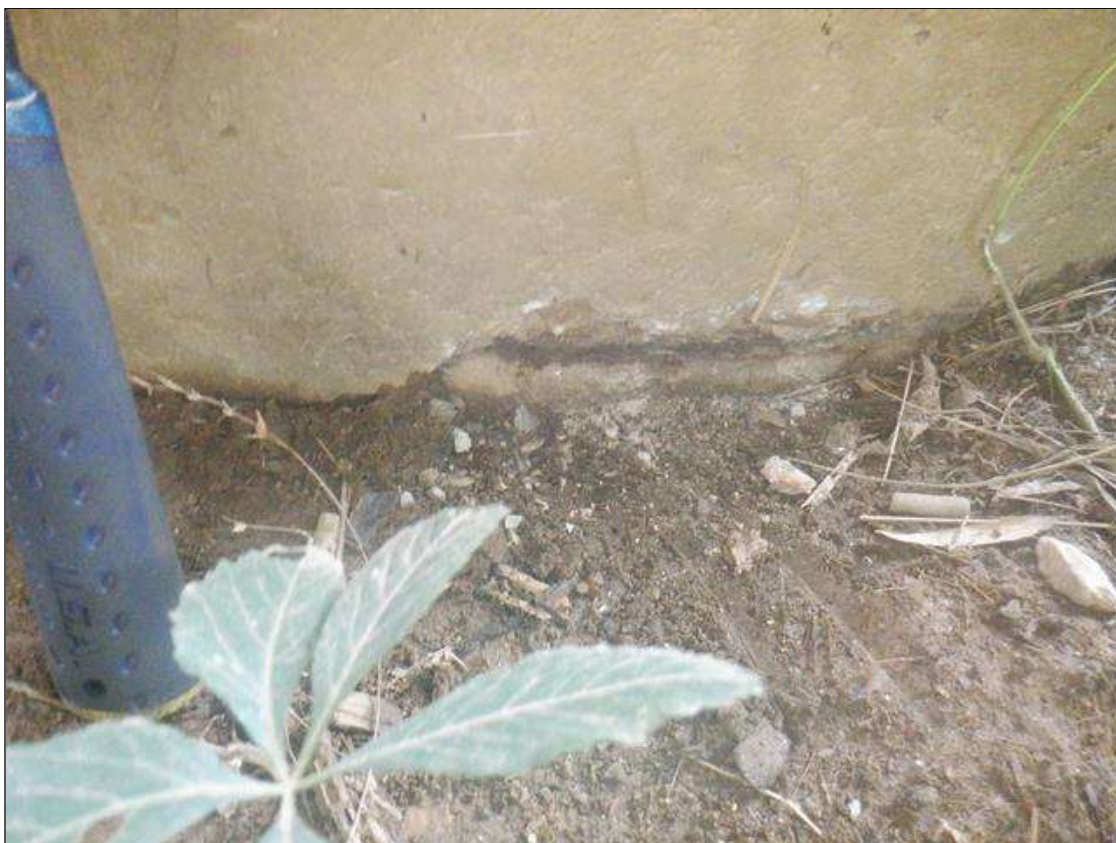
Bent 3 Pile 3: 10 IN LONG X UP TO 3 IN WIDE X 1/2 IN DEEP SPALL, WITH EXPOSED REINFORCING, WEST FACE AT GROUND LEVEL
