NC DEPARTMENT OF TRANSPORTATION
 DIVISION OF HIGHWAYS
 STRUCTURE MANAGEMENT UNIT

ATTENTION: **PAR SUBMITTED, CHANGE IN STRUCTURE DATA,
 CHANGE IN UNDERCLEARANCE.**

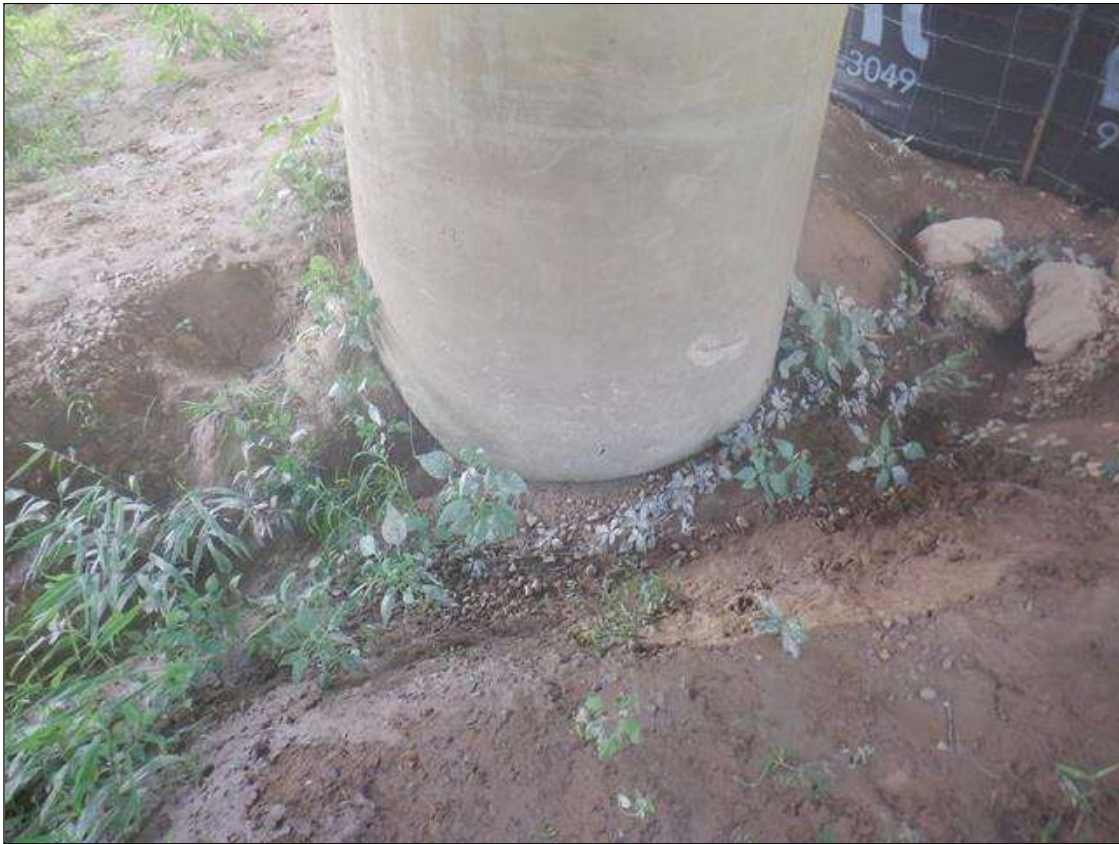
SOIL EROSION AROUND BENT 3 PILE 2 UP TO 7 FT IN DIAMETER X 2 FT DEEP DUE TO SCOUR.

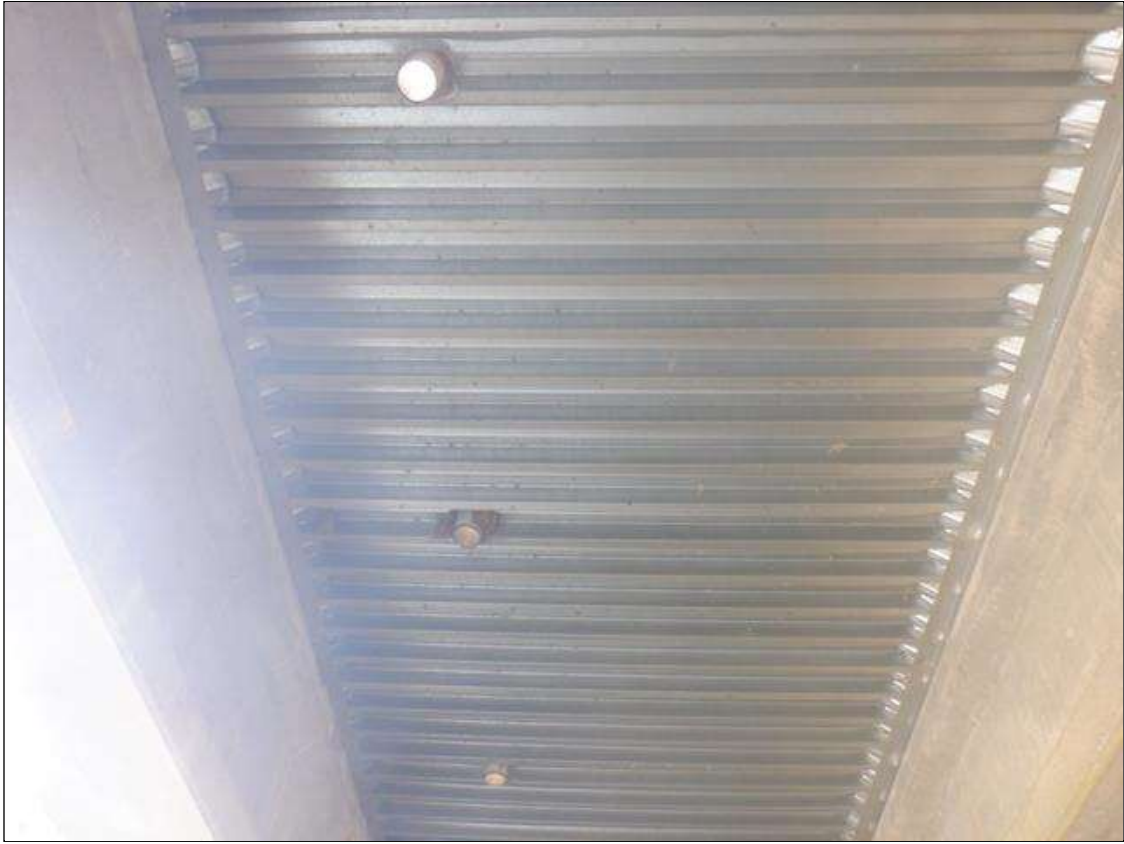
TYPICAL DRAINAGE PIPES IN SPAN 3 BAY 4

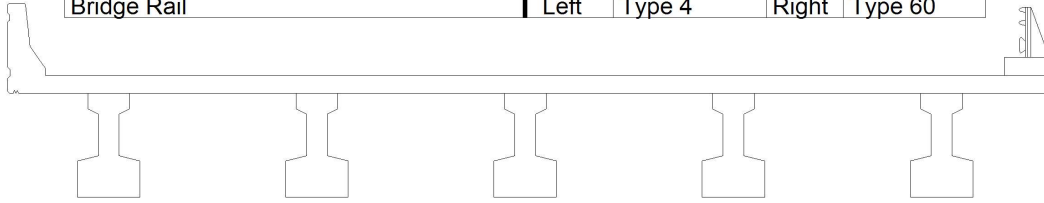
Measurements for Span #	1	SPAN 2 SIMILAR	
Deck Thickness	0.7	Left Overhang	3.25
Top of Rail to Bottom of Beam	8.5 (LT)	Right Overhang	3.16

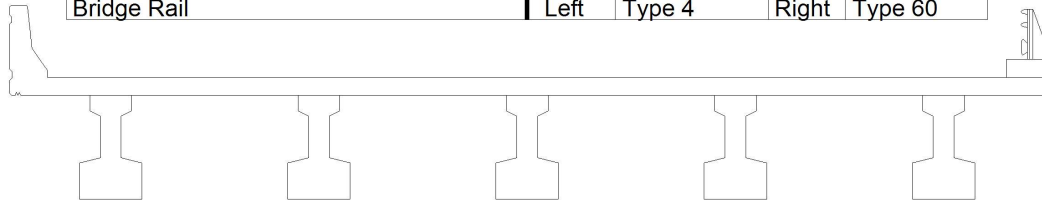
Measurements for Span #	3	SPAN 4 SIMILAR	
Deck Thickness	0.7	Left Overhang	3.25
Top of Rail to Bottom of Beam	7.58(LT)	Right Overhang	3.16

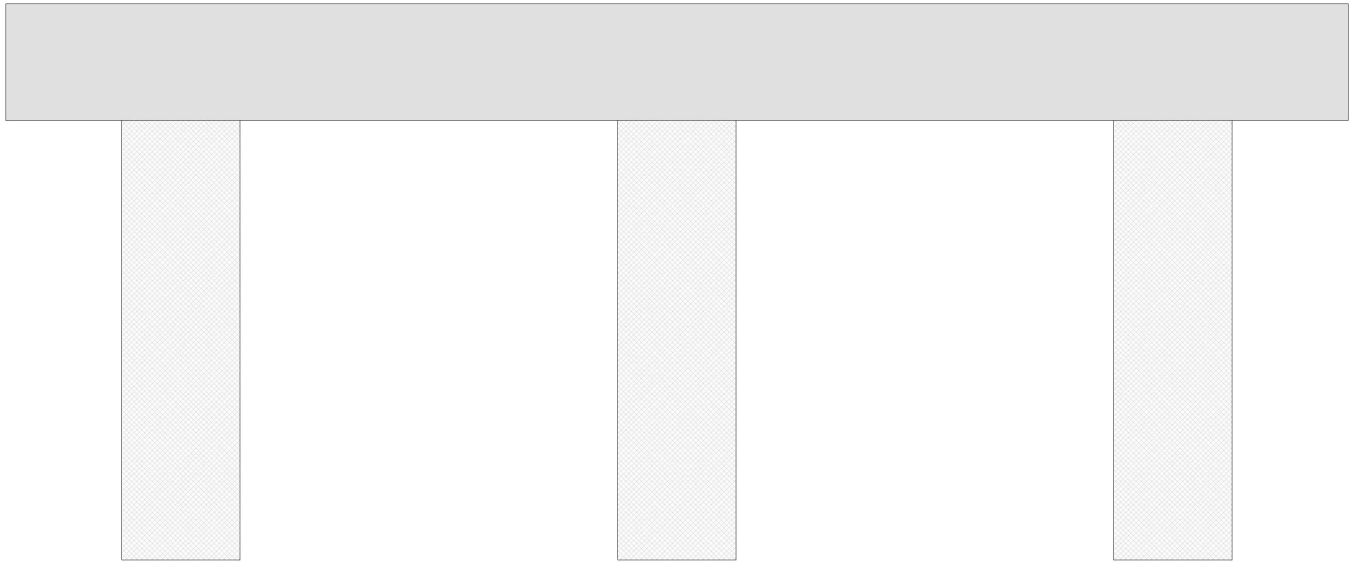
Cap Information			Material Cast-in-Place Concrete							
Length	Width	Height	Left Overhang	Right Overhang	Left Beam to End of Cap.	Right Beam to End of Cap.				
45.333 ft.	4.160 ft.	4.164 ft.	6.000 ft.	6.000 ft.	2.250 ft.	2.250 ft.				
Subcap Information			Material							
Length	Width	Height	Left Overhang	Right Overhang	Left Pile to Splice.					
Sill Information			Material							
Length	Width	Height								
Pile #	Material	Spacing	Width/Dia.	Height	Length	Orientation	Driven?	Replacement?	Removed?	Collar?
1	Concrete	16.67 ft.	4 ft.			Vertical	No	No	No	No
2	Concrete	16.67 ft.	4 ft.			Vertical	No	No	No	No
3	Concrete		4 ft.			Vertical	No	No	No	No
VERIFIED BY ZK ON 7/15/21										
Bent/Abutment #: 1			Similar Bents: 2 and 3

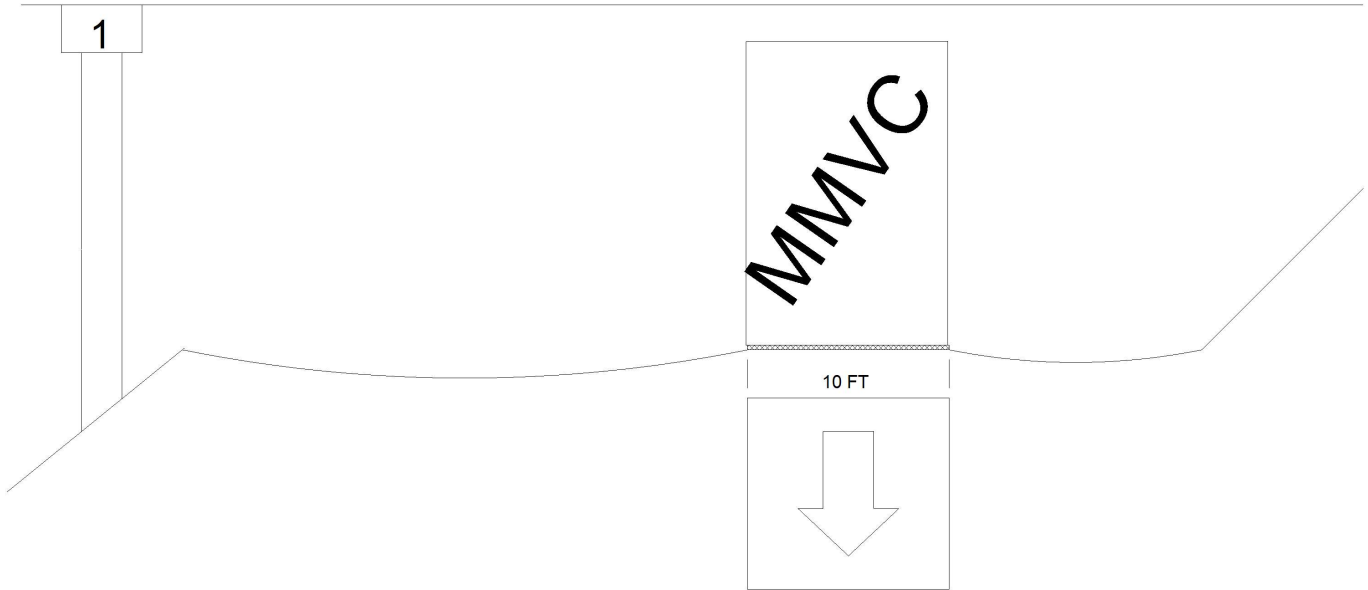
Roadway 1	10 FT	Direction of Traffic	East West
Distance to Left Rail		Distance to Right Rail	
Distance to Left Toe of Slope	28FT	Distance to Left Bent	42.25FT
Distance to Right Toe of Slope	12.5FT	Distance to Right Bent	
MMVC	8.5 Ft at Beam 5, 10FT FROM RIGHT EDGE OF TRAIL		
MVC	8.5 Ft at Beam 5, AT RIGHT EDGE OF TRAIL

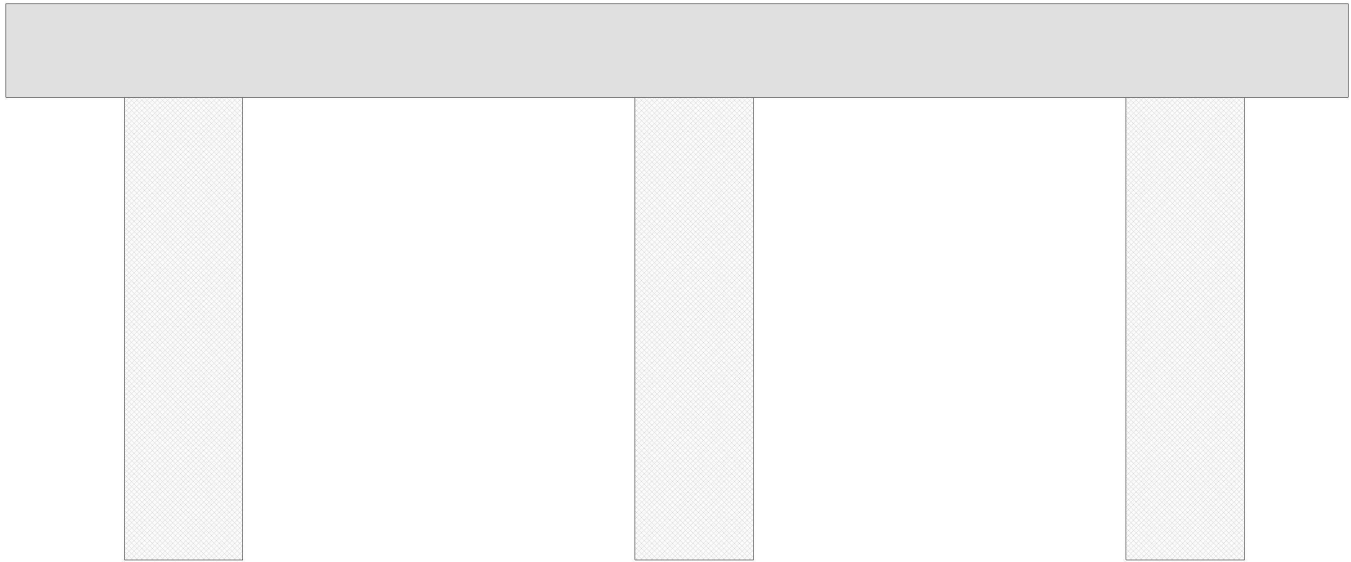
Cap Information			Material Cast-in-Place Concrete							
Length	Width	Height	Left Overhang	Right Overhang	Left Beam to End of Cap.	Right Beam to End of Cap.				
45.333 ft.	4.167 ft.	3.167 ft.	6.000 ft.	5.500 ft.	2.250 ft.	2.250 ft.				
Subcap Information			Material							
Length	Width	Height	Left Overhang	Right Overhang	Left Pile to Splice.					
Sill Information			Material							
Length	Width	Height								
Pile #	Material	Spacing	Width/Dia.	Height	Length	Orientation	Driven?	Replacement?	Removed?	Collar?
1	Concrete	17.25 ft.	4 ft.			Vertical	No	No	No	No
2	Concrete	16.583 ft.	4 ft.			Vertical	No	No	No	No
3	Concrete		4 ft.			Vertical	No	No	No	No
VERIFIED BY ZK ON 7-15-21										
Bent/Abutment #: 3			Similar Bents:

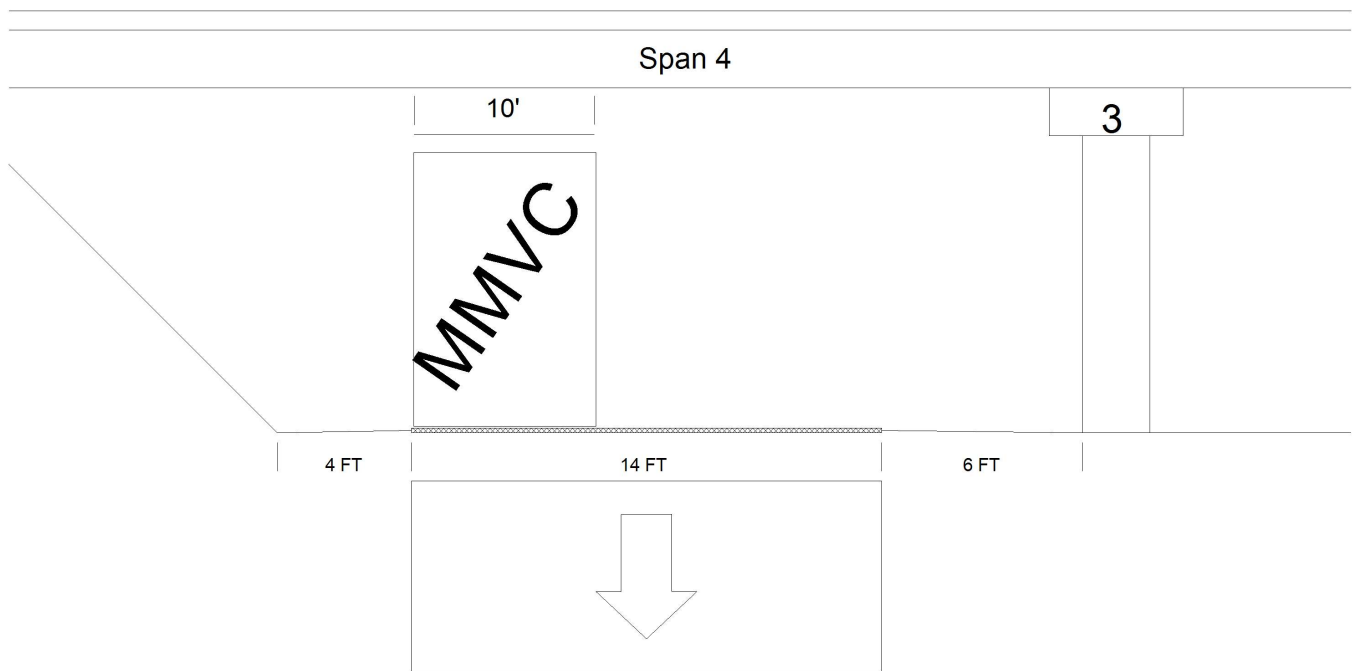
Roadway 1		Direction of Traffic	East West
Distance to Left Rail		Distance to Right Rail	
Distance to Left Toe of Slope	4FT	Distance to Left Bent	
Distance to Right Toe of Slope		Distance to Right Bent	6FT
MMVC	11.33 Ft at Beam 1, 10 FT from LT EDGE OF CONSTRUCTION ROAD		
MVC	11.33 Ft at Beam 1, 11FT FROM LT TOE OF SLOPE
