PROJECT NO. 15BPR.124.3
 _____ COUNTY
 DURHAM
 BRIDGE NO. 310306

STATE OF NORTH CAROLINA
 DEPARTMENT OF TRANSPORTATION
 RALEIGH
 SUBSTRUCTURE REPAIR
**BENT 1
 SPAN A FACE**

REVISIONS					SHEET NO. S1-12 TOTAL SHEETS 15
NO.	BY:	DATE:	NO.	BY:	
1			3		
2			4

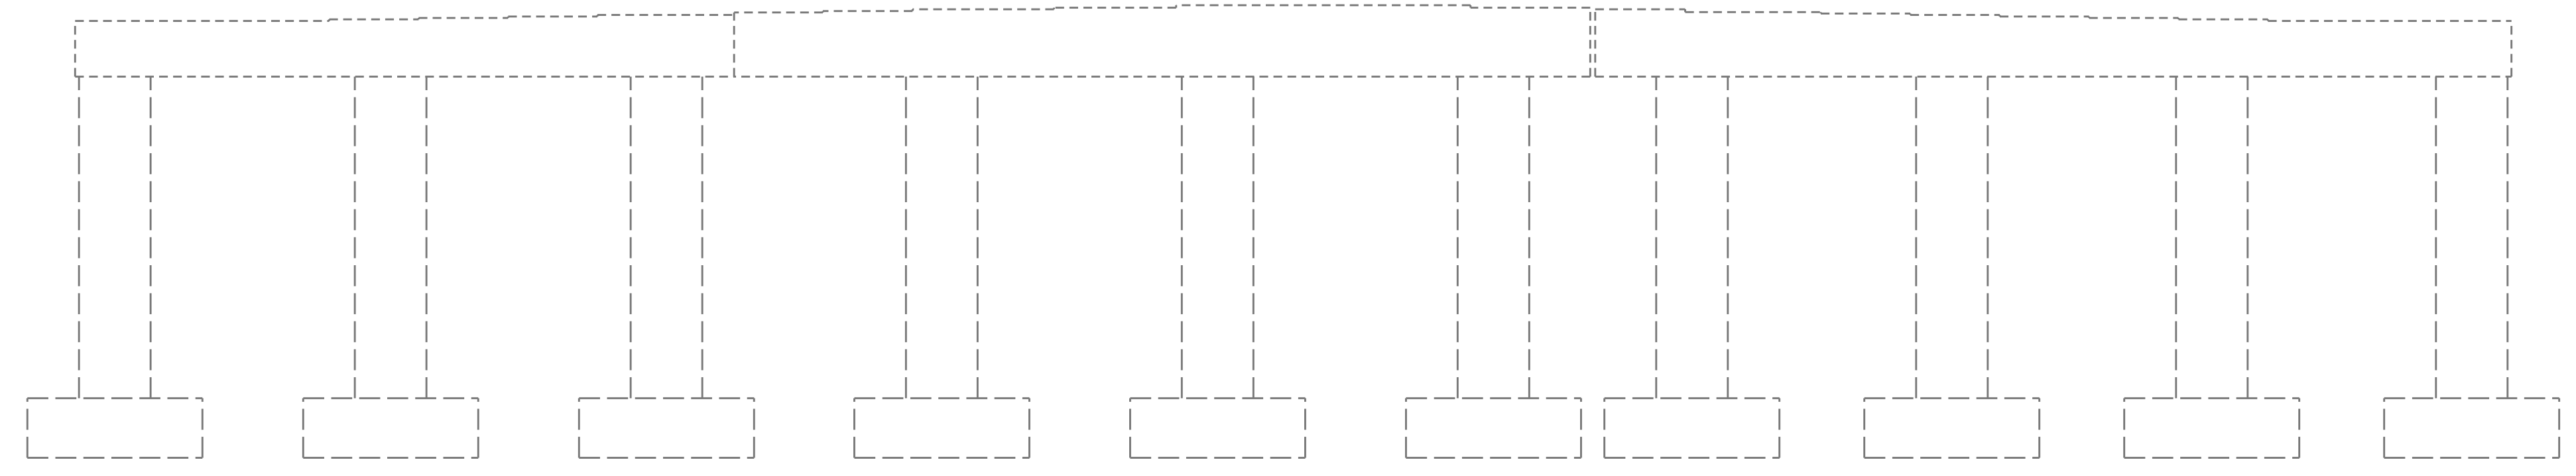
PLAN

CLEAN AND REMOVE DEBRIS FROM THE TOP OF THE CAP AND APPLY EPOXY PROTECTIVE COATING. EPOXY COATING SHALL BE APPLIED TO THE TOP SURFACE OF THE CAP. THE CONTRACTOR SHALL NOT COAT THE AREA OF THE CAP BENEATH THE MASONRY PLATES. FOR EPOXY COATING, SEE SPECIAL PROVISIONS.
