NC DEPARTMENT OF TRANSPORTATION
 DIVISION OF HIGHWAYS
 STRUCTURE MANAGEMENT UNIT

ATTENTION: Priority Maintenance; Approach Roadway, Typical Section Sketch Modified

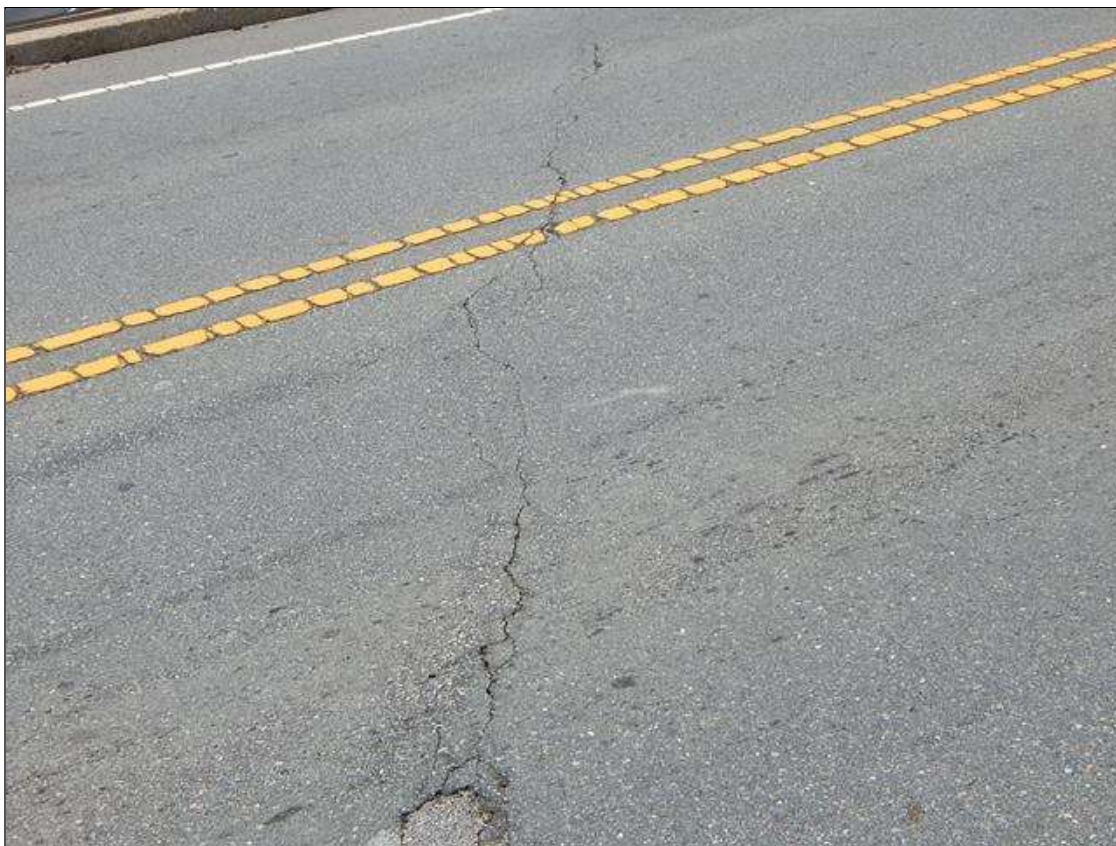
Span 1 Wearing Surface: 34 square feet up to 1/16" transverse cracks at End Bent 1

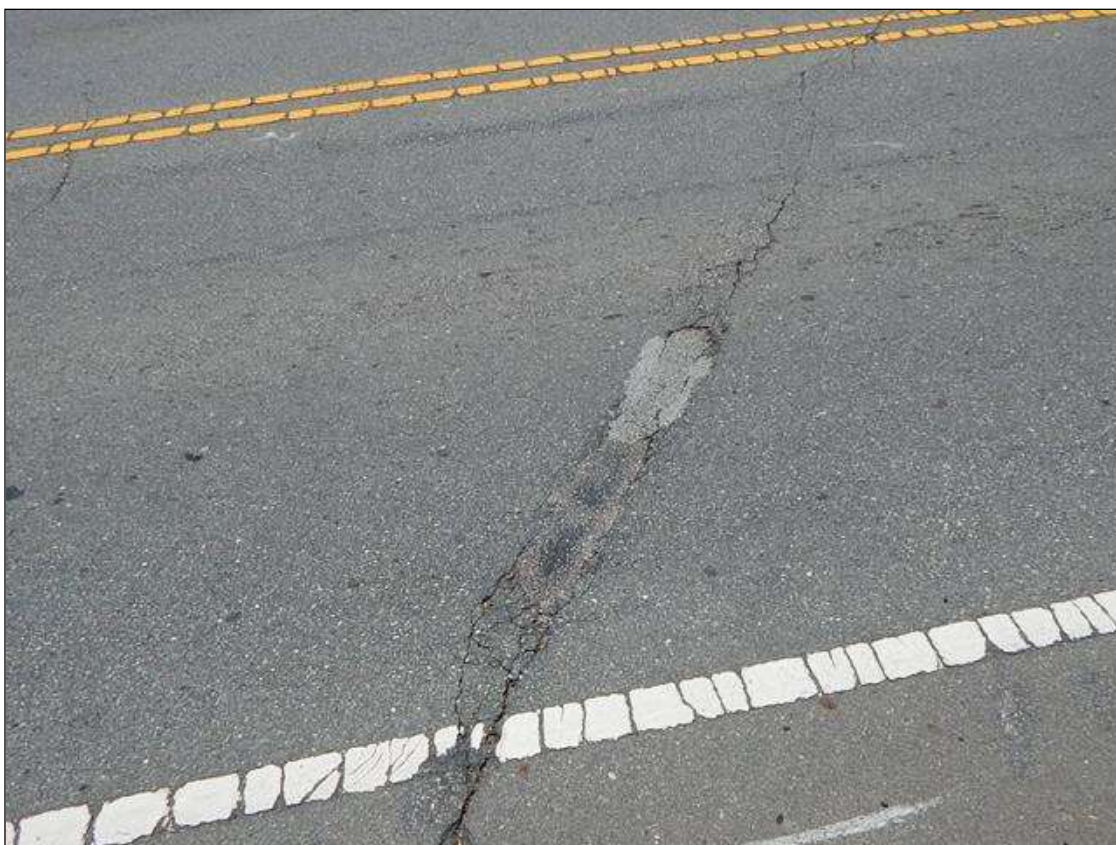
Span 1 Wearing Surface: 8" x 50" area of patch with 1/16" transverse cracks in Eastbound lane at End Bent 1

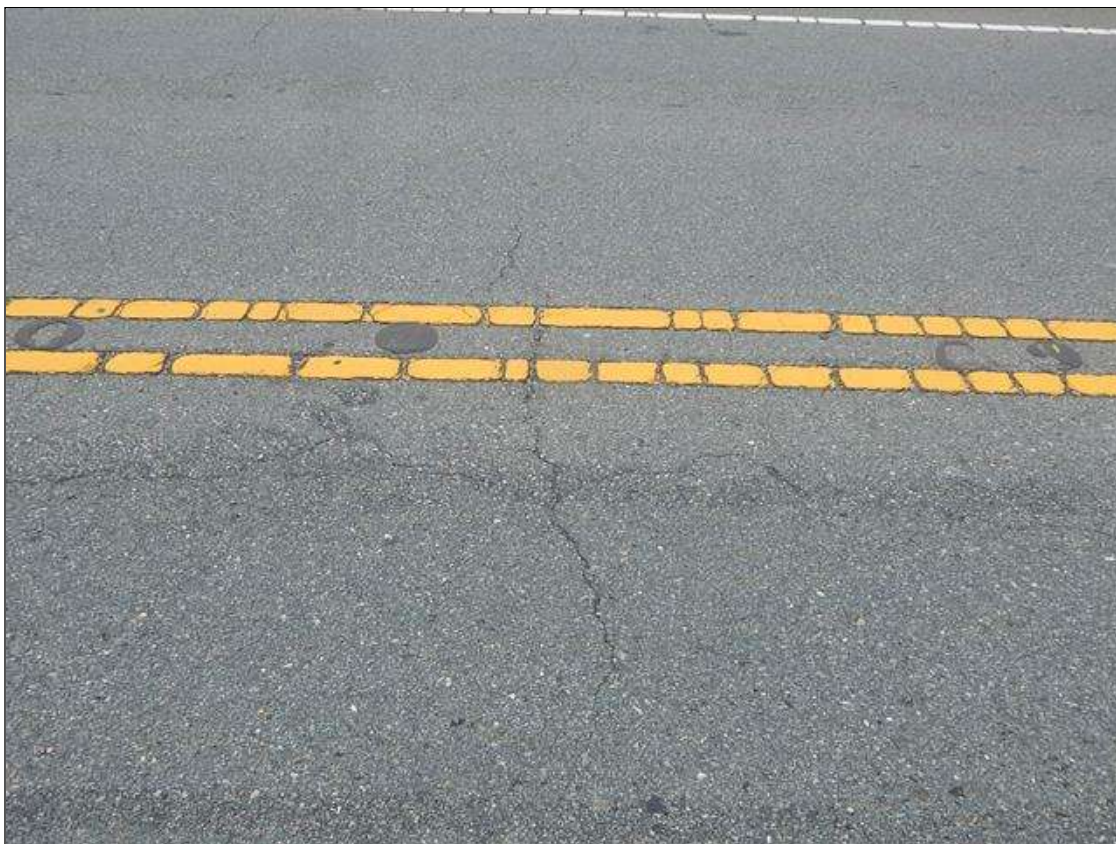
Span 1 Wearing Surface: 90 square feet up to 1/16" longitudinal and transverse cracks

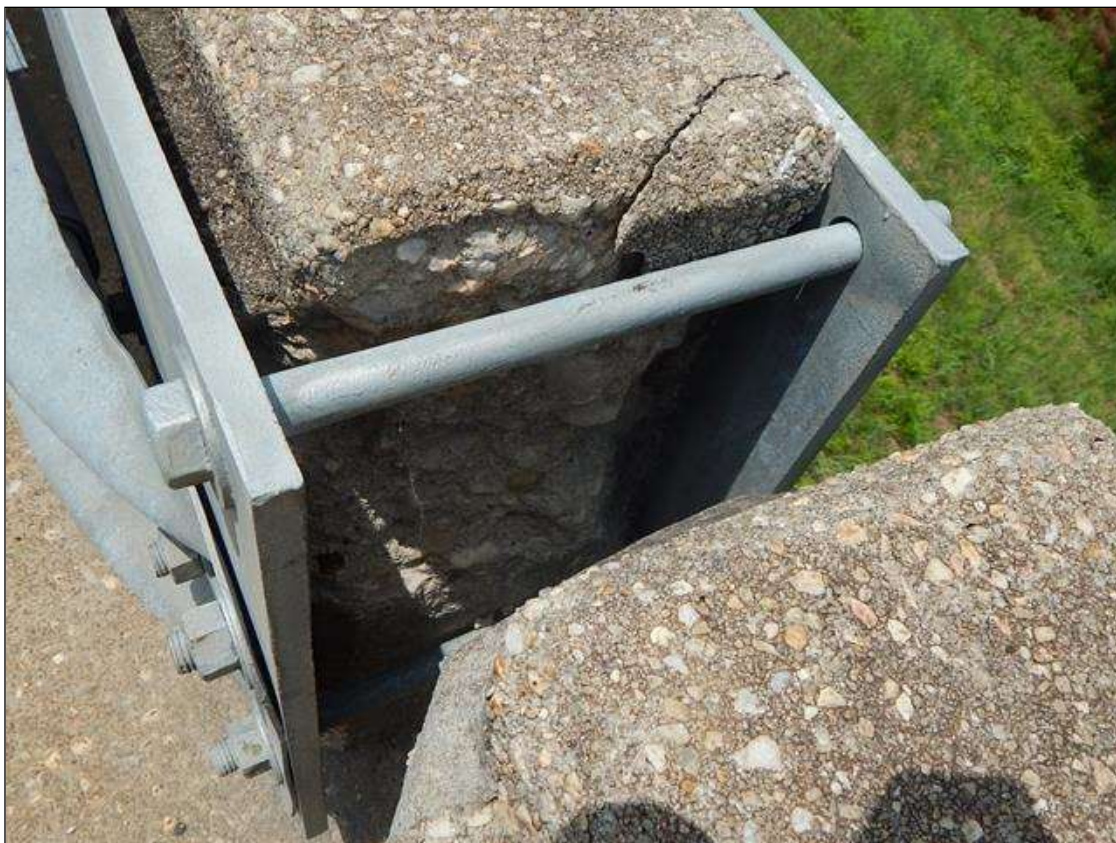
Span 1 Right Bridge Rail: 3" x 16" x 11" deep spall in rail and Post 2

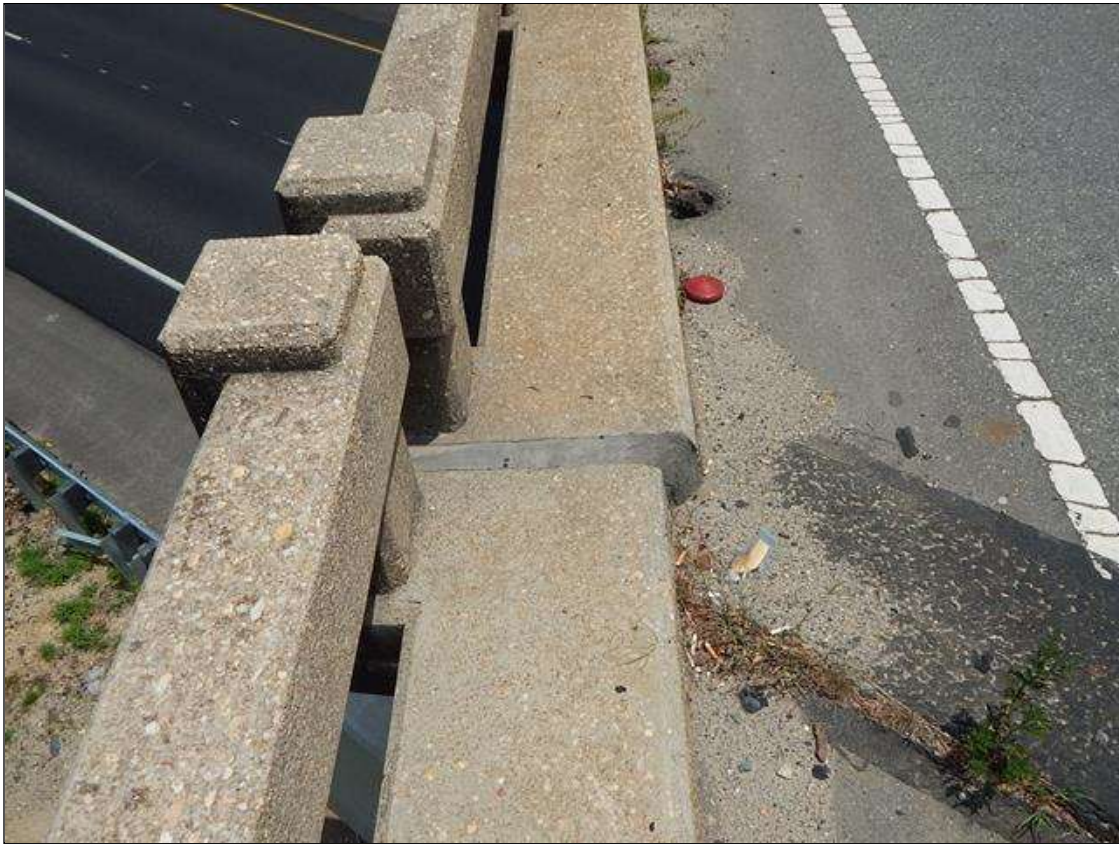
Span 1 Left Bridge Rail: 3" rotation to the North

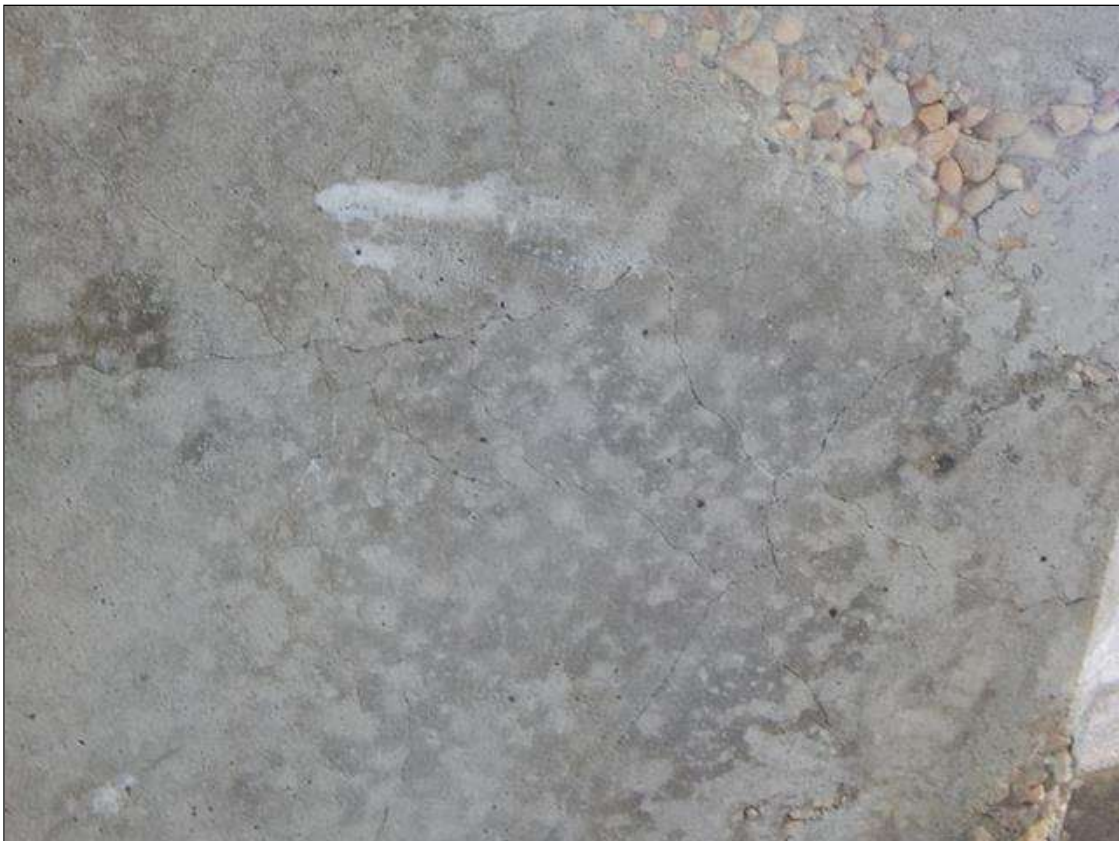
Span 1 Deck: 12' x 2' area of hairline longitudinal and transverse cracks in North overhang (South overhang similar)

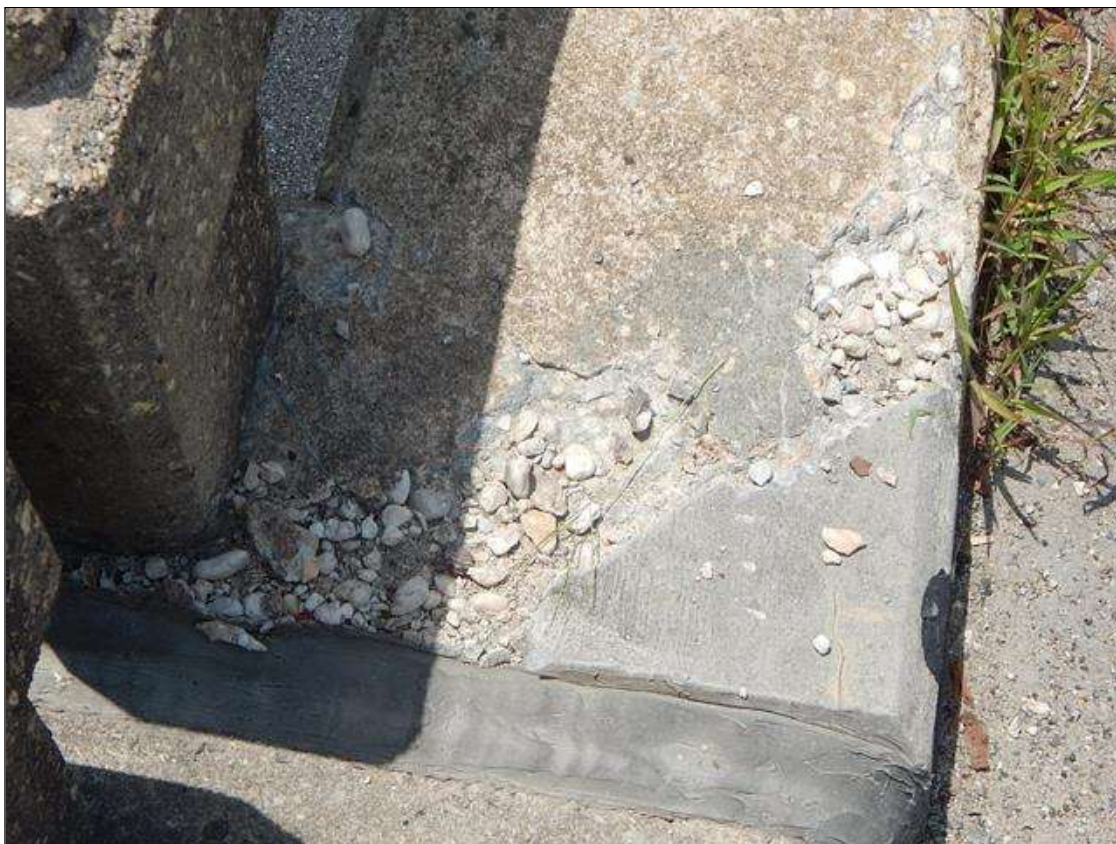
Span 3 Right Bridge Rail: 20" x 22" x 1" deep spall on curb at Bent 3

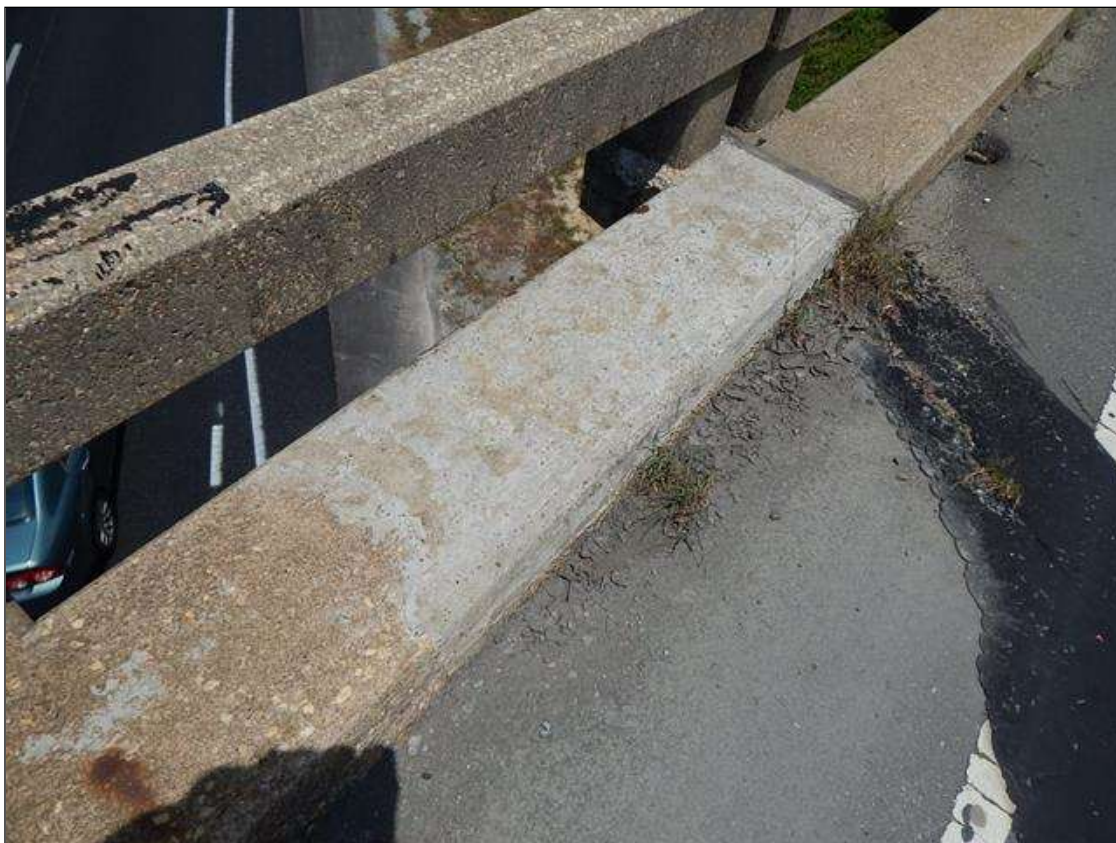
Span 3 Left Bridge Rail: 7' x 2' area of repaired section of curb at Bent 3

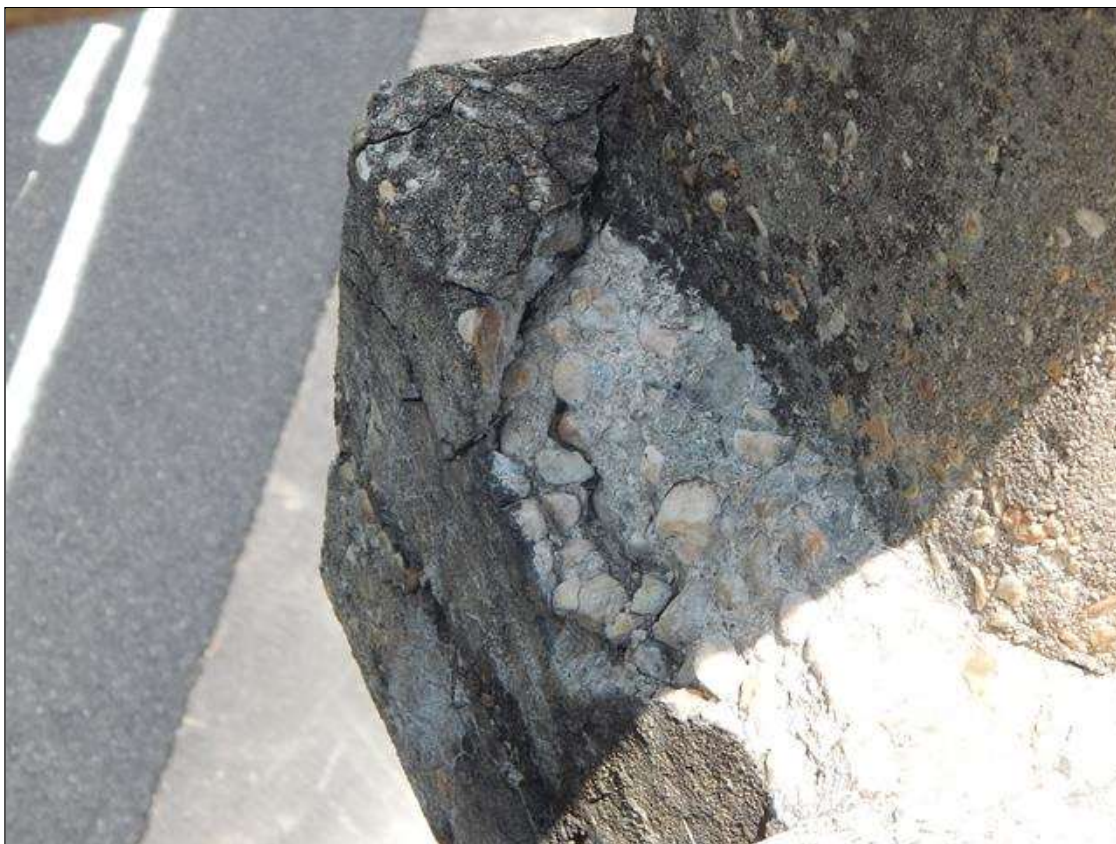
Span 3 Left Bridge Rail: 3" x 10" x 4" deep spall on Post 12 connection bracket

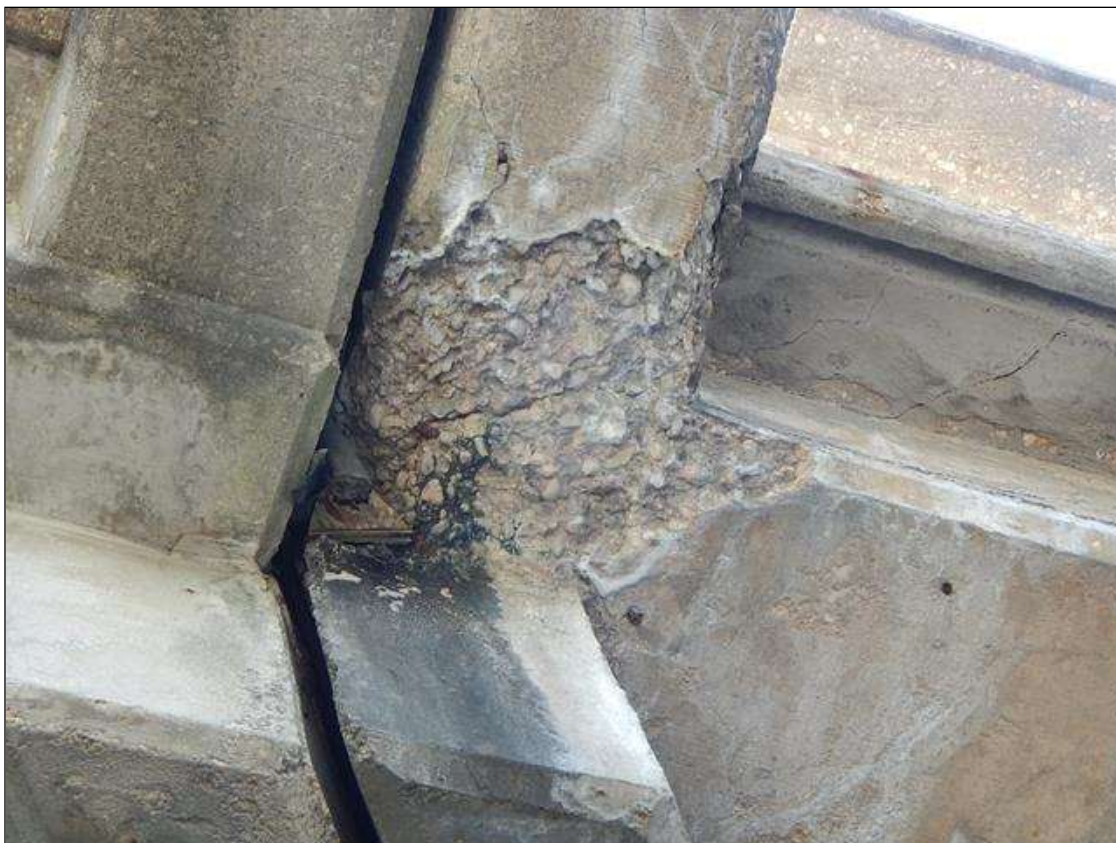
Span 3 Deck: 16" x 20" x 1 1/2" deep spall on North overhang at Bent 3

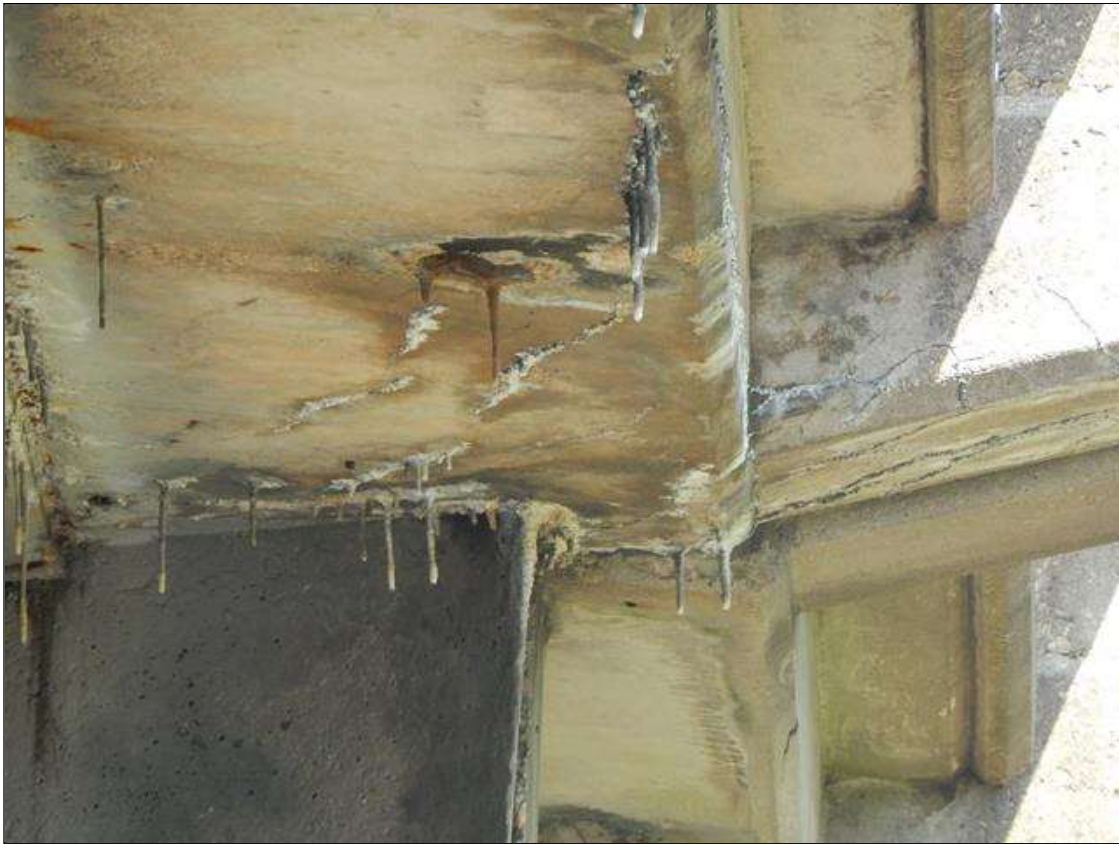
Span 3 Deck: 6' hairline longitudinal and diagonal cracks with efflorescence in South overhang at Bent 3

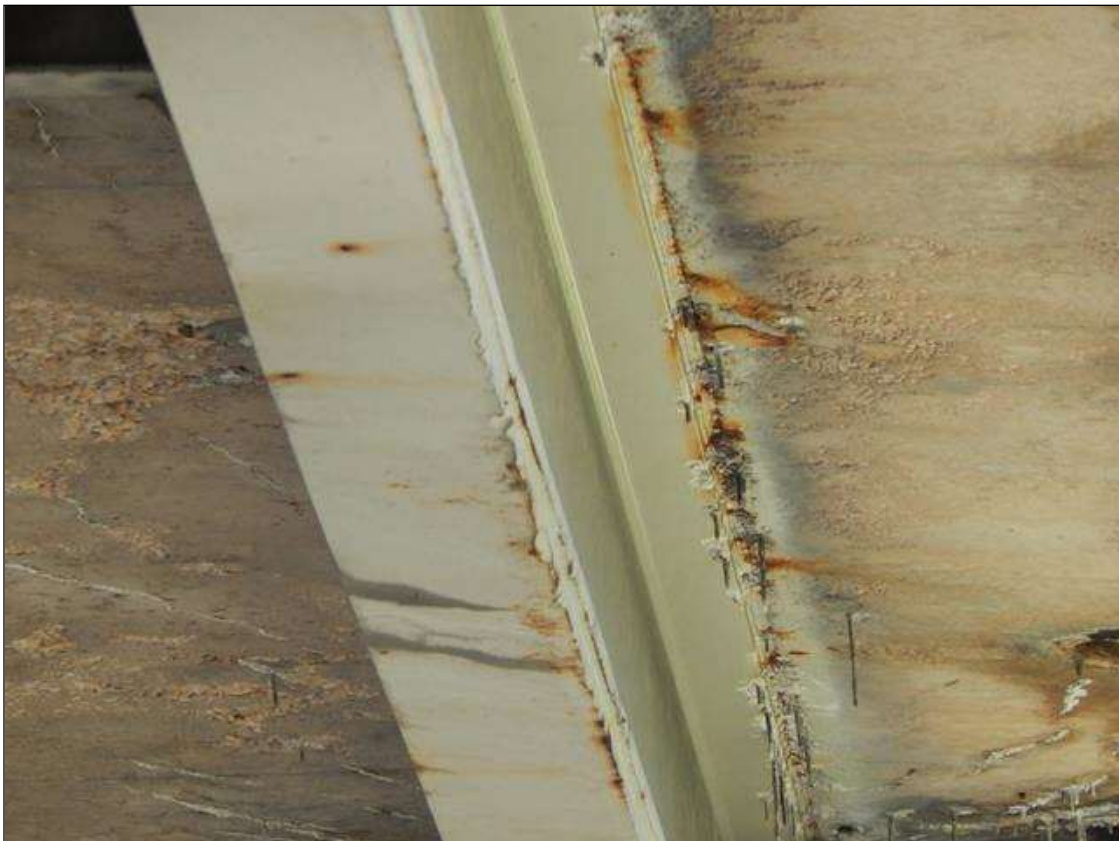
Span 3 Beam 4: 25' surface rust on both flanges

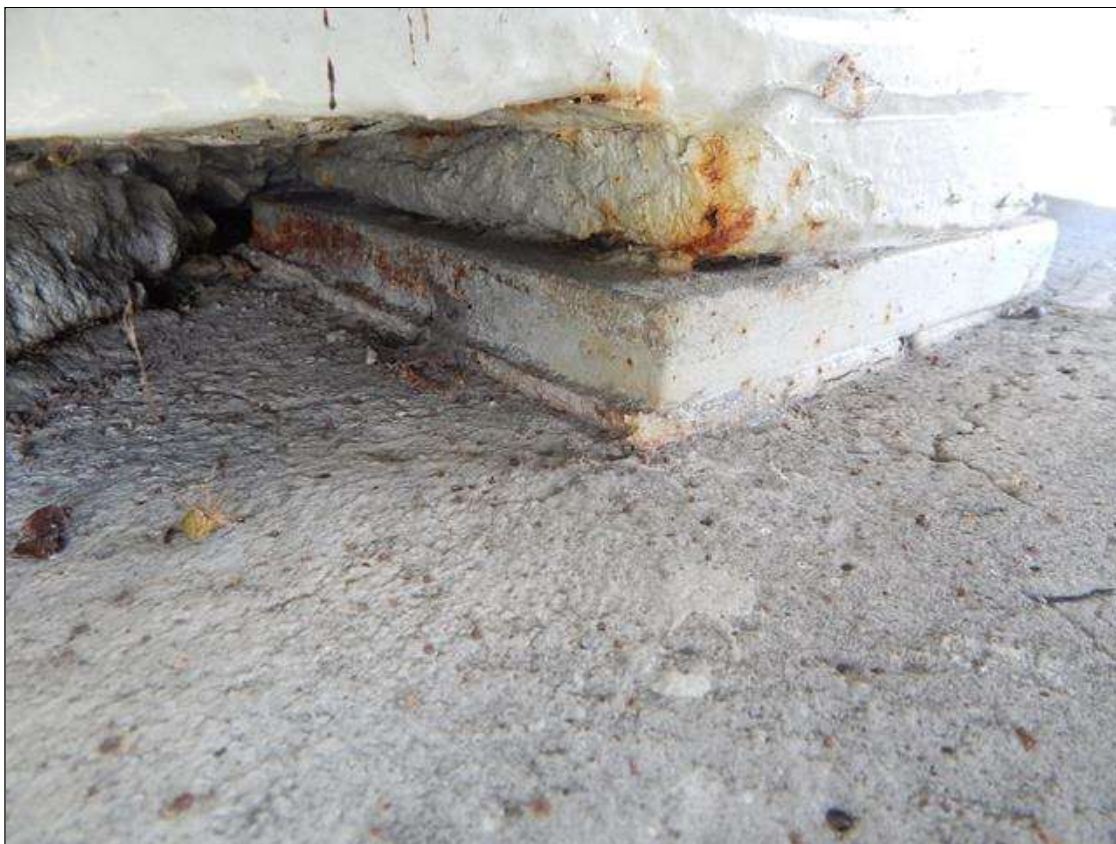
Span 4 Beam 1 Far Bearing: Surface rust

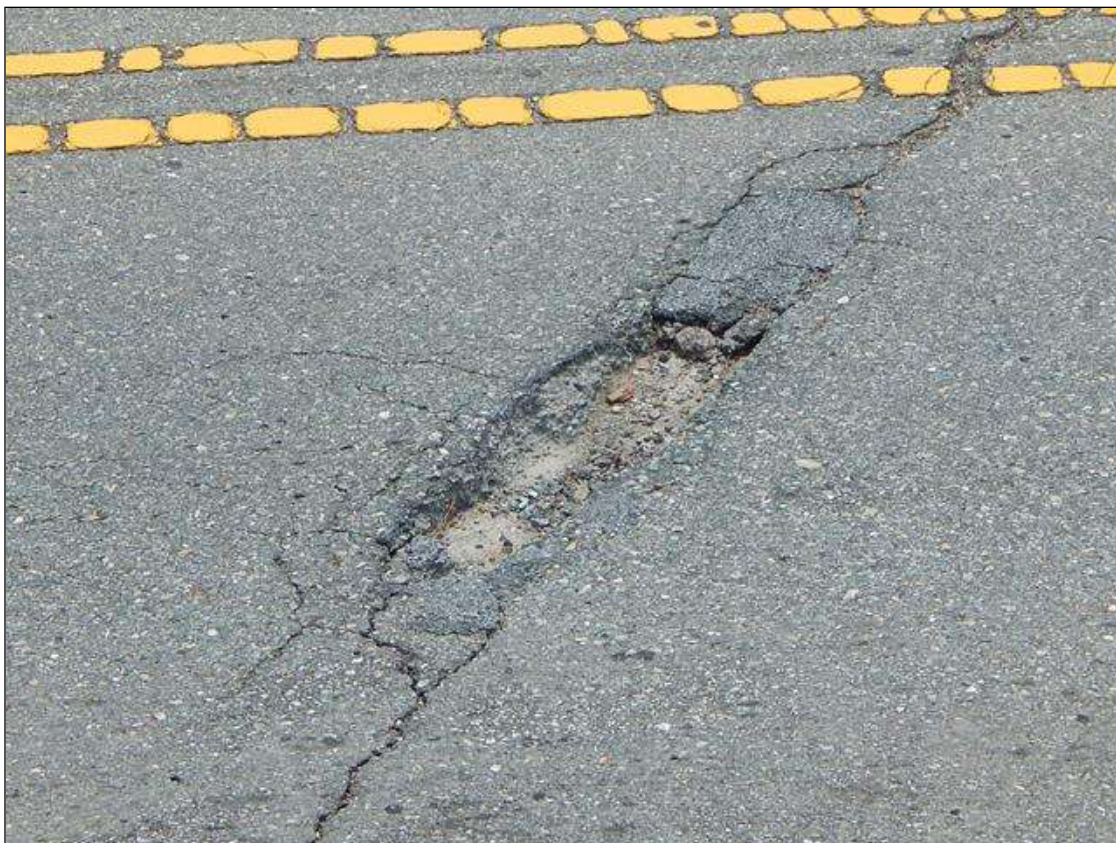
Span 4 Wearing Surface: (2) up to 29" x 8" x 3" deep area of missing asphalt wearing surface at End Bent 2

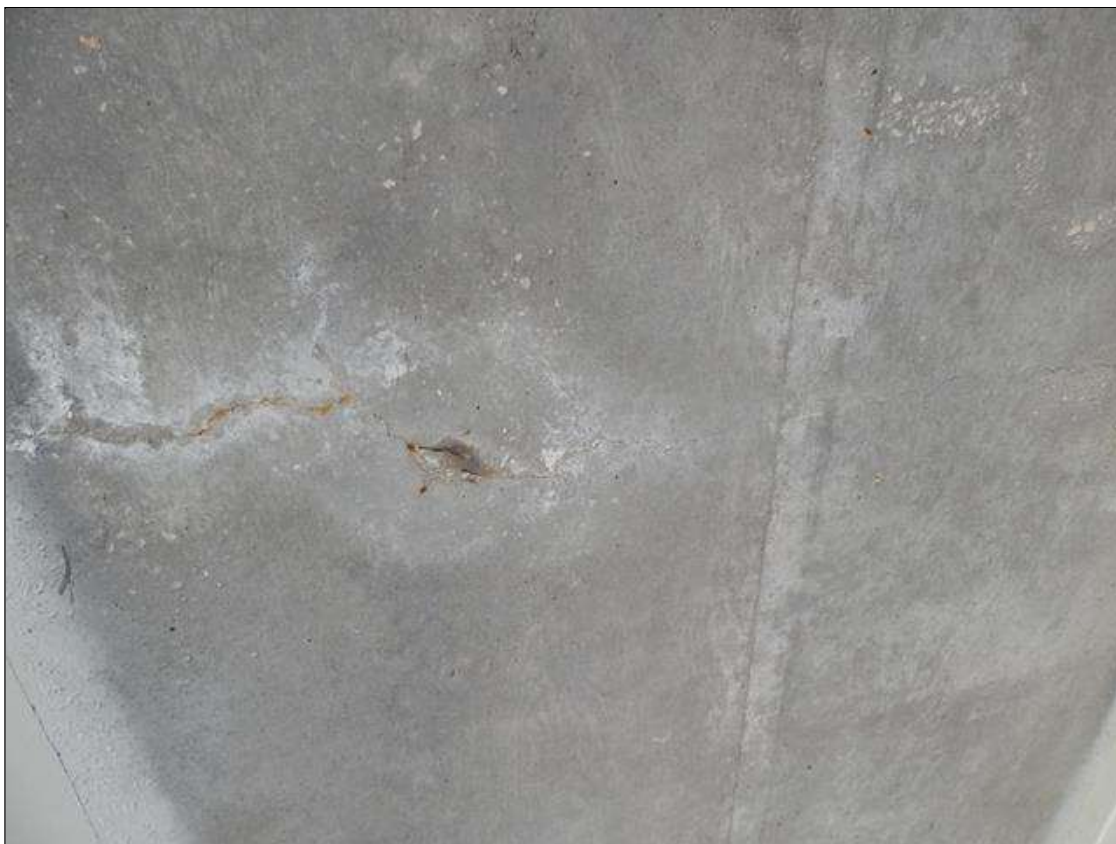
Span 4 Deck: 56 square feet hairline transverse cracks with efflorescence in bottom of deck

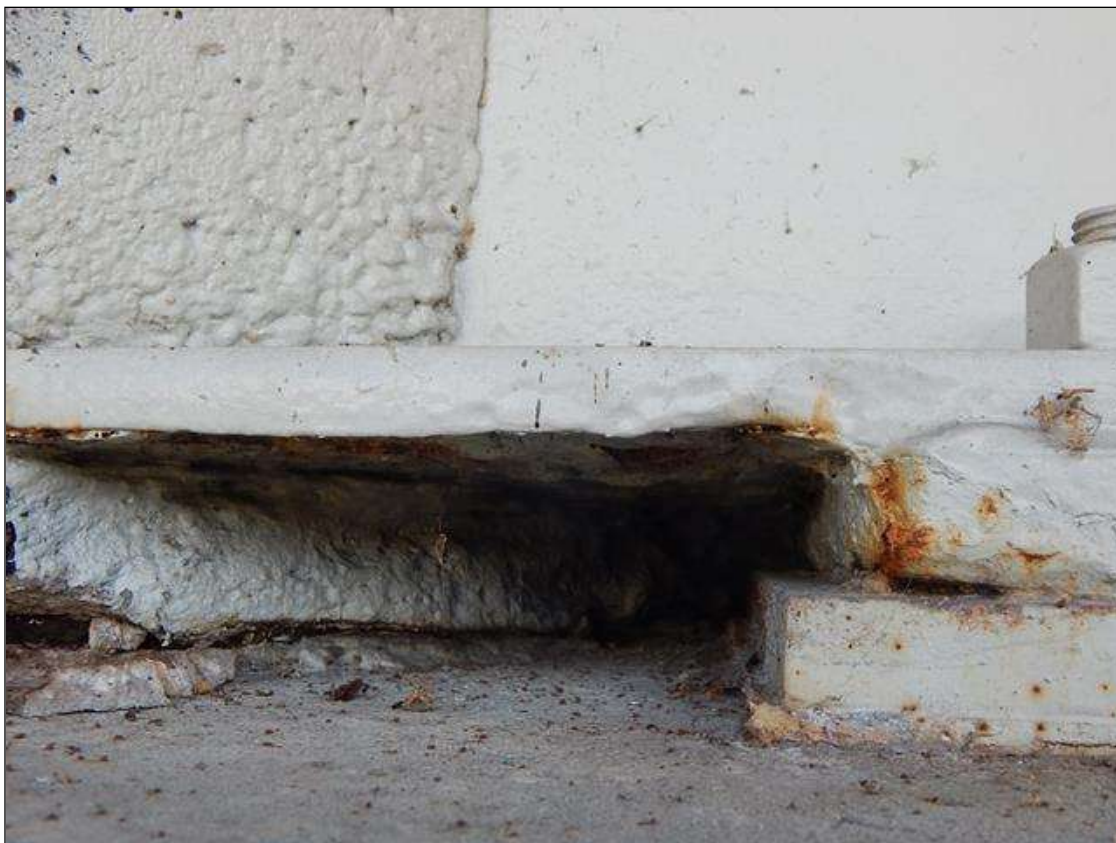
Span 4 Beam 1: 8" x 8" area of 1/4" section loss (11/16" remaining) on left side of bottom flange at End Bent 2 (PM)

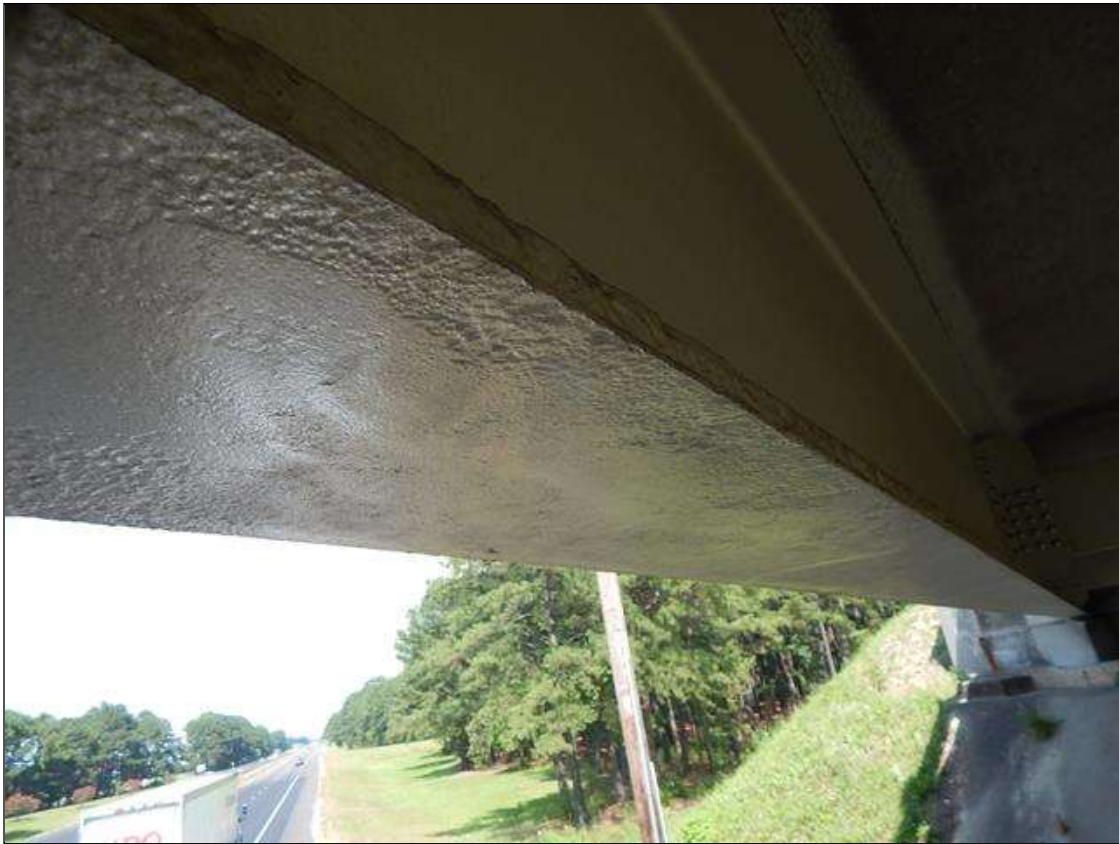
Span 4 Beam 1: 42" up to 1/16" pitting with no rust on bottom flange at Bent 3

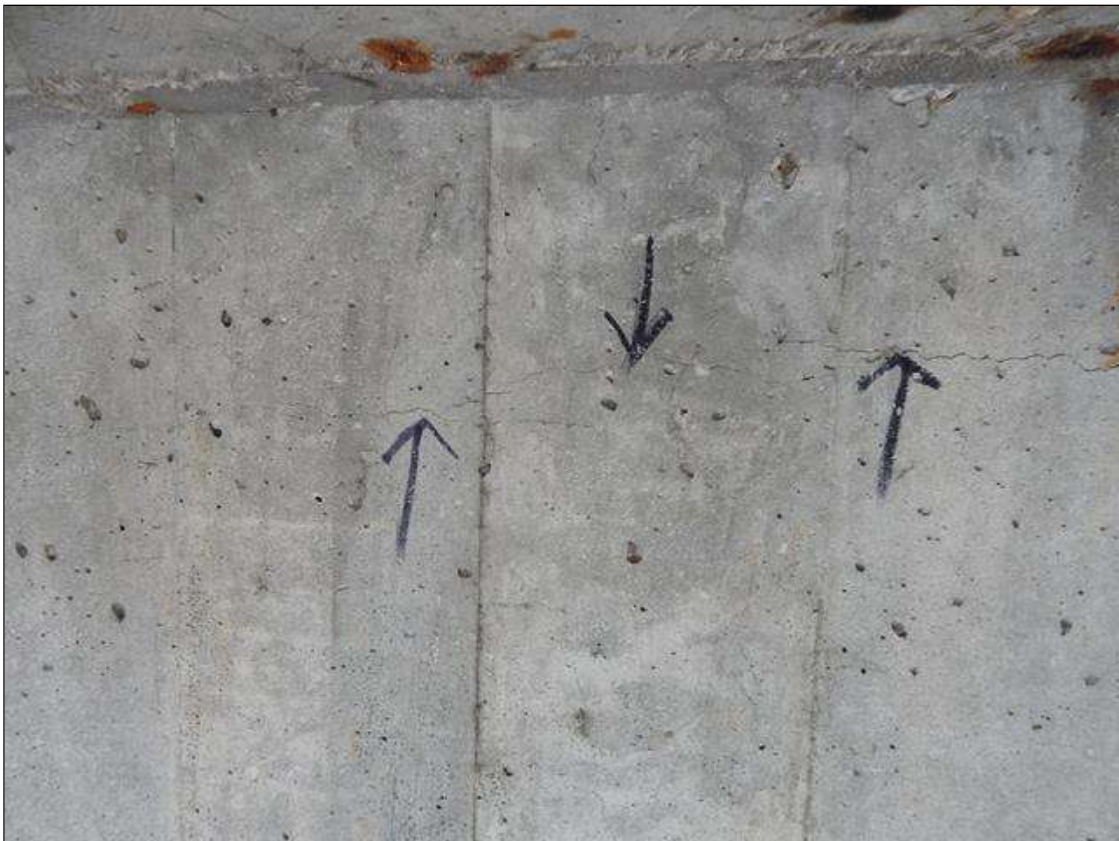
End Bent 1 Abutment/Backwall : 5' hairline horizontal crack in Bay 1

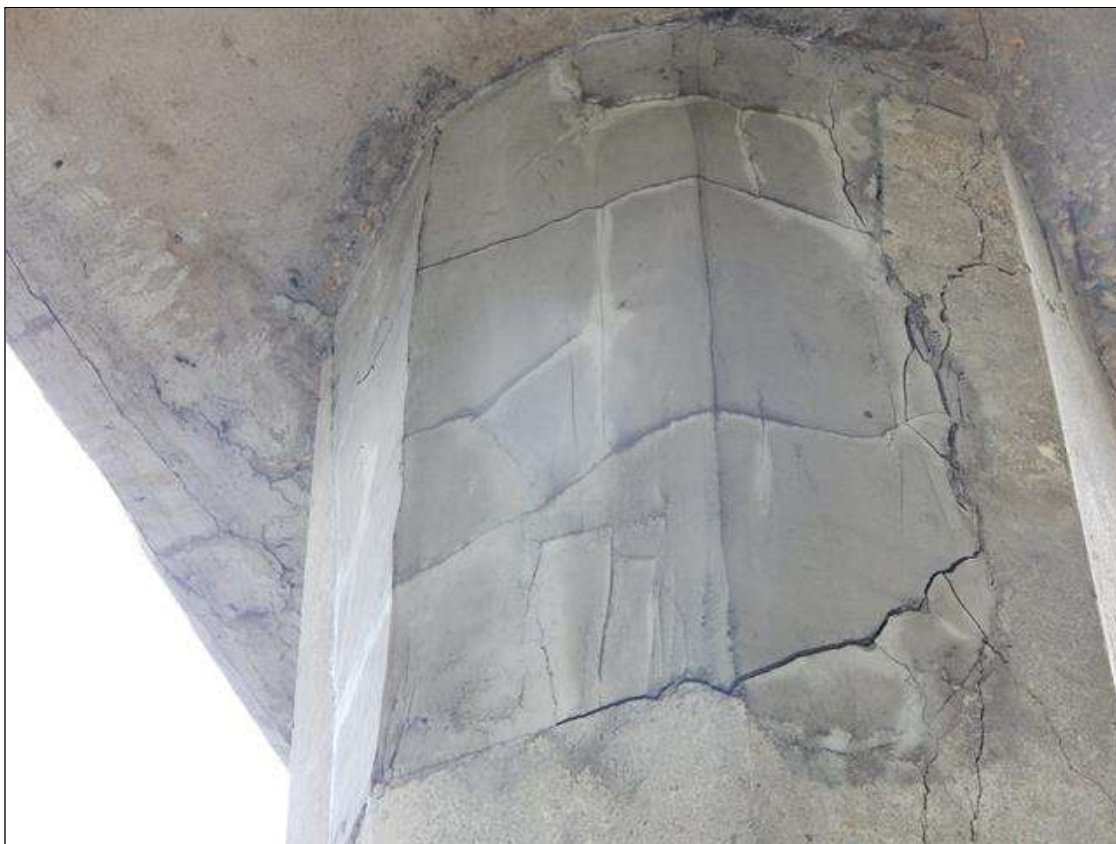
Bent 2 Pile 6: 2' x 2' area of patch with 1/8" vertical and horizontal cracks on North face

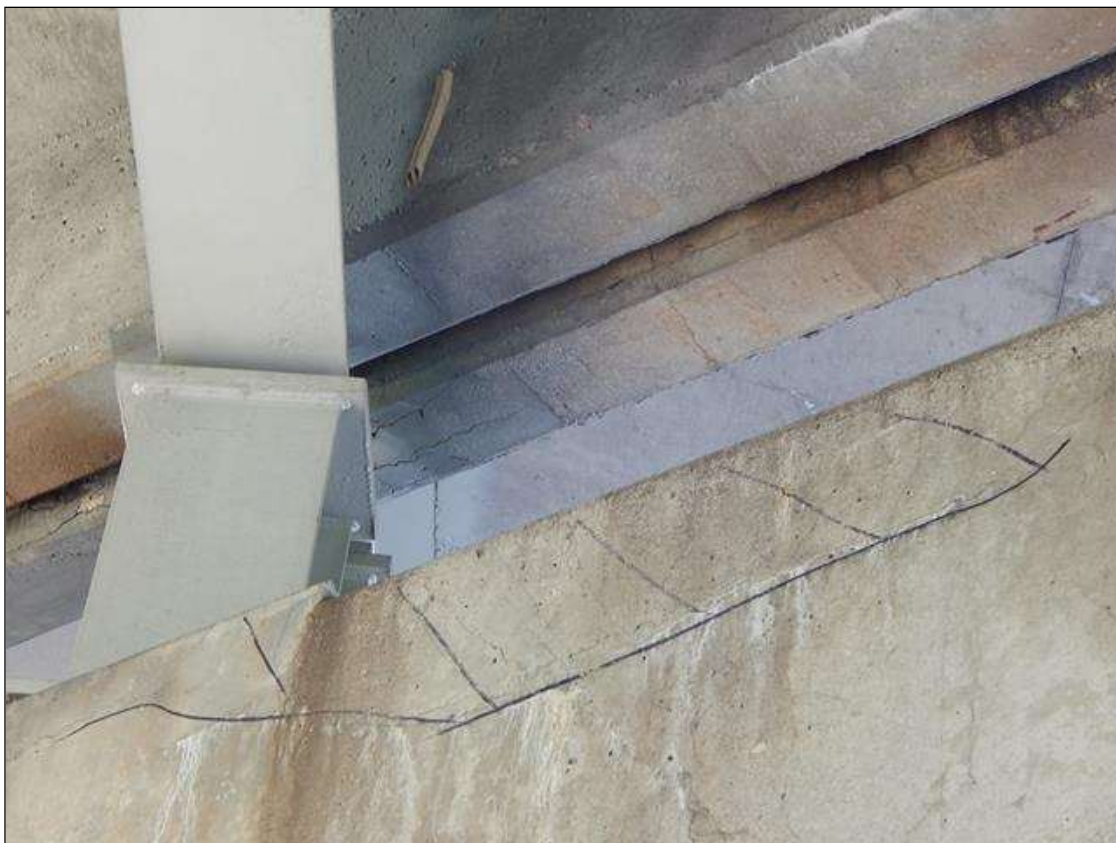
Bent 3 Cap 1: 7' x 1' area of delamination on Span 4 face under Bay 1 (Span 3 face similar)

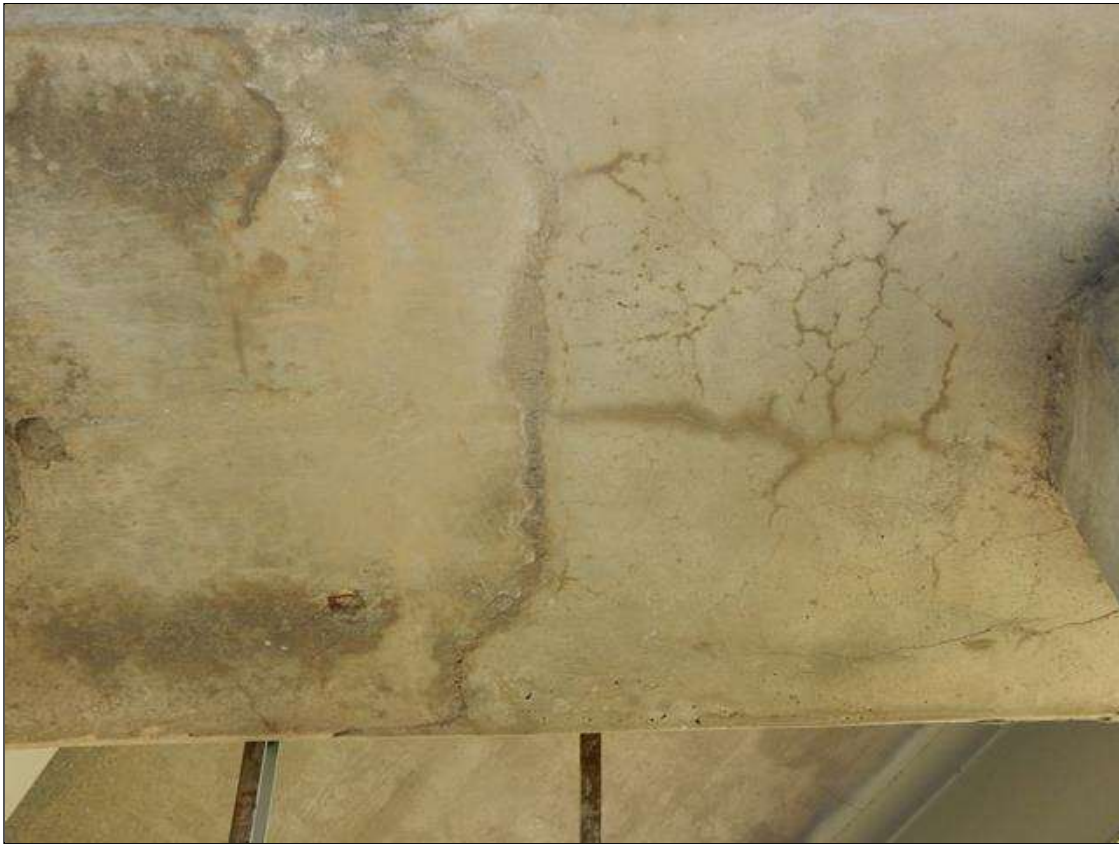
Bent 3 Cap 1: 34' x up to 3' area of hairline longitudinal and transverse cracks on bottom of cap

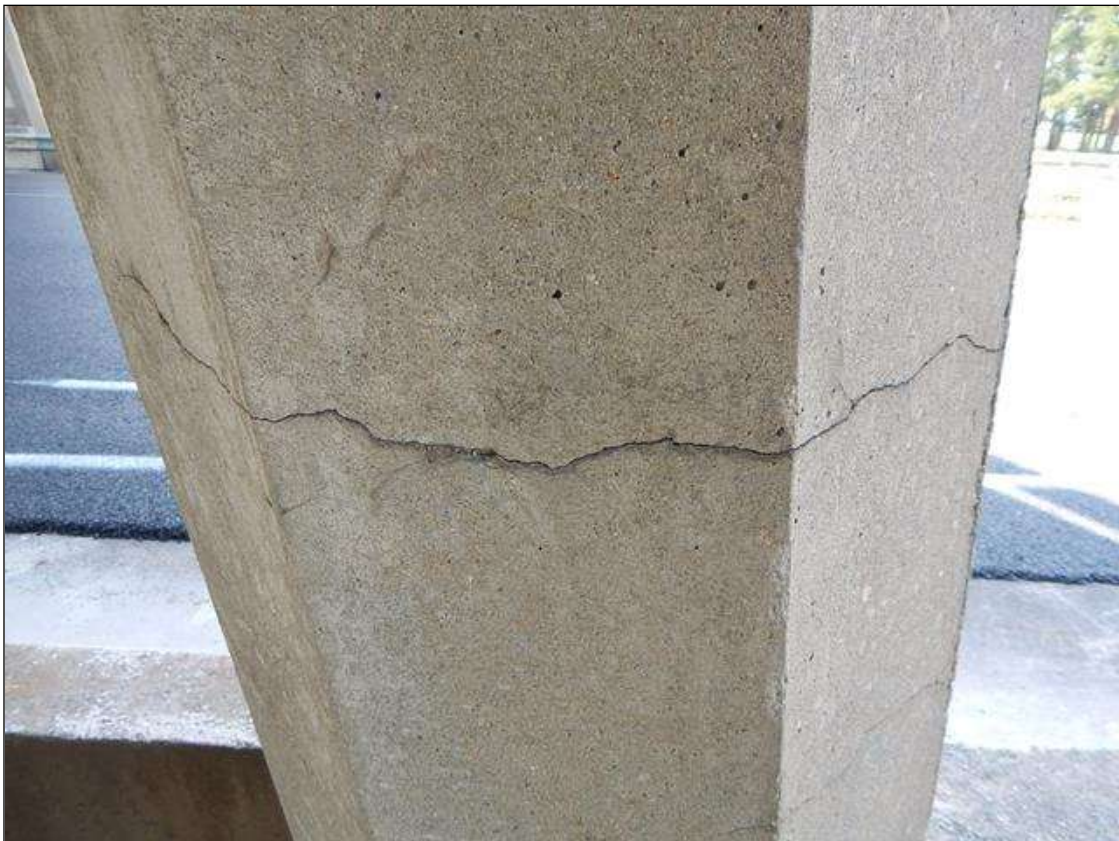
Bent 3 Pile 1: (3) up to 35" hairline horizontal cracks on Span 4 face

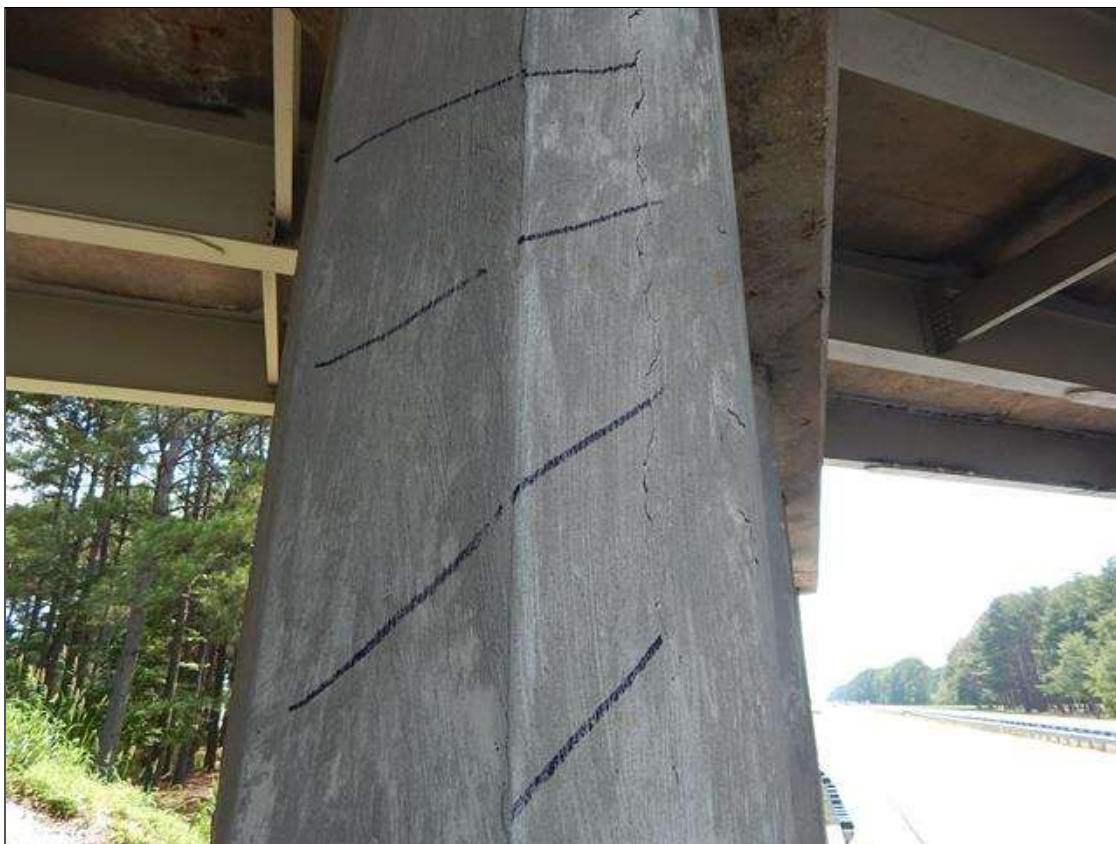
Bent 3 Pile 2: 4' x 1' area of delamination with 7' up to 1/16" vertical crack on North face

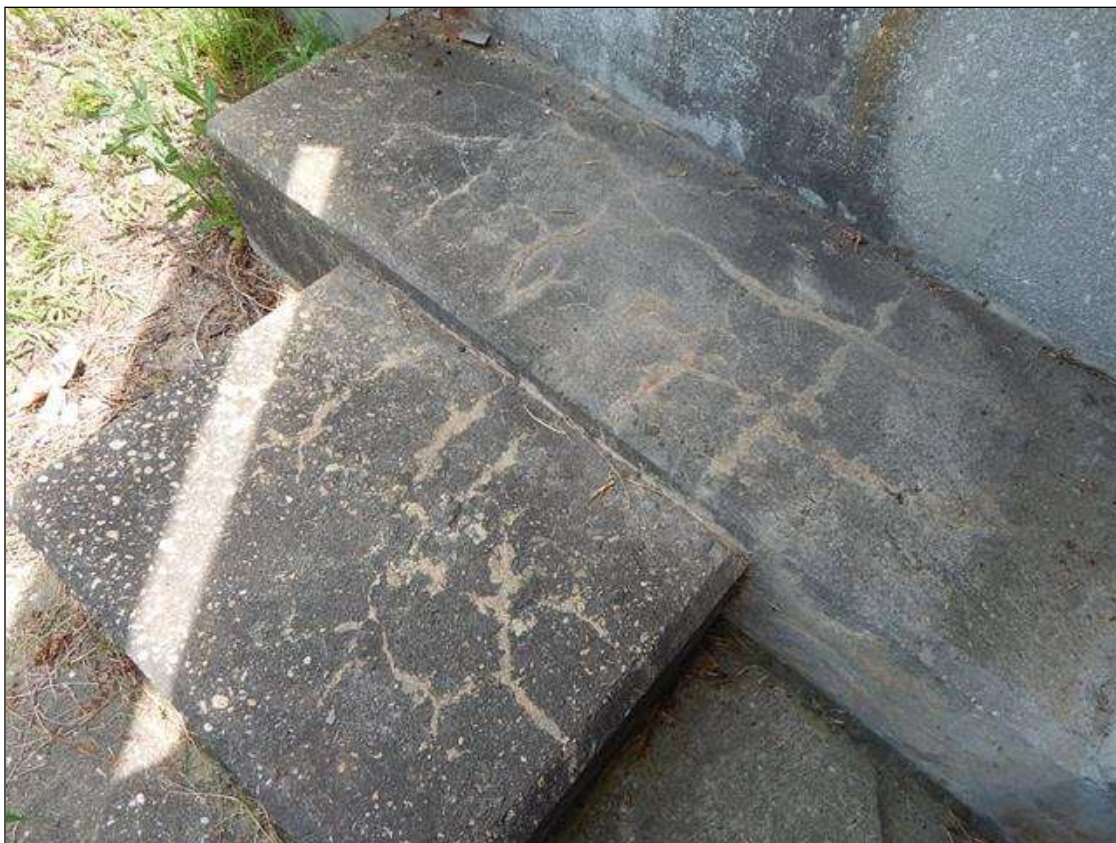
End Bent 2 Cap 1: 5' x 4' area of hairline longitudinal and transverse cracks on top of cap at North end
