NC DEPARTMENT OF TRANSPORTATION
 DIVISION OF HIGHWAYS
 STRUCTURE MANAGEMENT UNIT

ATTENTION: Priority Maintenance; Approach Roadway, Typical Section Sketch Modified

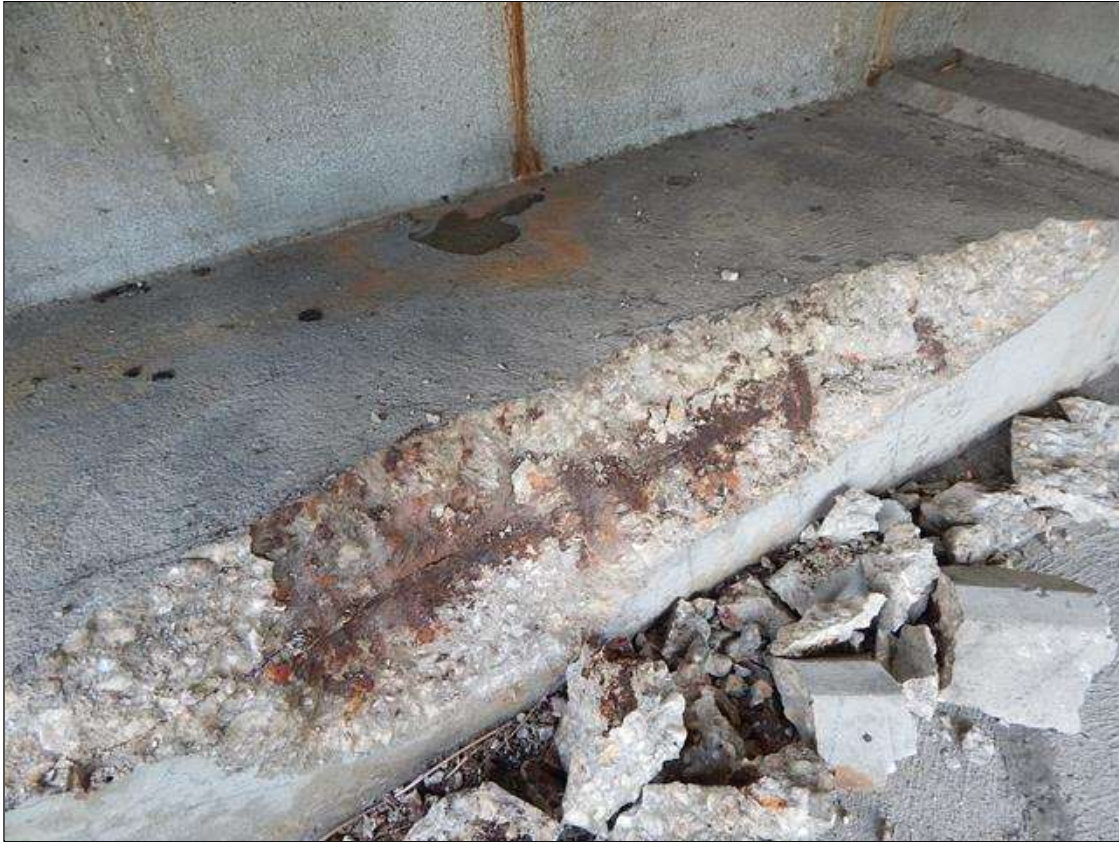
End Bent 2 Cap 1: 67" x 12" x 7" deep spall with exposed rebar under Bay 1 (PM)

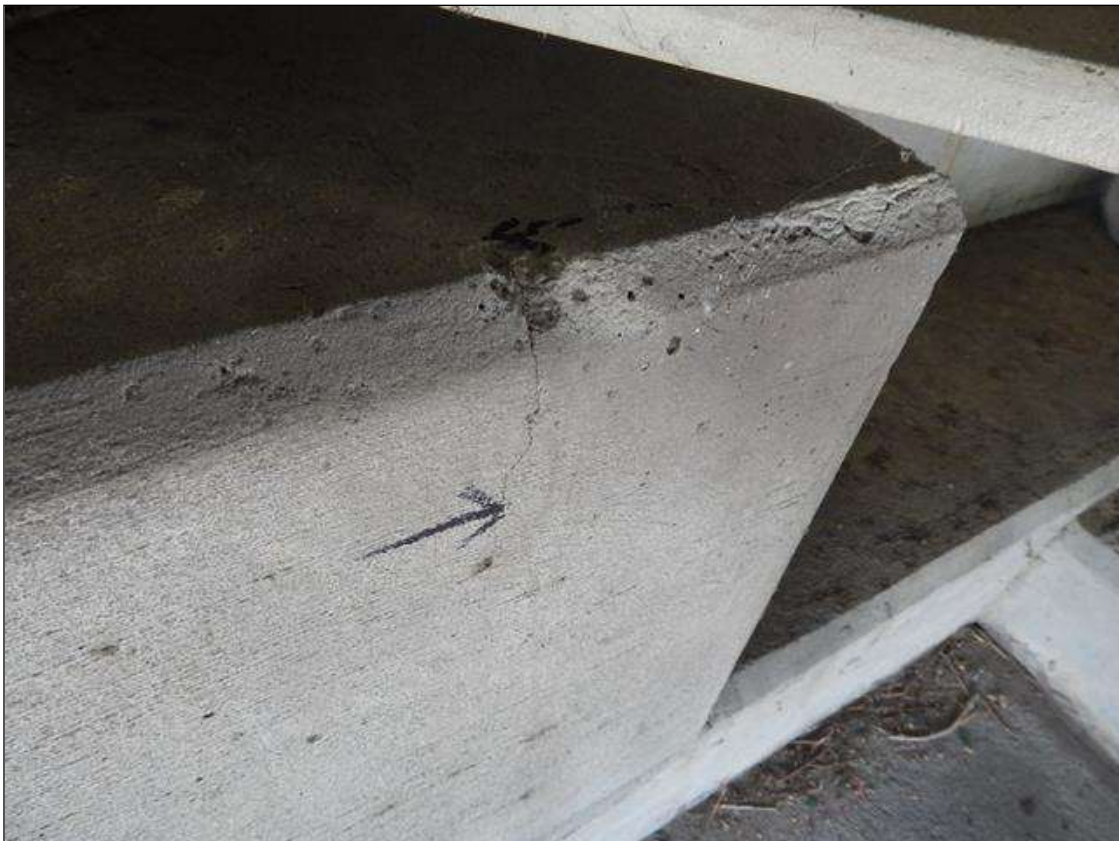
End Bent 2 Cap 1: 22" hairline vertical and longitudinal crack on Beam 2 pedestal

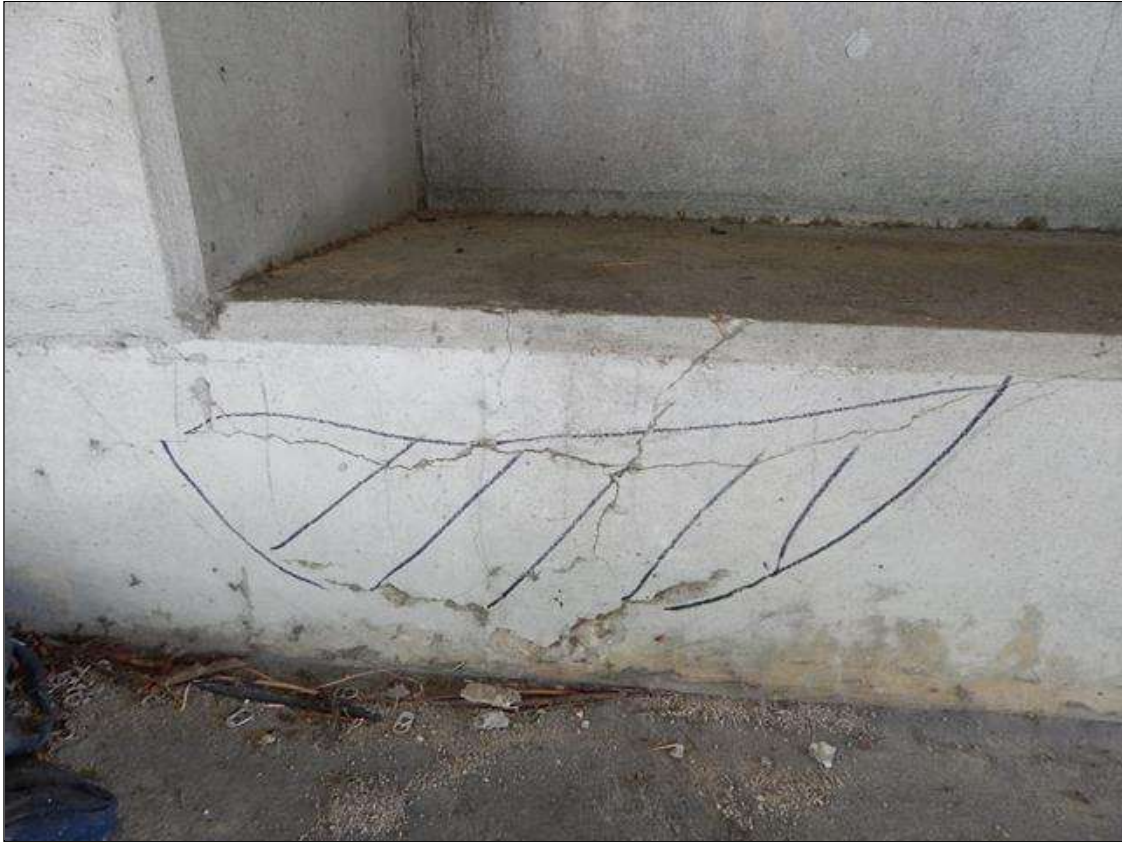
End Bent 2 Cap 1: 28" x 10" area of delamination under Bay 3

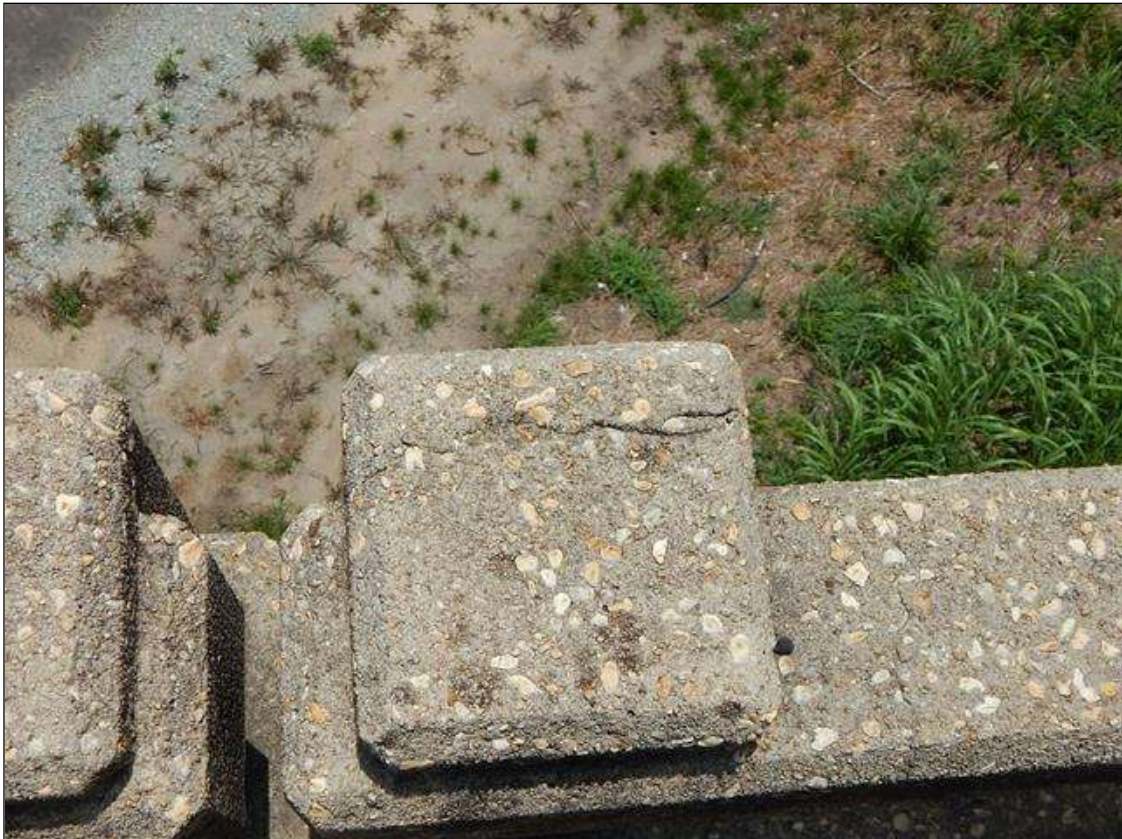
Span 1 Right Bridge Rail: 10" up to 1/8" longitudinal crack on top of Post 5

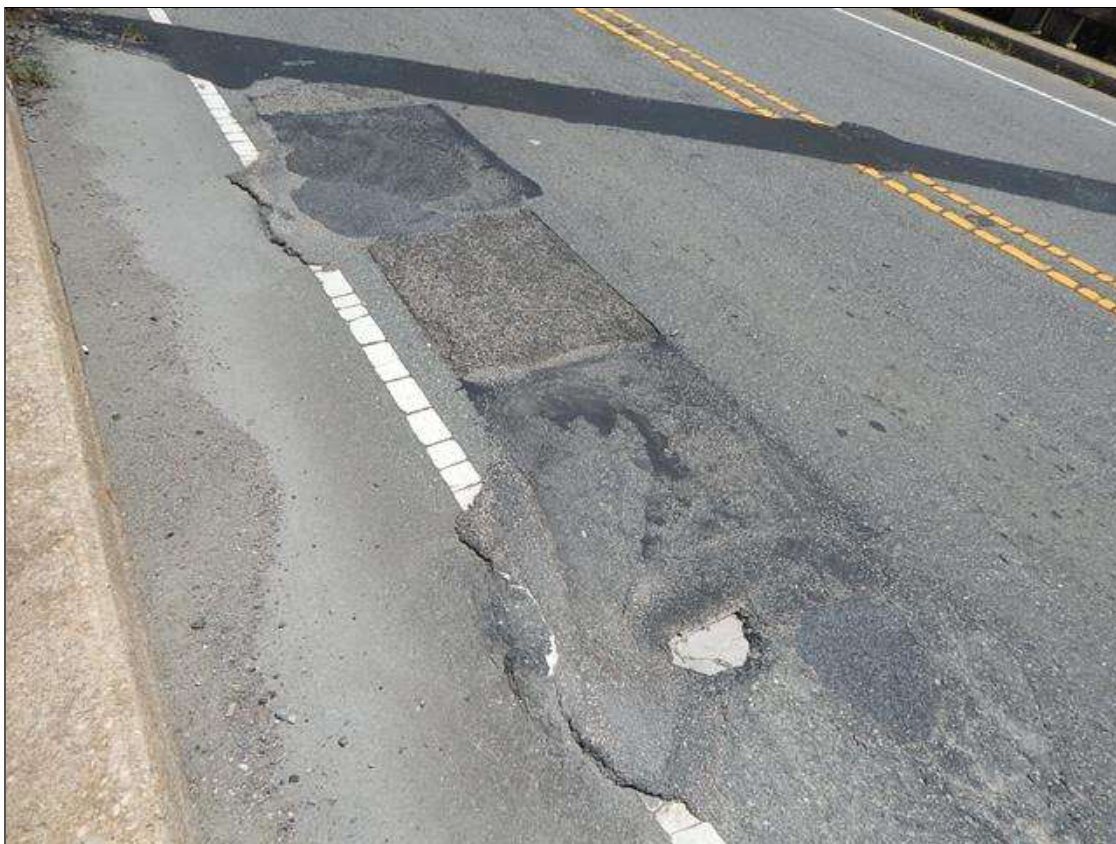
Span 3 Wearing Surface: 15' x 4' area of patch with (2) up to 8" x 12" x 2" deep spalls in Eastbound lane at Bent 3

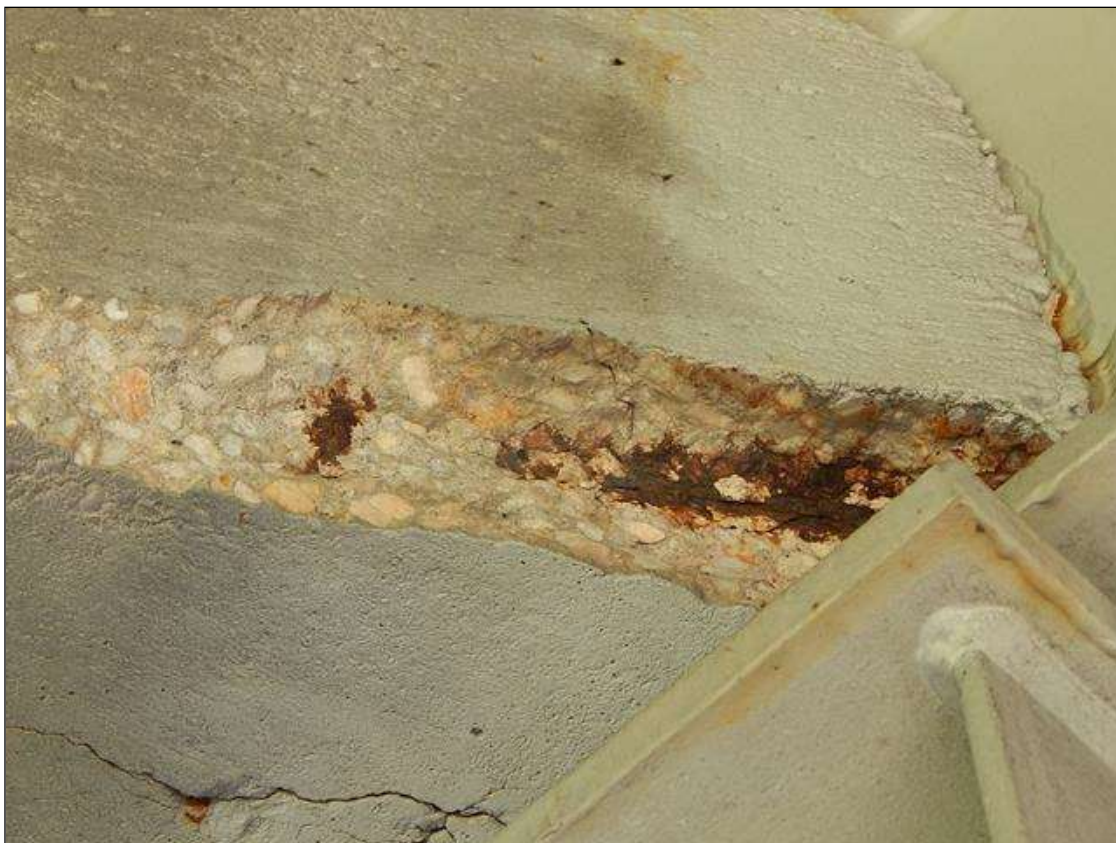
Span 4 Beam 3: 18" x 5" x 2" deep spall with exposed rebar on Bent 3 diaphragm in Bay 3

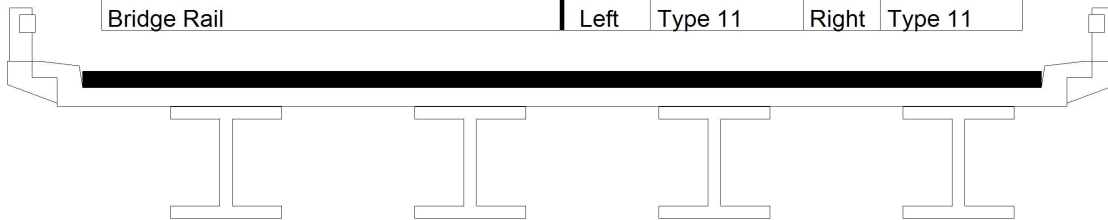
Measurements for Span #	1		
Deck Thickness	0.542	Left Overhang	4.583 *
Top of Rail to Bottom of Beam	5.208	Right Overhang	4.583 *

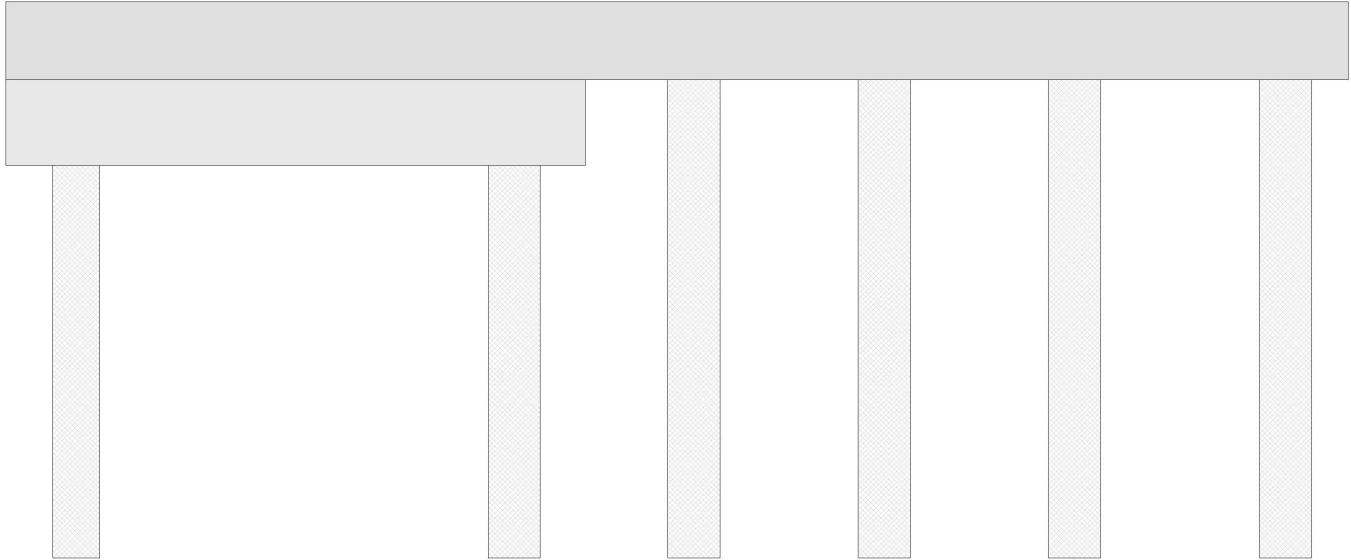
Cap Information			Material Cast-in-Place Concrete							
Length	Width	Height	Left Overhang	Right Overhang	Left Beam to End of Cap.	Right Beam to End of Cap.

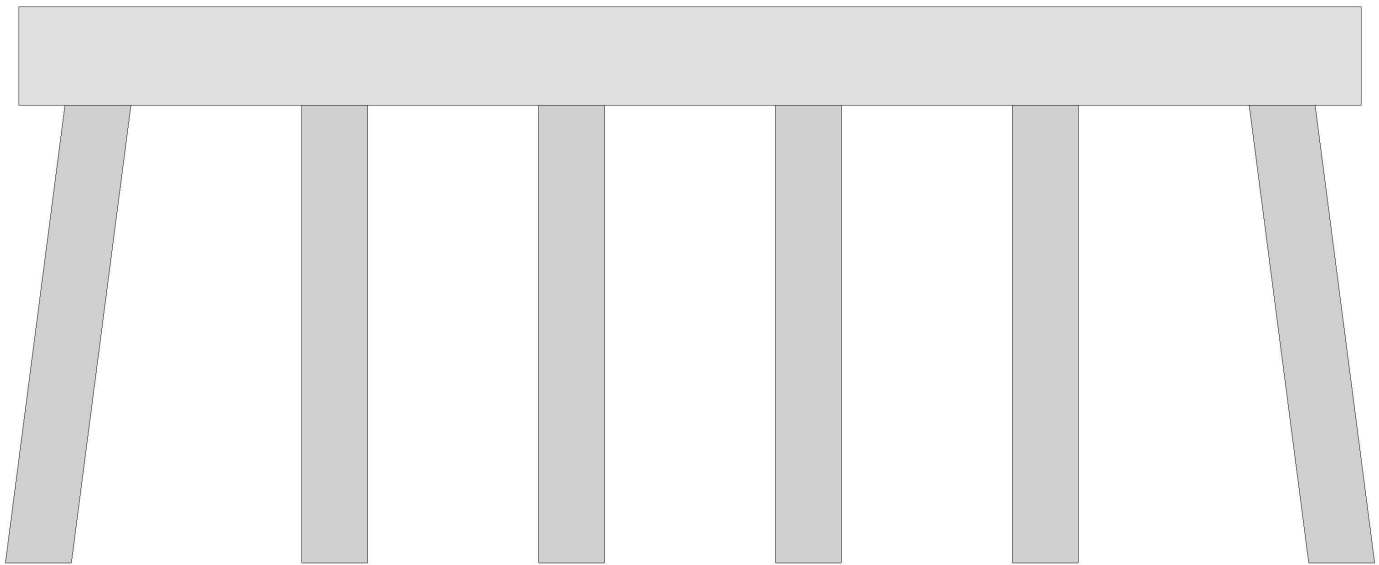
Cap Information			Material Cast-in-Place Concrete							
Length	Width	Height	Left Overhang	Right Overhang	Left Beam to End of Cap.	Right Beam to End of Cap.
