NC DEPARTMENT OF TRANSPORTATION
 DIVISION OF HIGHWAYS
 STRUCTURE MANAGEMENT UNIT

ATTENTION: PARS SUBMITTED, CHANGE TO VERTICAL CLEARANCE

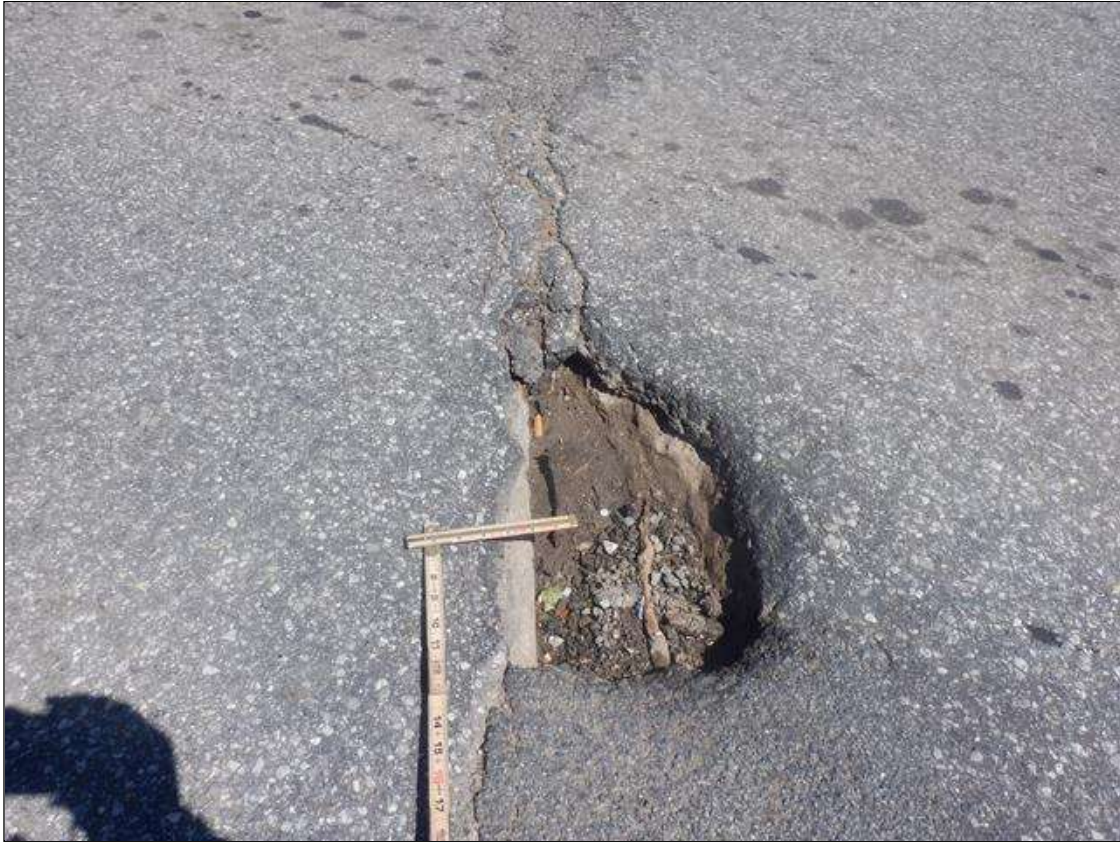
Span 2 Wearing Surface: (PAR) IN SOUTHBOUND LANE 7 FEET FROM CENTER LINE, FAILED PATCH/POTHOLE (20 INCHES X 11 INCHES X 5 INCHES DEEP)

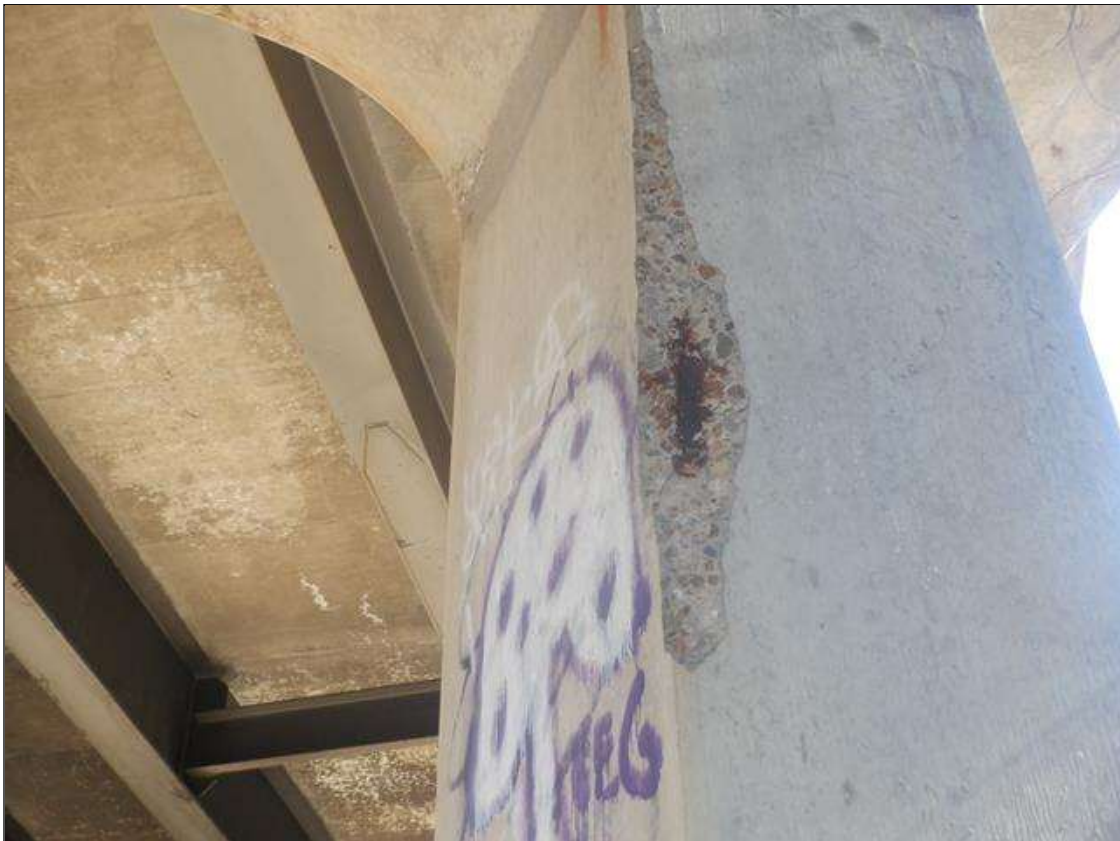
Bent 2 Pile 1: (PAR) 4 FEET FROM BOTTOM OF CAP AT NORTHEAST CORNER, 4 FEET HIGH X 3 INCHES WIDE X 3 INCHES DEEP SPALL WITH EXPOSED REBAR WITH 5 PERCENT SECTION LOSS

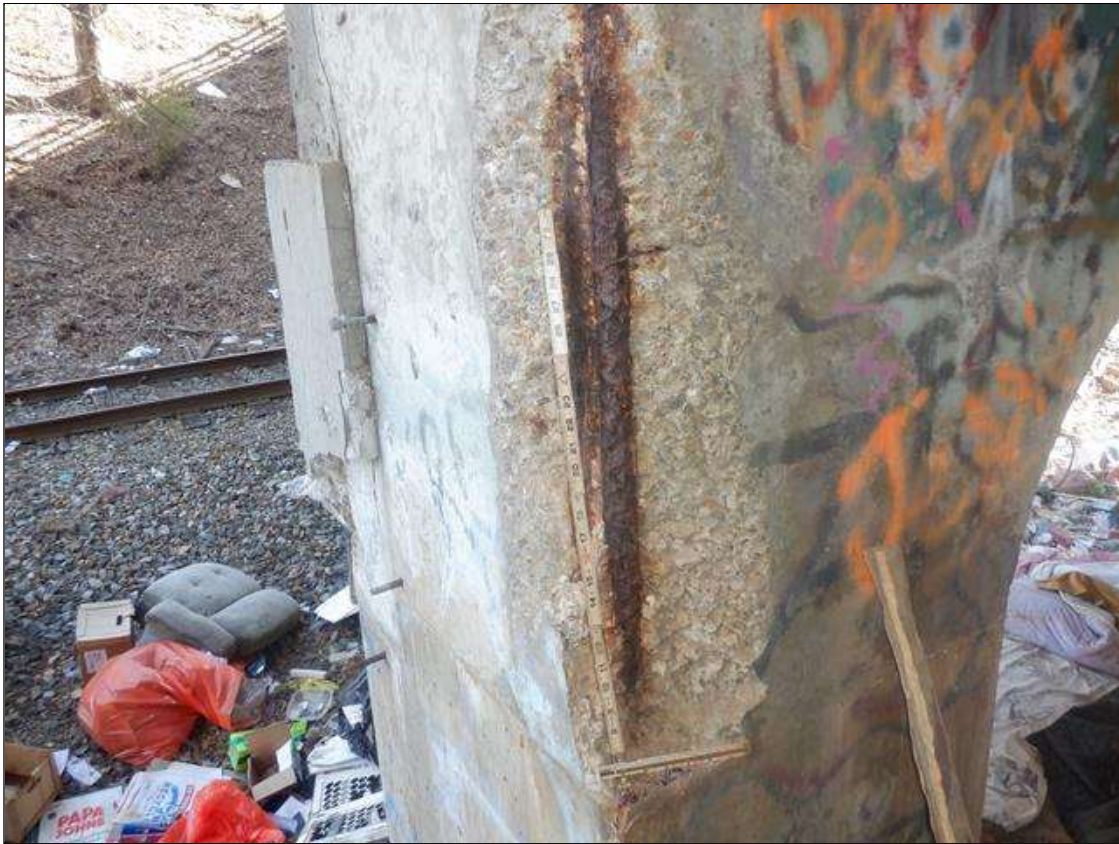
Bent 2 Pile 4: (PAR) 13 FEET FROM BOTTOM OF CAP AT NORTHEAST CORNER, 4 FEET TALL X 13 INCHES WIDE X 3 INCHES DEEP SPALL WITH EXPOSED REBAR, 10 PERCENT SECTION LOSS

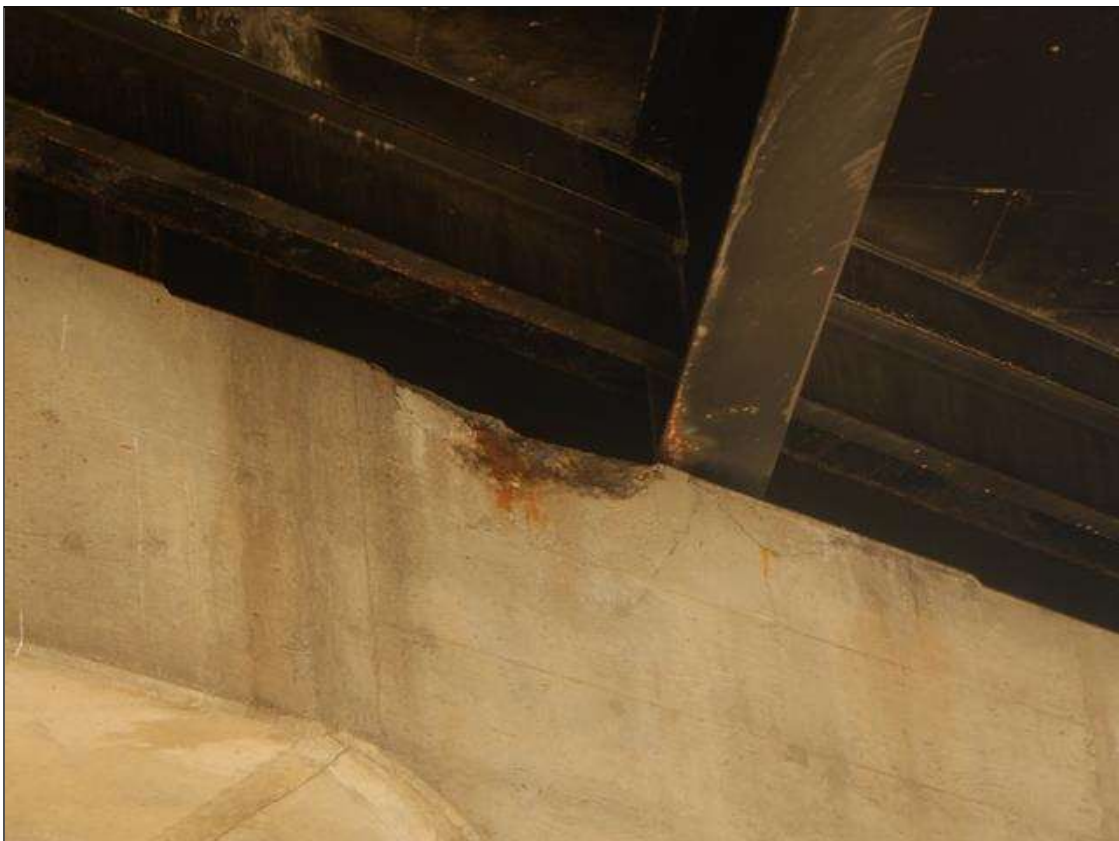
Bent 1 Cap 1: (PAR) NORTH FACE AT TOP OF CAP AT BEAM 3, 2 FEET X UP TO 1 FOOT X 1 INCHES DEEP SPAL WITH EXPOSED REBAR WITH 5 PERCENT SECTION LOSS

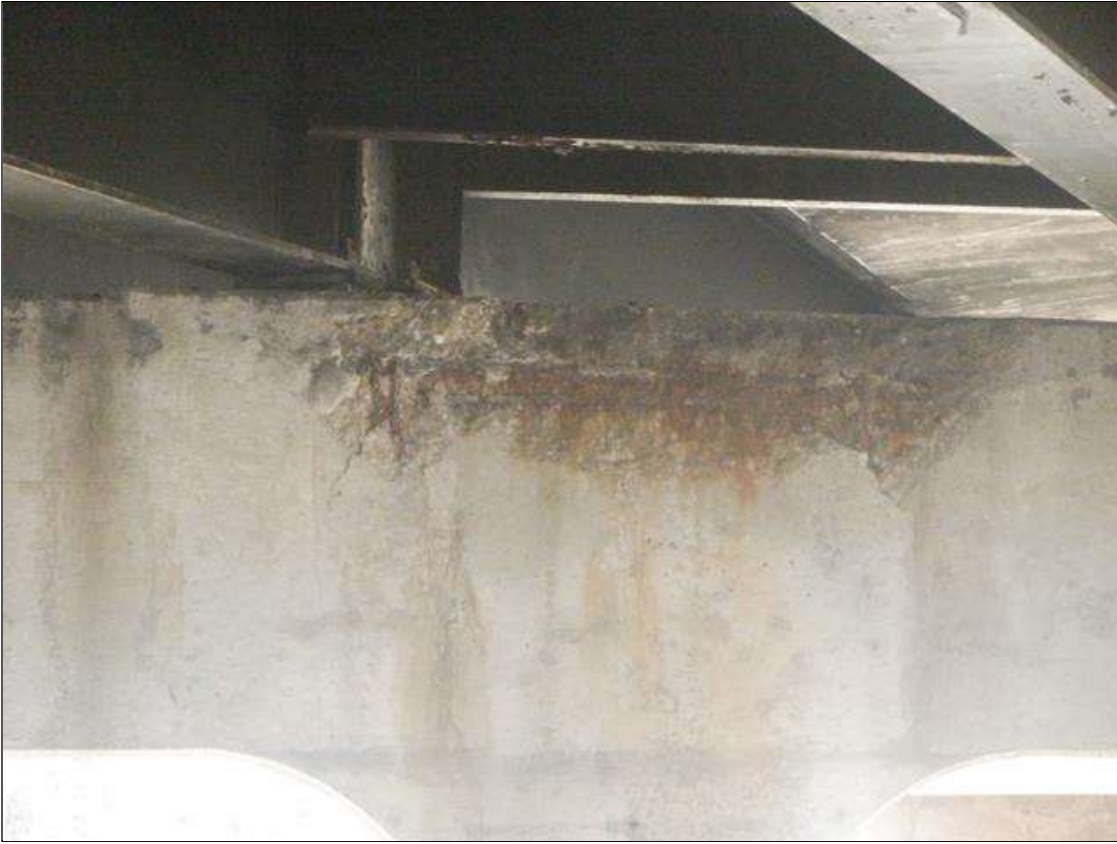
Bent 1 Cap 1: (PAR) TOP AND SOUTH FACES BELOW BEAM 3 AND 4, 5.5 FEET X UP TO 18 INCHES X 5 INCHES DEEP SPALL WITH EXPOSED REBAR WITH 10 PERCENT SECTION LOSS

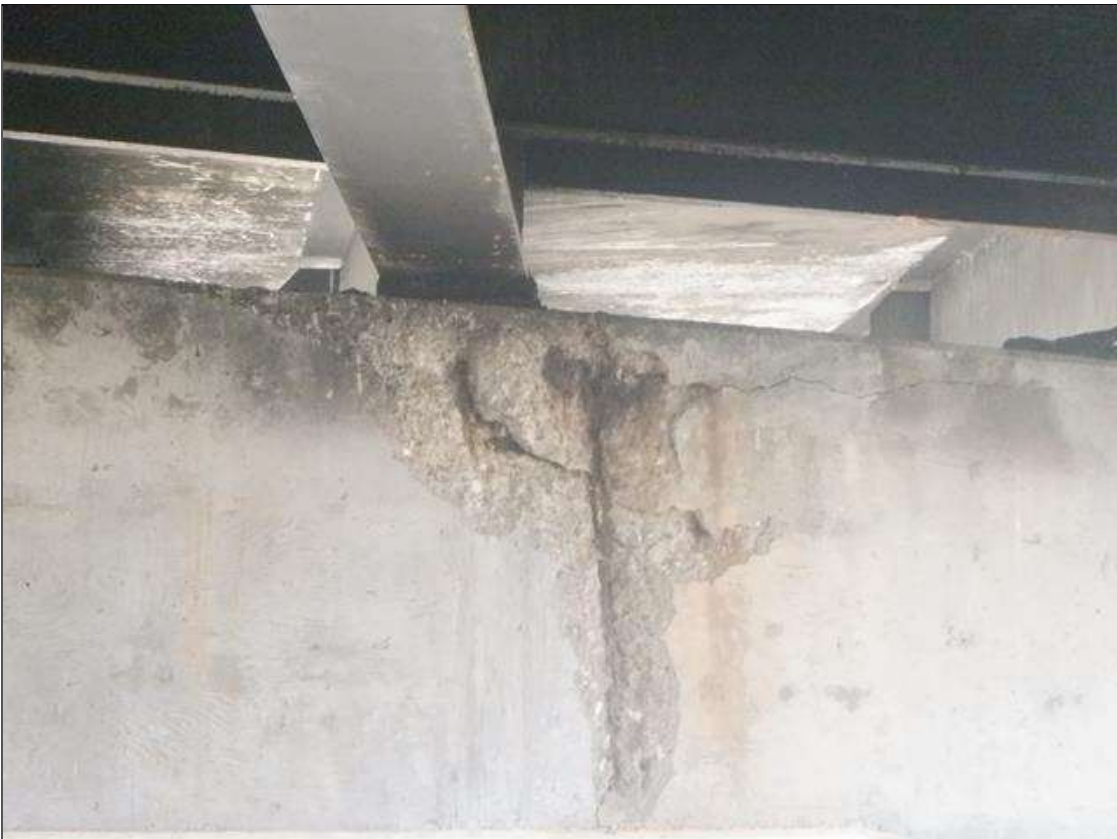
Bent 1 Cap 1: (PAR) SOUTH FACE BELOW BEAM 5, 5 FEET X UP TO 3 FEET X 3 INCHES DEEP SPALL WITH EXPOSED REBAR WITH 10 PERCENT SECTION LOSS

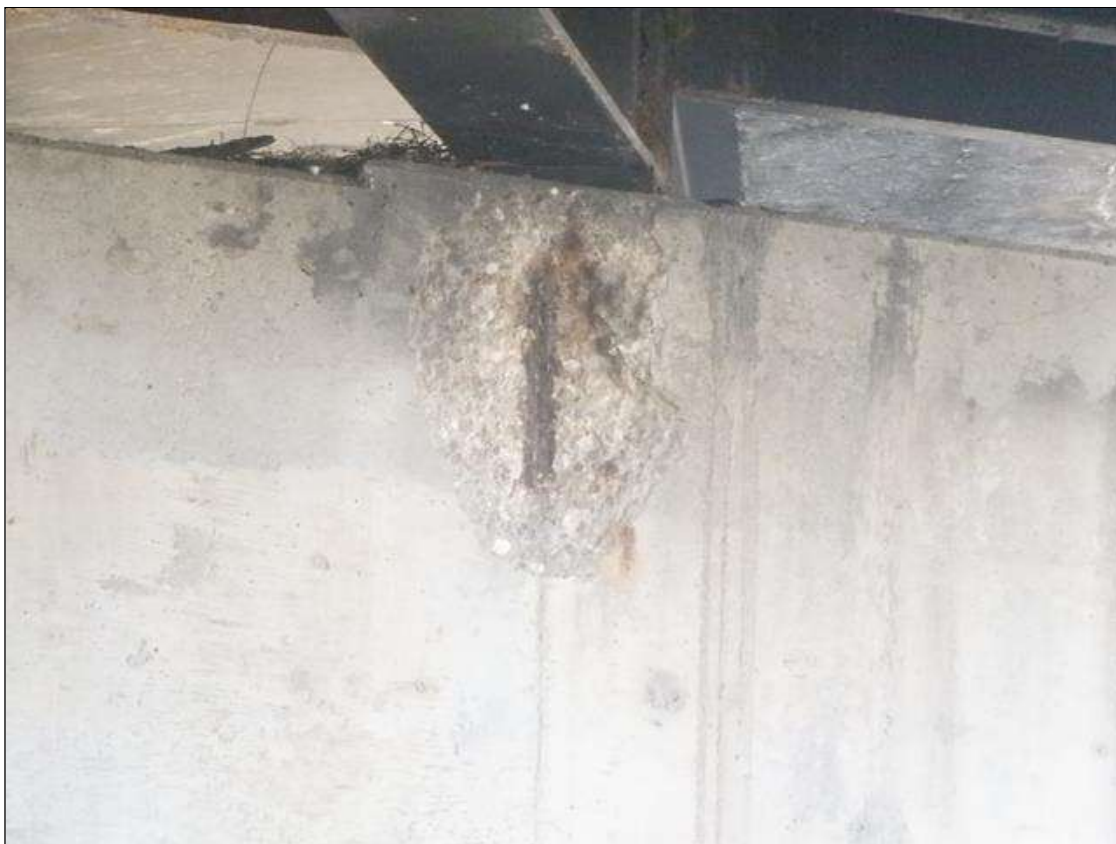
Bent 1 Cap 1: (PAR) SOUTH FACE BELOW BEAM 6, 18 INCHES X UP TO 24 INCHES X 2 INCHES DEEP SPALL WITH EXPOSED REBAR WITH 10 PERCENT SECTION LOSS

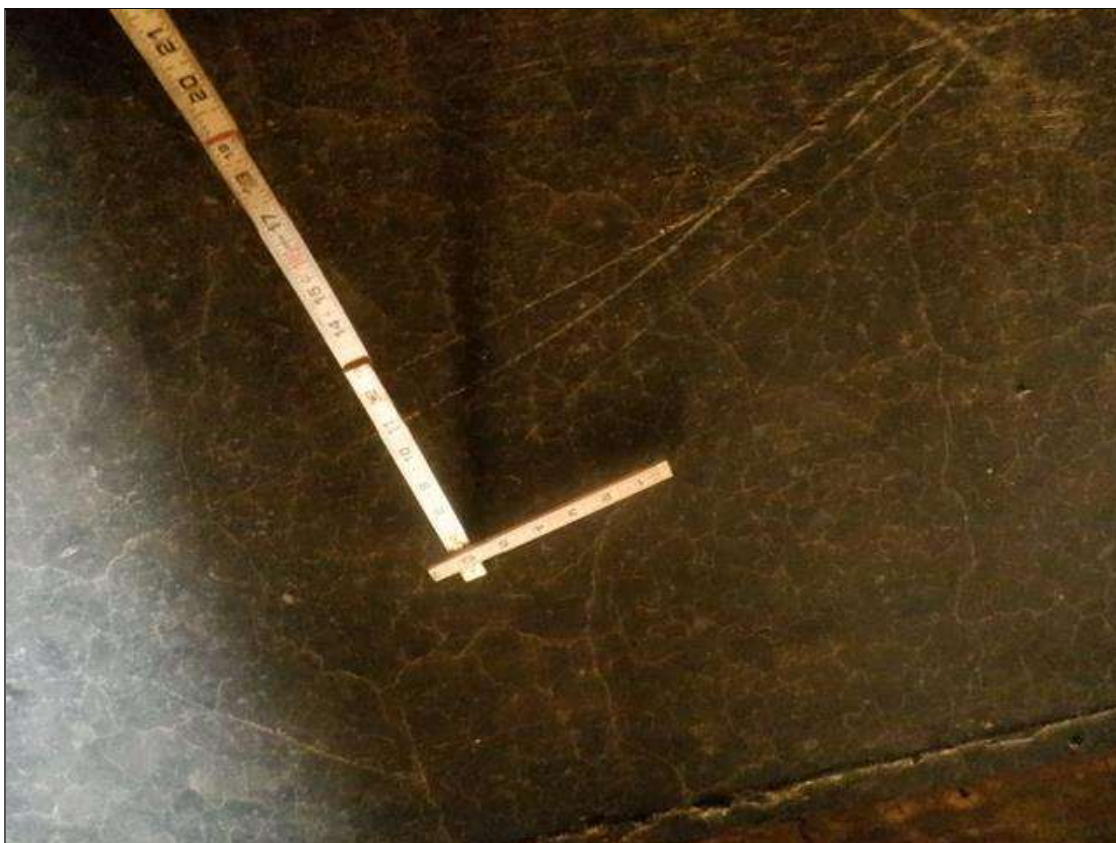
Span 1 Deck: DECK UNDERSIDE THROUGHOUT AREAS OF MAP CRACKING UP TO 1/64 INCHES

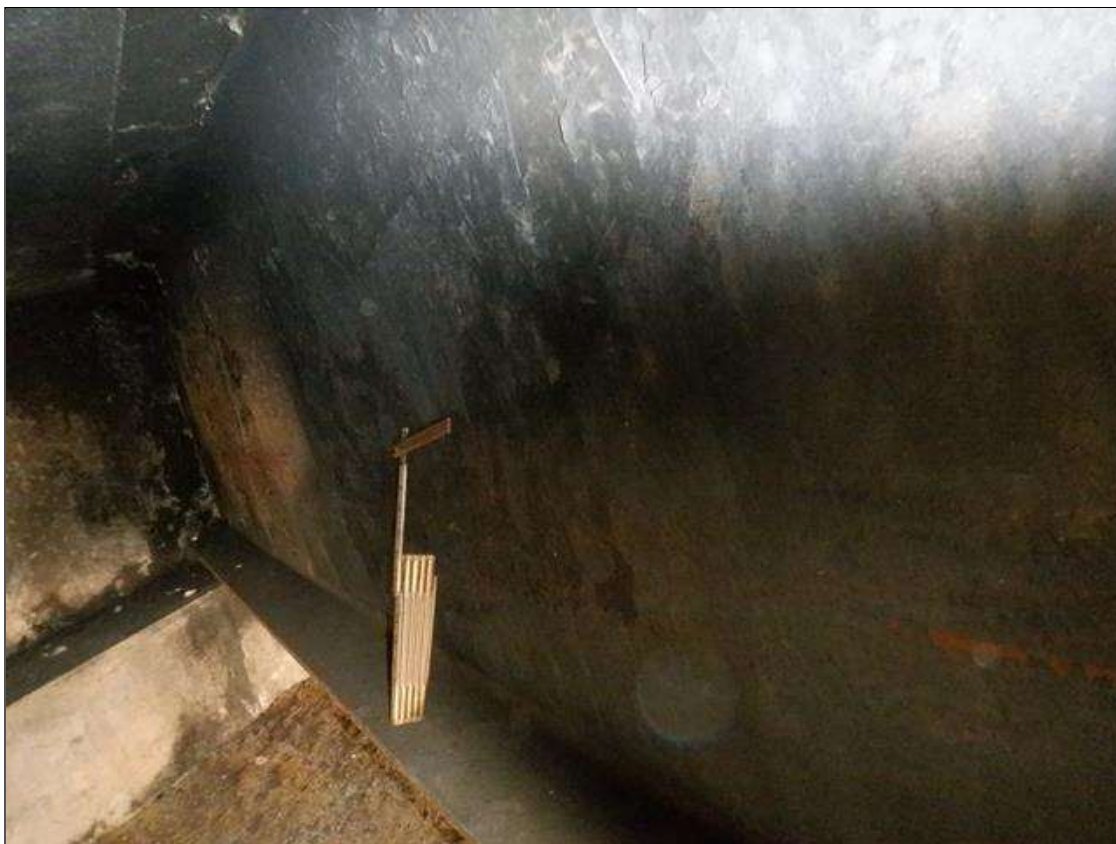
Span 1 Beam 2: 5 FEET OF BEAM / FIRE DAMAGE, 1/4 INCHES EASTWARD BULGING IN THE WEB 2 FEET FROM END BENT 1.

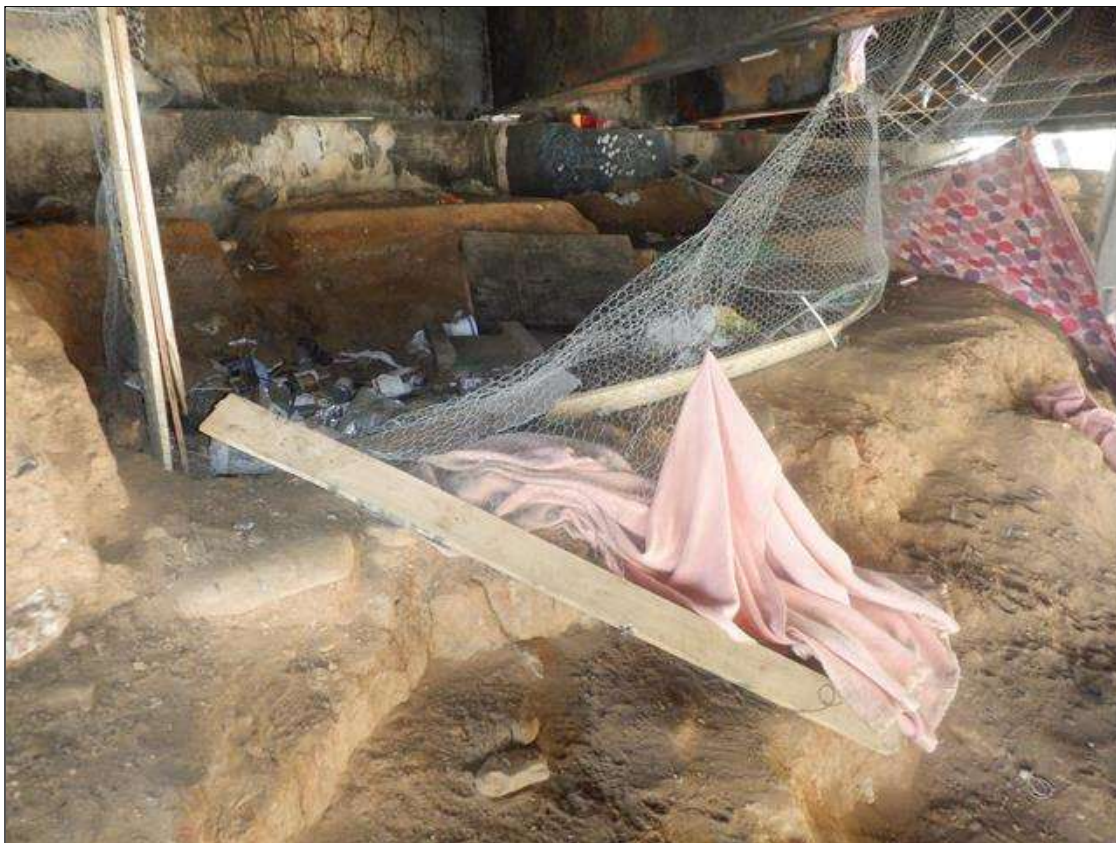
General Comments: AT BOTH END BENTS, EVIDENCE OF ACTIVE VAGRANCY

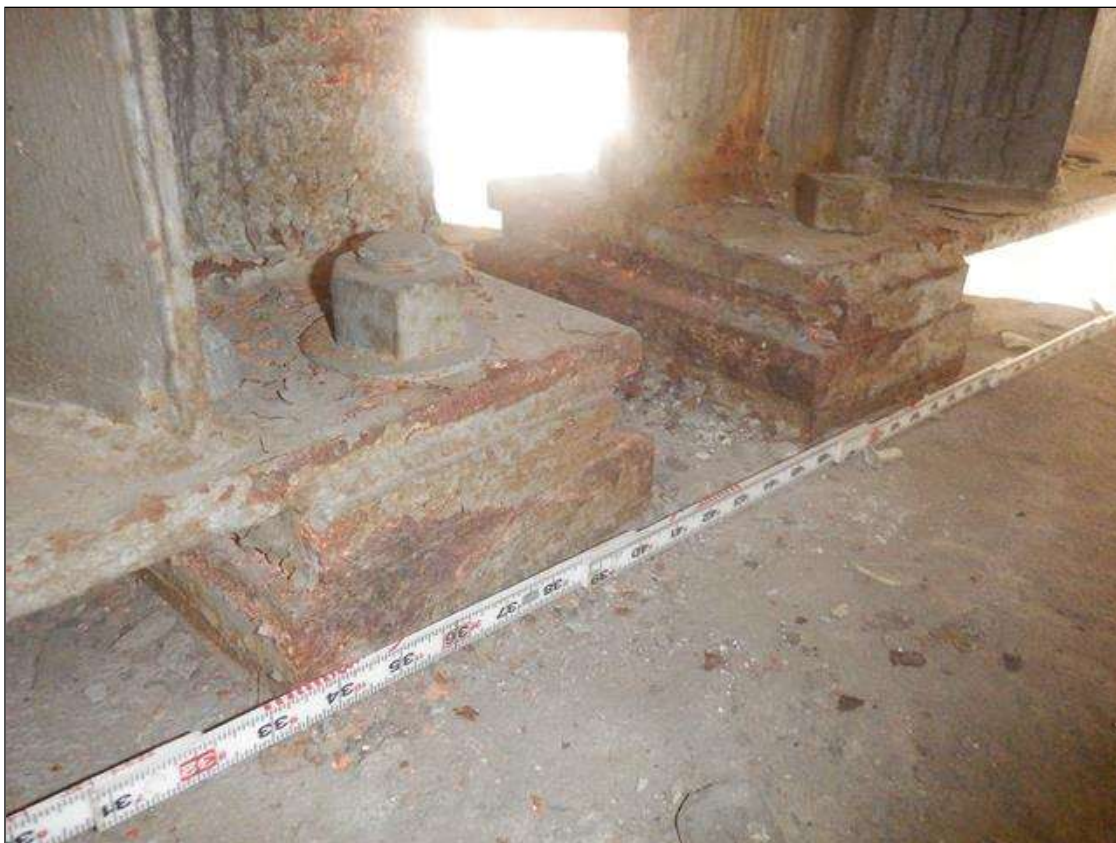
Span 3 Near Bearing: SURFACE CORROSION THROUGHOUT BEARING

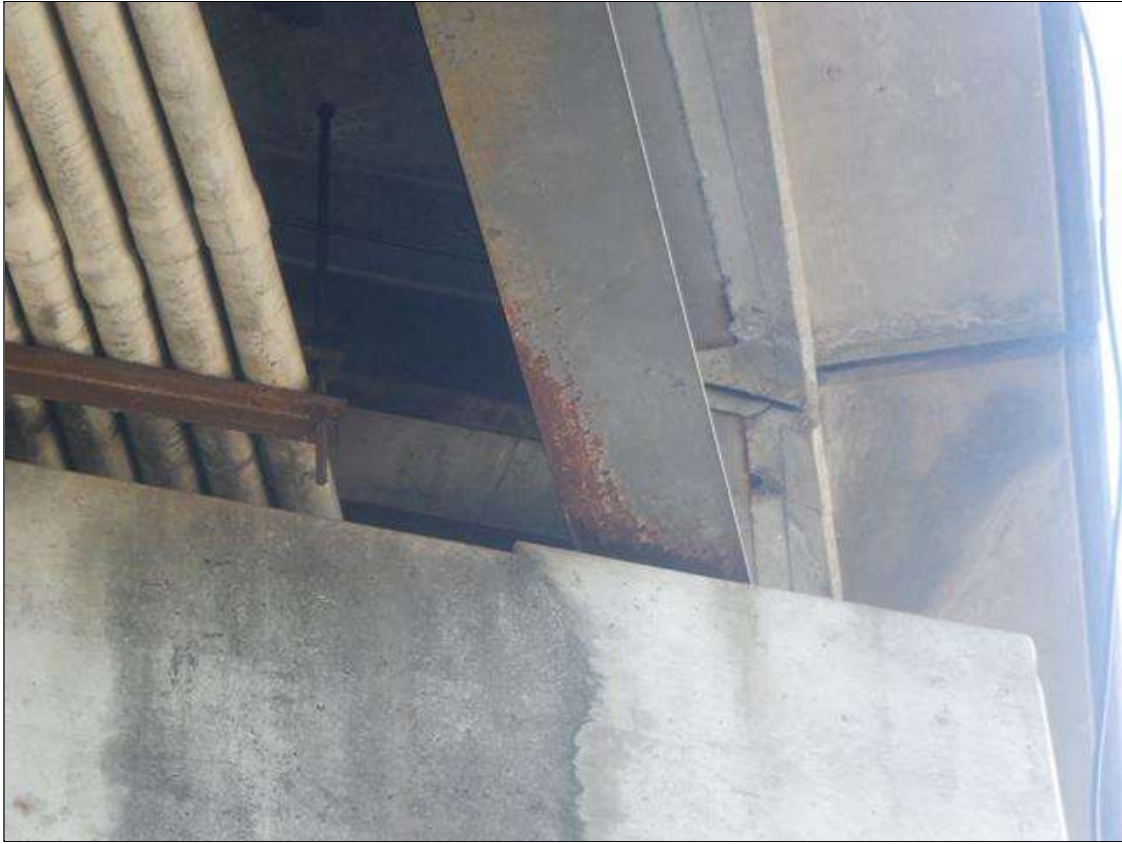
Span 2 Beam 8: AT BENT 1, 1 FEET LIGHT SCALING BOTTOM FLANGE AND UP TO 24 INCHES IN THE WEB

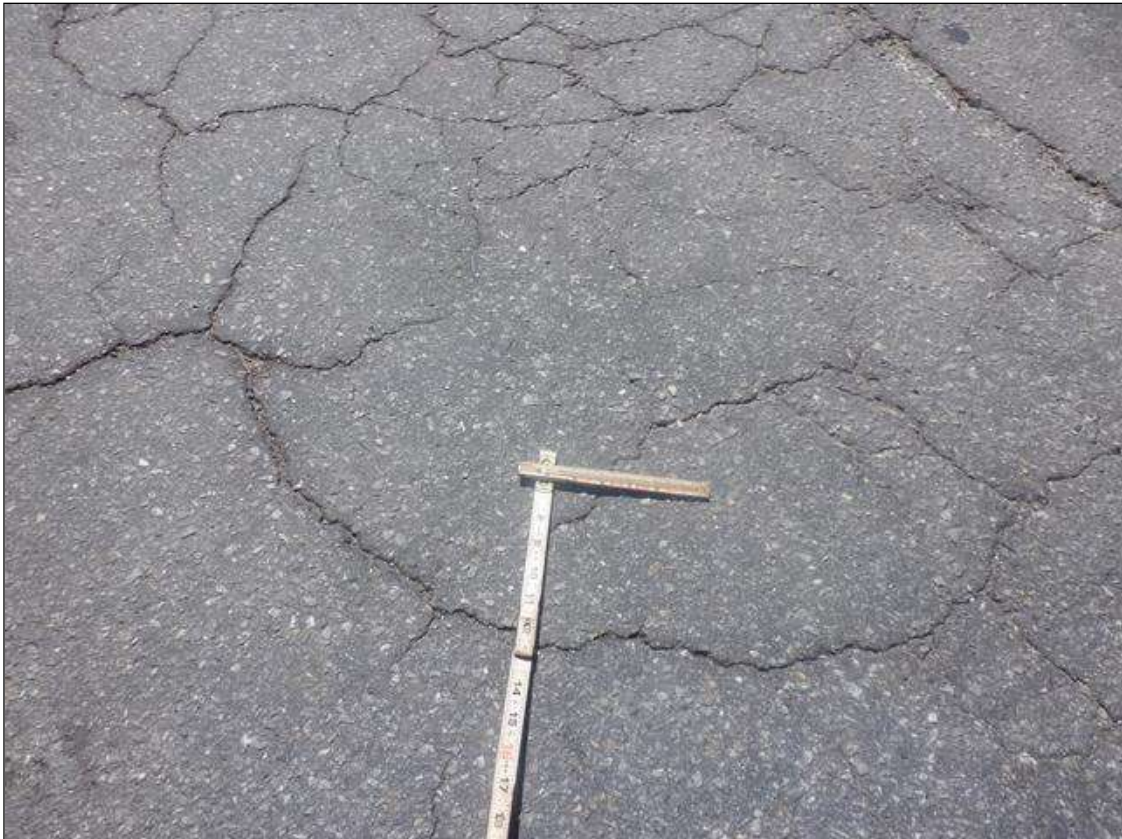
Span 2 Wearing Surface: THROUGHOUT NORTHBOUND LANES, MAP CRACKING UP TO 1/8 INCHES WIDE

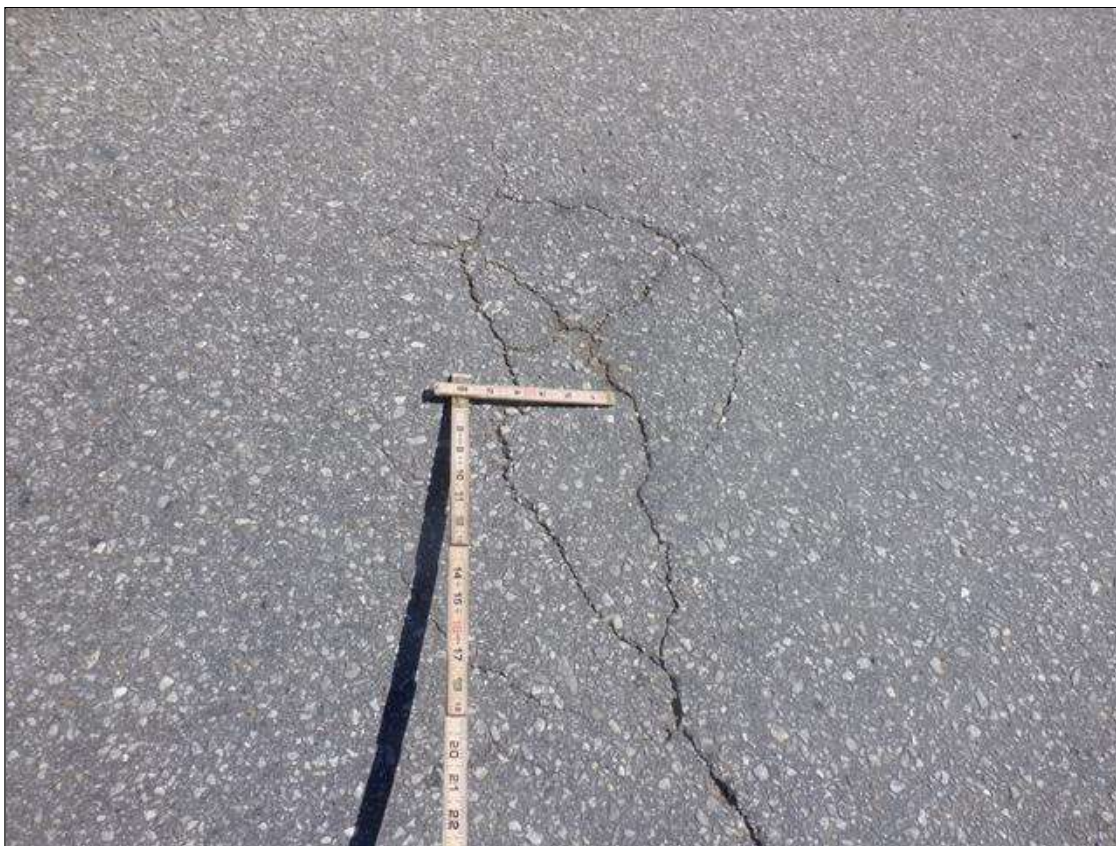
Span 2 Wearing Surface: THROUGHOUT SOUTHBOUND LANES, MAP CRACKING UP TO 1/8 INCHES WIDE SCATTERED THROUGHOUT

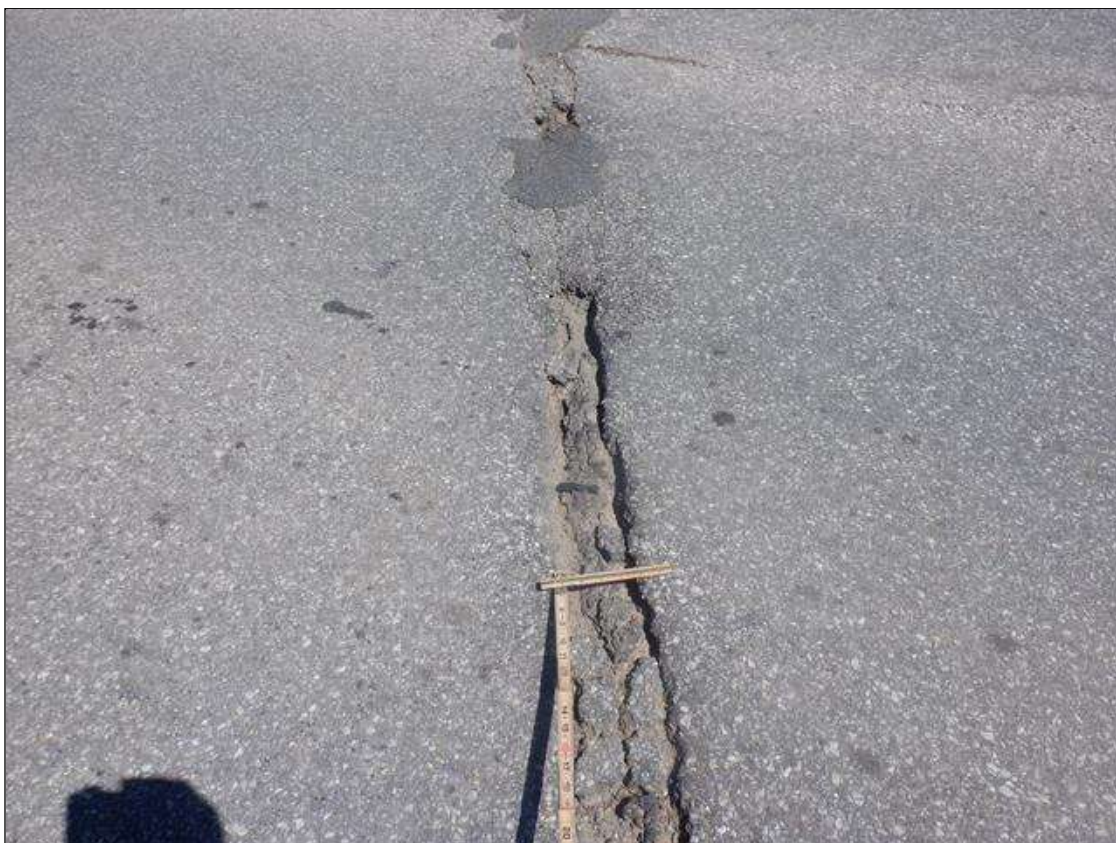
Span 2 Wearing Surface: AT BENT 1, MULTIPLE POTHOLES UP TO 3 FEET LONG X 4 INCHES WIDE X 2 INCHES DEEP

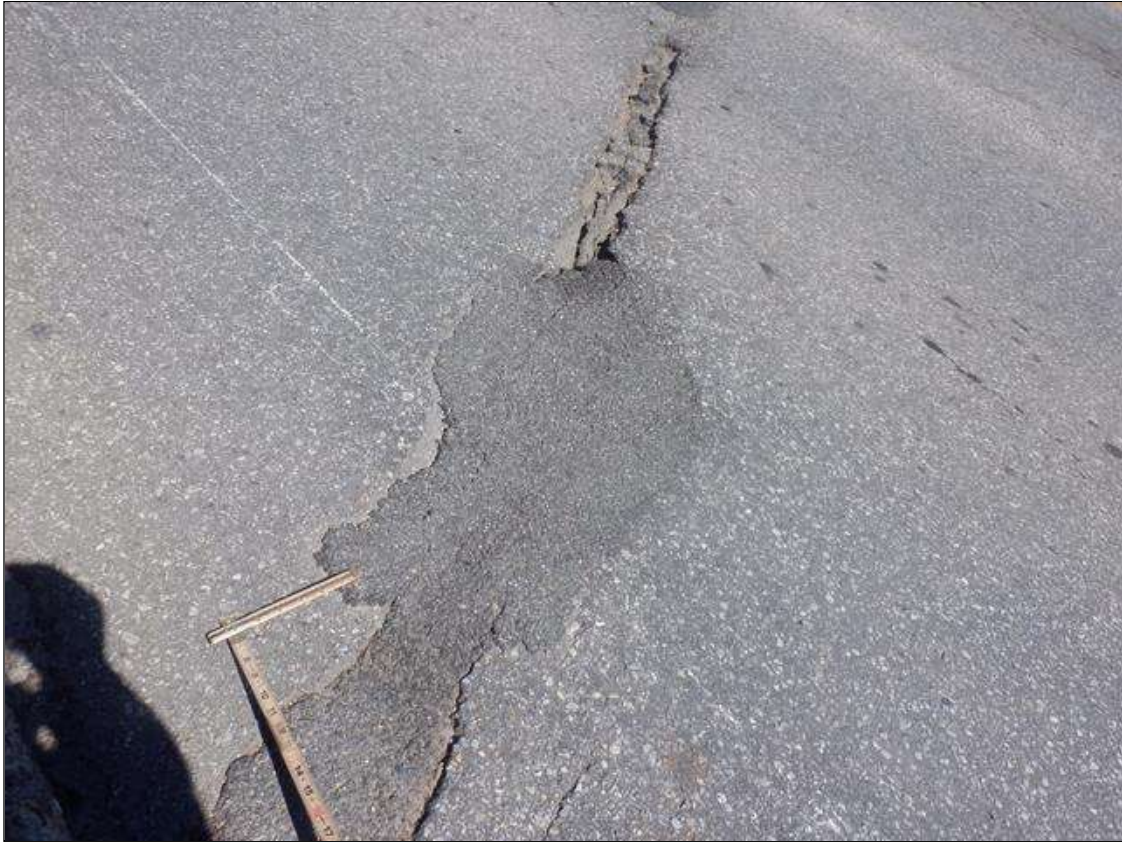
Span 2 Wearing Surface: AT BENT 1, 15 SQUARE FEET OF SOUND PATCHES SCATTERED THROUGHOUT

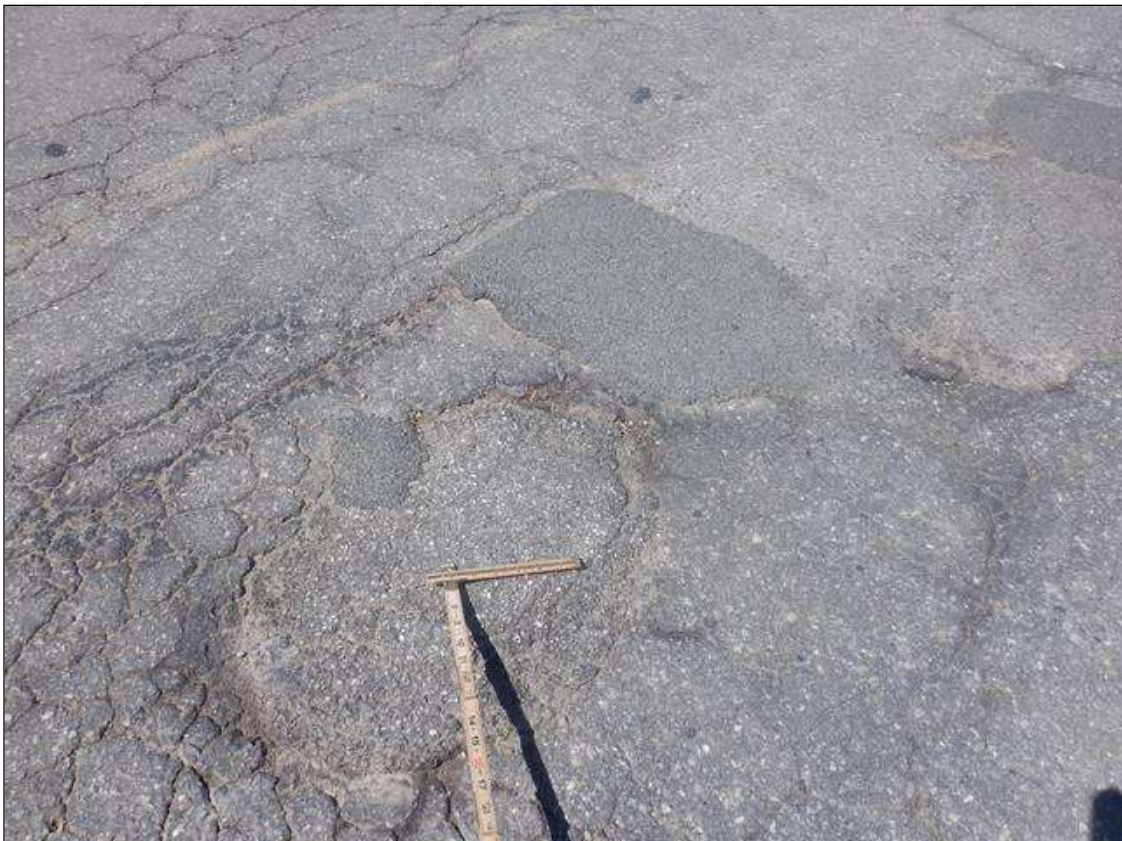
Span 2 Wearing Surface: BETWEEN NORTHBOUND LANES, 20 FEET FROM BENT 2, MULTIPLE SCATTERED SOUND PATCHES UP TO 3 FEET DIAMETER

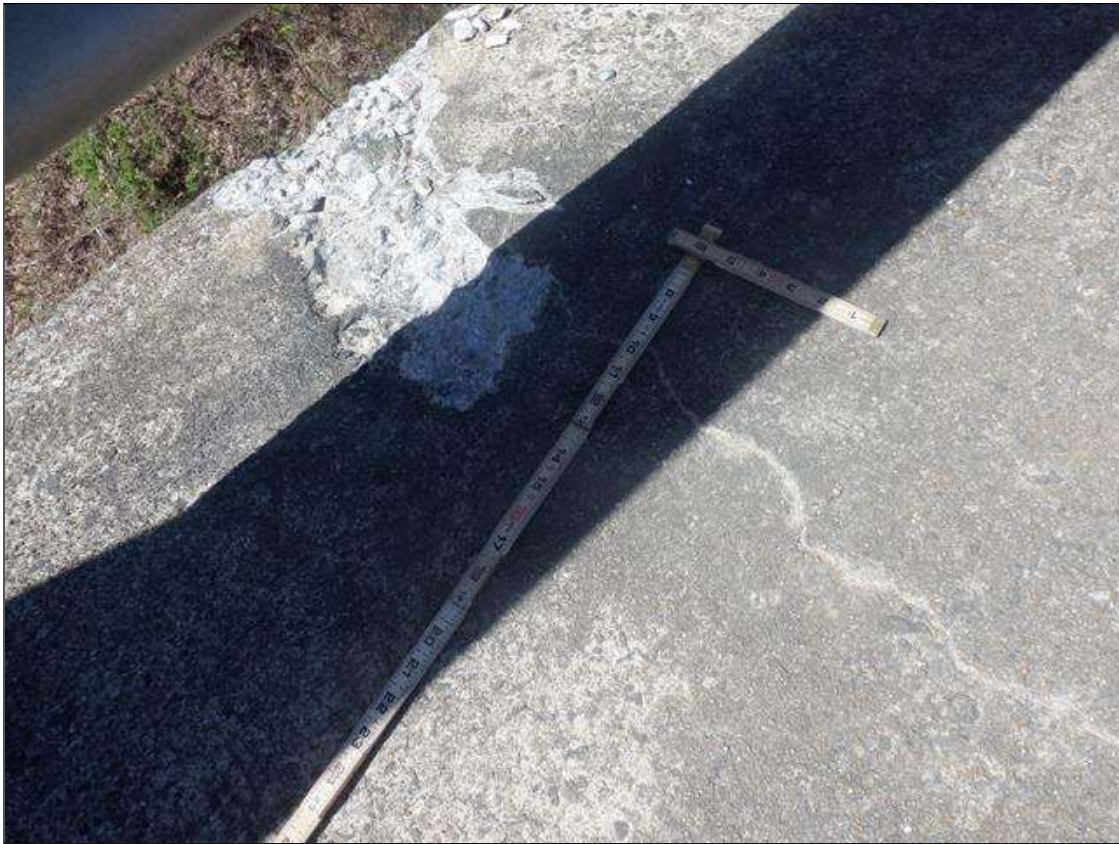
Span 2 Left Bridge Rail: SIDEWALK NEAR MID SPAN, HAIRLINE TRANSVERSE CRACK WITH ADJACENT SPALL (18 INCHES X 7 INCHES X 3/4 INCHES DEEP)

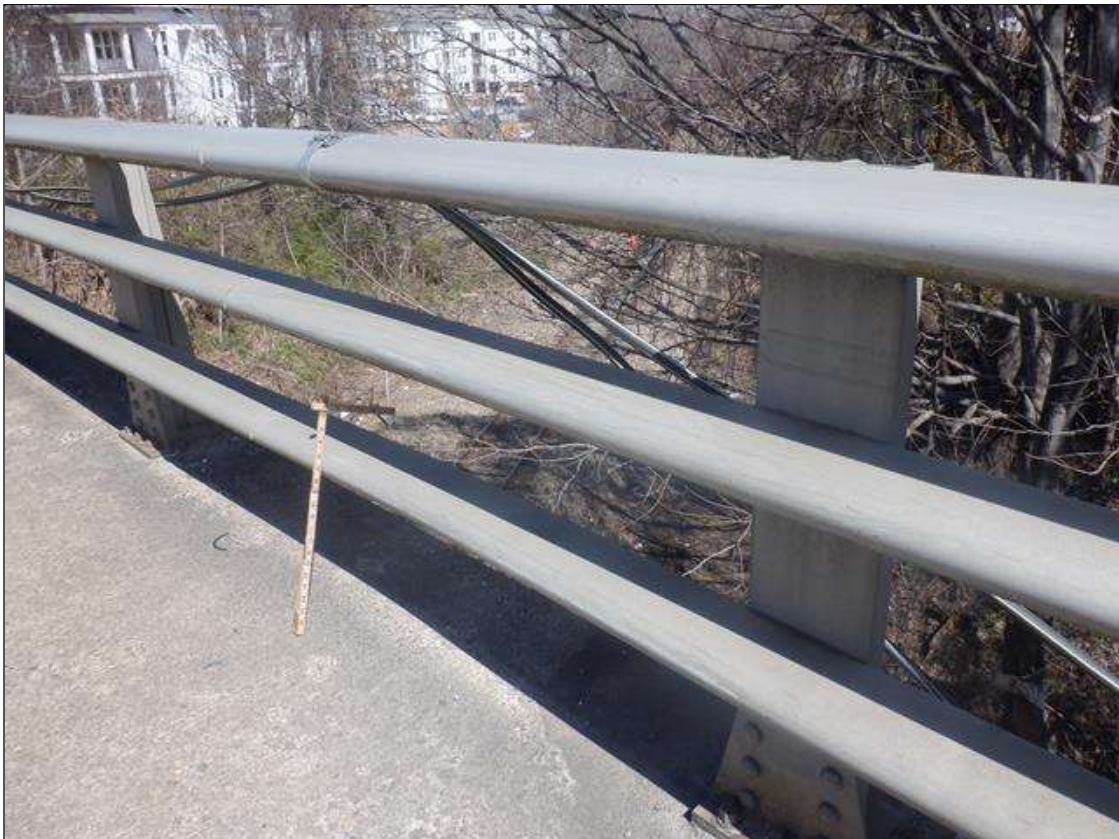
Span 2 Right Bridge Rail: STARTING AT BENT 1, VEHICULAR IMPACT DAMAGE (4 FEET LONG X 2 INCH DEFLECTION)

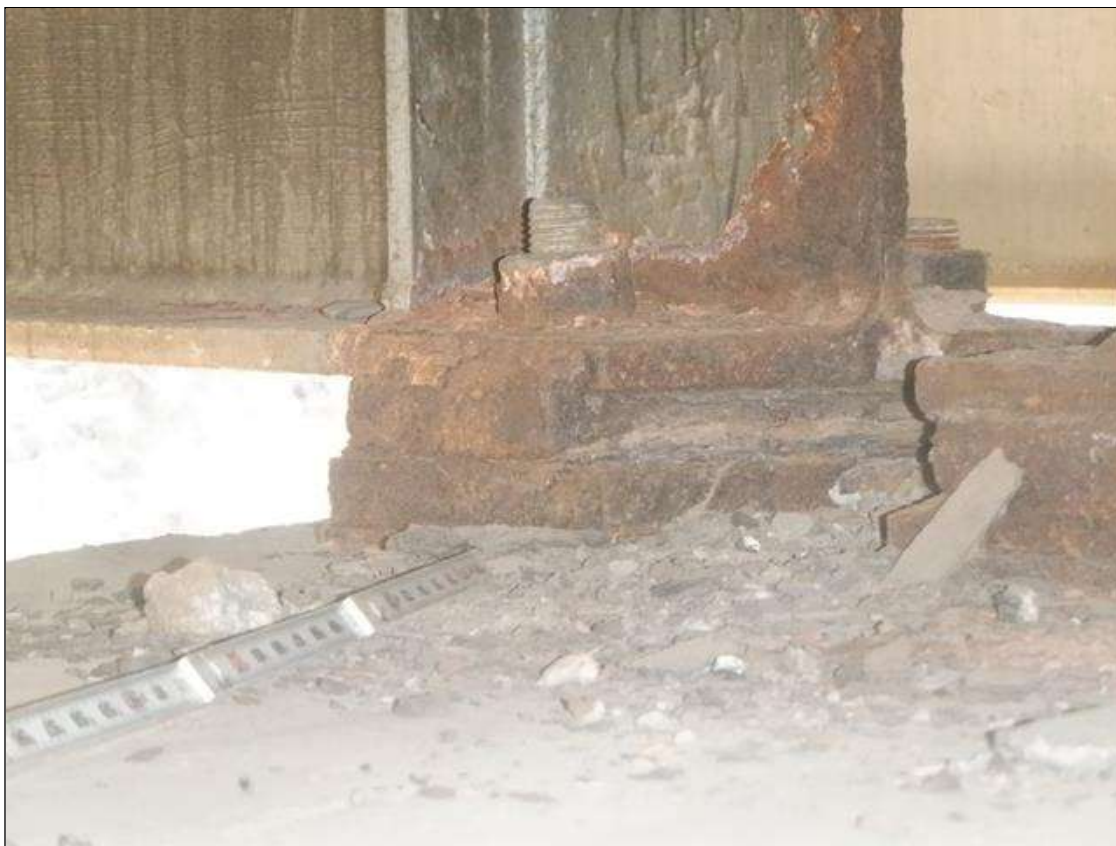
Span 2 Beam 2 - Far Bearing: CORROSION WITH ONSET OF SECTION LOSS

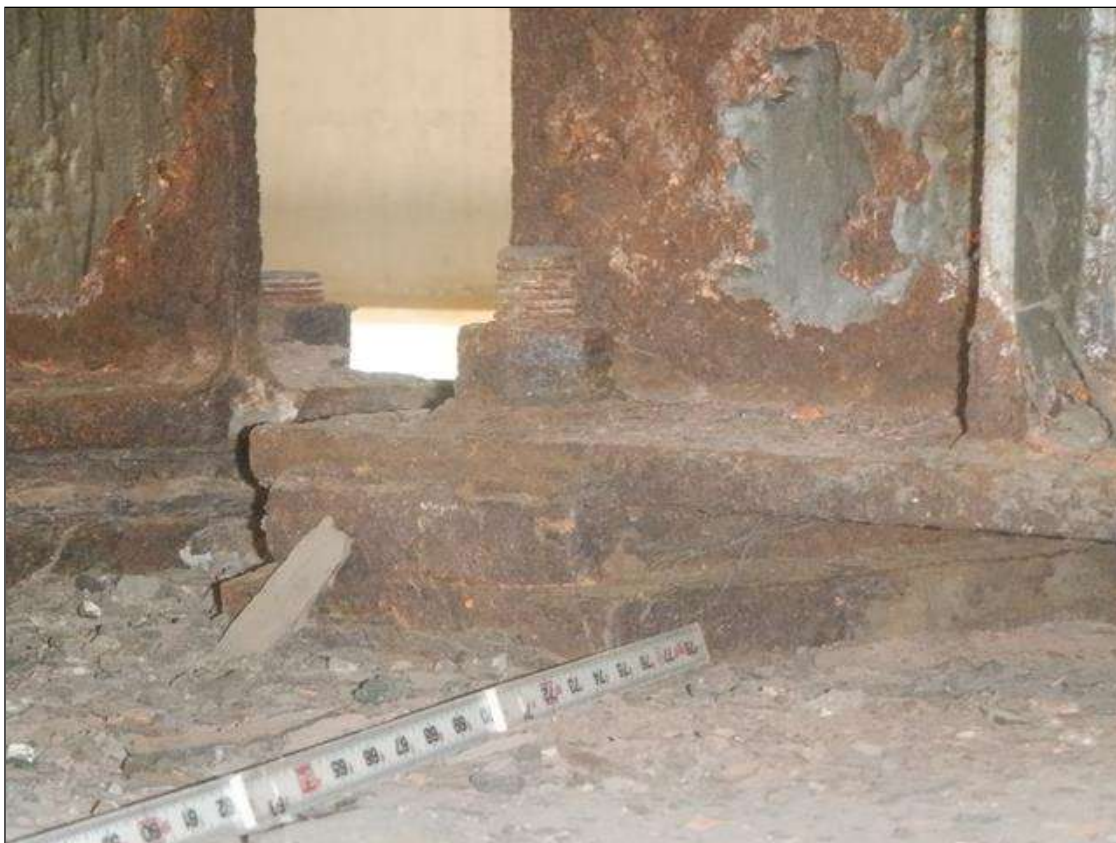
Span 3 Near Bearing: CORROSION WITH ONSET OF SECTION LOSS

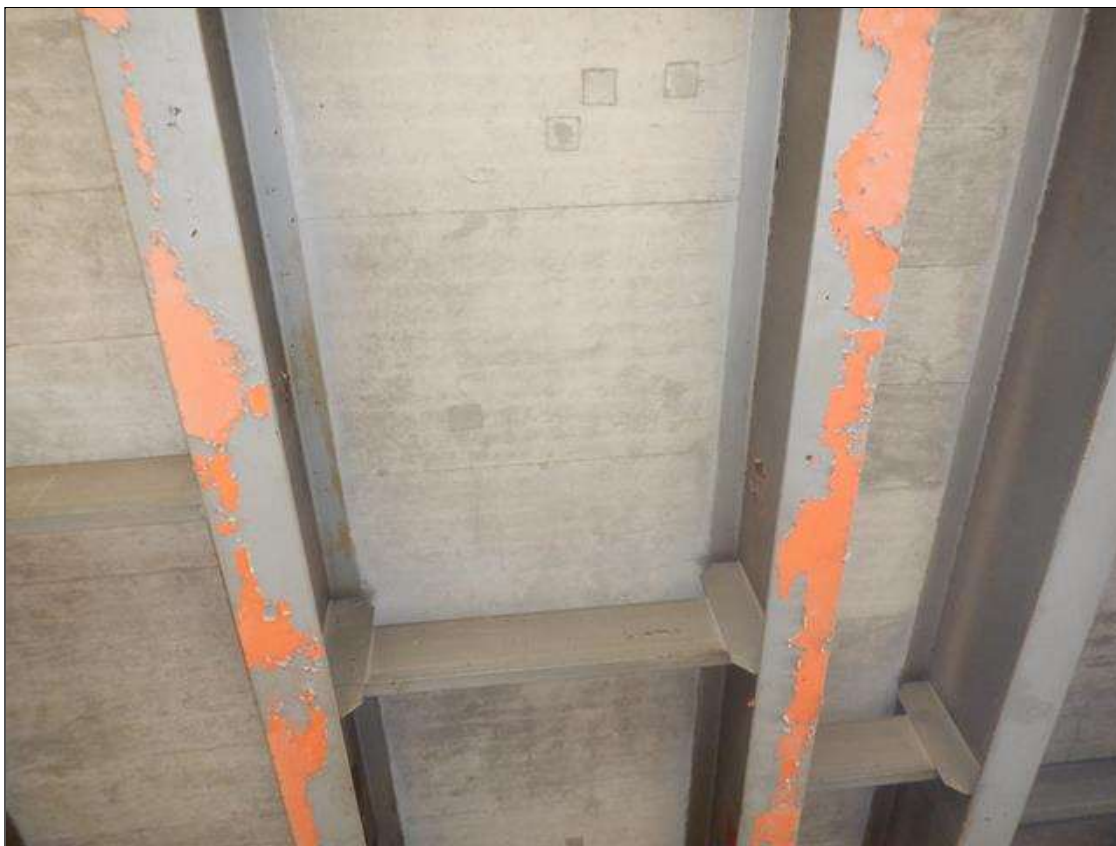
Span 3 Beam 4 - Protective System: PEELING FINISH COAT ALONG LENGTH OF BOTTOM FLANGE

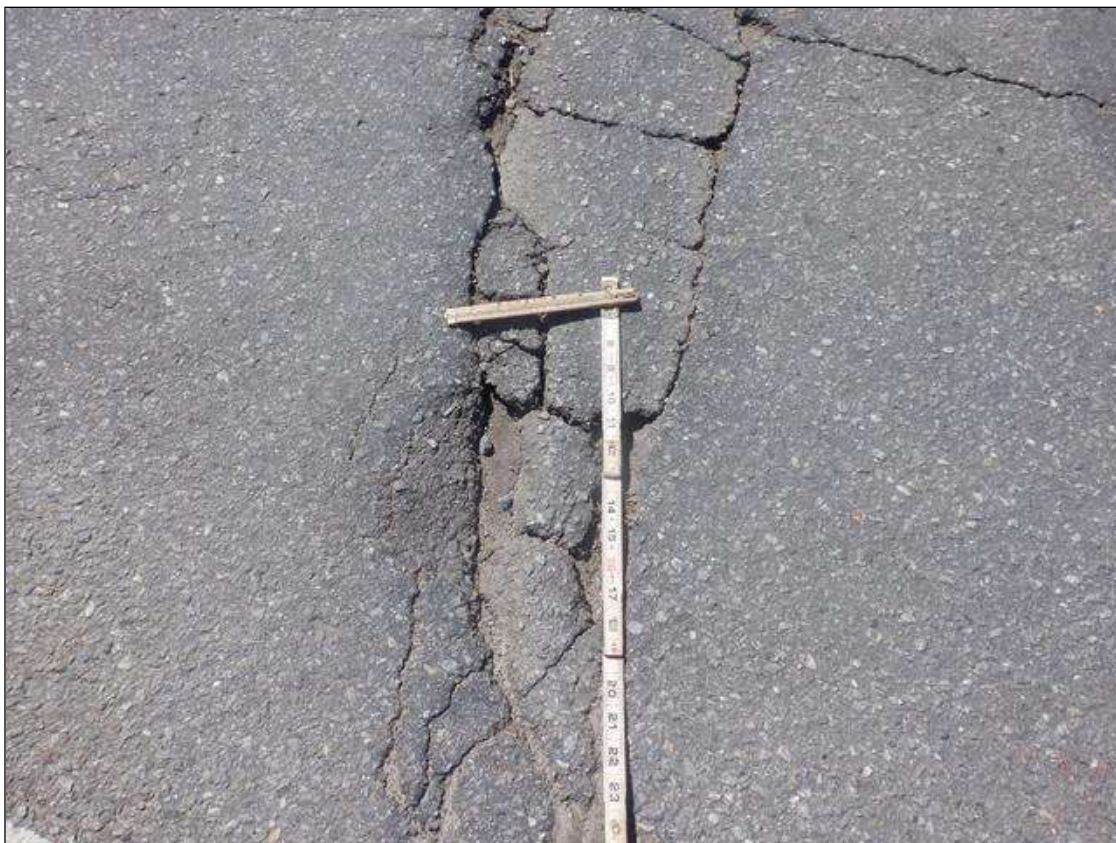
Span 3 Wearing Surface: AT END BENT 2, FULL LENGTH CRACK UP TO 1 INCHES WIDE WITH AREAS OF BROKEN AND MISSING ASPHALT

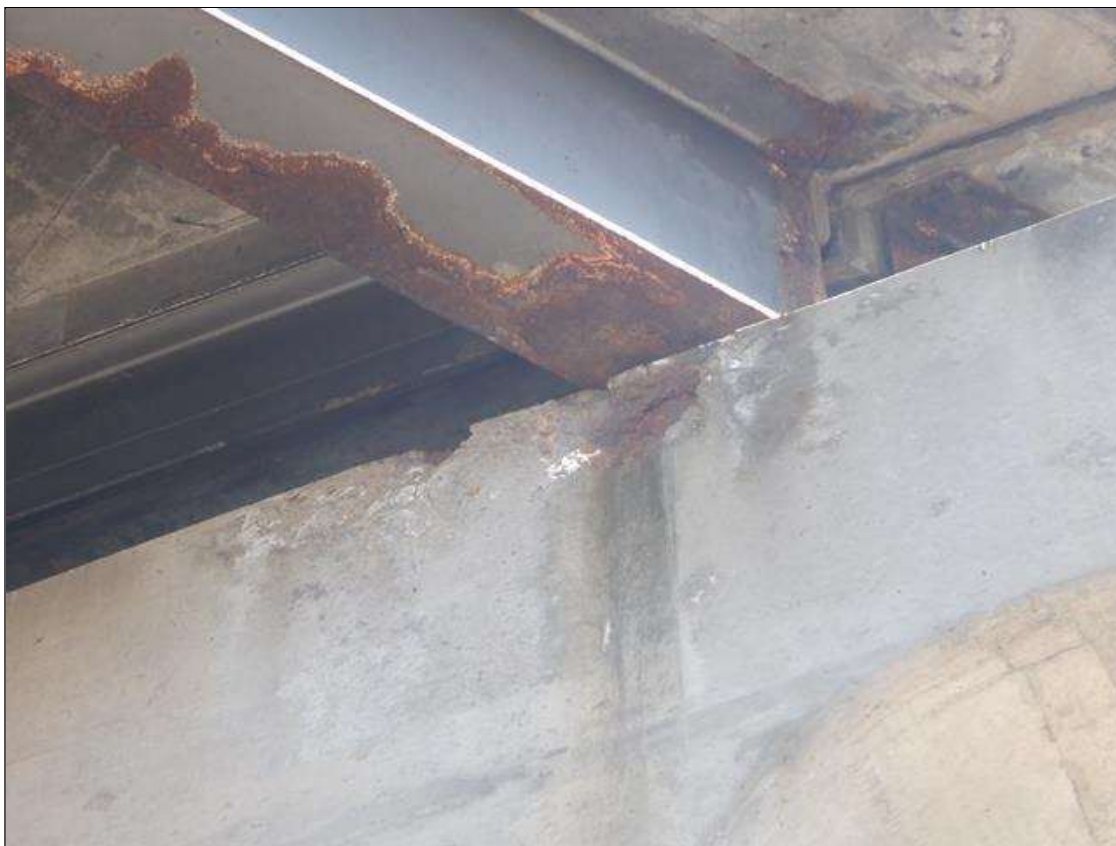
Bent 1 Cap 1: NORTH FACE AT TOP OF CAP AT BEAMS 1 AND 5, (2) UP TO 12 INCHES X 6 INCHES X 1 INCHES DEEP SPALLS
