NC DEPARTMENT OF TRANSPORTATION
 DIVISION OF HIGHWAYS
 STRUCTURE MANAGEMENT UNIT

ATTENTION: PARS SUBMITTED, CHANGE TO VERTICAL CLEARANCE

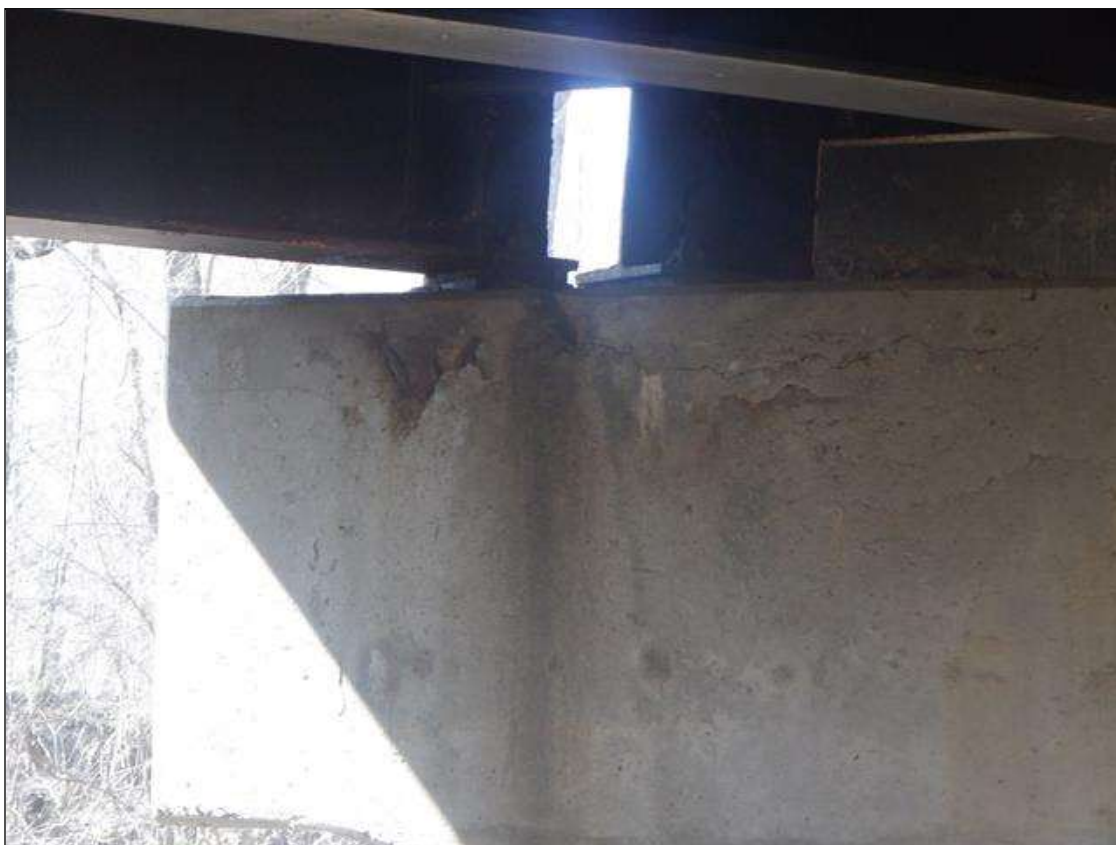
Bent 1 Cap 1: SOUTH FACE BELOW BEAM 1, 12 INCHES X UP TO 12 INCHES X 3/4 INCHES SPALL WITH EXPOSED REBAR. NO SECTION LOSS

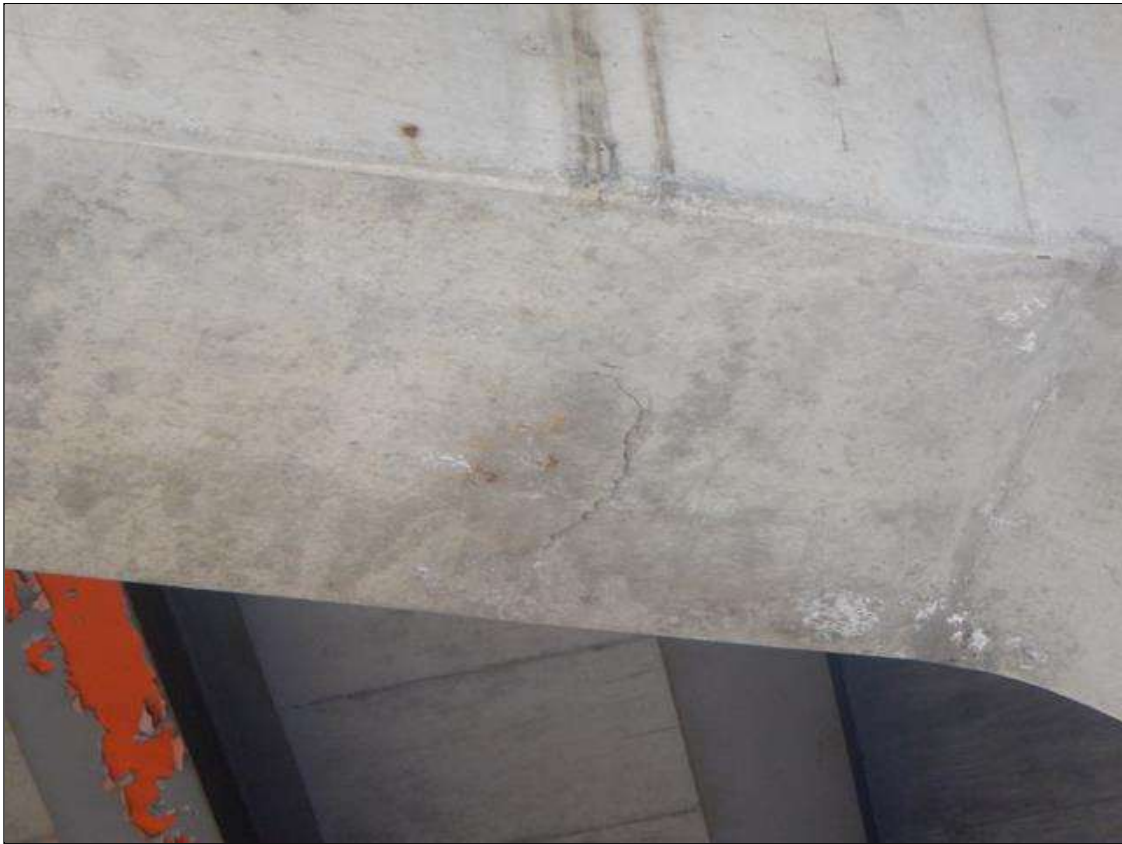
Bent 2 Cap 1: SOFFIT BETWEEN PILES 2 AND 3, 9 INCHES LONG DELAMINATION (SIMILAR BETWEEN PILE 1 AND PILE 2)

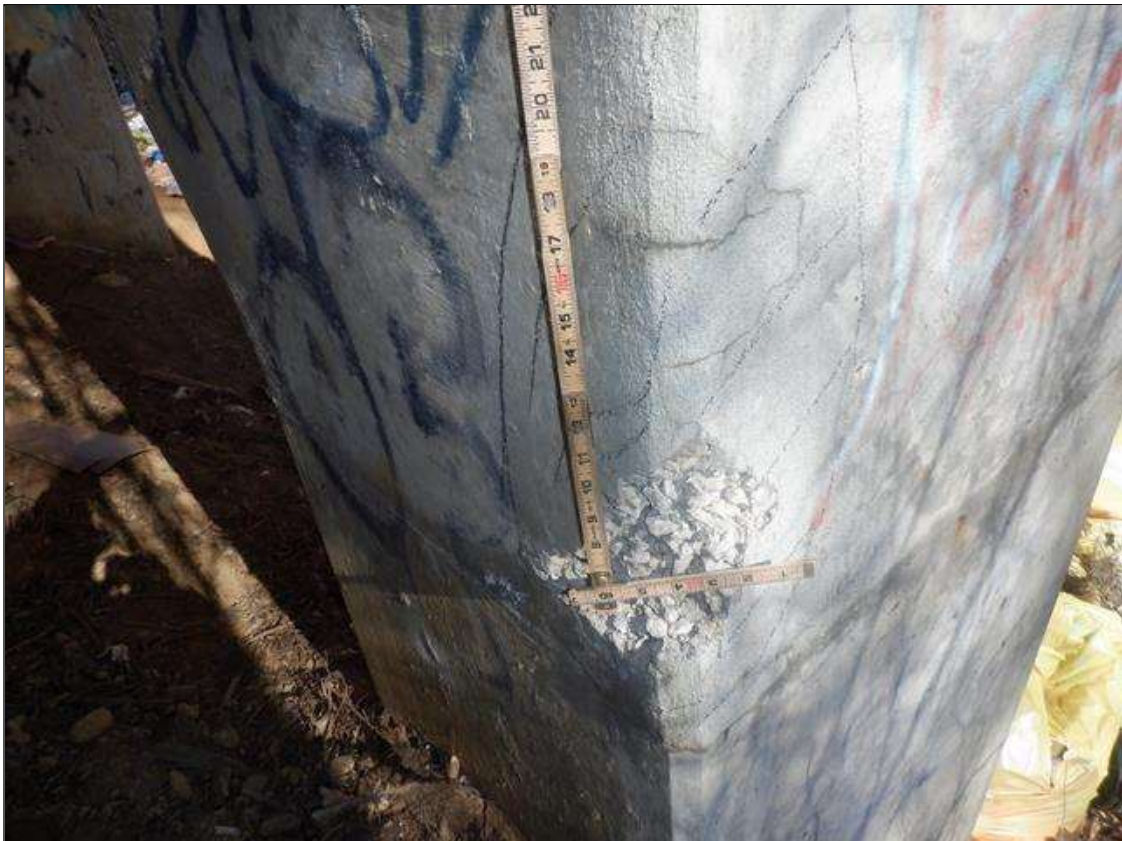
Bent 2 Pile 1: NORTHWEST CORNER, 3 FEET FROM GROUND, UNSOUND PATCH (2 FEET X 1 FEET) WITH ASSOCIATED SPALL (7 INCH DIAMETER X 2 INCH DEEP) NO EXPOSED REINFORCING

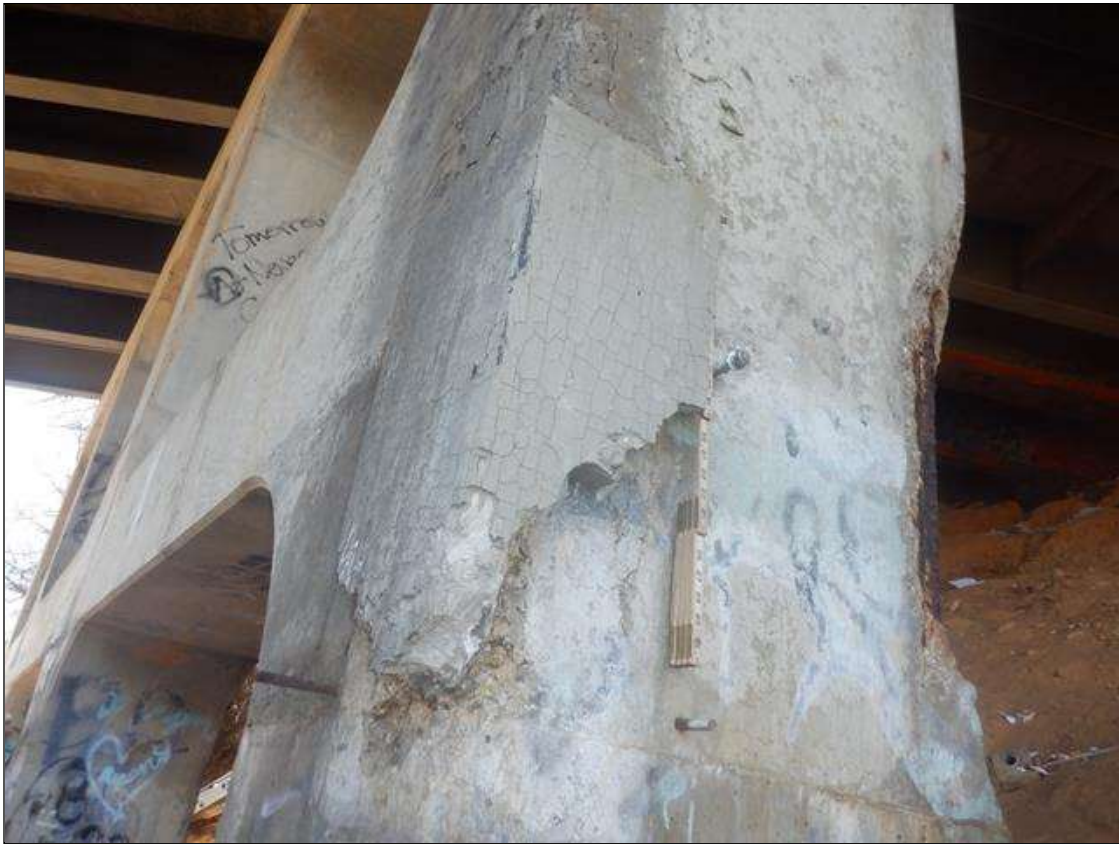
Bent 2 Pile 4: 13 FEET FROM BOTOM OF CAP AT SOUTHEAST CORNER, 2.25 FEET X 1 FEET X 2 INCHES DEEP UNSOUND CONCRETE. SPALL BENEATH PATCH WITH ASSOCIATED DELAMINATION (4 FEET X 20 INCHES)

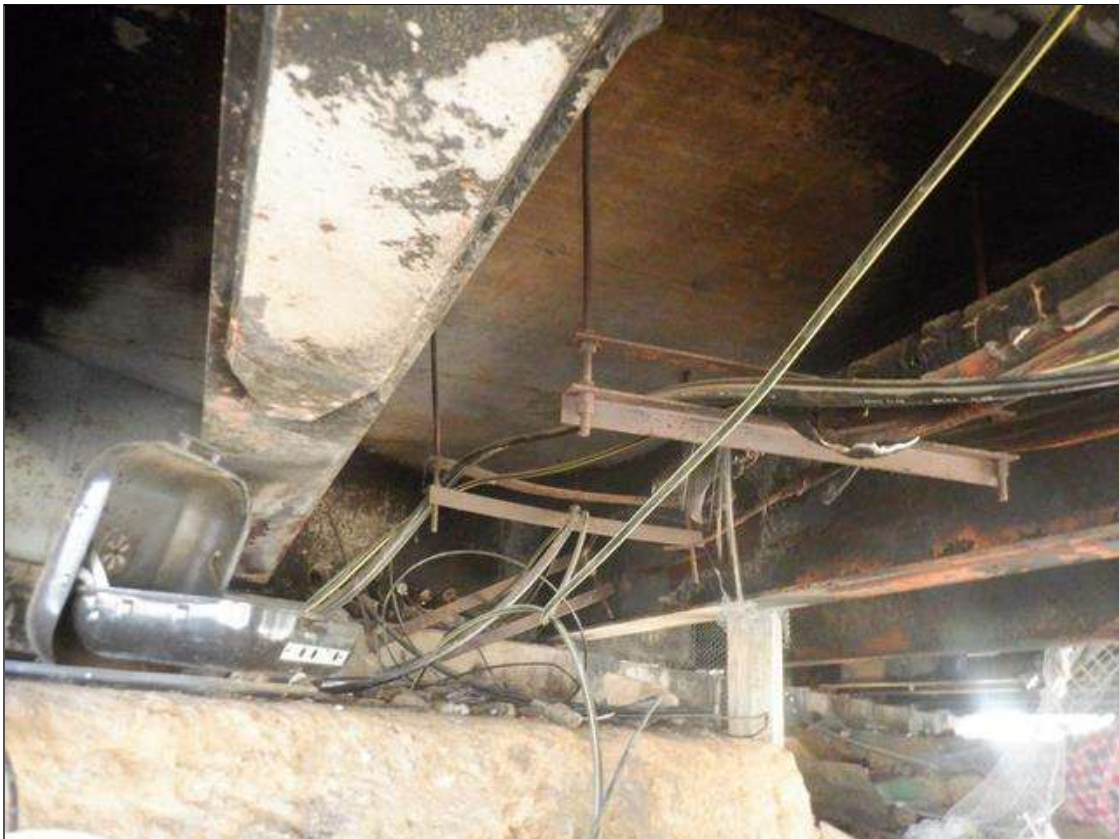
BAY 7 NINE (9) 4 INCH DIAMETER UTILITIES, BROKEN FROM FIRE DAMAGE

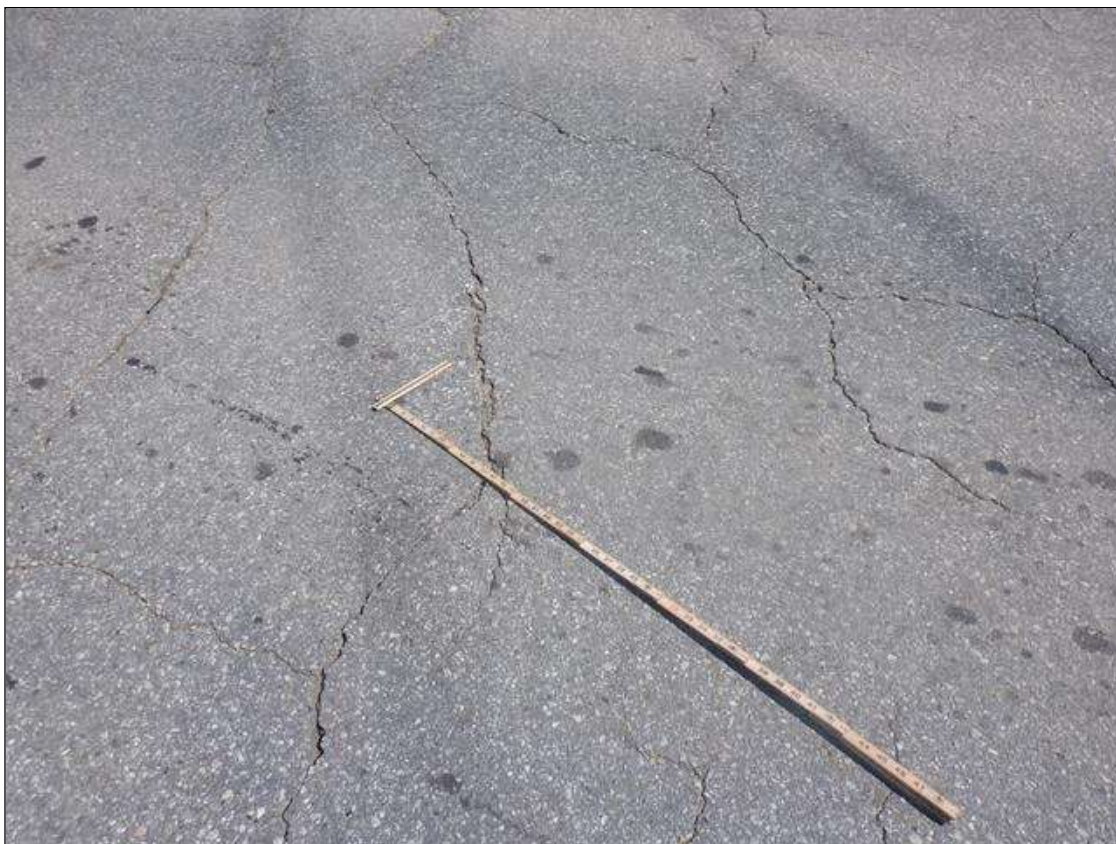
THROUGHOUT BOTH APPROACHES, MULTIPLE TRANSVERSE AND LONGITUDINAL CRACKS (8 FEET X UP TO 1/2 INCH) AND AREAS OF BROKEN AND MISSING ASPHALT

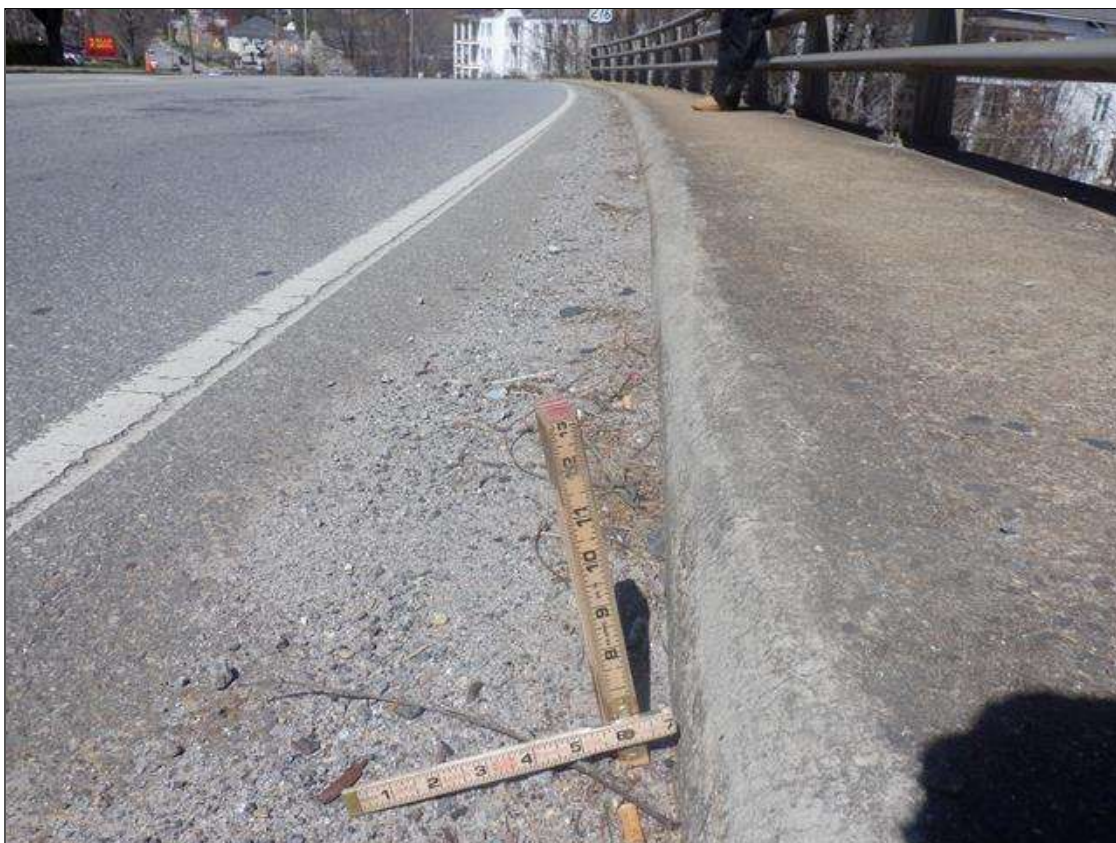
GRAVEL AND DEBRIS ALONG RIGHT CURB

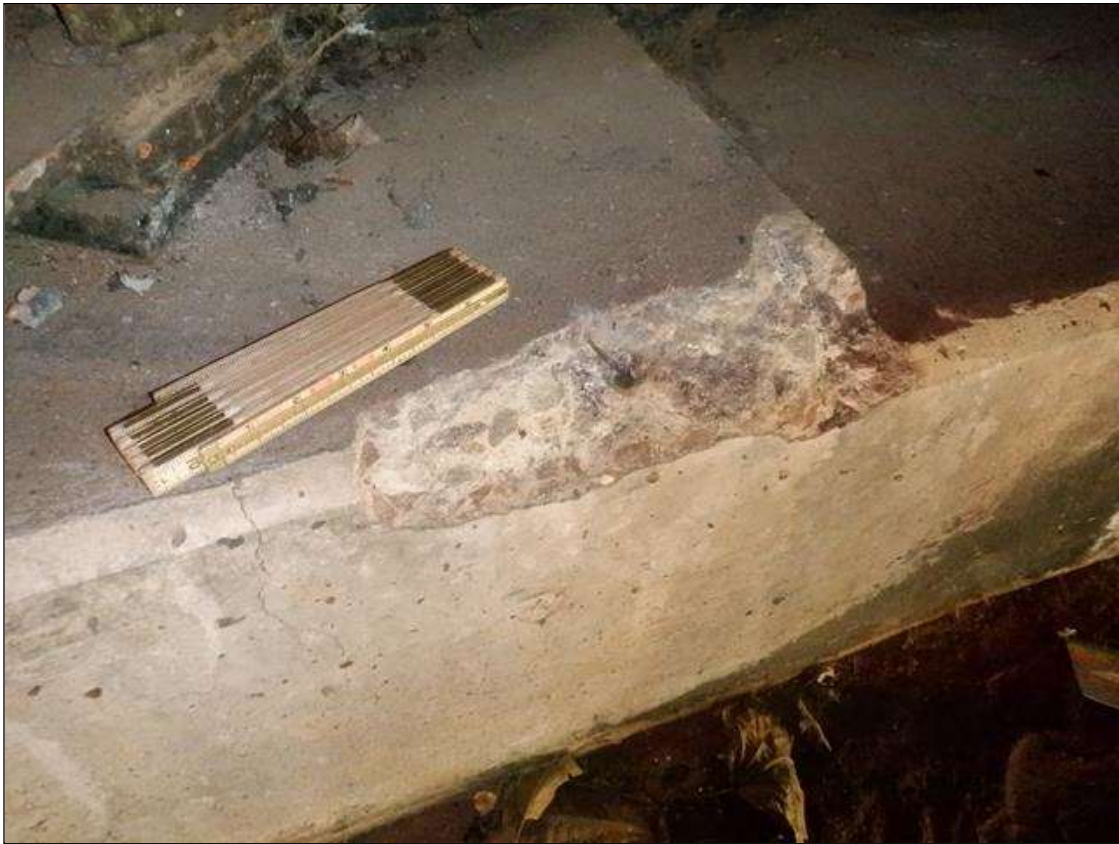
End Bent 1 Cap 1: TOP OF CAP AT STEP IN BAY 2, SPALL (13 INCHES X 4 INCHES X 1 INCH DEEP)

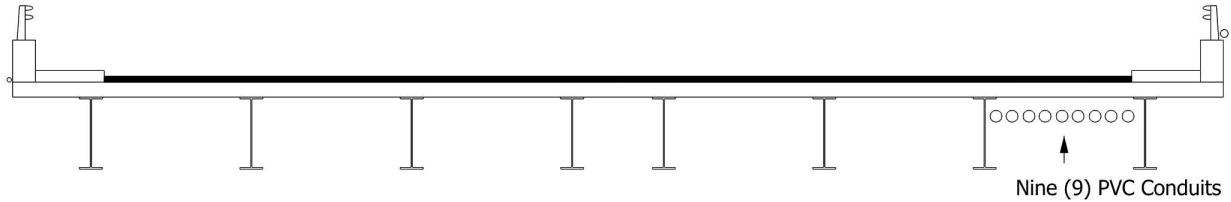
Measurements for Span #	3		
Deck Thickness	7.88in	Left Overhang	3.417ft
Top of Rail to Bottom of Beam (Avg)	7.67ft	Right Overhang	3.417ft

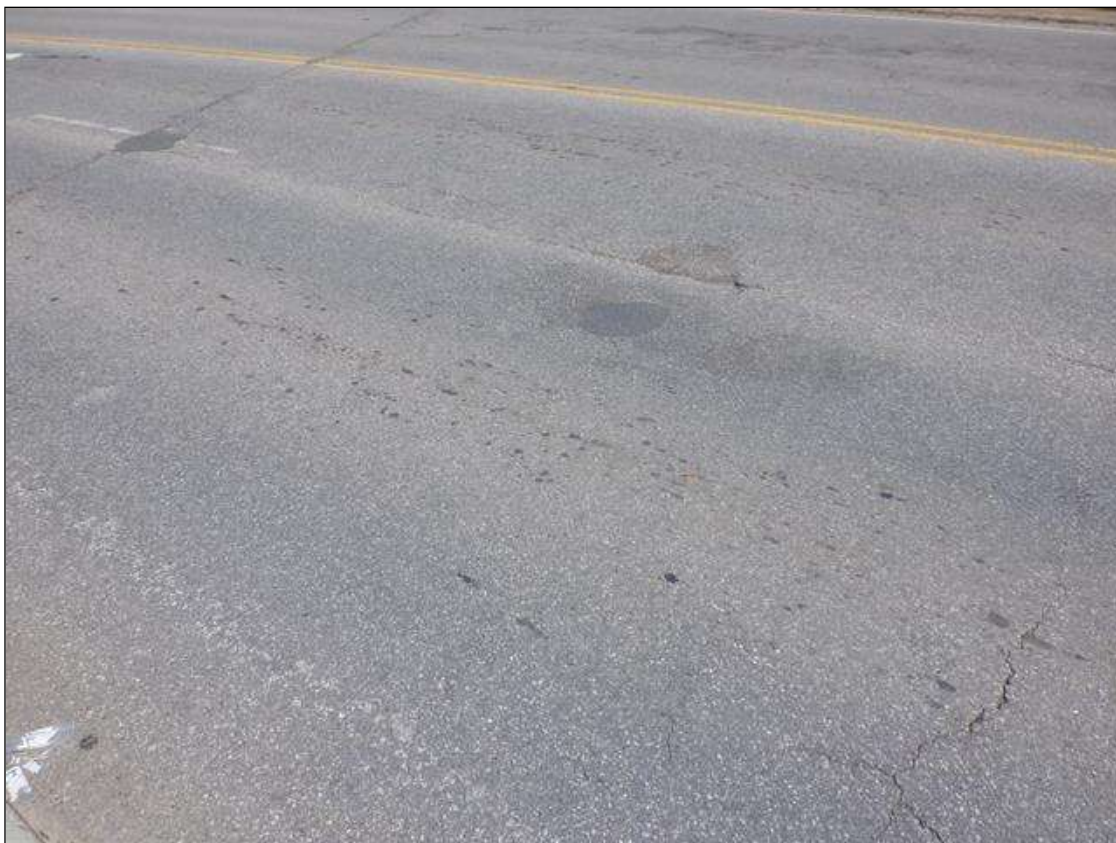
TYPICAL WEARING SURFACE

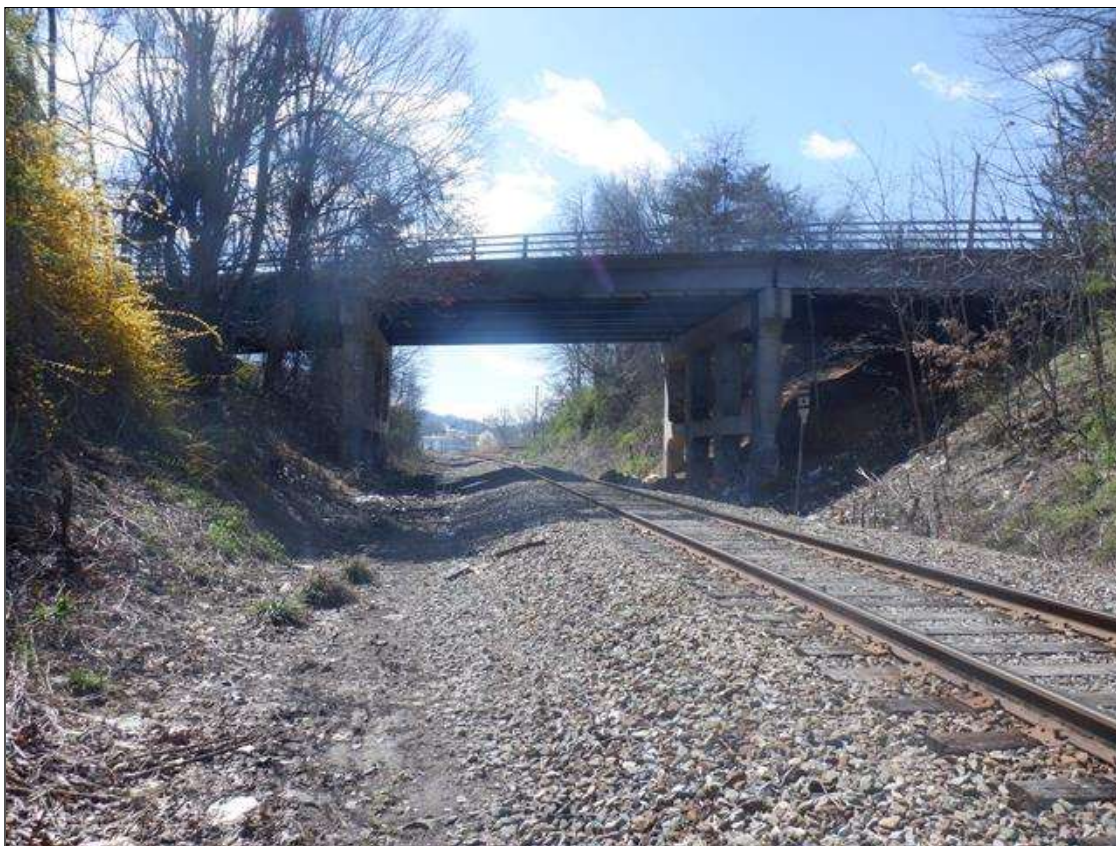
PROFILE LOOKING WEST
