NC DEPARTMENT OF TRANSPORTATION
 DIVISION OF HIGHWAYS
 STRUCTURE MANAGEMENT UNIT

ATTENTION: **PAR'S SUBMITTED FOR SPALLING WITH EXPOSED PRE-STRESSING AND CRACKING ON BEAMS**

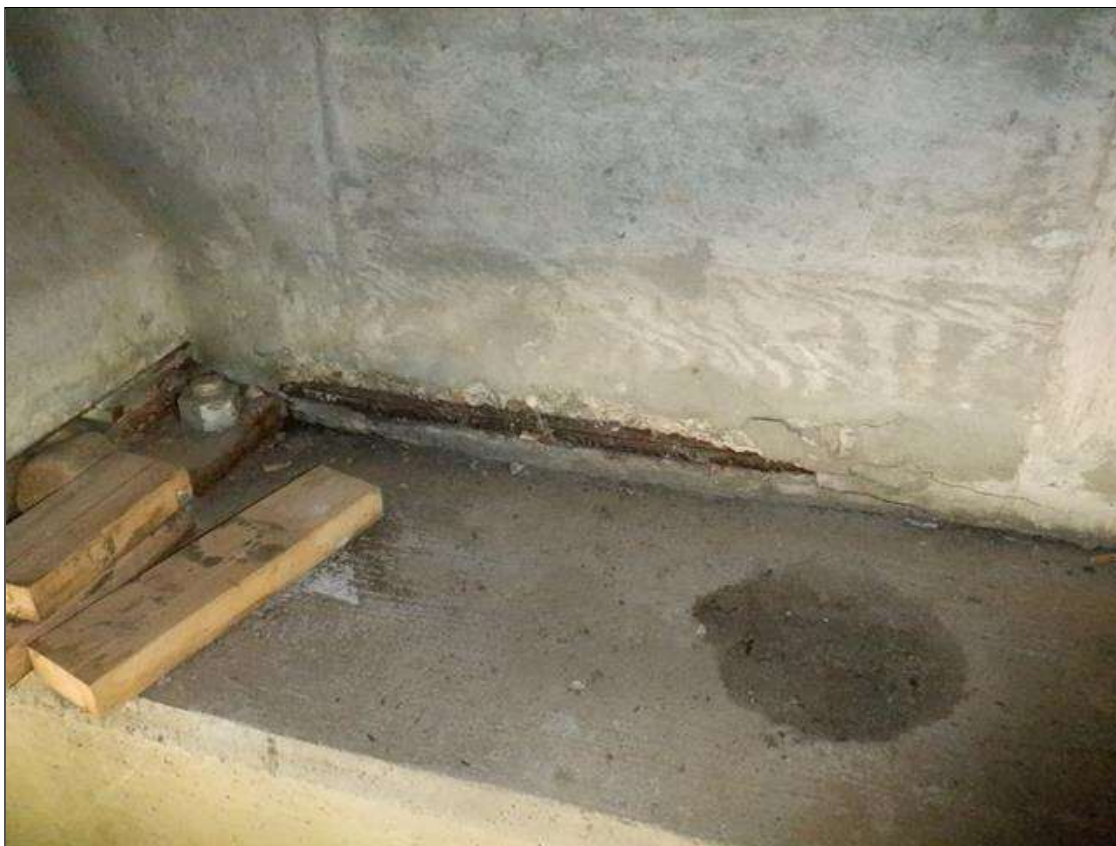
End Bent 1 Abutment: 27 INCHES X UP TO 4 INCHES X 1 INCHES SPALL WITH EXPOSED REINFORCING ON NORTH FACE BETWEEN BEAMS 6 AND 7.

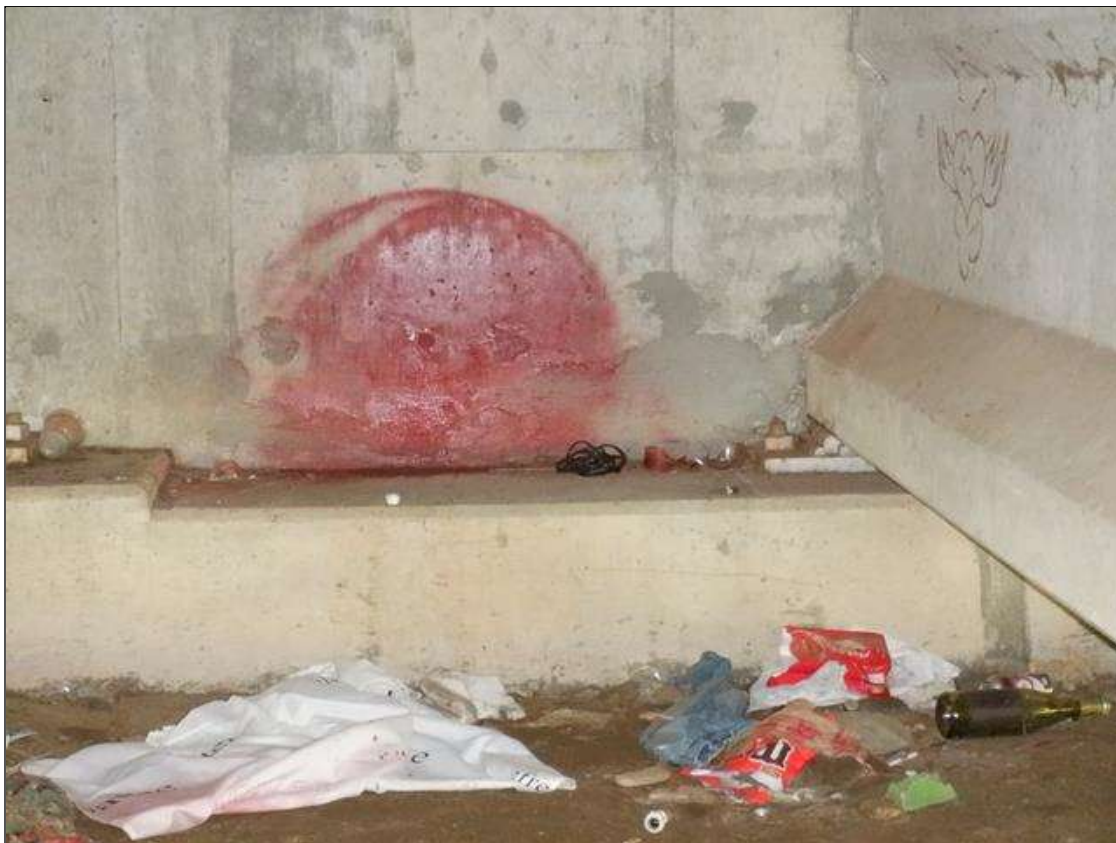
End Bent 1 Abutment: 5 FEET X 1 FEET PATCHED AREA ON NORTH FACE BETWEEN BEAMS 3 AND 4.

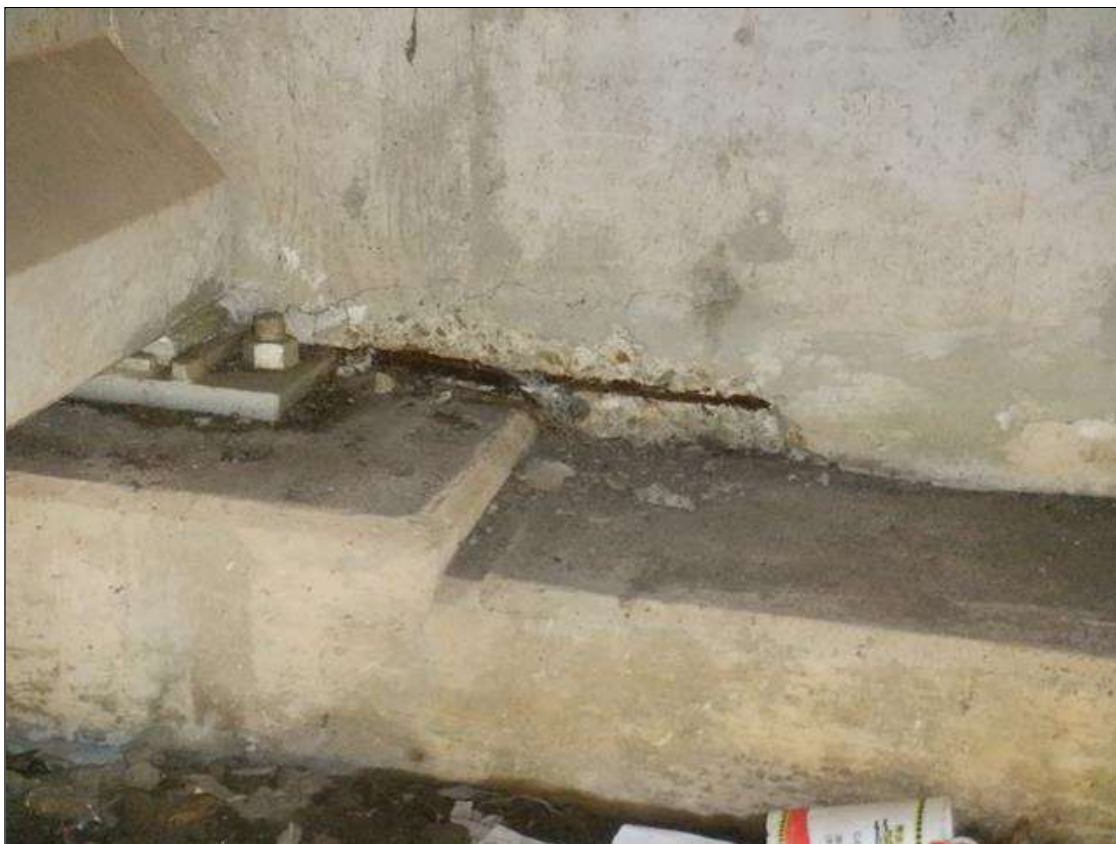
End Bent 1 Abutment: 3 FEET X UP TO 2 INCHES X 1 INCHES SPALL WITH EXPOSED REINFORCING ON NORTH FACE BETWEEN BEAMS 1 AND 2.

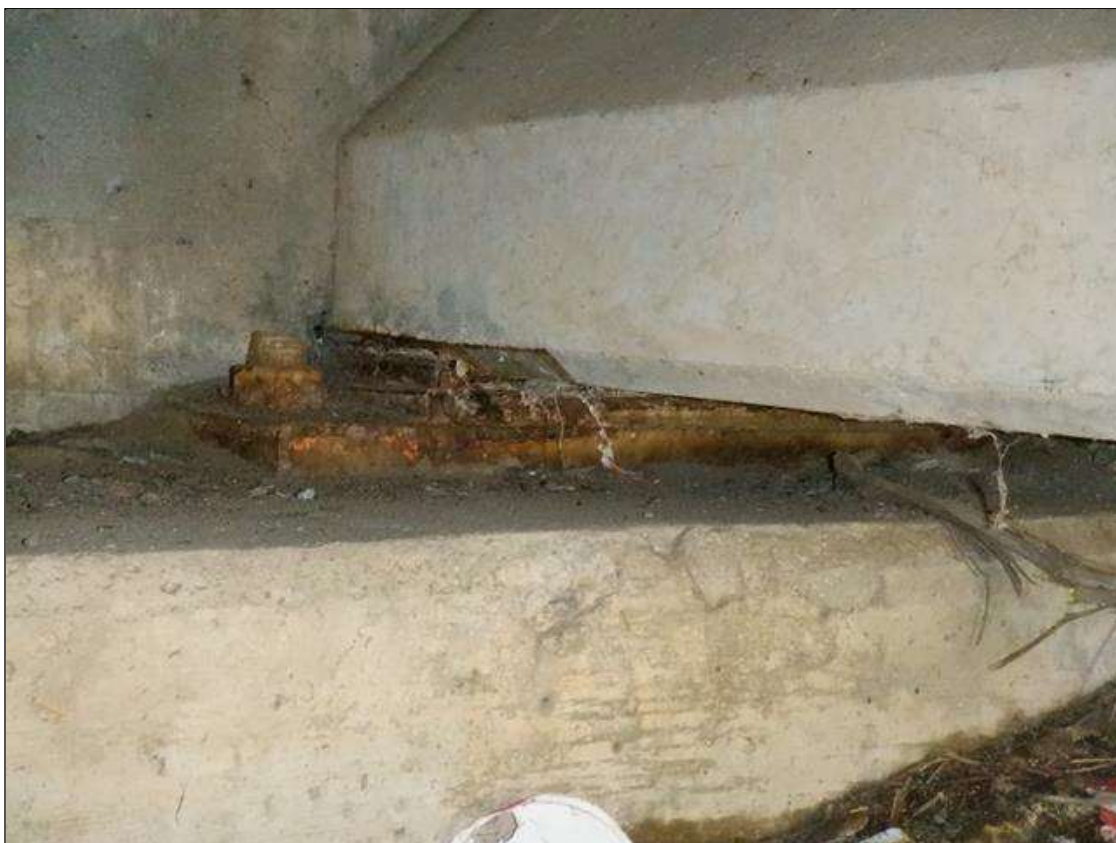
Span 1 Beam 1 - Near Bearing: RUST SCALE

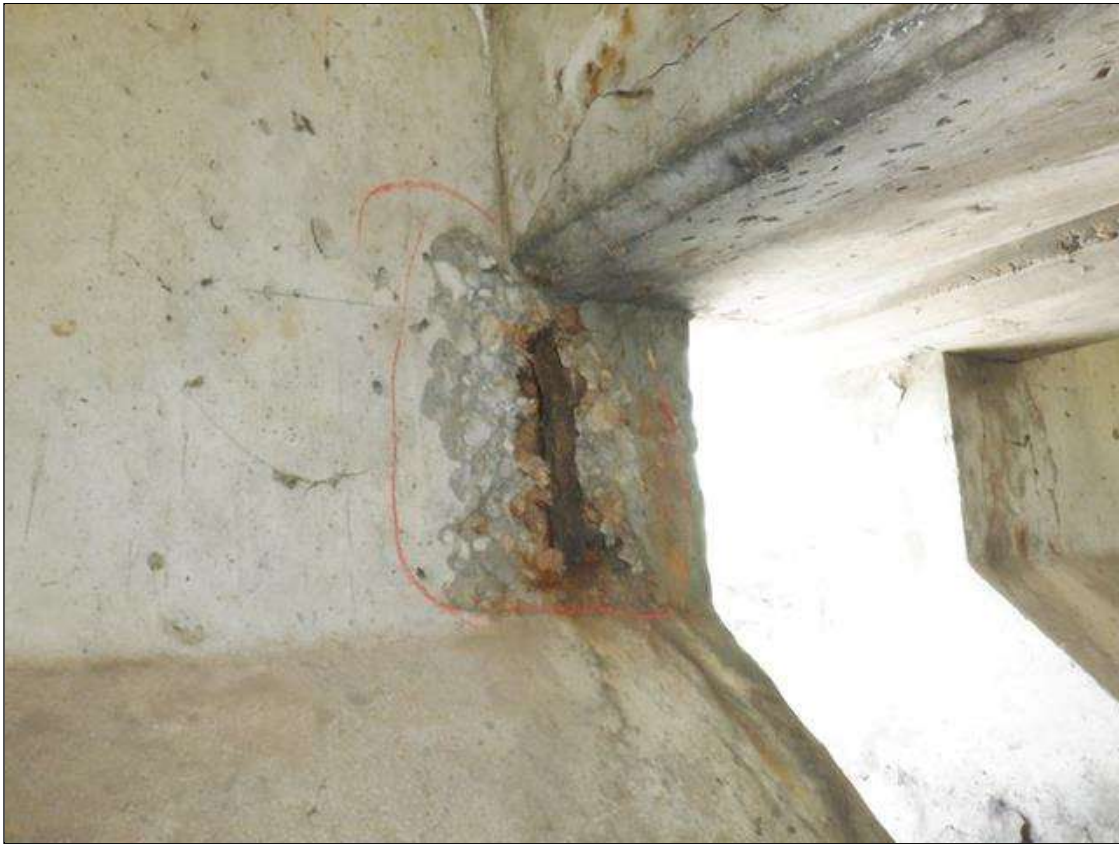
Span 1 Beam 1: 6 INCHES X UP TO 8 INCHES X 1 INCHES SPALL WITH EXPOSED REINFORCING ON EAST FACE AT BENT 1.

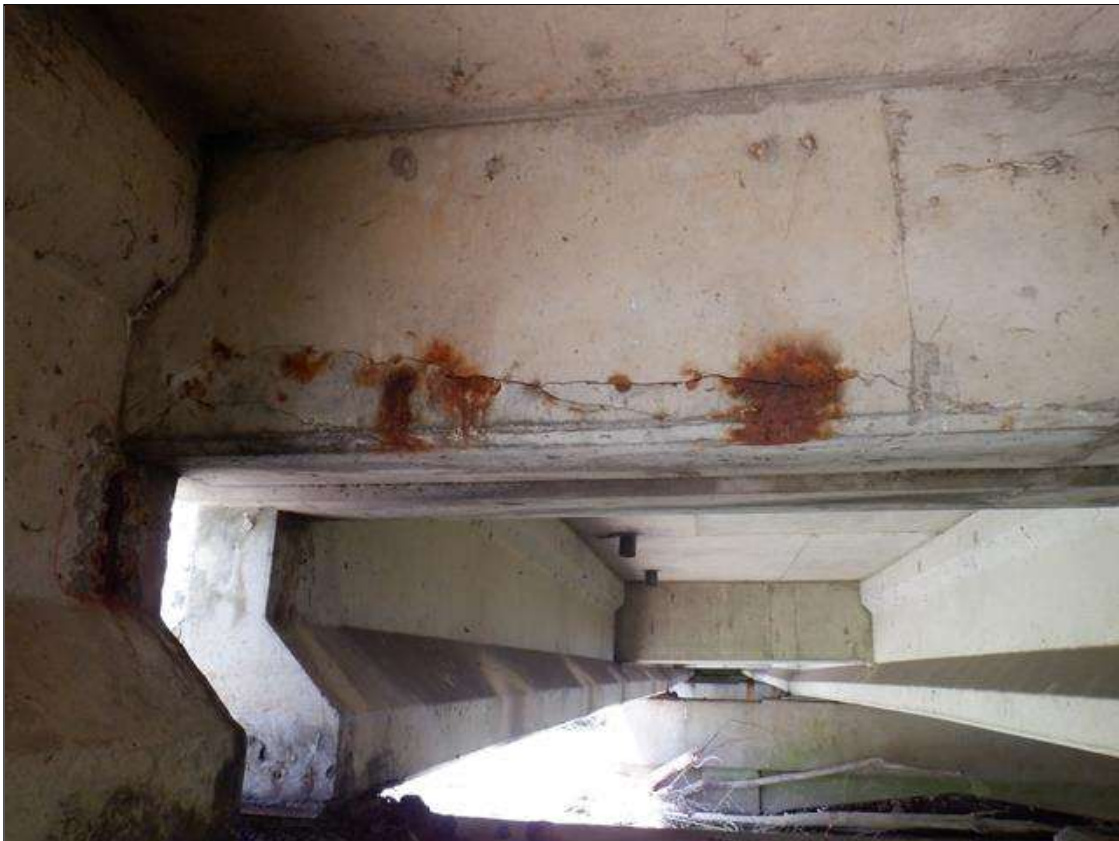
Span 1 Beam 1: 4 FEET X UP TO 8 INCHES CRACKED DELAMINATION WITH UP TO 0.063 INCHES CRACKING AND RUST STAINING ON SOUTH FACE OF END DIAPHRAGM BETWEEN BEAMS 1 AND 2 AT BENT 1.

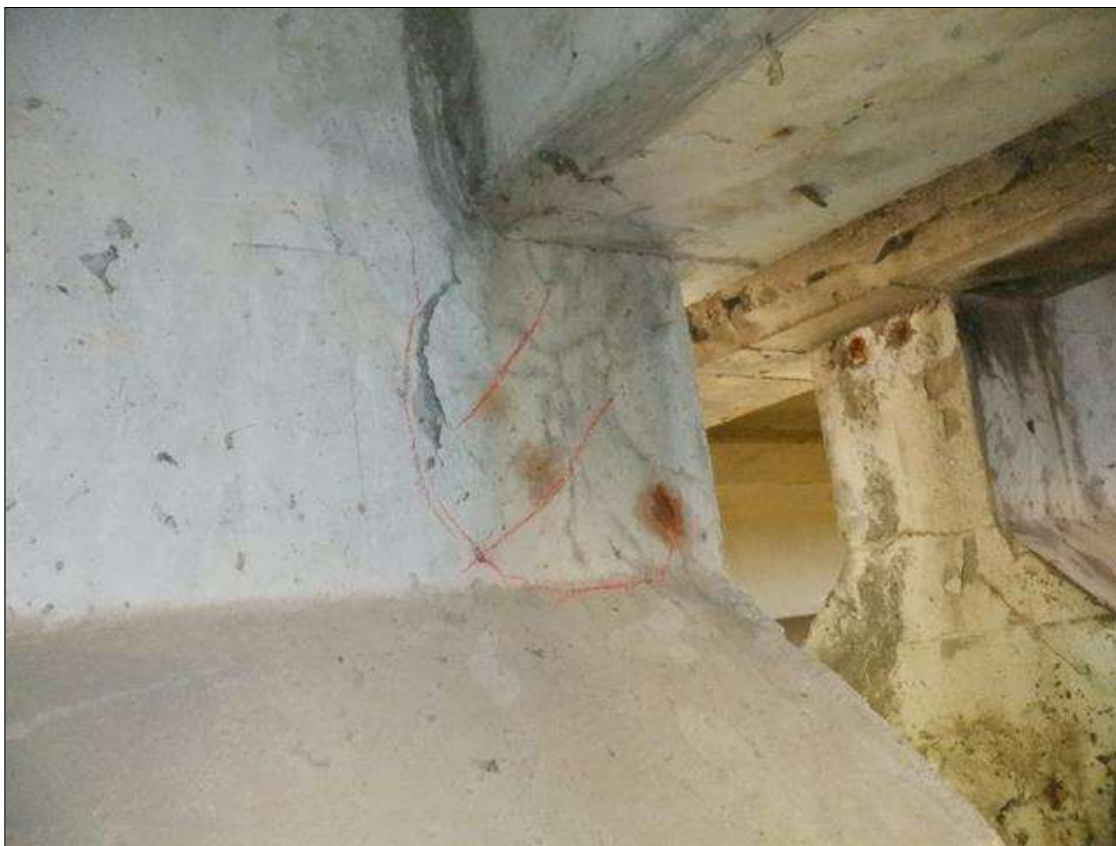
Span 1 Beam 3: 6 INCHES X UP TO 8 INCHES DELAMINATION WITH HAIRLINE MAP CRACKING AND RUST STAINING ON EAST FACE AT BENT 1.

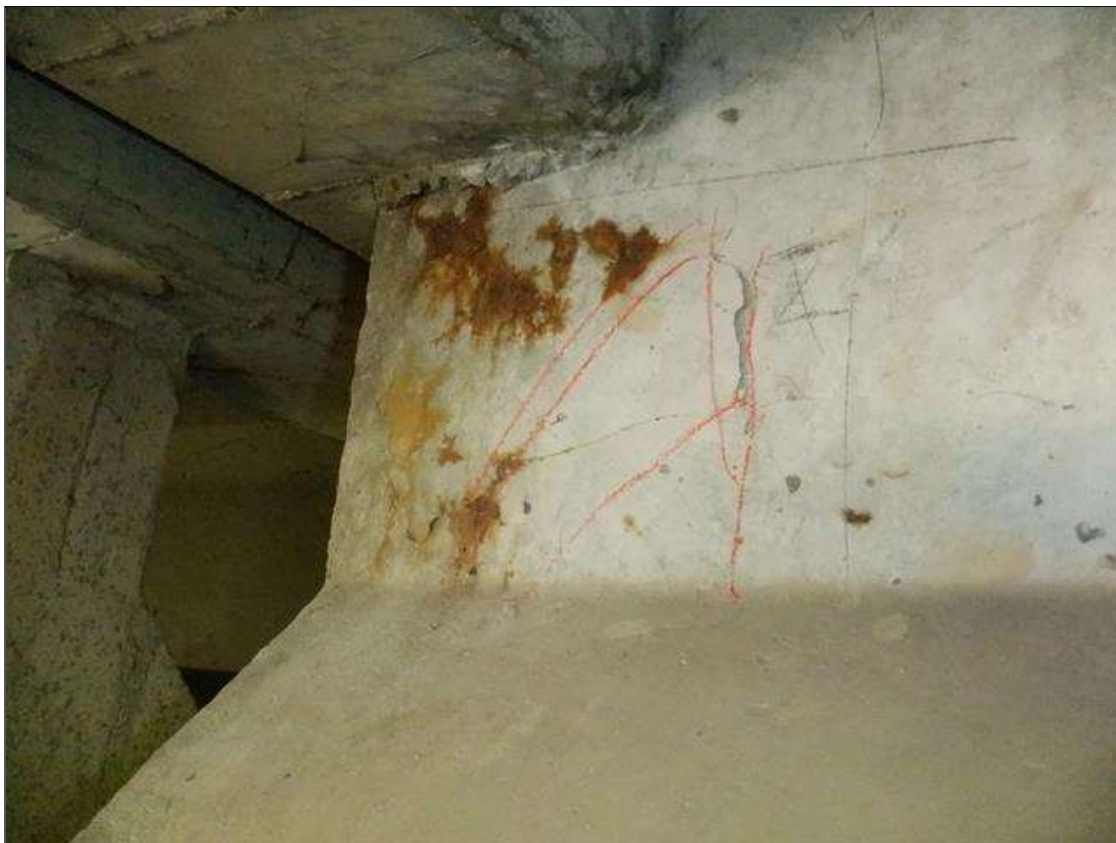
Span 1 Beam 4: 10 INCHES X UP TO 6 INCHES DELAMINATION WITH HAIRLINE MAP CRACKING AND RUST STAINING ON WEST FACE AT BENT 1.

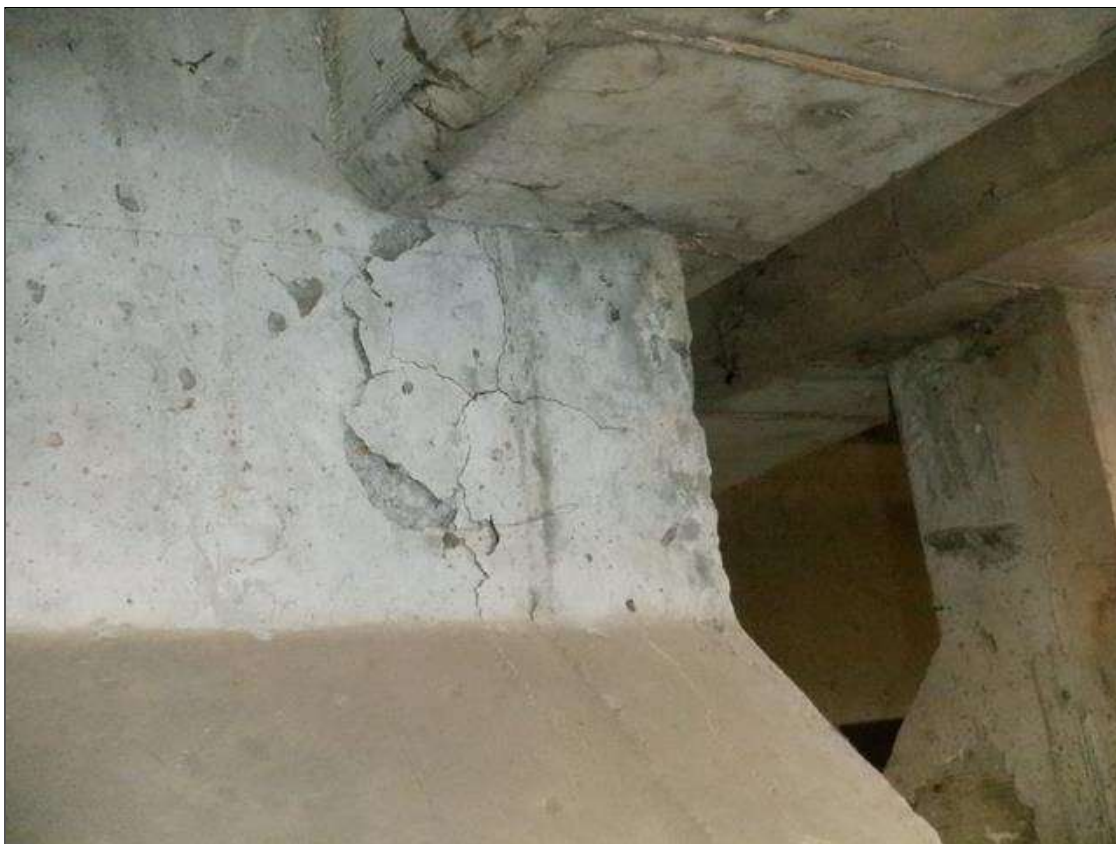
Span 1 Beam 5: 8 INCHES X UP TO 8 INCHES DELAMINATION WITH UP TO 0.006 INCHES MAP CRACKING ON EAST FACE AT BENT 1.

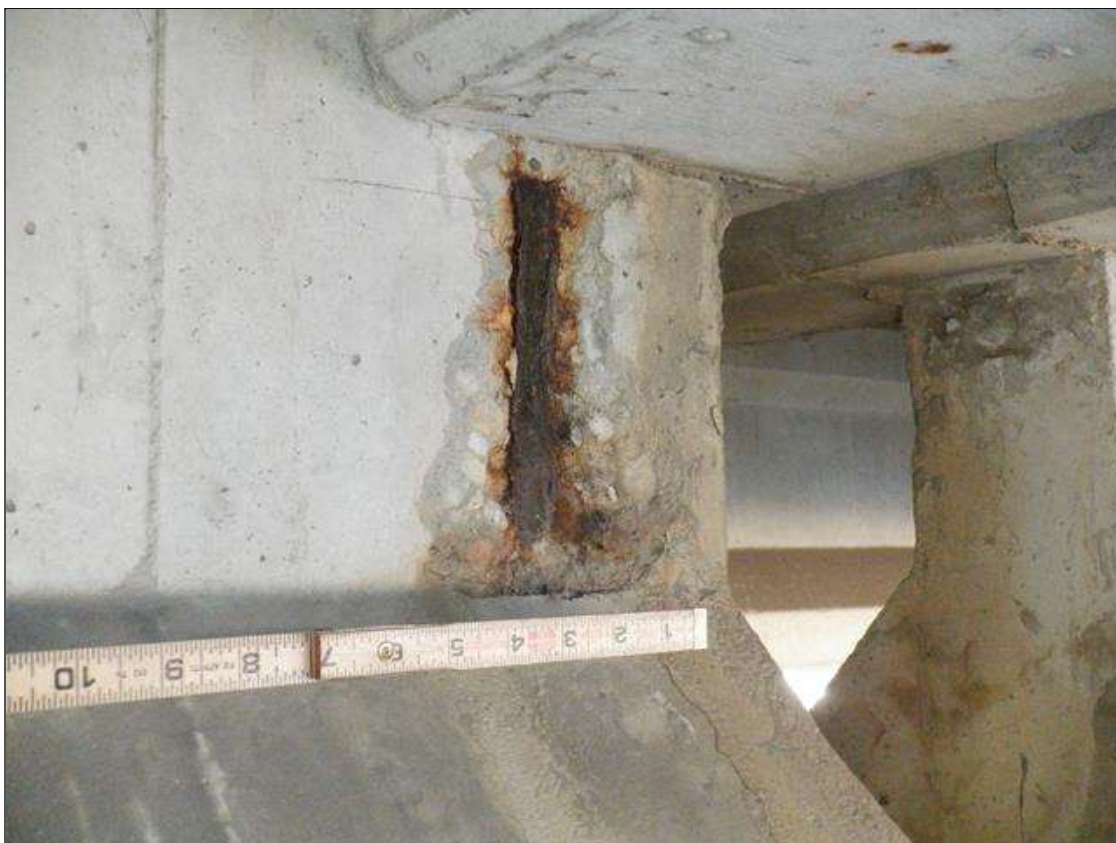
Span 1 Beam 6: 5 INCHES X UP TO 8 INCHES X 1/4 INCHES SPALL WITH EXPOSED REINFORCING ON EAST FACE AT BENT 1.

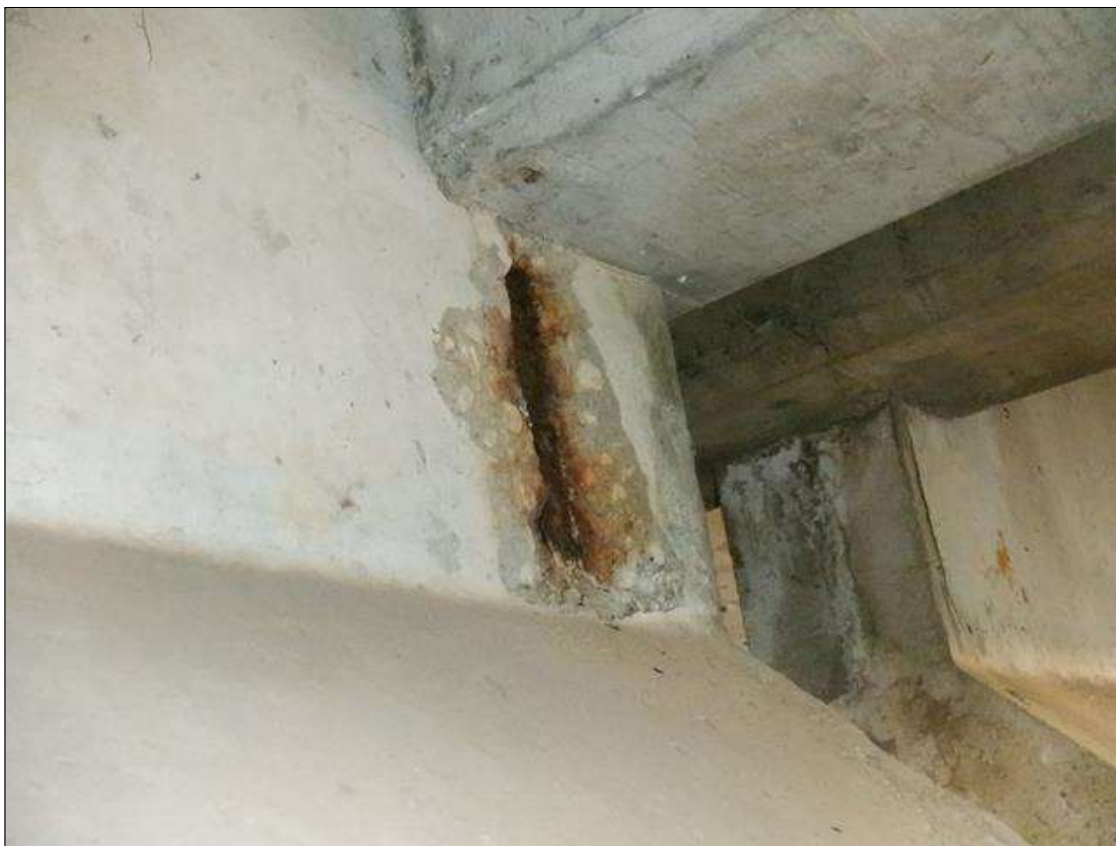
Span 1 Beam 7: 6 INCHES X UP TO 8 INCHES X 1 INCHES SPALL WITH EXPOSED REINFORCING ON EAST FACE AT BENT 1.

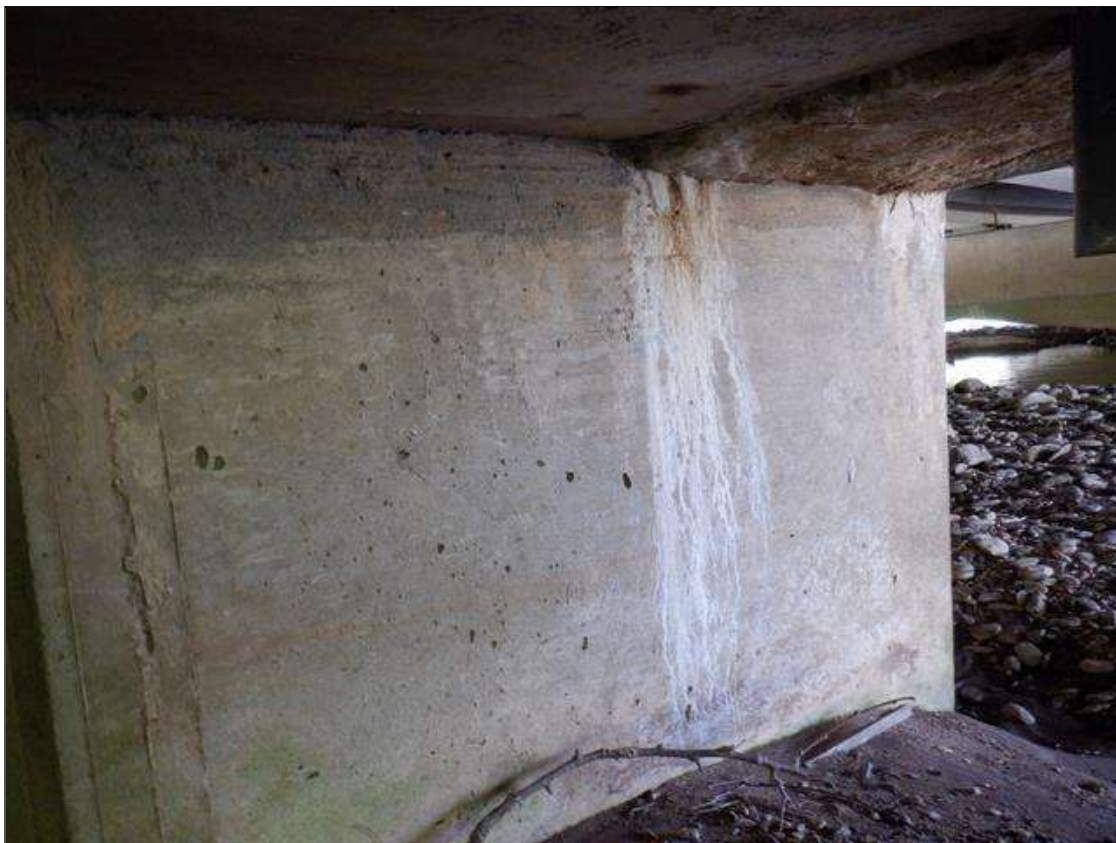
Bent 1 Pile 6: 14 INCHES X UP TO 1/64 INCHES VERTICAL CRACKS WITH EFFLORESCENCE AND HEAVY BUILDUP AT RANDOM, EXTENDING FROM BOTTOM OF CAP.

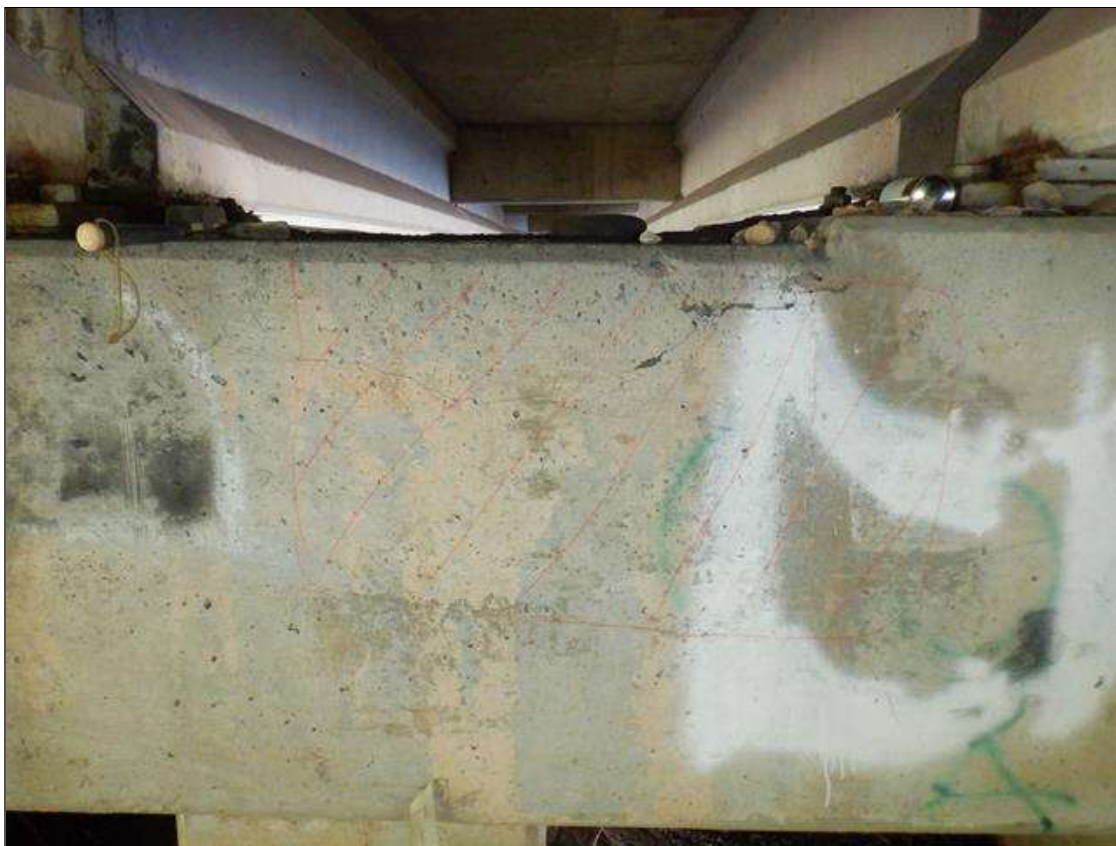
Bent 1 Cap 1: 3 FEET X UP TO 2 FEET DELAMINATION WITH UP TO 1/32 INCHES LONGITUDINAL CRACKS ON SOUTH FACE BELOW BAY 3.

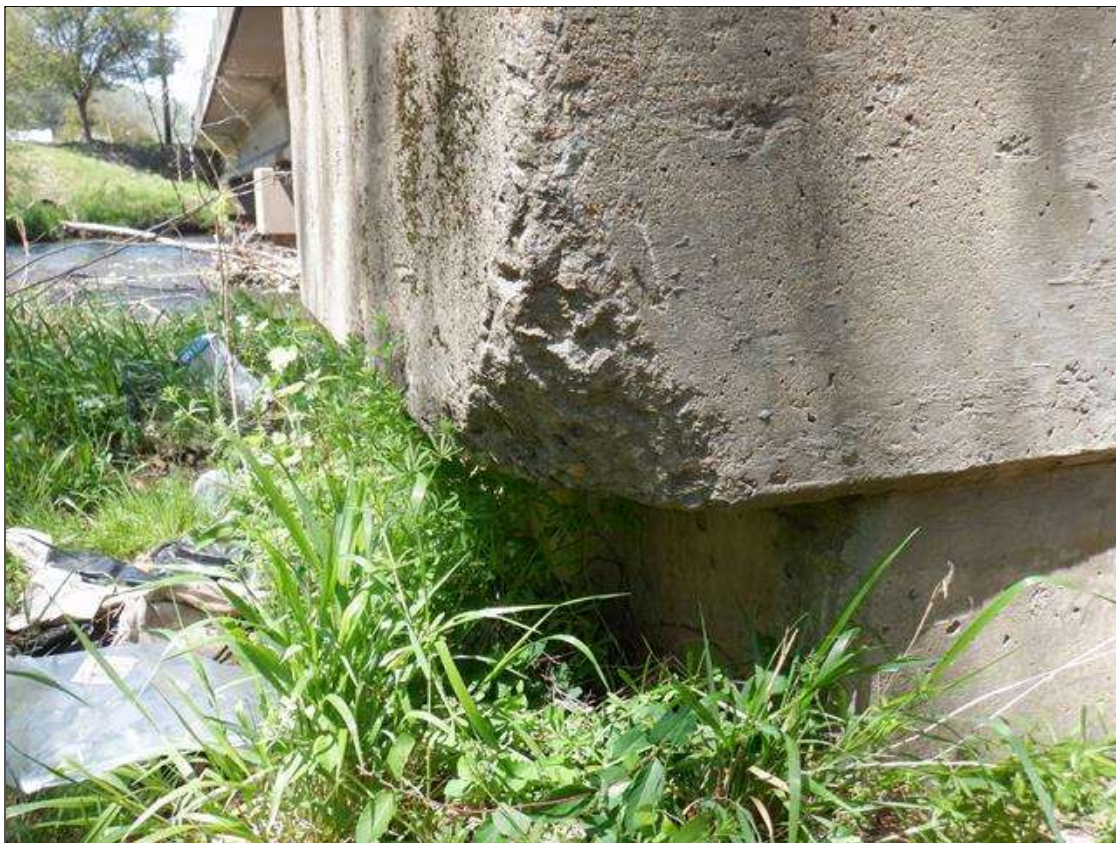
Bent 1 Cap 1: 10 INCHES X UP TO 10 INCHES X 10 INCHES SPALL ON SOUTHWEST CORNER OF SOUTH FACE.

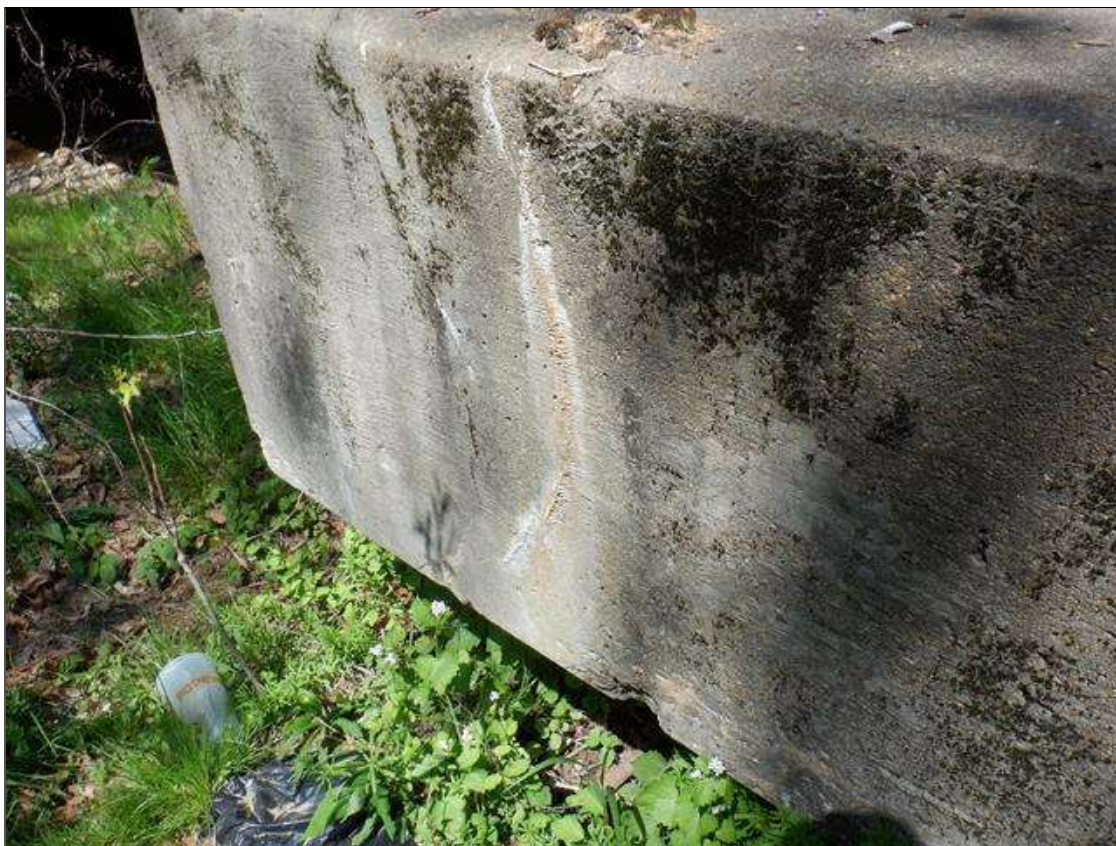
Bent 1 Cap 1: 30 INCHES X UP TO 1/64 INCHES VERTICAL CRACKS WITH EFFLORESCENCE AND HEAVY BUILDUP ON WEST FACE.

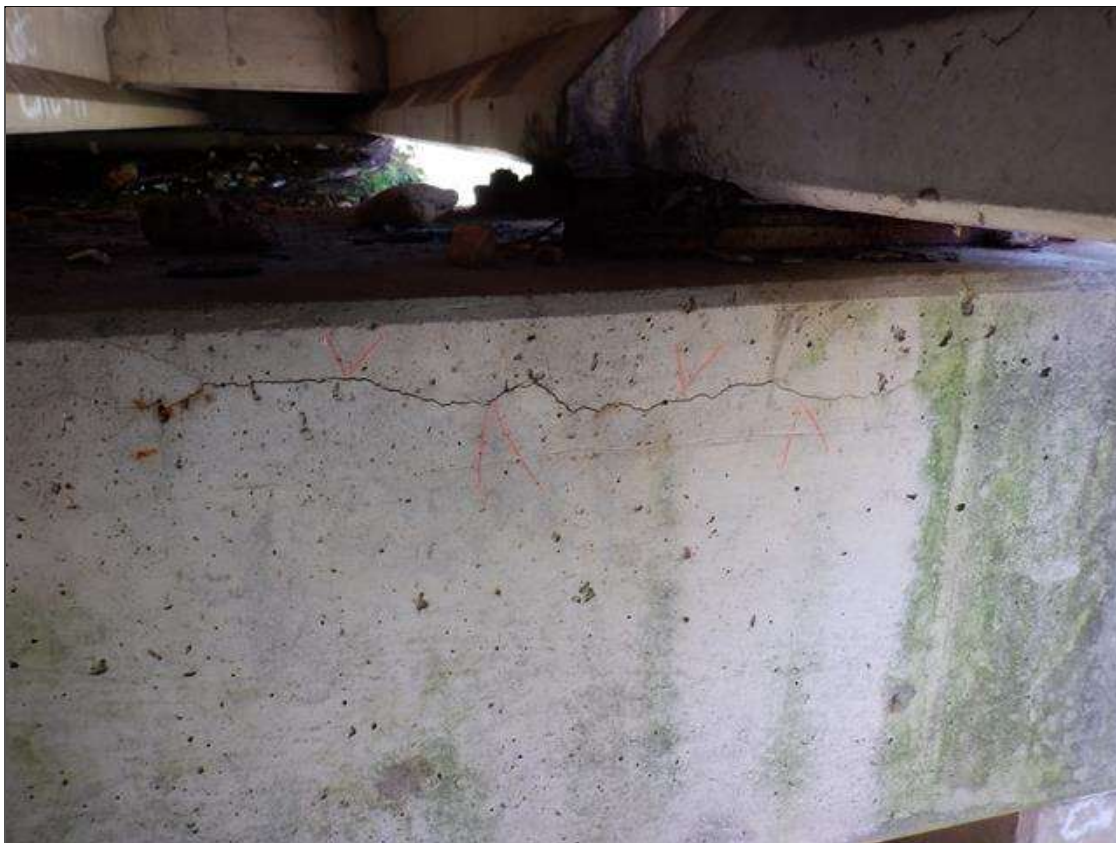
Bent 1 Cap 1: 3 FEET X UP TO 1/16 INCHES LONGITUDINAL CRACK ON NORTH FACE BETWEEN BEAMS 1 AND 2.

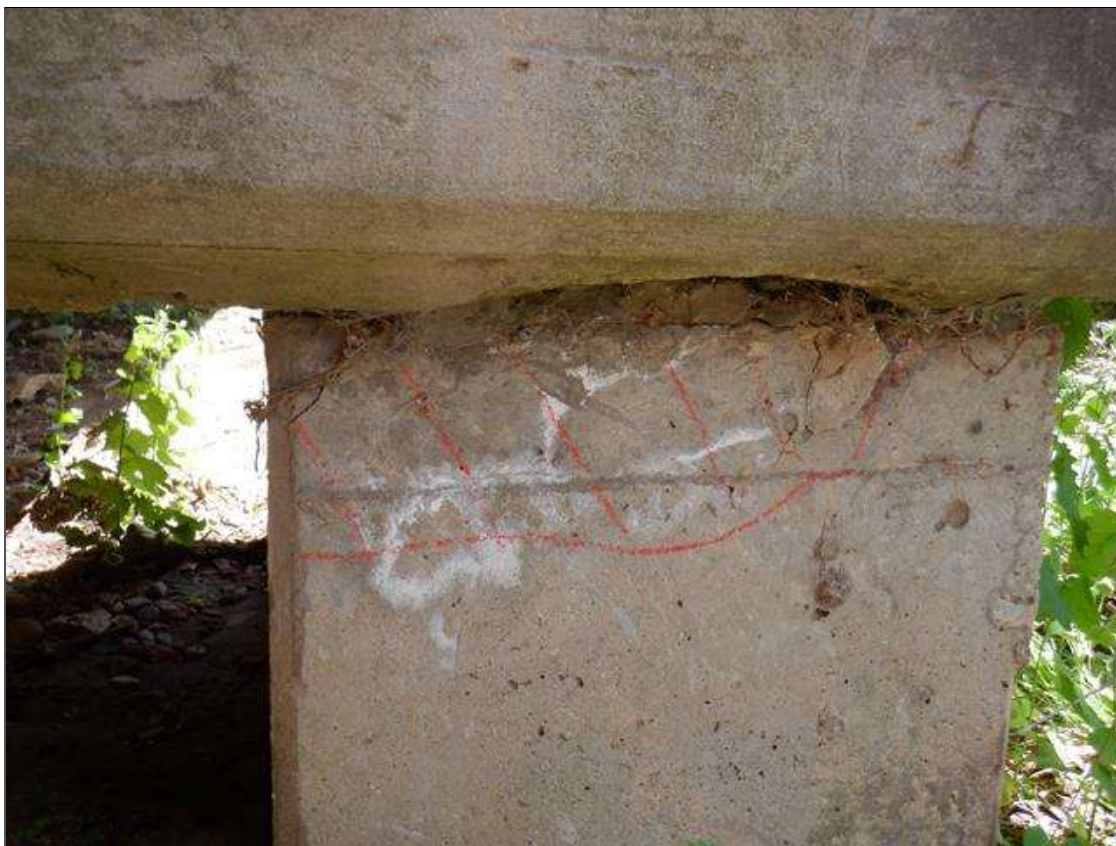
Bent 1 Pile 1: 6 INCHES X UP TO 18 INCHES DELAMINATION ON NORTH FACE AT BOTTOM OF CAP.

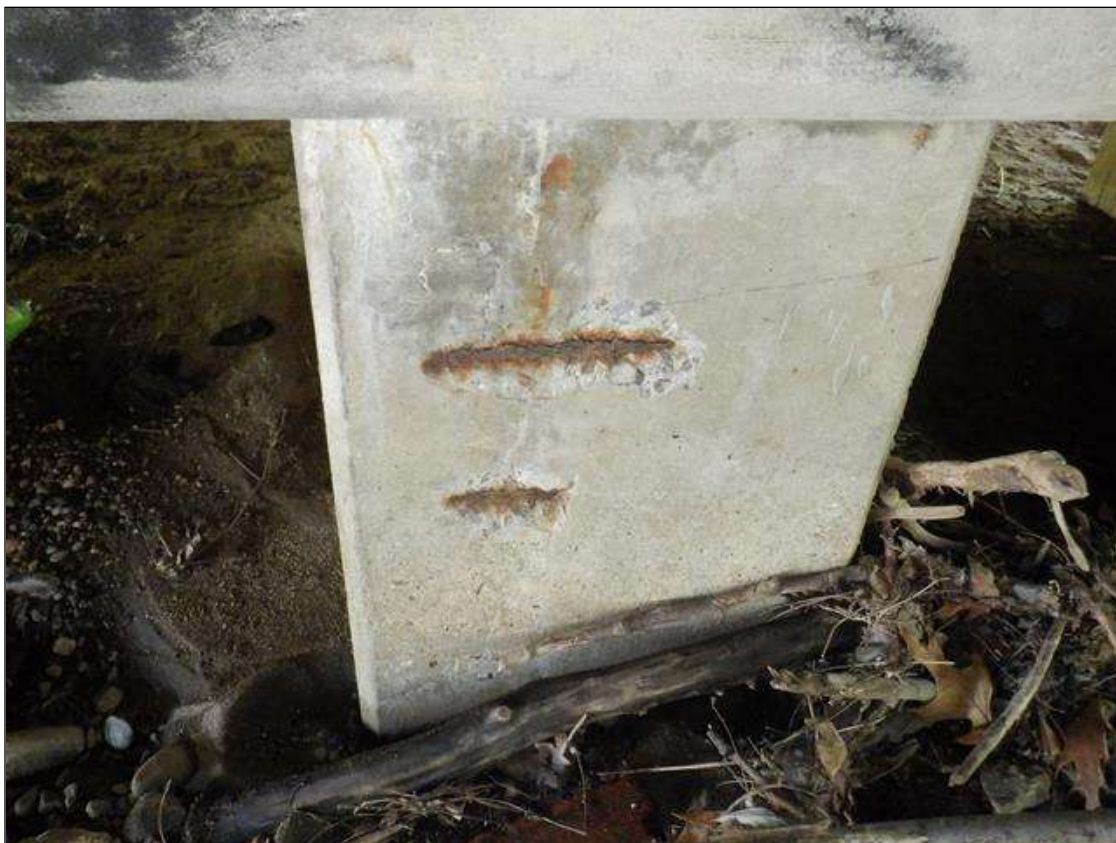
Bent 1 Pile 4: (2) UP TO 4 INCHES X 12 INCHES X 1 INCHES SPALLS WITH EXPOSED REINFORCING ON NORTH FACE, 1 FEET FROM BOTTOM OF CAP.

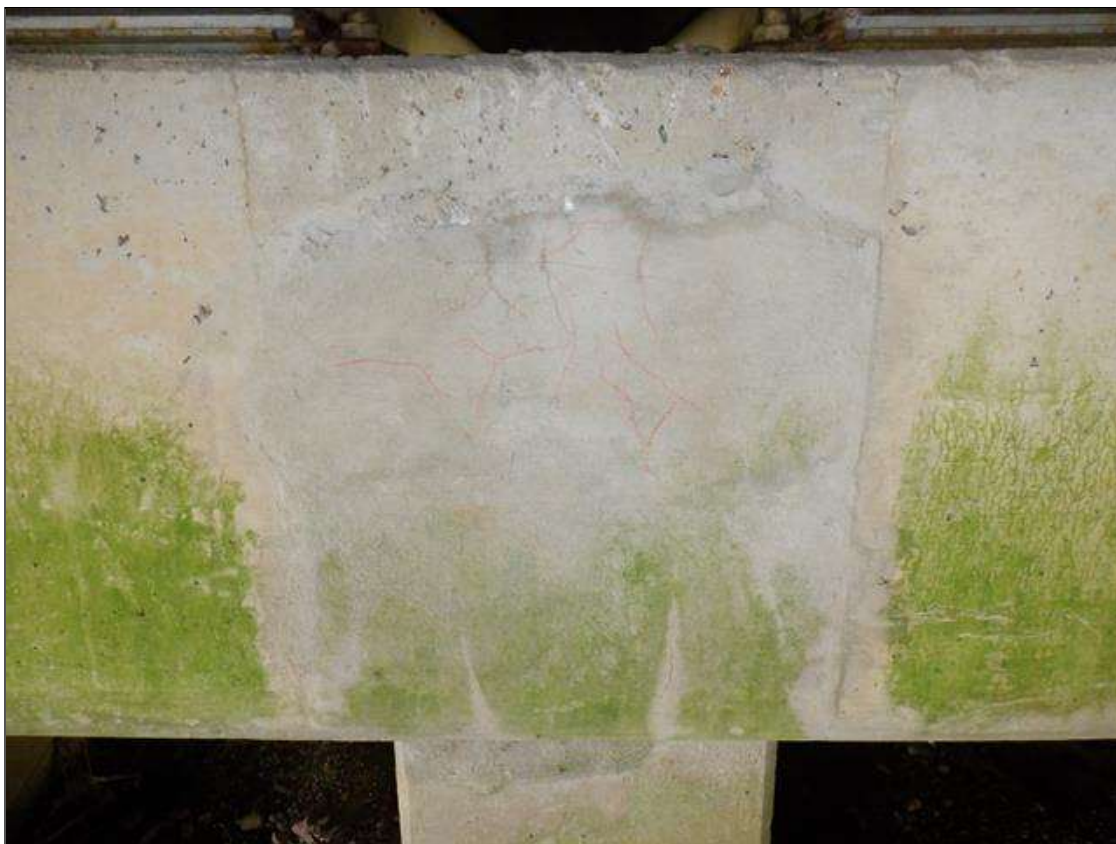
Bent 1 Cap 1: 3 FEET X UP TO 3 FEET CRACKED PATCHED AREA WITH HAIRLINE MAP CRACKING ON NORTH FACE BETWEEN BEAMS 4 AND 5.

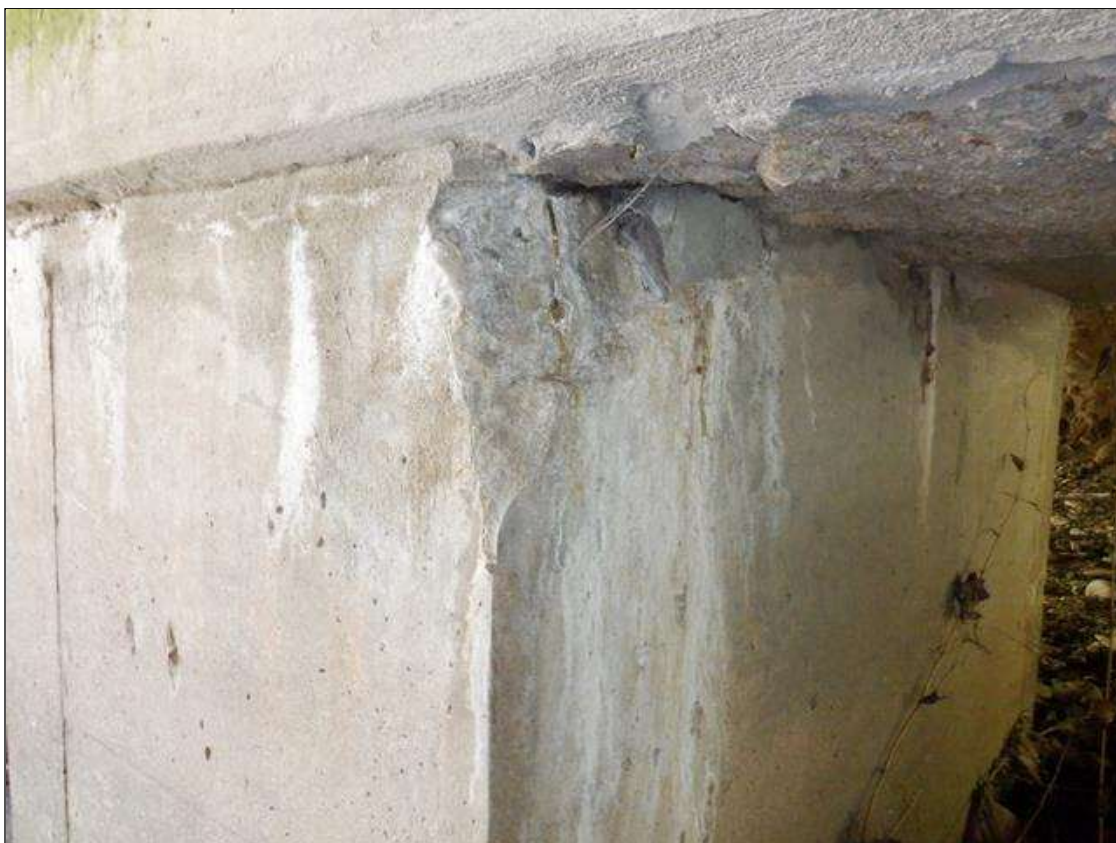
Bent 1 Pile 6: 6 INCHES X UP TO 8 INCHES X 4 INCHES SPALL ON NORTHWEST CORNER AT BOTTOM OF CAP.

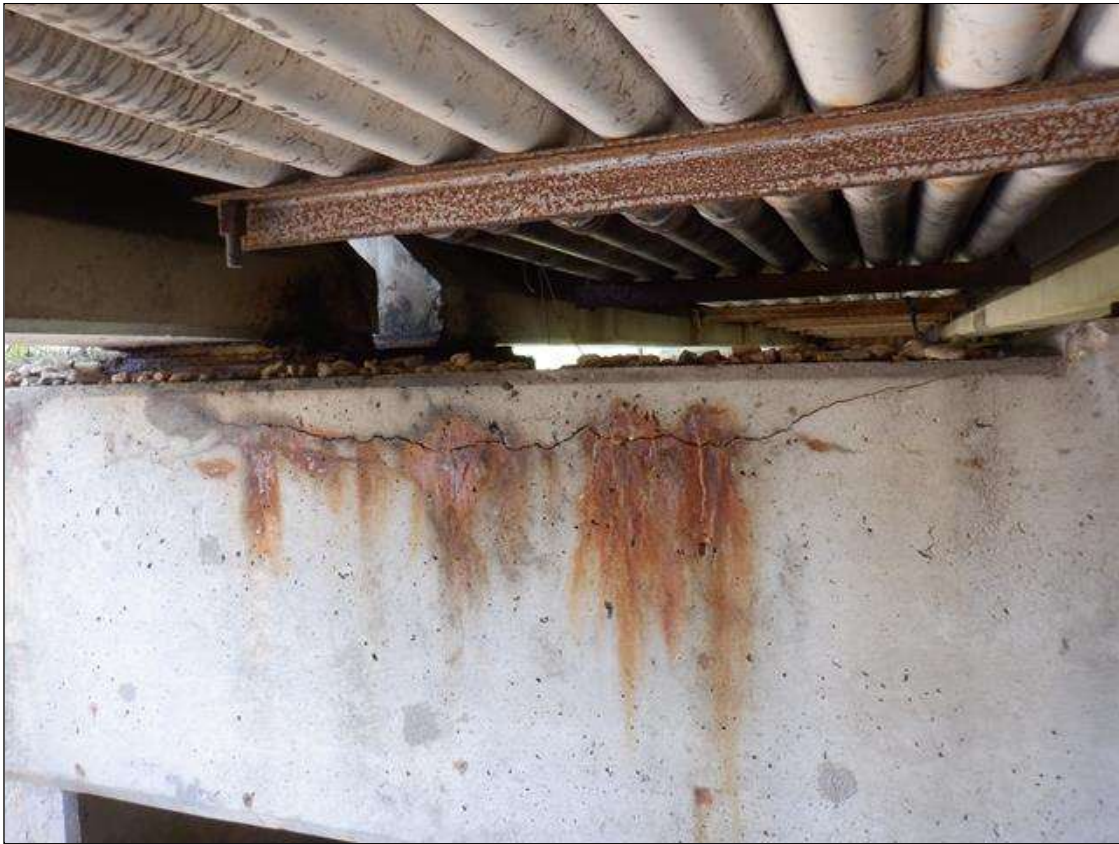
Bent 1 Cap 1: 43 INCHES X UP TO 1/8 INCHES LONGITUDINAL CRACK WITH RUST STAINING ON NORTH FACE BETWEEN BEAMS 7 AND 8.

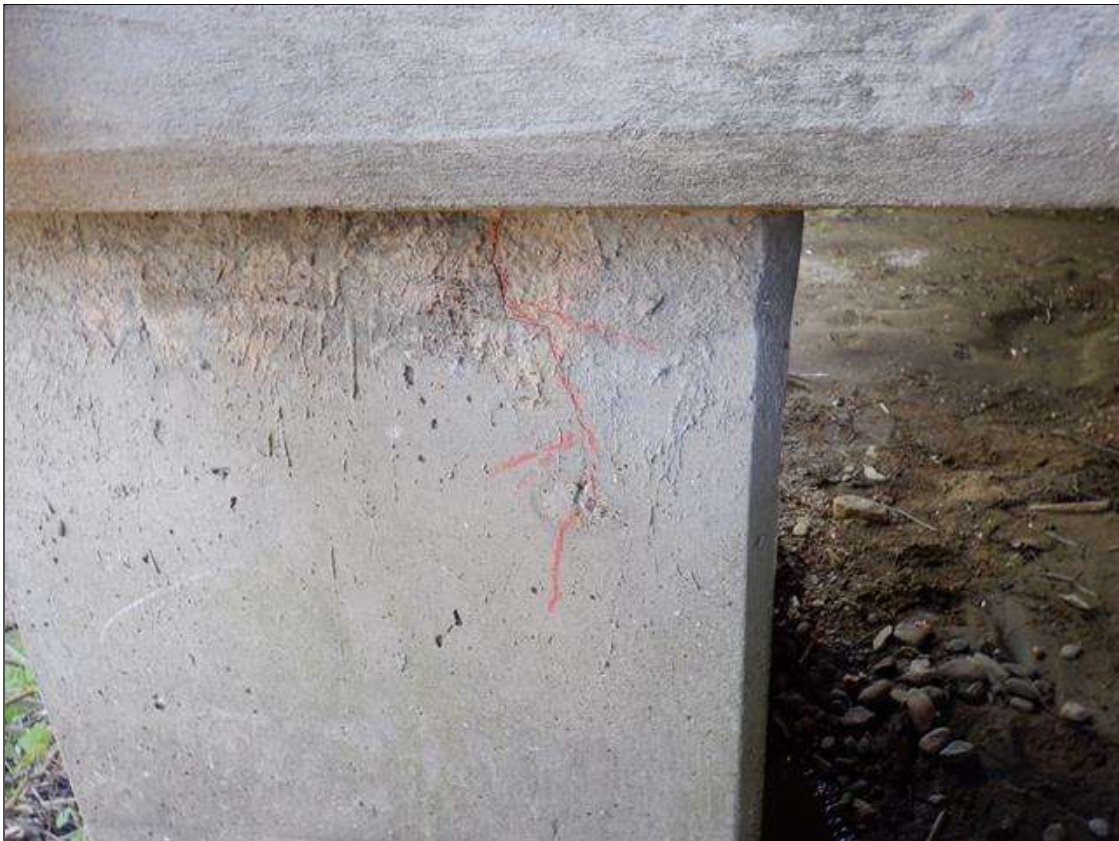
Bent 1 Pile 8: 12 INCHES X UP TO 1/64 INCHES VERTICAL CRACK ON NORTH FACE AT BOTTOM OF CAP.

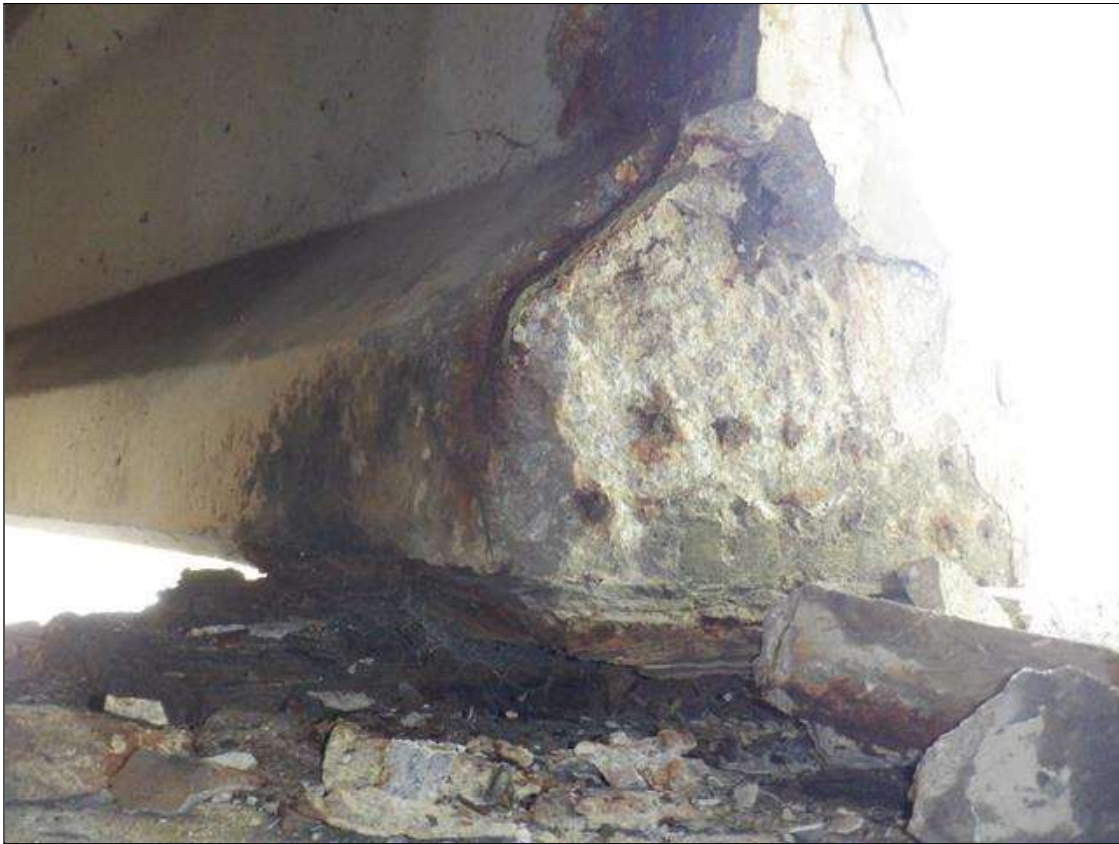
Span 2 Beam 8: (PAR) 7 INCHES X UP TO 1 FEET X 16 INCHES SPALL WITH EXPOSED REBAR AND PRESTRESSING STRANDS ON THE WEST AND SOUTH FACES OF BOTTOM FLANGE AND CHAMFER AT BENT 1.
